Ames Municipal Airport

Pavement Management Report

JULY 2023

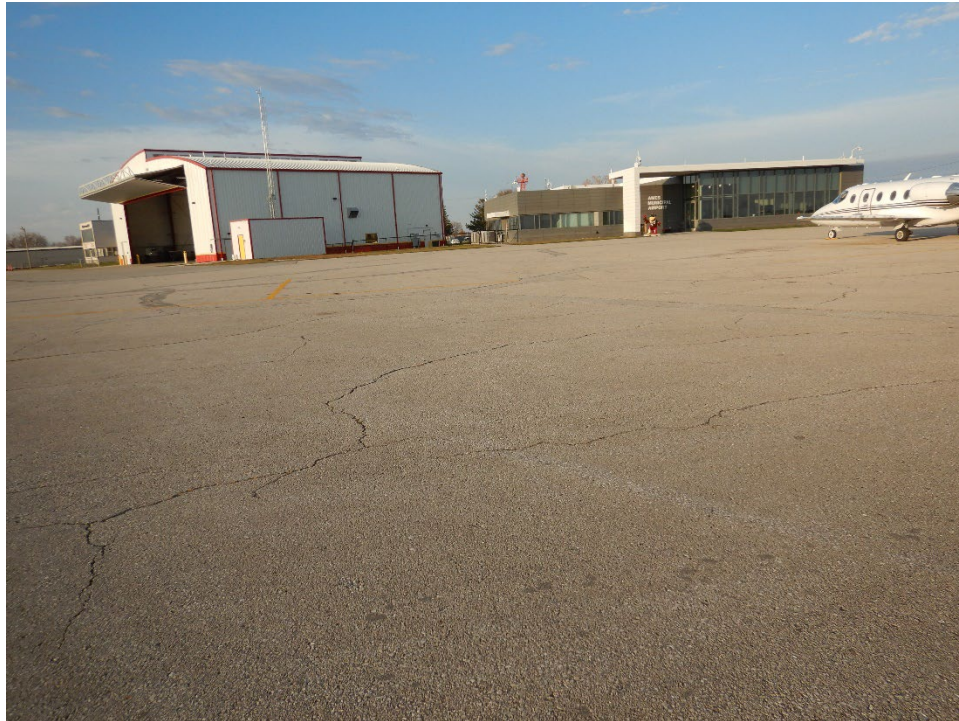
A01AM-01. Overview.

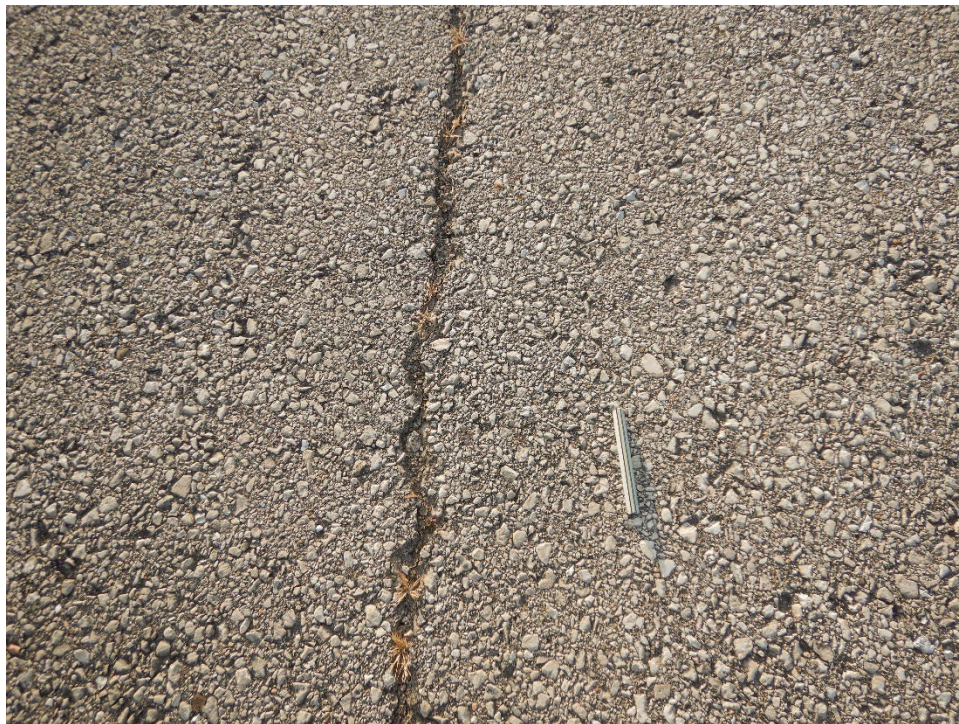
A01AM-01. L&T Cracking (Sample Unit No. 11).

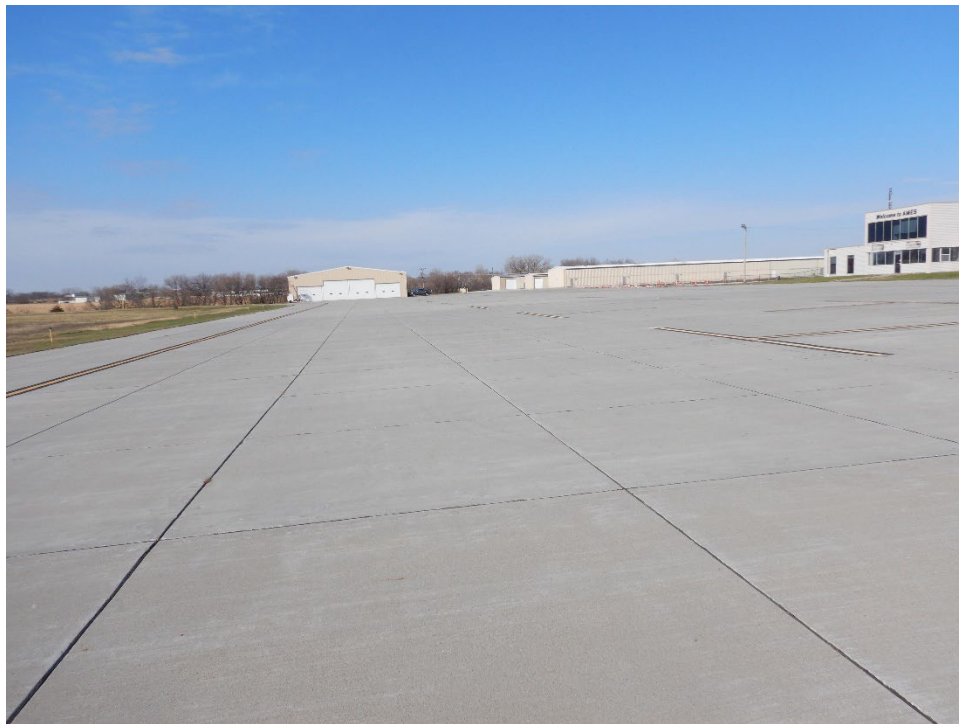
A01AM-02. Overview.

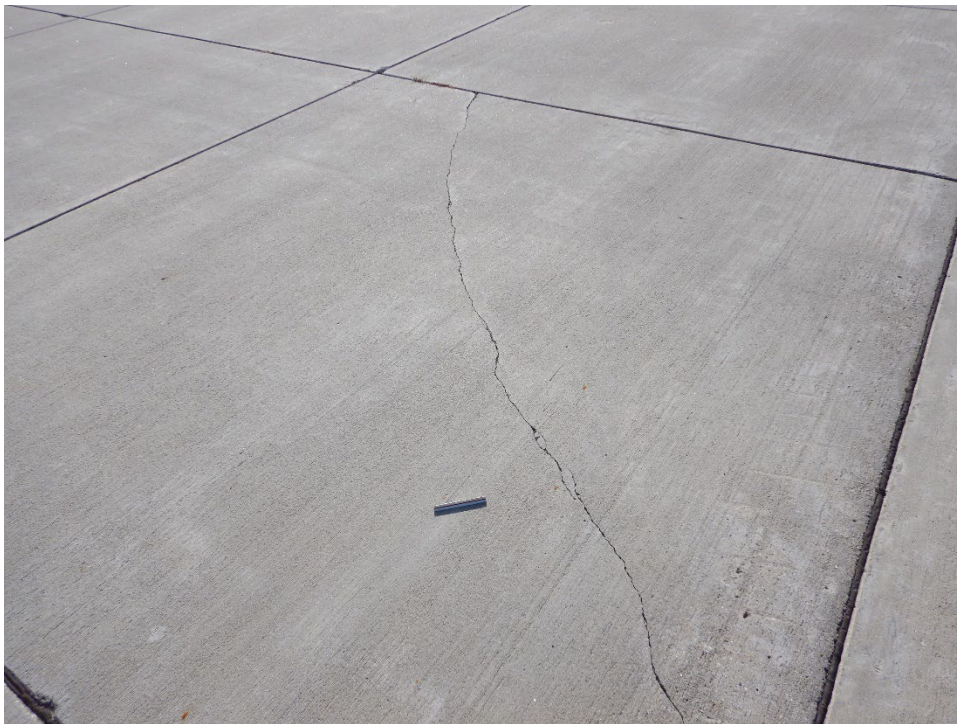
A01AM-02. LTD Cracking (Sample Unit No. 14).

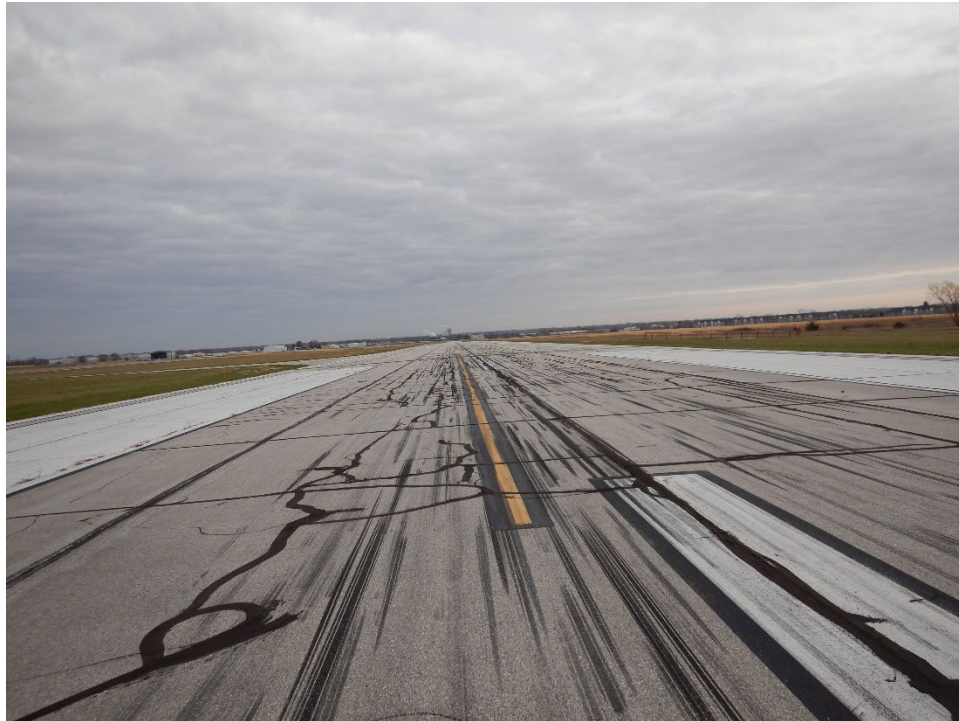
Runway 01/19 consisted of one section. Areas of medium-severity alligator cracking and weathering and low- and medium-severity block cracking, joint reflection cracking, longitudinal and transverse (L&T) cracking, and patching were identified in Section 01. The low-severity cracking was both sealed and unsealed, and the medium-severity cracking was due to either unsatisfactory crack sealant or unsealed crack widths that exceeded $\frac{1}{4}$ in.

R01AM-01. Overview.

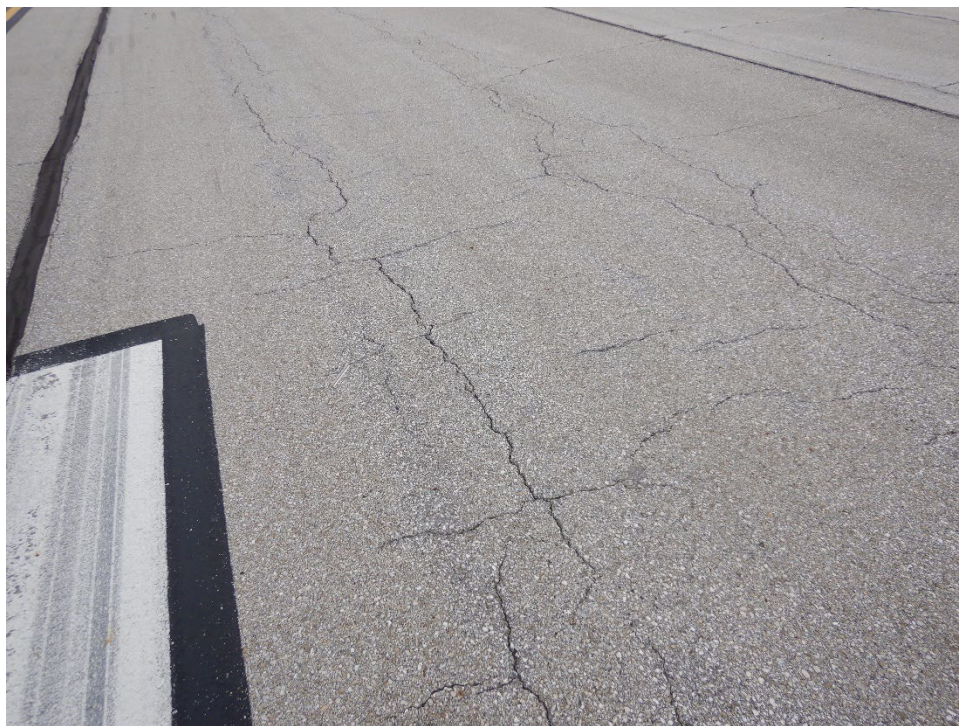
R01AM-01. Block Cracking (Sample Unit No. 58).

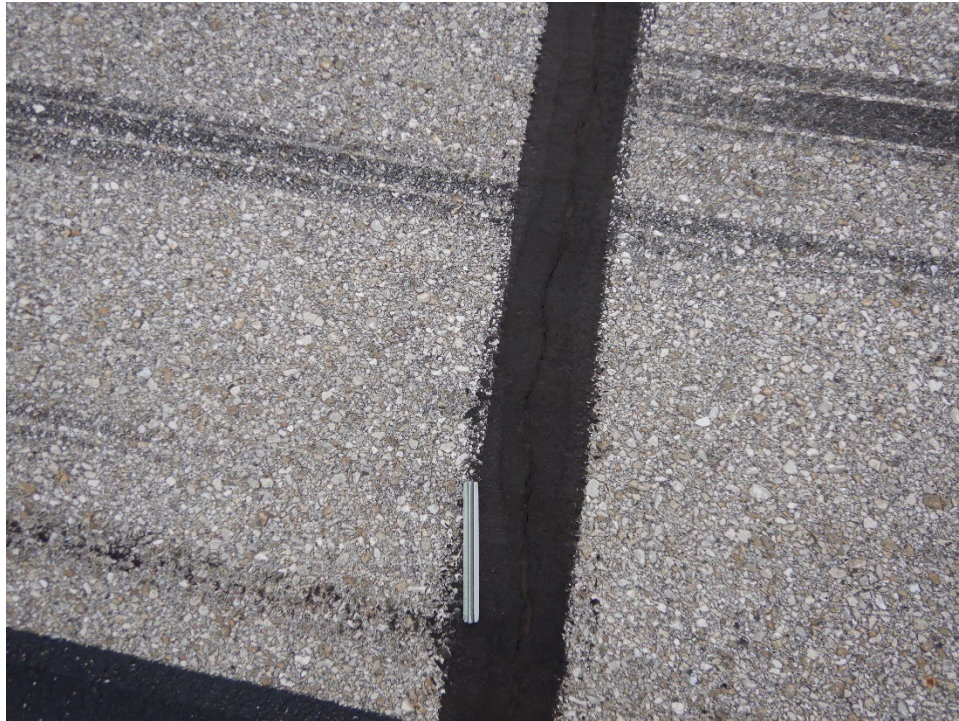
R01AM-01. L&T Cracking (Sample Unit No. 22).

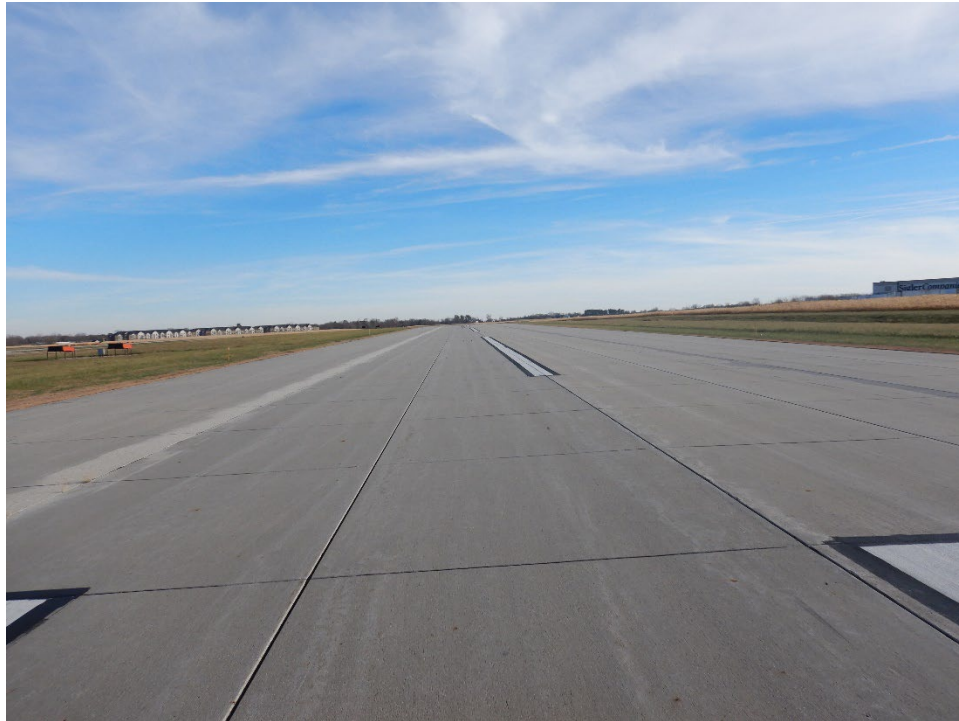
Runway 13/31 was defined by four sections. Section 01, which is located near the Runway 13 approach, was in excellent condition at the time of inspection with only low-severity faulting and large patching and low- and medium-severity joint seal damage recorded. Section 02 contained medium-severity alligator cracking, low- and medium-severity weathering, and all severities of L&T cracking. All severities of L&T cracking and medium- and high-severity weathering were observed in Section 03 at the time of inspection. The low-severity L&T cracking in Sections 02 and 03 was unsealed, and the medium-severity L&T cracking was due to either the development of secondary cracking or unsealed crack widths greater than $\frac{1}{4}$ in. Section 04, which is located near the Runway 31 approach, contained areas of low-severity faulting and medium-severity joint seal damage. An atypical area of low-severity longitudinal, transverse, and diagonal (LTD) cracking and high-severity corner spalling was observed and recorded as an additional sample unit in accordance with ASTM D5340-20.

R13AM-01. Overview.

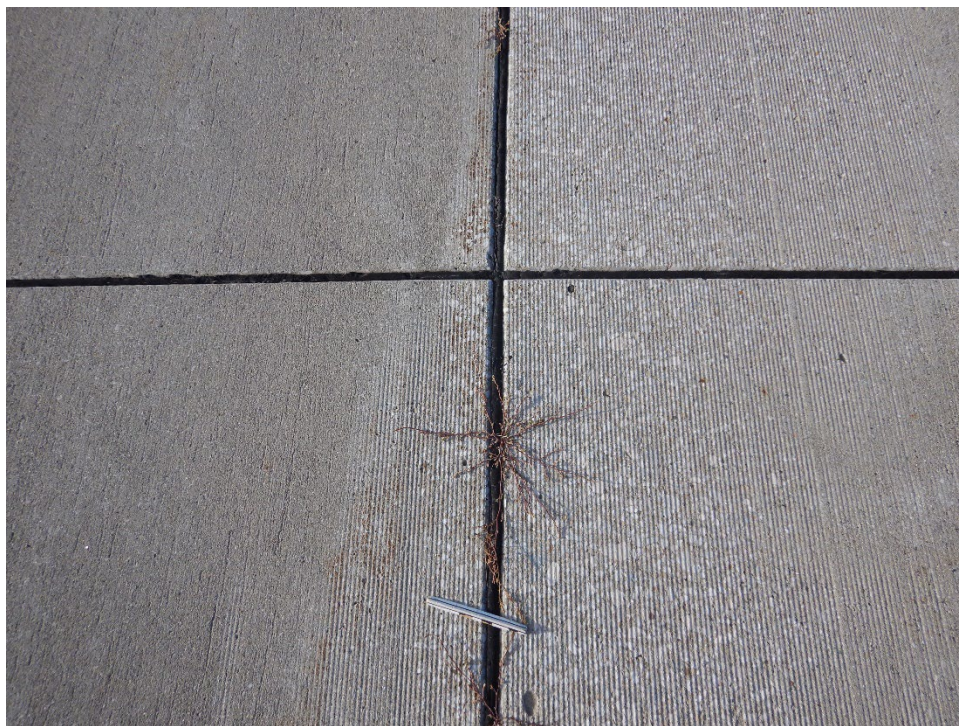
R13AM-01. Joint Seal Damage (Sample Unit No. 53).

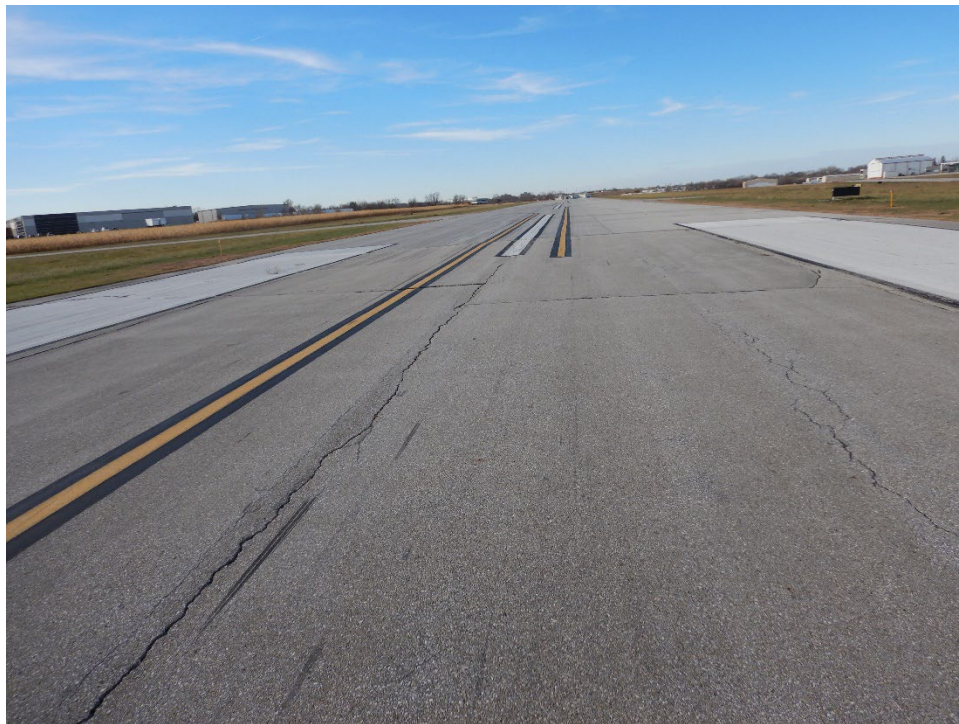
R13AM-02. Overview.

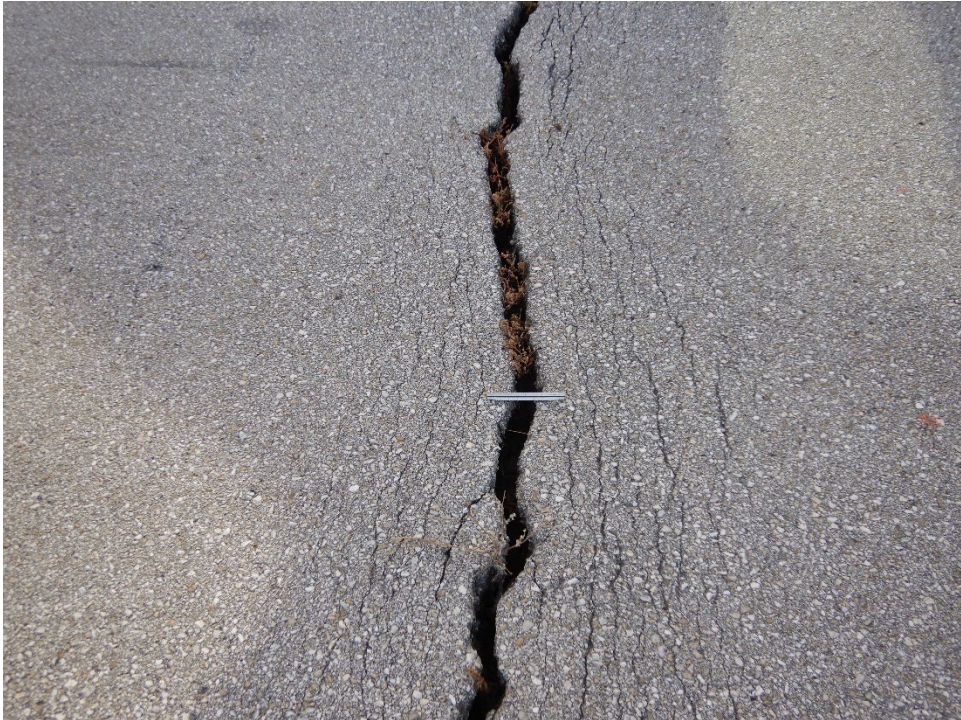
R13AM-02. L&T Cracking (Sample Unit No. 04).

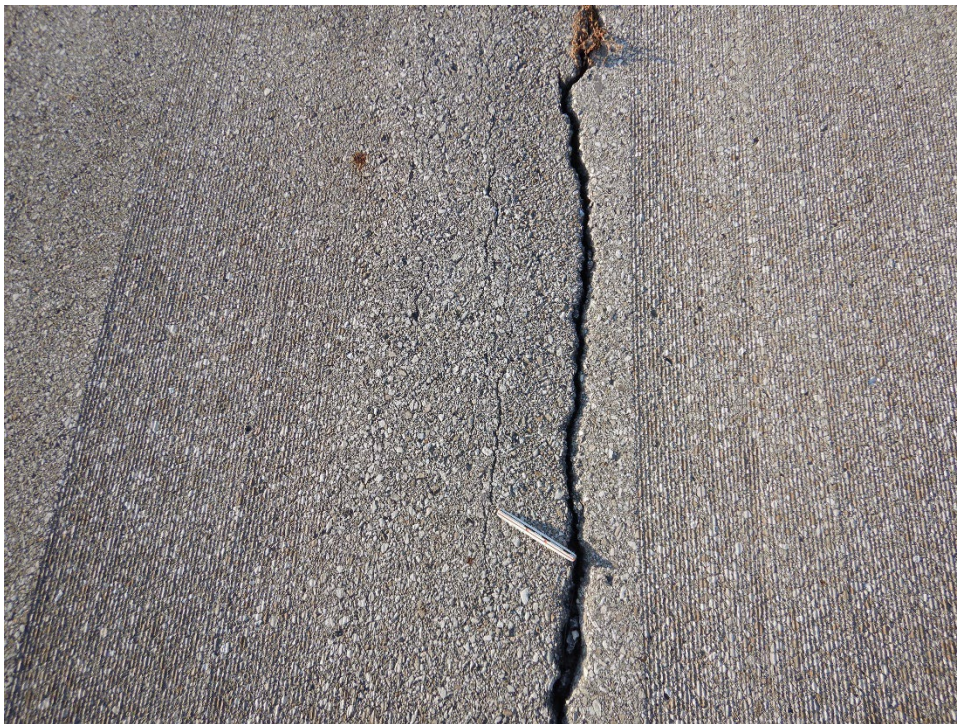
R13AM-03. L&T Cracking (Sample Unit No. 02).

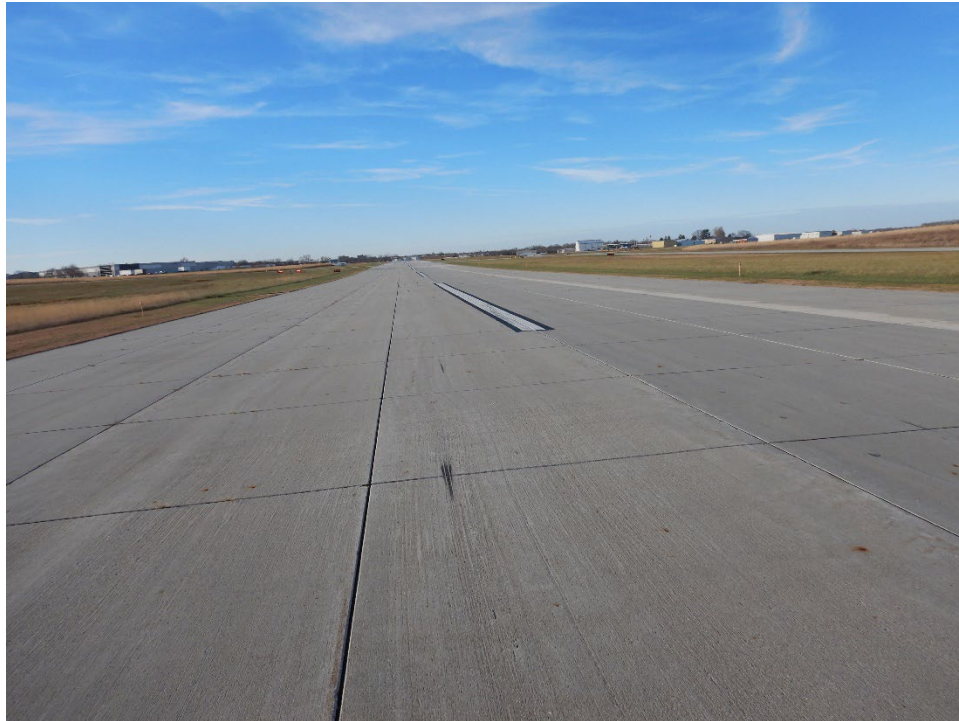
R13AM-04. Overview.

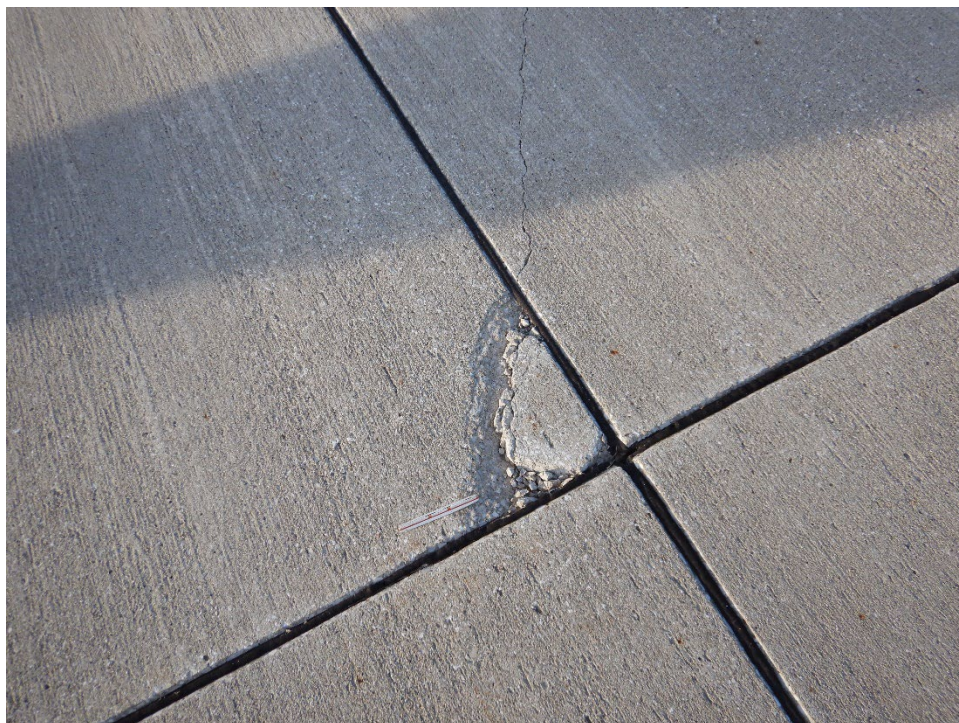
R13AM-04. Corner Spalling (Additional Sample Unit No. 05).

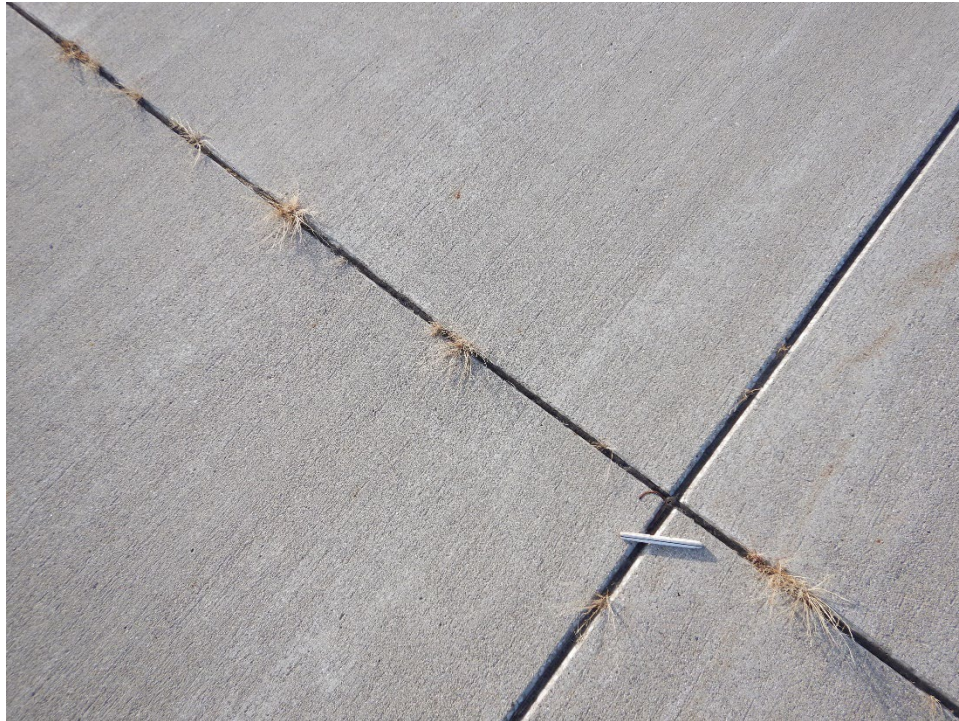
R13AM-04. Joint Seal Damage (Sample Unit No. 28).

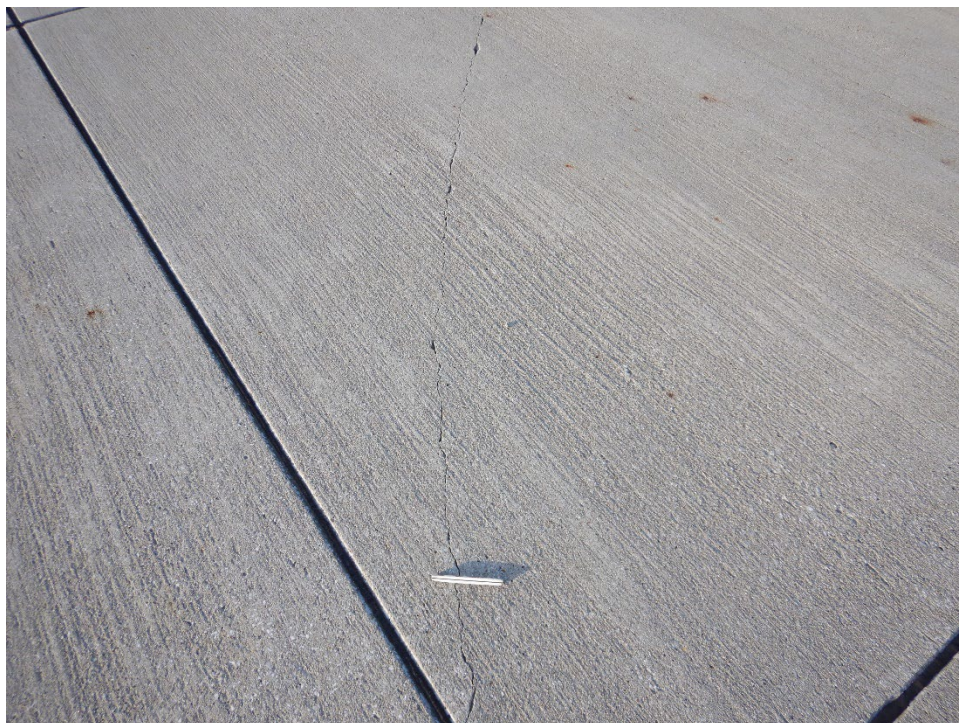
R13AM-04. LTD Cracking (Additional Sample Unit No. 05).

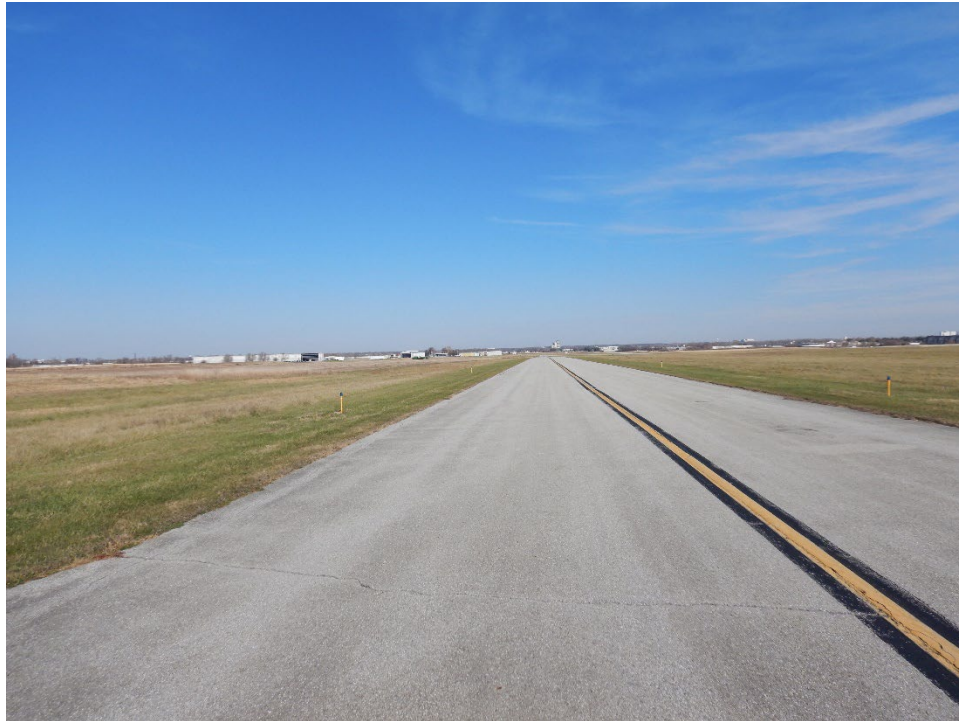
T01AM-02. Overview.

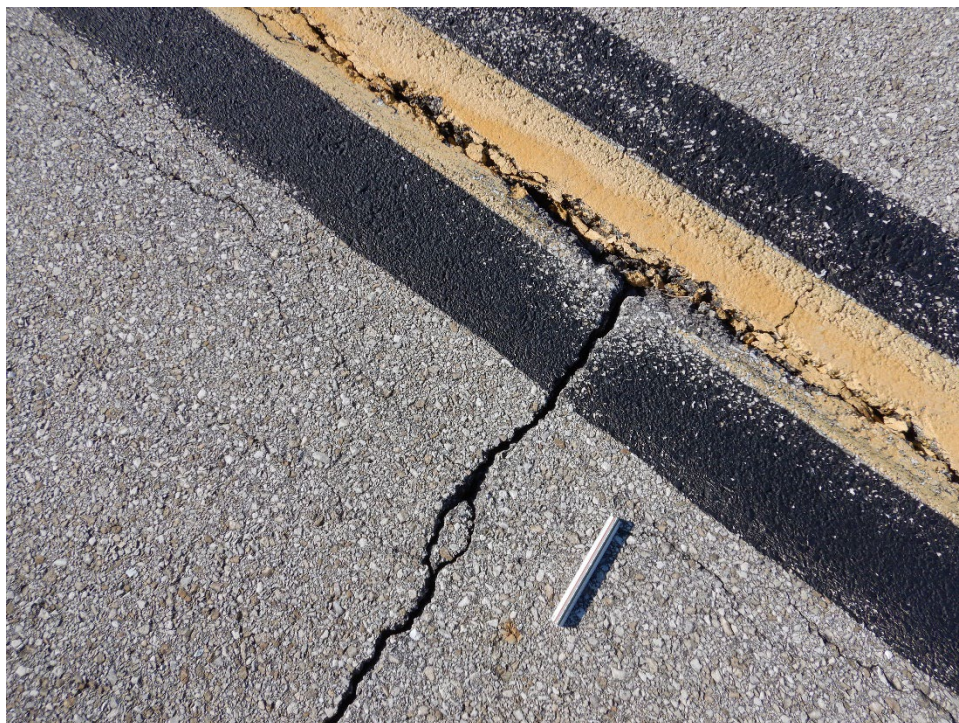
T01AM-02. L&T Cracking (Sample Unit No. 04).

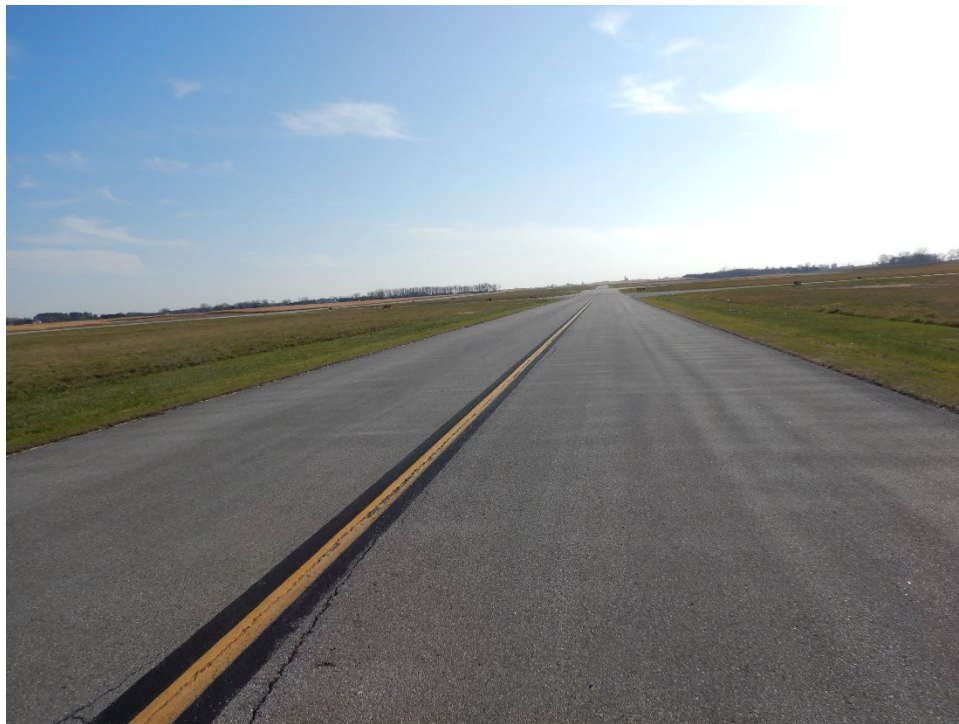
T01AM-04. Overview.

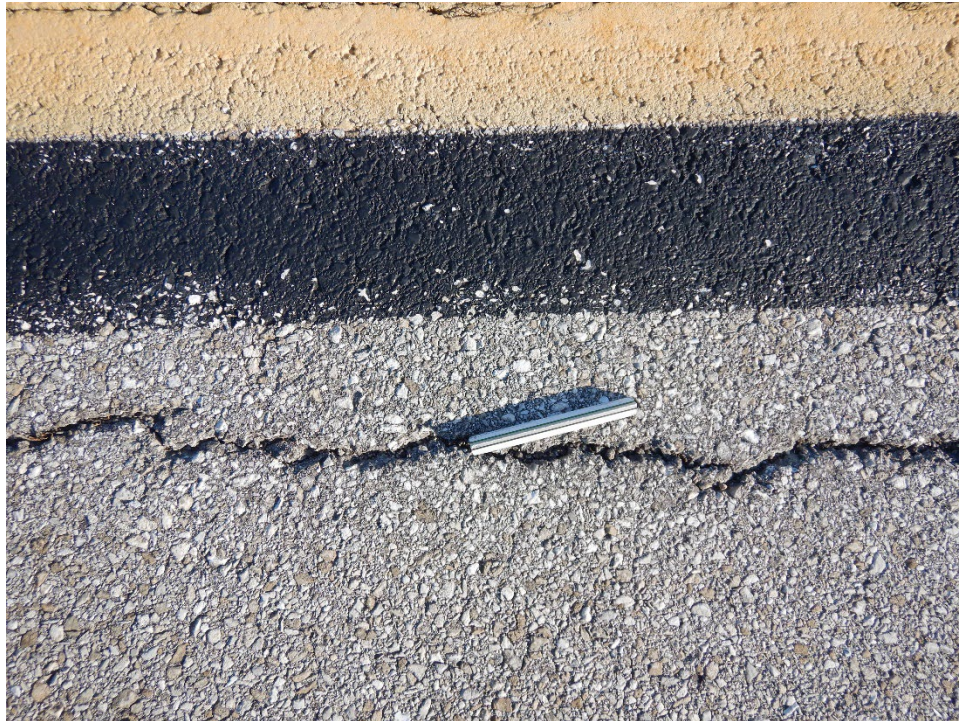
T01AM-04. L&T Cracking (Sample Unit No. 04) (1).

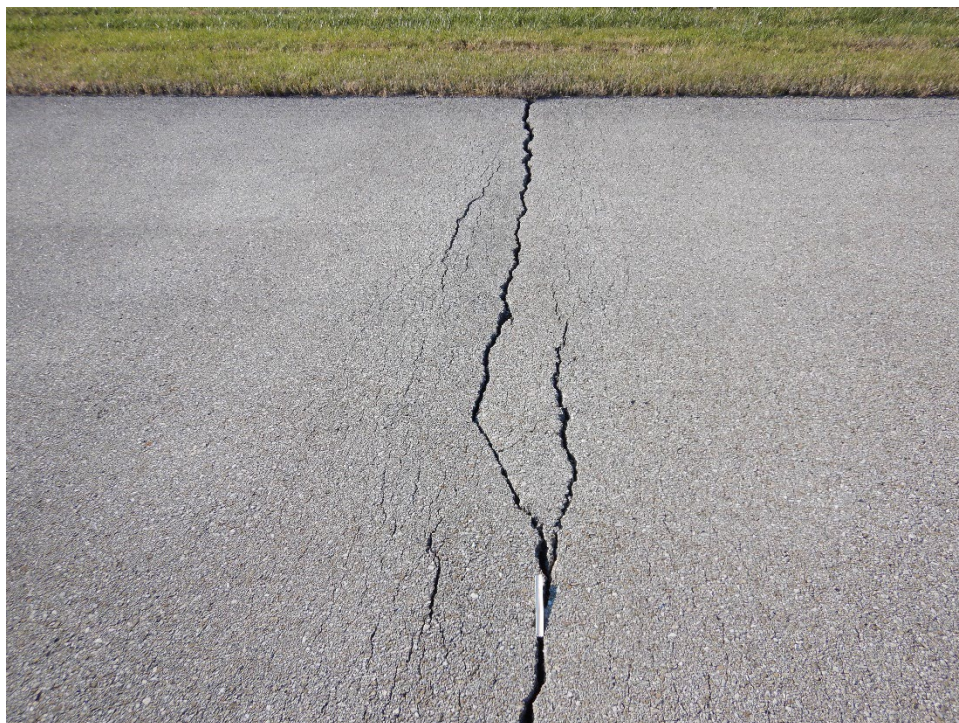
T01AM-04. L&T Cracking (Sample Unit No. 04) (2).

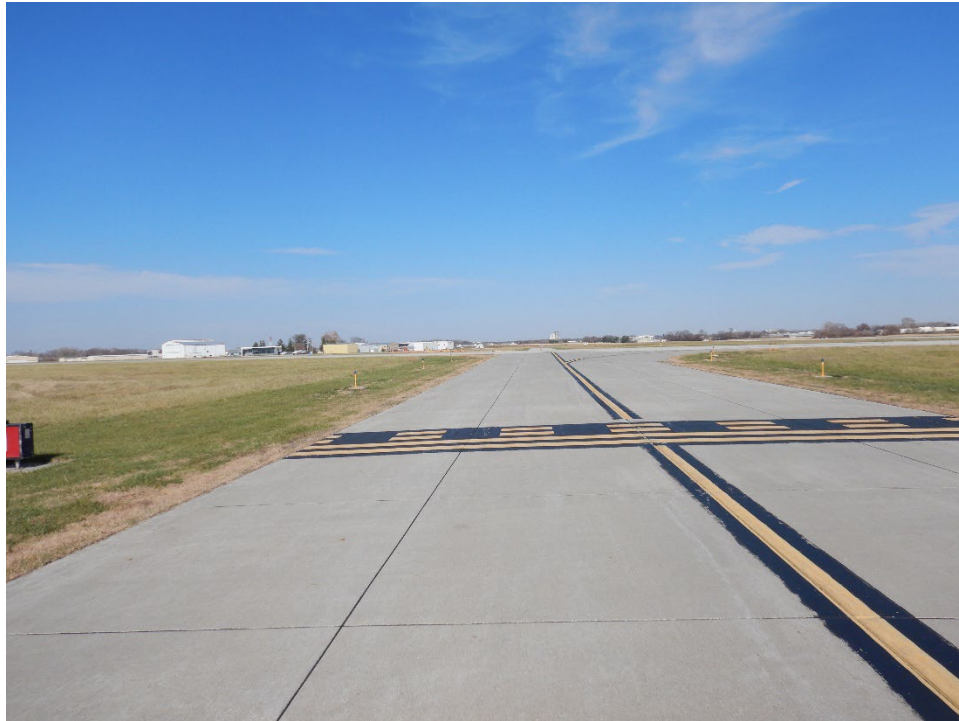
T01AM-05. Overview.

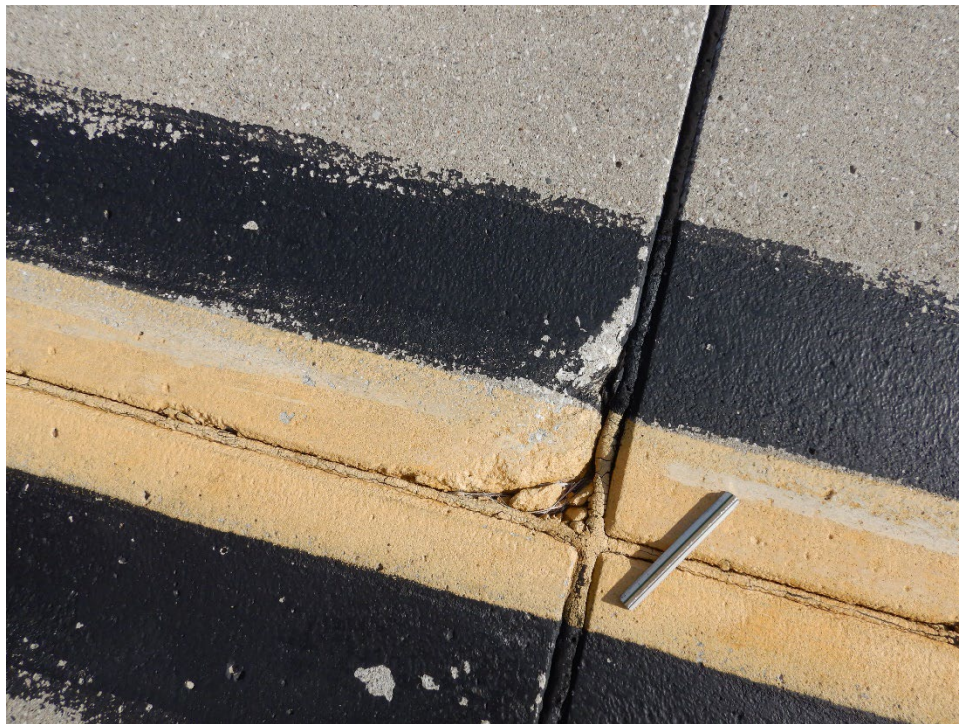
T01AM-05. Joint Seal Damage (Sample Unit No. 04).

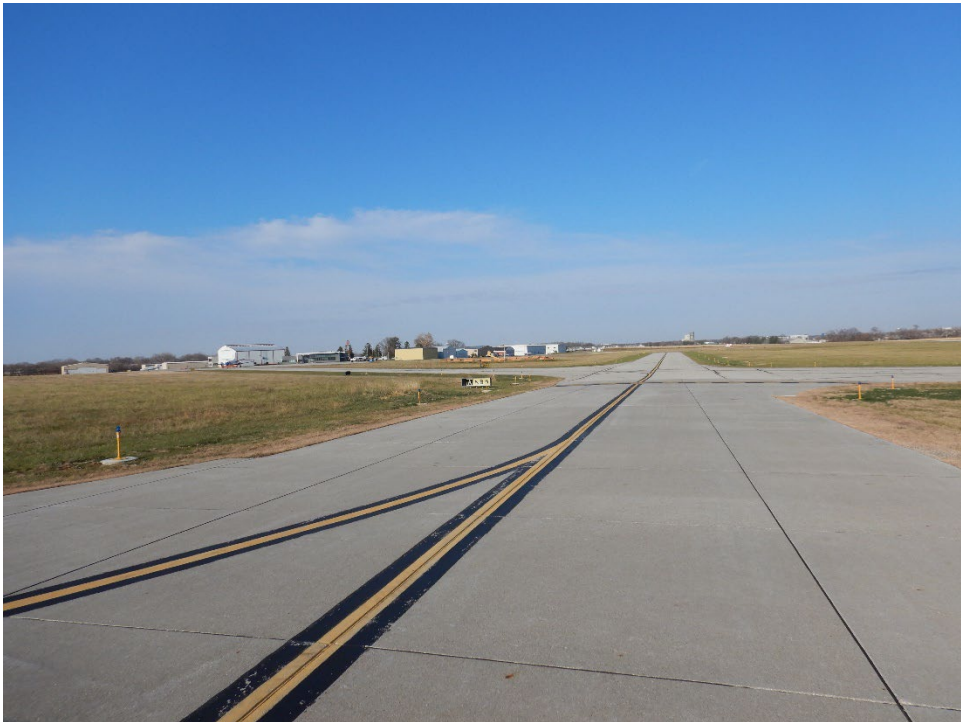
T01AM-06. Overview (2).

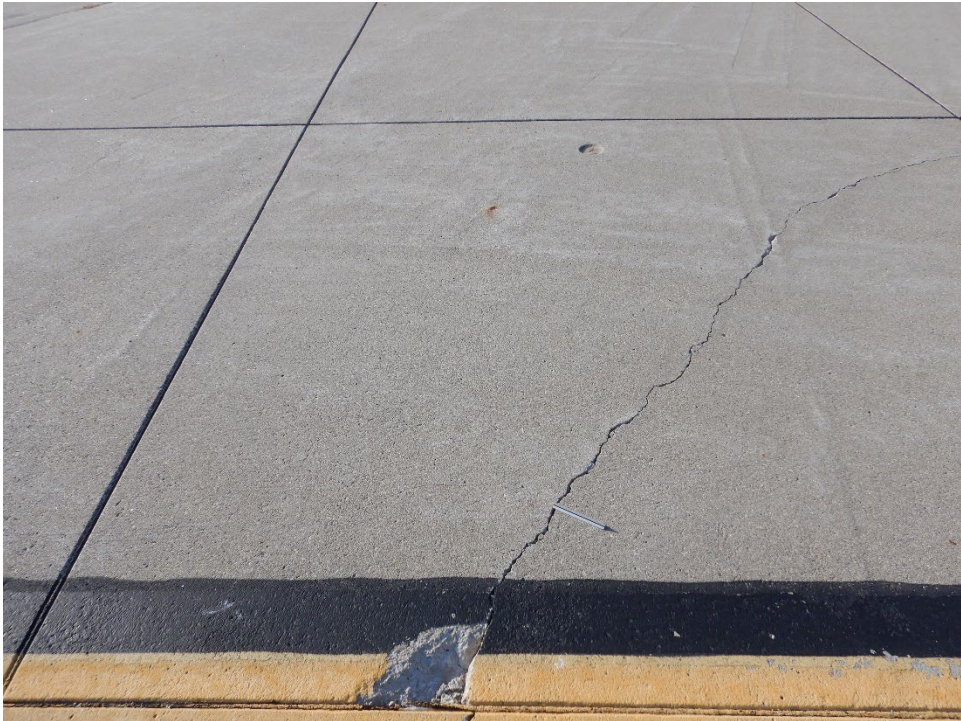
T01AM-06. LTD Cracking (Sample Unit No. 05).

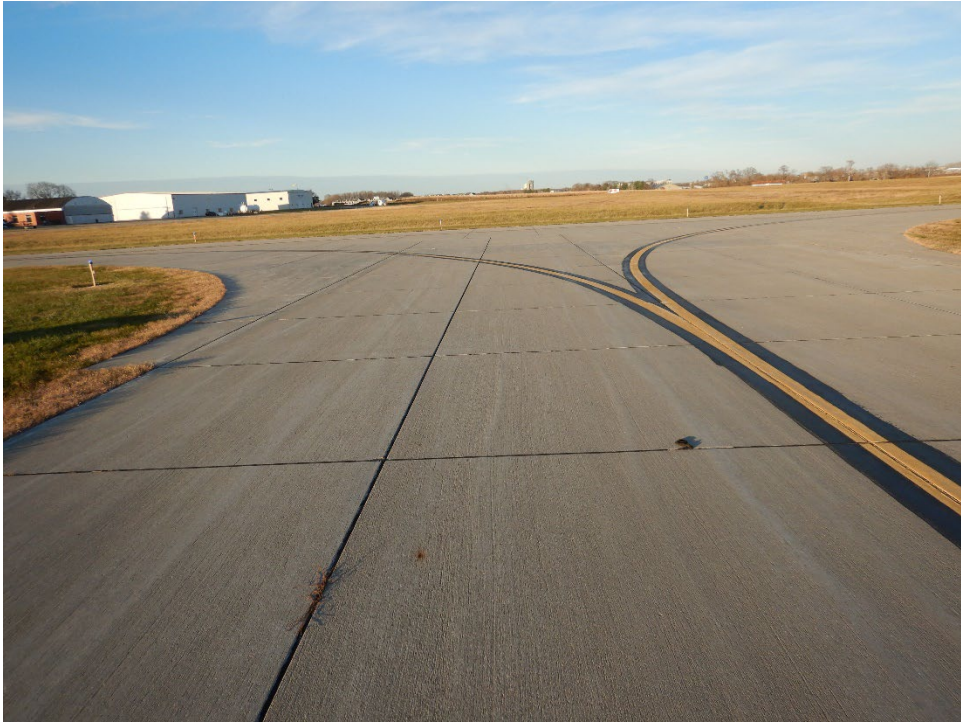
T01AM-07. Overview.

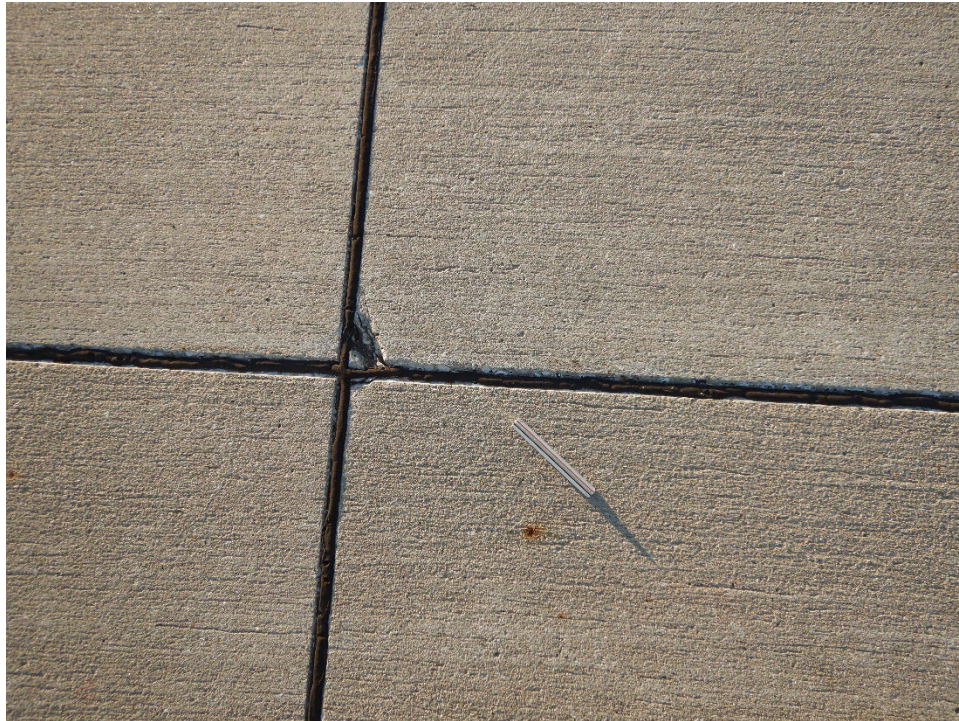
T01AM-07. Joint Seal Damage (Sample Unit No. 03).

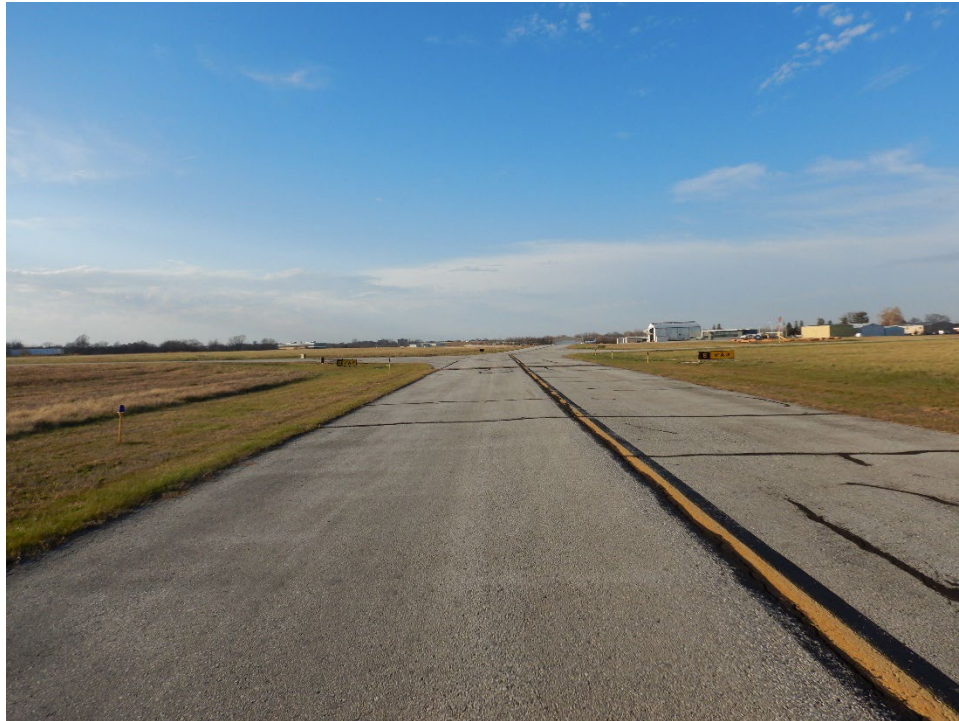
T02AM-01. Overview.

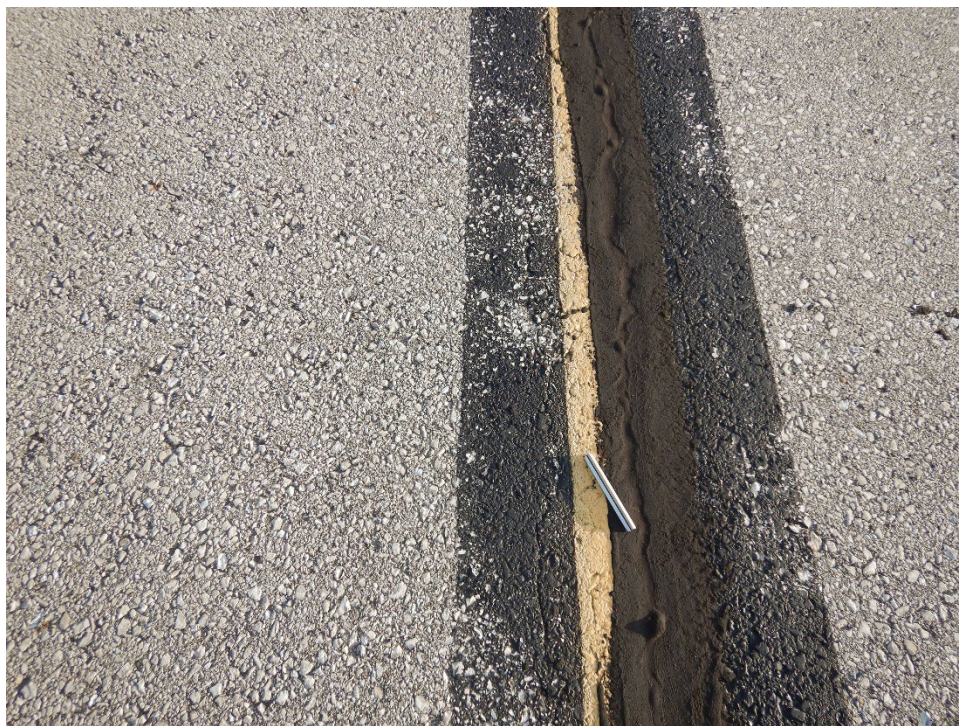
T02AM-01. L&T Cracking (Sample Unit No. 07) (1).

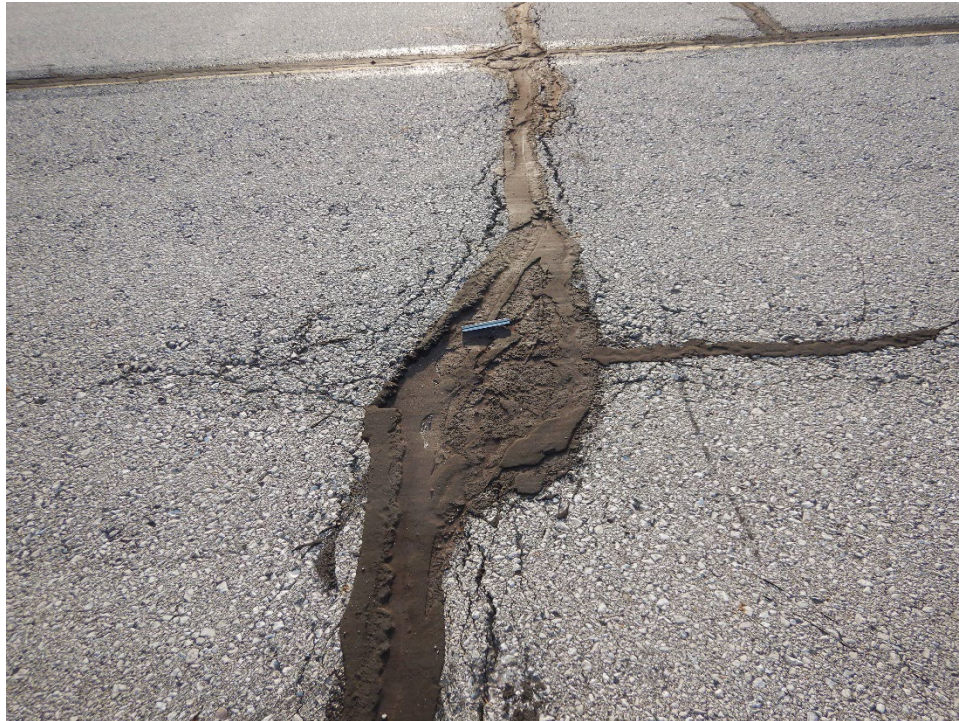
T02AM-01. L&T Cracking (Sample Unit No. 07) (2).

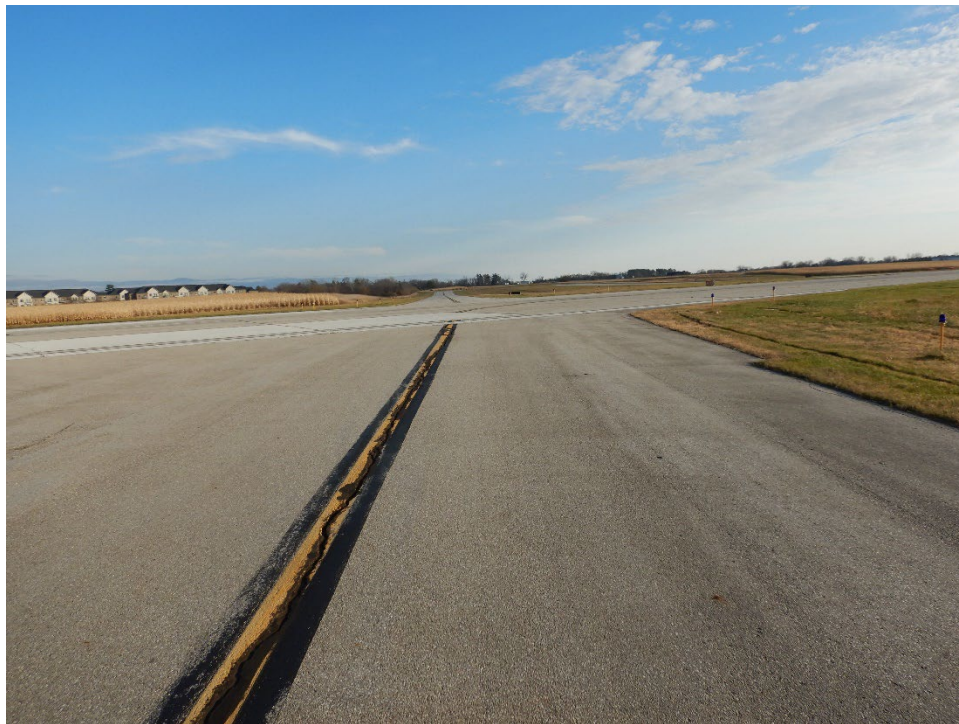
T02AM-02. Overview.

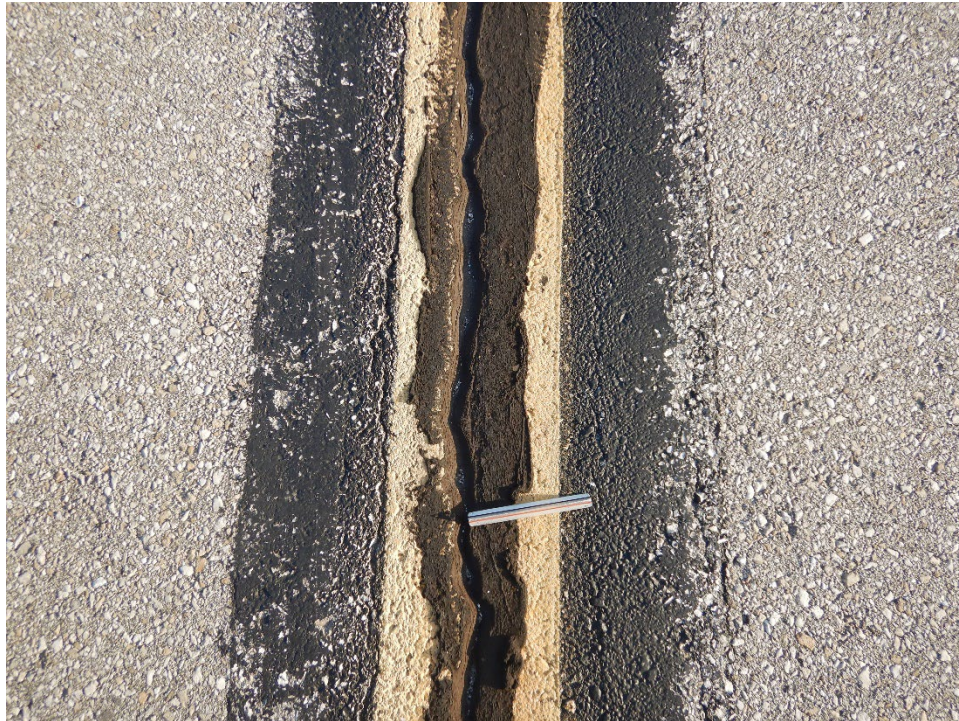
T02AM-02. L&T Cracking (Sample Unit No. 01) (1).
