Ames Municipal Airport

Pavement Management Report

JULY 2023

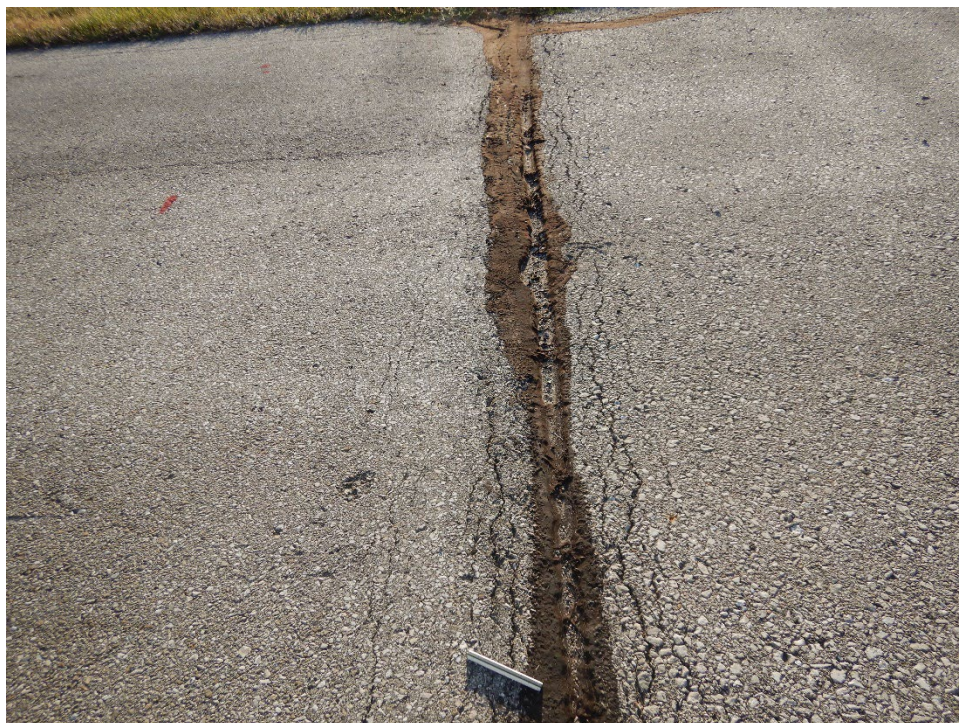
T02AM-02. L&T Cracking (Sample Unit No. 01) (2).

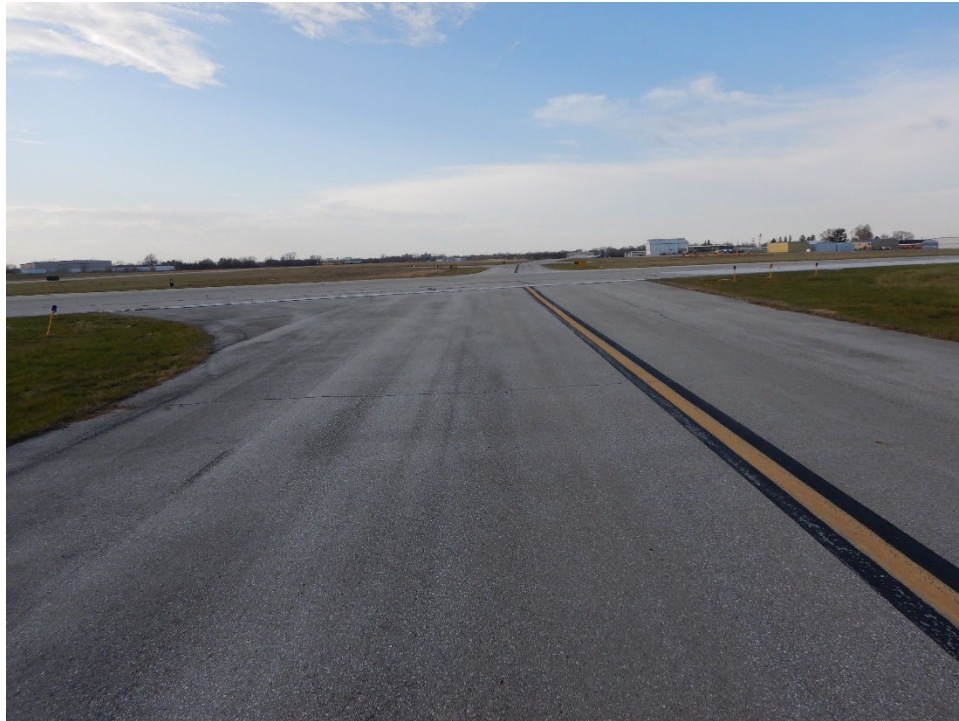
T02AM-03. Overview.

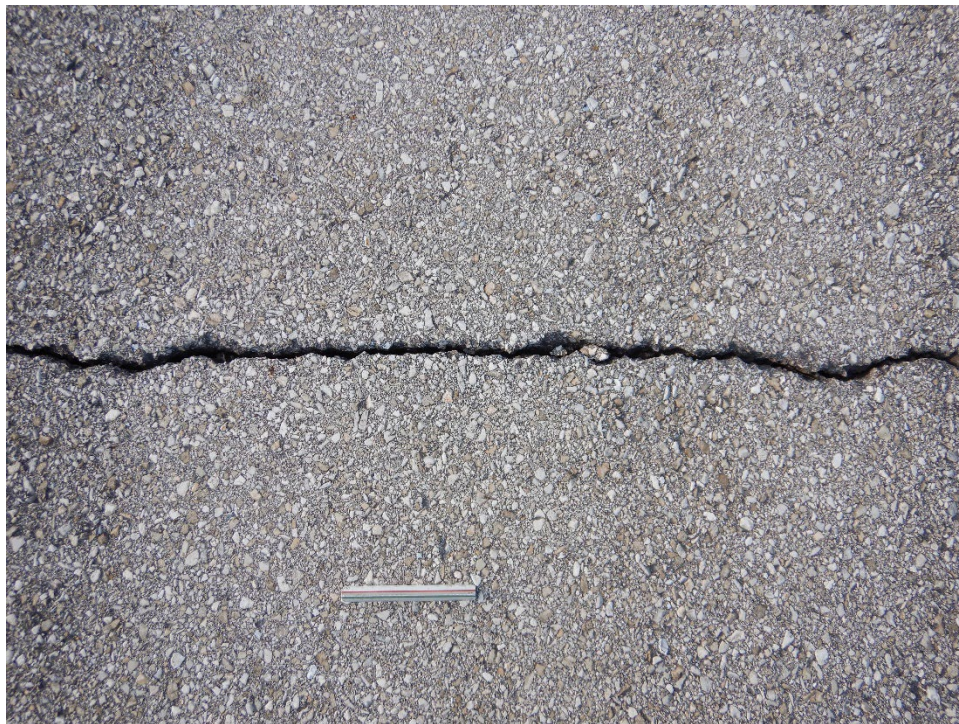
T02AM-03. L&T Cracking (Sample Unit No. 01).

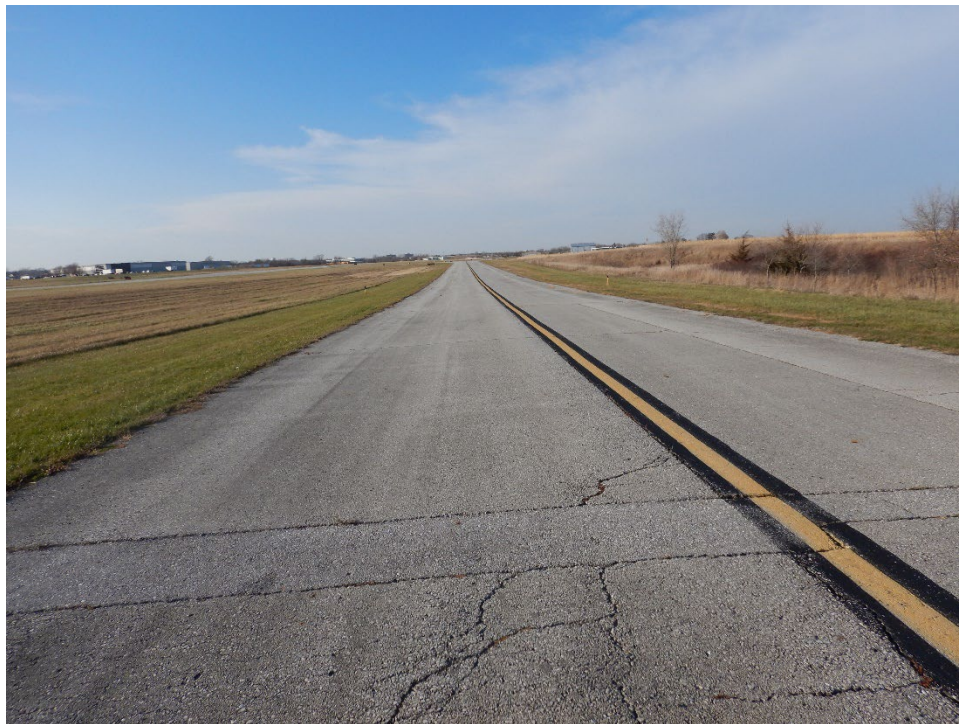
T02AM-04. Overview.

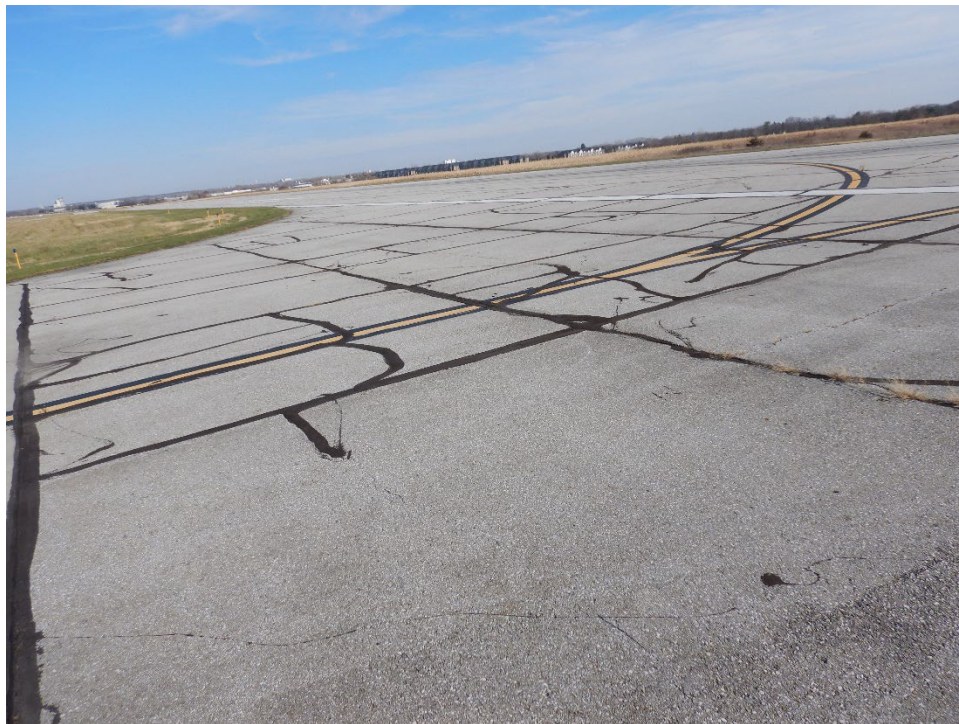
T03AM-02. Overview.

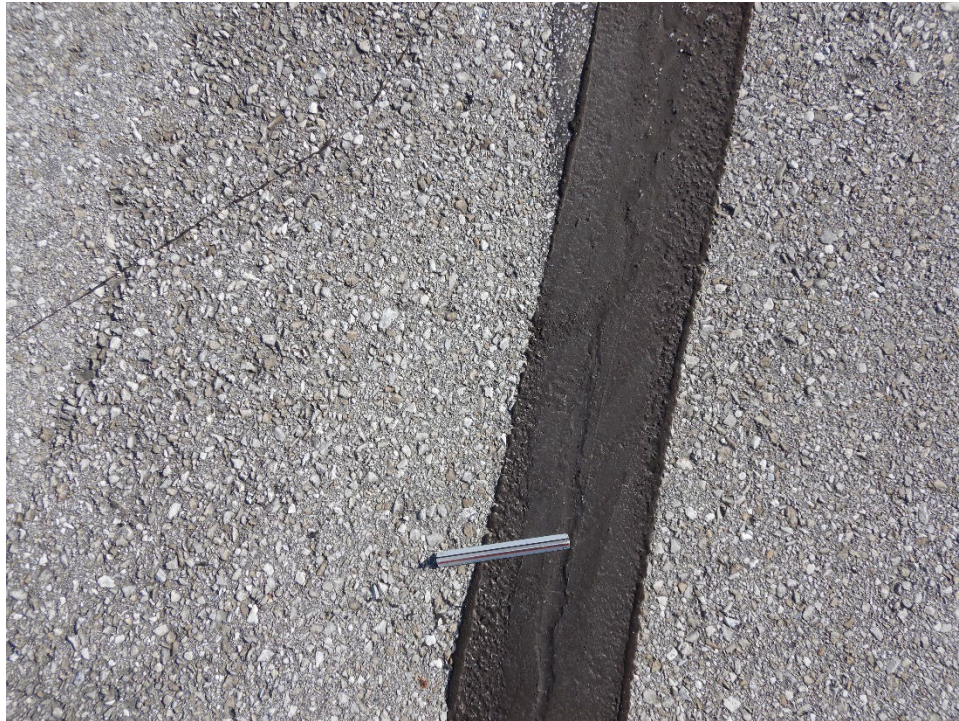
T03AM-02. L&T Cracking (Sample Unit No. 01).

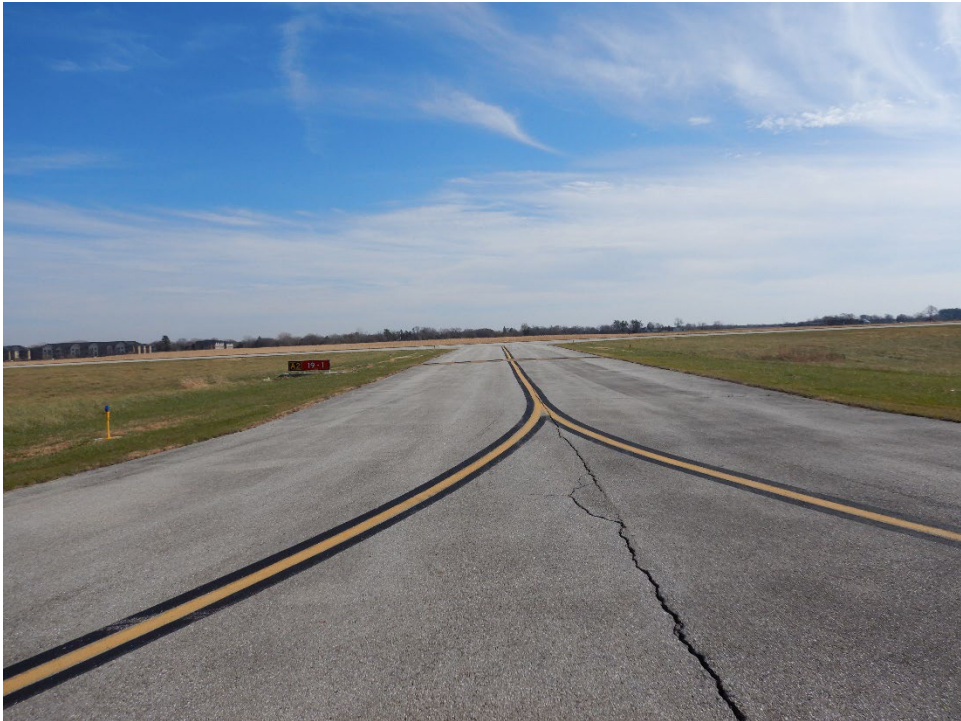
T04AM-01. Overview.

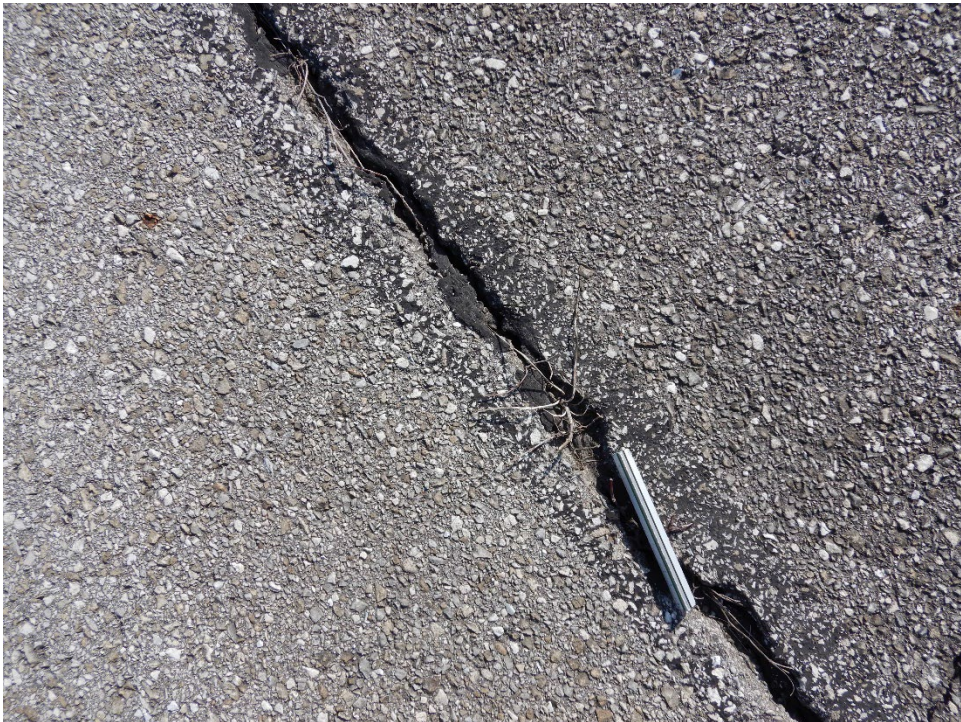
T04AM-01. L&T Cracking (Sample Unit No. 01).

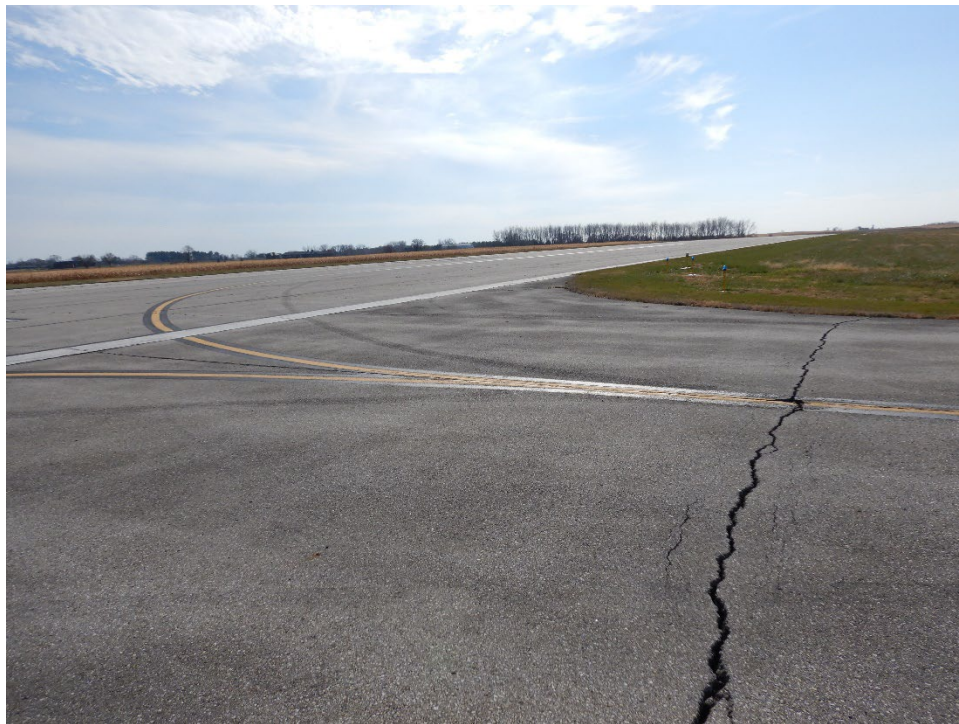
T04AM-02. Overview.

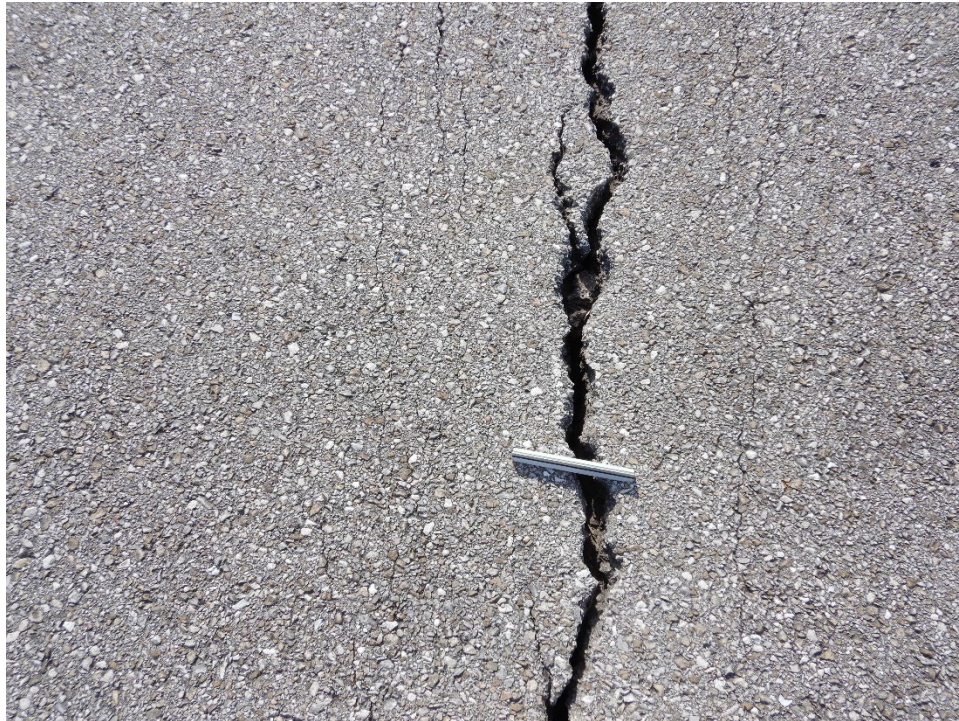
T04AM-02. L&T Cracking (Sample Unit No. 01).

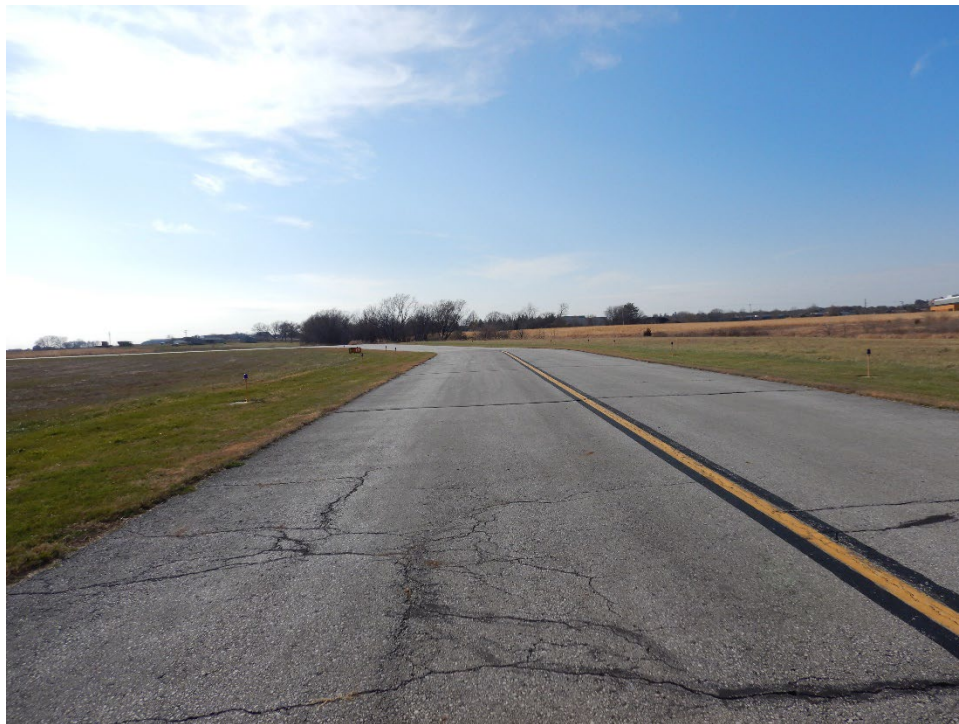
T05AM-01. Overview.

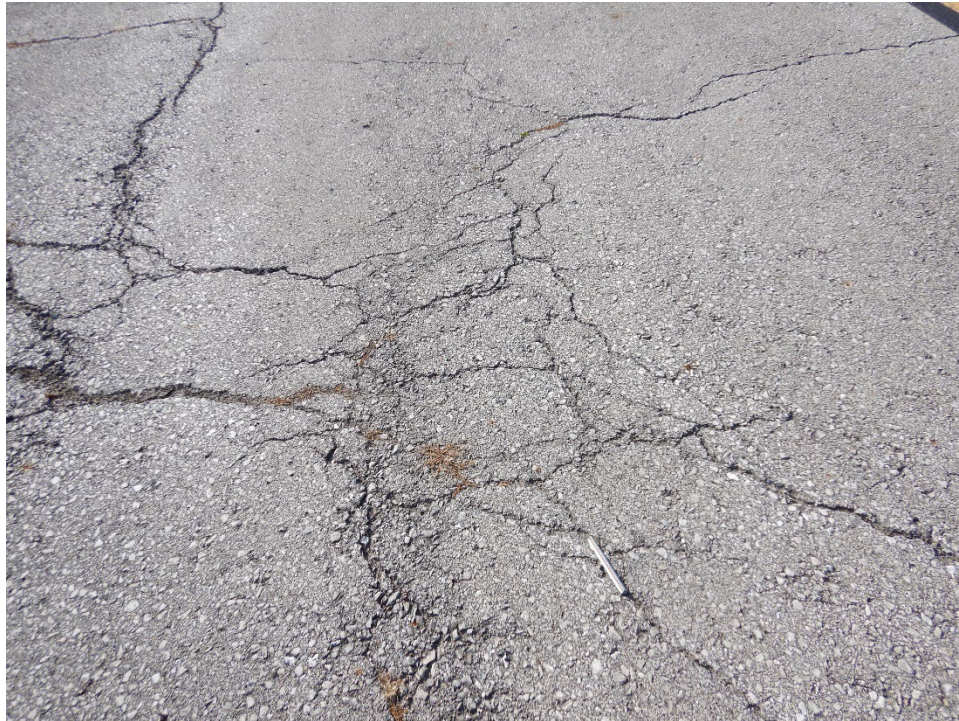
T05AM-01. Alligator Cracking (Sample Unit No. 01).

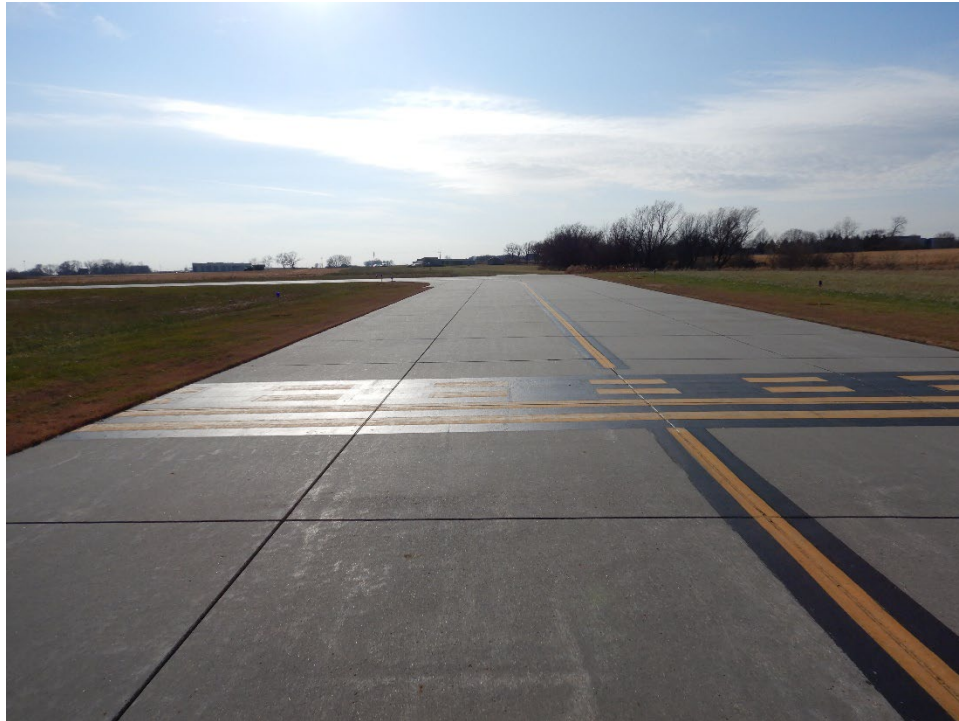
T05AM-02. Overview.

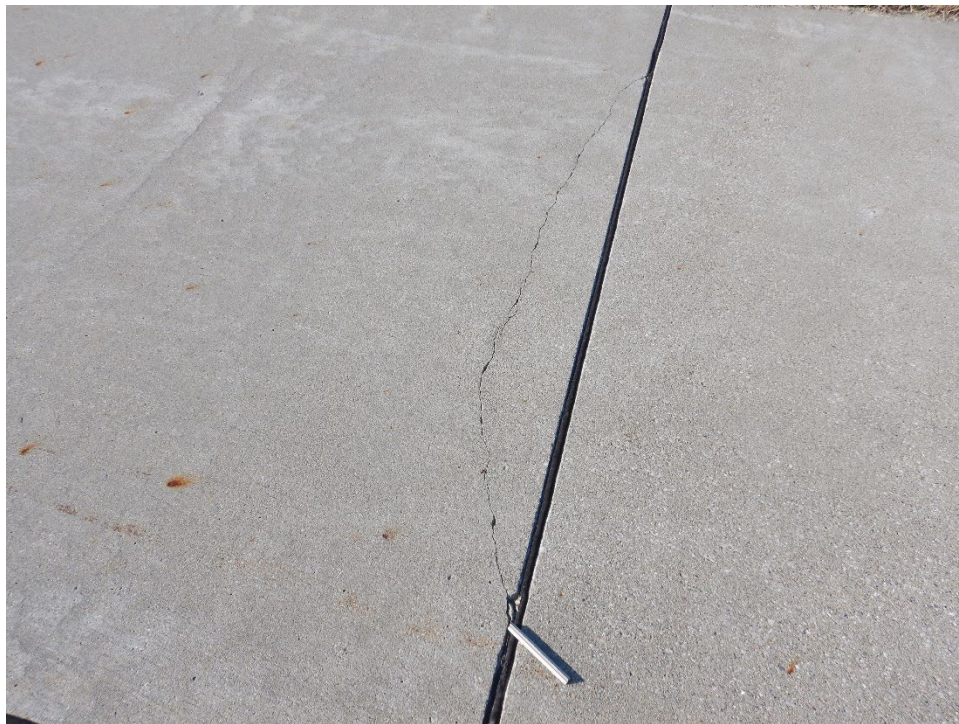
T05AM-02. Joint Spalling (Sample Unit No. 04).

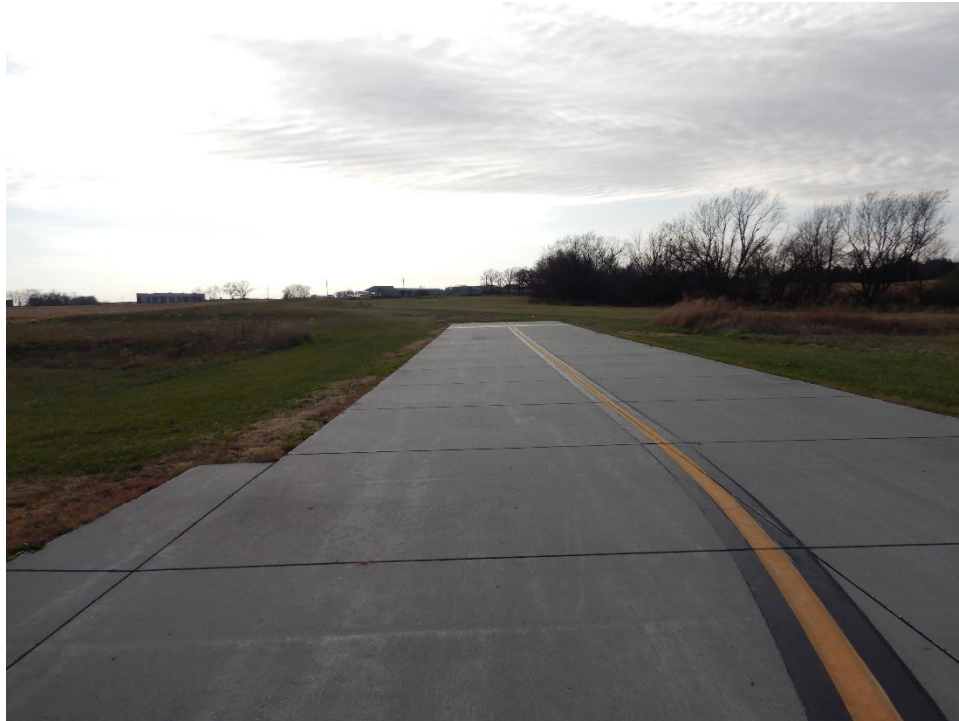
T05AM-03. Overview.

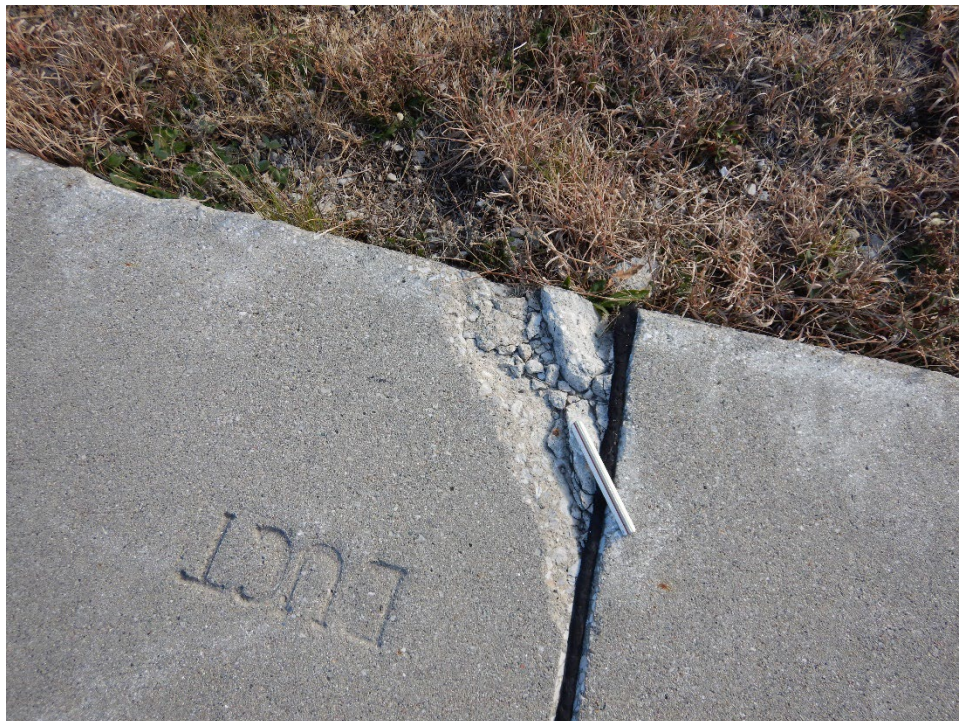
T05AM-03. Corner Spalling (Sample Unit No. 02).

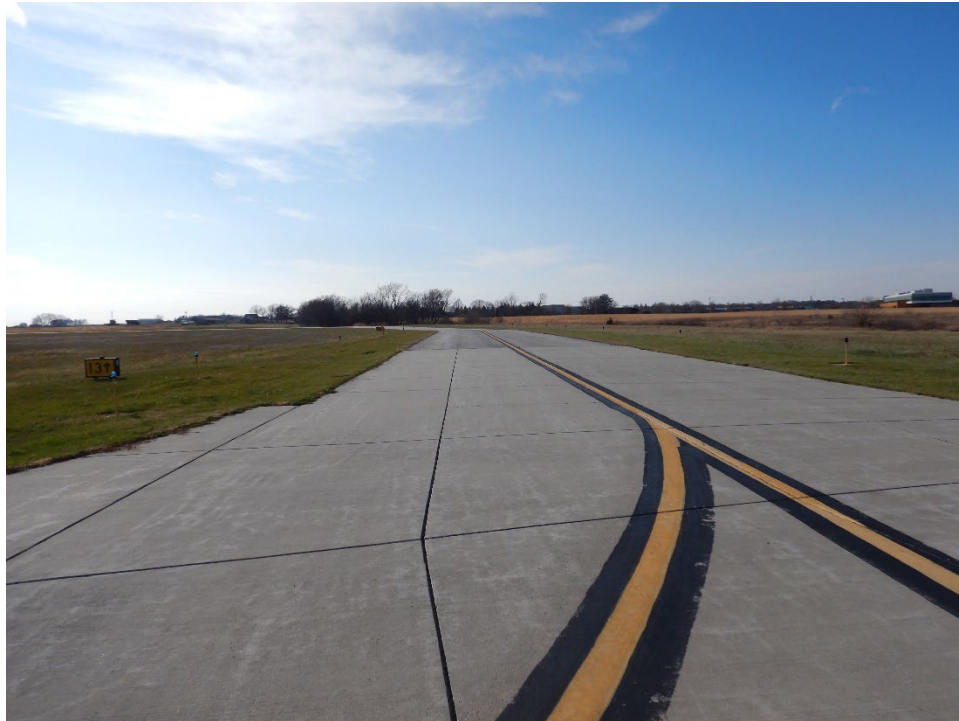
T05AM-04. Overview.

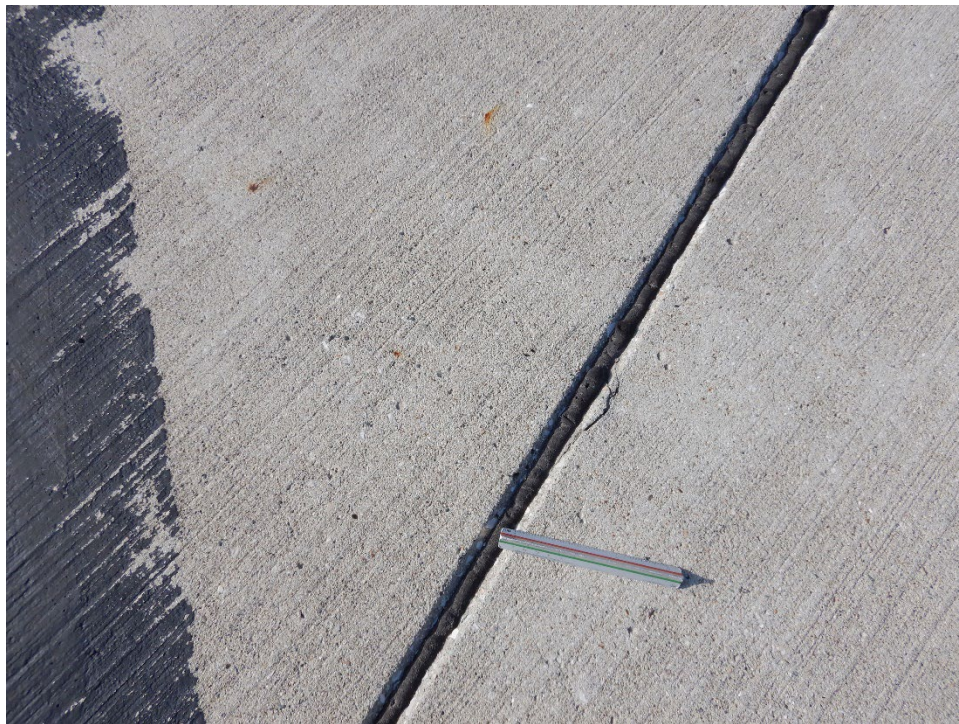
T05AM-04. Joint Seal Damage (Sample Unit No. 01).

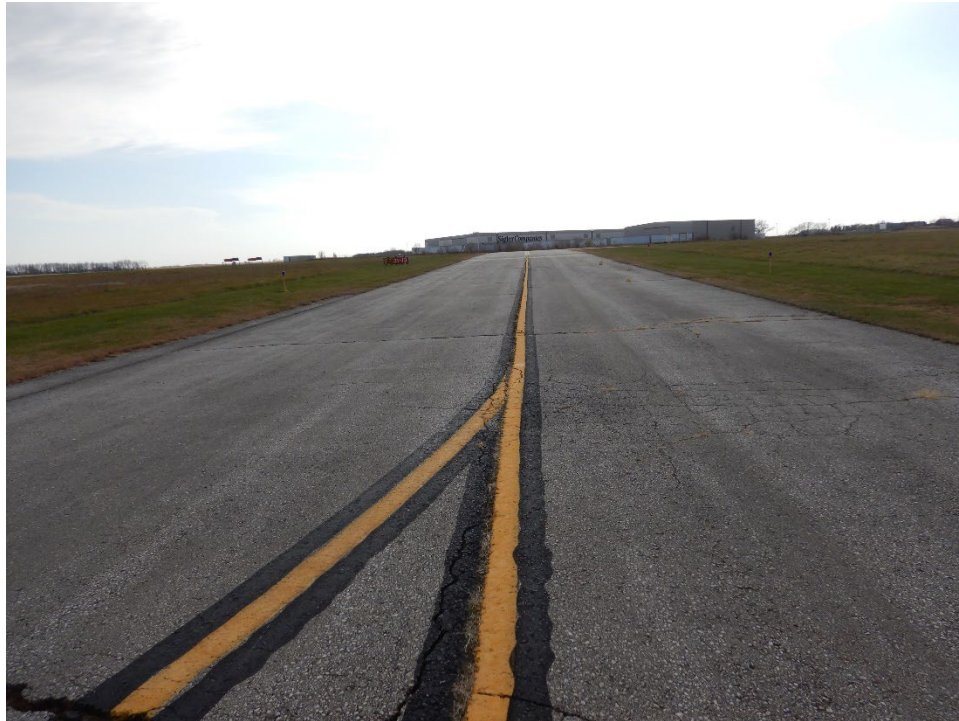
T06AM-01. Overview.

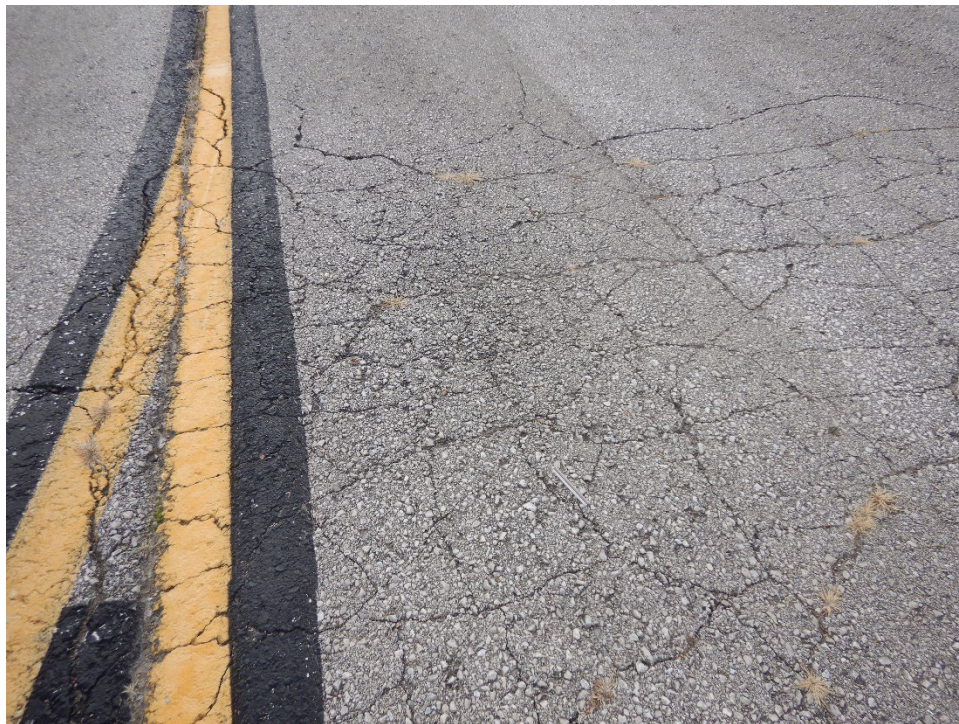
T06AM-01. Alligator Cracking (Sample Unit No. 01).

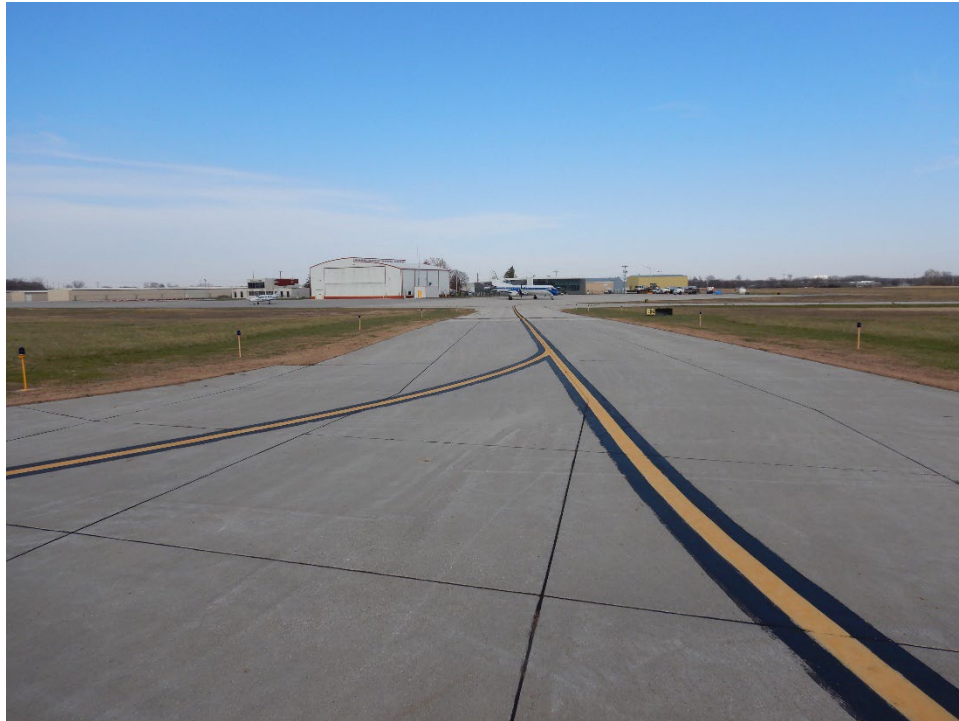
T06AM-02. Overview.

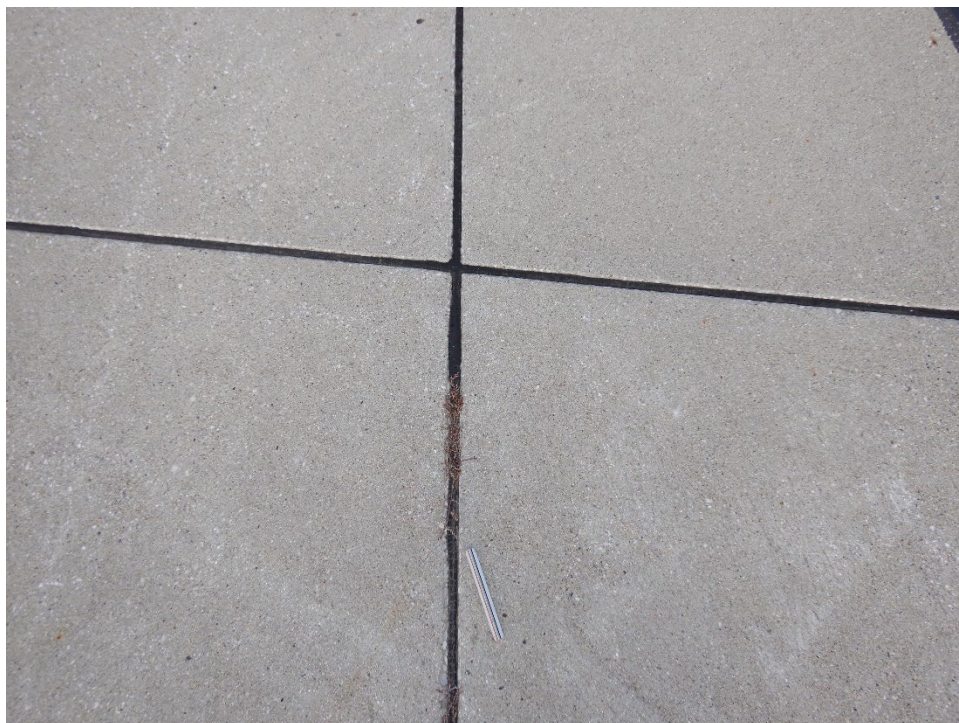
T06AM-02. Joint Seal Damage (Sample Unit No. 03).

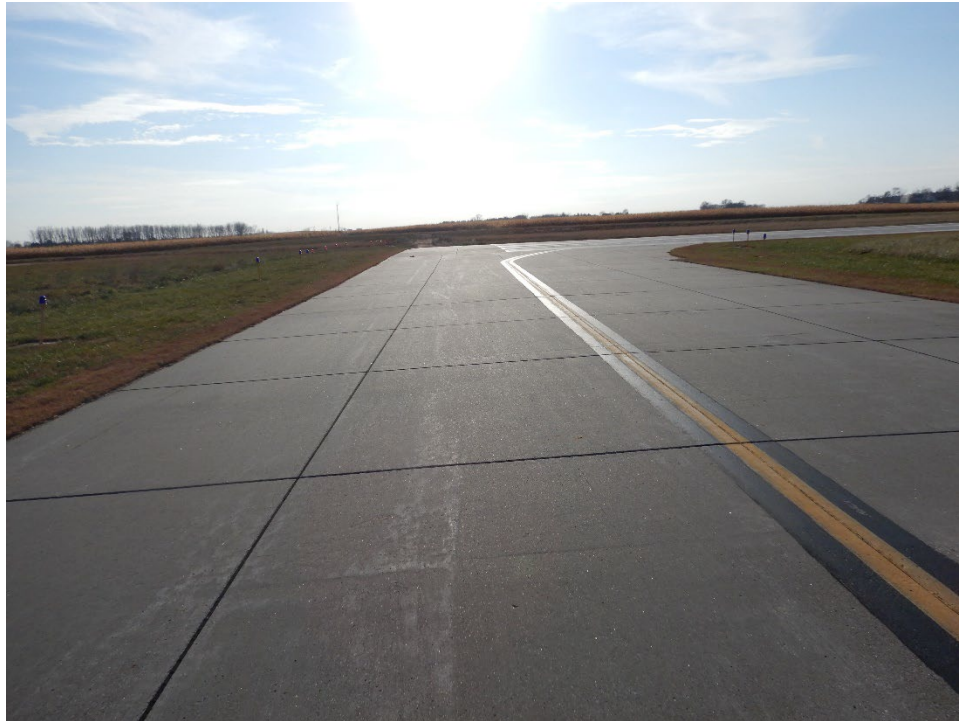
T07AM-01. Overview.

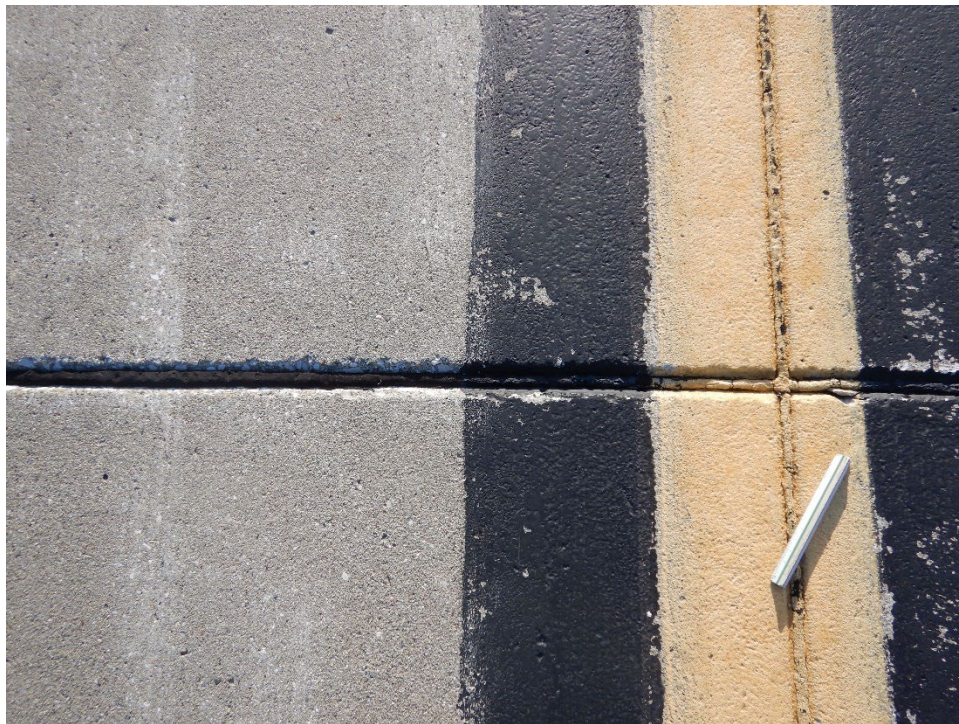
T07AM-01. Joint Seal Damage (Sample Unit No. 02).

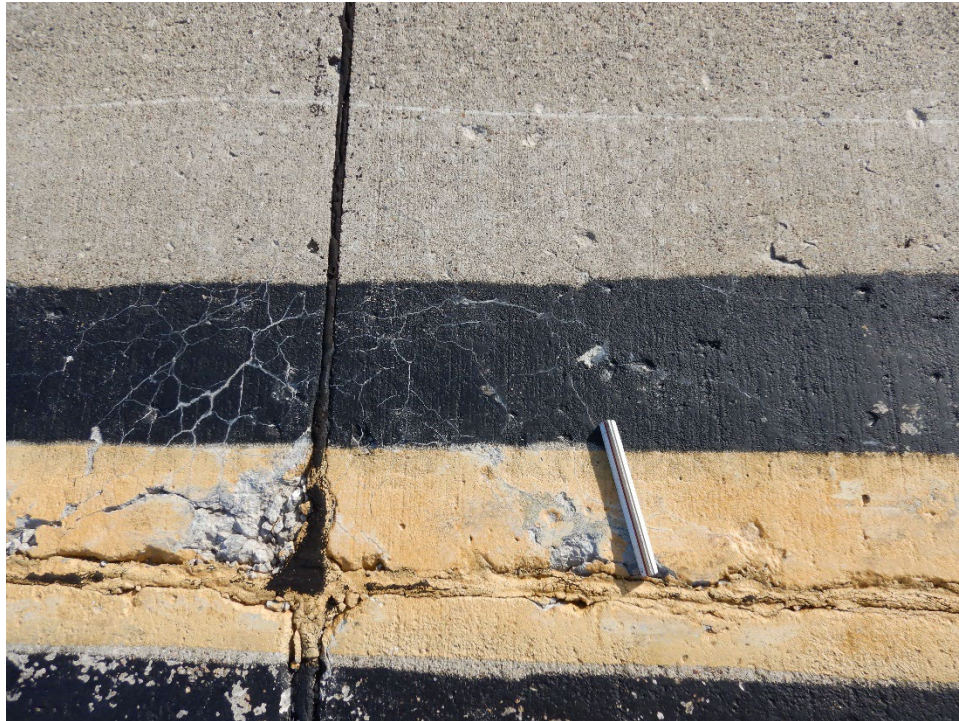
T10AM-01. ASR (Sample Unit No. 24).

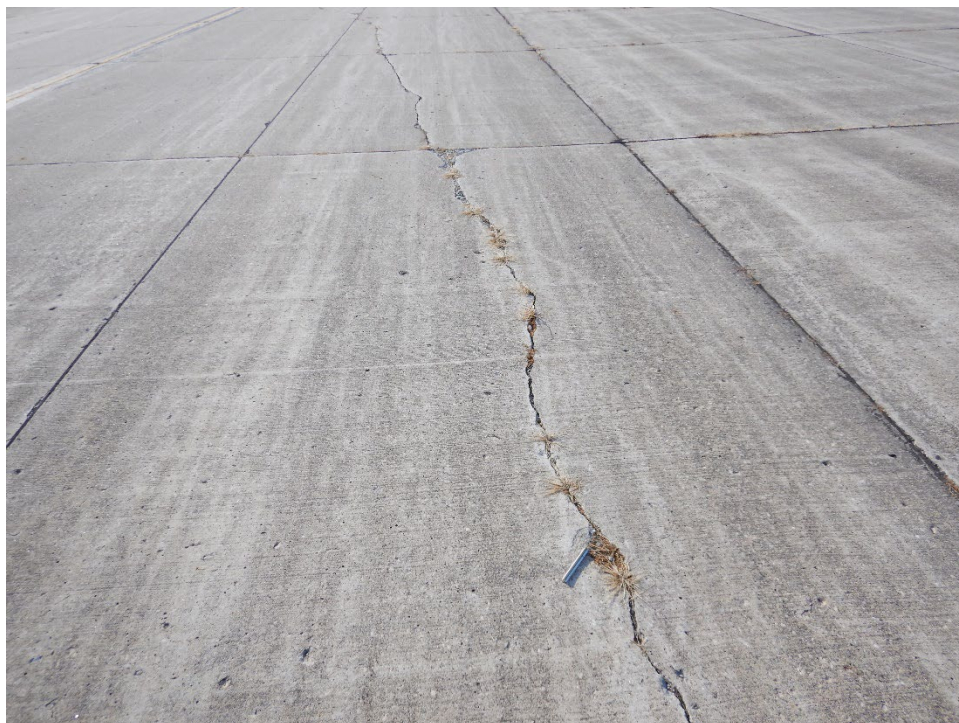
T10AM-01. LTD Cracking (Sample Unit No. 24).

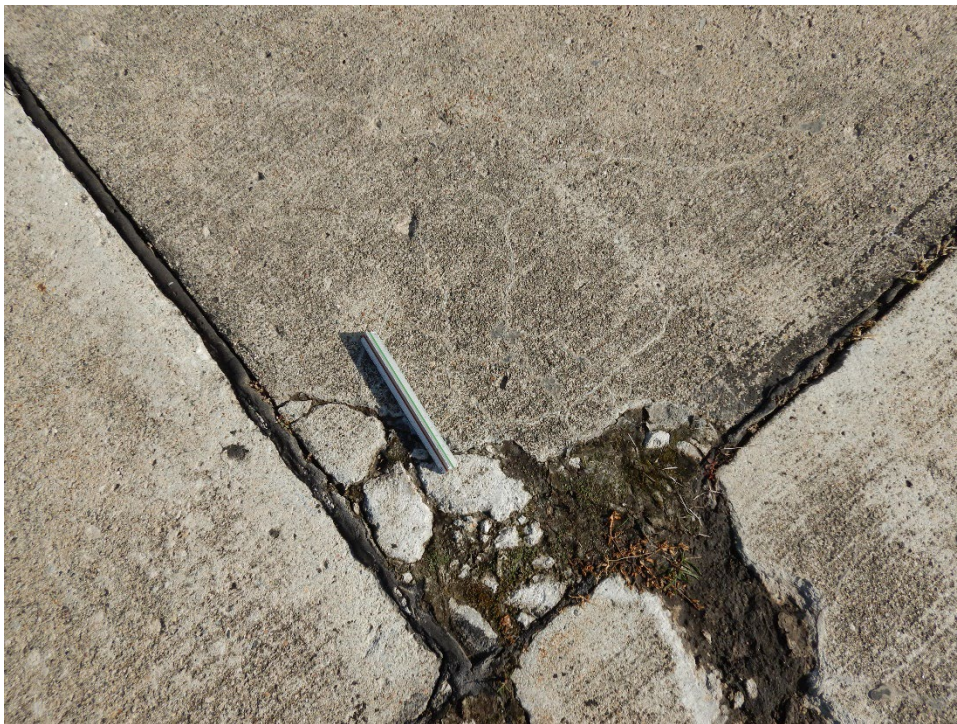
T11AM-01. ASR (Sample Unit No. 06).

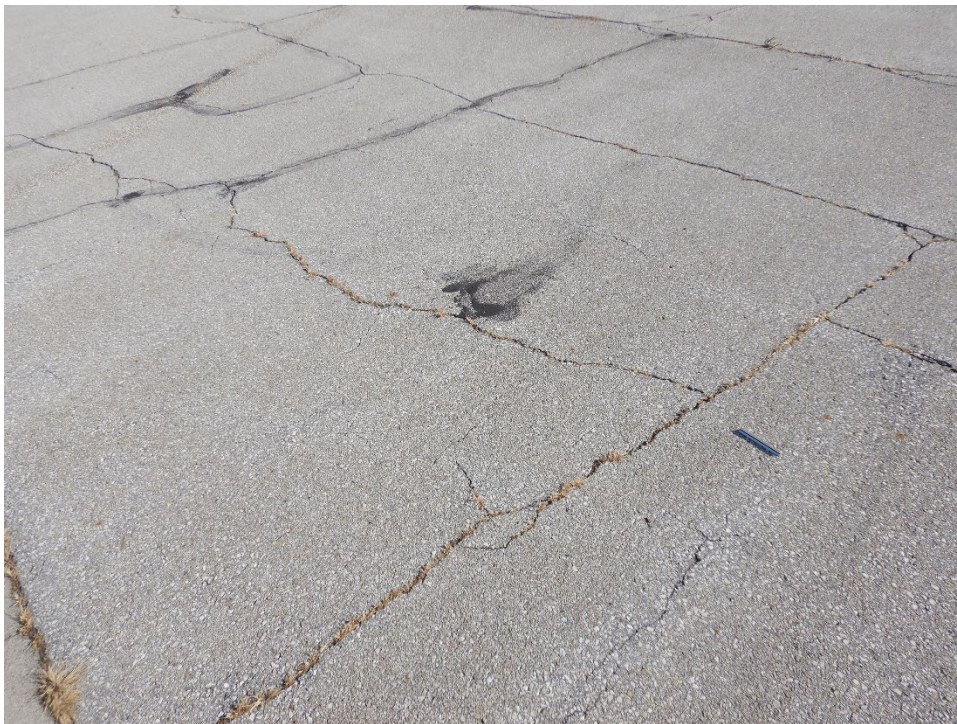
T12AM-02. Block Cracking (Sample Unit No. 01).

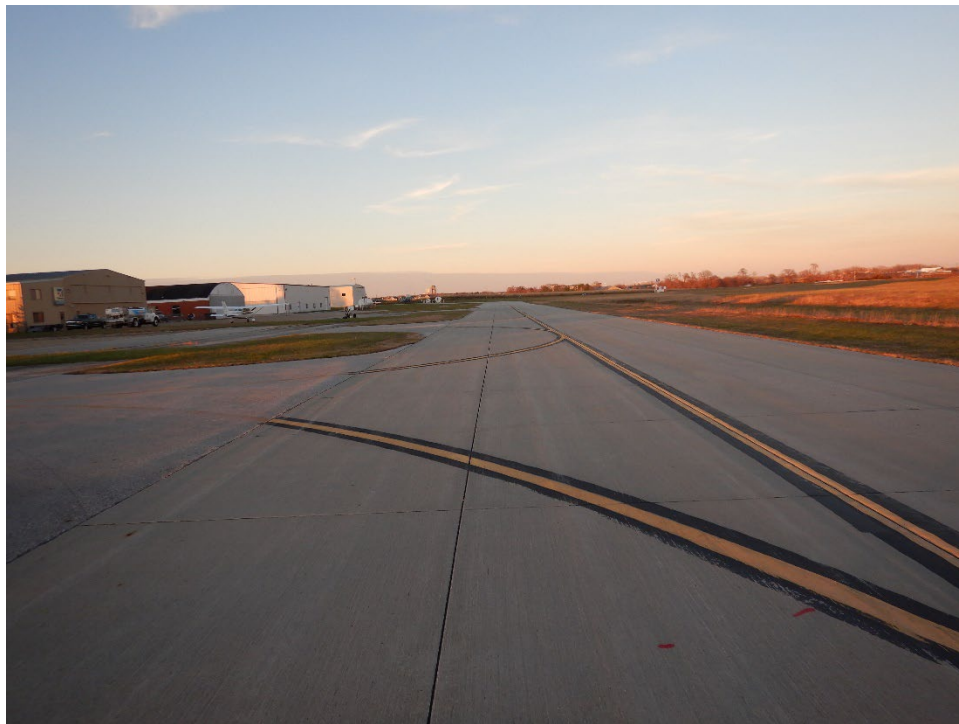
T13AM-01. Overview.

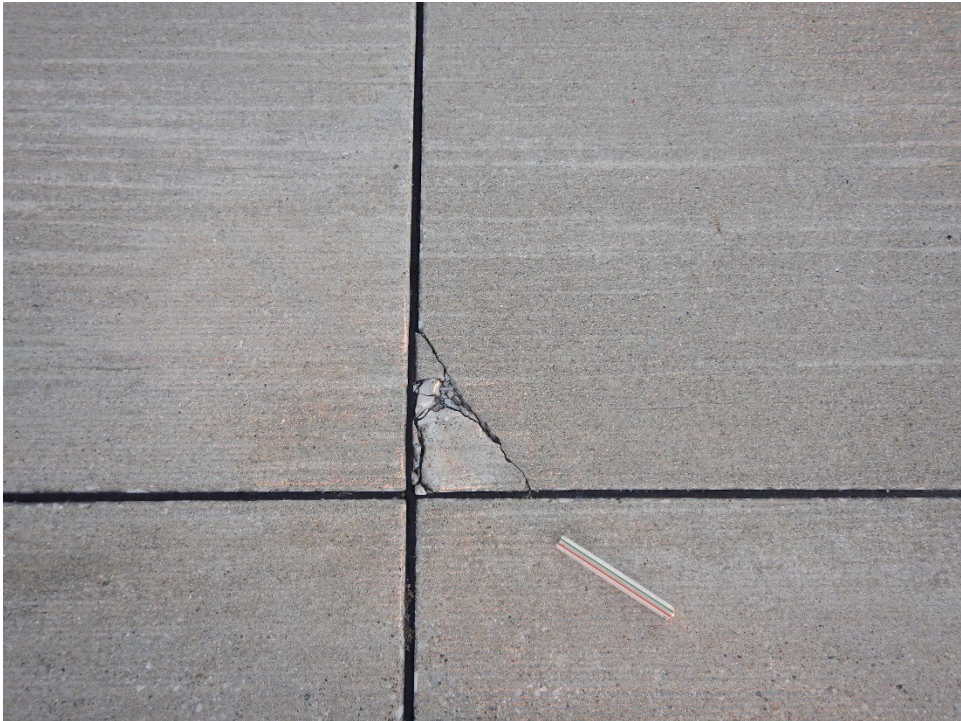
T13AM-01. Corner Spalling (Sample Unit No. 04).

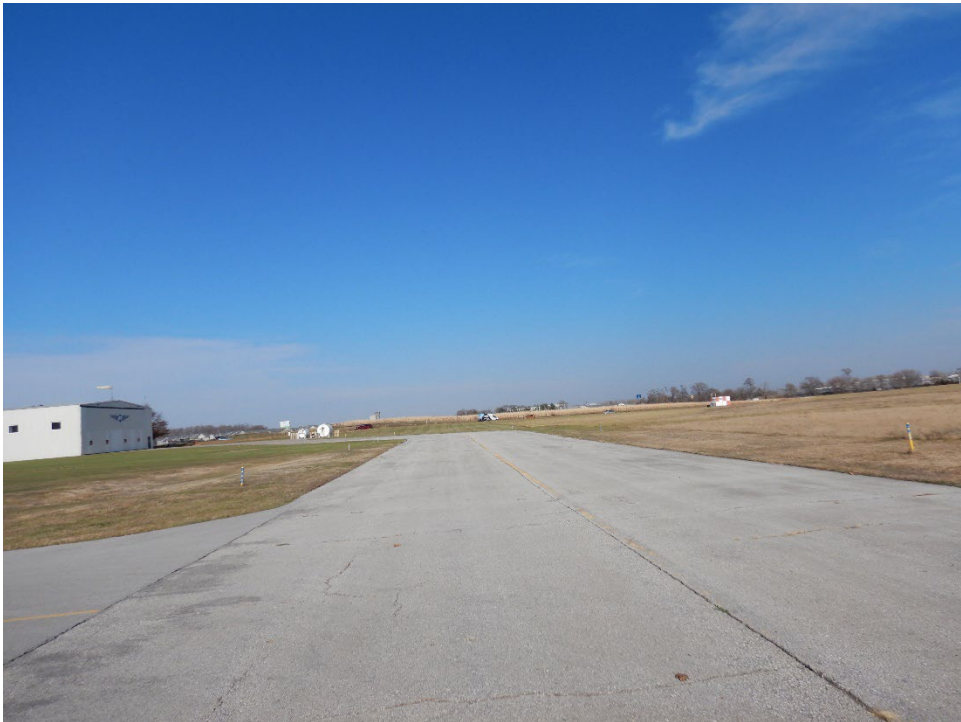
T13AM-02. Overview.

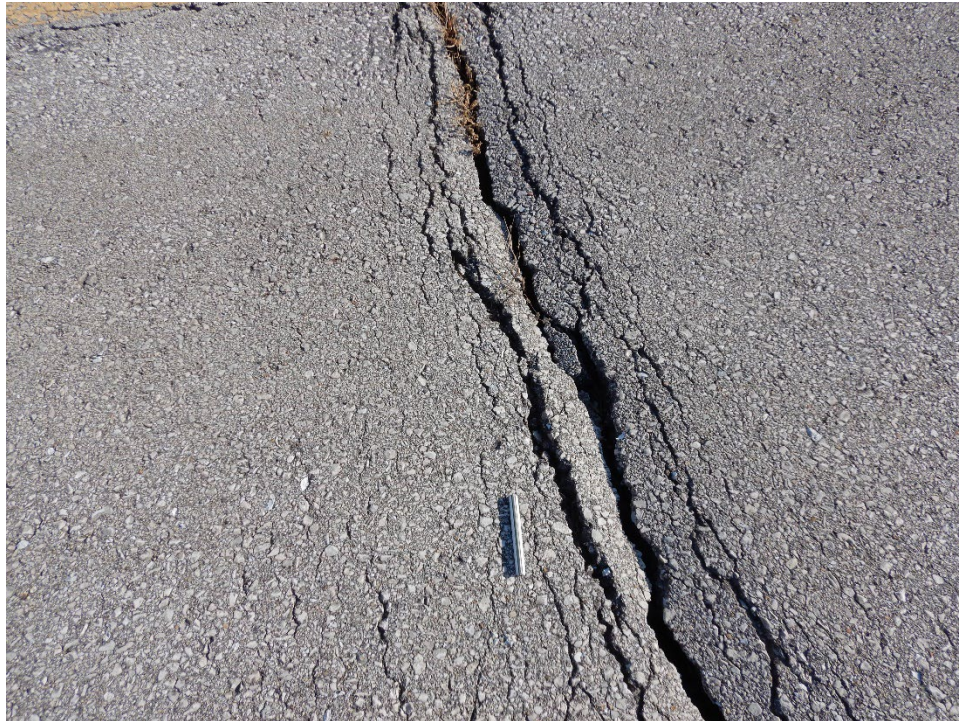
T13AM-02. L&T Cracking (Sample Unit No. 02).

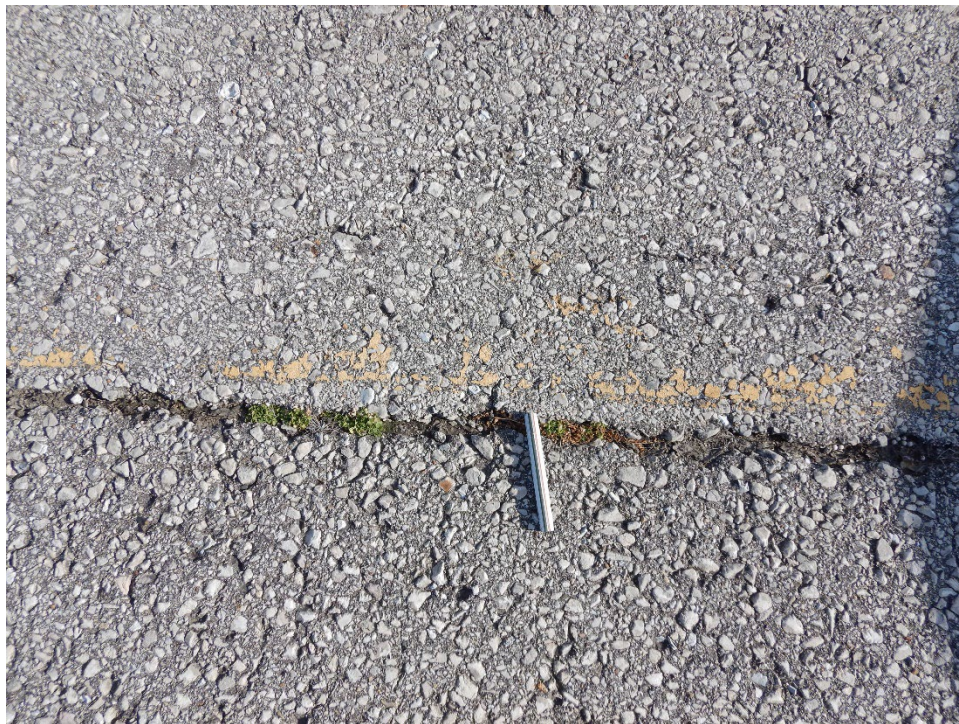
T13AM-02. L&T Cracking (Sample Unit No. 03).
