Ames Municipal Airport

Pavement Management Report

JULY 2023

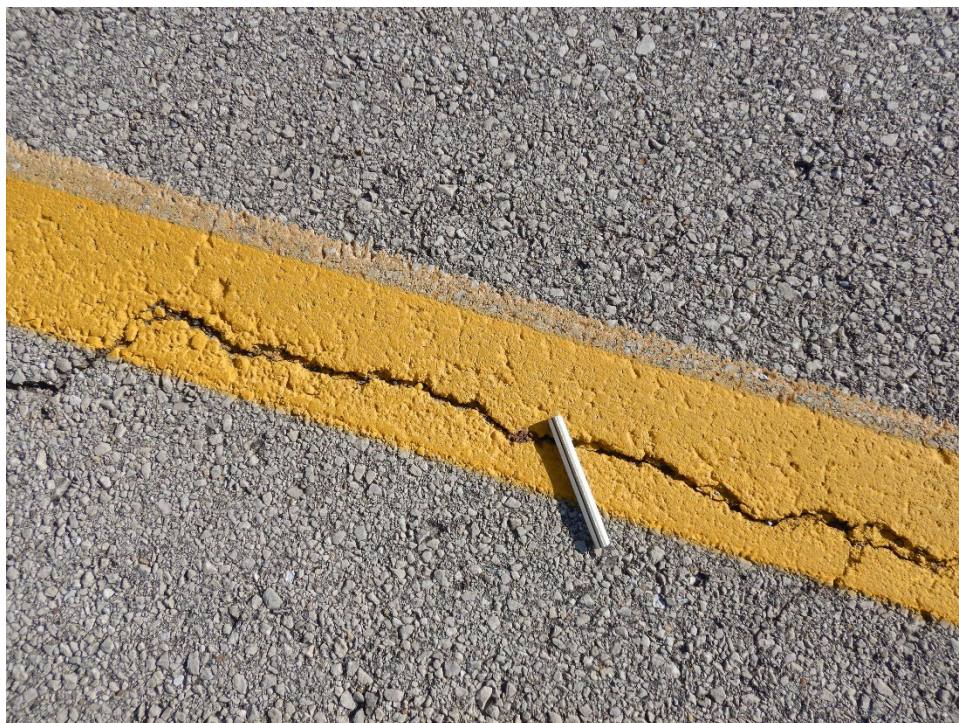
TH01AM-01. L&T Cracking (Sample Unit No. 07).
