Atlantic Municipal Airport

PAVEMENT MANAGEMENT REPORT

JULY 2021

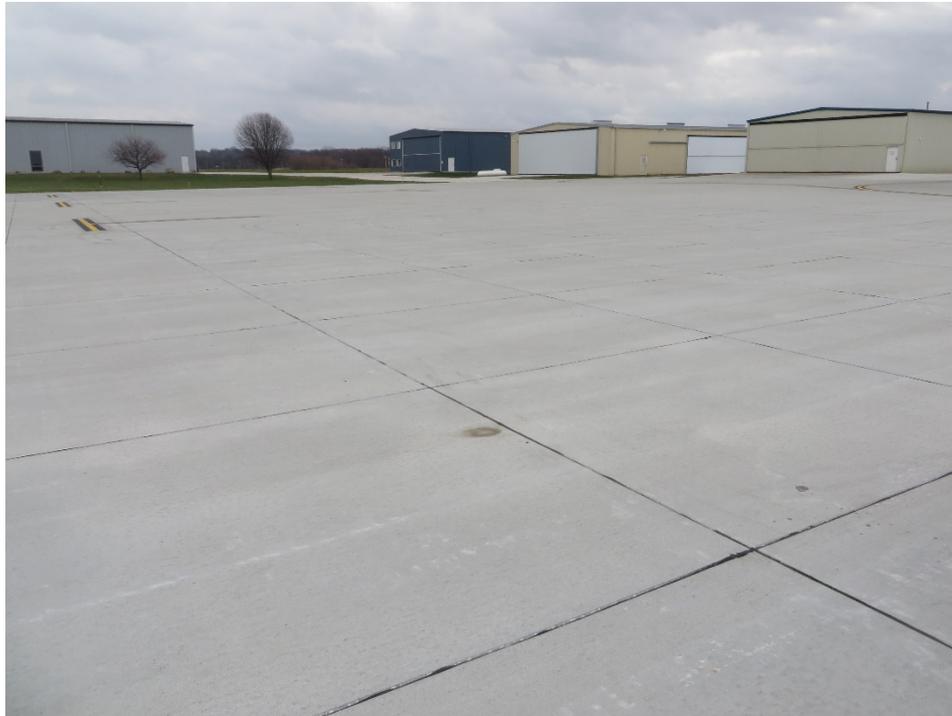
A01AT-01. Overview.

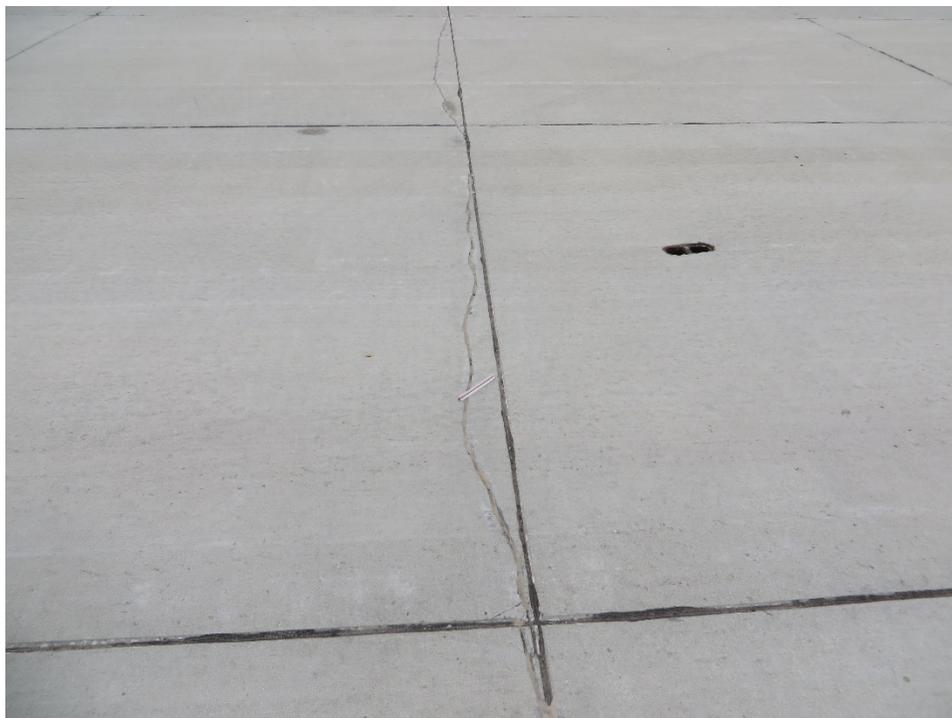
A01AT-01. Joint Spalling (Sample Unit No. 14).

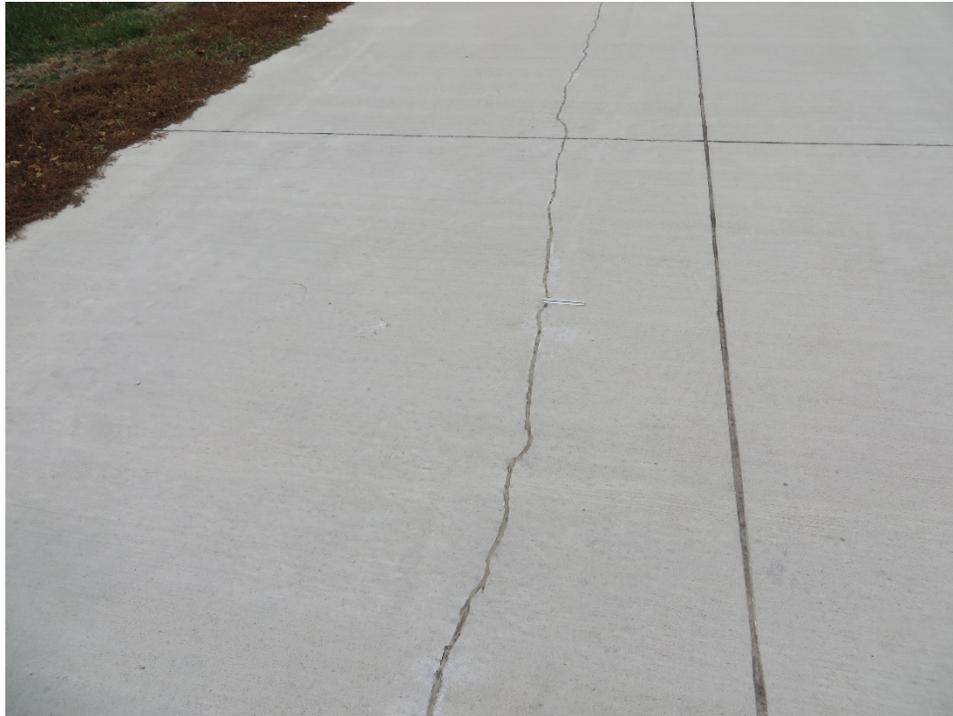
A01AT-01. LTD Cracking (Sample Unit No. 41).

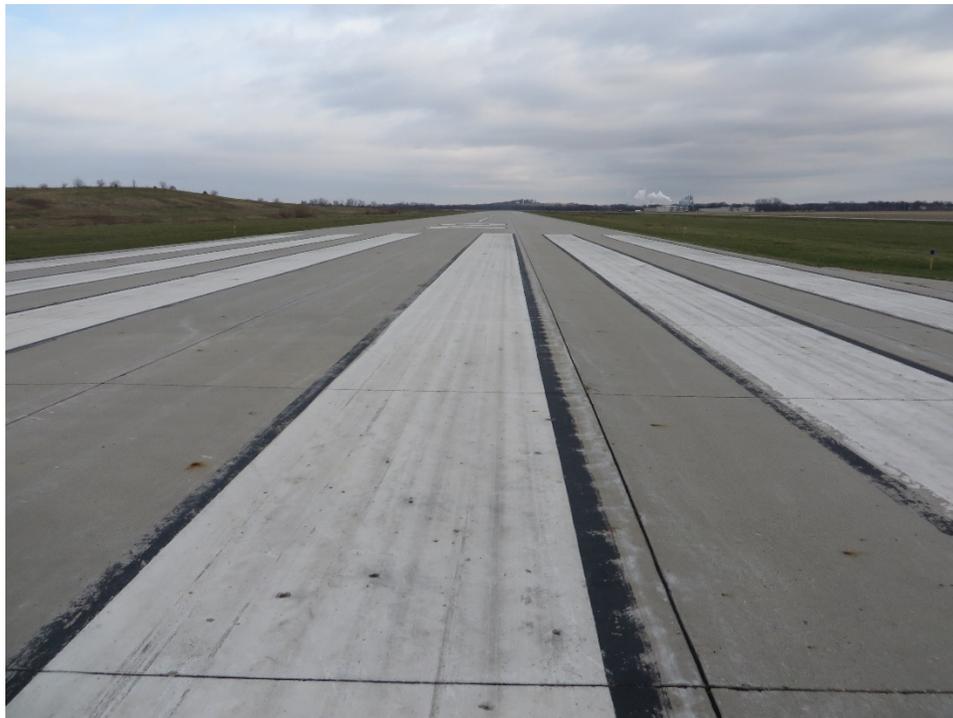
Runway 02/20 was defined by one section that had shrinkage cracking; low-severity corner break, faulting, and small patching; medium-severity corner spalling and joint spalling; and low-severity longitudinal, transverse, and diagonal (LTD) cracking. Significant amounts of high-severity joint seal damage were also recorded throughout the pavement area where joint sealant had significantly deteriorated or was missing. An atypical area of low-severity shattered slab and medium-severity LTD cracking was also identified and recorded as an additional sample unit, according to ASTM D5340-20.

R02AT-01. Overview.

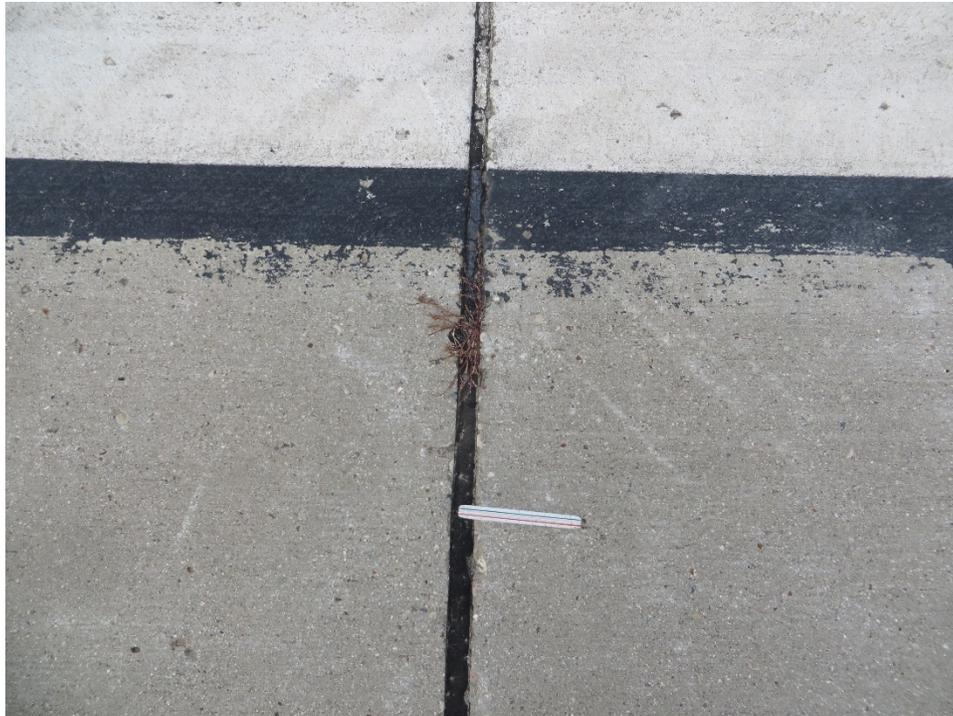
R02AT-01. Joint Seal Damage (Sample Unit No. 103).

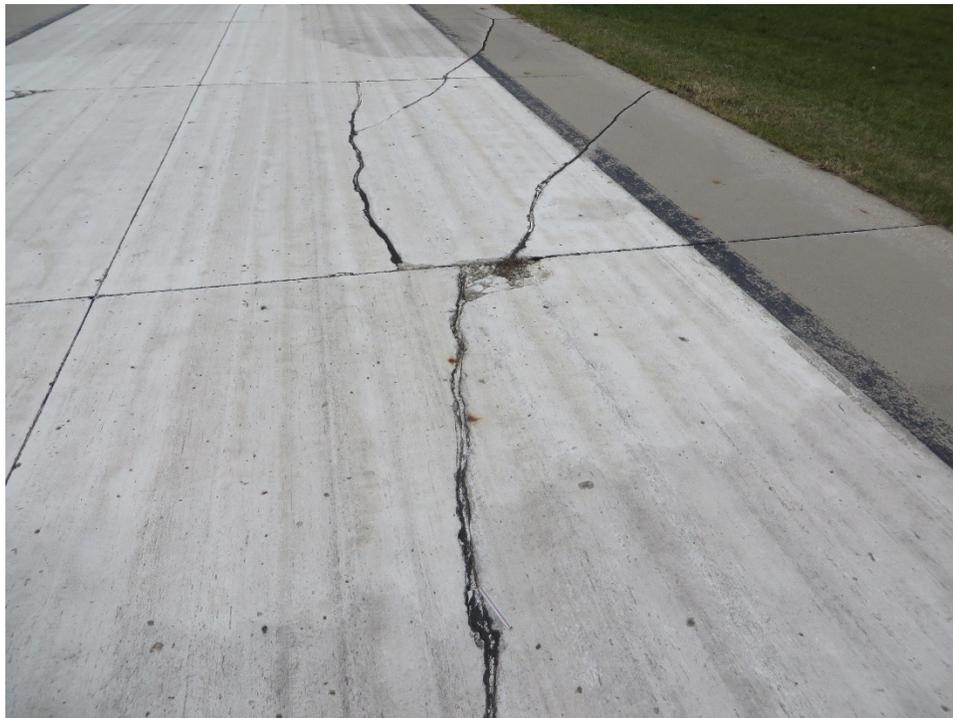
R02AT-01. LTD Cracking (Additional Sample Unit No. 81).

Sample Number: 81 Type: A Area: 24.00Slabs PCI = 45
Sample Comments:
63 LINEAR CRACKING L 1.00 Slabs Comments:
63 LINEAR CRACKING M 6.00 Slabs Comments:
72 SHATTERED SLAB L 1.00 Slabs Comments:
71 FAULTING L 1.00 Slabs Comments:

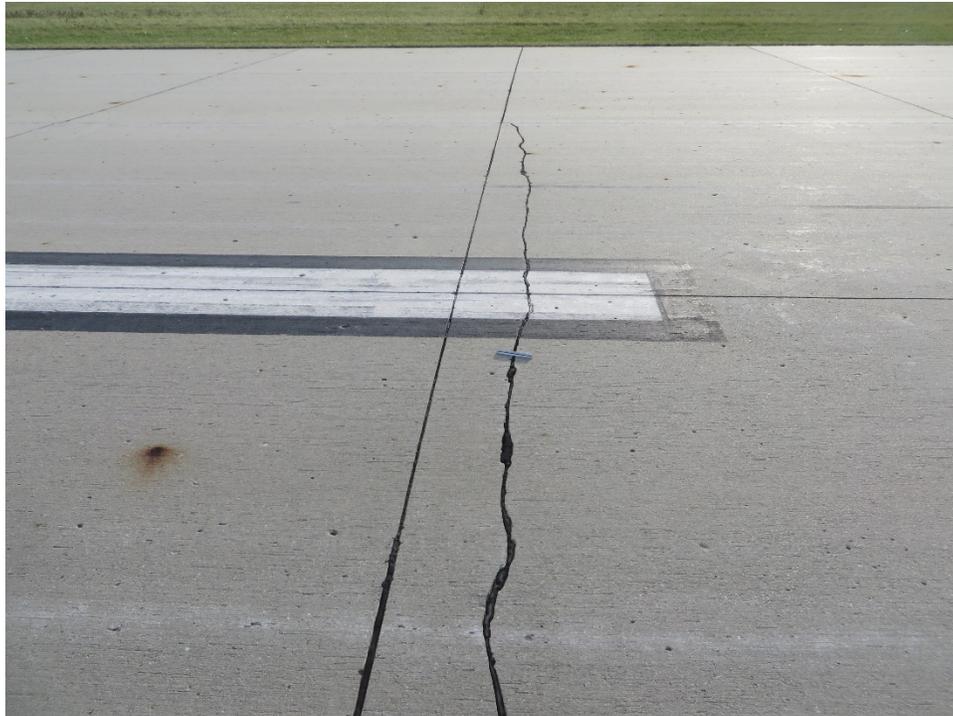
R02AT-01. LTD Cracking (Sample Unit No. 93).

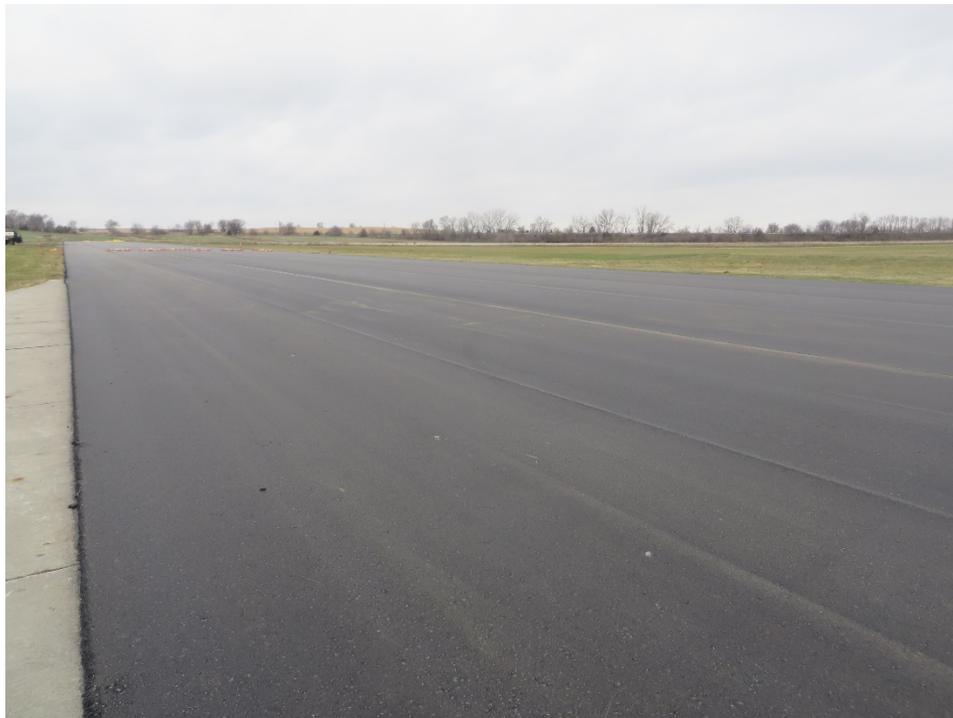
Runway 12/30 contained one recently rehabilitated section that was in excellent condition, with no distresses observed during the inspection.

R12AT-01. Overview.

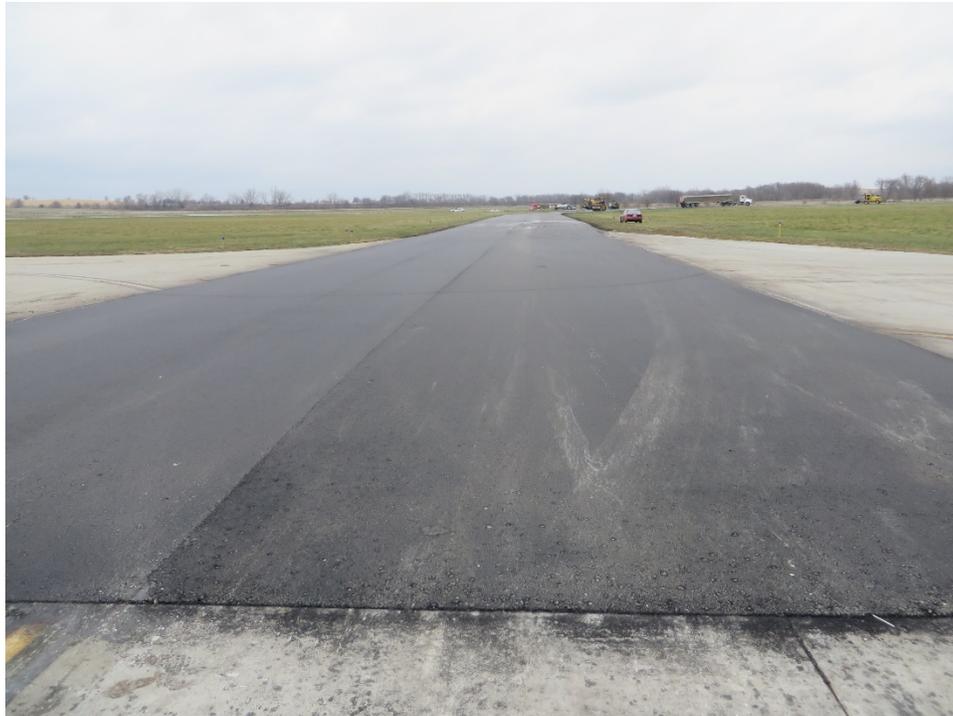
Taxiway 01 consisted of one recently rehabilitated section that was in excellent condition. No distresses were noted at the time of the inspection.

T01AT-01. Overview.

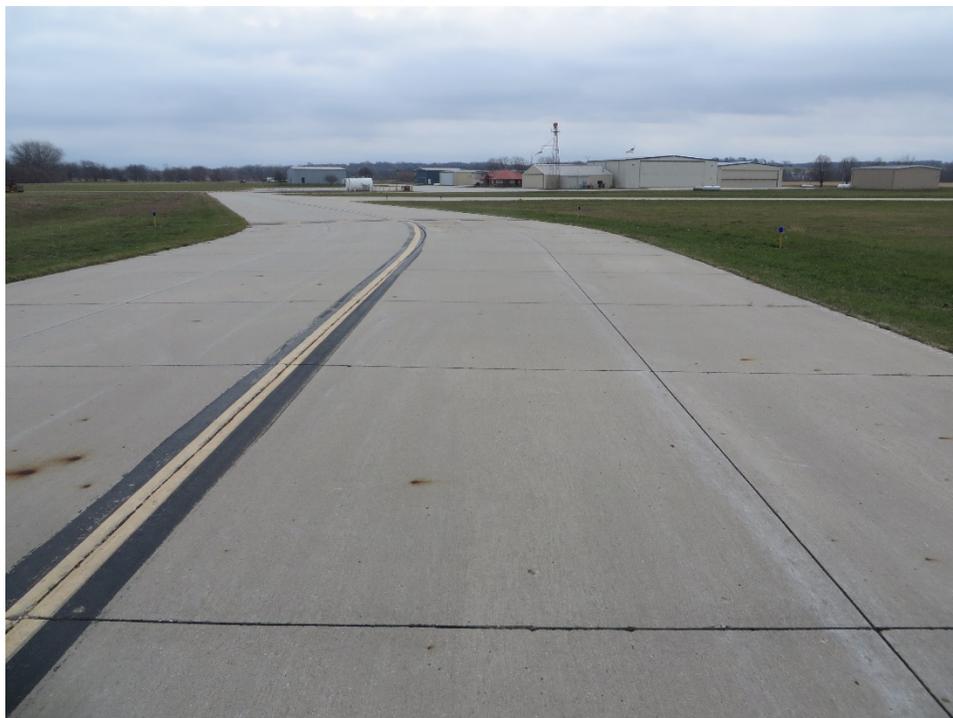
Taxiway 02 was defined by one section. Shrinkage cracking, low-severity faulting and joint spalling, and high-severity joint seal damage were recorded in Section 01.

T02AT-01. Overview.

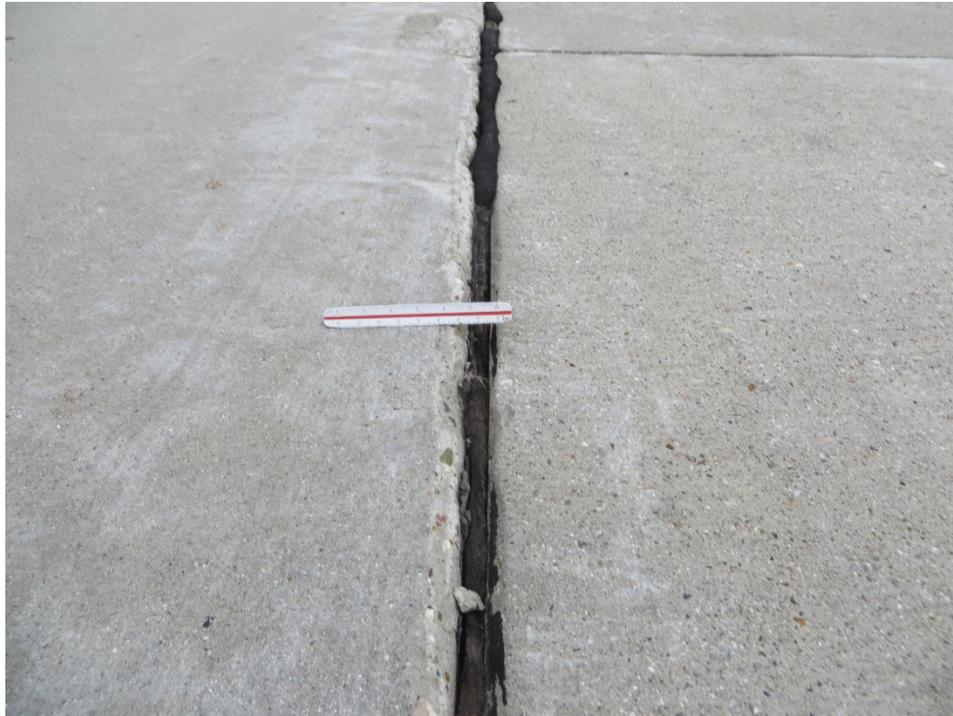
T02AT-01. Faulting (Sample Unit No. 03).

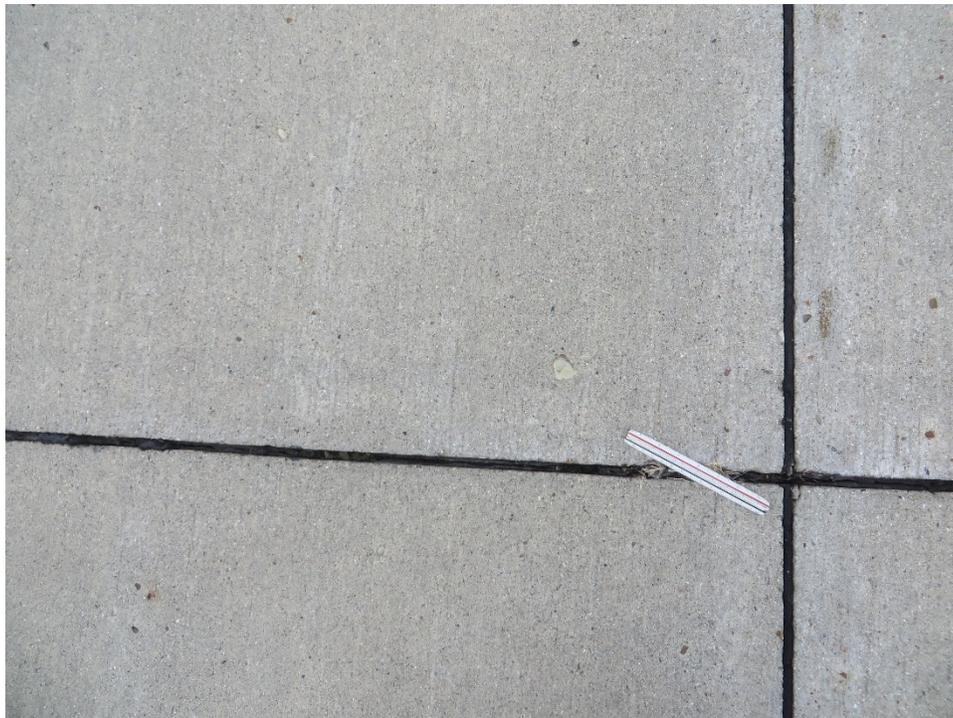
T02AT-01. Joint Seal Damage (Sample Unit No. 03).

Sample Number: 03 Type: R Area: 24.00Slabs PCI = 88
Sample Comments:
65 JOINT SEAL DAMAGE H 24.00 Slabs Comments:

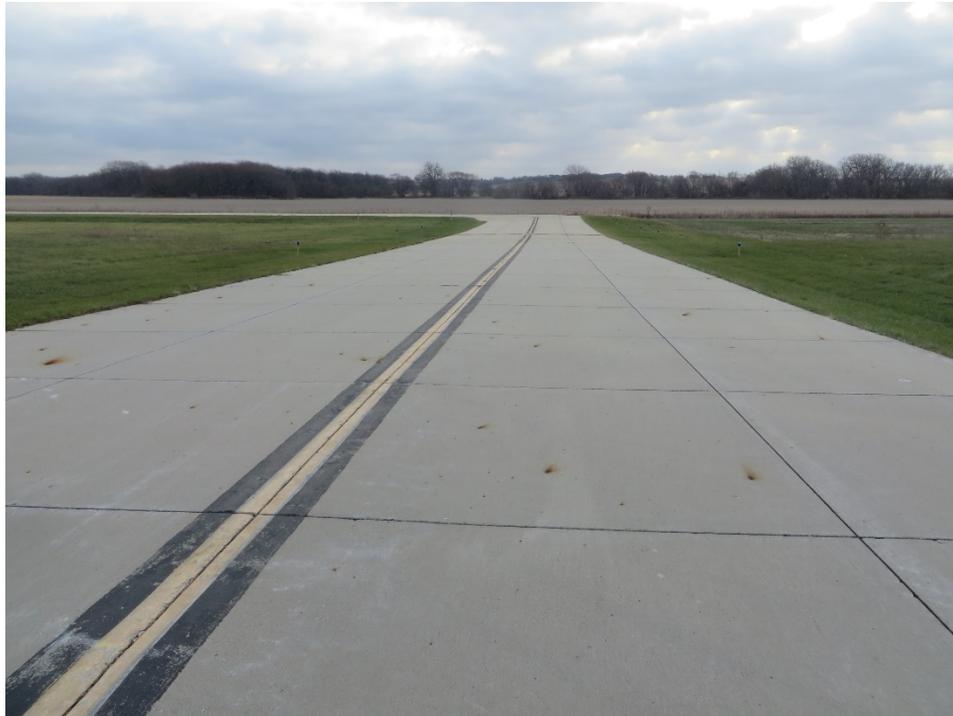
Taxiway 03 contained one section with low-severity corner break and small patching, medium-severity corner spalling, low- and medium-severity faulting, and high-severity joint seal damage were observed during the inspection.

T03AT-01. Overview.

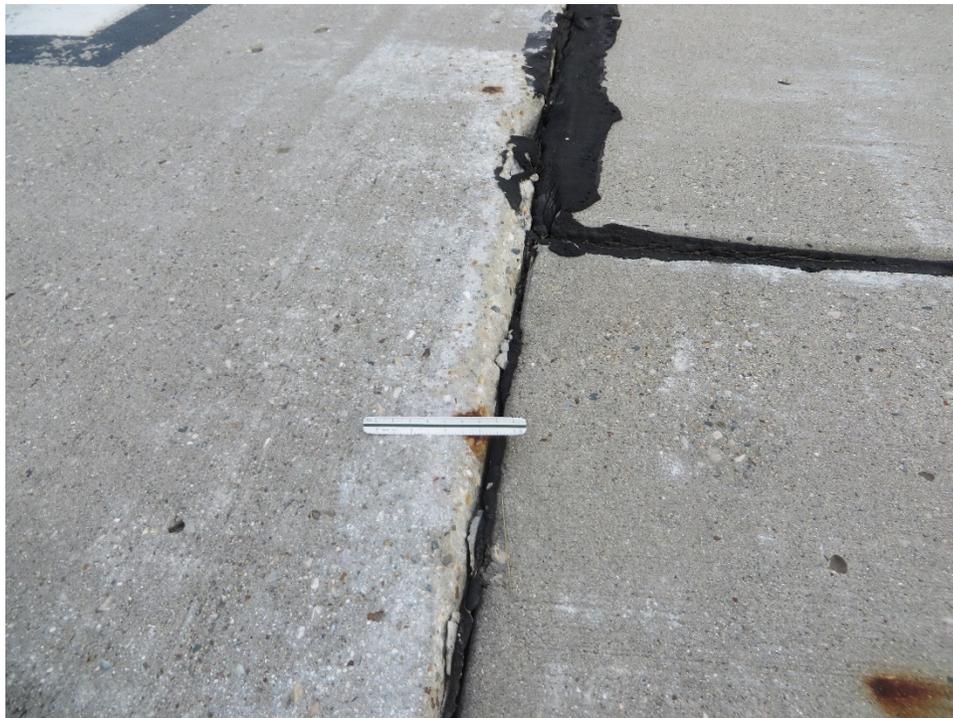
T03AT-01. Faulting (Sample Unit No. 01).

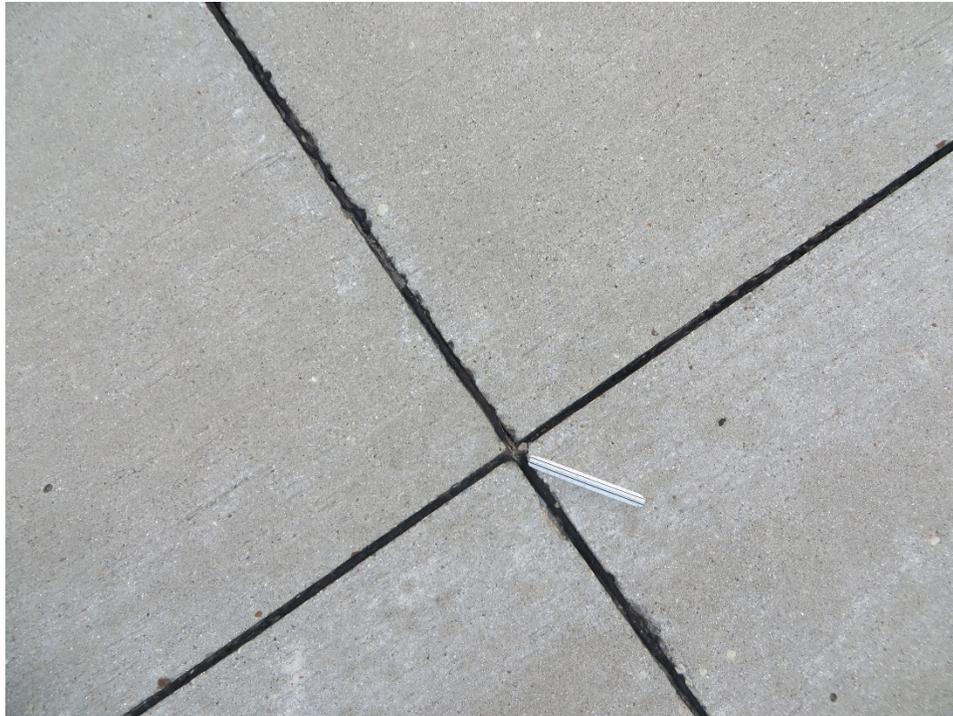
T03AT-01. Joint Seal Damage (Sample Unit No. 02).

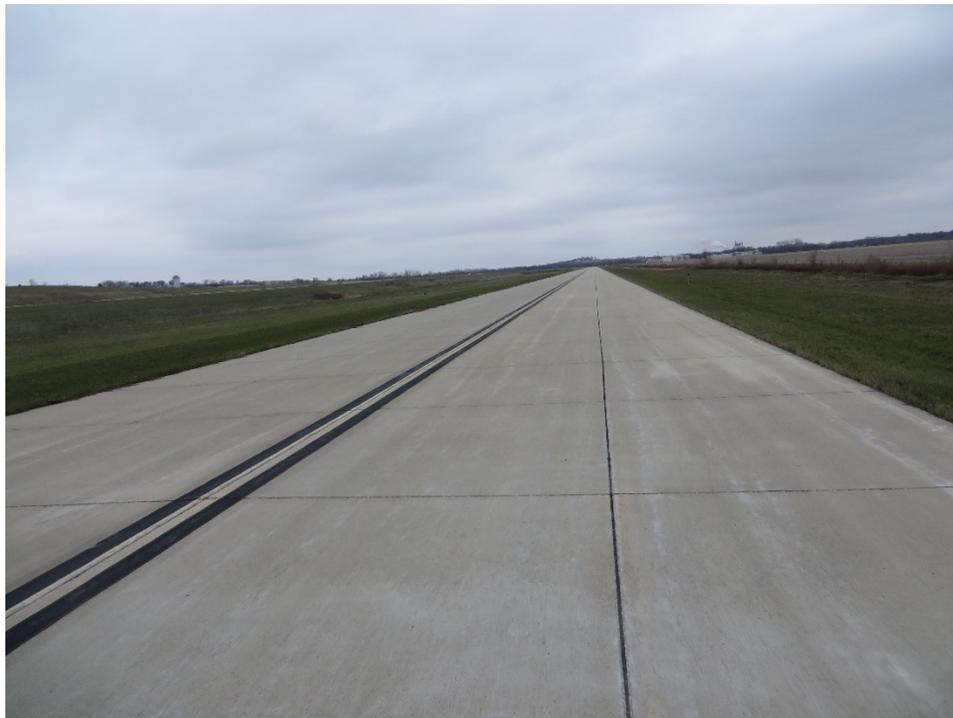
Taxiway 04 was defined by one section in excellent condition. An isolated area of medium-severity LTD cracking was observed in Section 01, along with low-severity joint seal damage noted throughout.

T04AT-01. Overview.

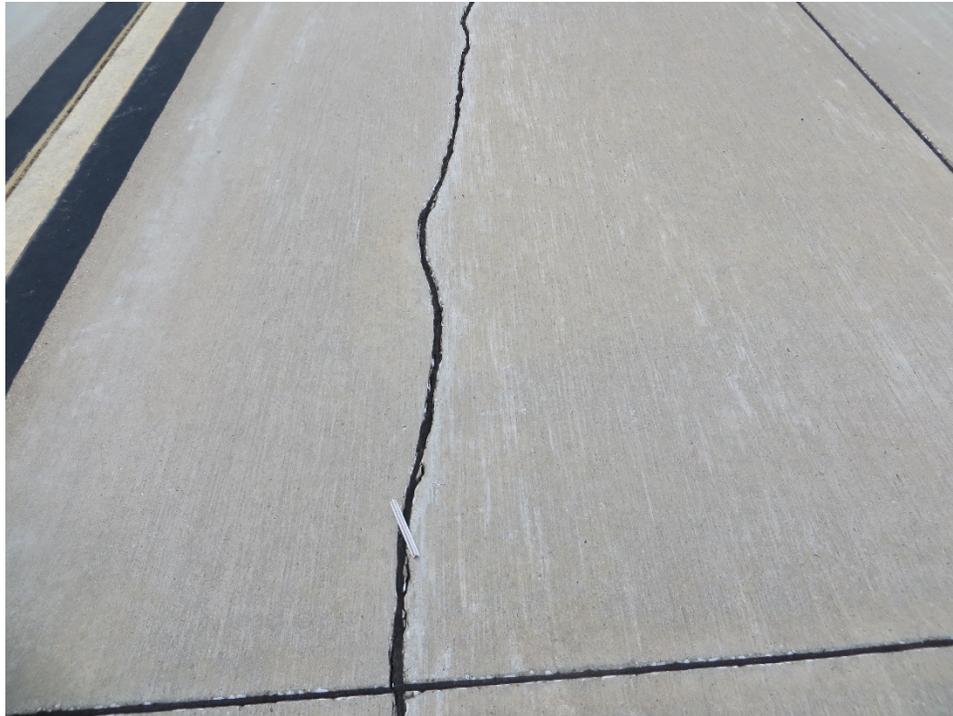
T04AT-01. LTD Cracking (Sample Unit No. 36).

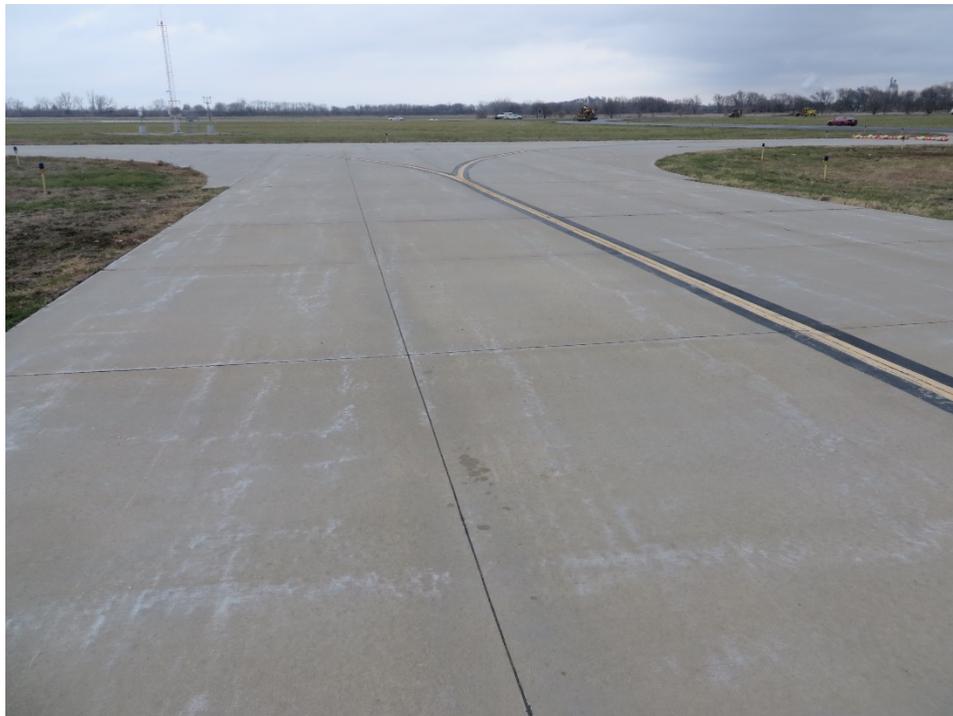
Taxiway 05 consisted of one section. Areas of shrinkage cracking, low-severity joint spalling and small patching, low- and medium-severity corner spalling, and medium-severity joint seal damage were recorded in Section 01.

T05AT-01. Overview.

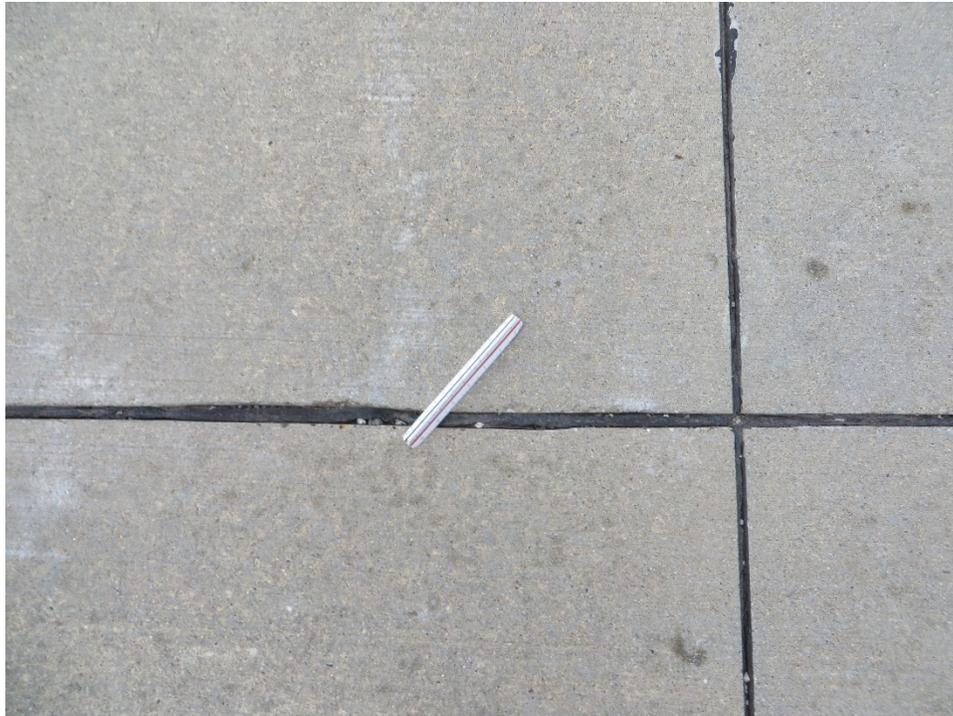
T05AT-01. Joint Seal Damage (Sample Unit No. 04).

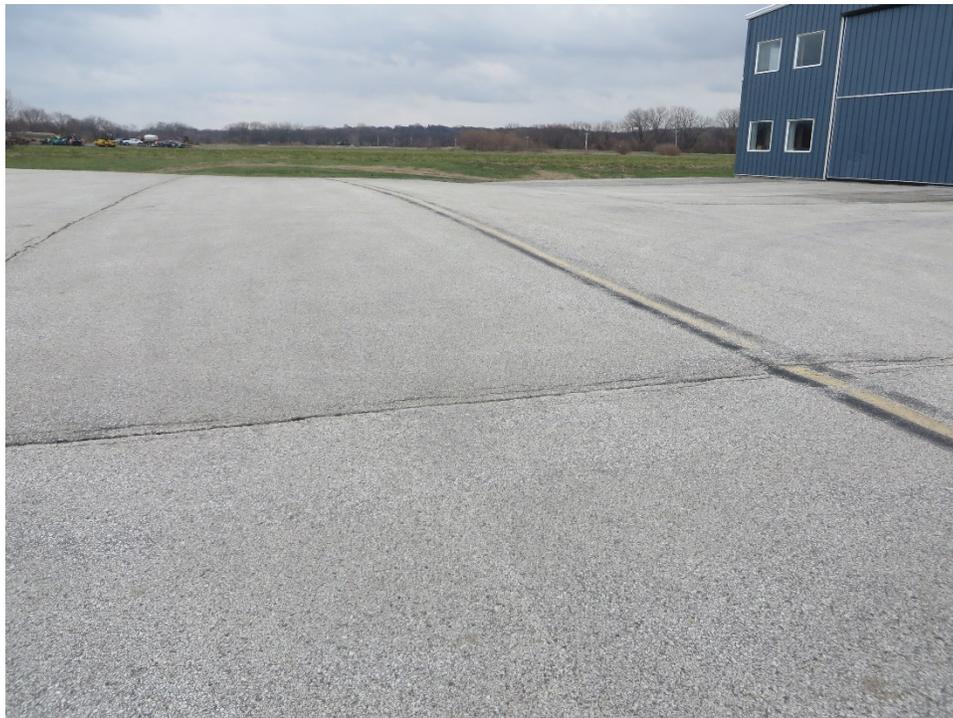
T-hangar 01 contained three sections. Low-severity depression and rutting, medium-severity weathering, medium- and high-severity raveling, low- and medium-severity alligator cracking, and all severities of longitudinal and transverse (L&T) cracking were observed in Section 01. Section 02 was in similar condition with low-severity depression and rutting, medium-severity weathering, low- and medium-severity alligator cracking and raveling, and all severities of L&T cracking recorded at the time of inspection. In both sections, the low- and medium-severity L&T cracking were unsealed, with the medium-severity cracking noted where unsealed crack widths exceeded ¼ in. The high-severity L&T cracking was identified where secondary cracking wider

TH01AT-01. Overview.

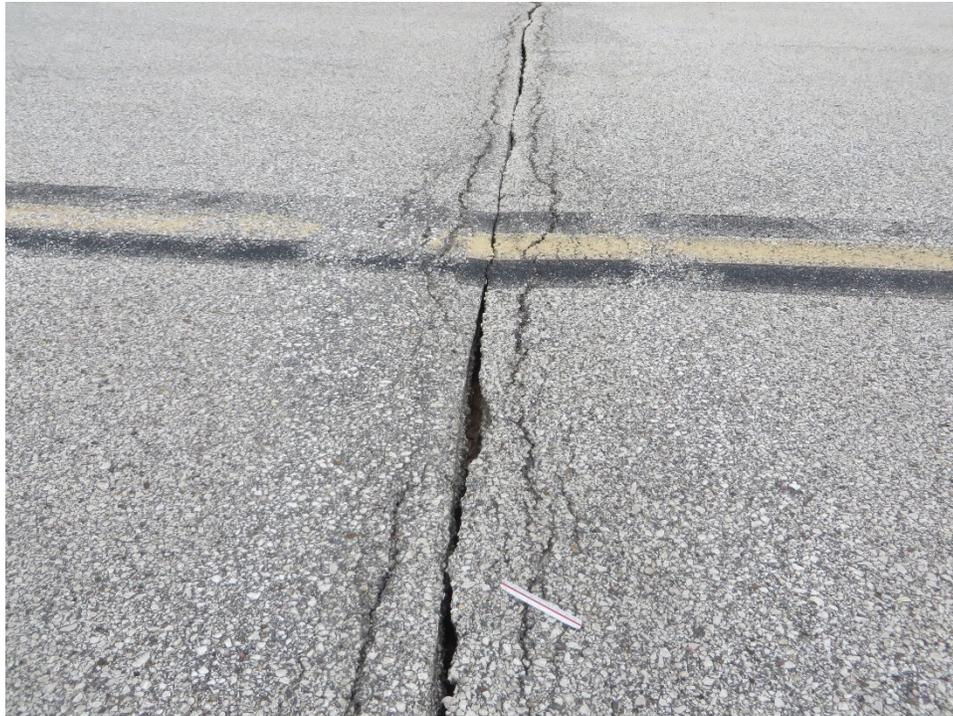
TH01AT-01. L&T Cracking (Sample Unit No. 02).

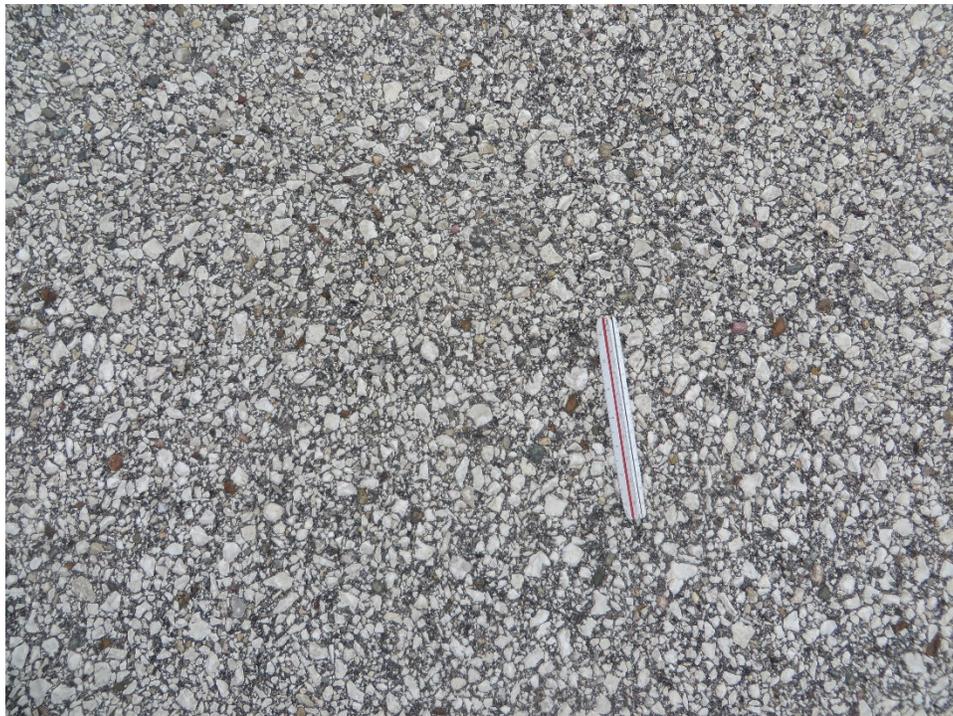
TH01AT-01. Weathering (Sample Unit No. 02).

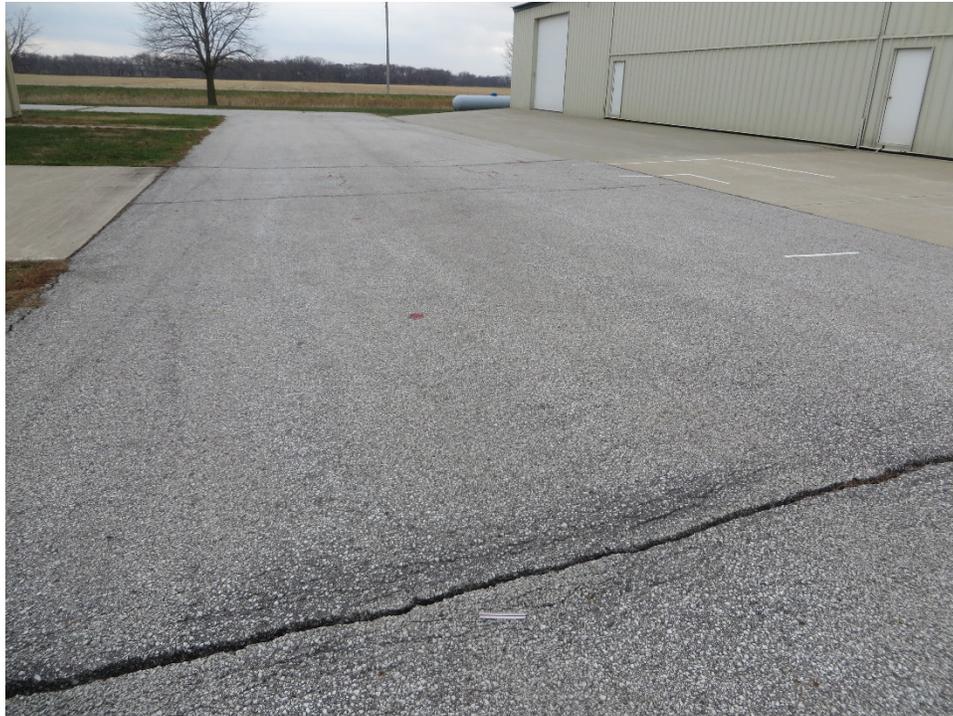
TH01AT-02. Overview.

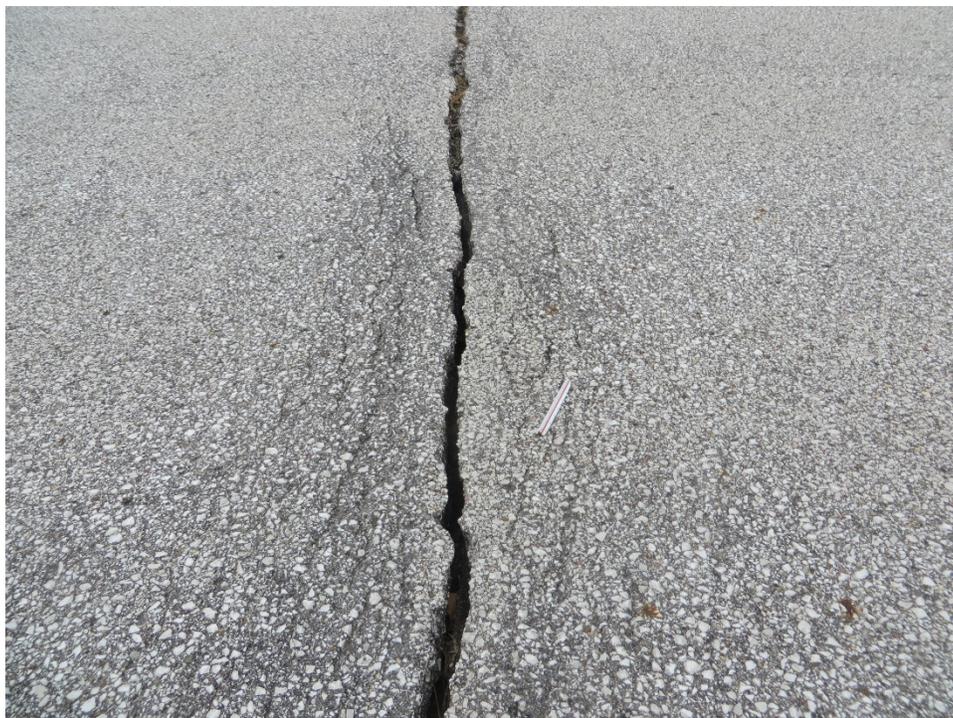
TH01AT-02. L&T Cracking (Sample Unit No. 02).

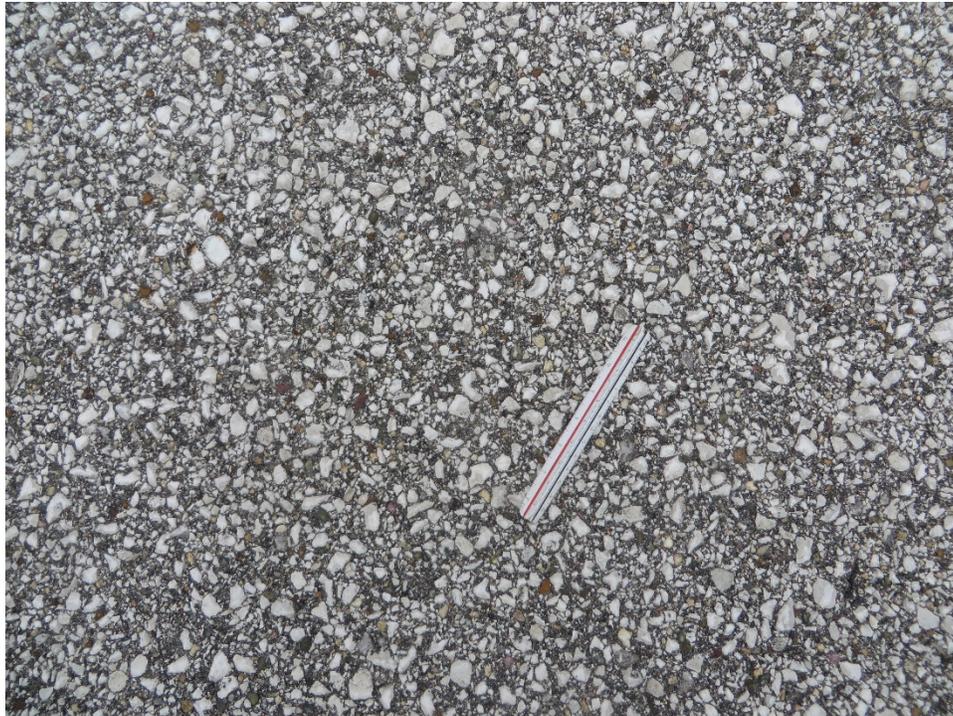
TH01AT-02. Weathering (Sample Unit No. 02).

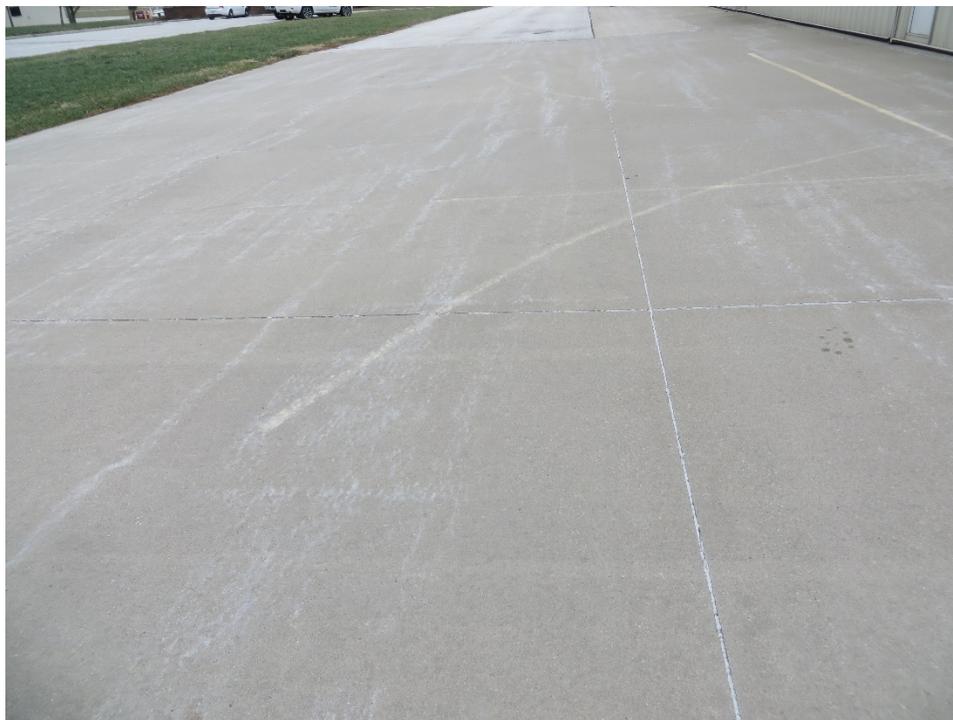
than 1 ft had developed. In Section 03, small amounts of shrinkage cracking and low-severity LTD cracking were recorded, along with high-severity joint seal damage that was observed throughout.

TH01AT-03. Overview.

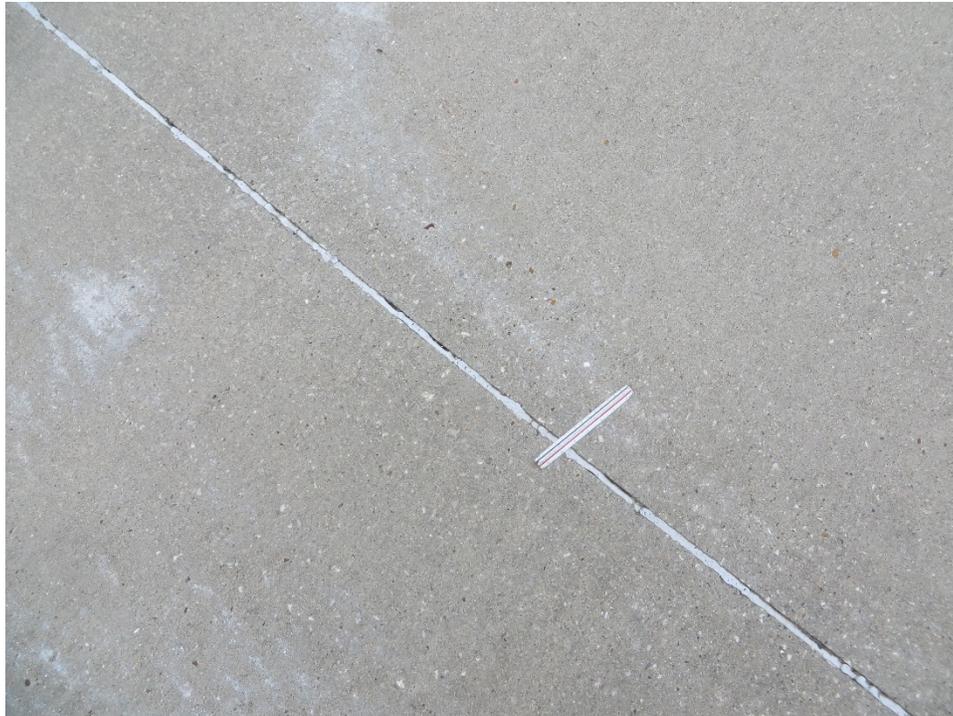
TH01AT-03. Joint Seal Damage (Sample Unit No. 01).

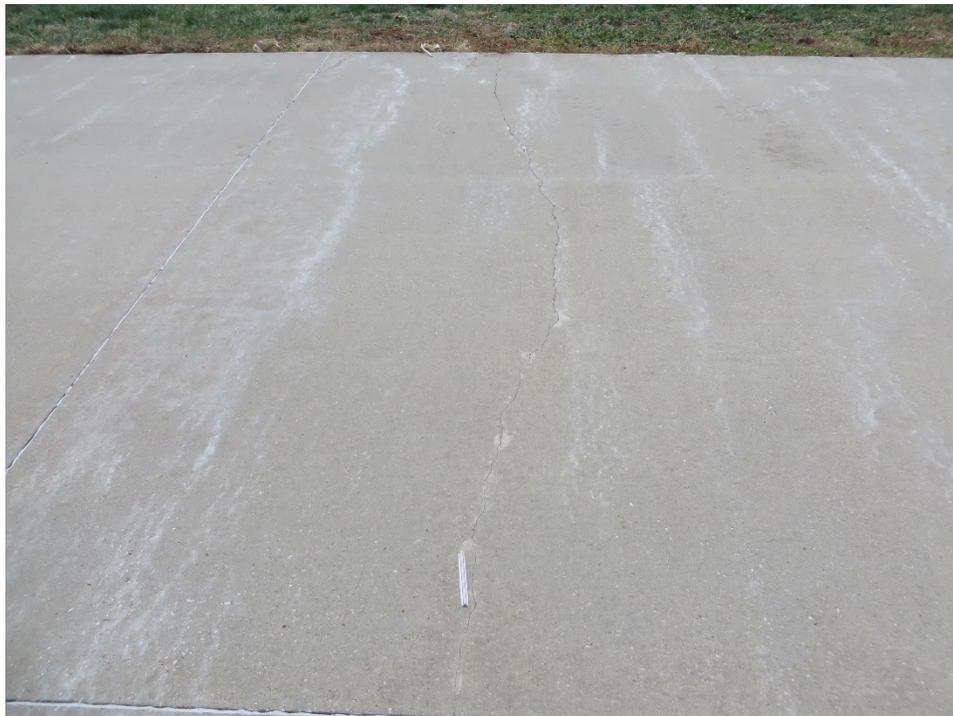
TH01AT-03. LTD Cracking (Sample Unit No. 01).

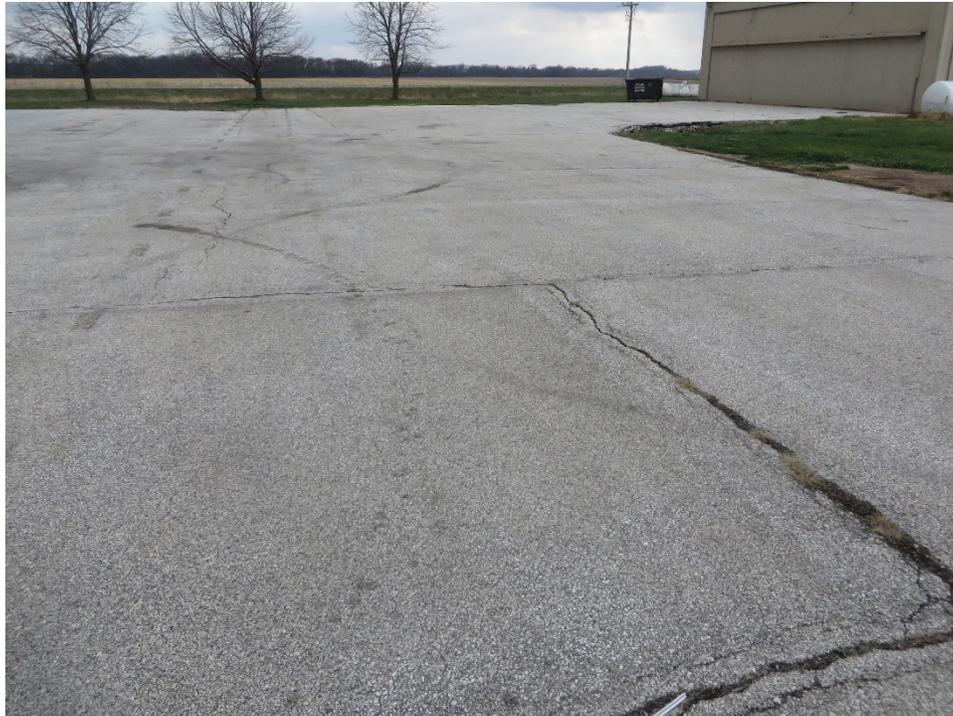
T-hangar 02 was defined by one section in poor condition. Section 01 had areas of low-severity rutting and medium-severity alligator cracking, raveling, and weathering. All severities of L&T cracking were also recorded during the inspection. The low-severity L&T cracking was identified in unsealed condition, while the medium-severity L&T cracking was recorded where either unsealed crack widths exceeded $\frac{1}{4}$ in or secondary cracking had developed. The high-severity L&T cracking was recorded where secondary cracking wider than 1 ft had developed.

TH02AT-01. Overview.

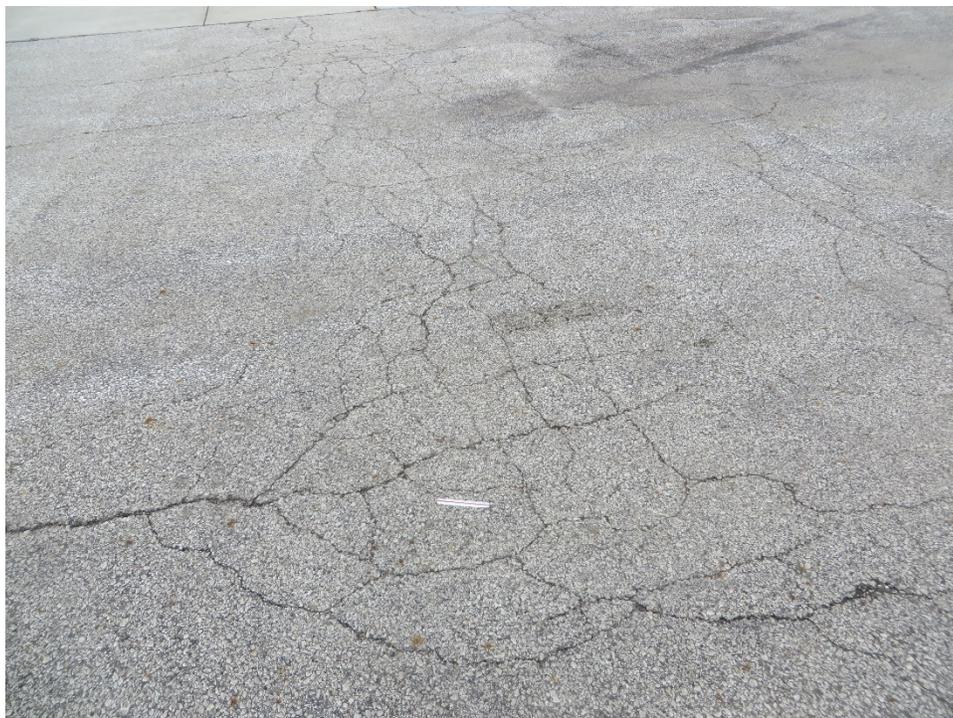
TH02AT-01. Alligator Cracking (Sample Unit No. 02).

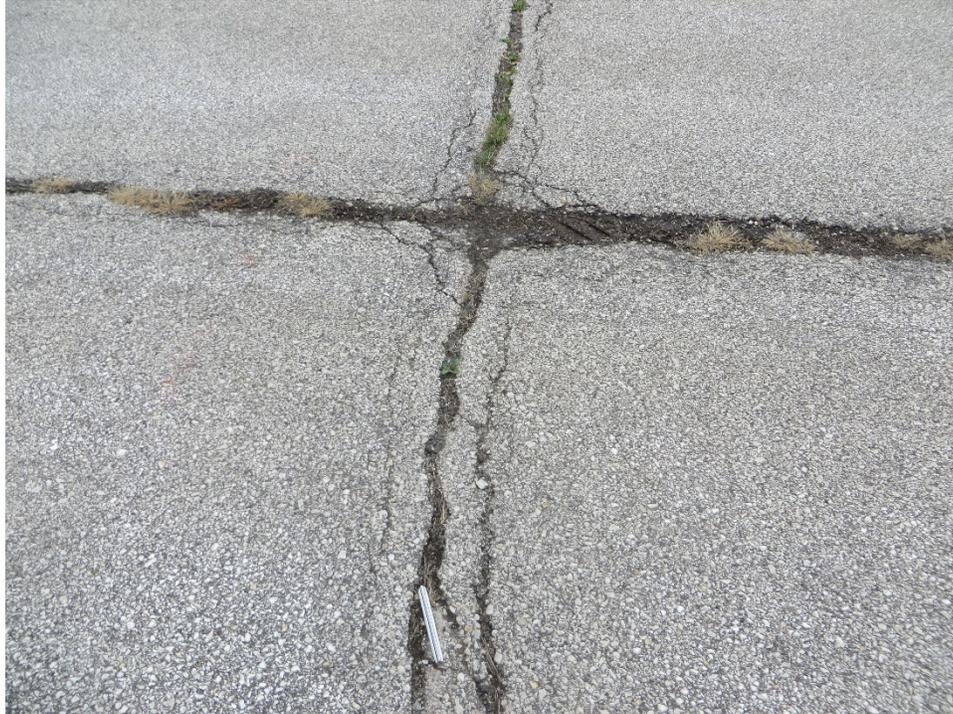
TH02AT-01. L&T Cracking (Sample Unit No. 02).

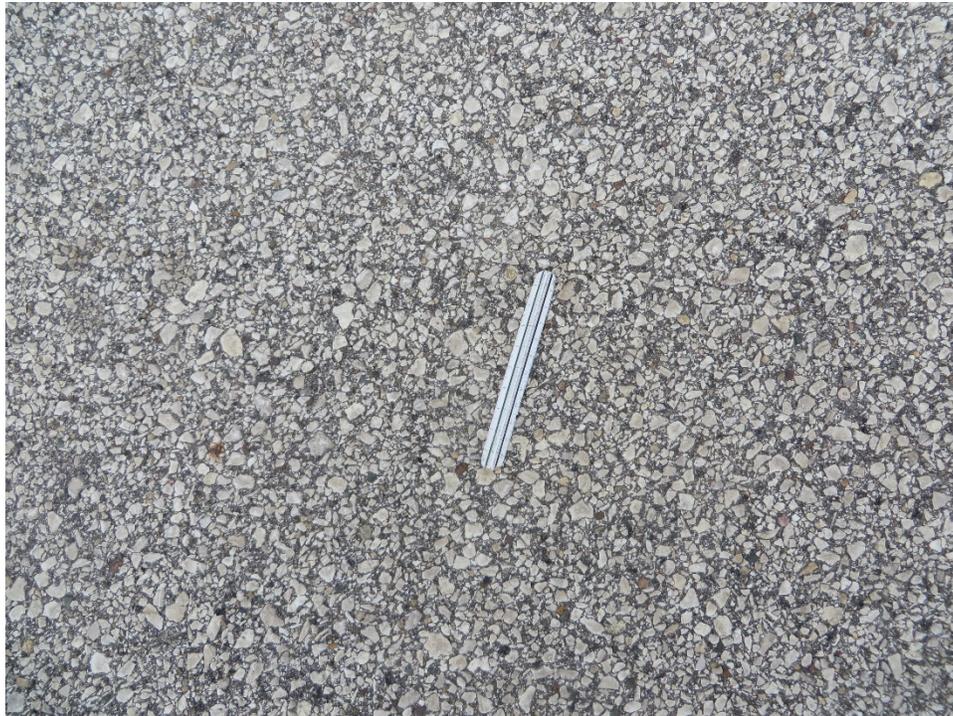
TH02AT-01. Weathering (Sample Unit No. 02).
