Atlantic Municipal Airport

Pavement Management Report

JULY 2024

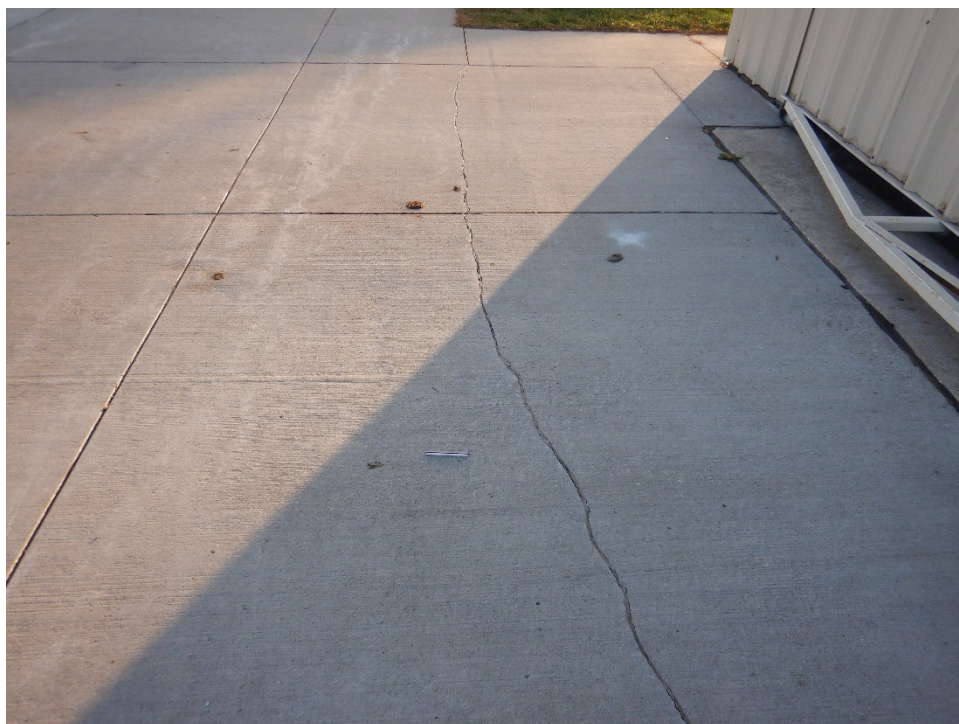
The apron area was defined by one section. Areas of low-severity corner spalling, joint spalling, and joint seal damage and medium-severity corner break and LTD cracking were recorded.

A01AT-01. LTD Cracking (Sample Unit No. 51).

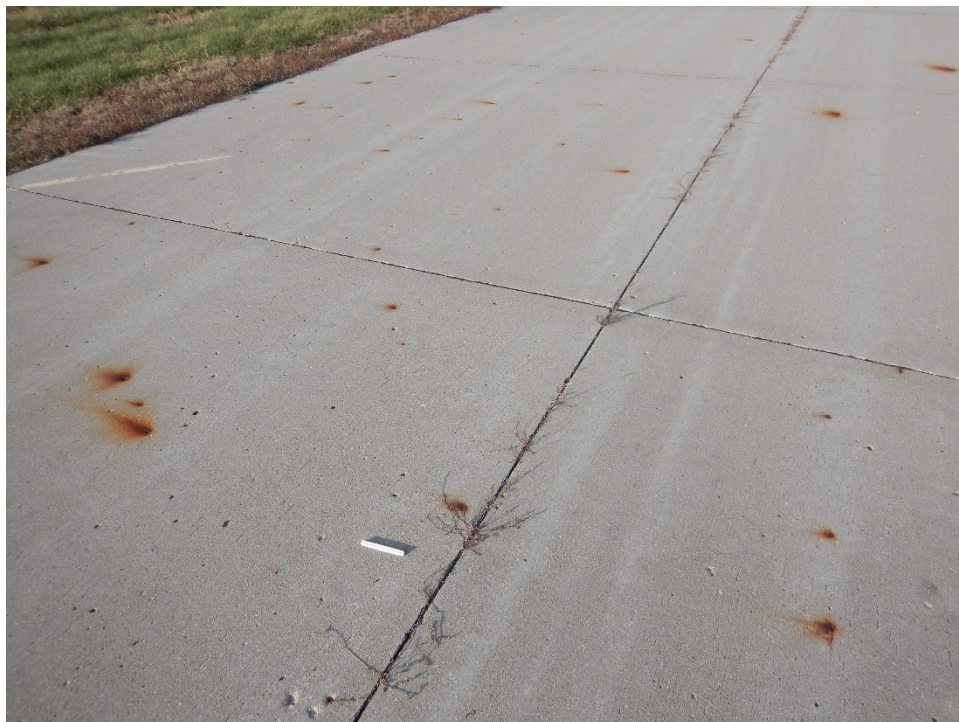
Runway 02/20 consisted of one section. Areas of low-severity faulting and small patching; shrinkage cracking; medium-severity corner break, corner spalling, joint spalling, and longitudinal, transverse, and diagonal (LTD) cracking; and high-severity joint seal damage were recorded in Section 01. An atypical area of medium-severity shattered slab was observed and recorded as an additional sample unit in accordance with ASTM D5340.

R02AT-01. Joint Seal Damage (Sample Unit No. 23).

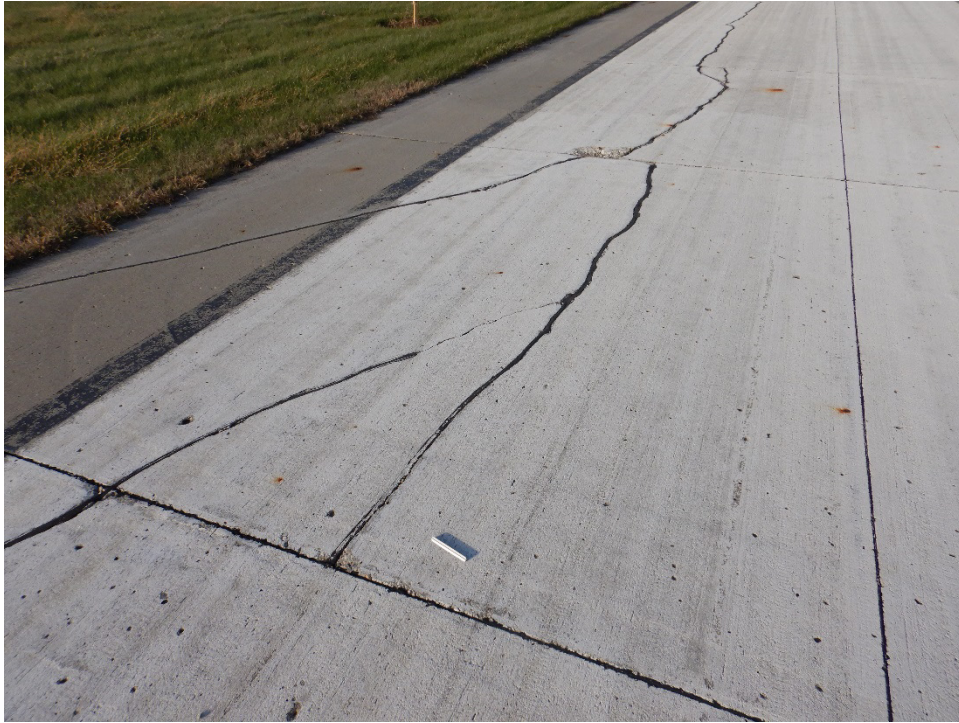
R02AT-01. Shattered Slab (Additional Sample Unit No. 81).

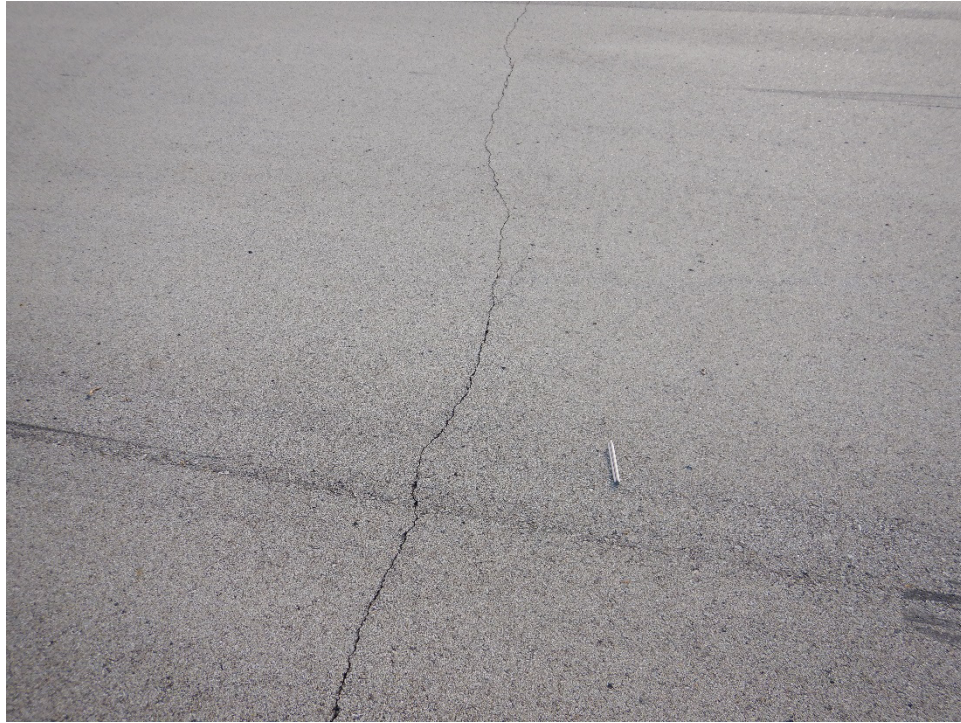
Runway 12/30 contained one section. Low- and medium-severity longitudinal and transverse (L&T) cracking and weathering and medium-severity raveling were identified. The low-severity L&T cracking was unsealed, and the medium-severity L&T cracking was primarily due to unsealed crack widths greater than 1/4 inch.

R12AT-01. L&T Cracking (Sample Unit No. 35).

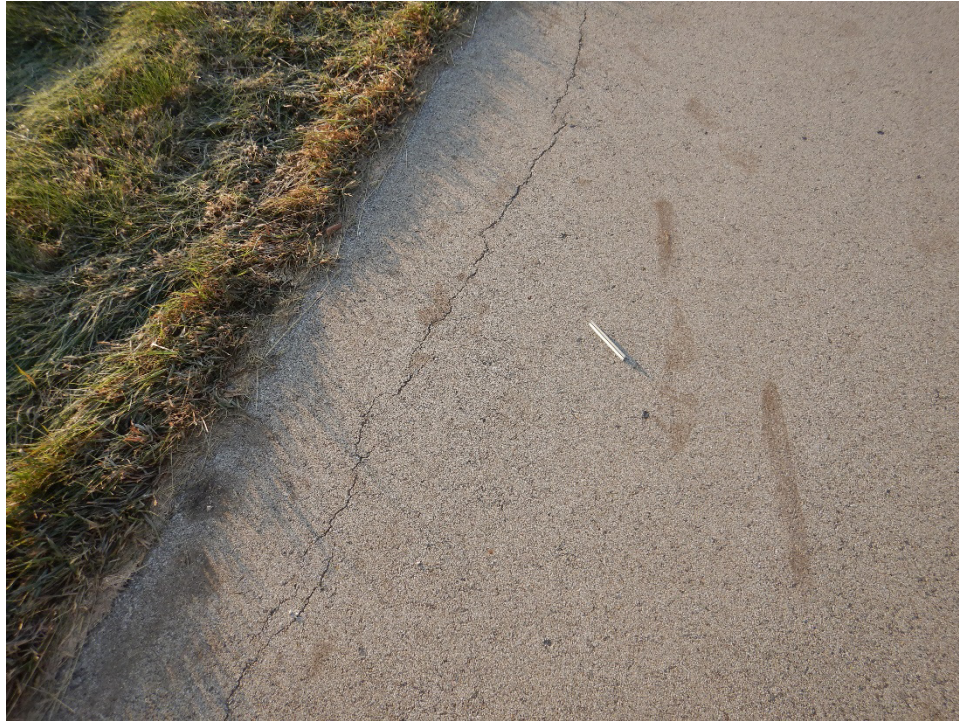
Taxiway 01 was defined by one section that connected the apron area to Runway 12/30. Low-severity L&T cracking in the unsealed condition and weathering were observed during the inspection.

T01AT-01. L&T Cracking (Sample Unit No. 04).

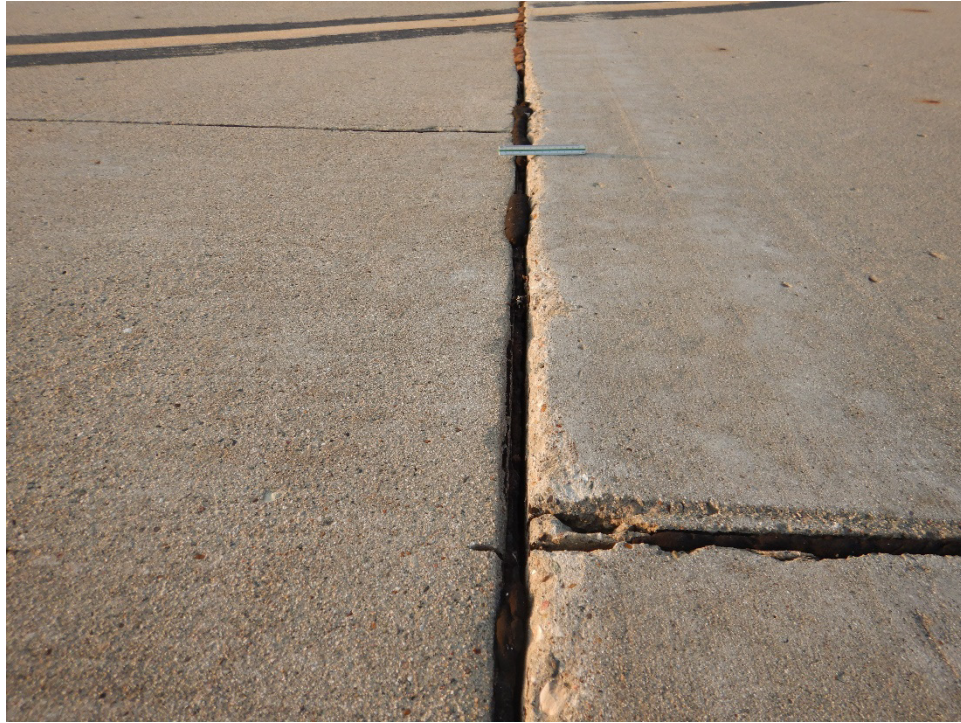
Taxiway 02 consisted of one section that connected Taxiway 01 to Runway 02/20. Low-severity joint spalling, low- and medium-severity faulting, high-severity joint seal damage, and shrinkage cracking were recorded in Section 01.

T02AT-01. Faulting (Sample Unit No. 03).

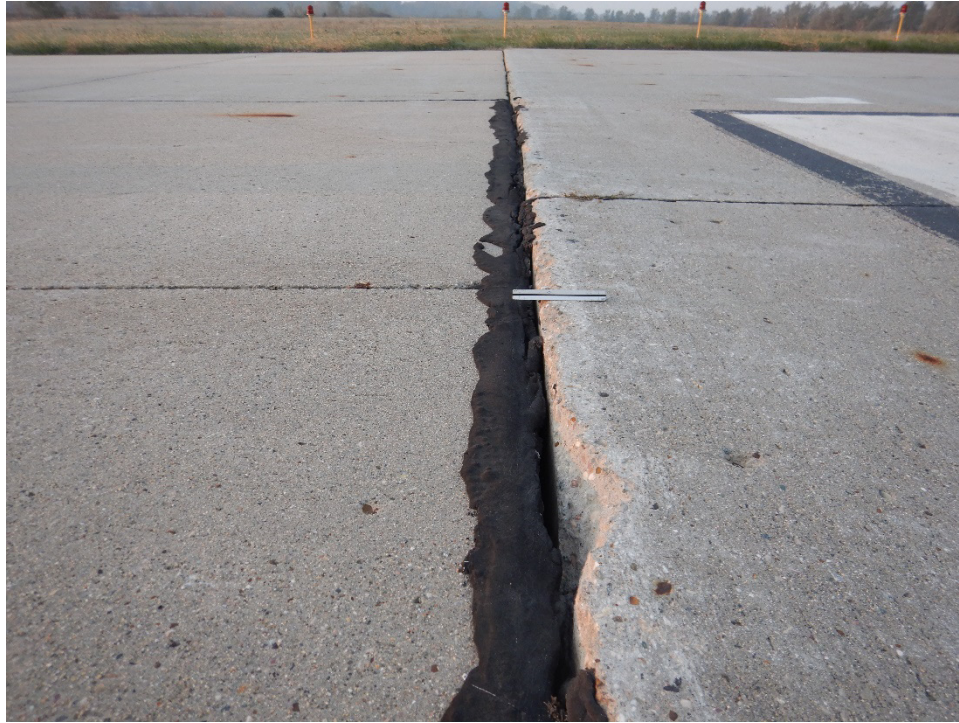
Taxiway 03 contained one section that connected Taxiway 04 to Runway 02/20. Areas of low-severity corner break and small patching, low- and medium-severity faulting, medium-severity joint spalling, and high-severity joint seal damage were identified.

T03AT-01. Faulting (Additional Sample Unit No. 01).

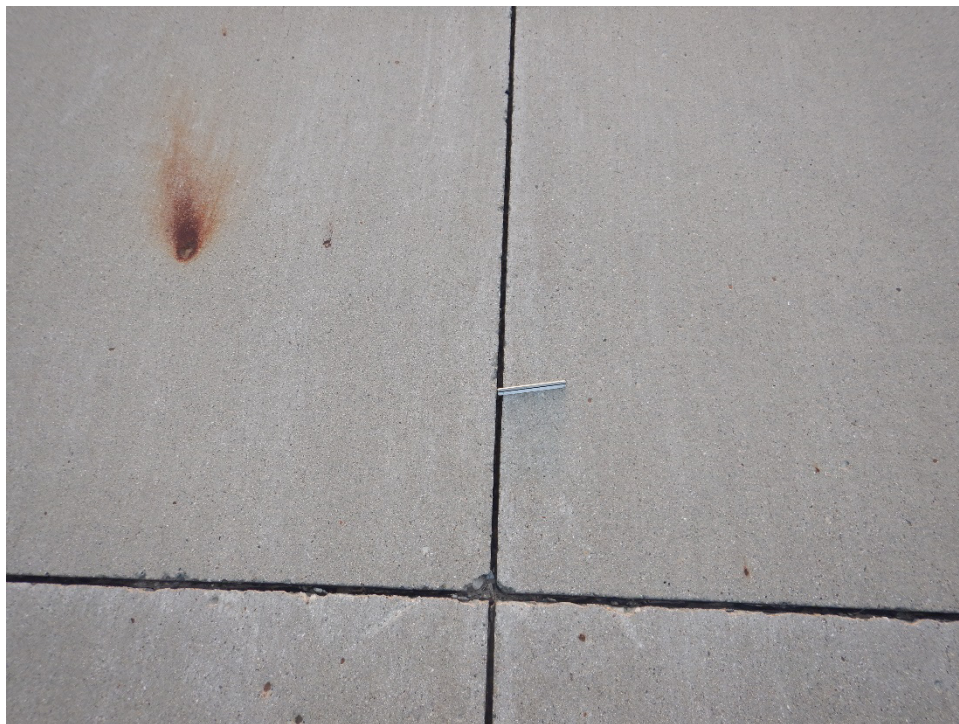
T03AT-01. Joint Seal Damage (Sample Unit No. 02).

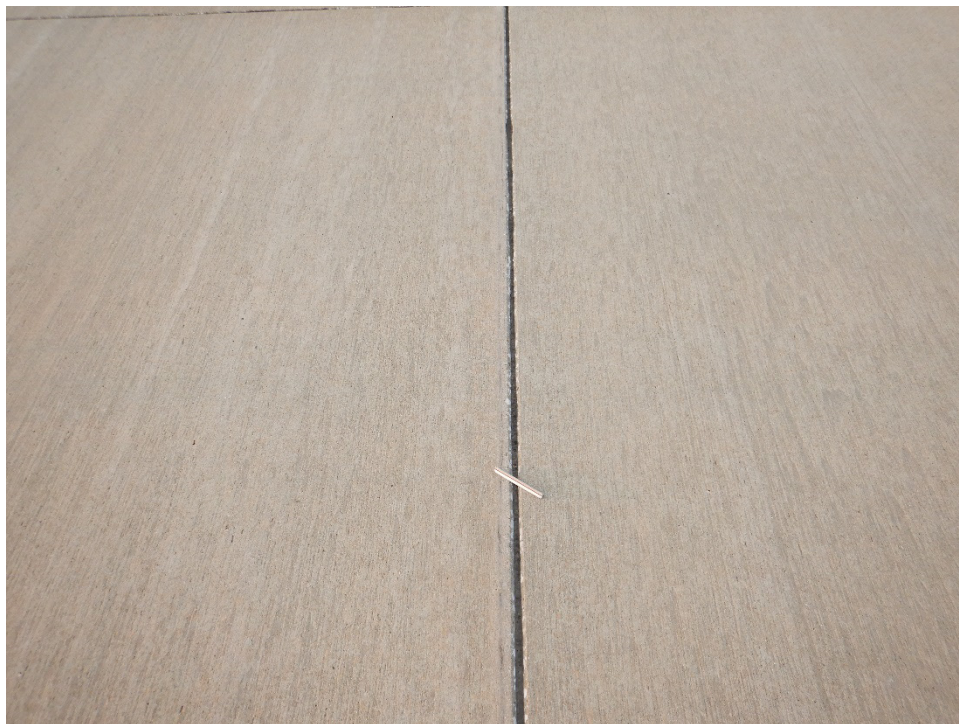
Taxiway 04 consisted of one section in excellent condition with only low-severity joint seal damage and medium-severity LTD cracking identified at the time of the inspection.

T04AT-01. Joint Seal Damage (Sample Unit No. 74).

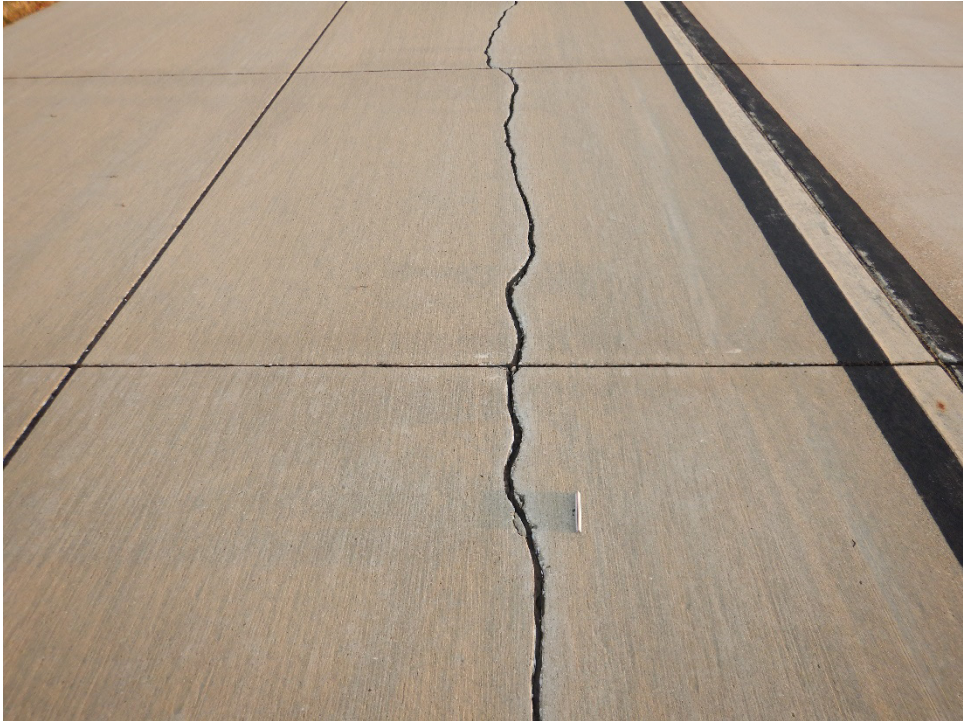
T04AT-01. LTD Cracking (Sample Unit No. 36).

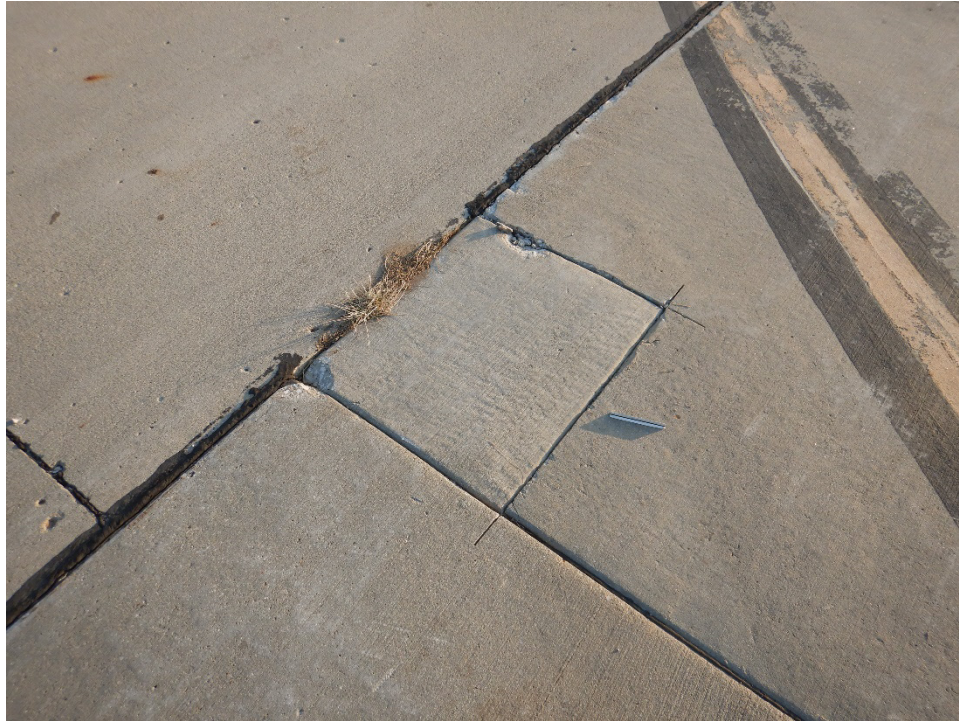
Taxiway 05 was defined by one section that connected Taxiway 02 to the apron area. Low-severity joint spalling, low- and medium-severity corner spalling and small patching, and high-severity joint seal damage were observed in Section 01.

T05AT-01. Small Patching (Sample Unit No. 01).

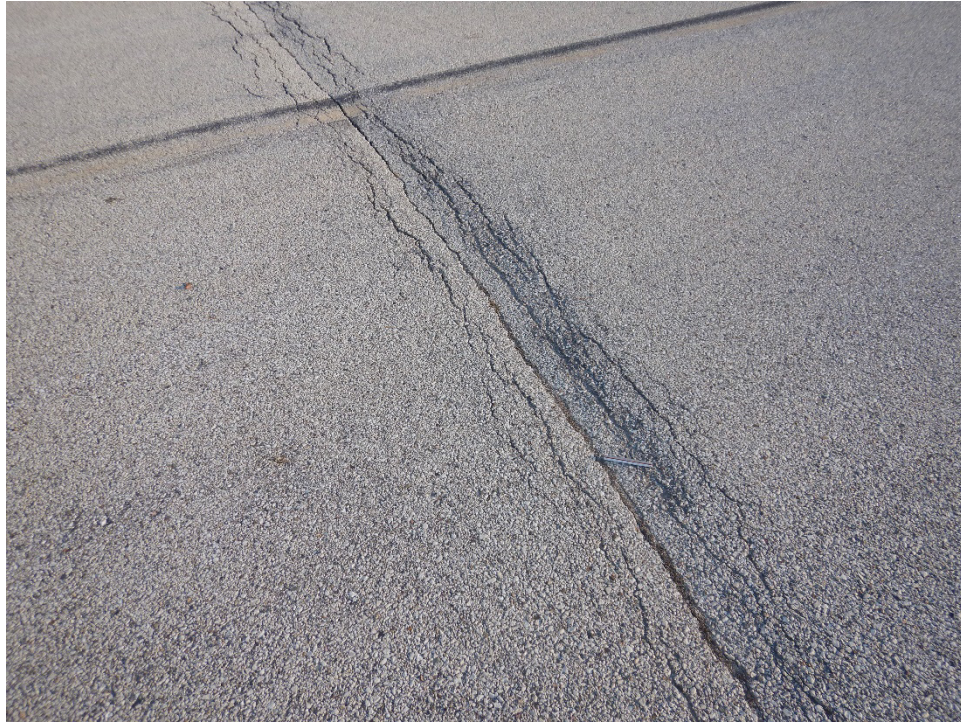
T-hangar 01 consisted of three sections. Sections 01 and 02 were in poor condition with low-severity depression and rutting, low- and medium-severity alligator cracking and raveling, medium- and high-severity weathering, and all severities of L&T cracking observed. Isolated amounts of high-severity raveling were also identified in Section 01. The low-severity L&T cracking was unsealed, and the medium-severity L&T cracking was identified where unsealed crack widths exceeded 1/4 inch. The high-severity L&T cracking was observed where areas of parallel secondary cracking wider than 1 ft had developed. Low-severity LTD cracking, high-severity joint seal damage, and shrinkage cracking were recorded in Section 03.

TH01AT-01. L&T Cracking (Sample Unit No. 01).

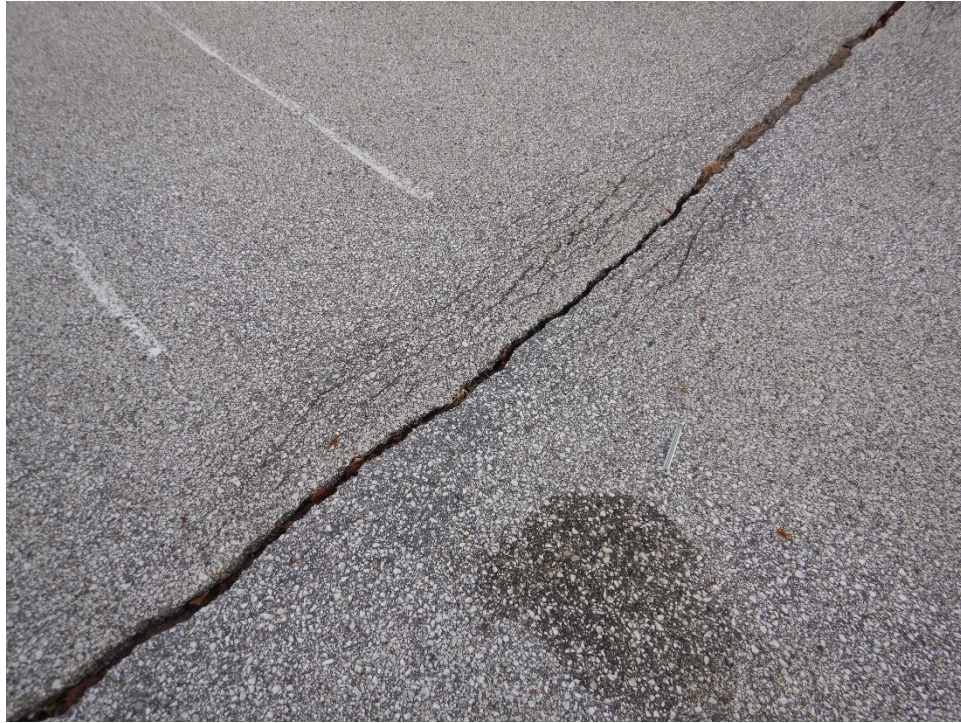
TH01AT-02. L&T Cracking (Sample Unit No. 01).

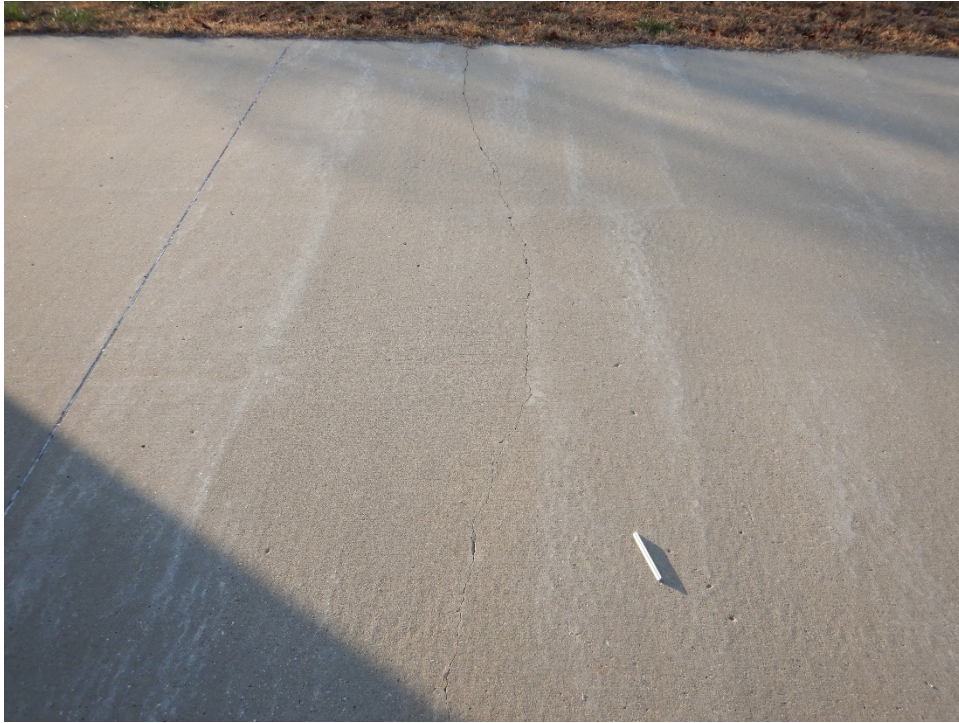
TH01AT-03. LTD Cracking (Sample Unit No. 01).

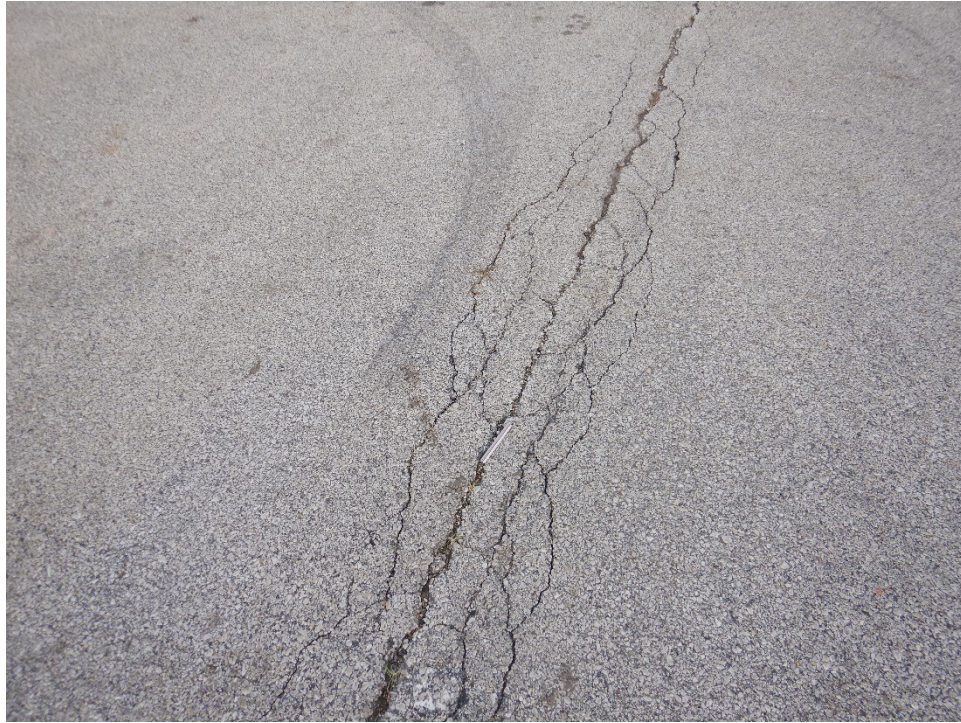
T-hangar 02 was defined by one section. Section 01 was in poor condition with low-severity depression and rutting; medium-severity alligator cracking, raveling, and weathering; and all severities of L&T cracking identified. The low-severity L&T cracking was unsealed, and the medium-severity L&T cracking was due to either the development of secondary cracking or unsealed crack widths that exceeded 1/4 in.

TH02AT-01. Alligator Cracking (Sample Unit No. 01).
