Audubon County Airport

PAVEMENT MANAGEMENT REPORT

JUNE 2018

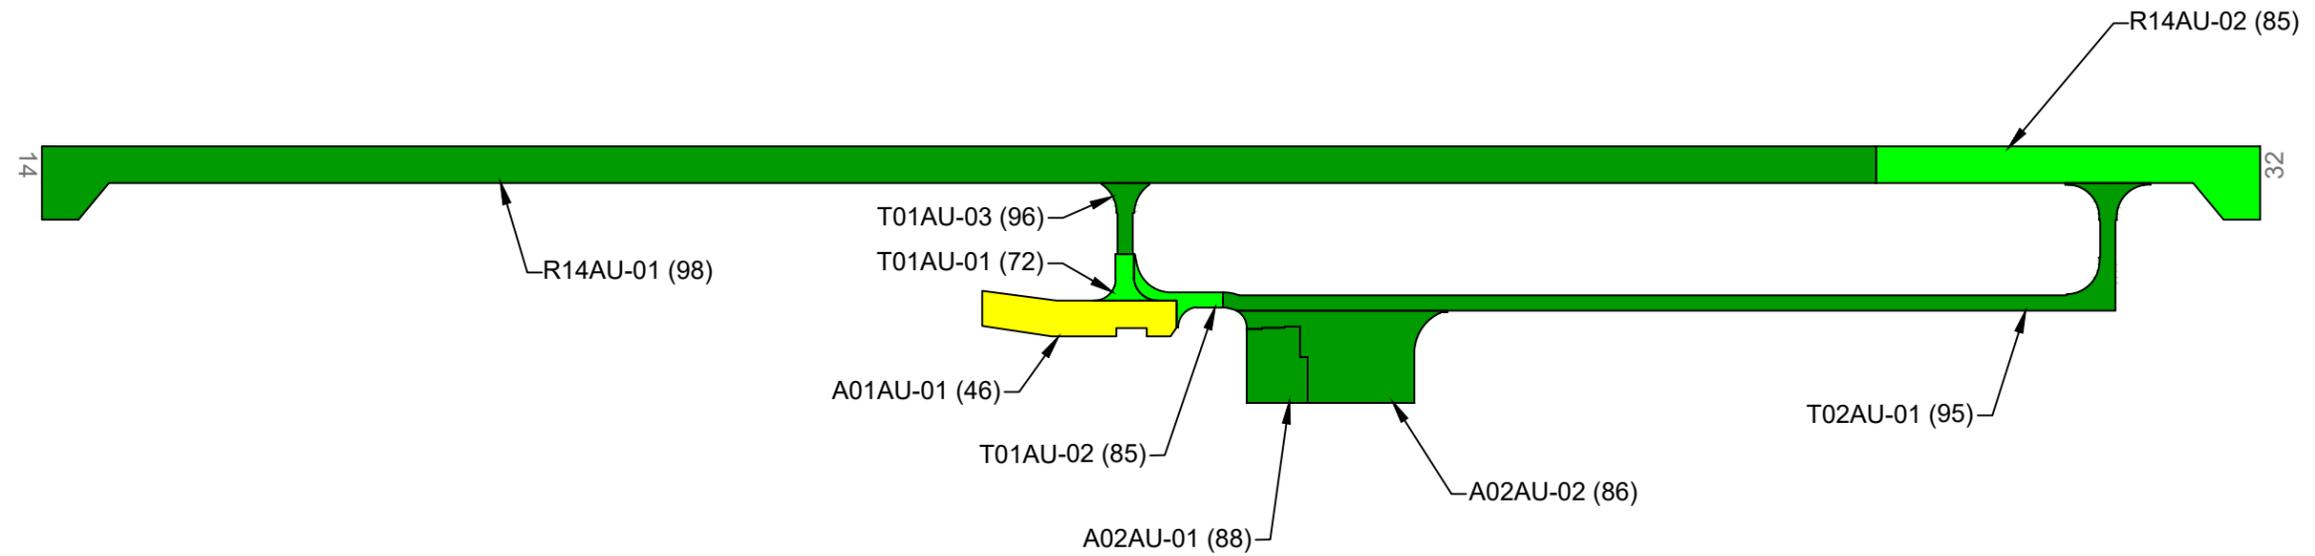
FIGURE 8. PCI MAP.

The pavements at Audubon County Airport were inspected on December 7, 2017. The 2017 area-weighted condition of Audubon County Airport is 91, with conditions ranging from 46 to 98 (on a scale of 0 [failed] to 100 [excellent]). During the previous pavement inspection in 2014, the area-weighted PCI of the airport was 92.

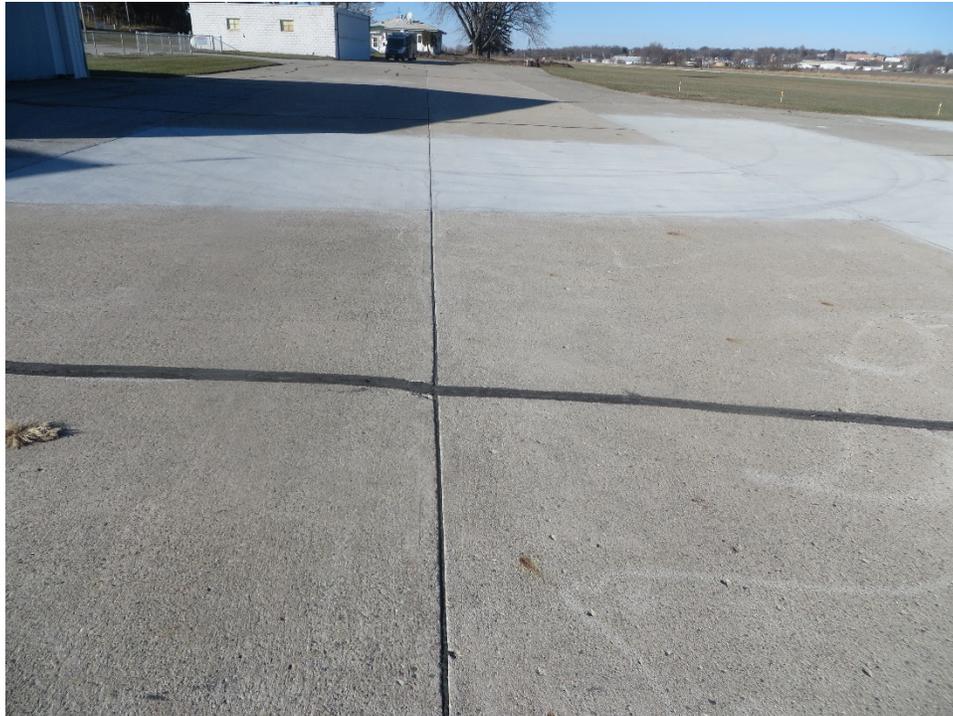
A01AU-01. Overview

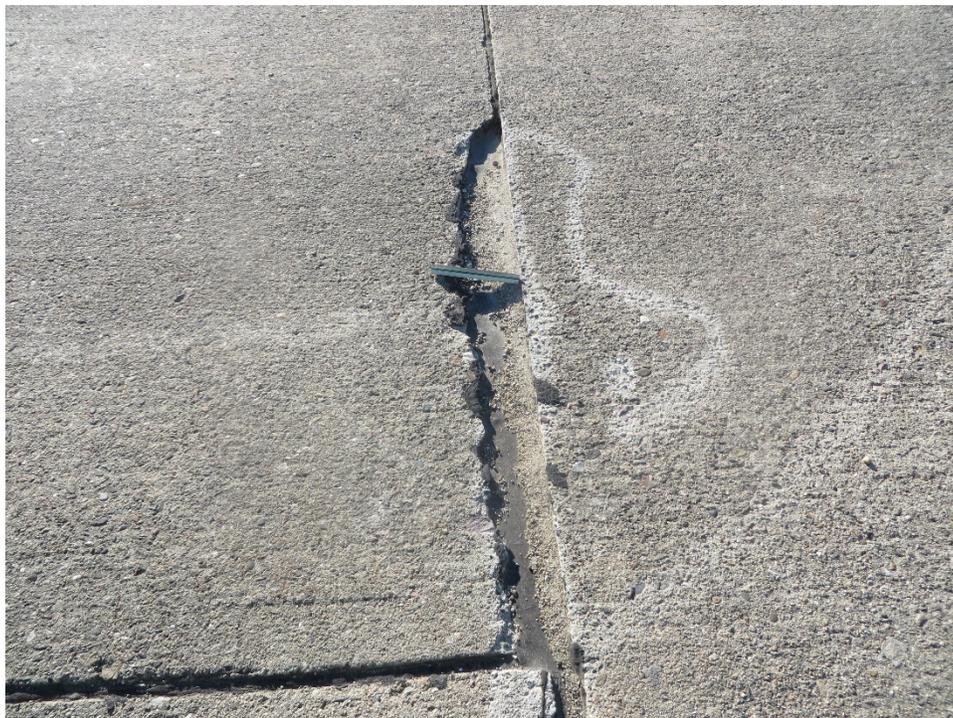
A01AU-01. Joint Spalling (Sample Unit No. 03).

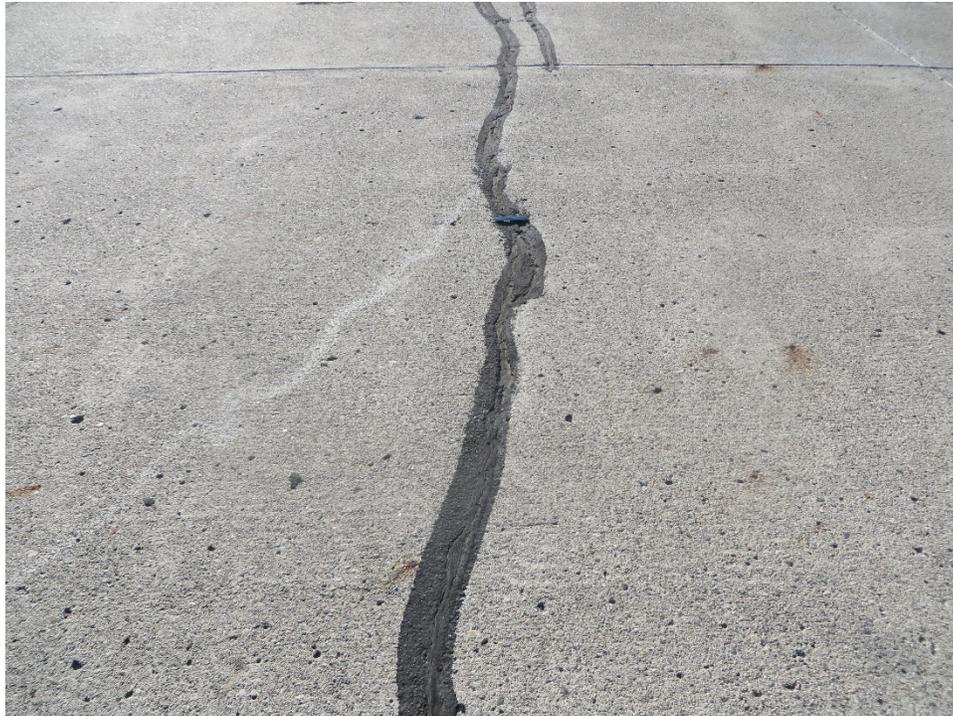
A01AU-01. LTD Cracking (Sample Unit No. 03).

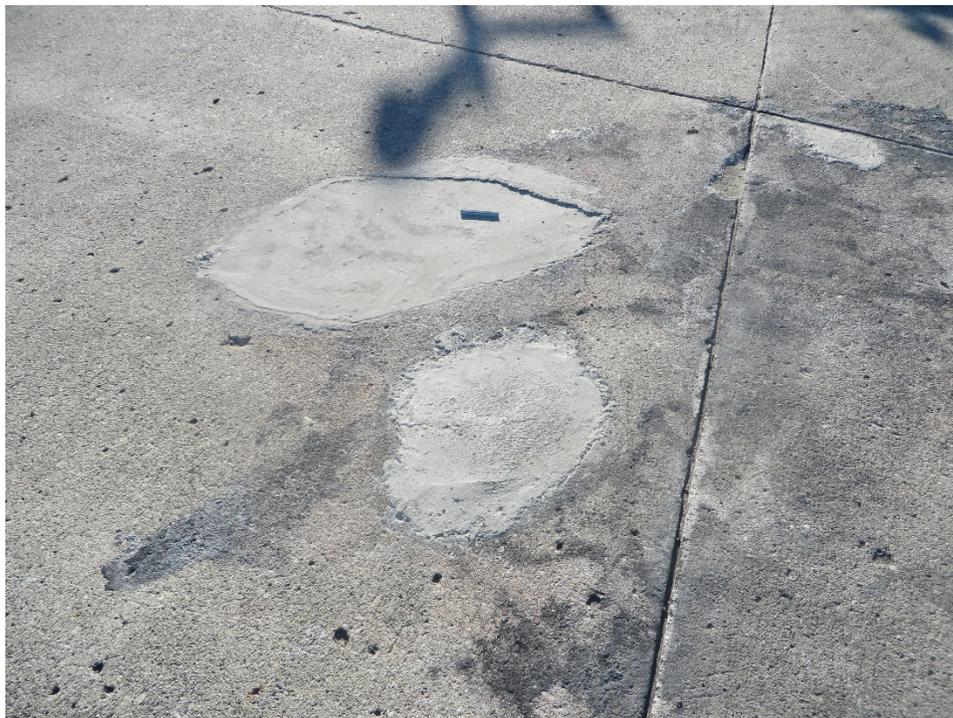
A01AU-01. Scaling (Sample Unit No. 01).

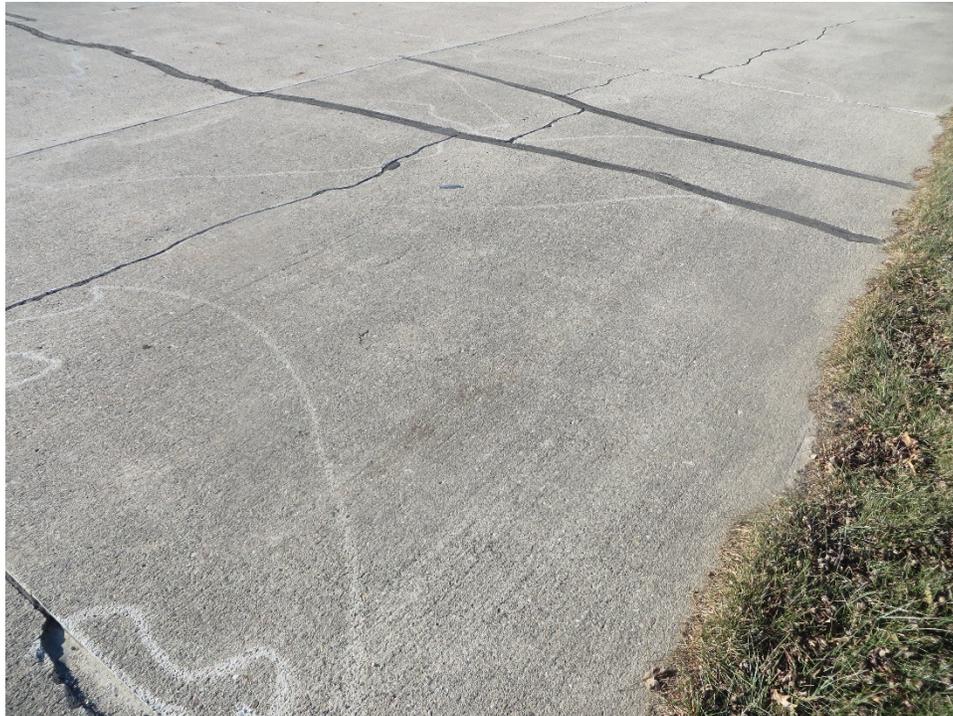
A01AU-01. Shattered Slab (Sample Unit No. 03).

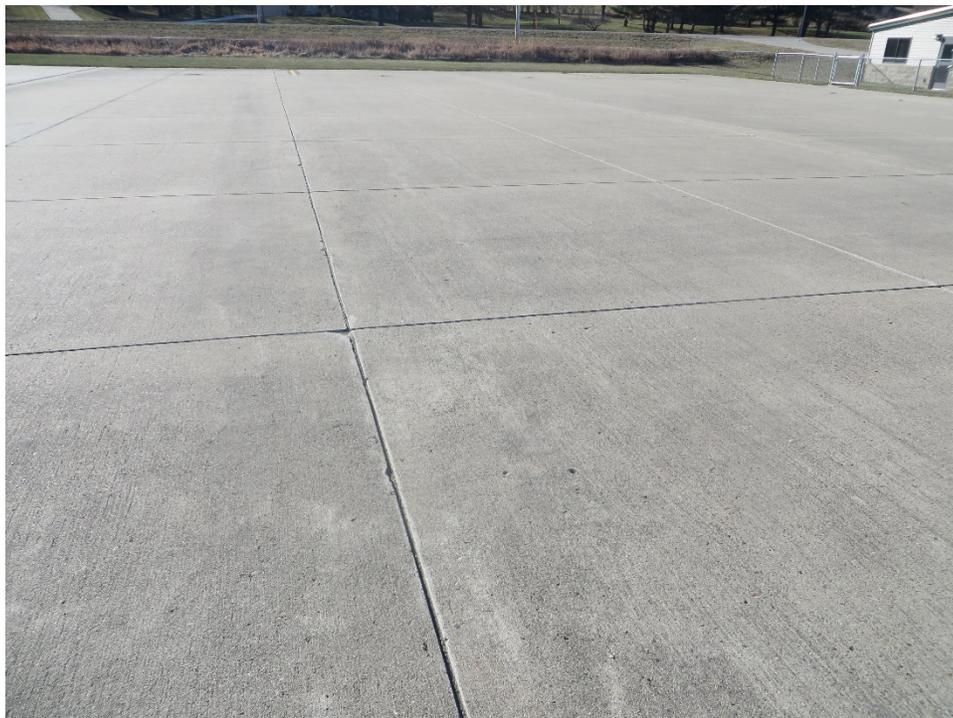
Apron 01 was defined by one section. Low-severity corner spalling and joint seal damage; low- and medium-severity joint spalling, LTD cracking, and shattered slab; and shrinkage cracking were identified in Section 01. An isolated amount of medium-severity scaling was also recorded.

A02AU-01. Overview

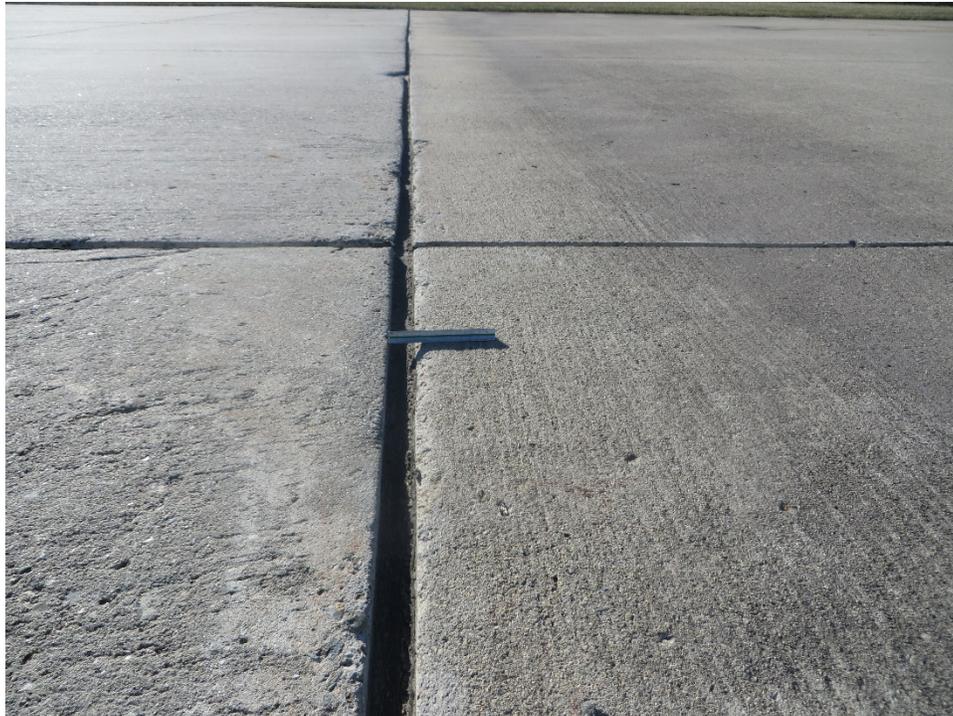
A02AU-01. Faulting (Sample Unit No. 03).

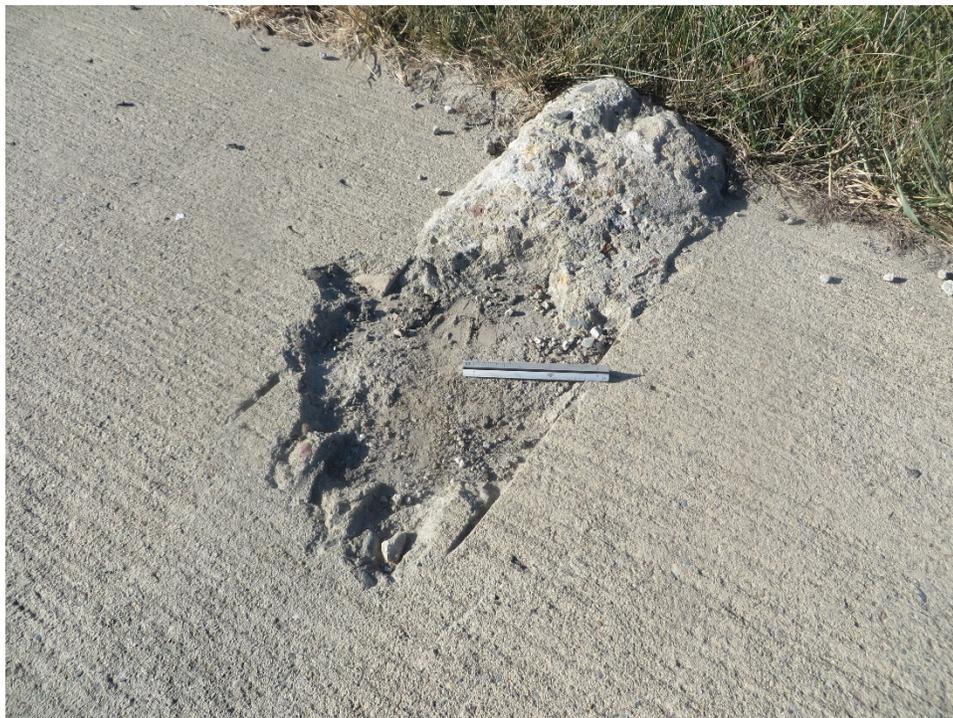
A02AU-01. Small Patching (Sample Unit No. 02).

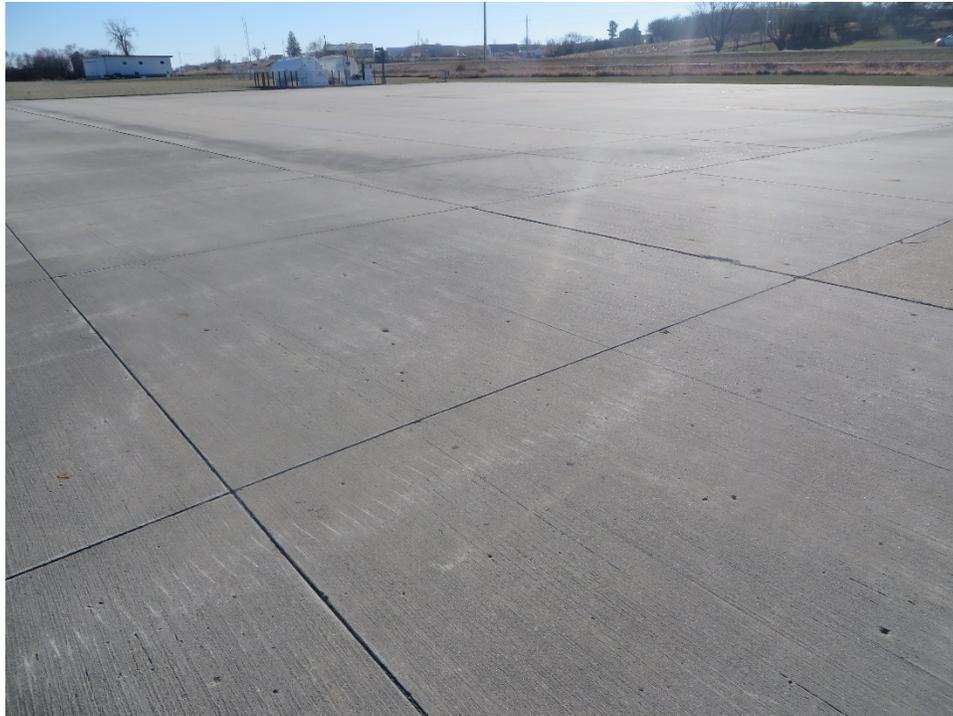
A02AU-02. Overview

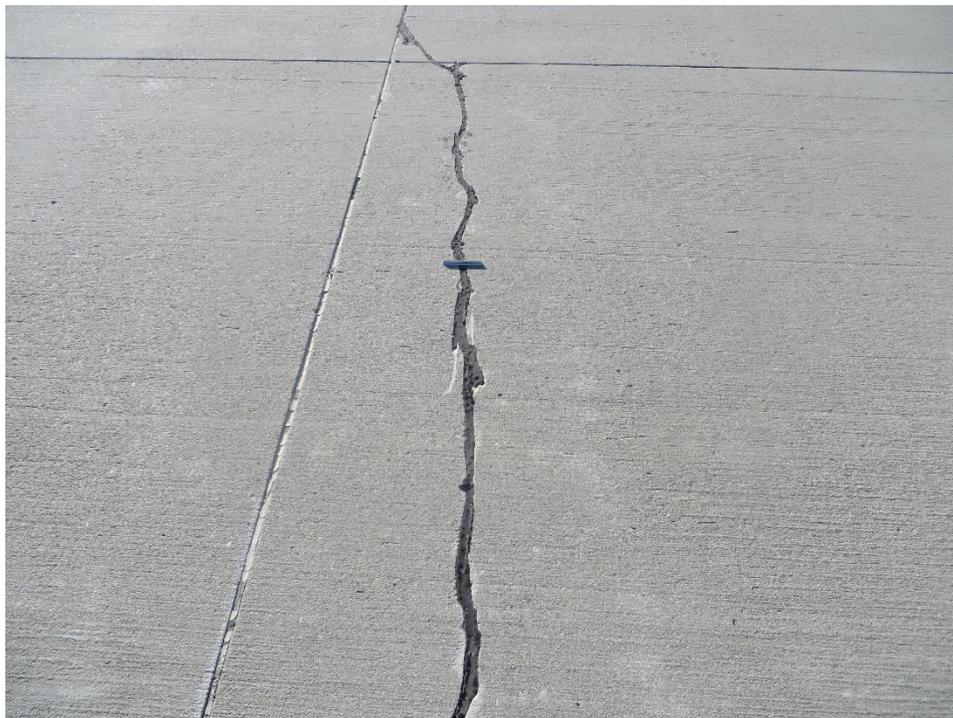
A02AU-02. Joint Spalling (Sample Unit No. 07).

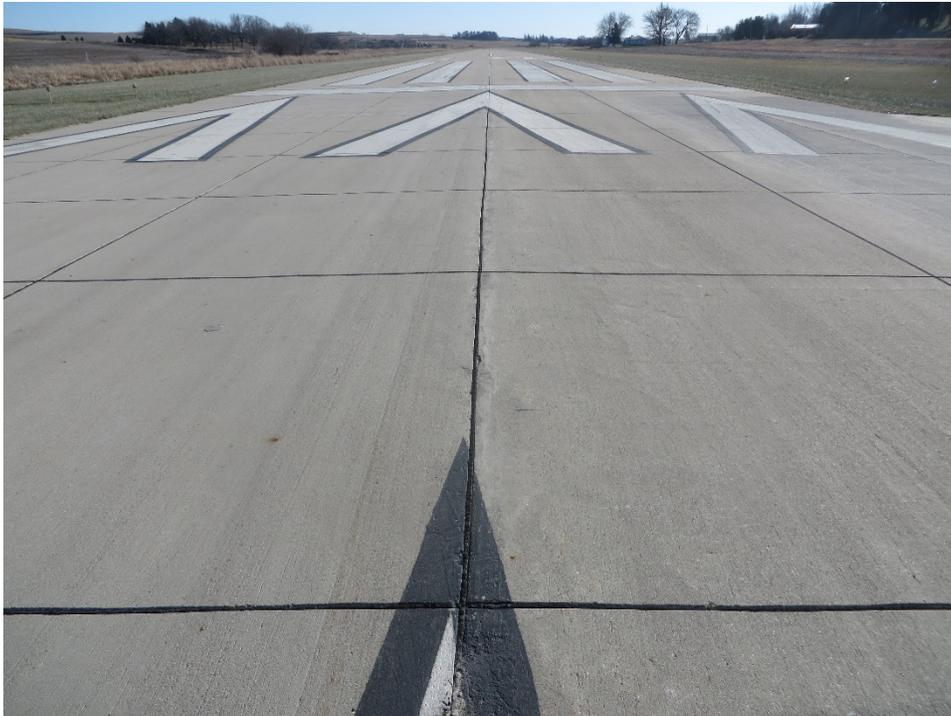
R14AU-01. Overview

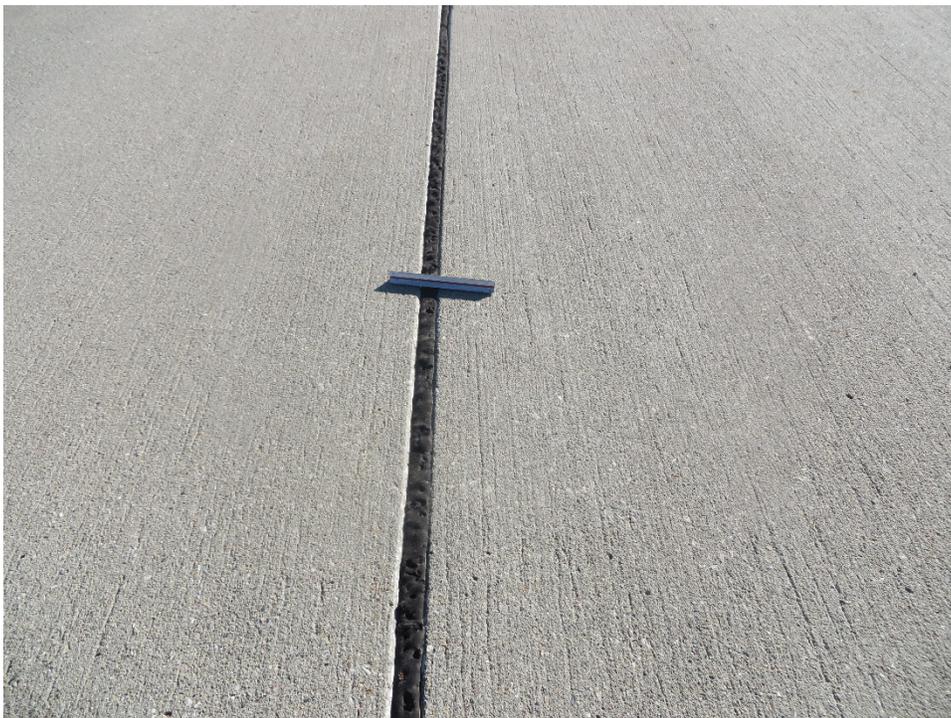
R14AU-01. Joint Seal Damage (Sample Unit No. 15).

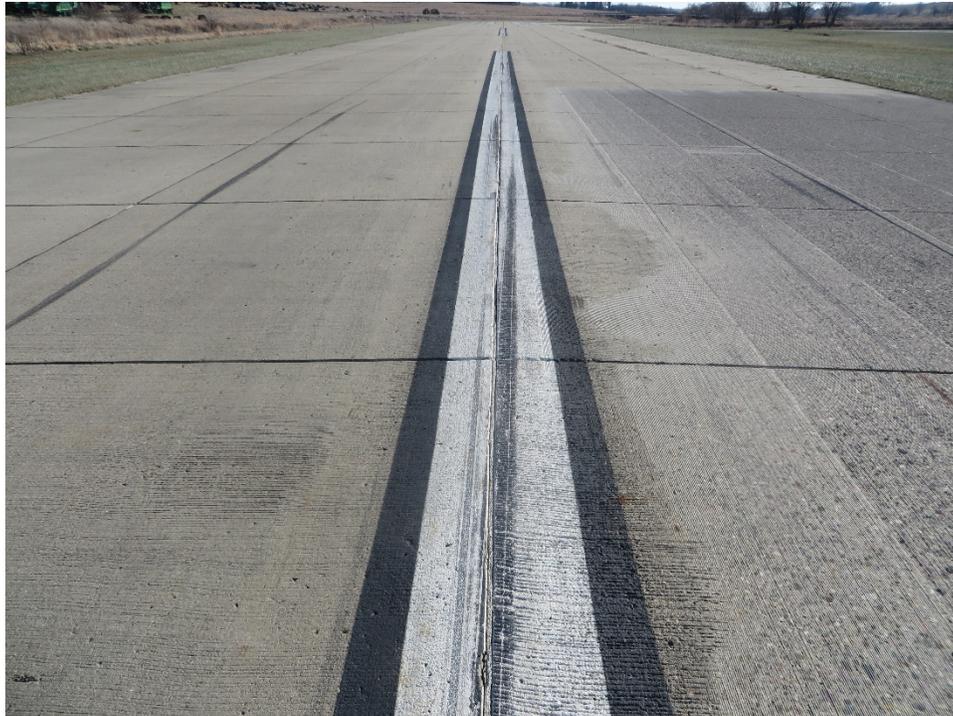
R14AU-02. Overview

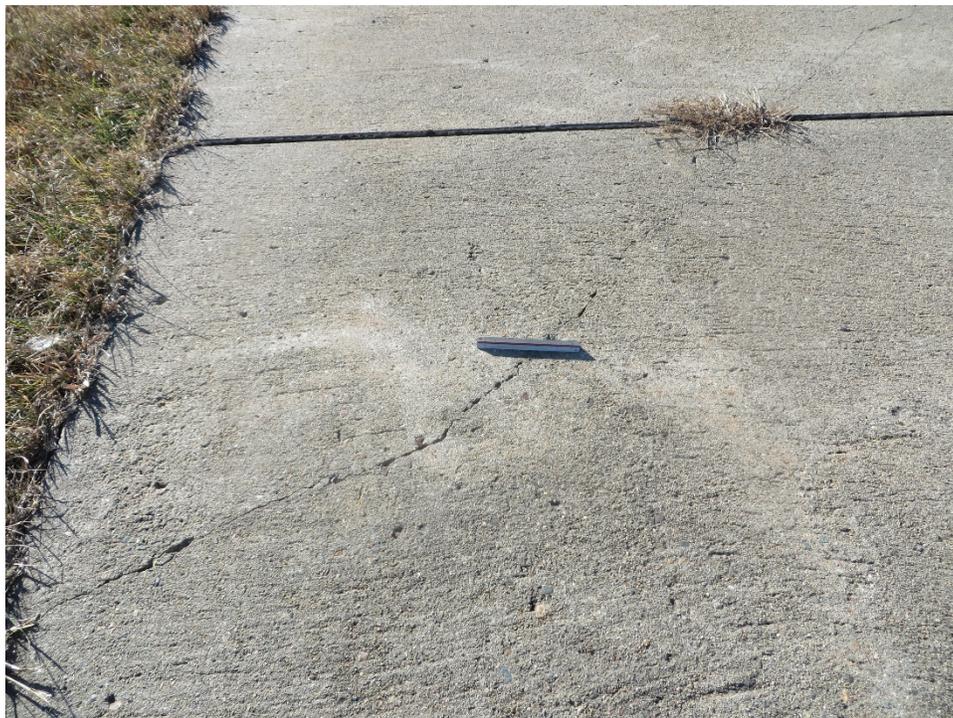
R14AU-02. Corner Break (Sample Unit No. 17).

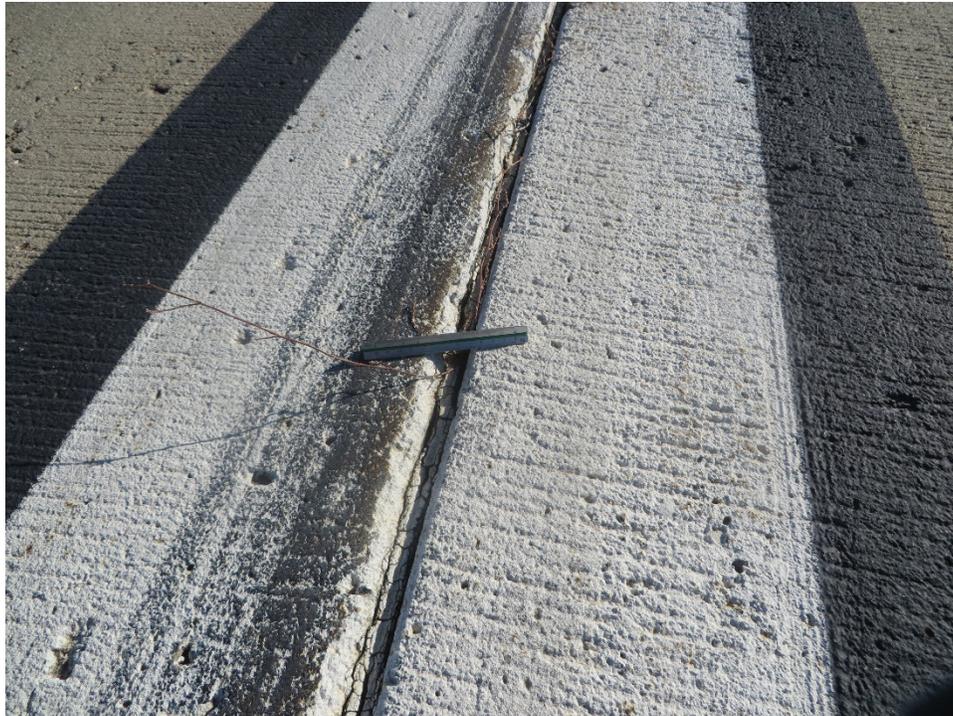
R14AU-02. Joint Seal Damage (Sample Unit No. 02).

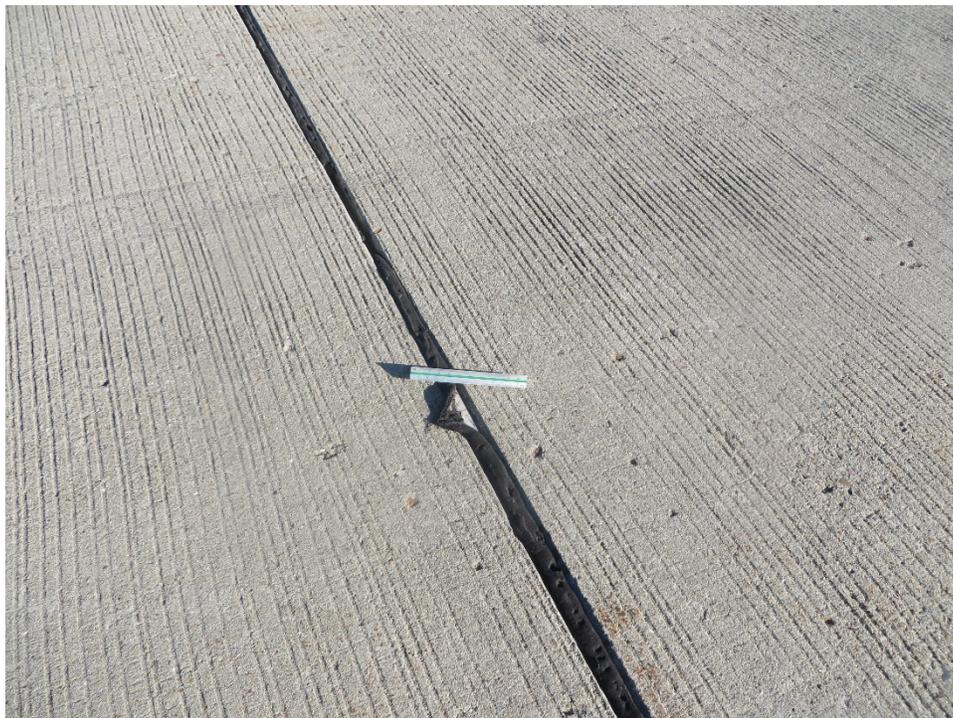
R14AU-02. Joint Seal Damage (Sample Unit No. 10).

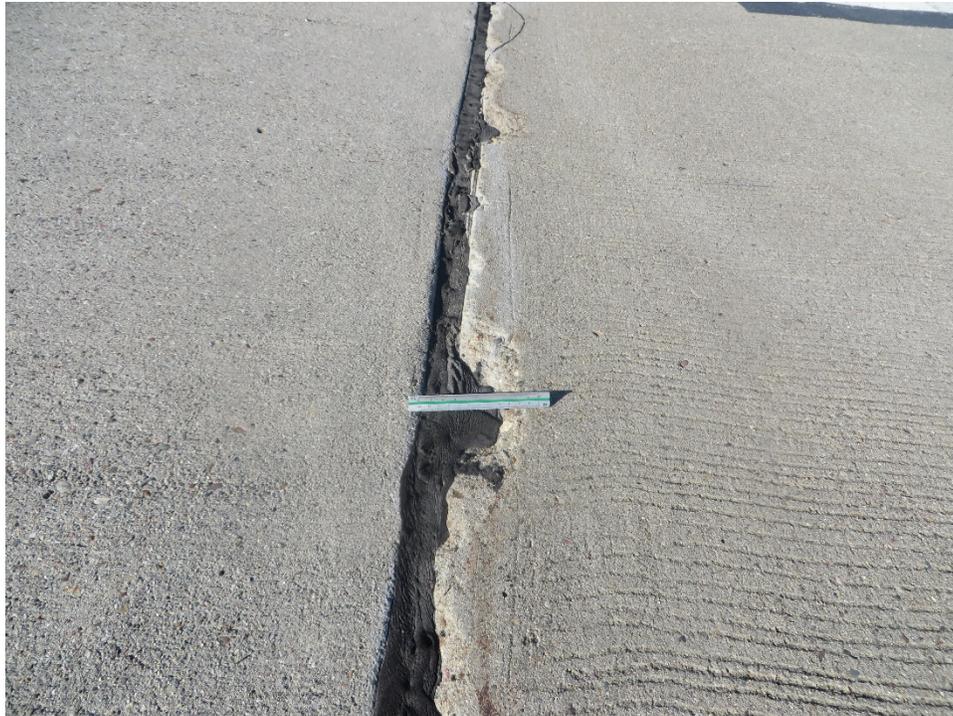
R14AU-02. Joint Spalling (Sample Unit No. 10).

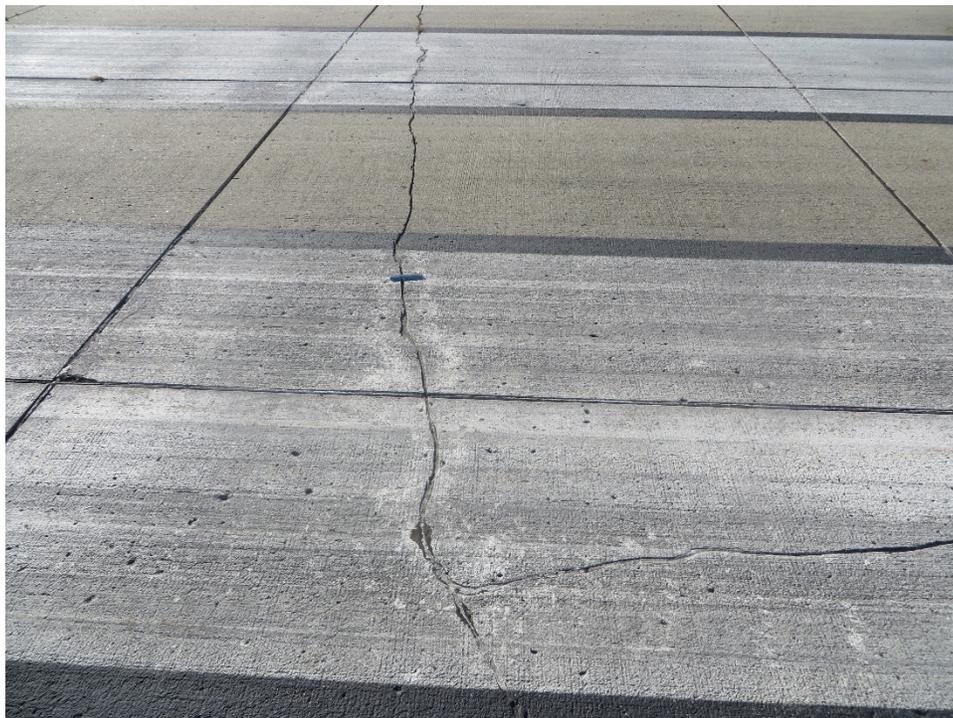
R14AU-02. LTD Cracking (Additional Sample Unit No. 14).

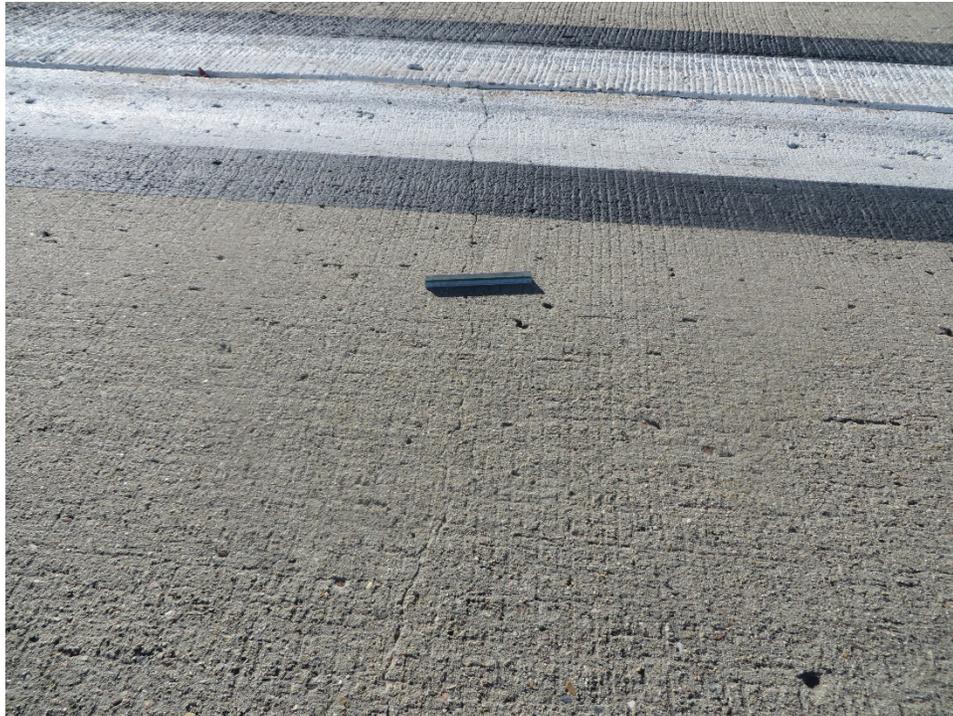
R14AU-02. Shrinkage Cracking (Sample Unit No. 02).

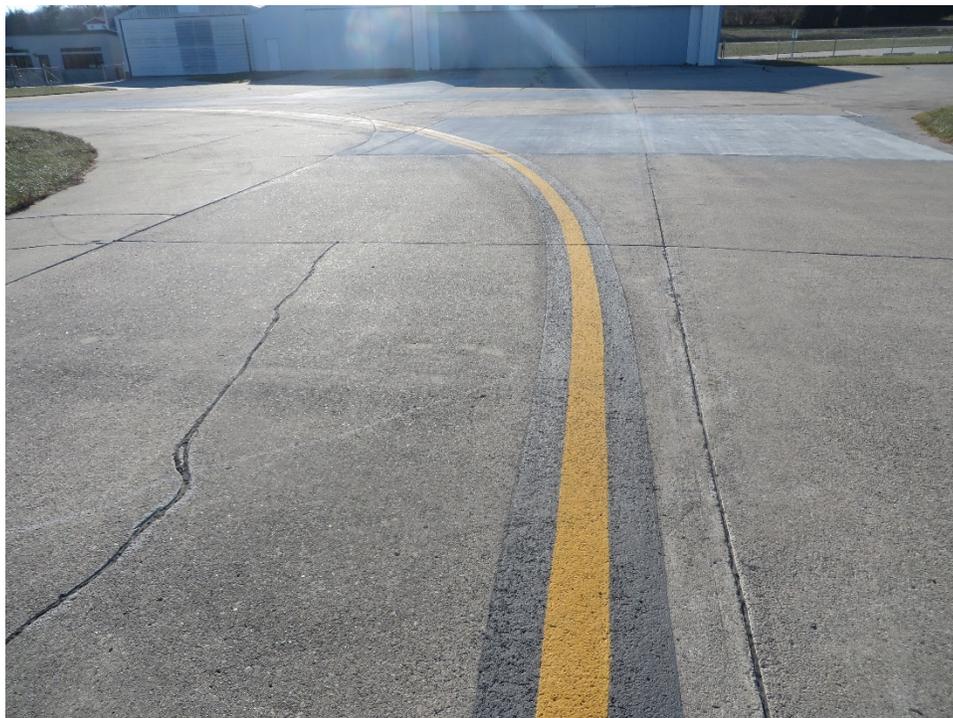
T01AU-01. Overview

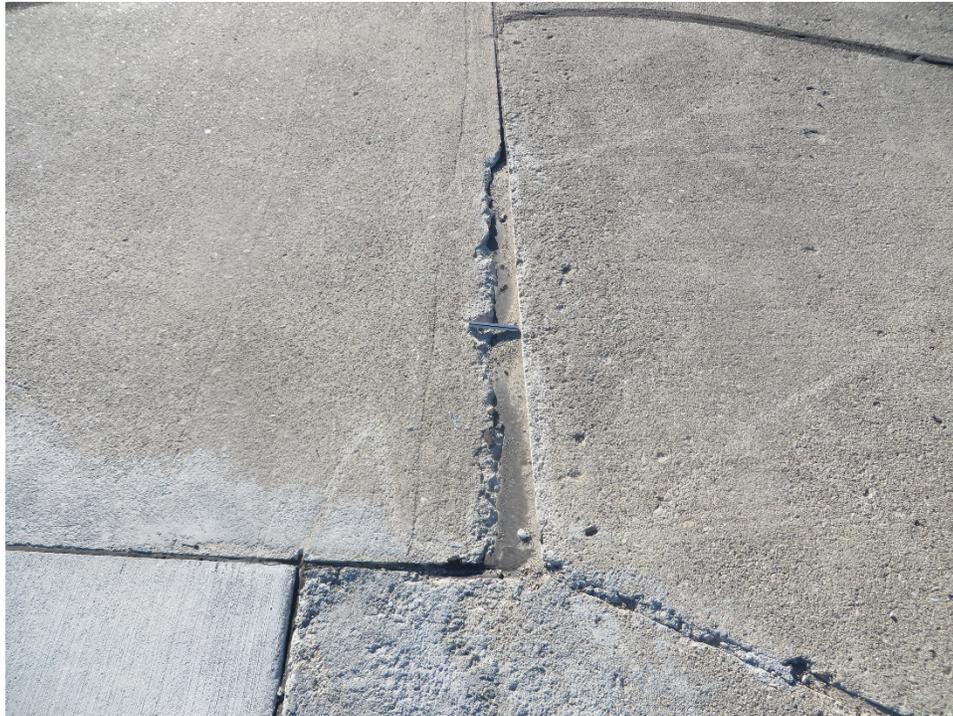
T01AU-01. Joint Spalling (Sample Unit No. 01).

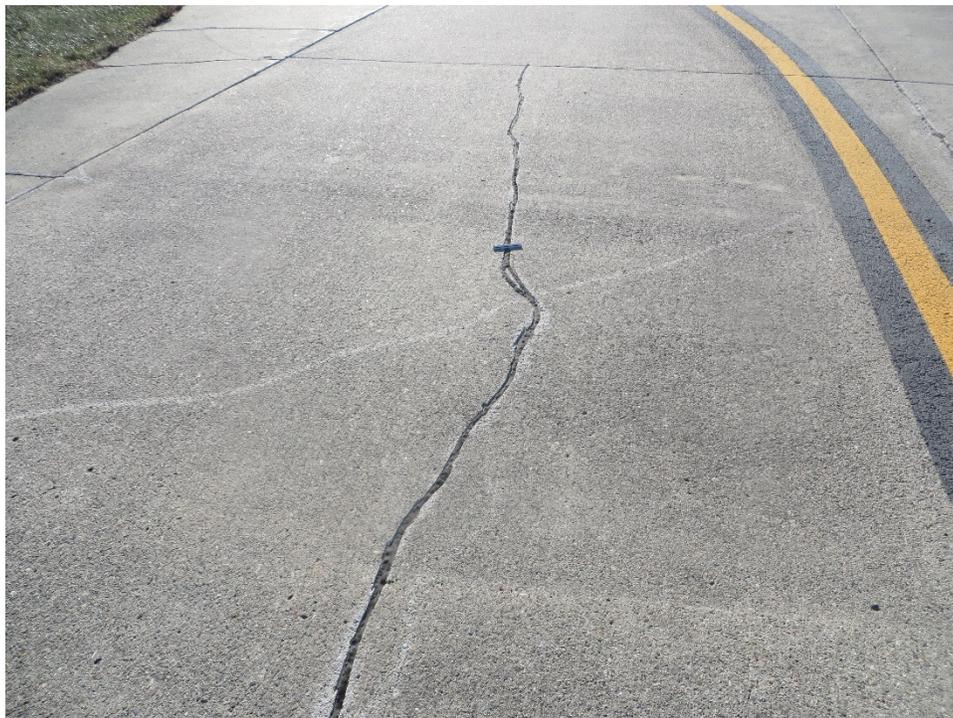
T01AU-01. LTD Cracking (Sample Unit No. 01).

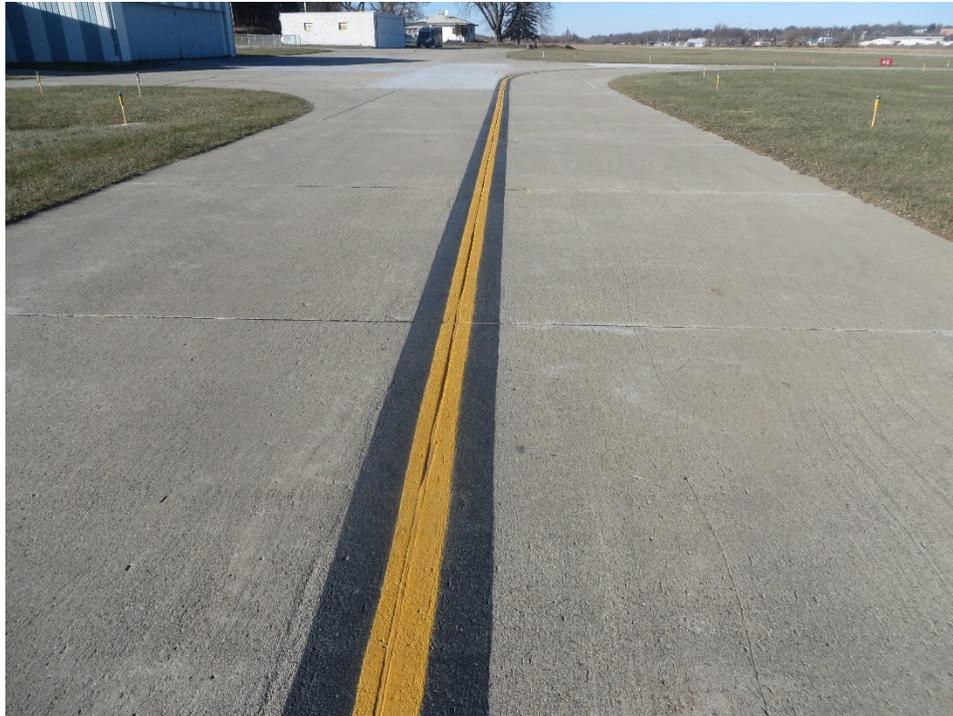
T01AU-02. Overview

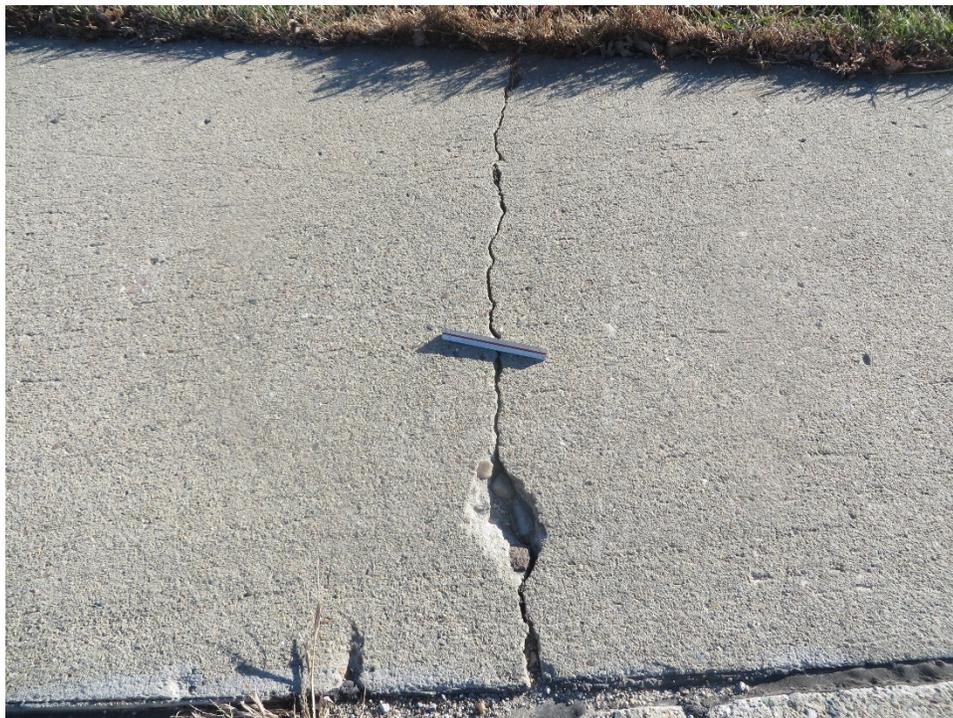
T01AU-02. LTD Cracking (Sample Unit No. 02).

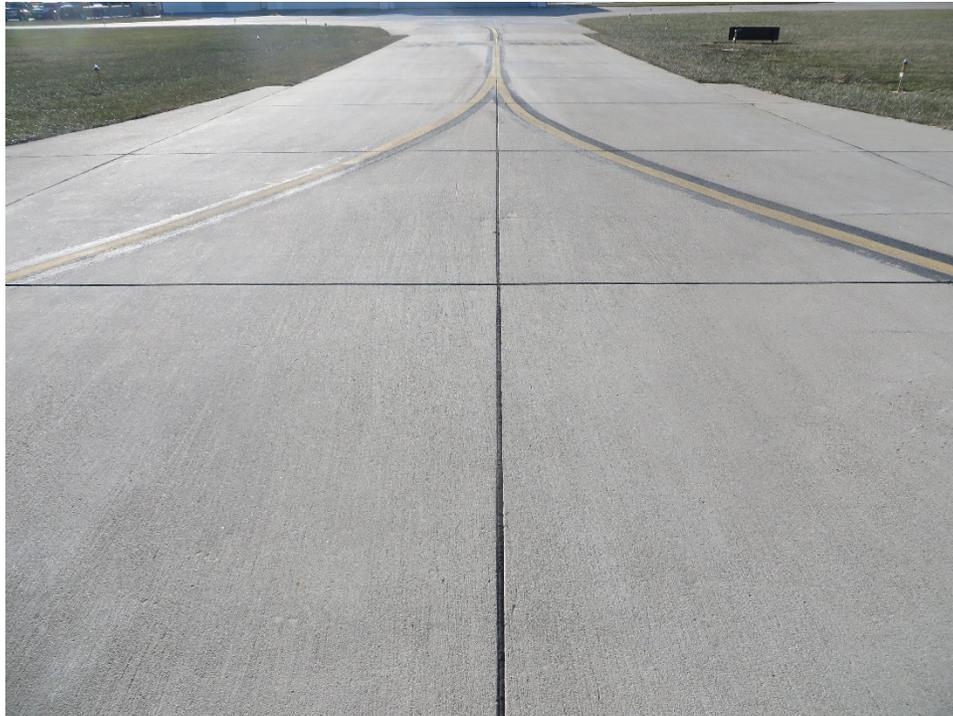
T01AU-03. Overview

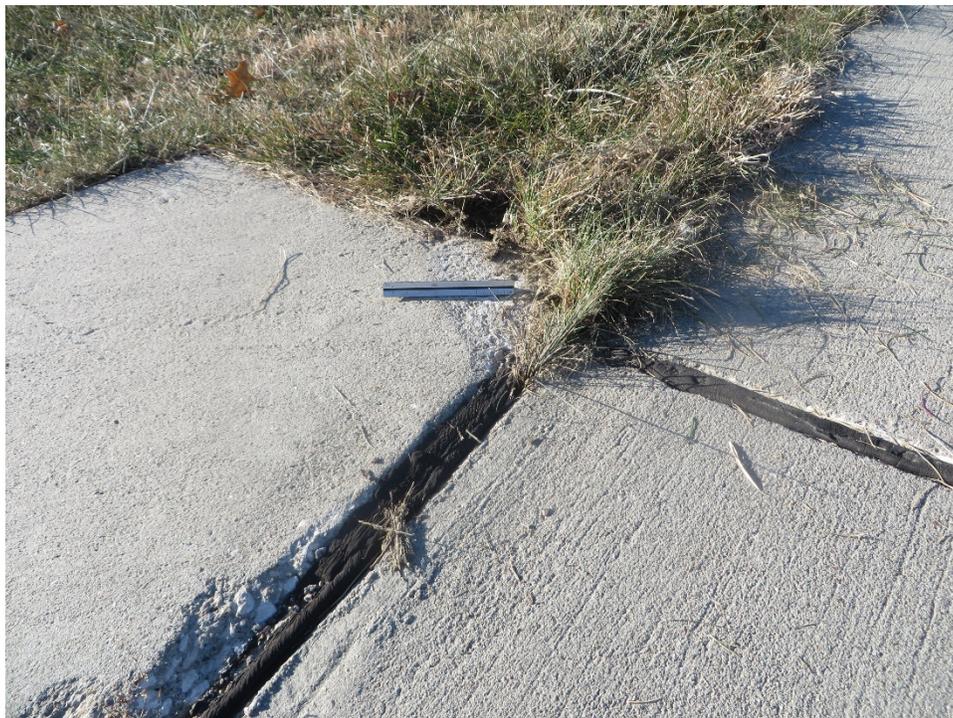
T01AU-03. Corner Spalling (Sample Unit No. 01).

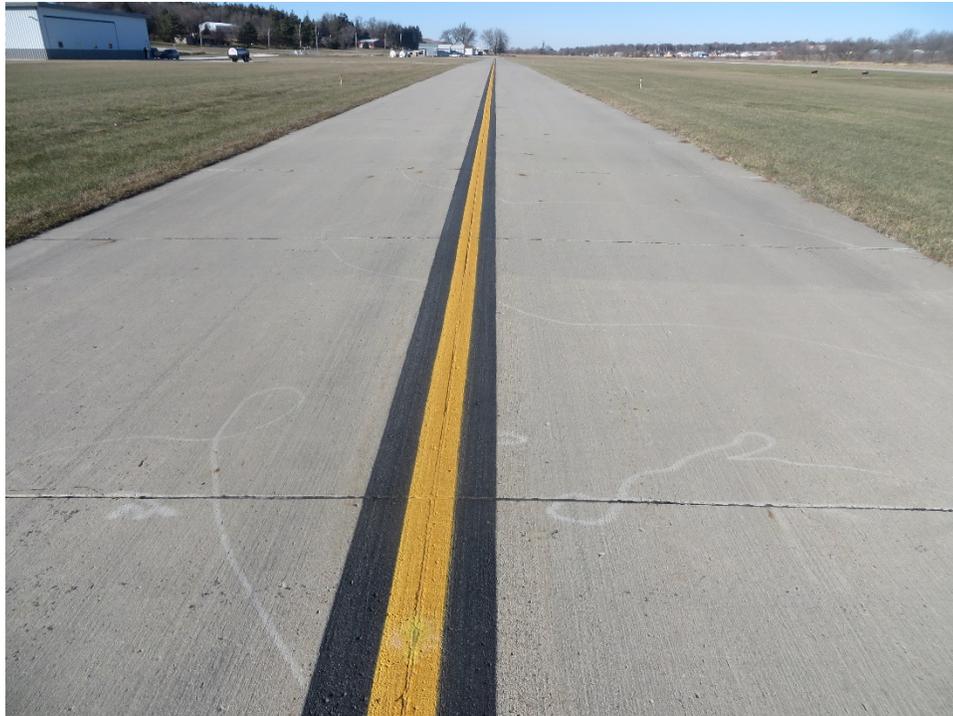
Taxiway 02 consisted of one section with low-severity joint seal damage observed throughout. In addition, smaller amounts of low-severity LTD cracking, large patching, and joint spalling were recorded.

T02AU-01. Overview

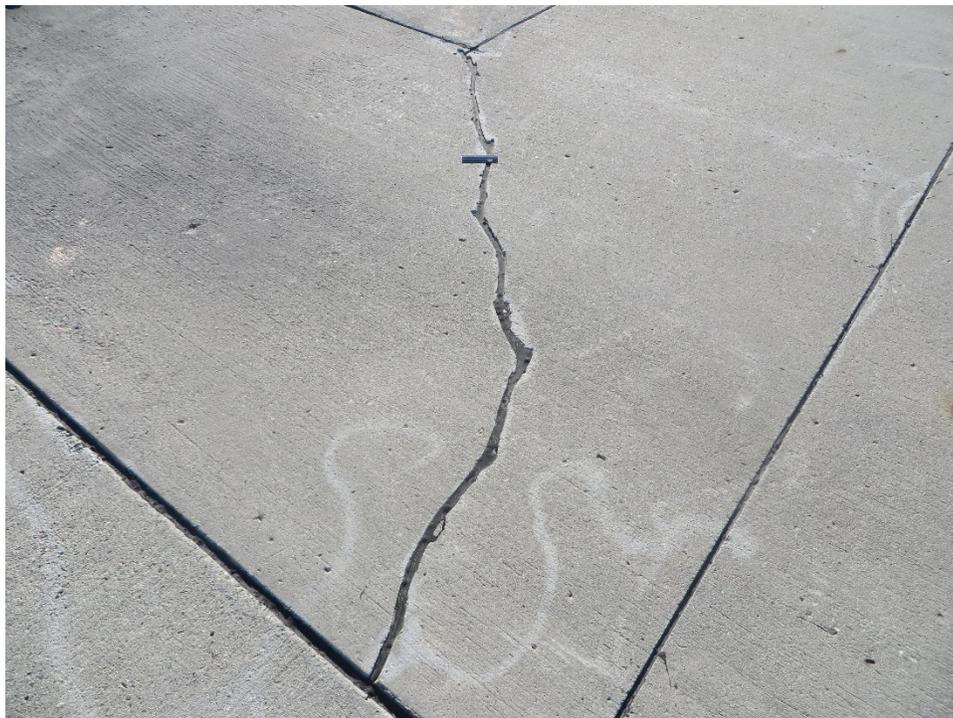
T02AU-01. LTD Cracking (Sample Unit No. 12).

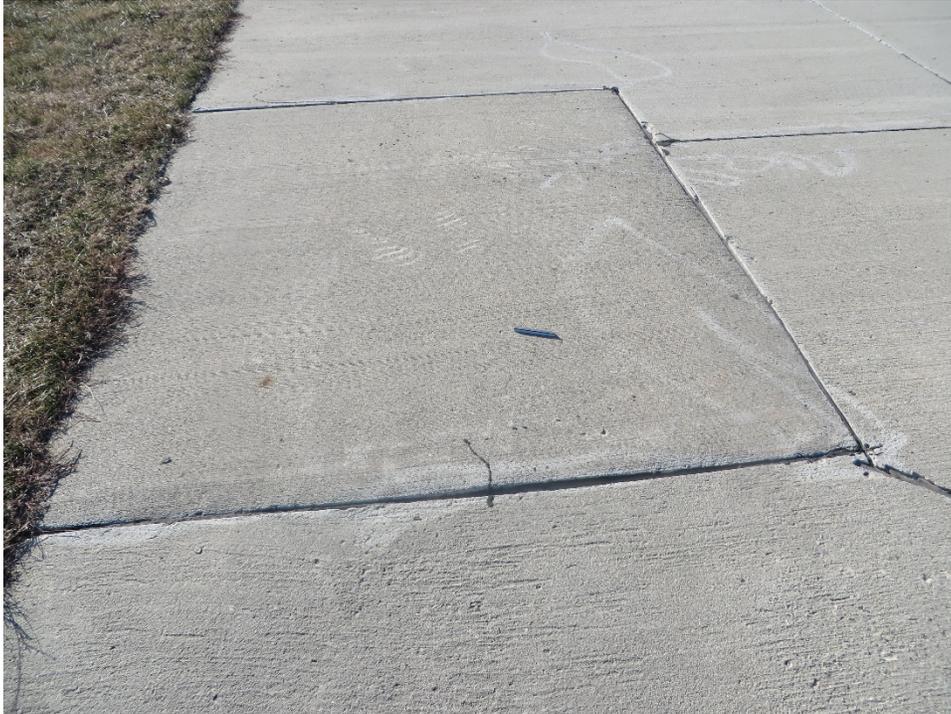
T02AU-01. Large Patching (Sample Unit No. 12).
