Audubon County Airport

PAVEMENT MANAGEMENT REPORT

JULY 2021

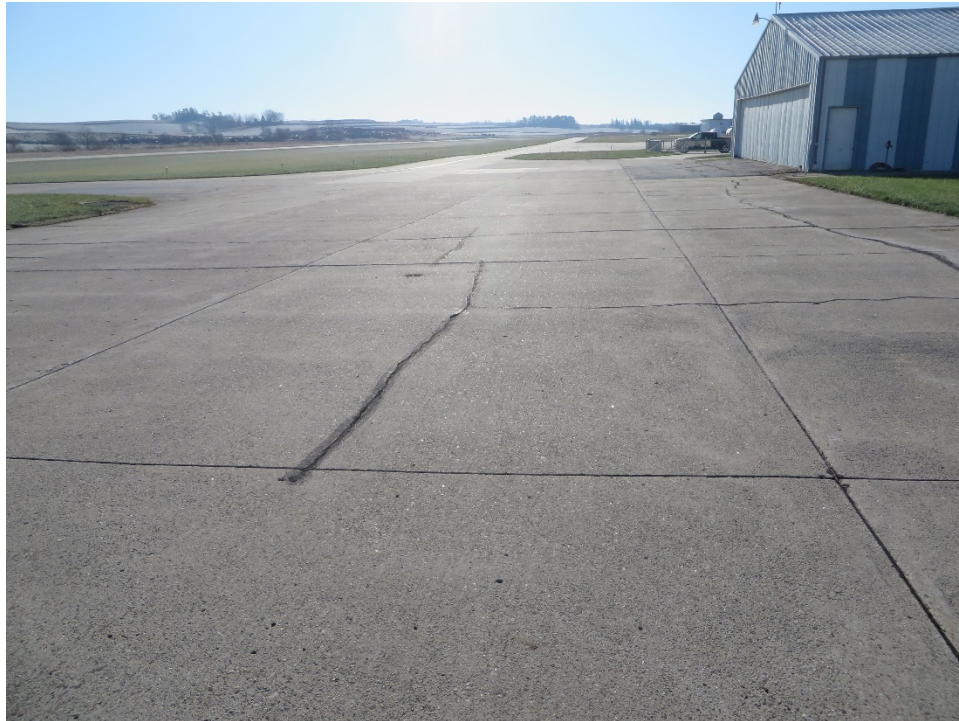
Apron 01 was defined by one section in poor condition. Low-severity corner spalling, large patching, and scaling; medium-severity faulting and joint seal damage; low- and medium-severity joint spalling and LTD cracking; all severity LTD cracking; popouts; and shrinkage cracking were recorded in Section 01.

A01AU-01. Overview.

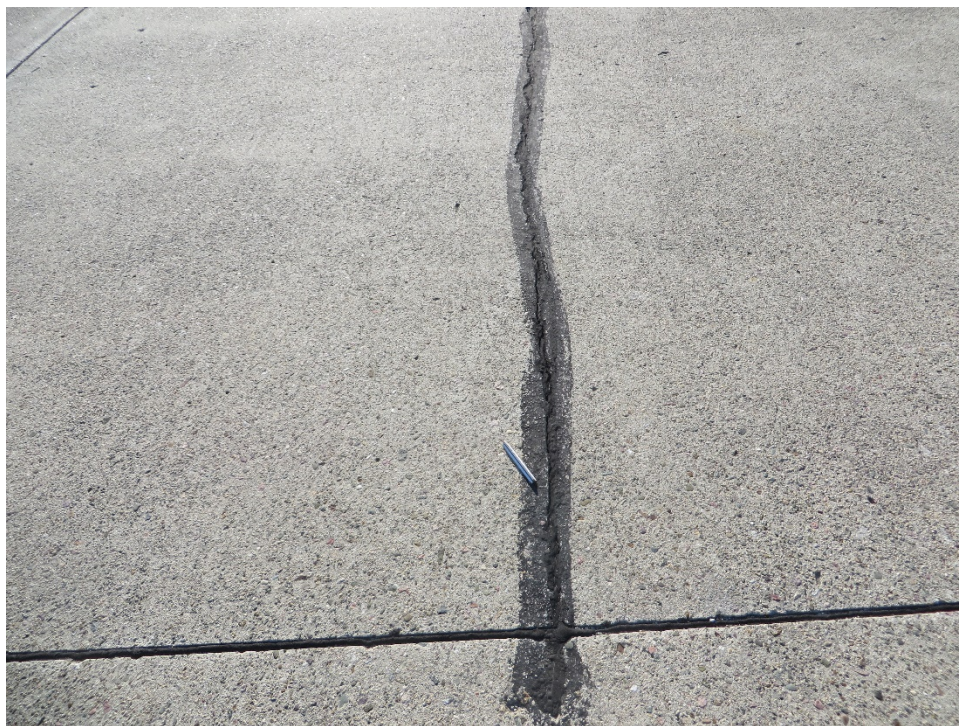
A01AU-01. LTD Cracking (Sample Unit No. 03).

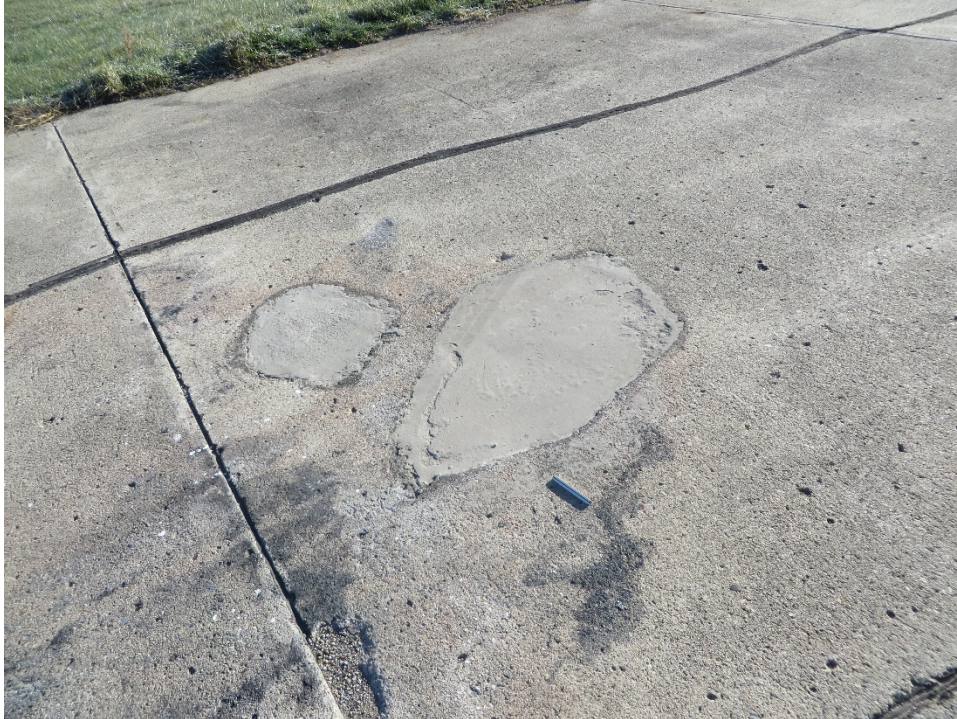
A01AU-01. Scaling (Sample Unit No. 01).

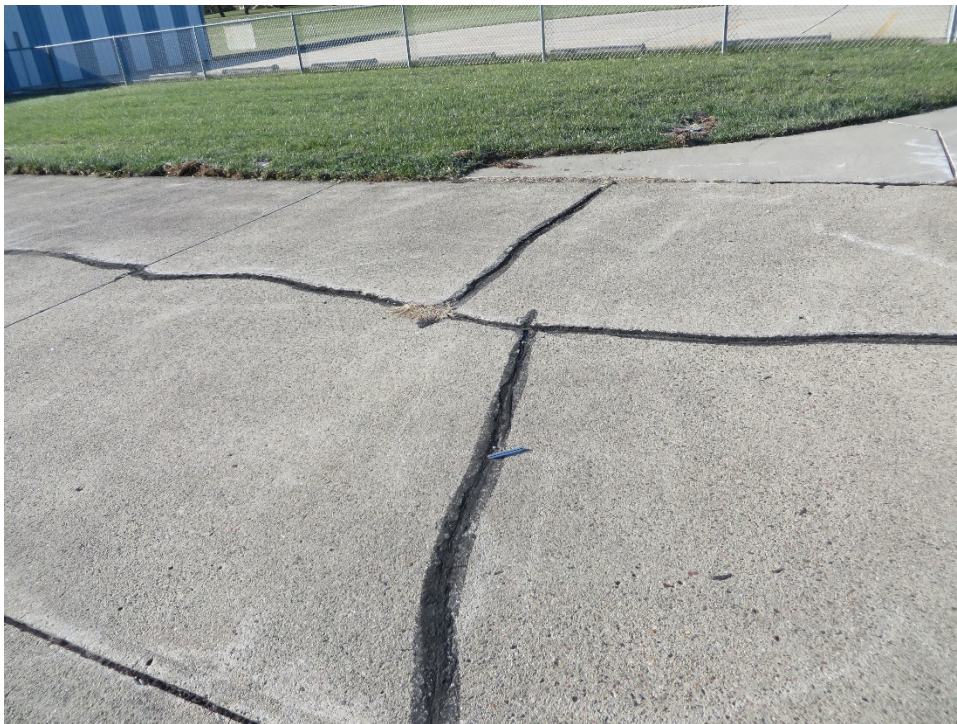
A01AU-01. Shattered Slab (Sample Unit No. 03).

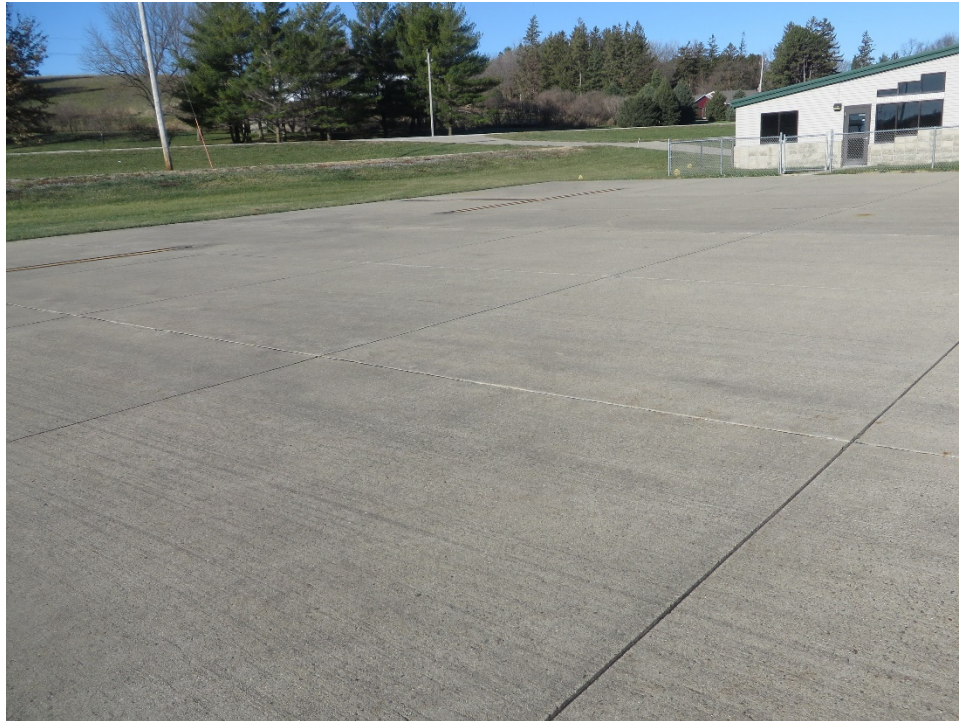
A02AU-01. Overview.

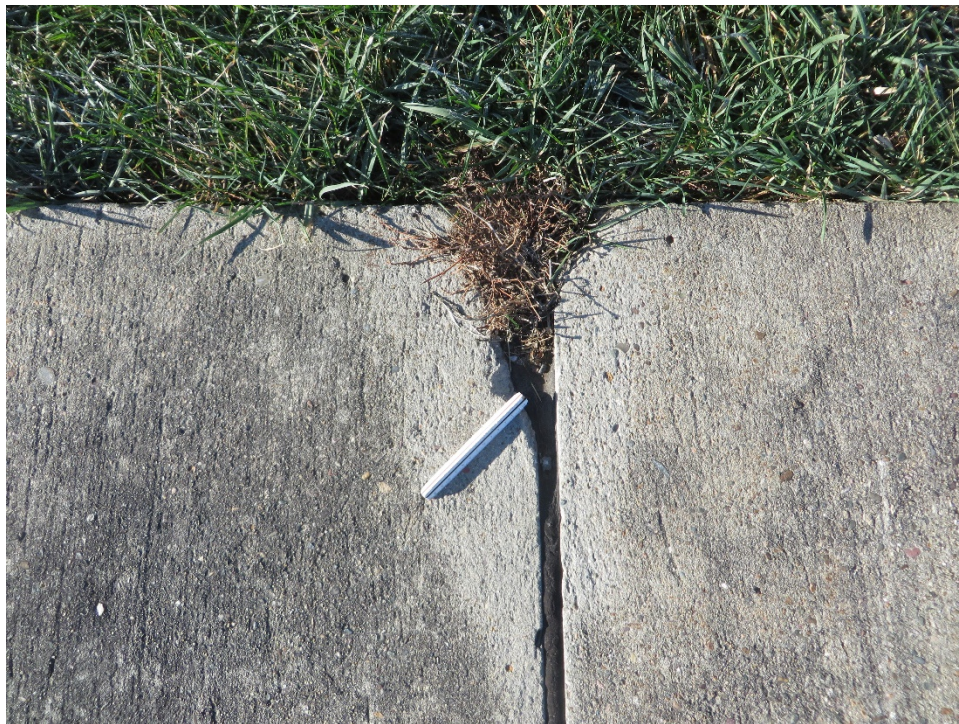
A02AU-01. Joint Spalling (Sample Unit No. 03).

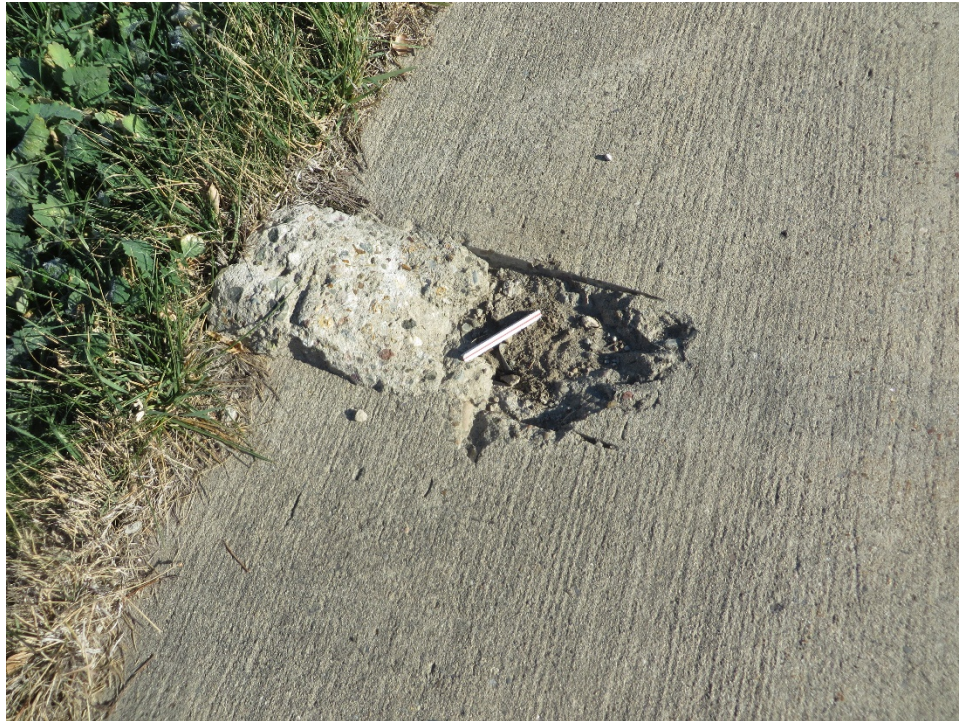
A02AU-01. Small Patching (Sample Unit No. 02).

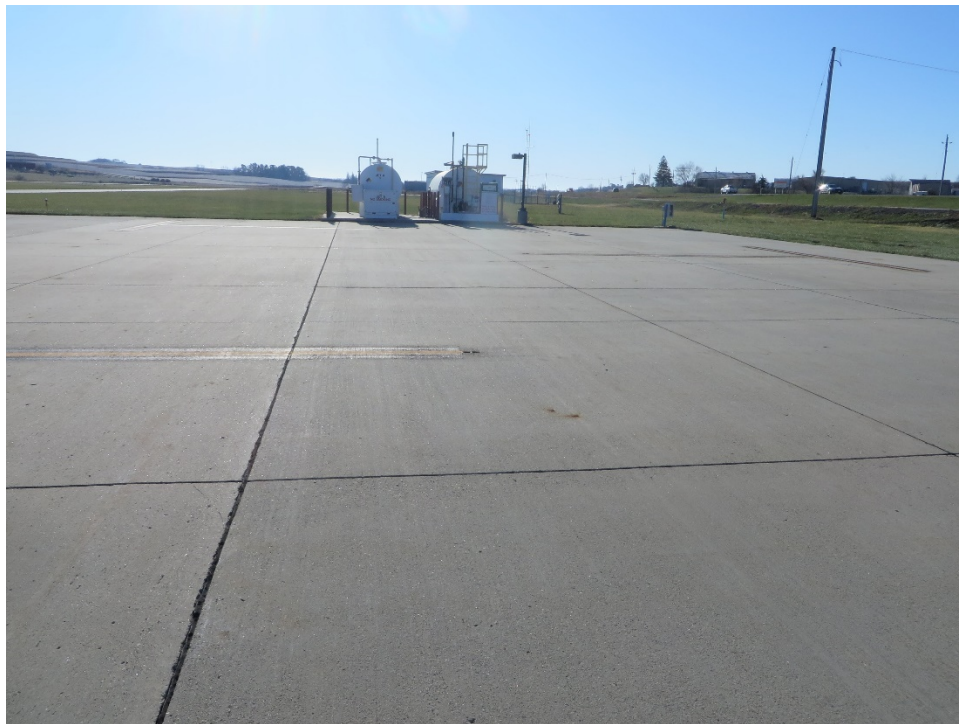
A02AU-02. Overview.

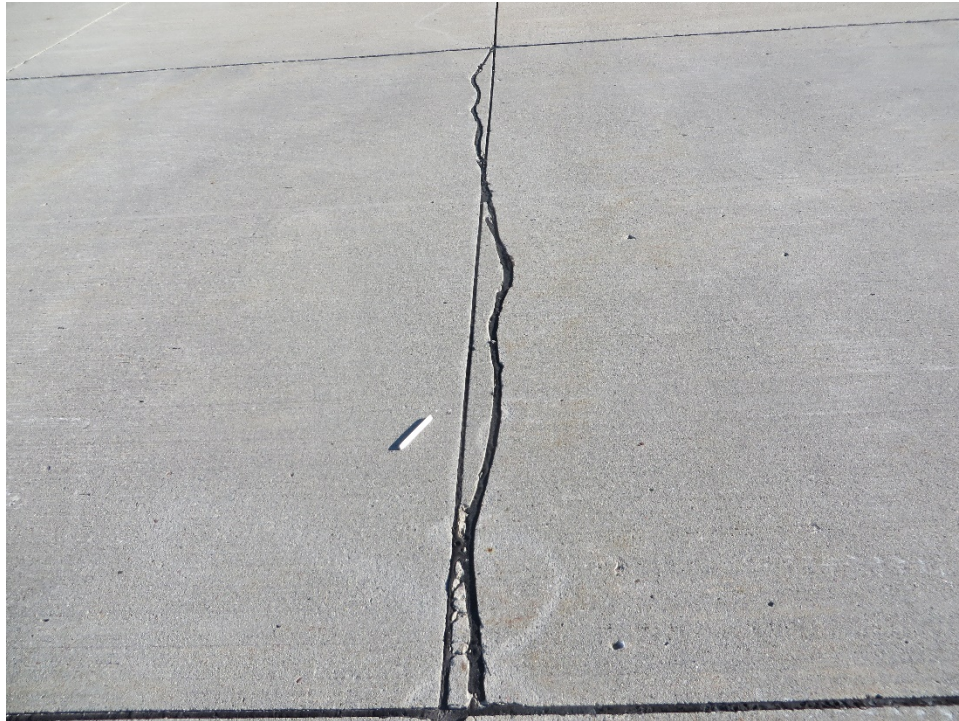
A02AU-02. Joint Spalling (Sample Unit No. 09).

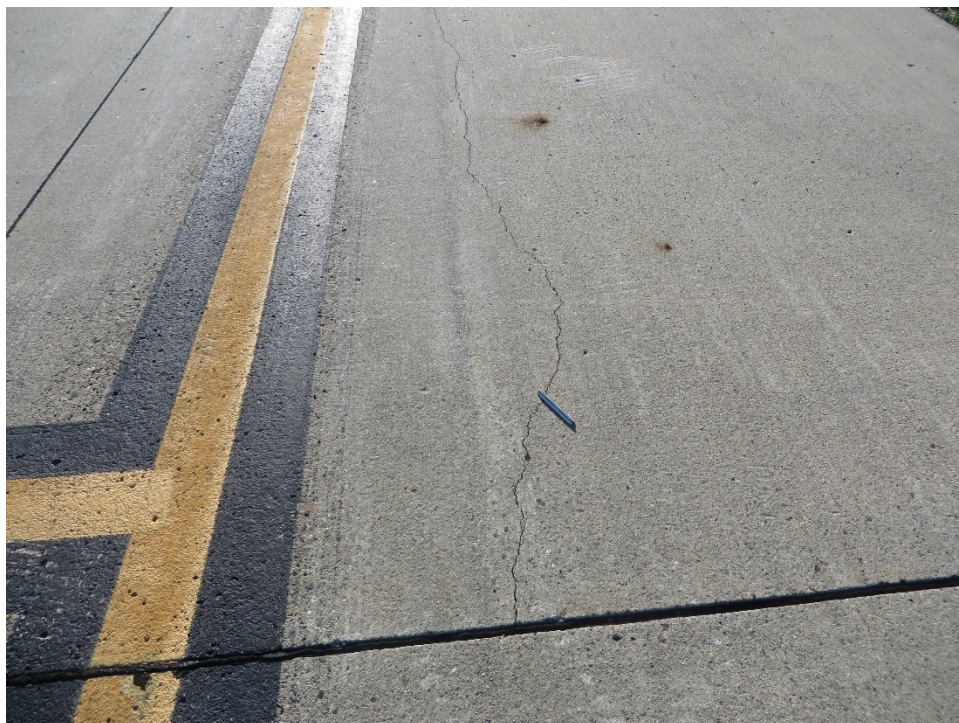
A02AU-02. LTD Cracking (Sample Unit No. 08).

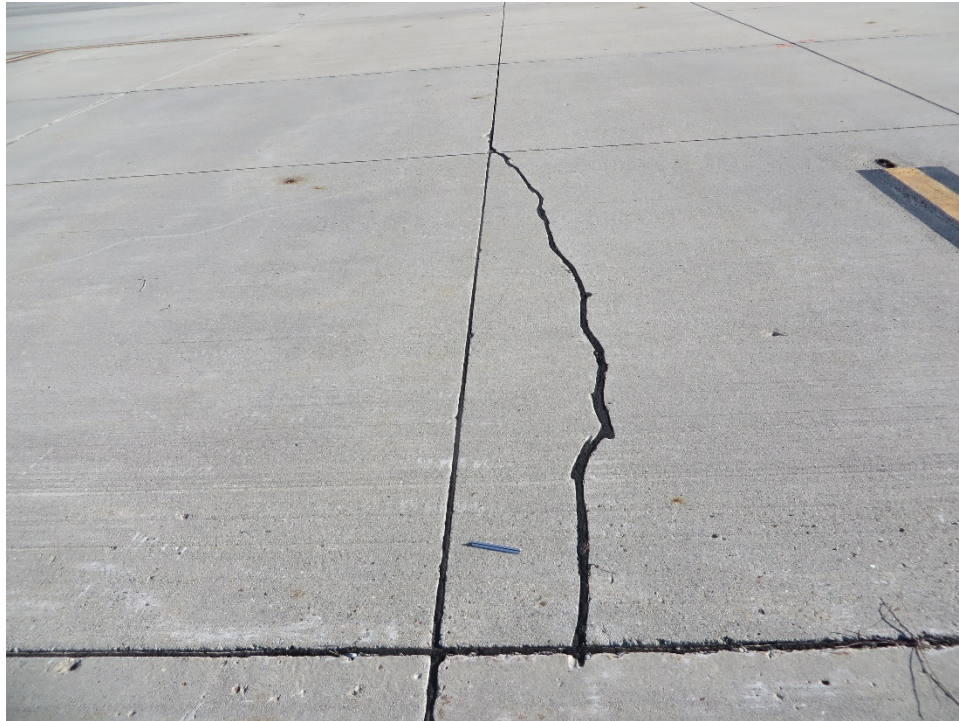
A02AU-02. LTD Cracking (Sample Unit No. 09).

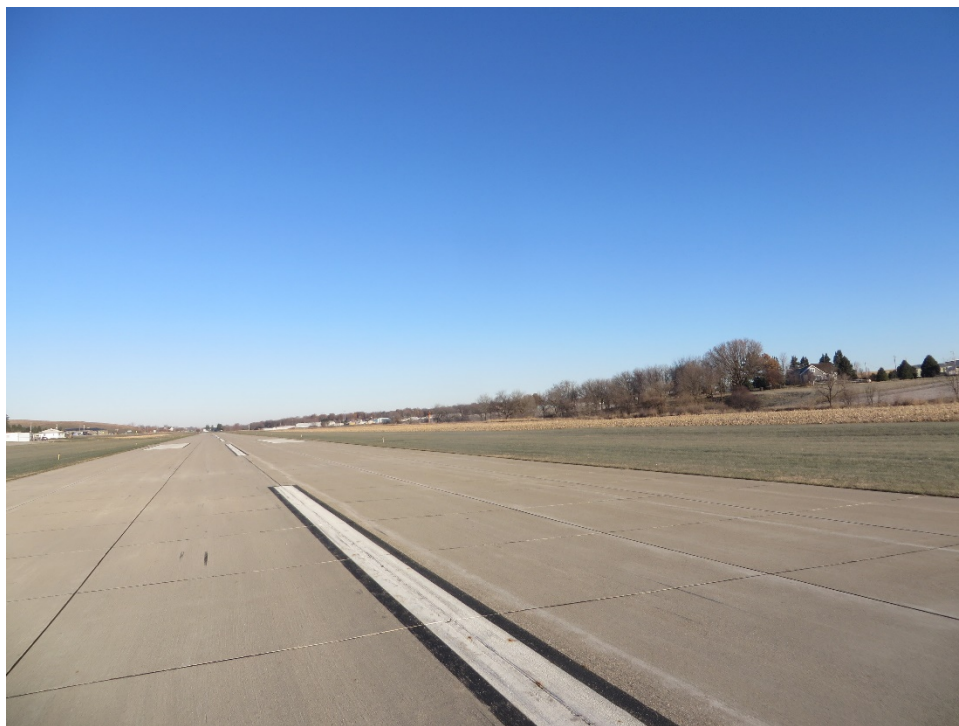
R14AU-01. Overview.

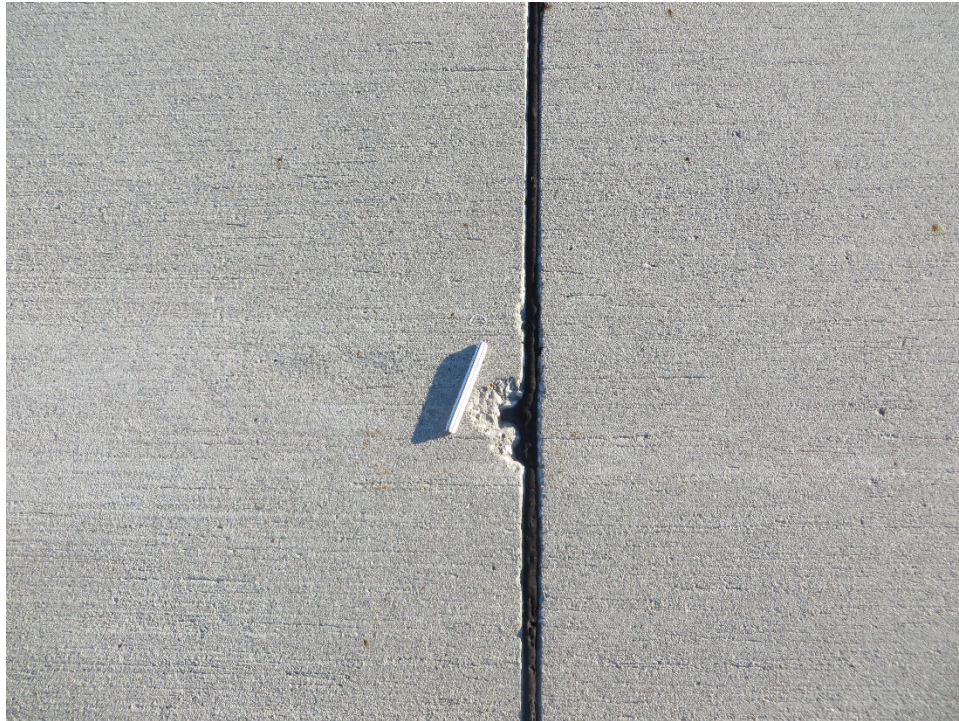
R14AU-01. Joint Spalling (Sample Unit No. 65).

Sample Number: 65 Type: R Area: 24.00Slabs PCI = 97
Sample Comments:
65 JOINT SEAL DAMAGE L 24.00 Slabs Comments:
74 JOINT SPALLING L 1.00 Slabs Comments:

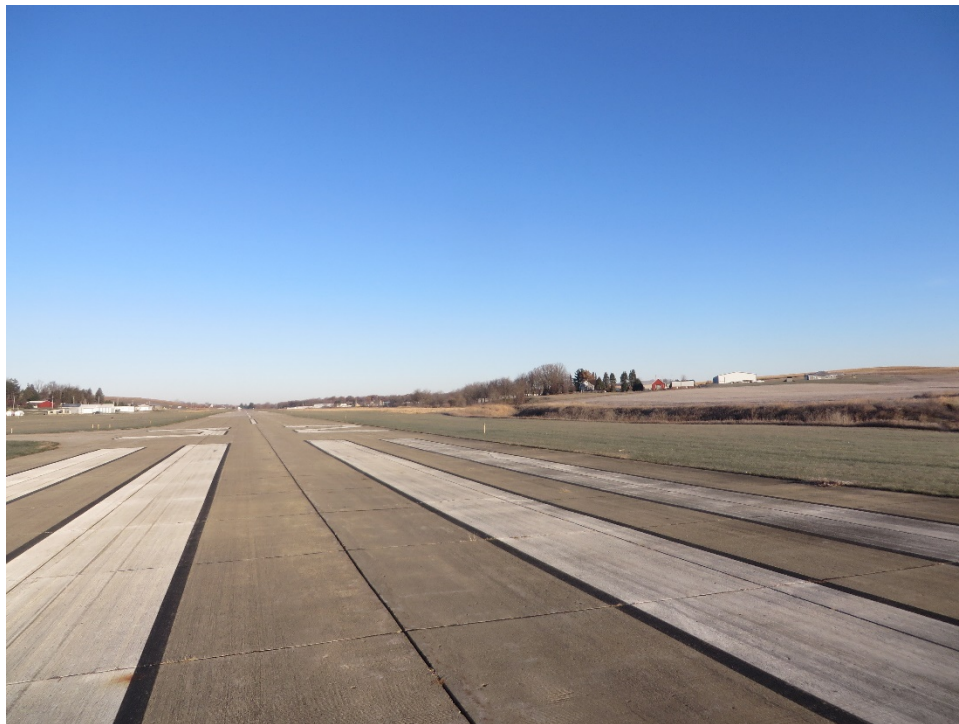
R14AU-02. Overview.

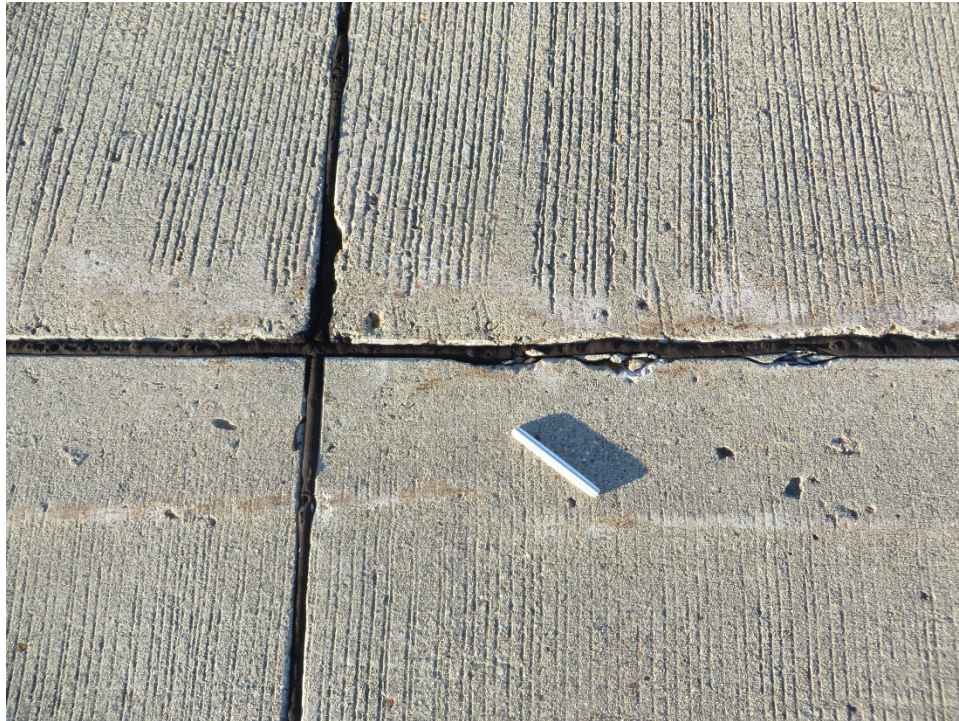
R14AU-02. Joint Seal Damage (Sample Unit No. 14).

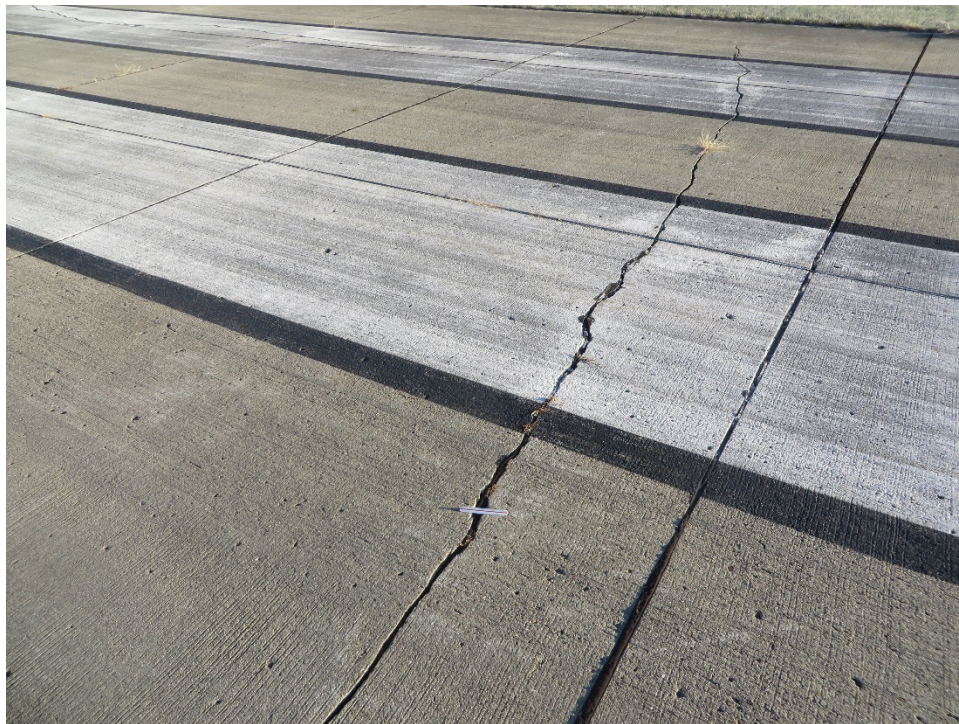
R14AU-02. LTD Cracking (Sample Unit No. 14).

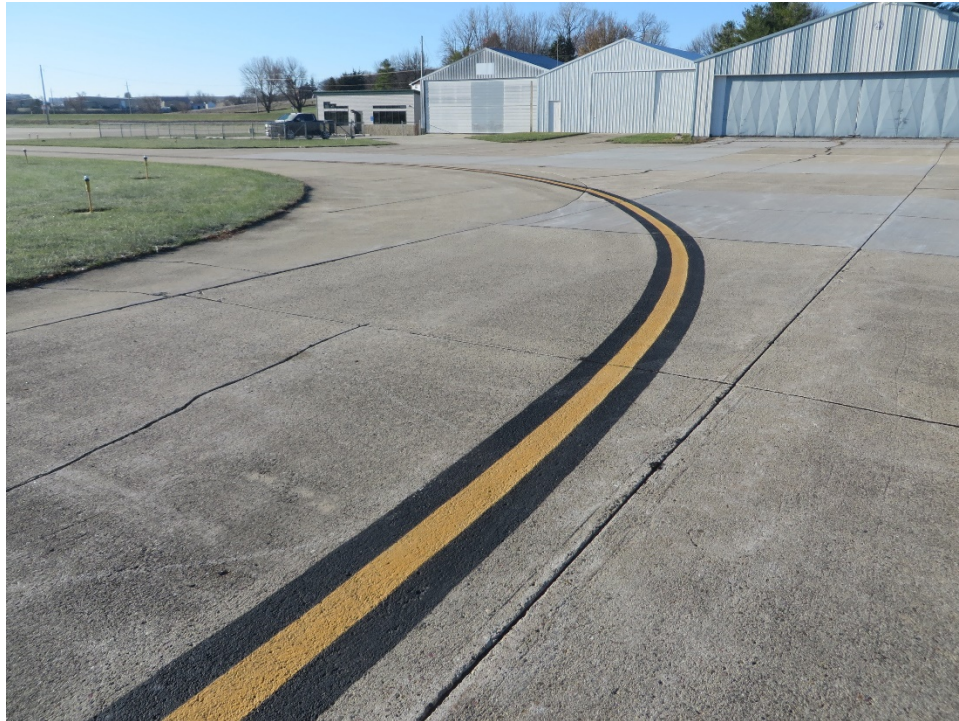
T01AU-01. Overview.

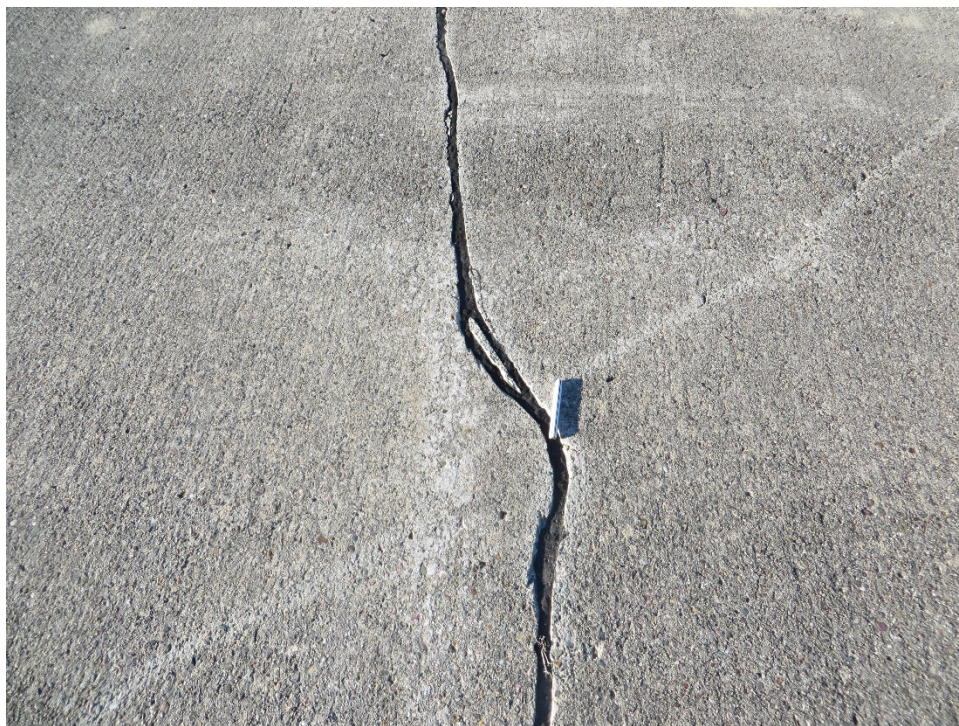
T01AU-01. LTD Cracking (Sample Unit No. 01).

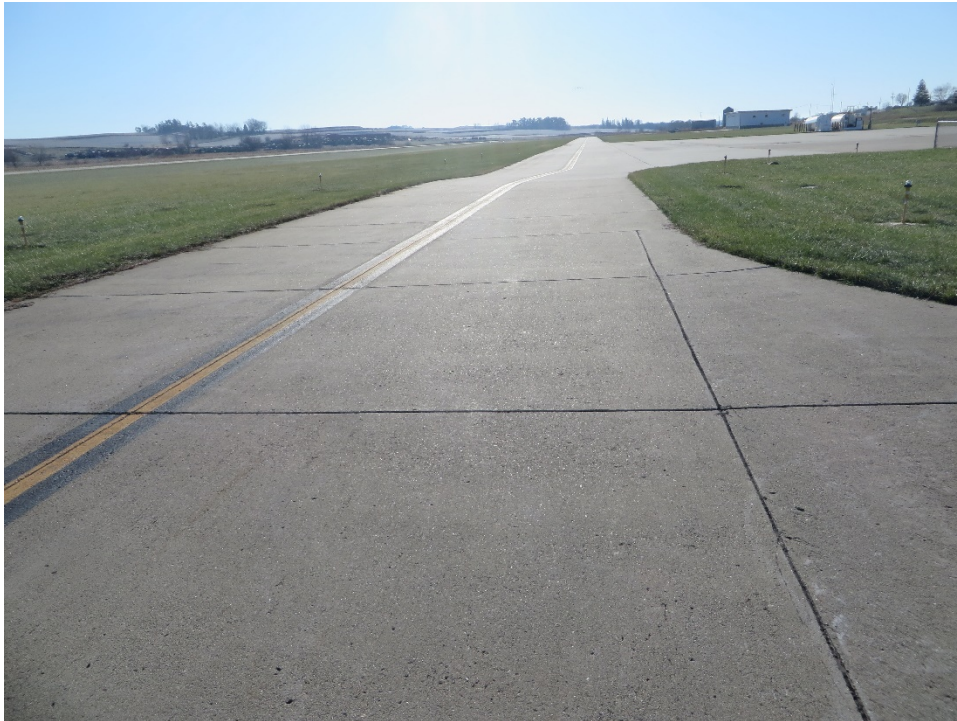
T01AU-02. Overview.

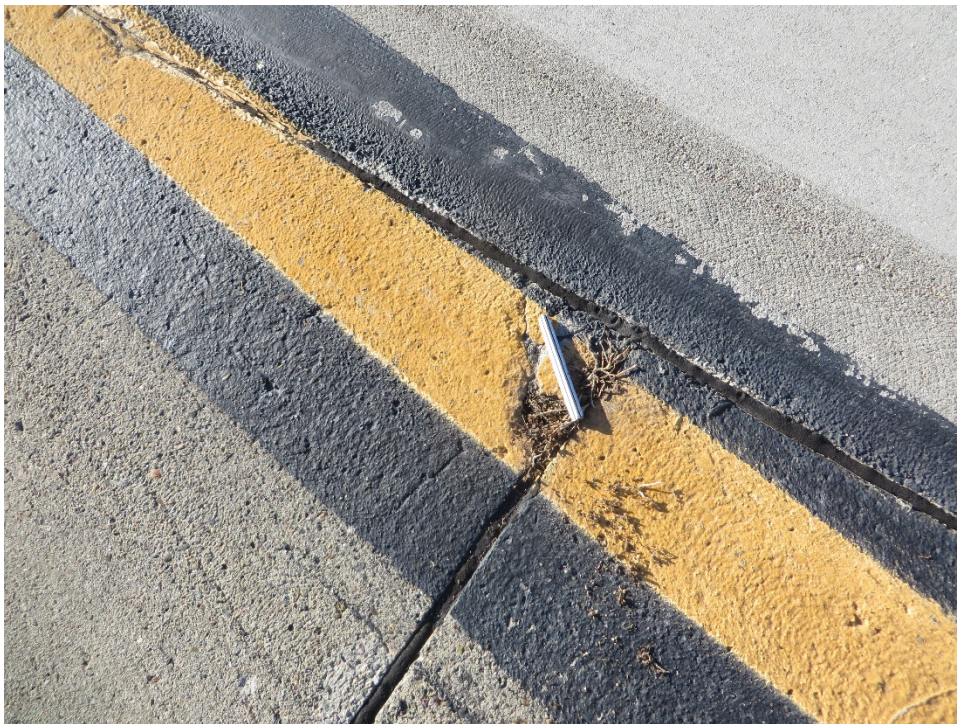
T01AU-02. Corner Spalling (Sample Unit No. 01).

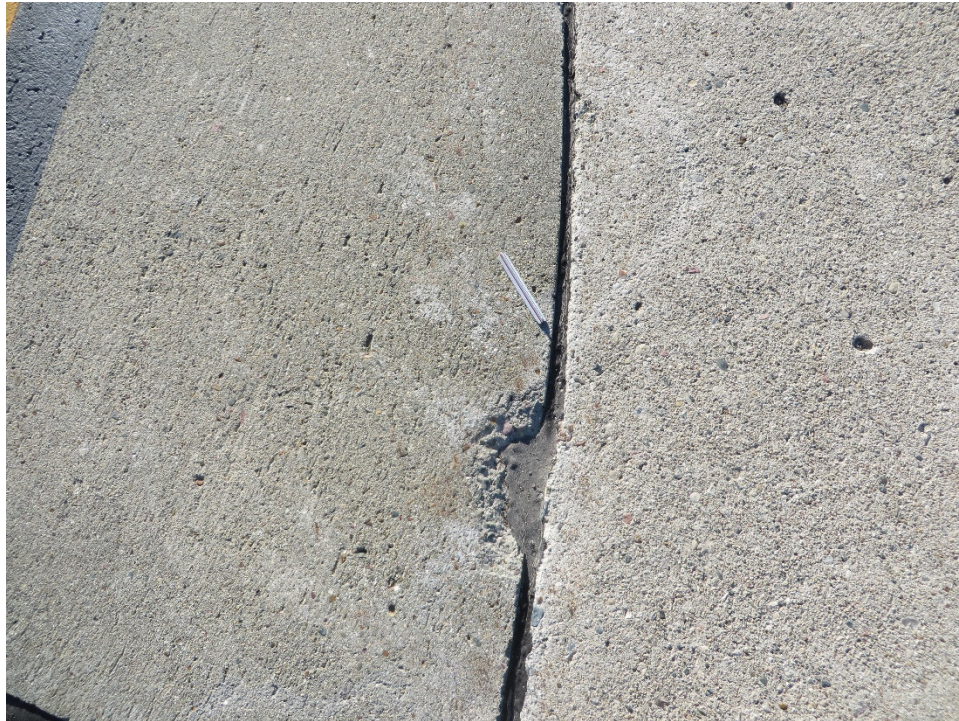
T01AU-02. Joint Spalling (Sample Unit No. 01).

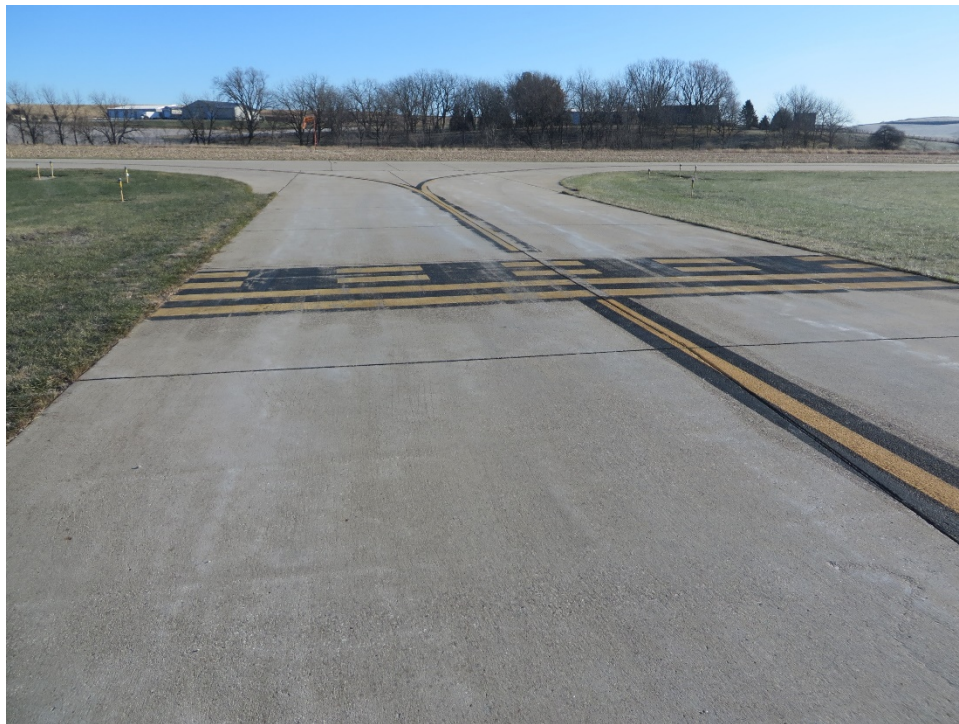
T01AU-03. Overview.

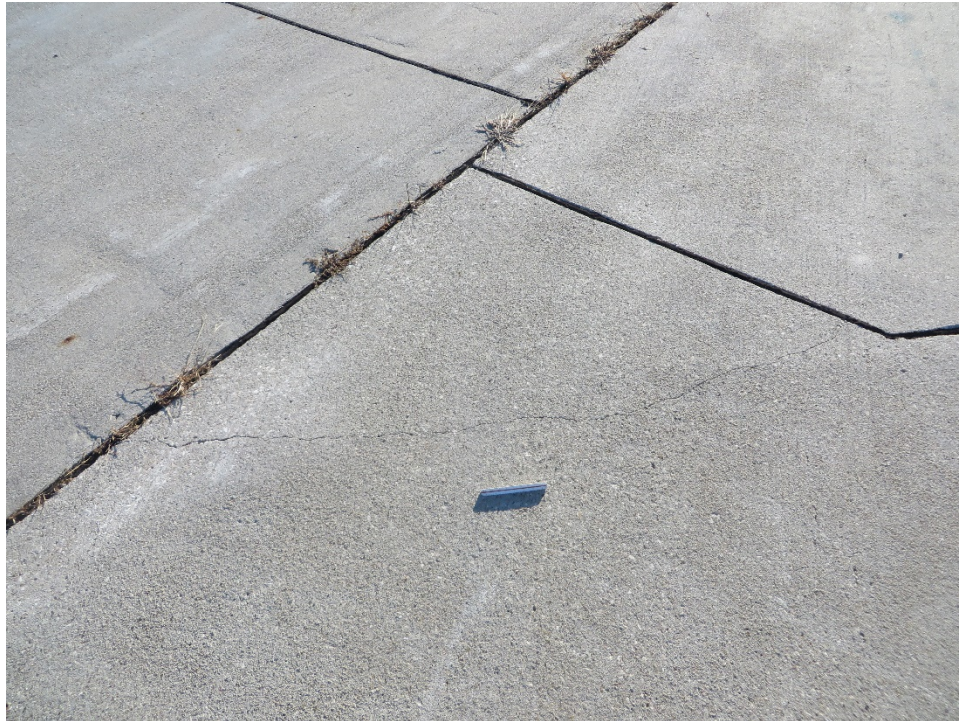
T01AU-03. Corner Break (Sample Unit No. 01).

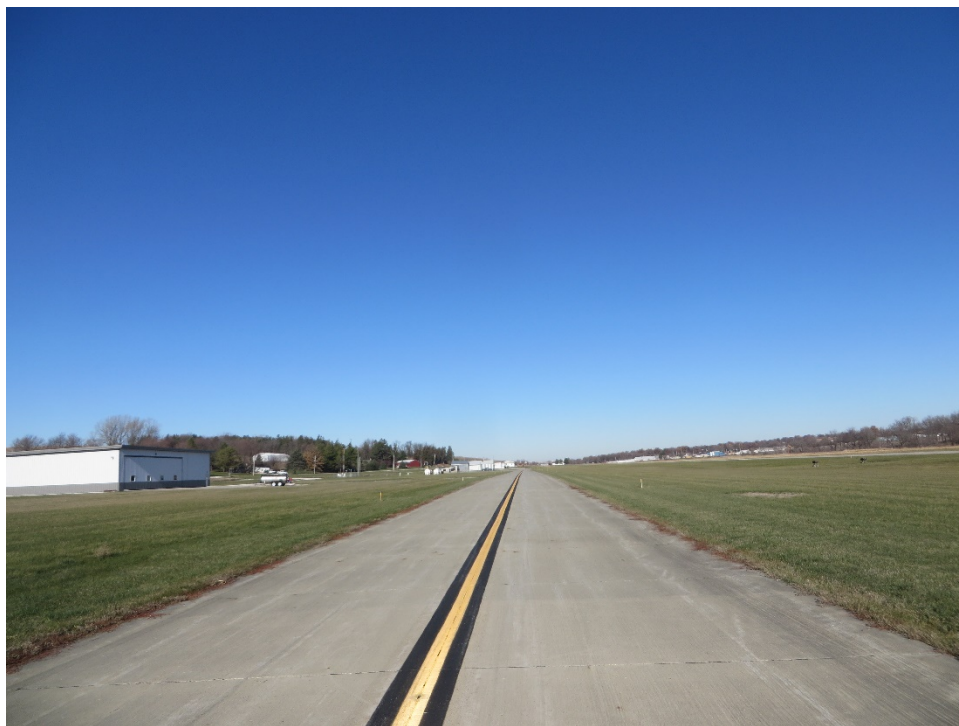
Taxiway 02 consisted of one section with low-severity joint seal damage noted throughout, along with areas of shrinkage cracking, low-severity LTD cracking and large patching, and medium-severity joint spalling.

T02AU-01. Overview.

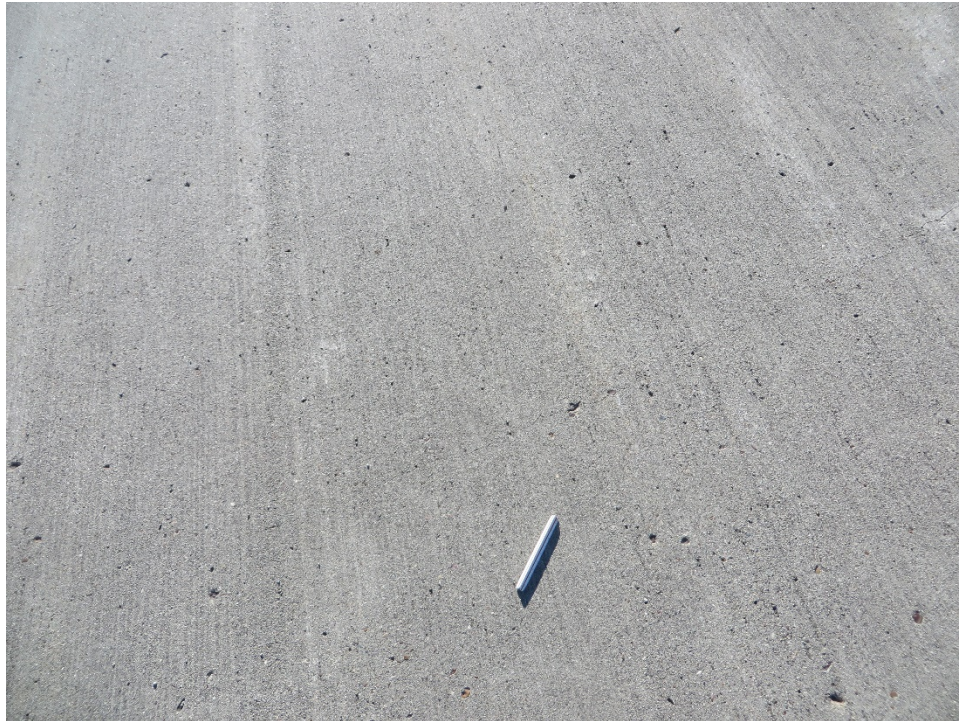
T02AU-01. Shrinkage Cracking (Sample Unit No. 12).
