Bloomfield Municipal Airport

PAVEMENT MANAGEMENT REPORT

JULY 2022

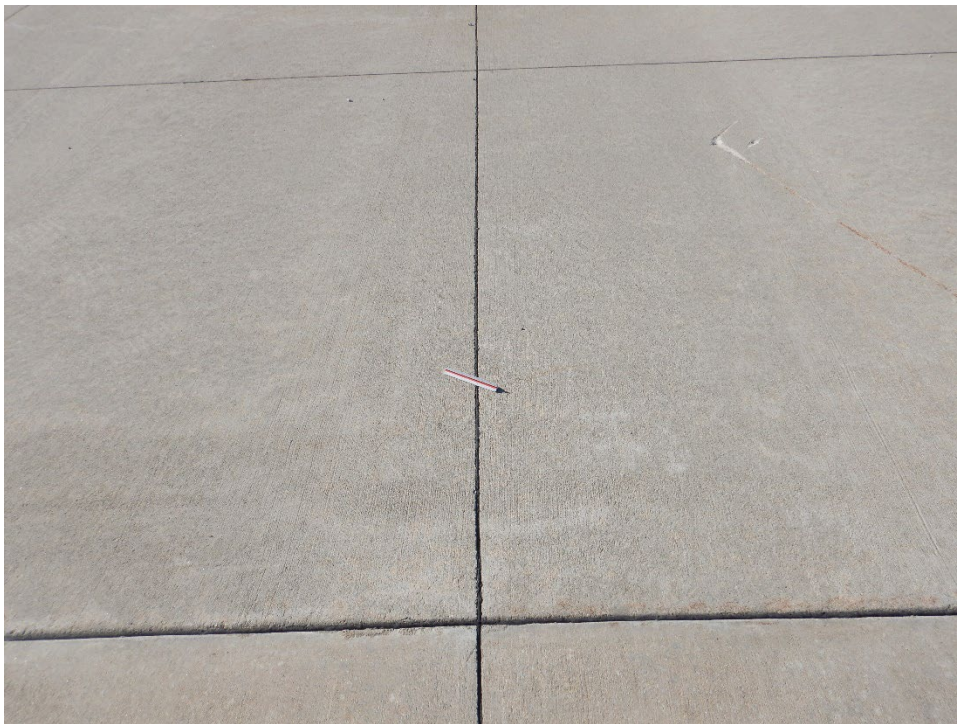
The apron consisted of two sections. All severities of joint seal damage were recorded in Section 01. Section 02 contained areas of low- and medium-severity corner break and joint spalling; low-severity corner spalling, faulting, and LTD cracking; and medium- and high-severity joint seal damage.

A01BL-01. Joint Seal Damage (Sample Unit No. 10).

Branch	Section	Distress Type	Severity	Distress Quantity	Distress Unit	Maintenance Action	Unit Cost	2022 Estimated Cost
A01BL	01	Joint Seal Damage	Medium	112	Slabs	Joint Seal (Localized)	\$3.02	\$6,232
A01BL	01	Joint Seal Damage	High	40	Slabs	Joint Seal (Localized)	\$3.02	\$2,226
A01BL	02	Corner Break	Low	2	Slabs	Crack Sealing - PCC	\$3.02	\$51
A01BL	02	Corner Break	Medium	2	Slabs	Patching - PCC Full Depth	\$16.76	\$1,110
A01BL	02	Joint Seal Damage	Medium	156	Slabs	Joint Seal (Localized)	\$3.02	\$8,825
A01BL	02	Joint Seal Damage	High	82	Slabs	Joint Seal (Localized)	\$3.02	\$4,645
A01BL	02	Joint Spalling	Medium	4	Slabs	Patching - PCC Partial Depth	\$37.54	\$995
R18BL	01	Corner Spalling	Medium	2	Slabs	Patching - PCC Partial Depth	\$37.54	\$193
R18BL	01	Faulting	Medium	2	Slabs	Grinding (Localized)	\$0.36	\$9
R18BL	01	Joint Seal Damage	Medium	38	Slabs	Joint Seal (Localized)	\$3.02	\$2,494
R18BL	01	Joint Seal Damage	High	153	Slabs	Joint Seal (Localized)	\$3.02	\$9,977

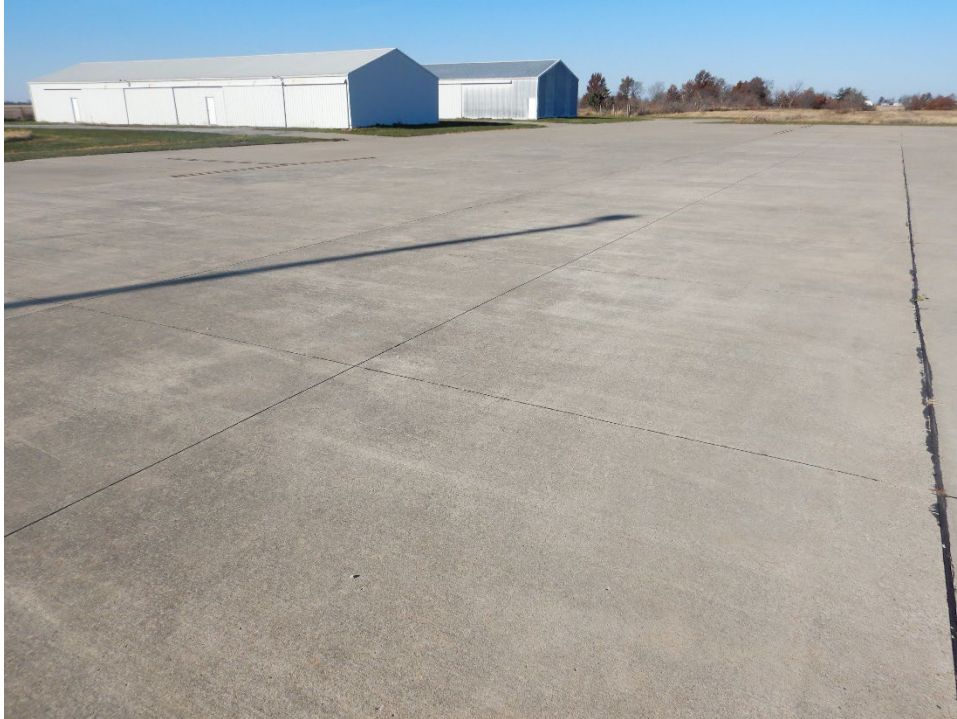
A01BL-02. Overview.

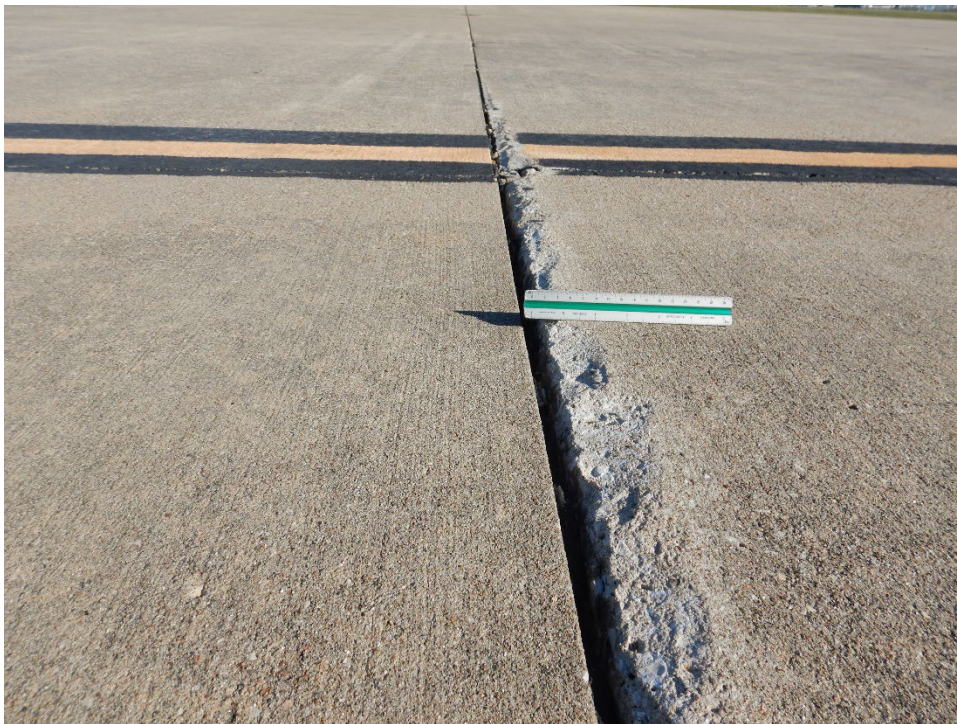
A01BL-02. Faulting (Sample Unit No. 02).

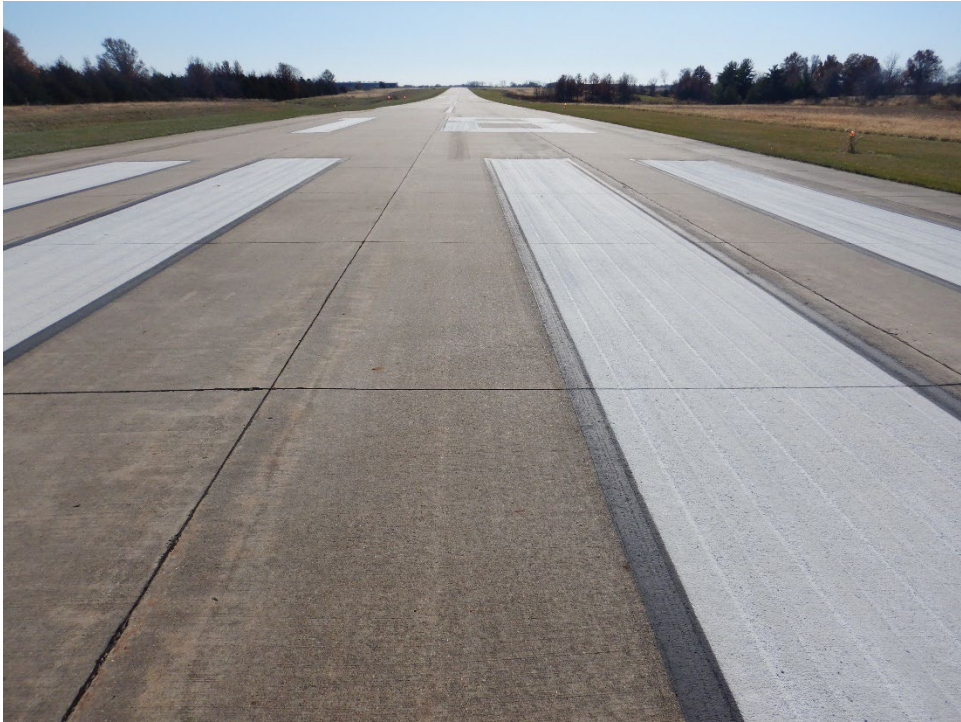
R18BL-01. Overview (2).

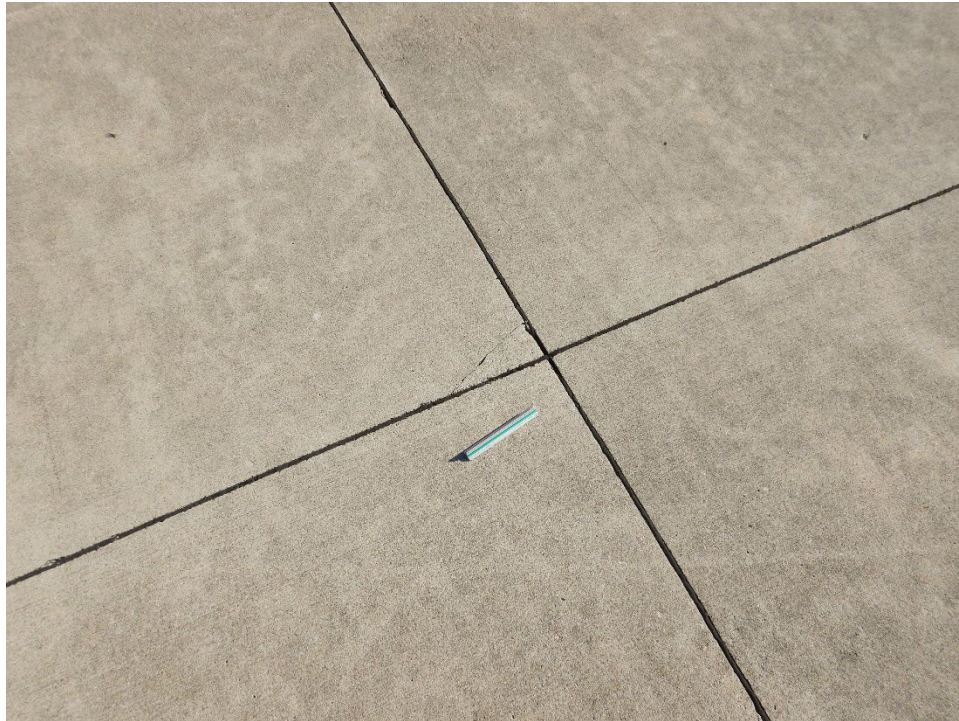
Runway 18/36 consisted of three sections. Section 01 contained areas of low- and medium-severity corner spalling and faulting; all severities of joint seal damage; and low-severity joint spalling and longitudinal, transverse, and diagonal (LTD) cracking. Section 02 was in excellent condition, with only low- and medium-severity joint seal damage recorded throughout. Low-severity corner break and LTD cracking, low- and medium-severity corner spalling and faulting, medium- and high-severity joint seal damage, and medium-severity joint spalling were observed in Section 02.

R18BL-01. Corner Spalling (Sample Unit No. 01).

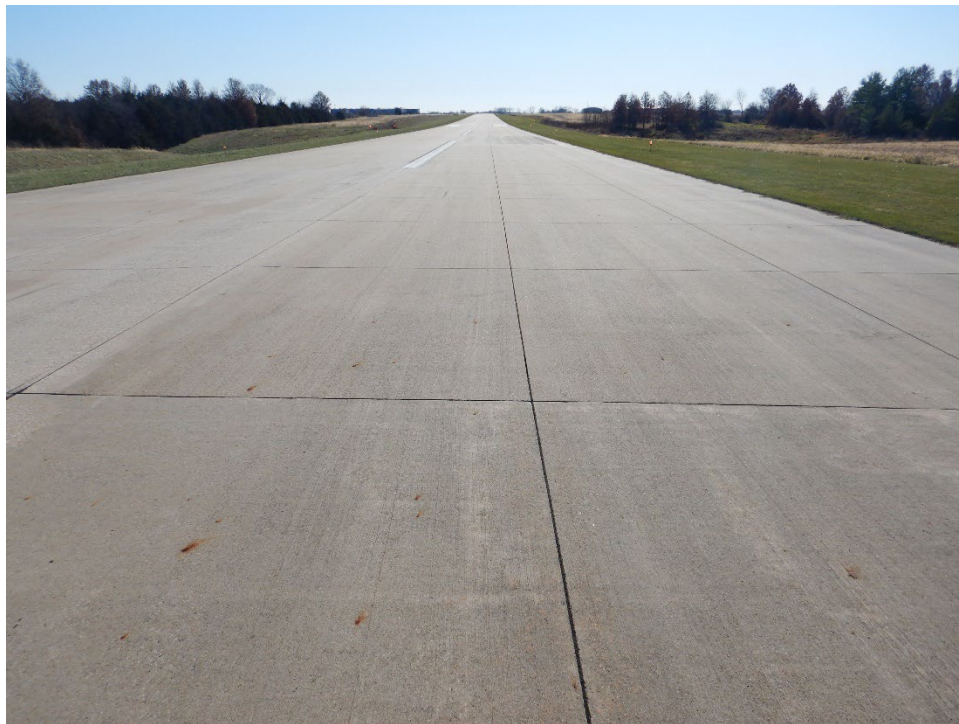
R18BL-02. Overview.

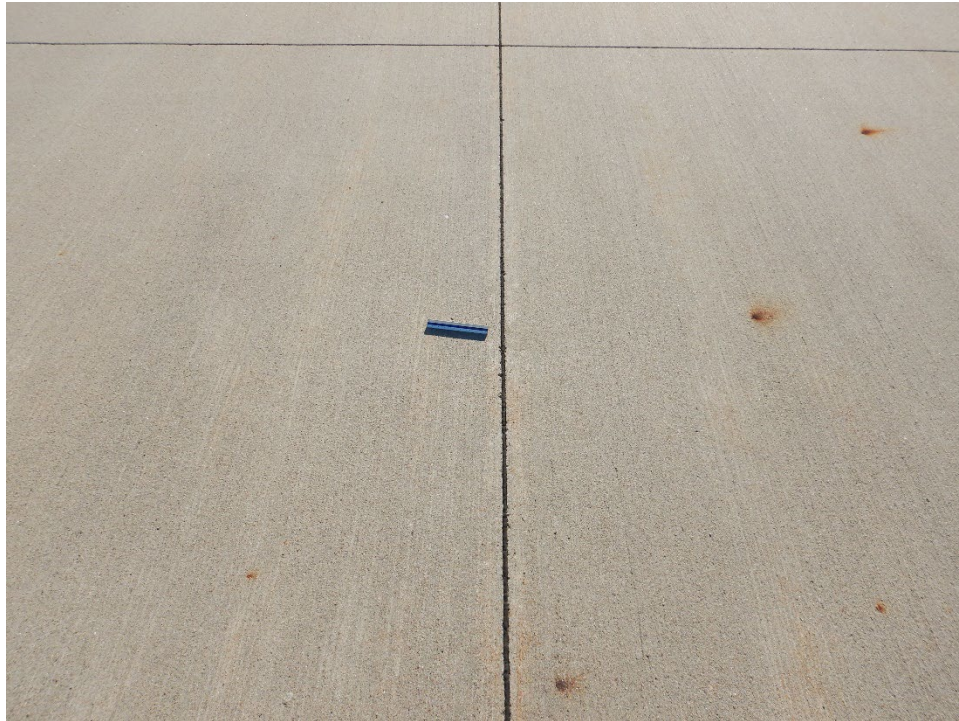
R18BL-02. Joint Seal Damage (Sample Unit No. 13).

R18BL	02	Joint Seal Damage	Medium	340	Slabs	Joint Seal (Localized)	\$3.02	\$20,905
R18BL	03	Corner Break	Low	1	Slabs	Crack Sealing - PCC	\$3.02	\$32
R18BL	03	Corner Spalling	Medium	1	Slabs	Patching - PCC Partial Depth	\$37.54	\$132
R18BL	03	Faulting	Medium	1	Slabs	Grinding (Localized)	\$0.36	\$6
R18BL	03	Joint Seal Damage	Medium	128	Slabs	Joint Seal (Localized)	\$3.02	\$8,326
R18BL	03	Joint Seal Damage	High	26	Slabs	Joint Seal (Localized)	\$3.02	\$1,699
R18BL	03	Joint Spalling	Medium	1	Slabs	Patching - PCC Partial Depth	\$37.54	\$316
TH01BL	02	Corner Break	Low	1	Slabs	Crack Sealing - PCC	\$3.02	\$25
TH01BL	02	Joint Seal Damage	High	24	Slabs	Joint Seal (Localized)	\$3.02	\$850

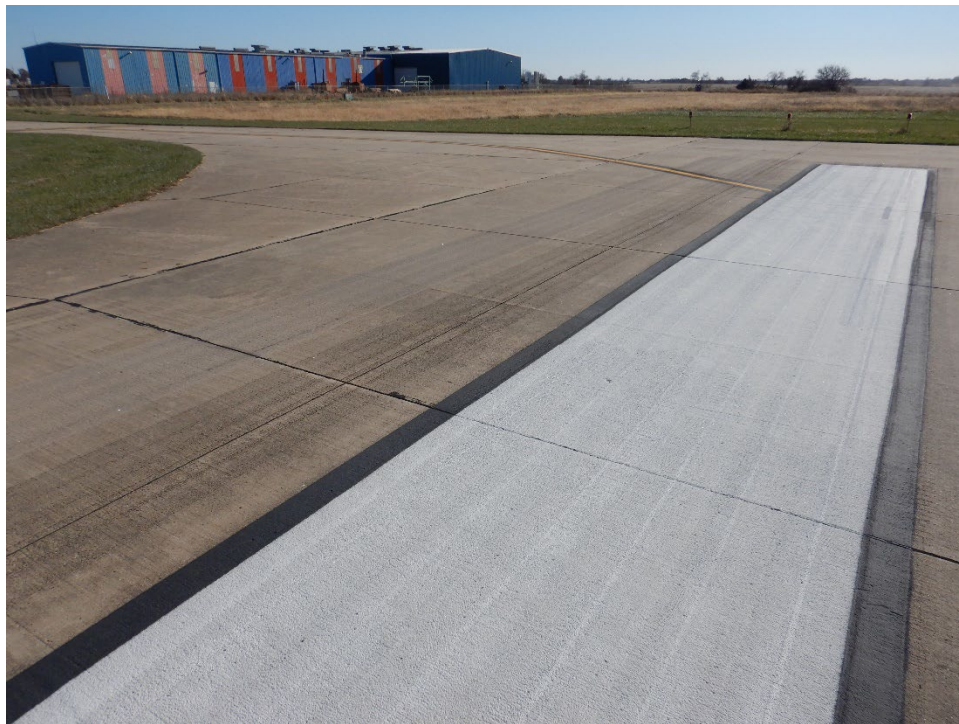
R18BL-03. Overview.

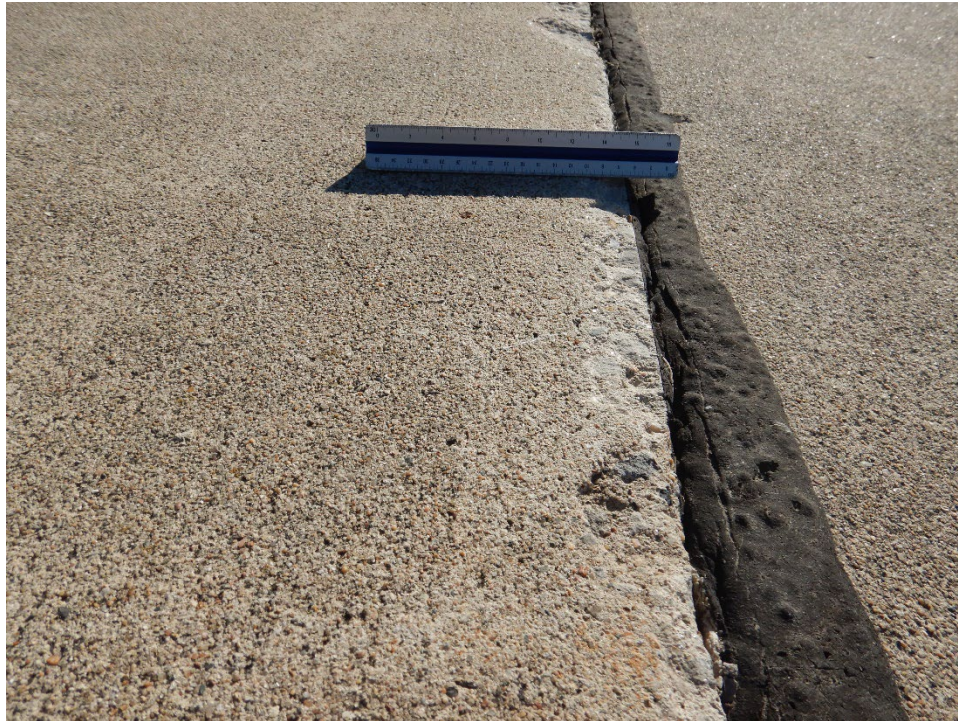
R18BL-03. Faulting (Sample Unit No. 09).

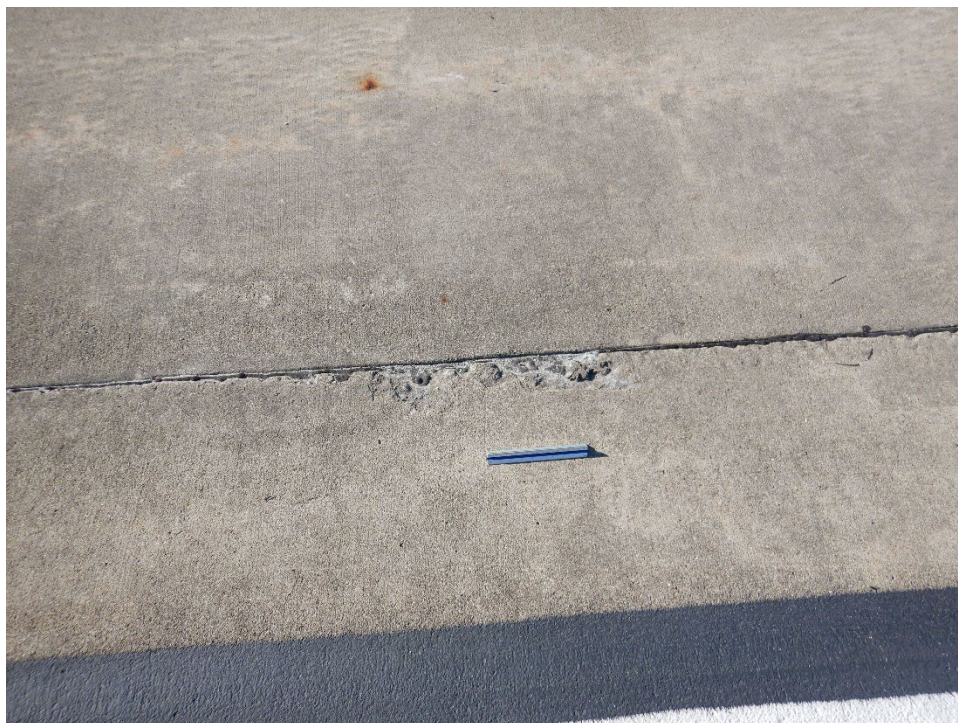
R18BL-03. Joint Spalling (Sample Unit No. 03).

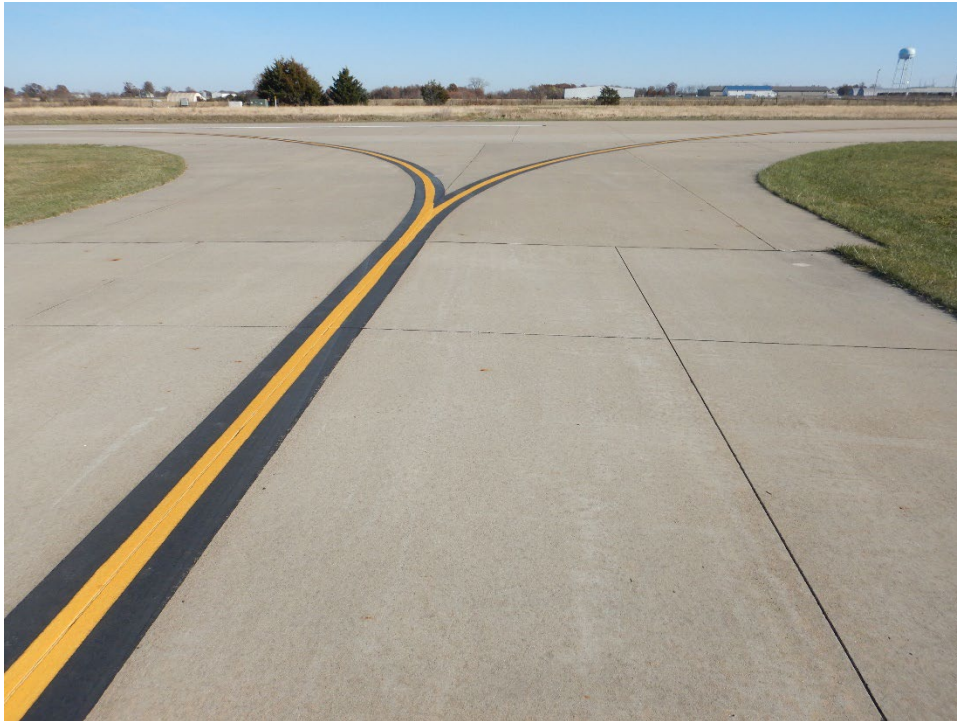
Taxiway 01 connected the apron area with Runway 18/36 and contained one section. Section 01 was in excellent condition with only low-severity joint seal damage noted.

T01BL-01. Overview.

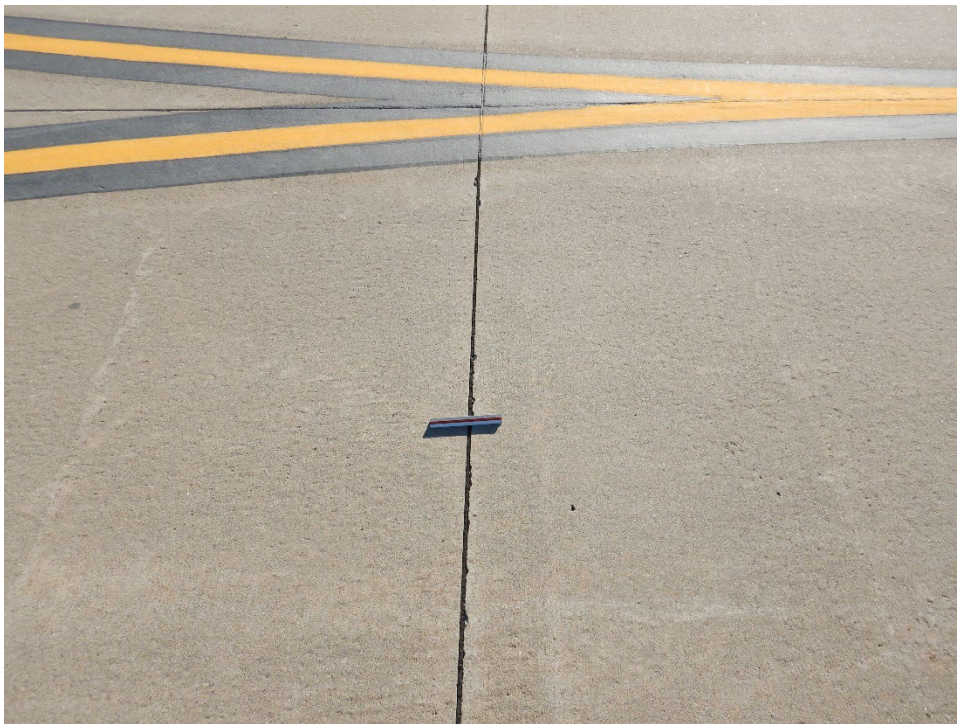
T01BL-01. Joint Seal Damage (Sample Unit No. 03).

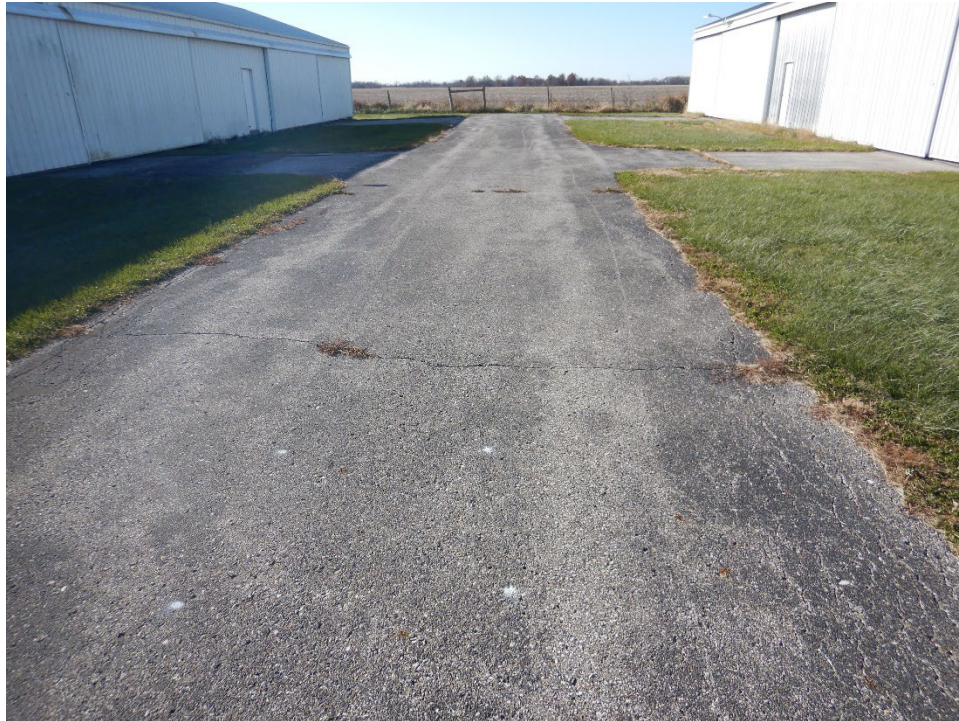
TH01BL-01. Overview.

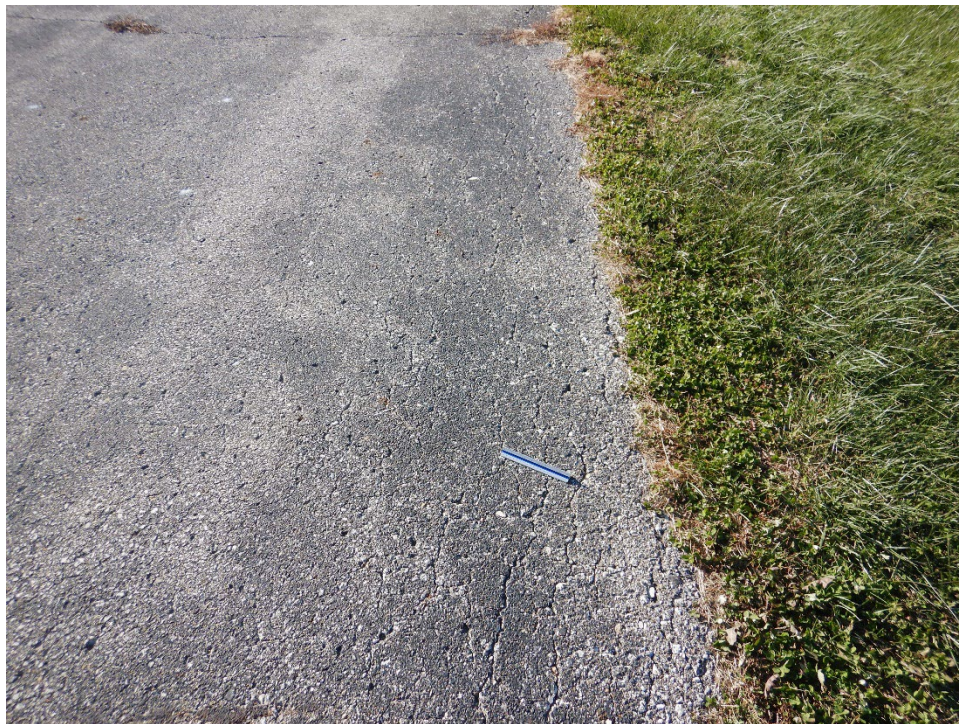
The T-hangar area was defined by three sections. Section 01 was poor condition with low-severity alligator cracking, low- and medium-severity, unsealed longitudinal and transverse (L&T) cracking, medium-severity shoving, and high-severity weathering. High-severity joint seal damage was recorded throughout Section 02, along with areas of low-severity corner break and faulting. Section 03 contained low- and medium-severity faulting, high-severity joint seal damage, and low-severity LTD cracking, shattered slab, and alkali-silica reaction (ASR). The suspected ASR was recorded at this airport in accordance with ASTM D5340-20. It should be noted that laboratory testing in the form of petrographic analysis is the only definitive way to validate the presence of ASR; however, the formation of a precipitate is evidence of a reaction consistent with this type of materials-related distress.

TH01BL-01. Alligator Cracking (Sample Unit No. 01).

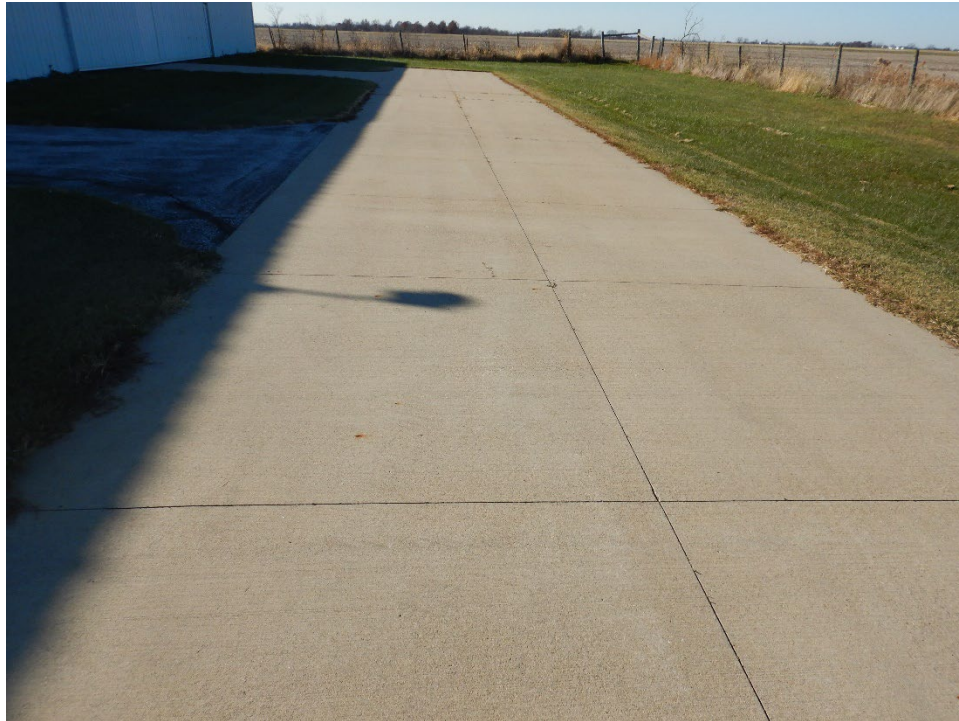
TH01BL-02. Overview.

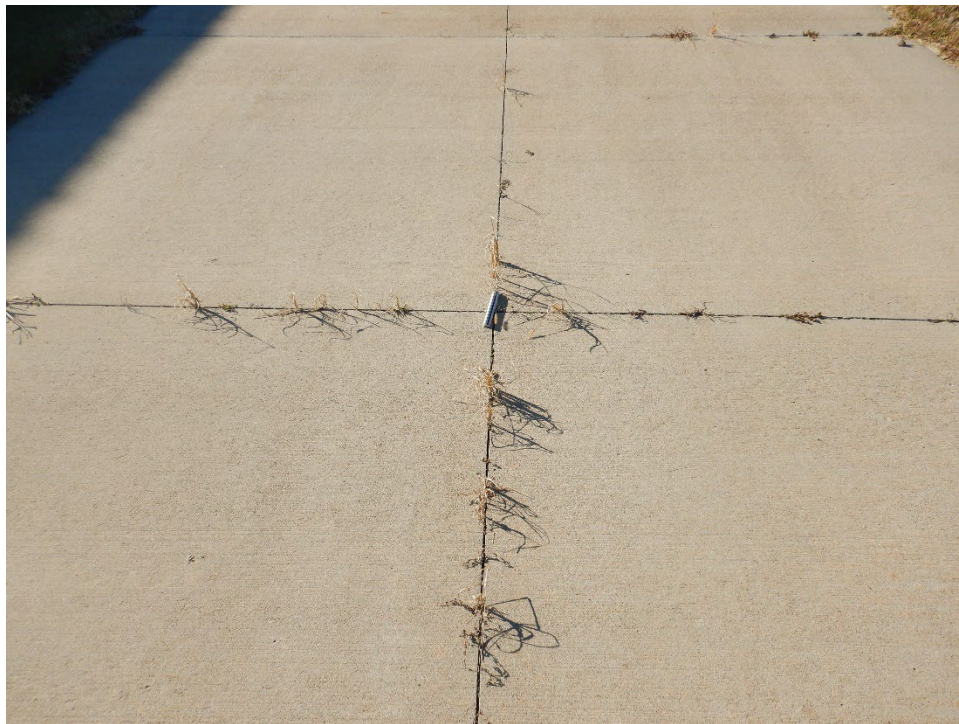
TH01BL-02. Joint Seal Damage (Sample Unit No. 01).

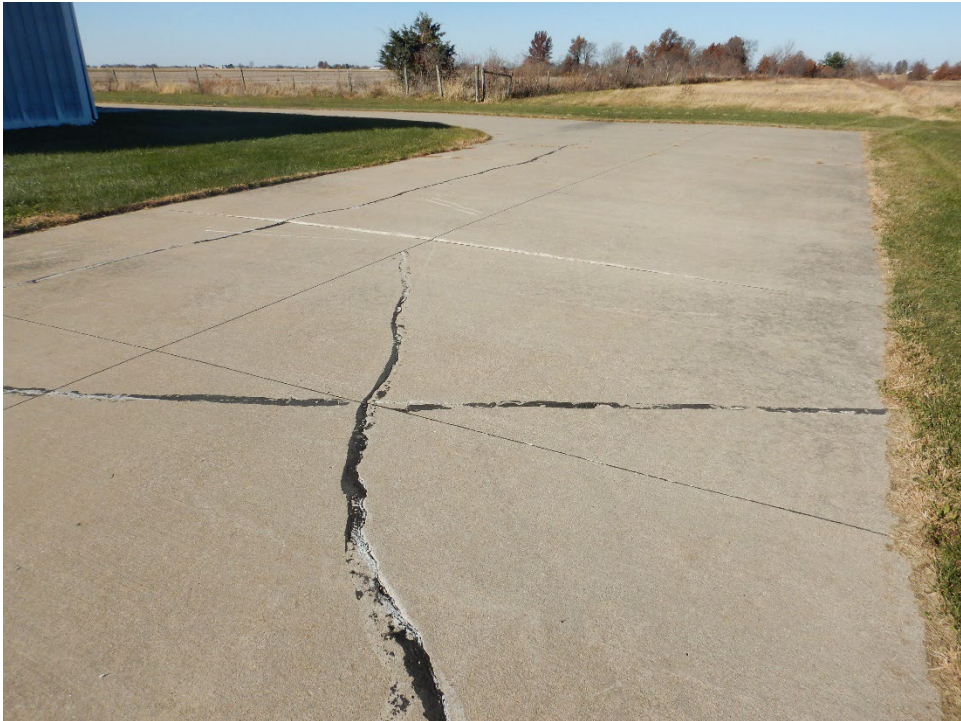
TH01BL-03. Overview.

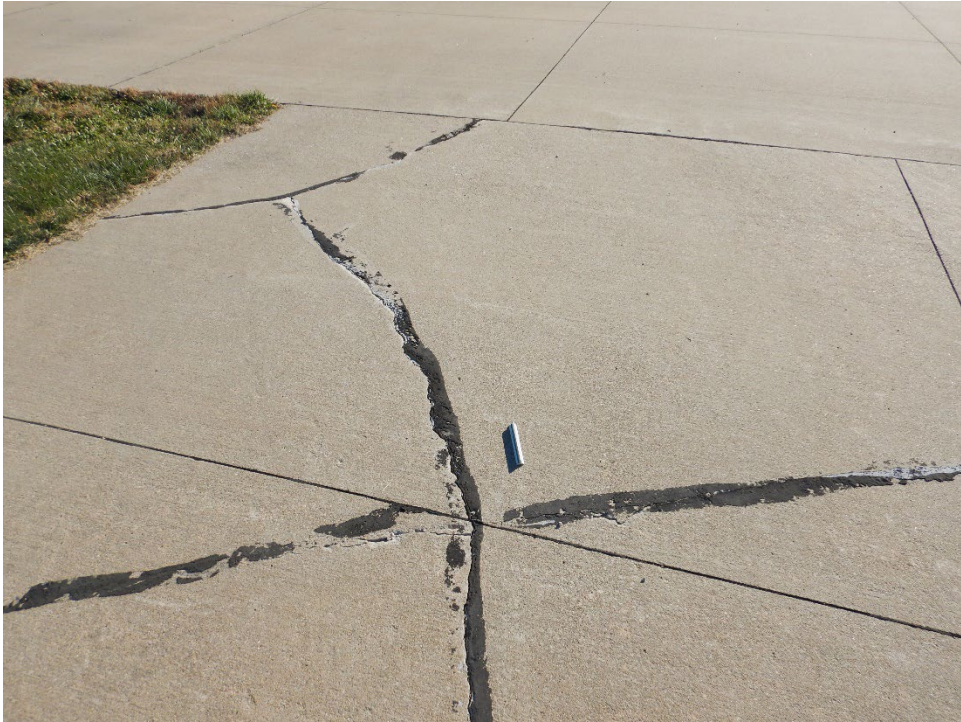
TH01BL-03. Shattered Slab (Sample Unit No. 01).

Year	Branch	Section	Surface Type	Type of Repair	Estimated Cost
2022	A01BL	01	PCC	Preventive Maintenance	\$8,458
2022	A01BL	02	PCC	Preventive Maintenance	\$15,625
2022	R18BL	01	PCC	Preventive Maintenance	\$12,673
2022	R18BL	02	PCC	Preventive Maintenance	\$20,905
2022	R18BL	03	PCC	Preventive Maintenance	\$10,511
2022	TH01BL	01	AC	Major Rehabilitation	\$43,730
2022	TH01BL	02	PCC	Preventive Maintenance	\$874
2022	TH01BL	03	PCC	Major Rehabilitation	\$24,473
Total Estimated Cost:					\$137,000
