Boone Municipal Airport

PAVEMENT MANAGEMENT REPORT

JULY 2021

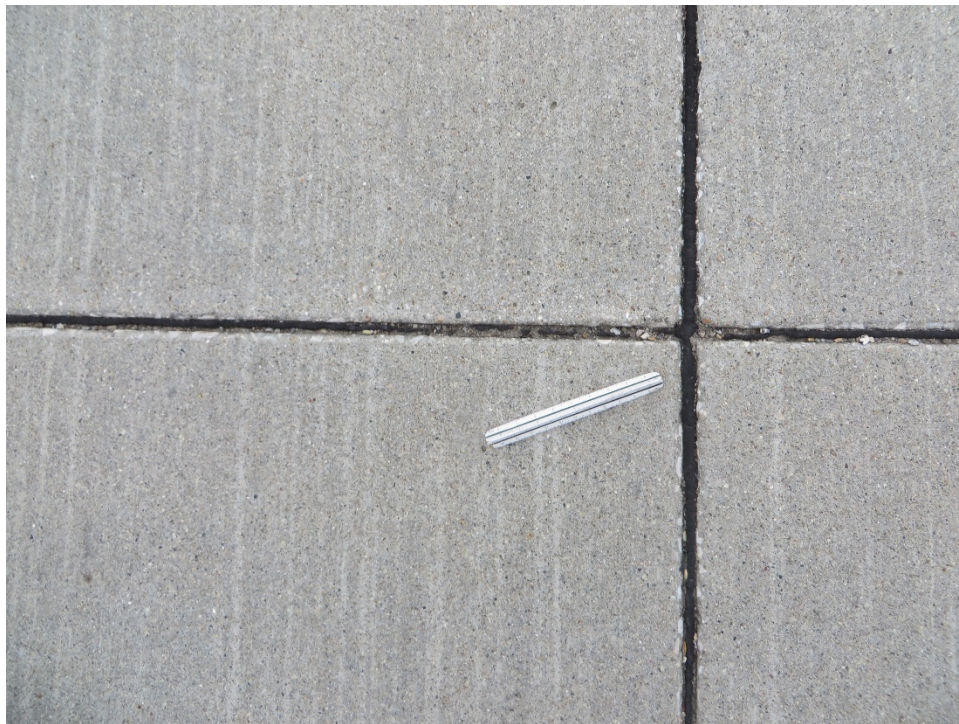
A01BO-01. Joint Seal Damage (Sample Unit No. 15).

Sample Number: 15 Type: R Area: 20.00Slabs PCI = 88
Sample Comments:
65 JOINT SEAL DAMAGE H 20.00 Slabs Comments:

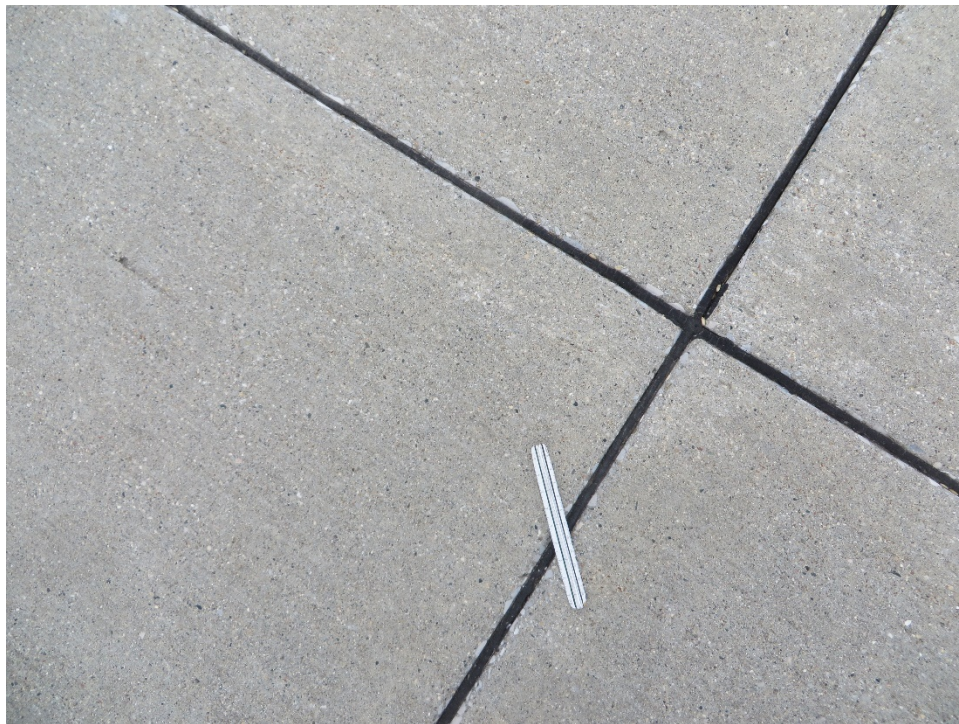
A01BO-02. Joint Seal Damage (Sample Unit No. 07).

Sample Number: 07 Type: R Area: 20.00Slabs PCI = 93
Sample Comments:
65 JOINT SEAL DAMAGE M 20.00 Slabs Comments:

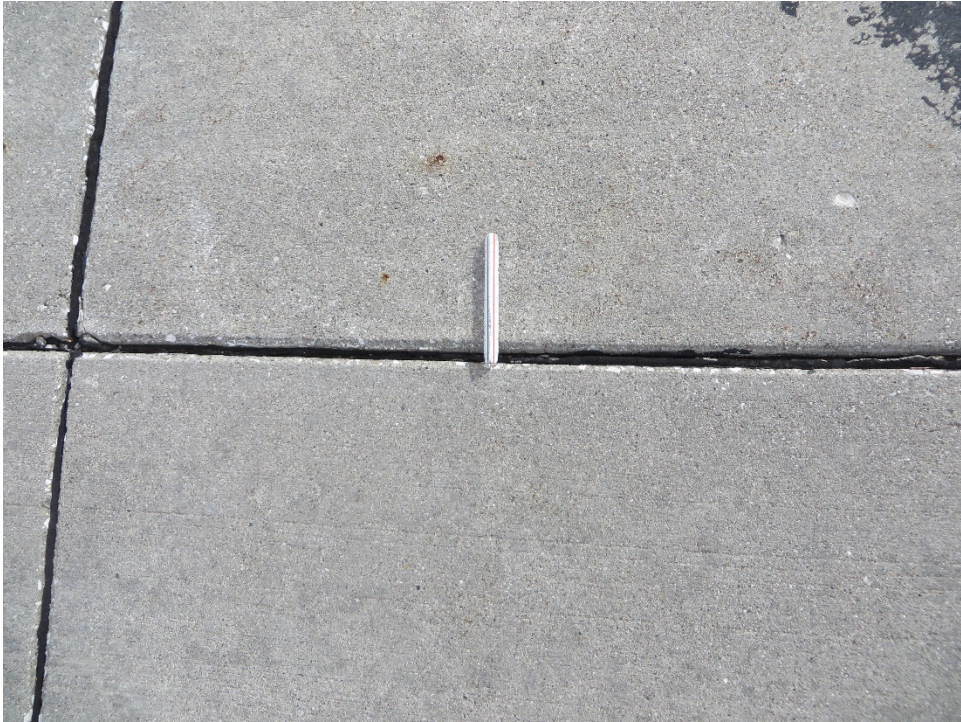
A01BO-03. Joint Seal Damage (Sample Unit No. 02).

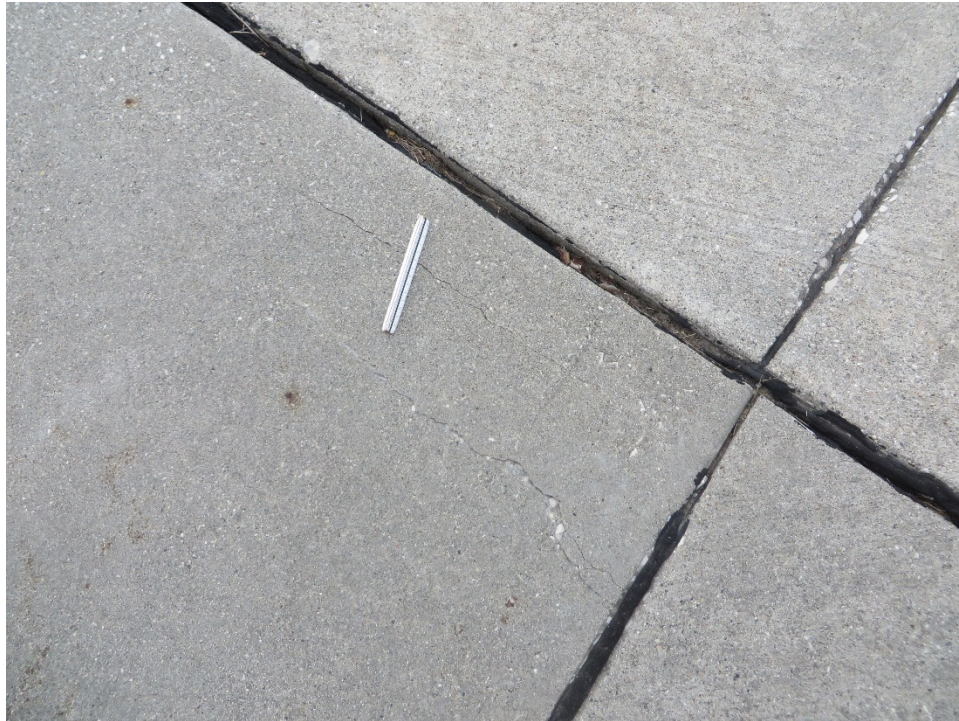
A01BO-03. Joint Spalling (Sample Unit No. 01).

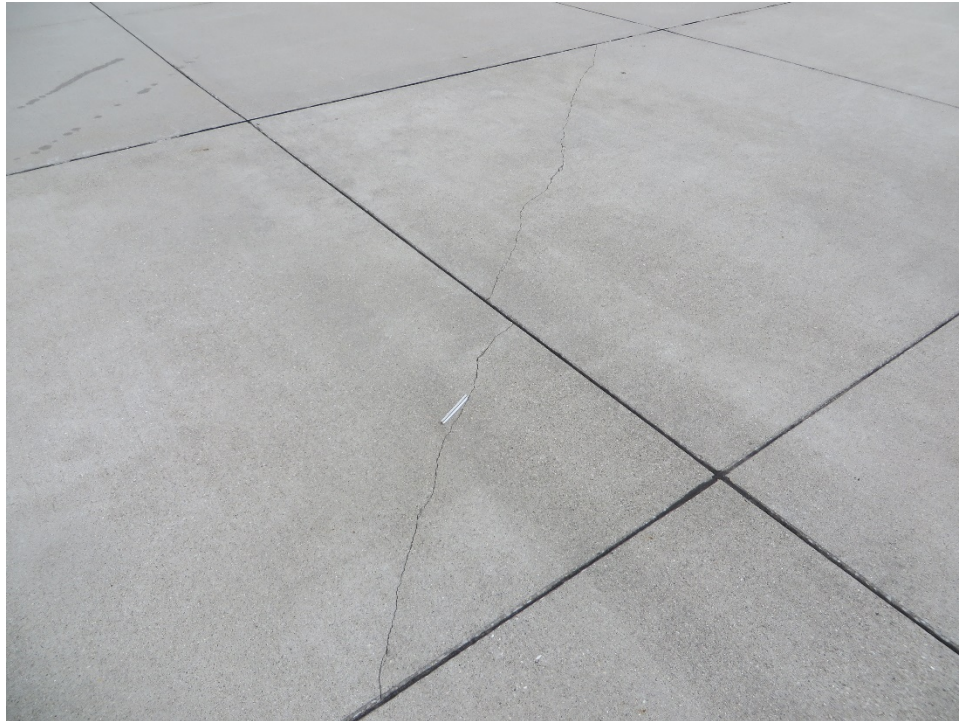
A01BO-04. Corner Break (Additional Sample Unit No. 07).

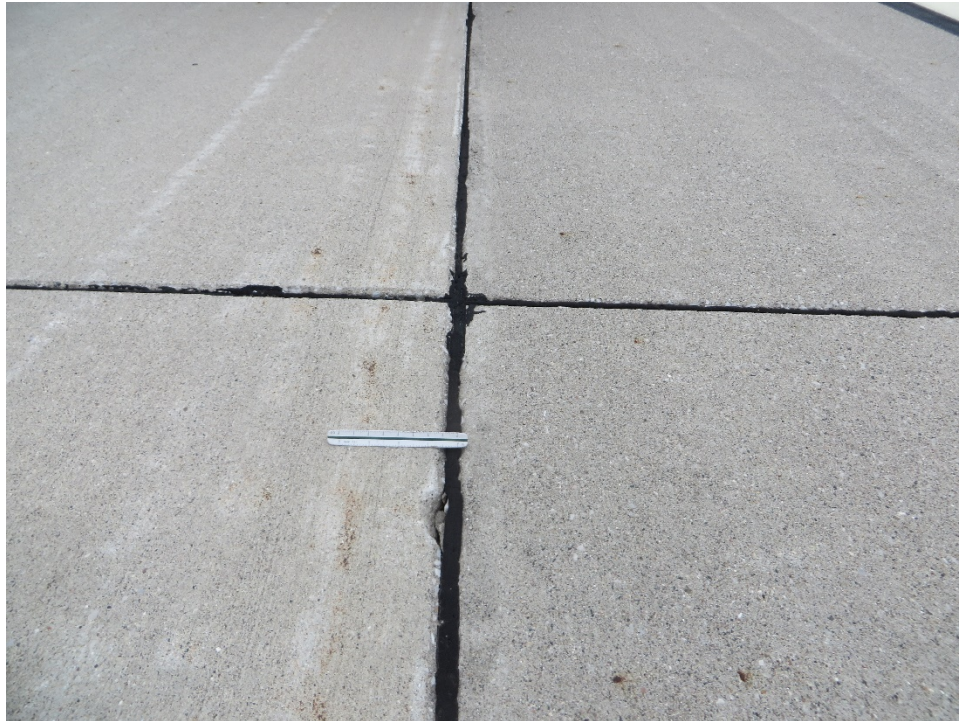
R15BO-01. Faulting (Sample Unit No. 30).

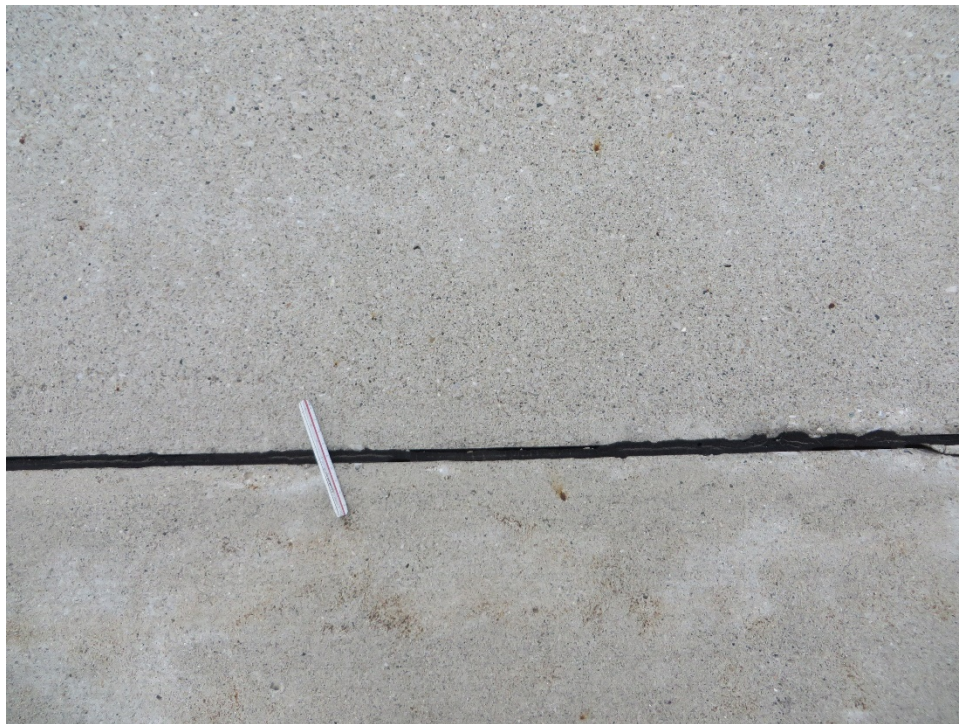
R15BO-01. Joint Seal Damage (Sample Unit No. 01).

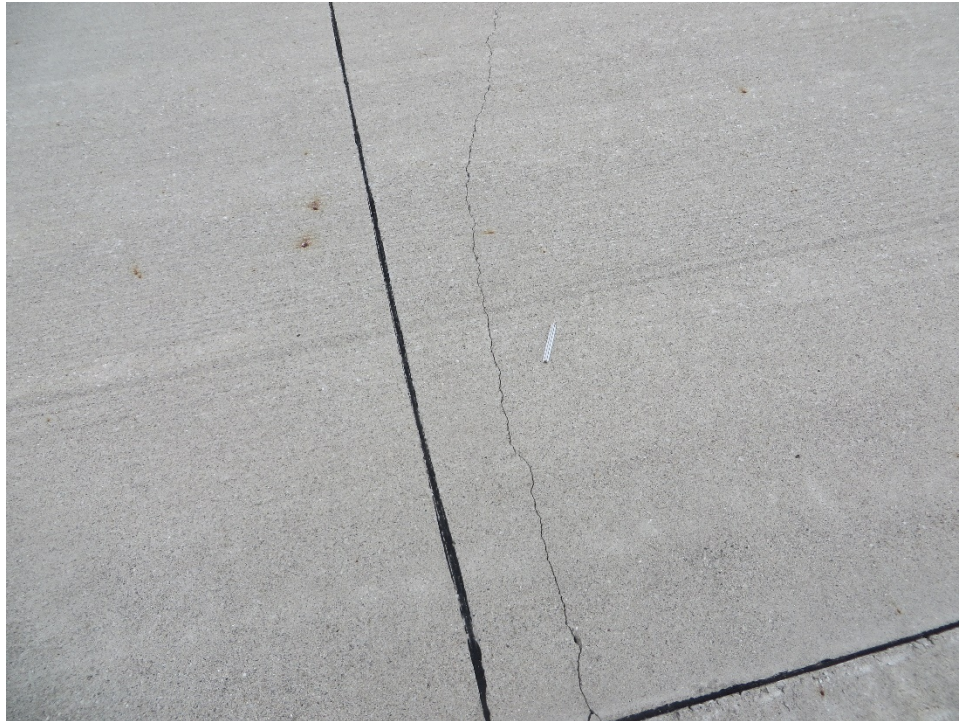
R15BO-01. LTD Cracking (Sample Unit No. 59).

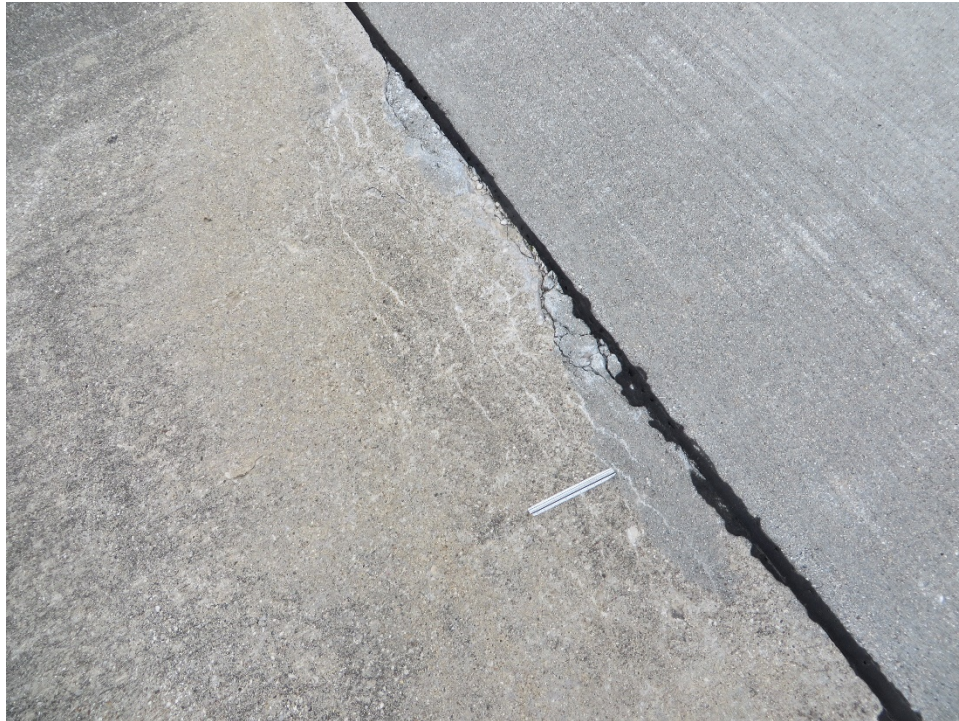
R15BO-02. ASR (Sample Unit No. 01).

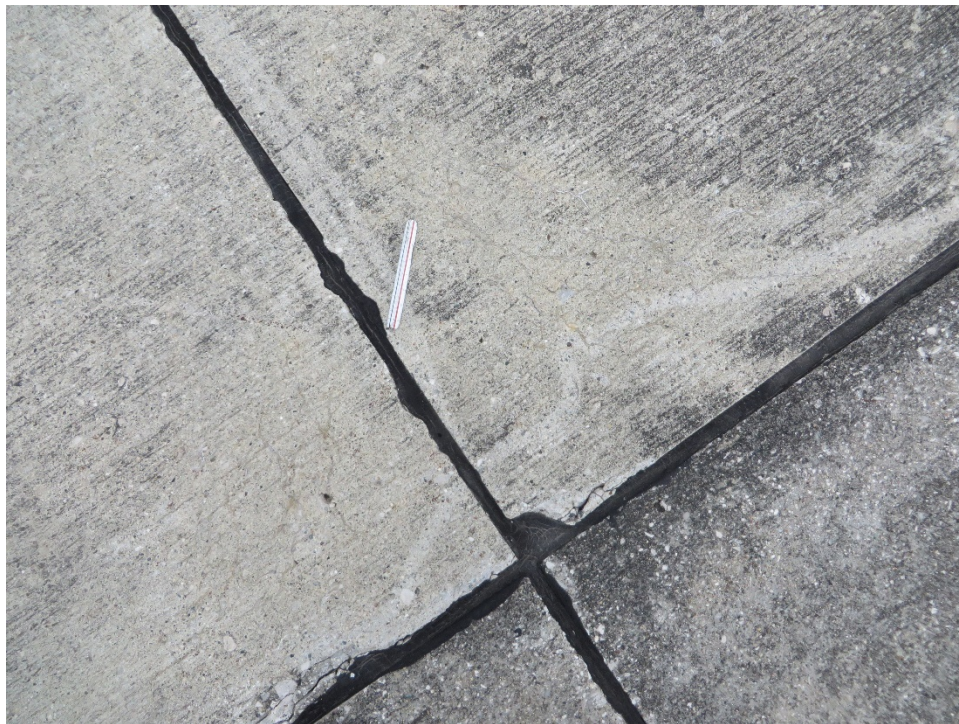
R15BO-02. ASR (Sample Unit No. 25).

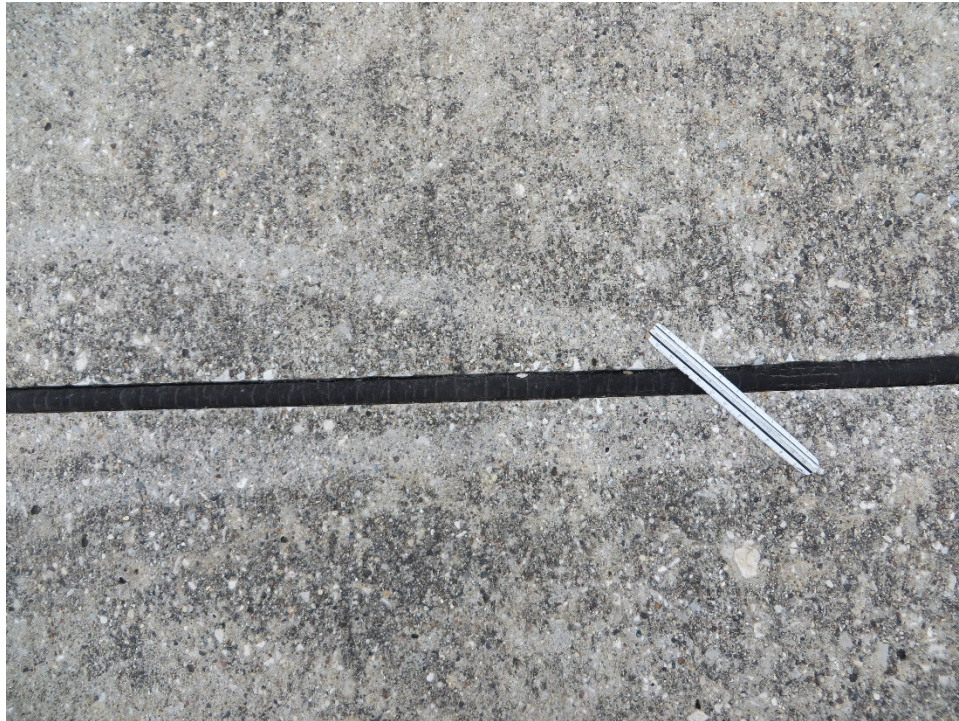
R15BO-02. Joint Seal Damage (Sample Unit No. 07).

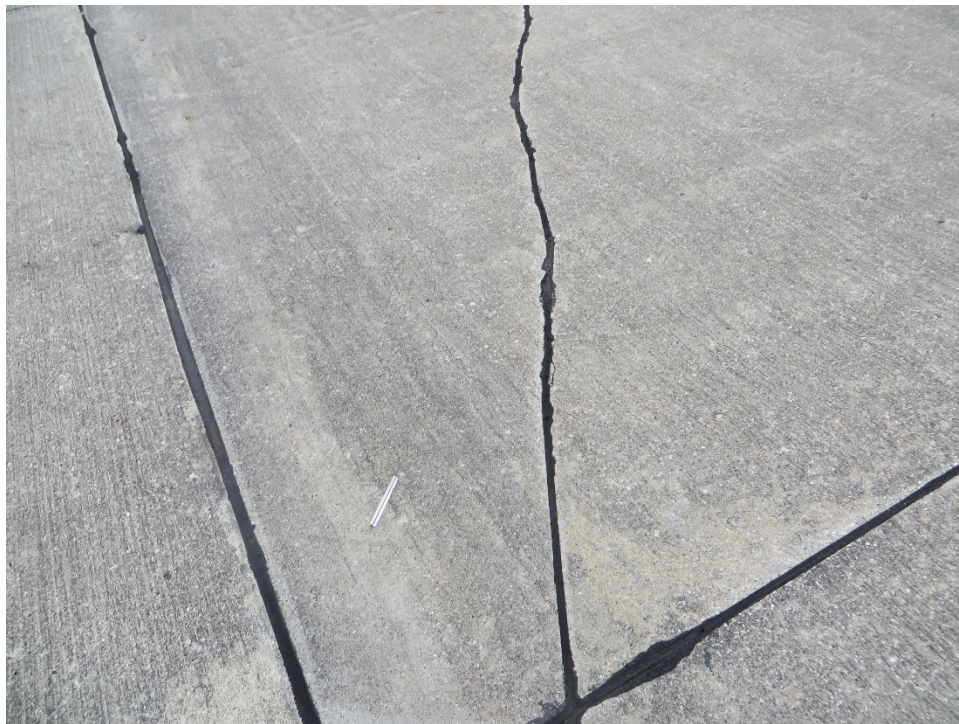
R15BO-02. LTD Cracking (Sample Unit No. 16).

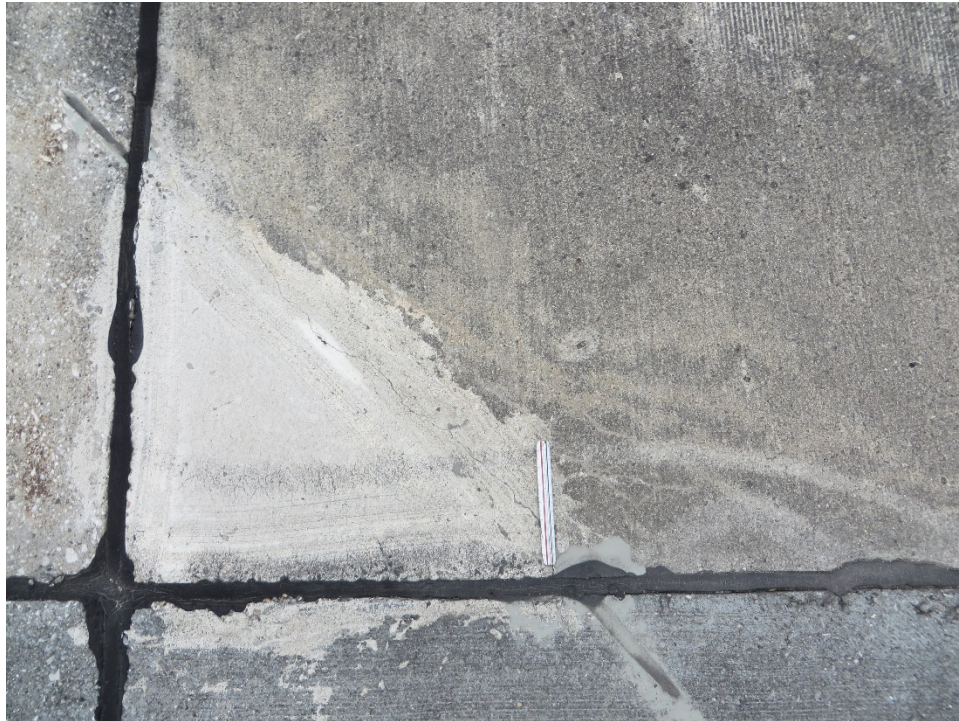
R15BO-02. Small Patching (Sample Unit No. 01).

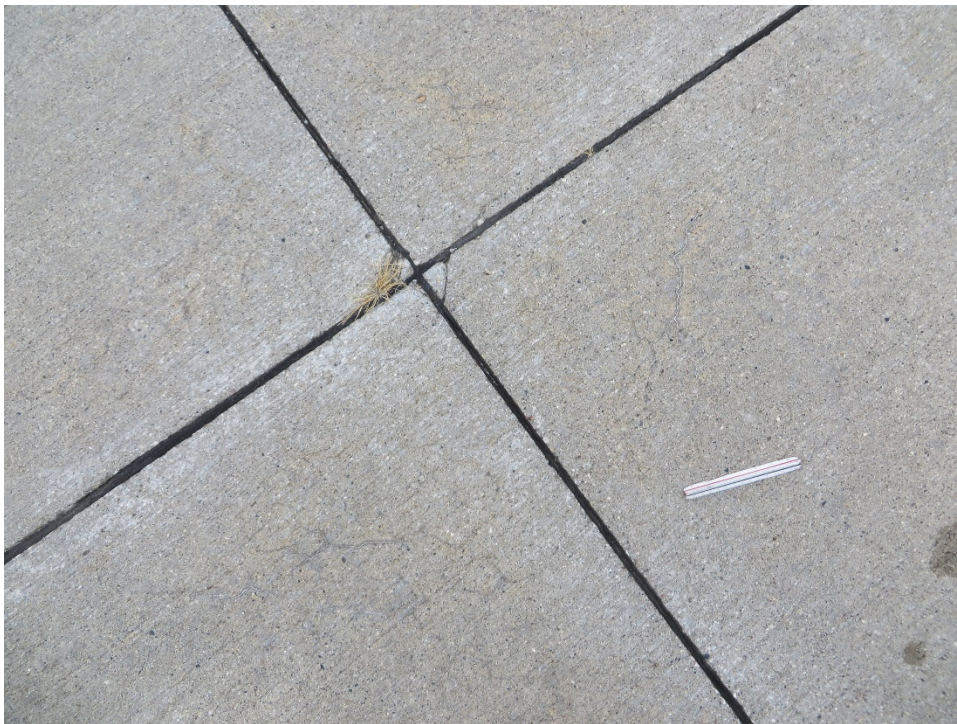
T01BO-02. ASR (Sample Unit No. 109).

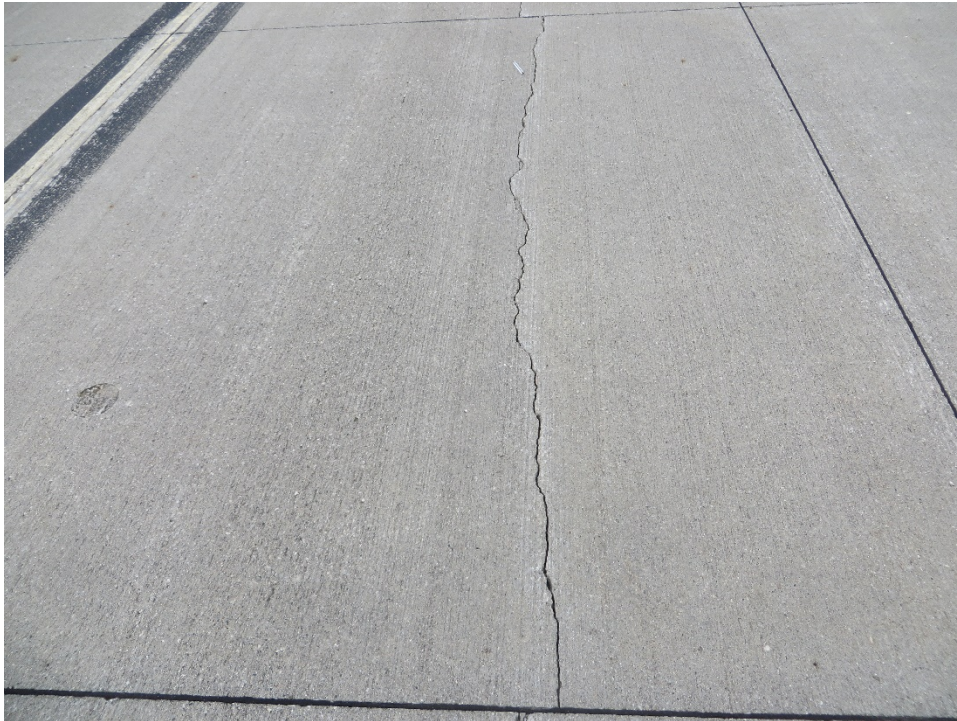
T01BO-02. LTD Cracking (Sample Unit No. 86).

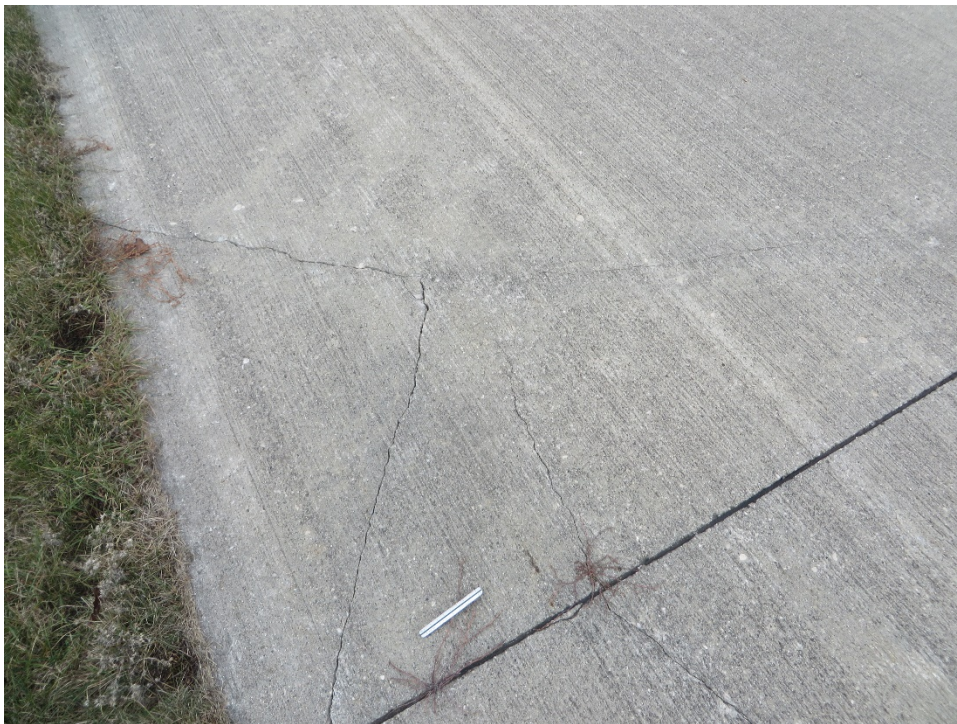
T01BO-02. Shattered Slab (Sample Unit No. 33).

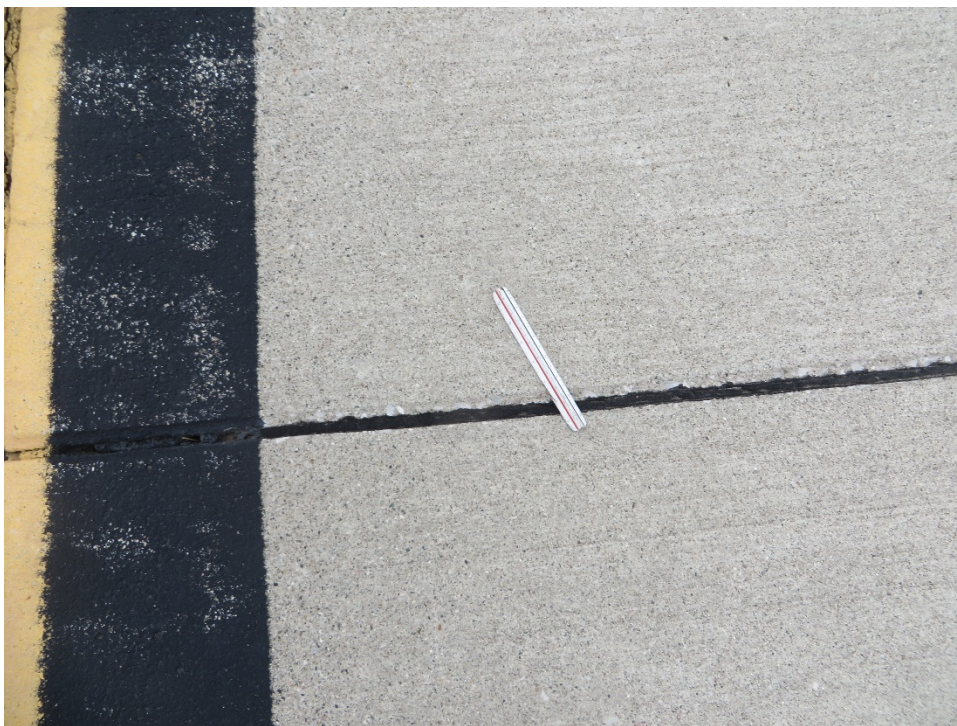
T01BO-03. Joint Seal Damage (Sample Unit No. 02).

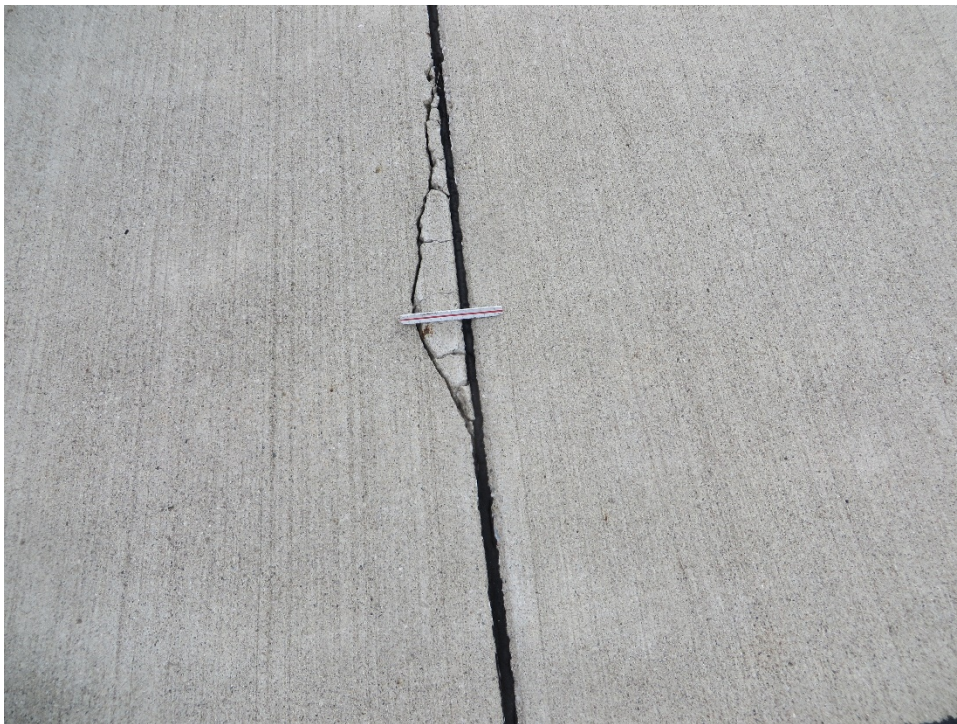
T01BO-04. Joint Spalling (Sample Unit No. 04).

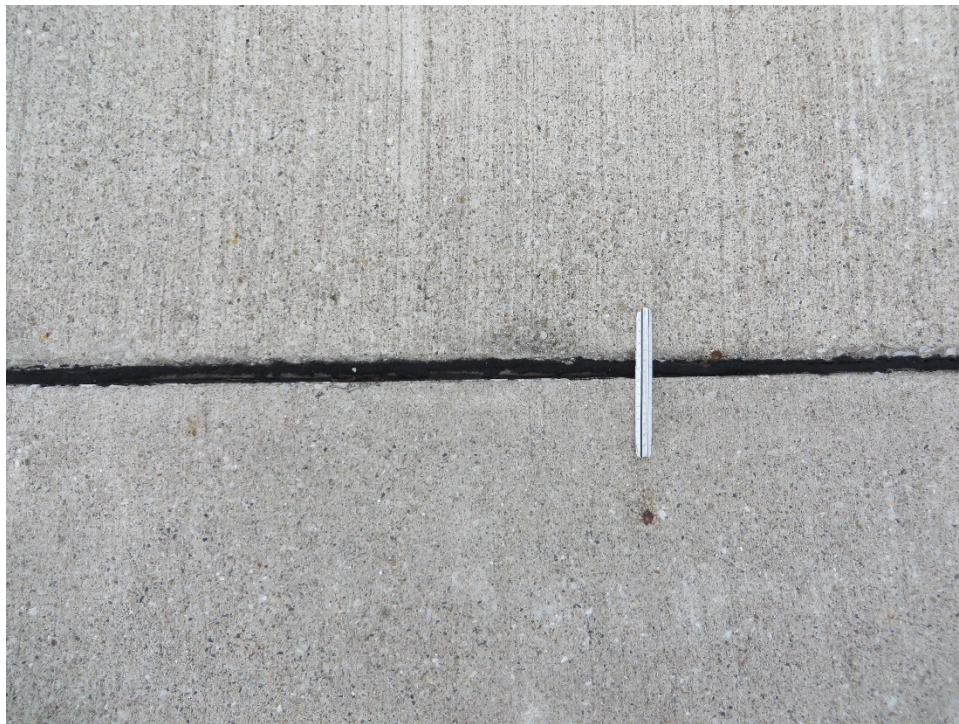
T01BO-05. Joint Seal Damage (Sample Unit No. 03).

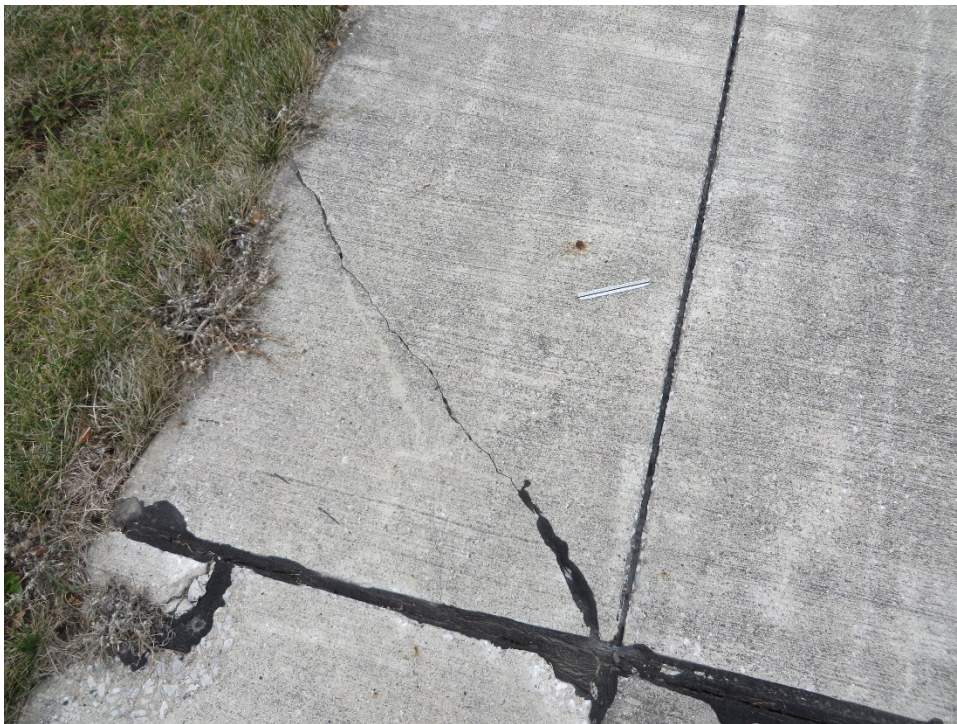
T01BO-06. Corner Break (Sample Unit No. 01).

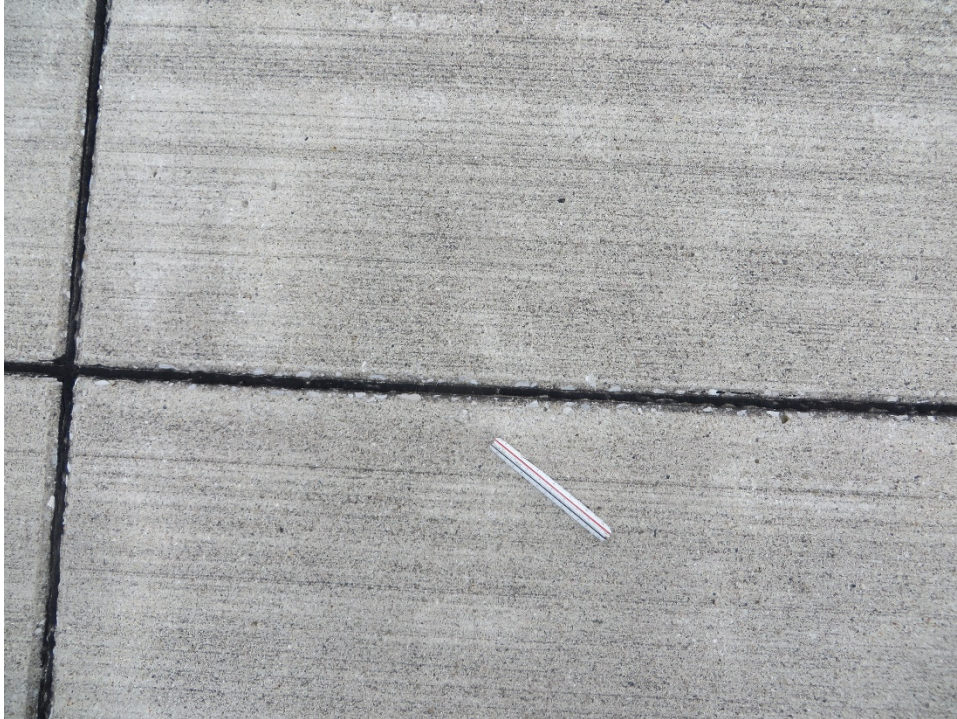
T01BO-06. Joint Seal Damage (Sample Unit No. 01).

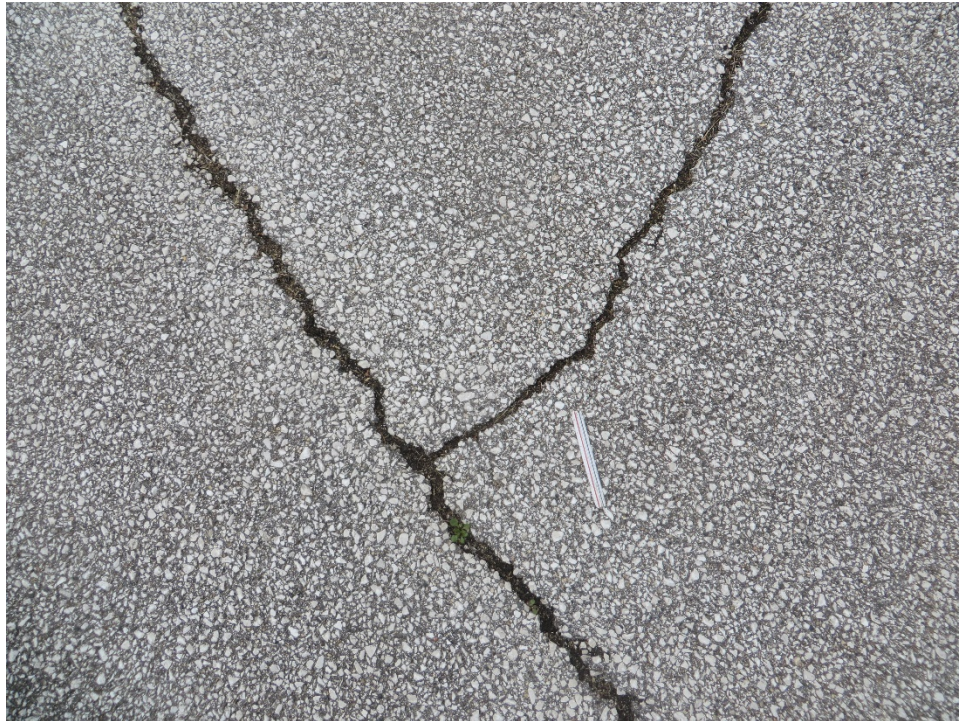
TH01BO-01. L&T Cracking (Sample Unit No. 02).

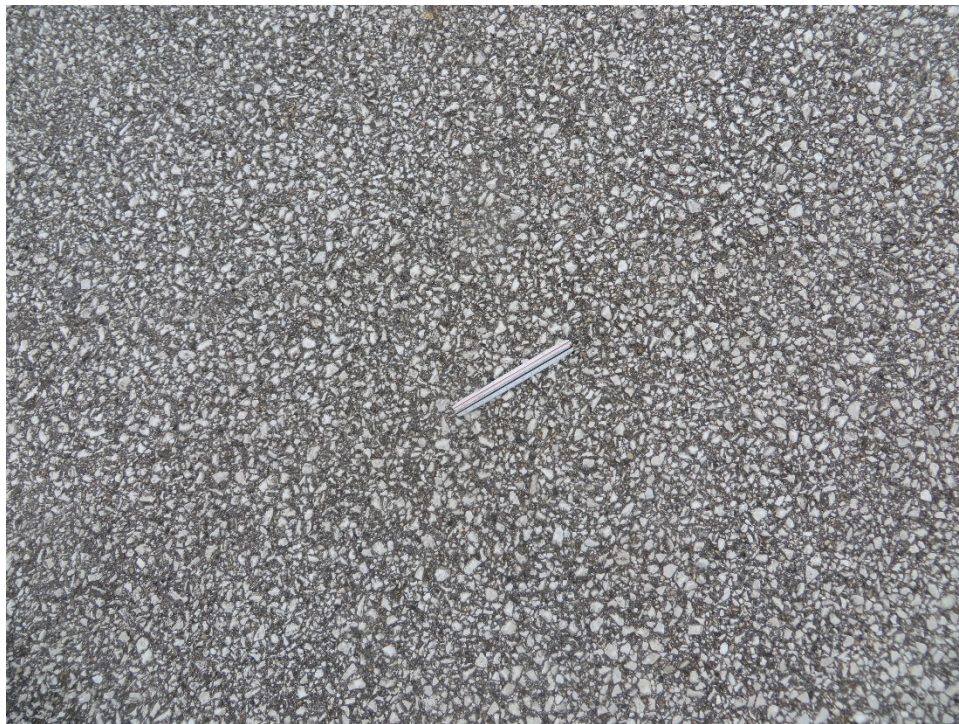
TH01BO-01. Weathering (Sample Unit No. 02).

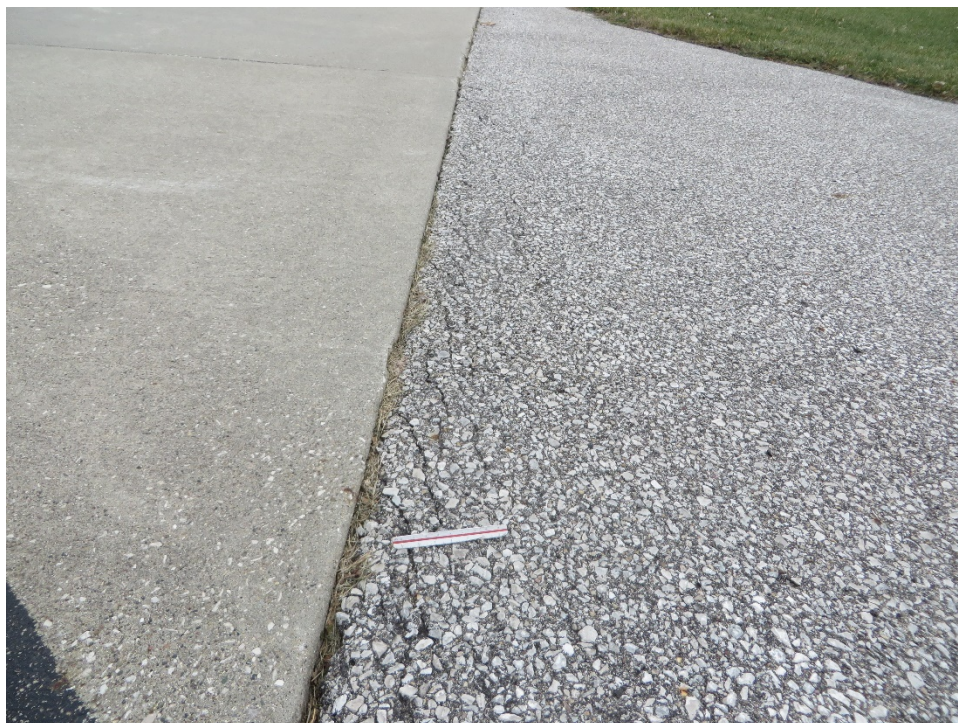
TH01BO-02. Depression (Sample Unit No. 01).

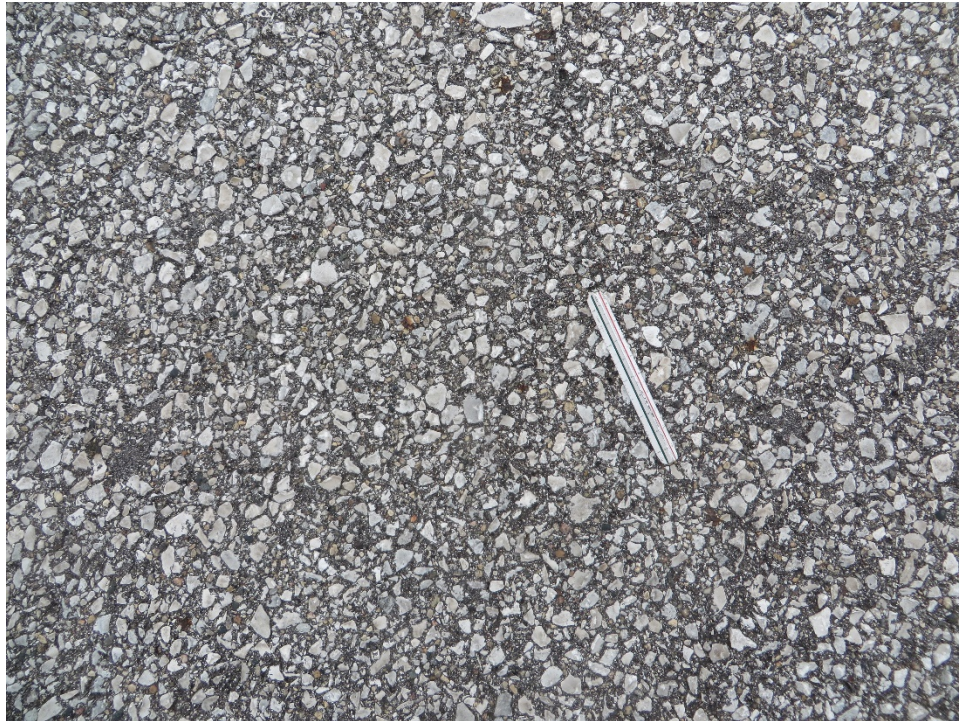
TH01BO-02. Weathering (Sample Unit No. 01).

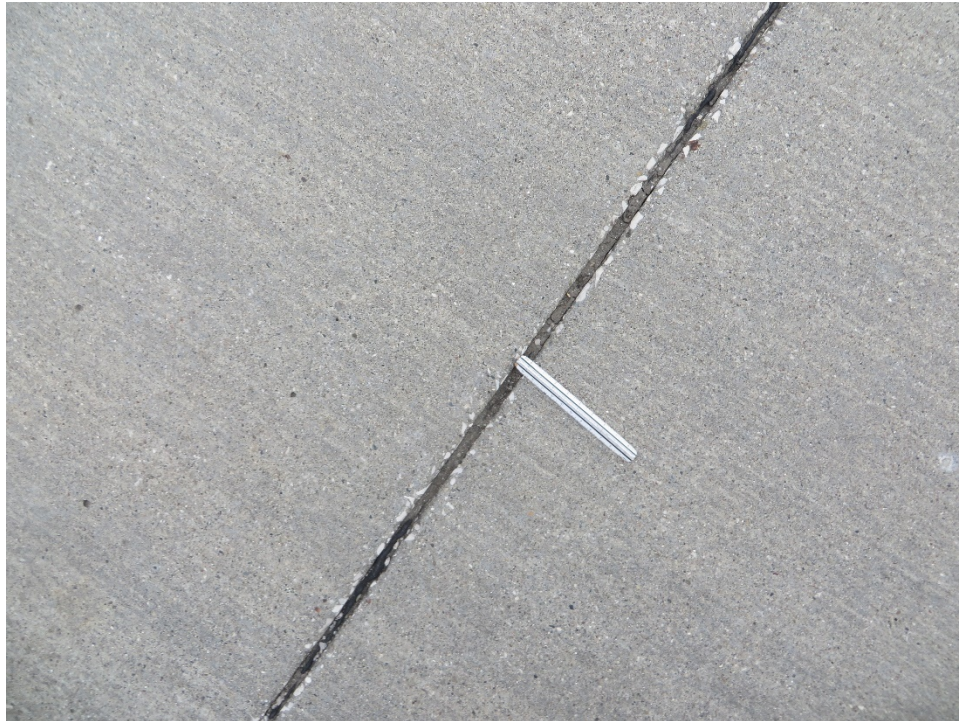
TH01BO-03. Joint Seal Damage (Sample Unit No. 10).

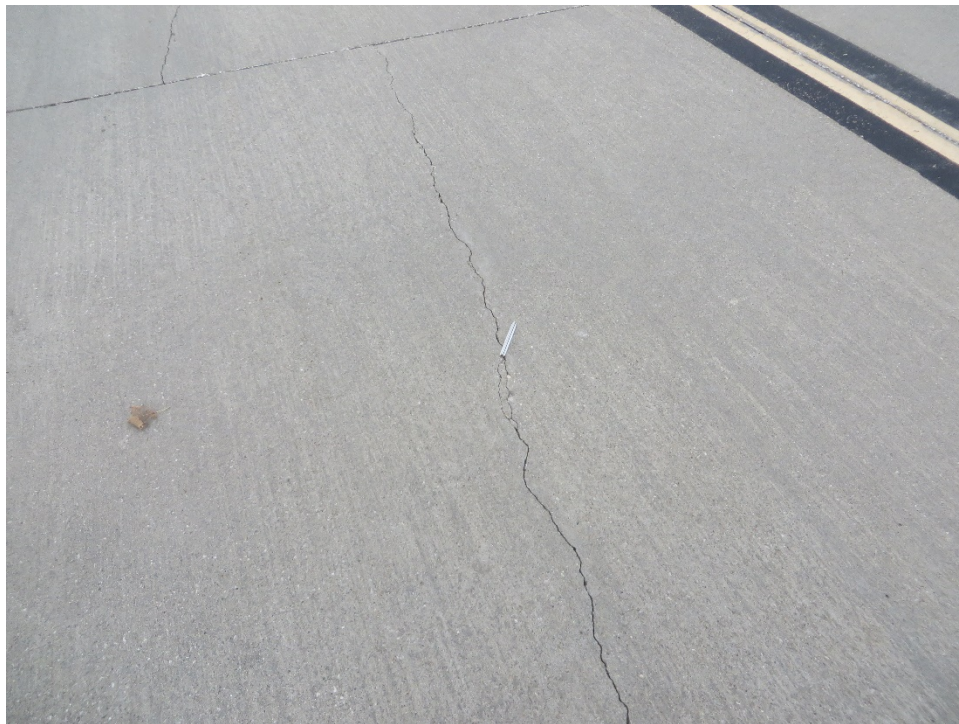
TH01BO-03. LTD Cracking (Sample Unit No. 10).

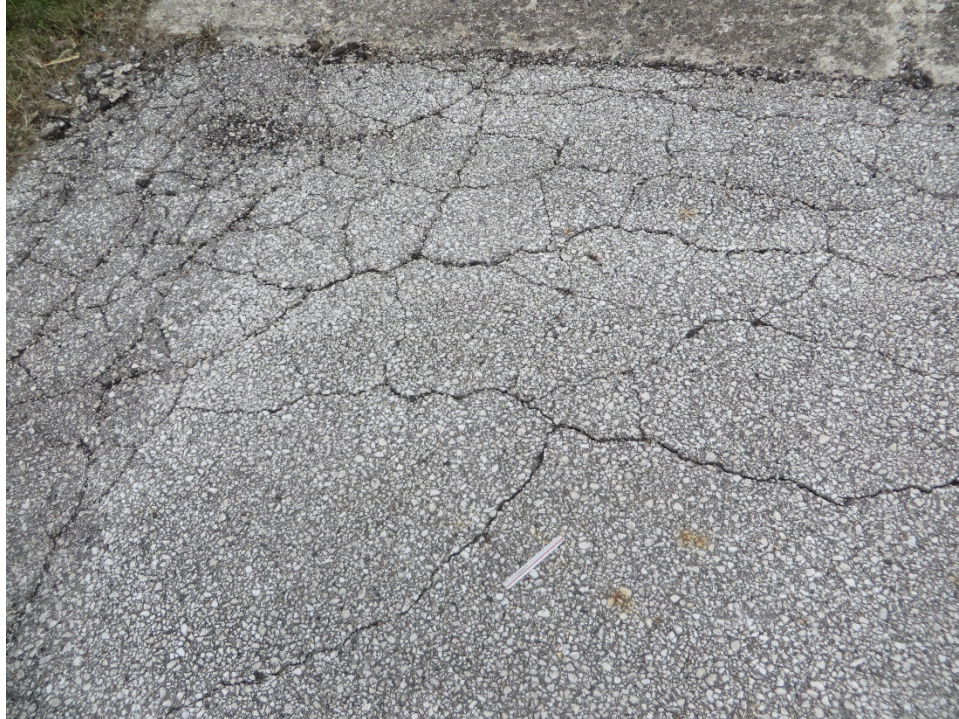
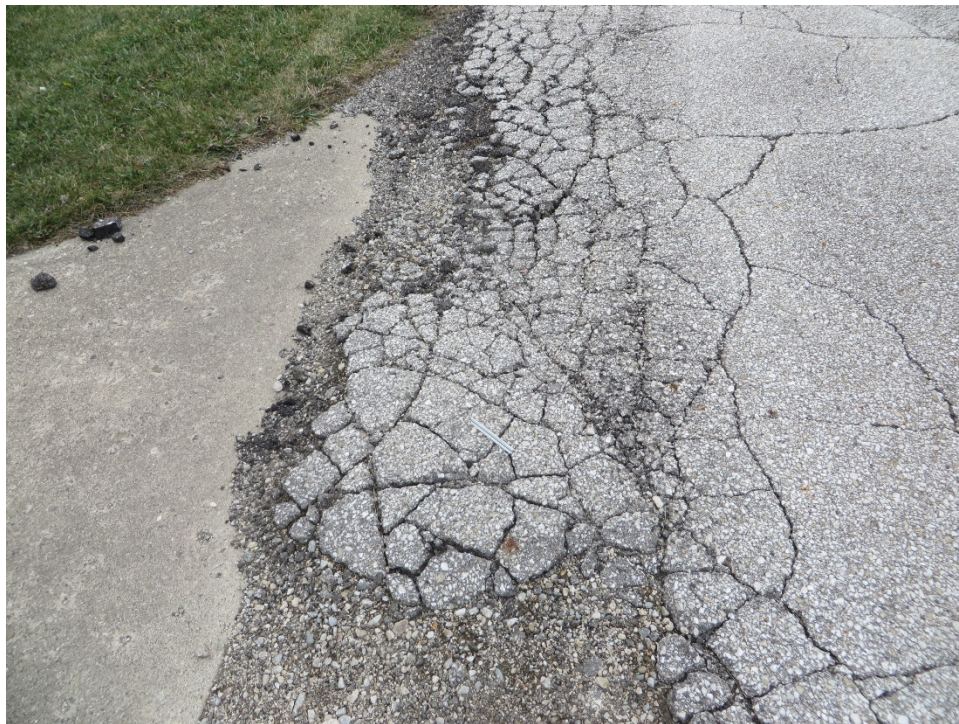
TH02BO-02. Alligator Cracking (Sample Unit No. 03) (1).

TH02BO-02. Alligator Cracking (Sample Unit No. 03) (2).

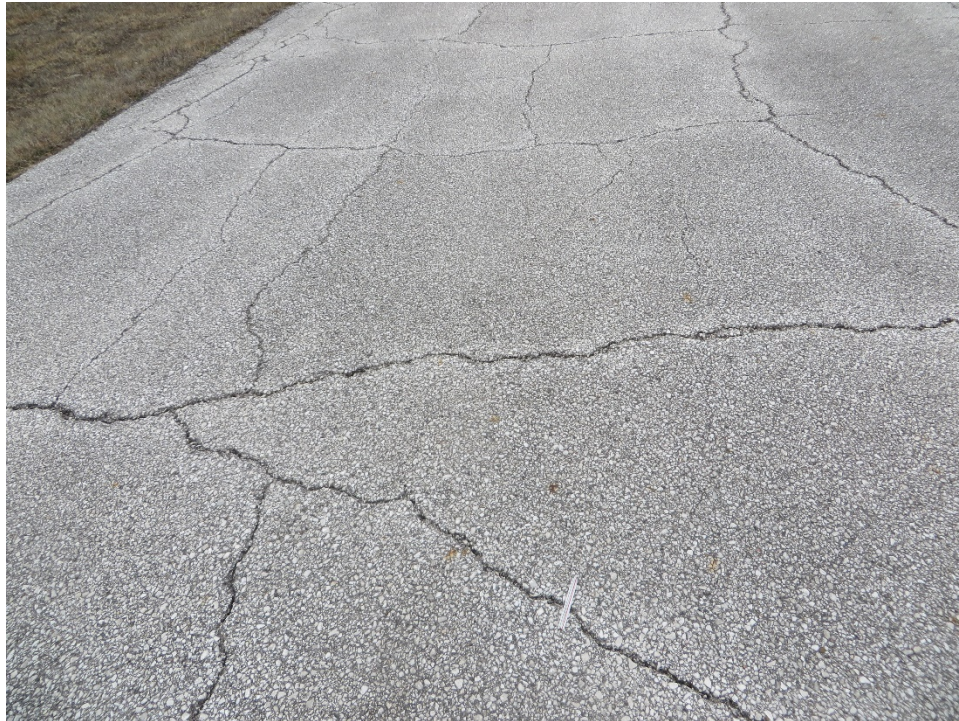
TH02BO-02. Block Cracking (Sample Unit No. 03).
