Southeast Iowa Regional Airport

PAVEMENT MANAGEMENT REPORT

AUGUST 2019

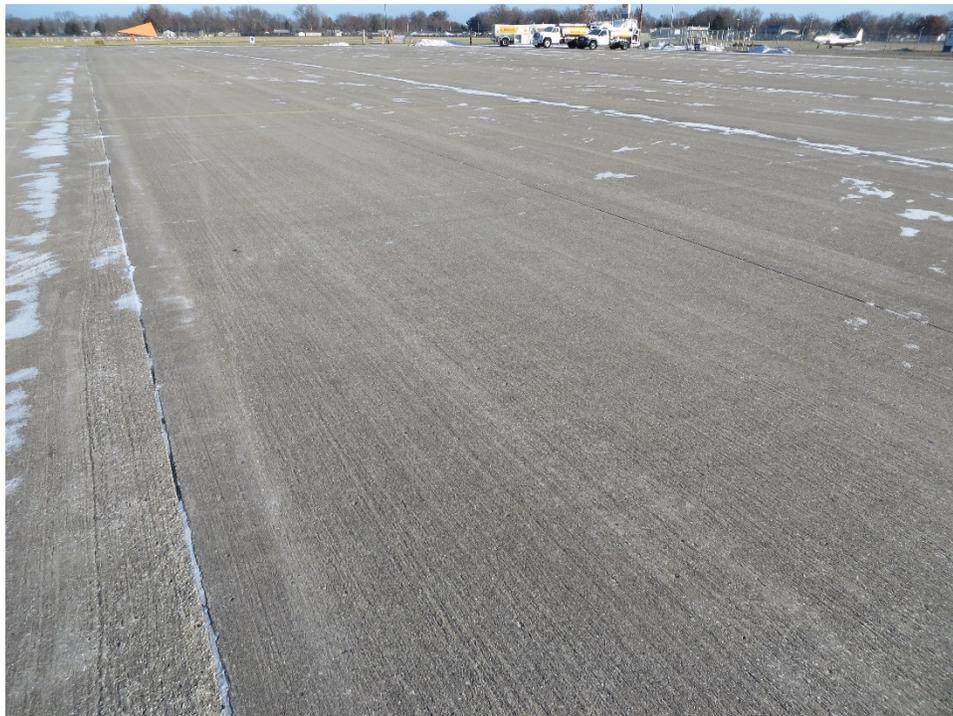
A01BR-02. Overview.

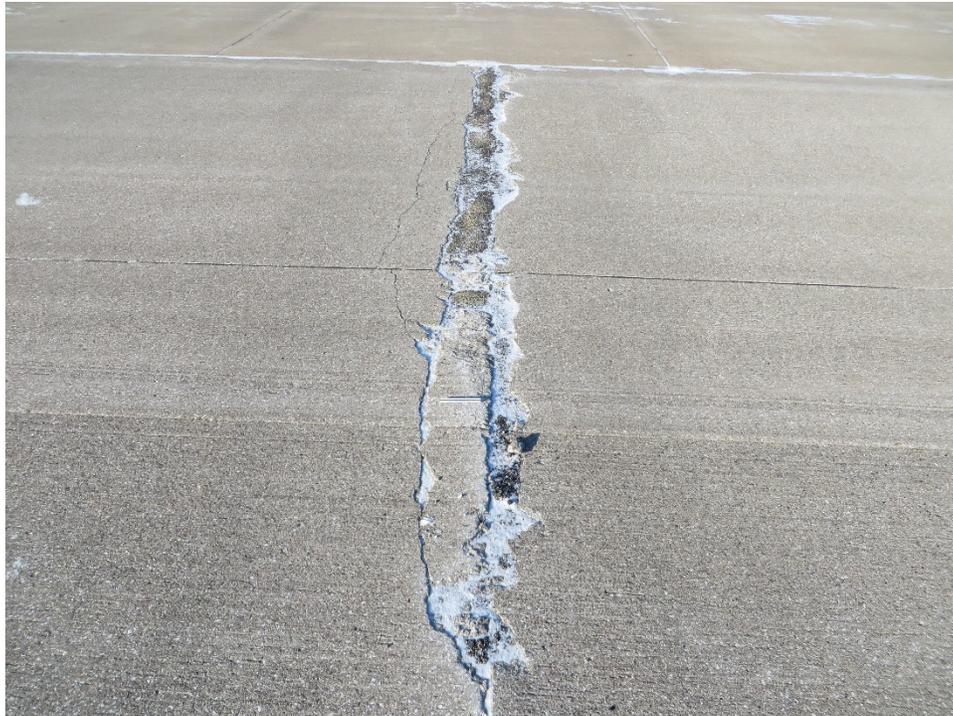
A01BR-02. Joint Spalling (Sample Unit No. 02).

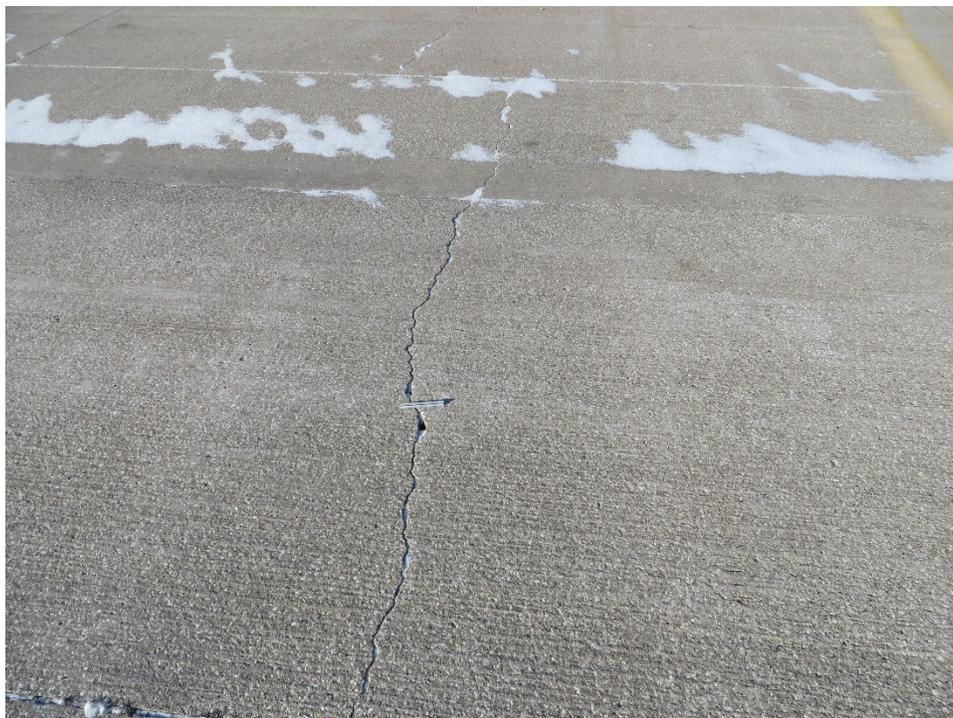
A01BR-02. LTD Cracking (Sample Unit No. 16).

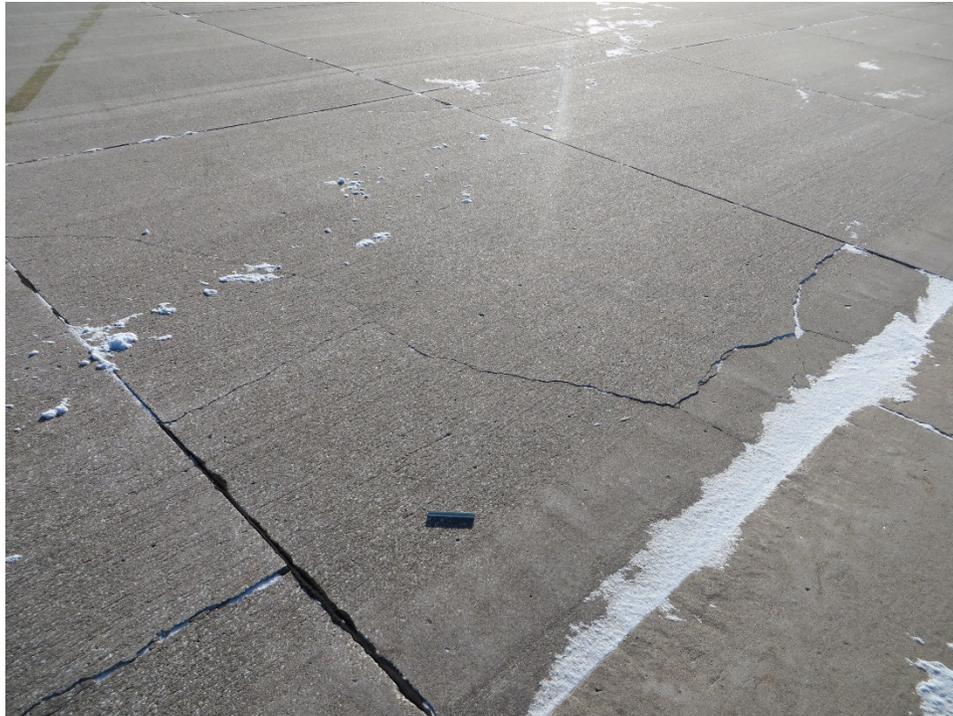
A01BR-02. Shattered Slab (Sample Unit No. 05).

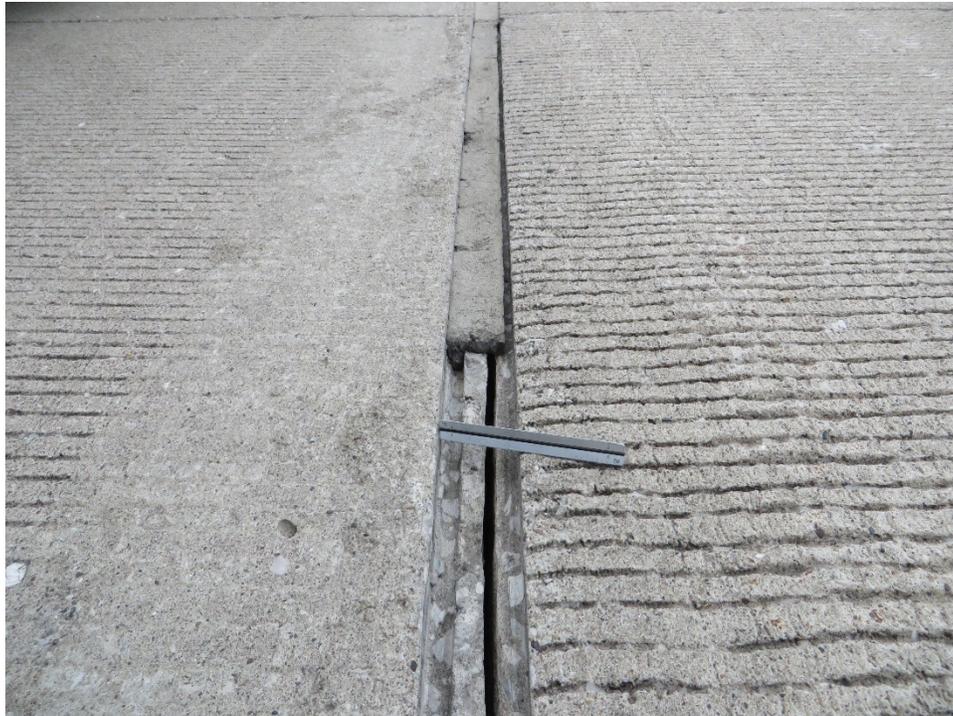
R12BR-01. Joint Seal Damage (Sample Unit No. 153).

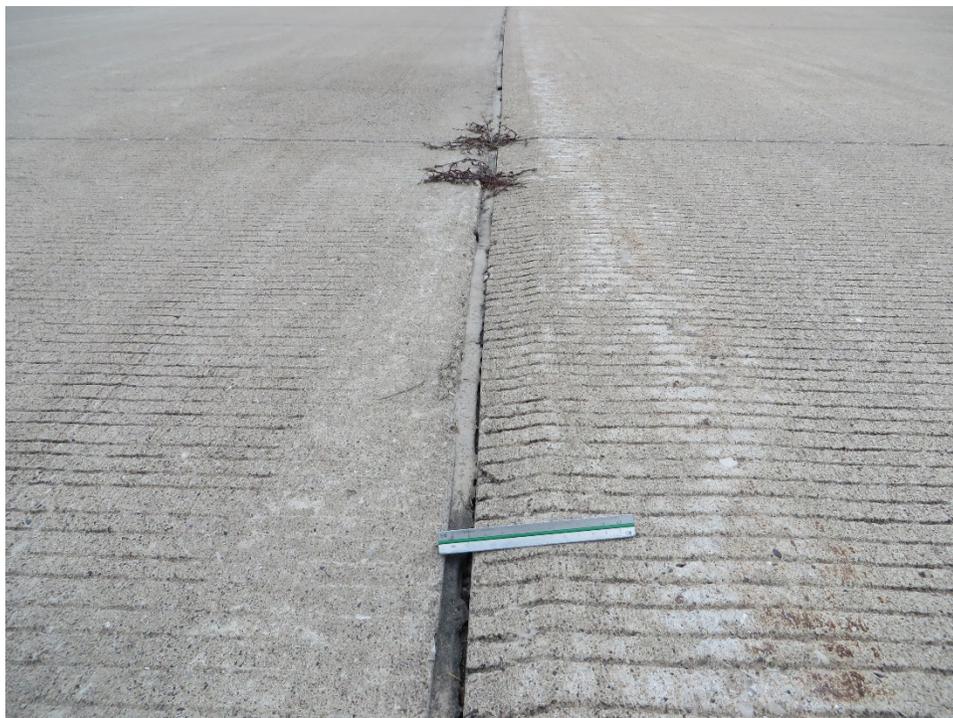
R12BR-01. Joint Seal Damage (Sample Unit No. 80).

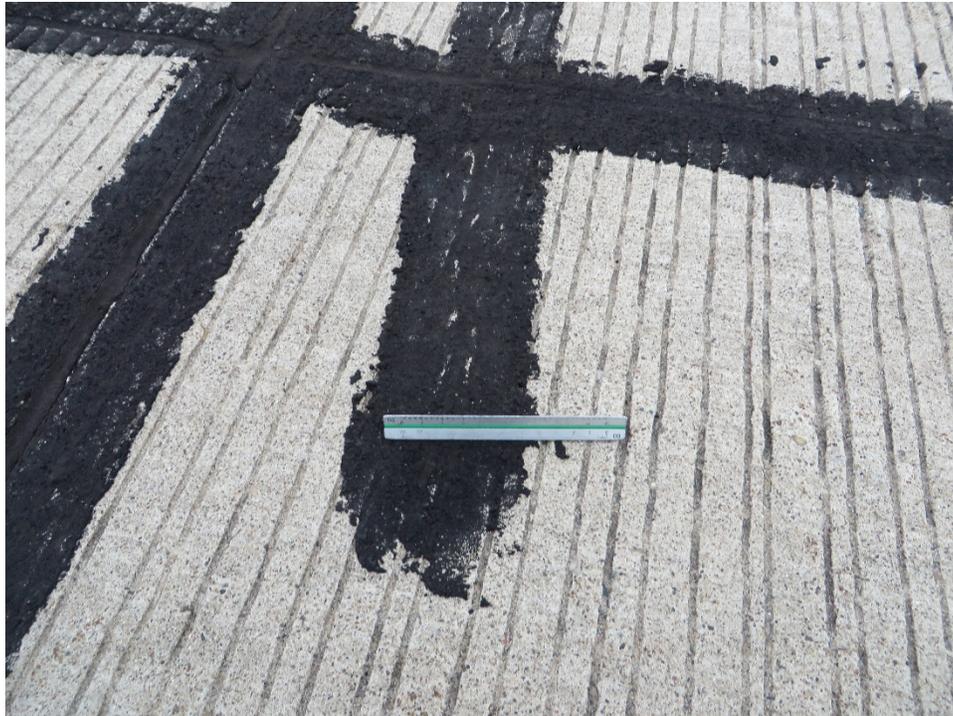
R12BR-01. Shrinkage Cracking (Sample Unit No. 25).

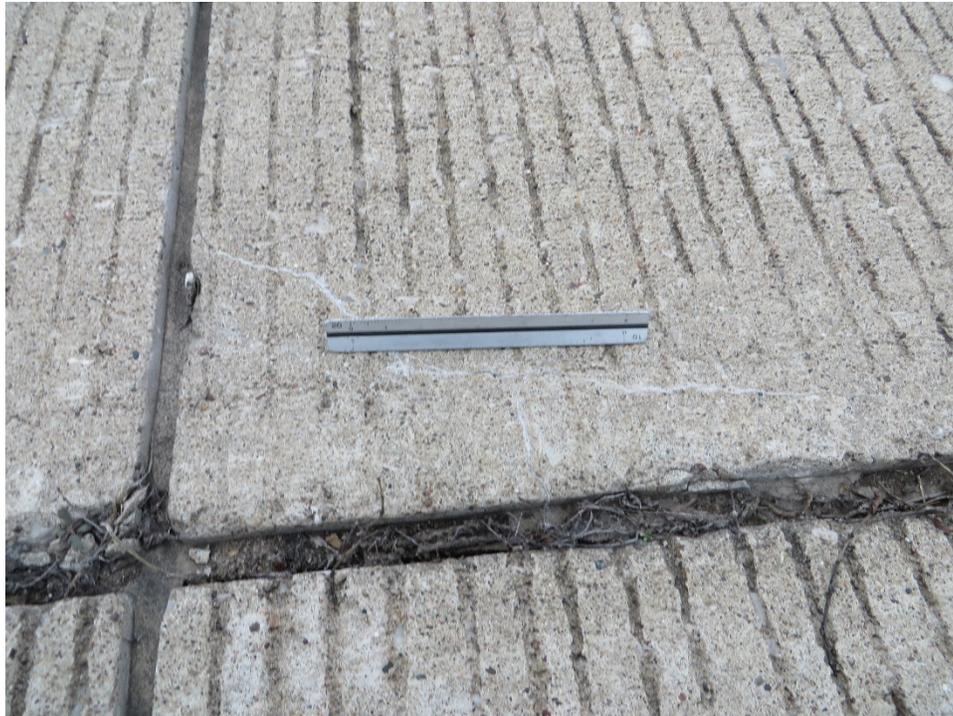
R12BR-02. ASR (Sample Unit No. 13).

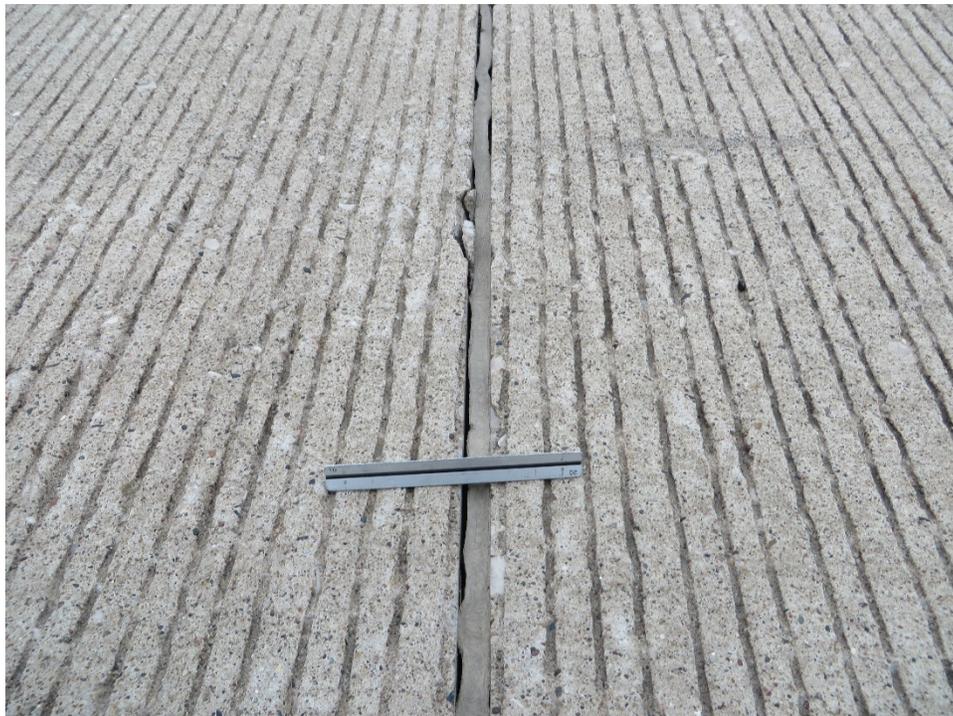
R12BR-02. Joint Seal Damage (Sample Unit No. 01).

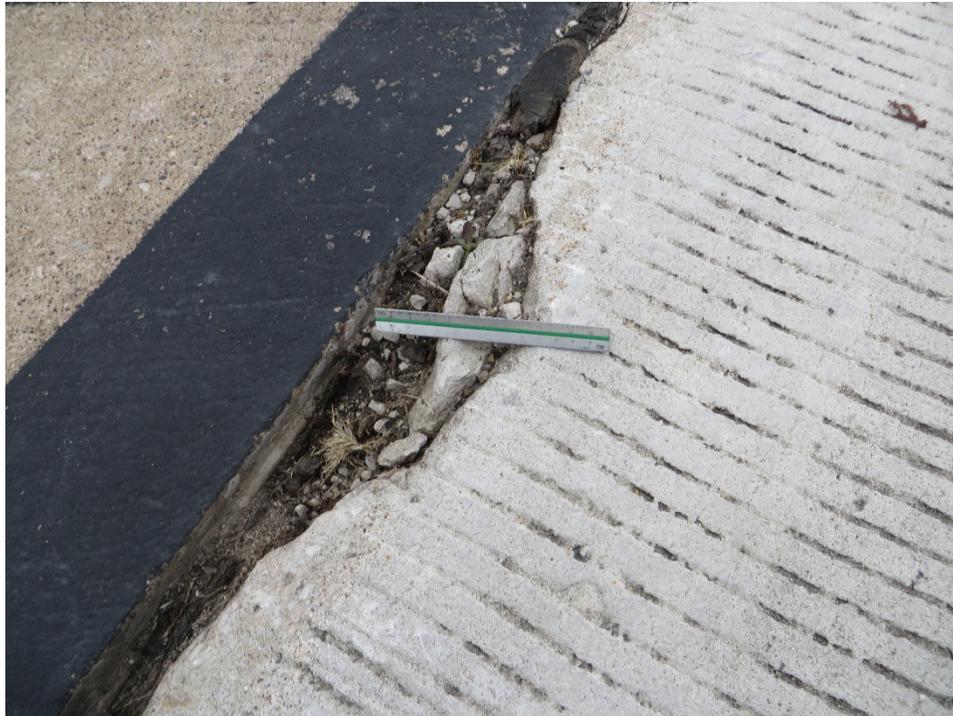
R12BR-02. Joint Spalling (Sample Unit No. 01).

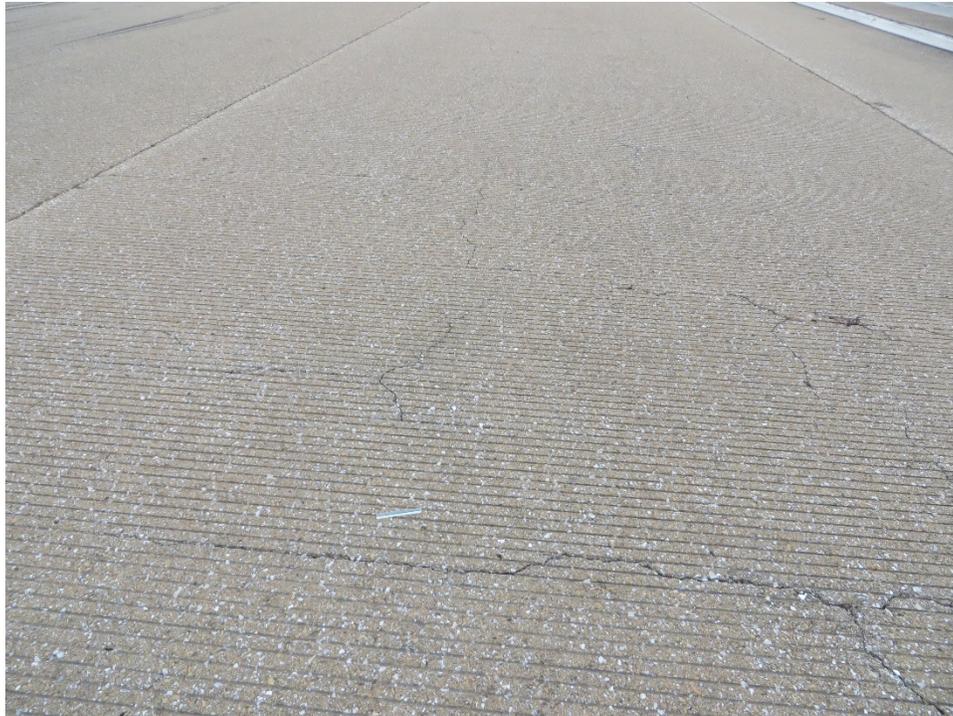
R12BR-03. Block Cracking (Sample Unit No. 06).

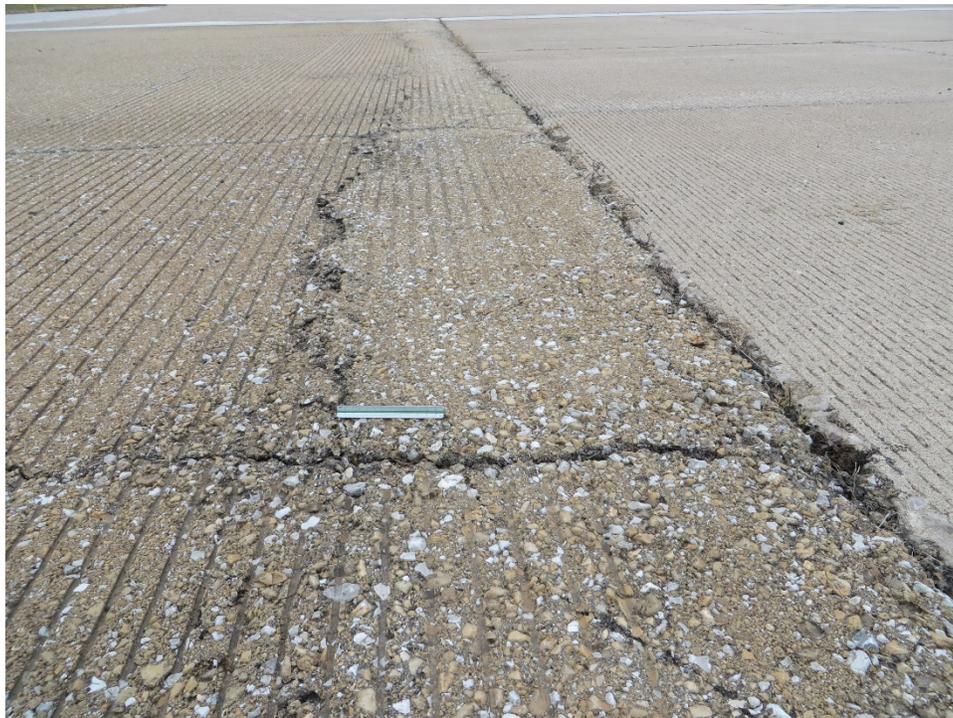
R12BR-03. Shoving (Sample Unit No. 06).

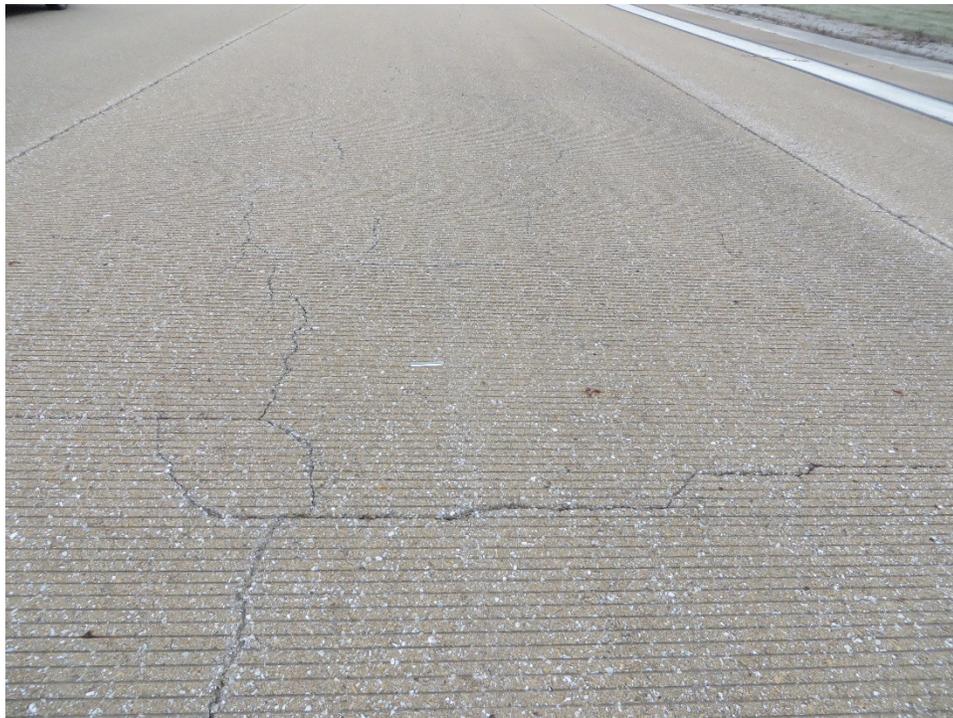
R12BR-04. Block Cracking (Sample Unit No. 01).

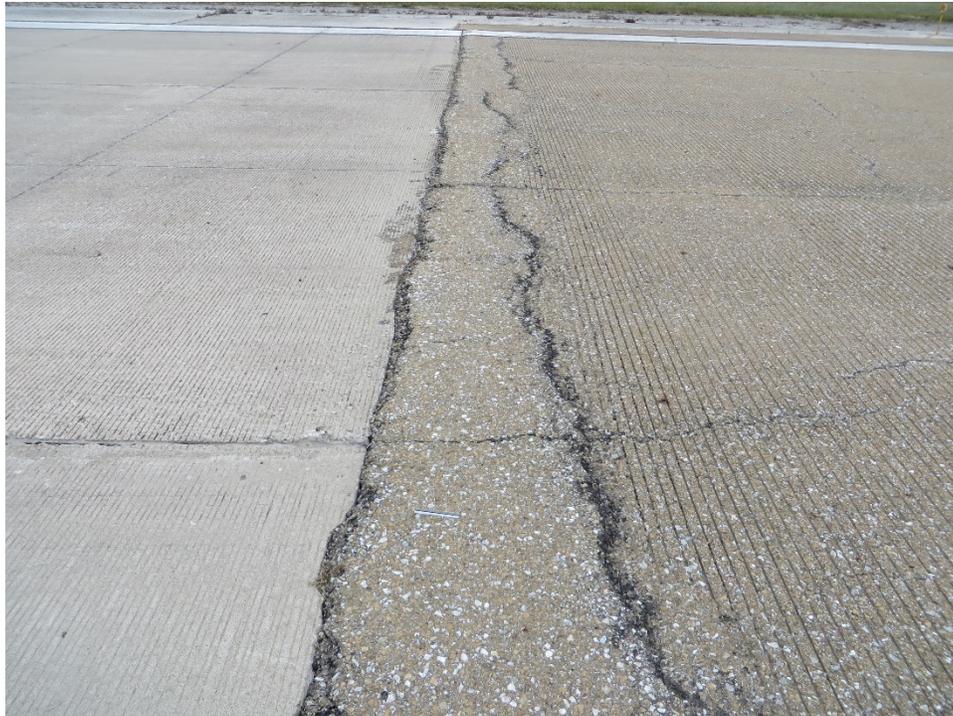
R12BR-04. Shoving (Sample Unit No. 01).

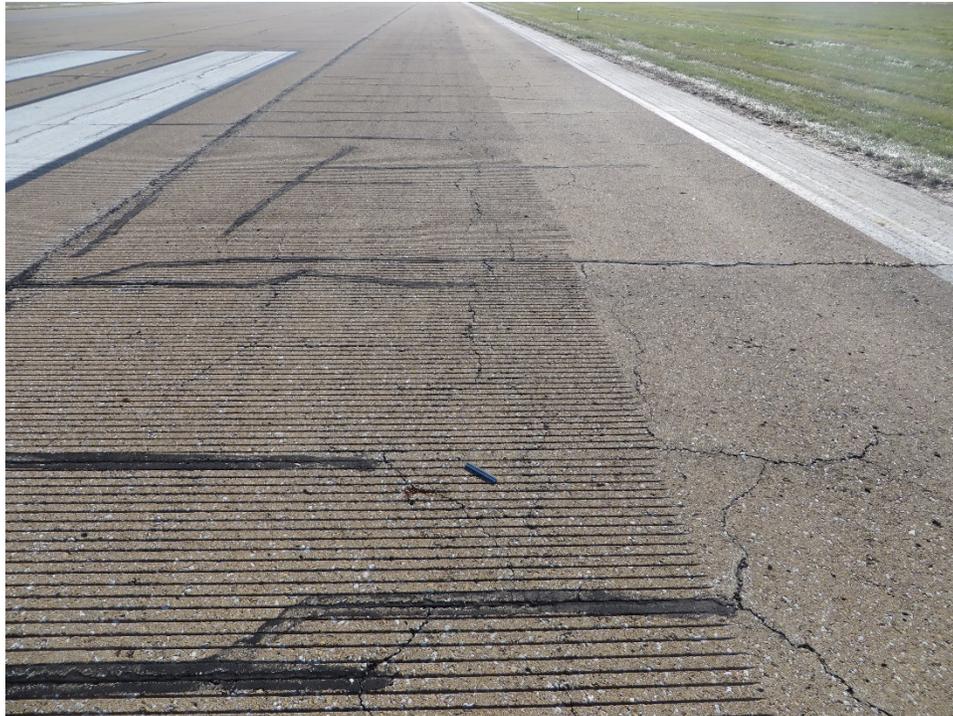
R18BR-01. Block Cracking (Sample Unit No. 143).

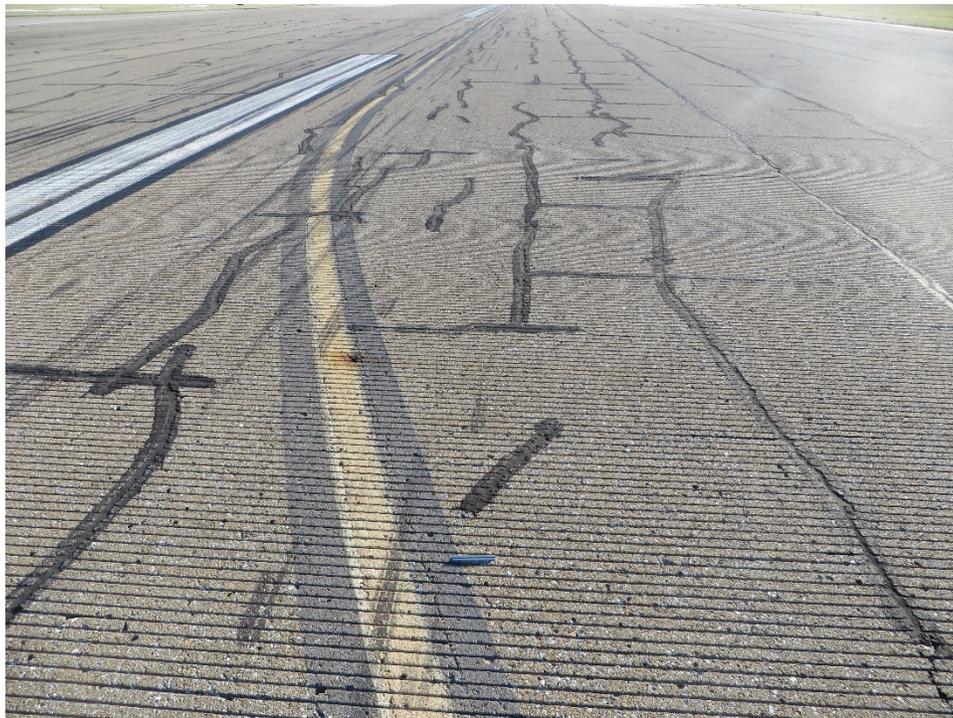
R18BR-01. Block Cracking (Sample Unit No. 43).

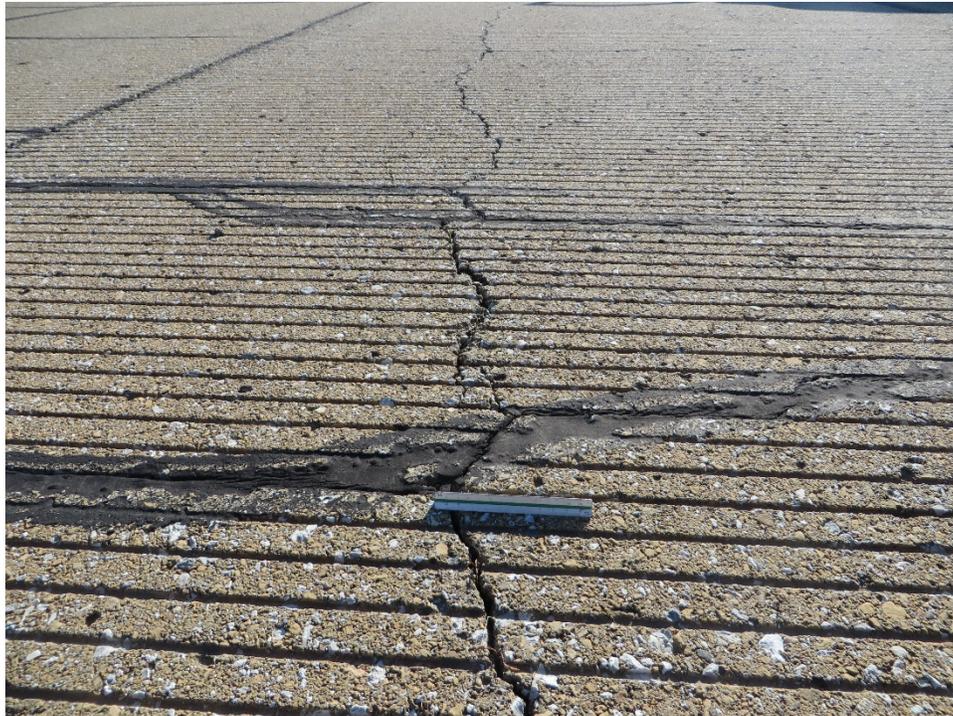
R18BR-01. L&T Cracking (Sample Unit No. 154).

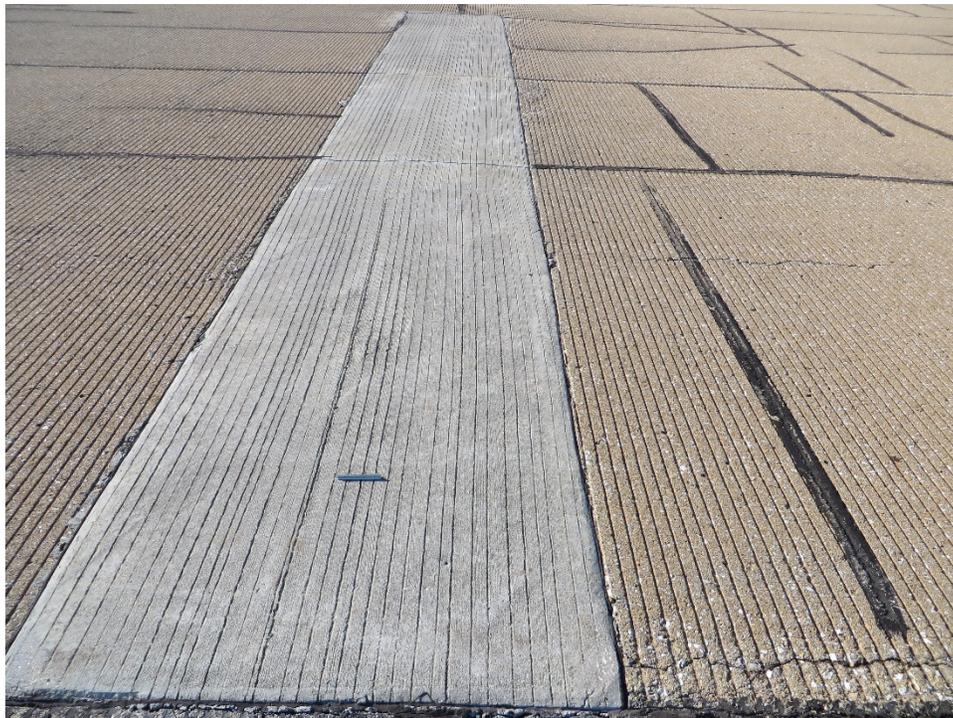
R18BR-01. Patching (Sample Unit No. 132).

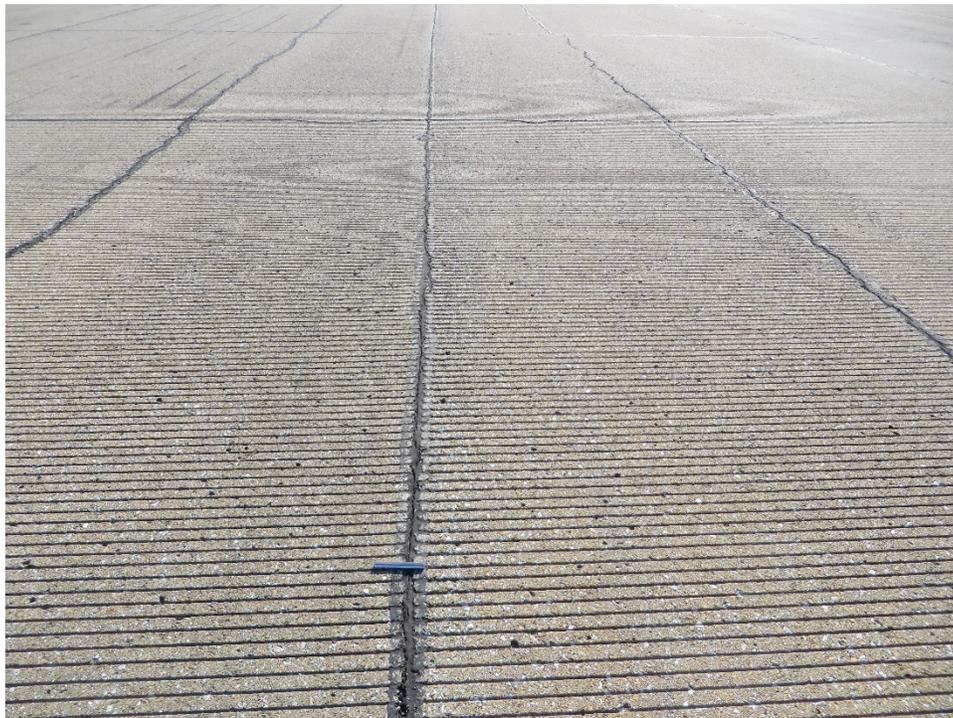
R18BR-02. Joint Reflection Cracking (Sample Unit No. 03).

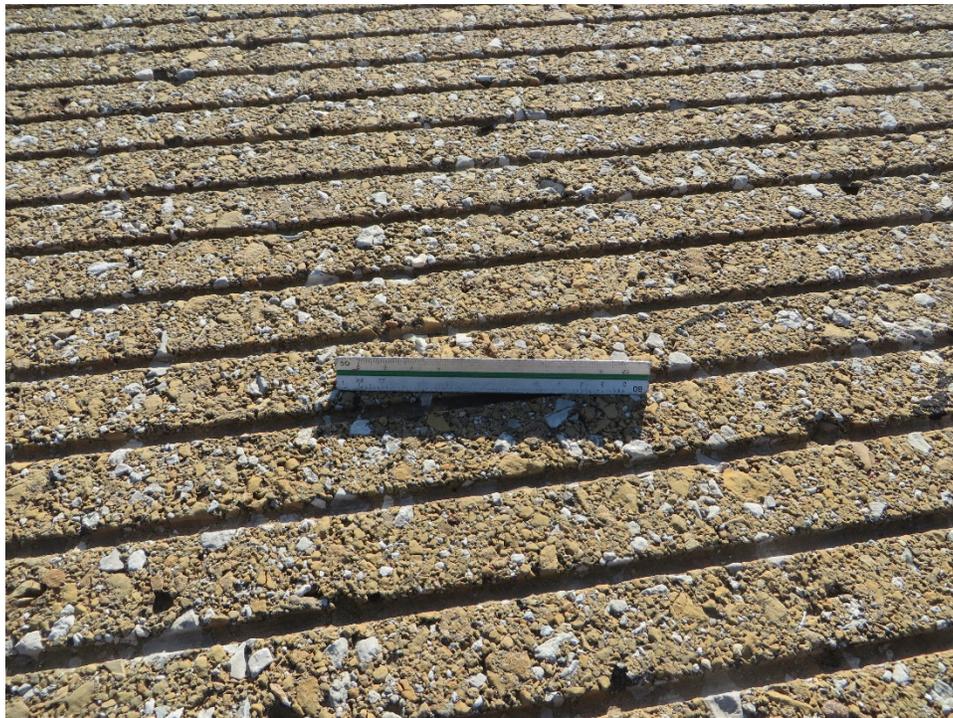
R18BR-02. Weathering (Sample Unit No. 01).

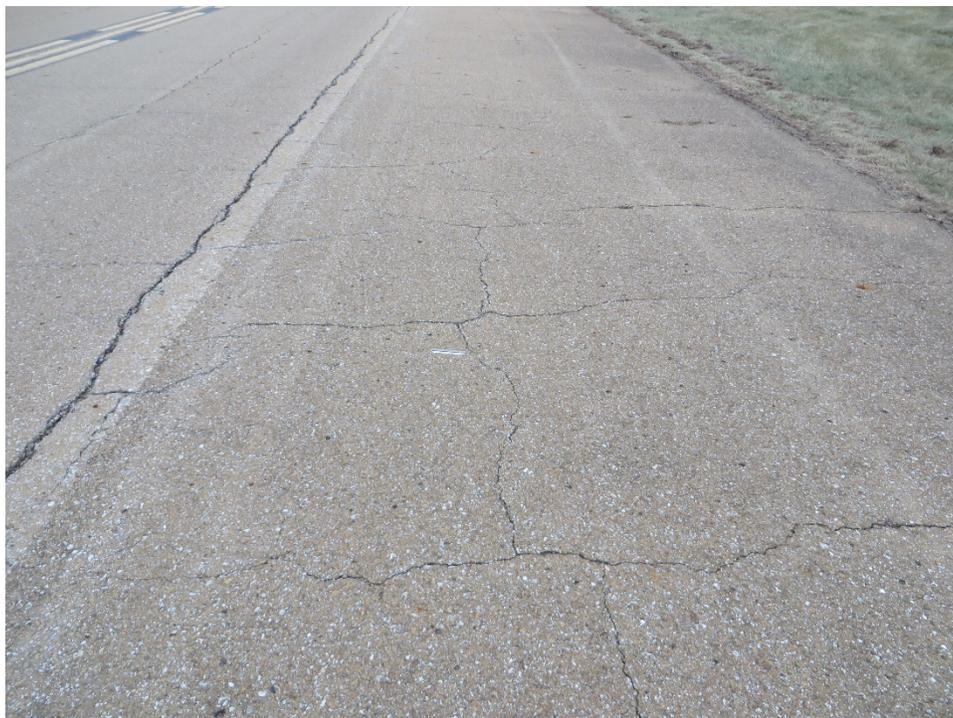
T01BR-01. Block Cracking (Sample Unit No. 41).

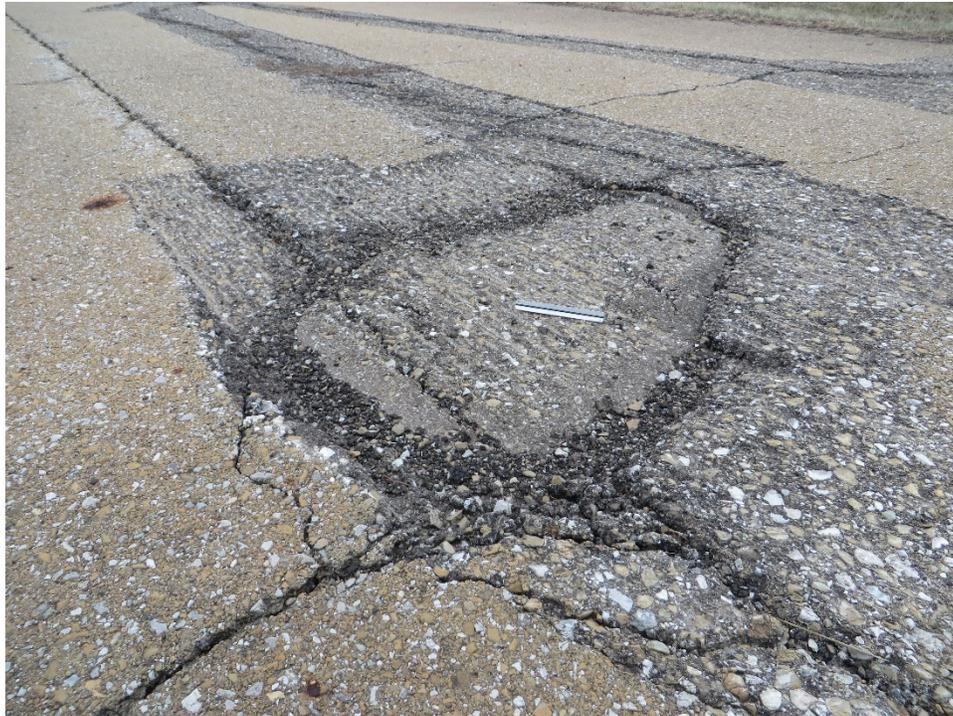
T01BR-01. L&T Cracking and Raveling (Additional Sample Unit No. 18).

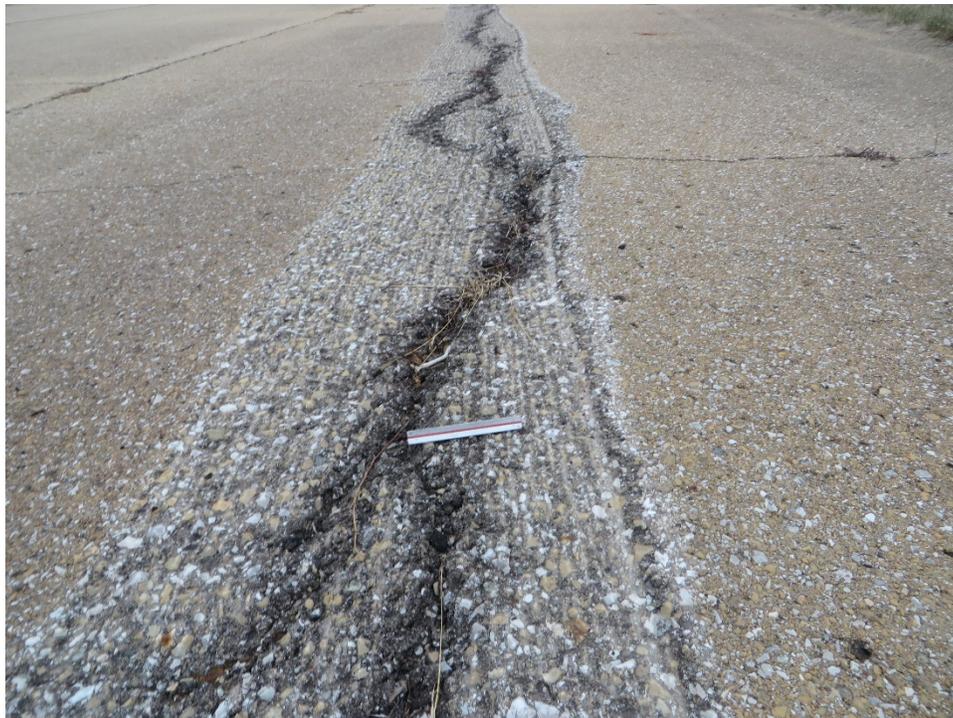
T01BR-01. L&T Cracking and Raveling (Additional Sample Unit No. 32).

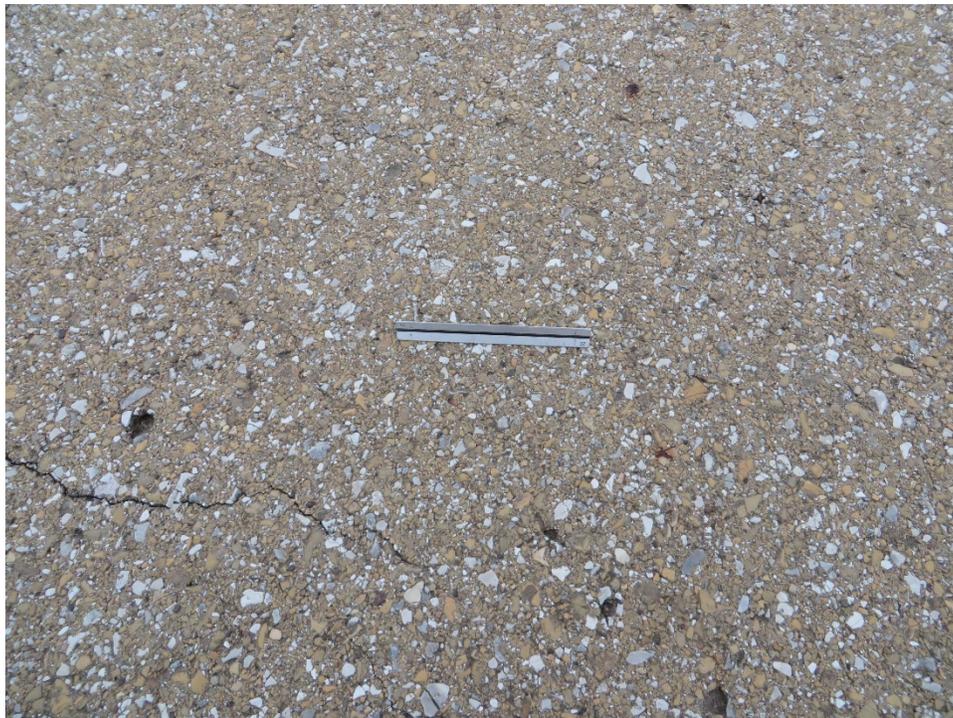
T01BR-01. Raveling (Sample Unit No. 41).

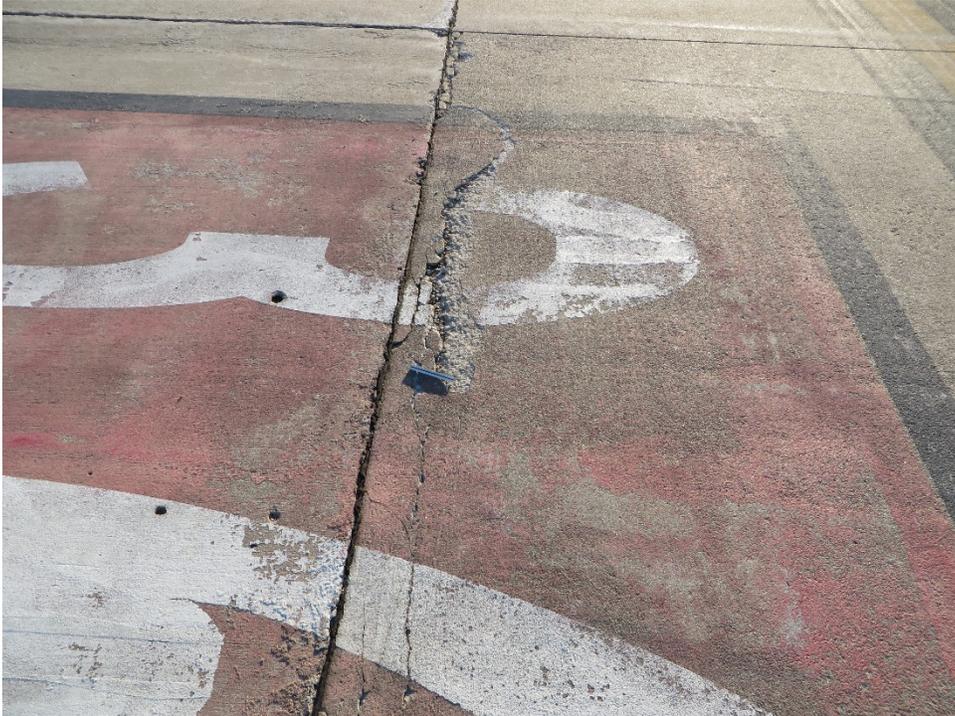
T01BR-02. Joint Spalling (Sample Unit No. 04).

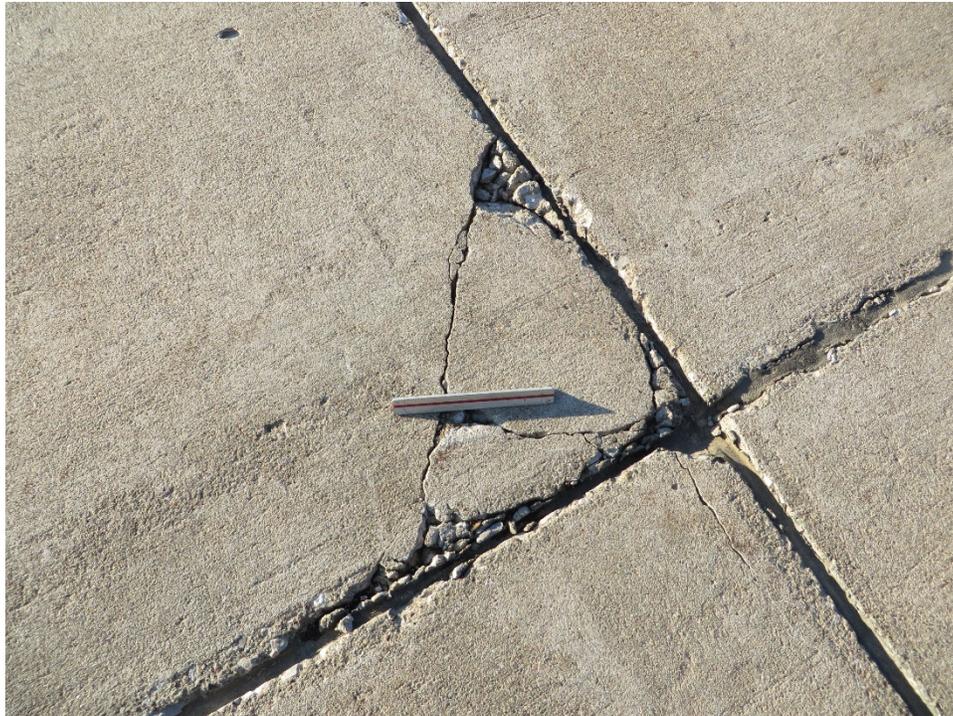
T02BR-01. Corner Spalling (Sample Unit No. 09).

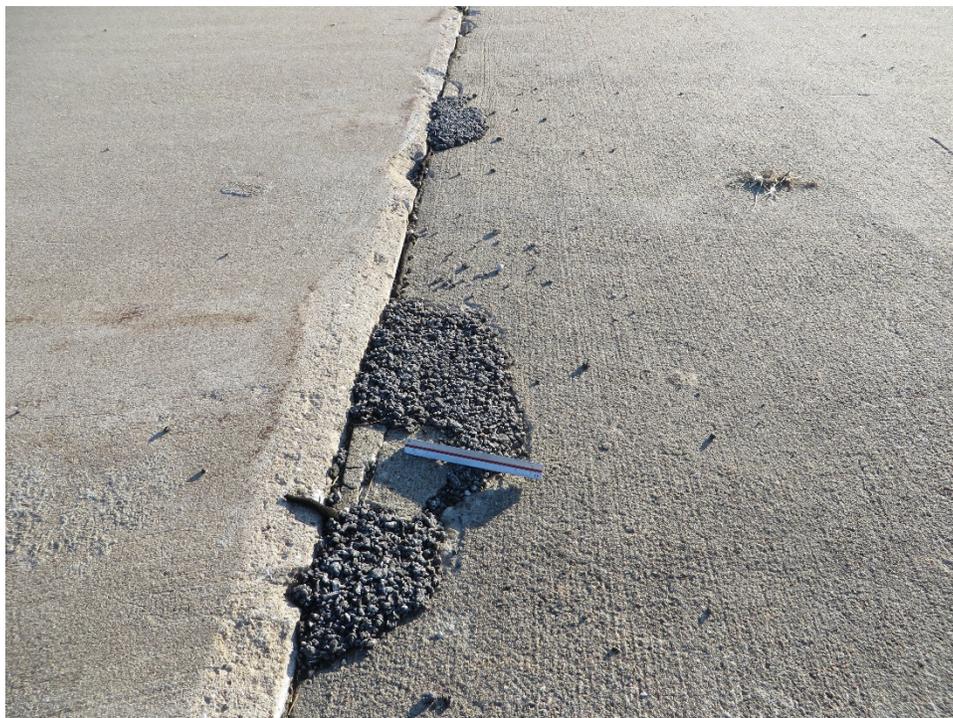
T02BR-01. Small Patching (Sample Unit No. 04).

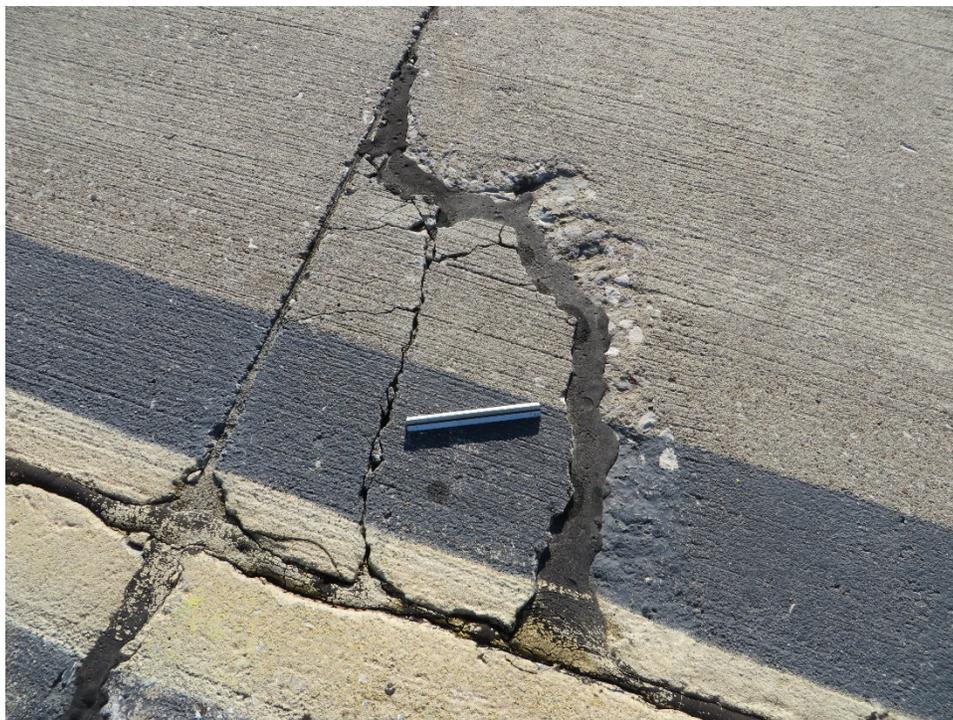
T02BR-02. Corner Spalling (Sample Unit No. 93).

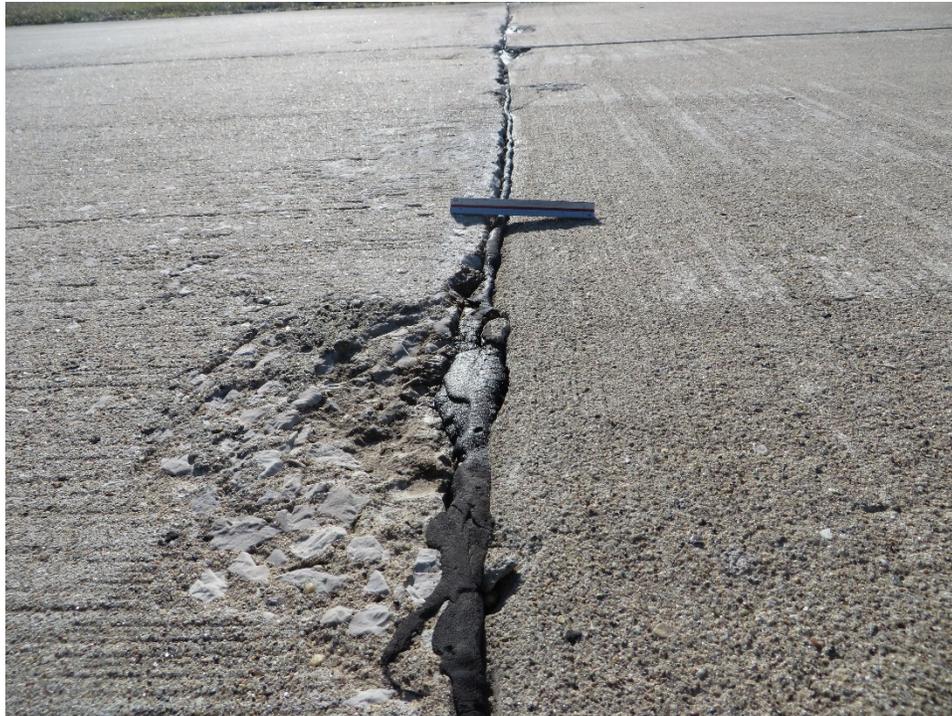
T02BR-02. Faulting (Sample Unit No. 93).

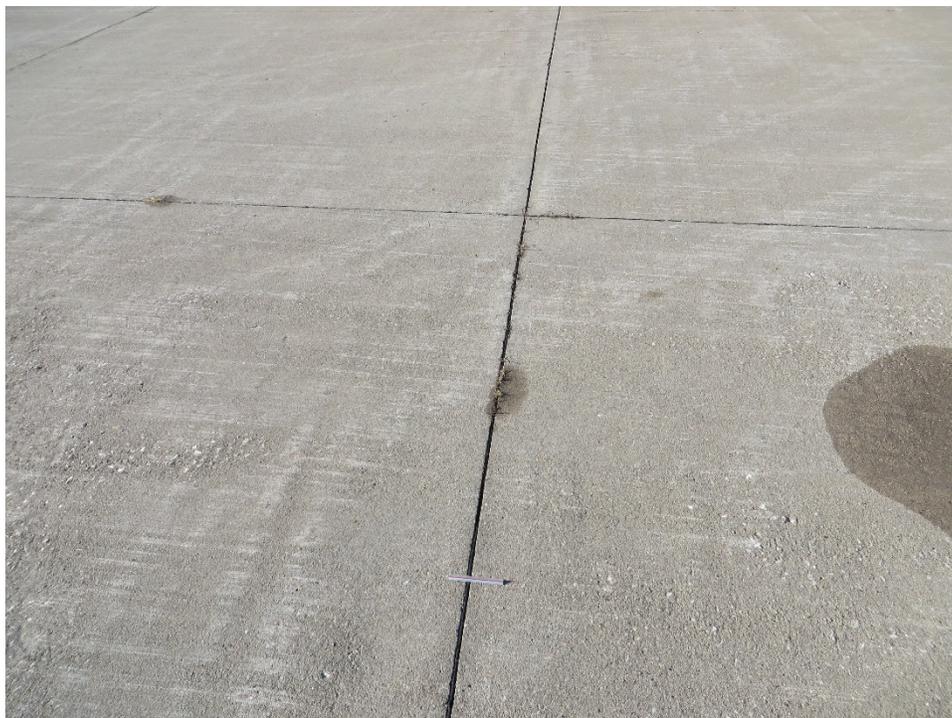
T02BR-02. Joint Seal Damage (Sample Unit No. 96).

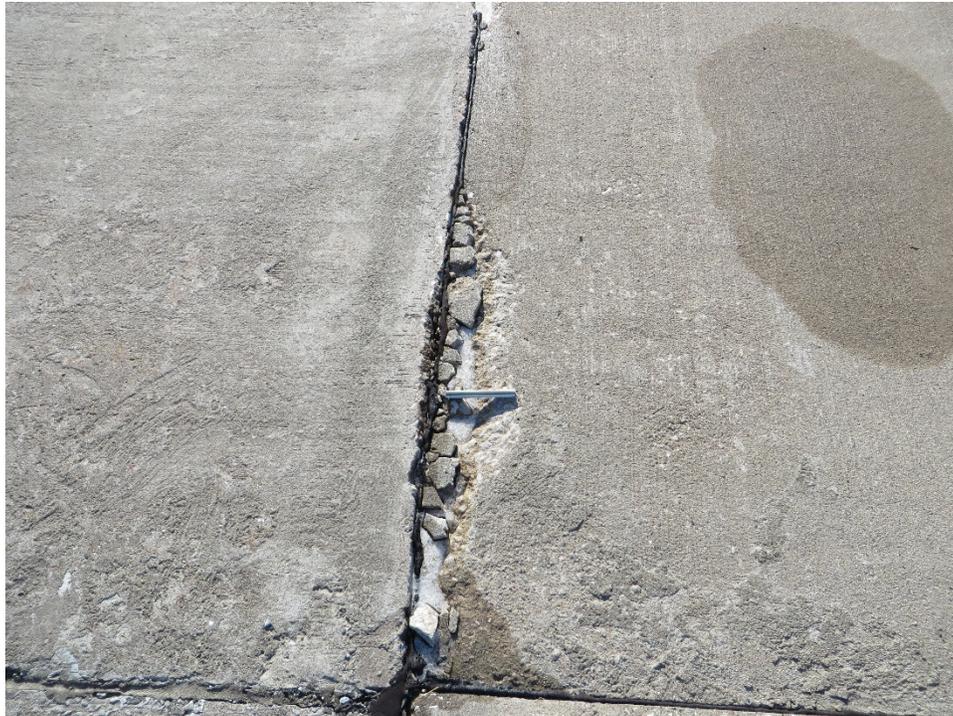
T02BR-02. Joint Spalling (Sample Unit No. 93).

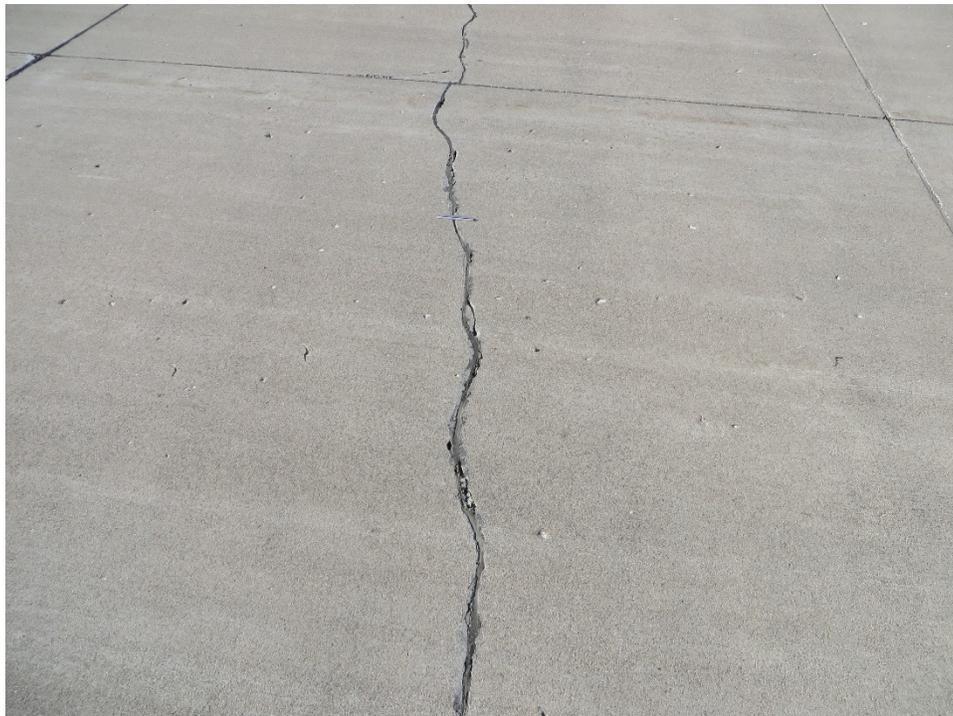
T02BR-02. LTD Cracking (Sample Unit No. 13).

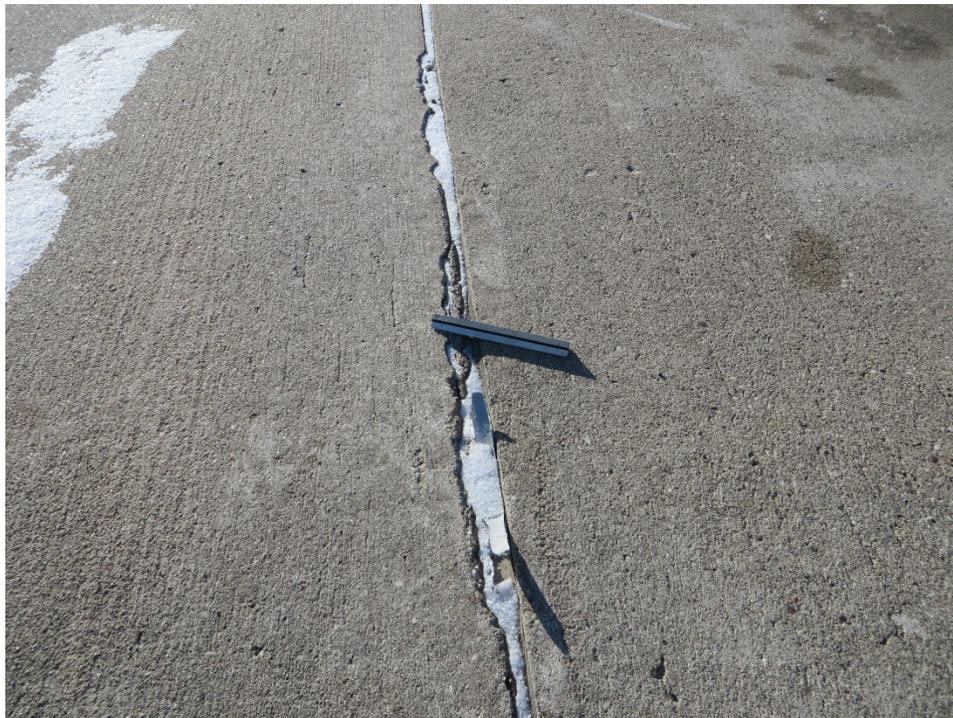
T03BR-03. Joint Seal Damage (Sample Unit No. 19).
