Southeast Iowa Regional Airport

PAVEMENT MANAGEMENT REPORT

AUGUST 2019

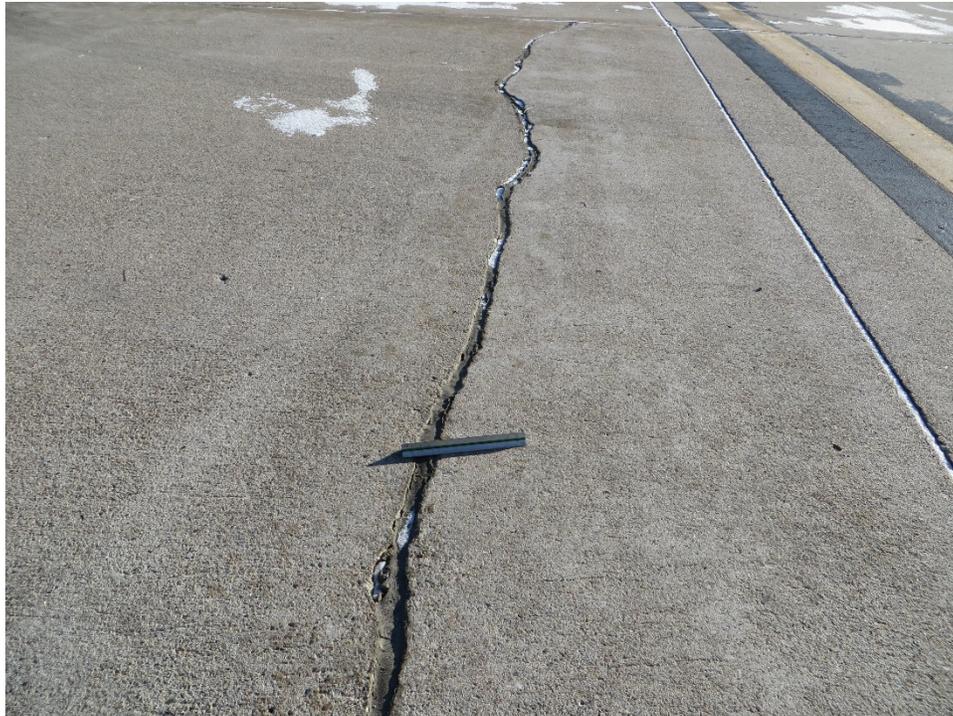
T03BR-03. LTD Cracking (Sample Unit No. 01).

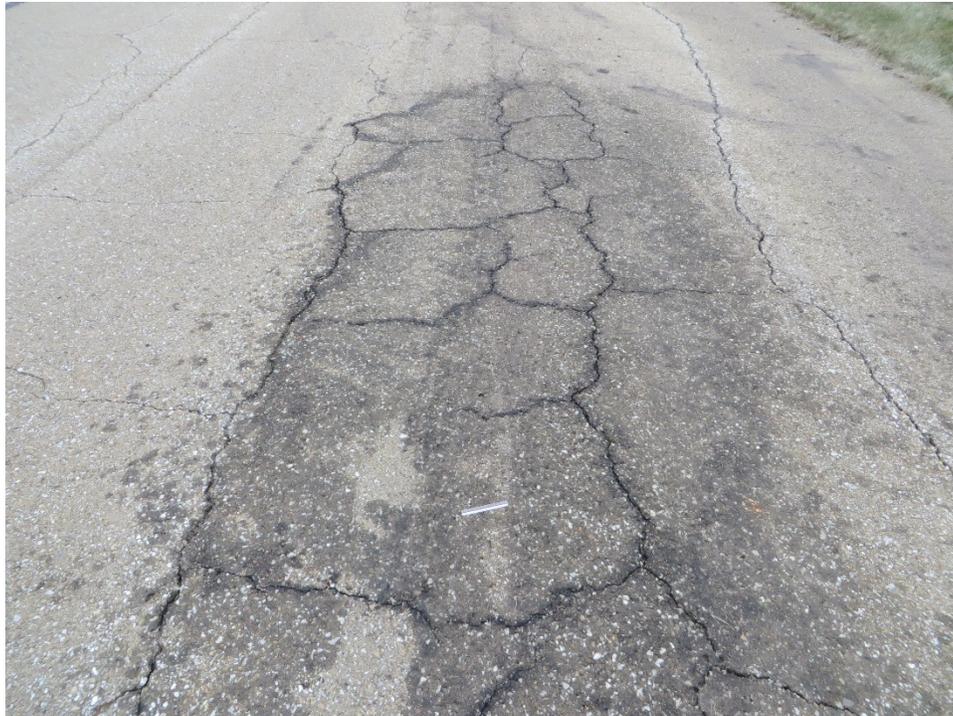
T03BR-04. Alligator Cracking (Sample Unit No. 05).

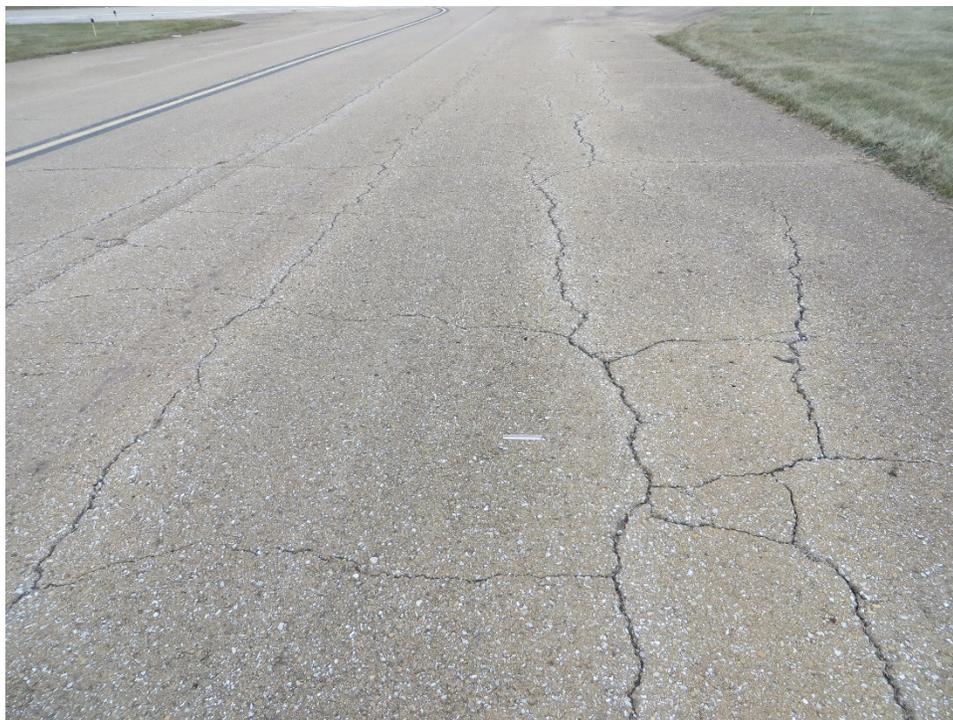
T03BR-04. Block Cracking (Sample Unit No. 02).

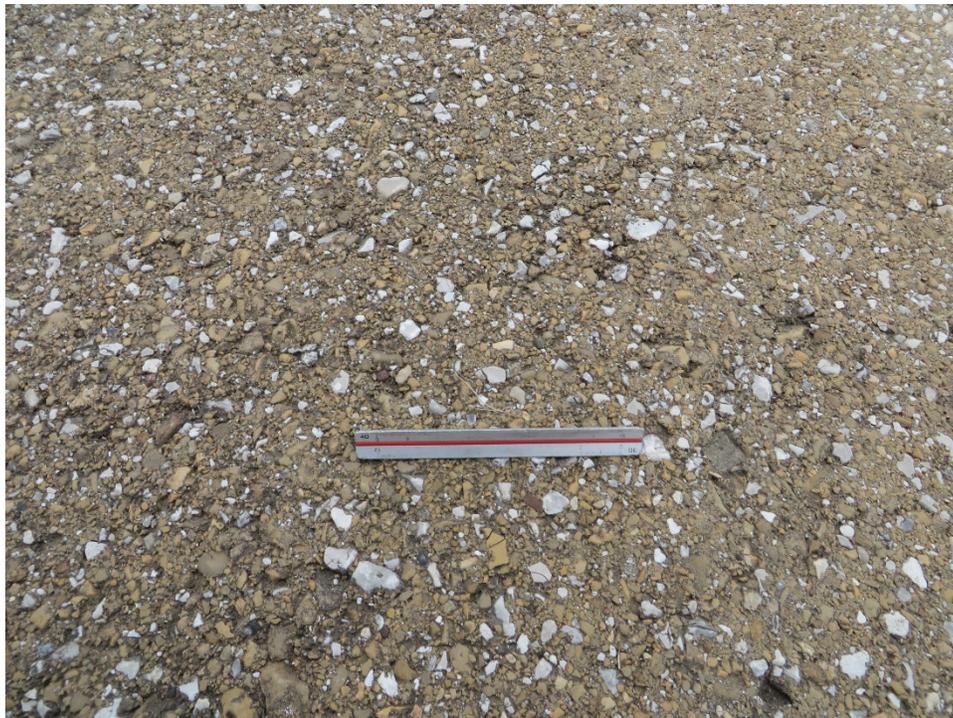
T03BR-04. Weathering (Sample Unit No. 02).

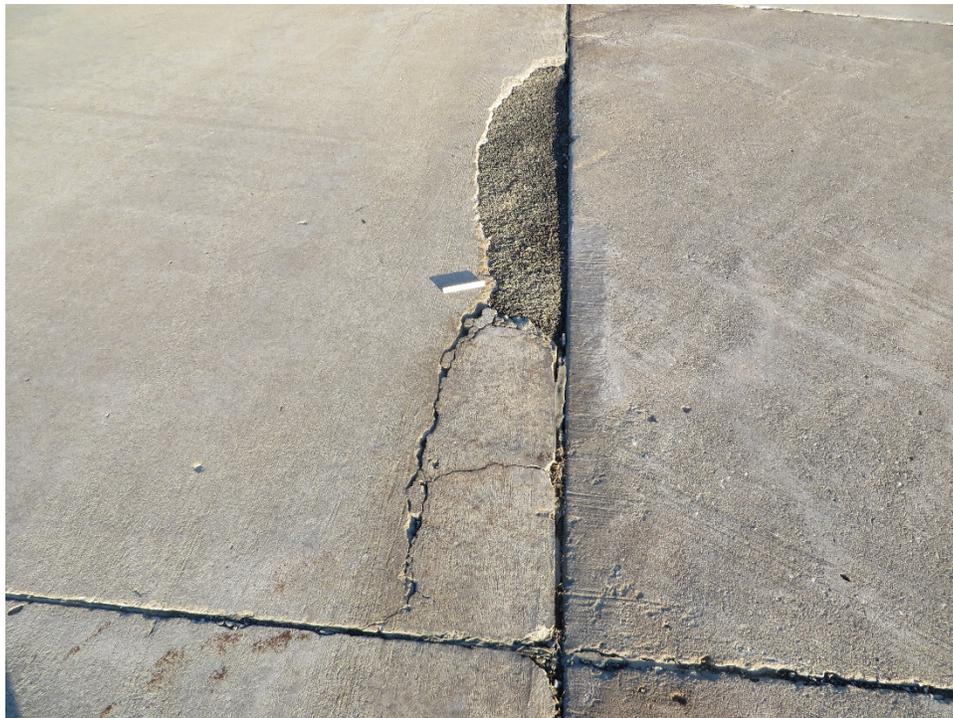
T04BR-01. Joint Spalling (Additional Sample Unit No. 11).

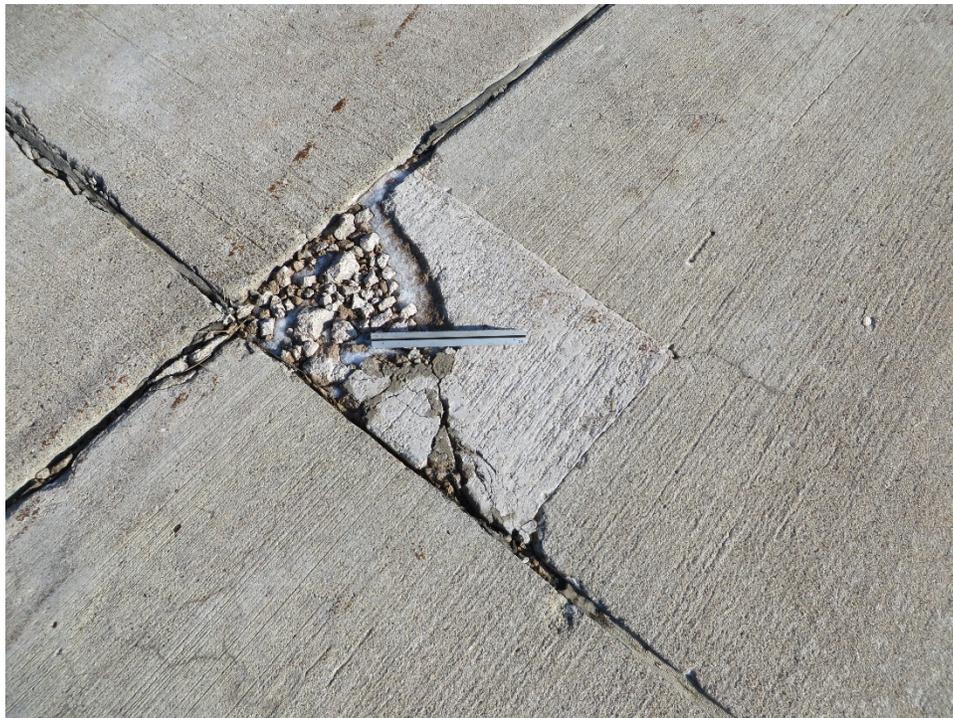
T05BR-01. Small Patching (Sample Unit No. 06).

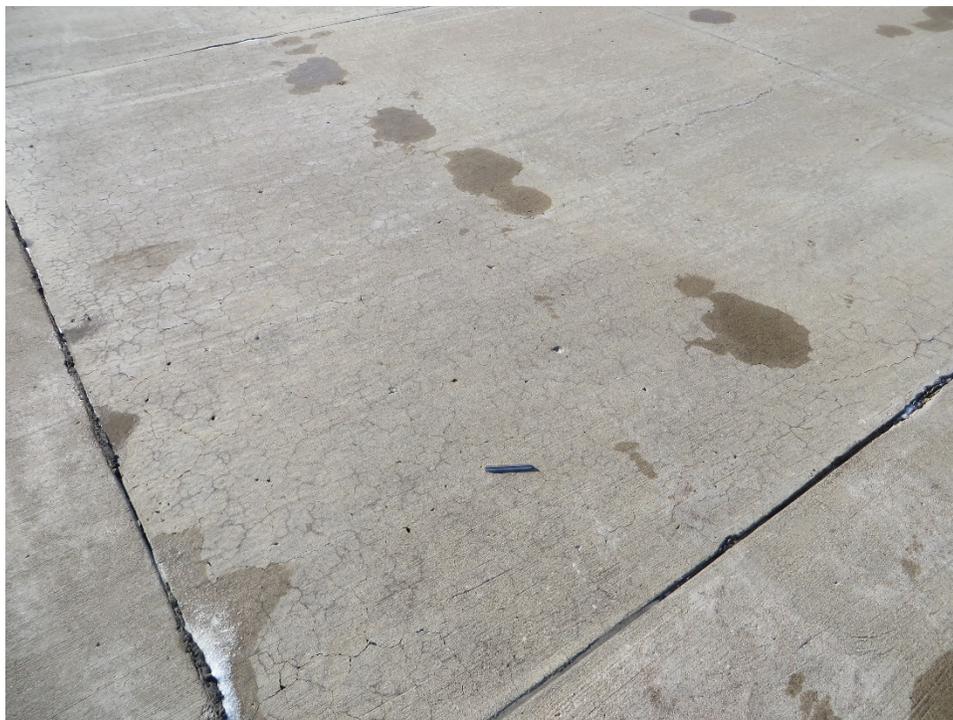
T05BR-02. ASR (Sample Unit No. 03).

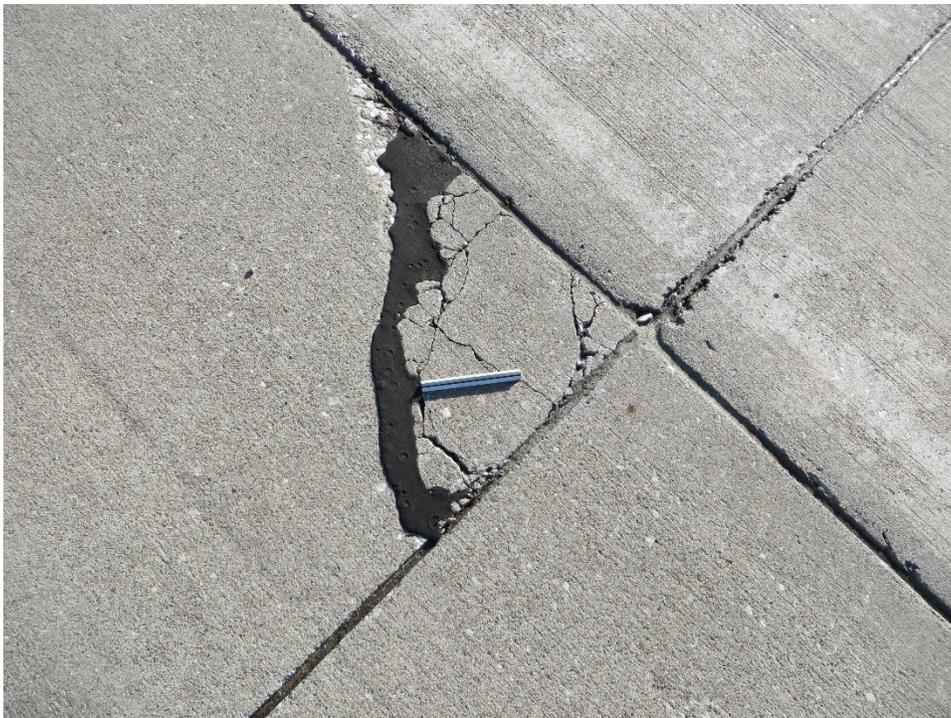
T06BR-01. Corner Spalling (Sample Unit No. 07).

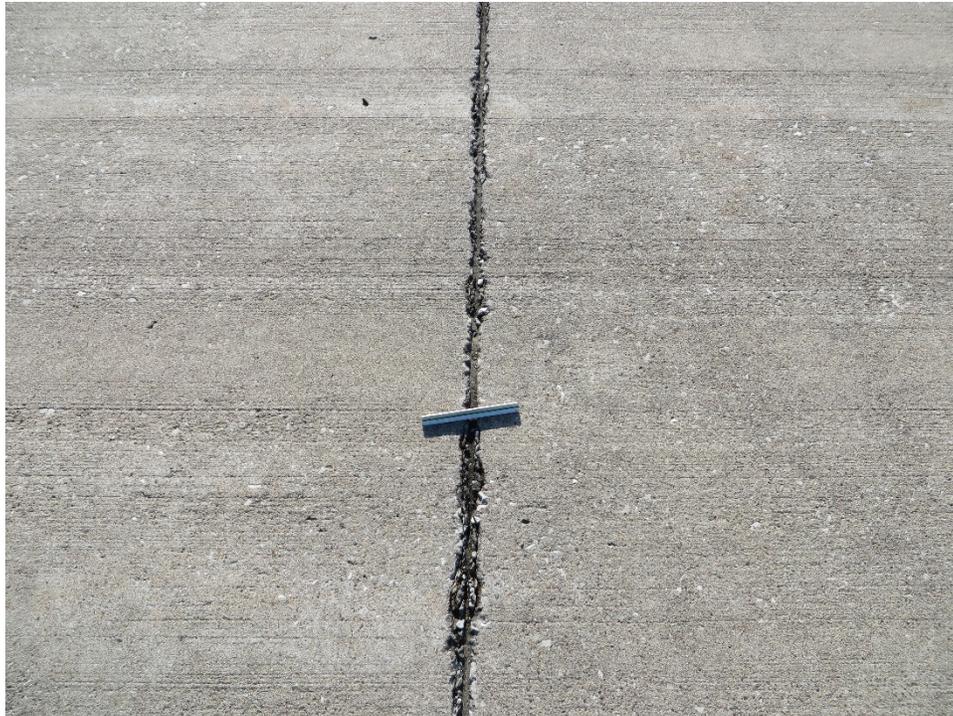
T06BR-01. Joint Seal Damage (Sample Unit No. 07).

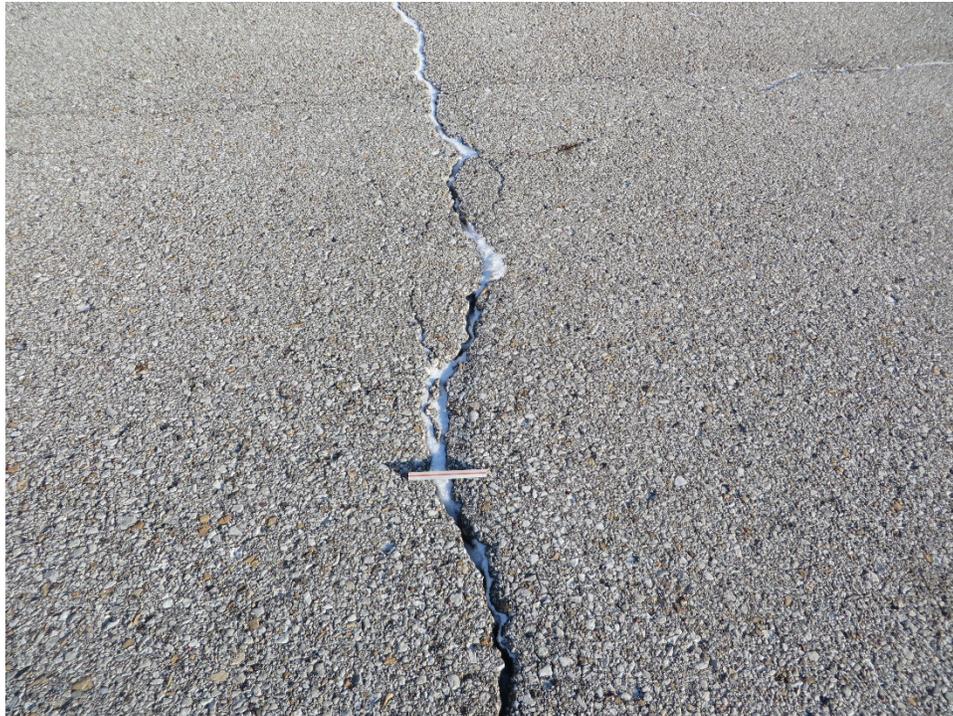
TH01BR-01. L&T Cracking (Sample Unit No. 02).

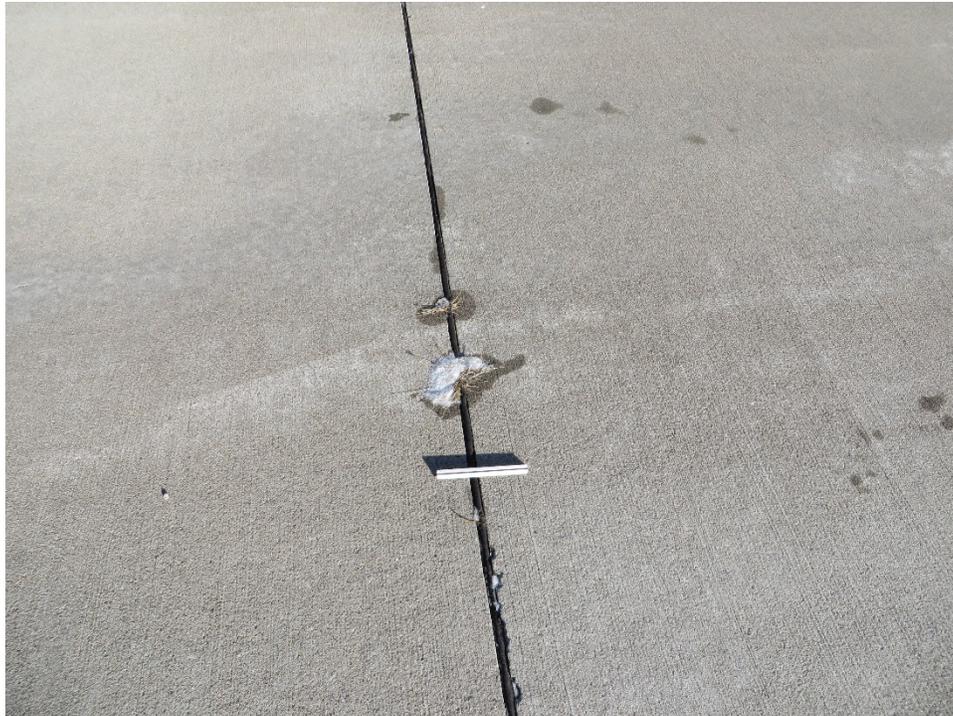
TH01BR-02. Joint Seal Damage (Sample Unit No. 16).

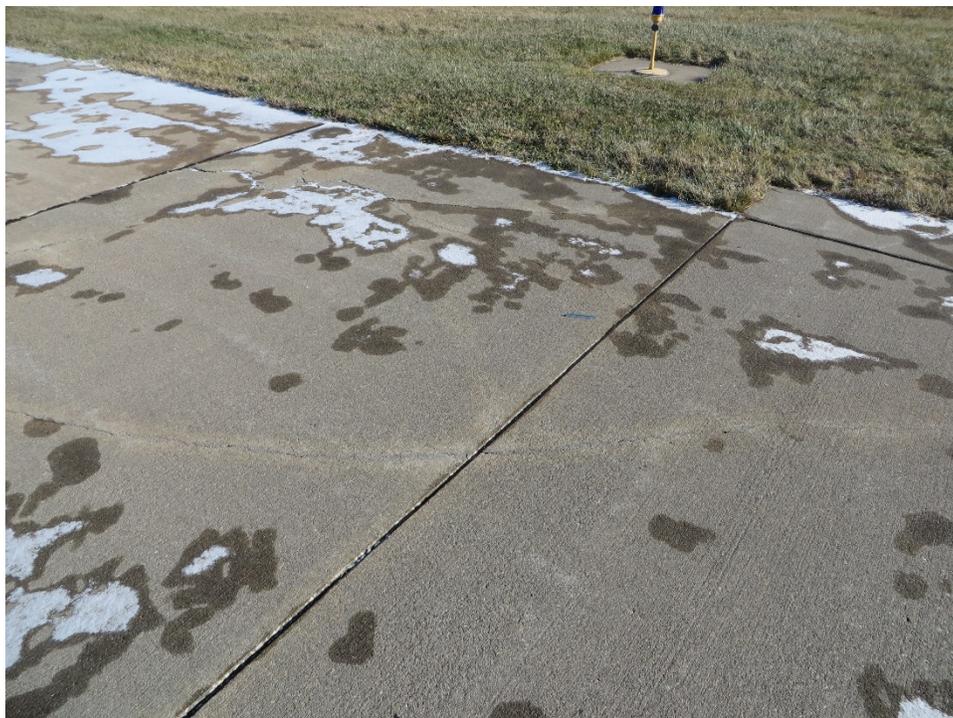
TH01BR-02. Shattered Slab (Additional Sample Unit No. 01).
