Southeast Iowa Regional Airport

PAVEMENT MANAGEMENT REPORT

JULY 2022

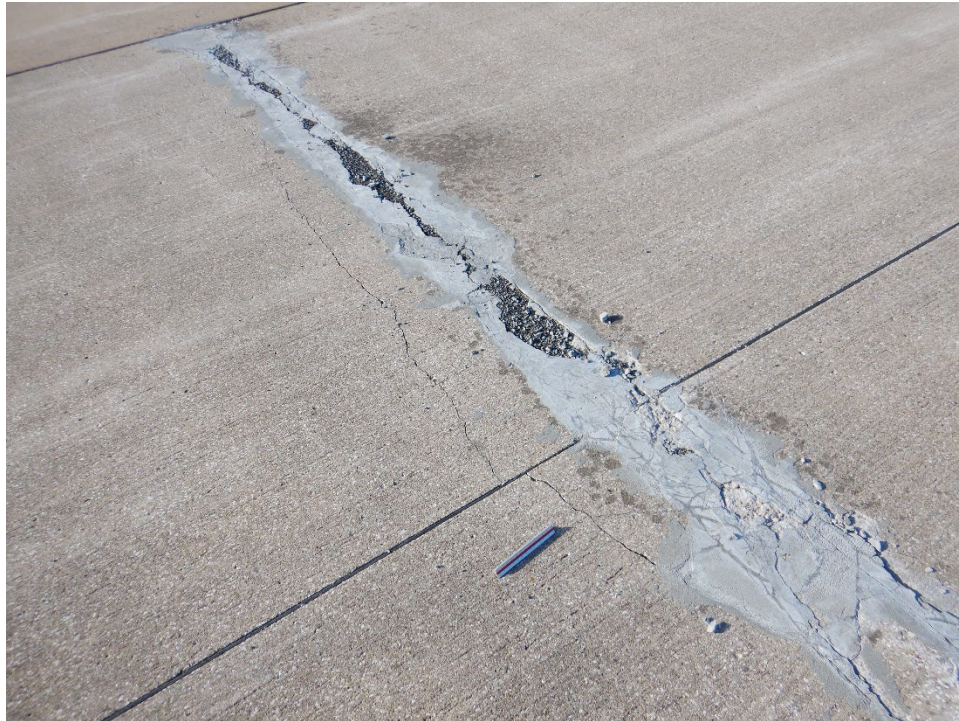
A01BR-02. ASR (Sample Unit No. 02).

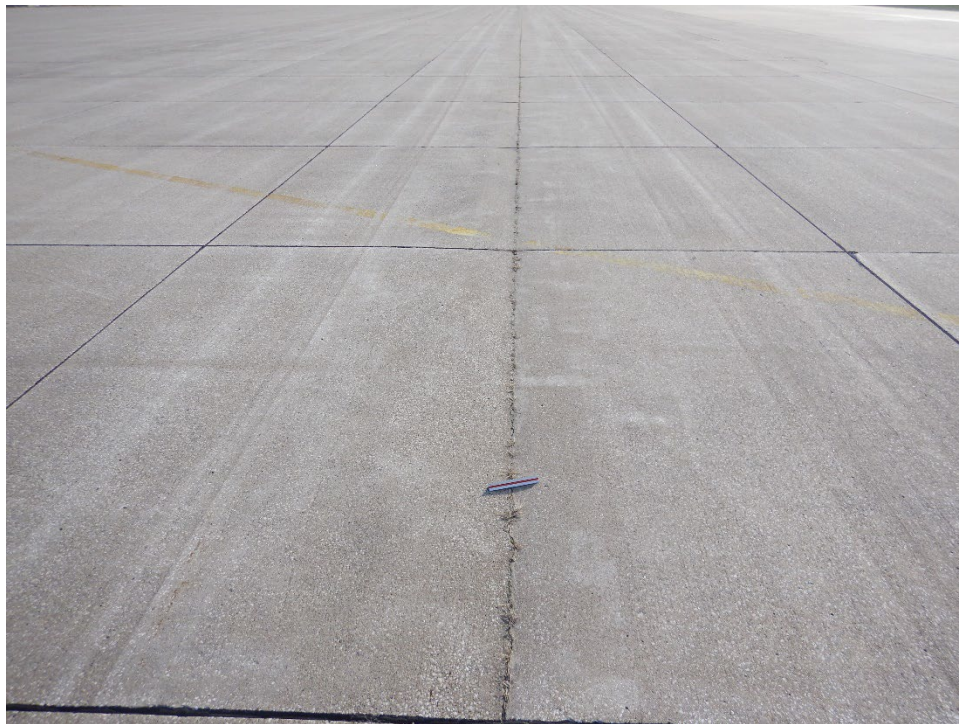
A01BR-02. LTD Cracking (Sample Unit No. 05).

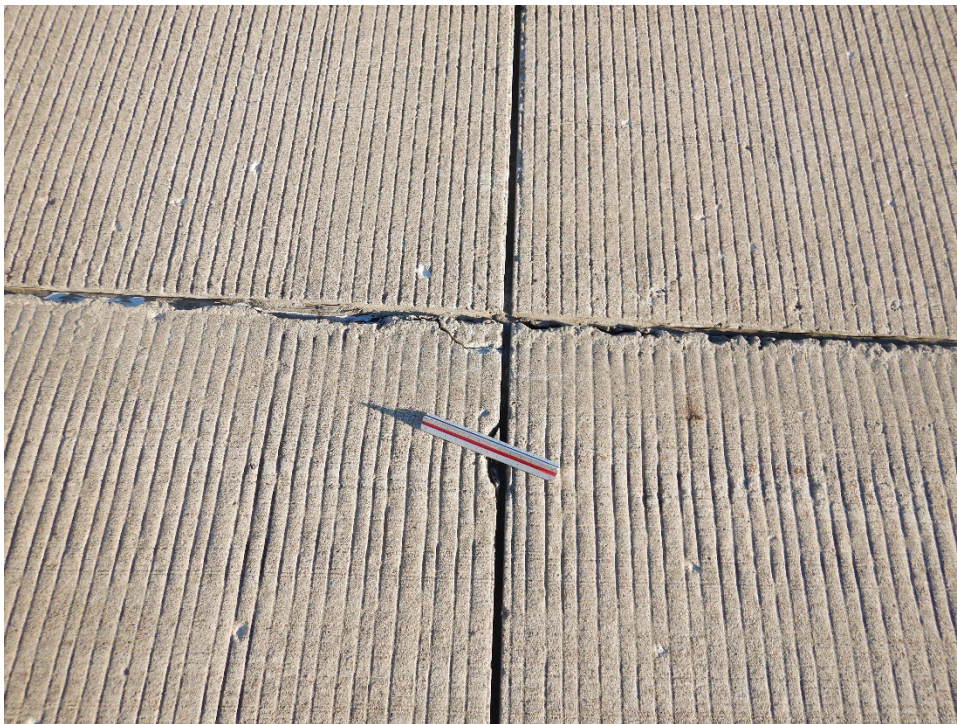
R12BR-01. ASR (Sample Unit No. 138).

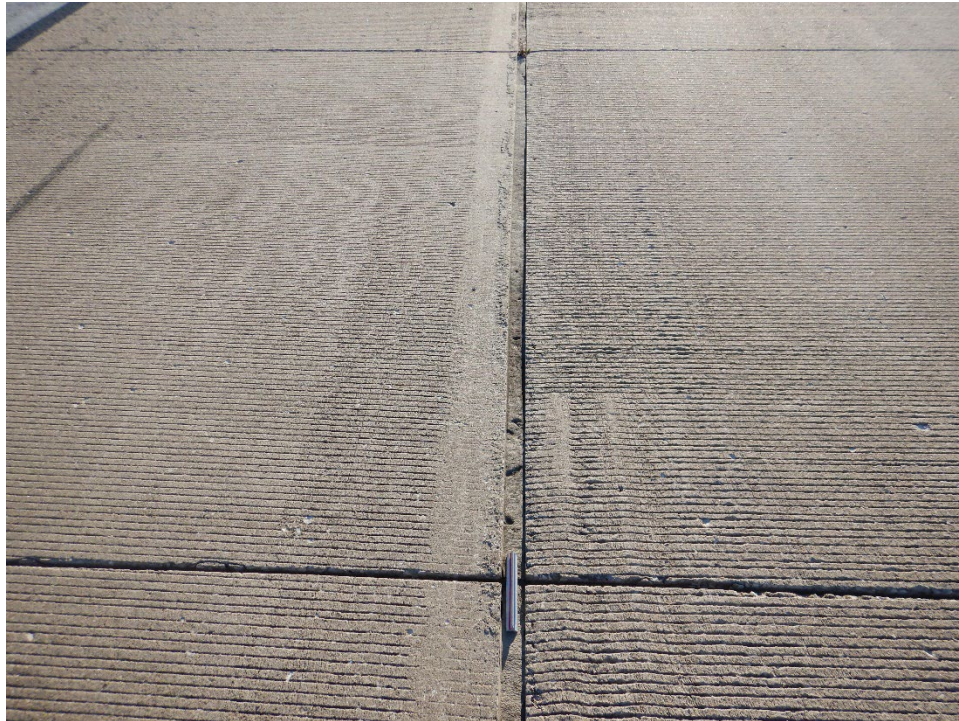
R12BR-01. Joint Seal Damage (Sample Unit No. 153).

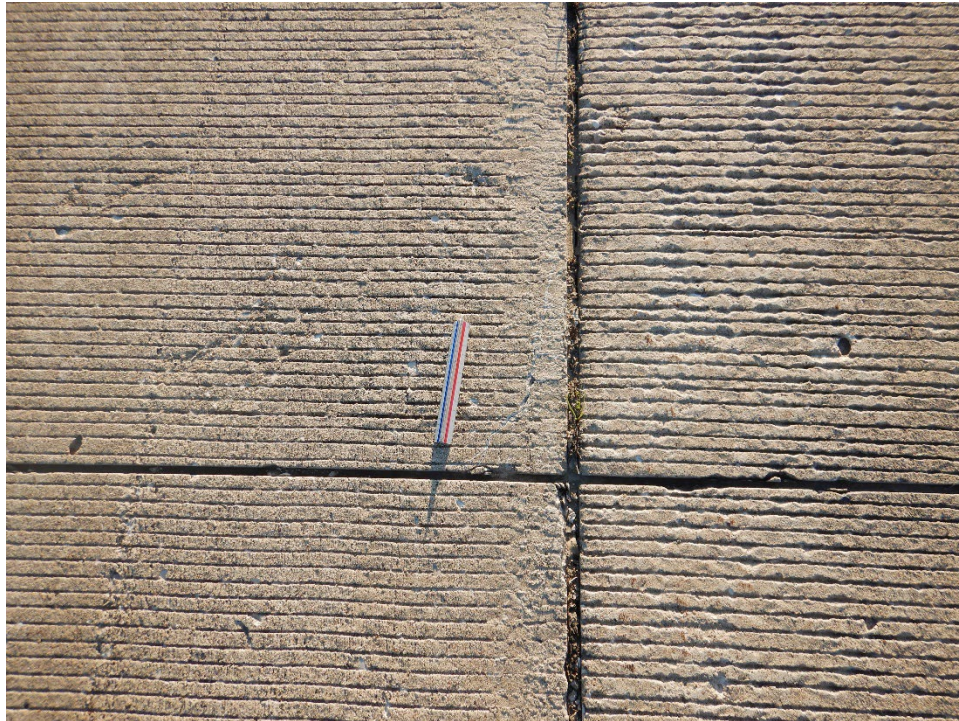
R12BR-02. ASR (Sample Unit No. 13).

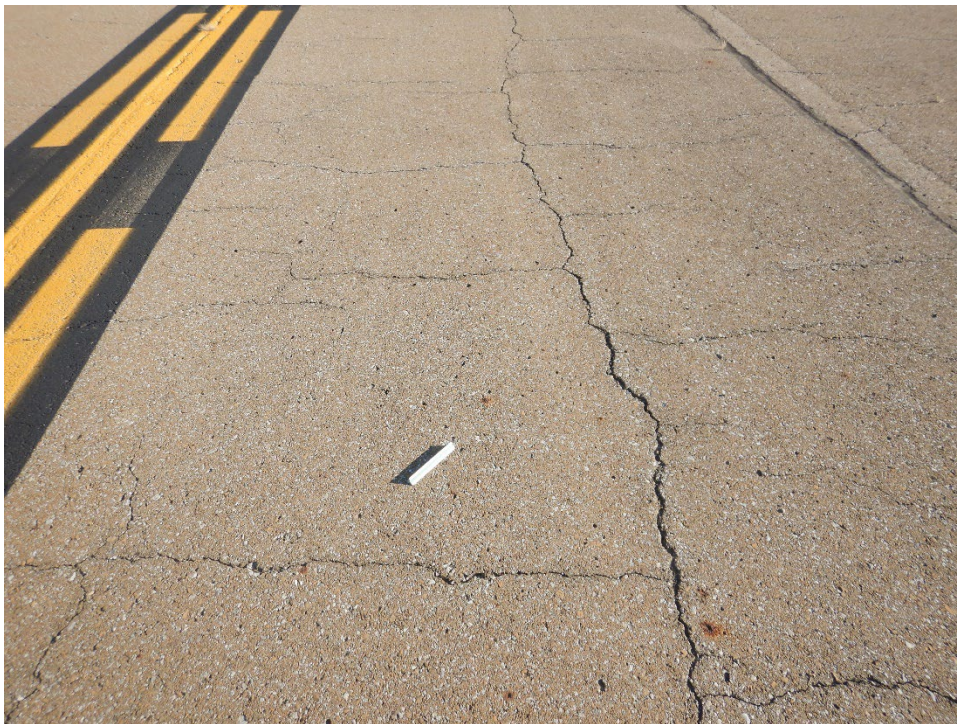
T01BR-01. Block Cracking (Sample Unit No. 27).

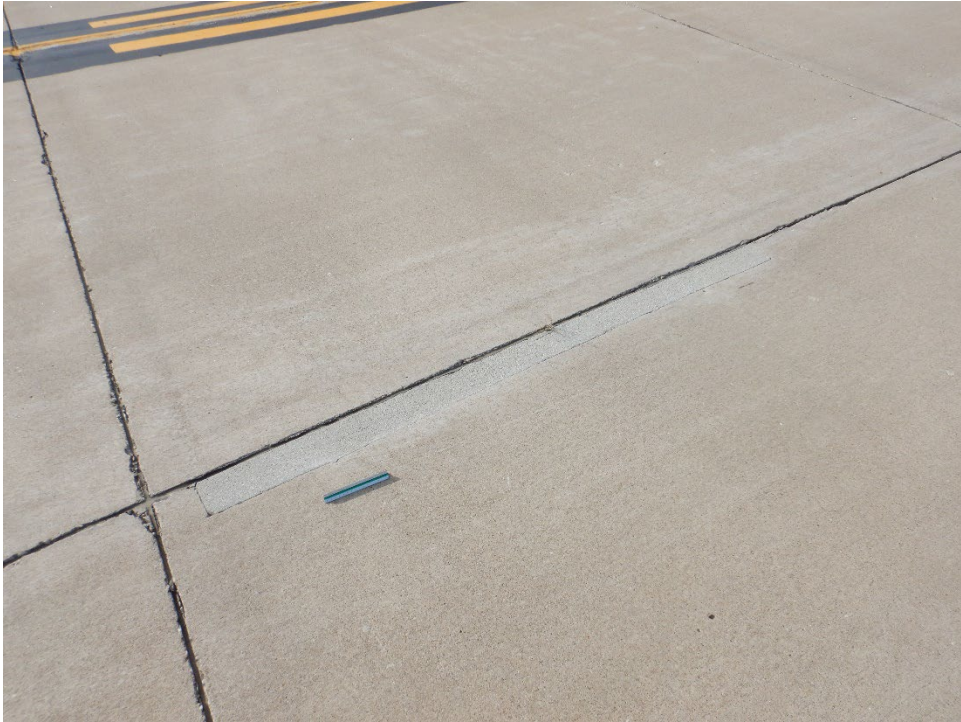
T01BR-02. Small Patching (Sample Unit No. 02).

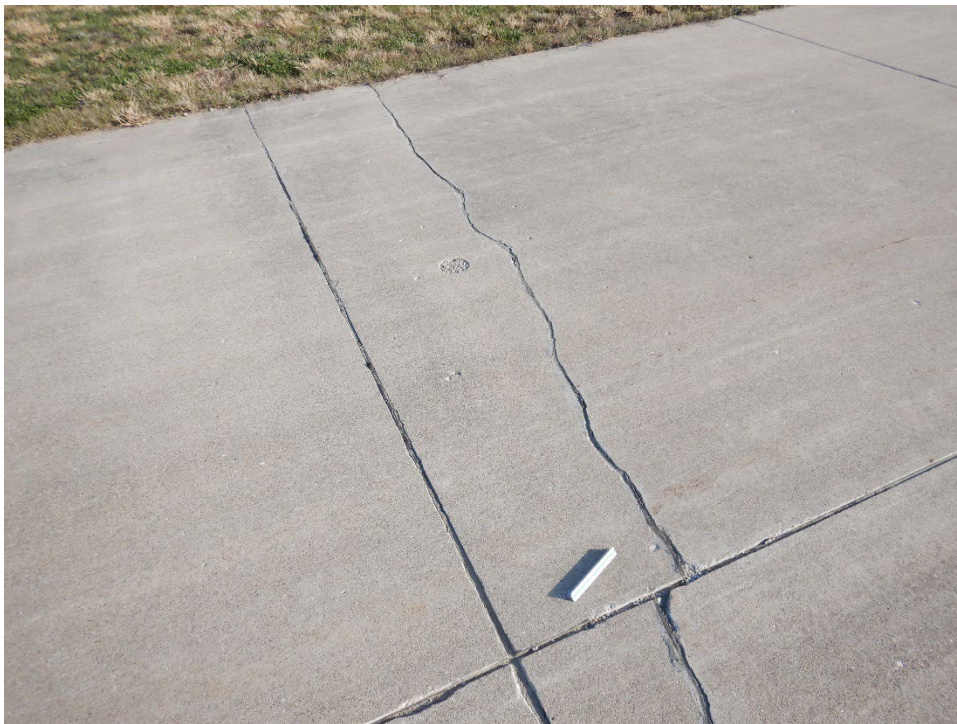
T02BR-01. LTD Cracking (Sample Unit No. 01).

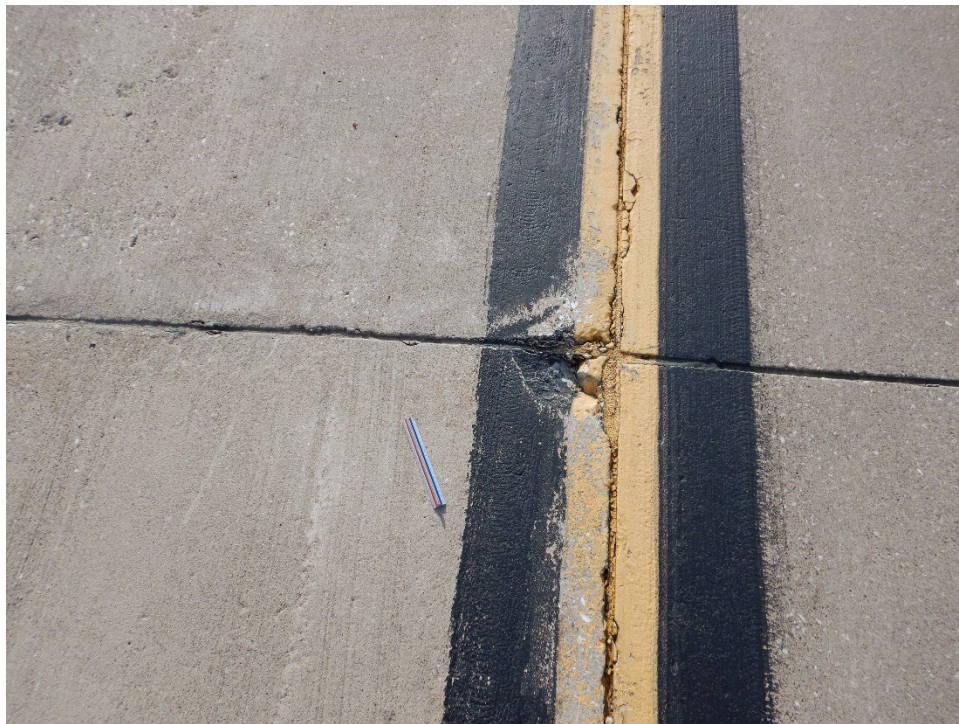
T02BR-02. Corner Spalling (Sample Unit No. 63).

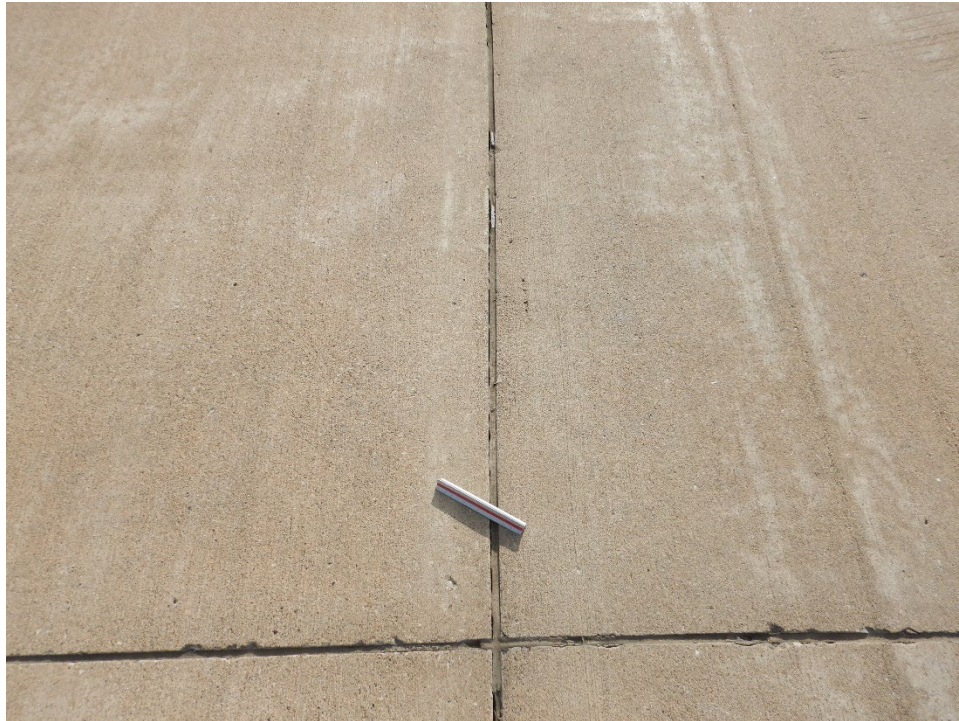
T03BR-03. Joint Seal Damage (Sample Unit No. 10).

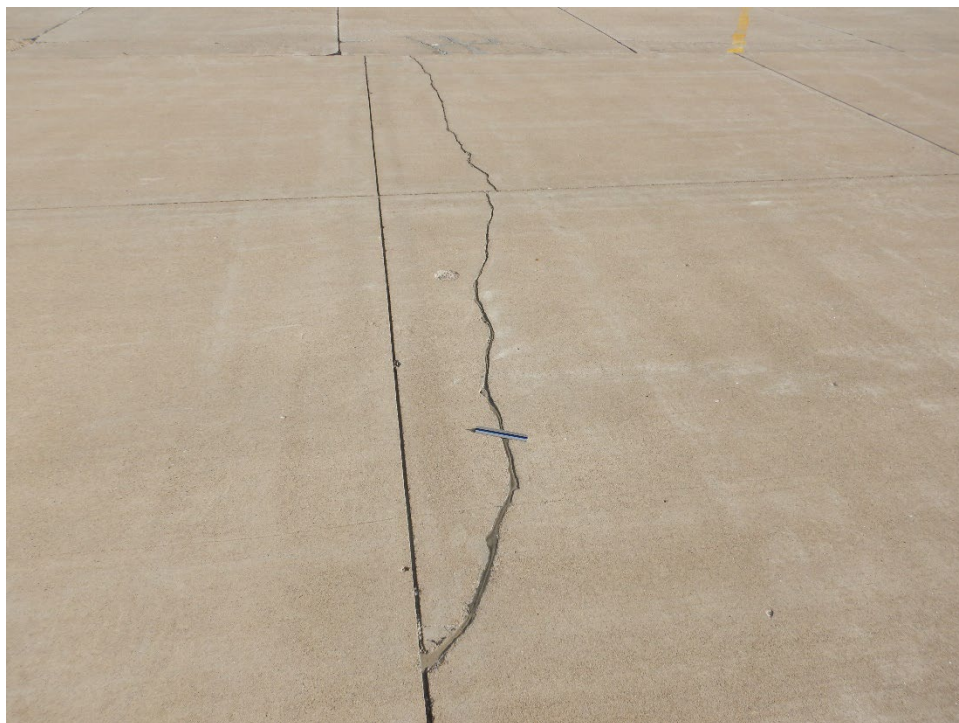
T03BR-03. LTD Cracking (Sample Unit No. 04).

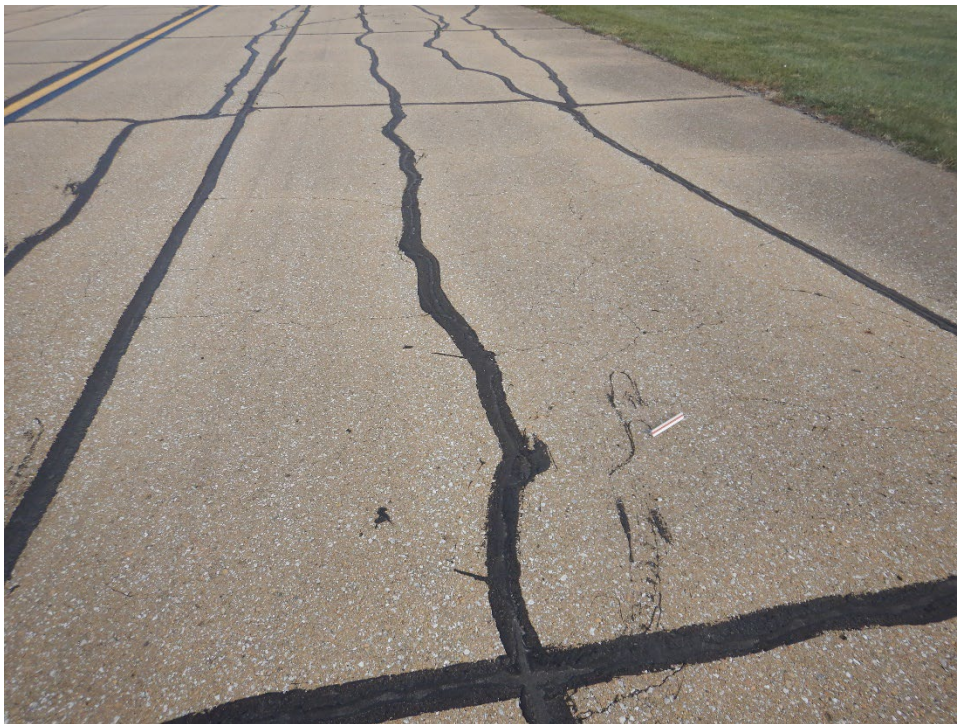
T03BR-04. Block Cracking (Sample Unit No. 02).

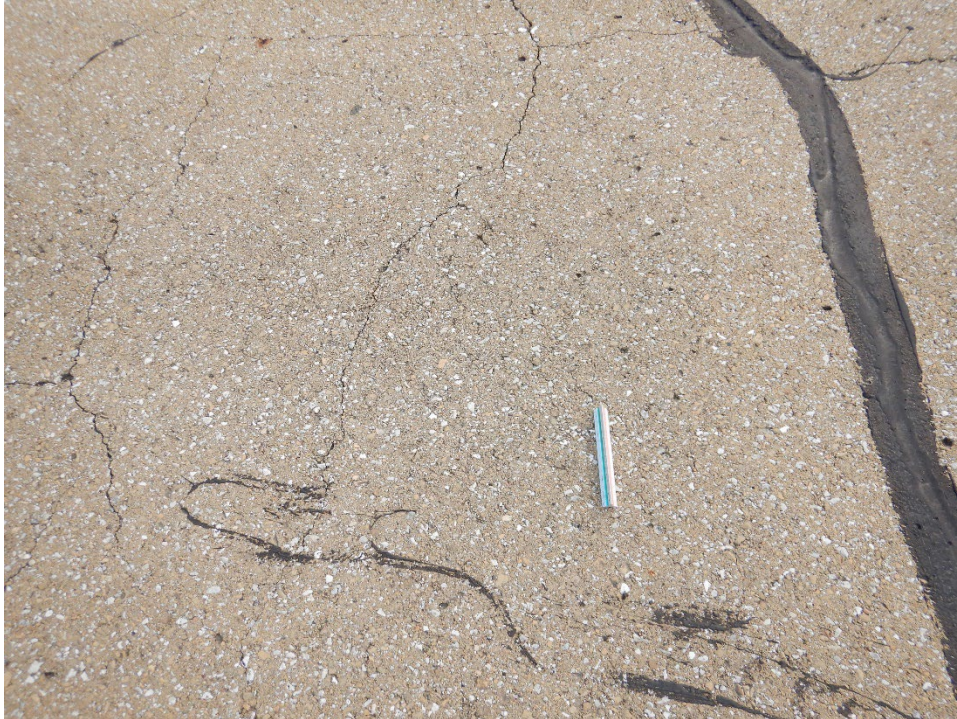
T03BR-04. Raveling (Sample Unit No. 02).

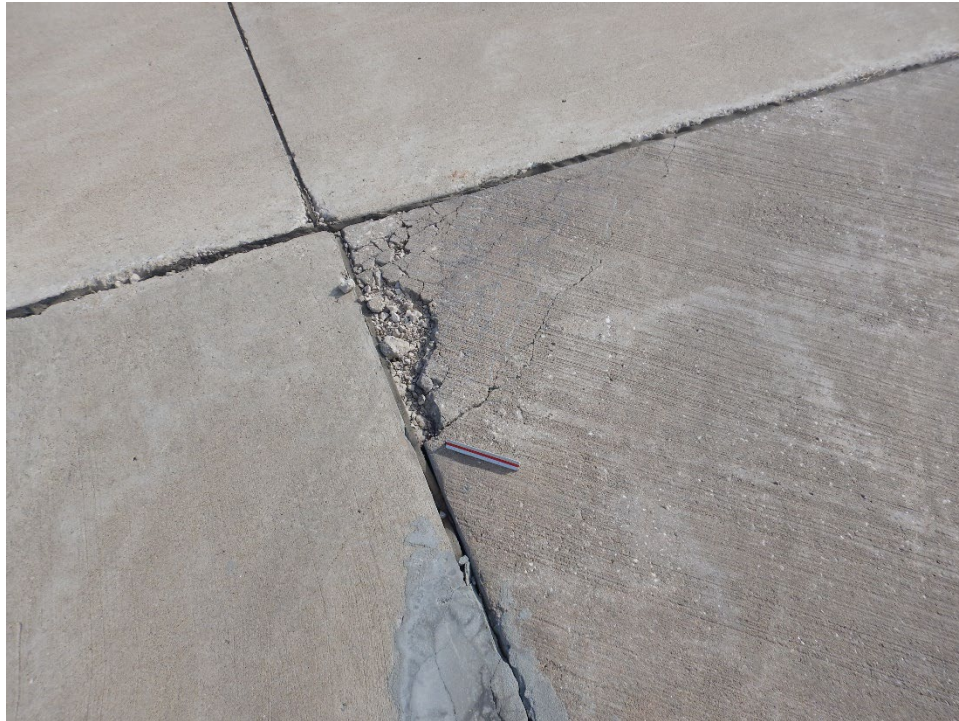
Taxiway 04 consisted of one section. All severities of small patching, low-severity ASR and corner break, medium-severity corner spalling and large patching, and low- and high-severity joint seal damage were recorded in Section 01. An area with medium- and high-severity ASR was recorded as an additional sample unit, in accordance with ASTM D5340-20.

T04BR-01. ASR (Additional Sample Unit No. 11).

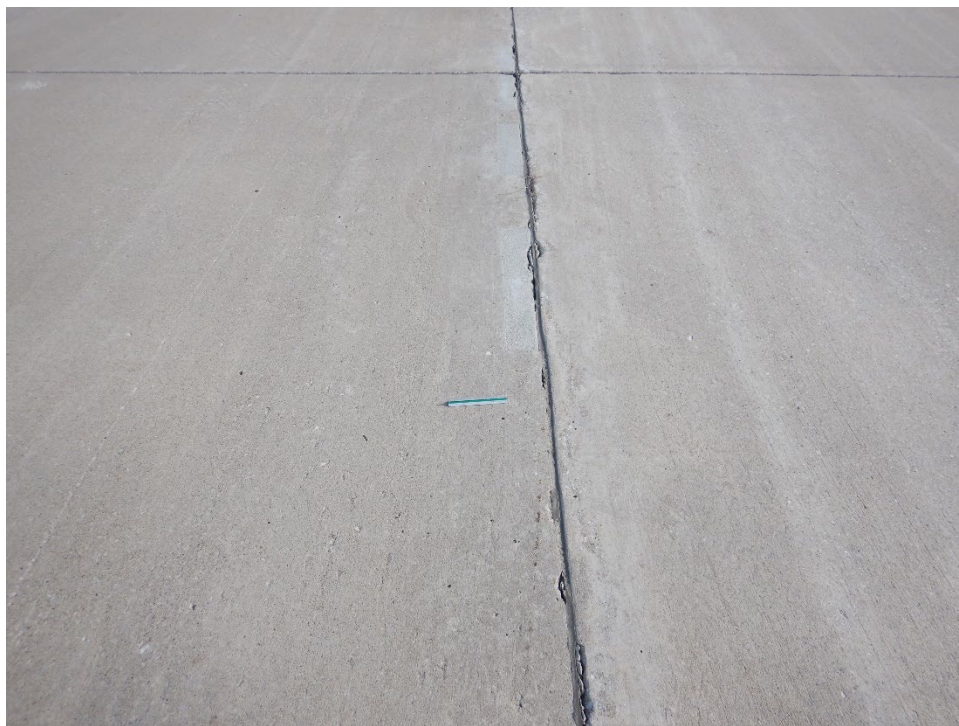
T04BR-01. Small Patching (Sample Unit No. 08).

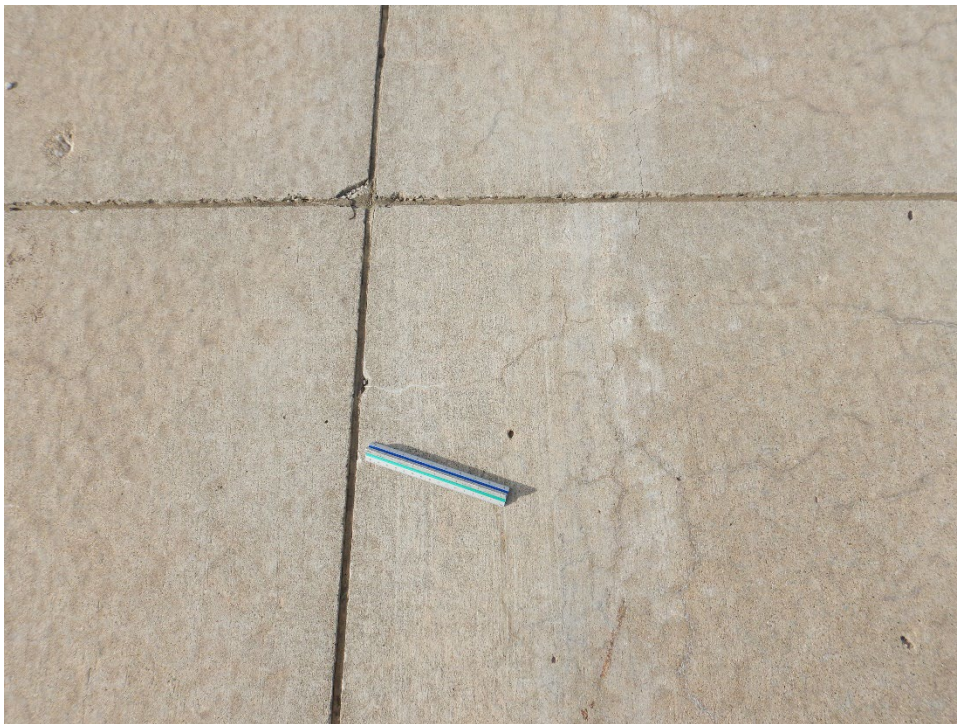
T05BR-01. ASR (Sample Unit No. 03).

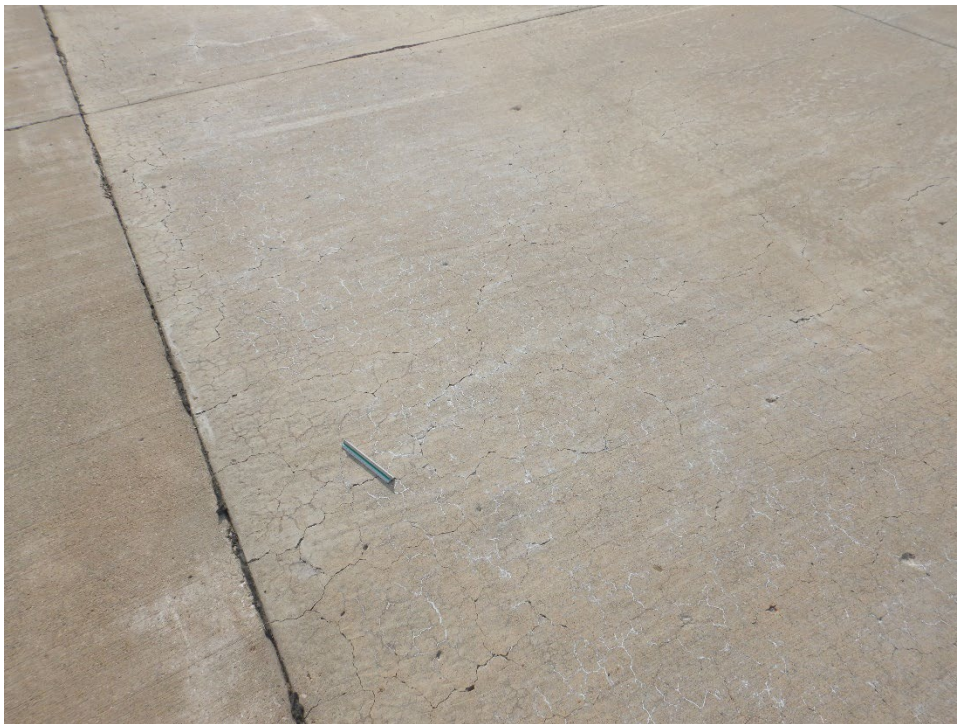
T05BR-02. ASR (Sample Unit No. 03).

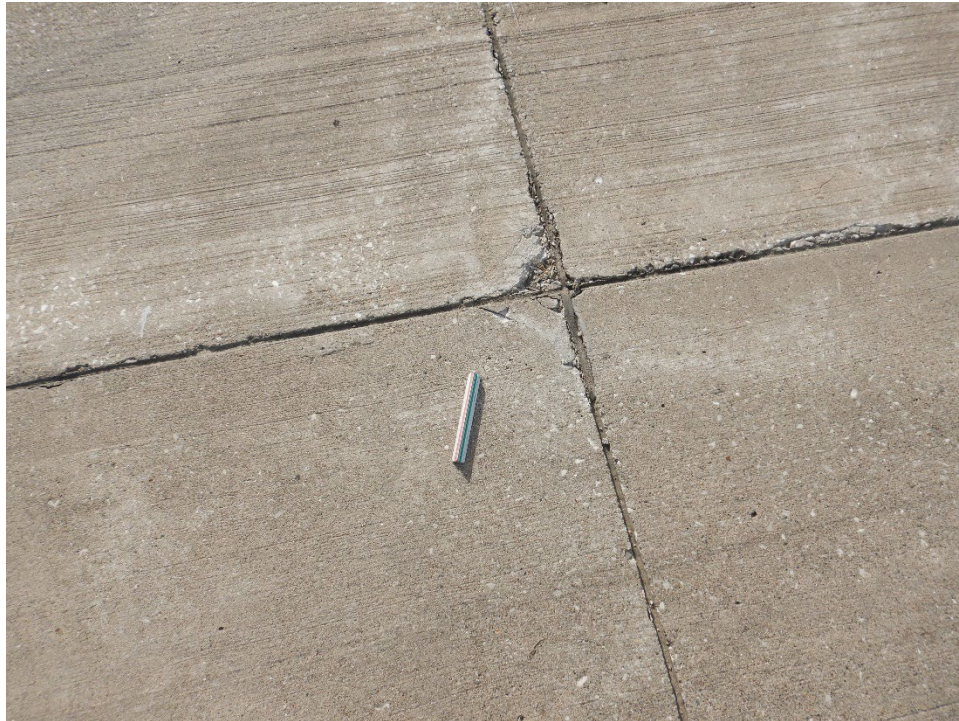
T06BR-01. Corner Spalling (Sample Unit No. 04).

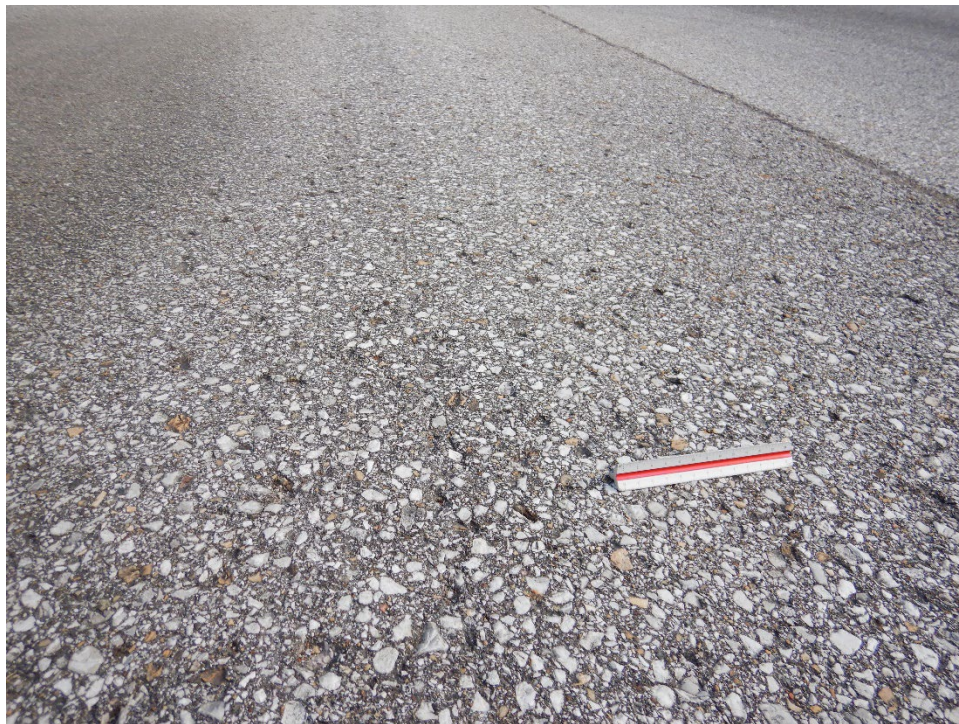
The T-hangar area consisted of two sections. Section 01 was in poor condition with low- and medium-severity alligator cracking and L&T cracking; bleeding; low-severity patching, swelling, and rutting; and high-severity raveling noted throughout. The low-severity L&T cracking was unsealed and the medium-severity L&T cracking was due to either the development of secondary cracking or to unsealed crack widths greater than $\frac{1}{4}$ in. Medium-severity joint spalling, all severities of joint seal damage, and low-severity LTD cracking and large patching were identified in Section 02. An atypical area that contained high-severity shattered slab was recorded as an additional sample unit, in accordance with ASTM D5340-20.

TH01BR-01. Raveling (Sample Unit No. 02).

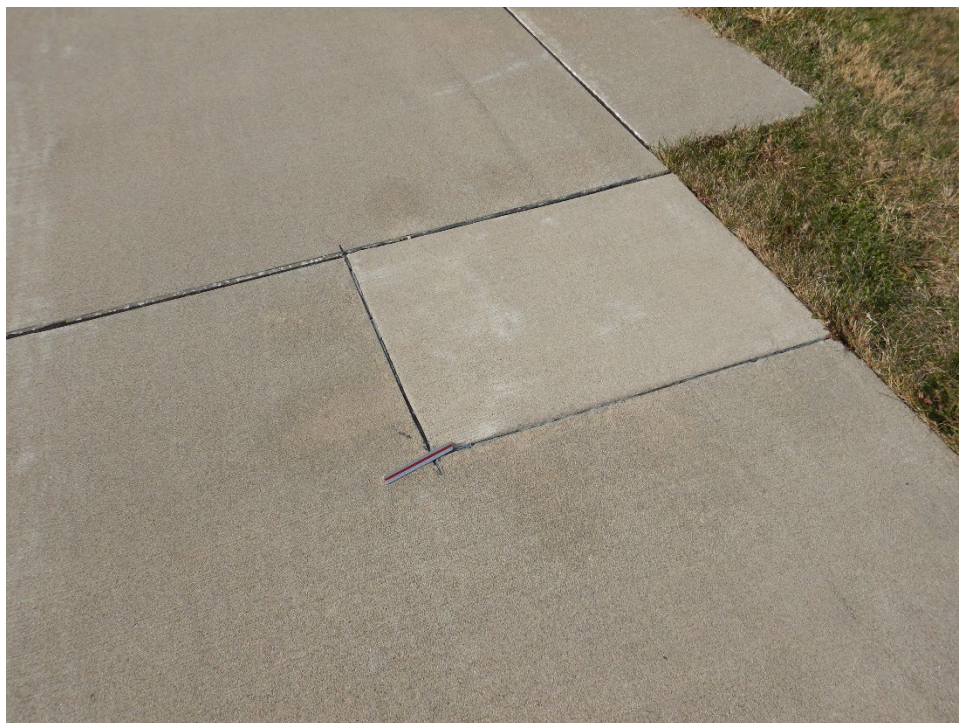
TH01BR-02. Large Patching (Sample Unit No. 14).

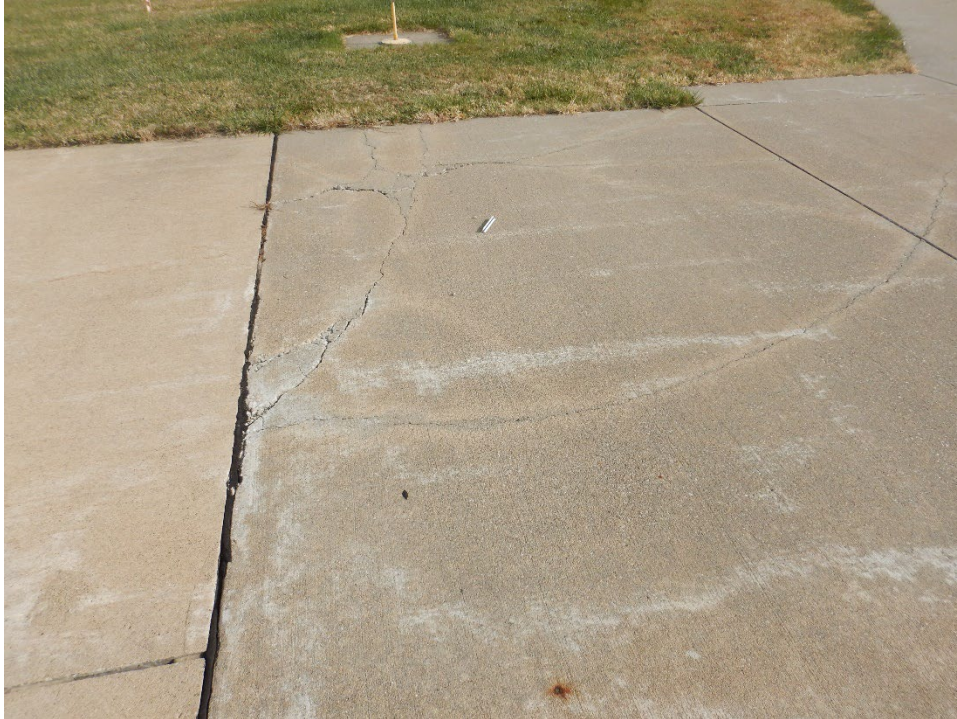
TH01BR-02. Shattered Slab (Additional Sample Unit No. 01).
