# Carroll-Arthur N Neu Airport

## Pavement Management Report

**JULY 2024**

# CARROLL-ARTHUR N NEU AIRPORT PAVEMENT MANAGEMENT REPORT

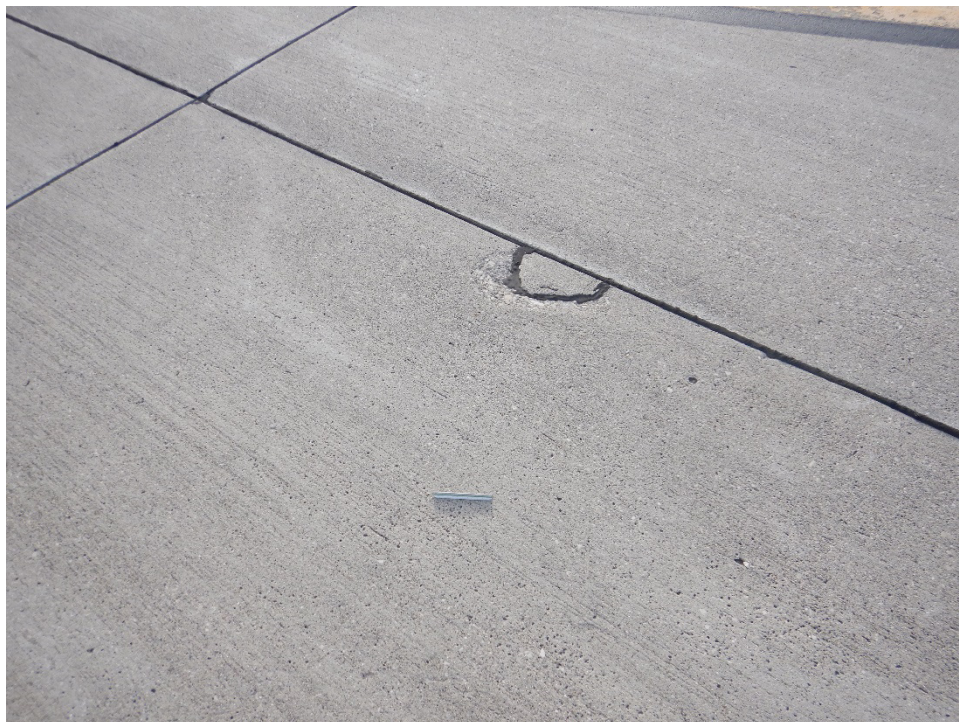
A01CA-01. Joint Spalling (Sample Unit No. 10).

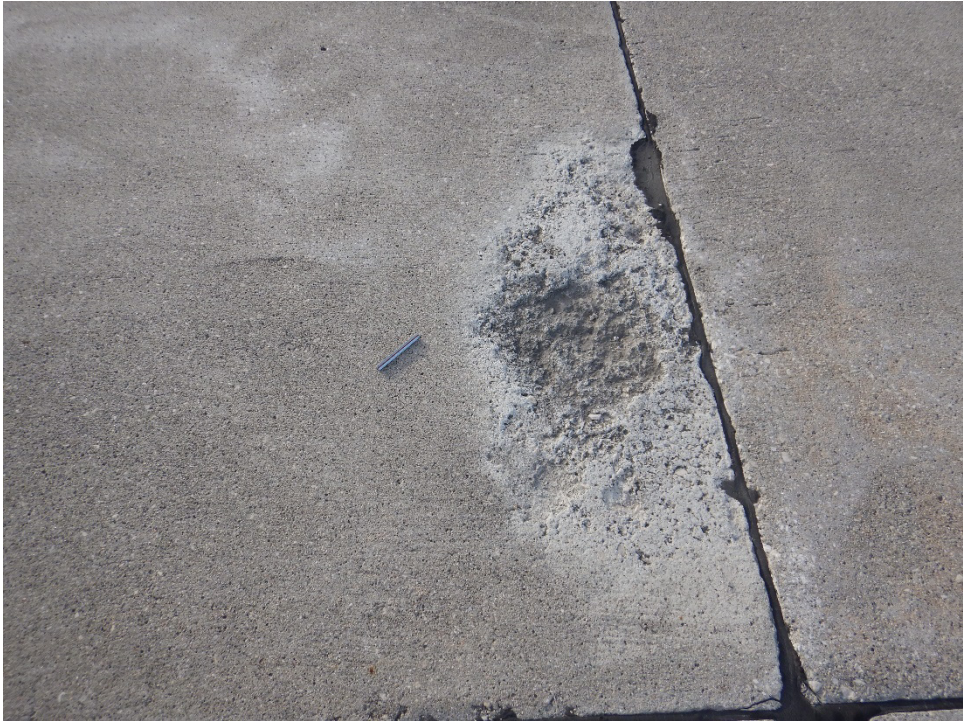
A01CA-01. Scaling (Additional Sample Unit No. 20).

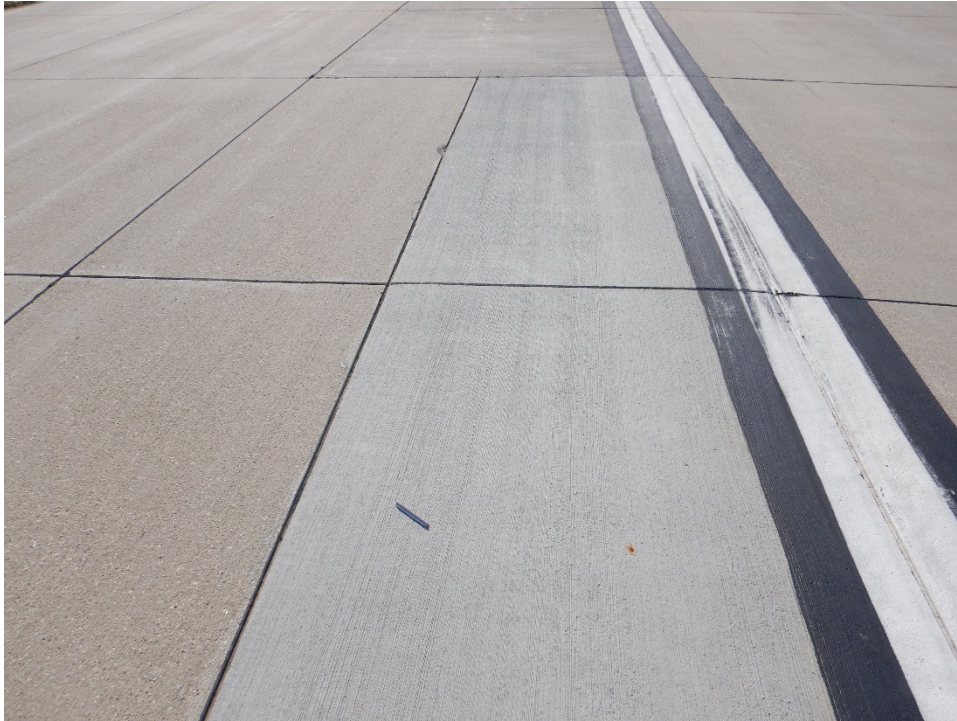
R03CA-01. Large Patching (Sample Unit No. 09).

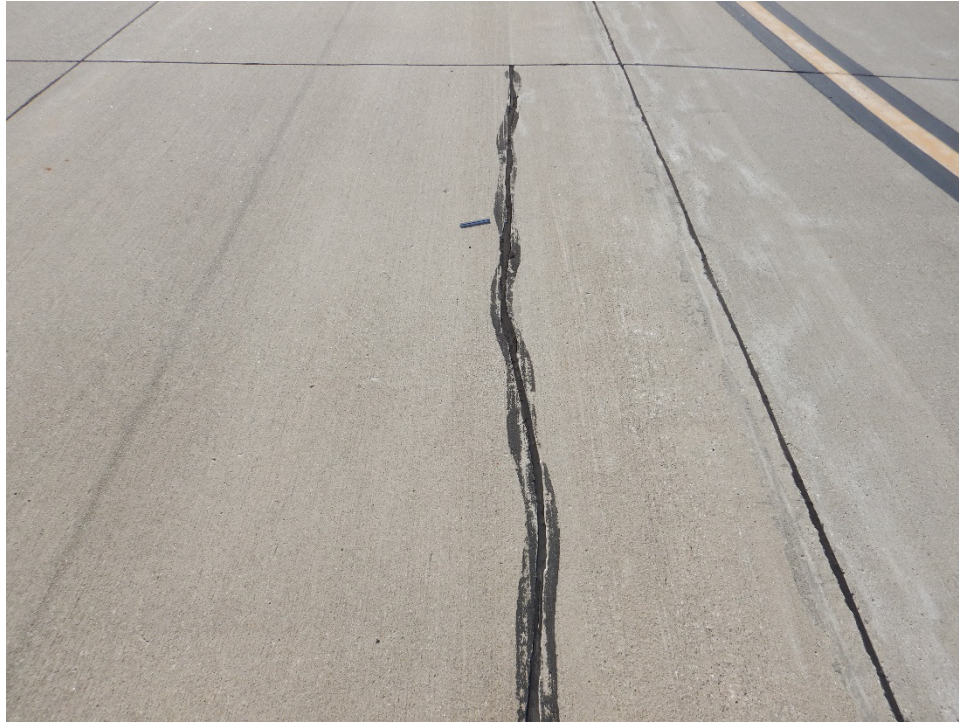
R03CA-02. LTD Cracking (Sample Unit No. 08).

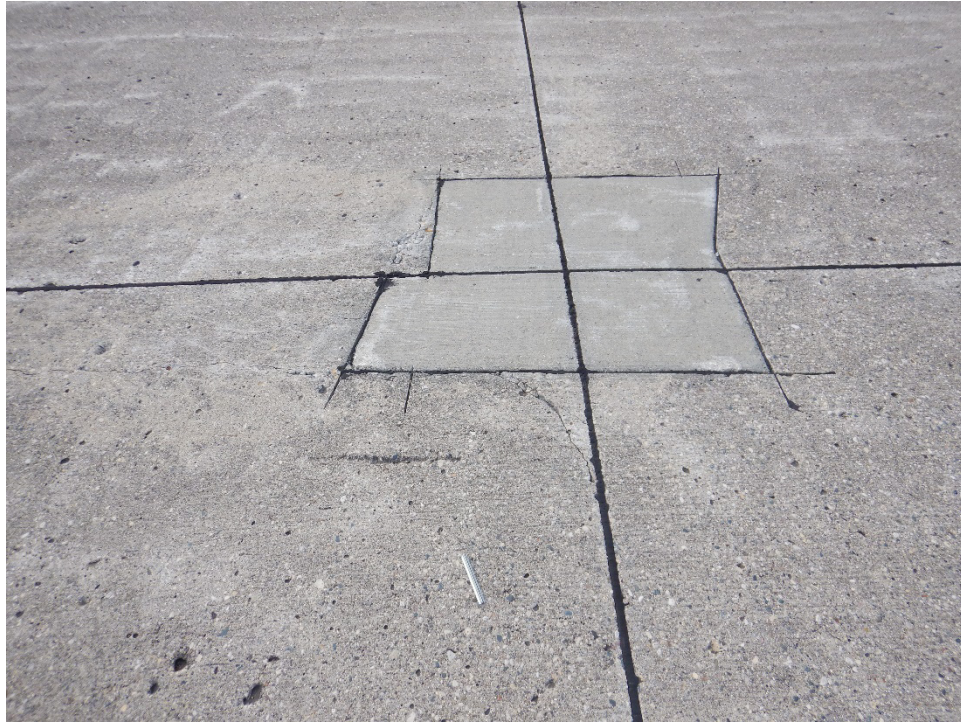
R13CA-02. Small Patching (Sample Unit No. 05).

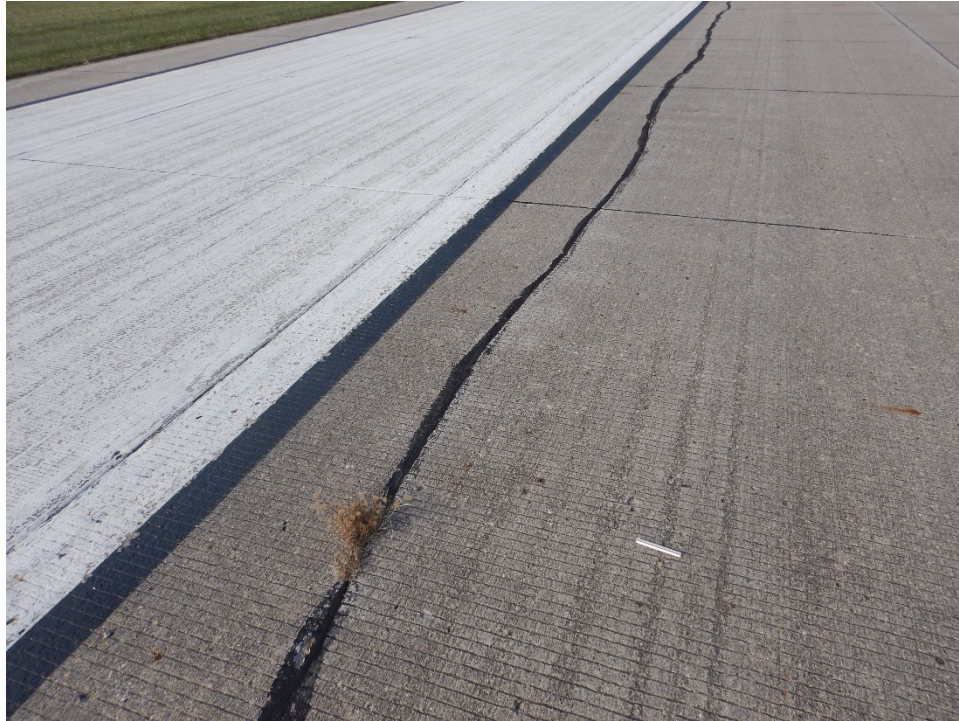
R13CA-03. LTD Cracking (Sample Unit No. 09).

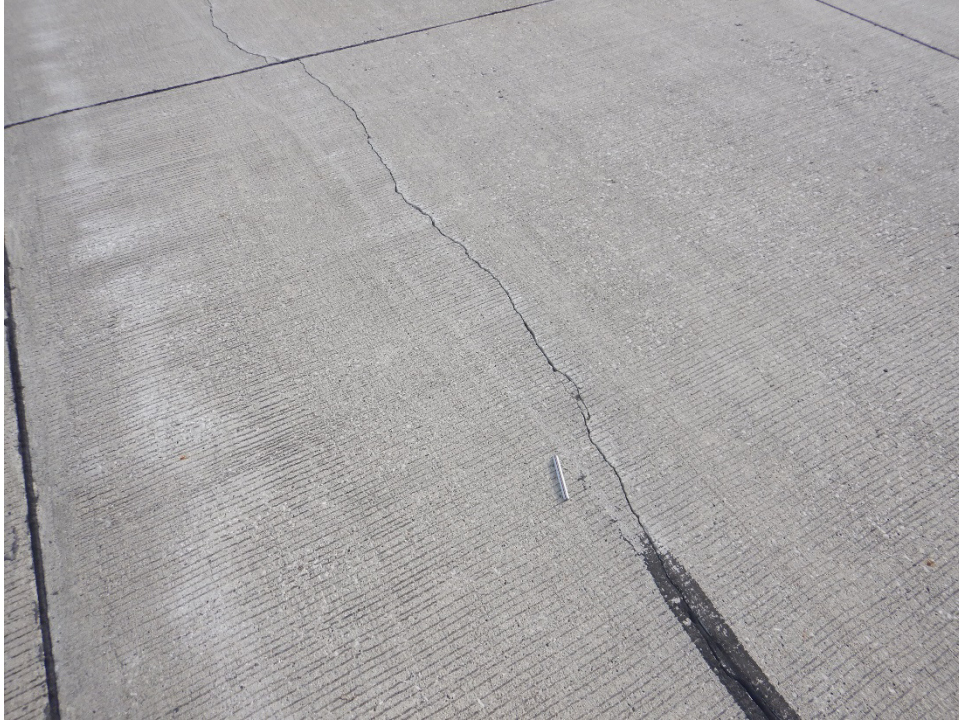
R13CA-04. LTD Cracking (Sample Unit No. 20).

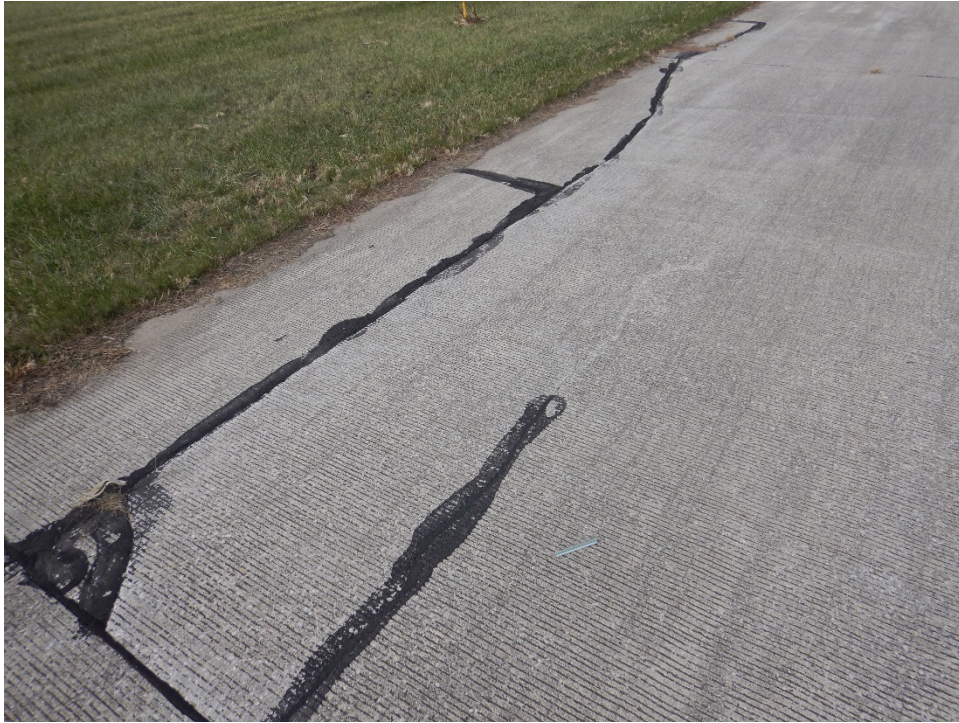
R13CA-05. LTD Cracking (Sample Unit No. 10).

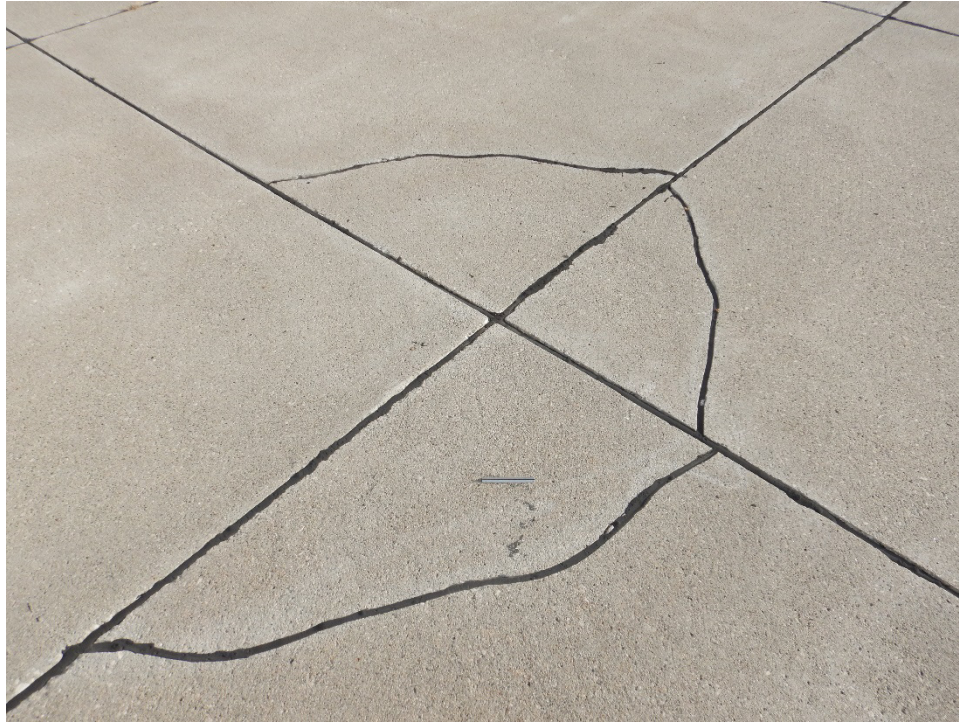
T01CA-01. Corner Break (Sample Unit No. 01).

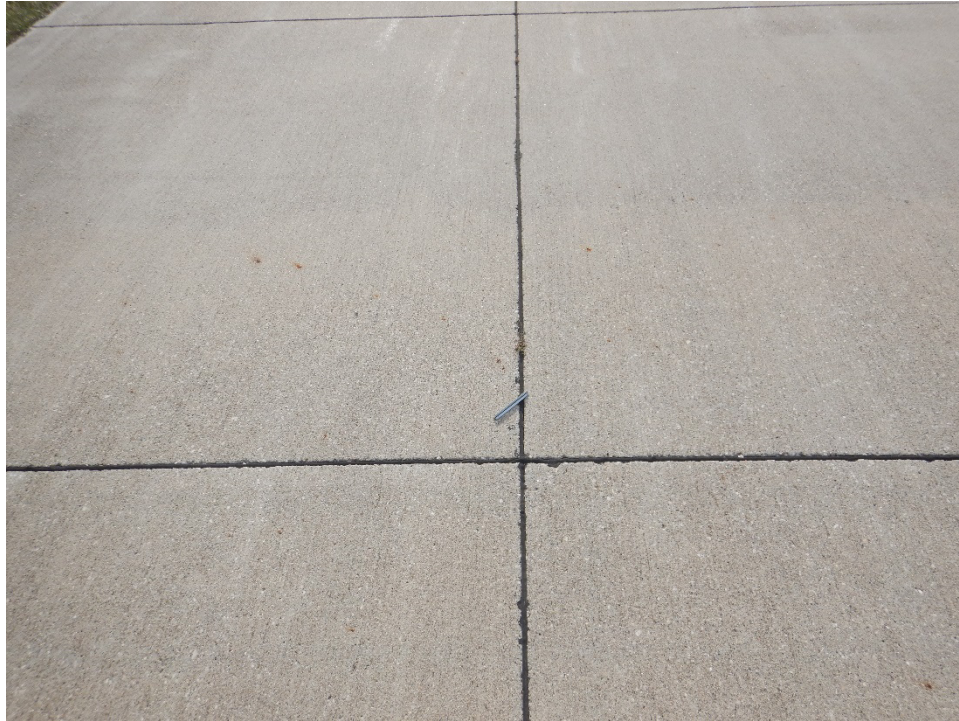
T01CA-02. Joint Seal Damage (Sample Unit No. 09).

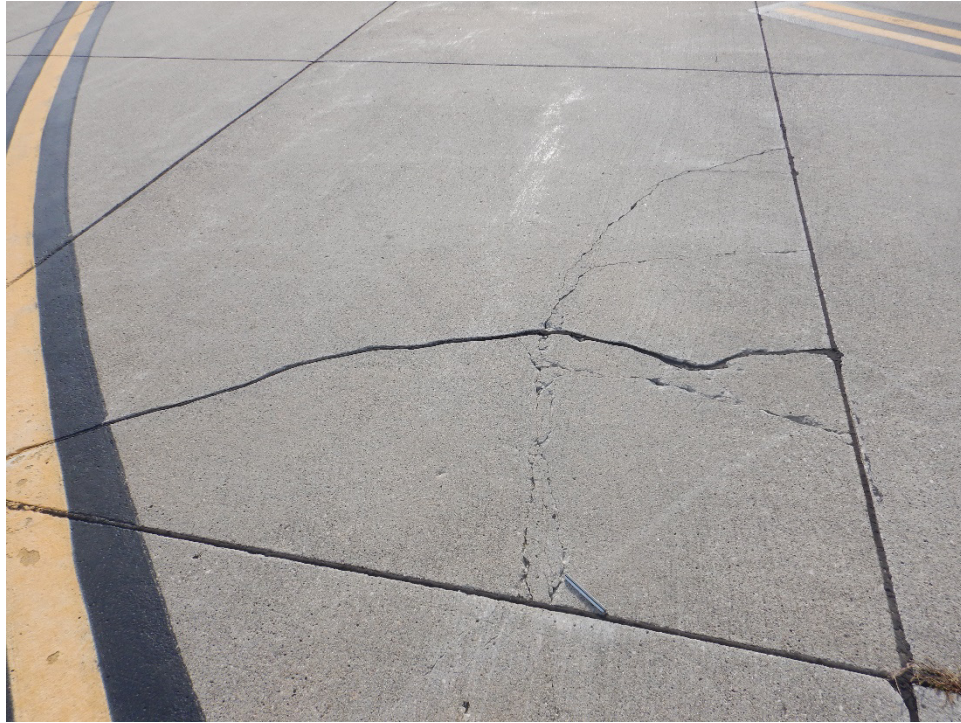
T02CA-01. Shattered Slab (Sample Unit No. 07).

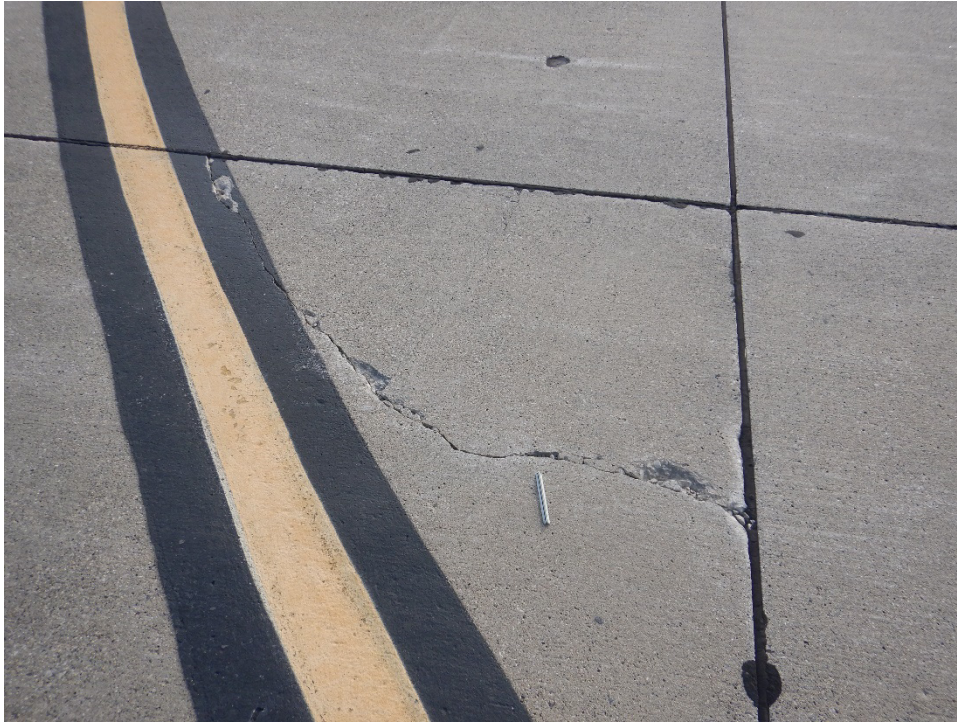
Taxiway 03 contained one section. Areas of low-severity faulting, medium-severity corner break, and high-severity corner spalling and joint seal damage were identified in Section 01.

T03CA-01. Corner Break (Sample Unit No. 08).

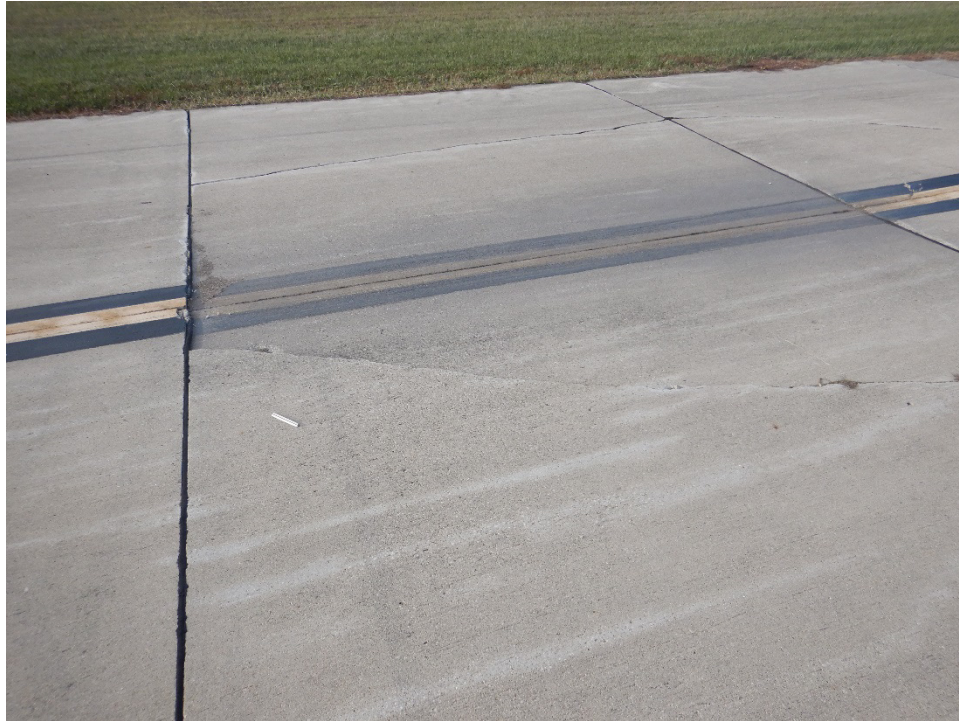
T04CA-01. Faulting (Additional Sample Unit No. 05).

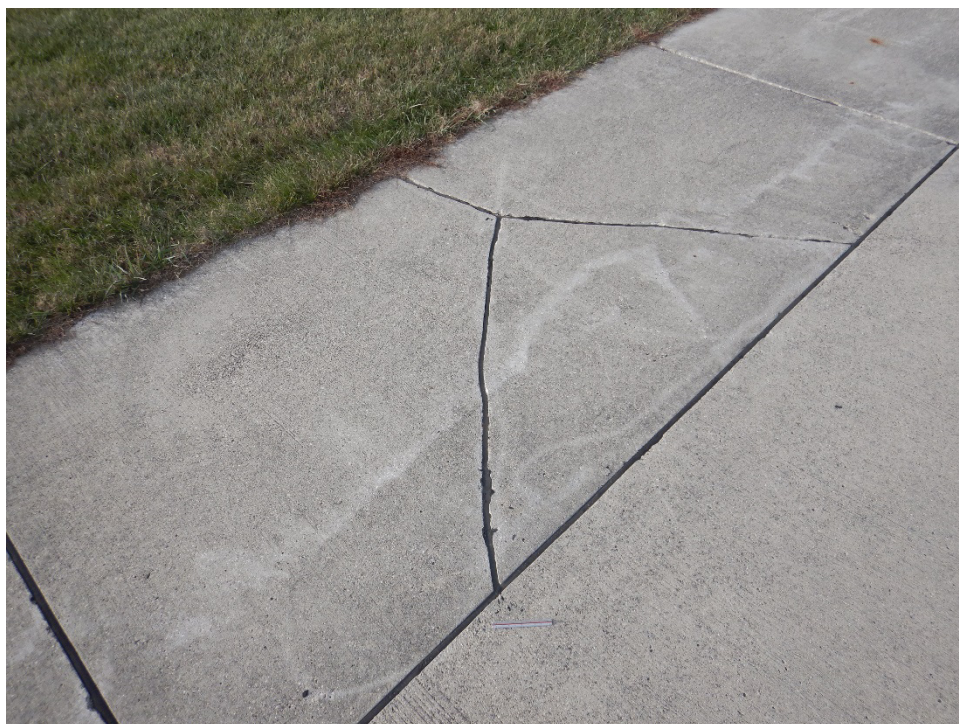
T04CA-01. LTD Cracking (Sample Unit No. 15).

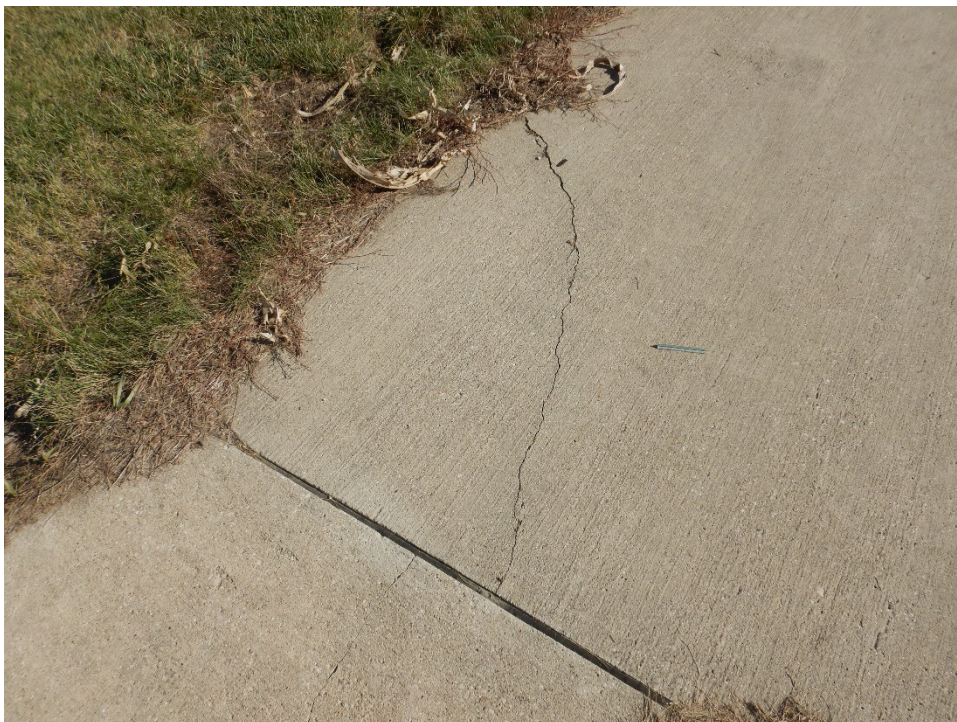
T05CA-01. Corner Break (Sample Unit No. 03).

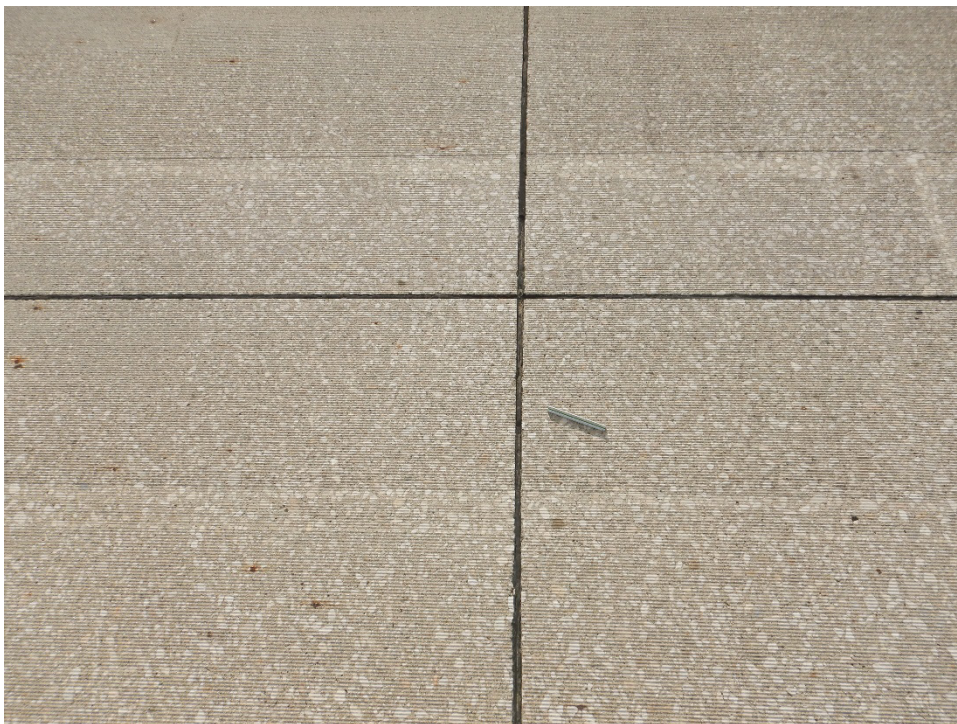
T06CA-01. Joint Seal Damage (Sample Unit No. 64).

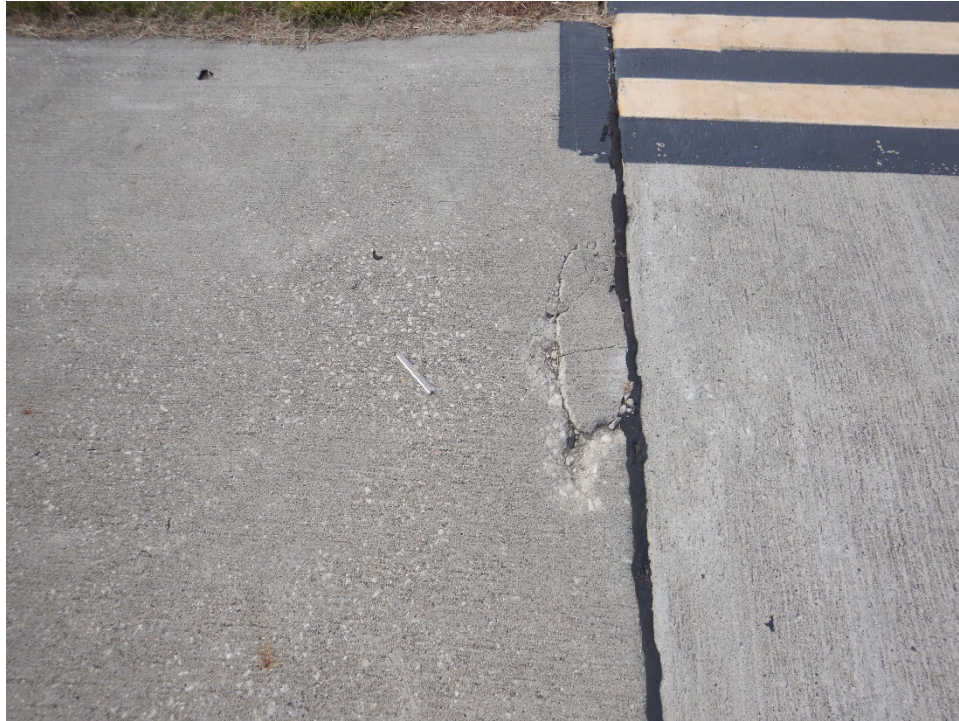
Taxiway 06 was defined by one section. Medium- and high-severity joint seal damage were identified. An atypical area of medium-severity corner break, joint spalling, and LTD cracking was observed and recorded as an additional sample unit in accordance with ASTM D5340.

T06CA-01. Joint Spalling (Additional Sample Unit No. 01).

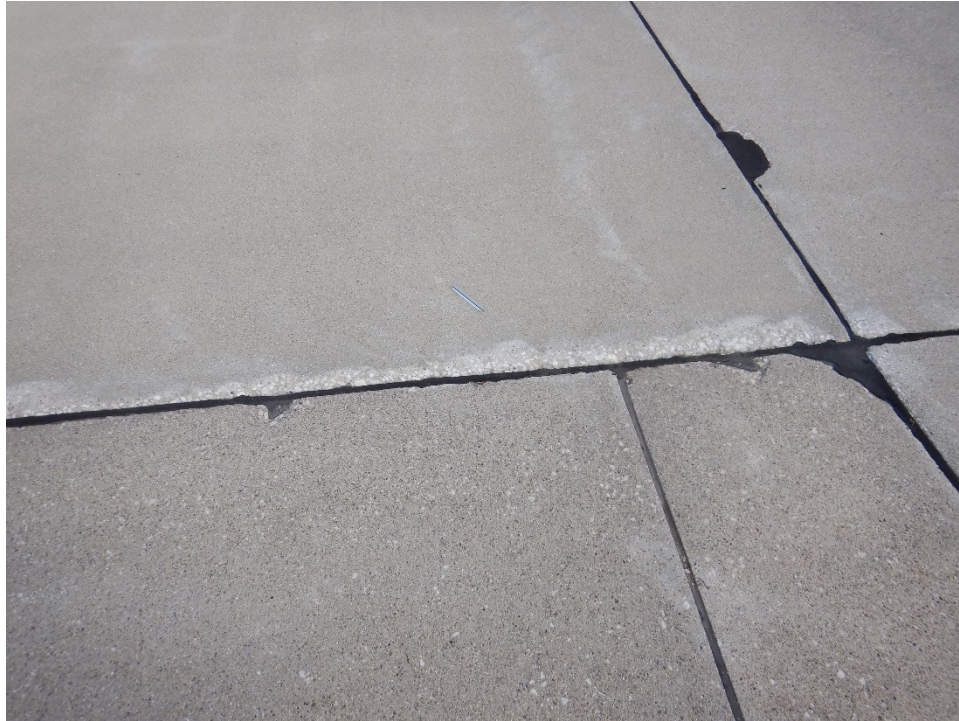
TH01CA-01. Faulting (Sample Unit No. 03).

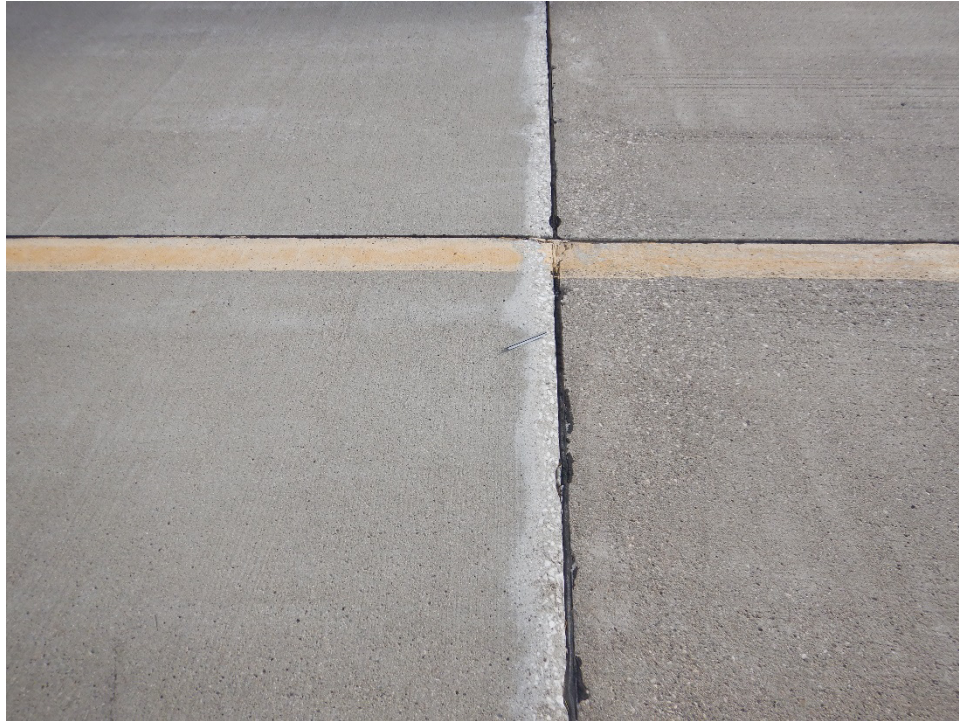
TH02CA-01. Faulting (Sample Unit No. 03).

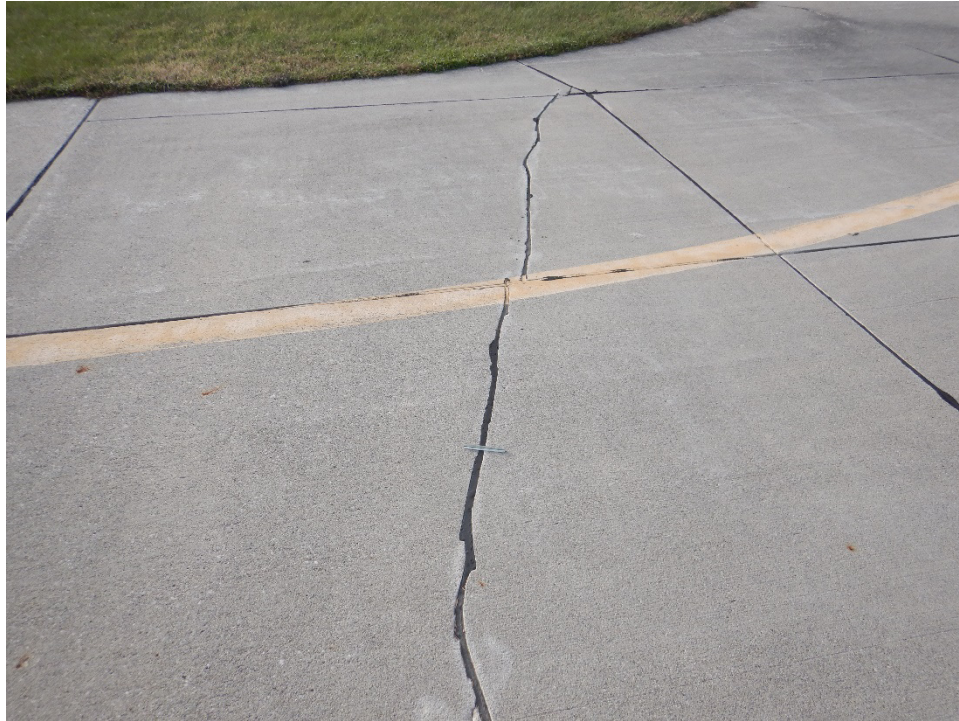
TH02CA-02. LTD Cracking (Sample Unit No. 01).

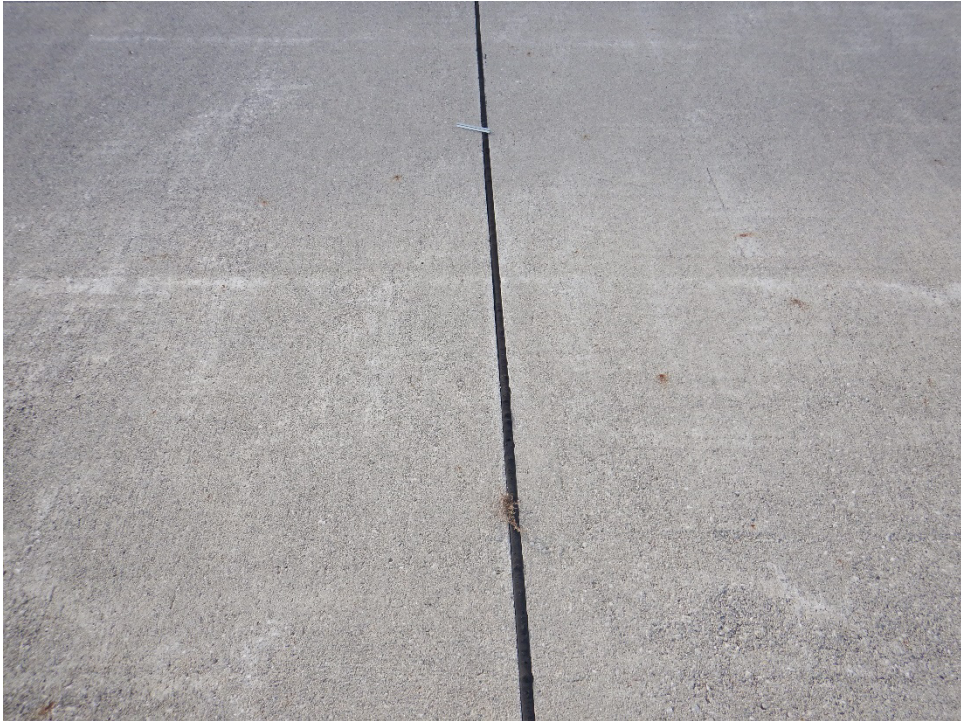
TH02CA-03. Joint Seal Damage (Sample Unit No. 01).
