# Clarion Municipal Airport

## Pavement Management Report

**JULY 2024**

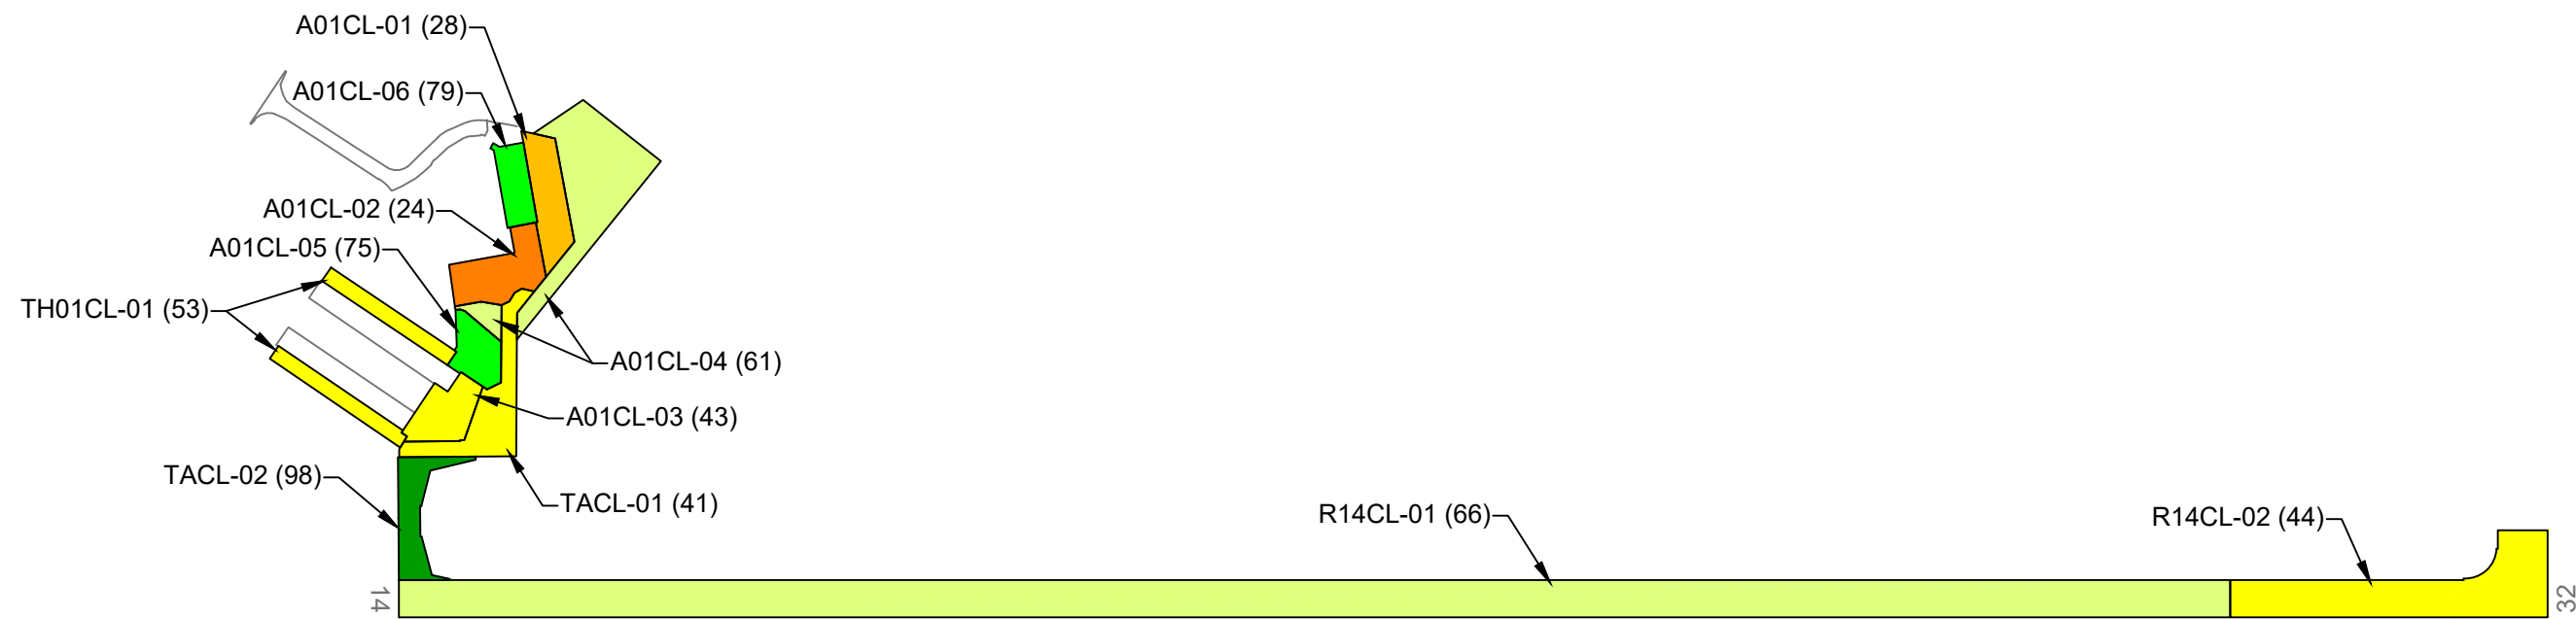
FIGURE 8. PCI MAP.

The pavements at Clarion Municipal Airport were inspected in November 2023. The 2023 area-weighted condition of Clarion Municipal Airport is 59, with conditions ranging from 24 to 98 (on a scale of 0 [failed] to 100 [excellent]). During the previous pavement inspection in 2020, the area-weighted PCI of the airport was 73.

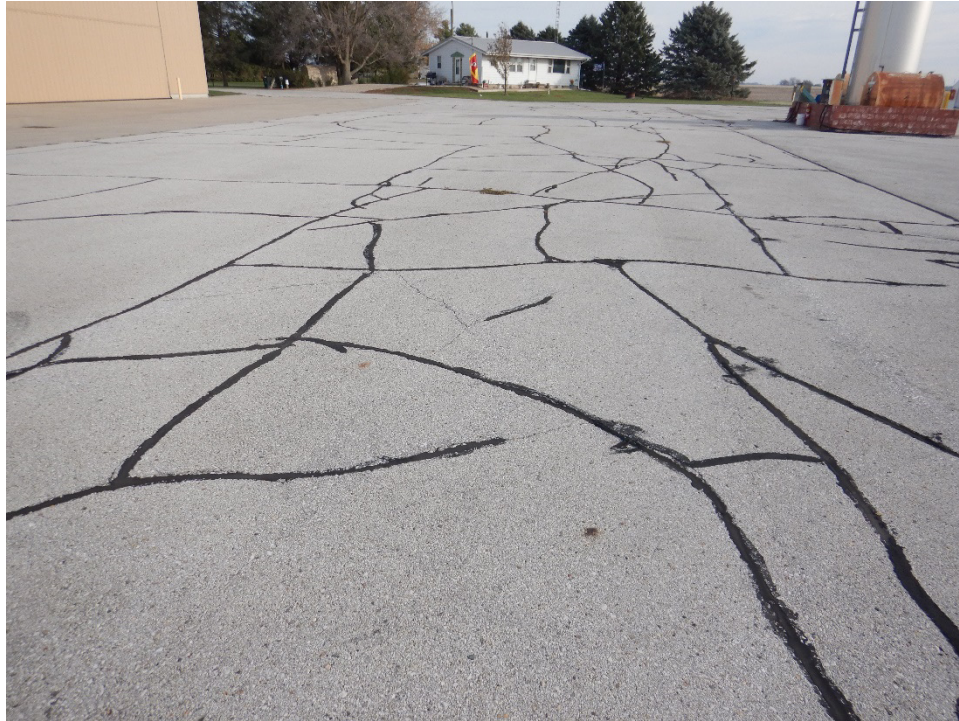
A01CL-01. Overview.

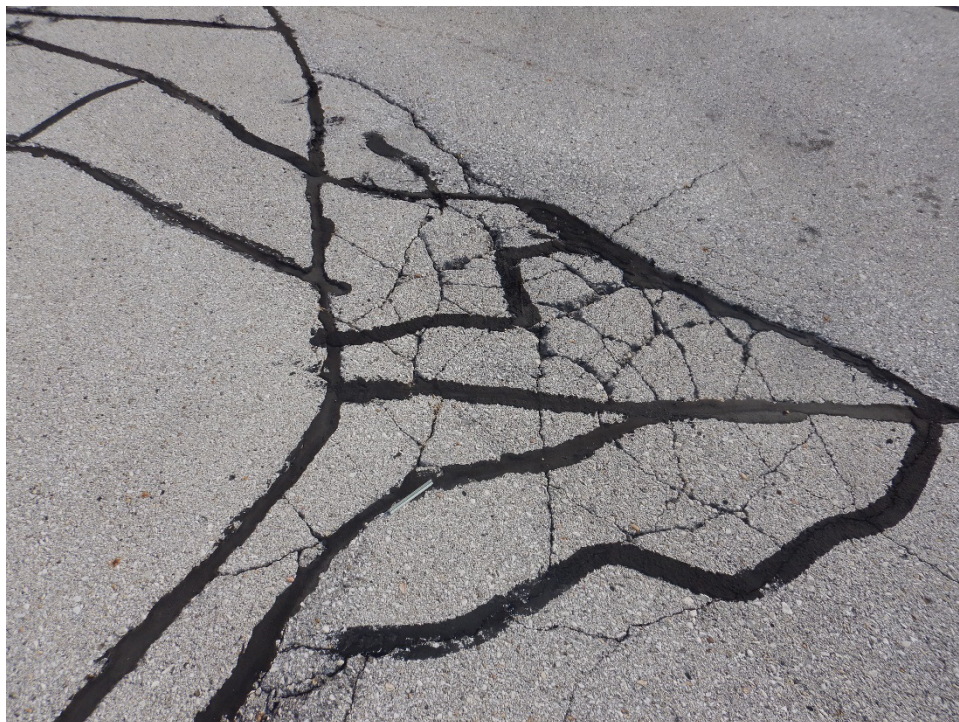
A01CL-01. Alligator Cracking (Sample Unit No. 01).

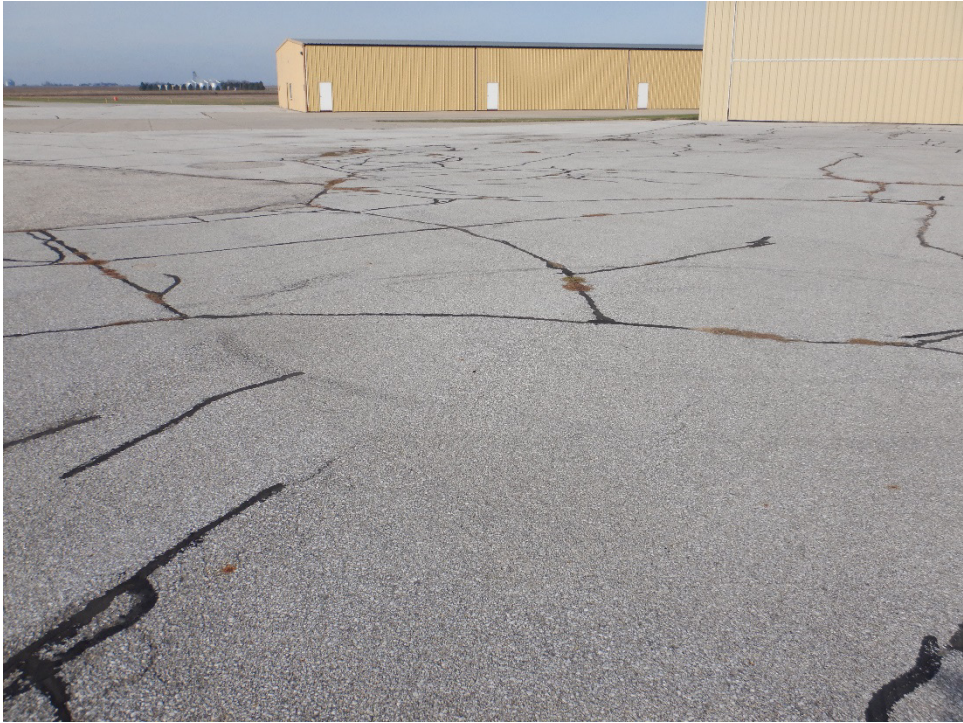
A01CL-02. Overview.

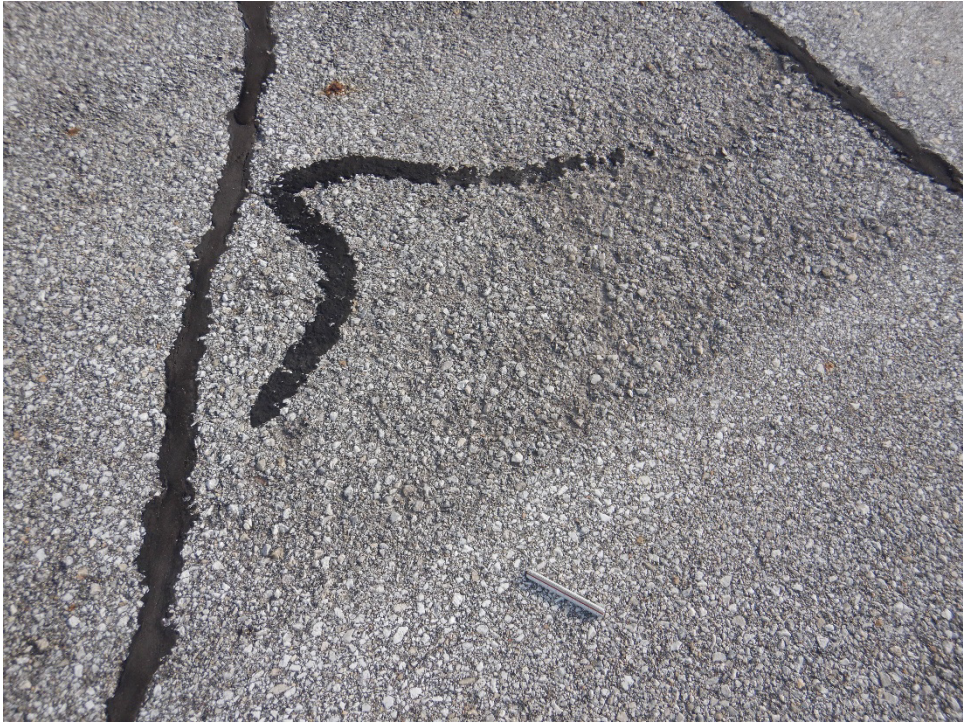
A01CL-02. Weathering (Sample Unit No. 02).

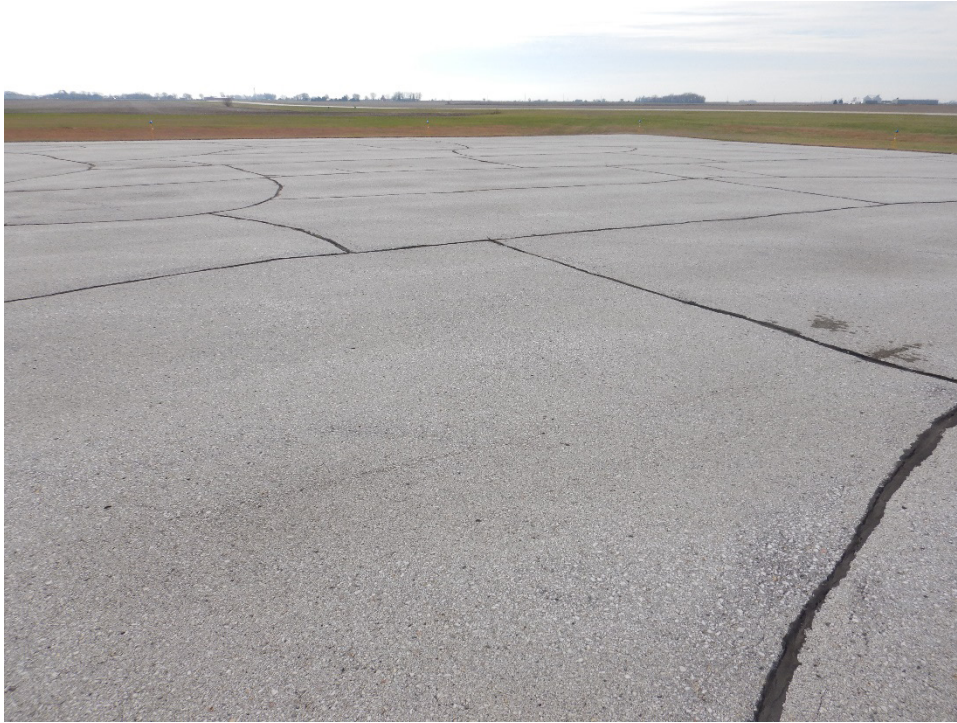
A01CL-03. Overview.

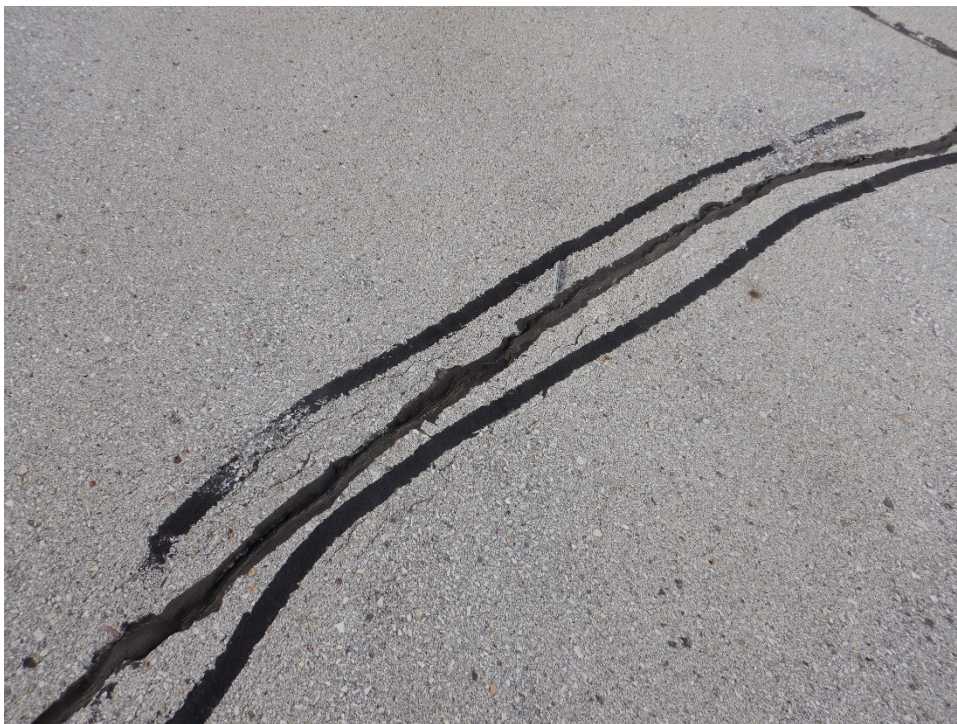
A01CL-03. L&T Cracking (Sample Unit No. 01).

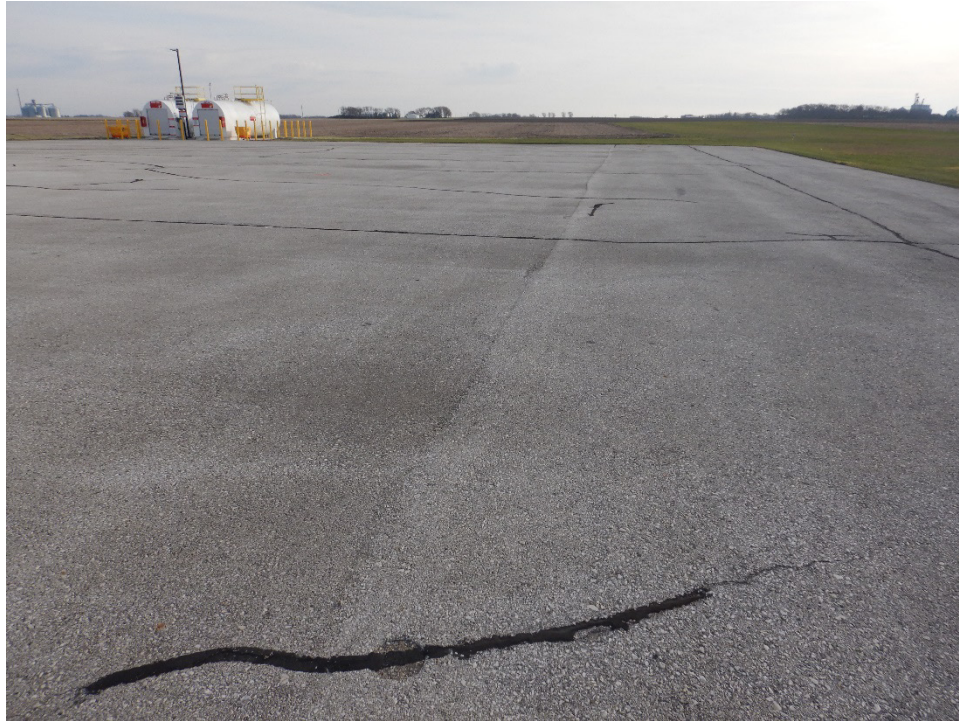
A01CL-04. Overview.

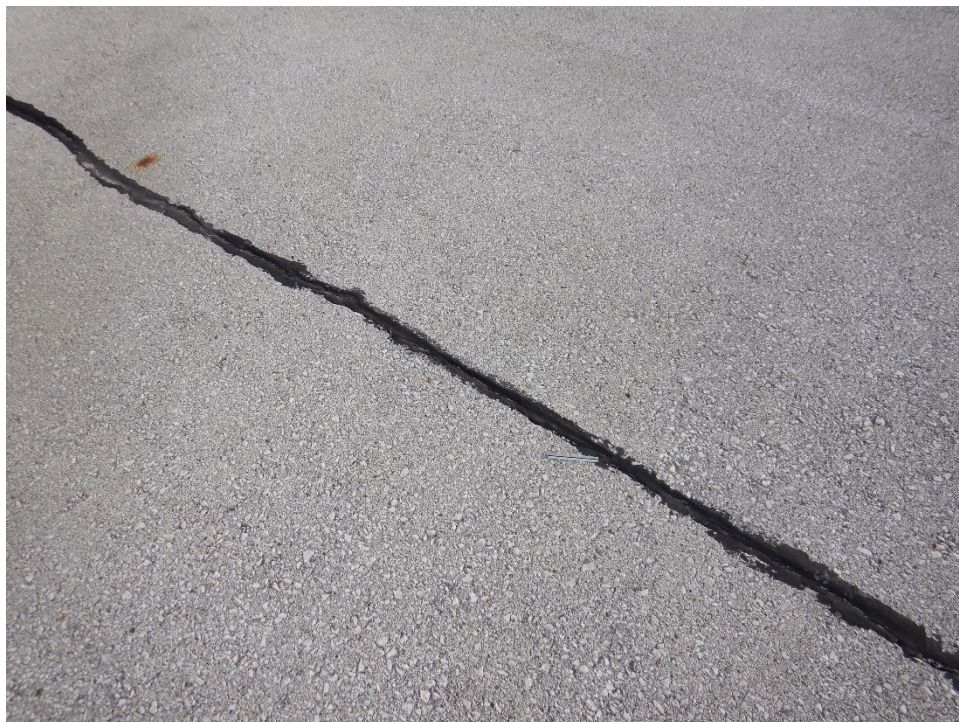
A01CL-04. L&T Cracking (Sample Unit No. 01).

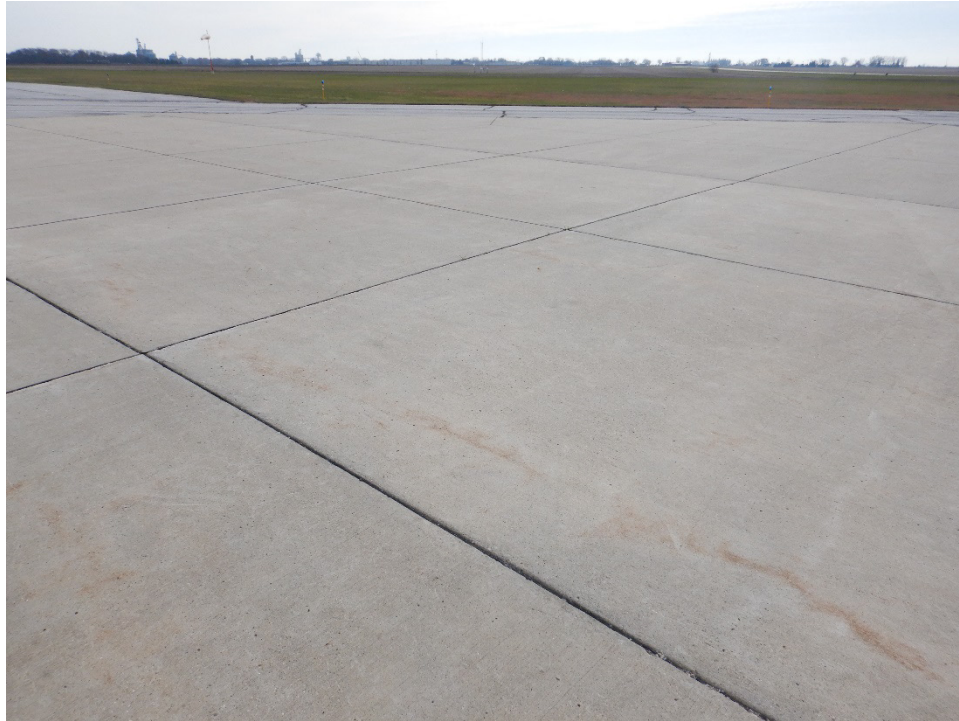
A01CL-05. Overview.

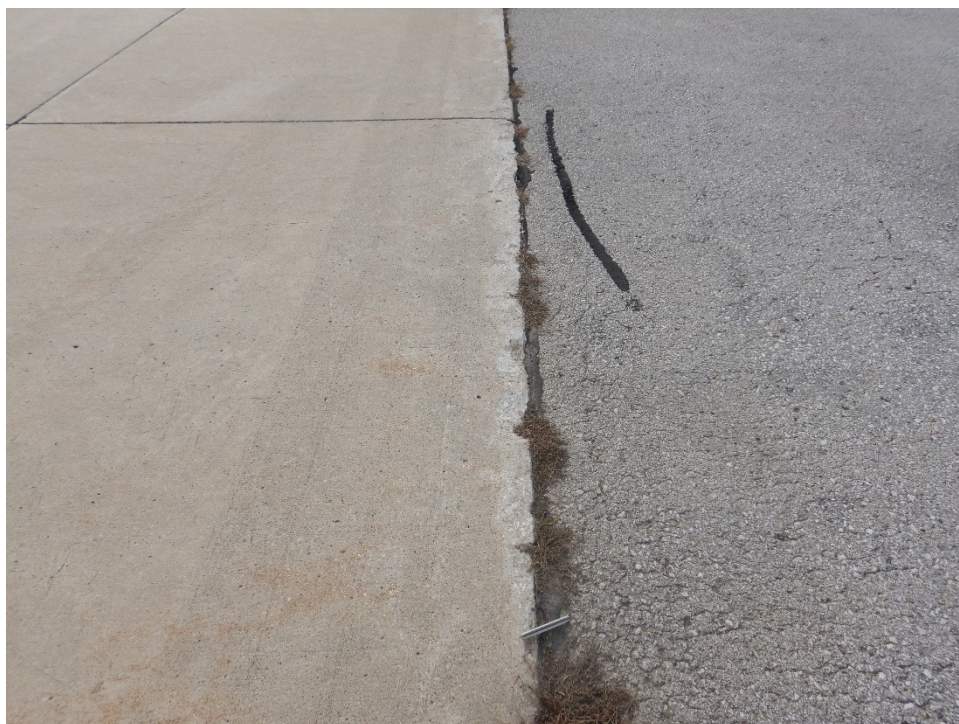
A01CL-05. Joint Spalling (Sample Unit No. 01).

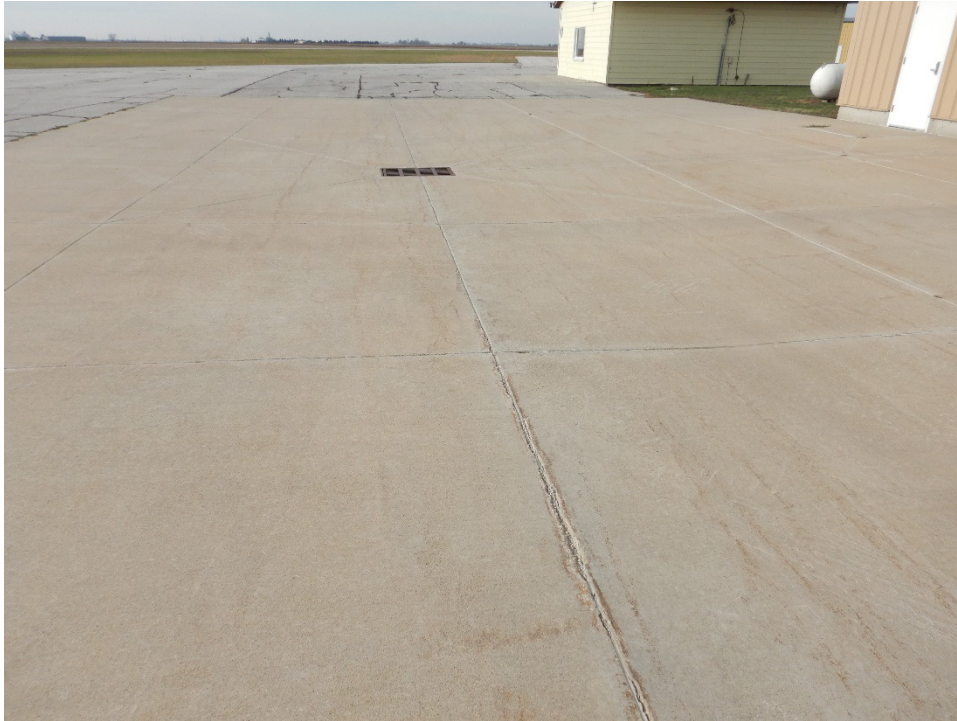
A01CL-06. Overview.

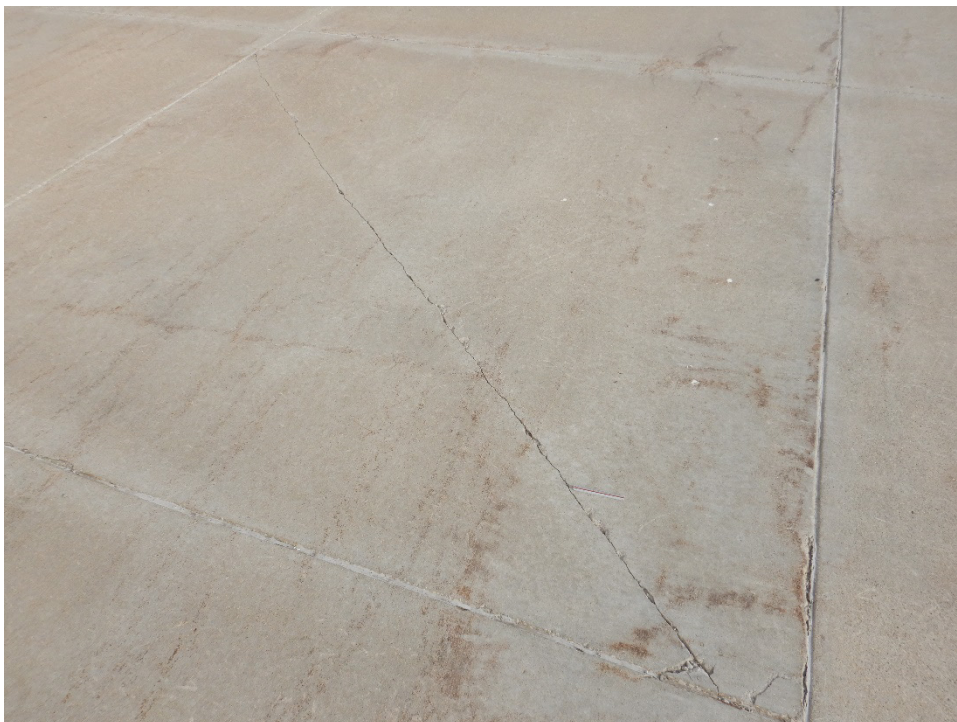
A01CL-06. LTD Cracking (Sample Unit No. 03).

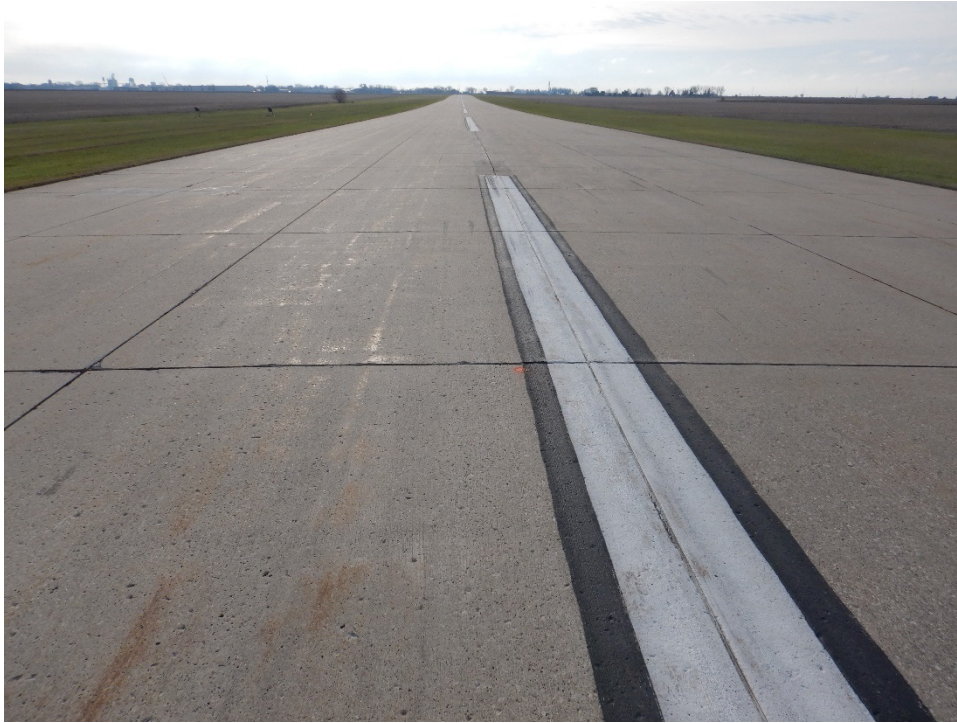
Runway 14/32 was defined by two sections. Section 01 consisted of most of Runway 14/32. Areas of low-severity joint seal damage and large patching; low- and medium-severity ASR, joint spalling, and small patching; medium-severity corner spalling; and popouts were observed in this section. Section 02 was located at the Runway 32 approach and had areas of low-severity corner break, large patching, and small patching; low- and medium-severity longitudinal, transverse, and diagonal (LTD) cracking; medium- and high-severity ASR and joint seal damage; and all severities of corner spalling and joint spalling recorded during the inspection.

R14CL-01. Overview.

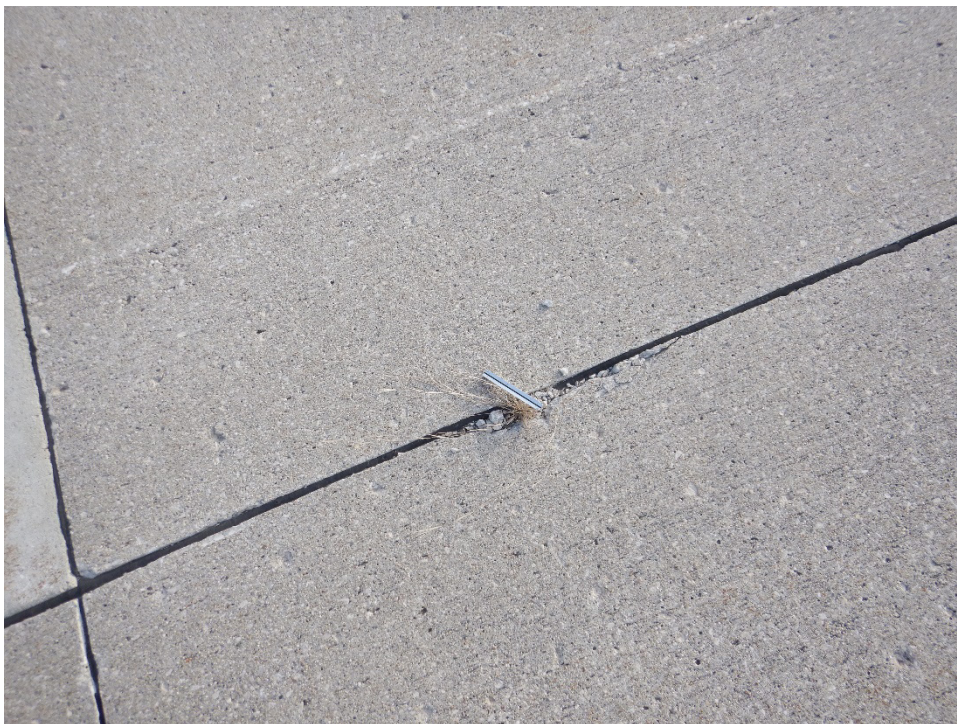
The Clarion Municipal Airport was inspected on November 7, 2023. There were eleven pavement sections defined during the inspection. Suspected alkali-silica reaction (ASR) was recorded at this airport in accordance with ASTM D5340. It should be noted that laboratory testing in the form of petrographic analysis is the only definitive way to validate the presence of ASR; however, the formation of a precipitate is evidence of a reaction consistent with this type of materials-related distress.

R14CL-01. ASR (Sample Unit No. 42).

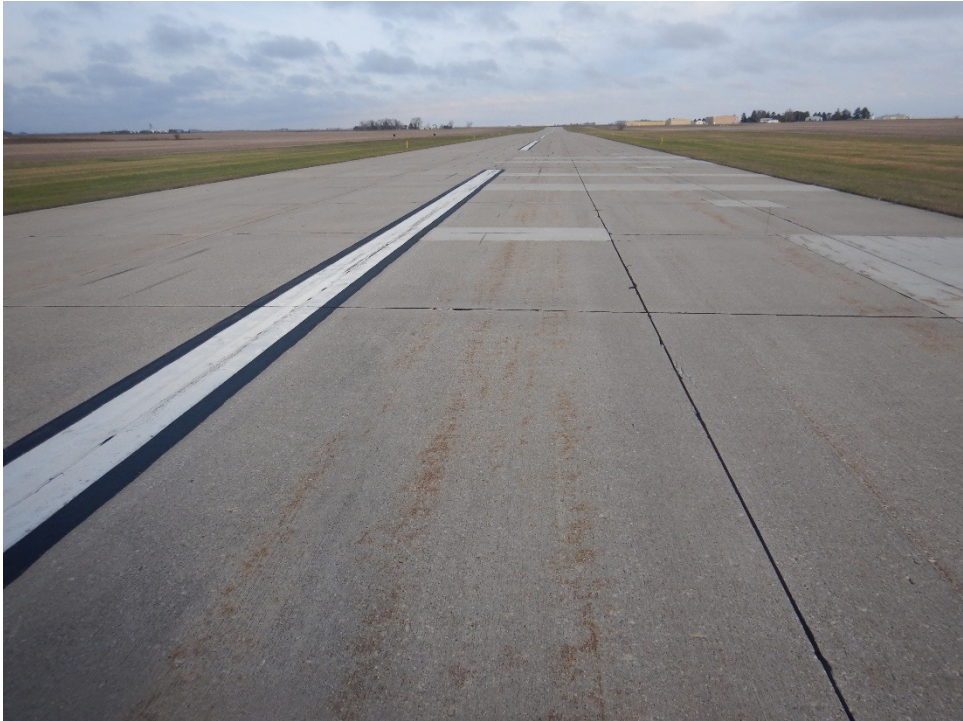
R14CL-02. Overview.

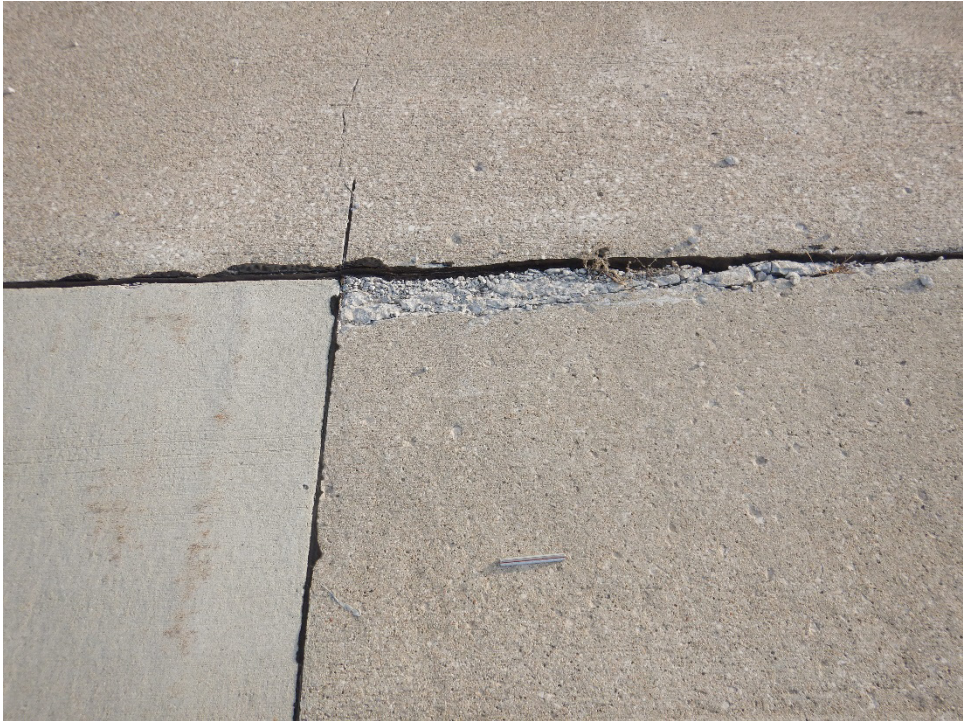
R14CL-02. ASR (Sample Unit No. 07).

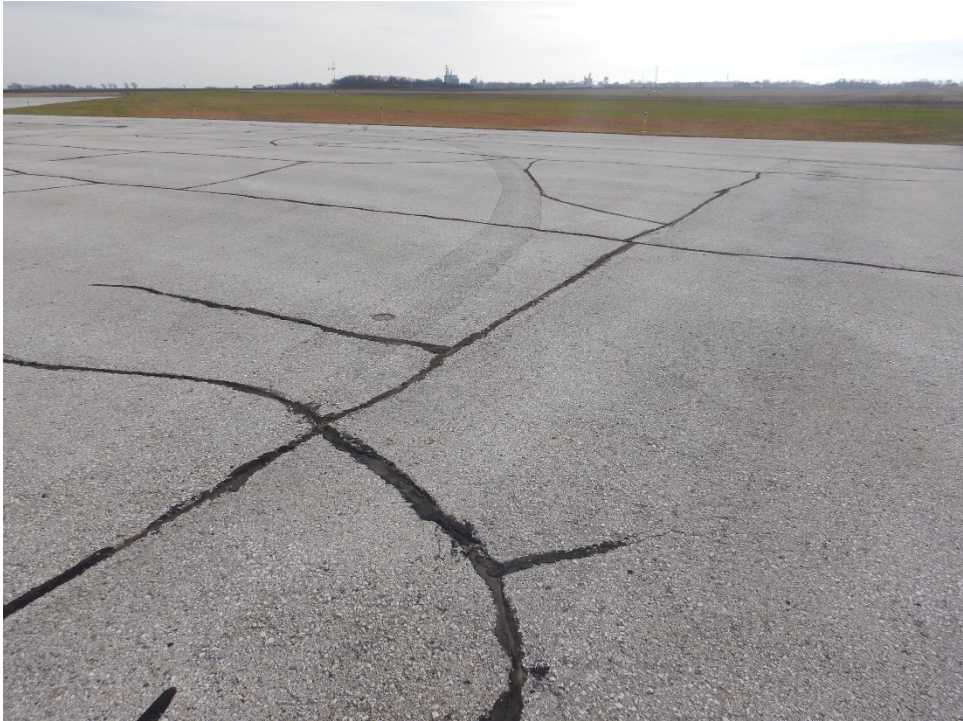
Taxiway A consisted of two sections. Section 01 contained low-severity depression and swelling, low- and medium-severity longitudinal and transverse (L&T) cracking, medium-severity alligator cracking and patching, medium- and high-severity weathering, and all severities of raveling. The low-severity L&T cracking was either sealed or unsealed, while the medium-severity L&T cracking was due to crack sealant that was no longer satisfactory. Section 02 was in excellent condition with only low- and medium-severity joint seal damage identified during the inspection.

TACL-01. Overview.

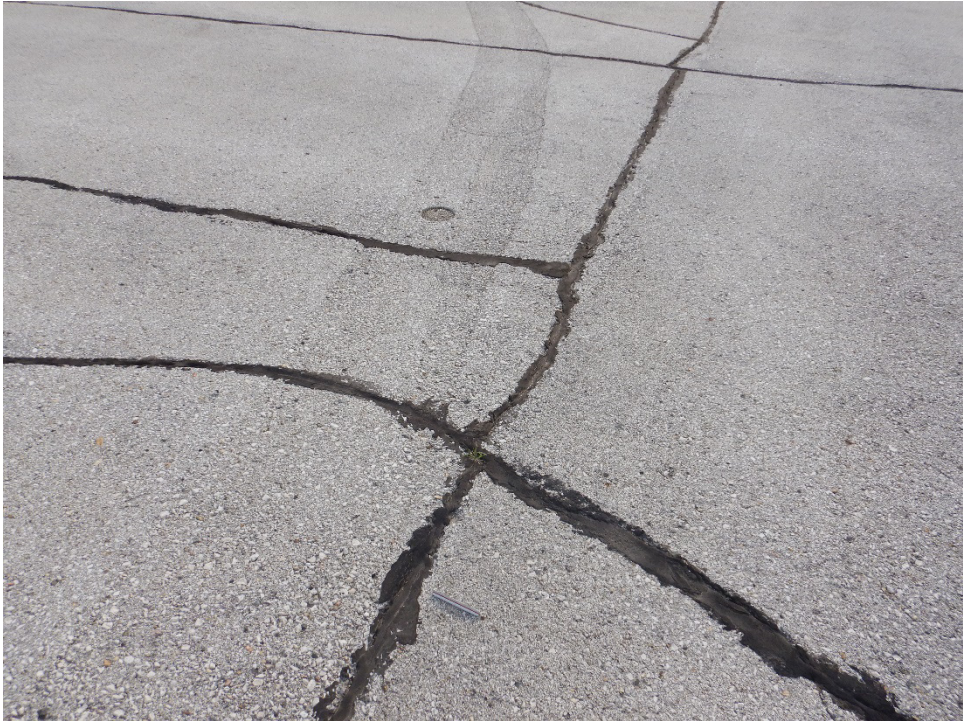
TACL-01. L&T Cracking (Sample Unit No. 01).

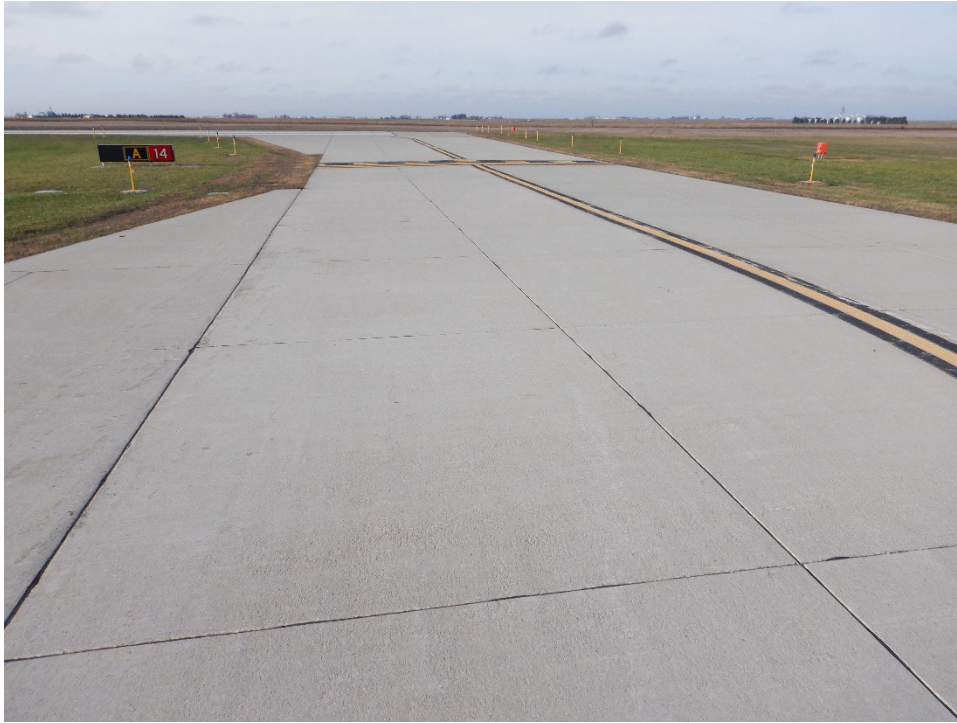
TACL-02. Overview.

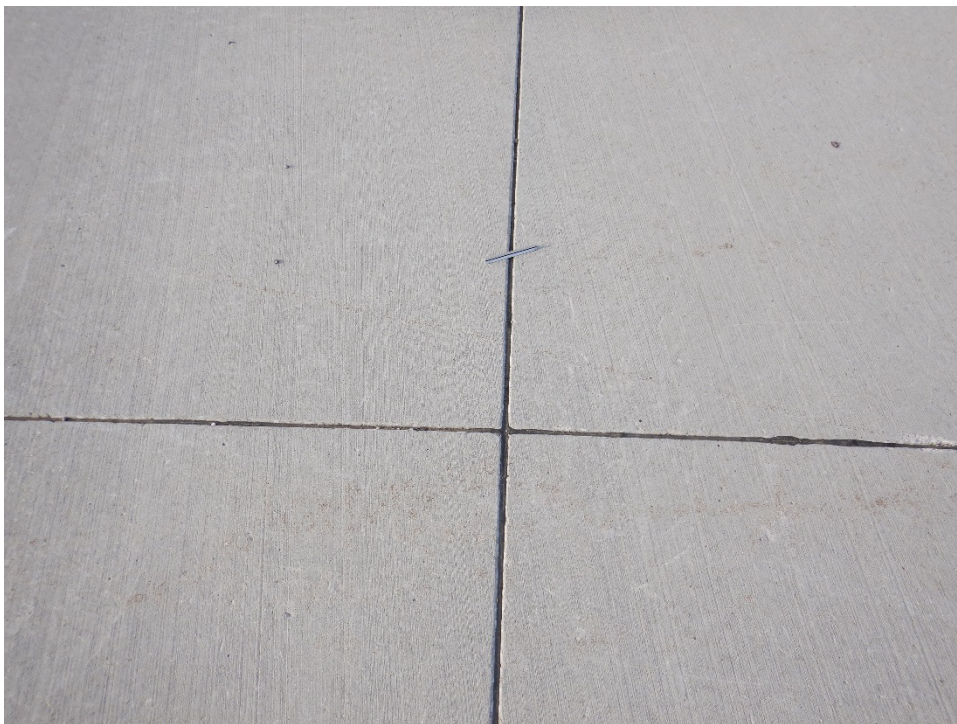
TACL-02. Joint Seal Damage (Sample Unit No. 01).

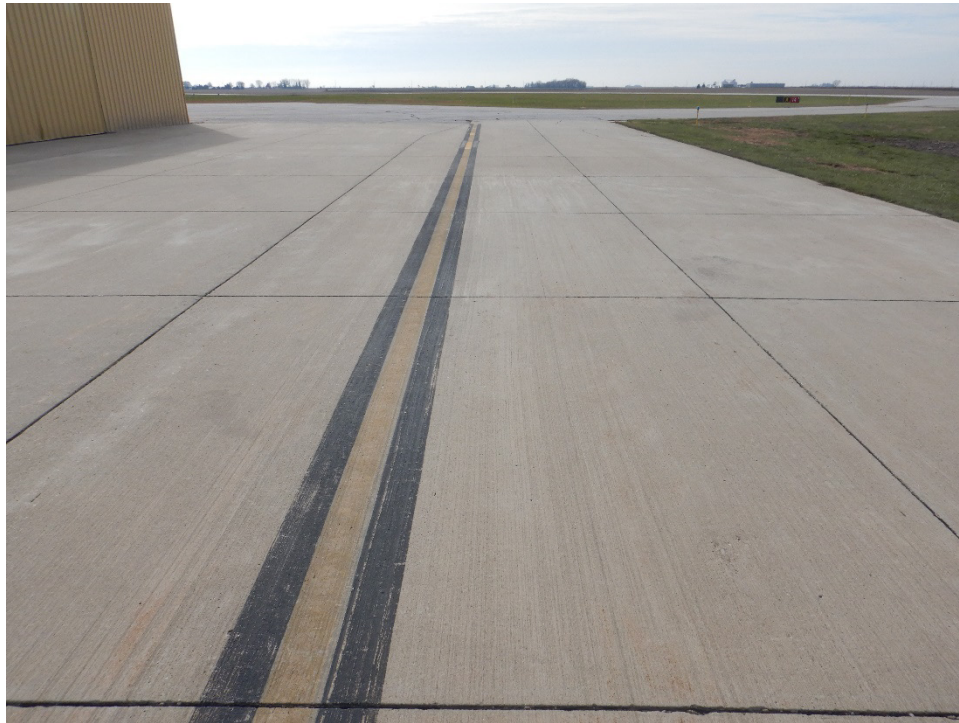
The T-hangar area contained one section. Areas of low- and medium-severity ASR, faulting, and LTD cracking; low- and high-severity corner break; high-severity joint seal damage and shattered slab; and shrinkage cracking were recorded in Section 01.

TH01CL-01. Overview.

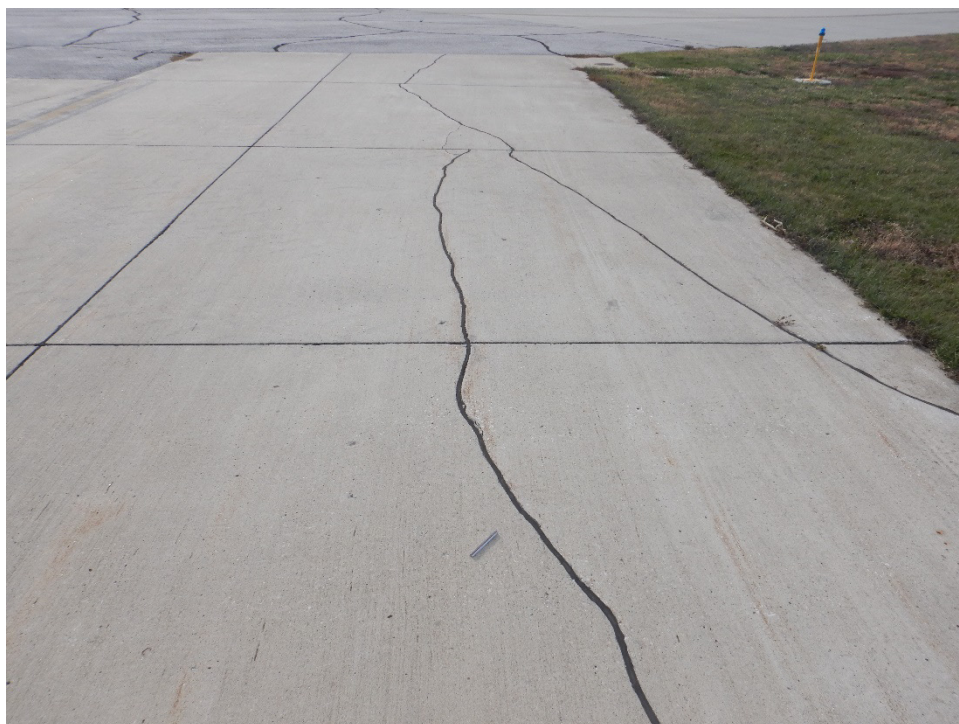
TH01CL-01. LTD Cracking (Sample Unit No. 01).
