Clinton Municipal Airport

PAVEMENT MANAGEMENT REPORT

JULY 2022

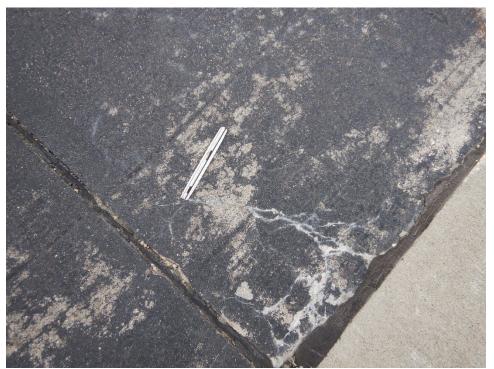
A01CN-01. ASR (Sample Unit No. 06).

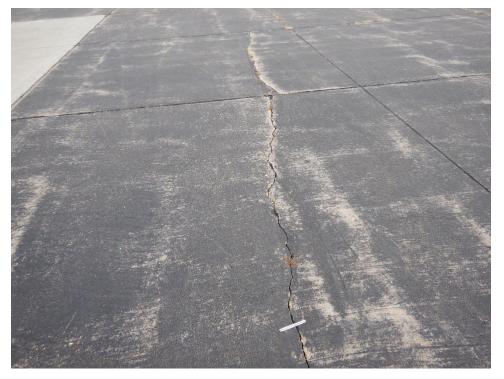
A01CN-01. LTD Cracking (Sample Unit No. 05).

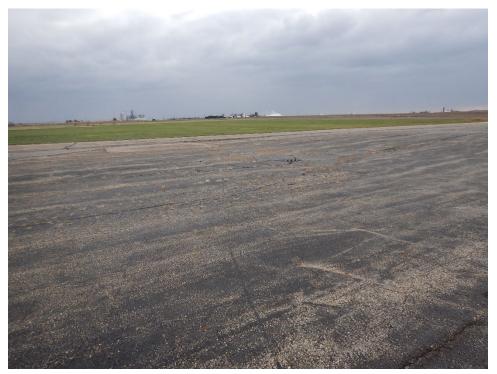
A01CN-03. Alligator Cracking (Sample Unit No. 03).

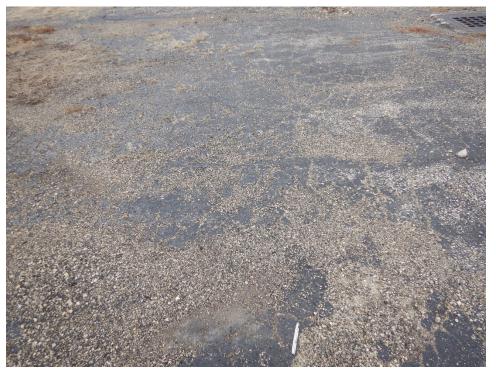
A01CN-03. Raveling (Sample Unit No. 03).

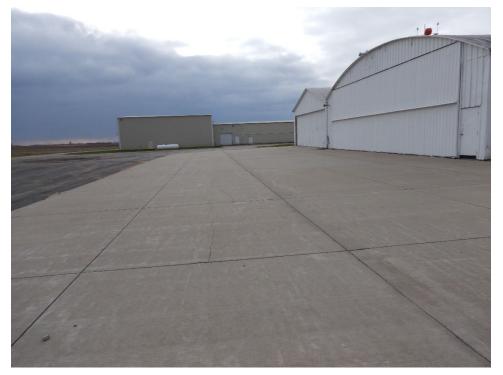
A01CN-04. LTD Cracking (Sample Unit No. 03).

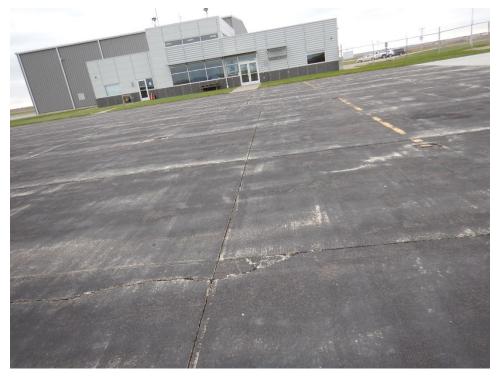
A02CN-01. ASR (Sample Unit No. 05).

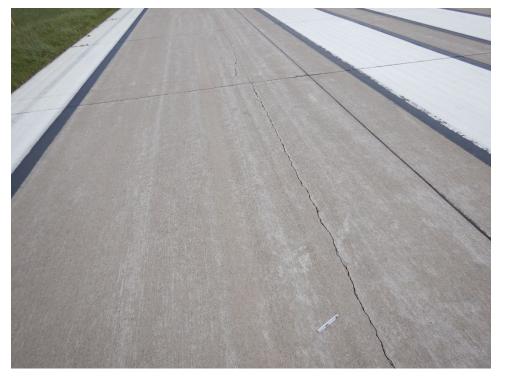
R03CN-01. LTD Cracking (Sample Unit No. 44).

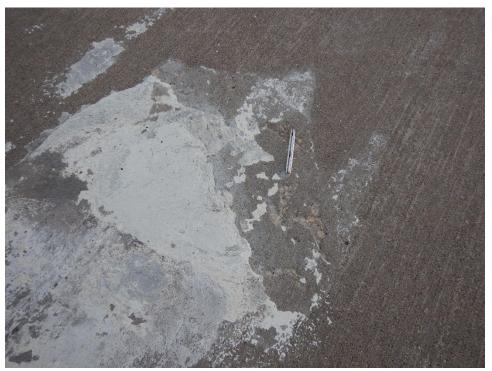
R03CN-01. Scaling (Additional Sample Unit No. 110).

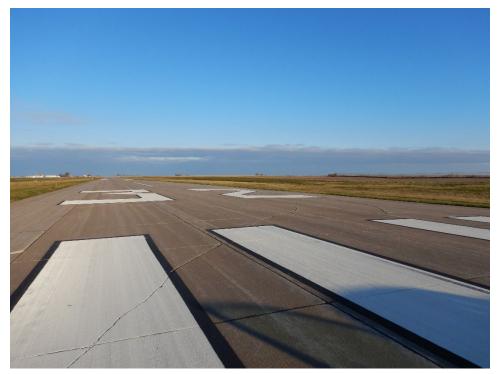
R14CN-01. Faulting (Sample Unit No. 88).

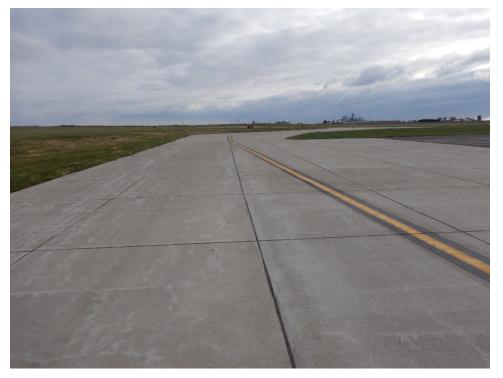
T01CN-03. LTD Cracking (Sample Unit No. 05).

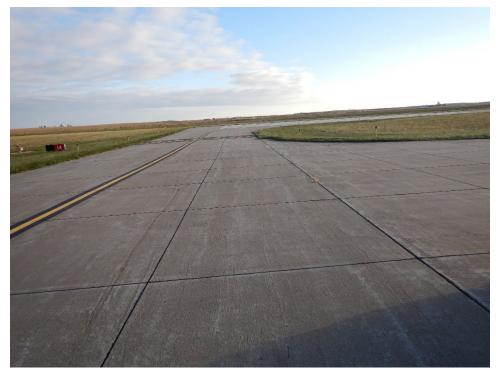
T02CN-01. Joint Seal Damage (Sample Unit No. 01).

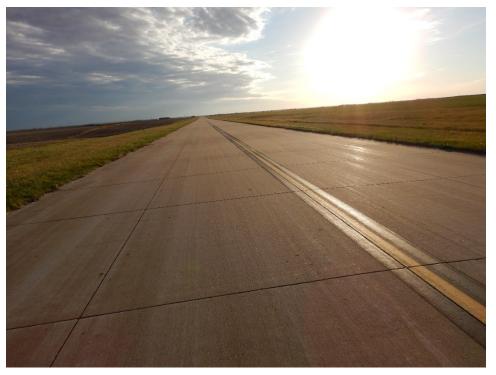
T03CN-03. LTD Cracking (Additional Sample Unit No. 42).

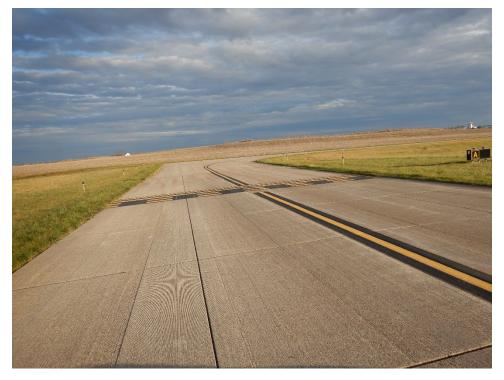
T03CN-04. Corner Break (Sample Unit No. 05).

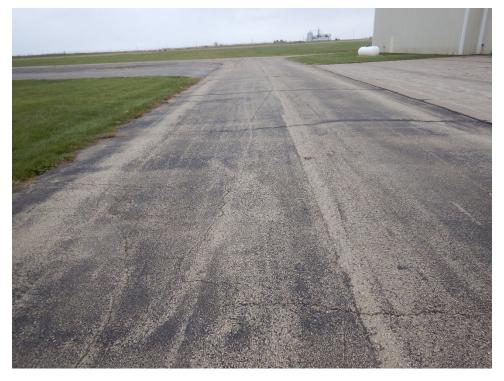
T04CN-01. Alligator Cracking (Sample Unit No. 05).

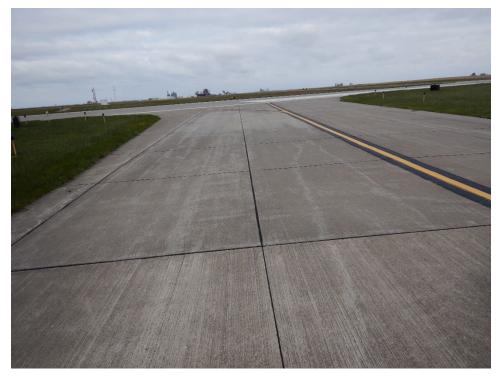
T06CN-01. Joint Spalling (Sample Unit No. 04).

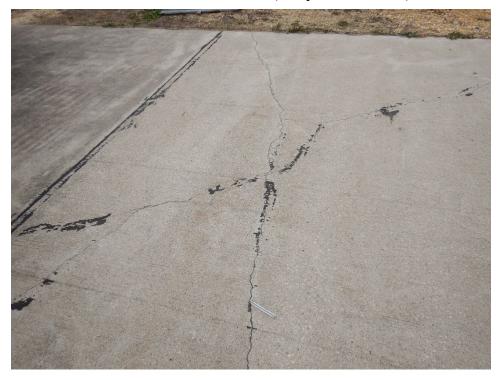
TH01CN-02. Shattered Slab (Sample Unit No. 01).

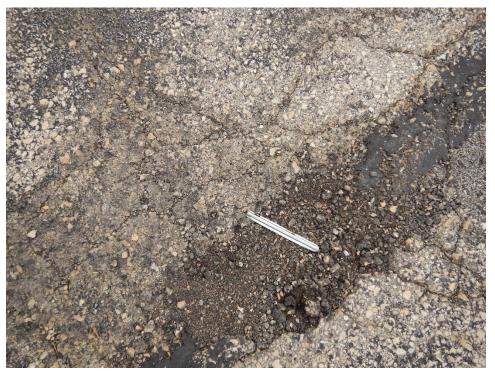
TH01CN-03. Raveling (Sample Unit No. 02).
