# Cresco-Ellen Church Field Airport

**PAVEMENT MANAGEMENT REPORT**

**AUGUST 2019**

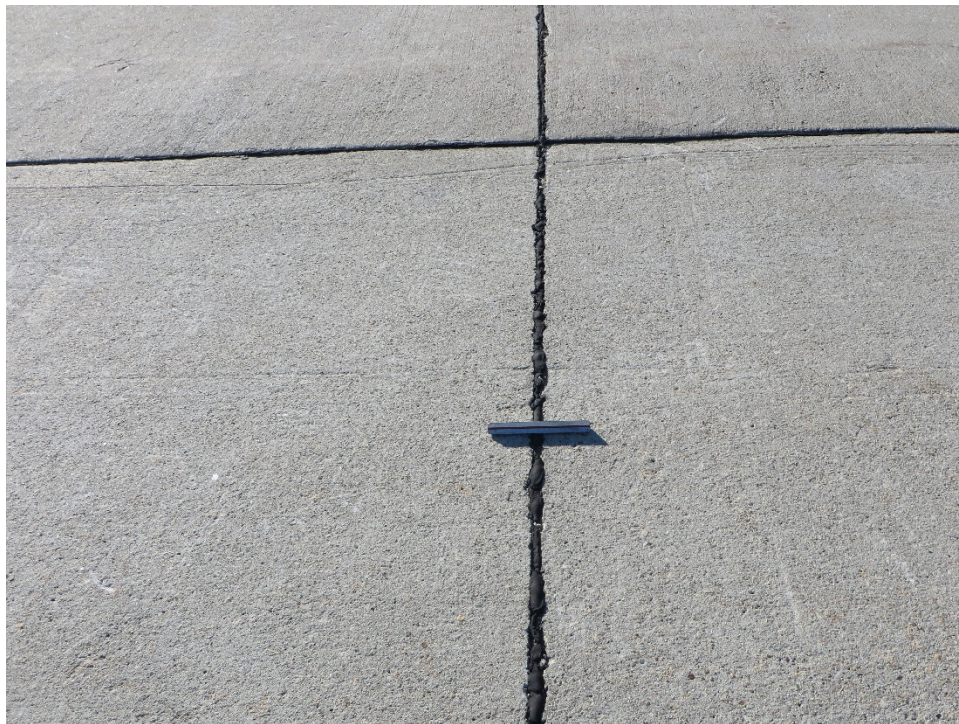
Apron 01 was defined by three sections. Section 01 had medium-severity joint seal damage recorded throughout. Section 02 was in poor condition with low- and medium-severity corner break, corner spalling, and LTD cracking and medium-severity joint seal damage and shattered slab observed. Section 03 was also in poor condition with low-severity corner break and corner spalling, medium-severity joint seal damage, and low- and medium-severity LTD cracking and shattered slab identified.

A01CR-01. Joint Seal Damage (Sample Unit No. 01).

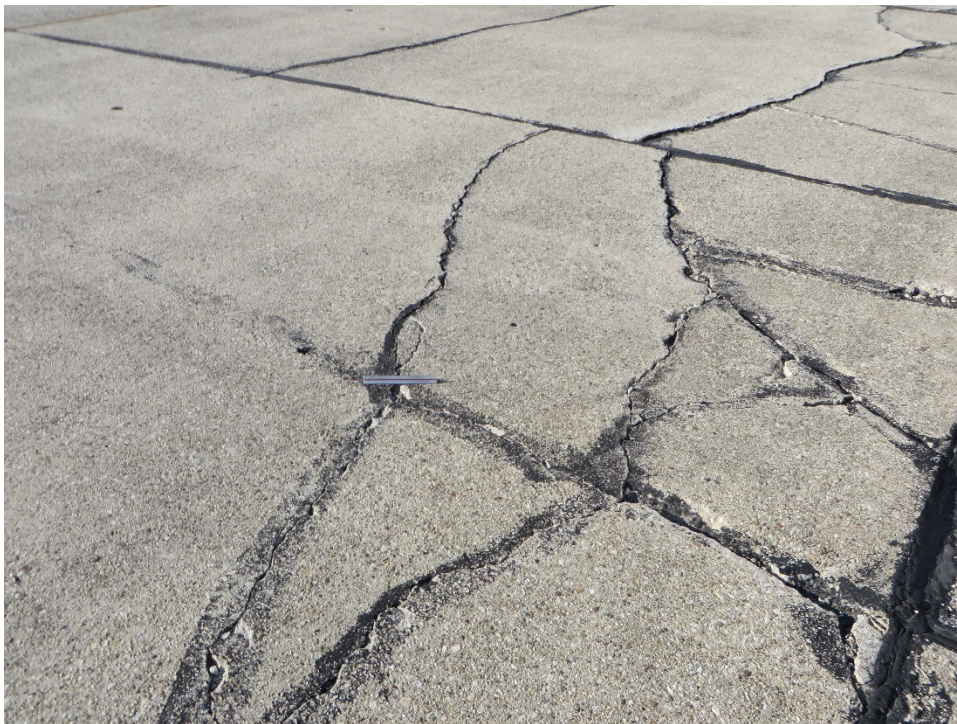
A01CR-02. Shattered Slab (Sample Unit No. 01).

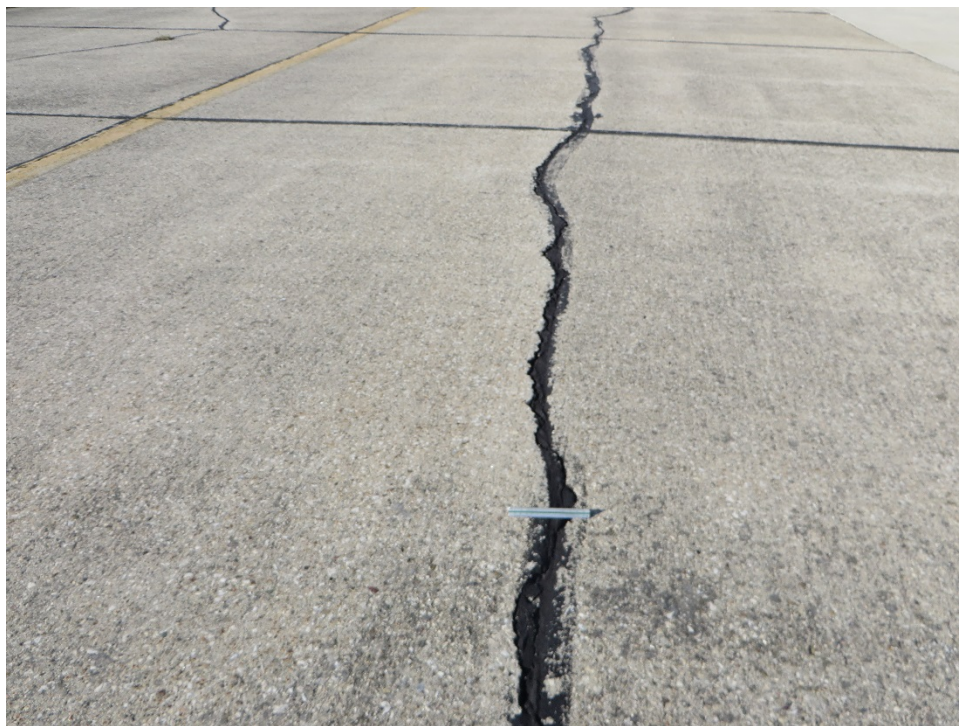
A01CR-03. LTD Cracking (Sample Unit No. 01).

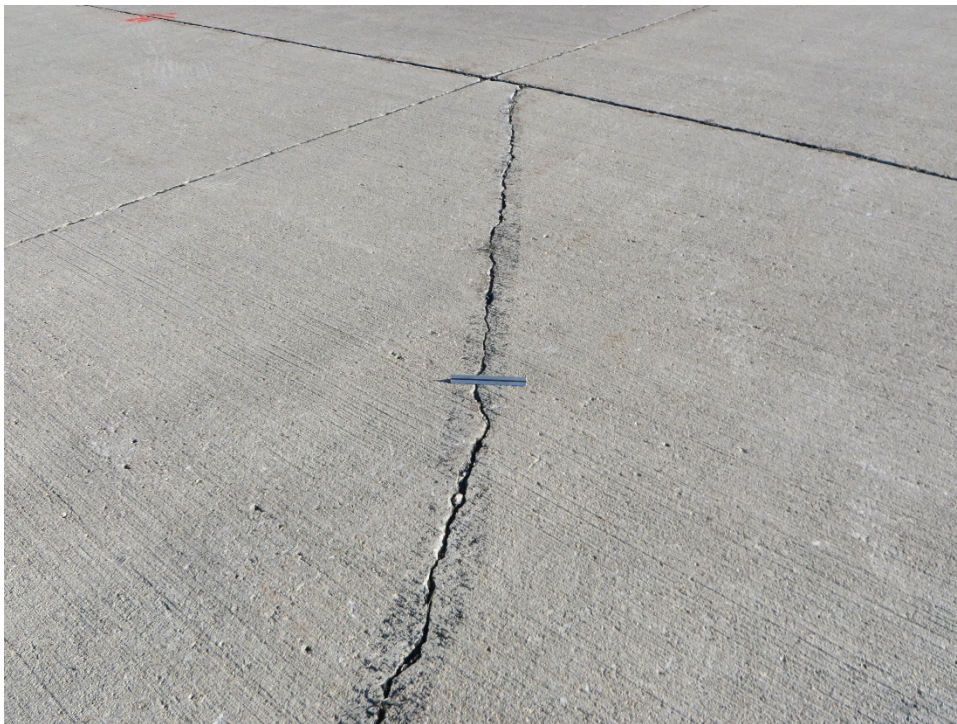
Apron 02 consisted of two sections. Medium-severity joint seal damage was recorded throughout Section 01 along with small amounts of low- and medium-severity joint spalling, medium-severity LTD cracking, and low-severity small patching. Section 02 had high-severity joint seal damage observed along with low-severity corner break and faulting and low- and medium-severity joint spalling and LTD cracking.

A02CR-01. LTD Cracking (Sample Unit No. 02).

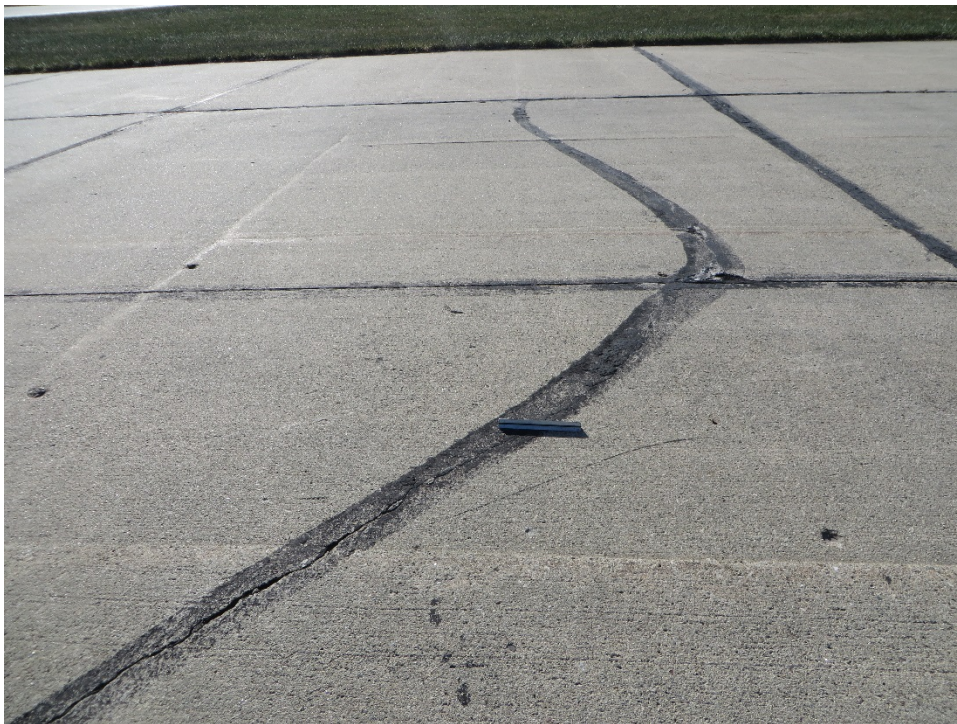
A02CR-02. LTD Cracking (Sample Unit No. 01).

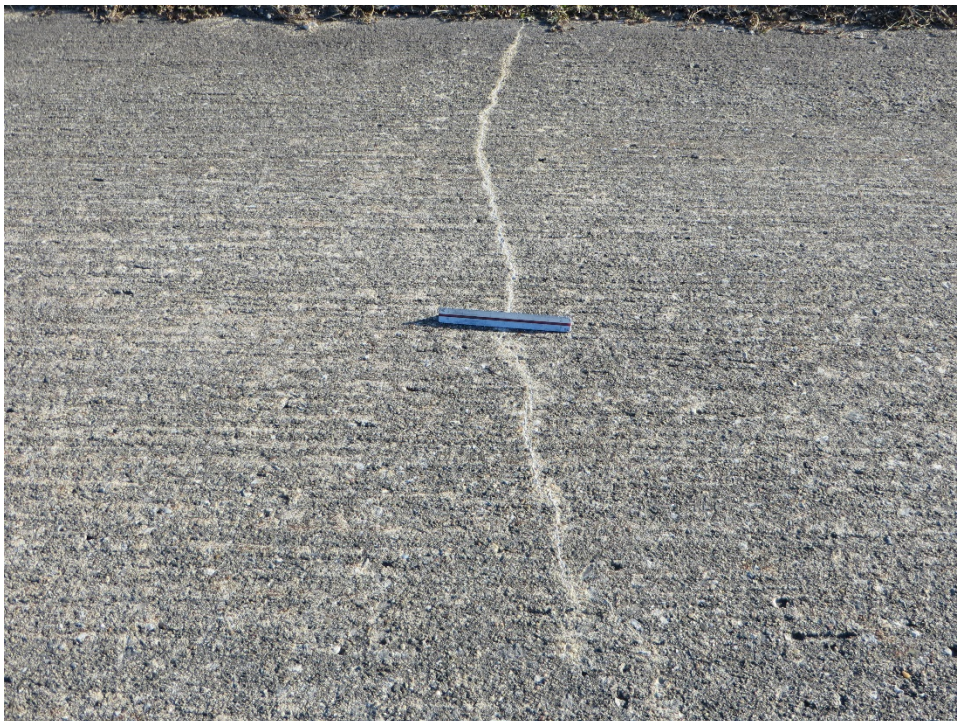
Runway 15/33 was defined by two sections. Section 01 comprised the majority of Runway 15/33. Low- and medium-severity ASR, corner break, large patching, faulting, and longitudinal, transverse, and diagonal (LTD) cracking; all severities of corner spalling, joint spalling, and small patching; and medium- and high-severity joint seal damage were recorded throughout the section. Section 02, located at the Runway 33 approach, had medium-severity joint seal damage and low-severity alkali-silica reaction (ASR), joint spalling, LTD cracking, and small patching observed during the inspection. The suspected ASR was recorded in accordance with ASTM D5340-12. Laboratory testing and analysis is the only definitive way to validate the presence of ASR.

R15CR-01. ASR (Sample Unit No. 32).

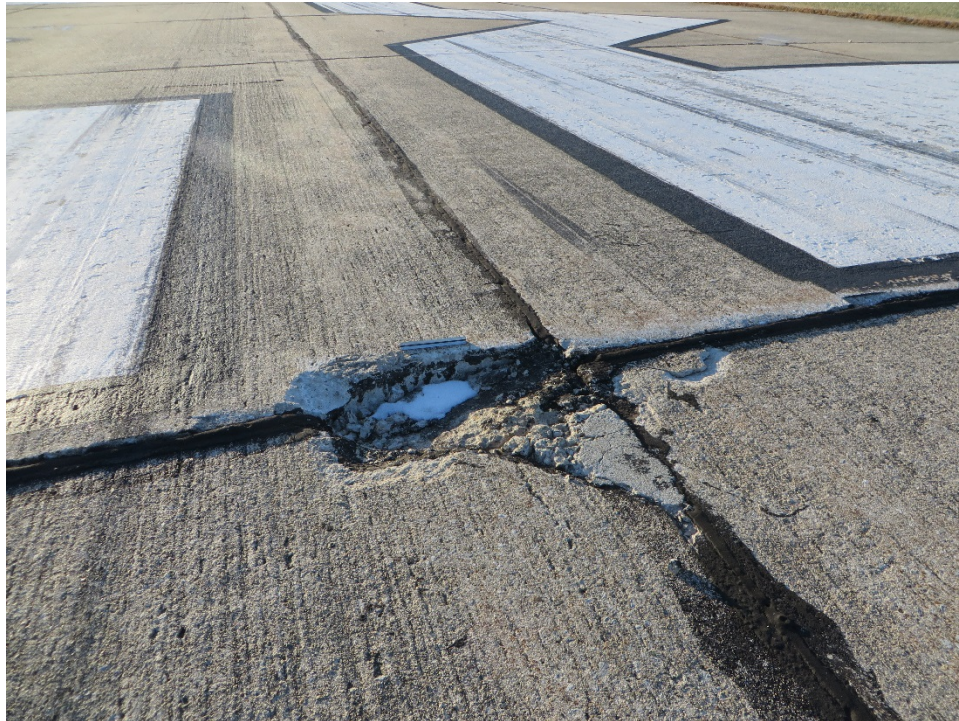
R15CR-01. Corner Spalling (Sample Unit No. 04).

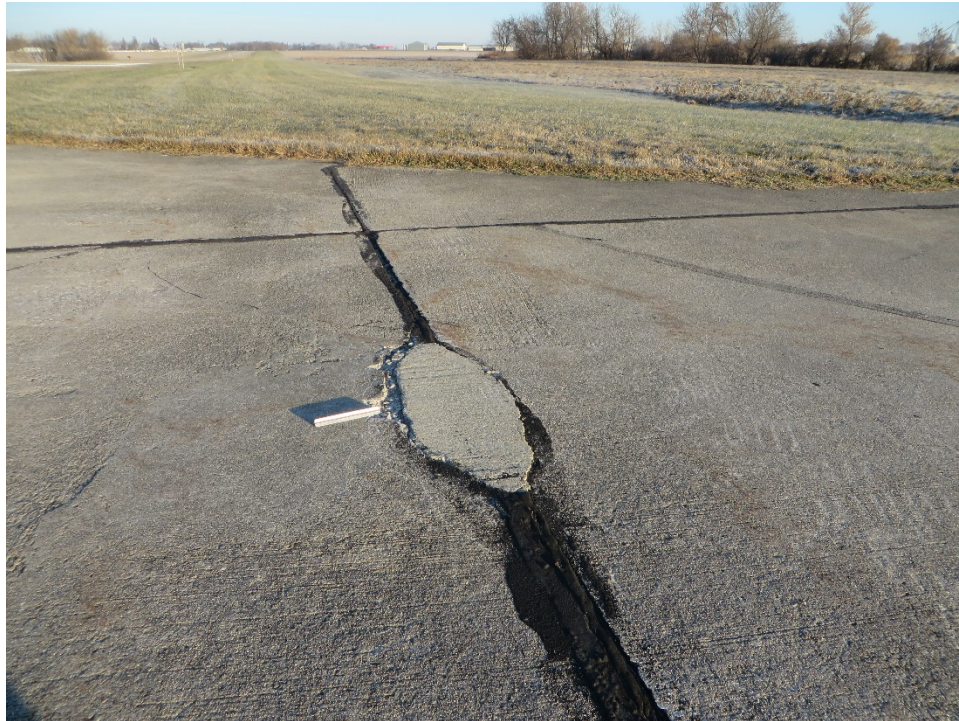
R15CR-02. ASR (Sample Unit No. 01).

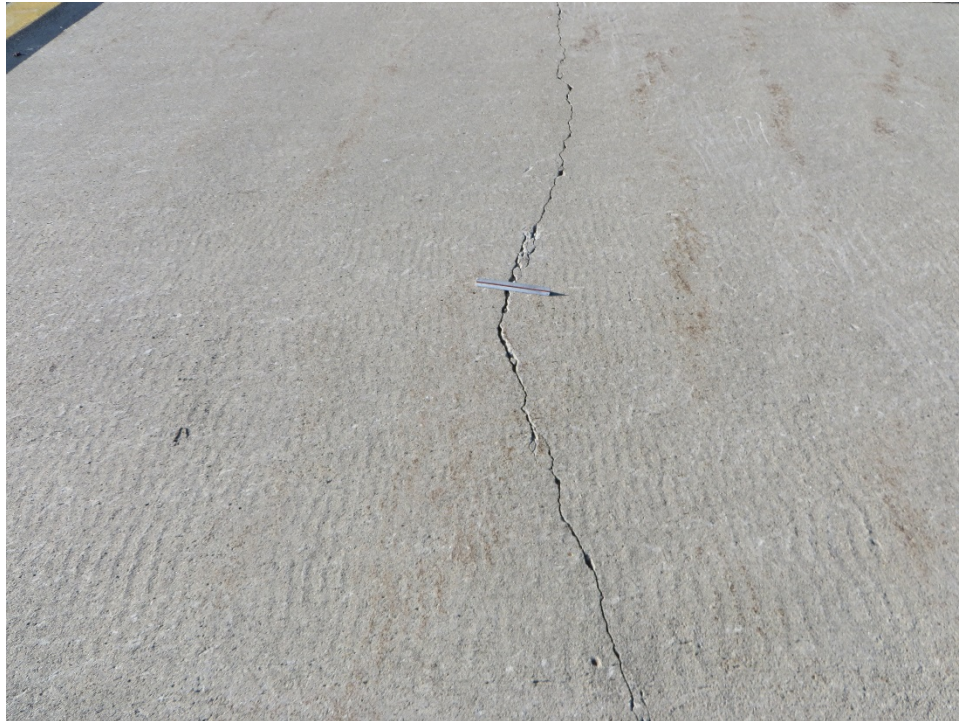
Taxiway 01 consisted of one section with medium-severity joint seal damage and low- and medium-severity LTD cracking.

T01CR-01. LTD Cracking (Sample Unit No. 01).

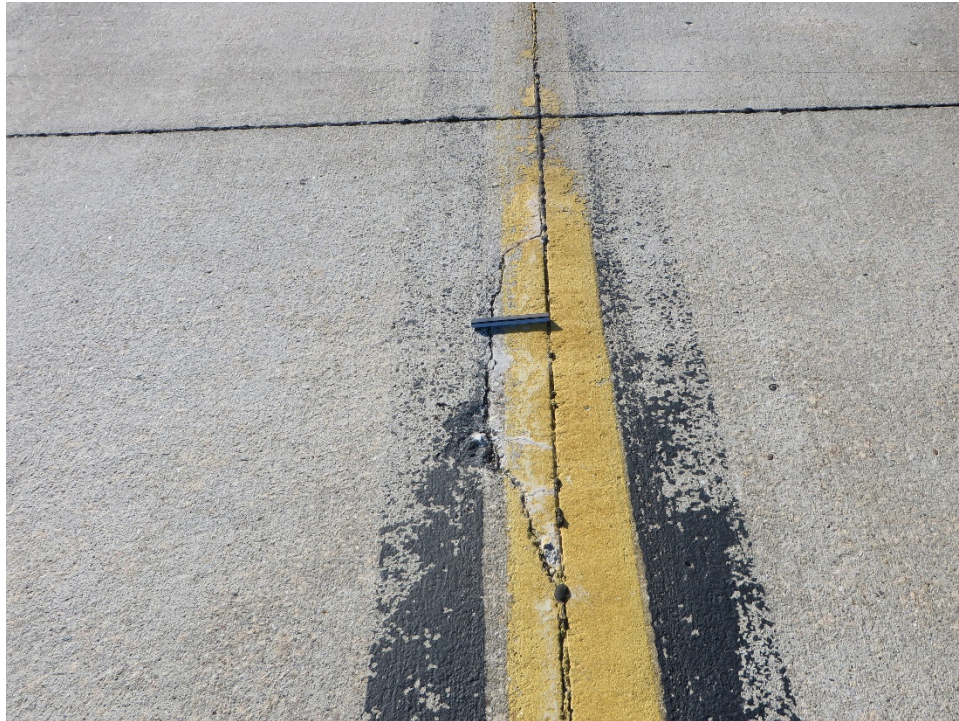
Taxiway 02 contained one section. Medium-severity joint seal damage, low-severity joint spalling, and shrinkage cracking were recorded.

T02CR-01. Joint Spalling (Sample Unit No. 01).

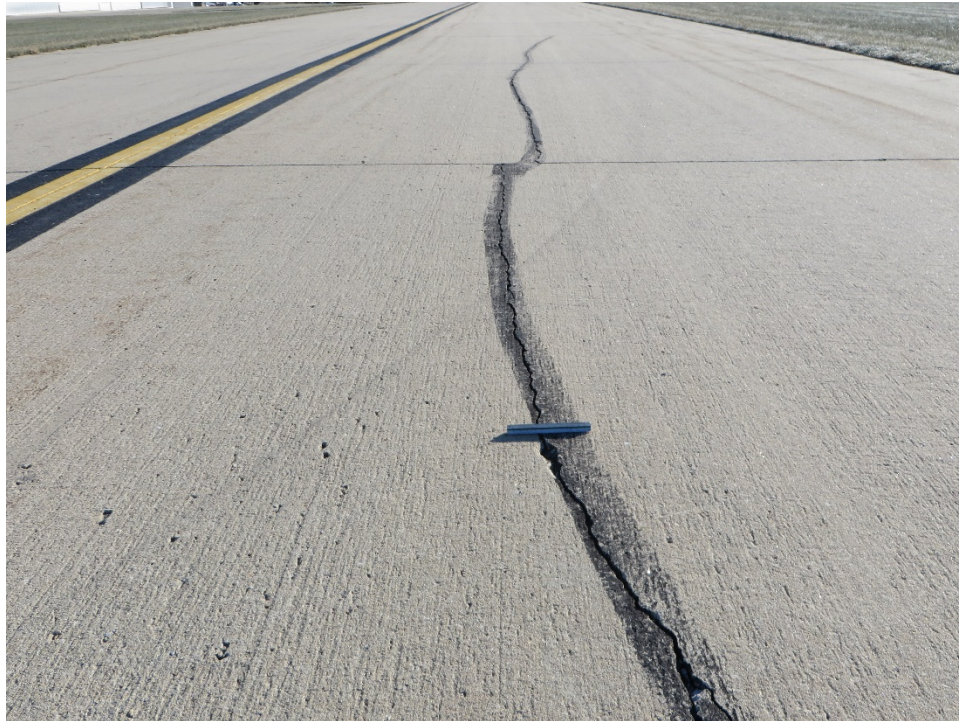
Taxiway 03 was defined by one section with low-severity corner spalling and faulting and low- and medium-severity joint seal damage and LTD cracking observed.

T03CR-01. LTD Cracking (Sample Unit No. 04).

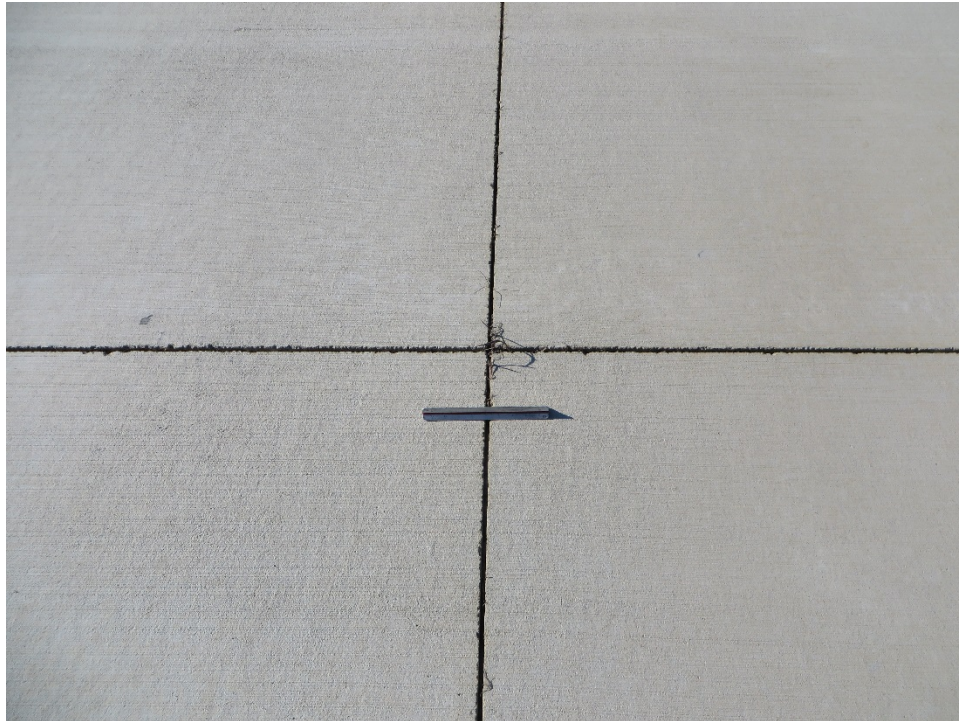
Taxiway 04 consisted of one recently constructed section with high-severity joint seal damage identified.

T04CR-01. Joint Seal Damage (Sample Unit No. 01).
