DAVENPORT MUNICIPAL AIRPORT PAVEMENT MANAGEMENT REPORT

Prepared For:
Iowa Department of Transportation
Office of Aviation

Prepared By:
Applied Pavement Technology, Inc.

April 2016

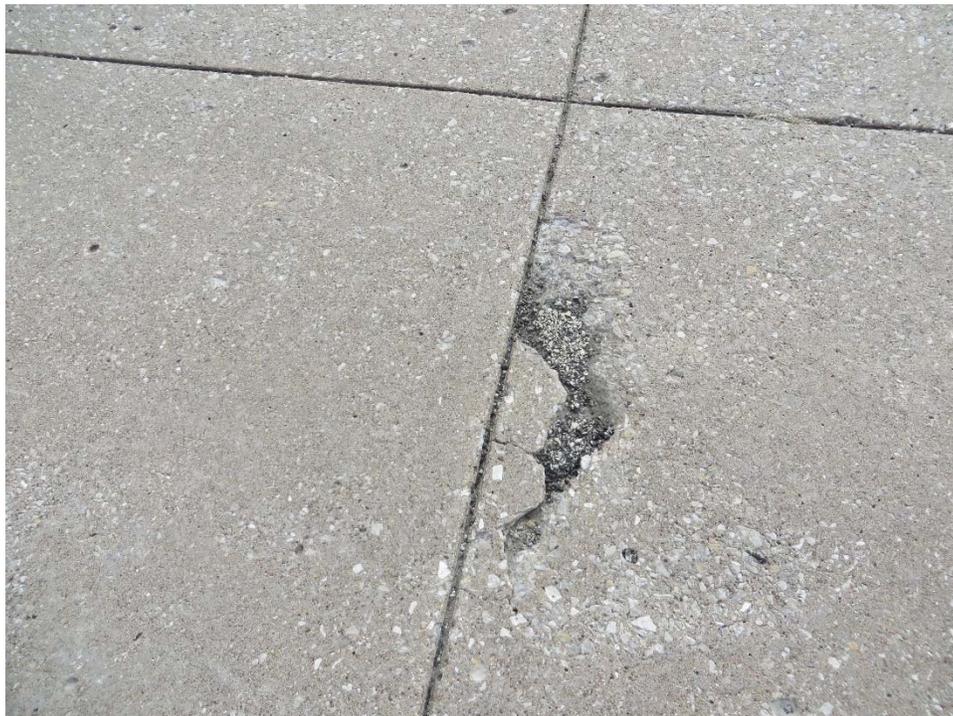
A01DA-01. Joint Spalling (Sample Unit No. 01).

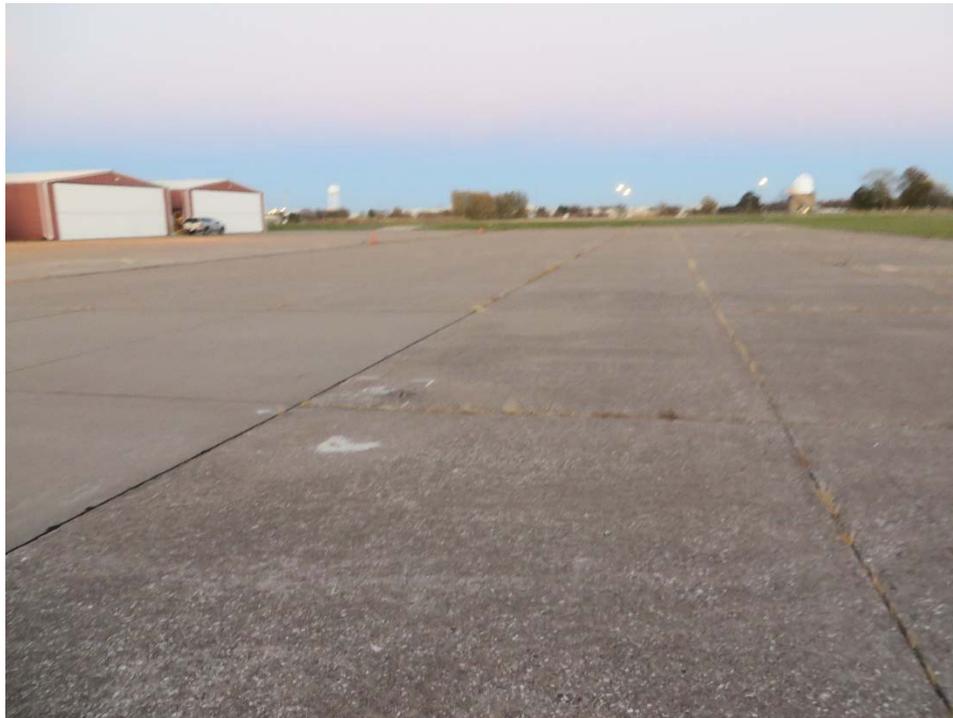
A02DA-01. Overview.

Apron 02 was located north of the main apron area near Taxiway 02 and contained two sections. Section 01, the majority of this apron area, had high-severity joint seal damage observed. Moderate amounts of low- and medium-severity LTD cracking and small quantities of medium-severity small patching and corner breaks and low- and medium-severity joint spalling and ASR were noted. Section 02, located adjacent to Taxiway 06, had high-severity joint seal damage recorded throughout along with isolated quantities of medium-severity joint spalling and low-severity corner spalling.

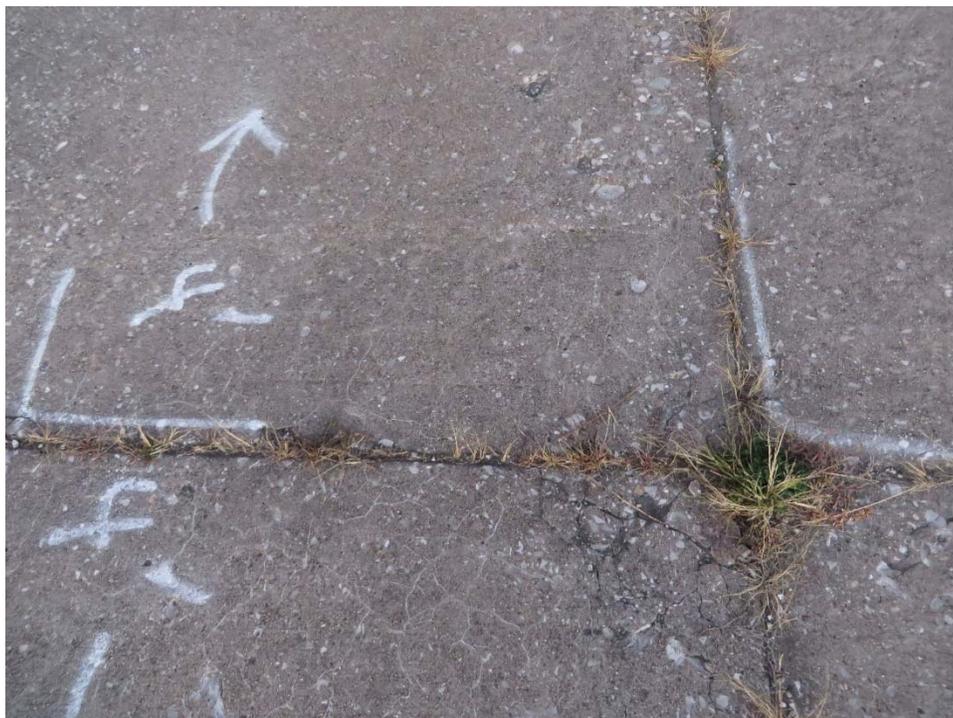
A02DA-01. ASR (Sample Unit No. 03).

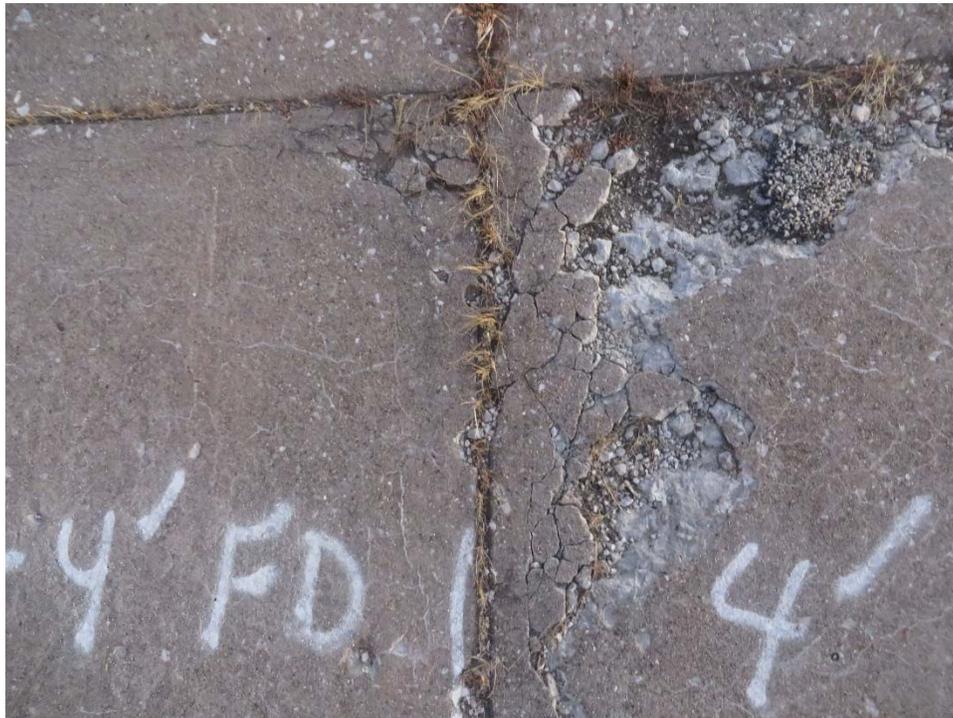
A02DA-01. ASR (Sample Unit No. 05).

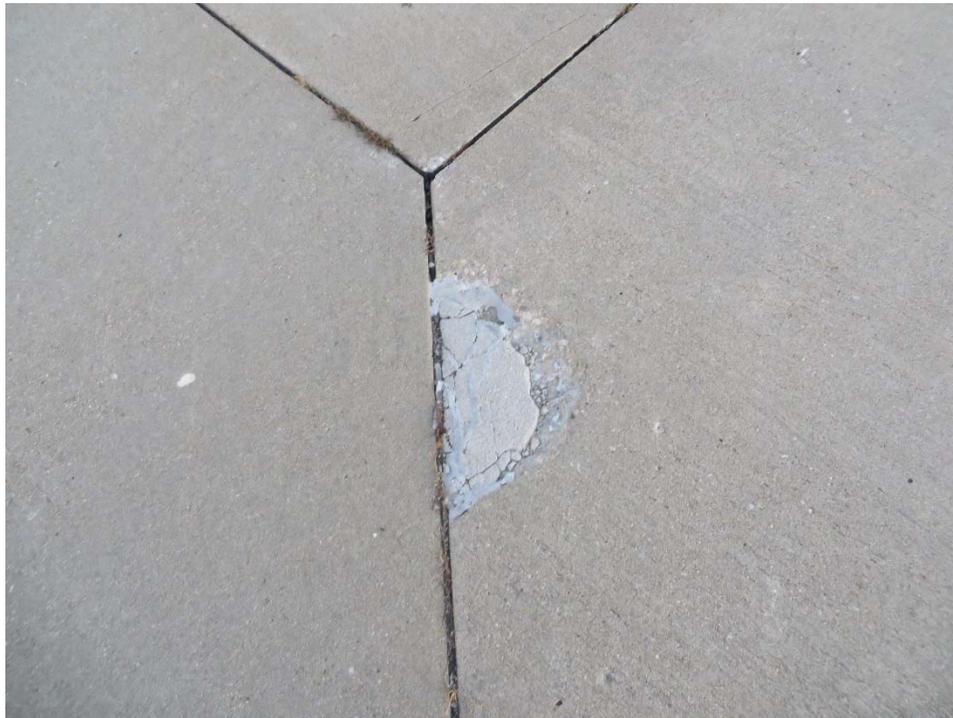
A02DA-02. Joint Spalling (Sample Unit No. 04).

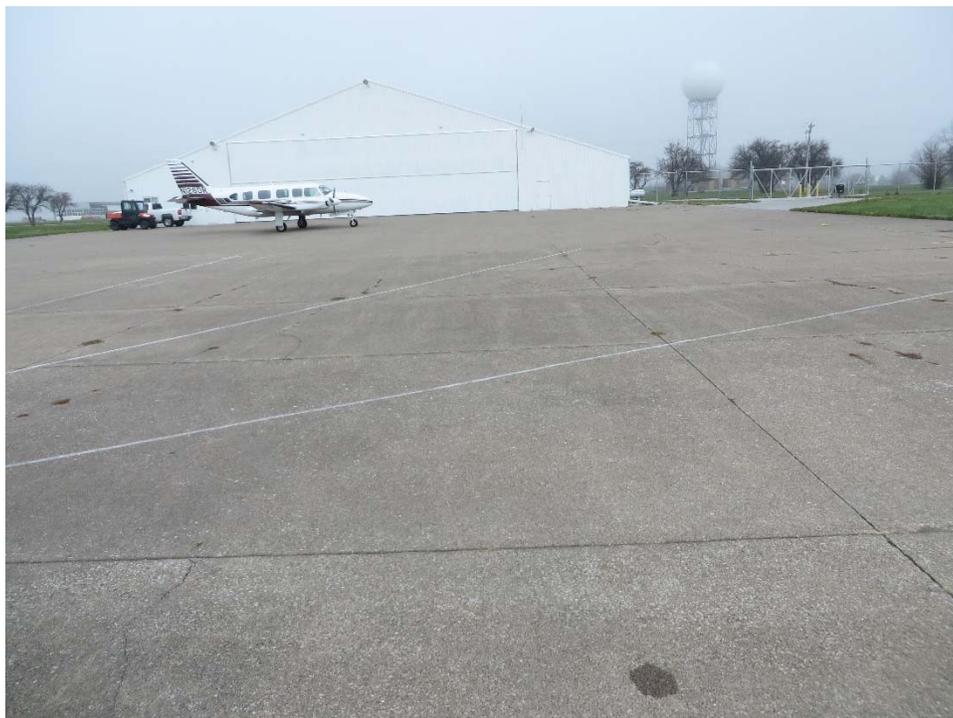
A03DA-01. Overview.

Apron 03, located on the east end of Taxiway 03, was defined by one section in poor condition. High-severity joint seal damage was observed along with extensive amounts of low- and medium-severity LTD cracking and corner spalling, all severities of shattered slabs, low-severity faulting, medium-severity joint spalling, and shrinkage cracking.

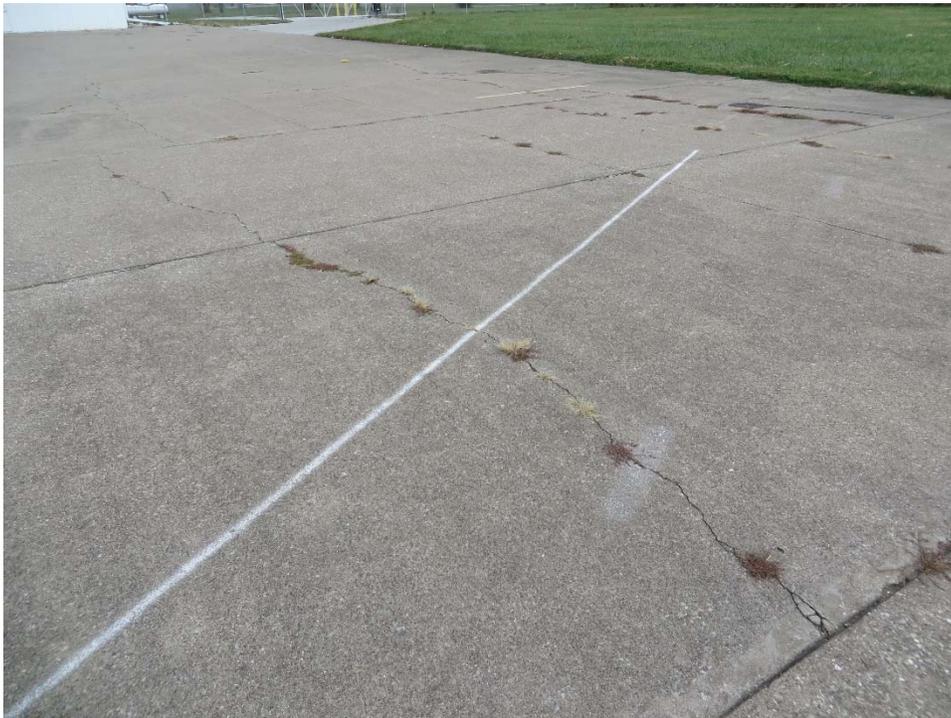
A03DA-01. LTD Cracking (Sample Unit No. 02).

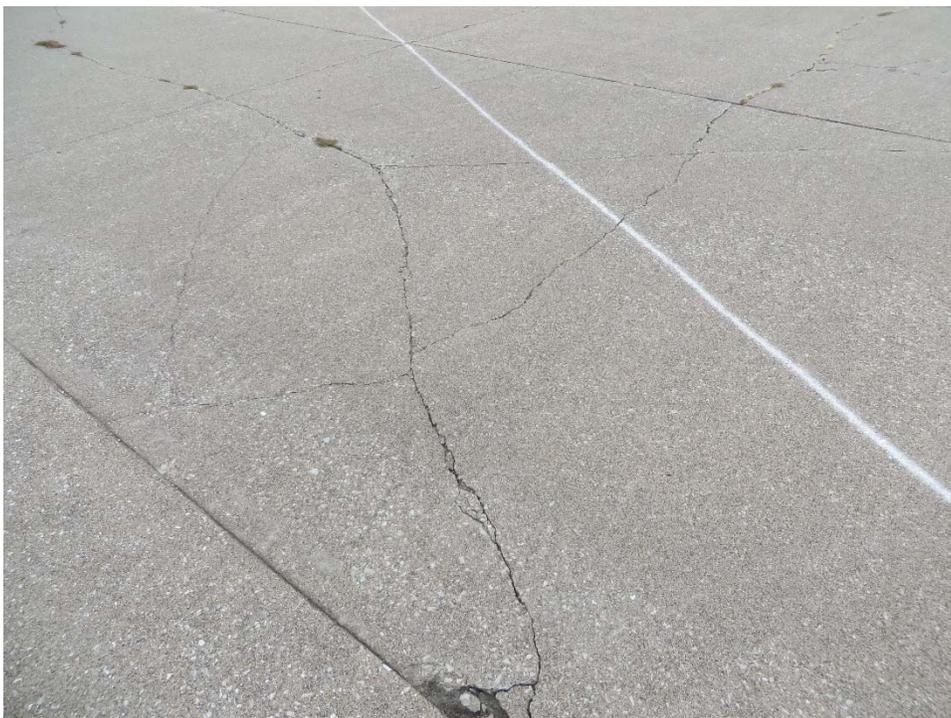
A03DA-01. Shattered Slab (Sample Unit No. 02).

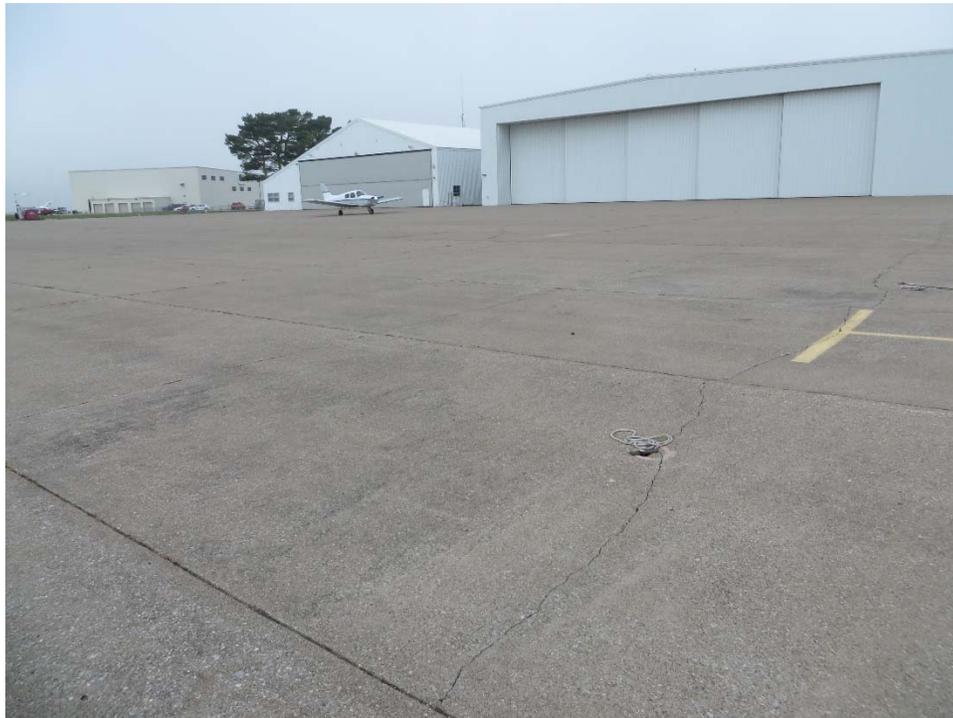
A04DA-01. Overview.

Apron 04 was located along Taxiway 03 and consisted of one section with high-severity joint seal damage identified. Extensive amounts of low- and medium-severity LTD cracking were recorded. In addition, small amounts of low- and medium-severity joint spalling and corner spalling and low-severity corner breaks and shattered slabs were noted.

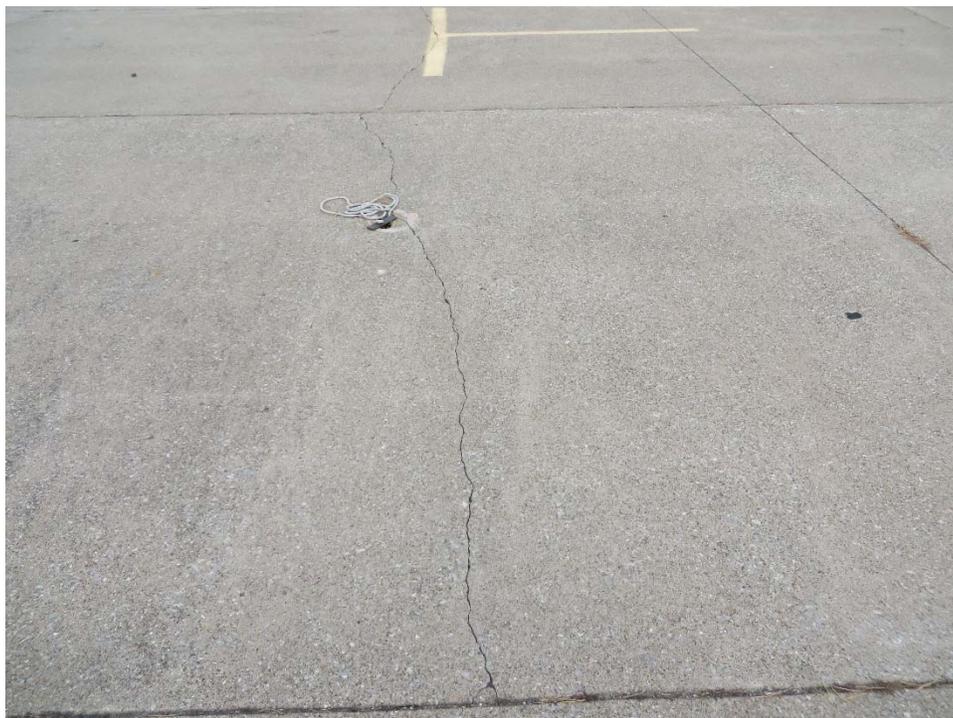
A04DA-01. LTD Cracking (Sample Unit No. 01).

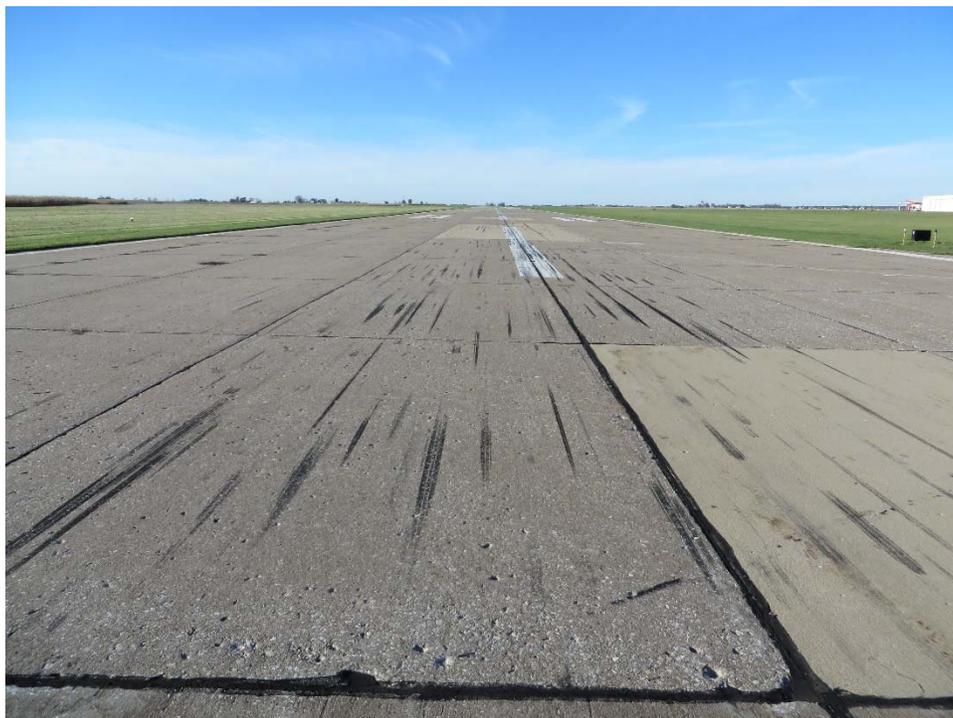
R15DA-01. Overview.

Runway 15-33 was defined by three sections. Section 01, the majority of the runway, had medium-severity joint seal damage recorded throughout. In addition, moderate amounts of all severities of ASR, low- and high-severity small patching, and popouts were identified. Small quantities of low-severity longitudinal, transverse, and diagonal (LTD) cracking and large patching; low- and medium-severity corner spalling; and medium-severity scaling were also observed. Section 02, the runway extension located at the Runway 33 approach, had low- and medium-severity joint seal damage recorded throughout along with isolated amounts of low-severity joint spalling and small patching. Section 03, located at the intersection of the runway with Runway 3-21, was recently reconstructed and was in excellent condition with no distresses identified at the time of inspection.

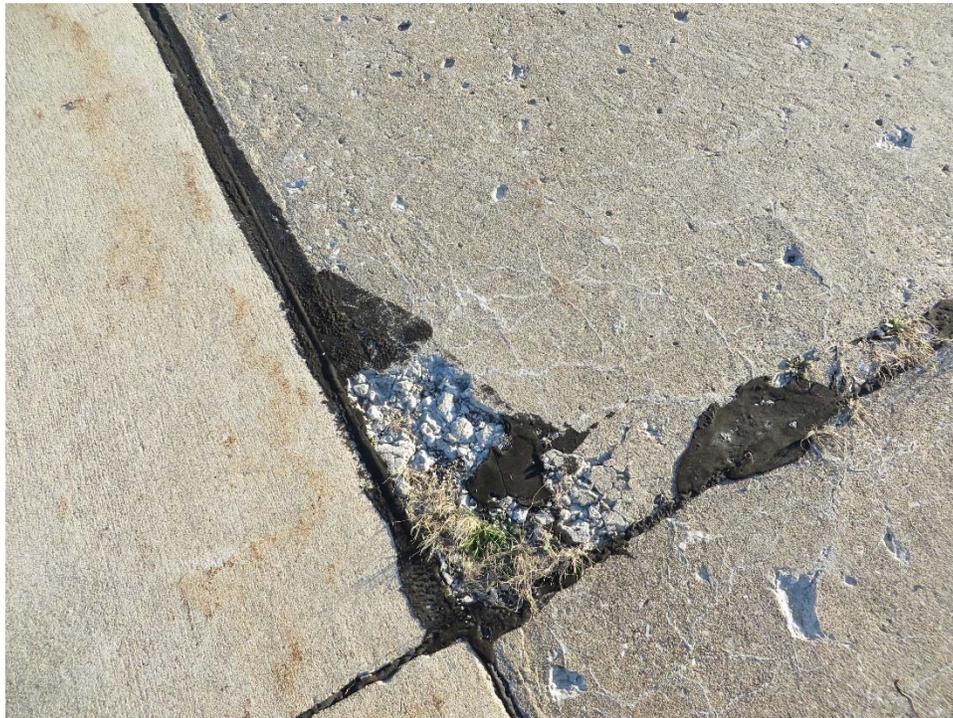
R15DA-01. ASR (Sample Unit No. 15).

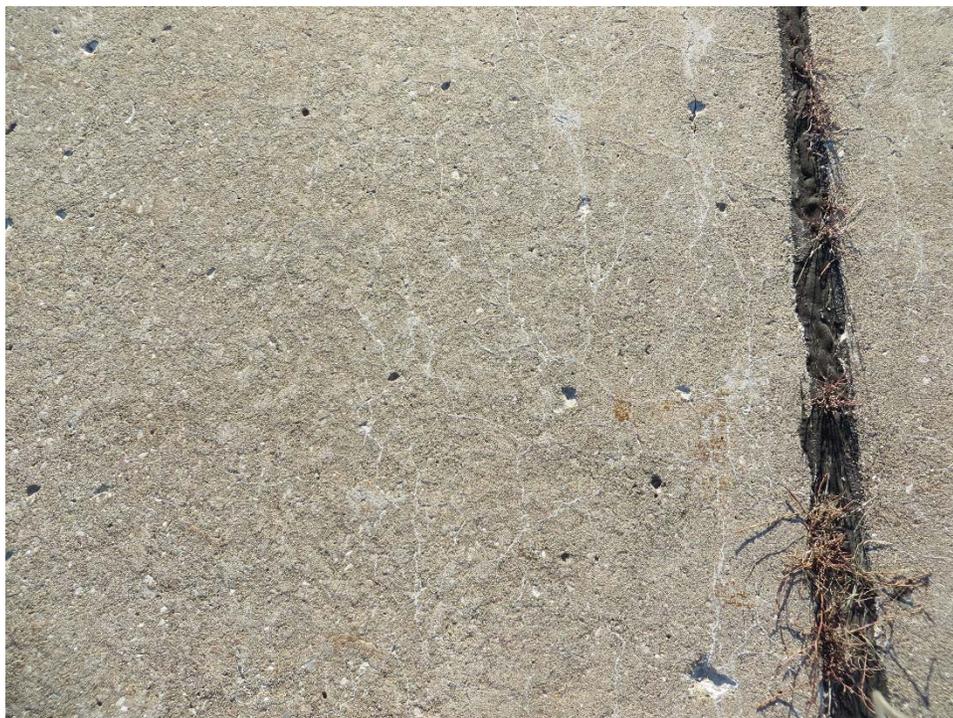
R15DA-01. ASR (Sample Unit No. 54).

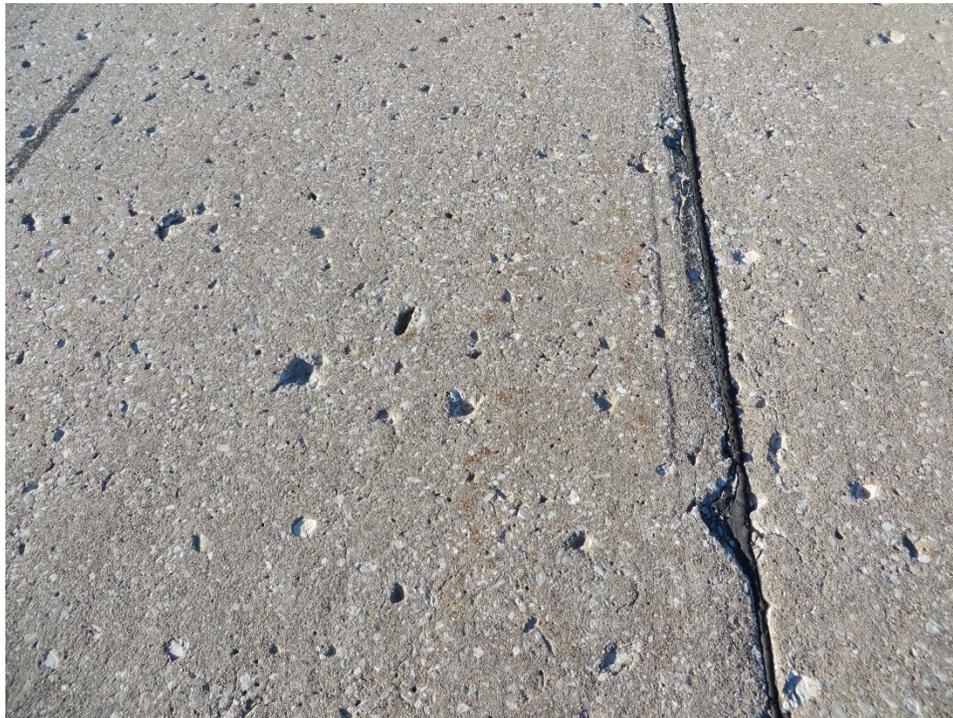
R15DA-01. Popouts (Sample Unit No. 68).

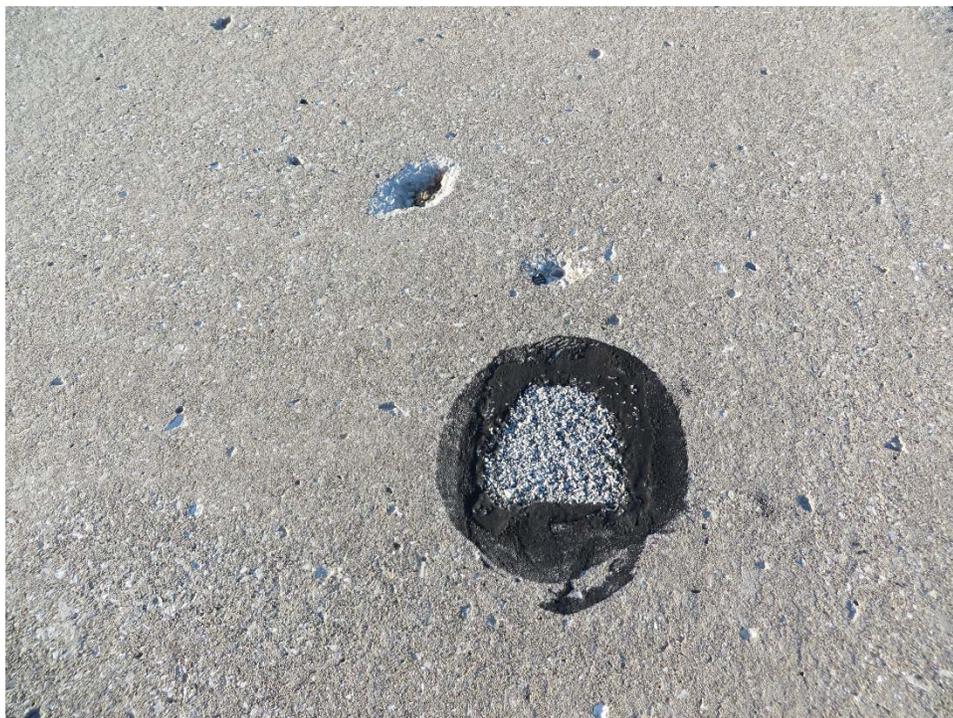
R15DA-01. Small Patch (Sample Unit No. 24).

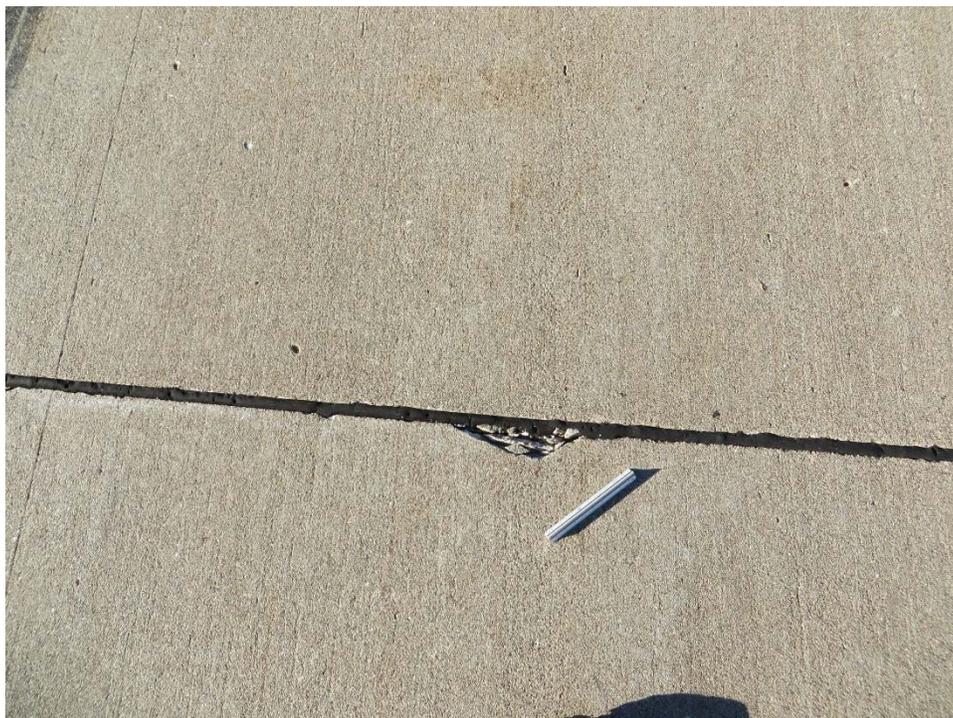
R15DA-02. Joint Spalling (Sample Unit No. 25).

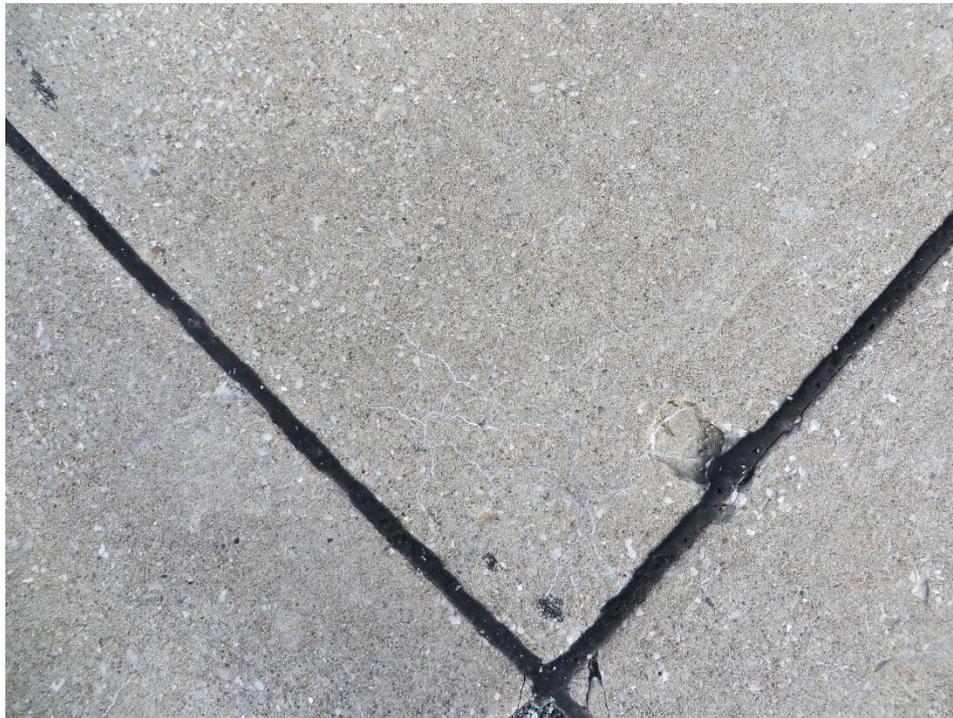
T01DA-01. ASR (Sample Unit No. 05).

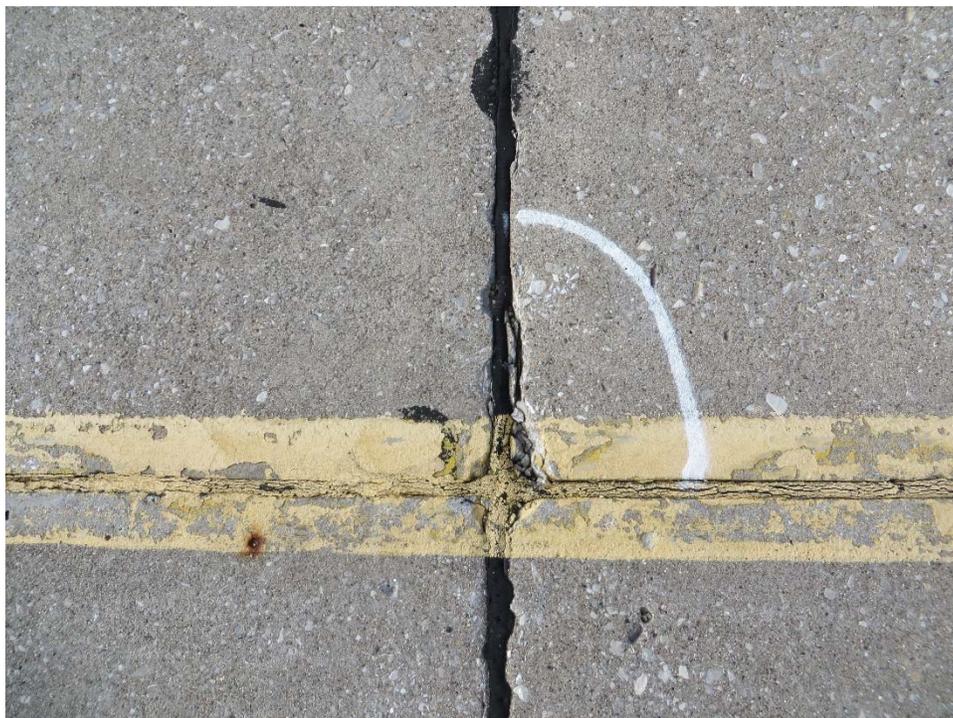
T01DA-01. Joint Seal Damage (Sample Unit No. 15).

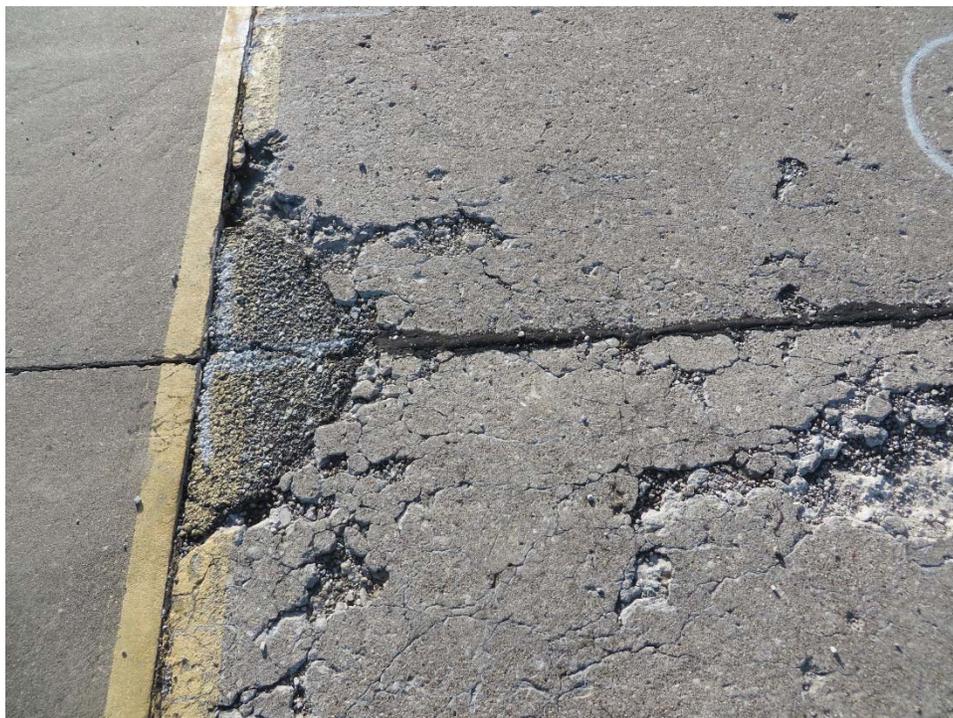
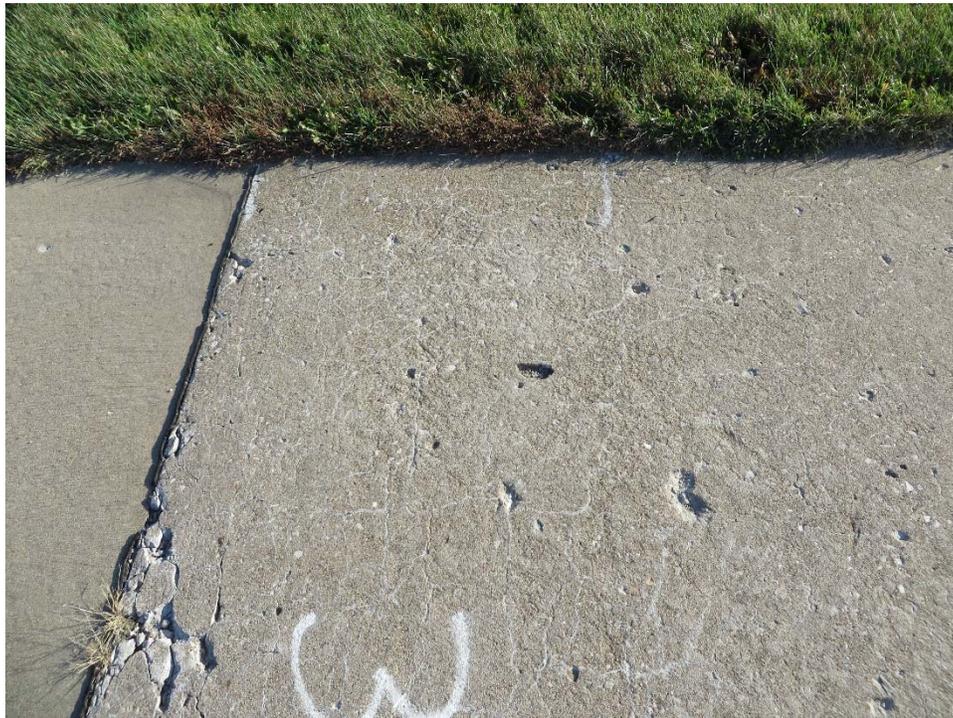
T01DA-02. ASR (Sample Unit No. 10).

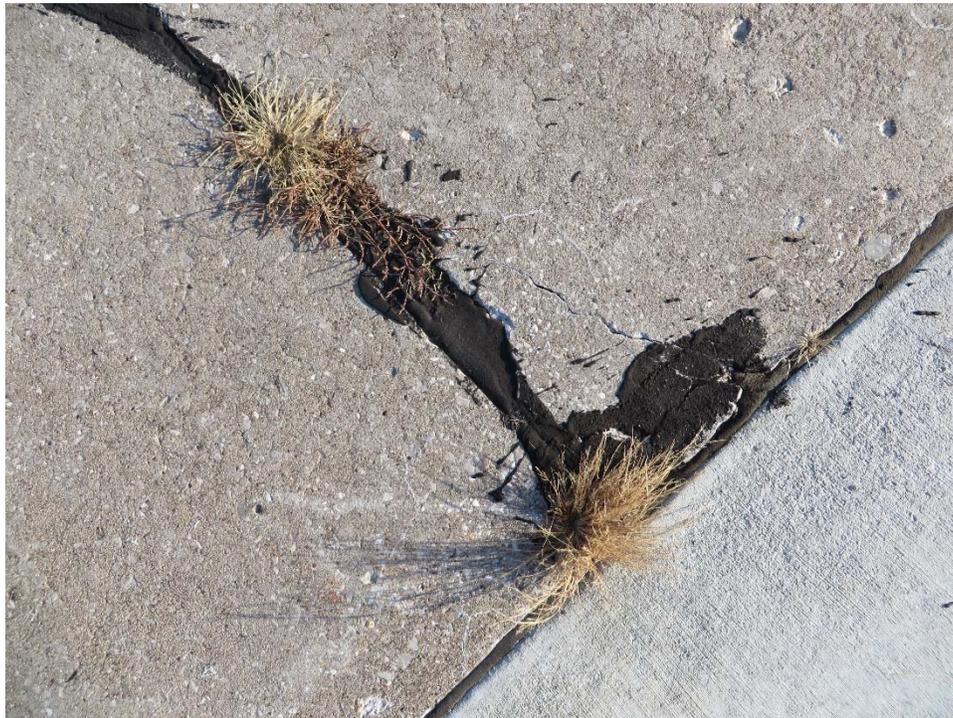
T01DA-03. ASR (Sample Unit No. 04).

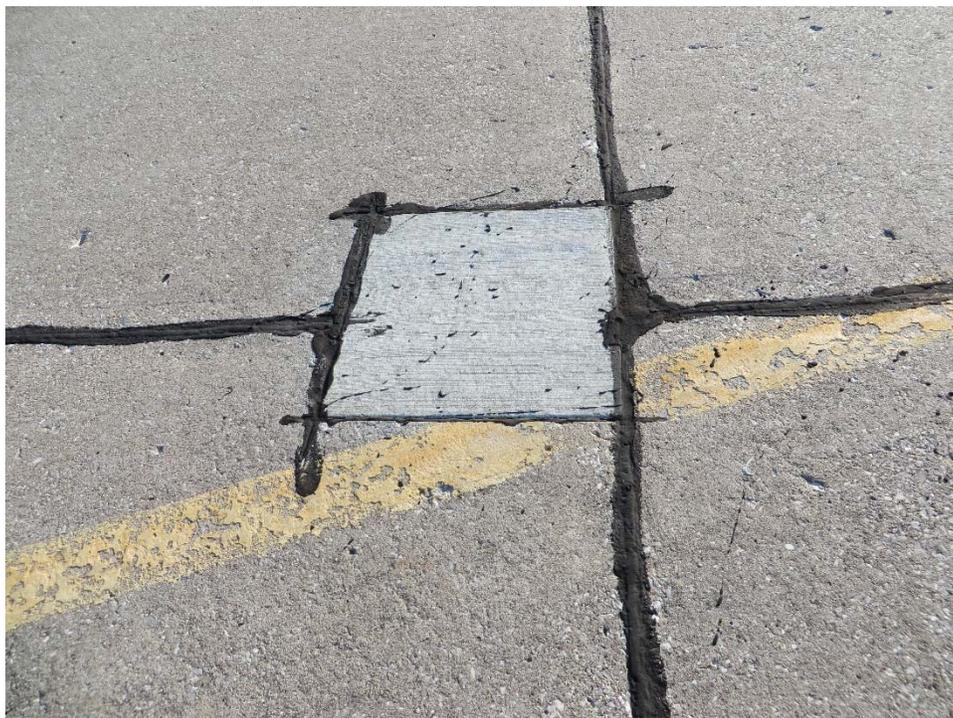
T01DA-03. Small Patching (Sample Unit No. 04).

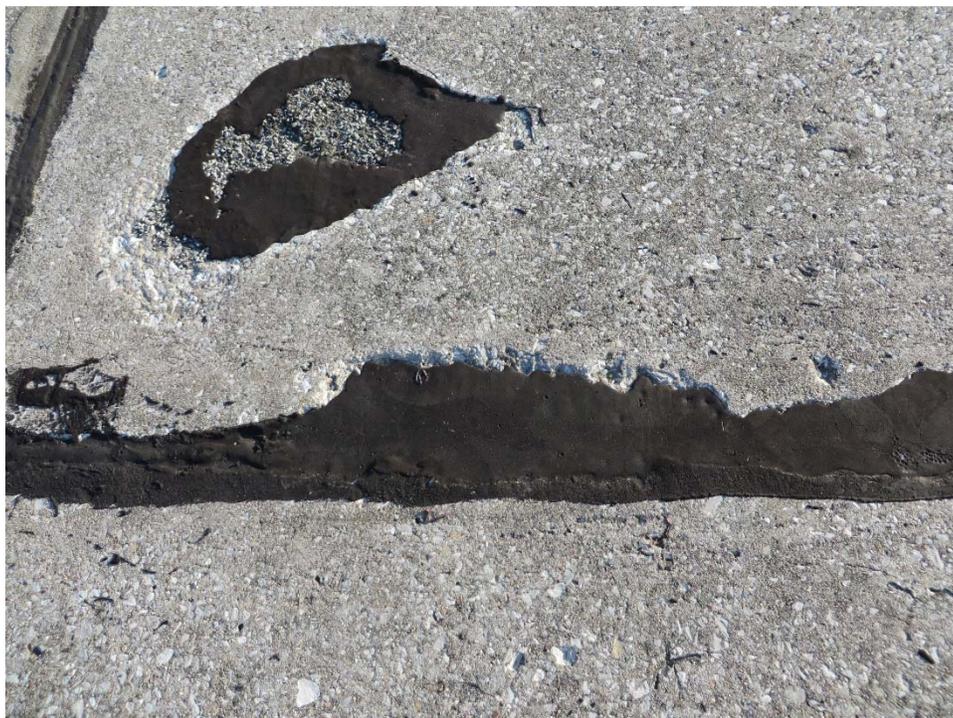
T01DA-04. Joint Spalling (Sample Unit No. 11).

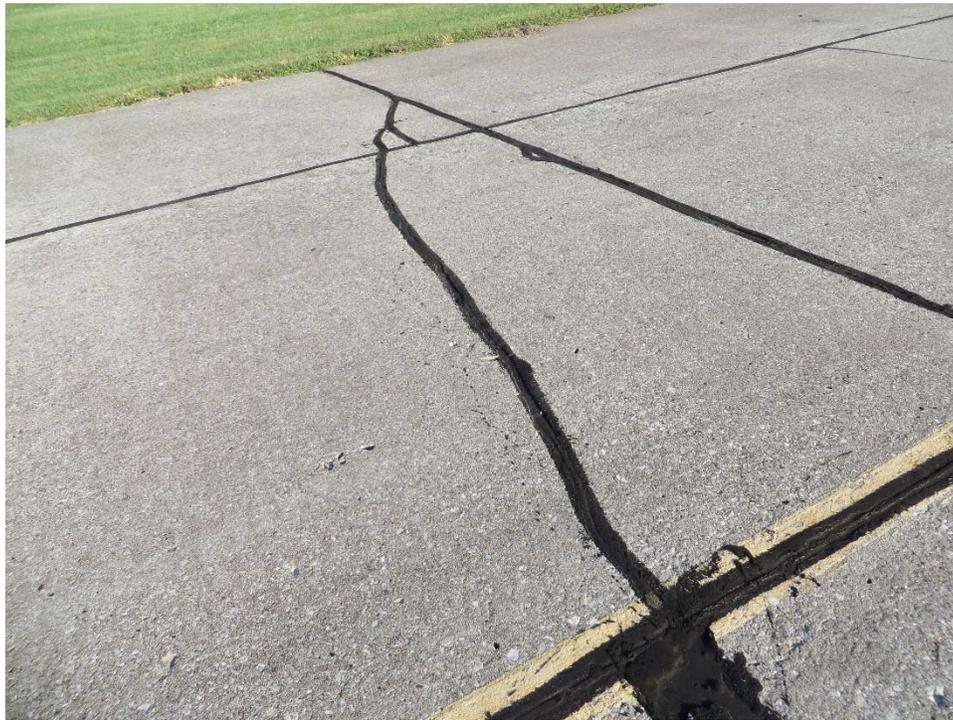
T01DA-04. LTD Cracking (Sample Unit No. 11).

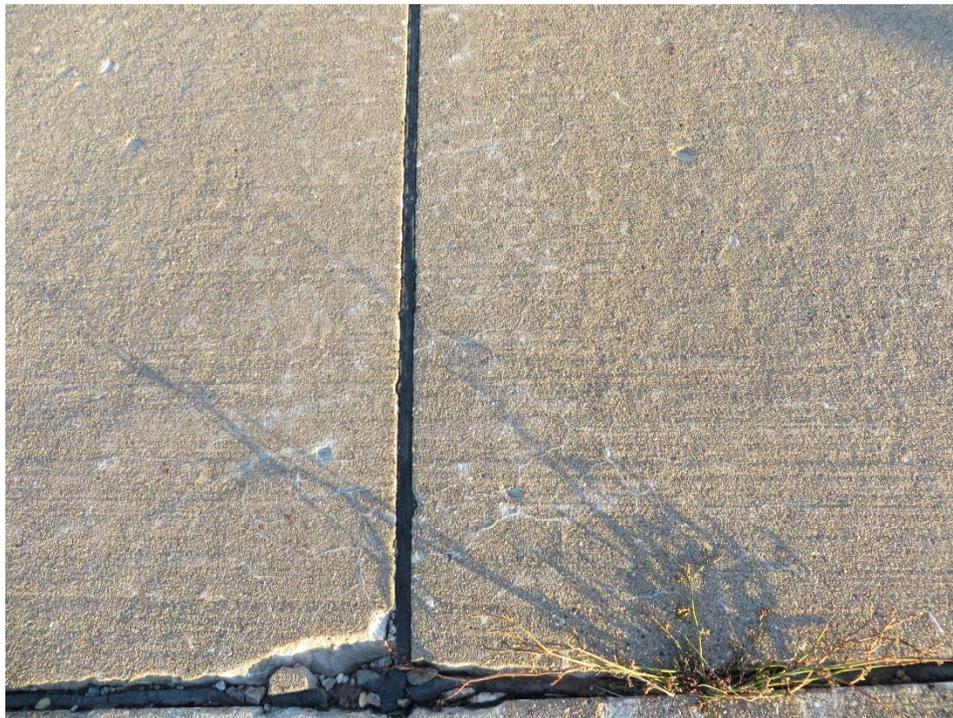
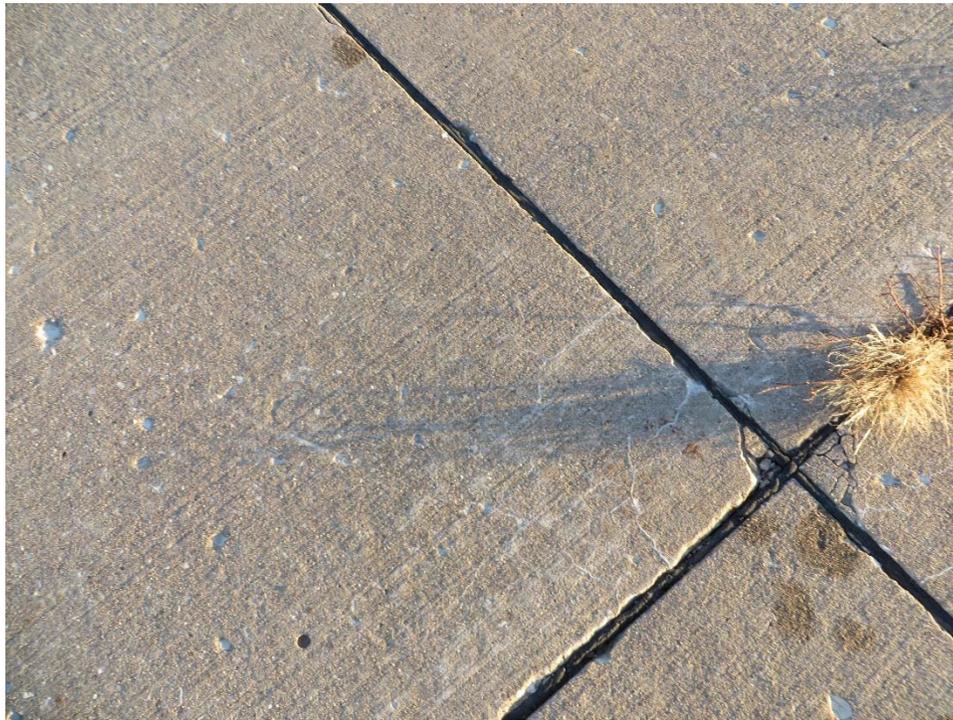
Taxiway 02, a partial parallel taxiway to Runway 03-21, consisted of six sections. Section 01, located near the Runway 21 approach, had high-severity joint seal damage recorded throughout along with extensive amounts of low-severity ASR. Isolated quantities of low- and medium-severity corner breaks and medium-severity LTD cracking were also identified. Section 02, also located near the Runway 21 approach, was in excellent condition with only low-severity joint seal damage recorded. Section 03 comprised the majority of the taxiway with medium- and high-severity joint seal damage and extensive amounts of low- and medium-severity LTD cracking identified. Additionally, small quantities of low-severity joint spalling, corner spalling,

T02DA-01. ASR (Sample Unit No. 01).

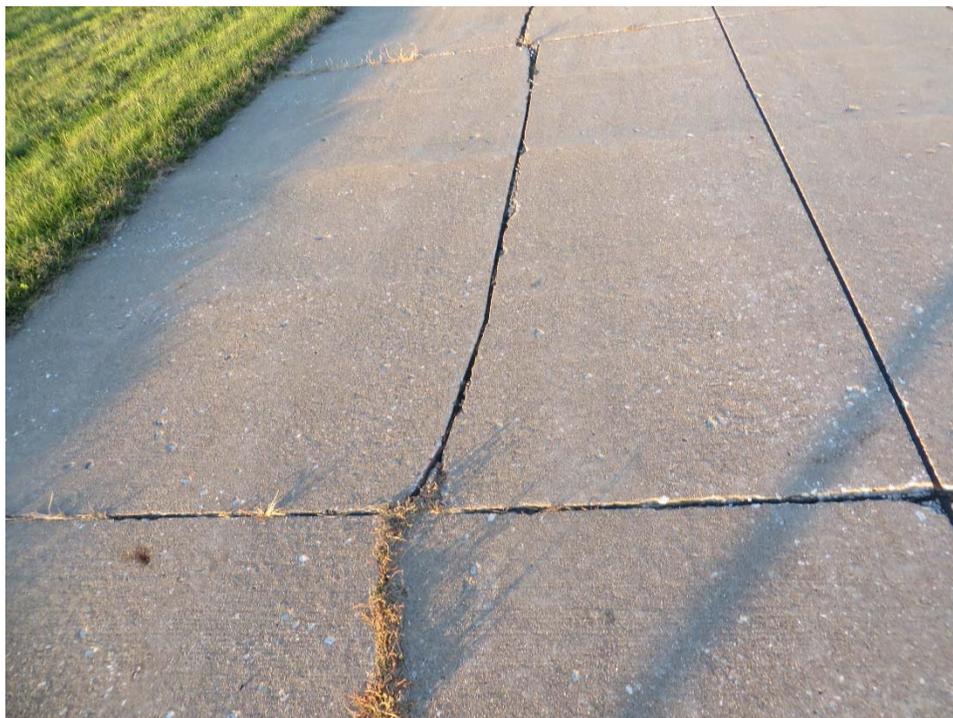
T02DA-03. LTD Cracking (Sample Unit No. 05).

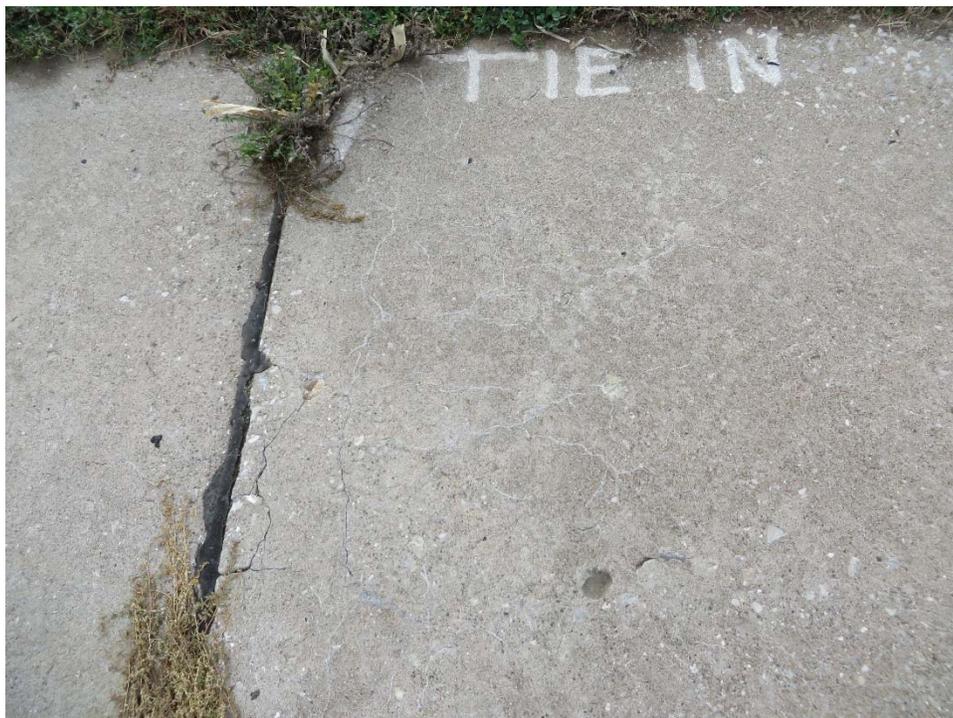
T02DA-04. ASR (Sample Unit No. 05).

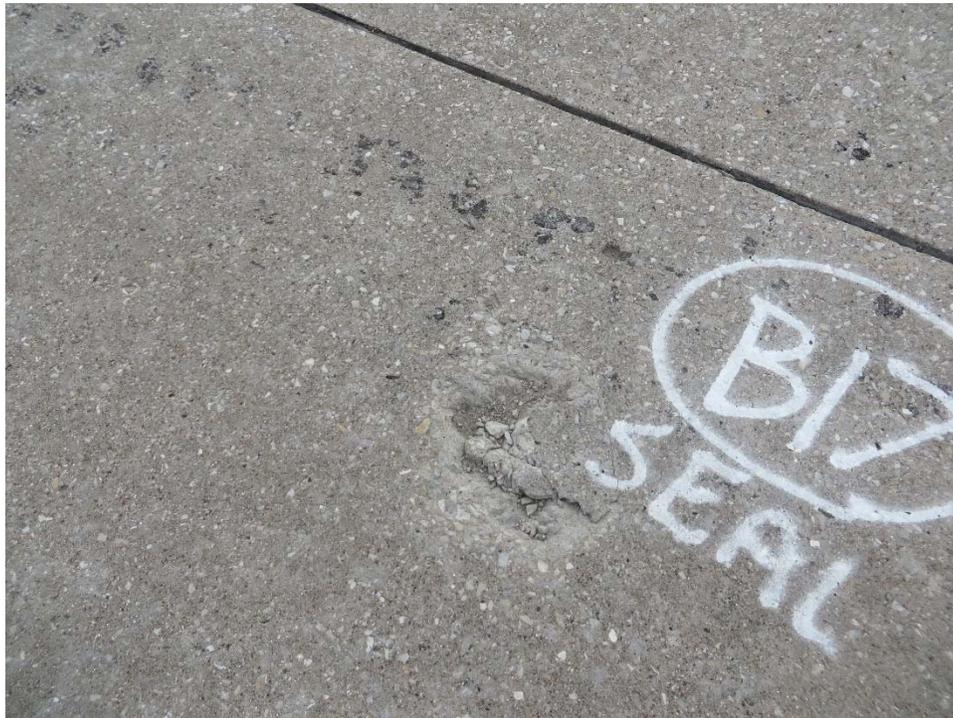
T02DA-04. Scaling (Sample Unit No. 05).

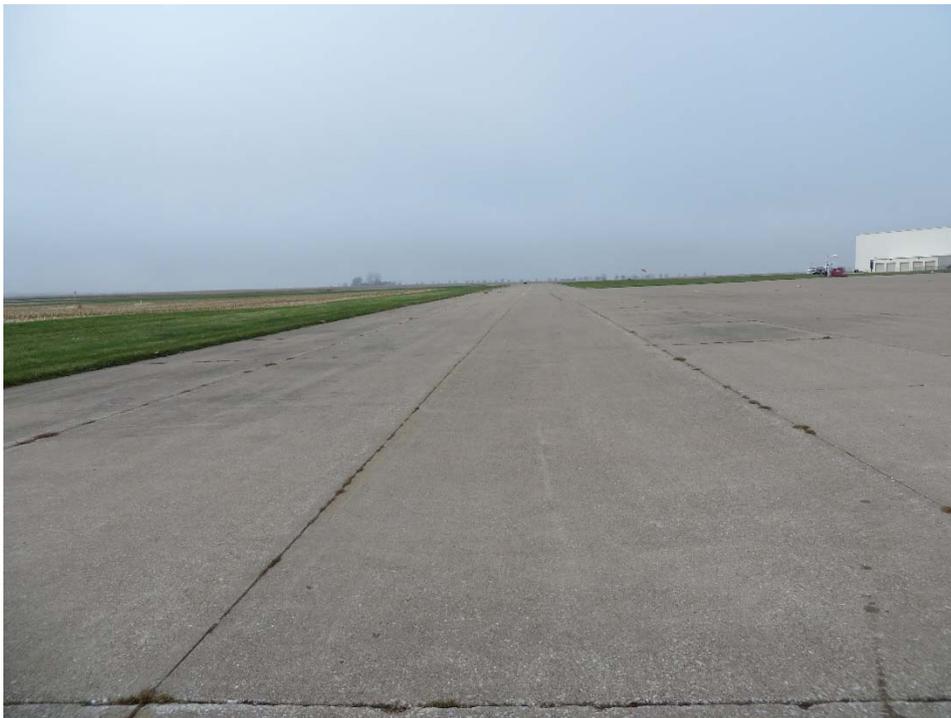
T03DA-01. Overview.

Taxiway 03 connected Apron 03 with Runway 15-33 and contained two sections. Section 01, located adjacent to the apron, was in poor condition with high-severity joint seal damage observed throughout. Moderate amounts of low- and medium-severity LTD cracking, all severities of shattered slabs, medium-severity joint spalling, low- and medium-severity corner spalling, low-severity durability cracking, and shrinkage cracking were also identified. Section 02, located between Runway 15-33 and Taxiway 01, only had small amounts of low-severity ASR, joint spalling, and corner spalling recorded.

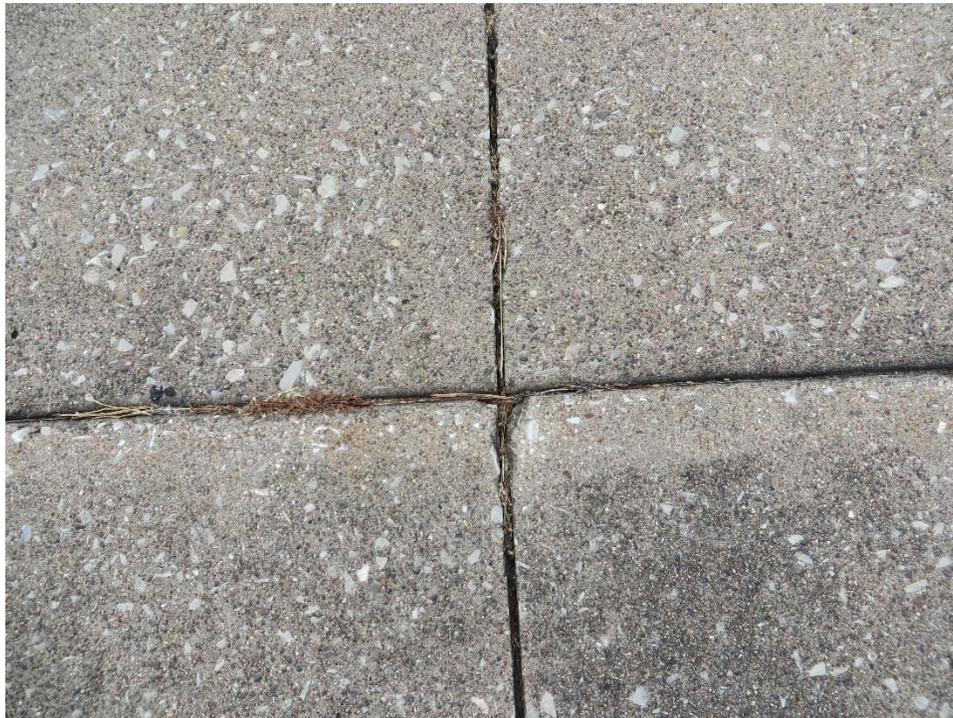
T03DA-01. Joint Seal Damage (Sample Unit No. 03).

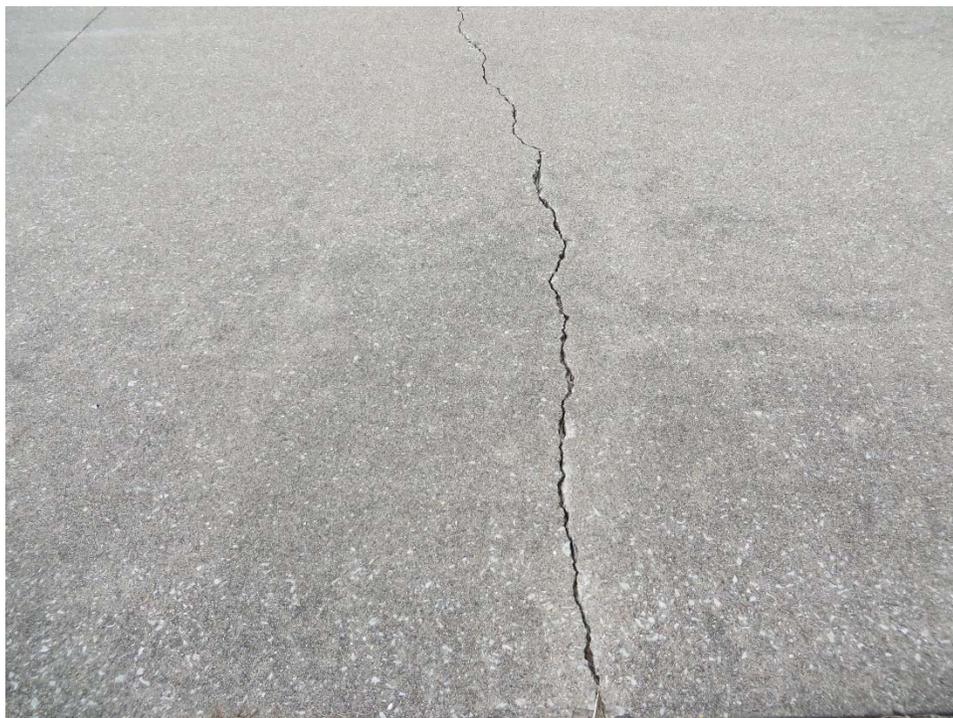
T03DA-01. LTD Cracking (Sample Unit No. 03).
