DAVENPORT MUNICIPAL AIRPORT PAVEMENT MANAGEMENT REPORT

Prepared For:
Iowa Department of Transportation
Office of Aviation

Prepared By:
Applied Pavement Technology, Inc.

April 2016

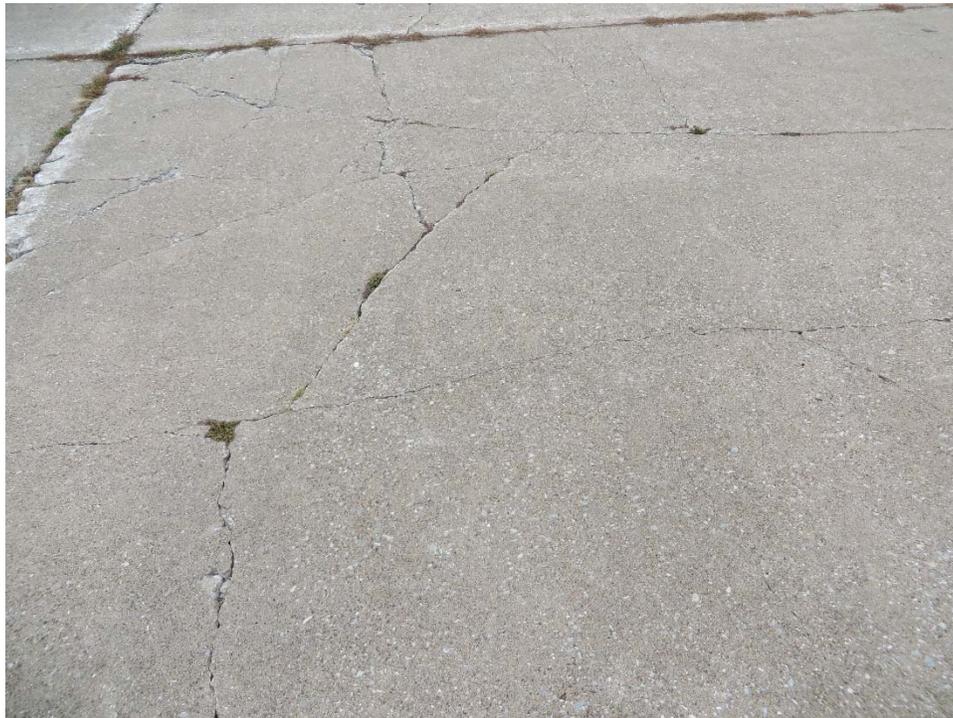
T03DA-01. Shattered Slab (Sample Unit No. 07).

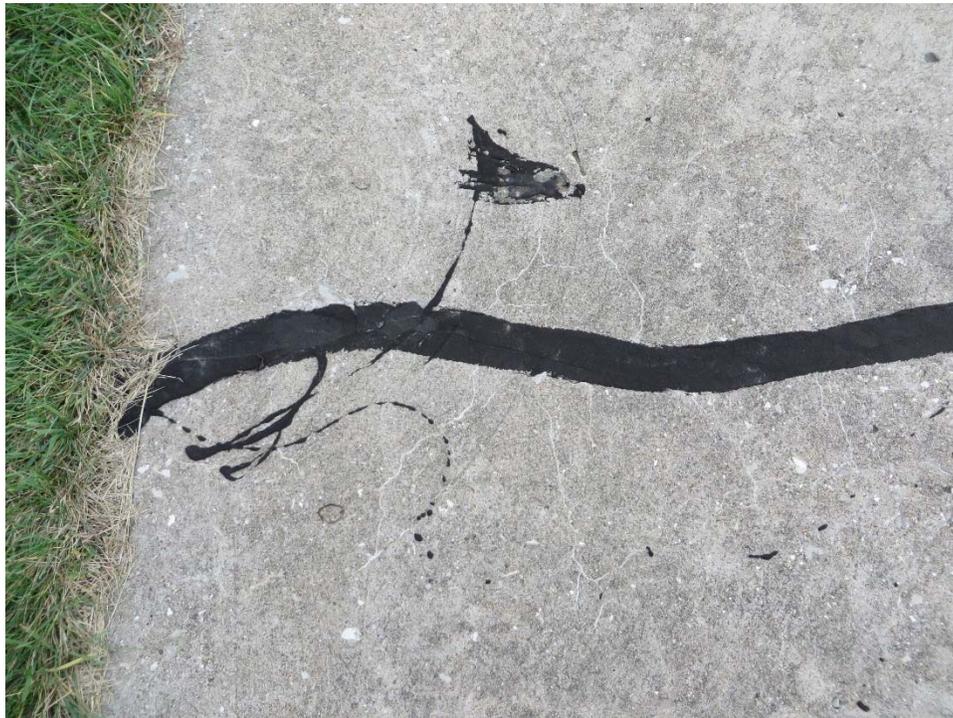
T03DA-02. ASR (Sample Unit No. 04).

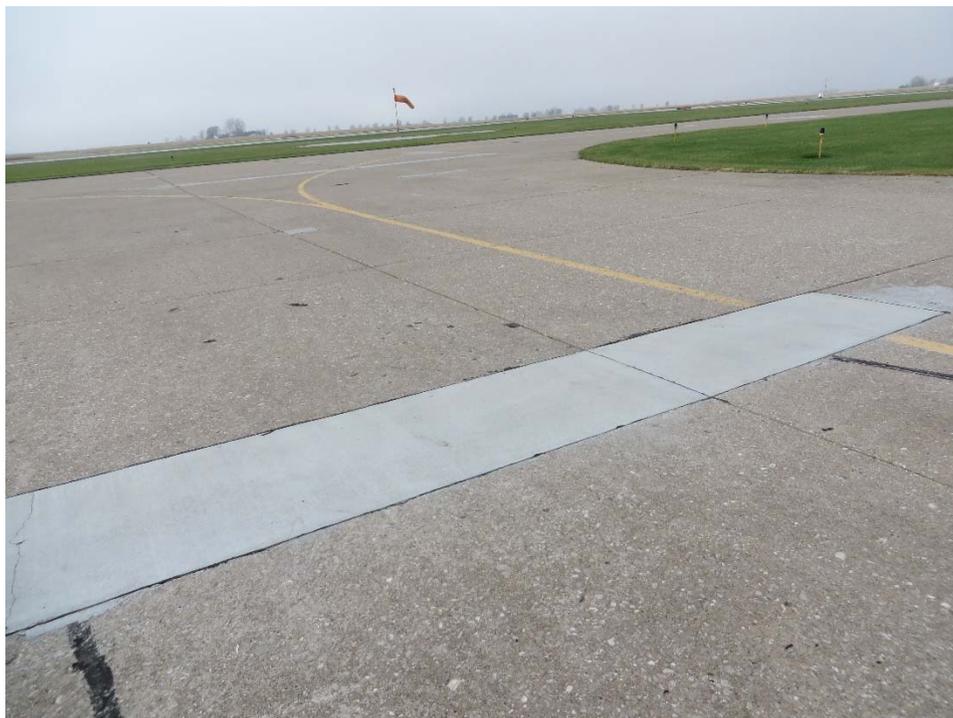
T04DA-01. Overview.

Taxiway 04 consisted of one section that connected the main apron with Taxiway 01 and had medium-severity joint seal damage identified throughout. Moderate amounts of low- and medium-severity LTD cracking and low-severity ASR were observed. In addition, small quantities of low-severity small patching, large patching, and shattered slabs; medium-severity joint spalling; and shrinkage cracking were noted.

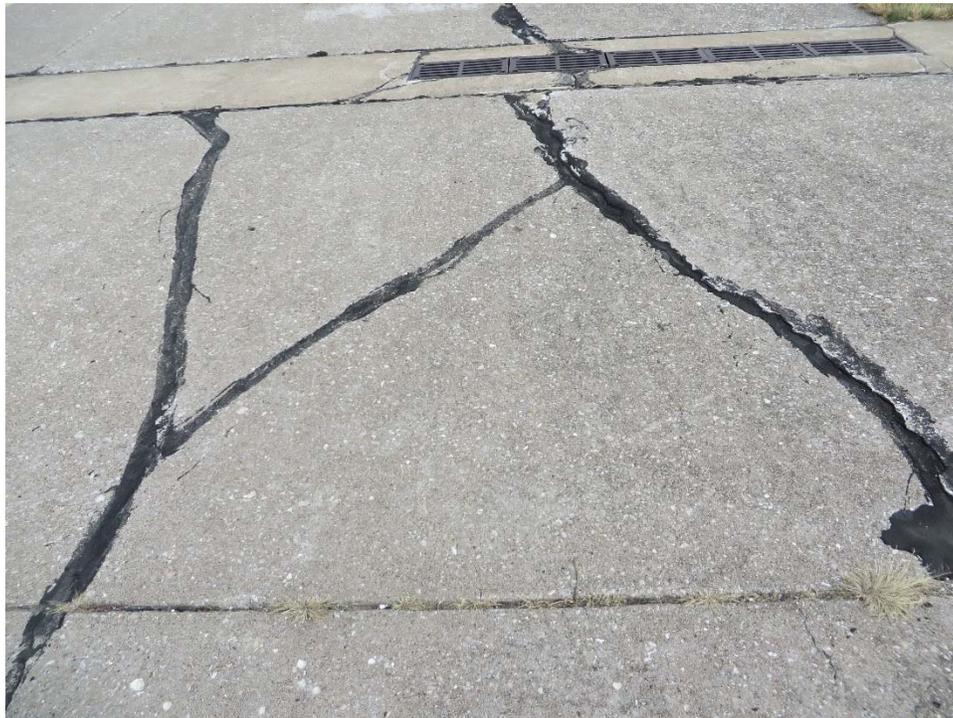
T04DA-01. Shattered Slab (Sample Unit No. 01).

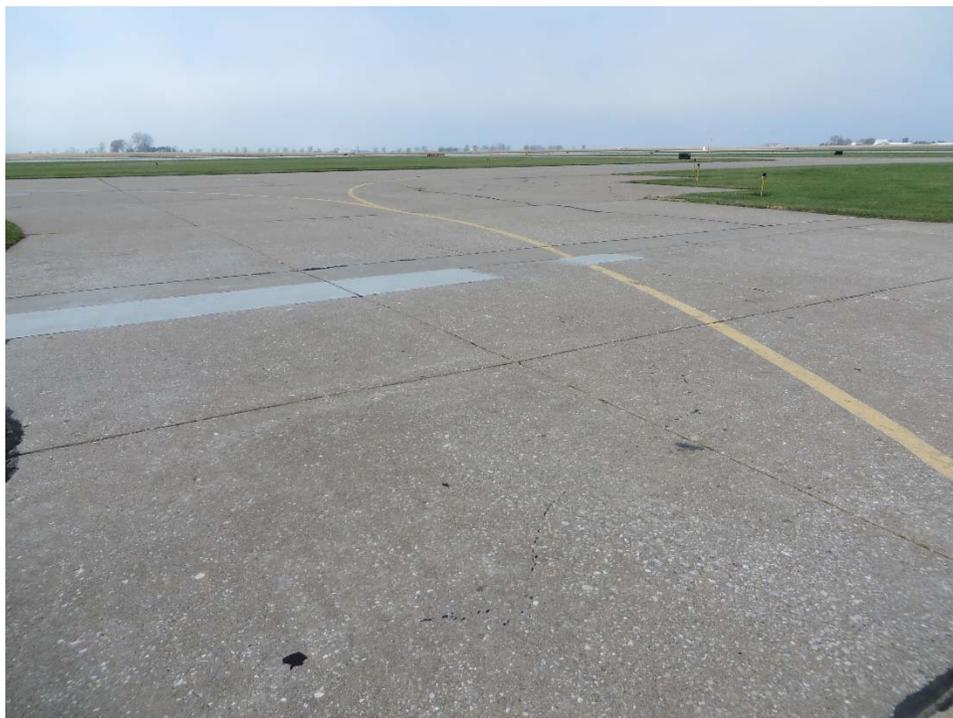
T05DA-01. Overview.

Taxiway 05 also connected the main apron with Taxiway 01 and was defined by one section with high-severity joint seal observed. Moderate amounts of low- and medium-severity LTD cracking along with small quantities of low-severity small and large patching, medium-severity corner breaks, and low- and medium-severity ASR were also identified.

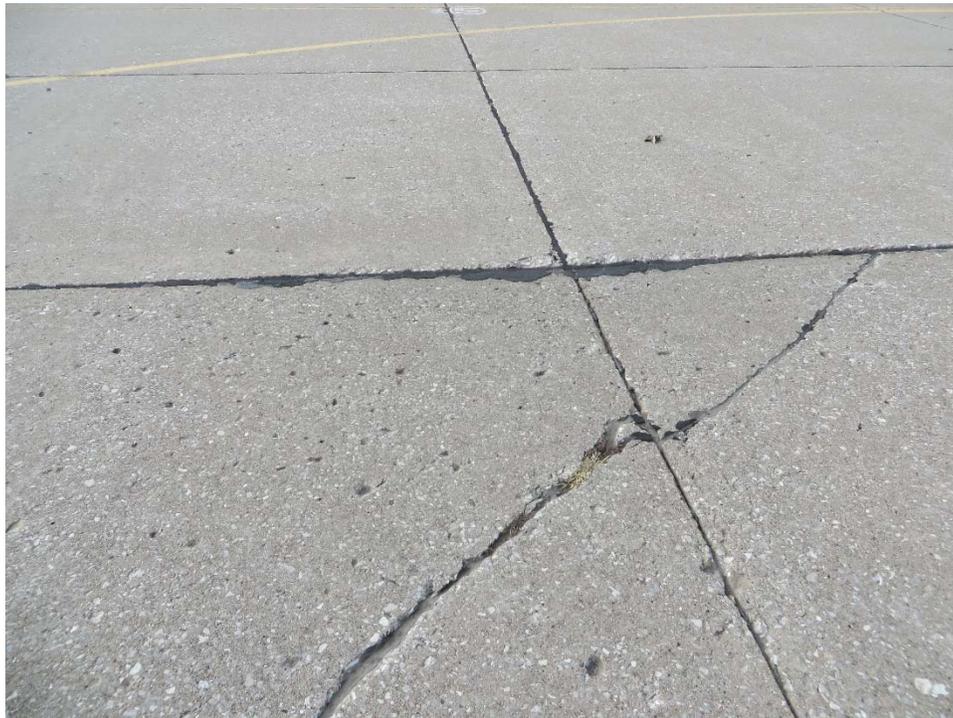
T05DA-01. LTD Cracking (Sample Unit No. 02).

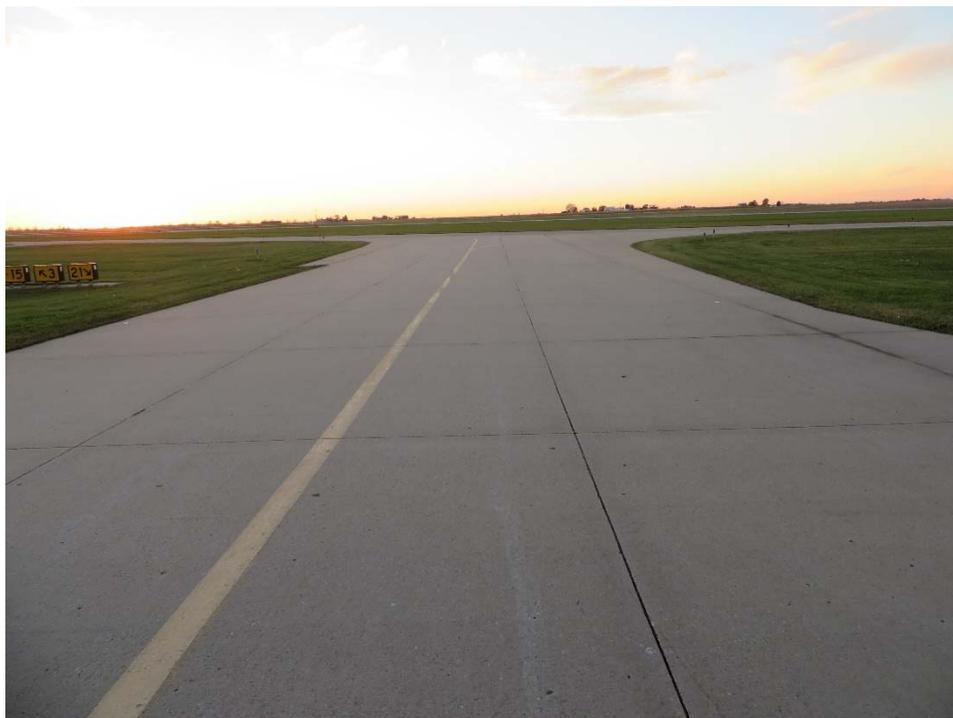
T06DA-01. Overview.

Taxiway 06 connected Apron 02 with Taxiway 02 and contained one section. Only high-severity joint seal damage was recorded on this taxiway.

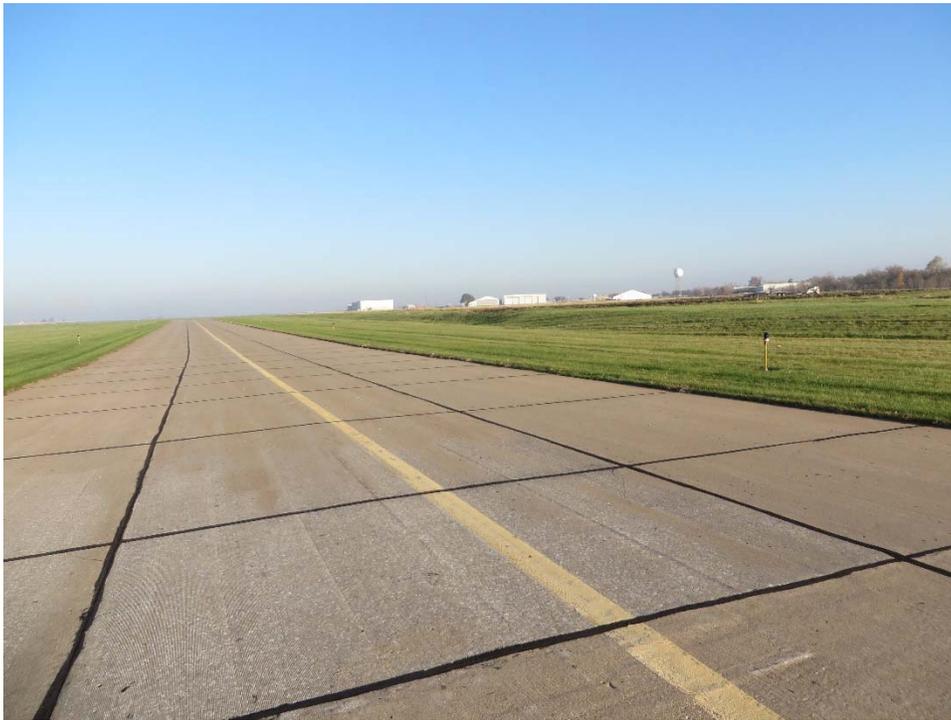
T07DA-01. Overview.

Taxiway 07, located near the Runway 33 approach, was defined by one section in excellent condition with isolated amounts of low-severity faulting and medium-severity joint spalling identified. The joints were recently resealed on this taxiway.
