Davenport Municipal Airport

Pavement Management Report

JULY 2023

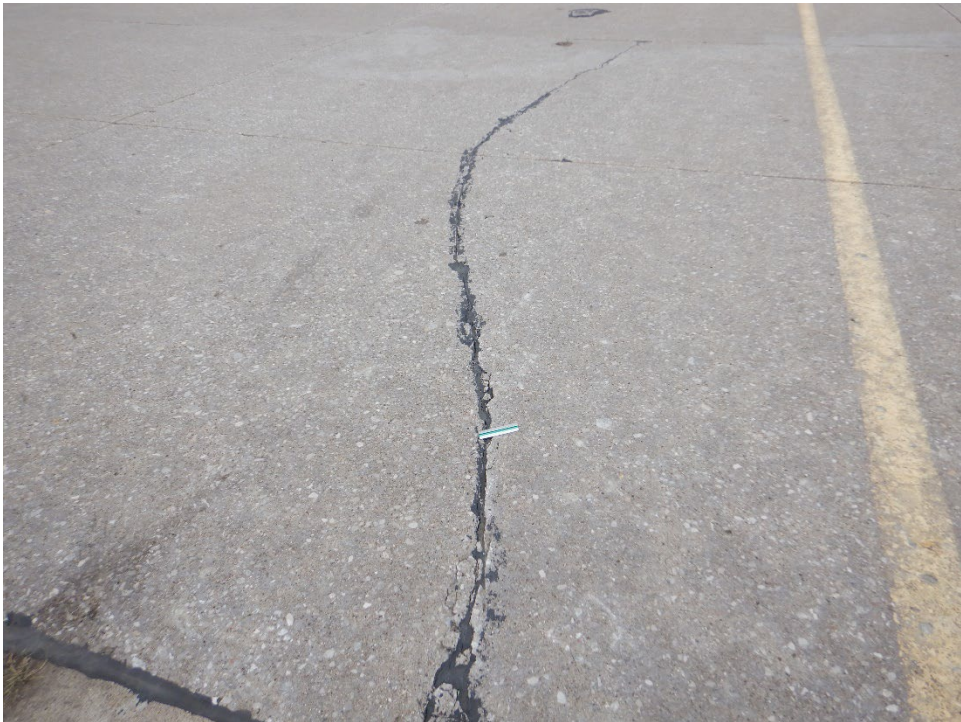
A01DA-01. LTD Cracking (Sample Unit No. 07).

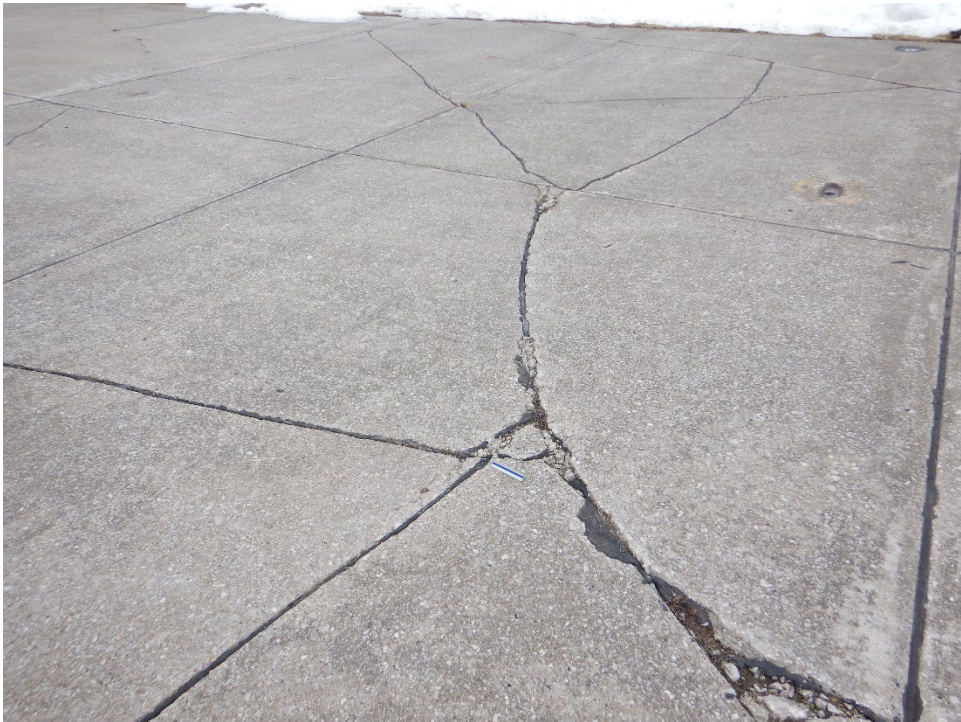
A02DA-01. Shattered Slab (Sample Unit No. 07).

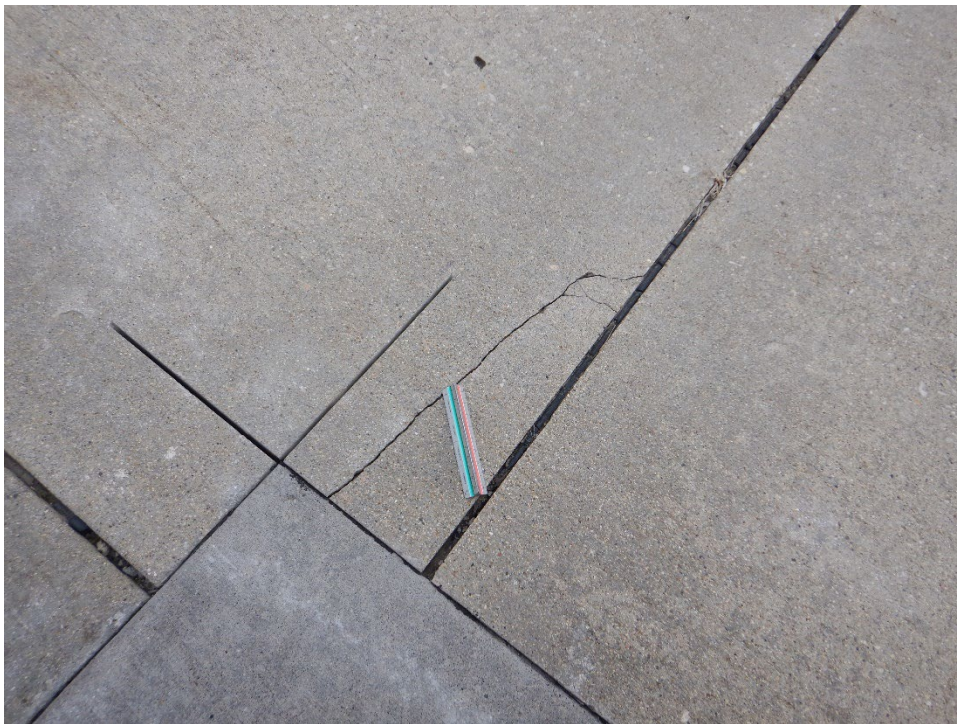
A02DA-02. Joint Spalling (Sample Unit No. 04).

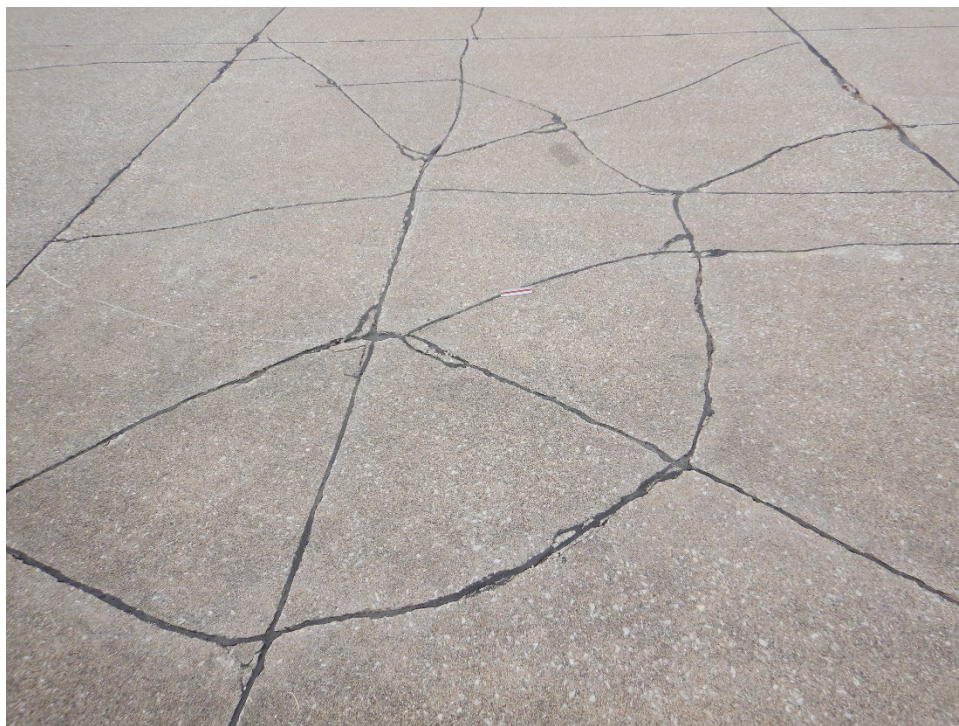
A03DA-01. Shattered Slab (Sample Unit No. 04).

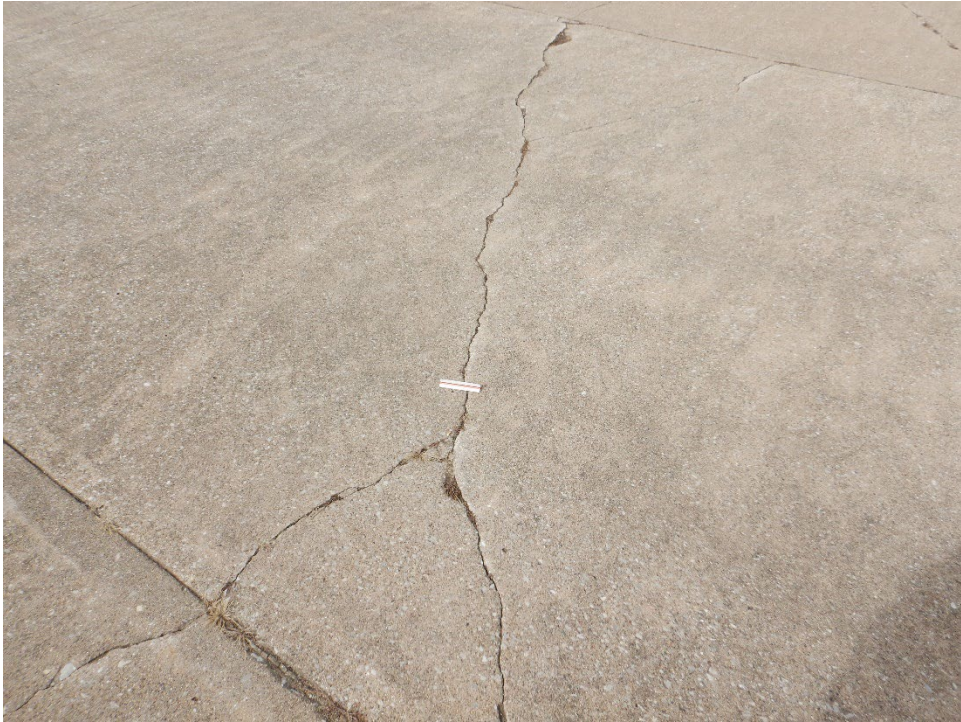
A04DA-01. Shattered Slab (Sample Unit No. 05).

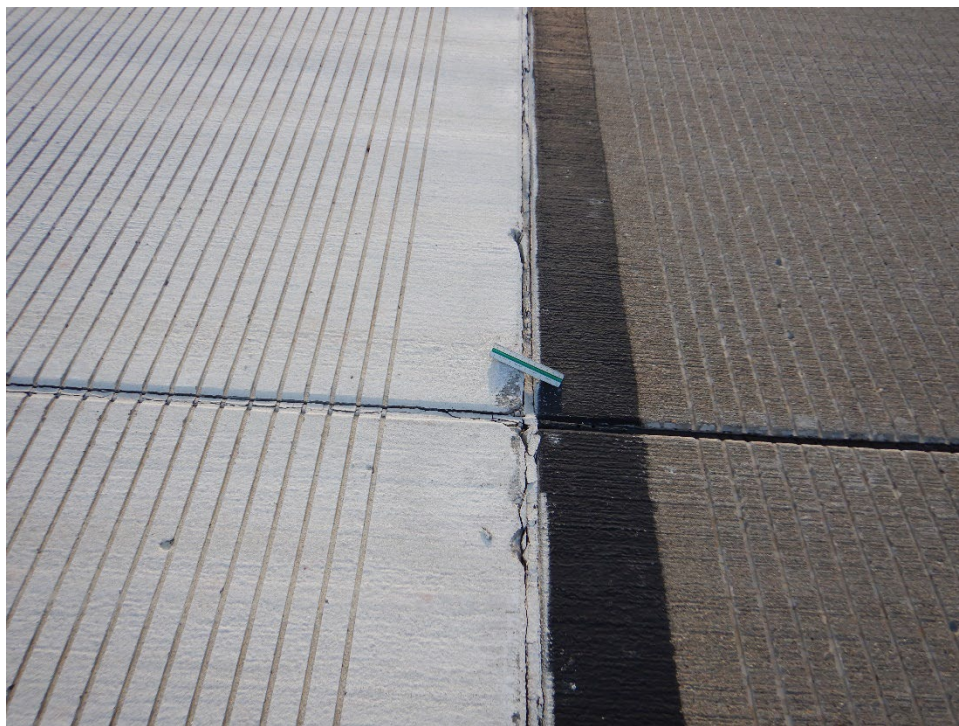
Runway 03/21 was defined by one section in excellent condition with areas of low-severity faulting and low- and medium-severity joint seal damage identified.

R03DA-01. Faulting (Sample Unit No. 07).

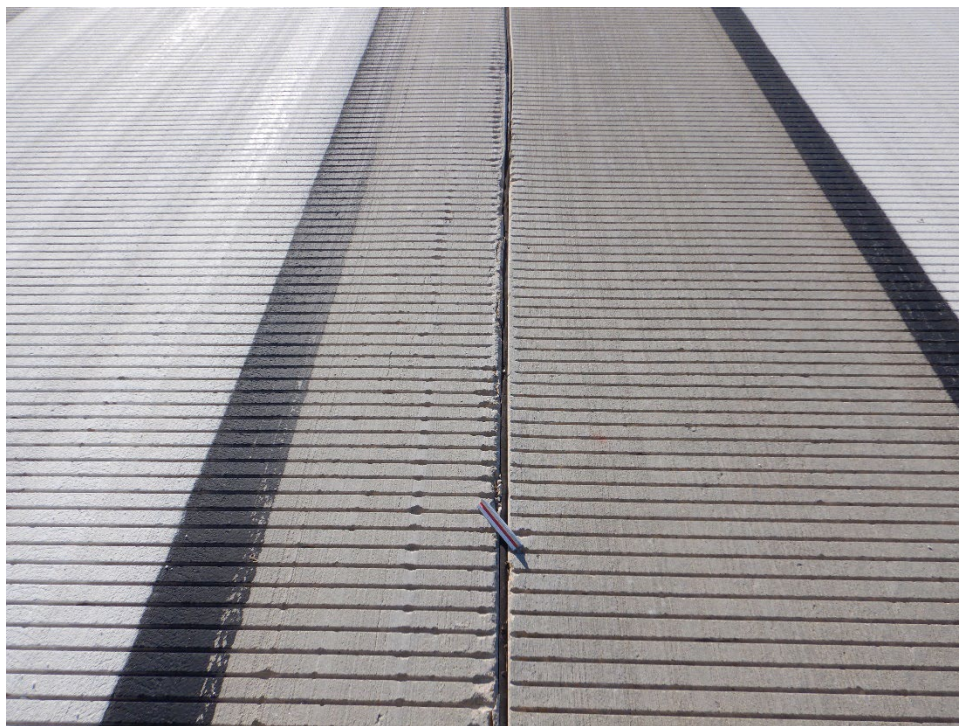
R15DA-01. Joint Seal Damage (Sample Unit No. 05).

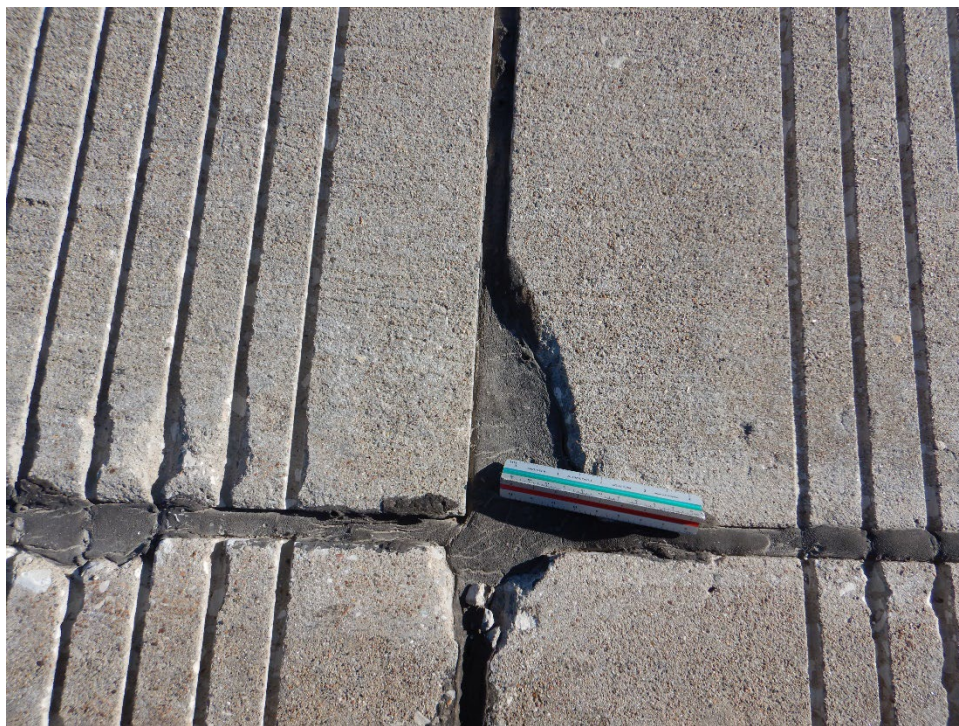
R15DA-02. Corner Spalling (Sample Unit No. 01).

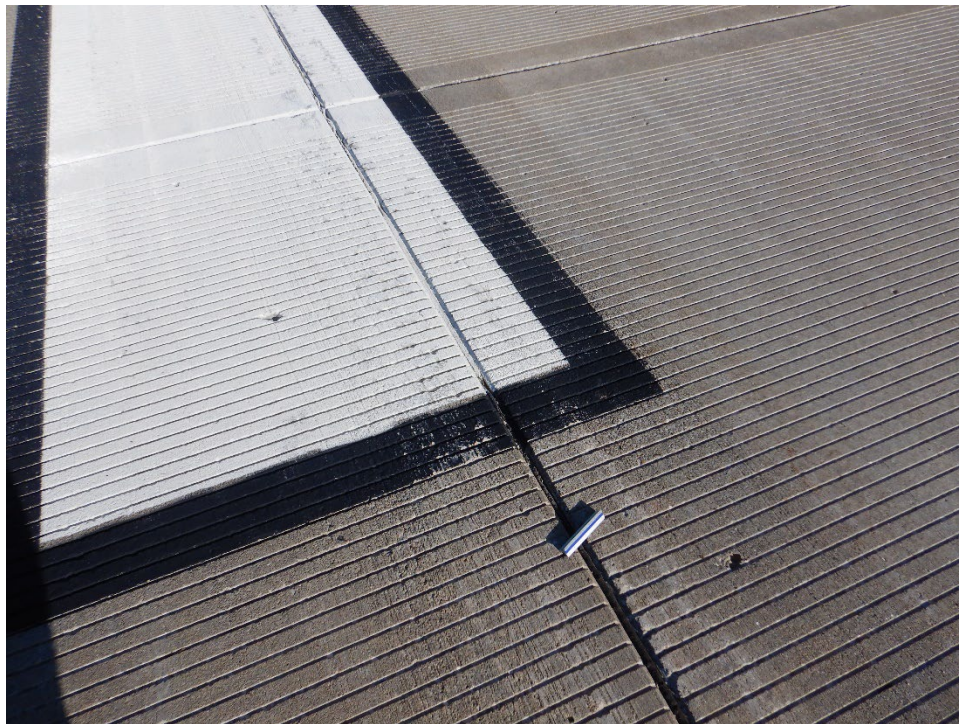
R15DA-03. Joint Seal Damage (Sample Unit No. 06).

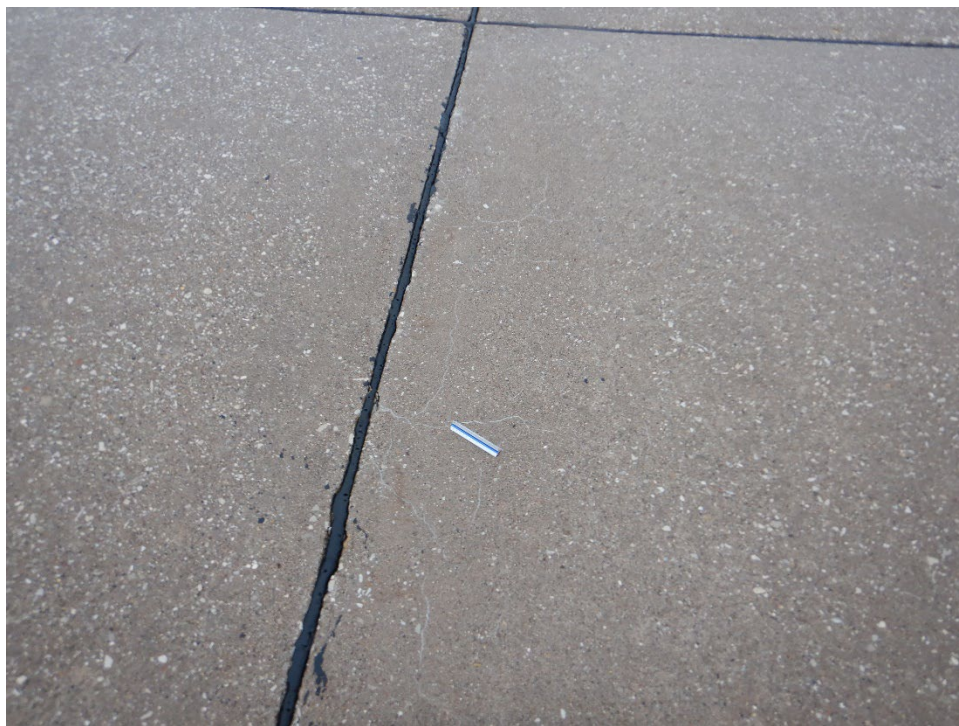
T01DA-01. ASR (Sample Unit No. 08).

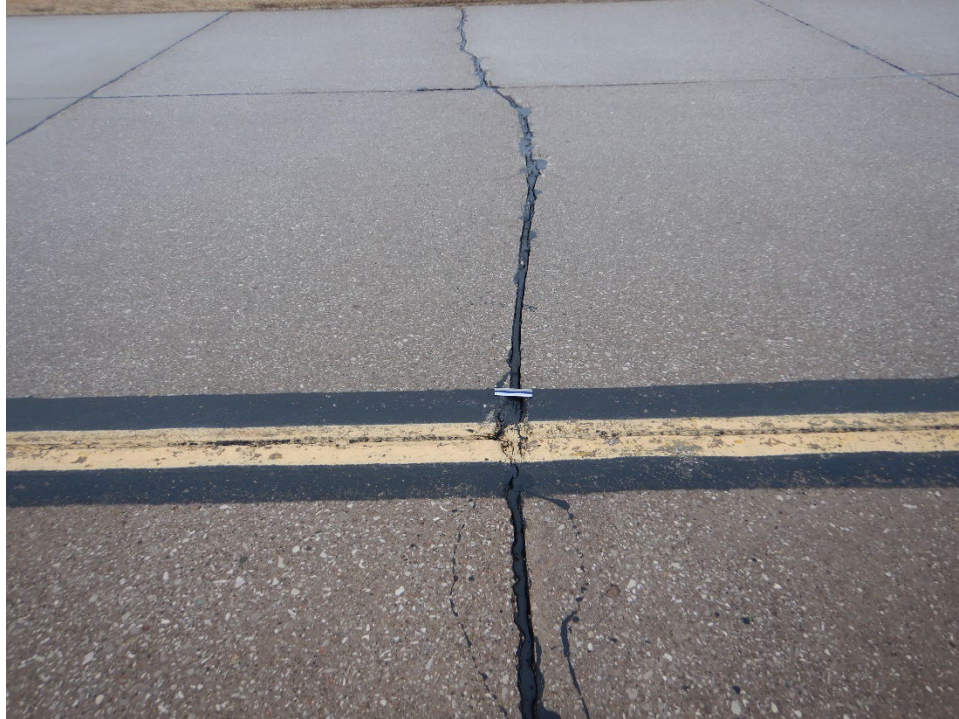
T01DA-01. LTD Cracking (Additional Sample Unit No. 04).

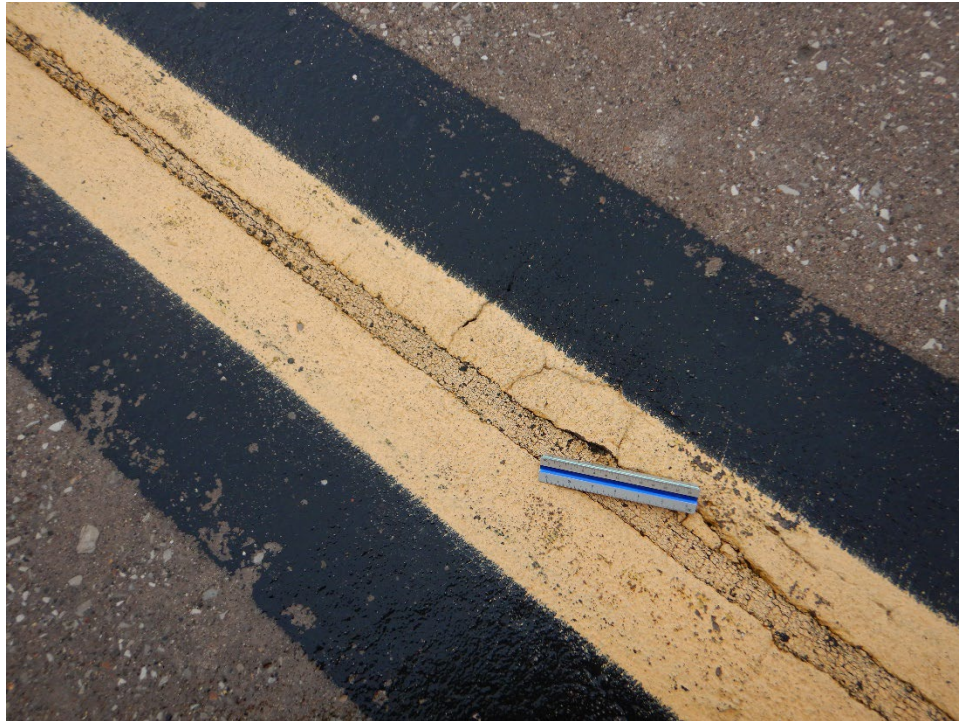
T01DA-02. ASR (Sample Unit No. 15).

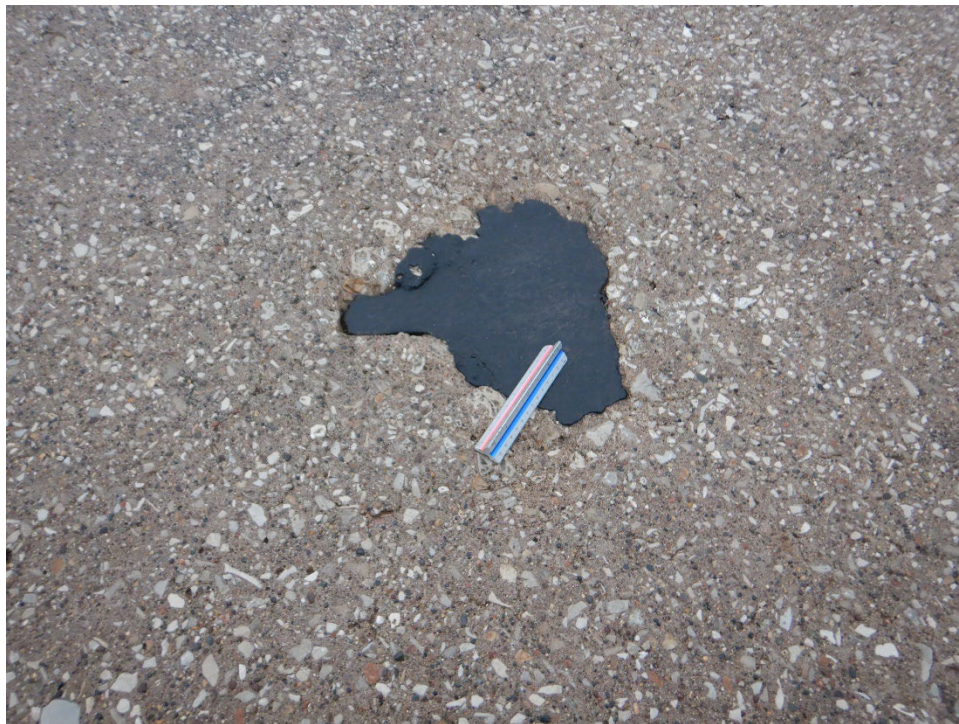
T01DA-02. Small Patching (Sample Unit No. 15).

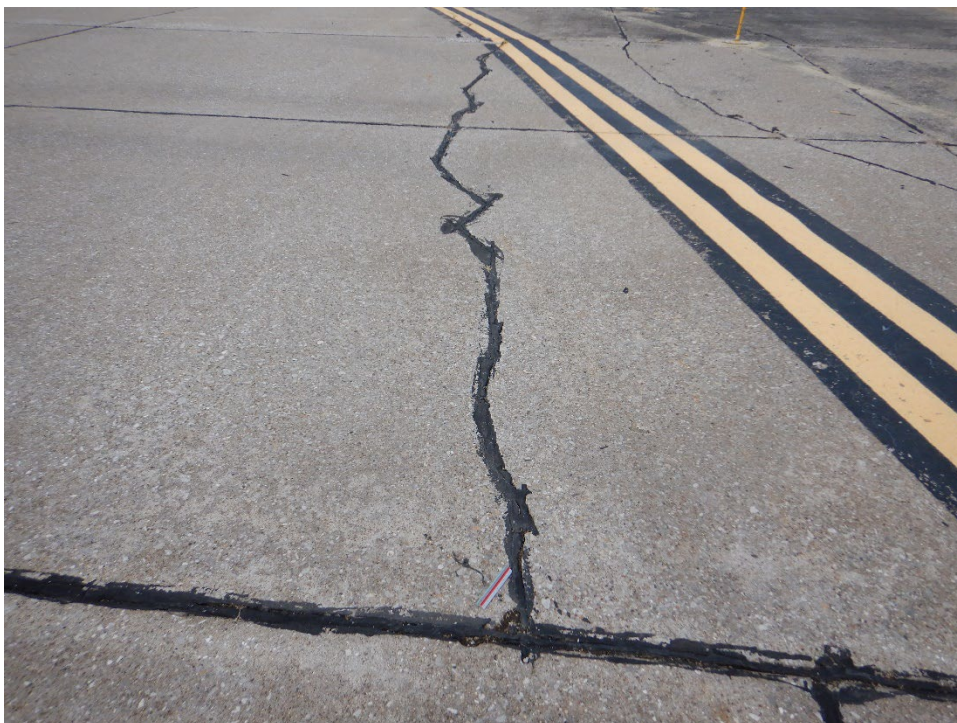
T01DA-03. LTD Cracking (Sample Unit No. 03).

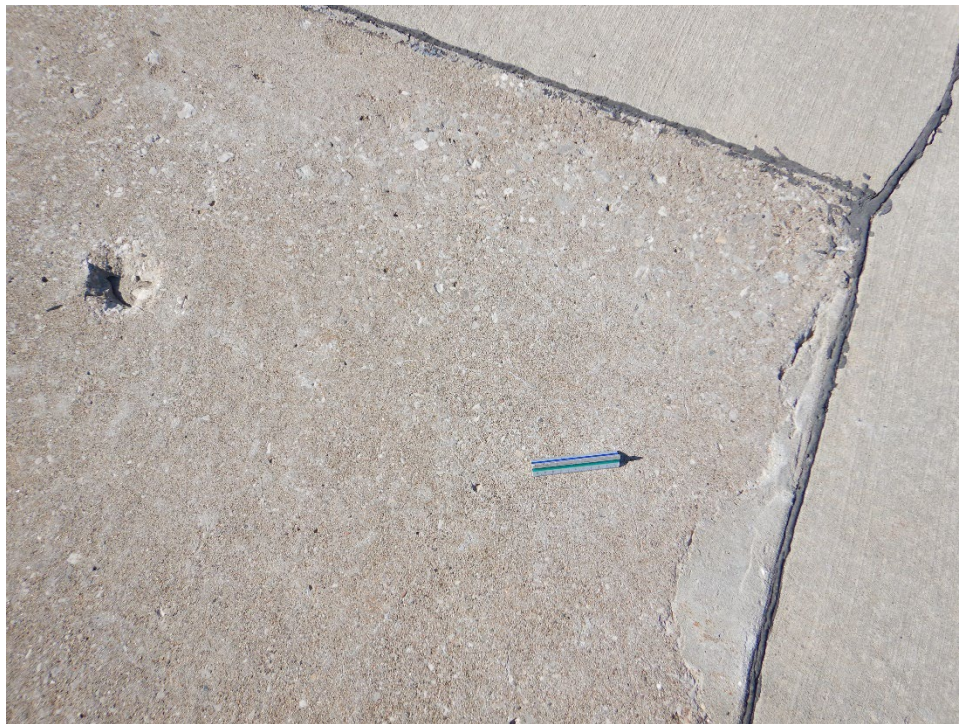
T01DA-04. ASR (Sample Unit No. 07).

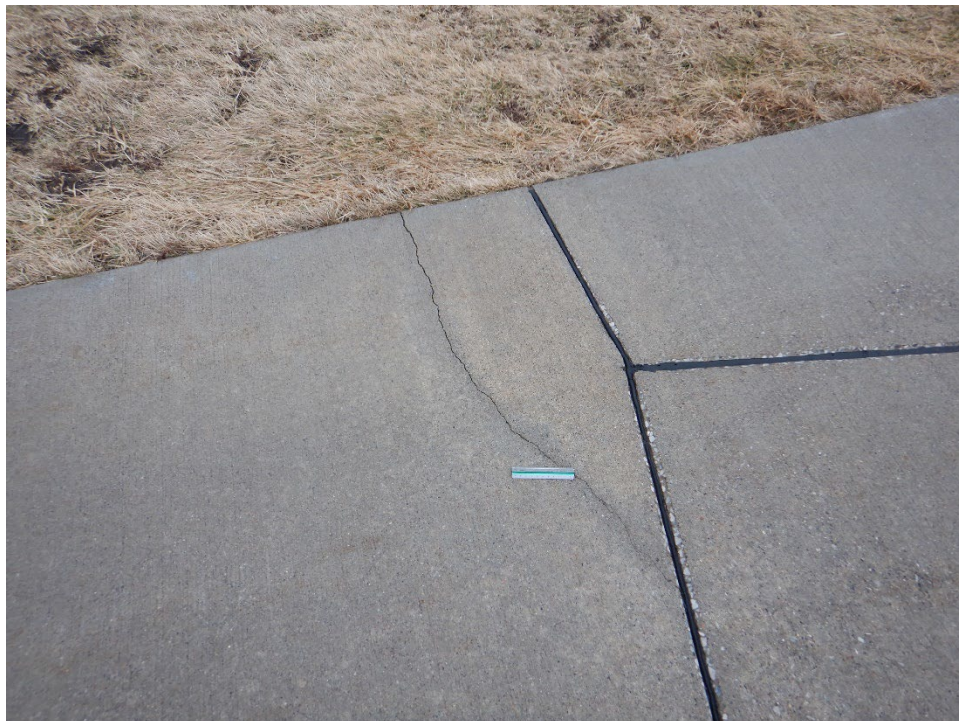
T01DA-05. Corner Break (Sample Unit No. 08).

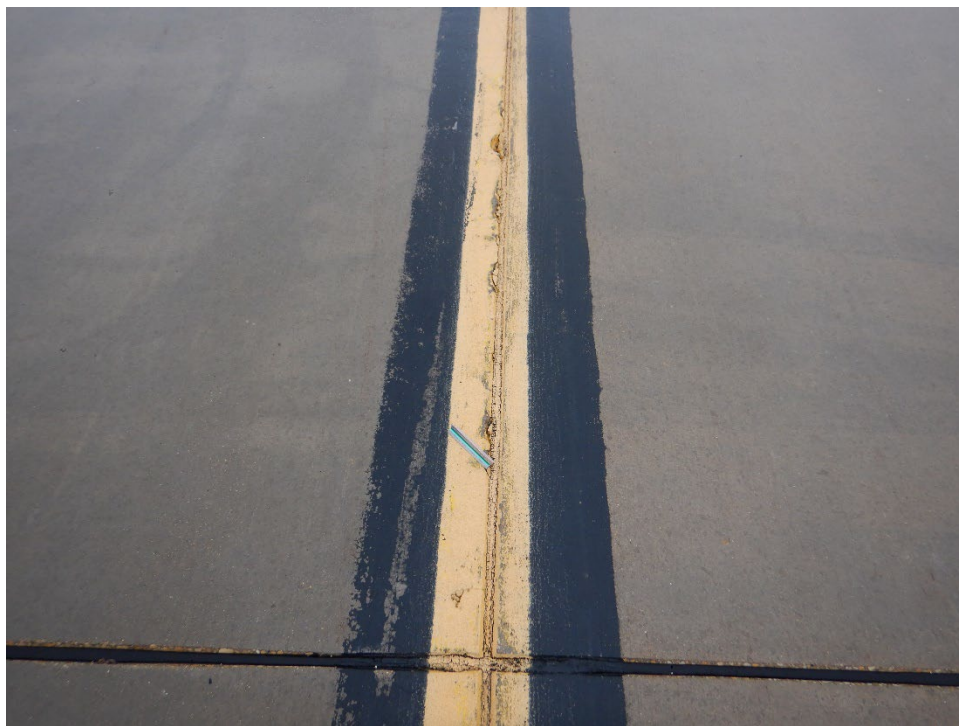
T01DA-06. Joint Seal Damage (Sample Unit No. 09).

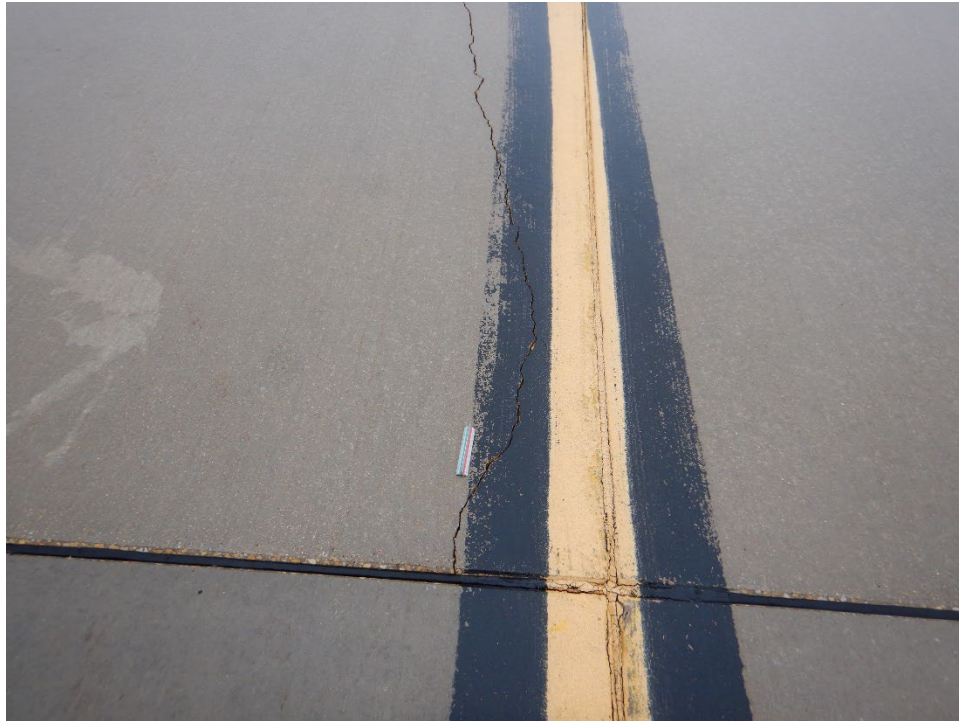
T01DA-06. LTD Cracking (Additional Sample Unit No. 08).

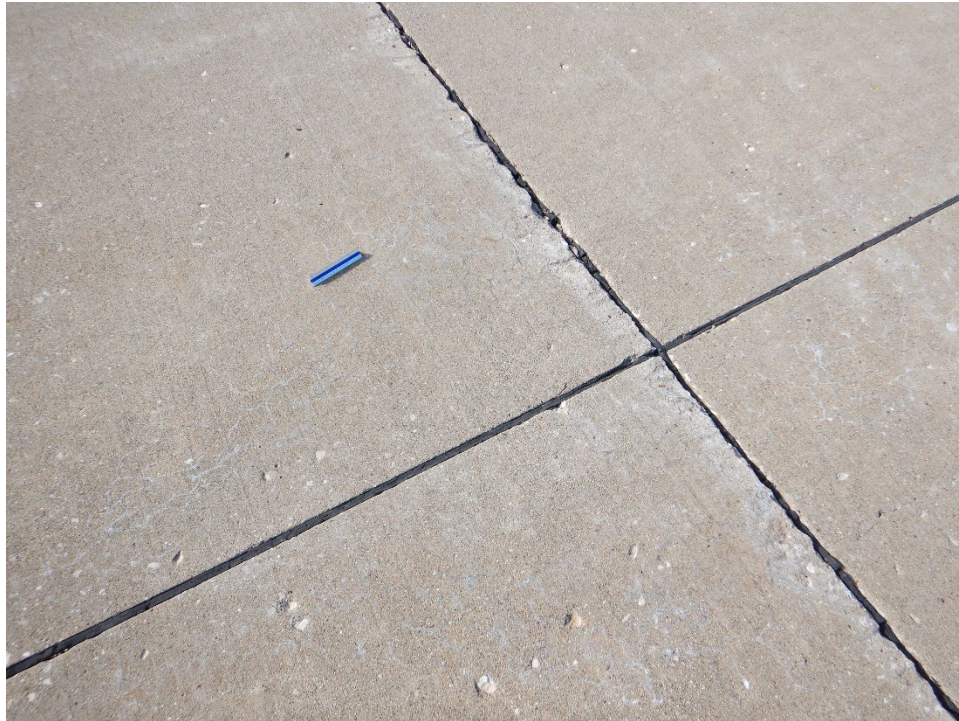
T02DA-01. ASR (Sample Unit No. 01).

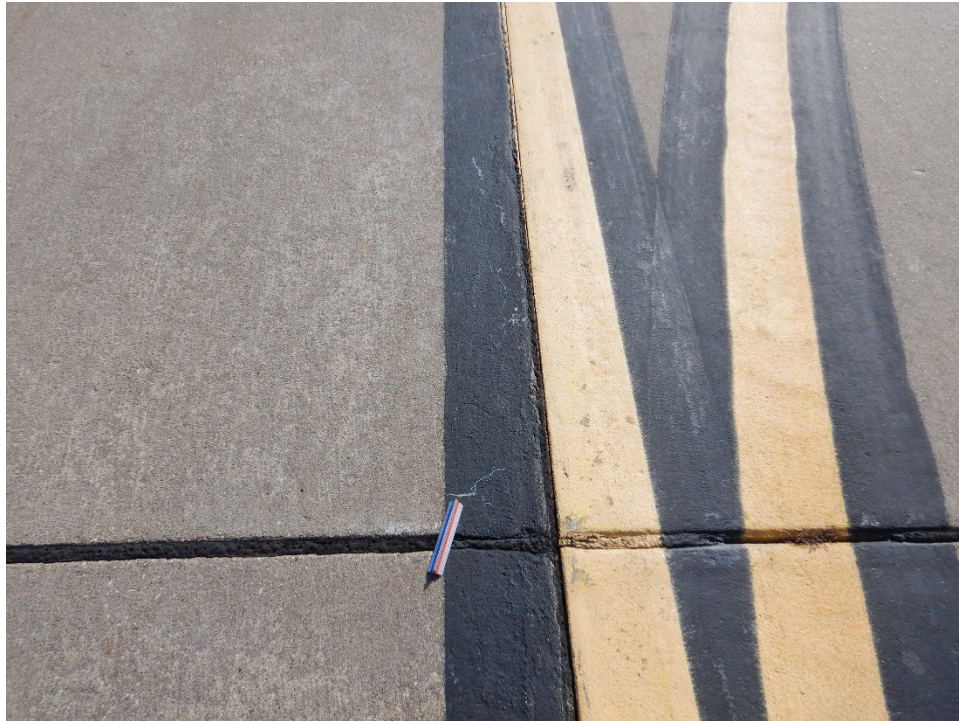
T02DA-02. ASR (Sample Unit No. 01).

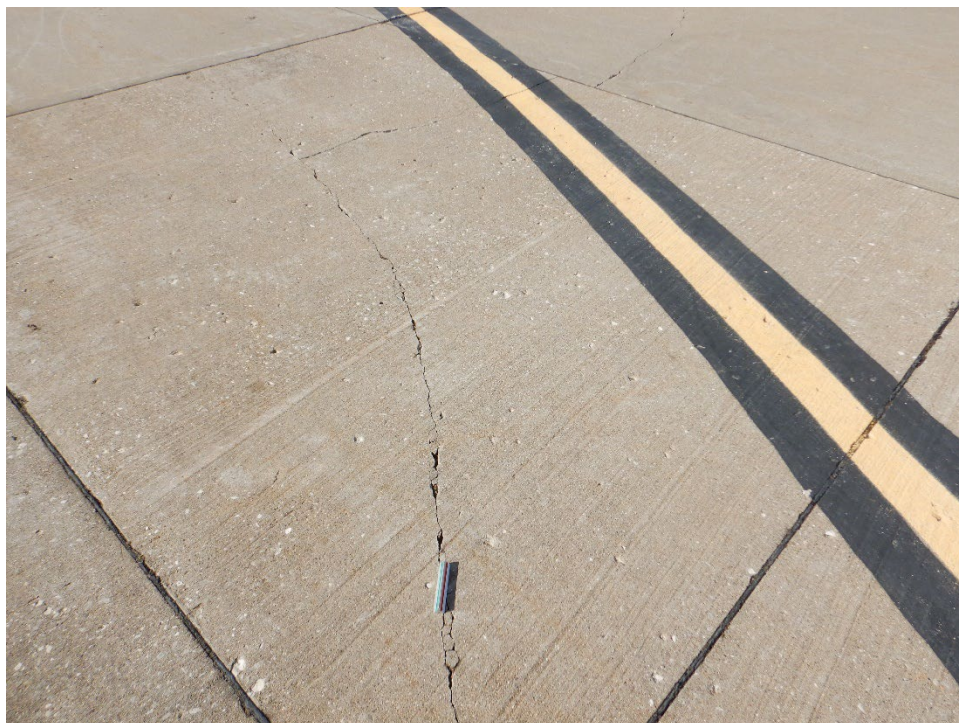
T02DA-02. LTD Cracking (Additional Sample Unit No. 04).

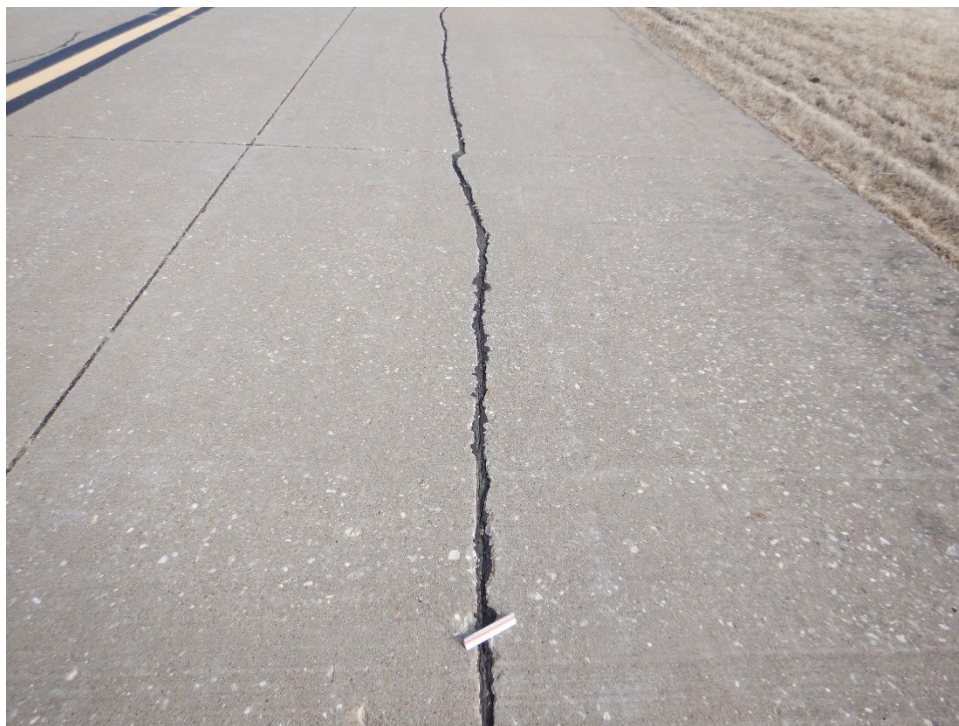
T02DA-03. LTD Cracking (Sample Unit No. 02).

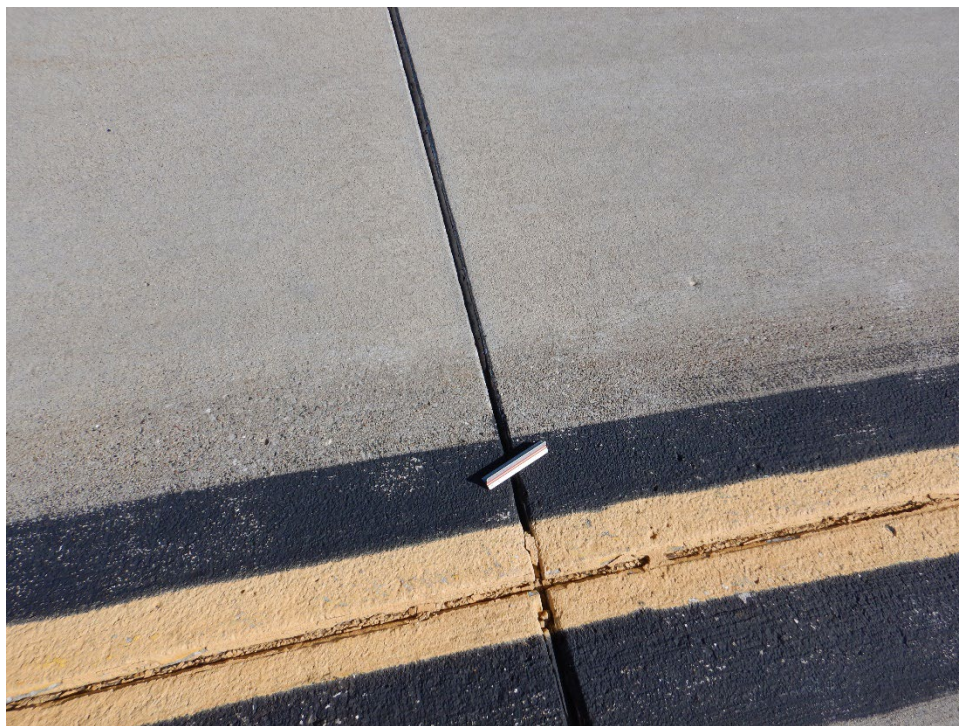
T02DA-04. Joint Seal Damage (Sample Unit No. 03).

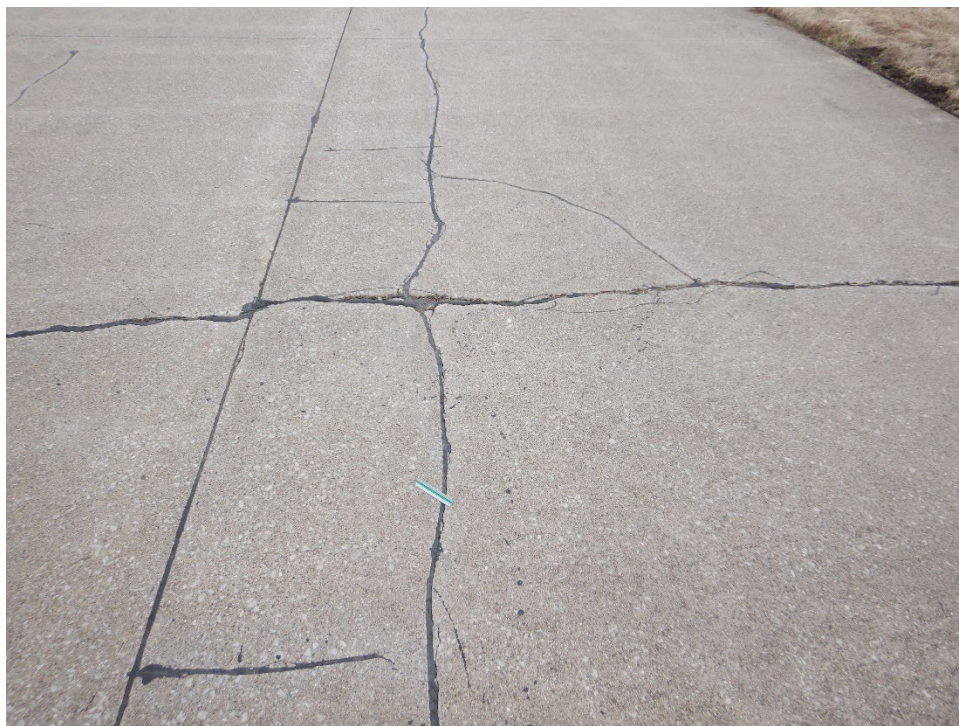
T03DA-01. Shattered Slab (Sample Unit No. 02).

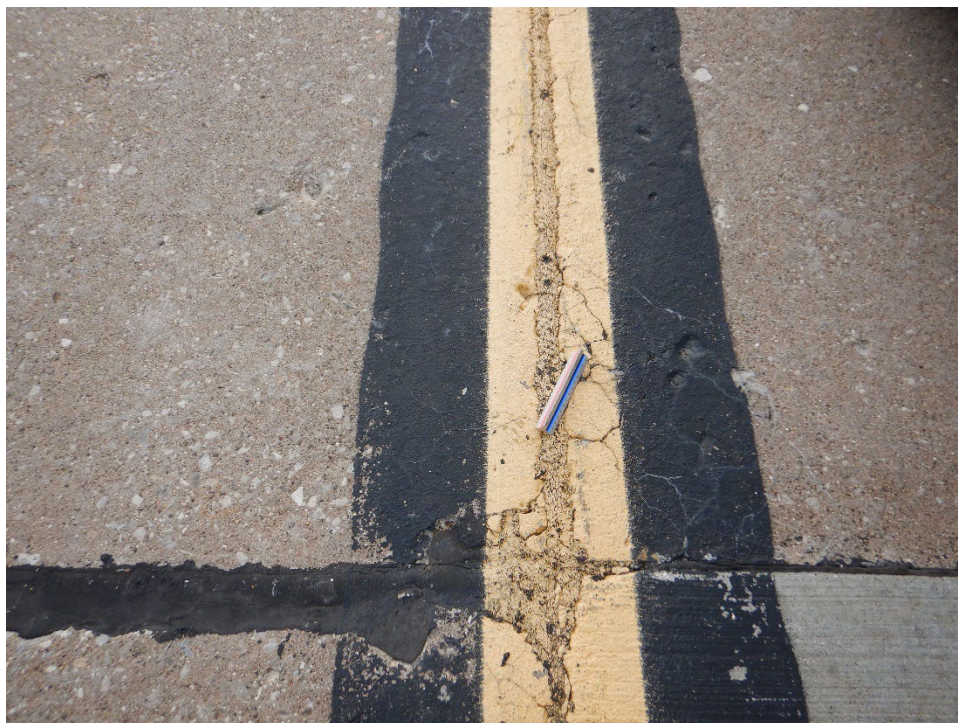
T03DA-02. ASR (Sample Unit No. 02).

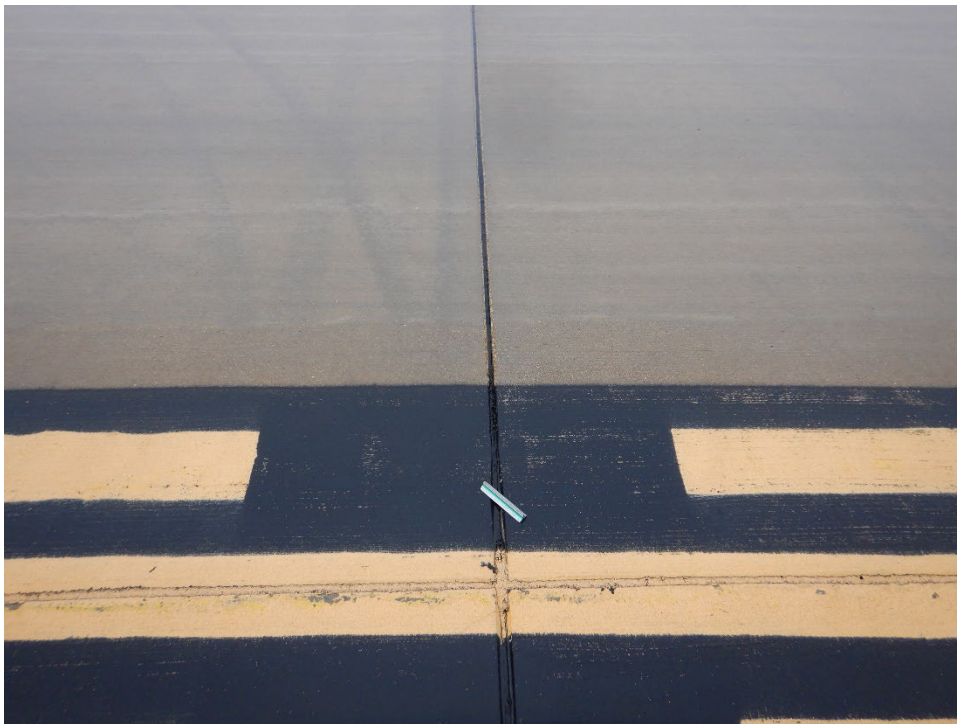
T03DA-03. Joint Seal Damage (Sample Unit No. 05).

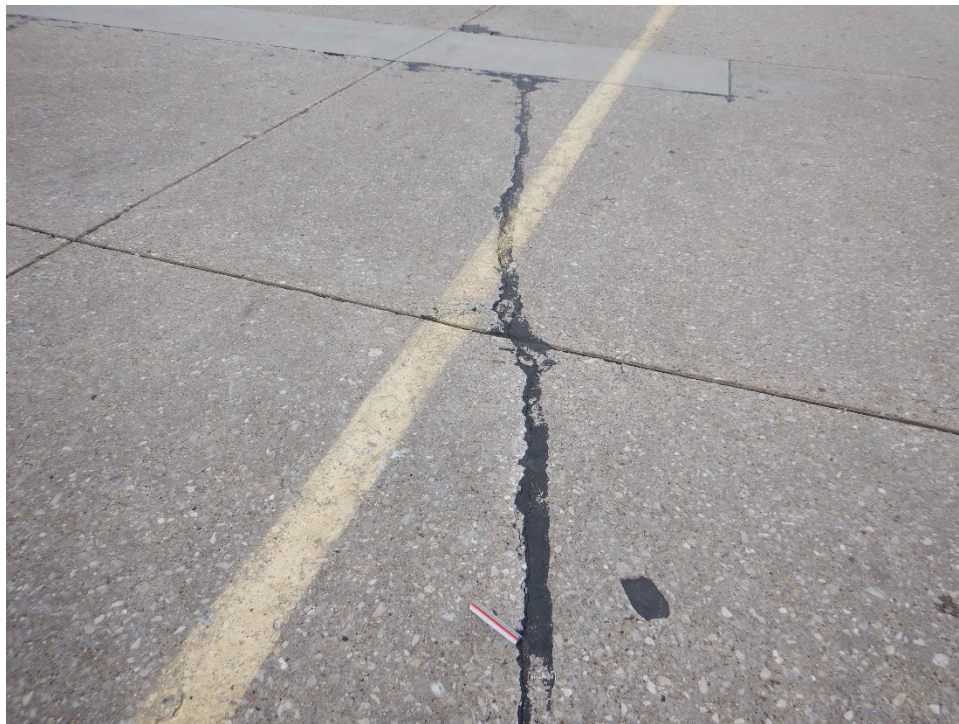
Taxiway 04 was defined by one section in poor condition, with areas of low- and medium-severity ASR and LTD cracking, high-severity joint seal damage, low-severity small patching and large patching, popouts, and medium-severity shattered slab.

T04DA-01. LTD Cracking (Sample Unit No. 01).

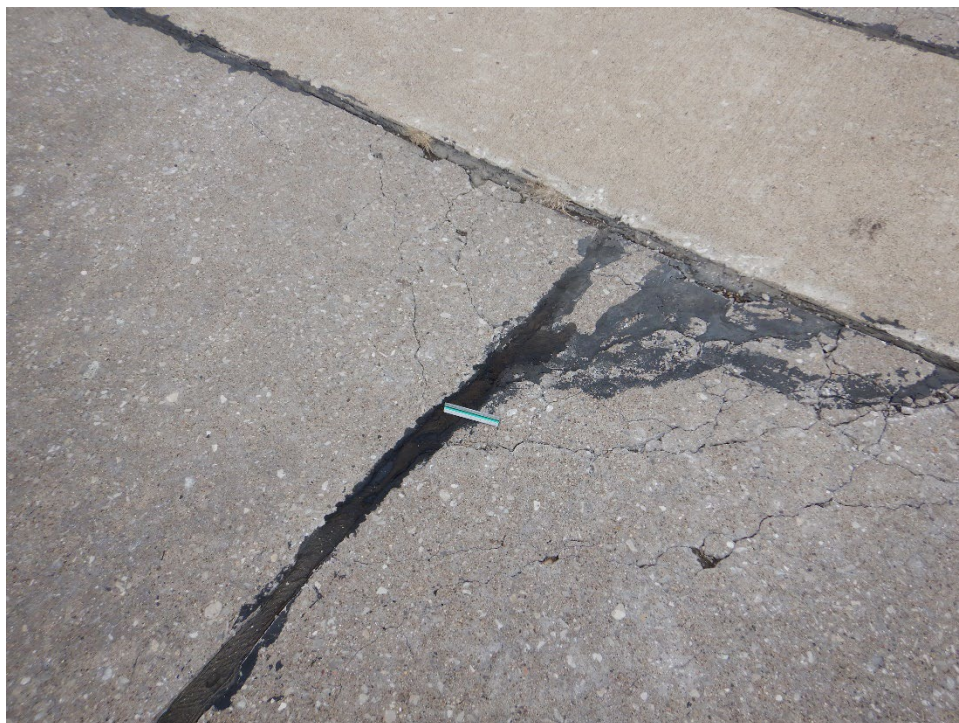
Taxiway 05 contained one section in poor condition. Areas of low-severity corner break, faulting, large patching, and shattered slab; low- and medium-severity ASR and LTD cracking; high-severity joint seal damage; and popouts were observed in Section 01.

T05DA-01. ASR (Sample Unit No. 01).

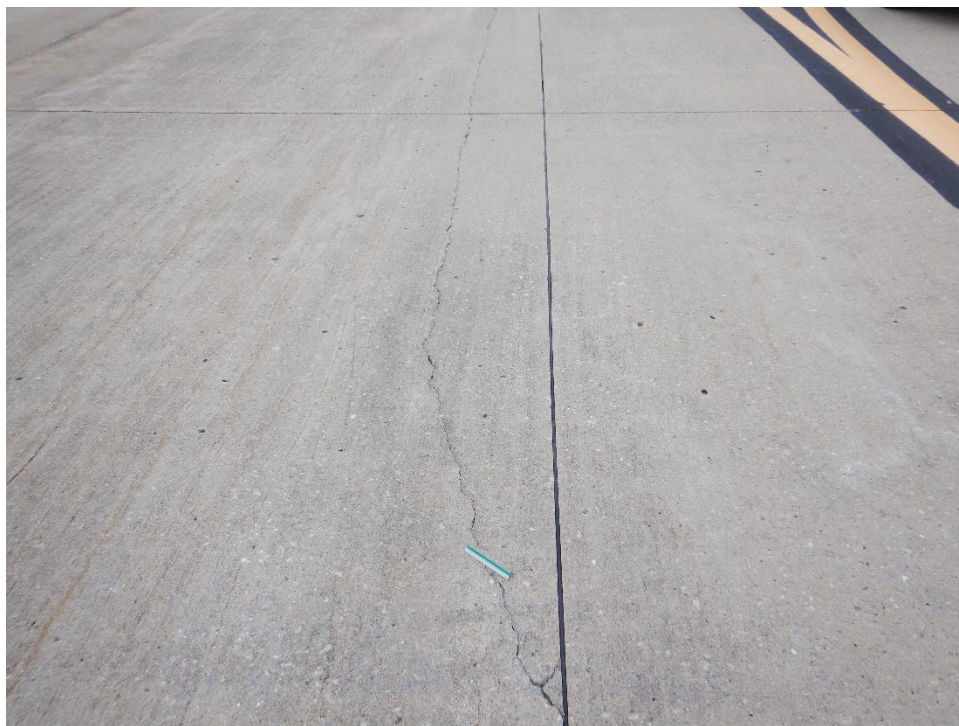
Taxiway 06 was defined by one section that contained areas of low-severity corner spalling and LTD cracking, high-severity joint seal damage, and medium-severity joint spalling.

T06DA-01. LTD Cracking (Sample Unit No. 02).

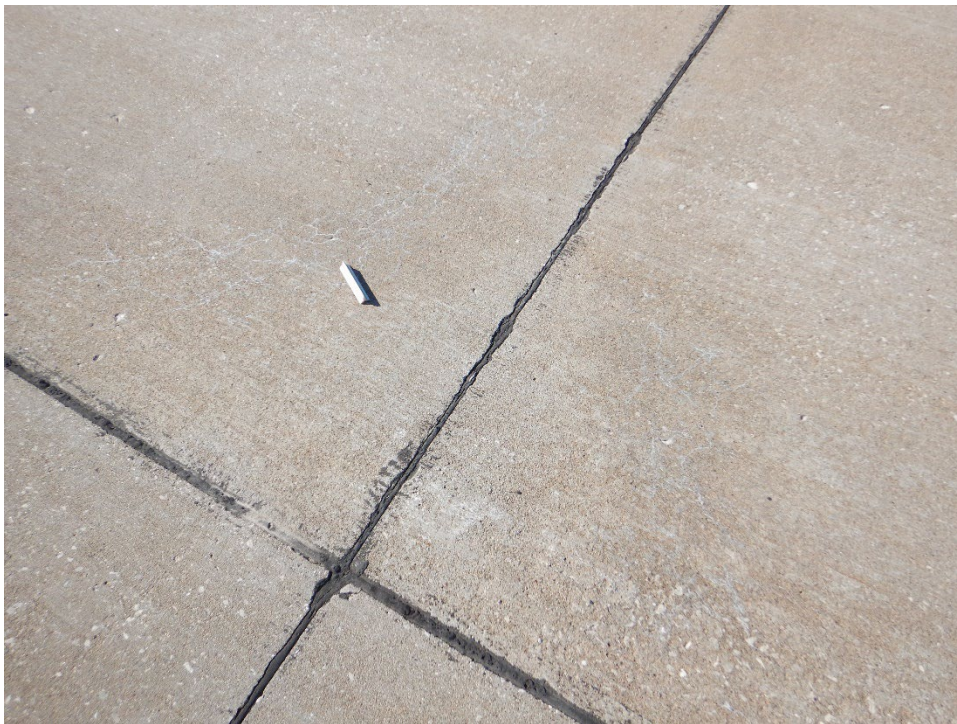
T07DA-01. ASR (Sample Unit No. 12) (1).

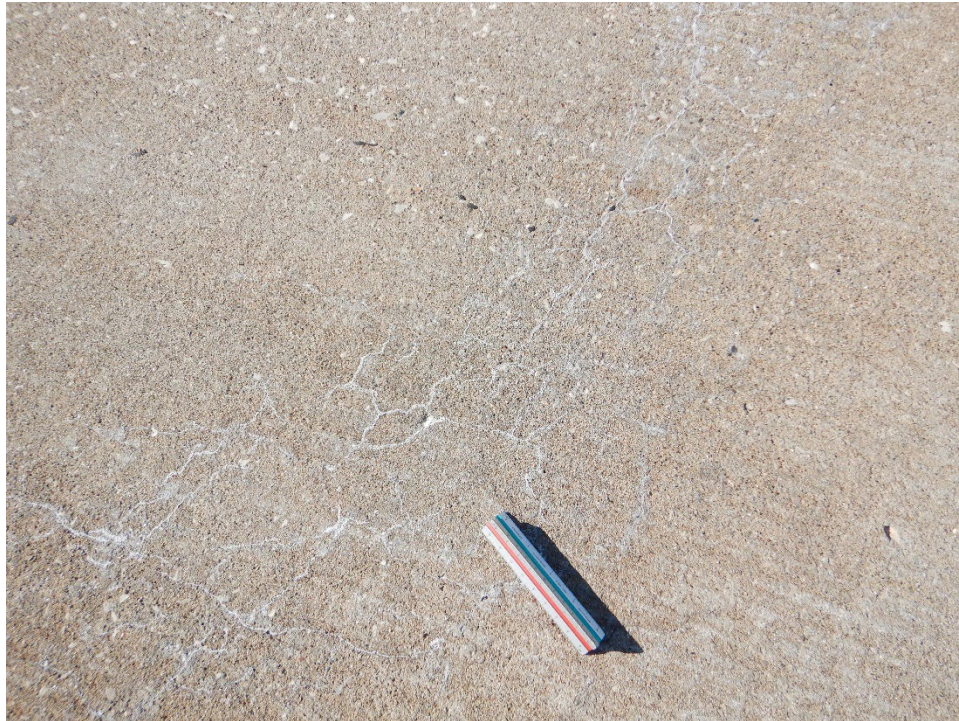
T07DA-01. ASR (Sample Unit No. 12) (2).

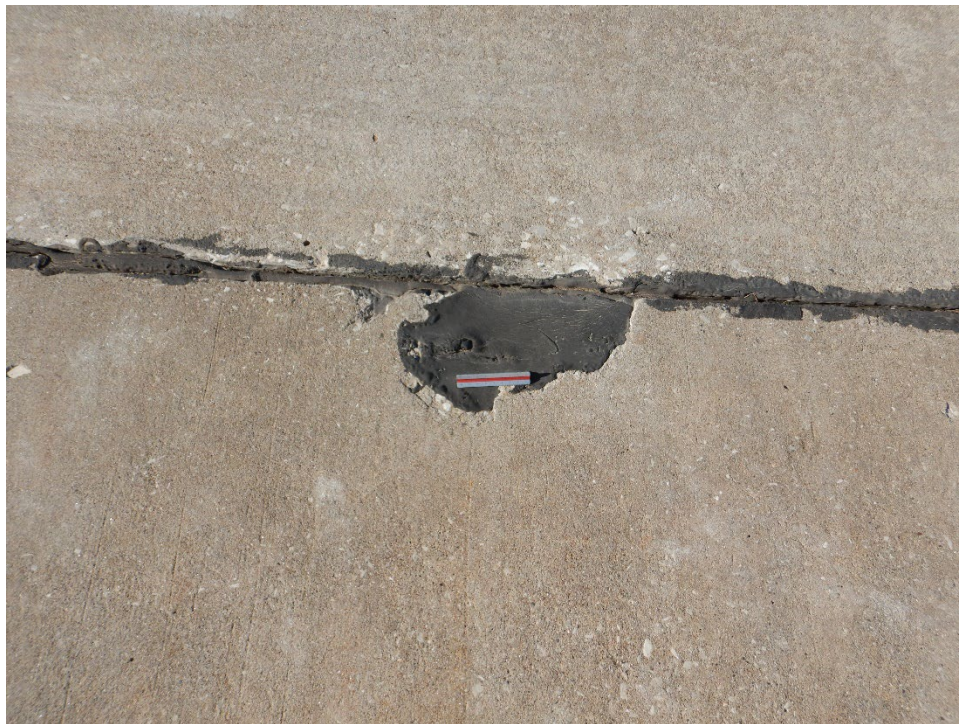
T07DA-01. Joint Spalling (Sample Unit No. 02).
