Davenport Municipal Airport

Pavement Management Report

JULY 2023

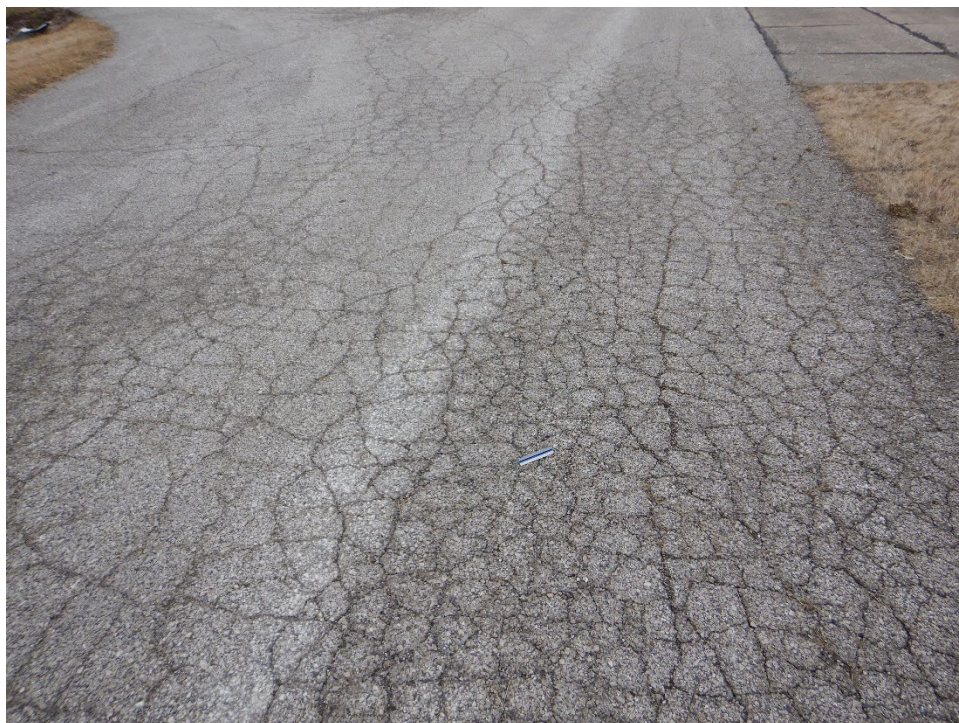
TH01DA-01. Alligator Cracking (Sample Unit No. 02).

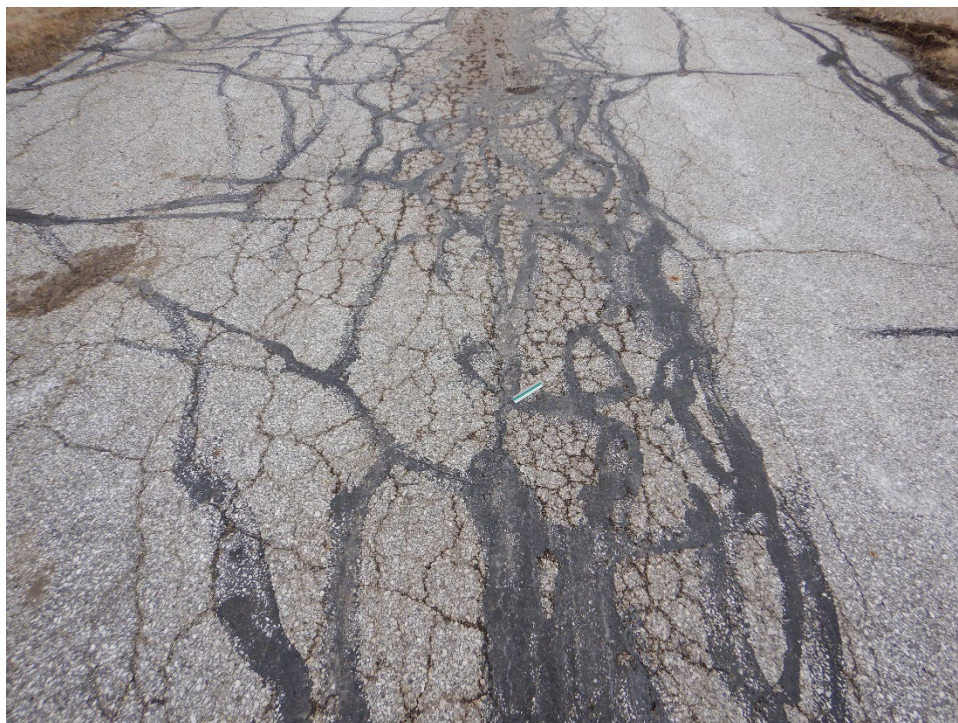
TH01DA-02. Alligator Cracking (Sample Unit No. 07).

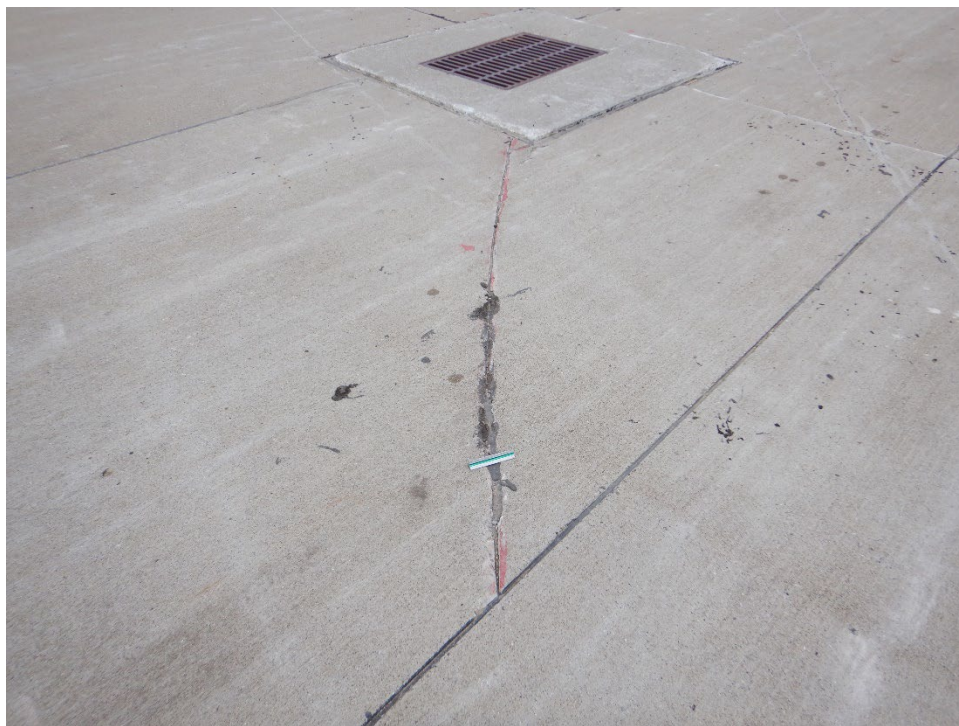
TH01DA-03. LTD Cracking (Sample Unit No. 07).

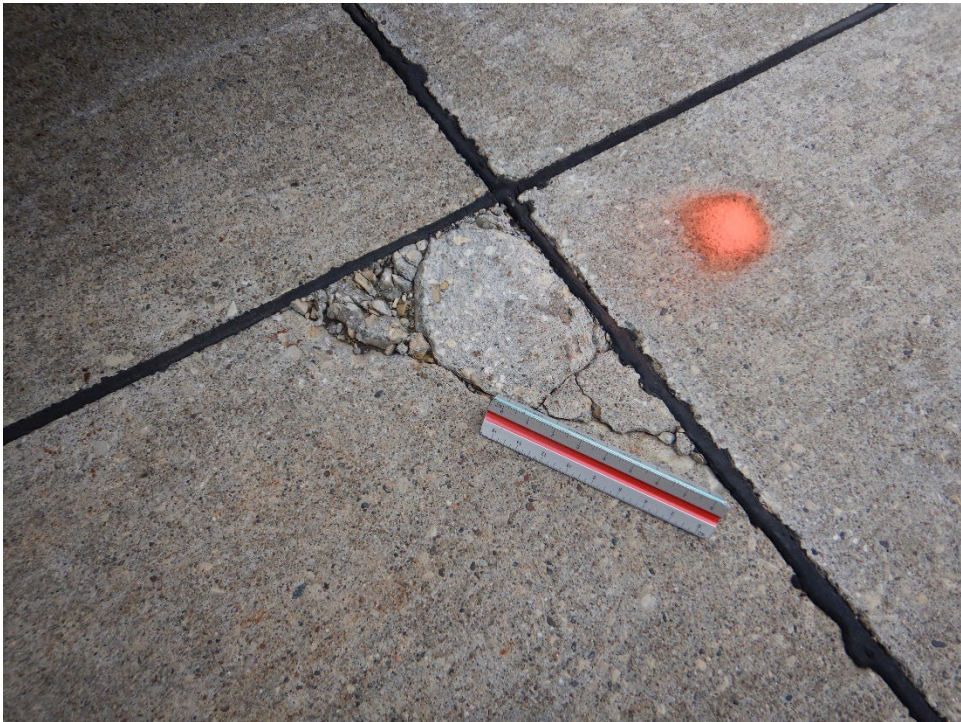
TH01DA-04. Corner Spalling (Sample Unit No. 09).
