Eagle Grove Municipal Airport

PAVEMENT MANAGEMENT REPORT

AUGUST 2019

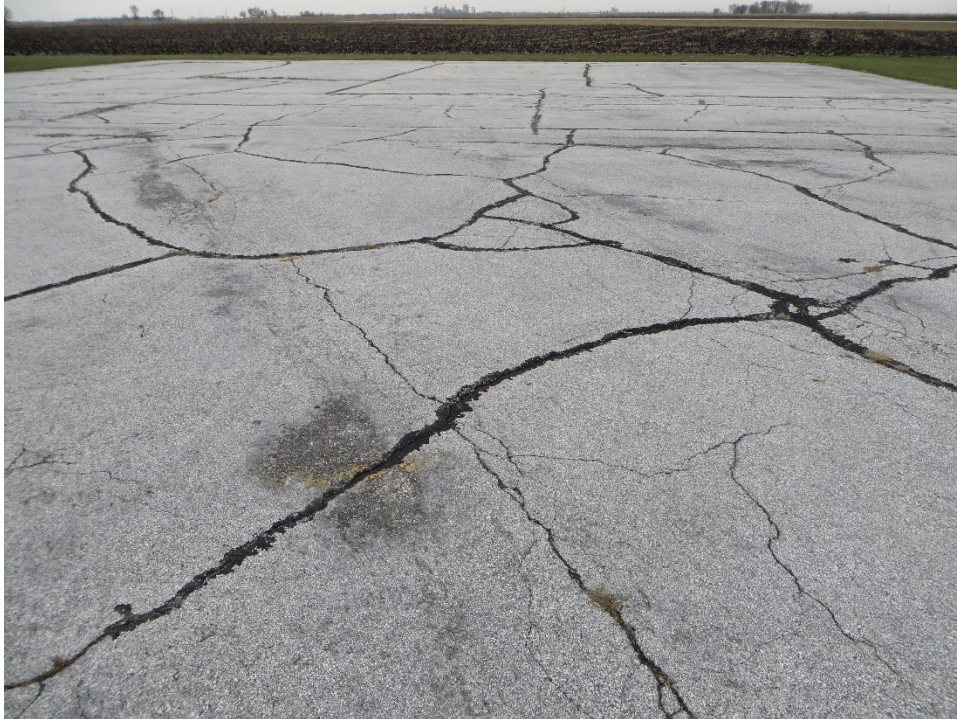
The apron area contained one section that was in poor condition. Low- and medium-severity alligator cracking and longitudinal and transverse (L&T) cracking, medium-severity block cracking, low-severity depression, high-severity raveling, and medium-severity rutting and weathering were observed in Section 01. The low-severity L&T cracking was unsealed; the medium-severity block and L&T cracking were due to either failed crack sealant, the development of secondary cracking, or unsealed crack widths greater than 1/4 in; and the low-severity alligator cracking was noted in areas where the width of the pattern cracking exceeded 1 ft.

A01EG-01. Overview.

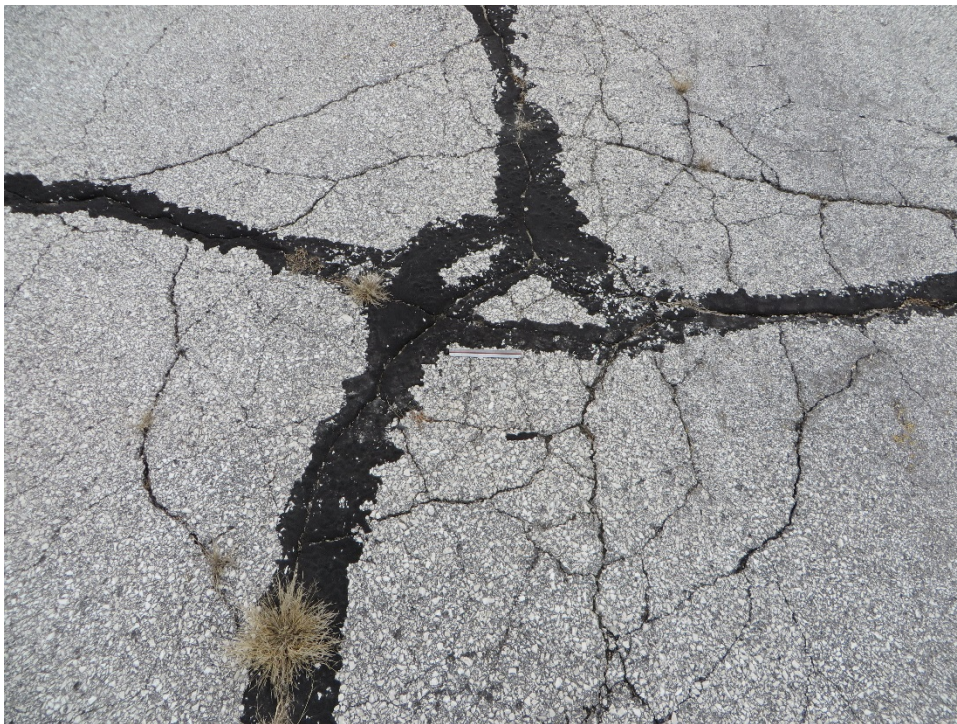
A01EG-01. Alligator Cracking (Sample Unit No. 01).

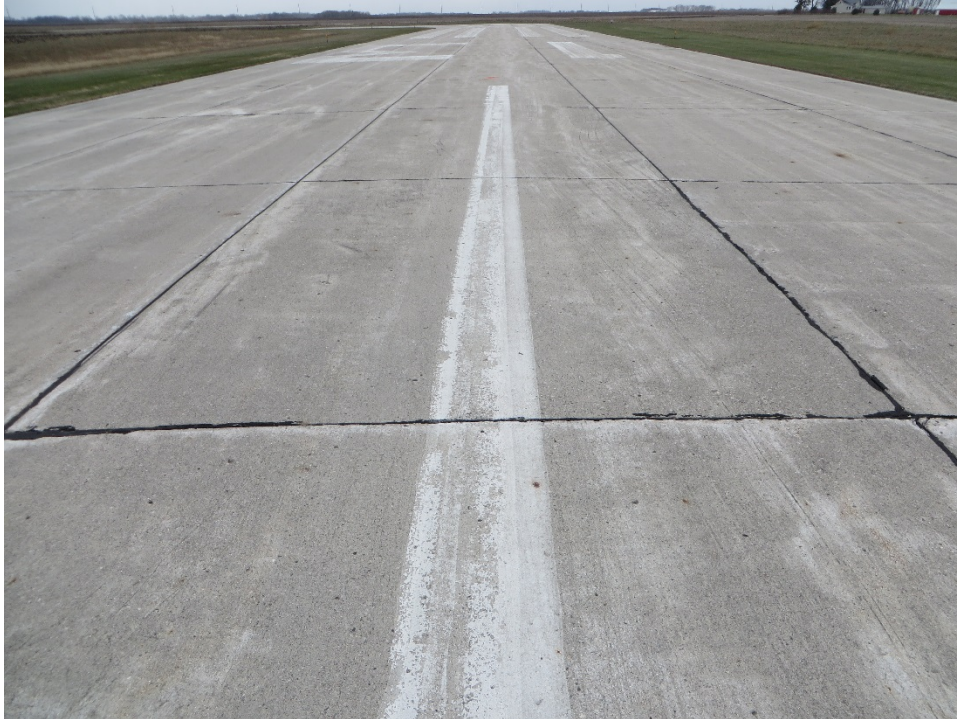
Runway 13/31 consisted of two sections. Section 01, located at the Runway 13 approach, had low- and medium-severity ASR, corner break, and longitudinal, transverse, and diagonal (LTD) cracking; medium-severity corner spalling, joint seal damage, and shattered slab; all severities of joint spalling; popouts; and low-severity small patching recorded throughout. Section 02 was defined by the majority of the runway. All severities of joint spalling and corner spalling, low-severity faulting and small patching, medium- and high-severity joint seal damage, low- and medium-severity LTD cracking, medium-severity shattered slab, and shrinkage cracking were observed in Section 02.

R13EG-01. Overview.

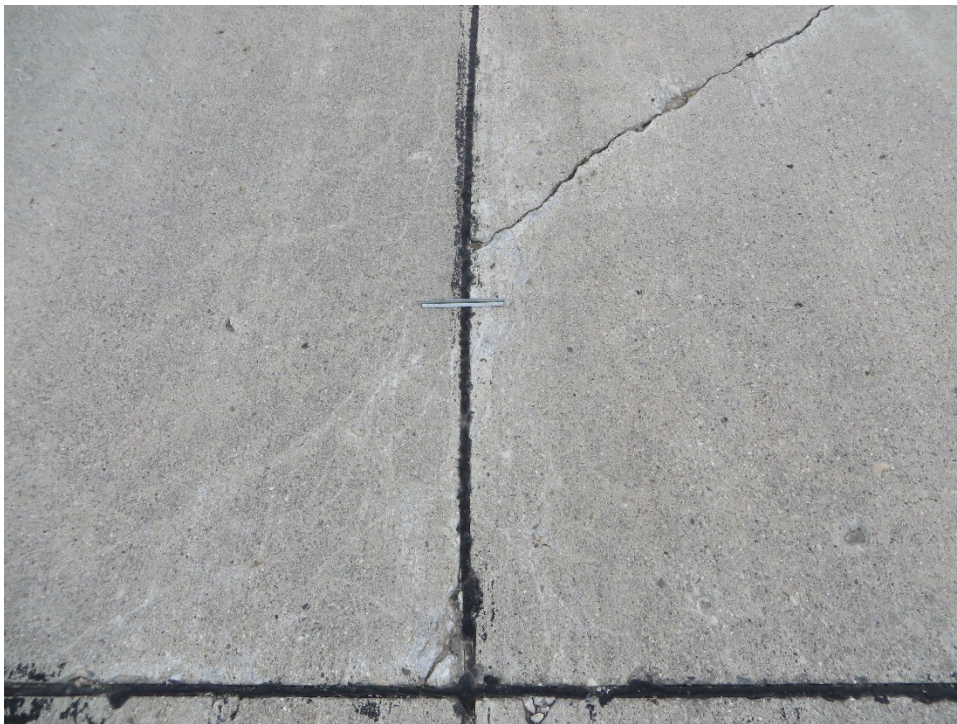
R13EG-01. ASR (Sample Unit No. 05).

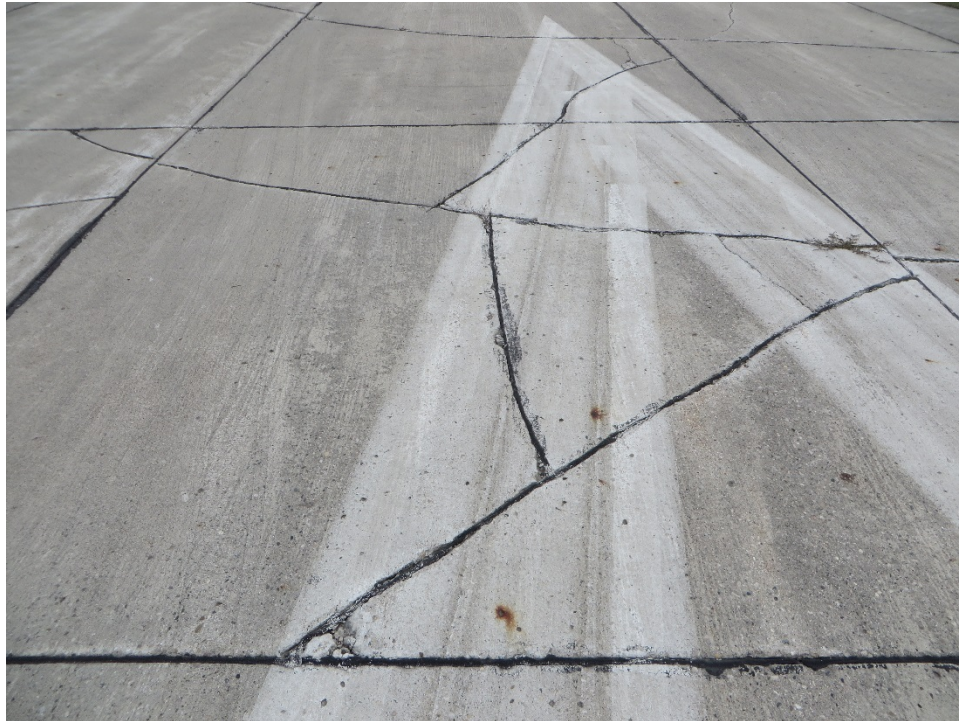
R13EG-01. Shattered Slab (Sample Unit No. 04).

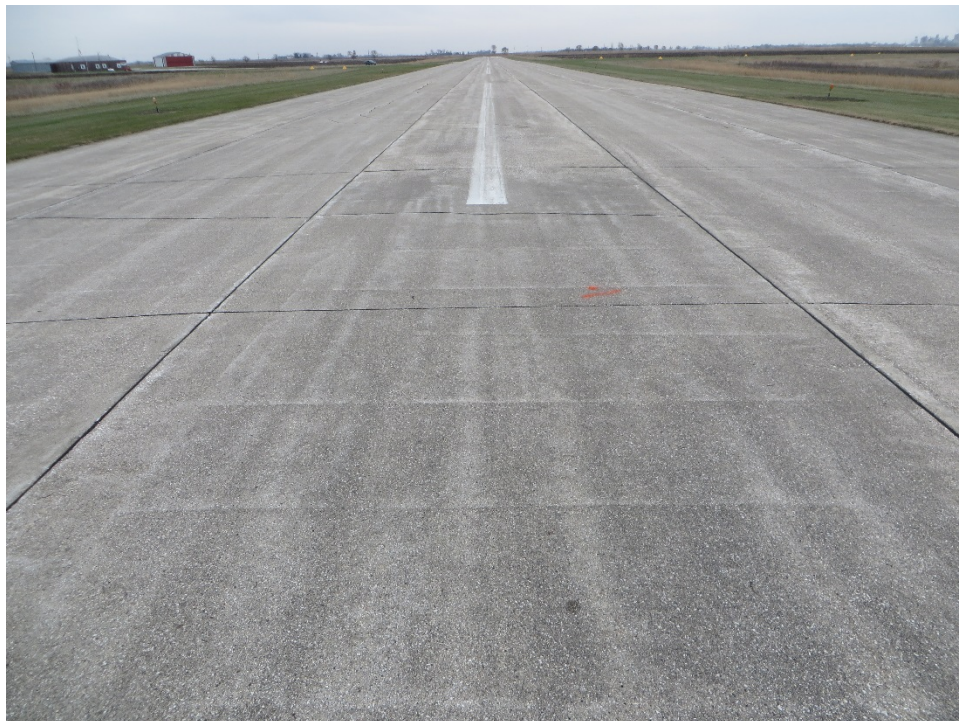
R13EG-02. Overview.

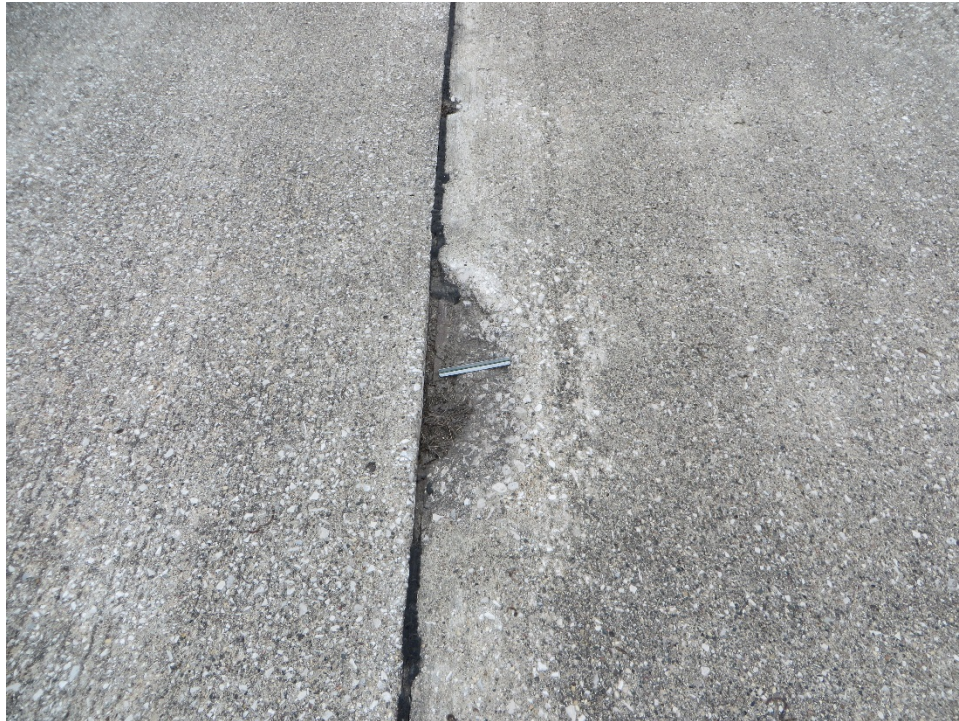
R13EG-02. Joint Spalling (Sample Unit No. 12).

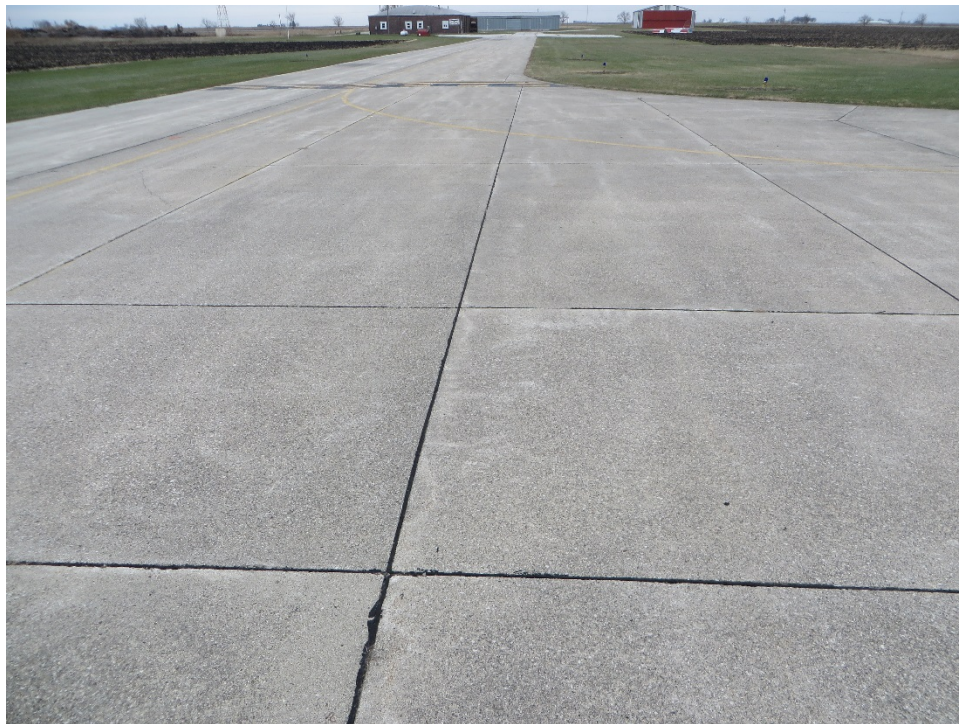
Taxiway 01 connected the apron area and Runway 13/31 and was defined by two sections. Low-severity corner break, faulting, and joint seal damage and low- and medium-severity joint spalling and LTD cracking were identified in Section 01. Section 02 had with low-severity ASR and faulting; all severities of corner spalling; low- and medium-severity joint seal damage, LTD cracking, and joint spalling; and popouts recorded at the time of inspection.

T01EG-01. Overview.

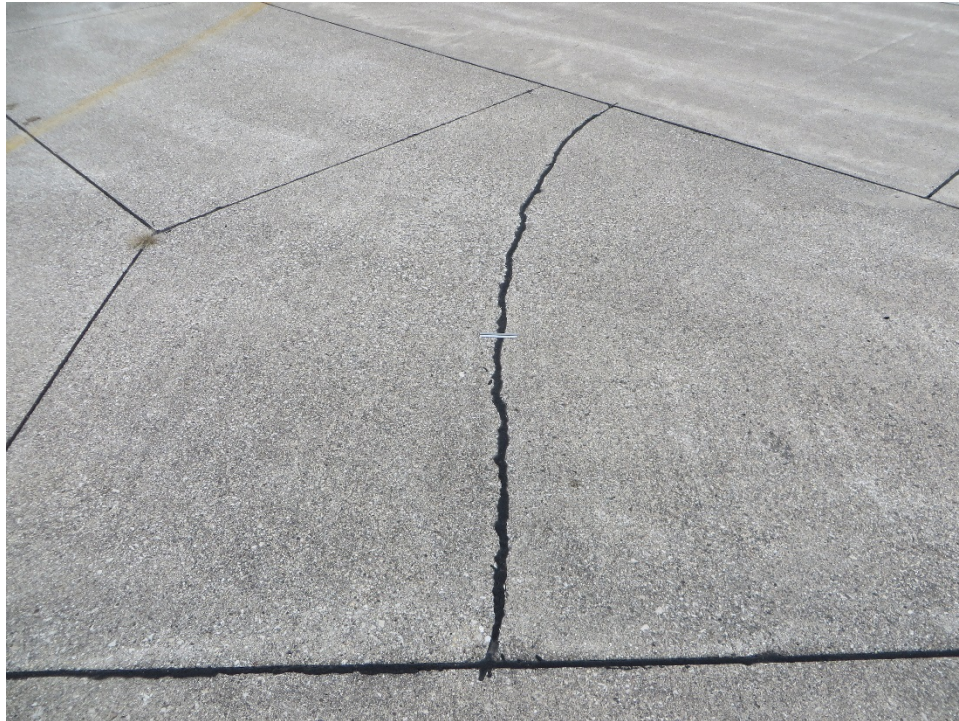
T01EG-01. LTD Cracking (Sample Unit No. 01).

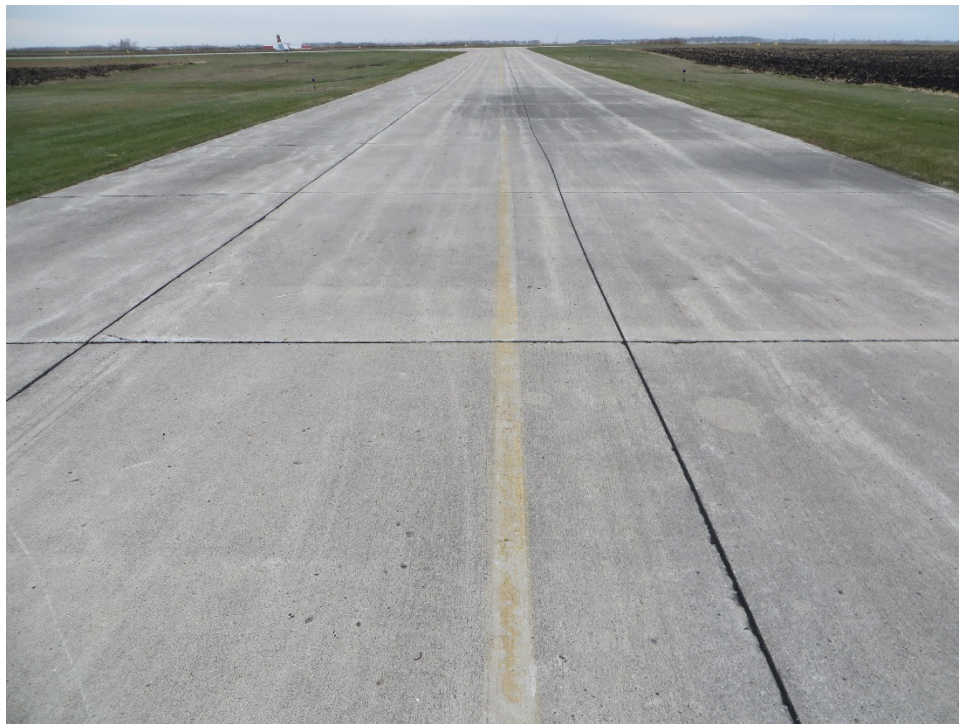
T01EG-02. Overview.

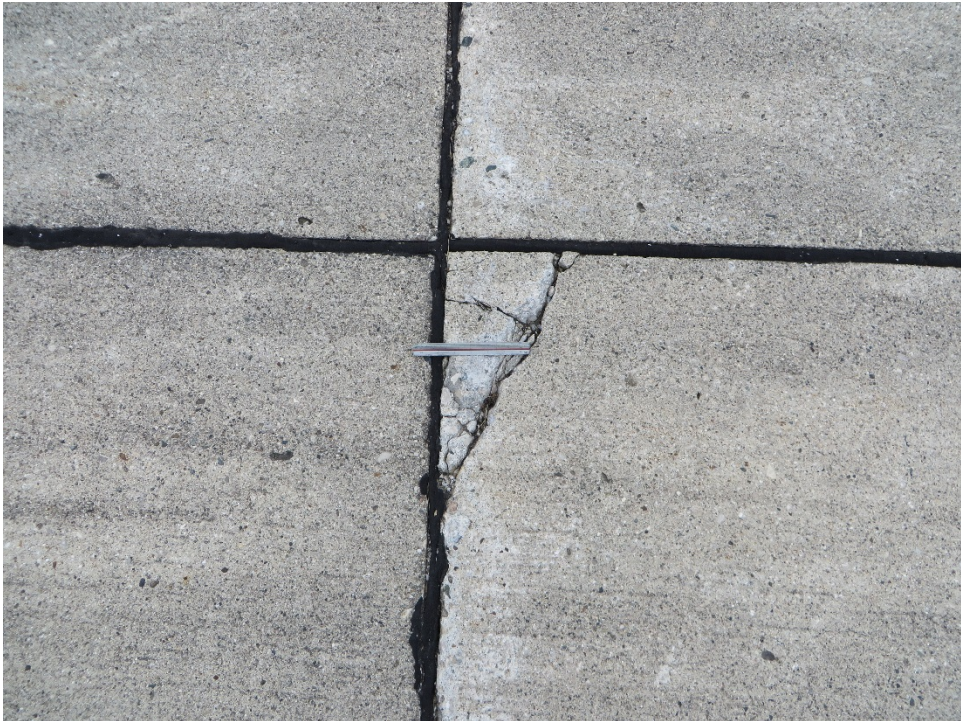
T01EG-02. Joint Spalling (Sample Unit No. 04).
