EMMETSBURG MUNICIPAL AIRPORT PAVEMENT MANAGEMENT REPORT

Prepared For:
Iowa Department of Transportation
Office of Aviation

Prepared By:
Applied Pavement Technology, Inc.

April 2016

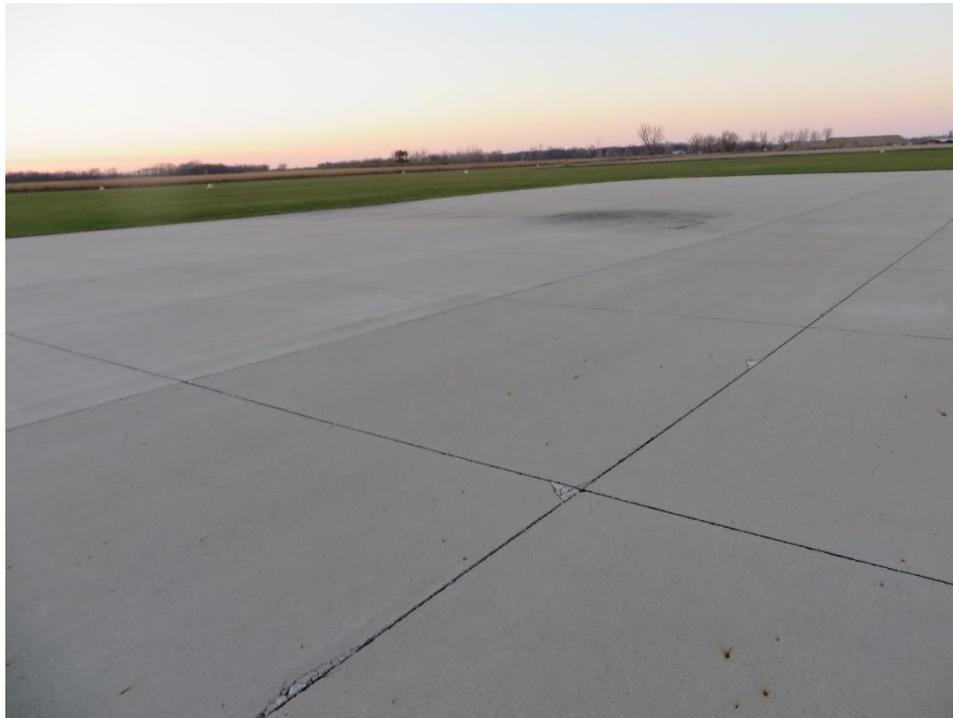
A01EM-01. Overview.

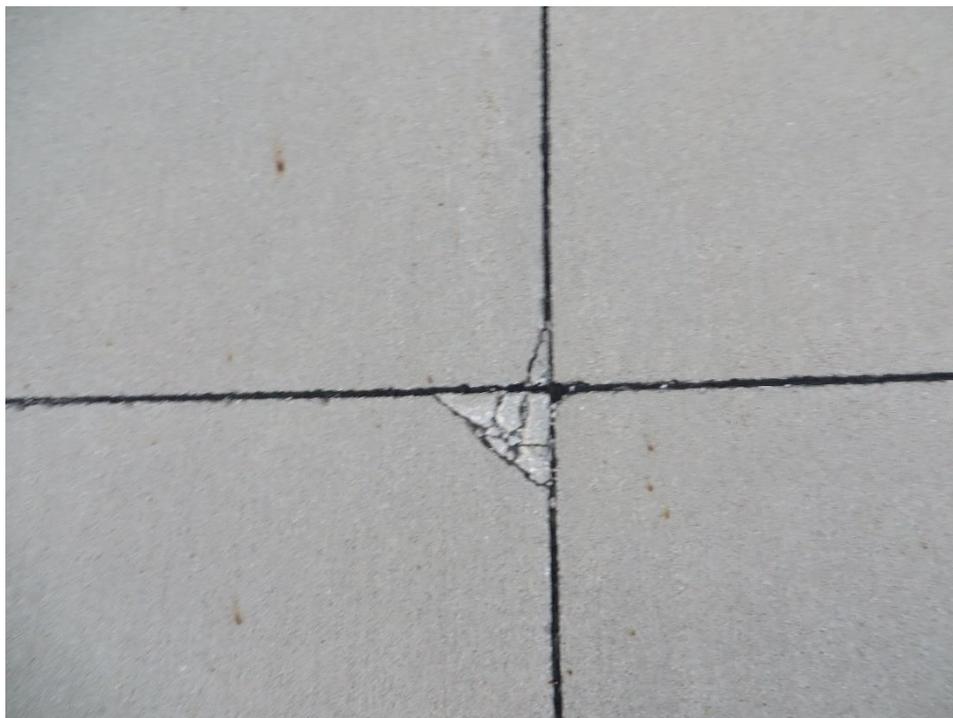
The apron area was defined by two sections. Section 01, the majority of the apron area, had low- and medium-severity joint seal damage identified throughout. Isolated quantities of medium-severity joint spalling and corner spalling were also noted. Section 02, the southern portion of the apron area, was recently constructed and had no distresses observed at the time of inspection.

A01EM-01. Corner Spalling (Sample Unit No. 16).

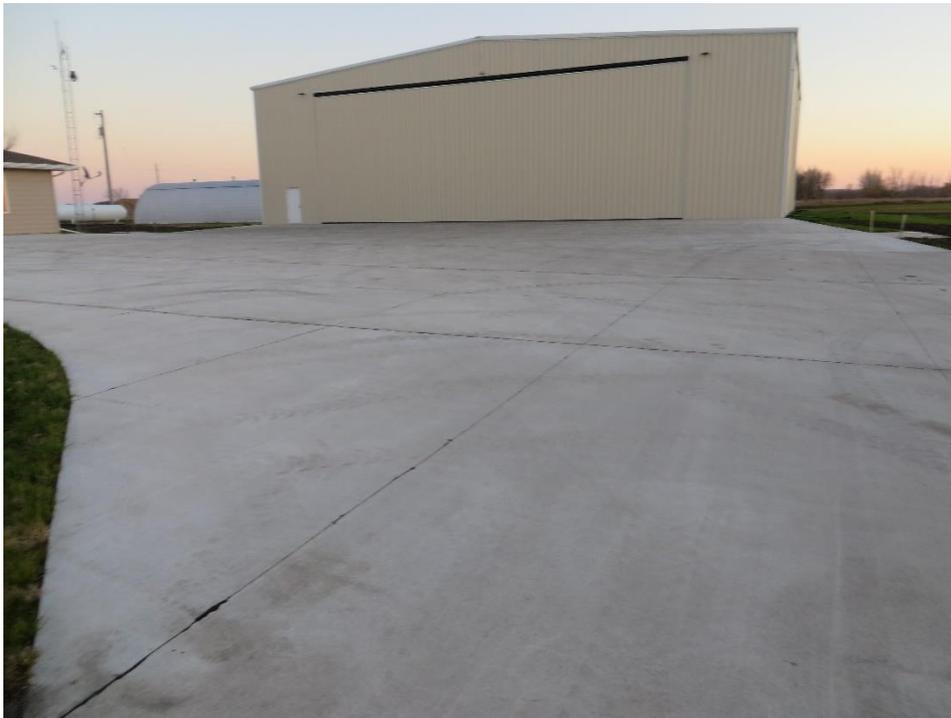
A01EM-02. Overview.

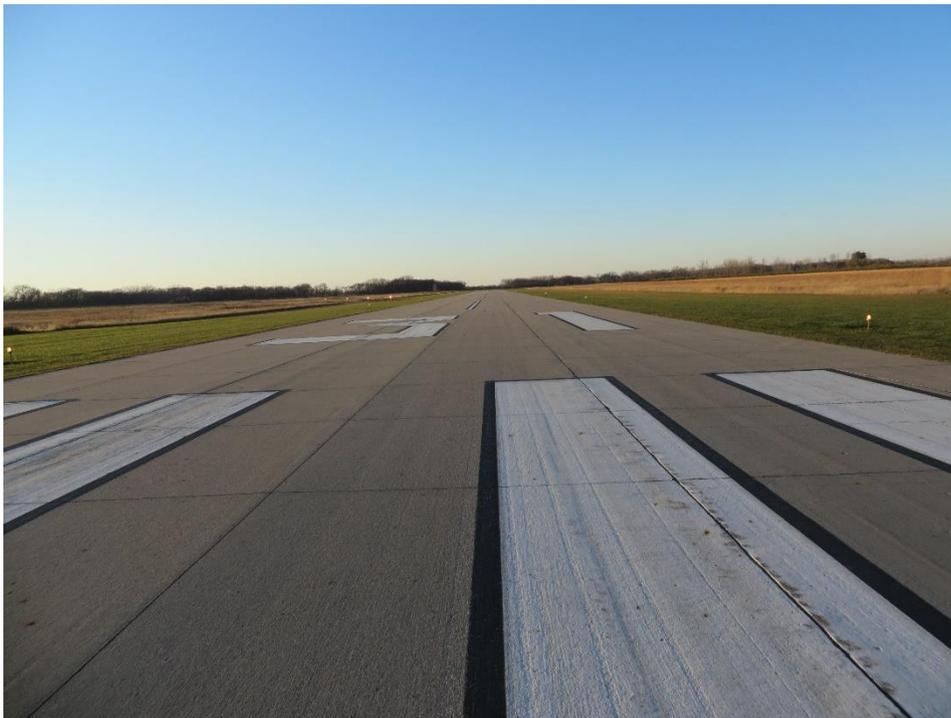
R13EM-01. Overview

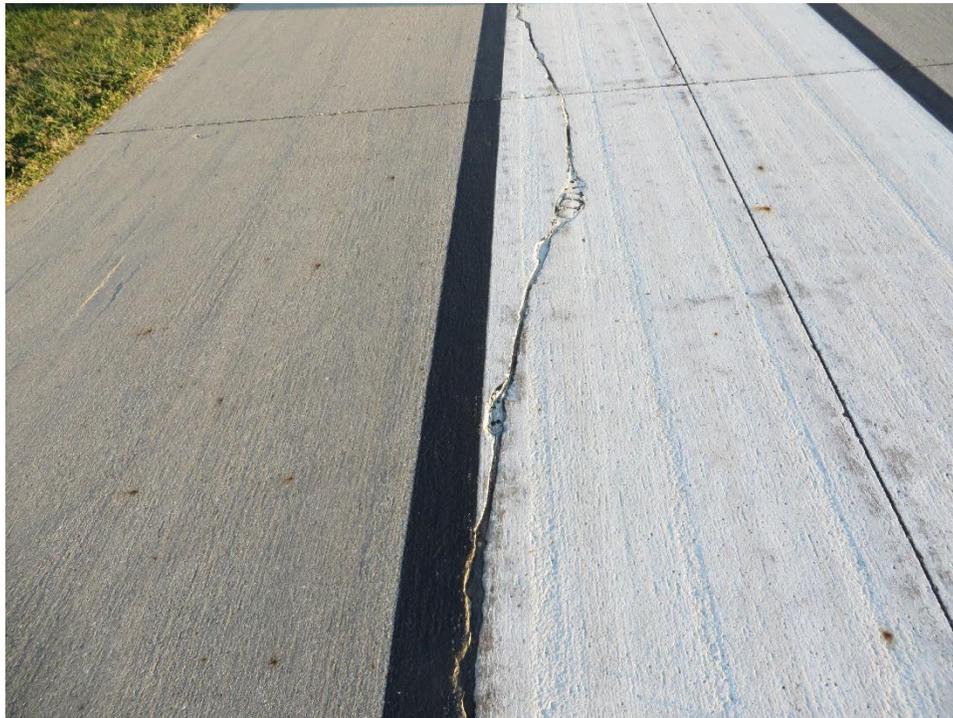
Runway 13-31 was defined by one section with medium-severity joint seal damage recorded throughout. In addition, small amounts of low-severity corner breaks and low- and medium-severity joint spalling and corner spalling were identified. Isolated areas of low- and medium-severity longitudinal, transverse, and diagonal (LTD) cracking were observed and recorded as additional sample units in accordance with the ASTM procedure.

R13EM-01. LTD Cracking (Additional Sample Unit No. 03).

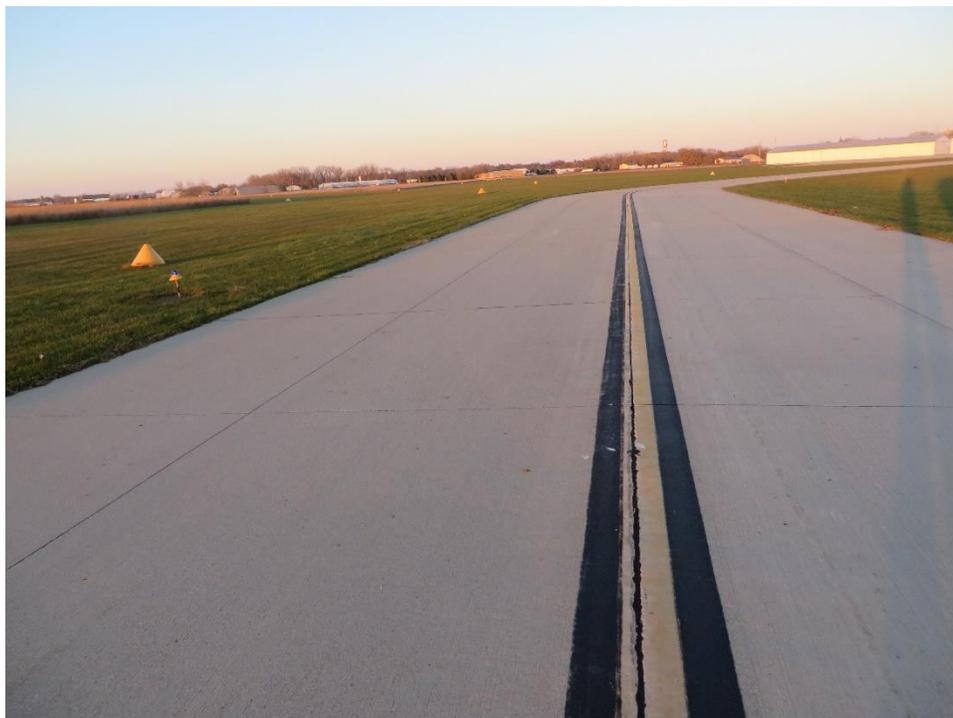
T01EM-01. Overview.

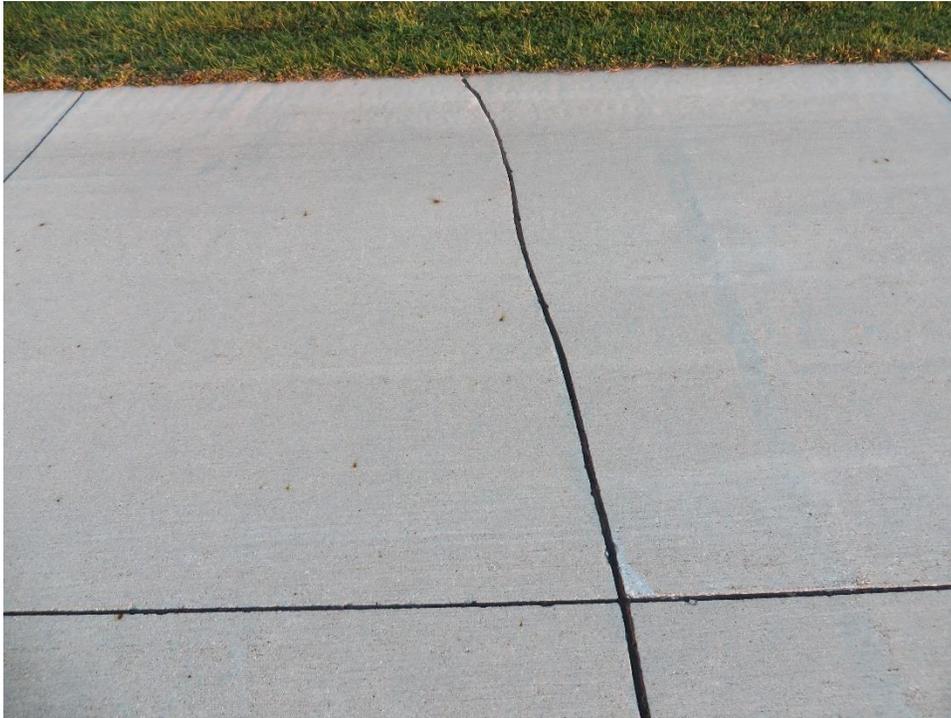
Taxiway 01 consisted of one section with low- and medium-severity joint seal damage identified throughout along with smaller quantities of low-severity LTD cracking.

T01EM-01. LTD Cracking (Sample Unit No. 02).
