Emmetsburg Municipal Airport

Pavement Management Report

JULY 2023

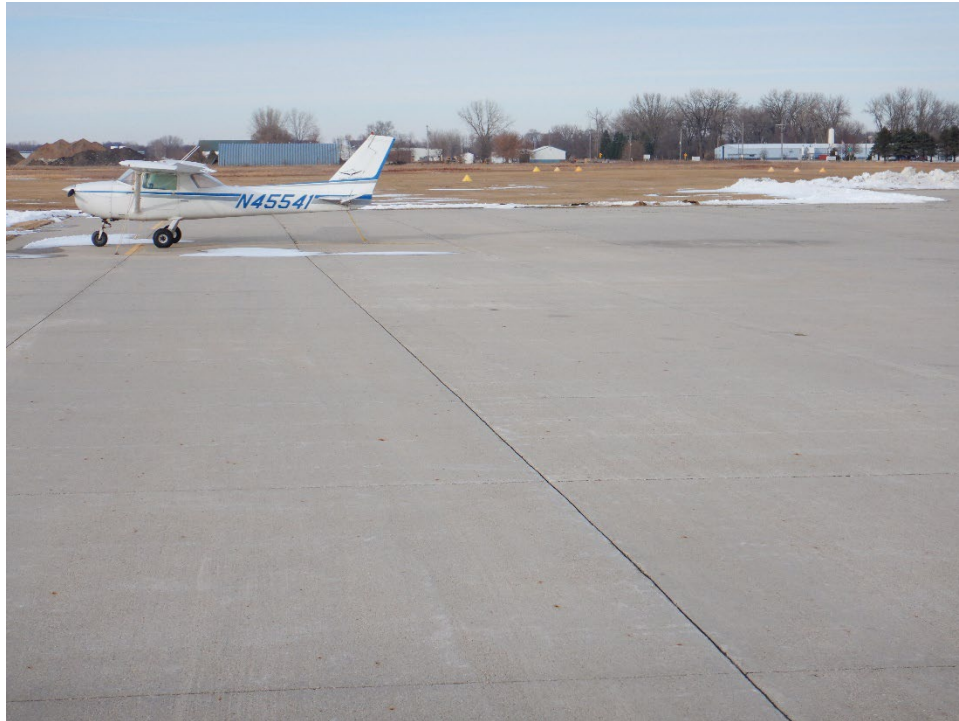
The apron area was defined by two sections. Areas of low-severity LTD cracking and corner break, medium-severity joint spalling and corner spalling, and high-severity joint seal damage were identified in Section 01. Section 02 contained high-severity joint seal damage and low-severity joint spalling.

A01EM-01. Overview.

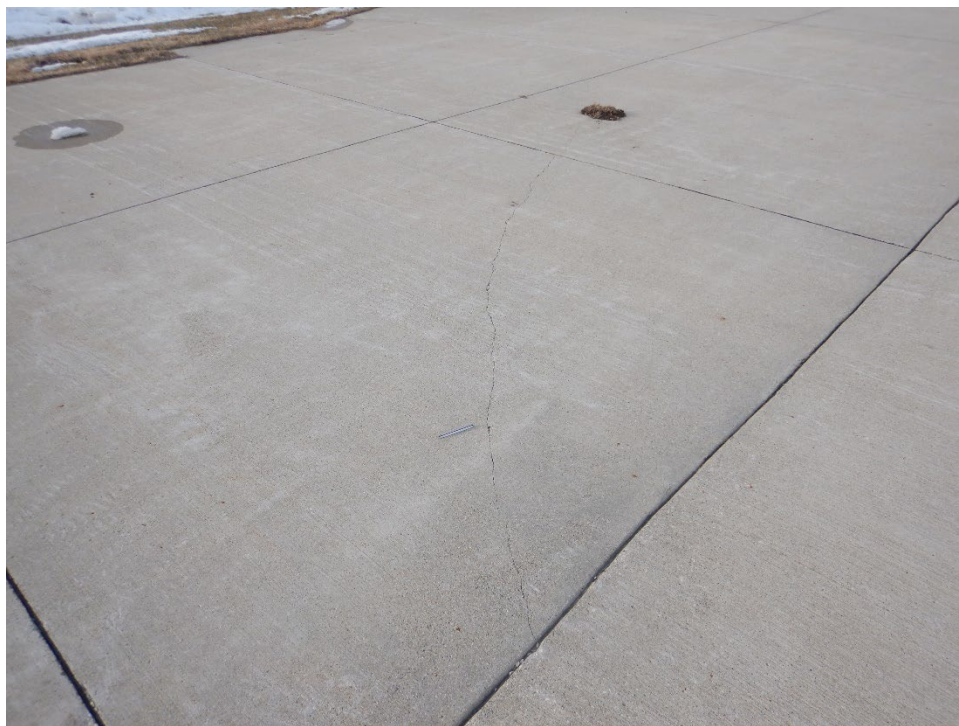
A01EM-01. LTD Cracking (Sample Unit No. 21).

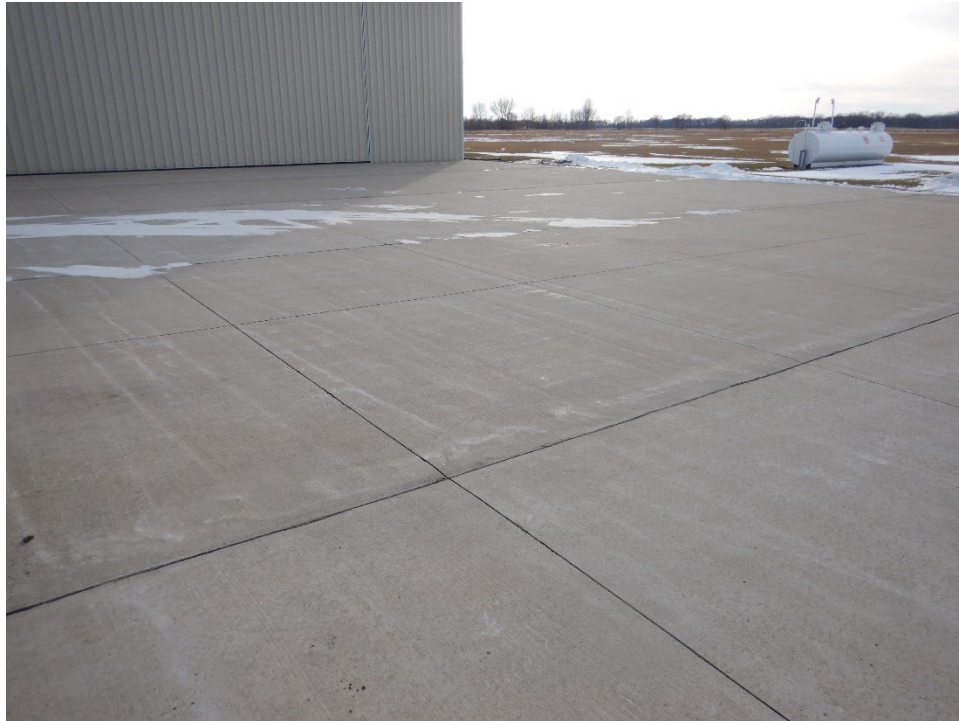
A01EM-02. Overview.

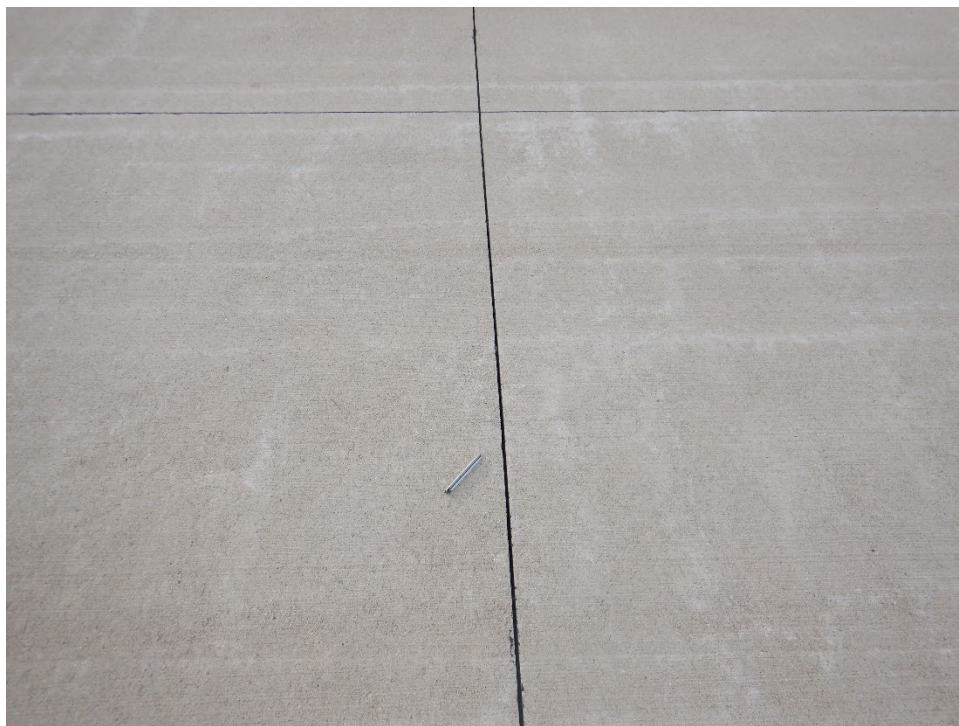
A01EM-02. Joint Seal Damage (Sample Unit No. 02).

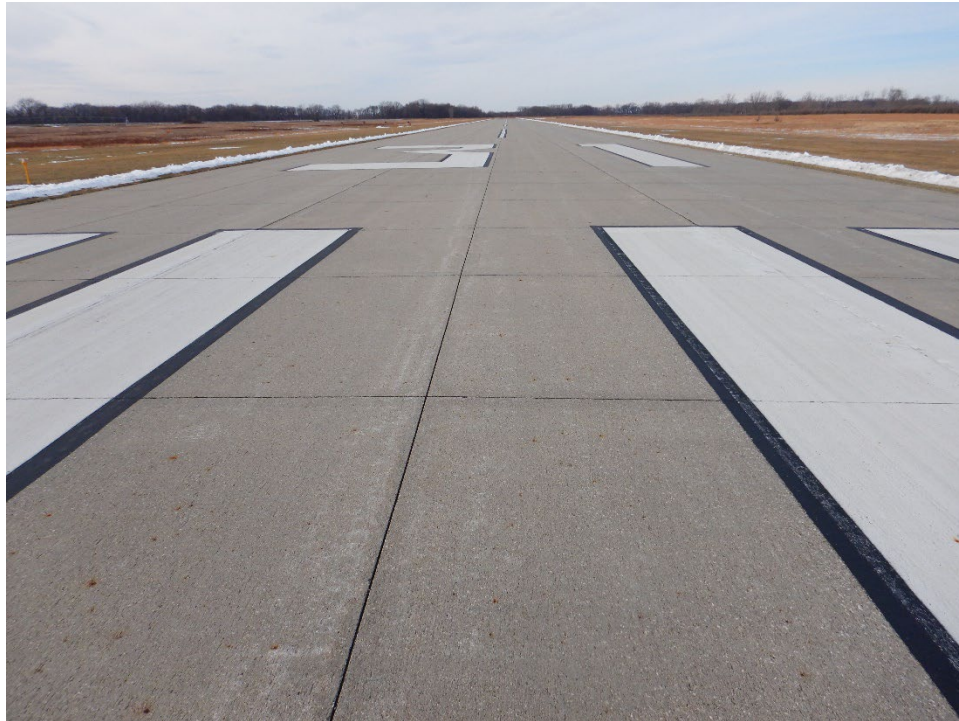
Runway 13/31 was defined by one section. Areas of low- and medium-severity joint spalling and corner spalling; medium- and high-severity joint seal damage; and medium-severity longitudinal, transverse, and diagonal (LTD) cracking were identified in Section 01.

R13EM-01. Overview.

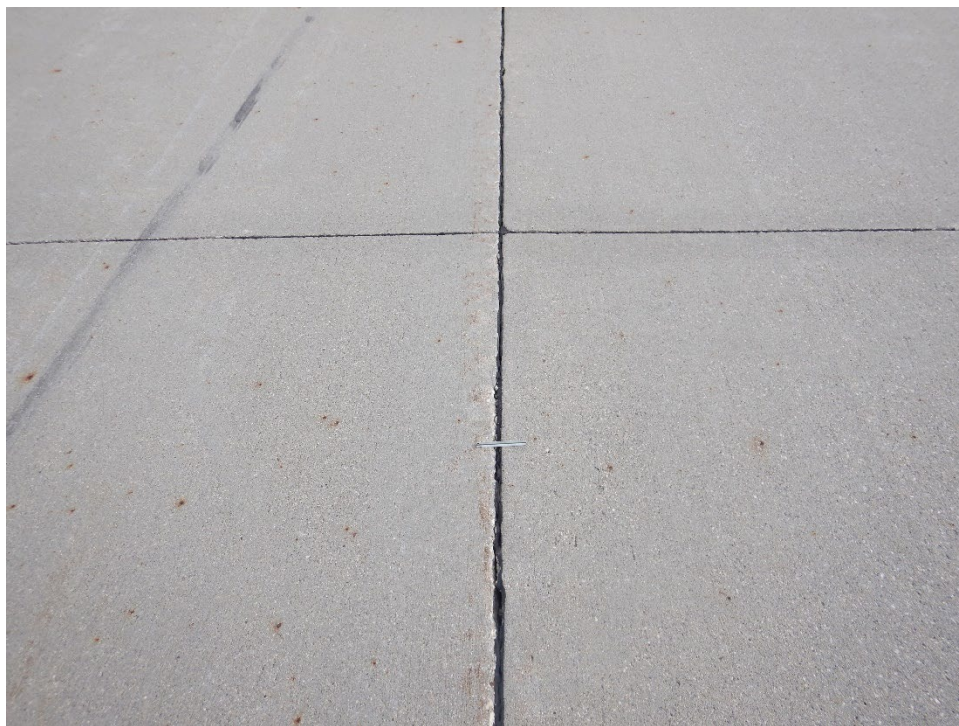
R13EM-01. Joint Seal Damage (Sample Unit No. 22).

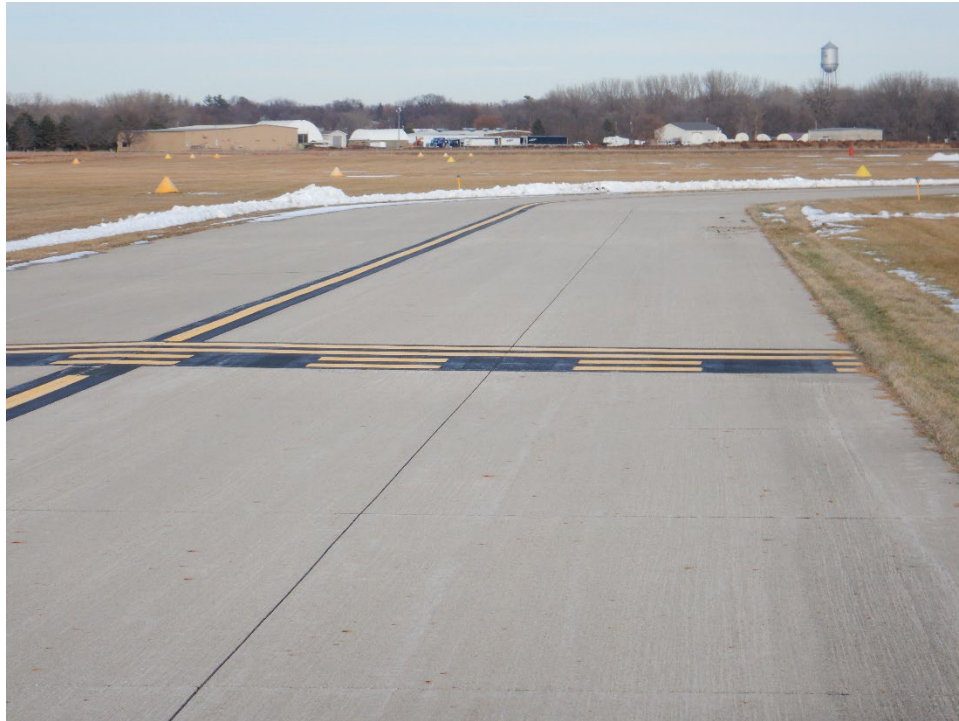
Taxiway 01 consisted of one section that had areas of low-severity LTD cracking and faulting, high-severity joint seal damage, and medium-severity joint spalling.

T01EM-01. Overview.

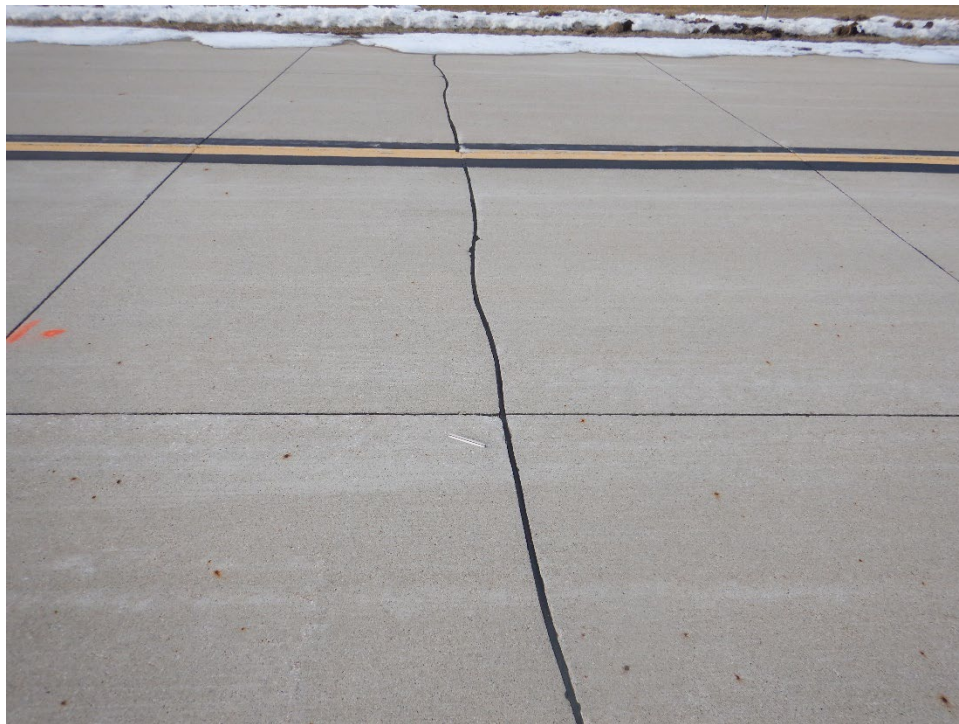
T01EM-01. LTD Cracking (Sample Unit No. 02).

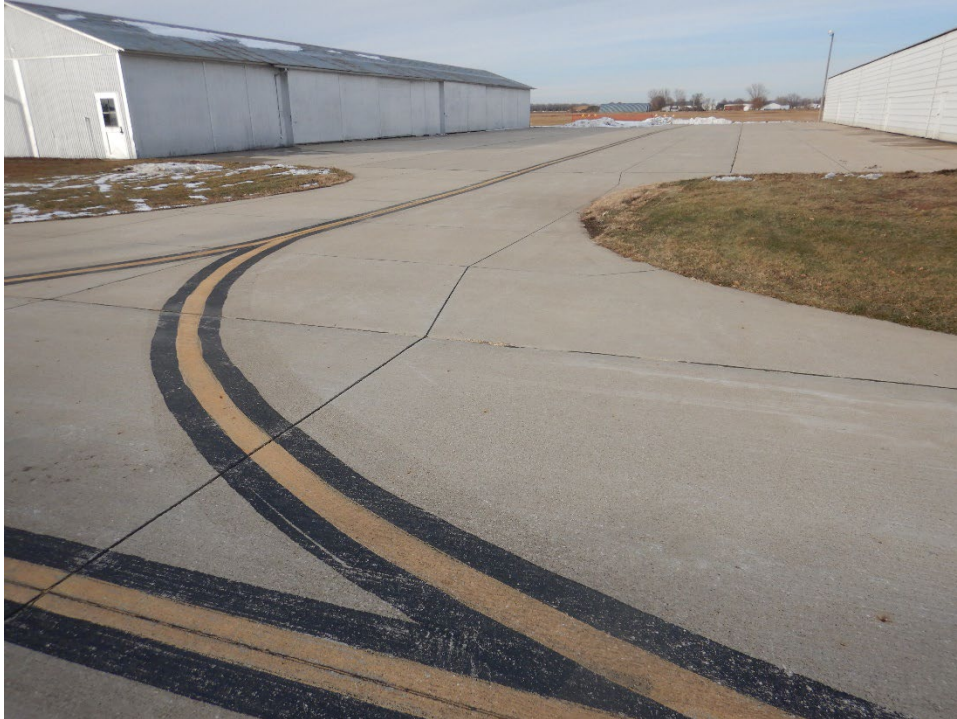
The T-hangar area contained one section. Section 01 contained medium-severity joint spalling and corner spalling, low-severity faulting, and medium- and high-severity joint seal damage.

TH01EM-01. Overview.

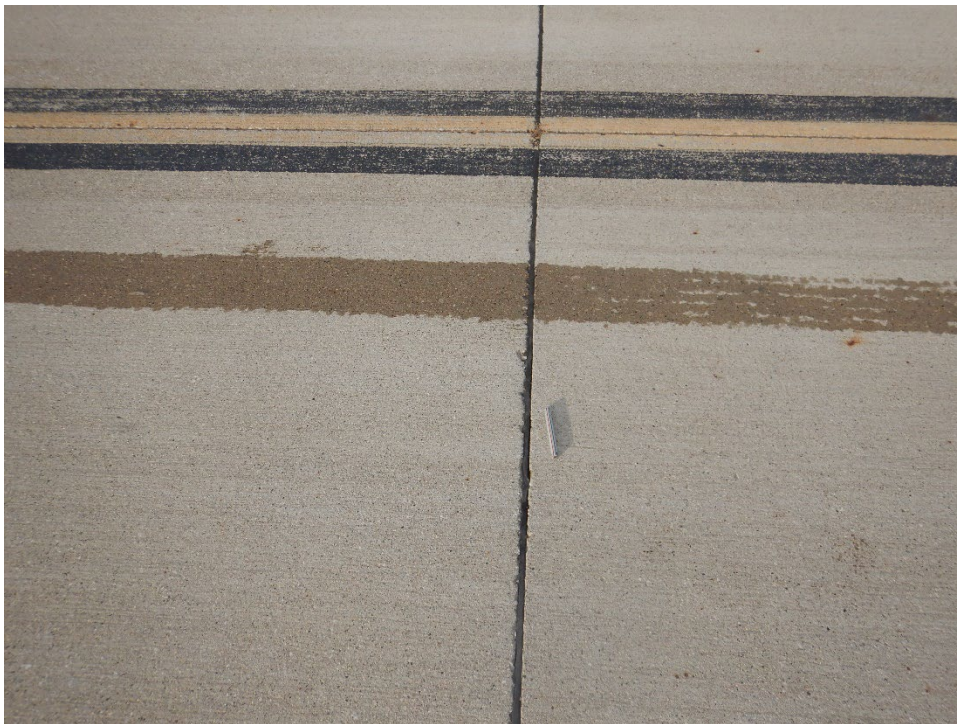
TH01EM-01. Joint Seal Damage (Sample Unit No. 05).
