# Estherville Municipal Airport

## Pavement Management Report

**JULY 2023**

# ESTHERVILLE MUNICIPAL AIRPORT PAVEMENT MANAGEMENT REPORT

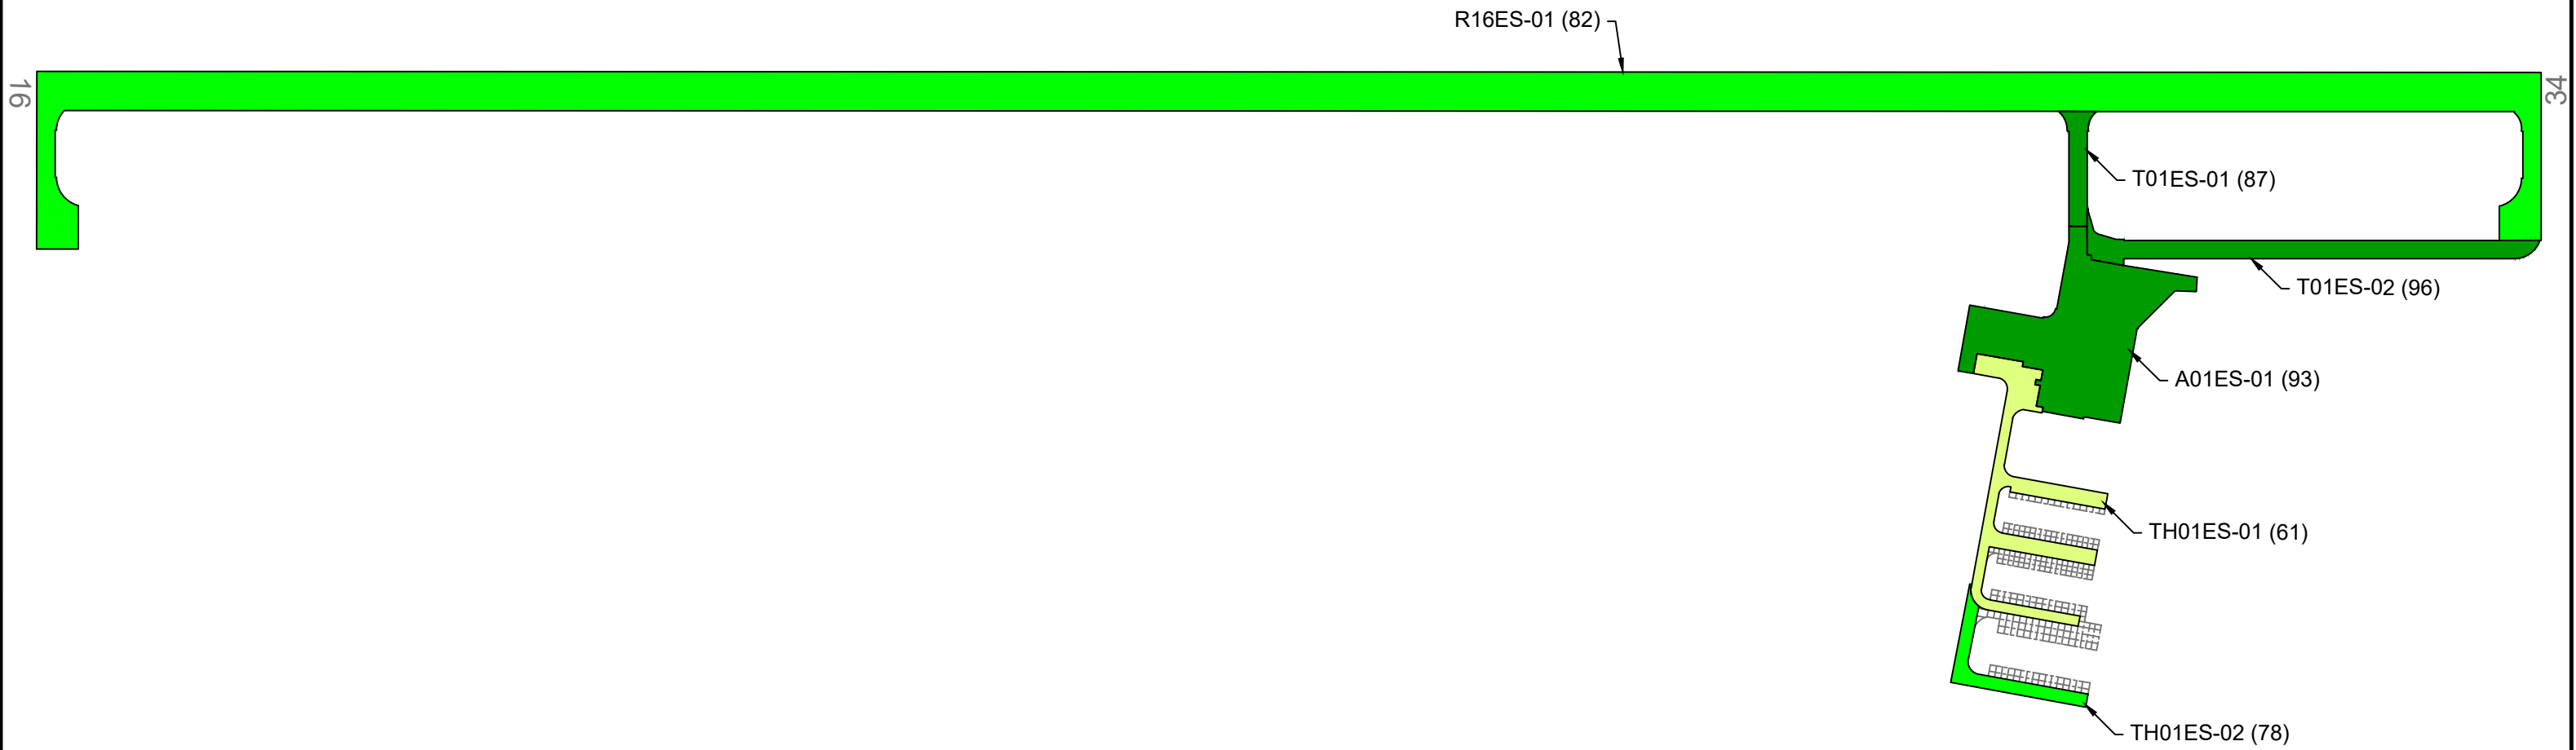
FIGURE 8. PCI MAP.

The pavements at Estherville Municipal Airport were inspected in November 2022. The 2022 area-weighted condition of Estherville Municipal Airport is 83, with conditions ranging from 61 to 96 (on a scale of 0 [failed] to 100 [excellent]). During the previous pavement inspection in 2019, the area-weighted PCI of the airport was 82.

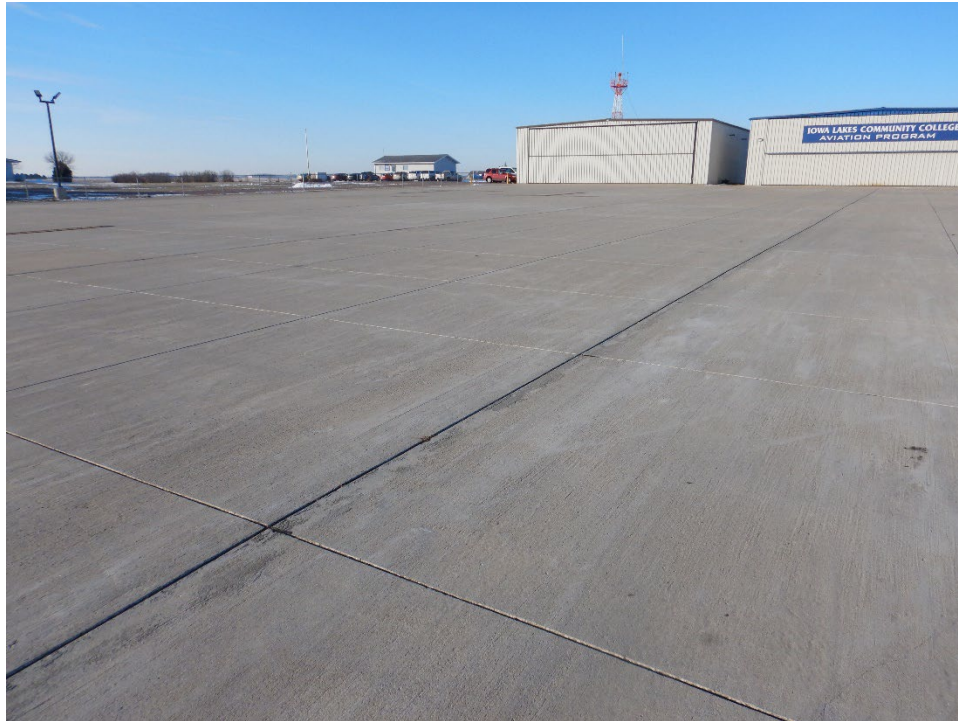
The apron area consisted of one section. Areas of low-severity corner break; medium-severity corner spalling; and low- and medium-severity joint seal damage, joint spalling, and LTD cracking were identified in Section 01.

A01ES-01. Overview.

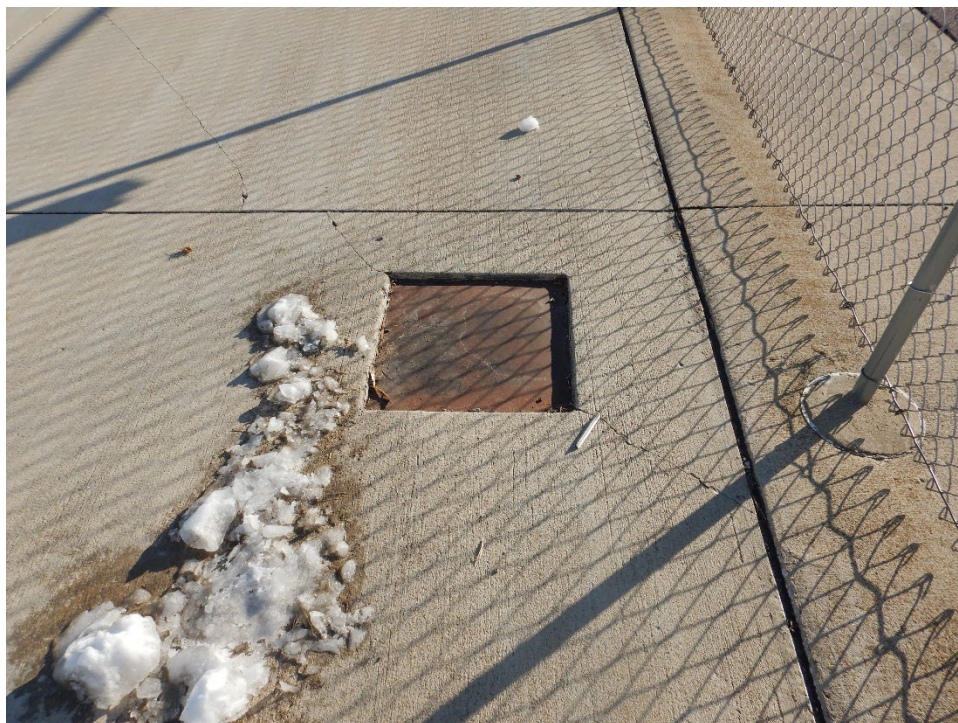
A01ES-01. Corner Break (Sample Unit No. 29).

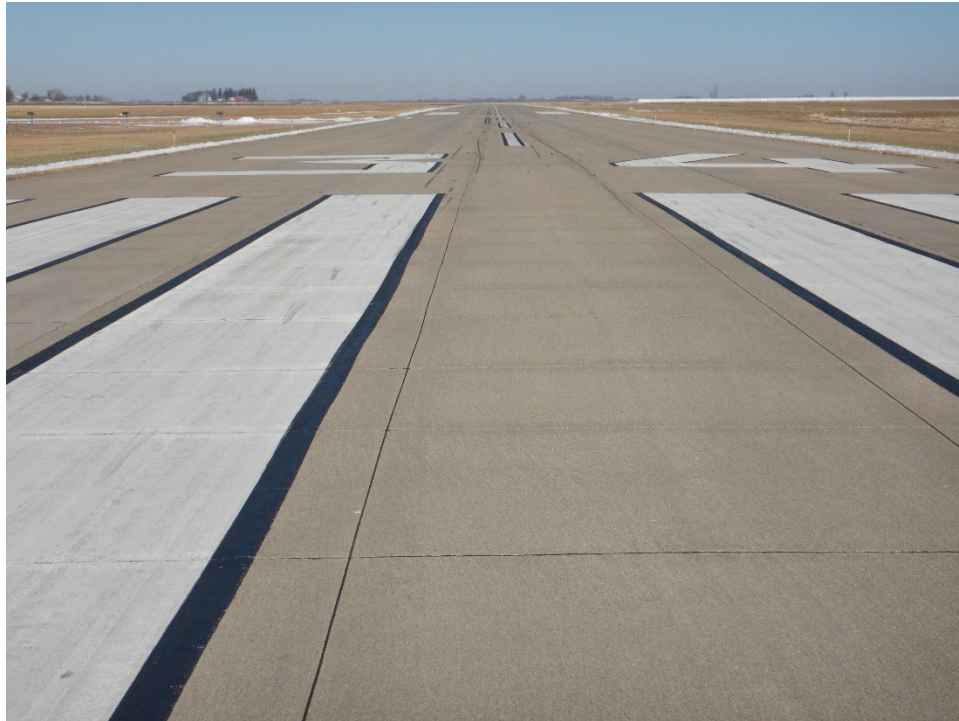
Runway 16/34 was defined by one section. Section 01 contained areas of medium- and high-severity joint seal damage and medium-severity shattered slab, joint spalling, and corner break. It also had areas of low- and medium-severity longitudinal, transverse, and diagonal (LTD) cracking; small patching; and corner spalling.

R16ES-01. Overview.

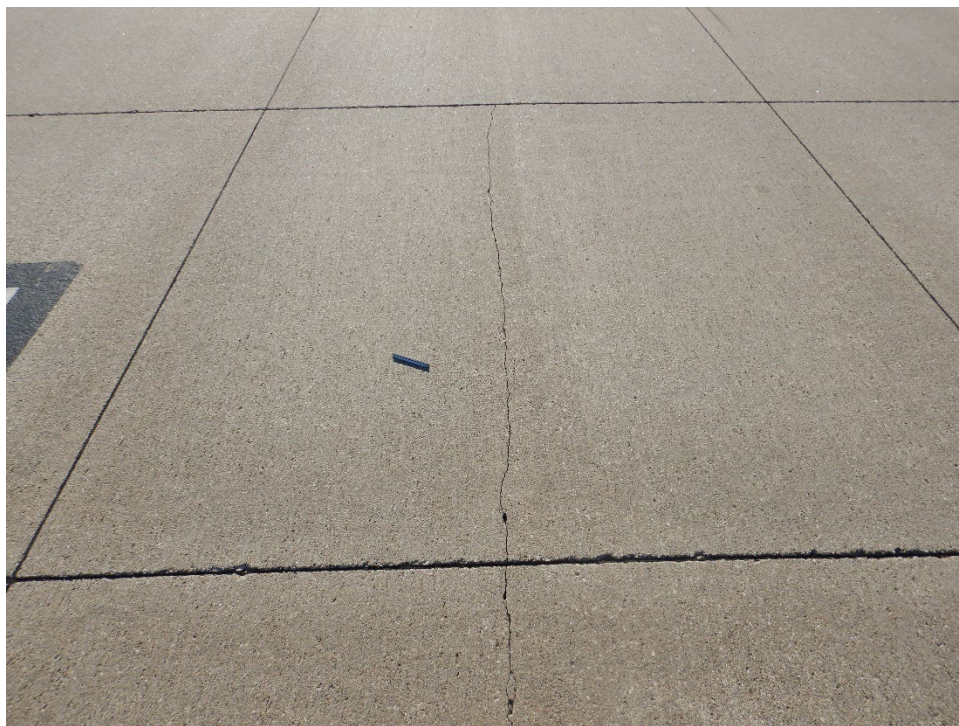
R16ES-01. LTD Cracking (Sample Unit No. 160).

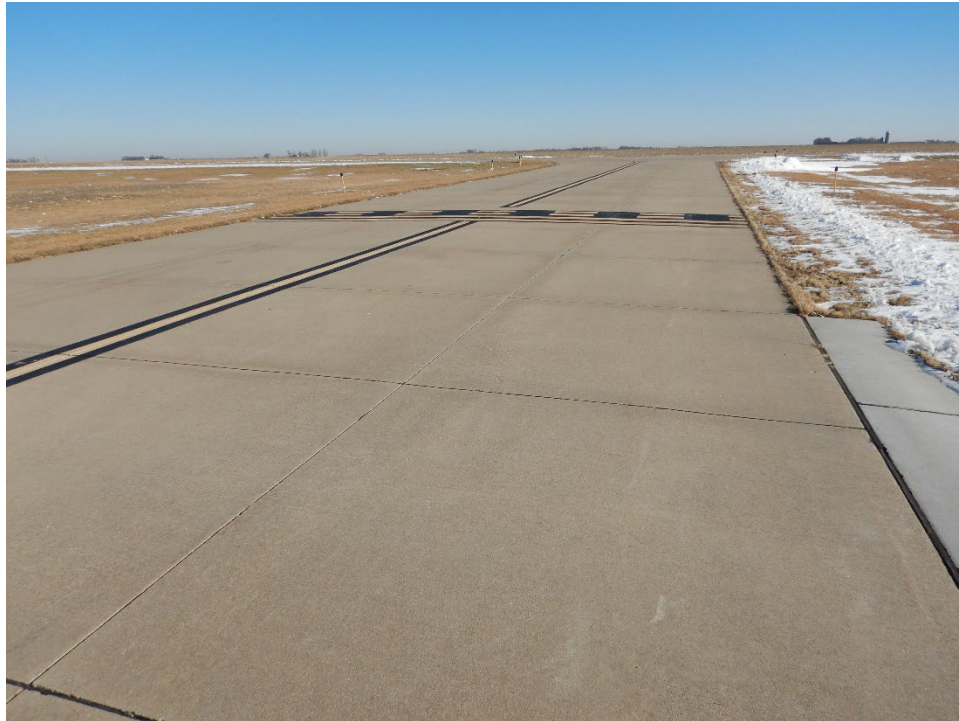
Taxiway 01 contained two sections. Medium-severity corner spalling and high-severity joint seal damage were noted in Section 01. Section 02 was in excellent condition with shrinkage cracking and low-severity corner break, joint seal damage, and LTD cracking recorded at the time of inspection.

T01ES-01. Overview.

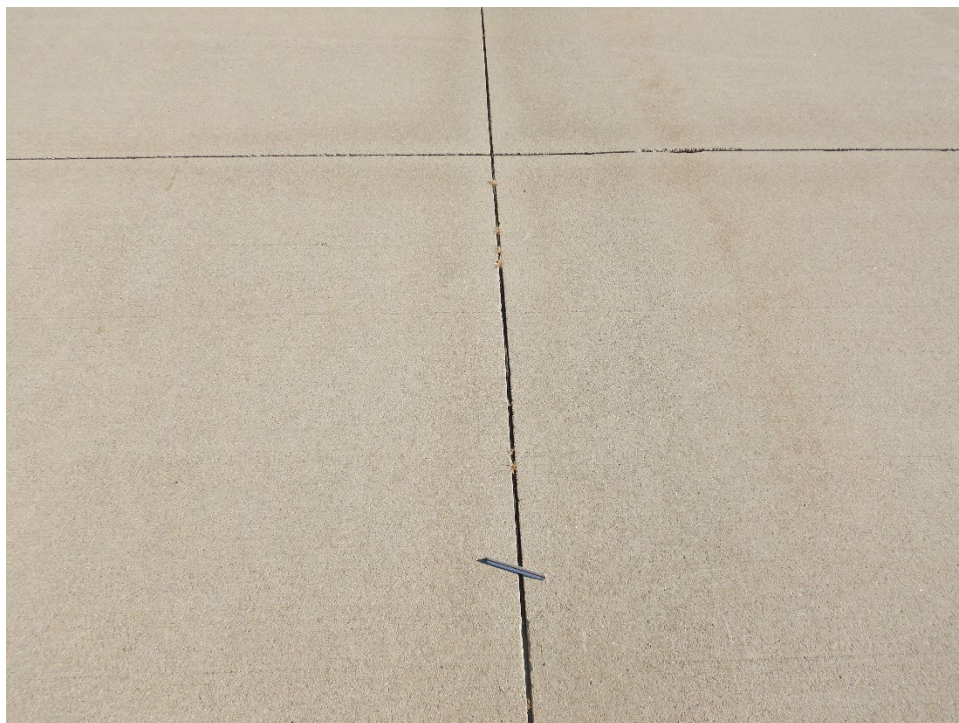
T01ES-01. Joint Seal Damage (Sample Unit No. 01).

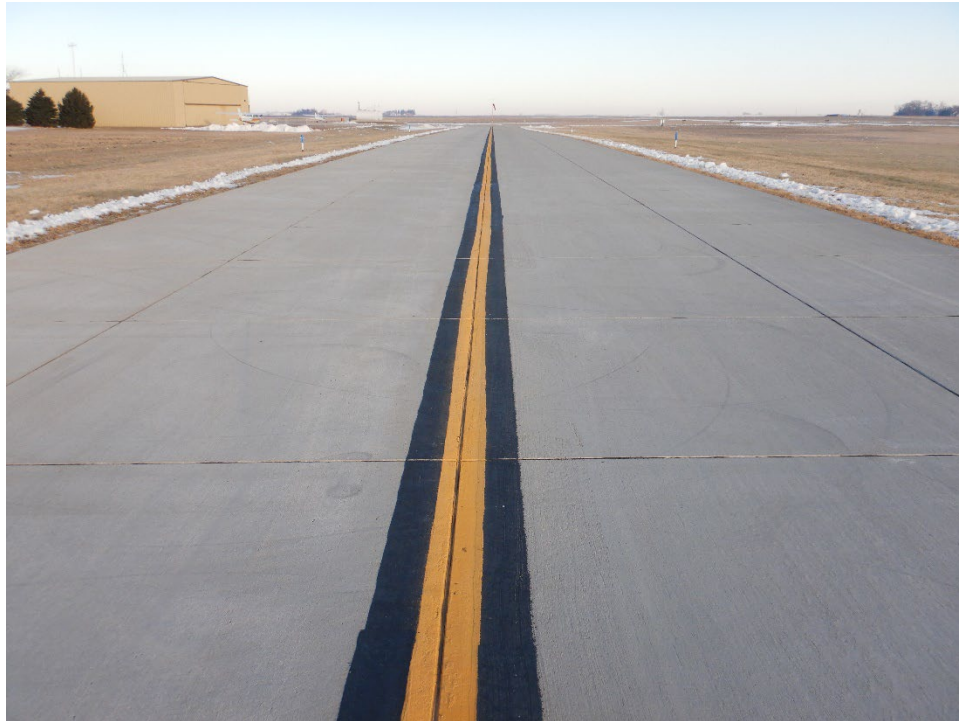
T01ES-02. Overview.

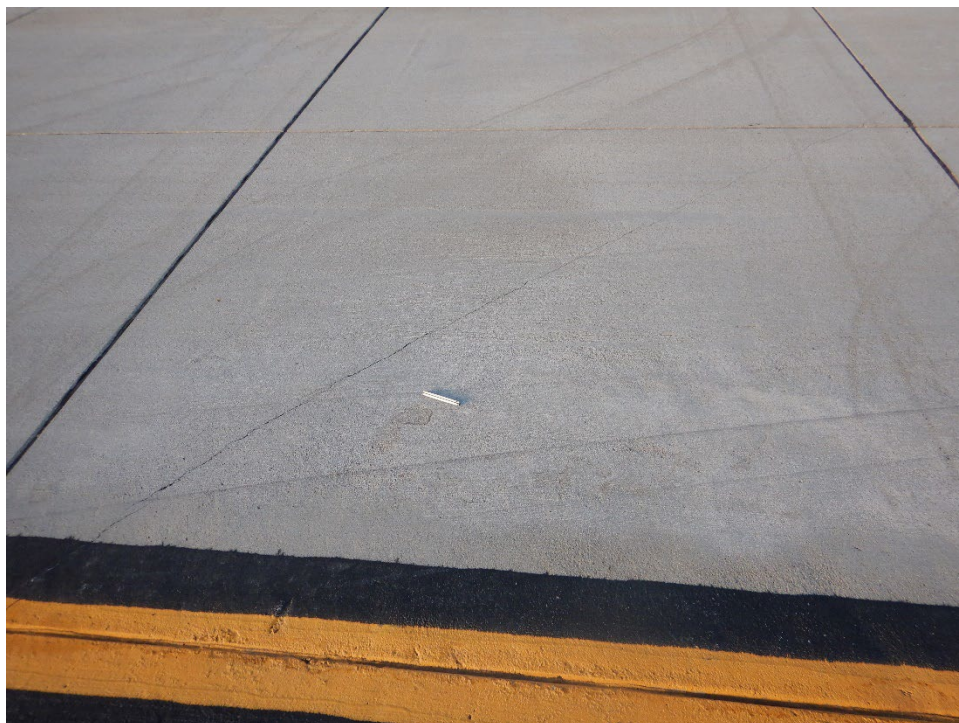
T01ES-02. LTD Cracking (Sample Unit No. 17).

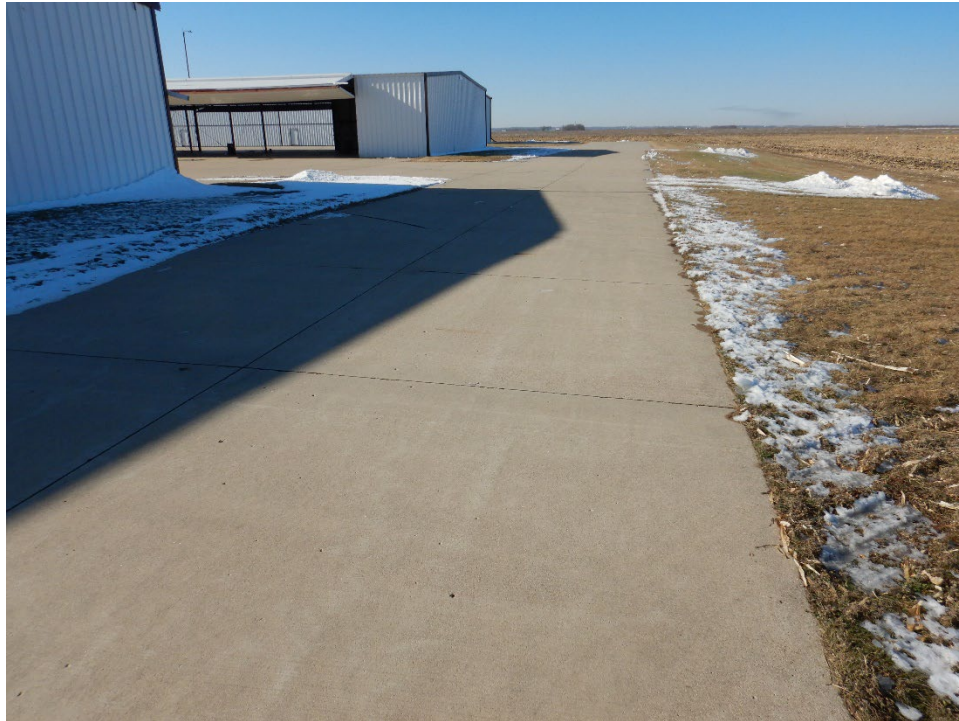
The T-hangar area was defined by two sections. Section 01 contained areas of low-severity ASR; medium-severity corner break, shattered slab, joint spalling, and corner spalling; low- and high-severity faulting; medium- and high-severity joint seal damage; low- and medium-severity LTD cracking; popouts; and shrinkage cracking. Low-severity corner break, corner spalling, and large patching; medium- and high-severity joint seal damage; low- and medium-severity joint spalling and LTD cracking; and shrinkage cracking were observed in Section 02.

TH01ES-01. Overview.

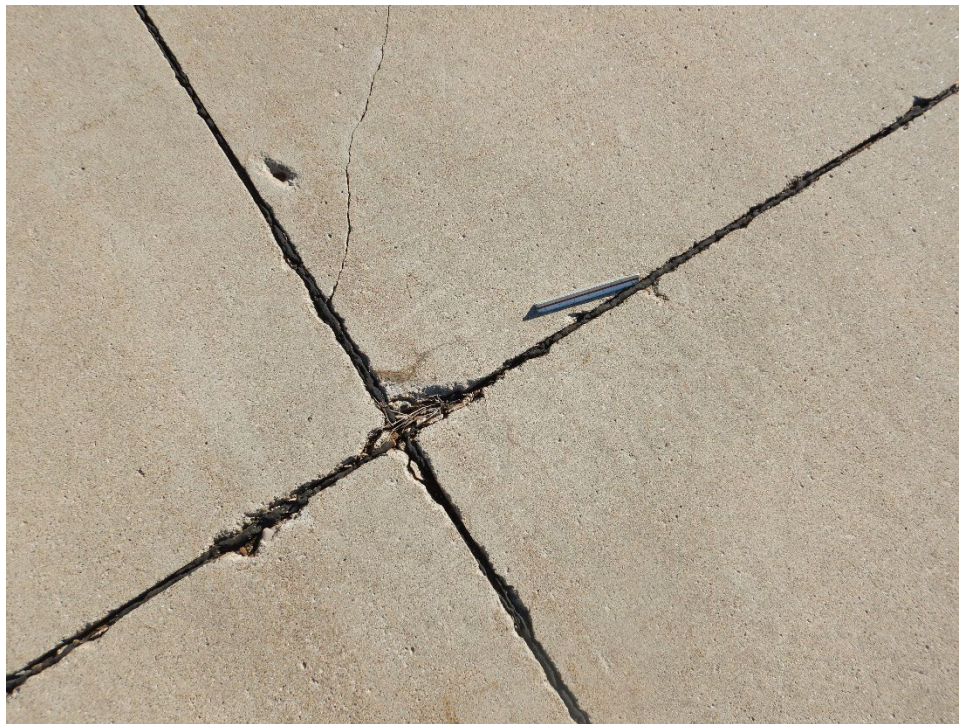
<b>Distress Type</b>	<b>Probable Cause of Distress</b>
ASR	Chemical reaction of alkalis in the portland cement with certain reactive silica minerals. ASR may be accelerated by the use of chemical pavement deicers.
Blowup	Incompressible materials in the joints.
Corner Break	Load repetition combined with loss of support and curling stresses.
Durability Cracking	Concrete's inability to withstand environmental factors such as freeze-thaw cycles.
Faulting	Upheaval or consolidation.
Joint Seal Damage	Stripping of joint sealant, extrusion of joint sealant, weed growth, hardening of the filler (oxidation), loss of bond to the slab edges, or absence of sealant in the joint.
LTD Cracking	Combination of load repetition, curling stresses, and shrinkage stresses.
Patching (Small and Large)	N/A
Popouts	Freeze-thaw action in combination with expansive aggregates.
Pumping	Poor drainage, poor joint sealant.
Scaling	Over finishing of concrete, deicing salts, improper construction, freeze-thaw cycles, and poor aggregate.

TH01ES-01. ASR (Sample Unit No. 06).

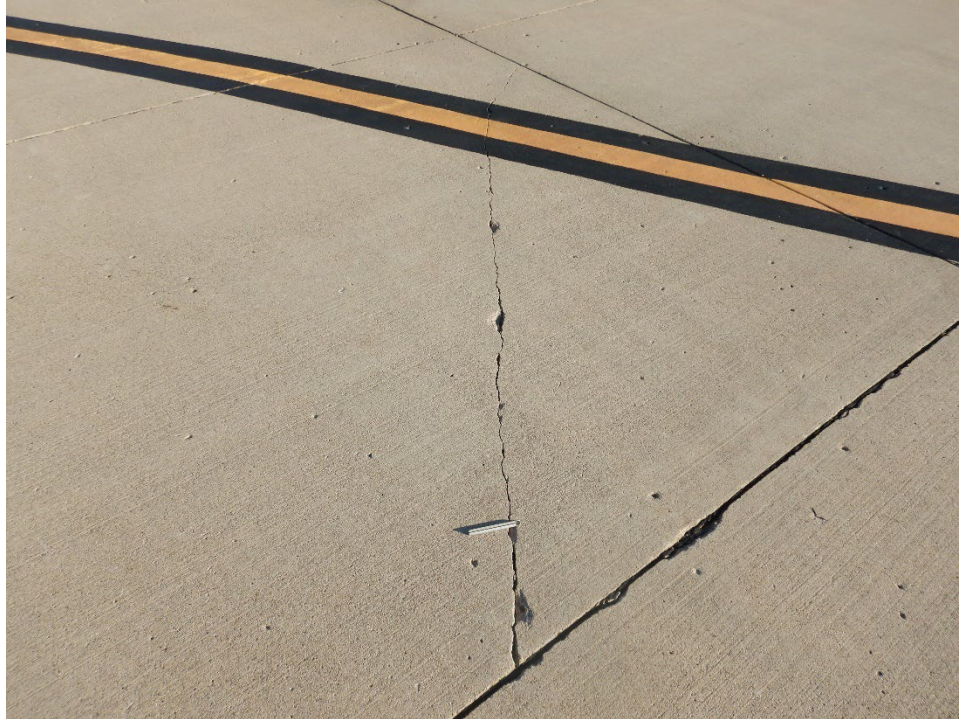
TH01ES-01. LTD Cracking (Sample Unit No. 03).

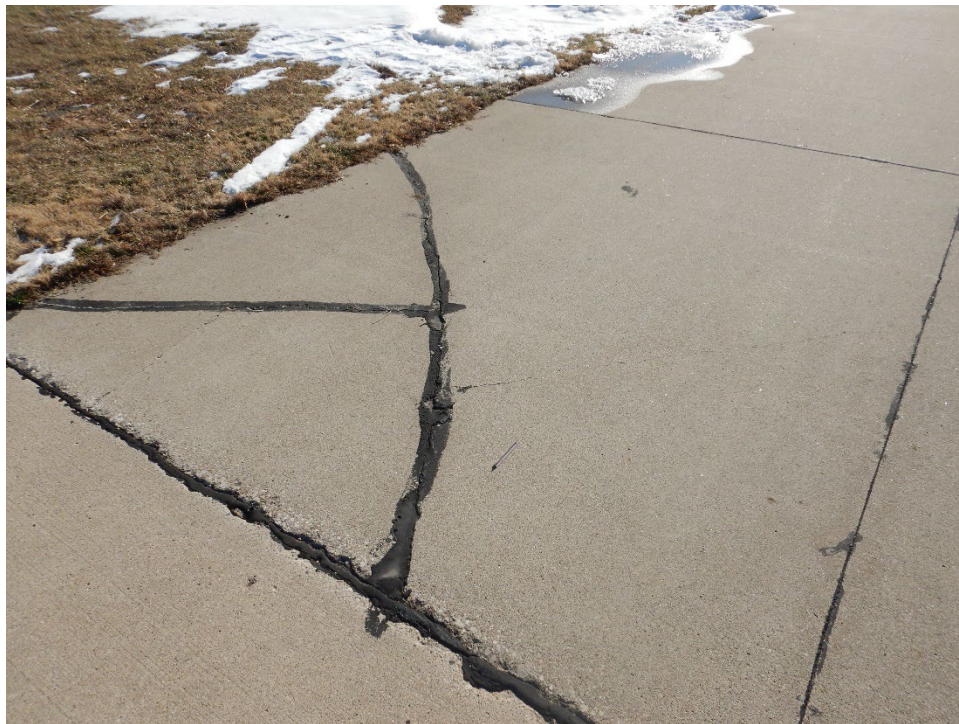
Shattered Slab	Load repetition.
Shrinkage Cracking	Setting and curing of the concrete.
Spalling (Joint and Corner)	Excessive stresses at the joint caused by infiltration of incompressible materials or traffic loads; weak concrete at the joint combined with traffic loads.

TH01ES-01. Shattered Slab (Sample Unit No. 05).

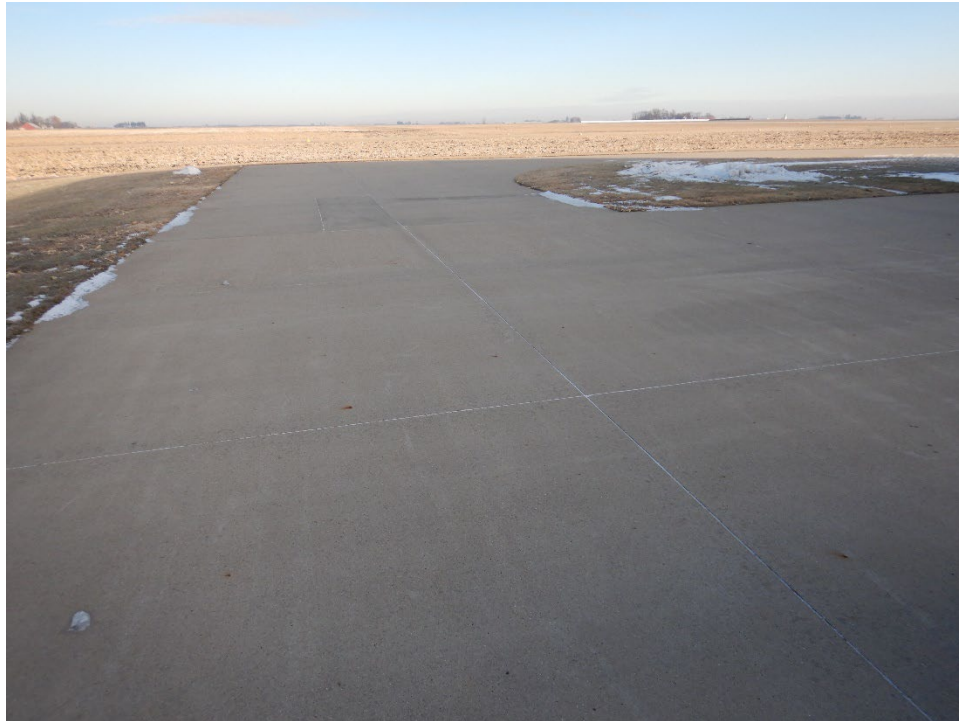
TH01ES-02. Overview.

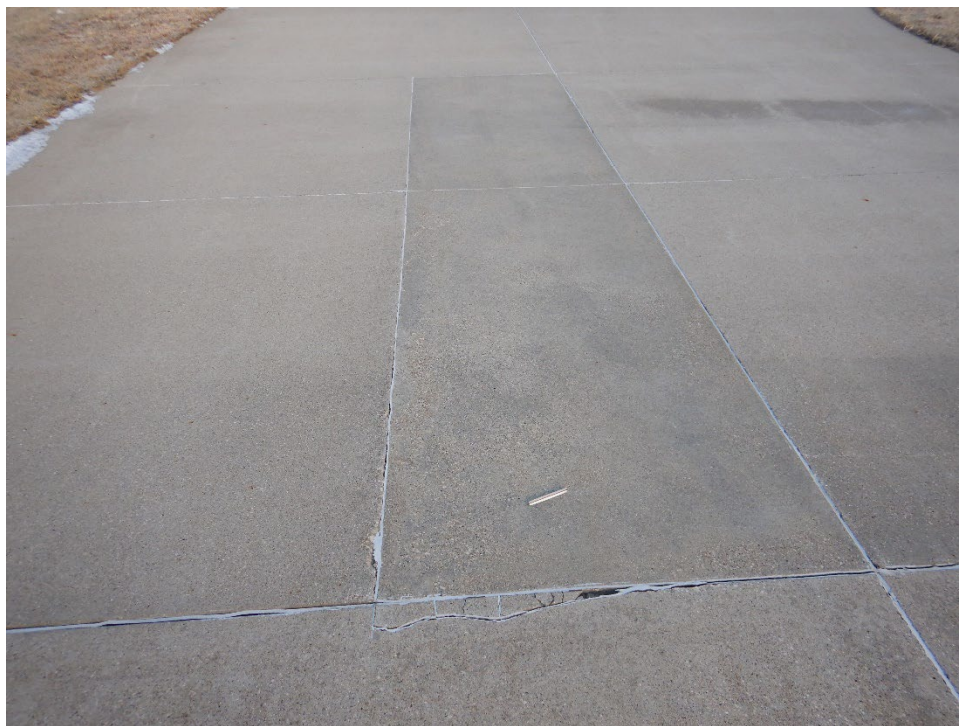
TH01ES-02. Large Patching (Sample Unit No. 02).
