# FOREST CITY MUNICIPAL AIRPORT PAVEMENT MANAGEMENT REPORT

**Prepared For:**  
Iowa Department of Transportation  
Office of Aviation

**Prepared By:**  
Applied Pavement Technology, Inc.

April 2016

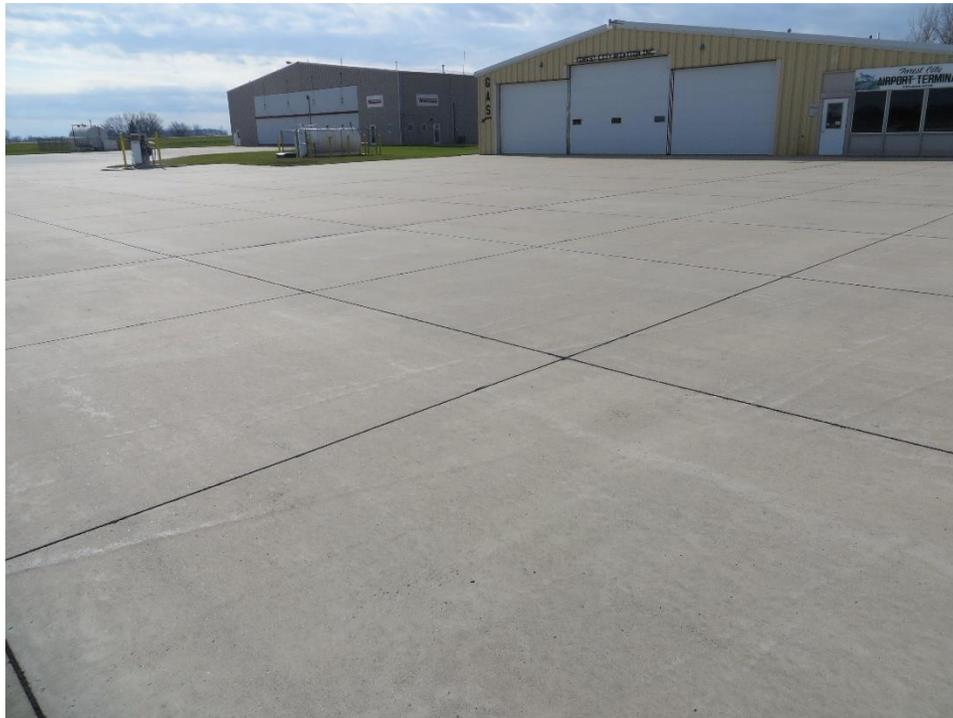
A01FC-01. Overview.

The apron area consisted of two sections. Section 01 was in excellent condition with only low-severity joint seal damage observed. Section 02 was recently reconstructed with areas of low-severity longitudinal, transverse, and diagonal (LTD) cracking; low-severity joint spalling; and shrinkage cracking identified.

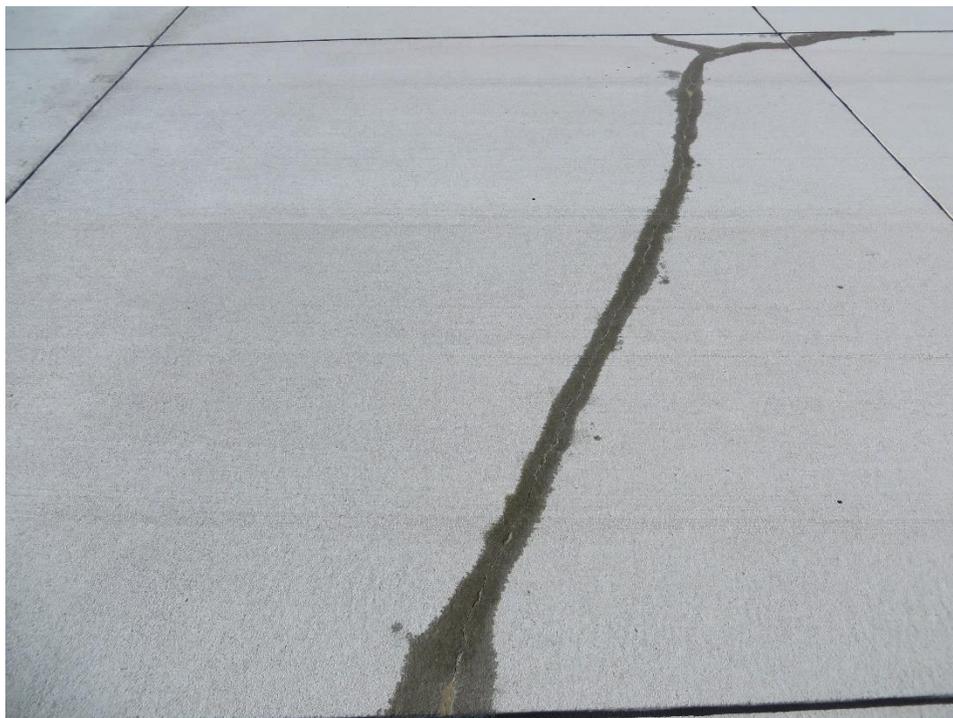
A01FC-02. LTD Cracking (Sample Unit No. 16).

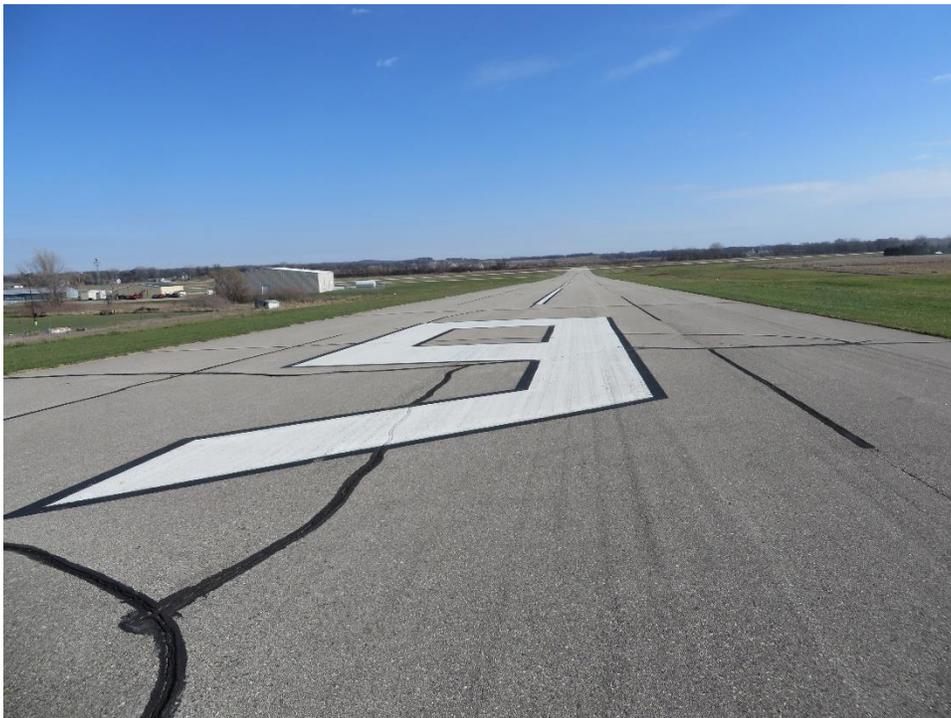
R09FC-01. Overview.

Runway 9-27 was defined by four sections. Sections 01 and 02 were in similar condition with moderate amounts of low- and medium-severity L&T cracking and low-severity weathering identified. Sections 03 and 04 had smaller quantities of low-severity L&T cracking and weathering observed. The low-severity cracking was mostly sealed with the crack sealant in good condition. The medium-severity cracking was recorded where the crack sealant had failed.

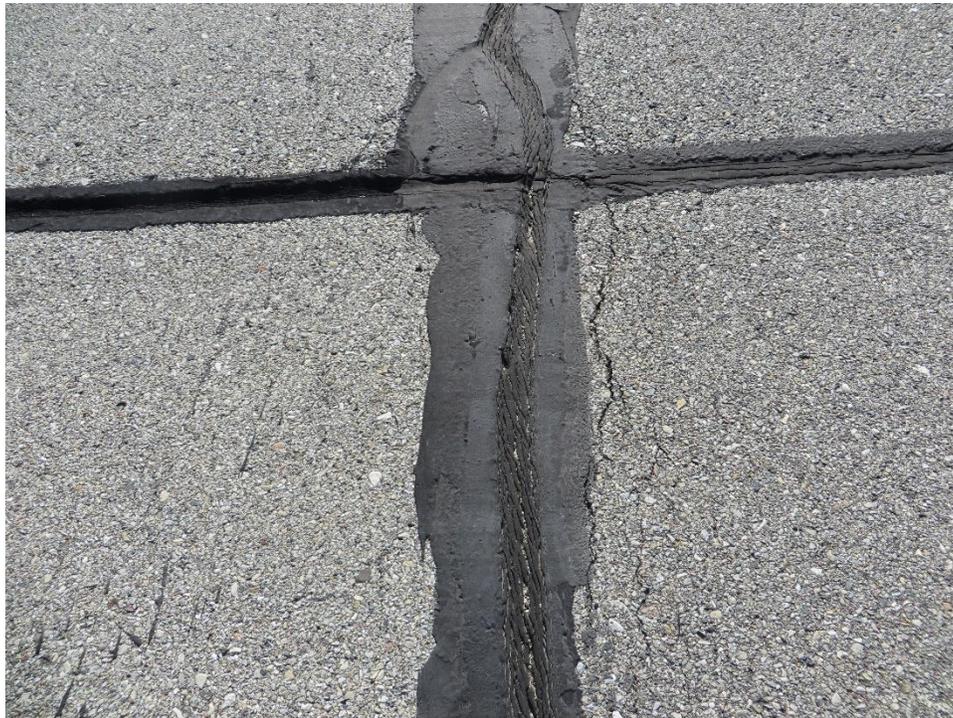
R09FC-01. L&T Cracking (Sample Unit No. 03).

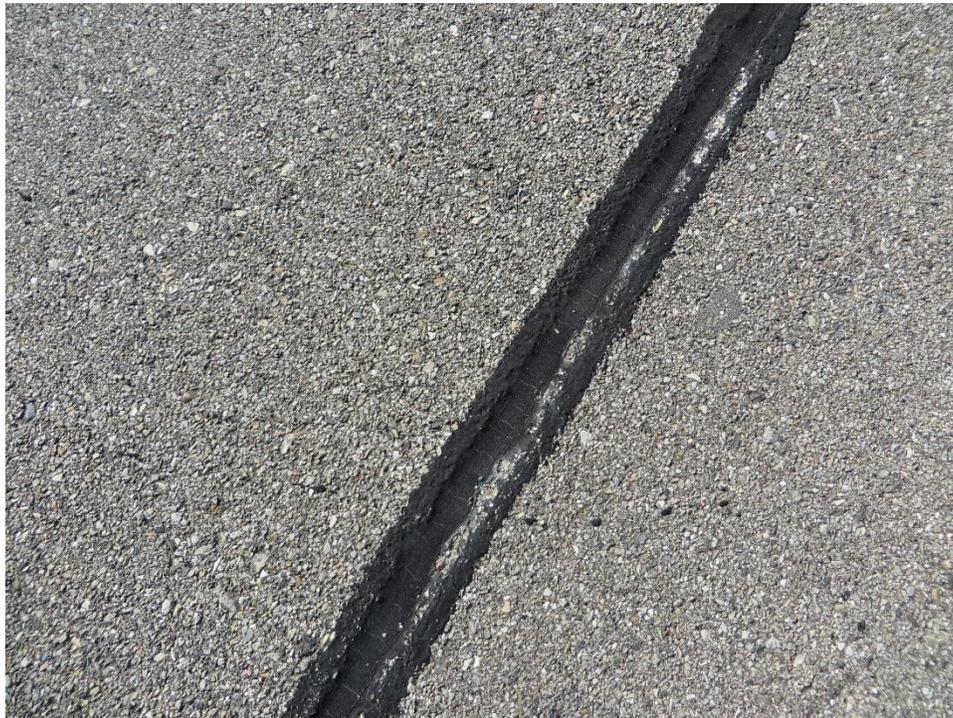
R09FC-02. L&T Cracking (Sample Unit No. 05).

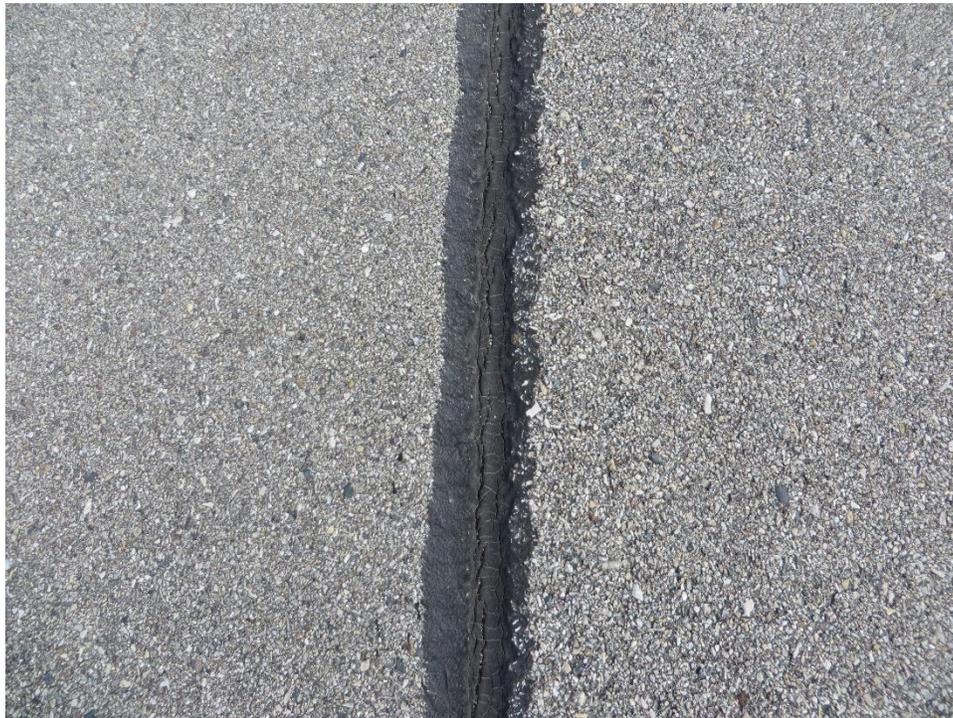
R09FC-03. L&T Cracking (Sample Unit No. 02).

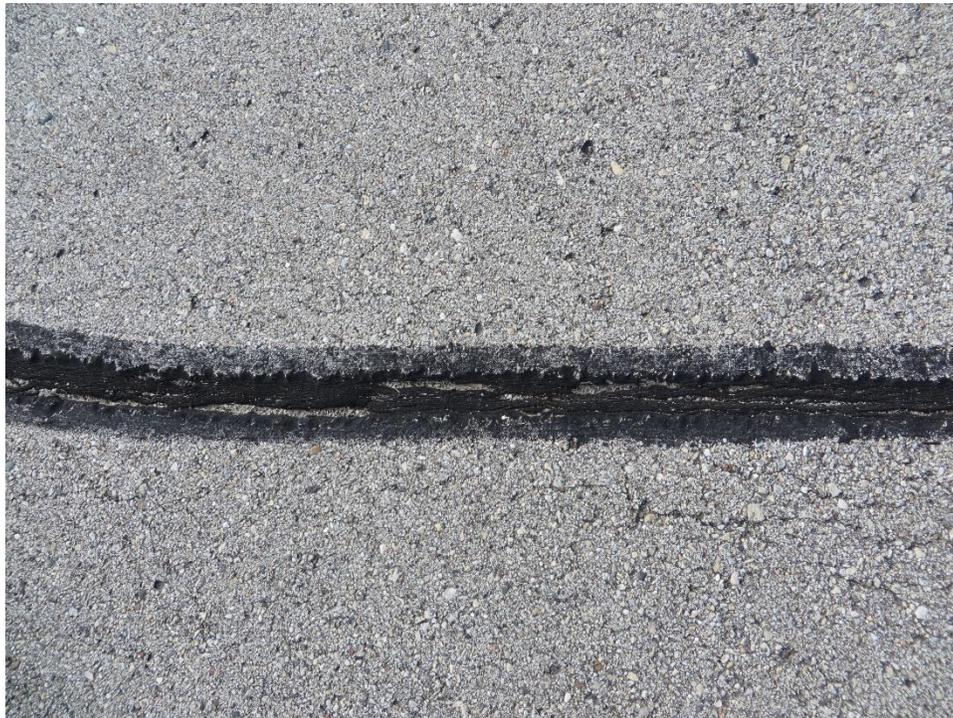
R09FC-04. L&T Cracking (Sample Unit No. 01).

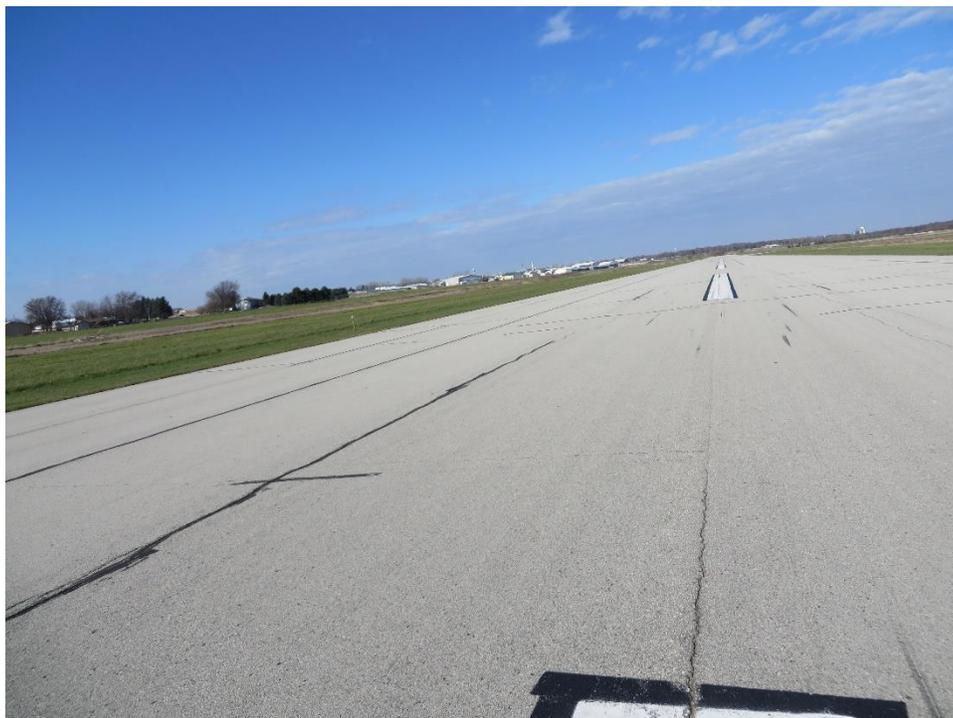
R15FC-01. Overview.

Runway 15-33 consisted of two sections in similar condition. Moderate amounts of low- and medium-severity longitudinal and transverse (L&T) cracking were observed in both sections. In addition, low- and medium-severity weathering in Section 01, and low-severity weathering and patching in Section 02 were identified. The majority of the low-severity cracking was sealed with the crack sealant in good condition, while the medium-severity cracking was recorded in areas where the crack sealant had failed.

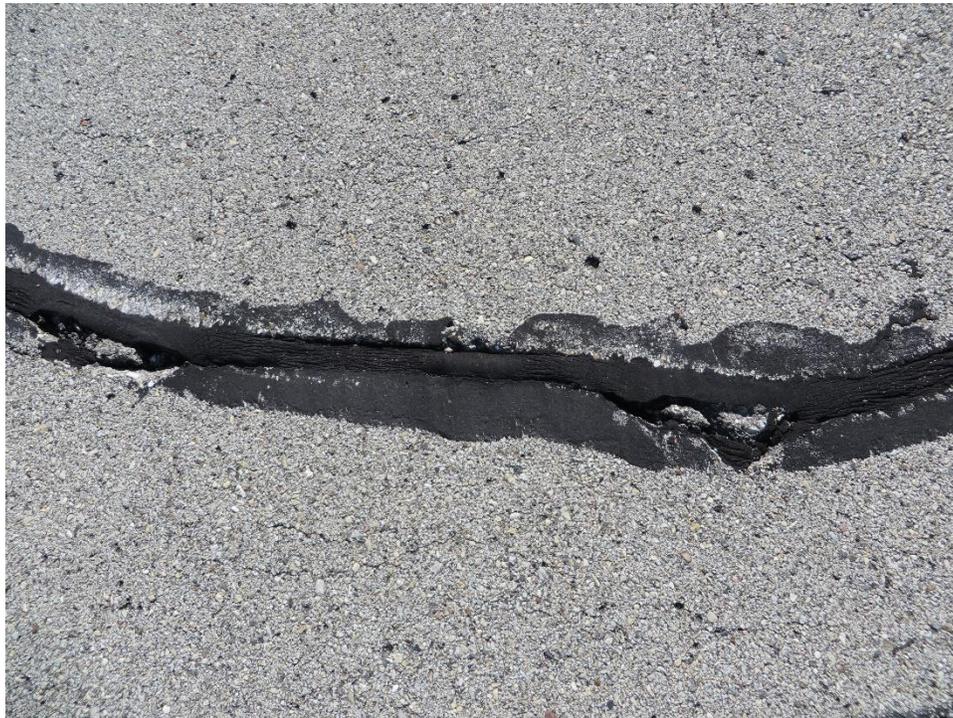
R15FC-01. L&T Cracking (Sample Unit No. 59).

Sample Number:	059	Type:	R	Area:	5,000.00SqFt	PCI =	72
Sample Comments:							
48	LONGITUDINAL/TRANSVERSE	CRACKING	L	130.00	Ft	Comments:	sealed
48	LONGITUDINAL/TRANSVERSE	CRACKING	L	208.00	Ft	Comments:	unsealed
48	LONGITUDINAL/TRANSVERSE	CRACKING	M	100.00	Ft	Comments:	failed sealant
57	WEATHERING		L	2,500.00	SqFt	Comments:

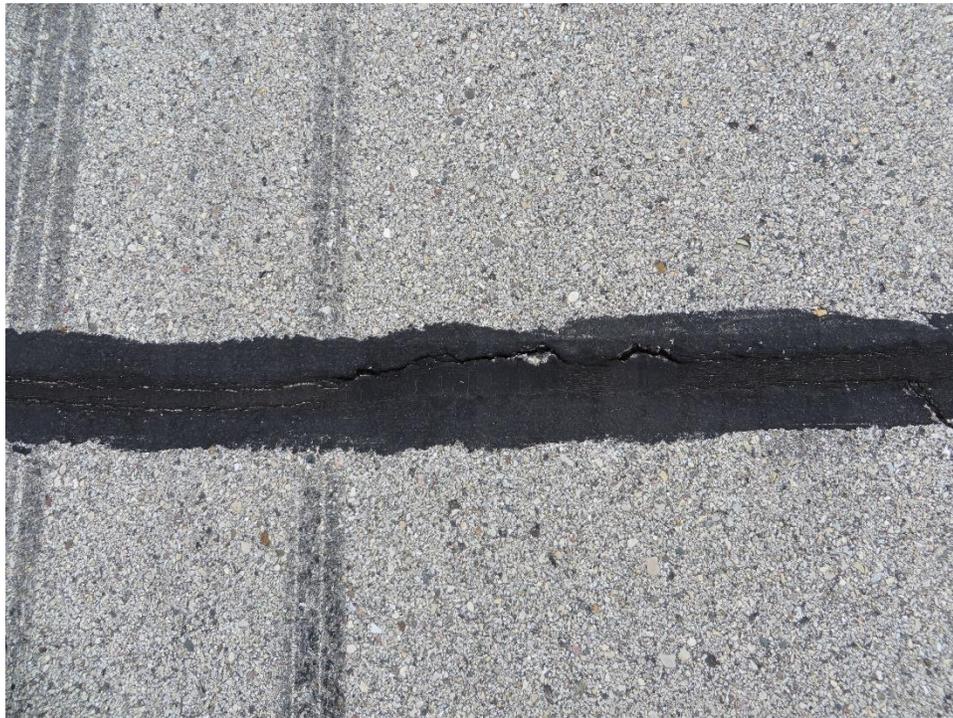
R15FC-02. L&T Cracking (Sample Unit No. 41).

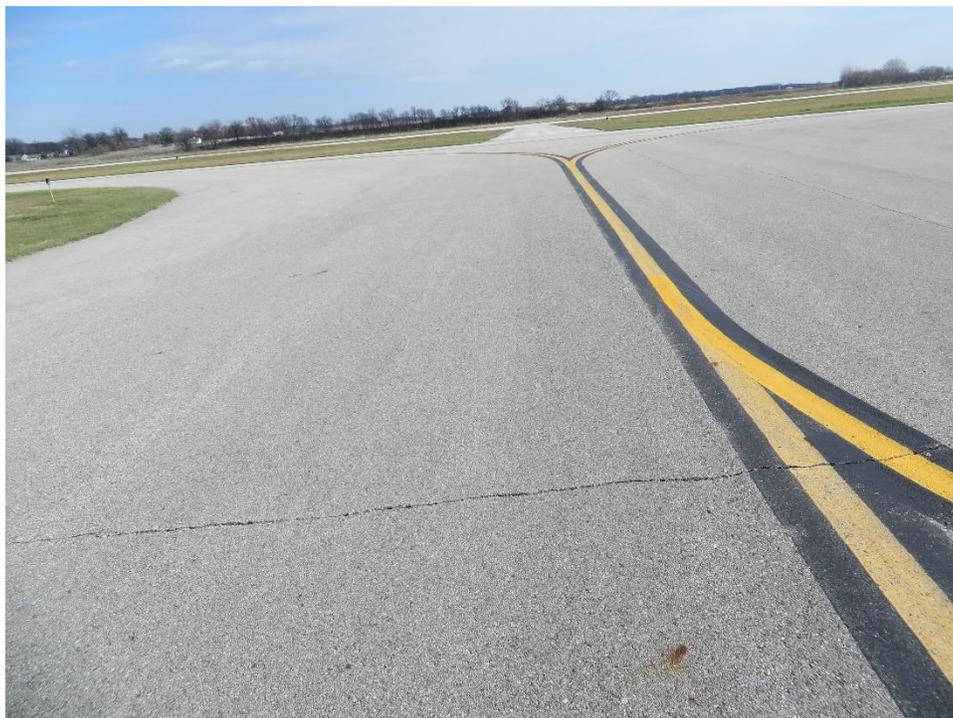
T01FC-01. Overview.

Taxiway 01 contained two sections. Section 01, which connected the apron area to Taxiway 02, had small amounts of low- and medium-severity L&T cracking and low-severity weathering observed at the time of inspection. Section 02 connected Runway 15-33 with Taxiway 02 and had moderate quantities of medium-severity L&T cracking and low- and medium-severity weathering identified throughout. The low-severity cracking was unsealed and the medium-severity cracking was recorded where unsealed crack widths were greater than ¼ in.

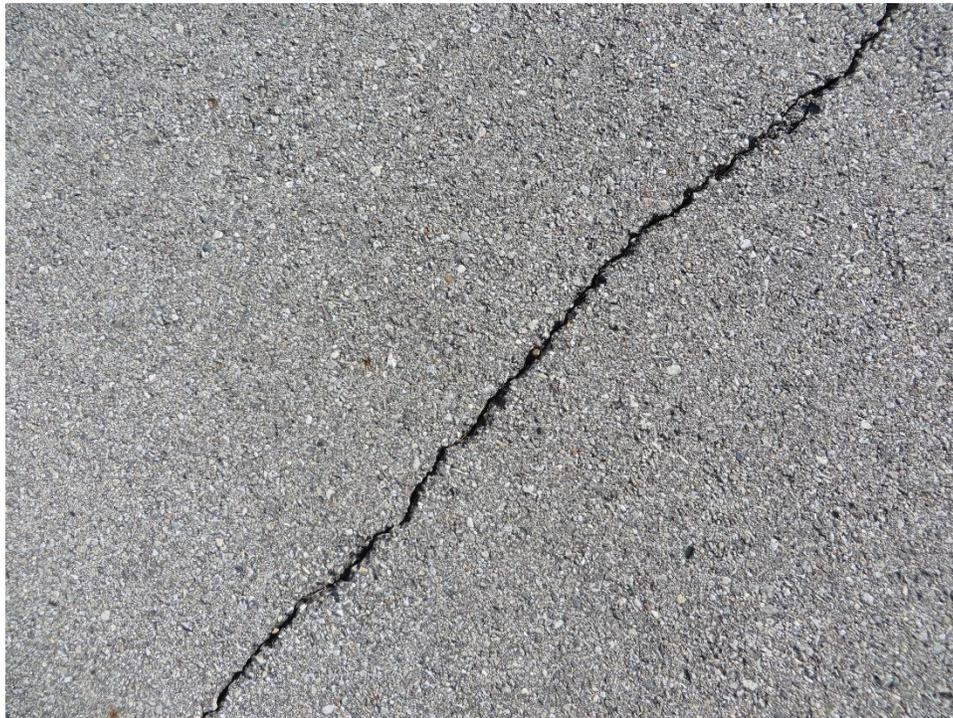
T01FC-01. L&T Cracking (Sample Unit No. 01).

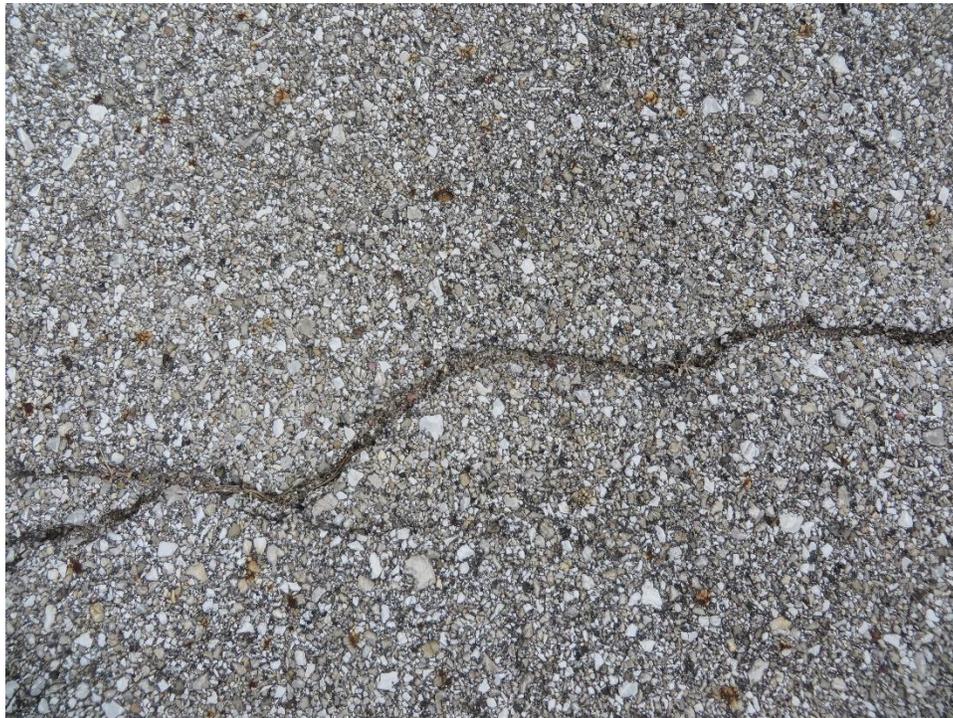
T01FC-02. L&T Cracking (Sample Unit No. 02).

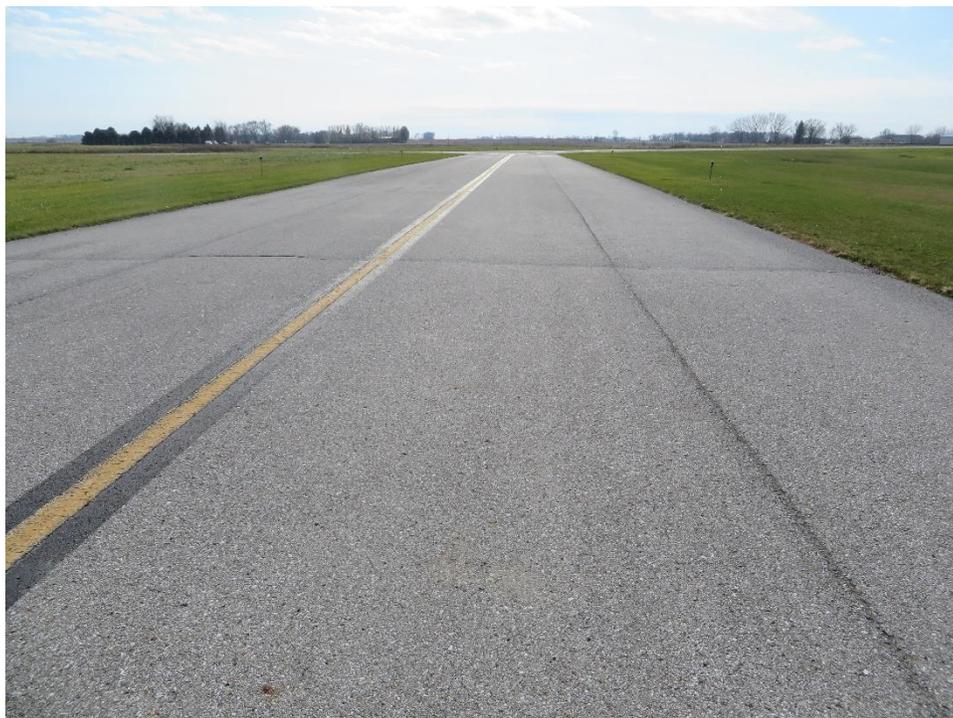
T02FC-01. Overview.

Taxiway 02 connected the Runway 15 approach with Runway 9-27 midfield and was defined by three sections. Section 01 had small amounts of low- and medium-severity L&T cracking, low-severity weathering, and low-severity raveling along with isolated quantities of medium-severity alligator cracking noted. Sections 02 and 03 were in similar condition with small amounts of low- and medium-severity L&T cracking and low-severity weathering observed. The low-severity cracking was unsealed and the medium-severity cracking was recorded where unsealed crack widths exceeded ¼ in.

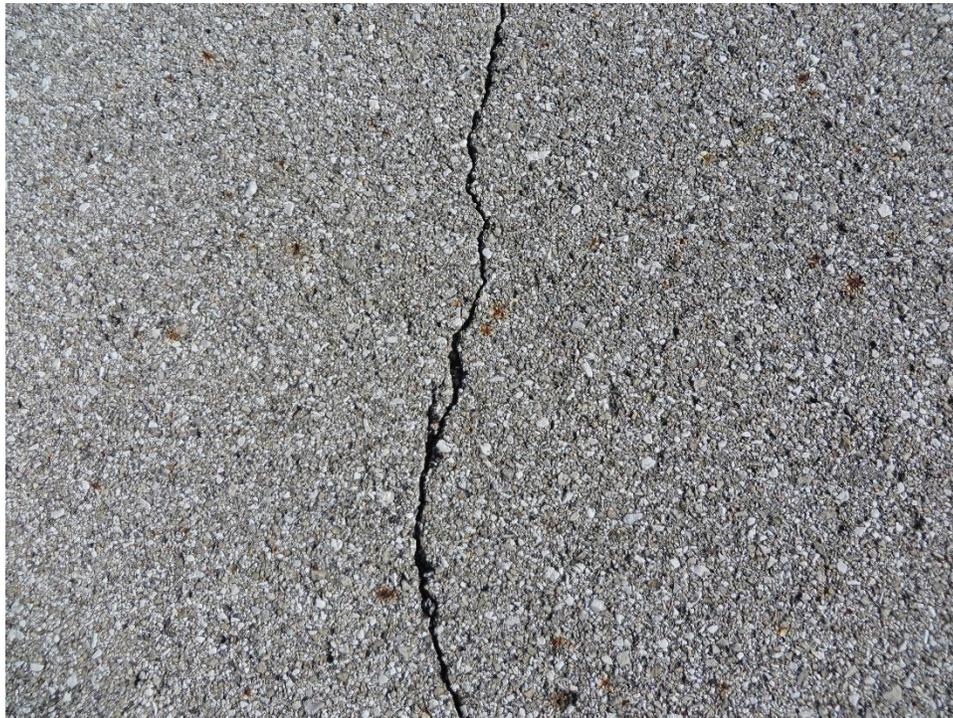
T02FC-01. L&T Cracking (Sample Unit No. 04).

Sample Number: 004 Type: R Area: 5,000.00SqFt PCI = 71  
Sample Comments:  
48 LONGITUDINAL/TRANSVERSE CRACKING M 150.00 Ft Comments:failed sealant; widt  
48 LONGITUDINAL/TRANSVERSE CRACKING L 148.00 Ft Comments:sealed  
48 LONGITUDINAL/TRANSVERSE CRACKING L 76.00 Ft Comments:unsealed  
57 WEATHERING L 2,500.00 SqFt Comments:

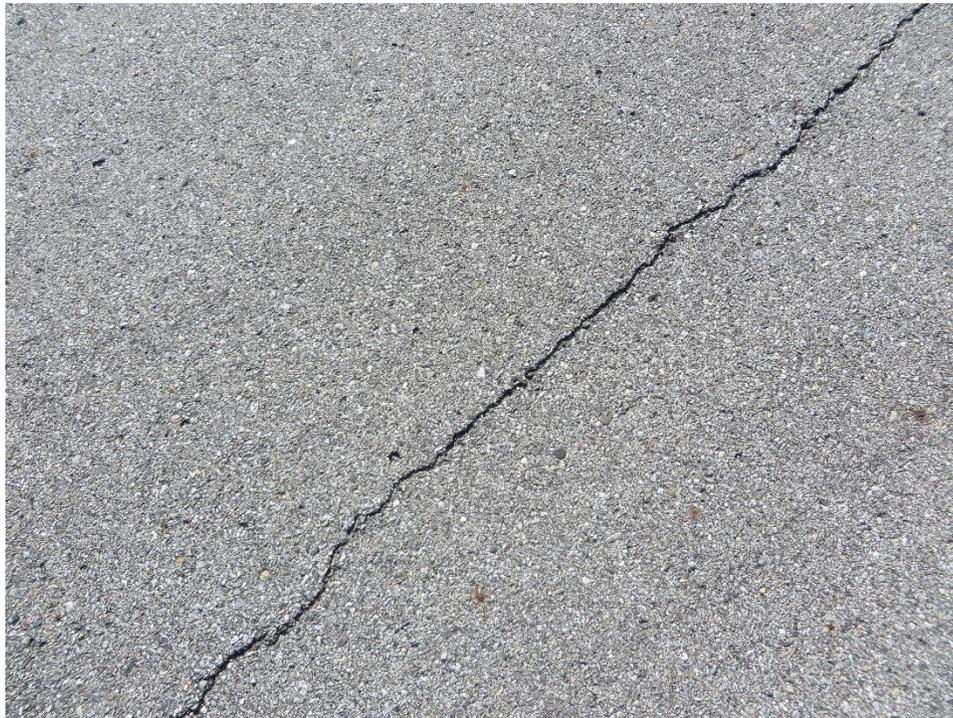
T02FC-02. L&T Cracking (Sample Unit No. 01).

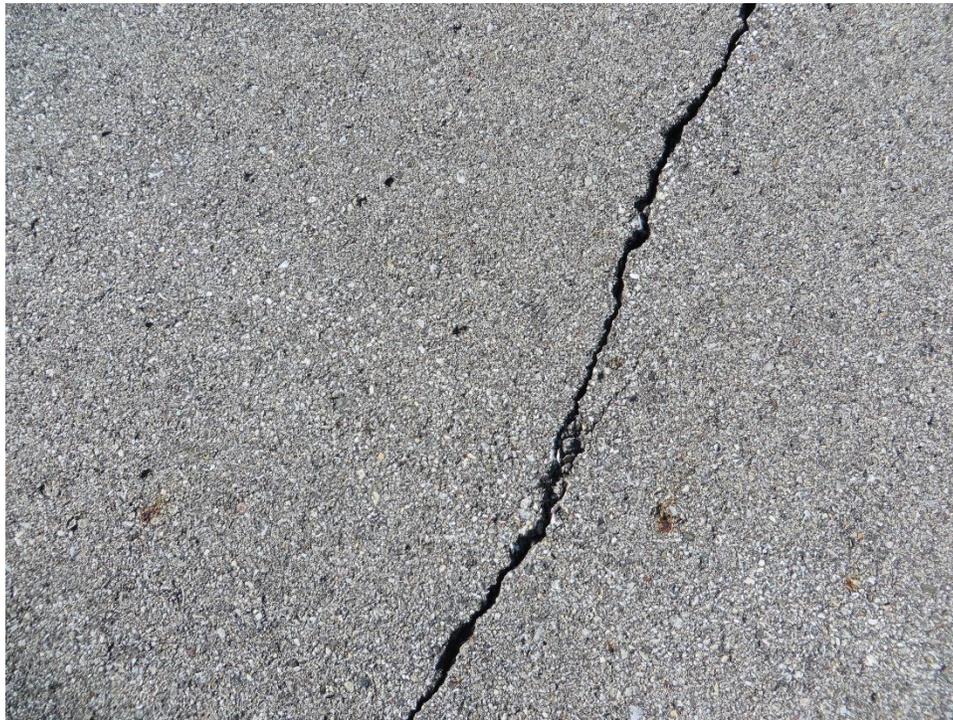
T02FC-03. L&T Cracking (Sample Unit No. 02).
