Fort Dodge Regional Airport

Pavement Management Report

JULY 2023

FORT DODGE REGIONAL AIRPORT PAVEMENT MANAGEMENT REPORT

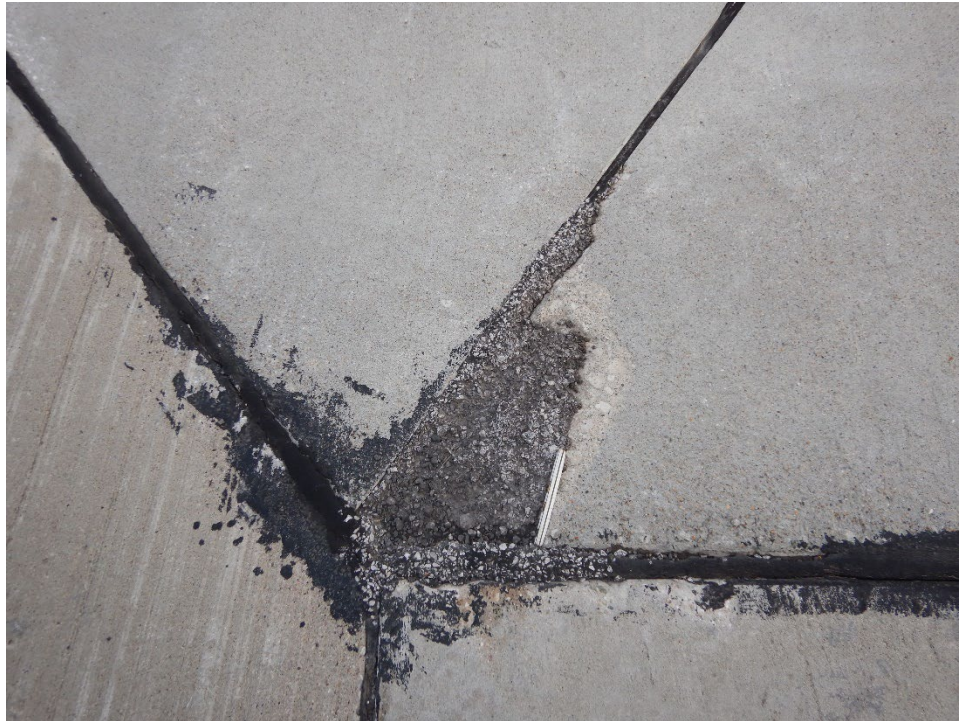
A01FD-02. Corner Spalling (Additional Sample Unit No. 15).

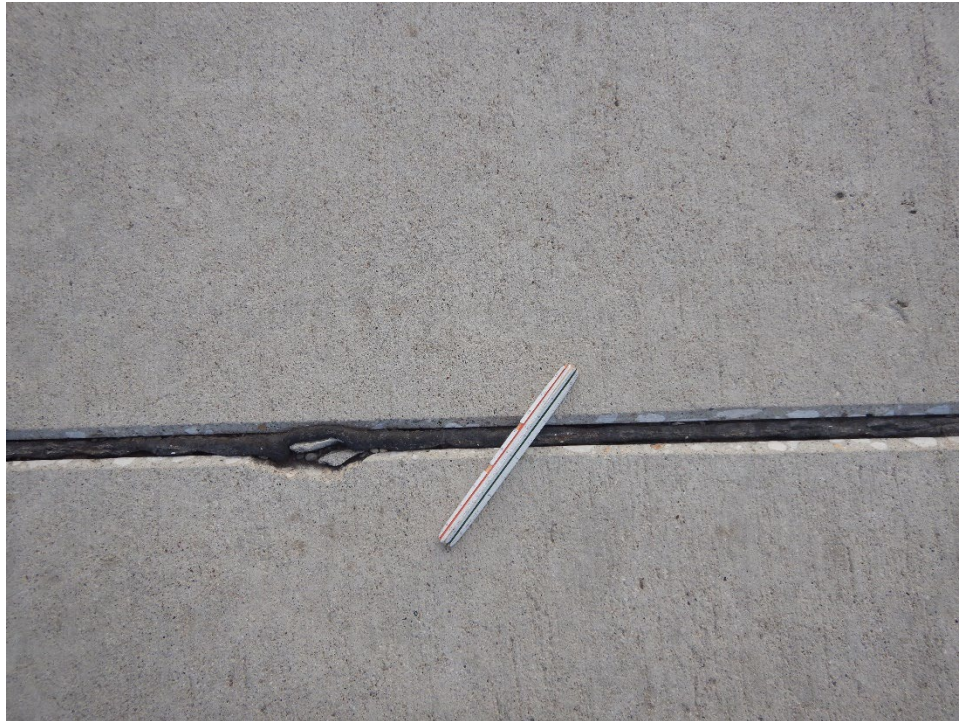
A02FD-01. Joint Seal Damage (Sample Unit No. 07).

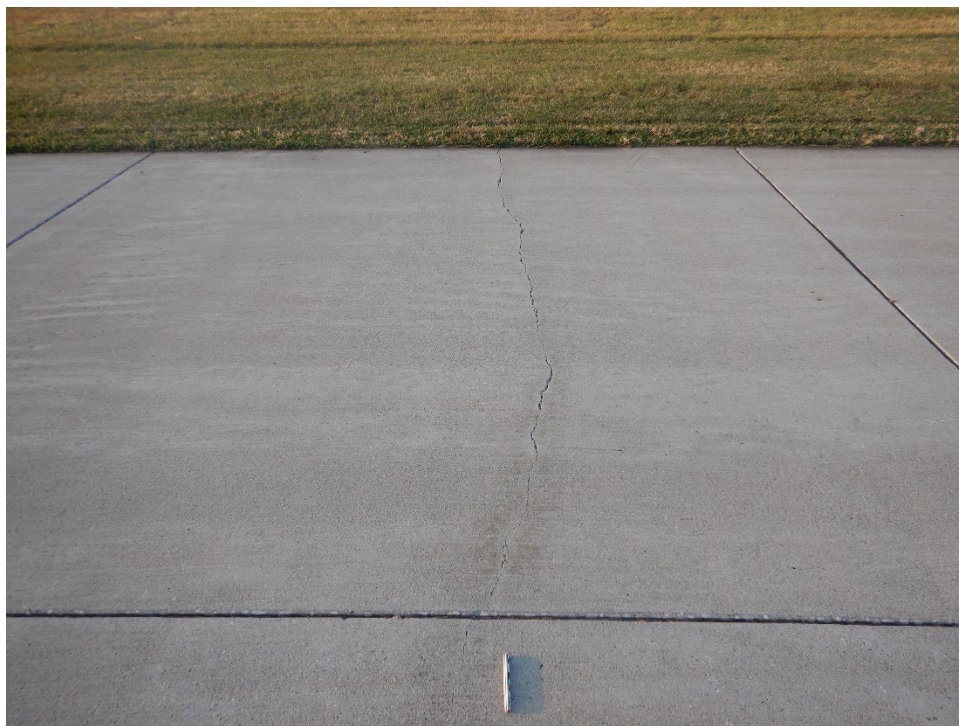
A02FD-01. LTD Cracking (Additional Sample Unit No. 14).

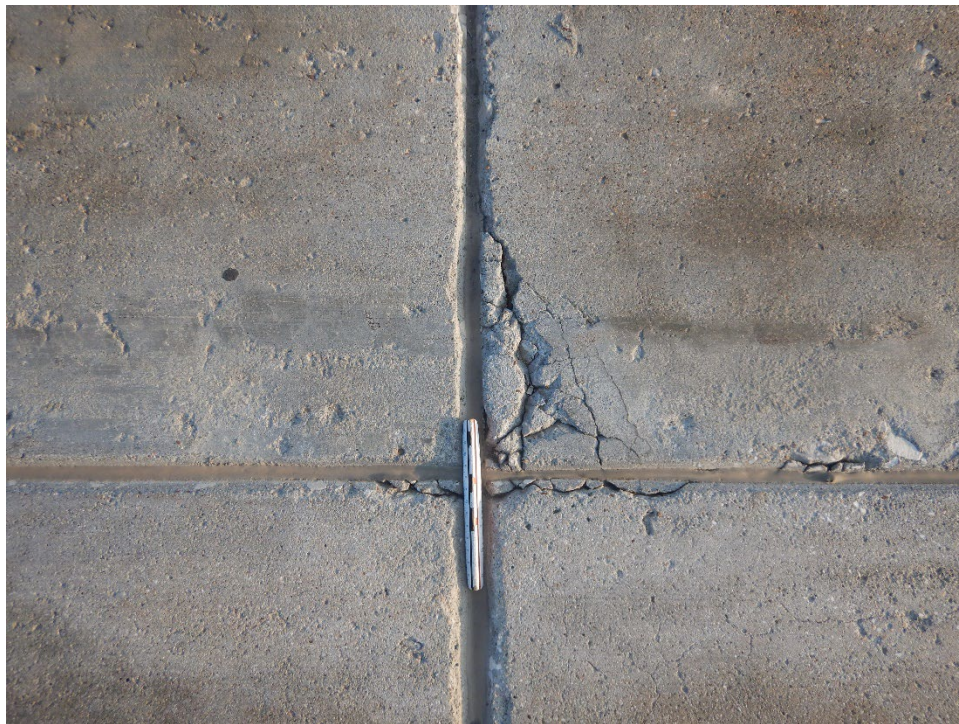
A02FD-02. Joint Spalling (Sample Unit No. 04).

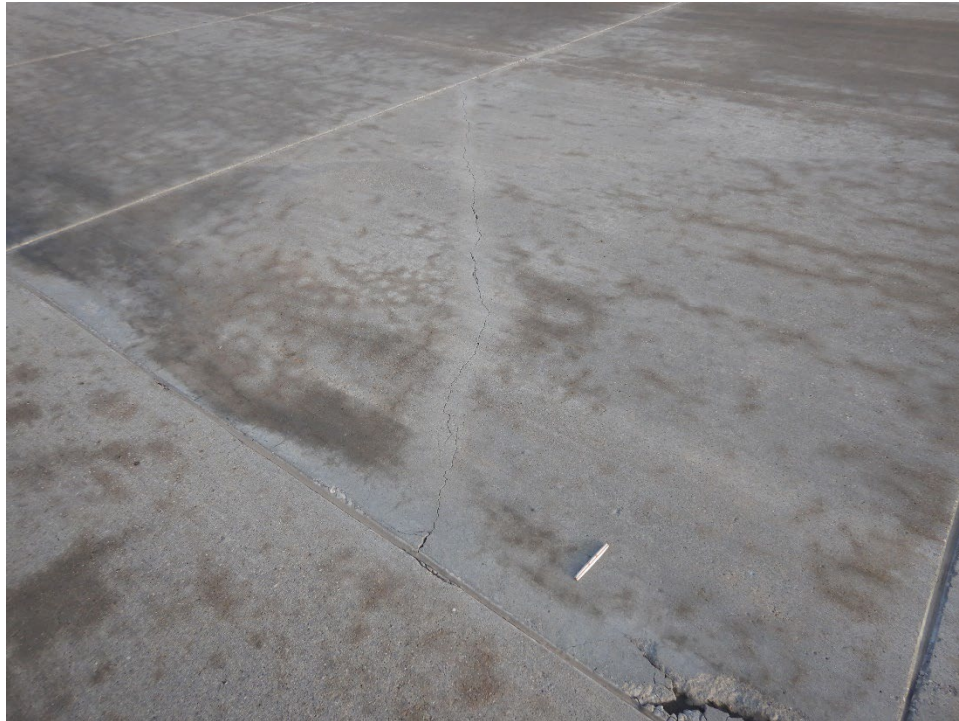
A02FD-02. LTD Cracking (Sample Unit No. 04).

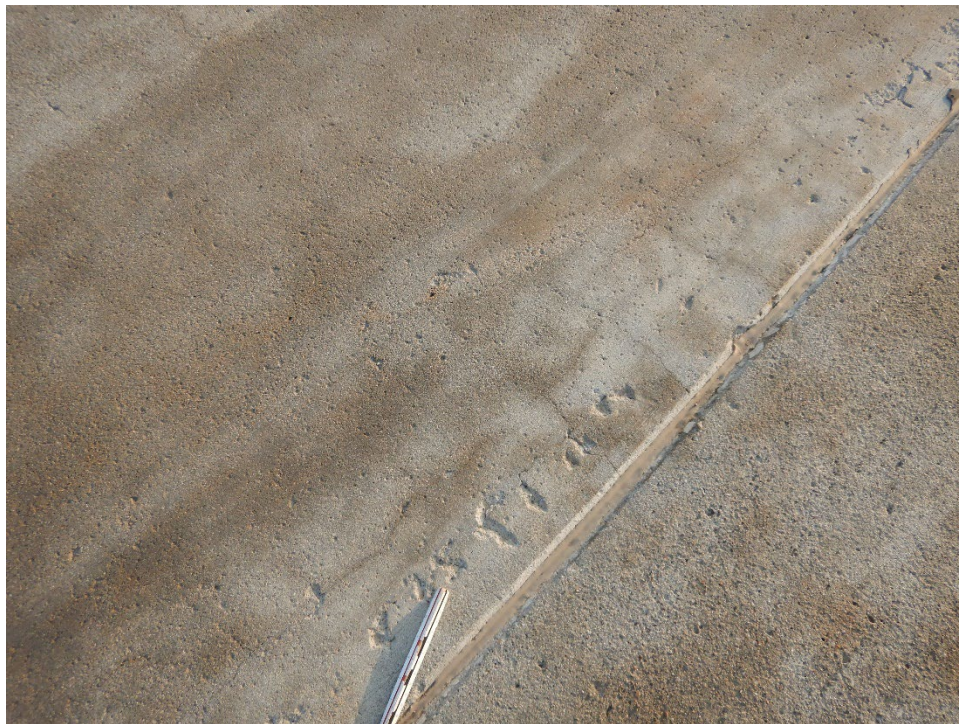
A02FD-02. Shrinkage Cracking (Sample Unit No. 04).

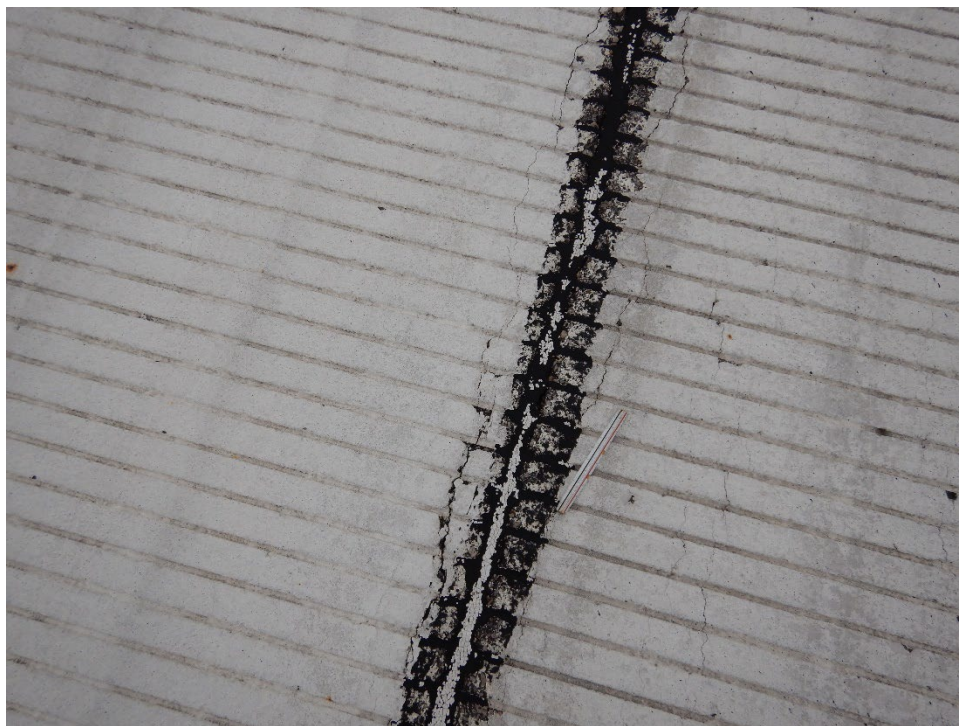
R06FD-01. L&T Cracking (Sample Unit No. 155).

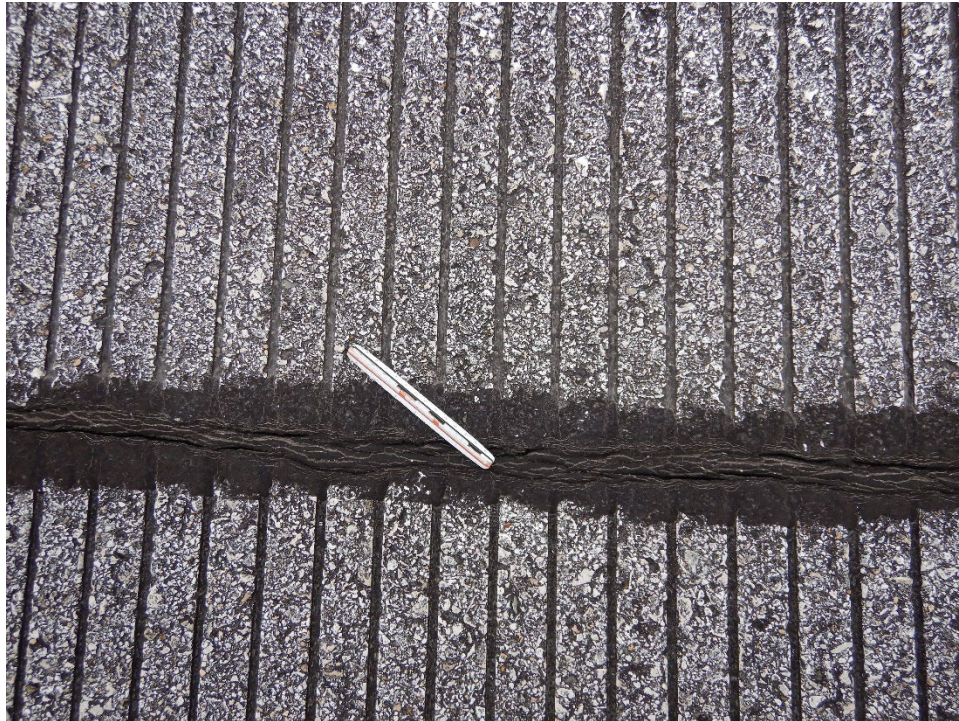
R06FD-01. L&T Cracking (Sample Unit No. 96).

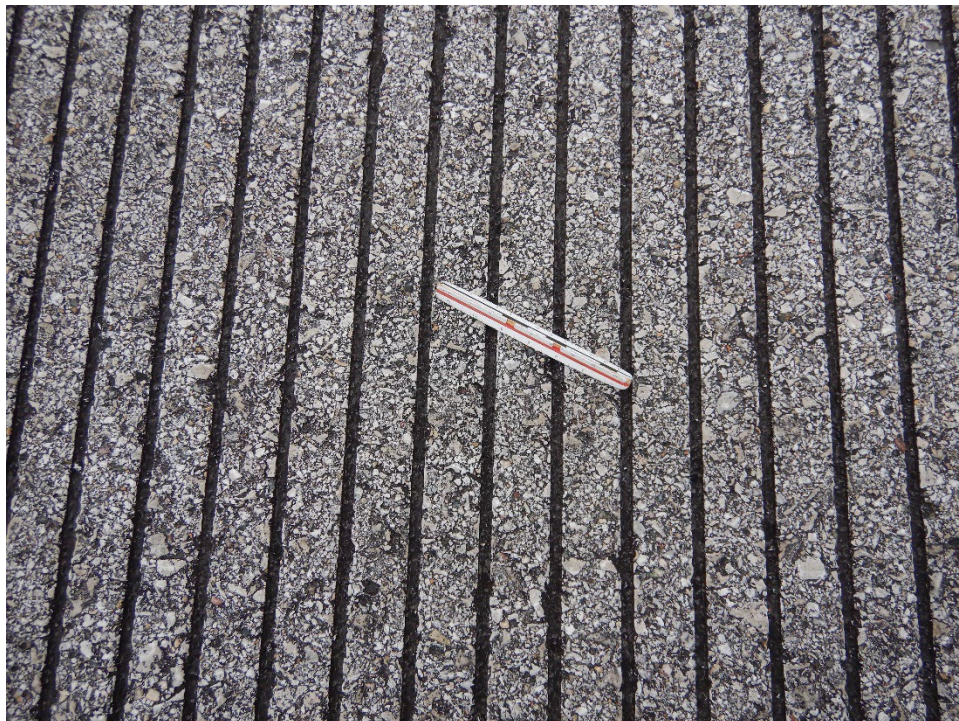
R06FD-01. Weathering (Sample Unit No. 155).

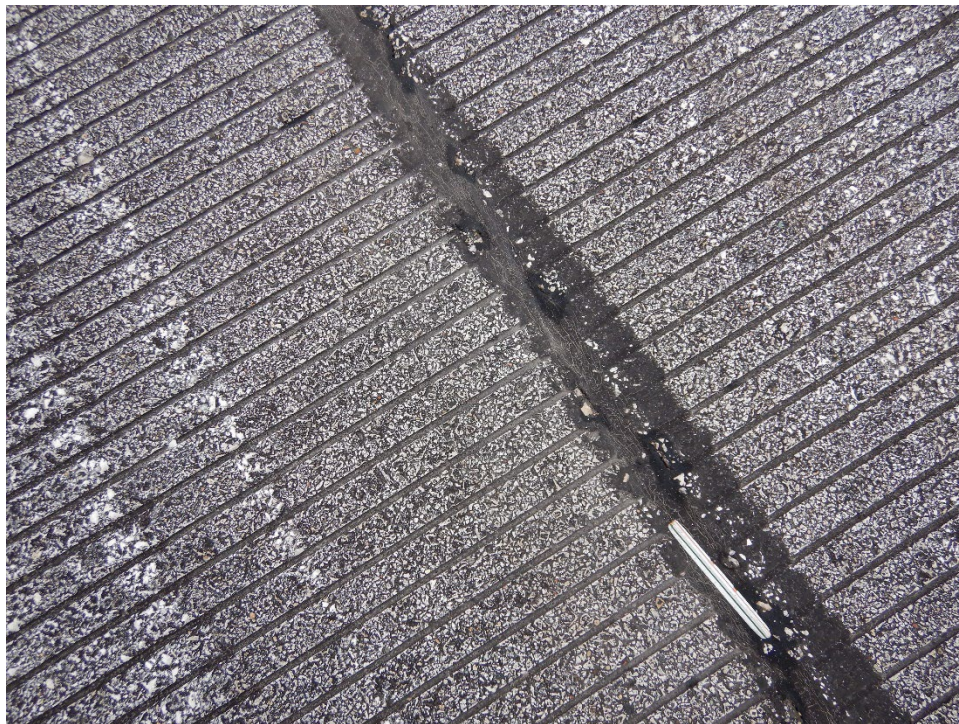
R06FD-02. L&T Cracking (Sample Unit No. 18).

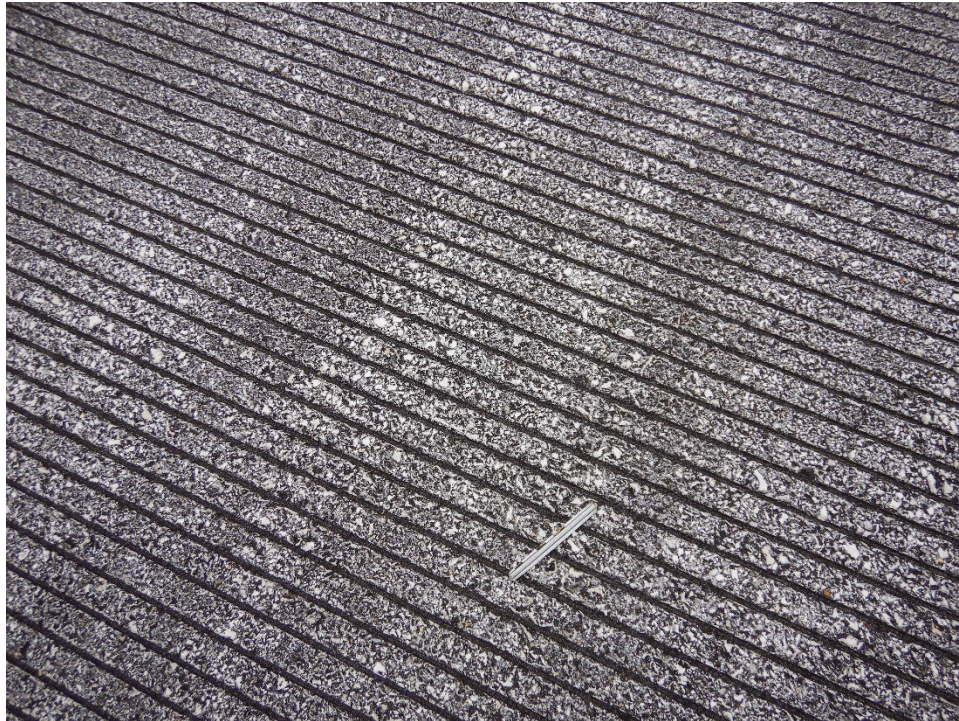
R06FD-02. Weathering (Sample Unit No. 18).

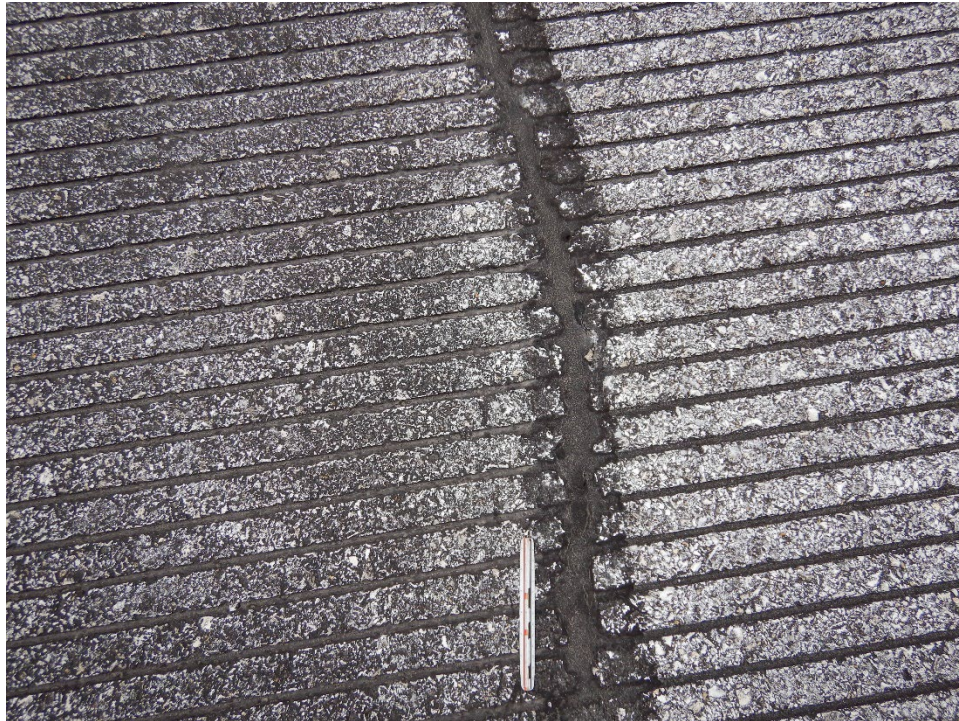
R12FD-01. L&T Cracking (Sample Unit No. 24).

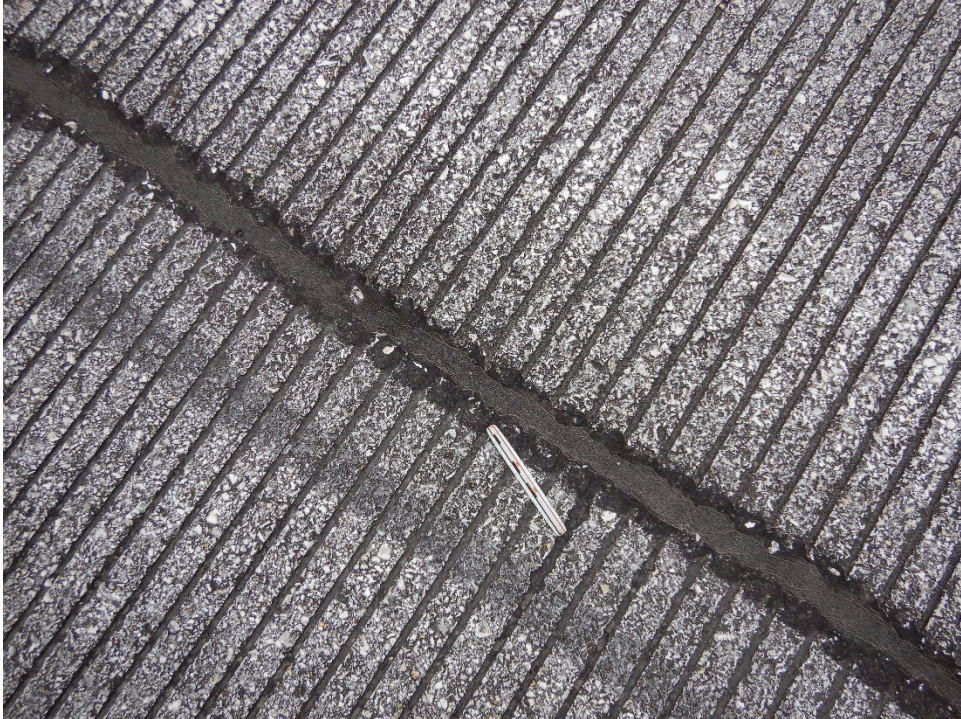
R12FD-02. L&T Cracking (Sample Unit No. 53).

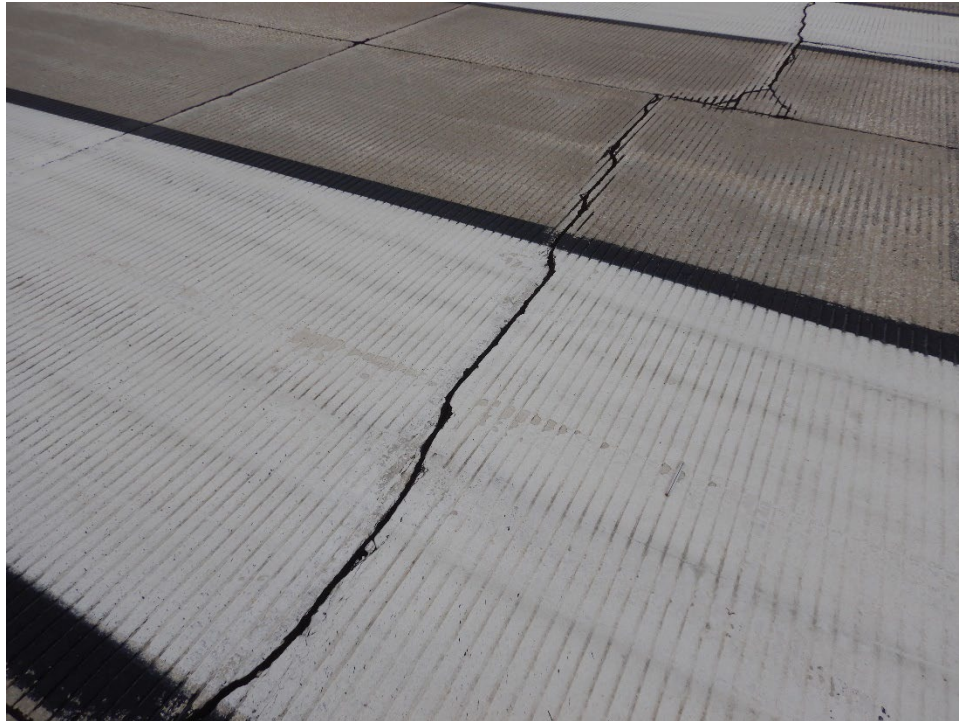
R12FD-03. LTD Cracking (Sample Unit No. 02).

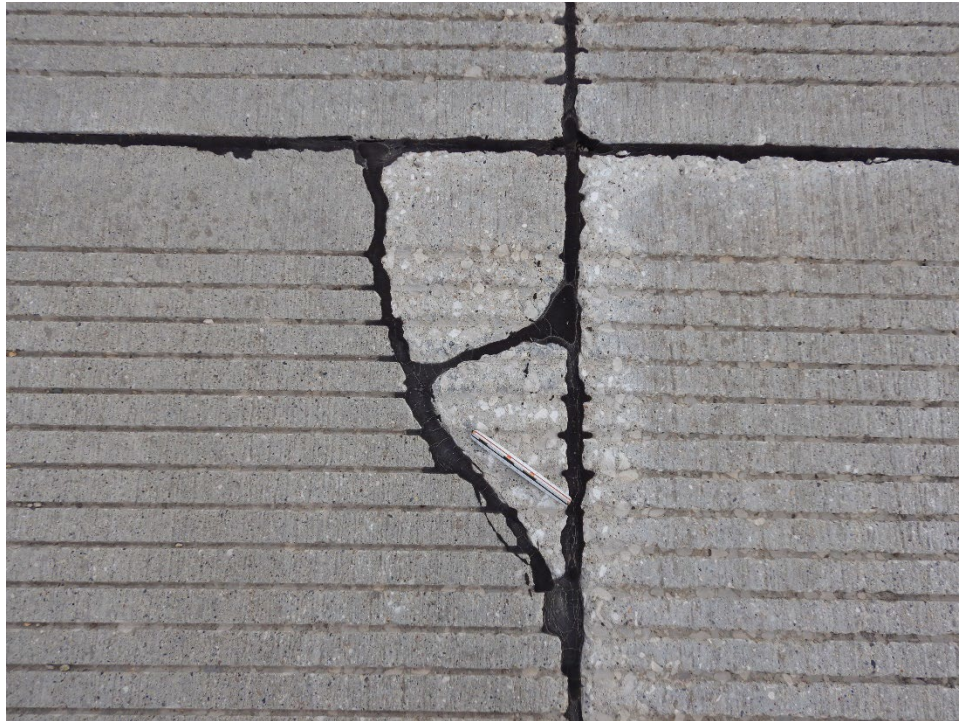
R12FD-04. Corner Spalling (Sample Unit No. 12).

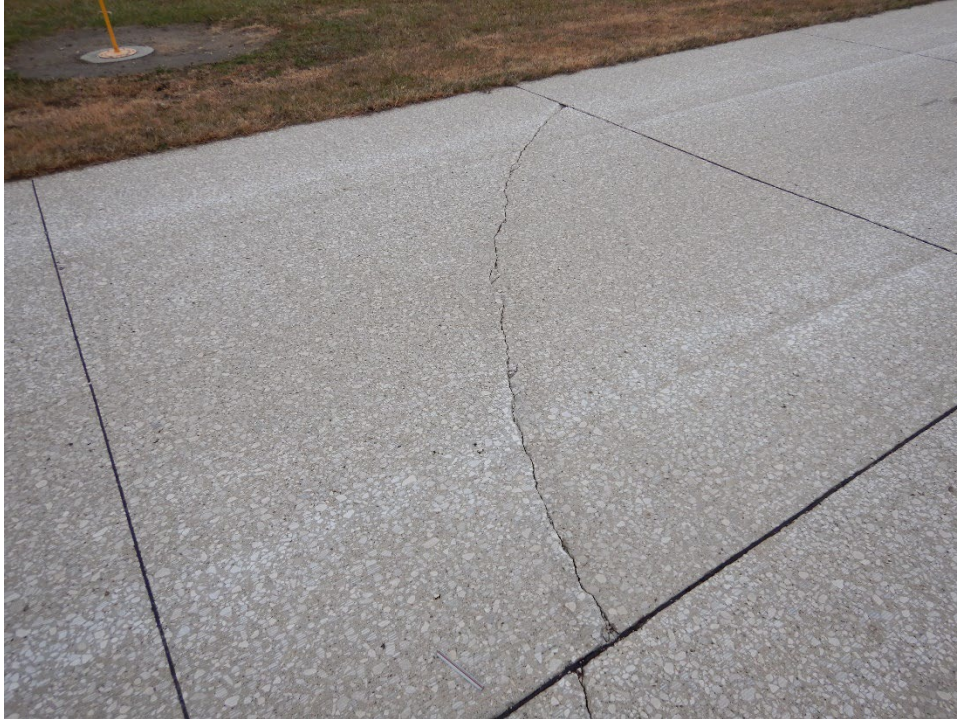
Taxiway A contained one section that had areas of high-severity joint seal damage and medium-severity corner break, joint spalling, and LTD cracking.

TAFD-01. LTD Cracking (Sample Unit No. 10).

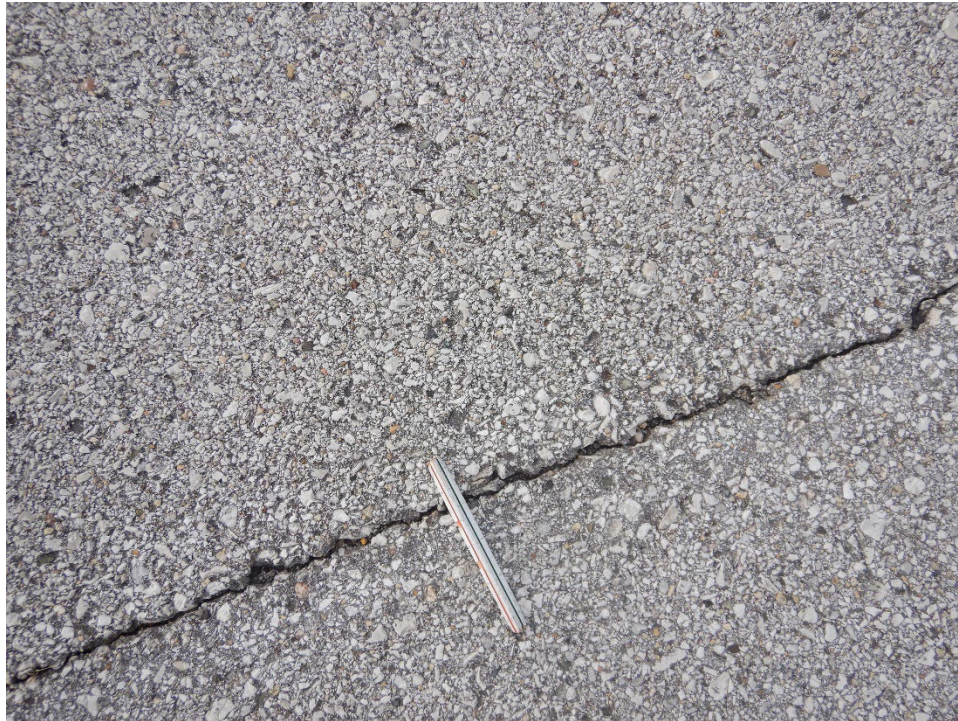
TBFD-01. L&T Cracking (Sample Unit No. 11).

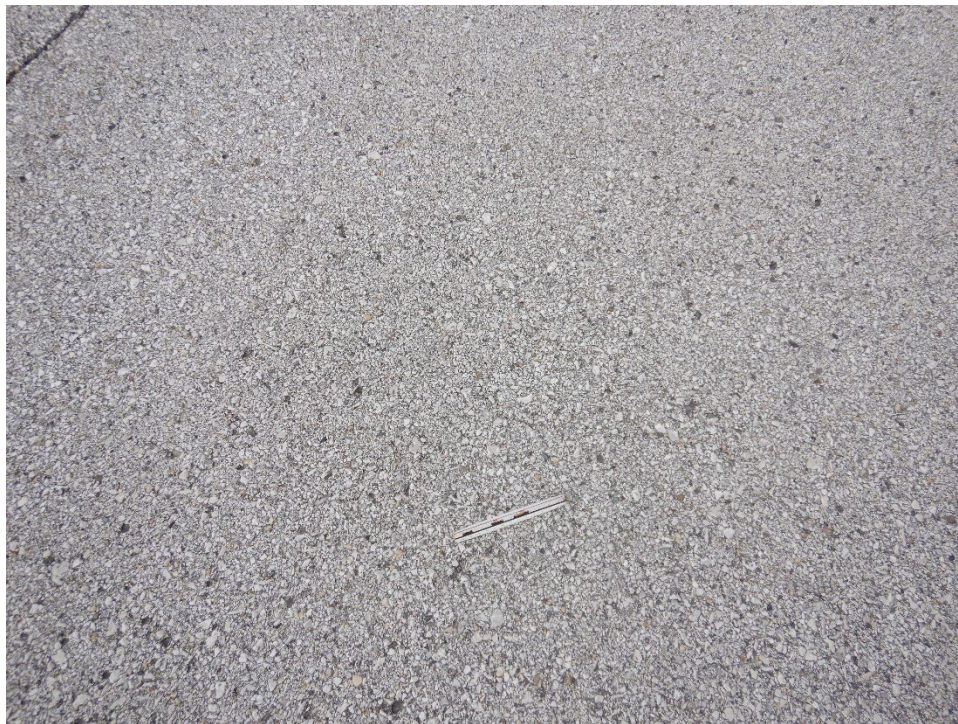
TBFD-01. Weathering (Sample Unit No. 11).

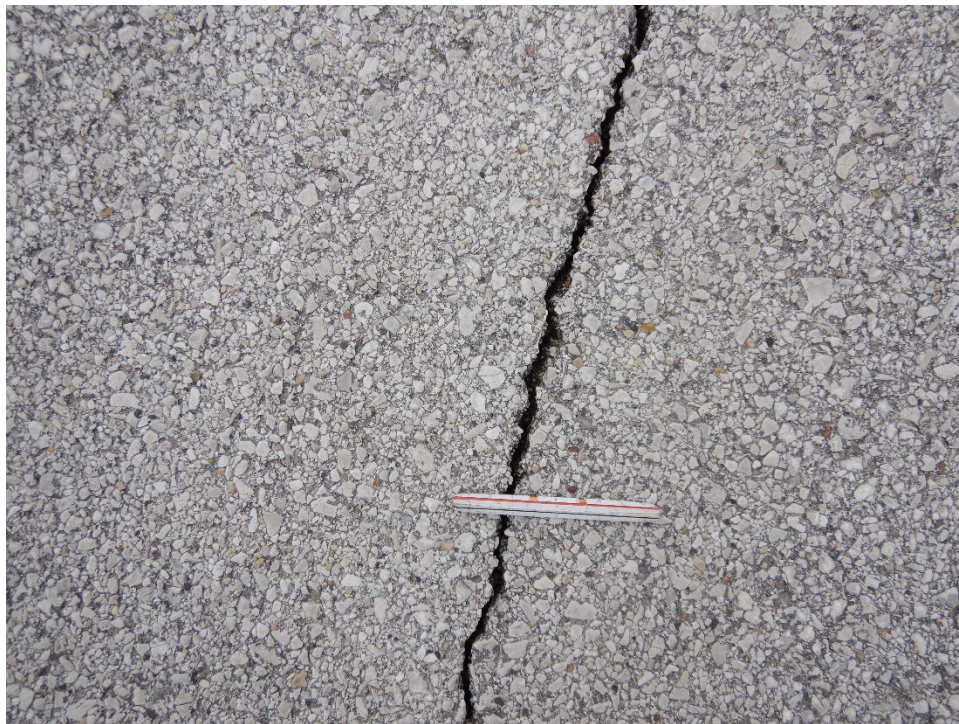
TBFD-02. L&T Cracking (Sample Unit No. 09).

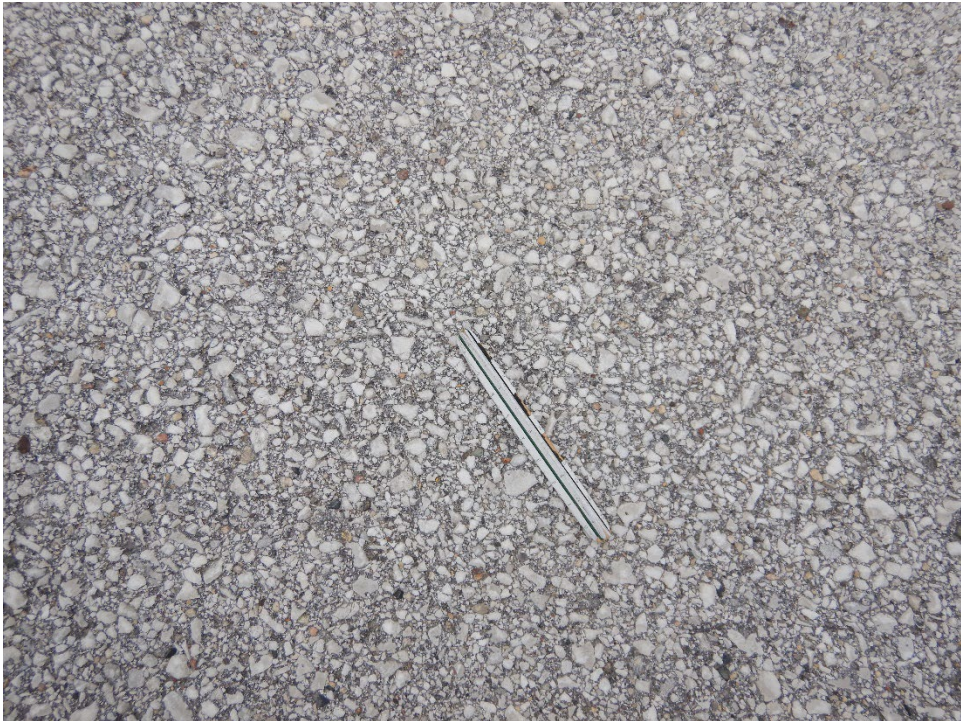
TBFD-02. Weathering (Sample Unit No. 09).

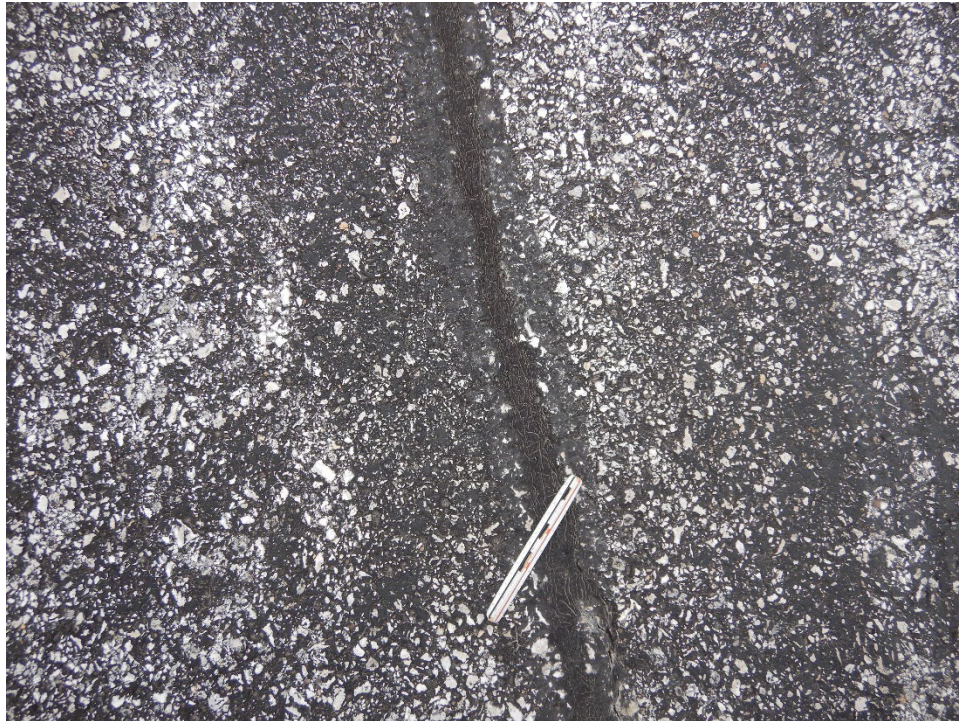
TBFD-04. L&T Cracking (Sample Unit No. 03).

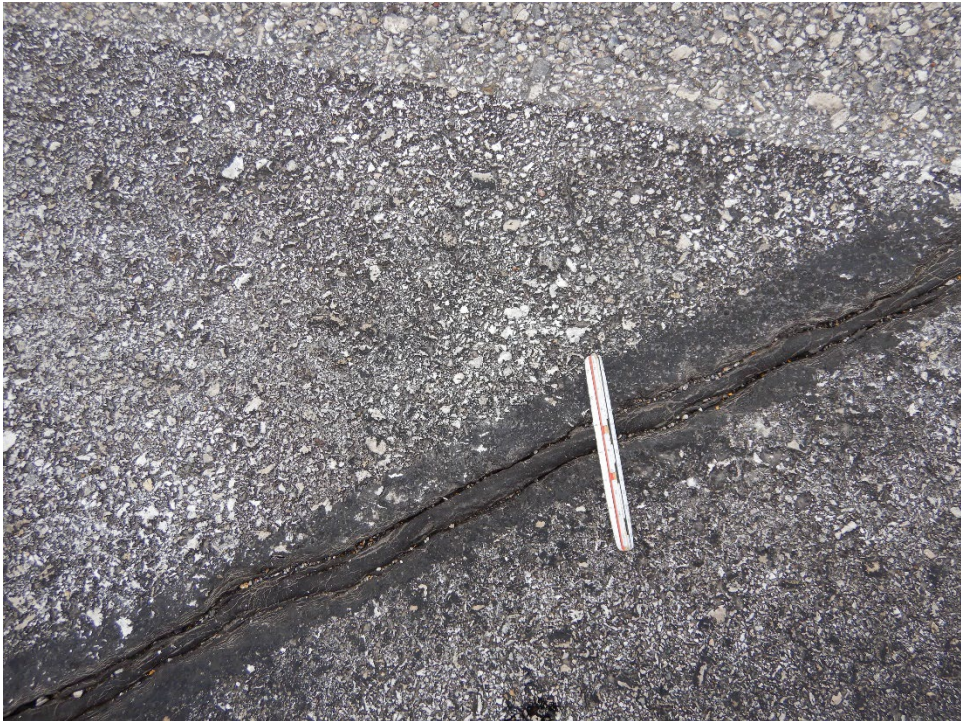
TBFD-05. L&T Cracking (Sample Unit No. 03).

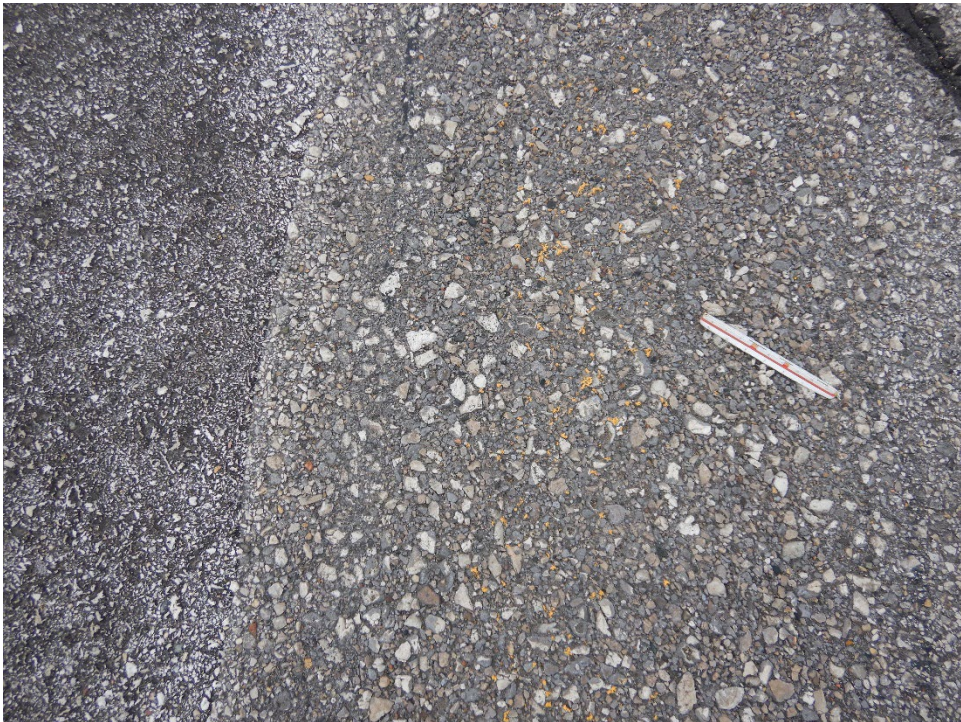
TBFD-05. Weathering (Sample Unit No. 03).

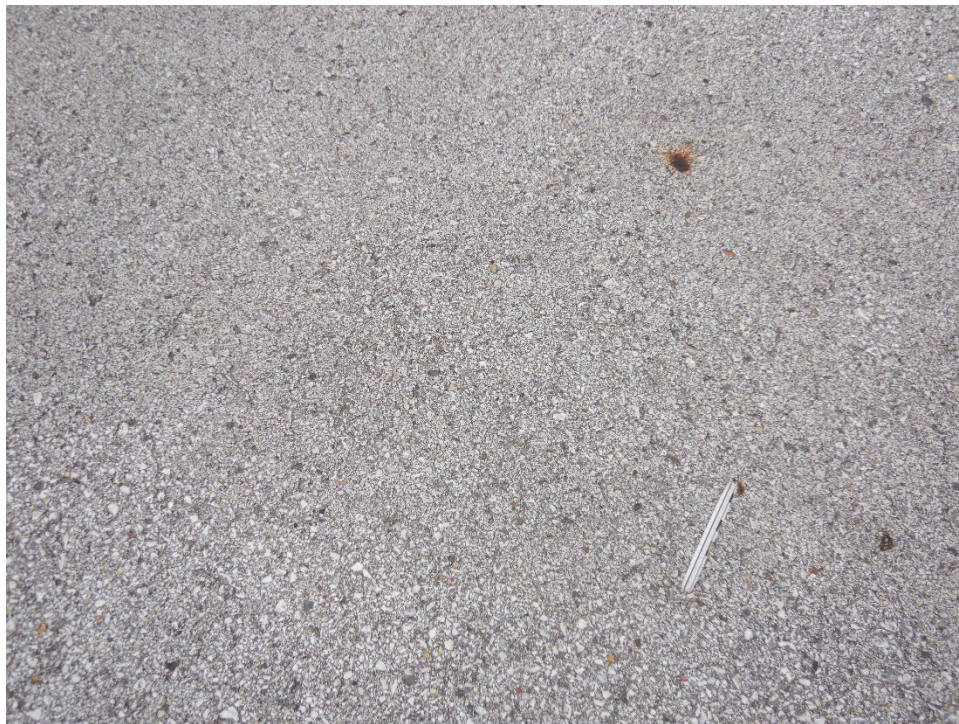
TBFD-06. Weathering (Sample Unit No. 01).

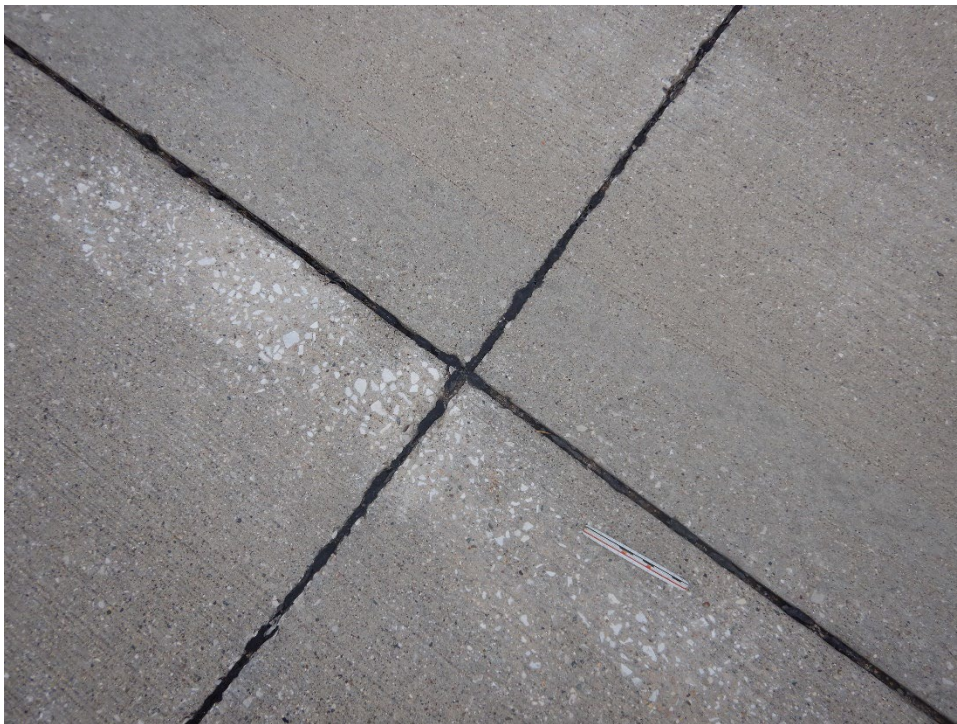
Taxiway C consisted of one section. Section 01 contained areas of high-severity joint seal damage and low-severity corner break, corner spalling, faulting, and joint spalling.

TCFD-01. Joint Seal Damage (Sample Unit No. 12).

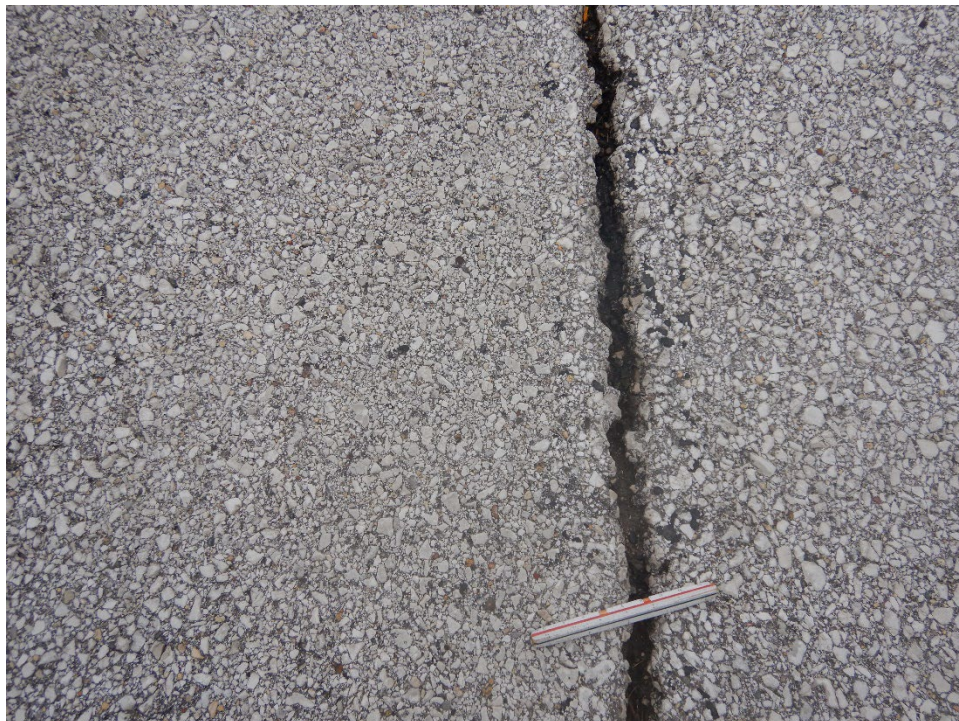
TDFD-01. L&T Cracking (Sample Unit No. 05).

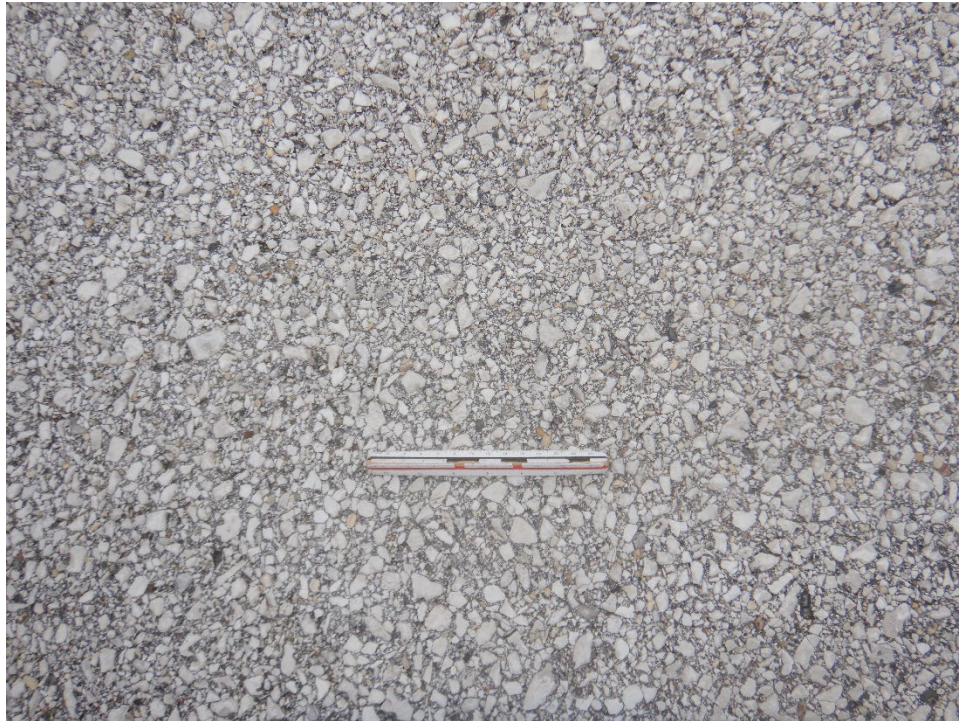
TDFD-01. Weathering (Sample Unit No. 05).

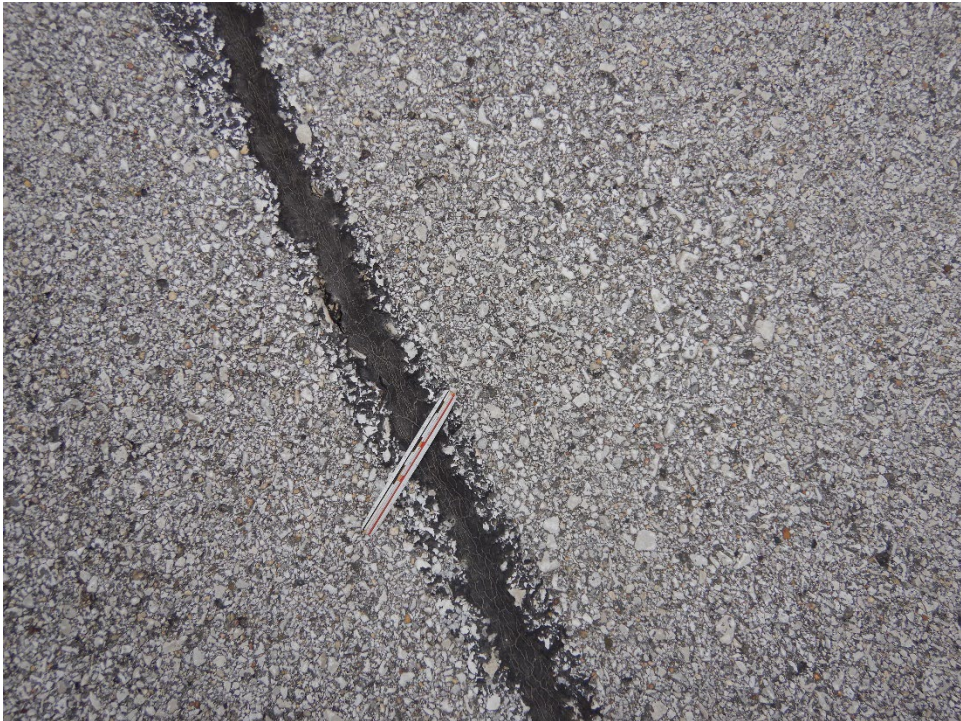
TDFD-02. L&T Cracking (Sample Unit No. 04).

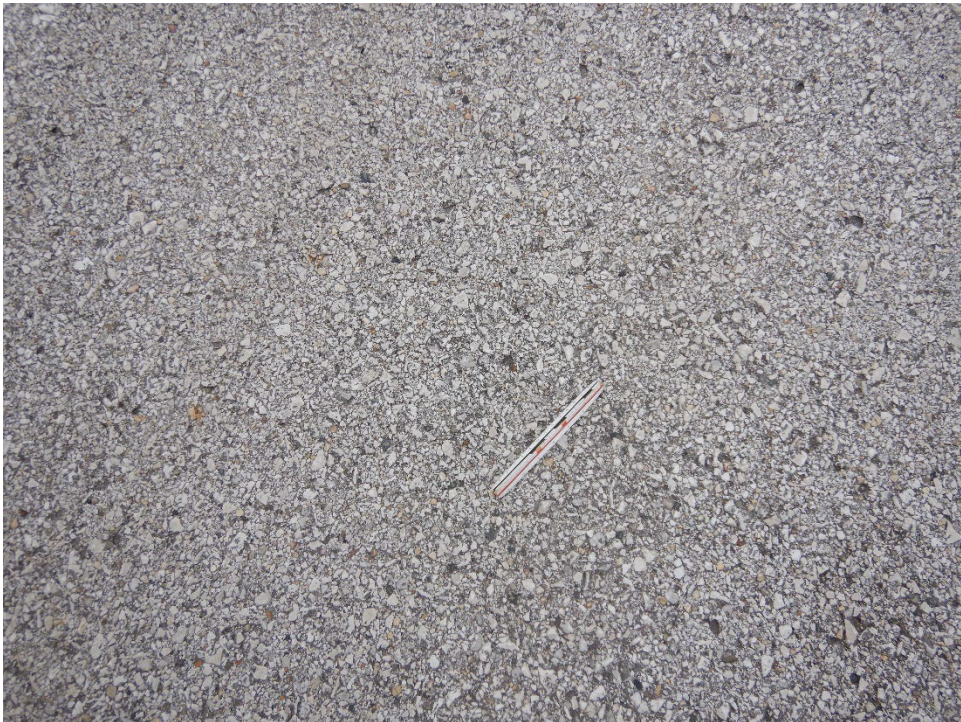
TDFD-02. Weathering (Sample Unit No. 04).

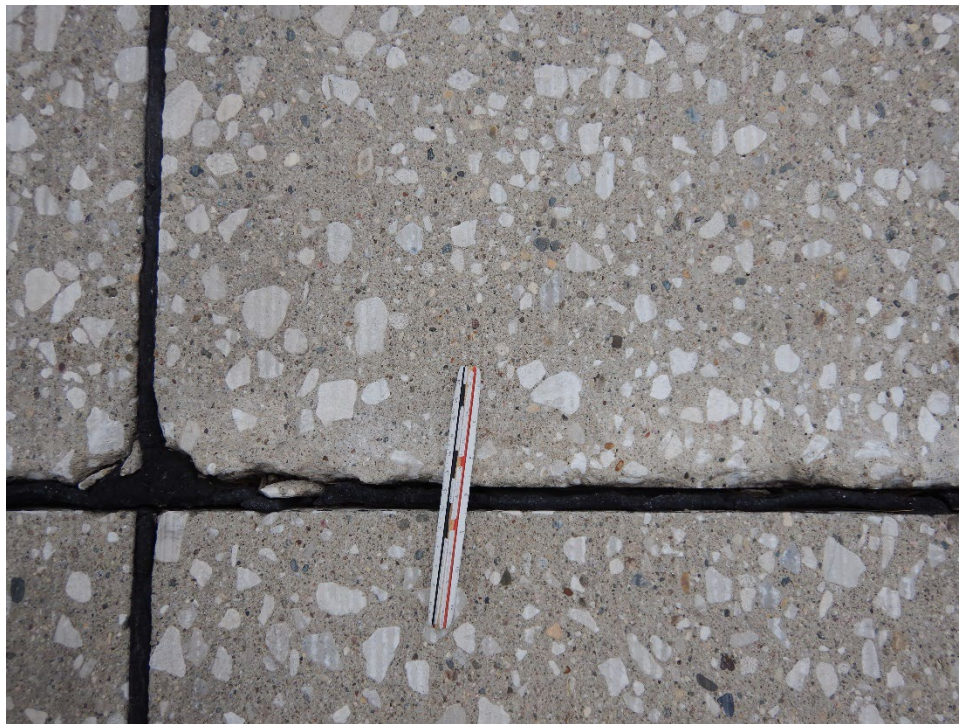
TDFD-03. Joint Seal Damage (Sample Unit No. 03).

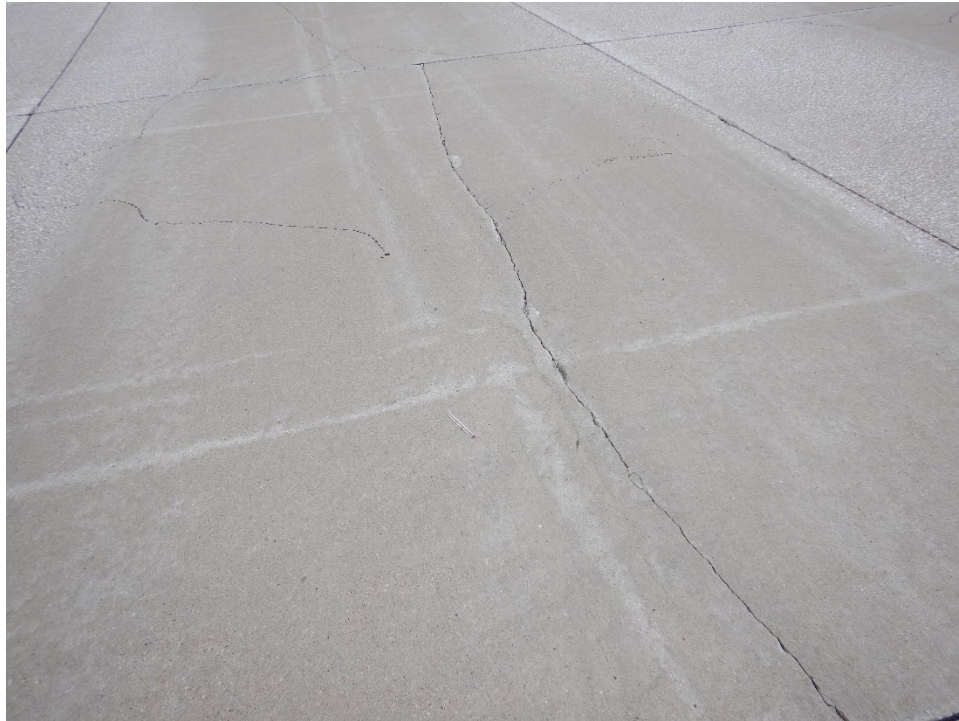
TDFD-03. LTD Cracking (Sample Unit No. 03).

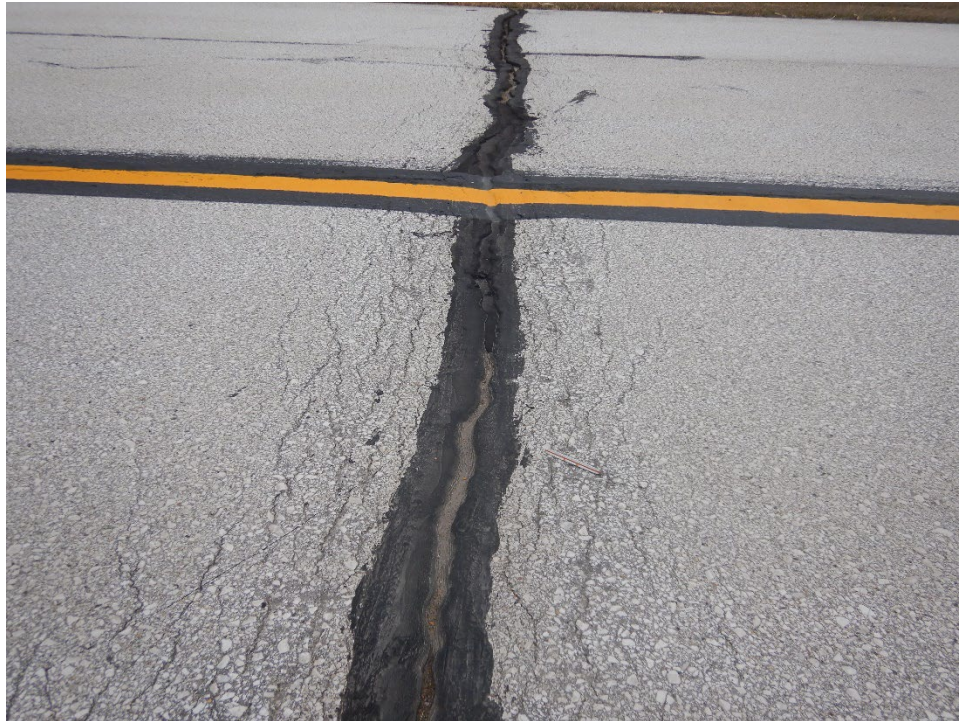
TFFD-01. L&T Cracking (Sample Unit. 05).

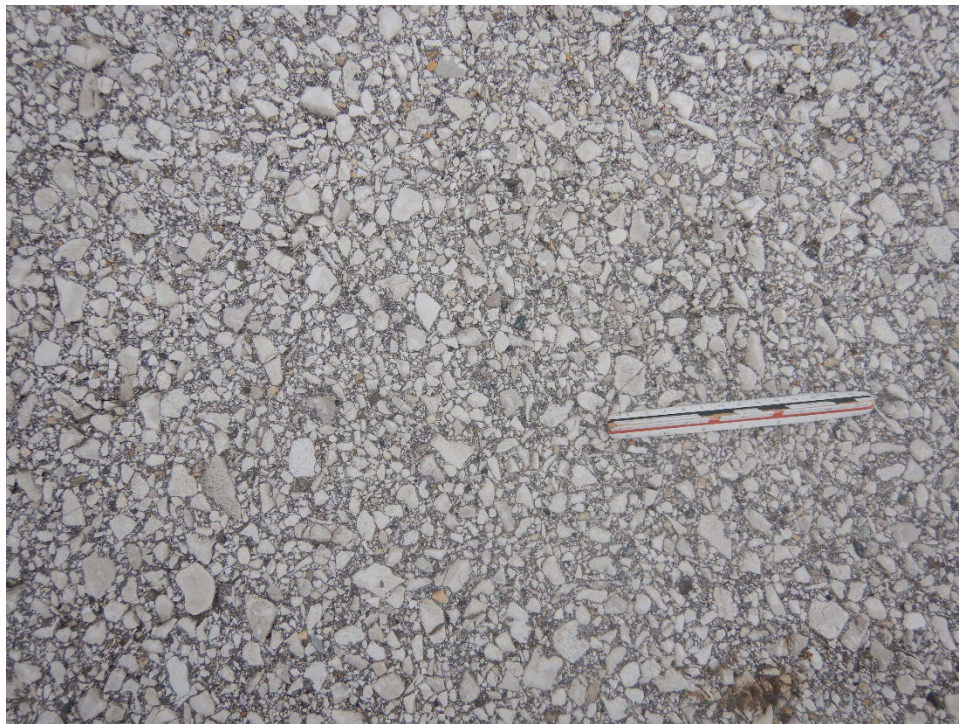
TFFD-01. Weathering (Sample Unit. 05).
