Fort Dodge Regional Airport

Pavement Management Report

JULY 2023

FORT DODGE REGIONAL AIRPORT PAVEMENT MANAGEMENT REPORT

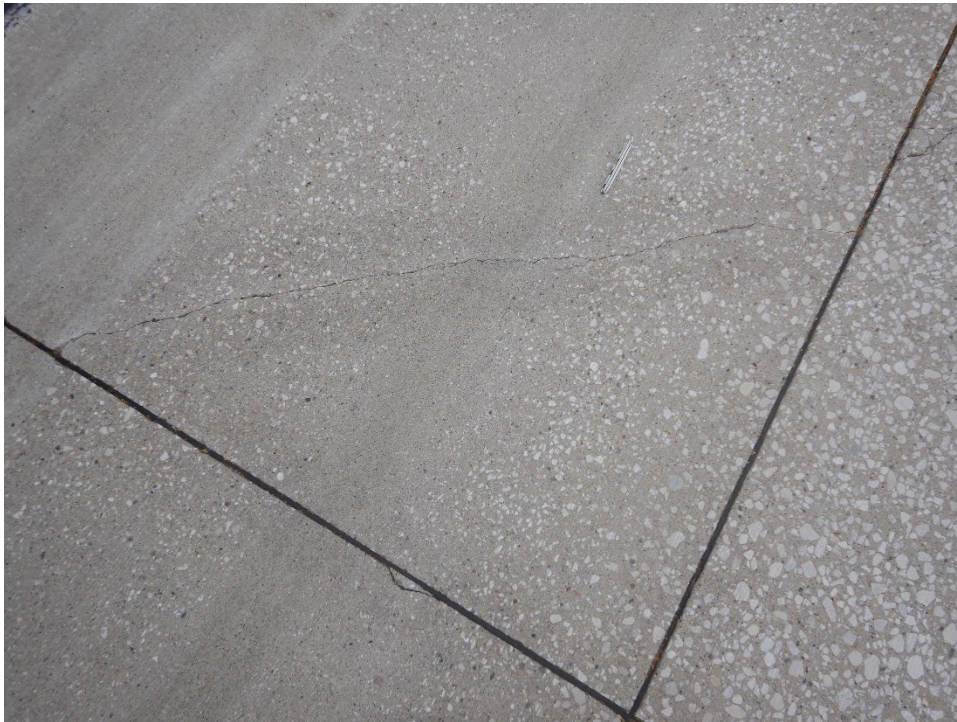
TFFD-02. Corner Break (Sample Unit No. 03).

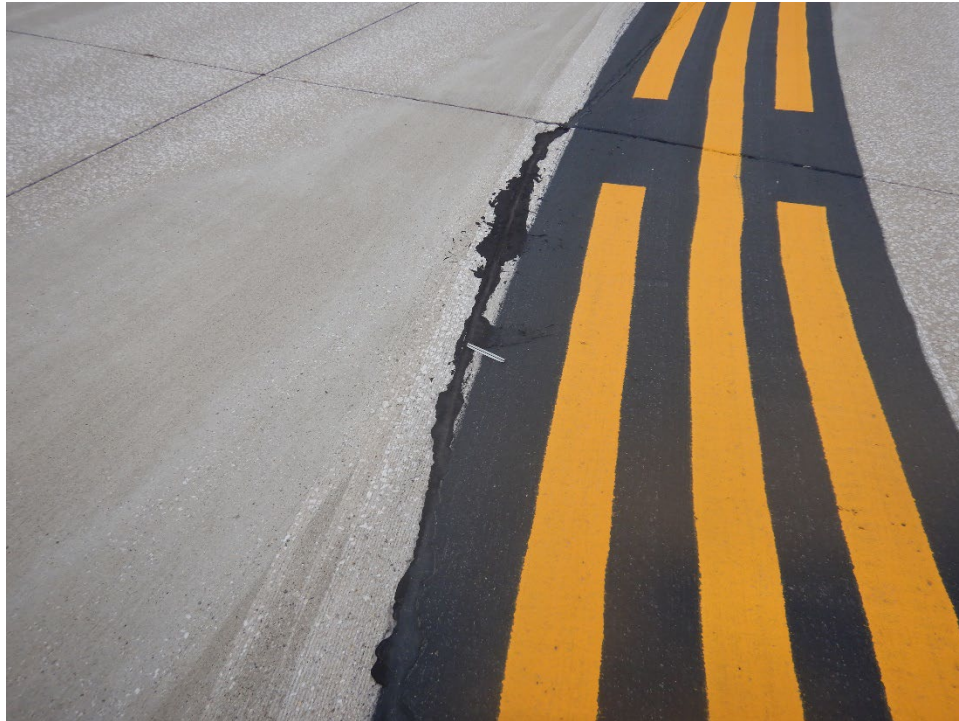
TFFD-02. LTD Cracking (Sample Unit No. 12).

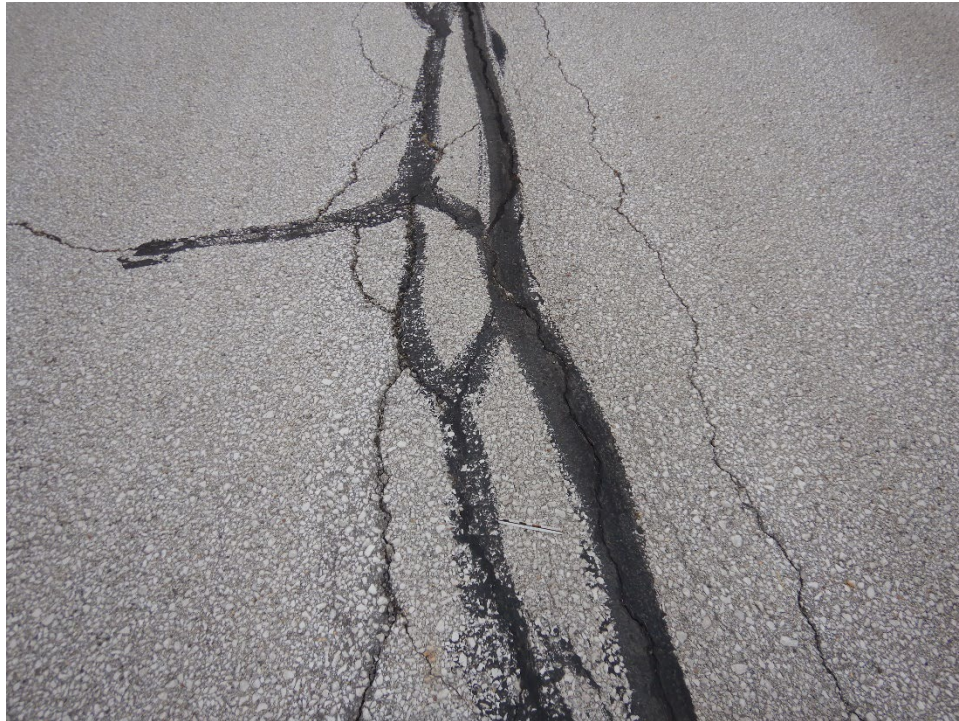
TH01FD-01. Alligator Cracking (Sample Unit No. 07).

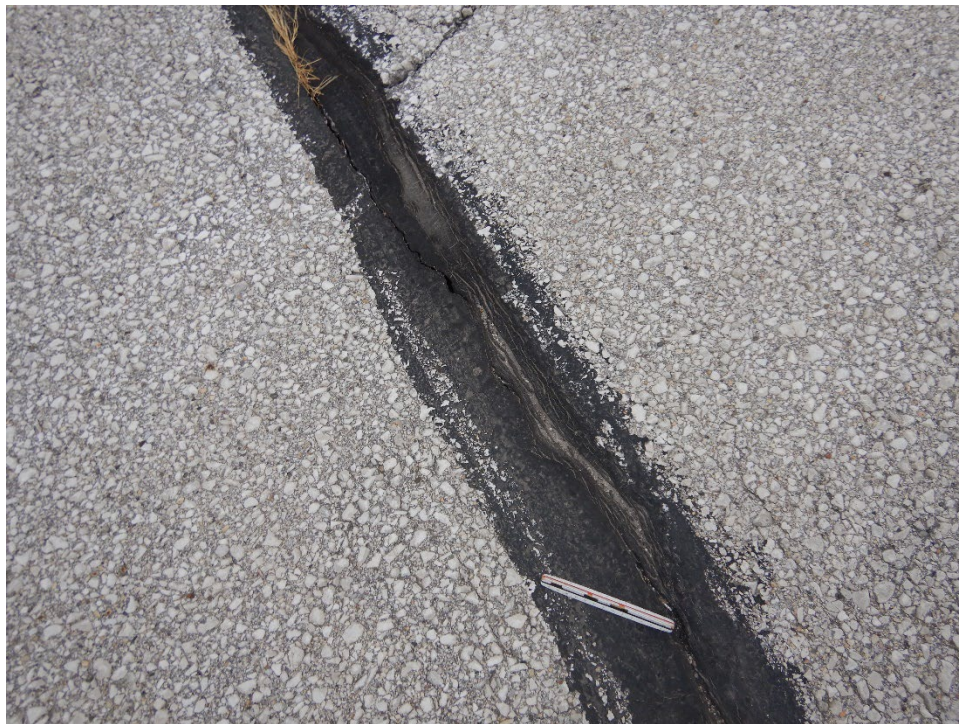
TH01FD-01. L&T Cracking (Sample Unit No. 09).
