Fort Madison Municipal Airport

PAVEMENT MANAGEMENT REPORT

JULY 2021

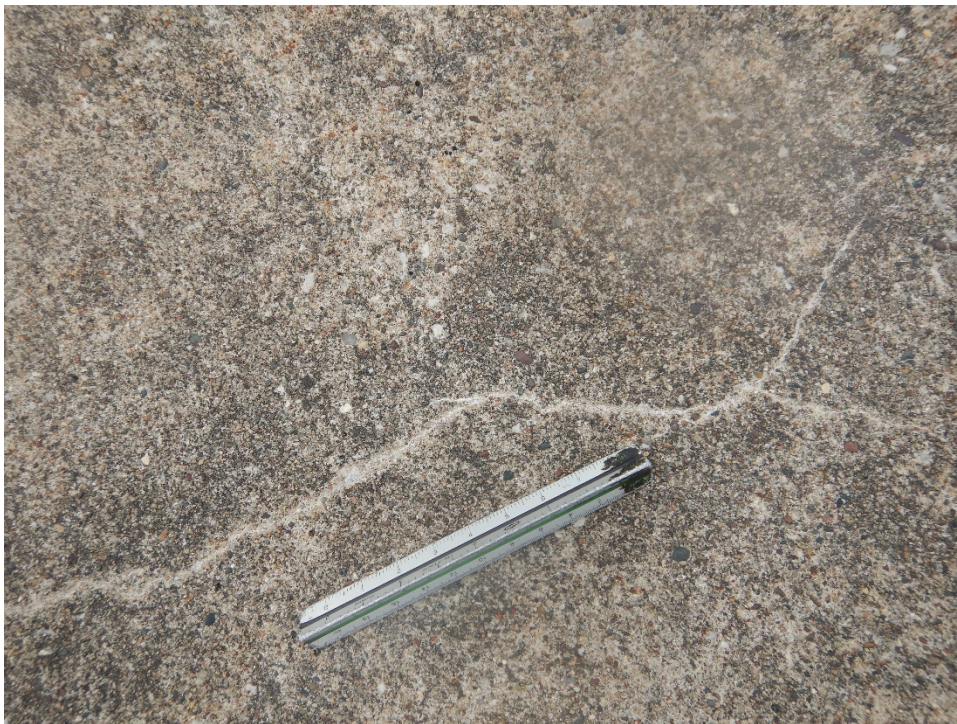
A01FM-01. ASR (Sample Unit No. 01).

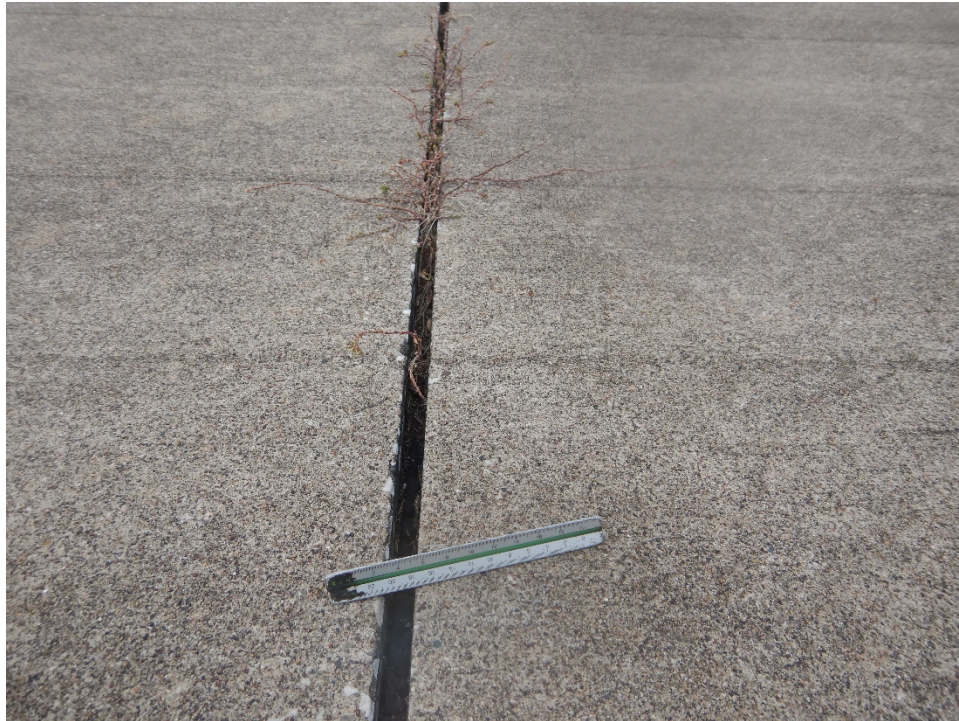
A01FM-01. Joint Seal Damage (Sample Unit No. 05).

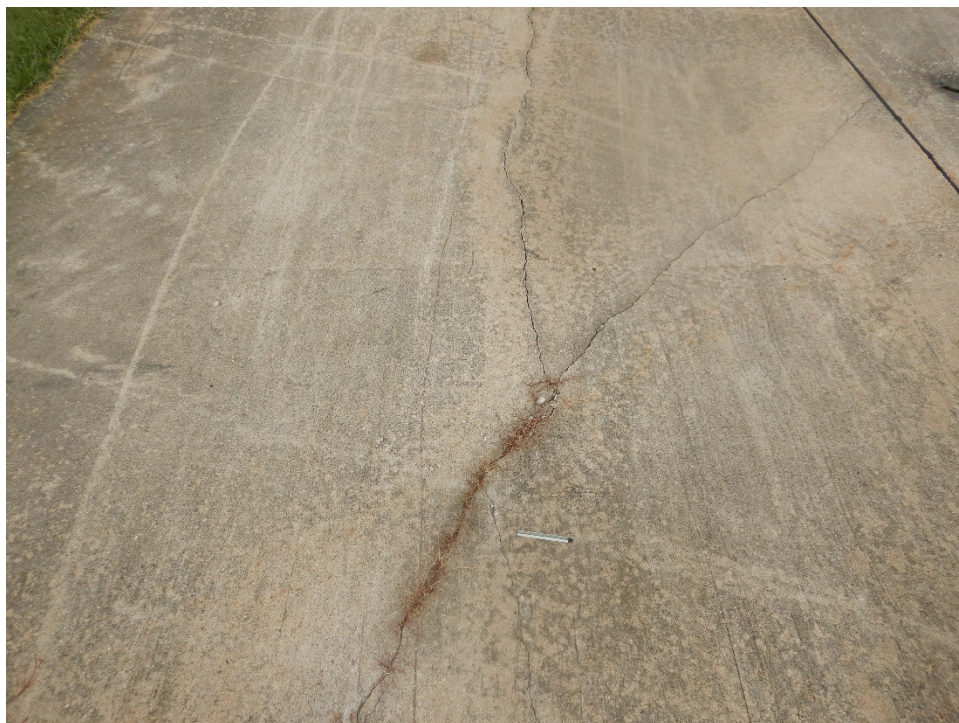
A01FM-01. Shattered Slab (Sample Unit No. 08).

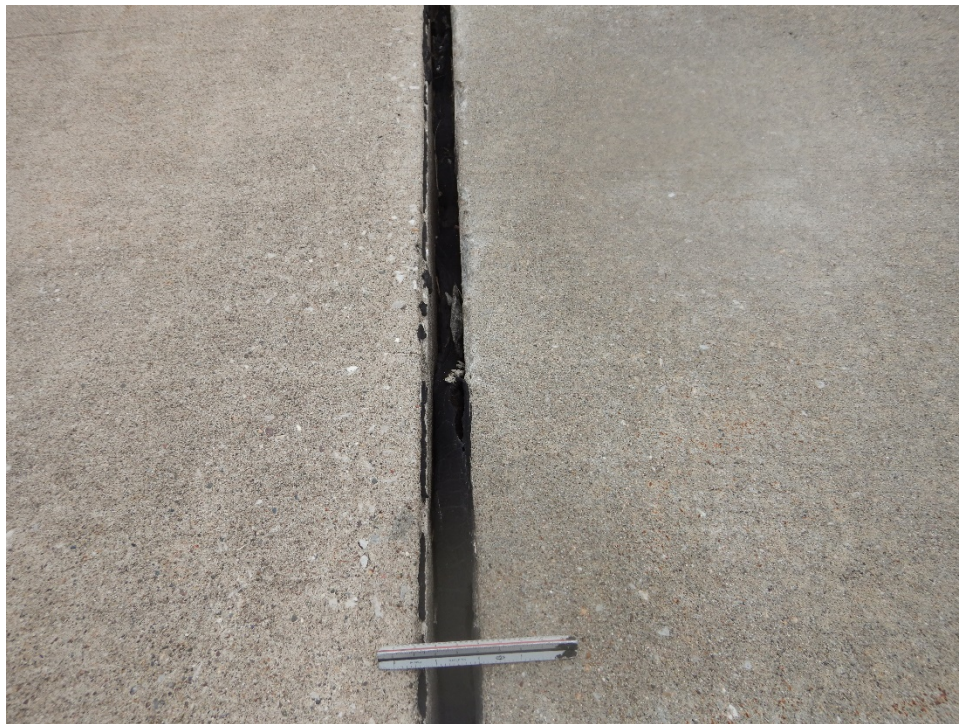
A01FM-02. Joint Seal Damage (Sample Unit No. 01).

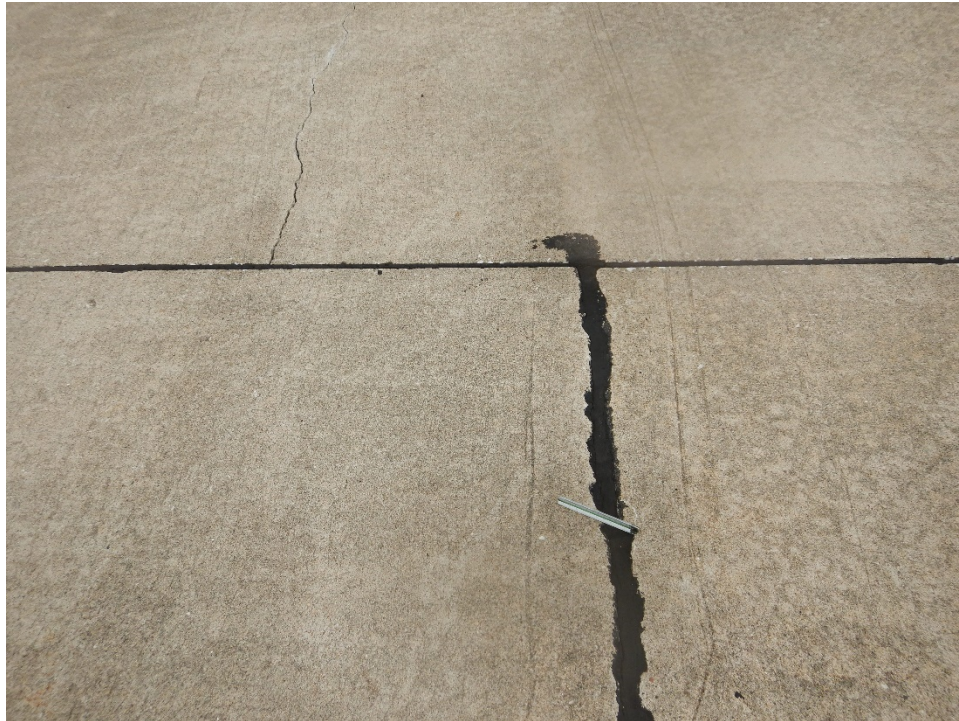
A01FM-02. LTD Cracking (Sample Unit No. 01).

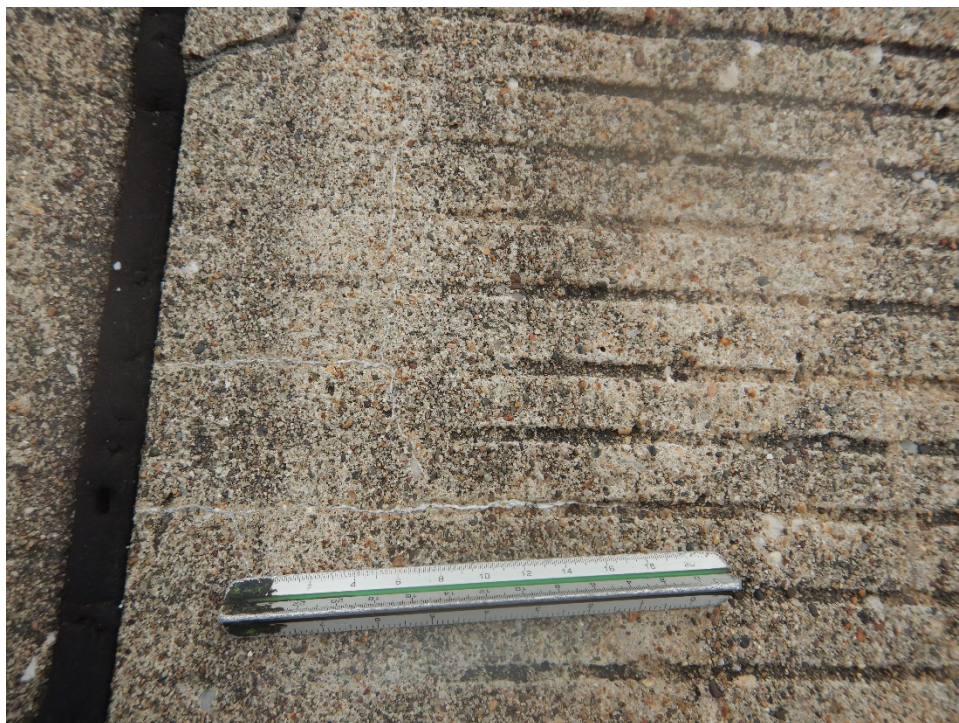
Runway 17/35 was defined by one section with low-severity ASR and faulting; low- and medium-severity corner break, small patching, and longitudinal, transverse, and diagonal (LTD) cracking; and medium-severity corner spalling, joint seal damage, and joint spalling.

R17FM-01. ASR (Sample Unit No. 35).

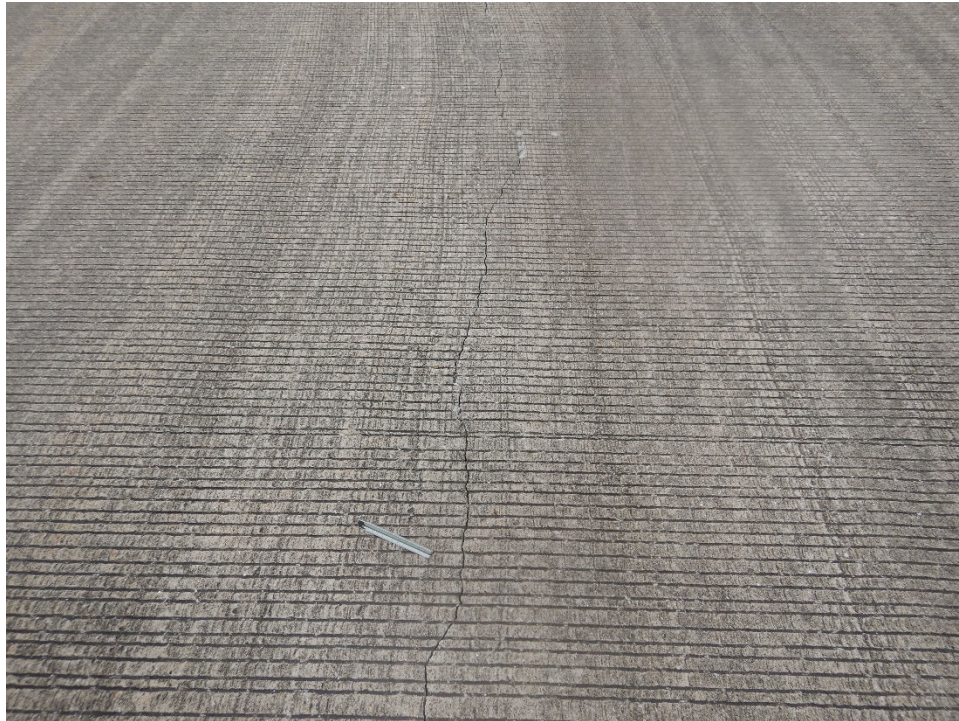
R17FM-01. LTD Cracking (Sample Unit No. 08).

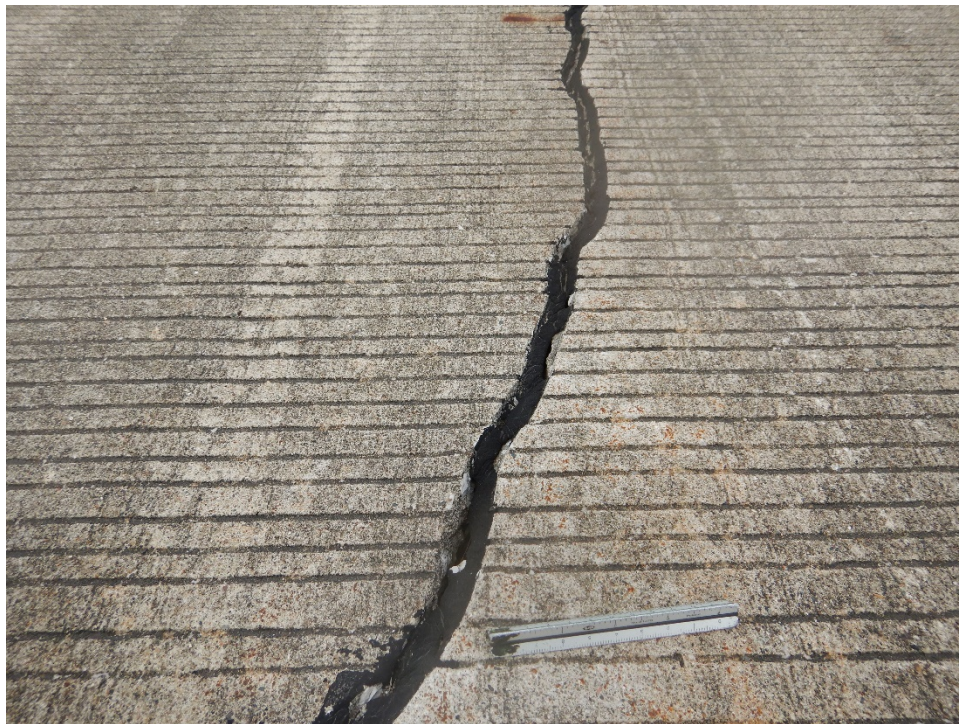
R17FM-01. LTD Cracking (Sample Unit No. 48).

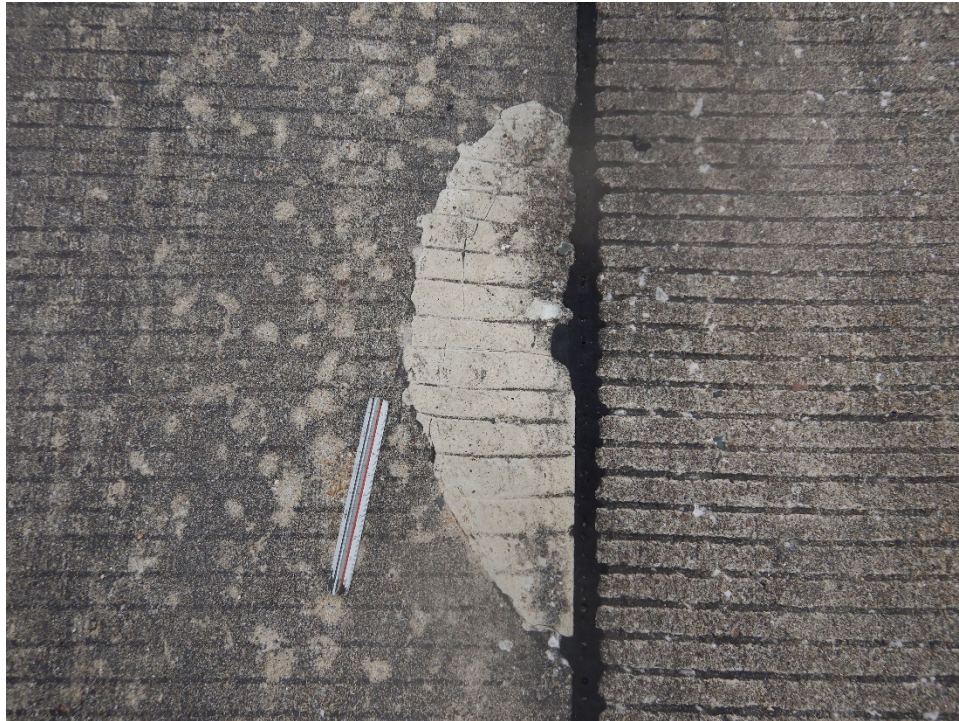
R17FM-01. Small Patching (Sample Unit No. 08).

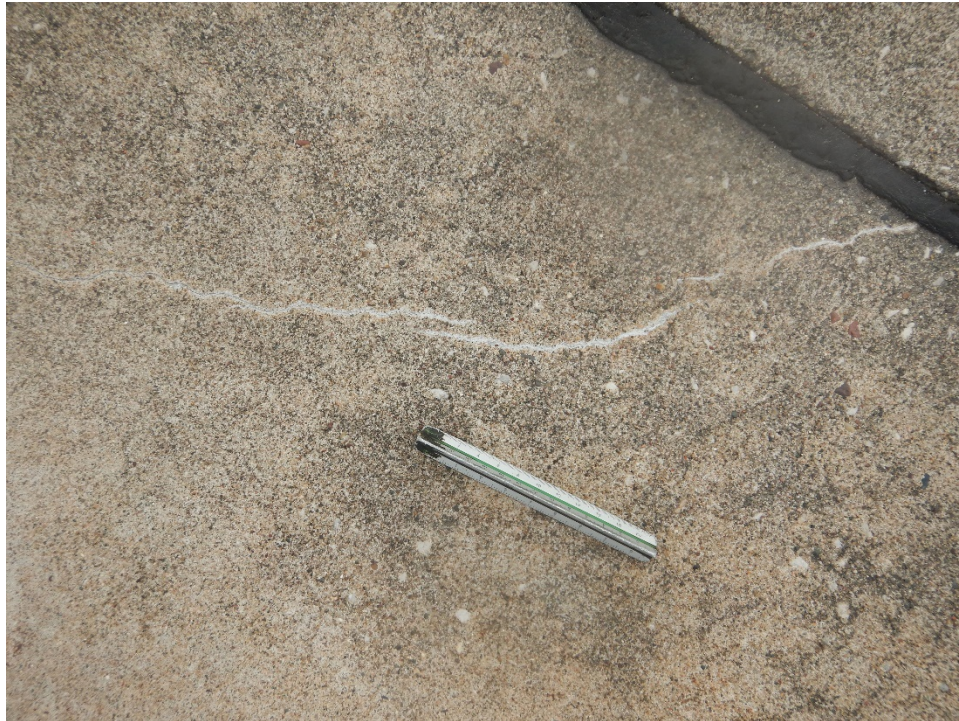
T01FM-01. ASR (Sample Unit No. 02).

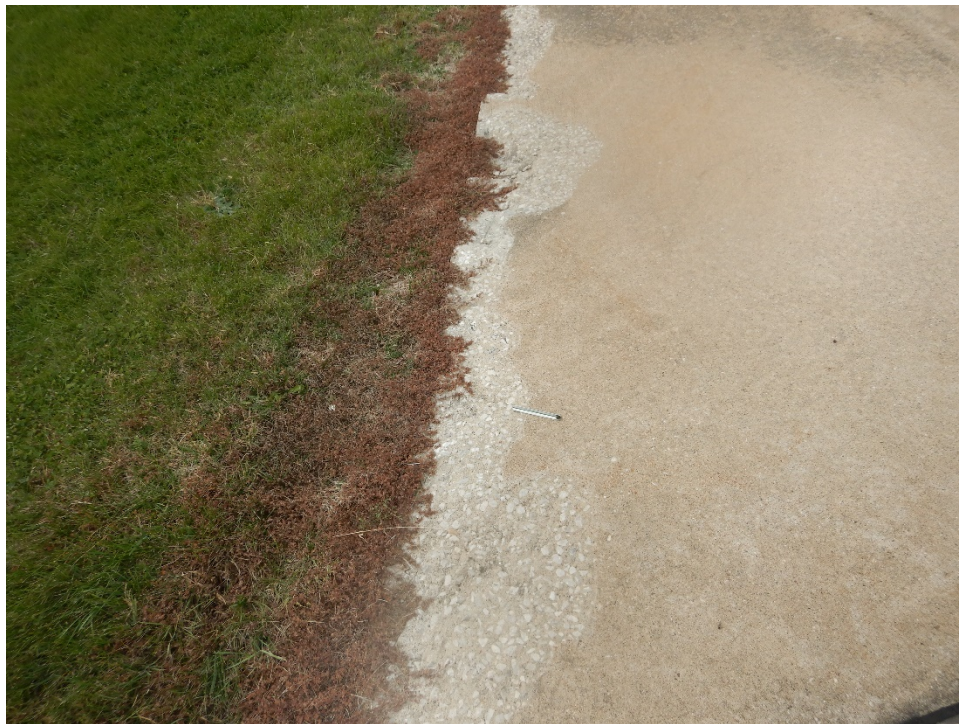
T01FM-01. Joint Spalling (Sample Unit No. 01).

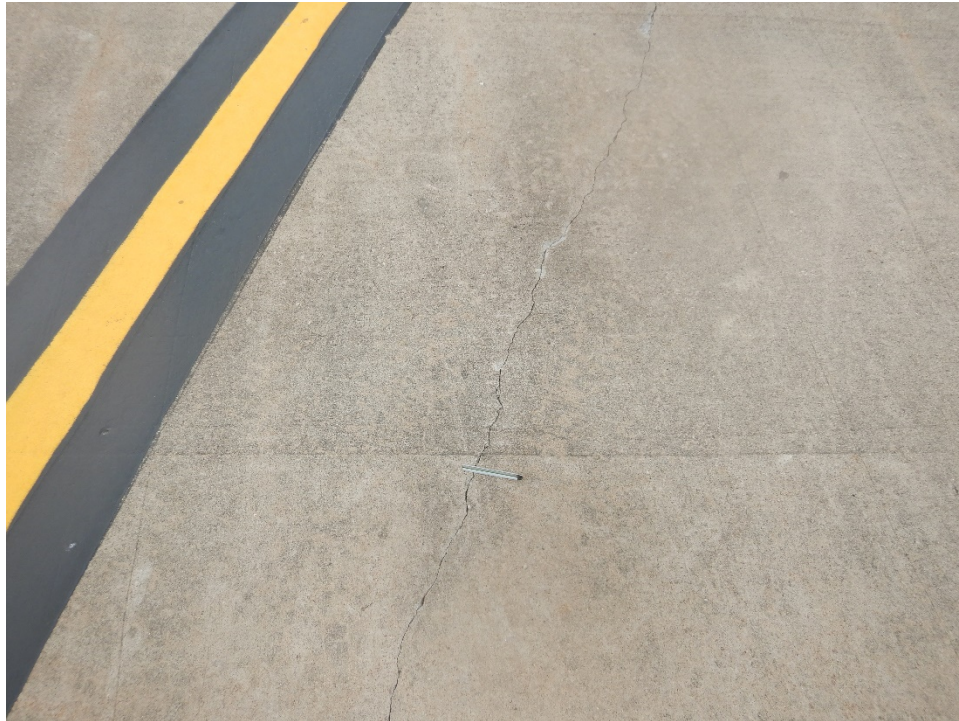
T01FM-01. LTD Cracking (Sample Unit No. 02).

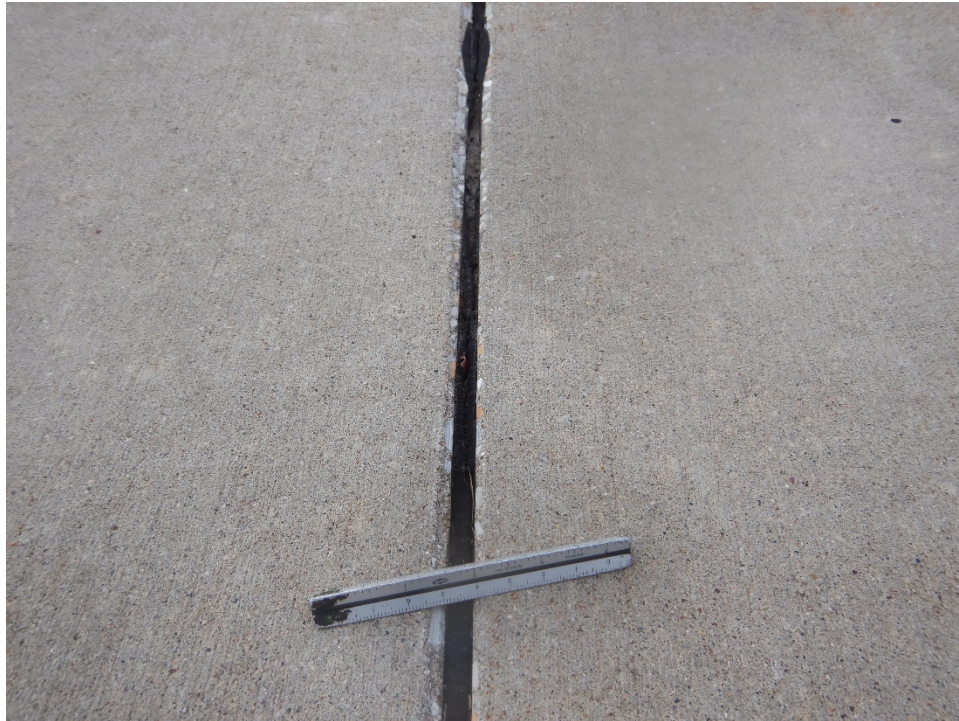
T01FM-02. Joint Seal Damage (Sample Unit No. 02).

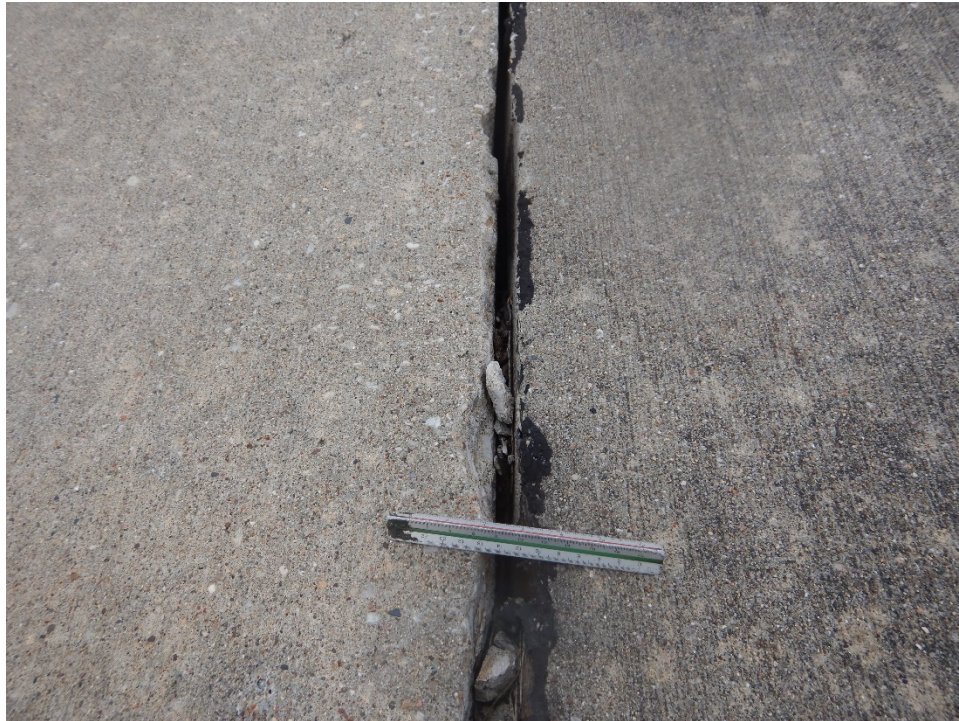
Taxiway 05 was defined by one section located near the Runway 17 approach. Low-severity ASR and medium- and high-severity joint seal damage were identified in Section 01.

T05FM-01. Joint Seal Damage (Sample Unit No. 02).

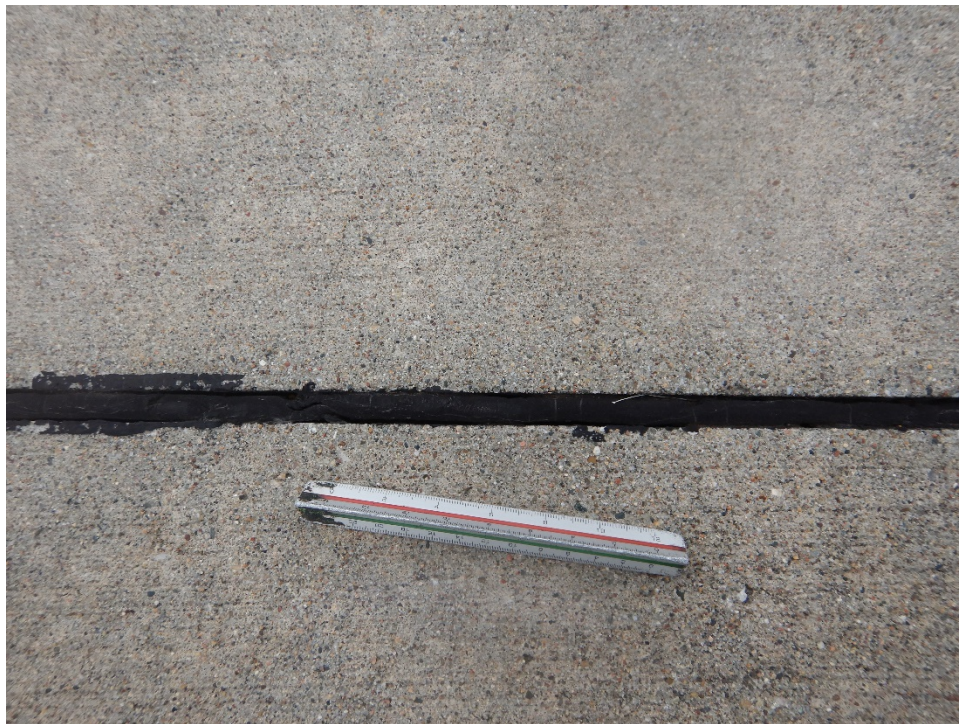
T05FM-01. Joint Seal Damage (Sample Unit No. 03).

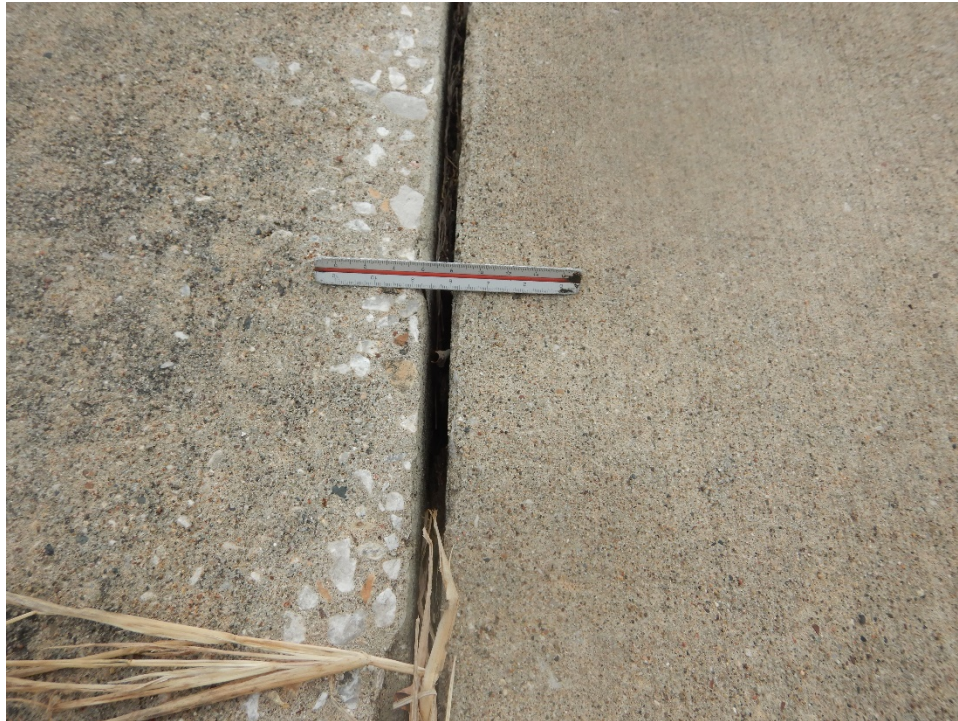
Taxiway 06, which was located near the Runway 35 approach, contained one section with medium- and high-severity joint seal damage recorded at the time of inspection.

T06FM-01. Joint Seal Damage (Sample Unit No. 03).

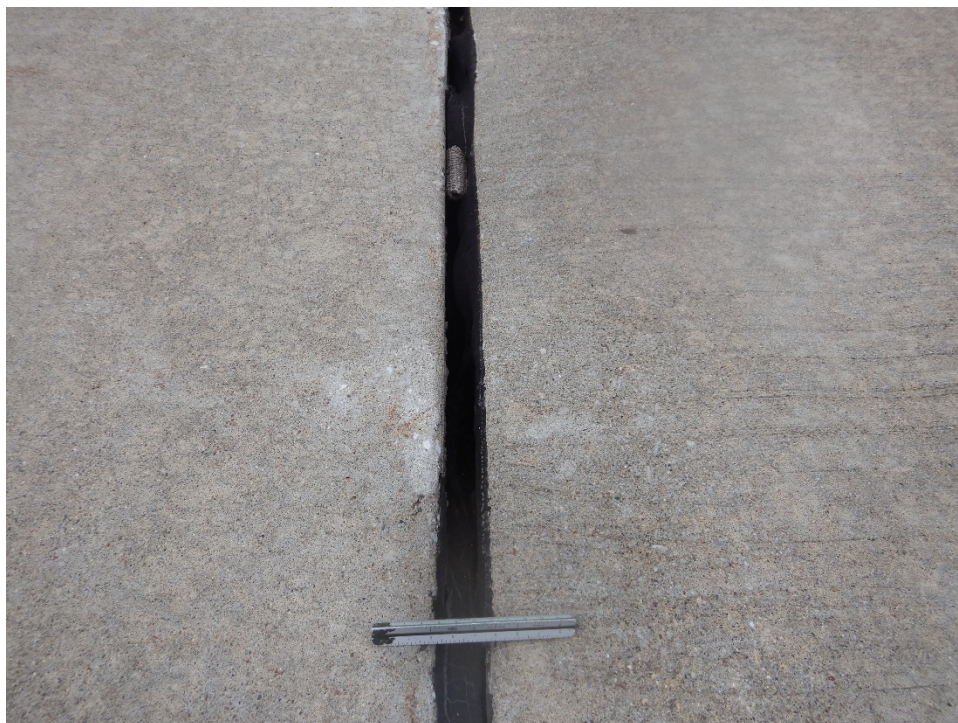
T-Hangar 01 was defined by one section with all severities of joint seal damage identified during the inspection.

TH01FM-01. Joint Seal Damage (Sample Unit No. 04).

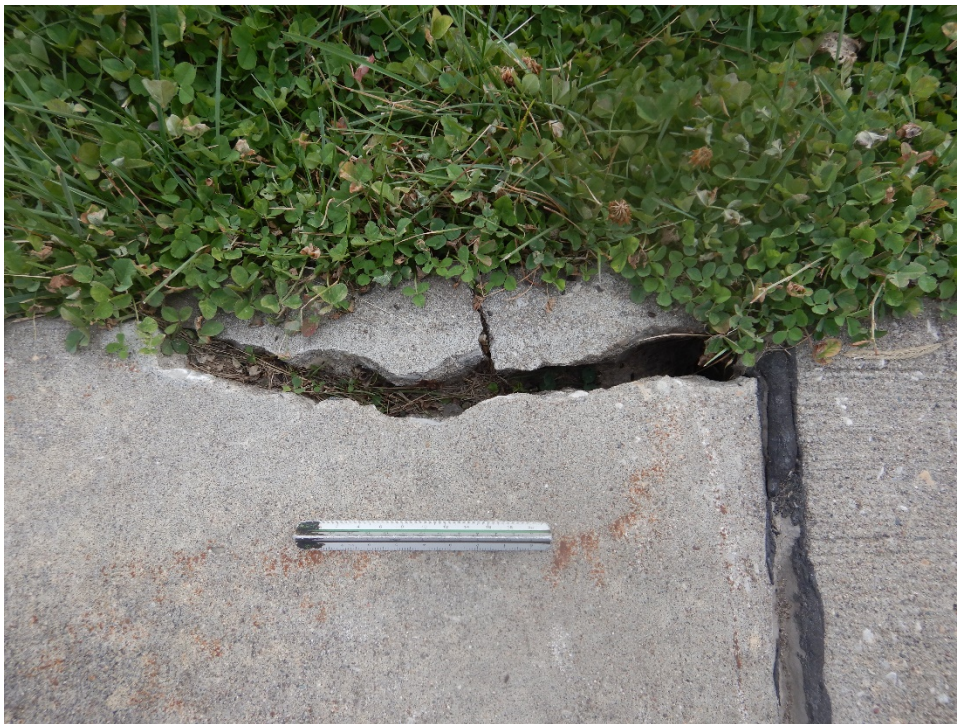
TH02FM-01. Joint Spalling (Sample Unit No. 05).
