Fort Madison Municipal Airport

Pavement Management Report

JULY 2024

FORT MADISON MUNICIPAL AIRPORT PAVEMENT MANAGEMENT REPORT

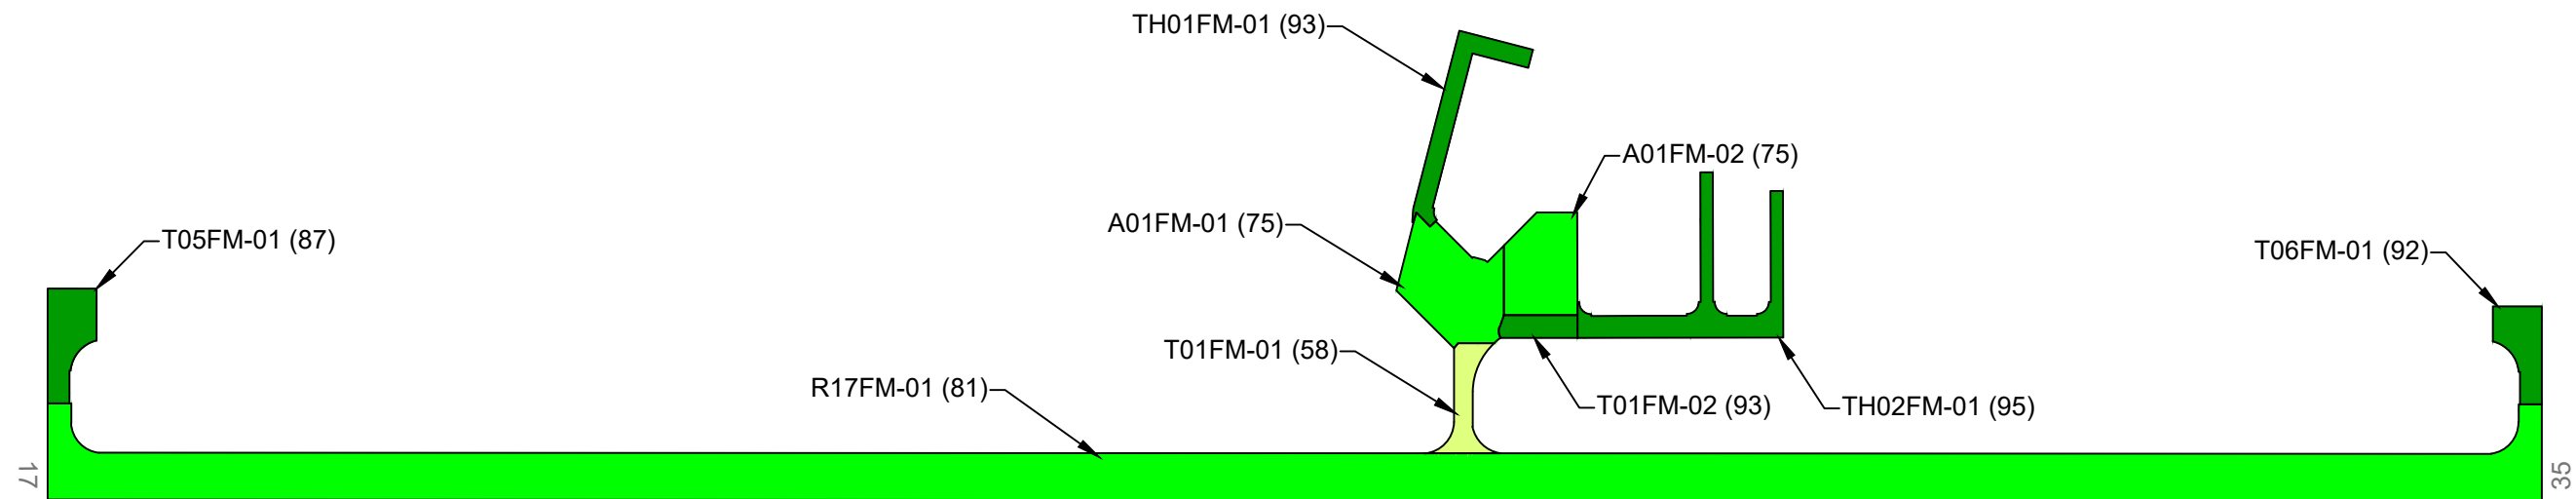
FIGURE 8. PCI MAP.

The pavements at Fort Madison Municipal Airport were inspected in November 2023. The 2023 area-weighted condition of Fort Madison Municipal Airport is 82, with conditions ranging from 58 to 95 (on a scale of 0 [failed] to 100 [excellent]). During the previous pavement inspection in 2020, the area-weighted PCI of the airport was 83.

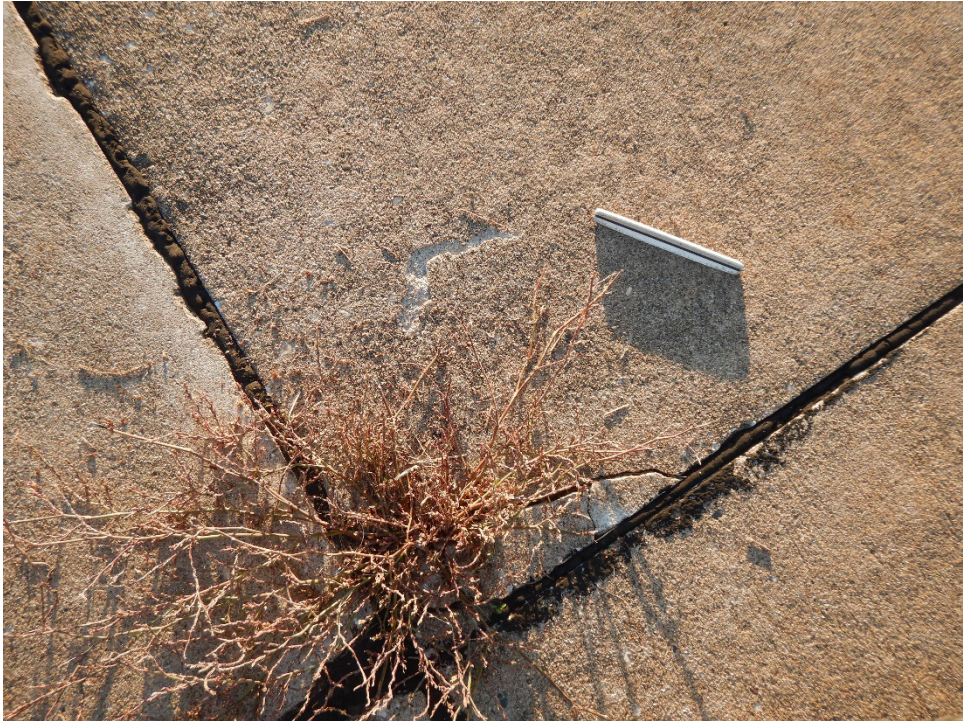
Taxiway 01 contained two sections that connected Runway 17/35 to the apron area. Low-severity ASR and scaling; low- and medium-severity LTD cracking; medium-severity corner break, corner spalling, and joint seal damage; and medium- and high-severity joint spalling were identified in Section 01. Section 02 only contained medium-severity joint seal damage.

A01FM-01. ASR (Sample Unit No. 07).

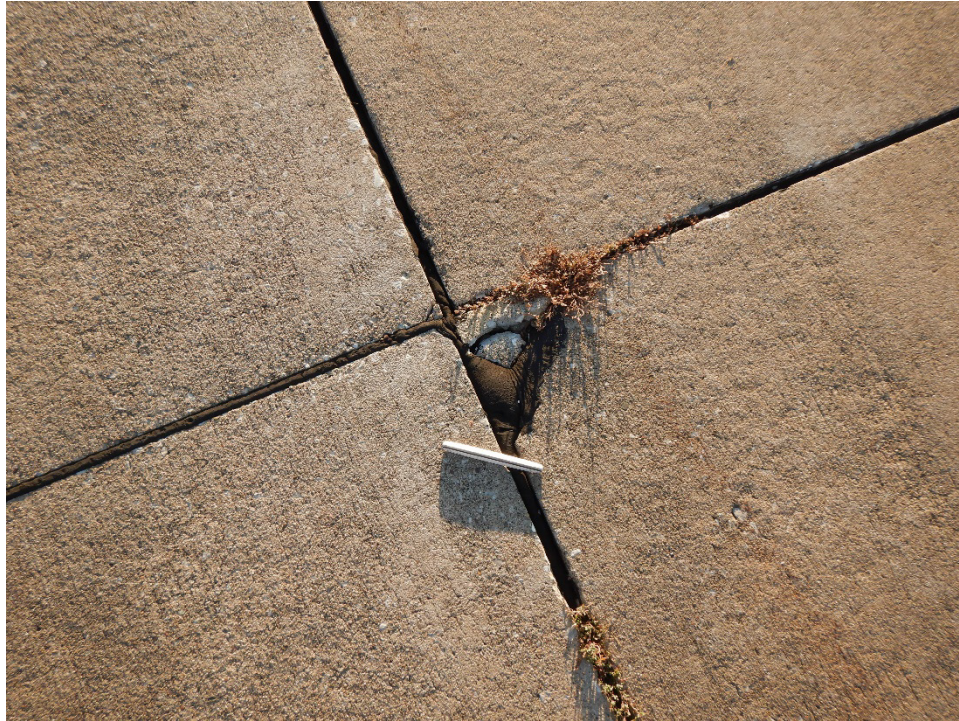
A01FM-01. Corner Spalling (Sample Unit No. 01).

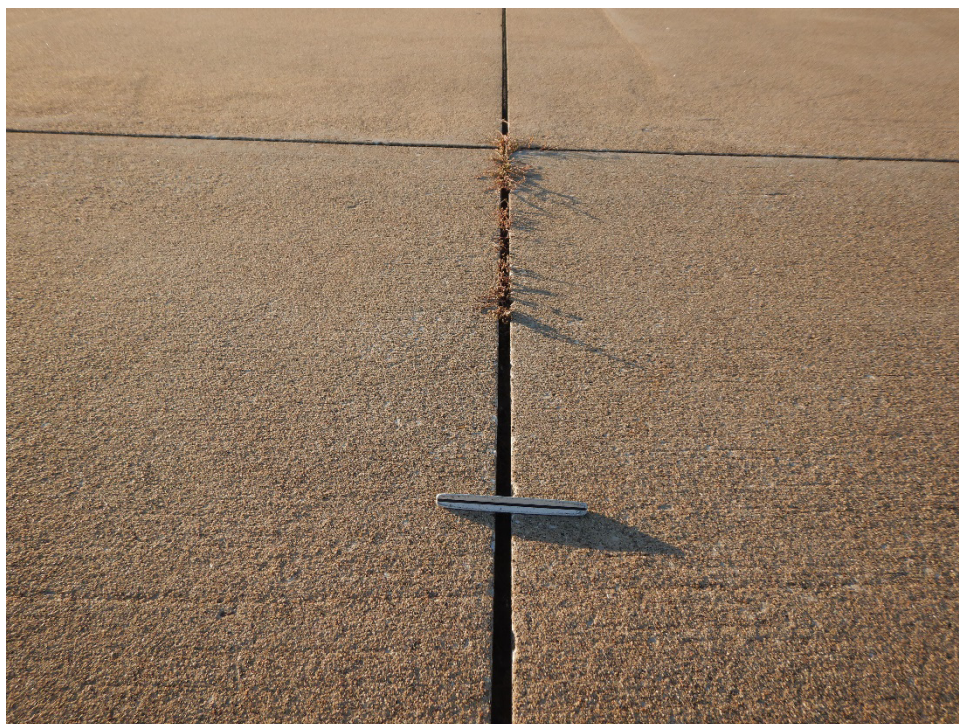
A01FM-01. Joint Seal Damage (Sample Unit No. 05).

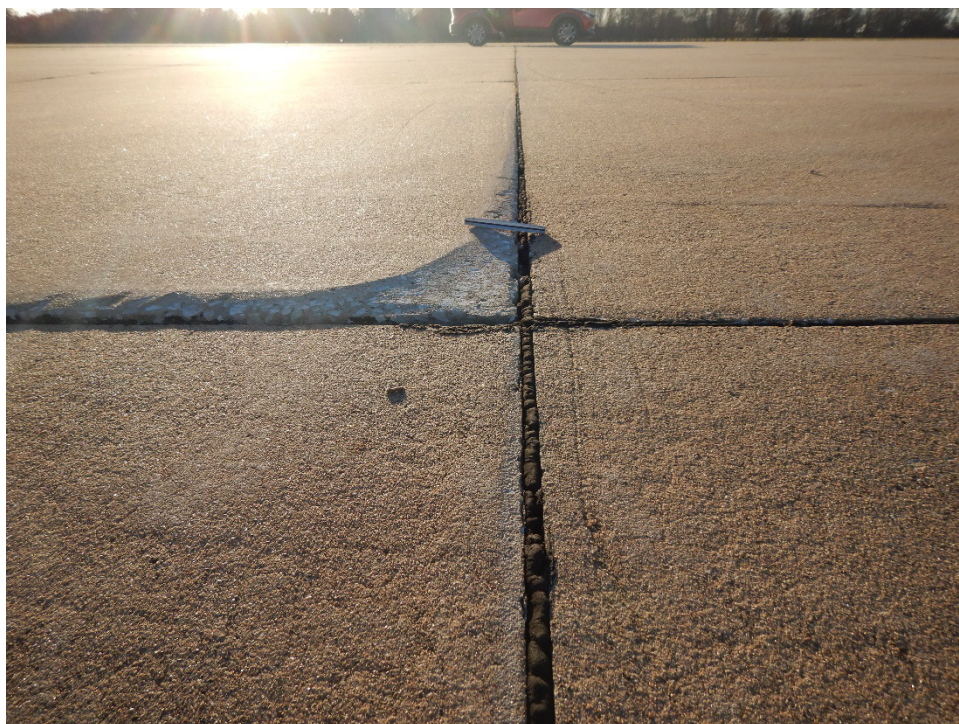
A01FM-02. Faulting (Sample Unit No. 02).

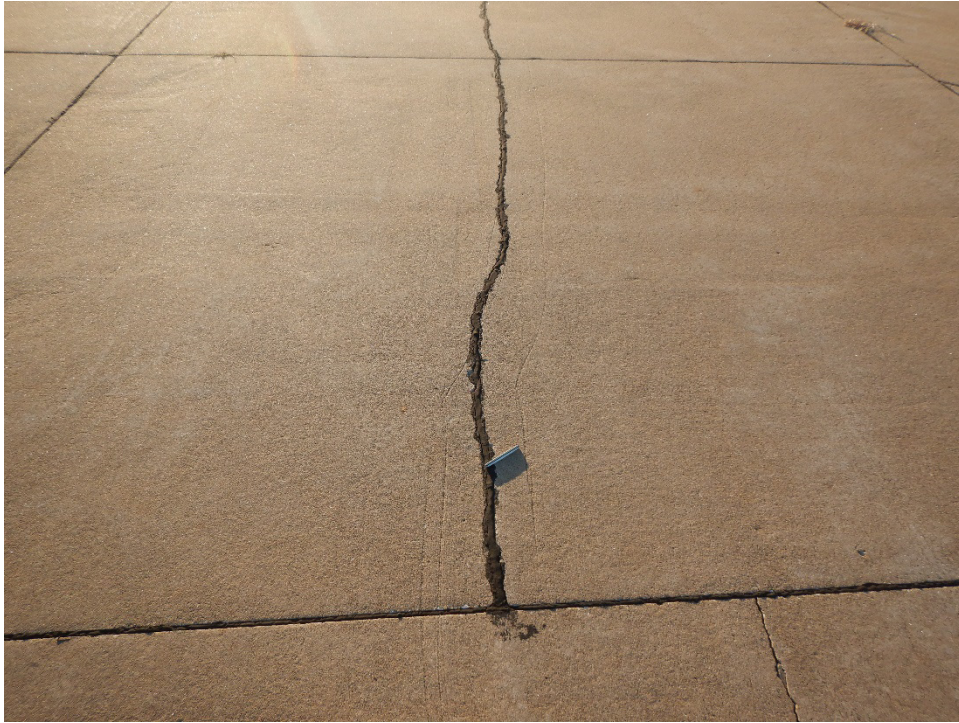
A01FM-02. LTD Cracking (Sample Unit No. 01).

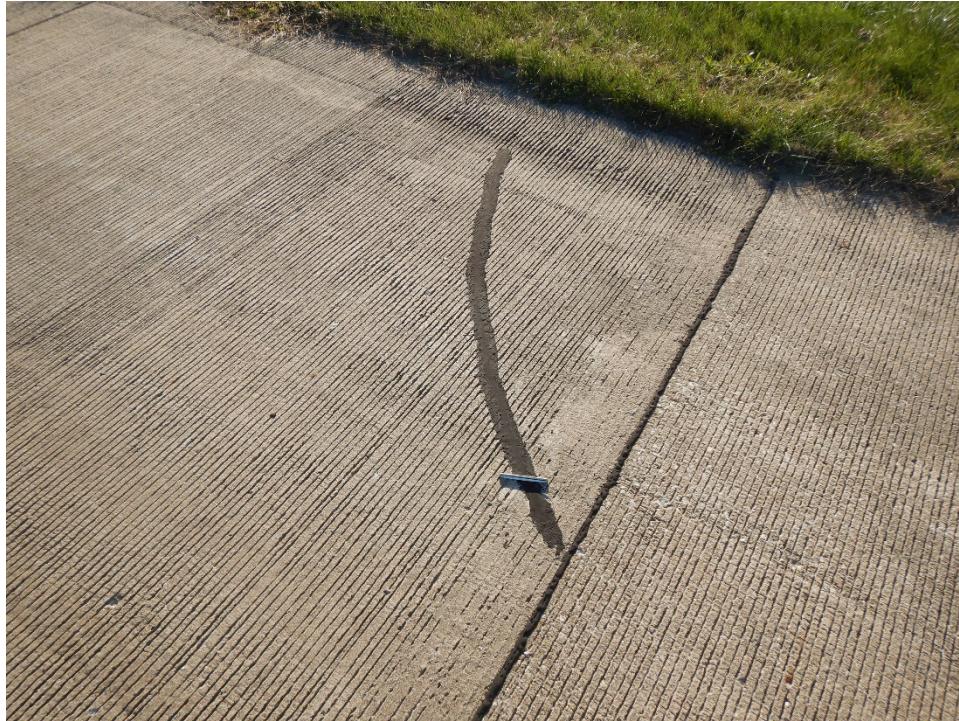
Runway 17/35 was defined by one section. Low-severity faulting; low- and medium-severity corner break, corner spalling, small patching, and longitudinal, transverse, and diagonal (LTD) cracking; and medium-severity joint spalling and joint seal damage were identified in Section 01.

R17FM-01. Corner Break (Sample Unit No. 44).

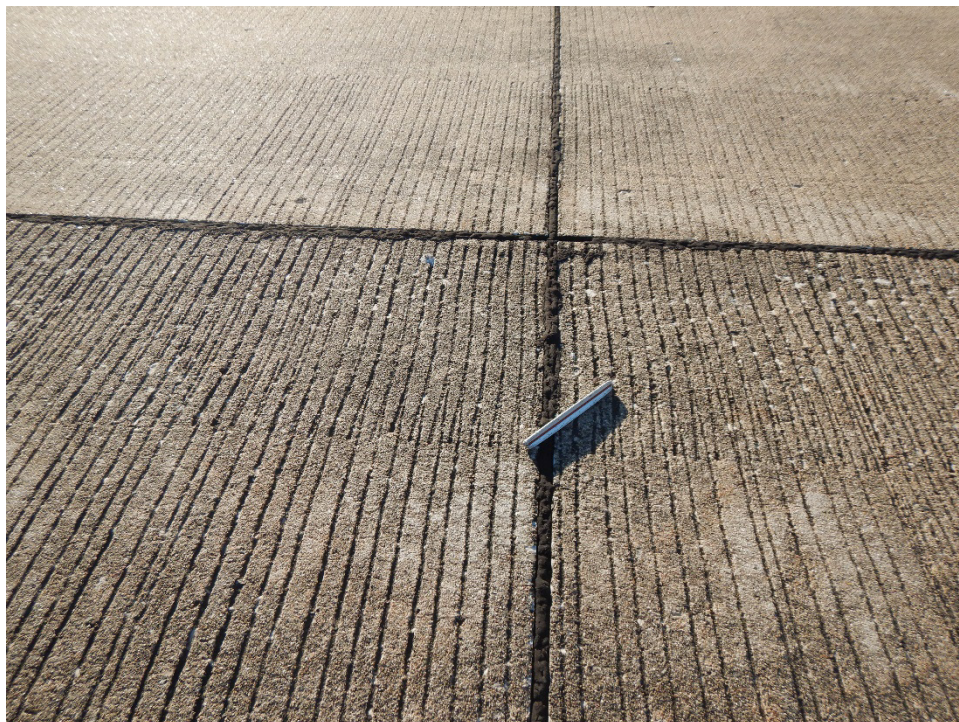
R17FM-01. Joint Seal Damage (Sample Unit No. 62).

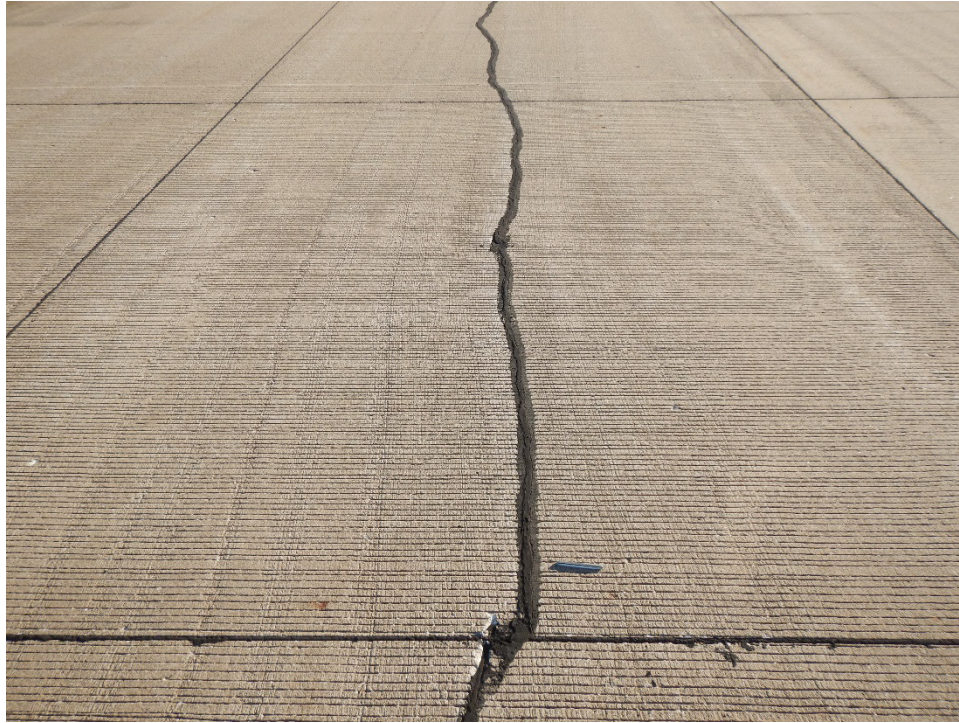
R17FM-01. LTD Cracking (Sample Unit No. 08).

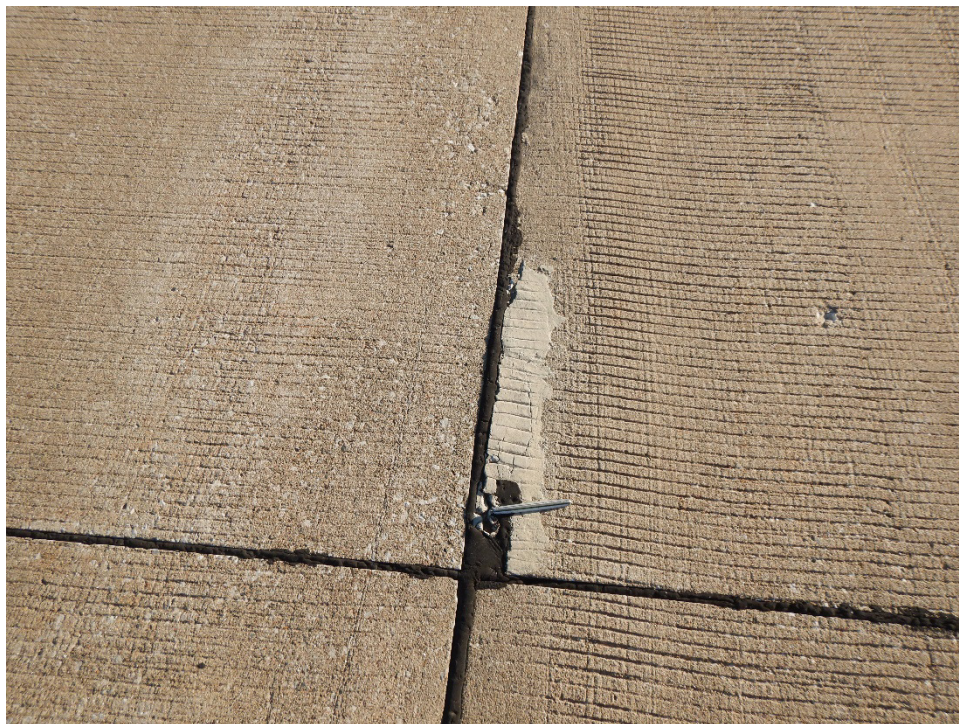
R17FM-01. Small Patching (Sample Unit No. 71).

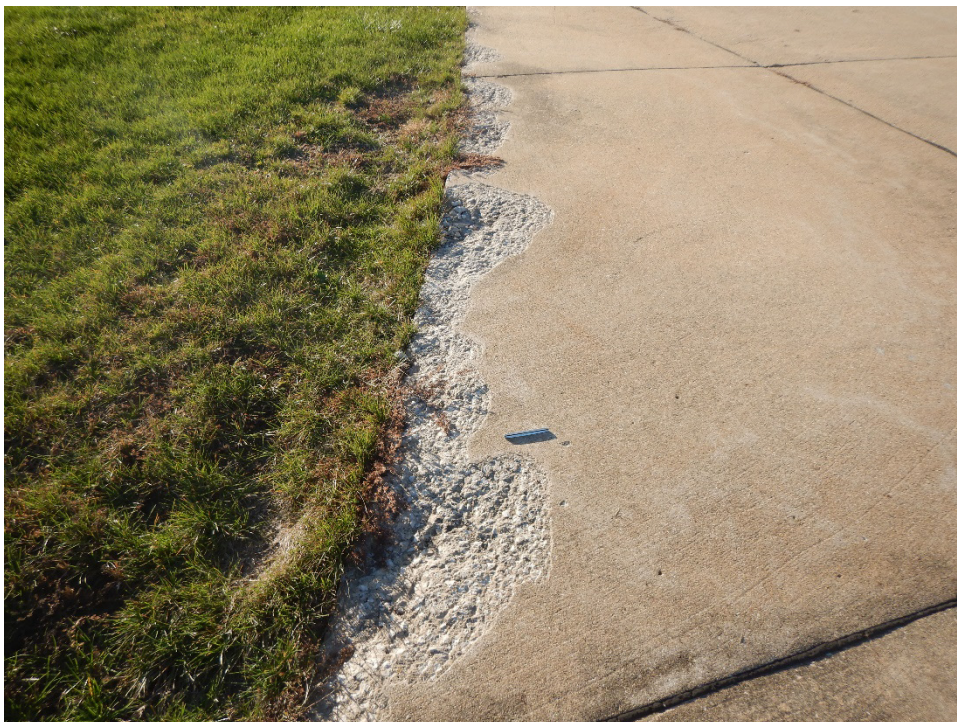
T01FM-01. Joint Spalling (Sample Unit No. 01).

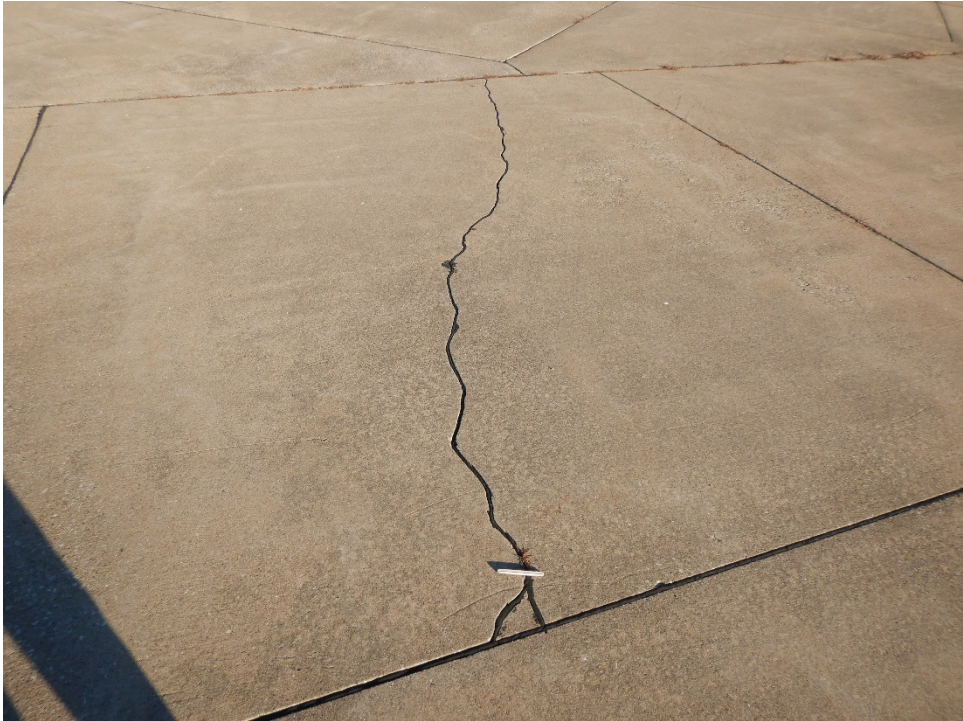
T01FM-01. LTD Cracking (Sample Unit No. 02).

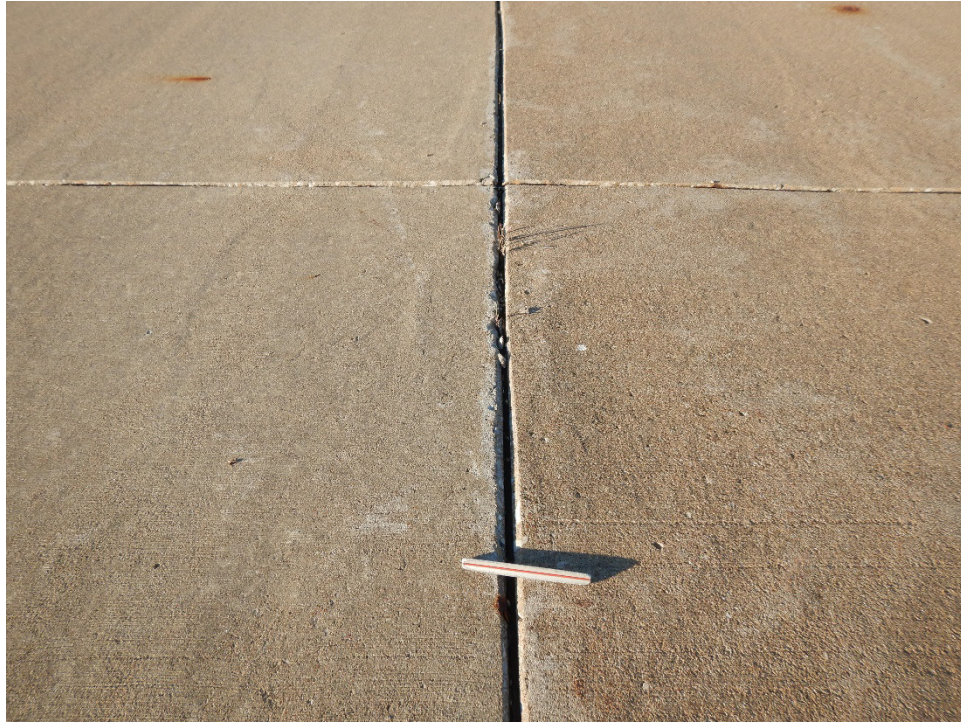
T01FM-02. Joint Seal Damage (Sample Unit No. 01).

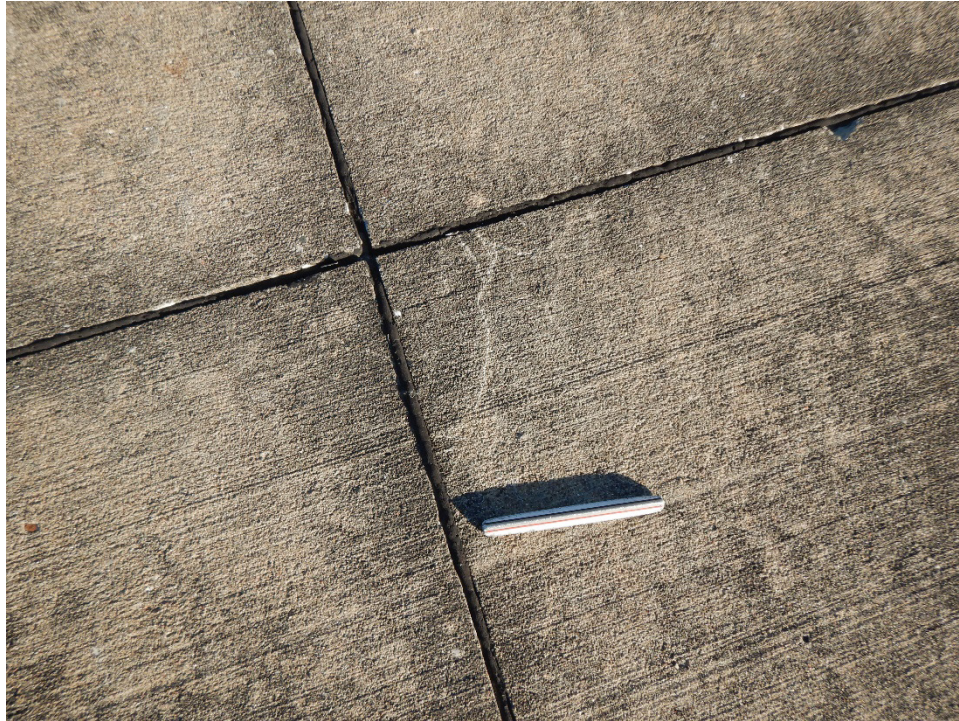
Taxiway 05 was defined by one section that was connected to the Runway 35 approach. It only contained areas of low-severity ASR and high-severity joint seal damage.

T05FM-01. ASR (Sample Unit No. 05).

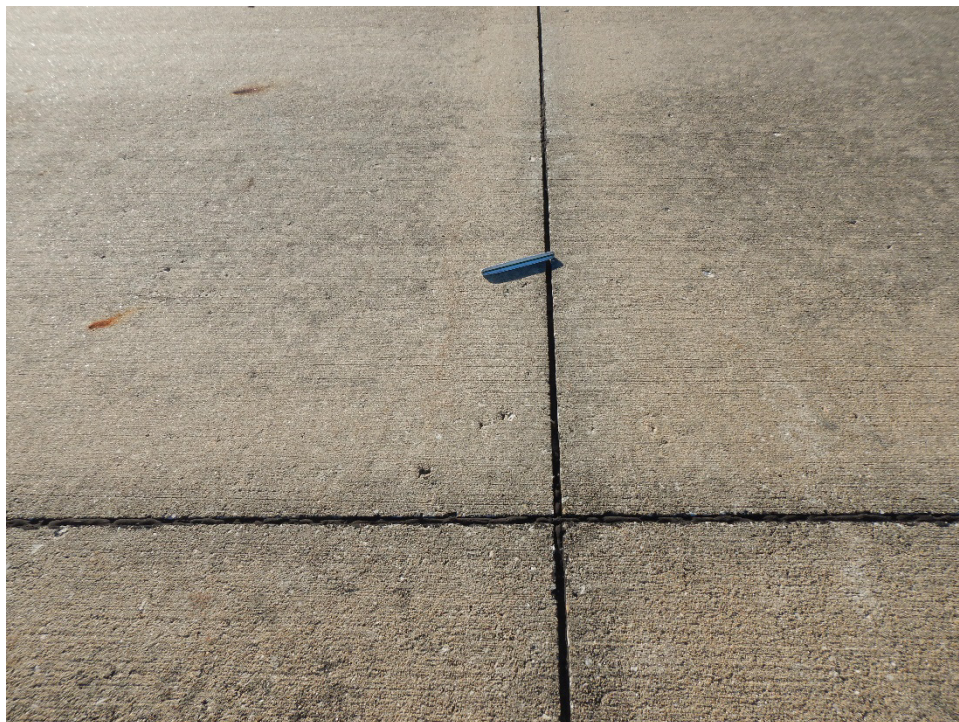
T05FM-01. Joint Seal Damage (Sample Unit No. 03).

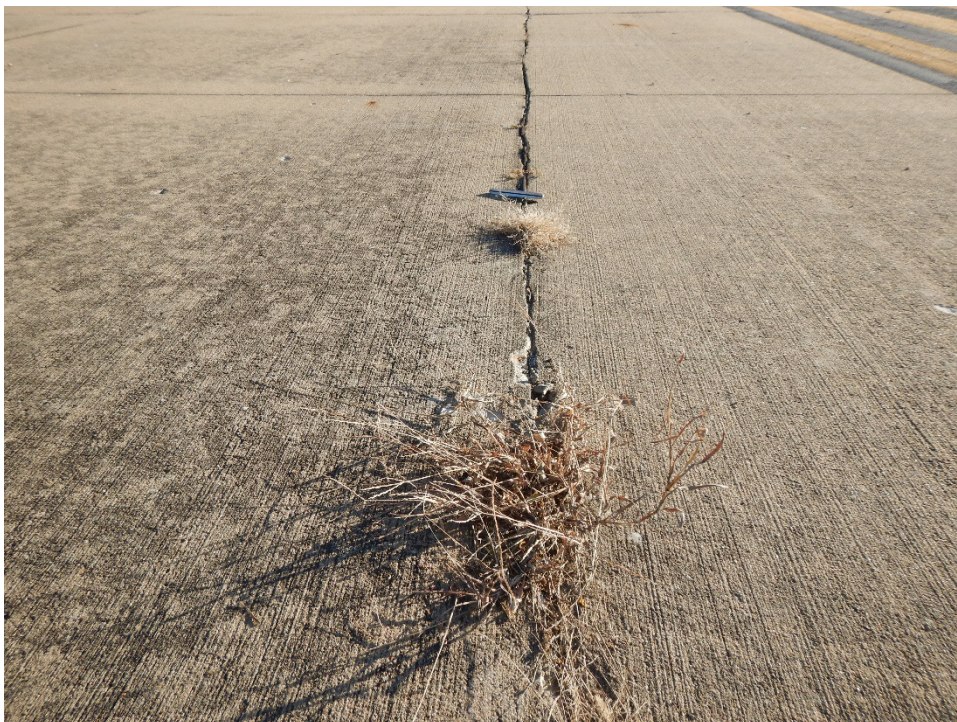
Taxiway 06 consisted of one section that was connected to the Runway 17 approach. Medium- and high-severity joint seal damage were observed throughout Section 01.

T06FM-01. Joint Seal Damage (Sample Unit No. 03).

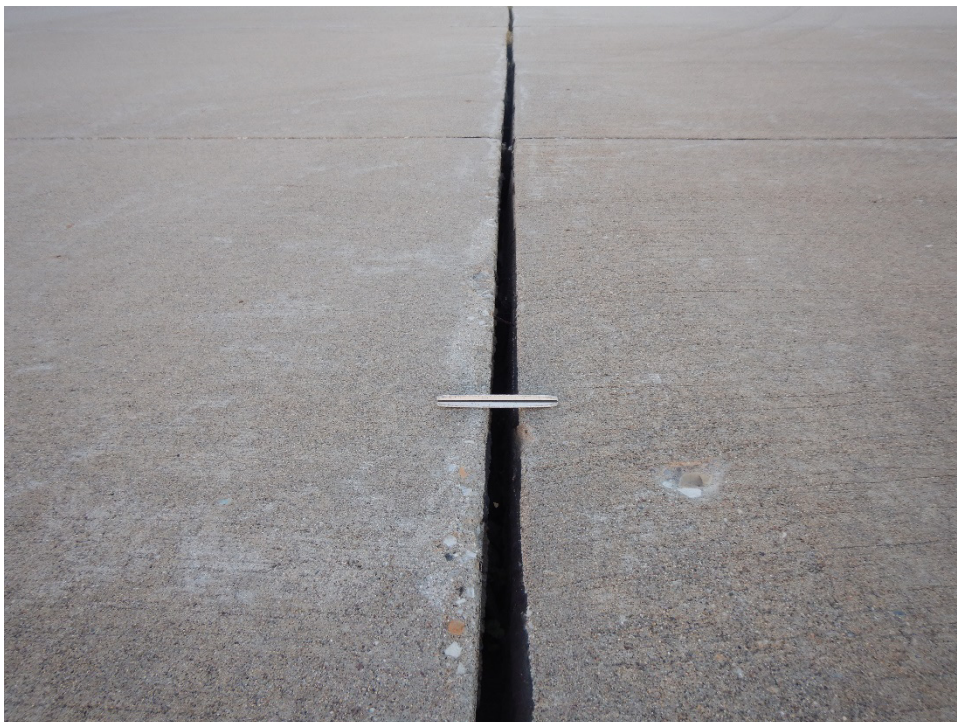
T-hangar 01 consisted of one section. Areas of low-severity LTD cracking and all severities of joint seal damage were identified in Section 01.

TH01FM-01. Joint Seal Damage (Sample Unit No. 04).

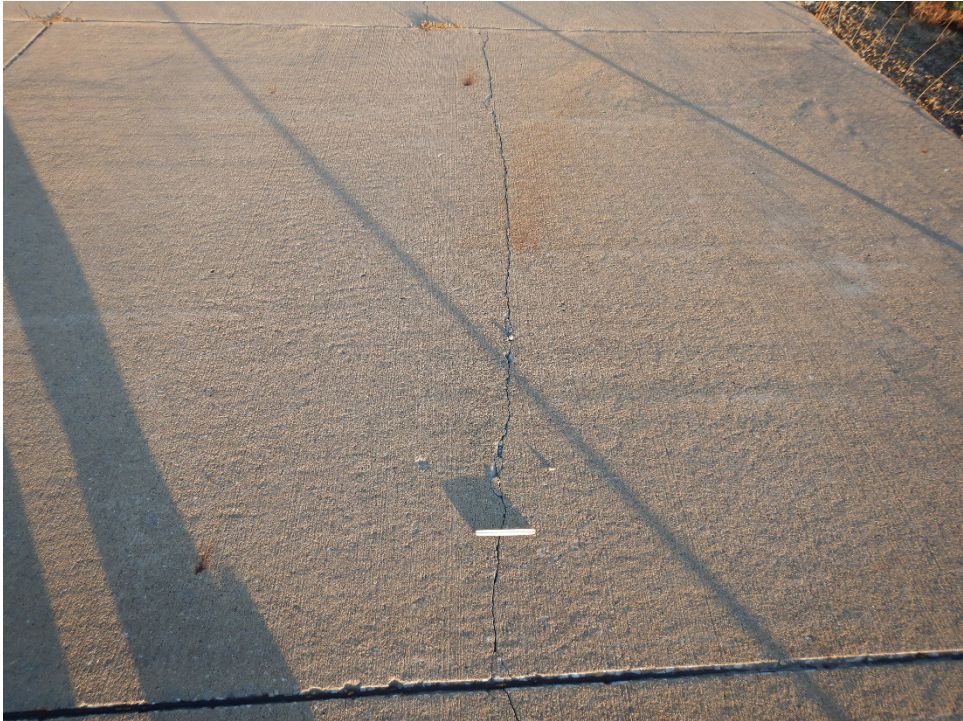
TH01FM-01. LTD Cracking (Sample Unit No. 05).

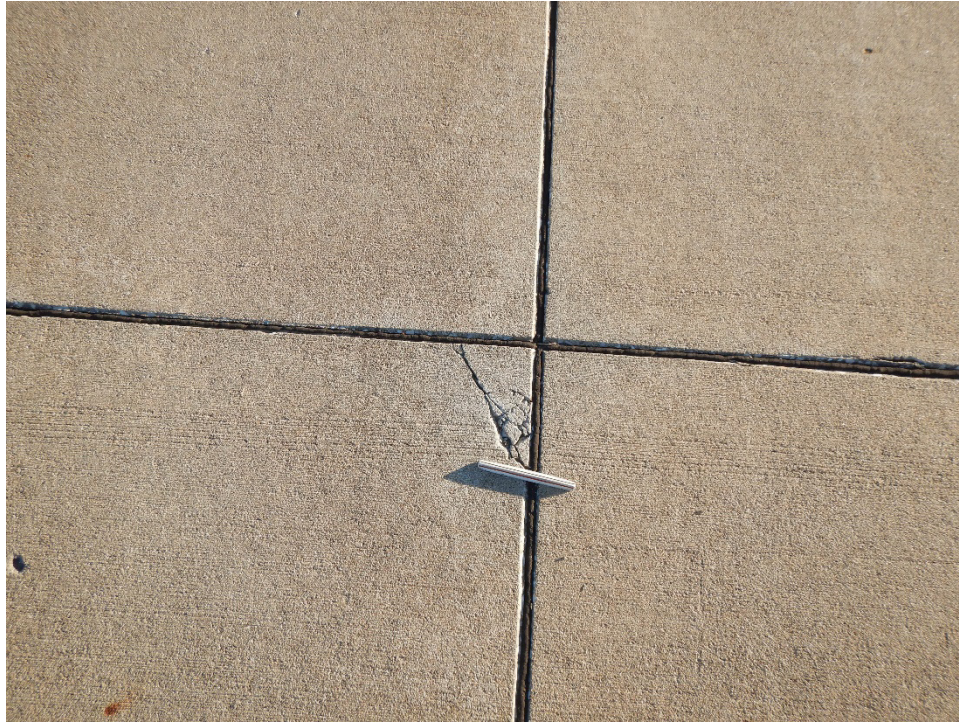
T-hangar 02 was defined by one section in excellent condition with low-severity LTD cracking, low- and medium-severity corner spalling and joint seal damage, and medium-severity joint spalling recorded during the inspection.

TH02FM-01. Corner Spalling (Sample Unit No. 01).

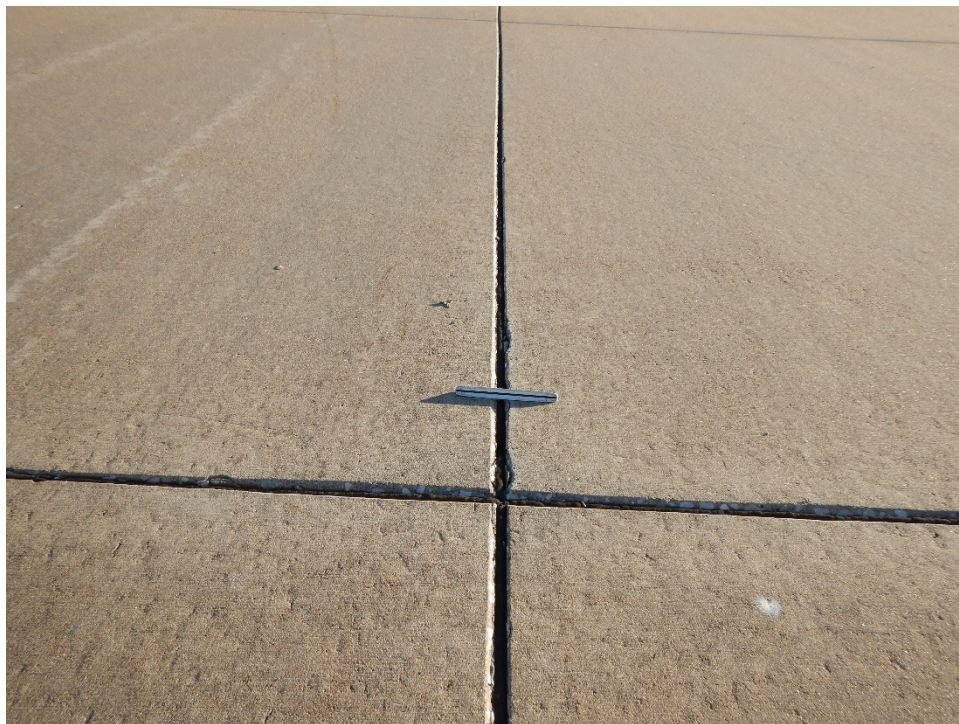
TH02FM-01. Joint Seal Damage (Sample Unit No. 02).
