# Guthrie County Regional Airport

## PAVEMENT MANAGEMENT REPORT

**JULY 2021**

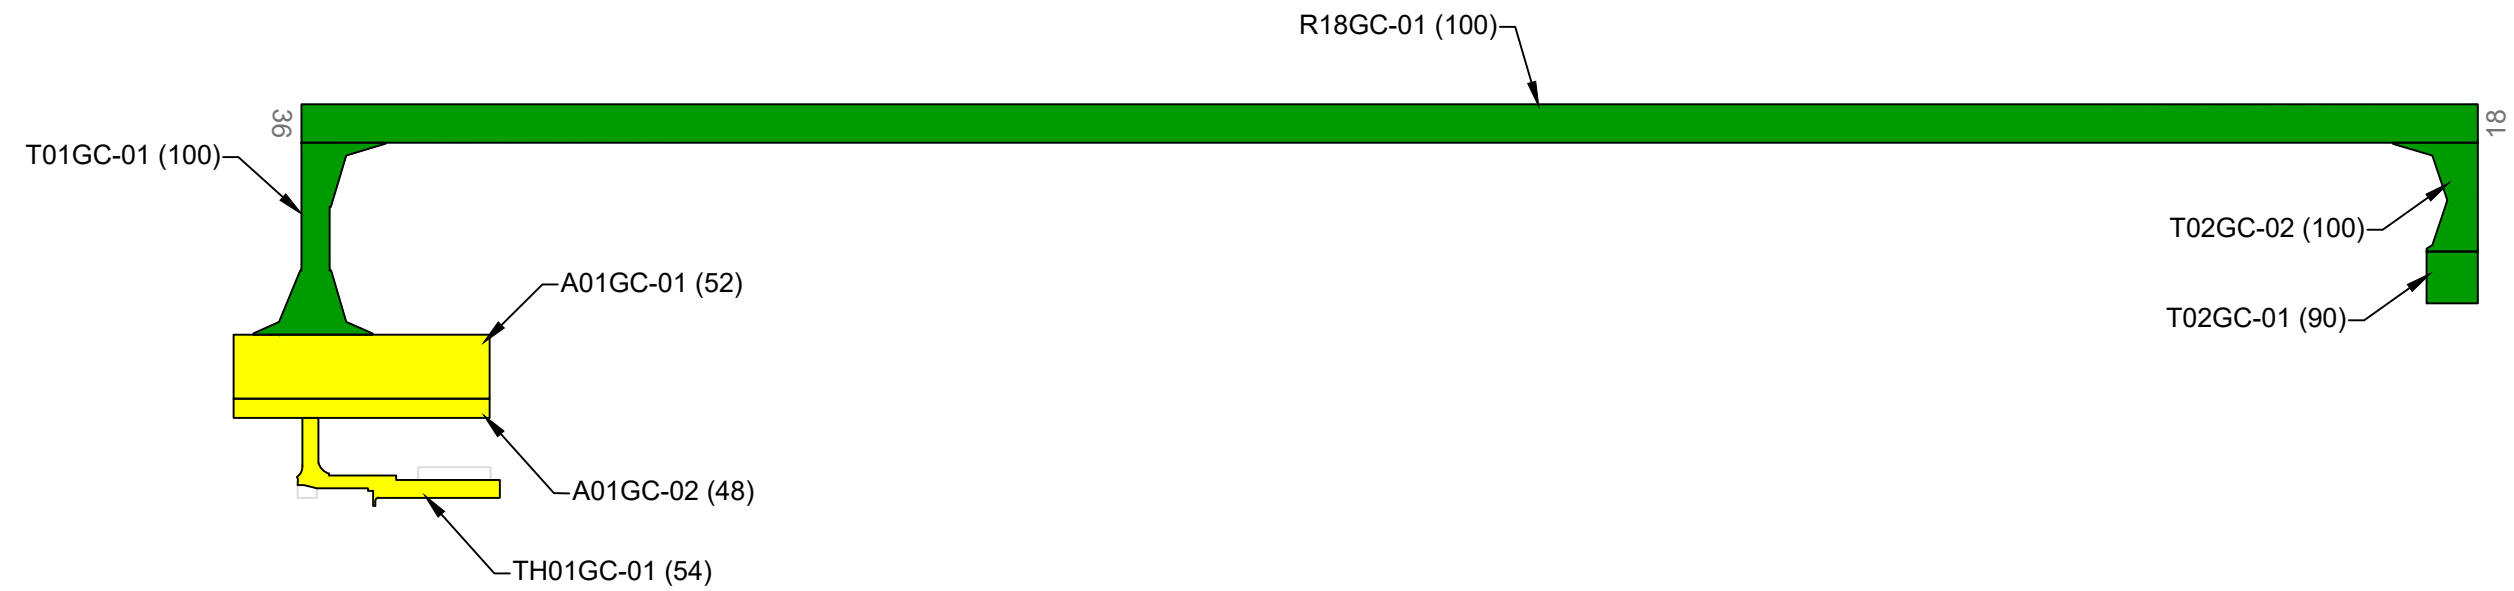
FIGURE 8. PCI MAP.

The pavements at Guthrie County Regional Airport were inspected in November 2020. The 2020 area-weighted condition of Guthrie County Regional Airport is 90, with conditions ranging from 48 to 100 (on a scale of 0 [failed] to 100 [excellent]). During the previous pavement inspection in 2017, the area-weighted PCI of the airport was 55.

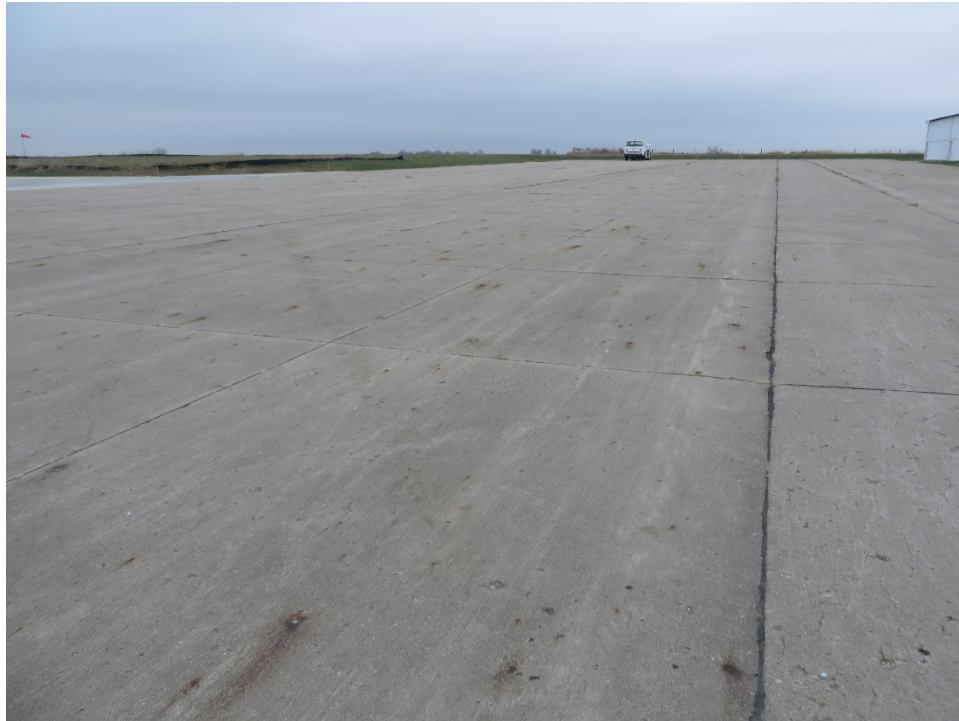
A01GC-01. Overview.

The apron area was defined by two sections. Low-severity small patching; low- and medium-severity ASR; medium-severity longitudinal, transverse, and diagonal (LTD) cracking; high-severity joint seal damage; and popouts were identified in Section 01. Areas of popouts, low- and medium-severity ASR, and high-severity joint seal damage were recorded in Section 02.

Year	Branch	Section	Surface Type	Type of Repair	Estimated Cost
2021	A01GC	01	PCC	Major Rehabilitation	\$316,000
2021	A01GC	02	PCC	Major Rehabilitation	\$135,714
2021	T02GC	01	PCC	Localized Maintenance	\$2,800
2021	TH01GC	01	PCC	Major Rehabilitation	\$83,321
<b>Total Estimated Cost:</b>					<b>\$538,000</b>

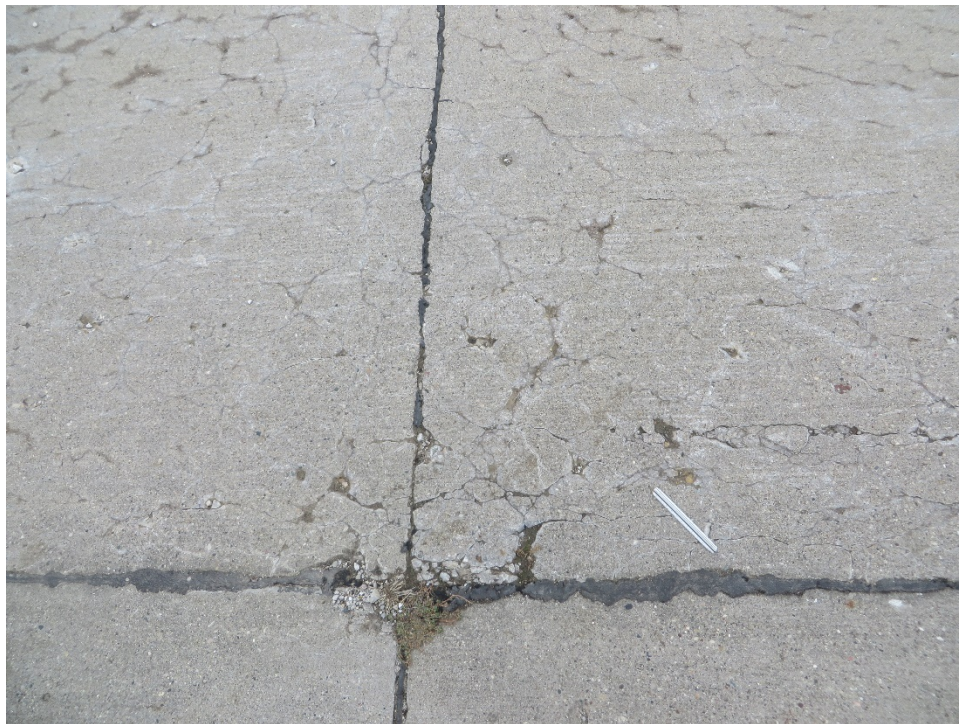
<b>Distress Type</b>	<b>Probable Cause of Distress</b>
ASR	Chemical reaction of alkalis in the portland cement with certain reactive silica minerals. ASR may be accelerated by the use of chemical pavement deicers.
Blowup	Incompressible materials in the joints.
Corner Break	Load repetition combined with loss of support and curling stresses.
Durability Cracking	Concrete's inability to withstand environmental factors such as freeze-thaw cycles.
Faulting	Upheaval or consolidation.
Joint Seal Damage	Stripping of joint sealant, extrusion of joint sealant, weed growth, hardening of the filler (oxidation), loss of bond to the slab edges, or absence of sealant in the joint.
LTD Cracking	Combination of load repetition, curling stresses, and shrinkage stresses.
Patching (Small and Large)	N/A
Popouts	Freeze-thaw action in combination with expansive aggregates.
Pumping	Poor drainage, poor joint sealant.
Scaling	Over finishing of concrete, deicing salts, improper construction, freeze-thaw cycles, and poor aggregate.

A01GC-01. ASR (Sample Unit No. 14).

Sample Number: 14 Type: R Area: 20.00Slabs PCI = 49  
Sample Comments:  
76 ASR L 16.00 Slabs Comments:  
76 ASR M 4.00 Slabs Comments:  
65 JOINT SEAL DAMAGE H 20.00 Slabs Comments:  
66 SMALL PATCH L 2.00 Slabs Comments:

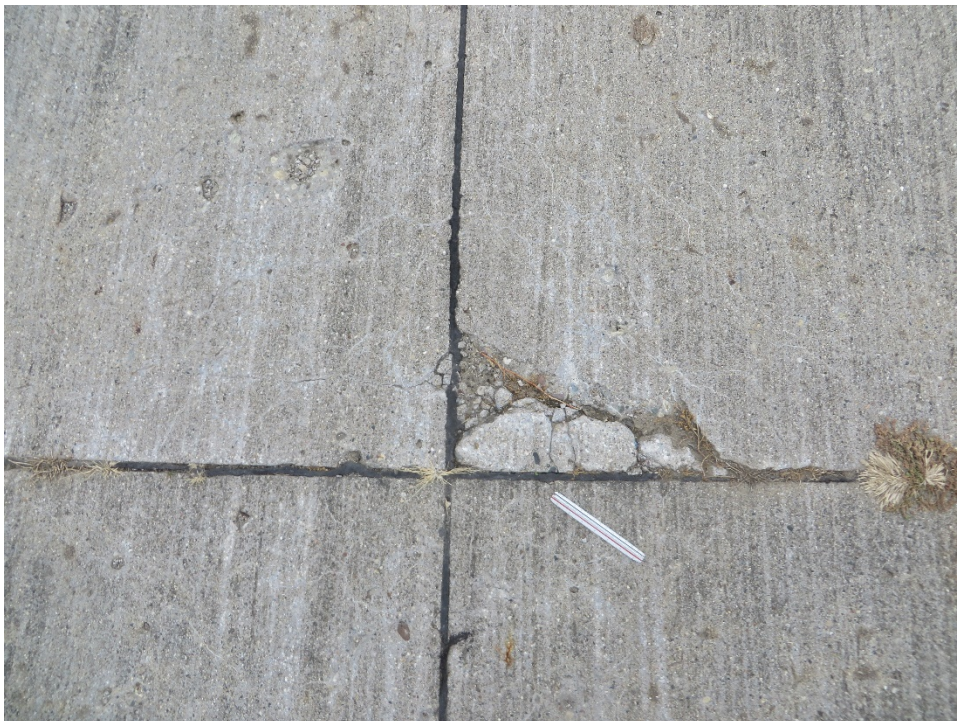
A01GC-02. ASR (Sample Unit No. 02).

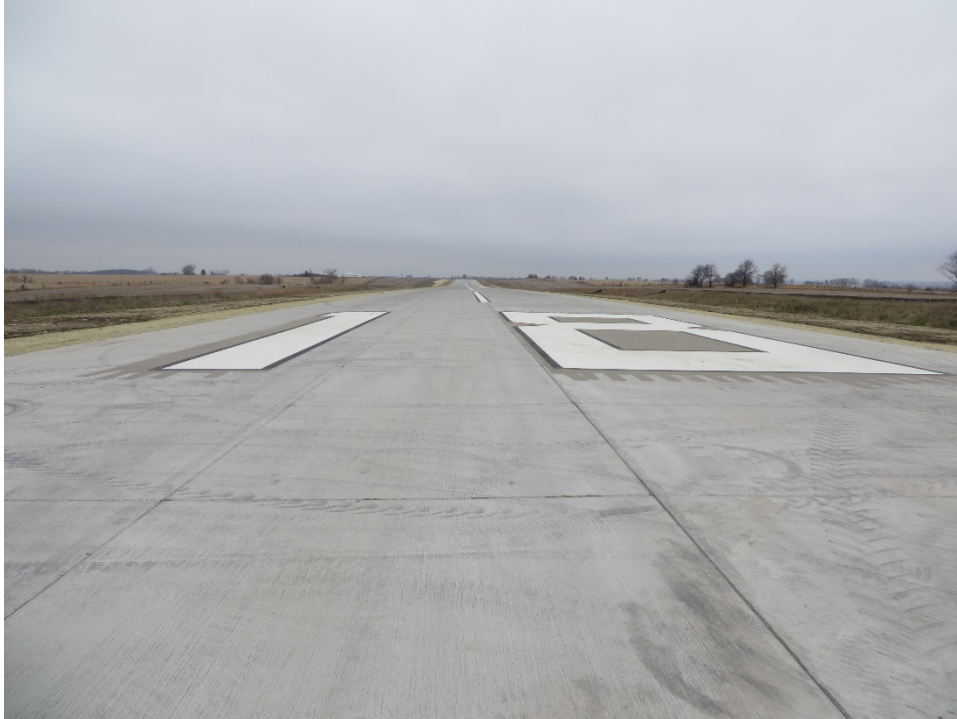
R18GC-01. Overview.

Runway 18/36 was defined by one recently reconstructed section. Section 01 was in excellent condition with no distress noted at the time of inspection.

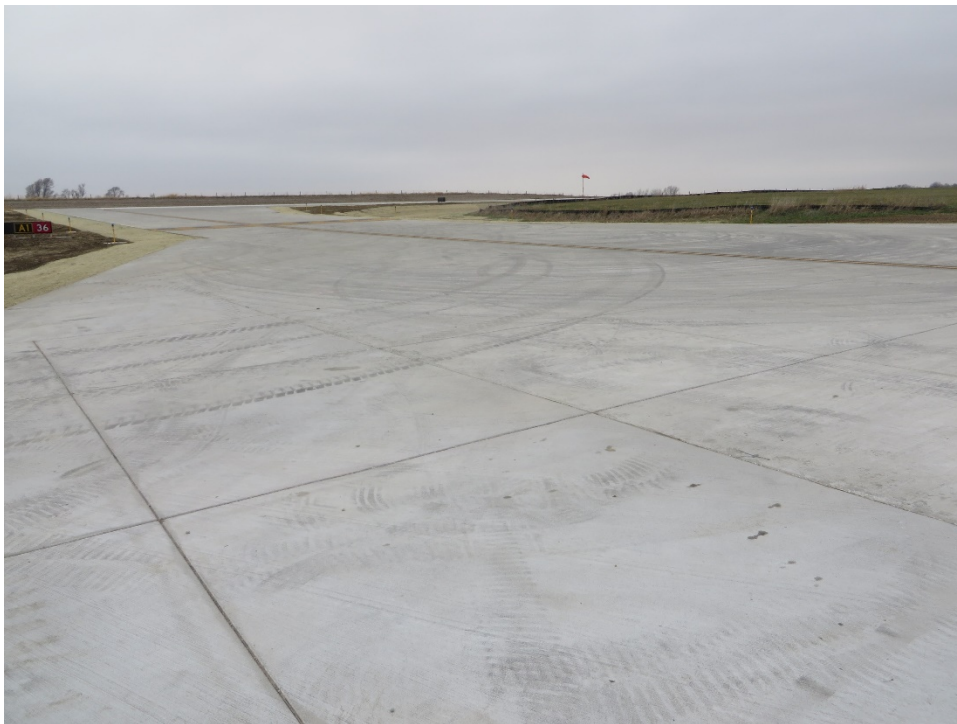
T01GC-01. Overview.

Taxiway 01 contained one section in excellent condition that was recently reconstructed. No distress was observed at the time of the inspection.

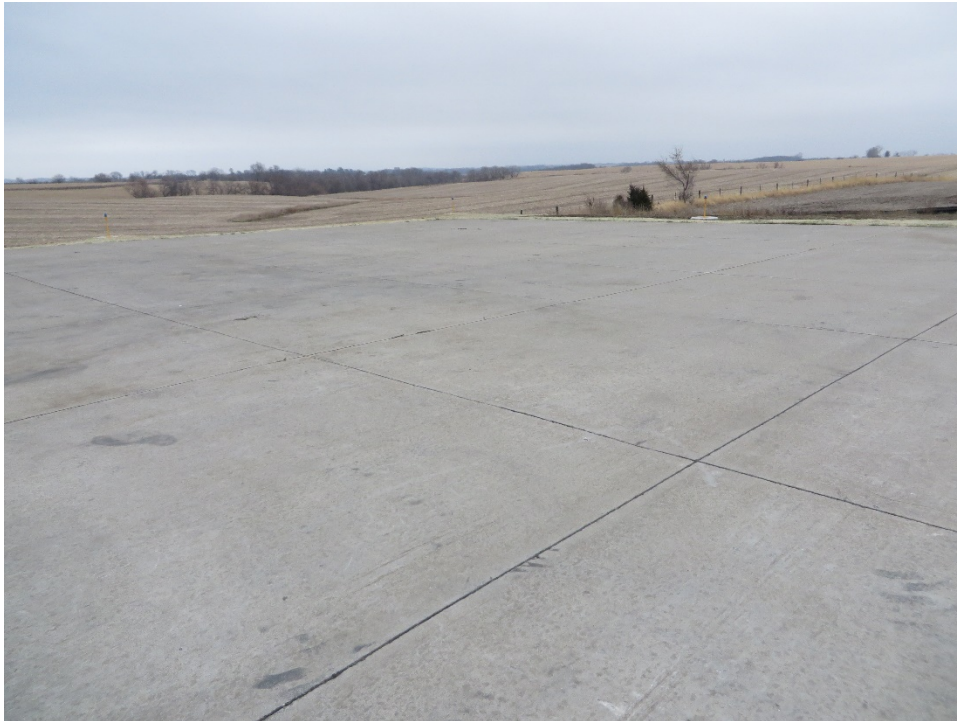
T02GC-01. Overview.

Taxiway 02 was located at the Runway 18 approach and consisted of two sections. Medium- and high-severity joint seal damage was recorded throughout Section 01. Section 02 was in excellent condition with no distress identified during the inspection.

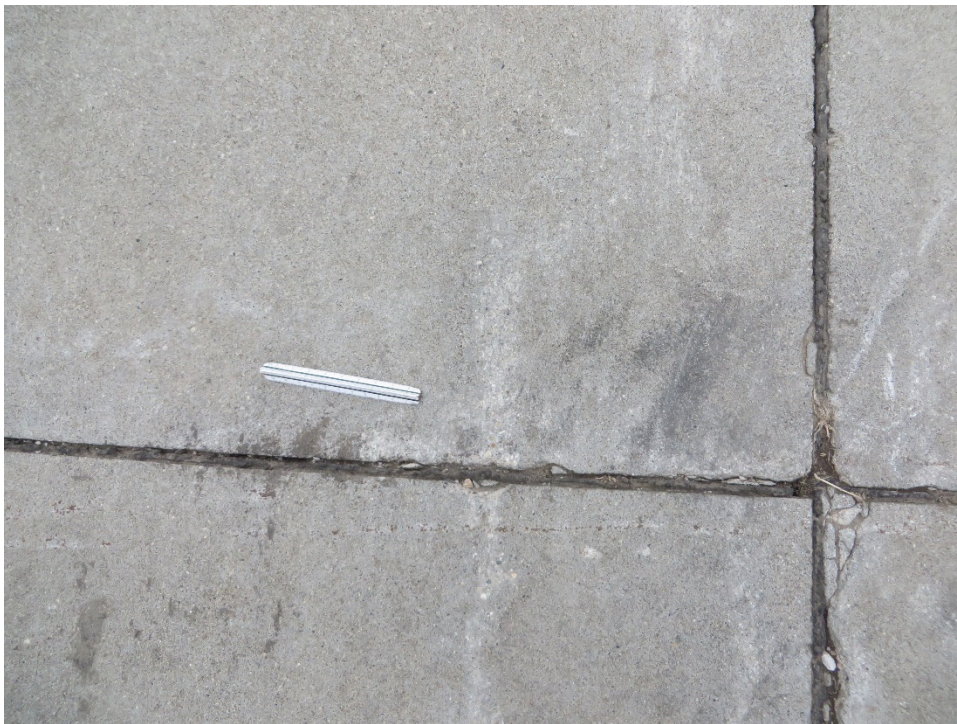
T02GC-01. Joint Seal Damage (Sample Unit No. 02).

4. Implement a periodic crack and joint sealing program. Keeping water and debris out of the pavement system by sealing cracks and joints is a proven and cost-effective method of extending the life of the pavement system.

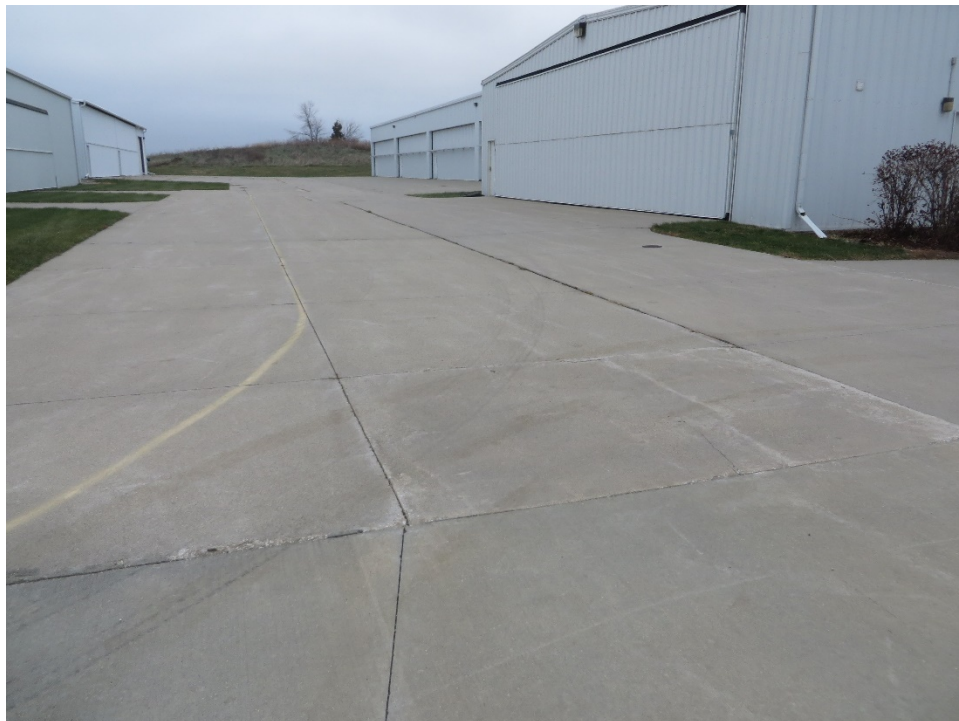
TH01GC-01. Overview.

The T-Hangar area contained one section that had low-severity ASR and large patching; low- and medium-severity corner break, joint spalling, and LTD cracking; high-severity joint seal damage, medium-severity corner spalling; all severities of shattered slab; and shrinkage cracking recorded during the inspection.

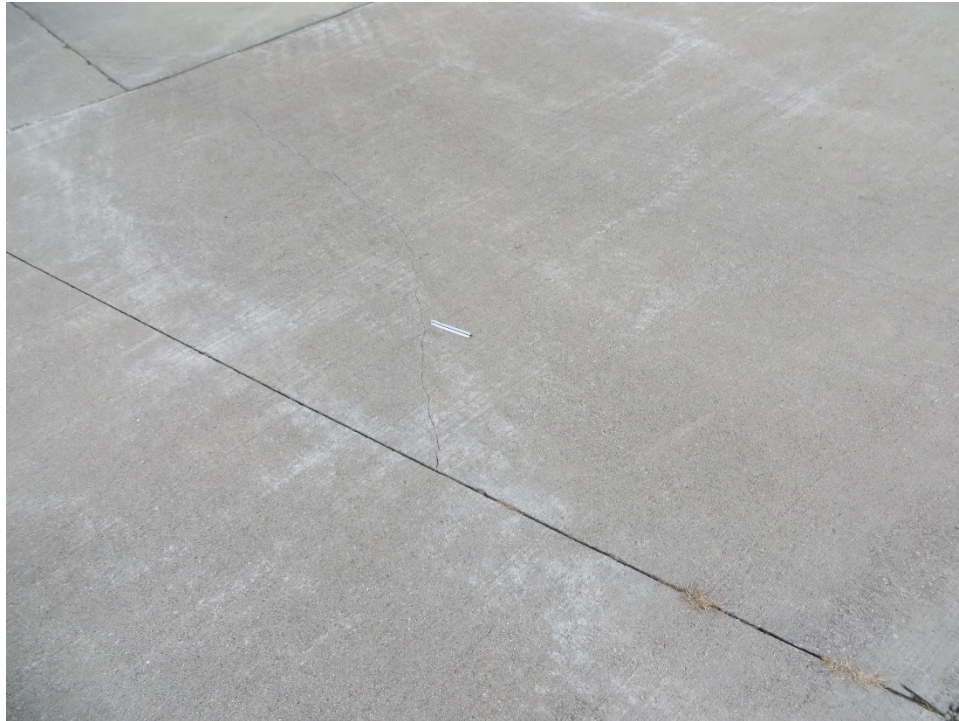
TH01GC-01. Corner Break (Sample Unit No. 02).

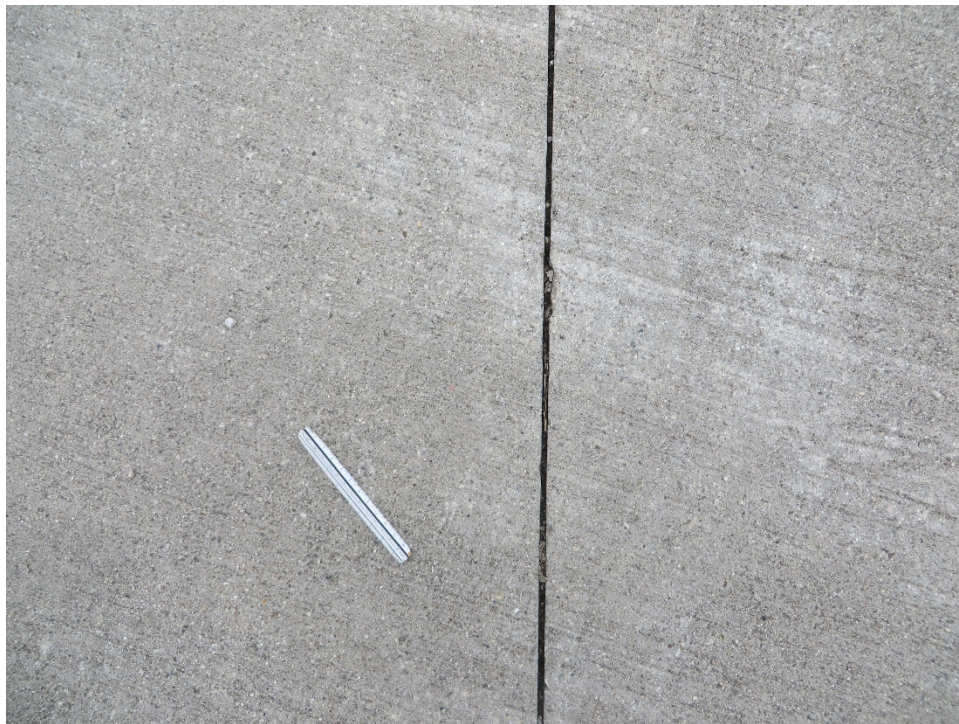
TH01GC-01. Joint Seal Damage (Sample Unit No. 02).
