# Guthrie County Regional Airport

## Pavement Management Report

**JULY 2024**

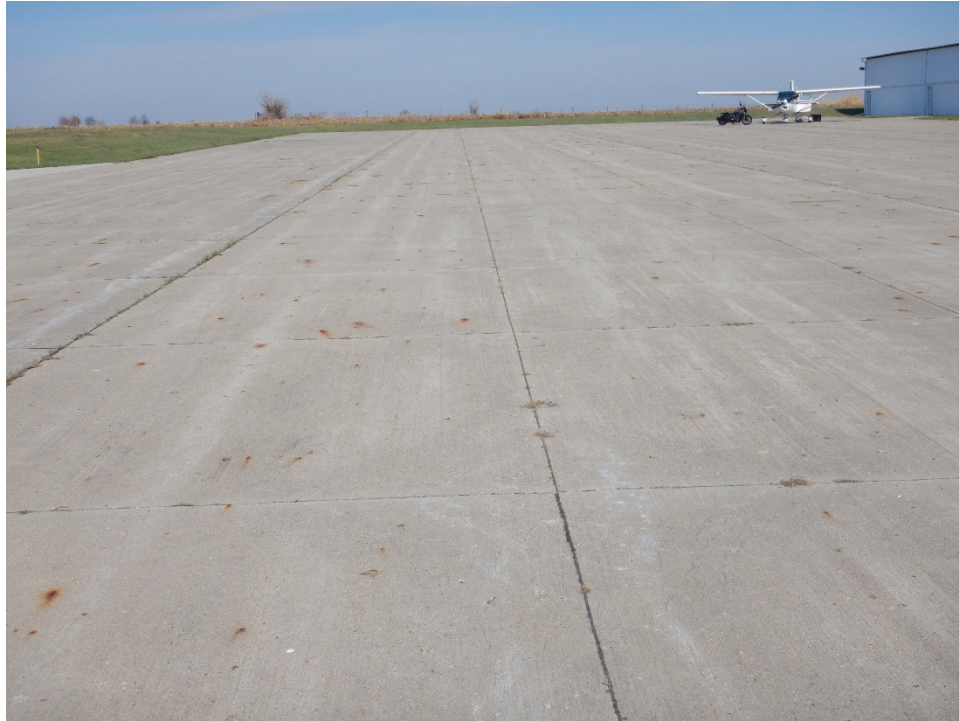
The apron area contained two sections that were in poor condition. Low-severity joint spalling and small patching; medium-severity corner break, corner spalling, scaling, and longitudinal, transverse, and diagonal (LTD) cracking; high-severity joint seal damage; all severities of ASR; and popouts were observed in Section 01. Section 02 contained areas of low- and medium-severity ASR and joint spalling, medium-severity corner spalling and LTD cracking, medium- and high-severity scaling, high-severity joint seal damage, and popouts.

A01GC-01. Overview.

Year	Branch	Section	Surface Type	Type of Repair	Estimated Cost
2024	A01GC	01	PCC	Major Rehabilitation	\$730,735
2024	A01GC	02	PCC	Major Rehabilitation	\$221,295
2024	TA2GC	01	PCC	Preventive Maintenance	\$3,087
2024	TH01GC	01	PCC	Major Rehabilitation	\$92,008
<b>Total Estimated Cost:</b>					<b>\$1,047,000</b>

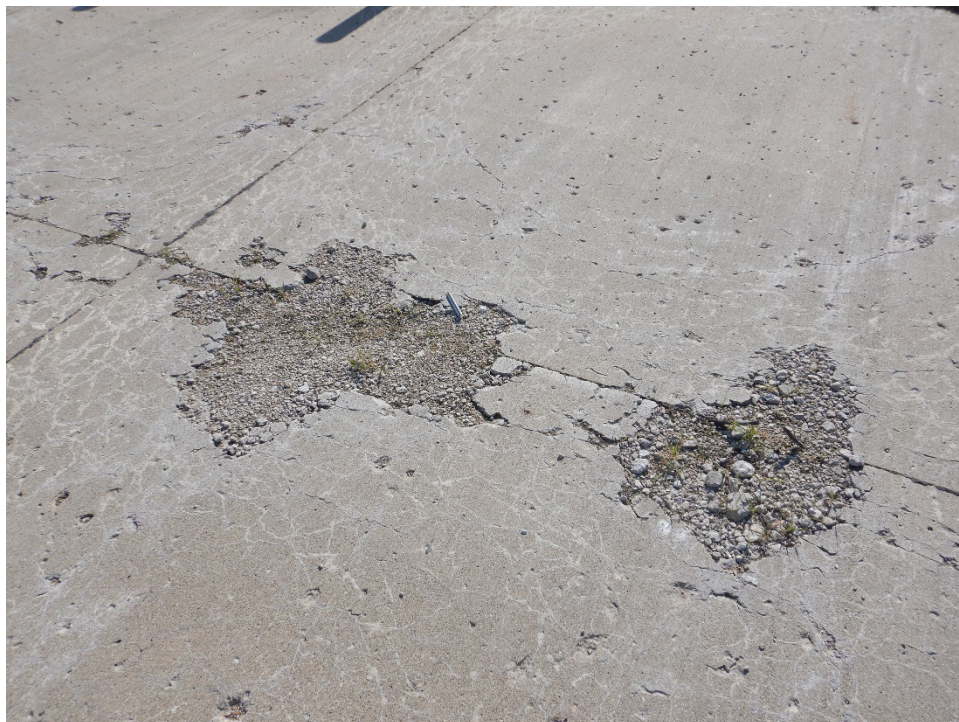
Guthrie County Regional Airport was inspected on November 4, 2023. There were seven pavement sections defined during the inspection. Suspected alkali-silica reaction (ASR) was recorded at this airport in accordance with ASTM D5340. It should be noted that laboratory testing in the form of petrographic analysis is the only definitive way to validate the presence of ASR; however, the formation of a precipitate is evidence of a reaction consistent with this type of materials-related distress.

A01GC-01. ASR (Sample Unit No. 15).

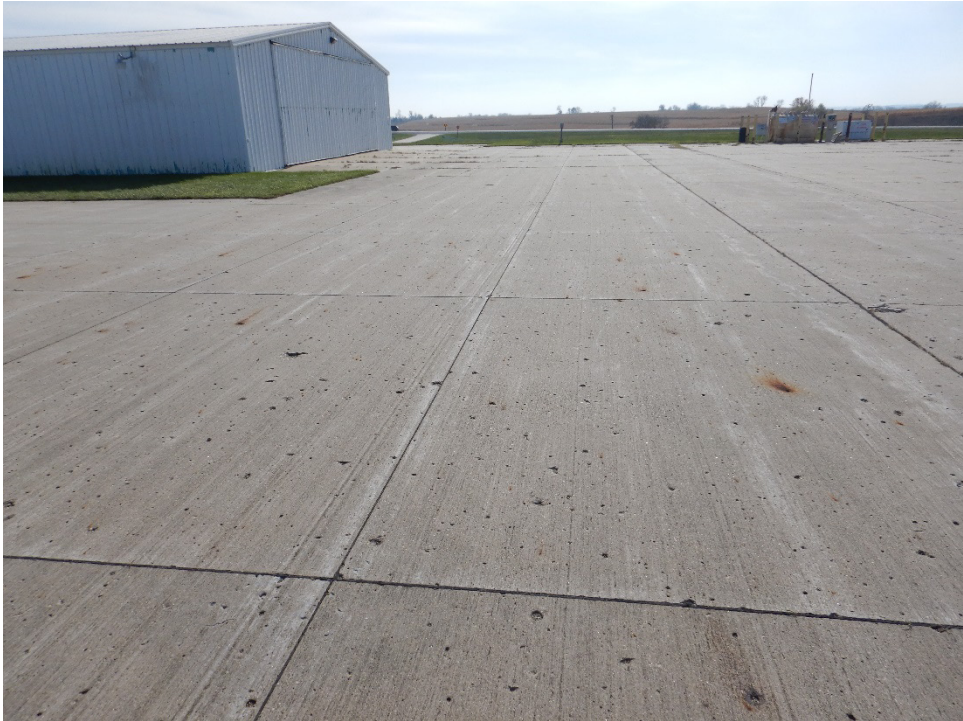
A01GC-02. Overview.

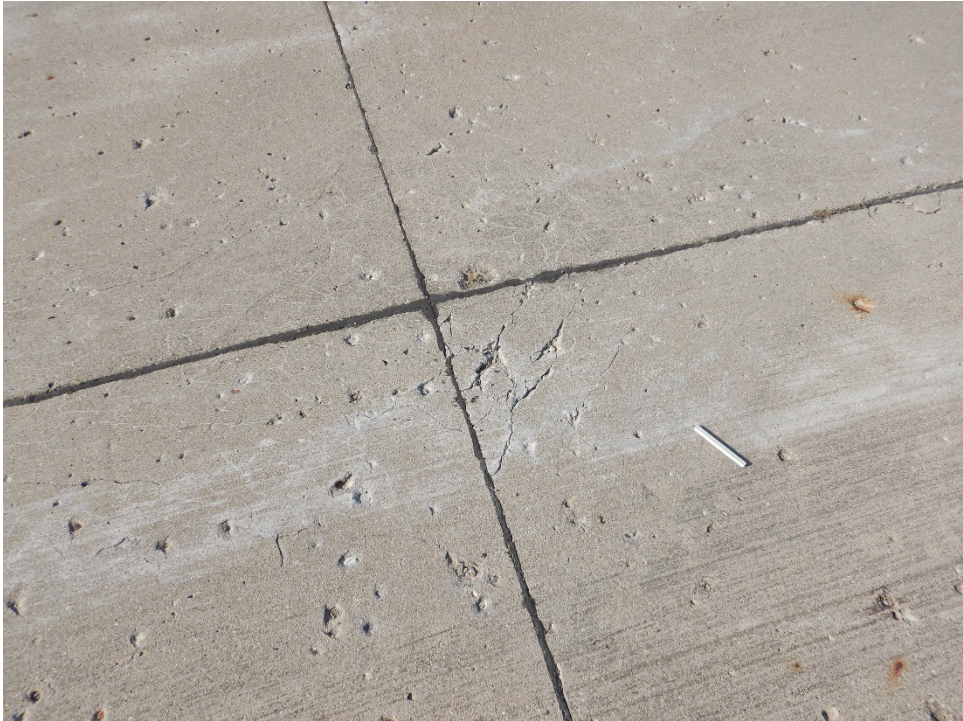
A01GC-02. ASR (Sample Unit No. 02).

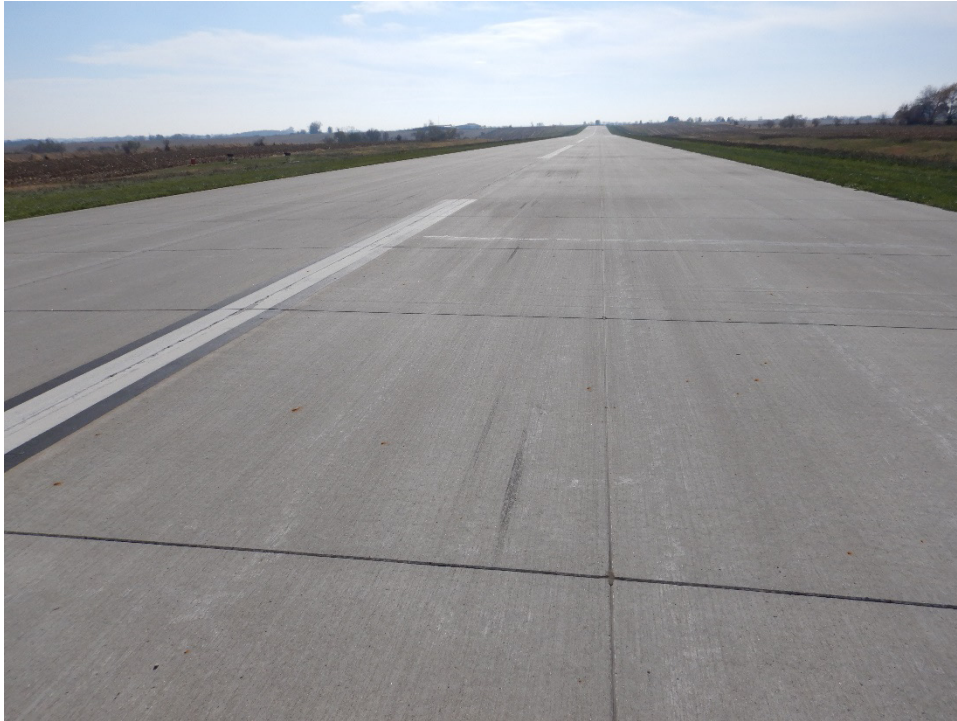
Runway 18/36 was defined by one section that was in excellent condition. No distress was observed during the inspection.

R18GC-01. Overview.

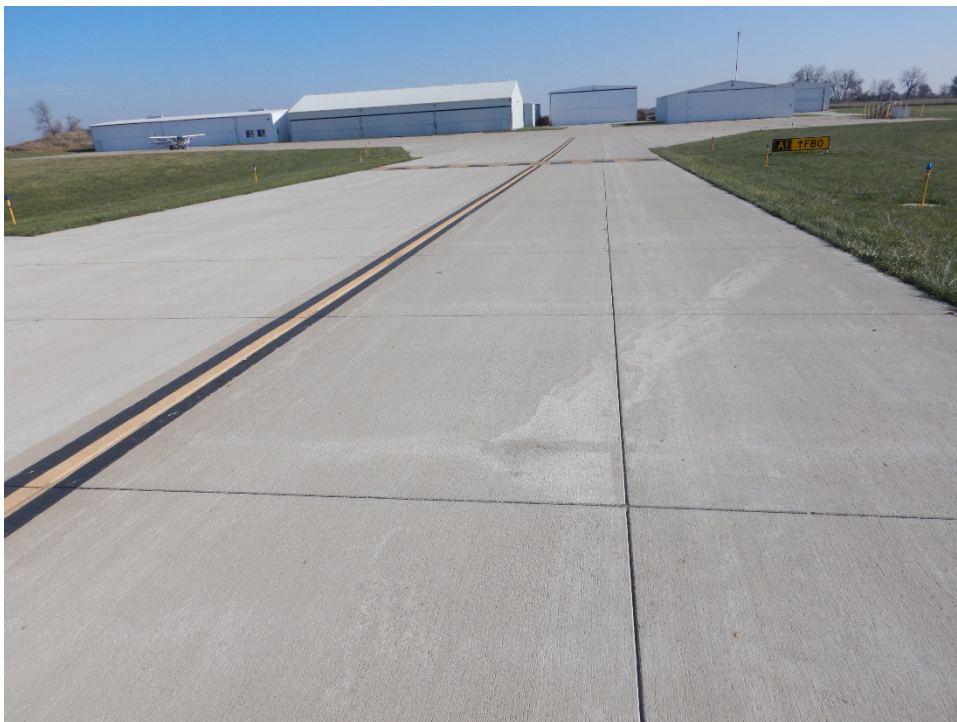
Taxiway A1 consisted of one section that connected the apron area to Runway 18/36 and was in excellent condition. No distress was identified at the time of inspection.

TA1GC-01. Overview.

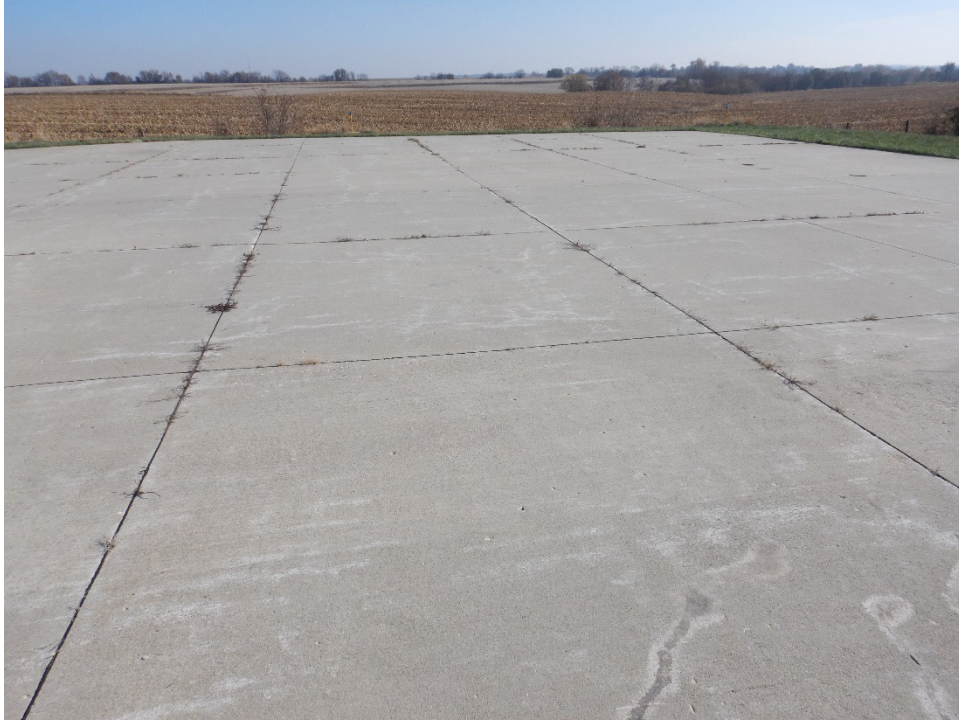
Taxiway A2 was defined by two sections. High-severity joint seal damage was recorded throughout Section 01, along with smaller areas of low-severity faulting. Section 02 was in excellent condition. Only low-severity faulting was observed at the time of the inspection.

TA2GC-01. Overview.

Branch	Section	Distress Type	Severity	Distress Quantity	Distress Unit	Maintenance Action	Unit Cost	2024 Estimated Cost
TA2GC	01	Joint Seal Damage	High	49	Slabs	Joint Seal (Localized)	\$3.20	\$3,087

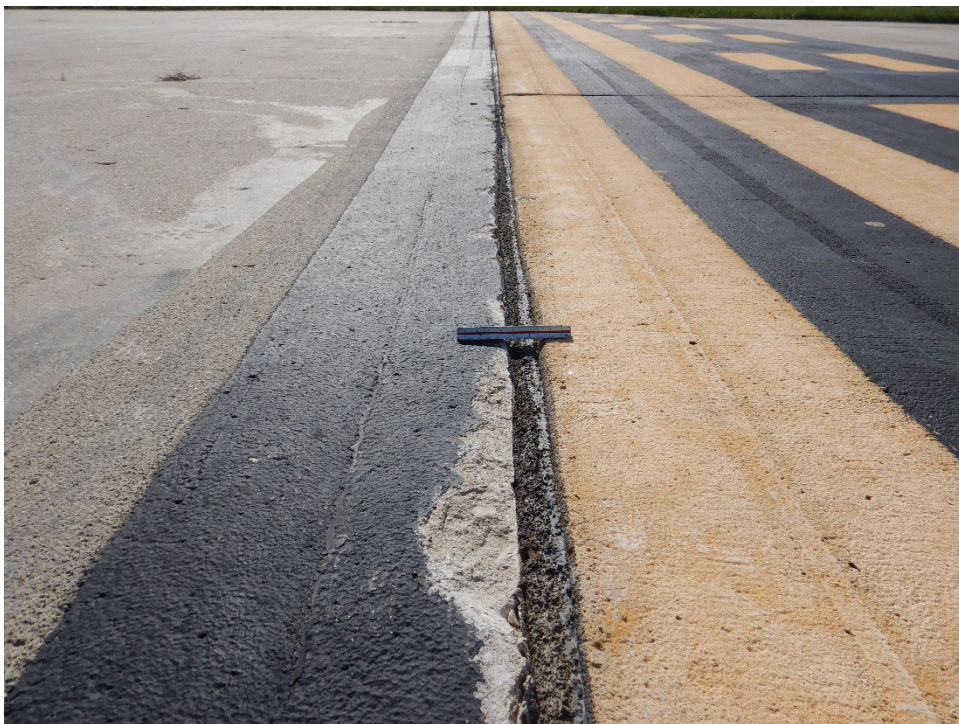
TA2GC-01. Faulting (Sample Unit No. 01).

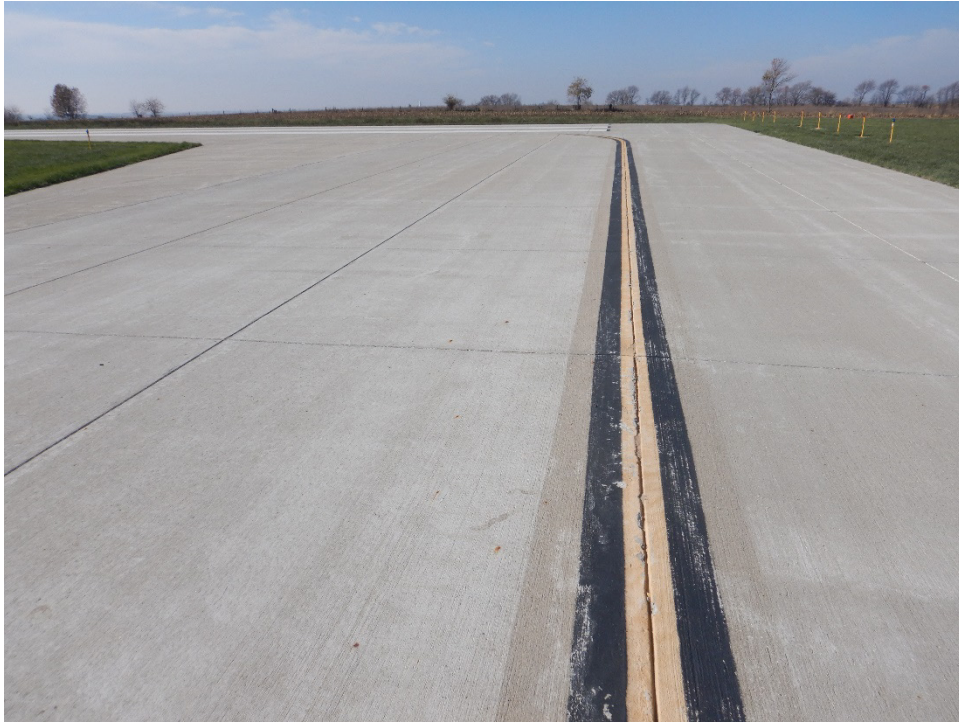
TA2GC-02. Overview.

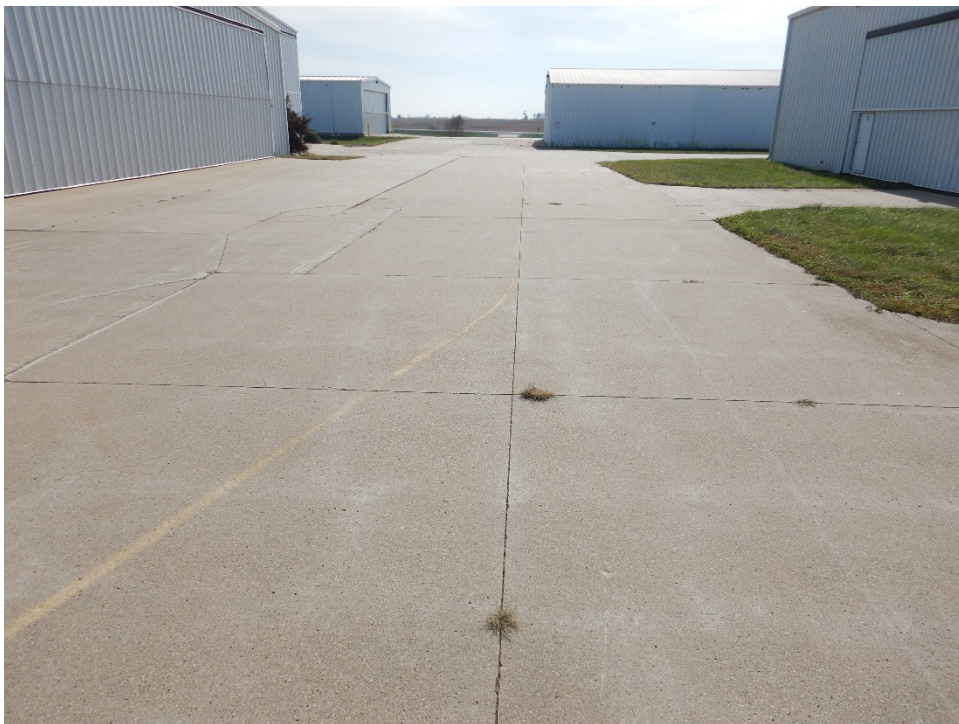
The T-hangar area consisted of one section. Areas of low-severity ASR and large patching, low- and medium-severity joint spalling and LTD cracking, medium- and high-severity corner break, high-severity joint seal damage, all severities of shattered slab, and shrinkage cracking were observed in Section 01.

TH01GC-01. Overview.

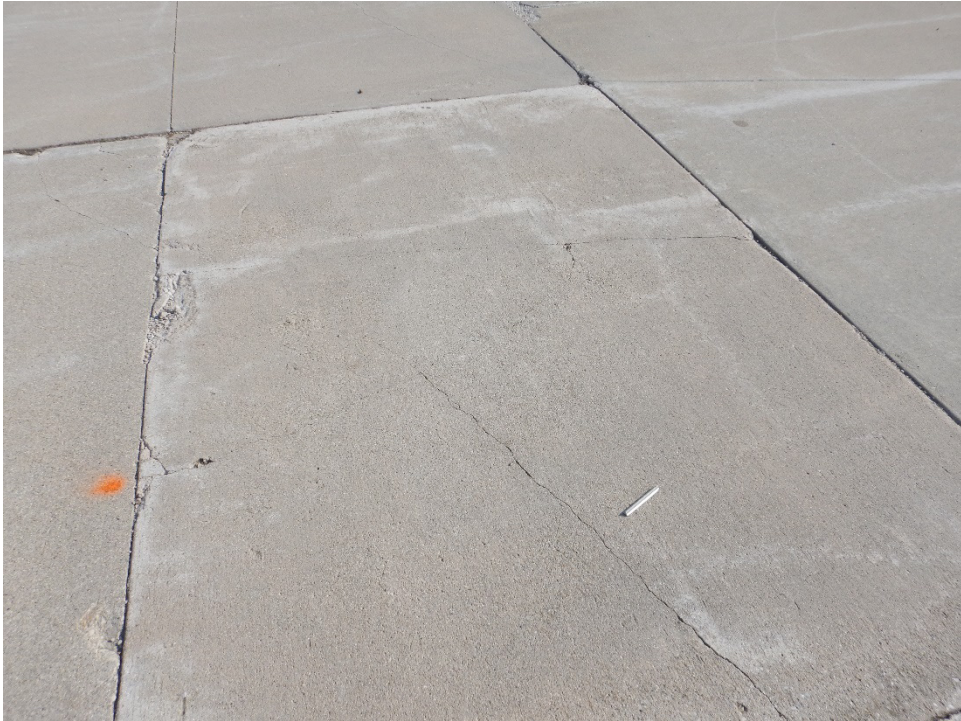
TH01GC-01. Shattered Slab (Sample Unit No. 02).
