Hampton Municipal Airport

PAVEMENT MANAGEMENT REPORT

JULY 2021

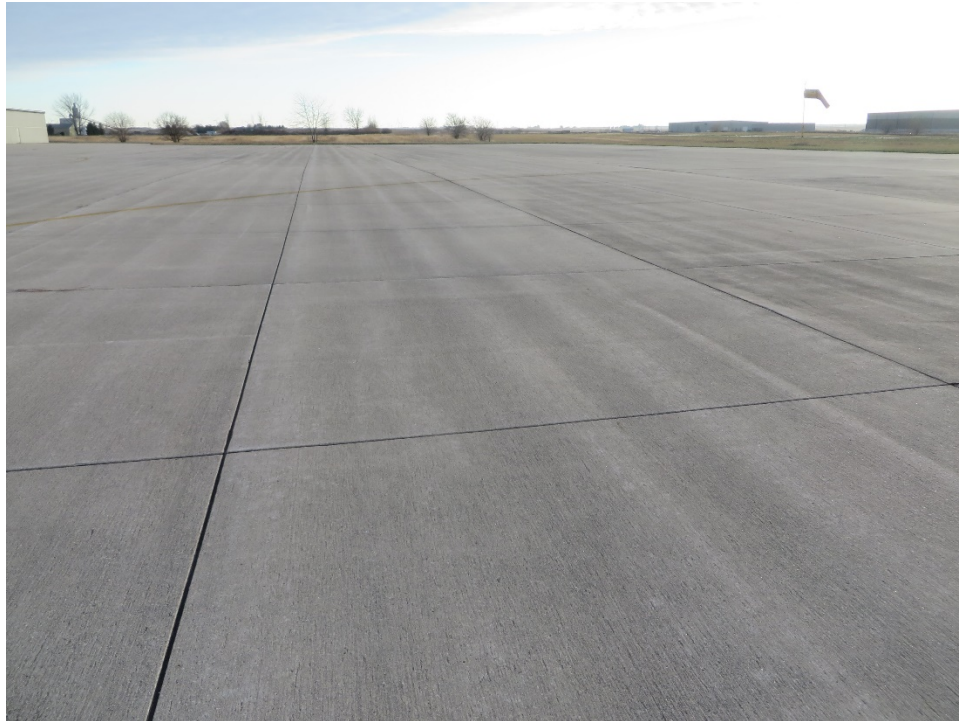
The apron area was defined by one section. Low-severity faulting; low- and medium-severity corner spalling and LTD cracking; and medium- and high-severity joint seal damage were observed in Section 01. In addition, an atypical area of low-severity large patching and medium-severity small patching was identified and recorded as an additional sample unit according to ASTM D5340-20.

A01HA-01. Overview.

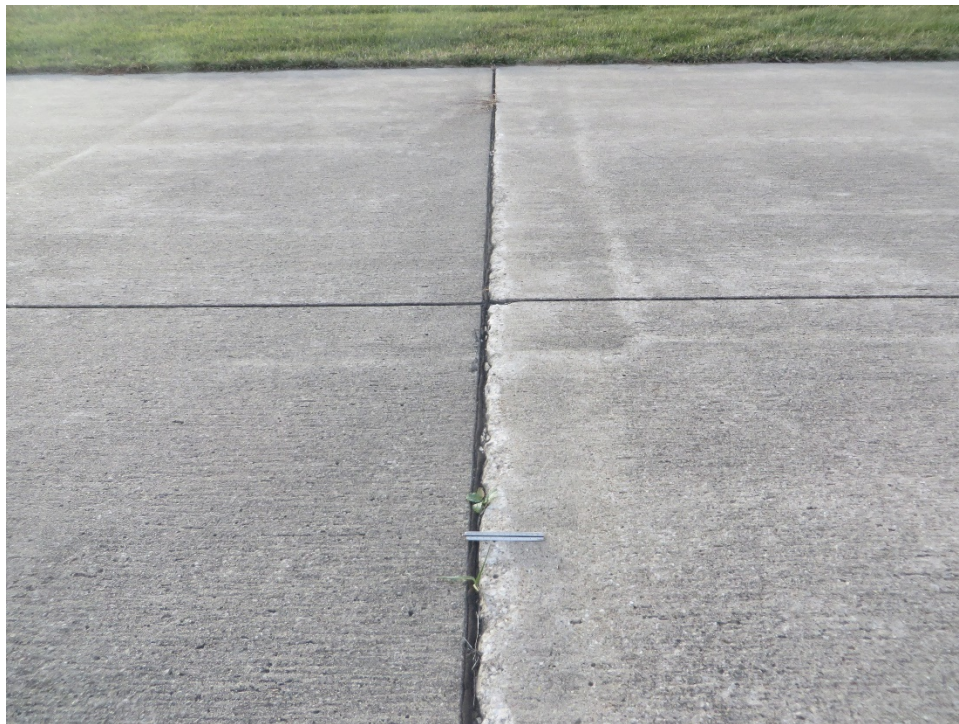
A01HA-01. Faulting (Sample Unit No. 14).

Sample Number: 14 Type: R Area: 24.00Slabs PCI = 83
Sample Comments:
71 FAULTING L 2.00 Slabs Comments:
65 JOINT SEAL DAMAGE H 24.00 Slabs Comments:

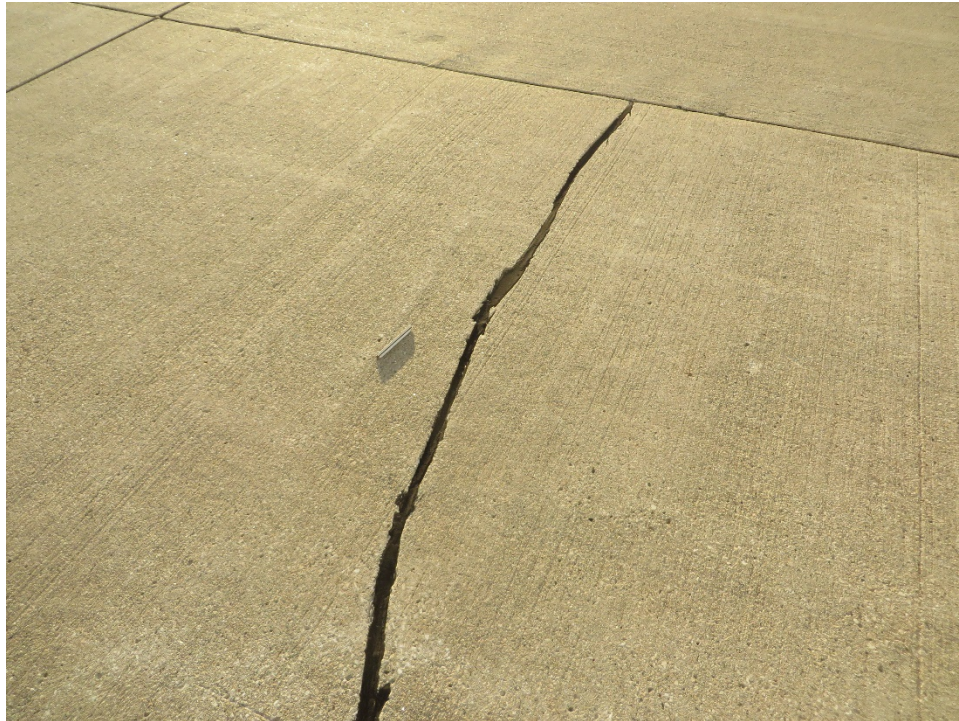
A01HA-01. LTD Cracking (Sample Unit No. 26).

Sample Number: 26 Type: R Area: 16.00Slabs PCI = 88
Sample Comments:
63 LINEAR CRACKING L 1.00 Slabs Comments:
65 JOINT SEAL DAMAGE M 16.00 Slabs Comments:

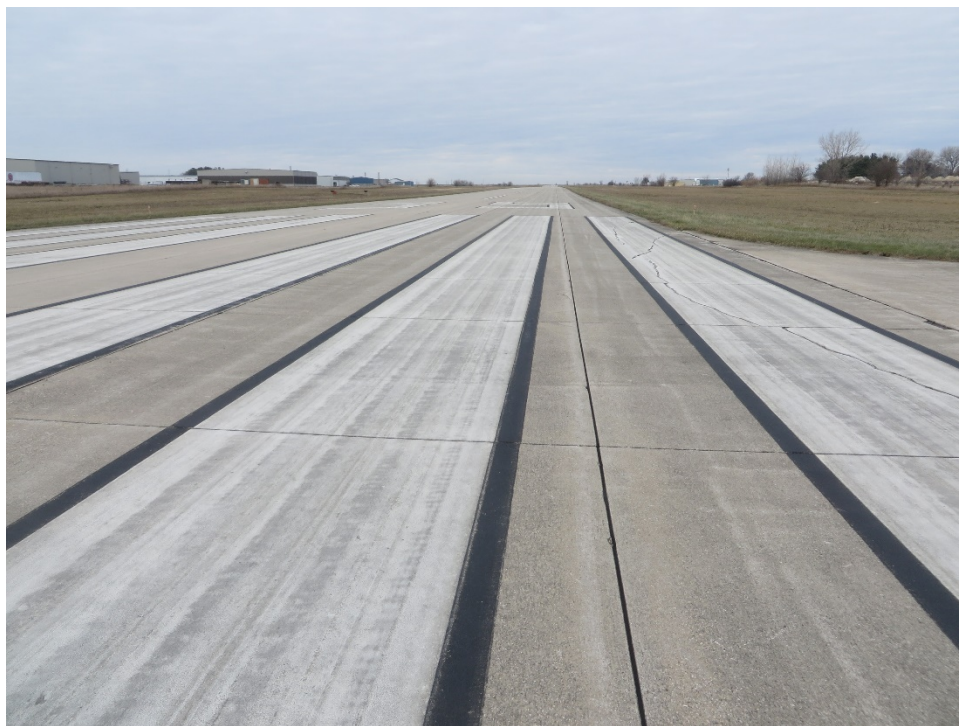
Runway 17/35 was defined by one section with low-severity corner break, faulting, and large patching; low- and medium-severity corner spalling, joint seal damage, and longitudinal, transverse, and diagonal (LTD) cracking; low- and high-severity small patching; and medium- and high-severity joint spalling. An atypical area of medium-severity scaling was also identified and recorded as an additional sample unit according to ASTM D5340-20.

R17HA-01. Overview.

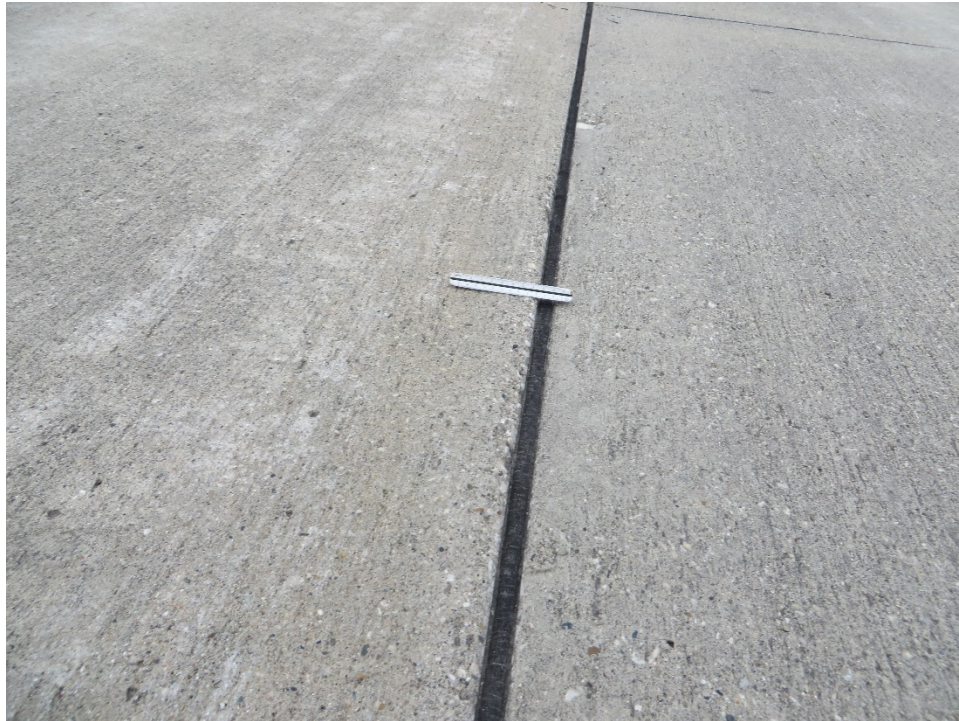
R17HA-01. Faulting (Sample Unit No. 35).

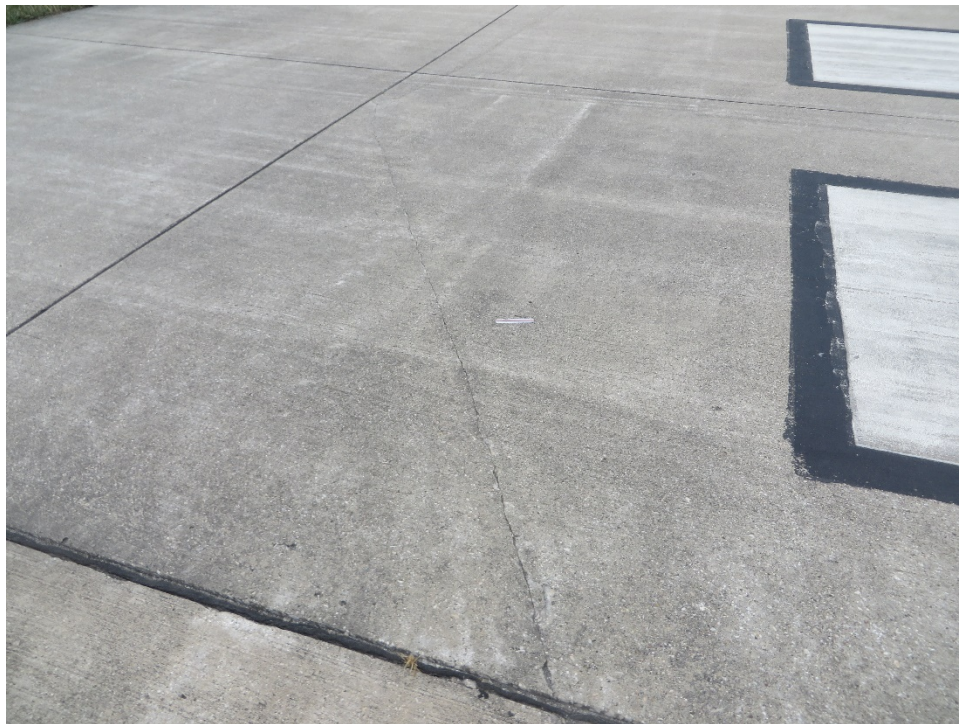
R17HA-01. LTD Cracking (Sample Unit No. 05).

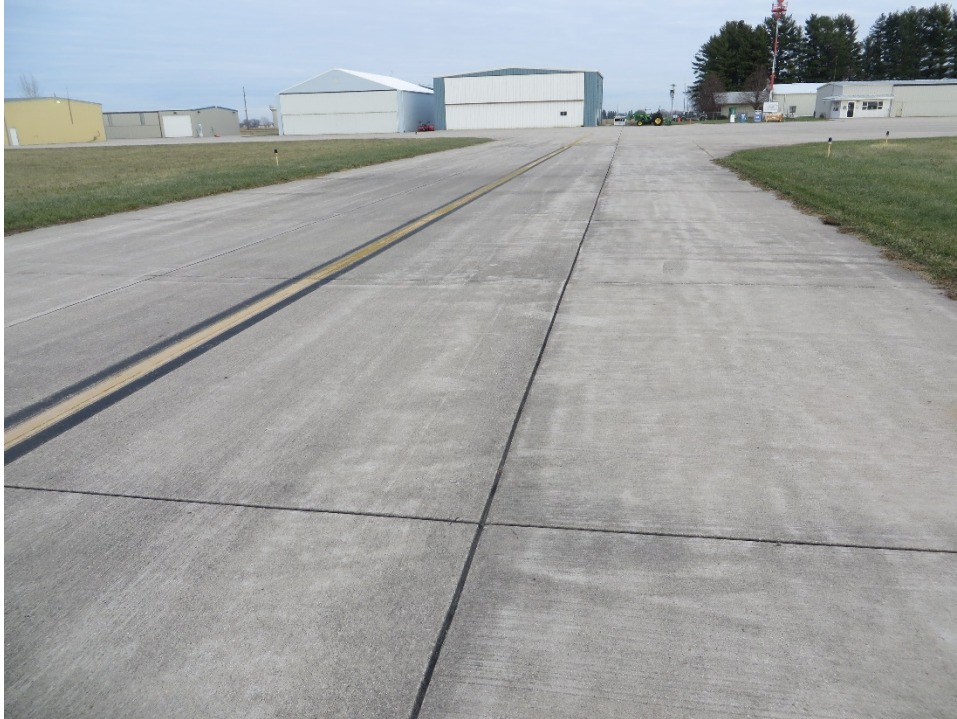
Taxiway 01 contained one section that connected Runway 17/35 with the apron area. Low-severity corner spalling, joint seal damage, and LTD cracking and medium-severity joint spalling were identified in Section 01 at the time of the inspection.

T01HA-01. Overview.

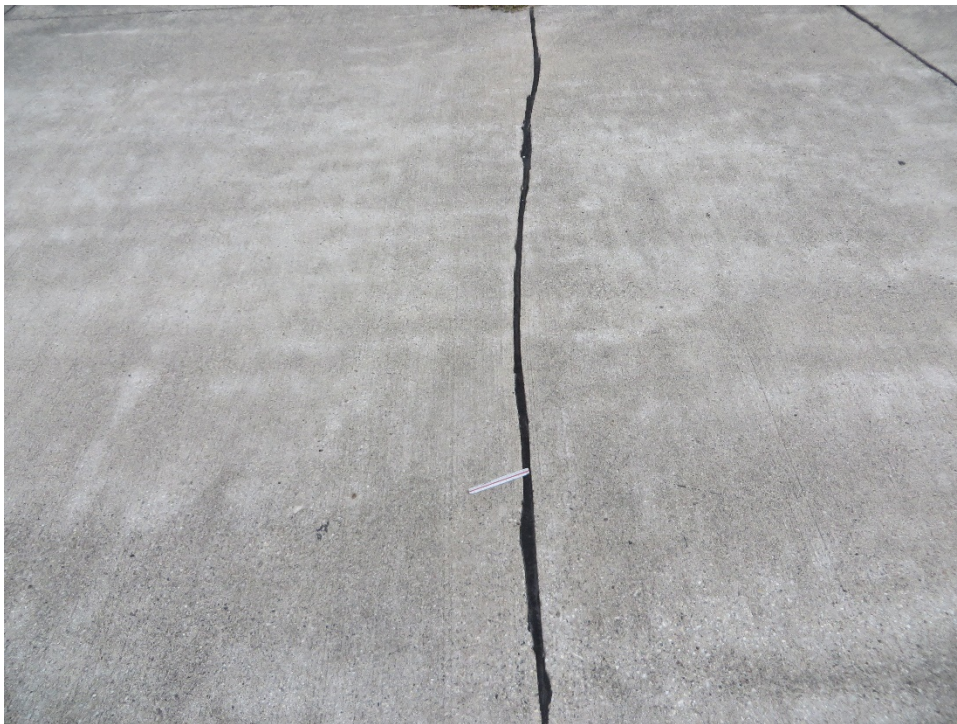
T01HA-01. LTD Cracking (Sample Unit No. 04).

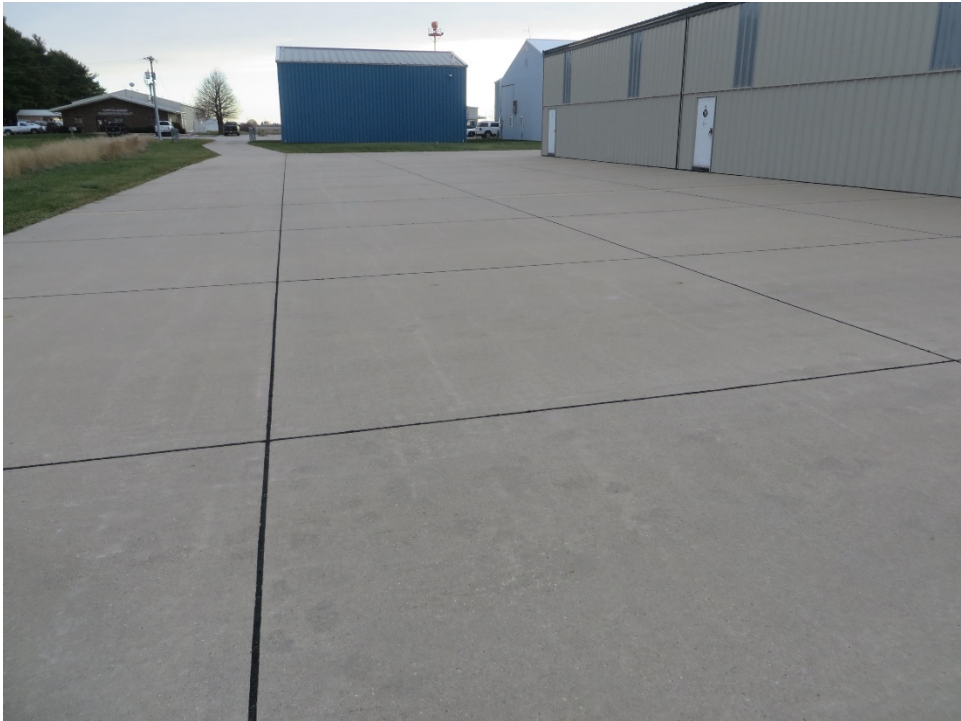
The T-Hangar area consisted of one section. Low-severity corner break, corner spalling, and LTD cracking, along with medium-severity joint seal damage were identified at the time of the inspection.

TH01HA-01. Overview.

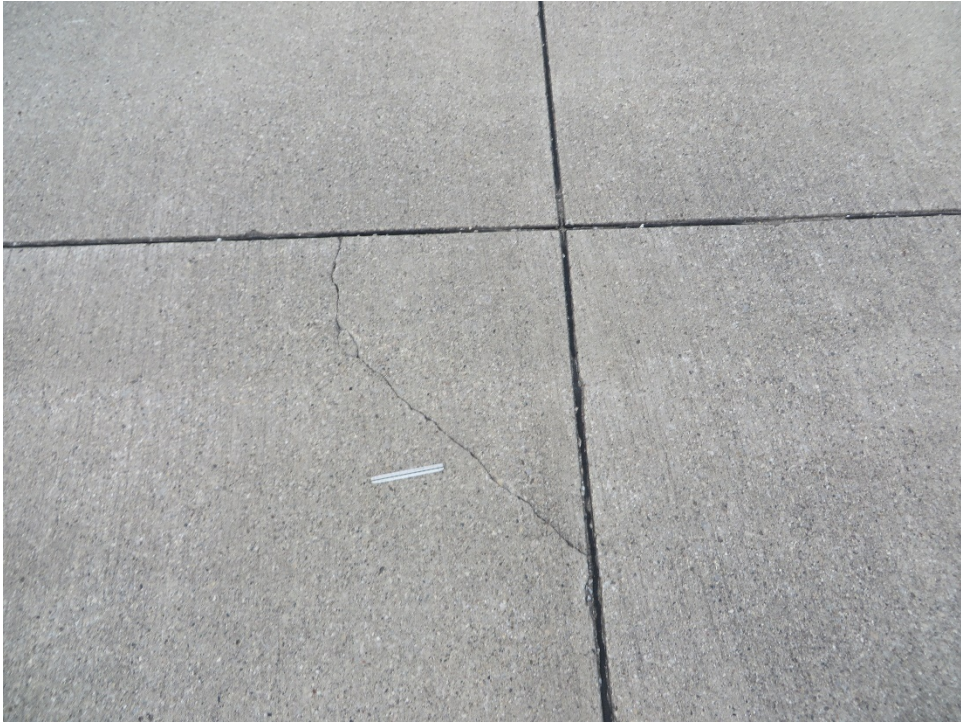
TH01HA-01. Corner Break (Sample Unit No. 01).
