Hampton Municipal Airport

Pavement Management Report

JULY 2024

HAMPTON MUNICIPAL AIRPORT PAVEMENT MANAGEMENT REPORT

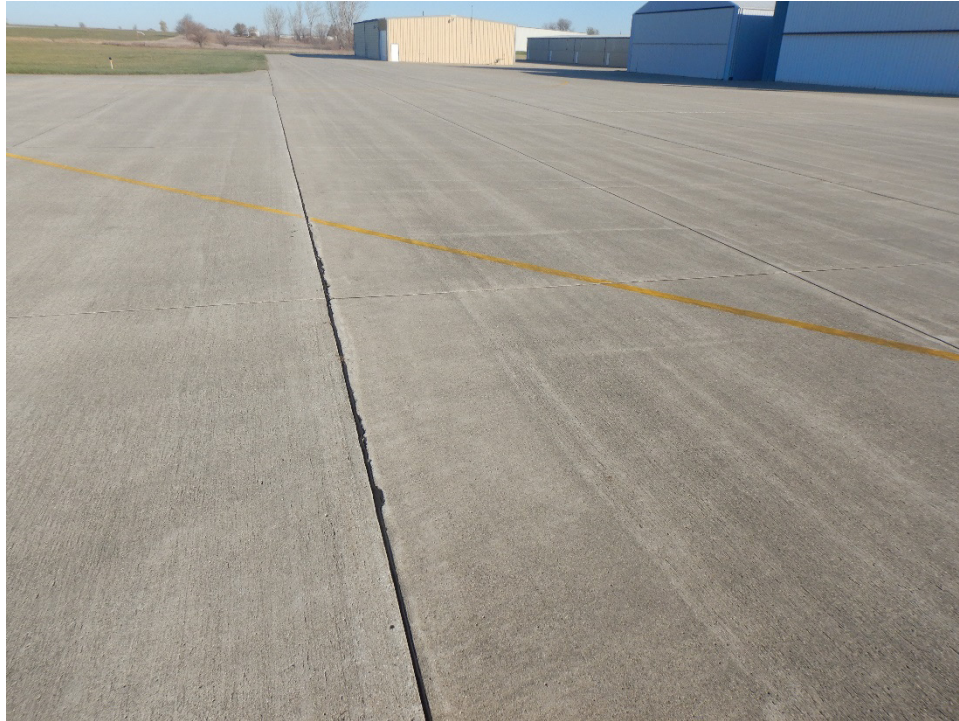
The apron area was defined by one section. Section 01 contained low-severity faulting, low- and medium-severity corner spalling and LTD cracking, and medium- and high-severity joint seal damage. An atypical area of medium-severity large patching and small patching was identified and recorded as an additional sample unit in accordance with ASTM D5340.

A01HA-01. Overview.

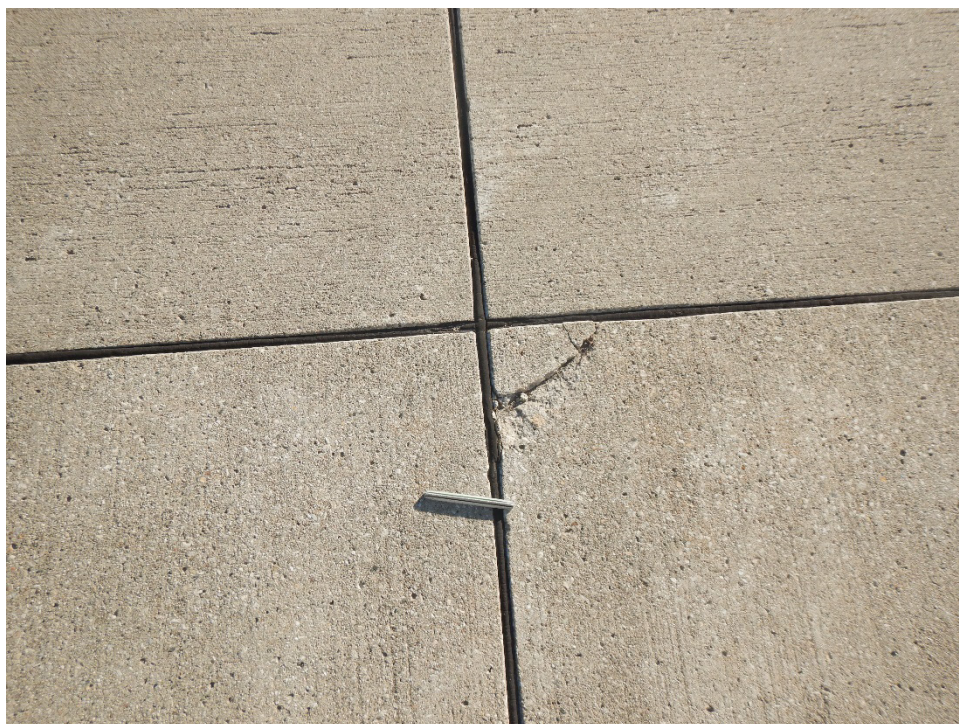
A01HA-01. Corner Spalling (Sample Unit No. 39).

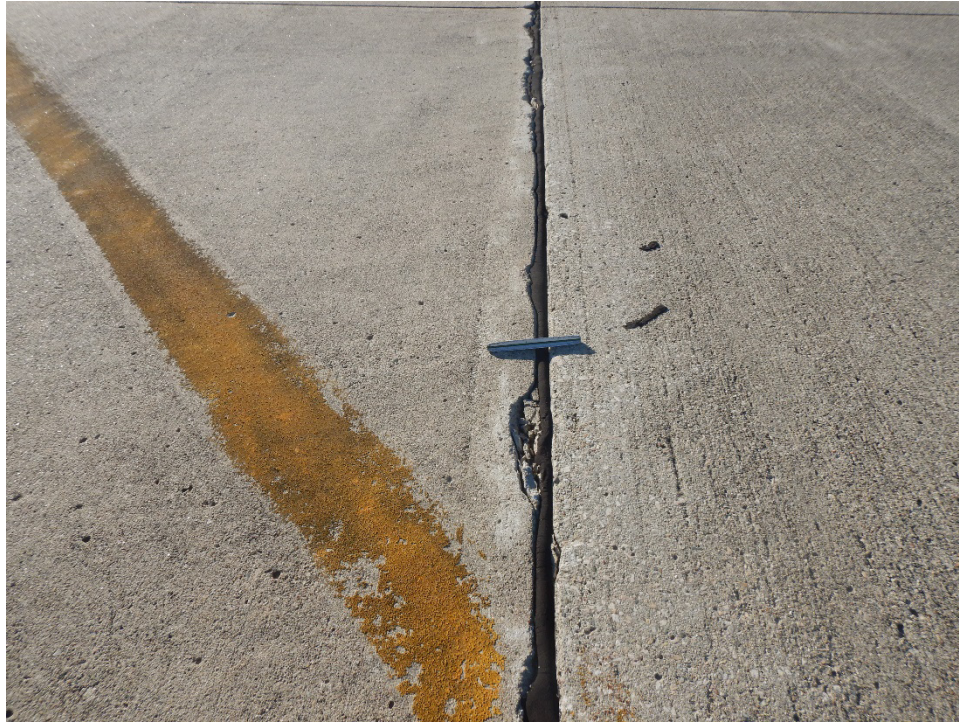
A01HA-01. Joint Seal Damage (Sample Unit No. 10).

Branch	Section	Distress Type	Severity	Distress Quantity	Distress Unit	Maintenance Action	Unit Cost	2024 Estimated Cost
A01HA	01	Joint Seal Damage	High	615	Slabs	Joint Seal (Localized)	\$3.20	\$47,045
A01HA	01	Small Patch	Medium	1	Slabs	Patching - PCC Full Depth	\$17.78	\$48
A01HA	01	Corner Spalling	Medium	9	Slabs	Patching - PCC Partial Depth	\$39.82	\$970
A01HA	01	Large Patch	Medium	1	Slabs	Patching - PCC Full Depth	\$17.78	\$1,094
A01HA	01	LTD Cracking	Medium	2	Slabs	Crack Sealing - PCC	\$3.20	\$80
A01HA	01	Joint Seal Damage	Medium	163	Slabs	Joint Seal (Localized)	\$3.20	\$12,456
R17HA	01	Joint Spalling	Medium	18	Slabs	Patching - PCC Partial Depth	\$39.82	\$4,729
R17HA	01	LTD Cracking	Medium	28	Slabs	Crack Sealing - PCC	\$3.20	\$1,103
R17HA	01	Joint Spalling	High	9	Slabs	Patching - PCC Partial Depth	\$39.82	\$2,956
R17HA	01	Corner Break	Medium	9	Slabs	Patching - PCC Full Depth	\$17.78	\$5,279
R17HA	01	Corner Break	Low	28	Slabs	Crack Sealing - PCC	\$3.20	\$724

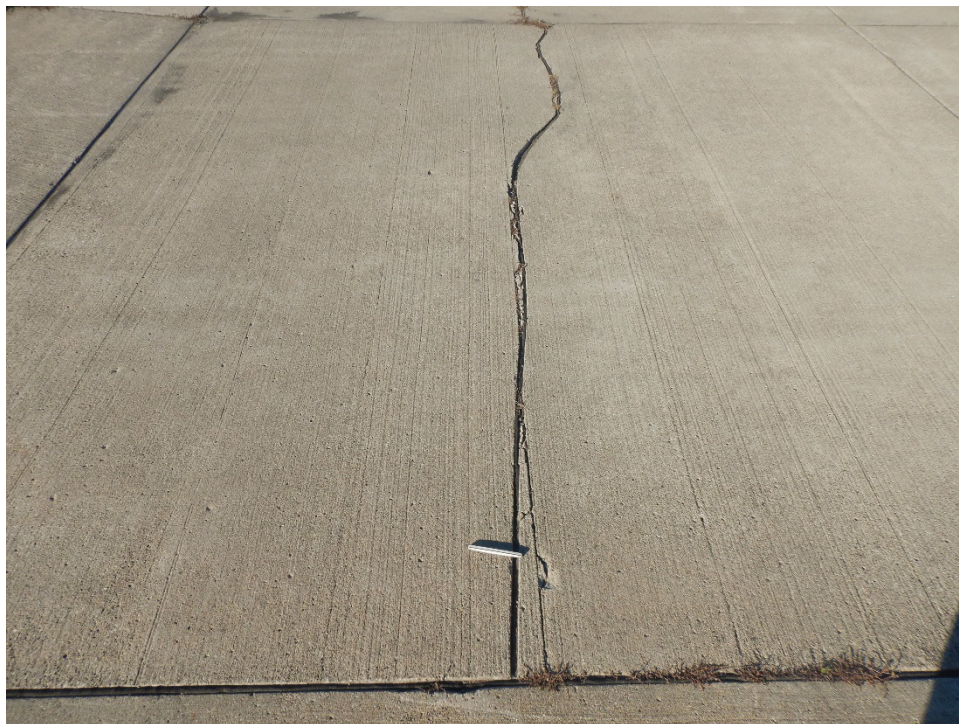
A01HA-01. LTD Cracking (Additional Sample Unit No. 18).

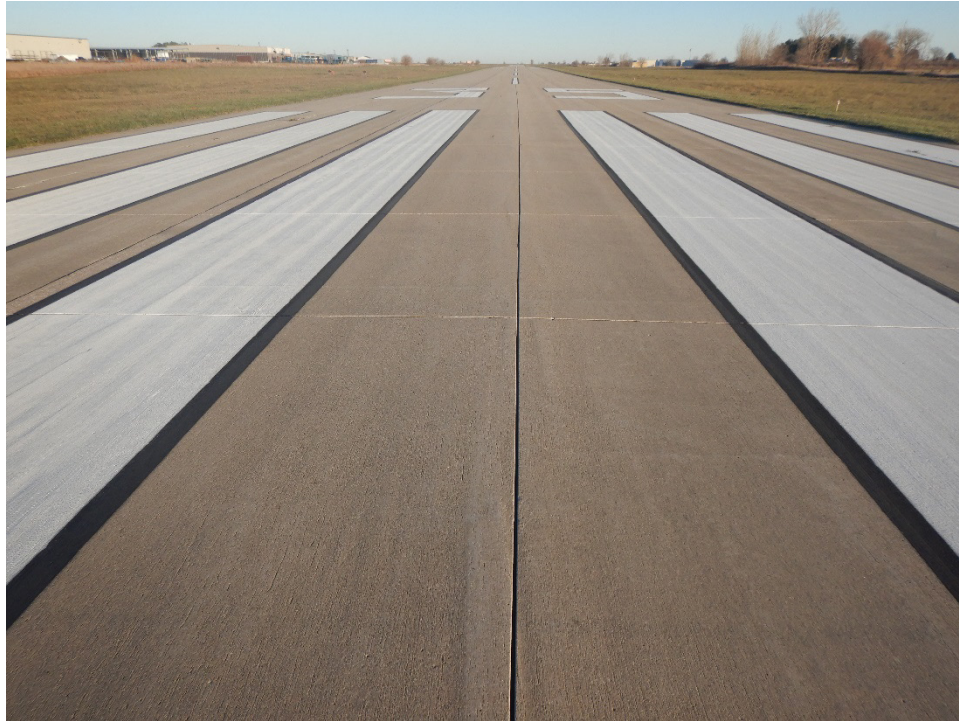
Runway 17/35 was defined by one section. Areas of low-severity corner spalling, faulting, joint seal damage, large patching, and small patching; low- and medium-severity corner break and longitudinal, transverse, and diagonal (LTD) cracking; and medium- and high-severity joint spalling were identified in Section 01. An atypical area of medium-severity scaling was noted and recorded as an additional sample unit in accordance with ASTM D5340.

R17HA-01. Overview.

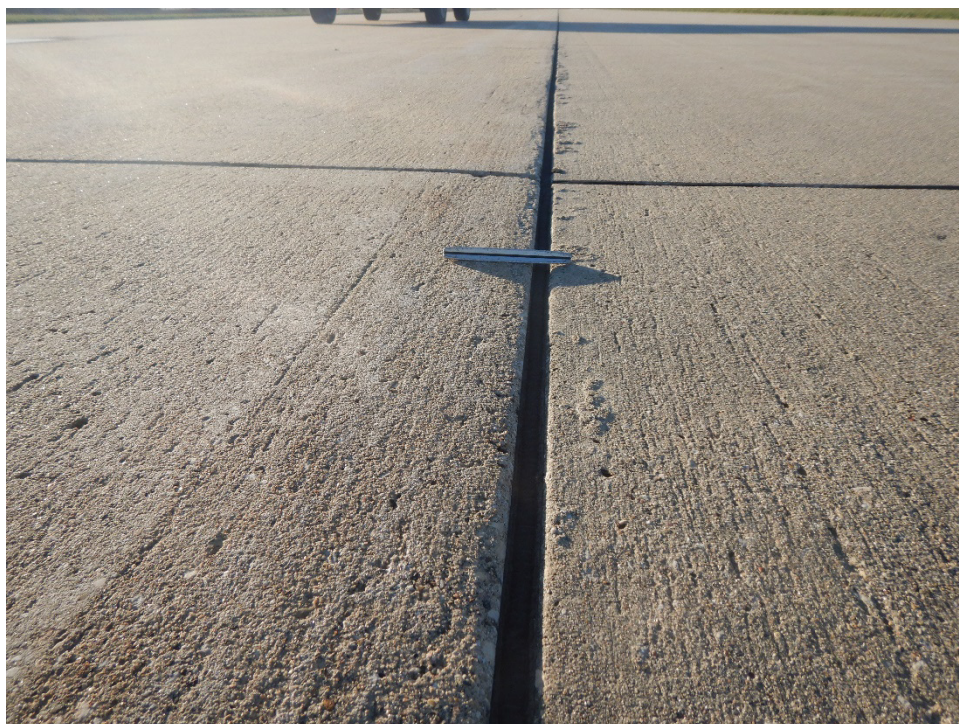
R17HA-01. Faulting (Sample Unit No. 35).

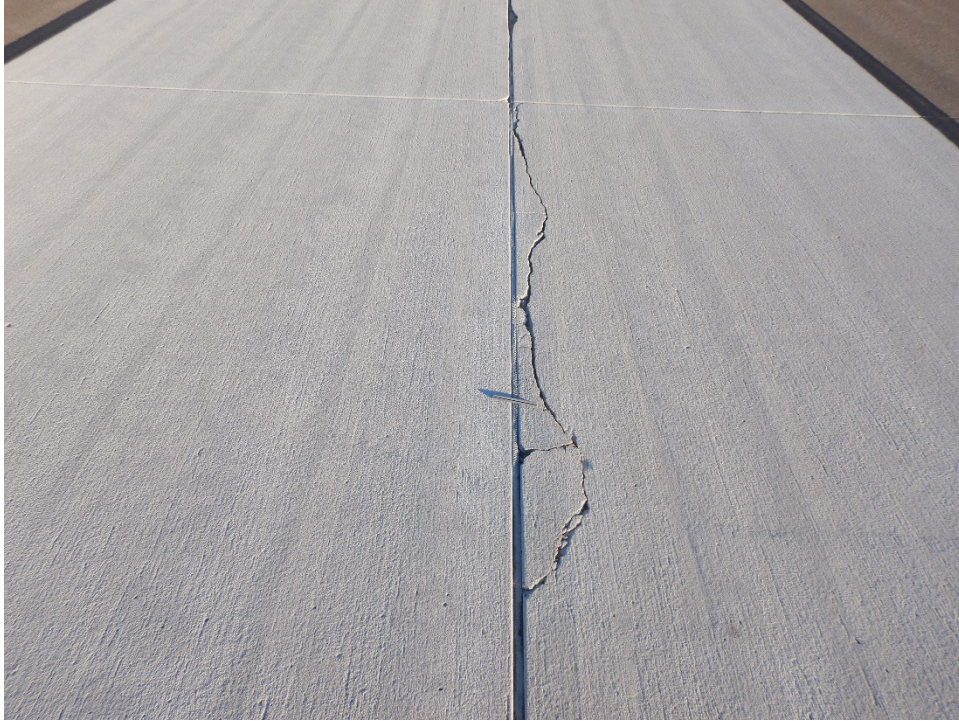
R17HA-01. Joint Spalling (Sample Unit No. 25).

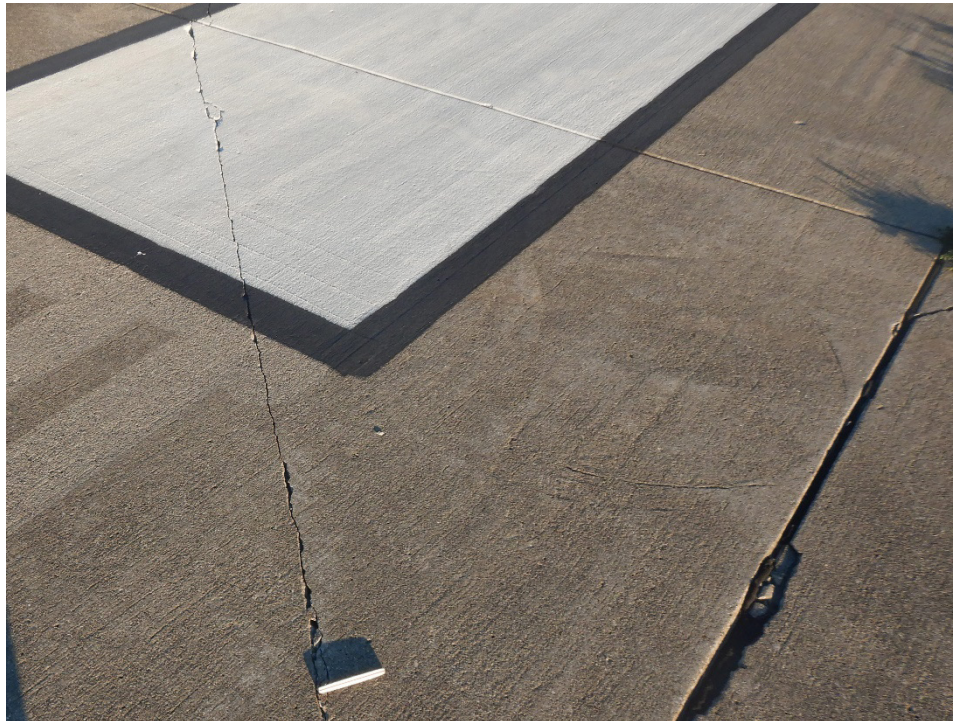
R17HA-01. LTD Cracking (Sample Unit No. 05).

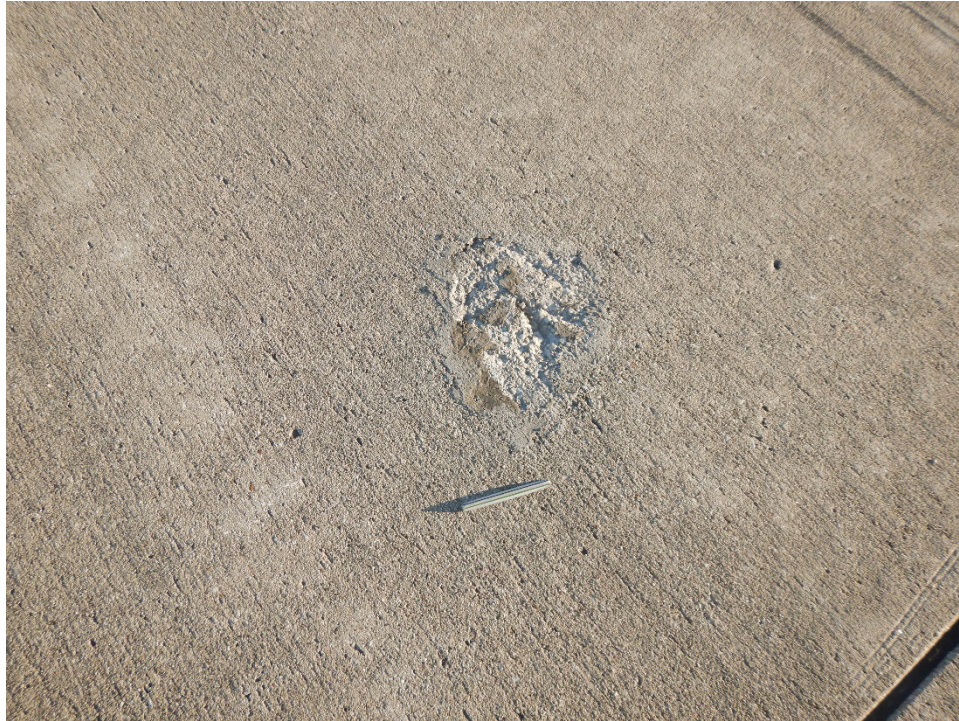
R17HA-01. Scaling (Additional Sample Unit No. 24).

R17HA	01	Scaling	Medium	1	Slabs	Patching - PCC Partial Depth	\$39.82	\$2,041
TH01HA	01	Joint Seal Damage	Medium	153	Slabs	Joint Seal (Localized)	\$3.20	\$10,296
TH01HA	01	Corner Break	Low	2	Slabs	Crack Sealing - PCC	\$3.20	\$45

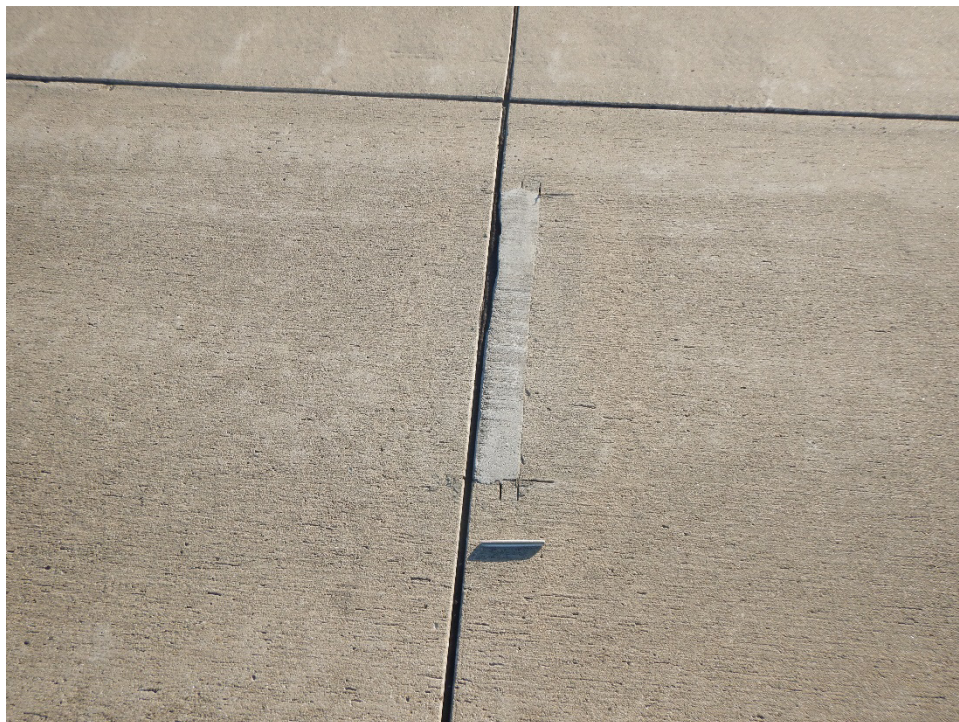
R17HA-01. Small Patching (Sample Unit No. 75).

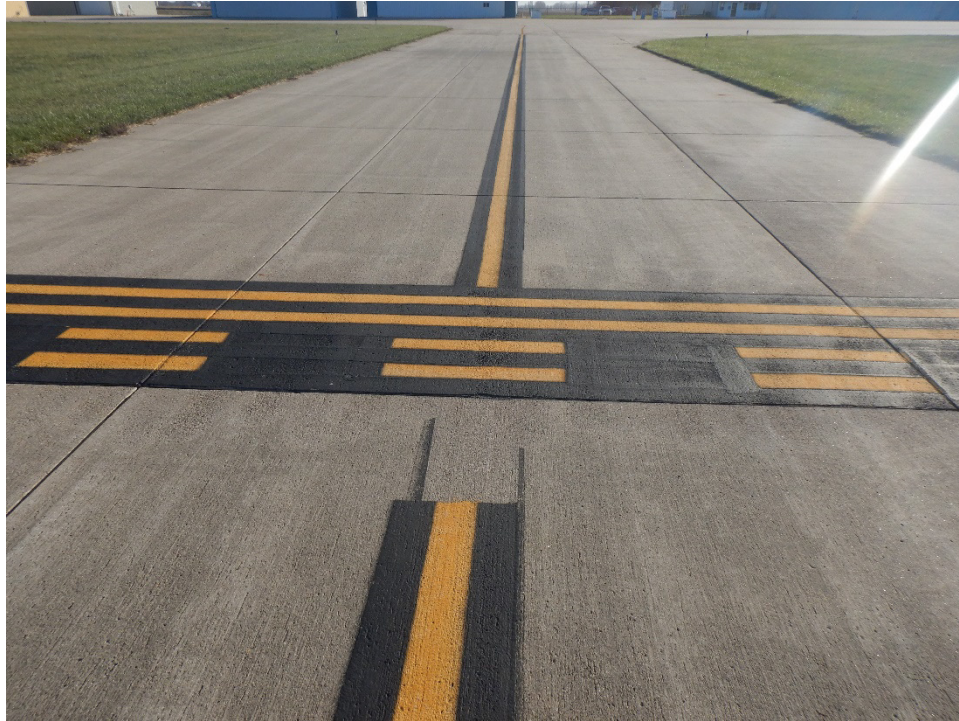
Taxiway A contained one section that connected Runway 17/35 to the apron area. Low-severity corner spalling, joint spalling, joint seal damage, and LTD cracking were observed at the time of inspection in Section 01.

TAHA-01. Overview.

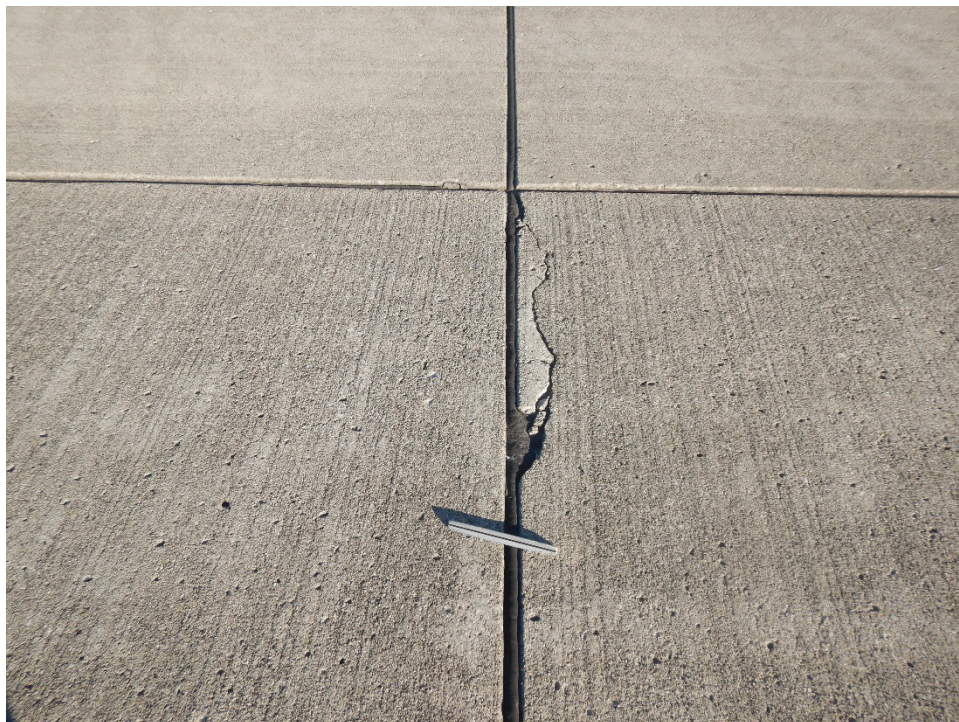
TAHA-01. Joint Seal Damage (Sample Unit No. 03).

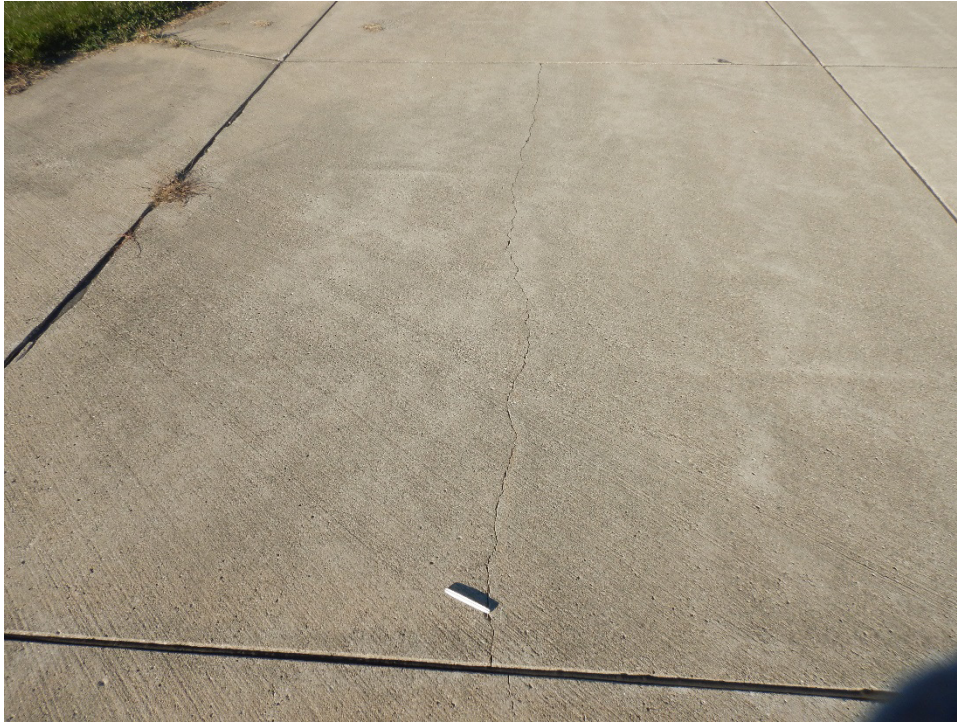
TAHA-01. LTD Cracking (Sample Unit No. 04).

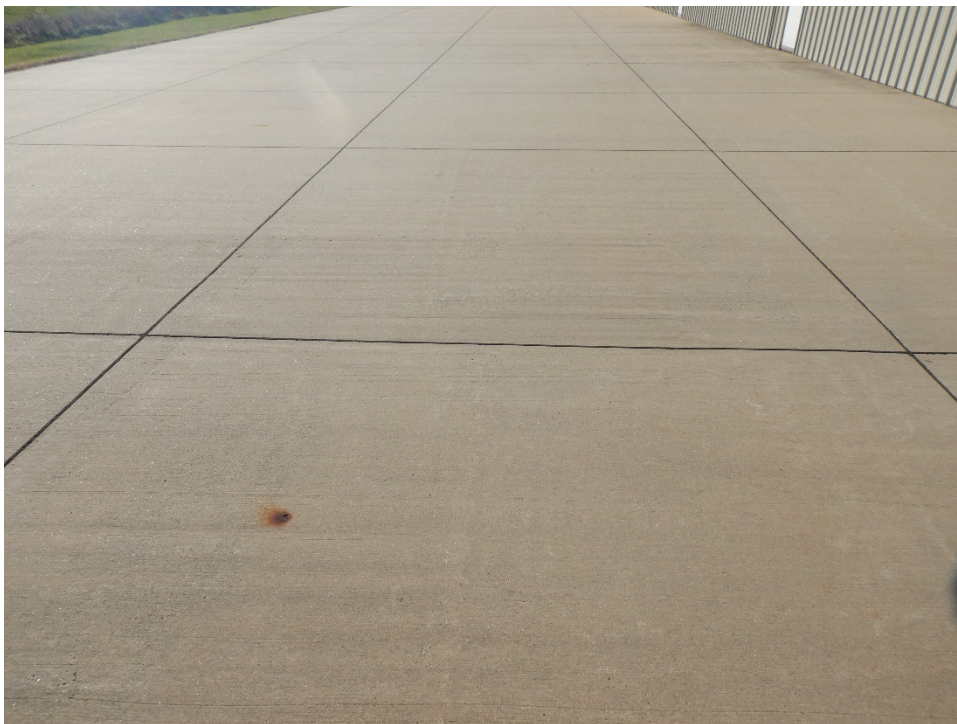
The T-hangar area consisted of one section that contained areas of medium-severity joint seal damage and low-severity corner break and LTD cracking.

TH01HA-01. Overview.

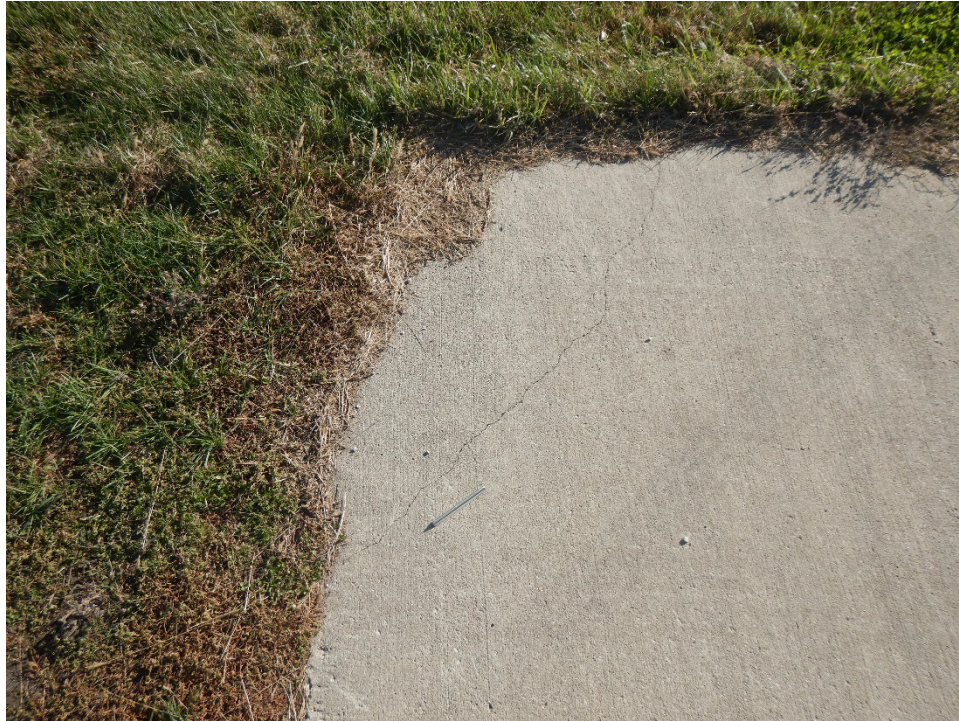
TH01HA-01. Corner Break (Sample Unit No. 08).

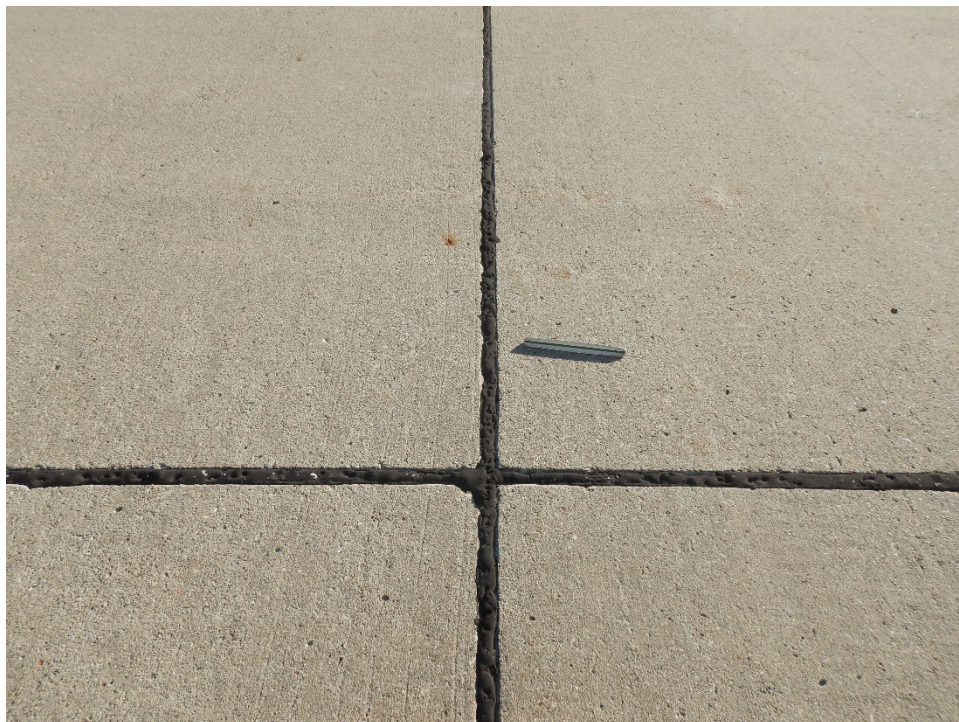
TH01HA-01. Joint Seal Damage (Sample Unit No. 07).
