# Harlan Municipal Airport

## PAVEMENT MANAGEMENT REPORT

**JULY 2022**

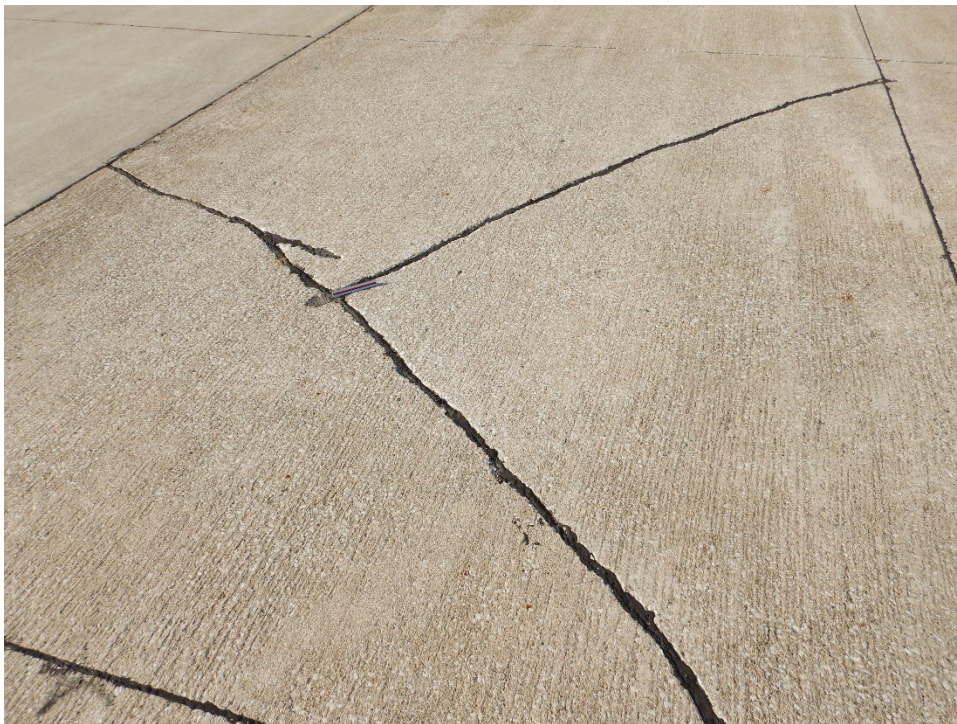
A01HL-01. LTD Cracking (Sample Unit No. 02)

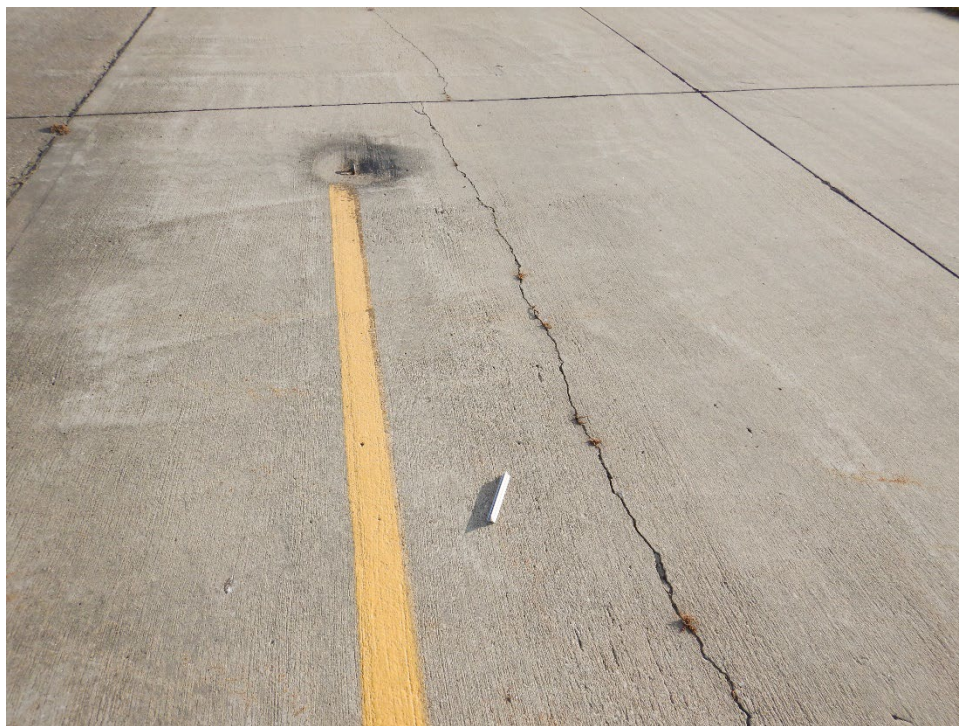
A01HL-02. LTD Cracking (Sample Unit No. 01).

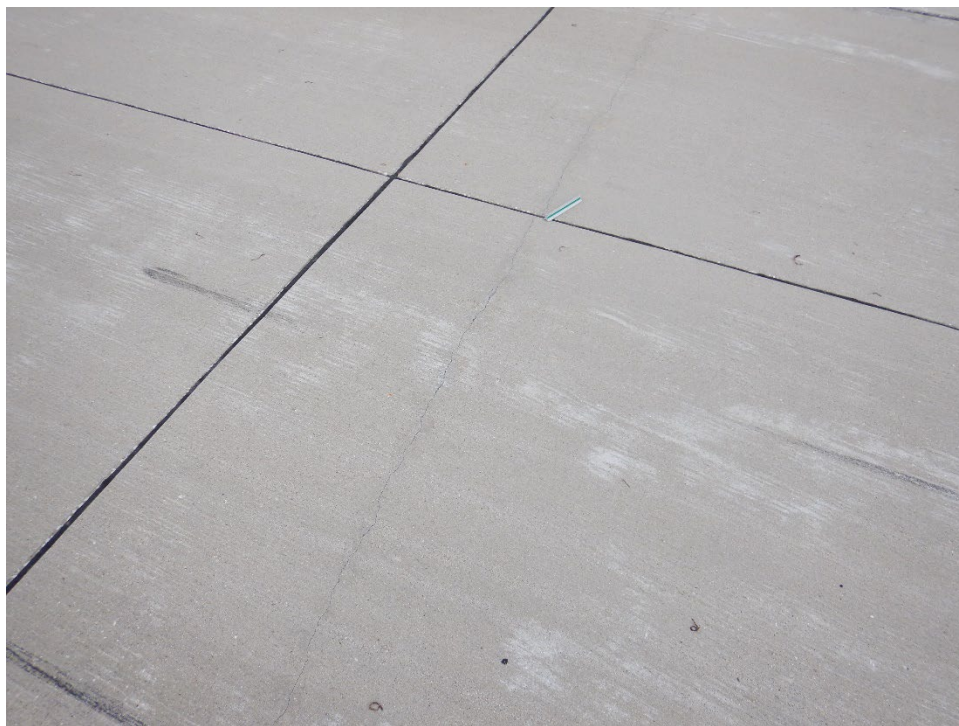
R15HL-01. LTD Cracking (Sample Unit No. 15).

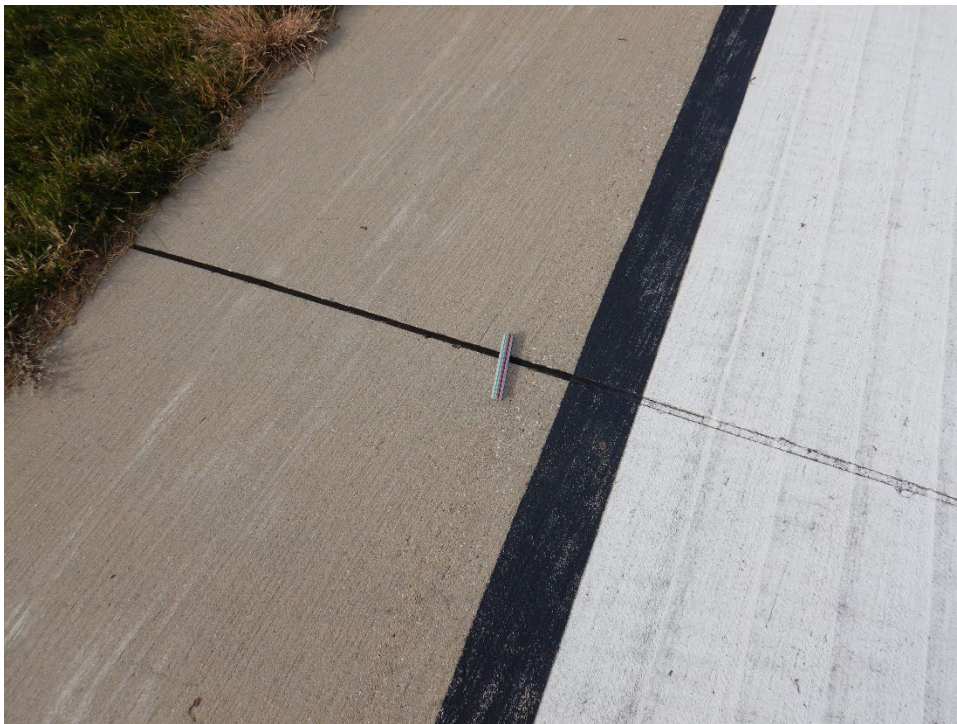
R15HL-02. Joint Seal Damage (Sample Unit No. 10).

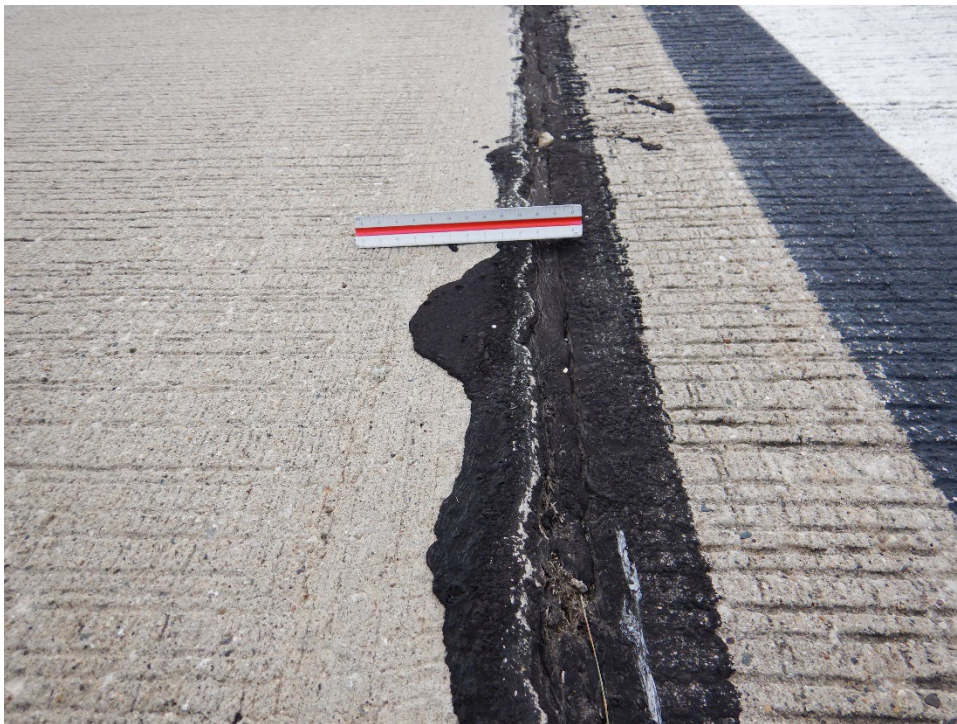
R15HL-03. Faulting (Sample Unit No. 11).

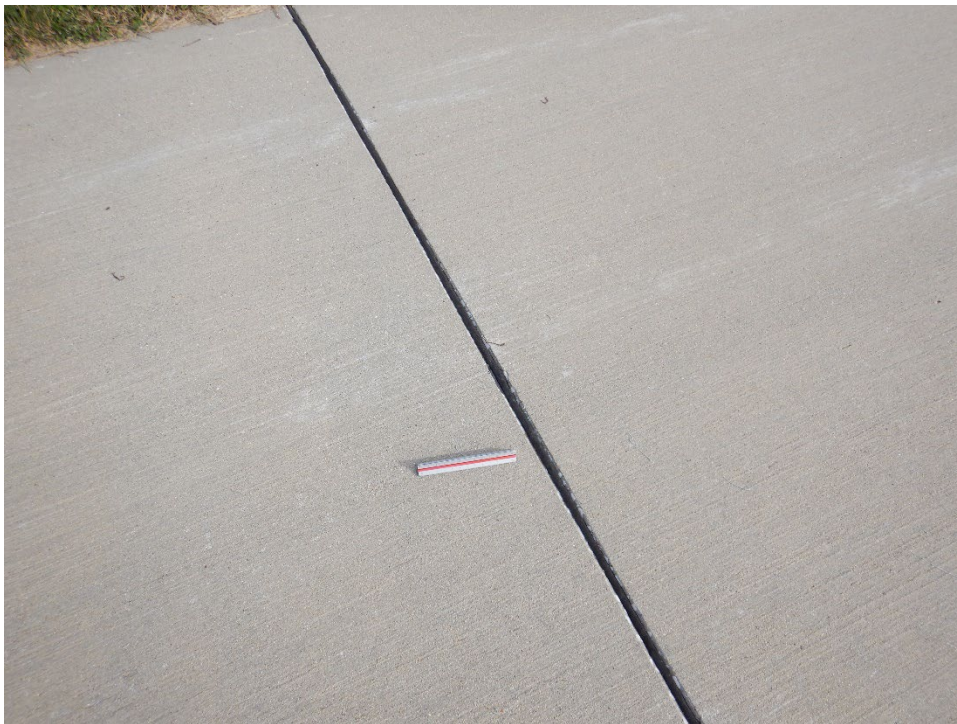
R15HL-04. Joint Seal Damage (Sample Unit No. 12).

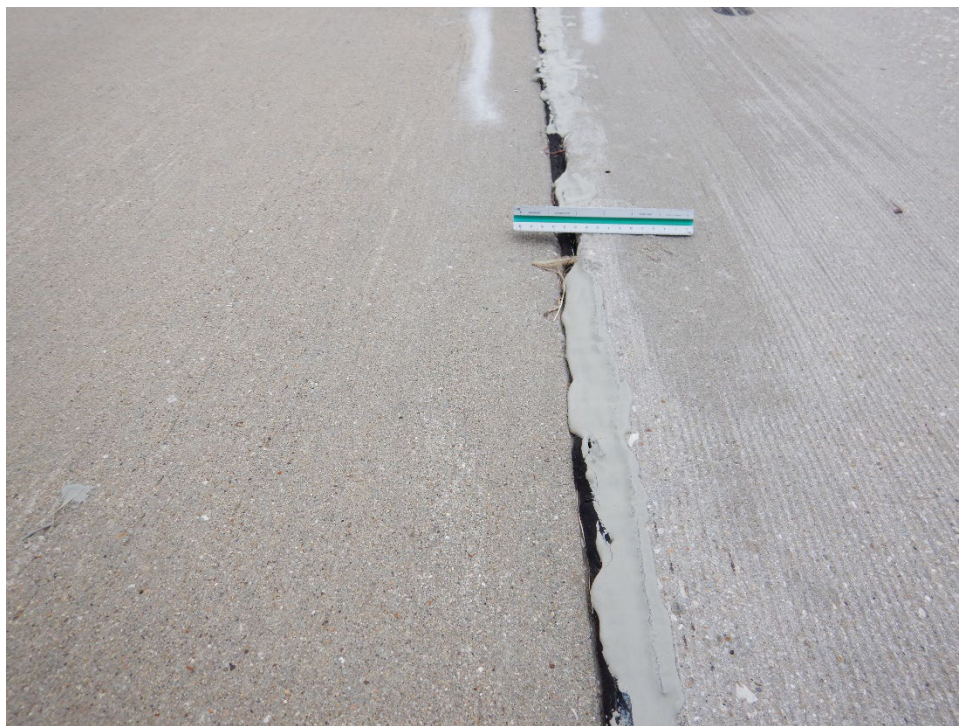
R15HL-05. Faulting (Sample Unit No. 03).

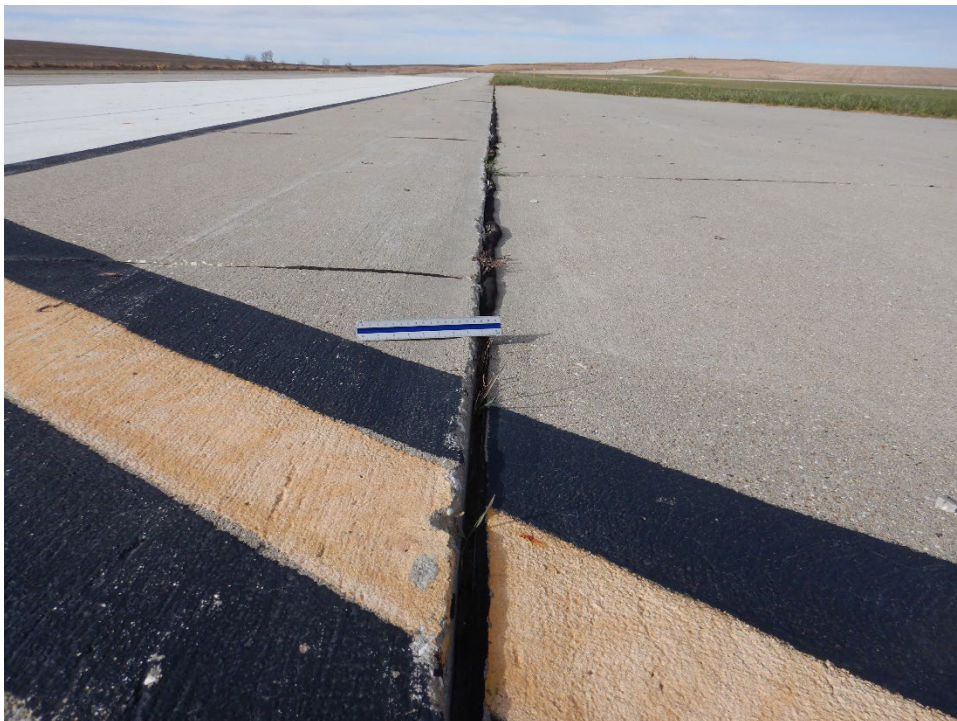
T01HL-01. Faulting (Sample Unit No. 02).

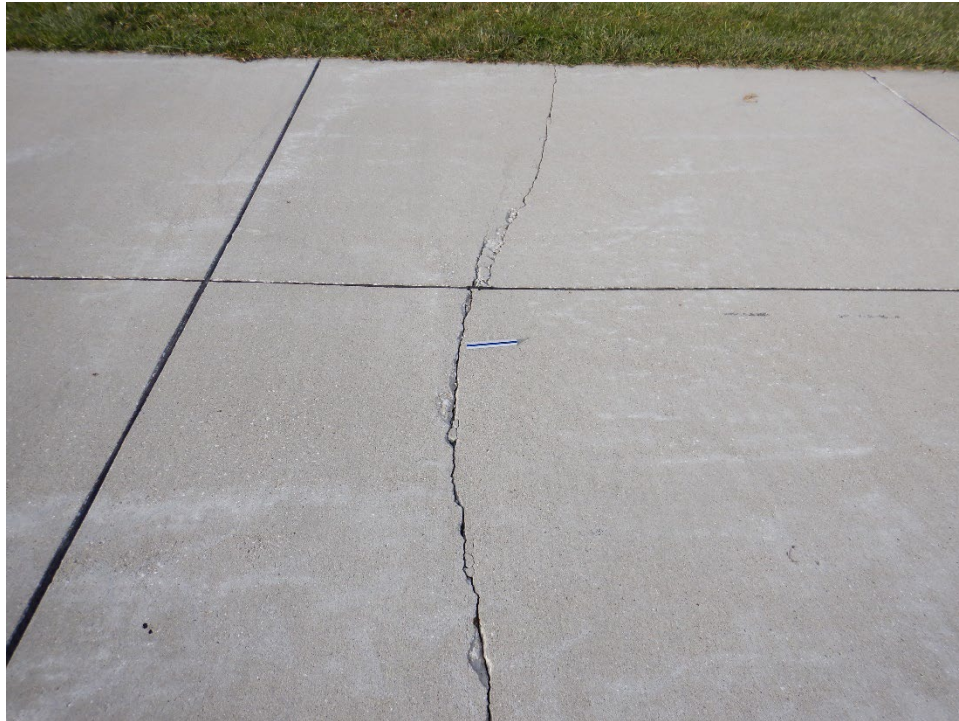
T01HL-01. LTD Cracking (Sample Unit No. 03).

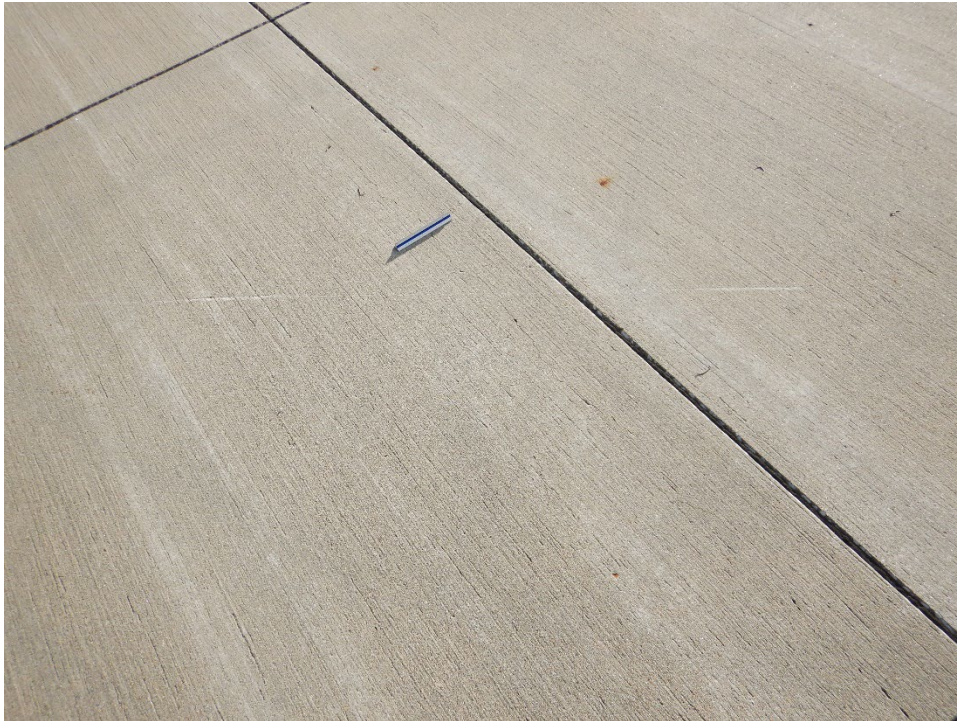
T02HL-01. LTD Cracking (Sample Unit No. 14).

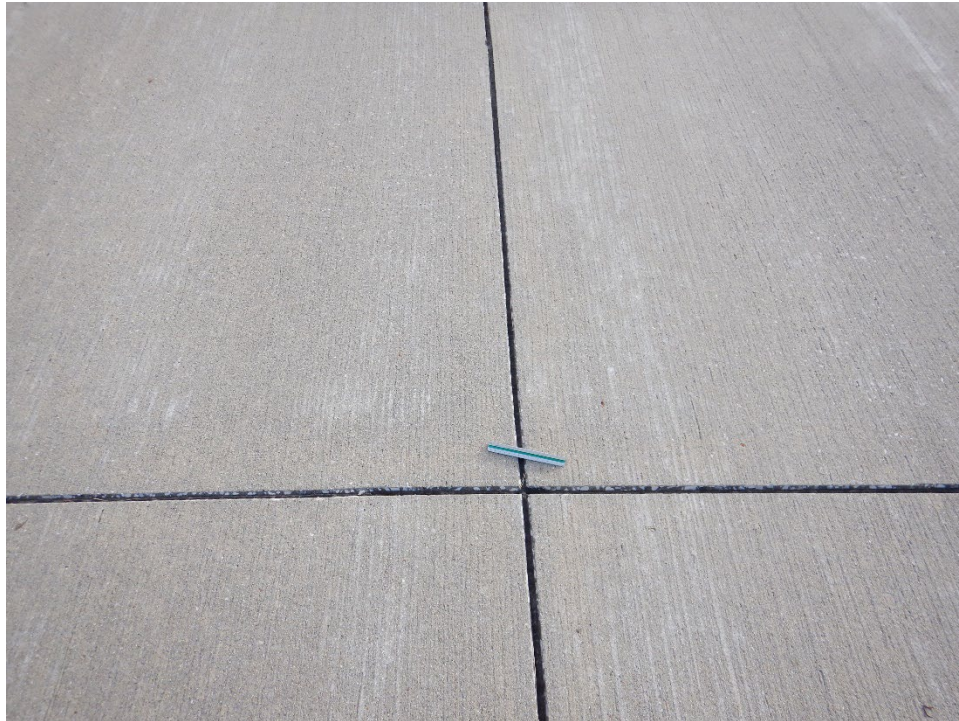
T02HL-03. Joint Seal Damage (Sample Unit No. 35).

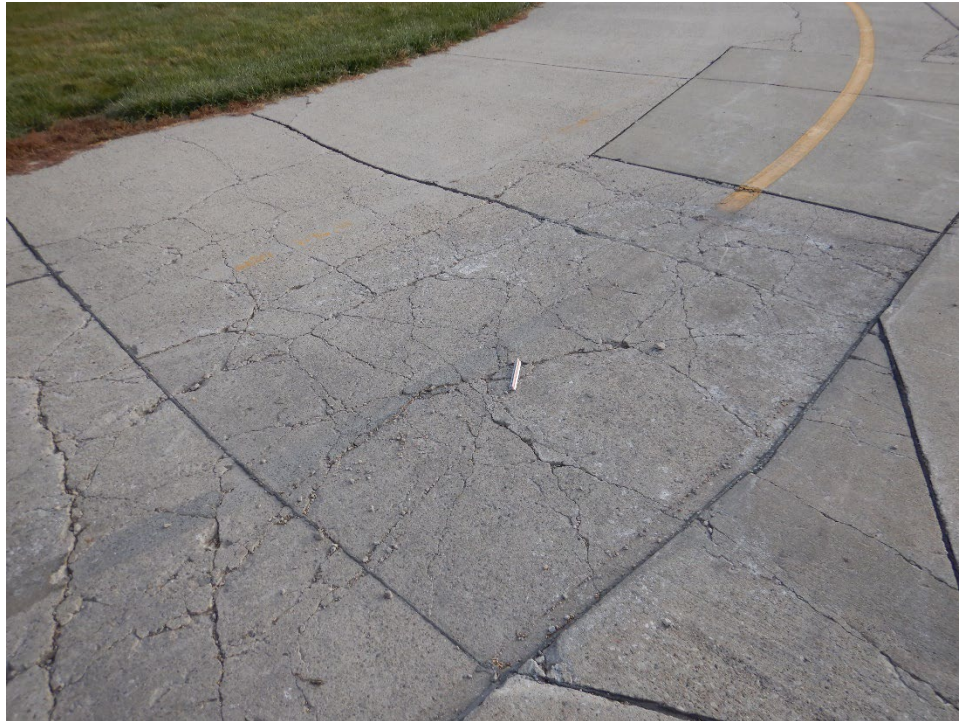
TH01HL-01. Shattered Slab (Sample Unit No. 01).

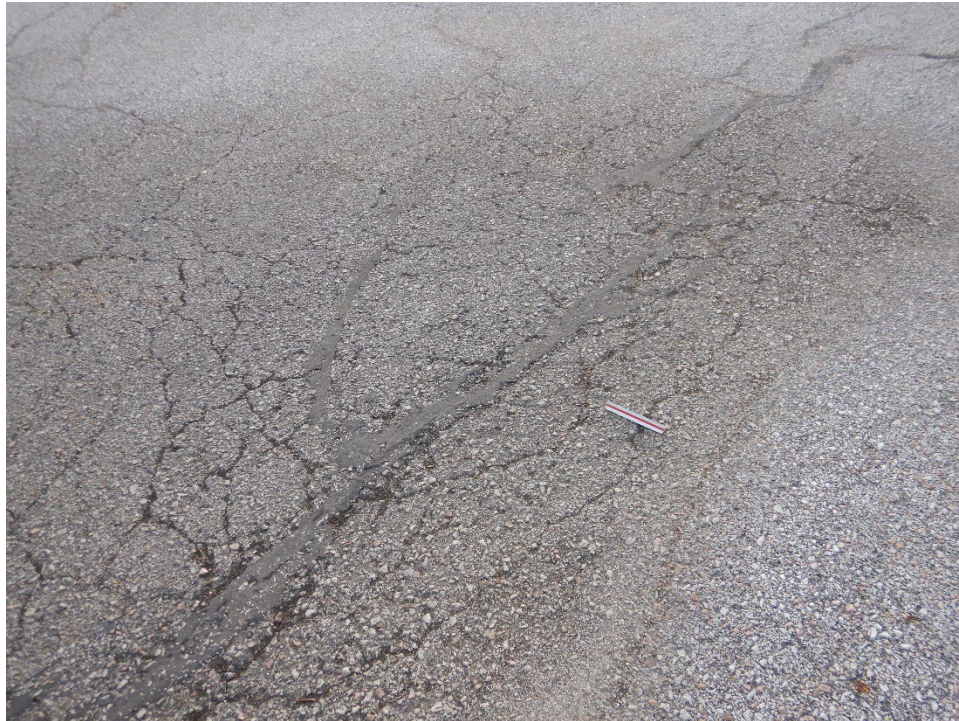
TH01HL-02. Alligator Cracking (Sample Unit No. 05).

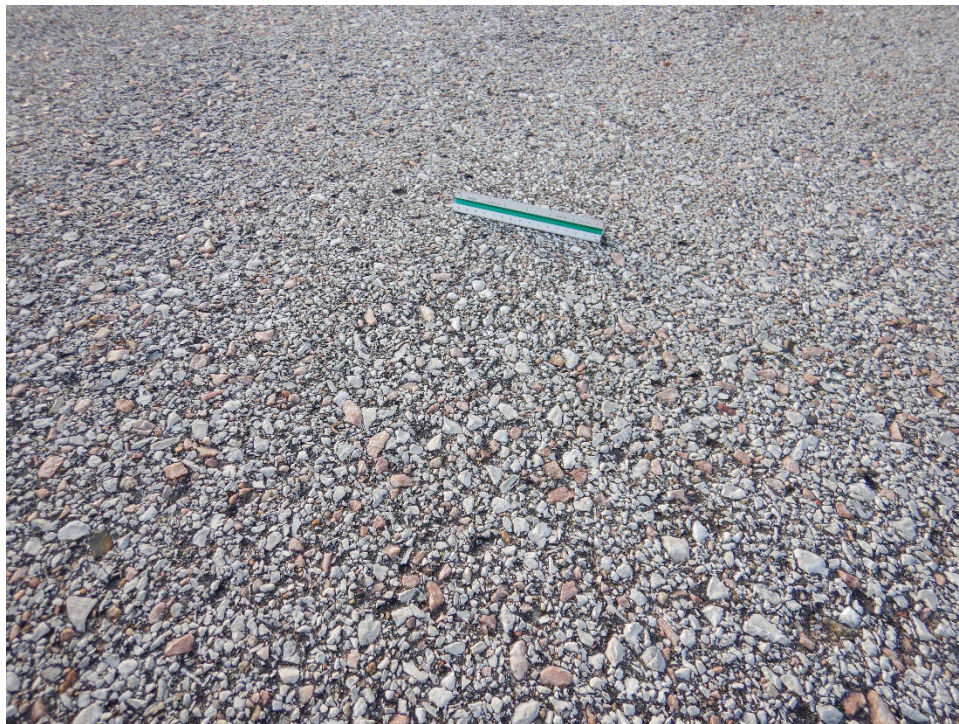
TH01HL-02. Raveling (Sample Unit No. 03).

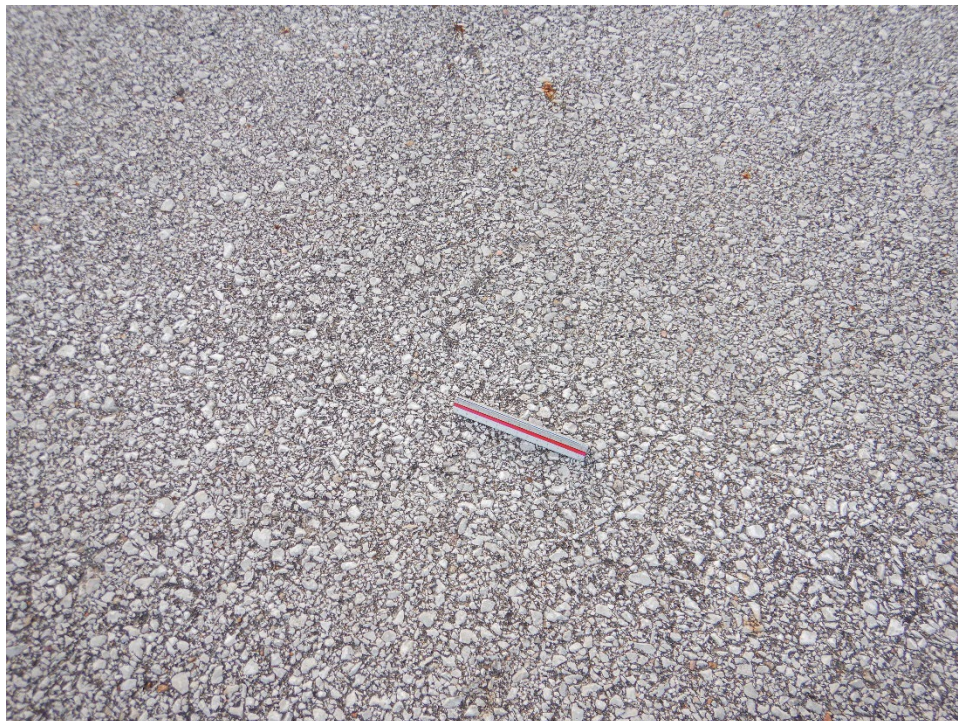
TH01HL-03. Raveling (Sample Unit No. 01).

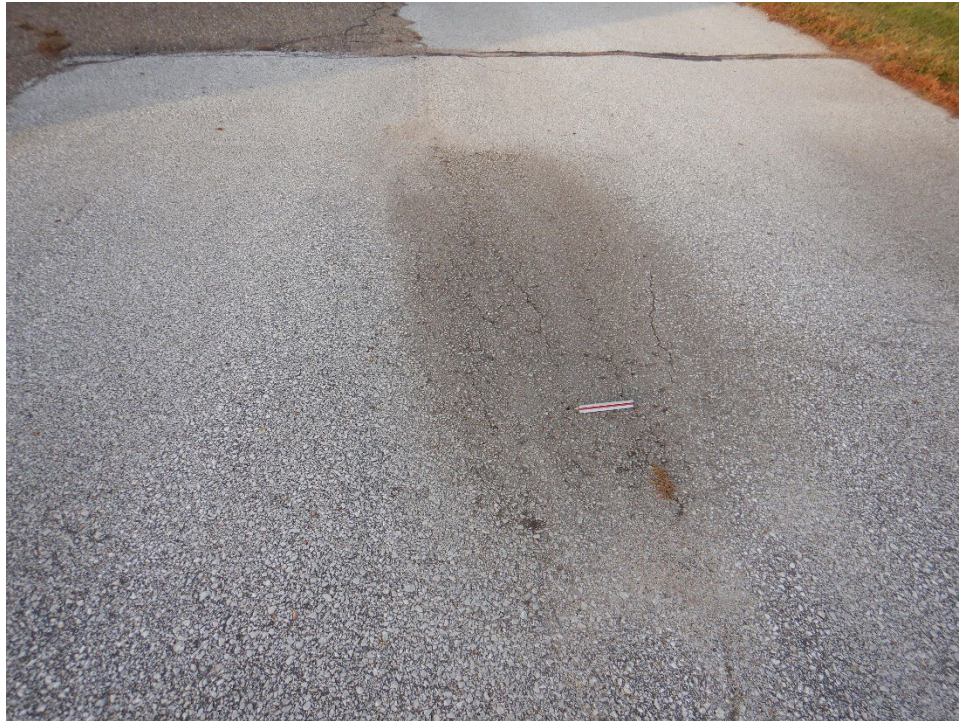
TH01HL-03. Rutting (Sample Unit No. 01).

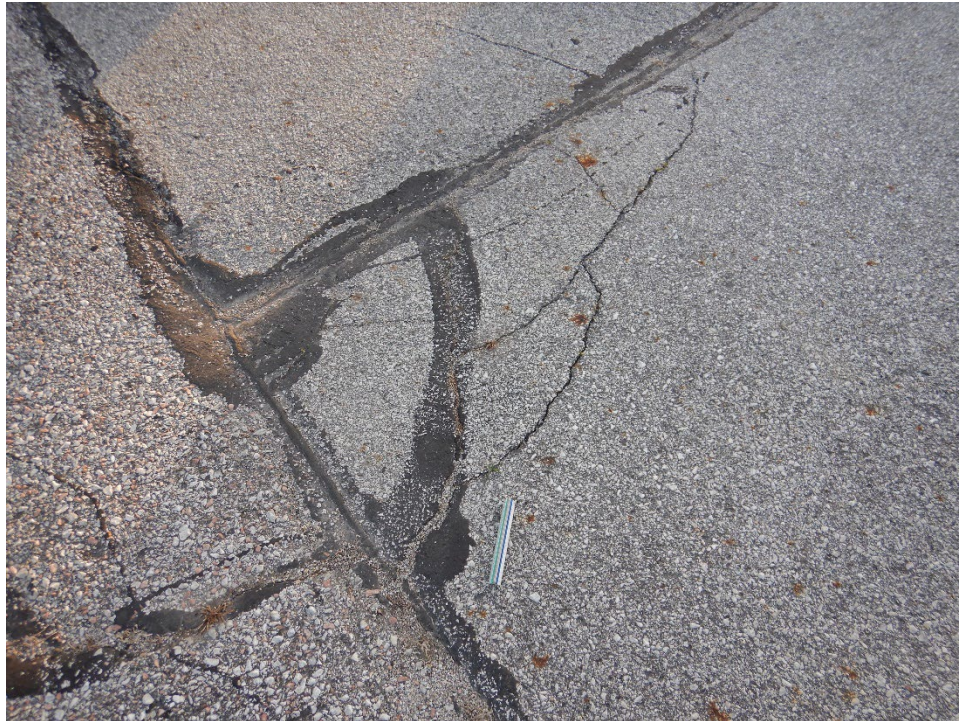
TH01HL-04. Alligator Cracking (Sample Unit No. 01).

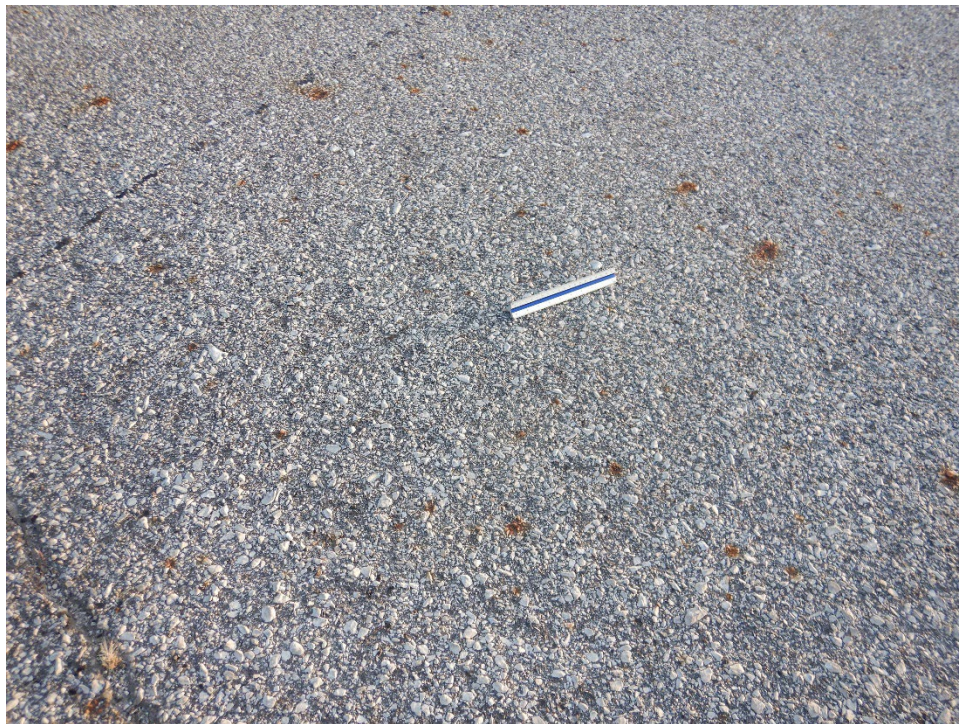
TH01HL-04. Raveling (Sample Unit No. 01).
