Humboldt Municipal Airport

Pavement Management Report

JULY 2023

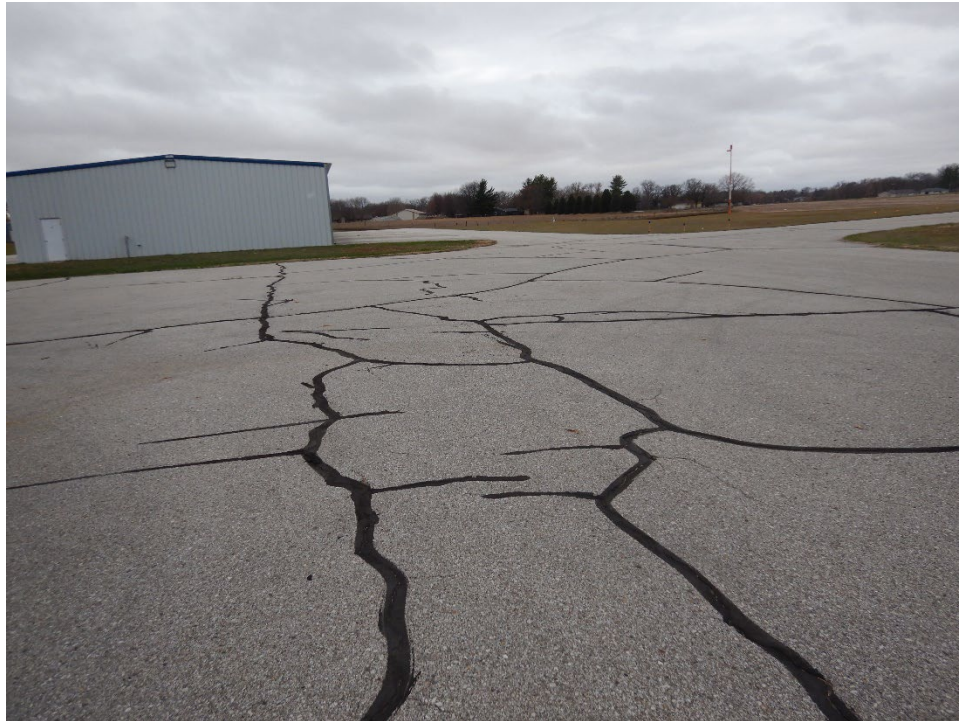
A01HU-01. Overview.

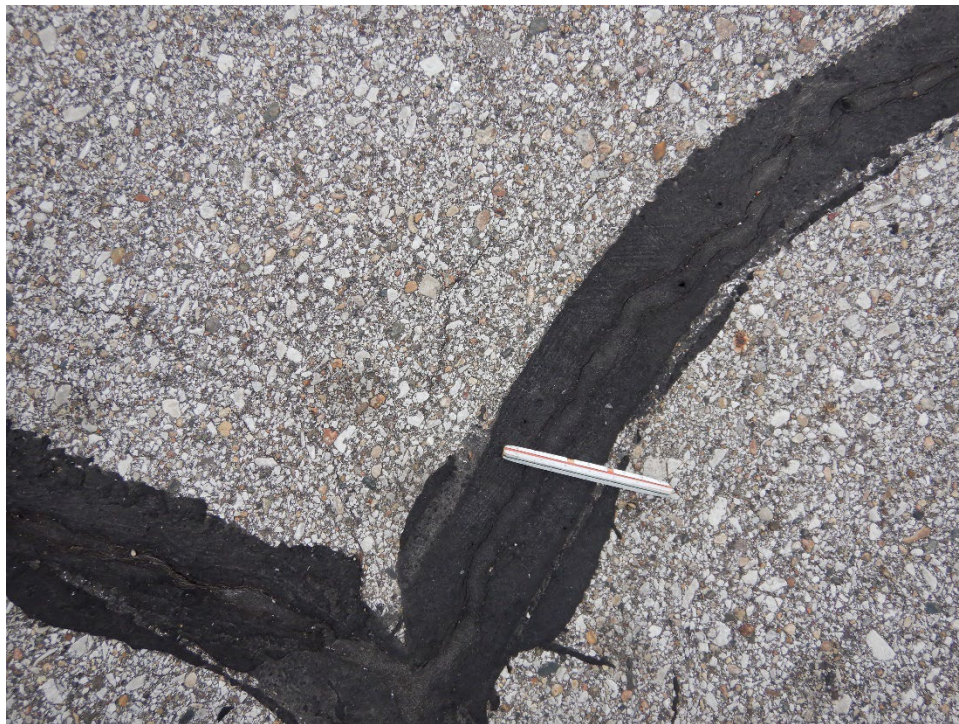
A01HU-01. L&T Cracking (Sample Unit No. 01).

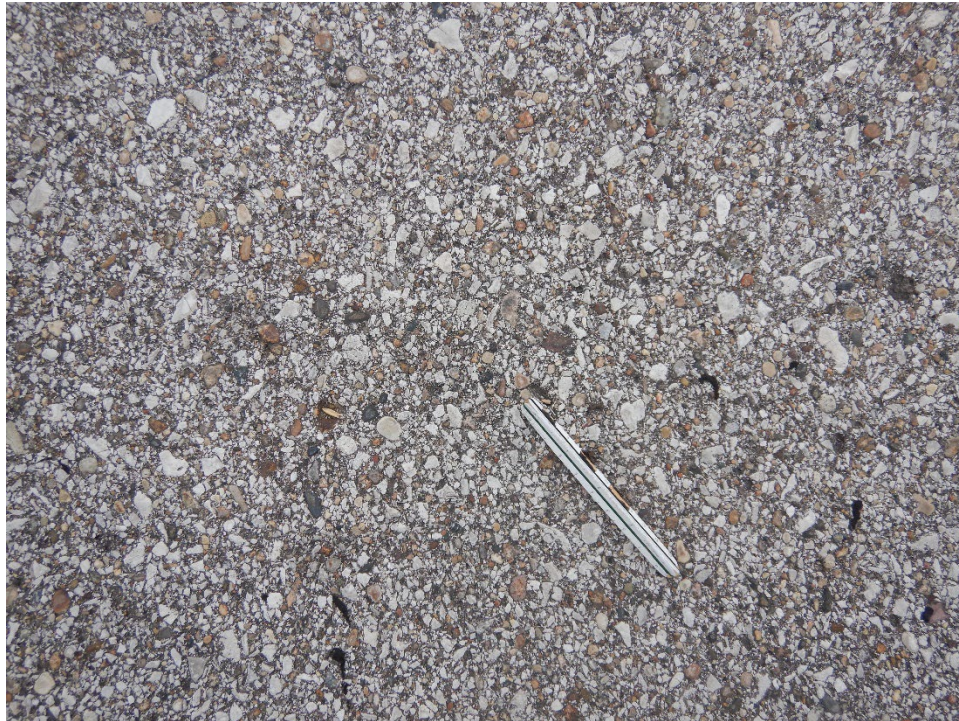
A01HU-01. Weathering (Sample Unit No. 01).

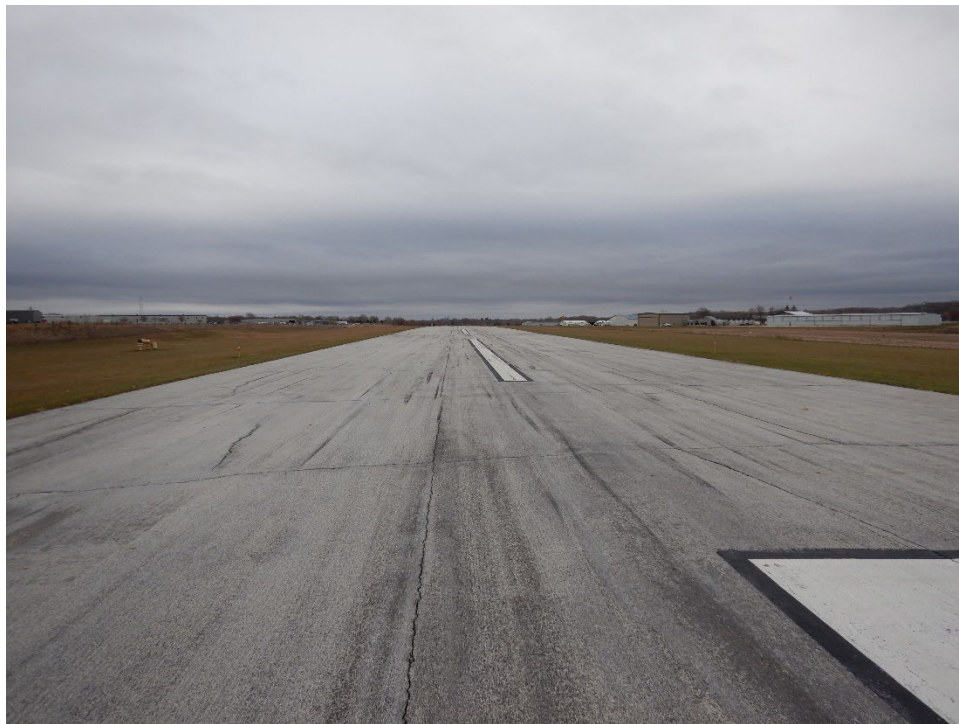
R12HU-01. Overview.

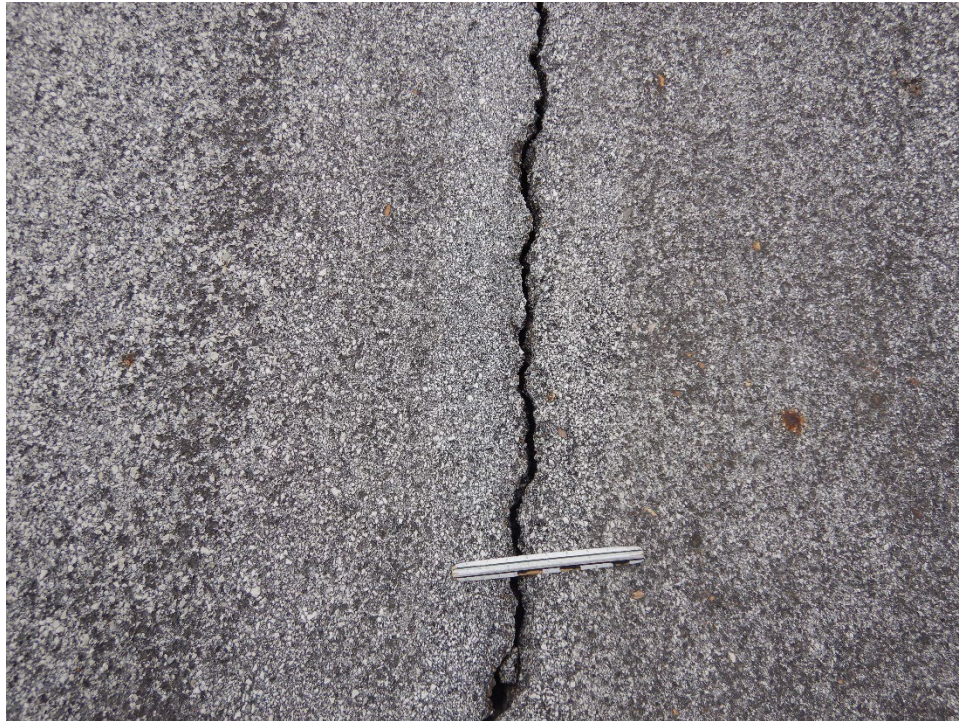
Runway 12/30 was defined by two sections. Section 01 contained areas of medium-severity longitudinal and transverse (L&T) cracking and high-severity weathering. Medium-severity alligator cracking and L&T cracking and high-severity weathering were observed in Section 02. The medium-severity L&T cracking in Sections 01 and 02 was due to unsealed crack widths that exceeded $\frac{1}{4}$ in.

R12HU-01. L&T Cracking (Sample Unit No. 04).

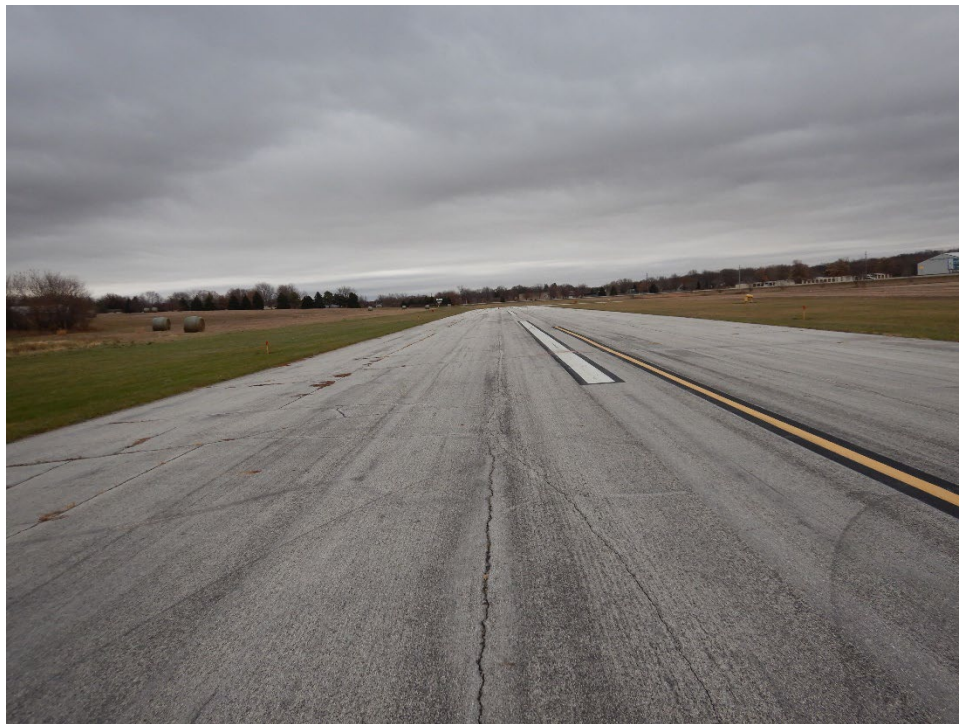
R12HU-02. Overview.

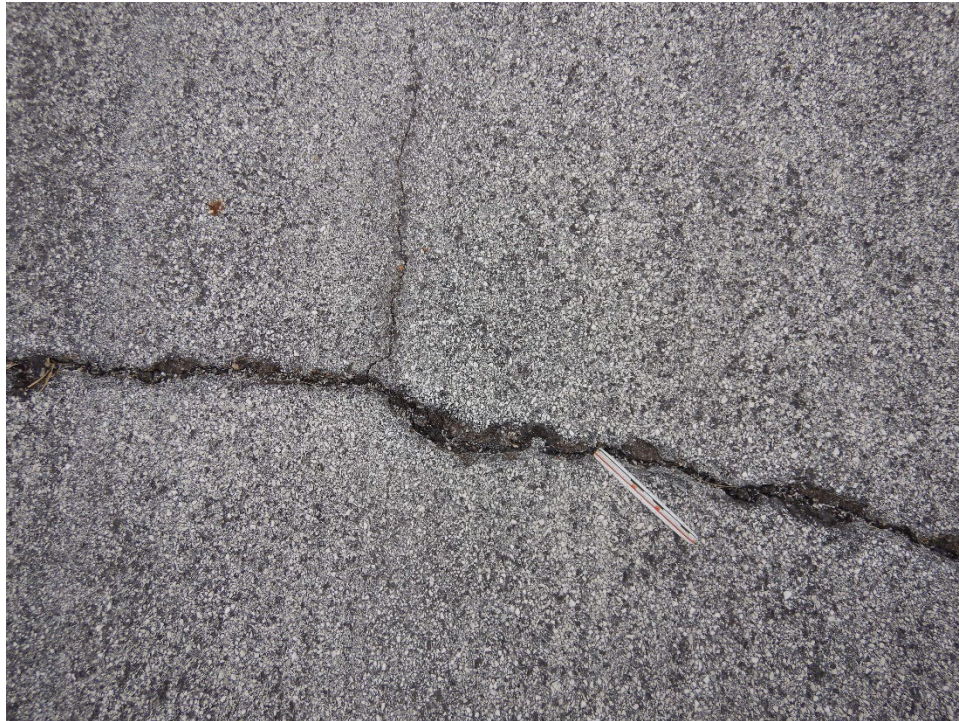
R12HU-02. L&T Cracking (Sample Unit No. 02).

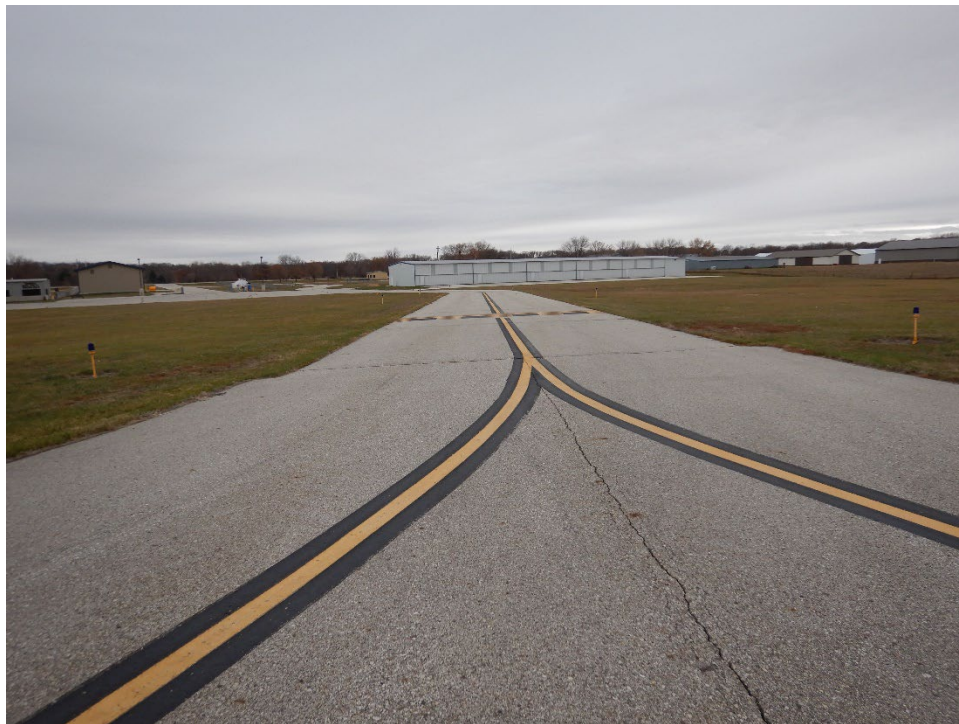
T01HU-01. Overview.

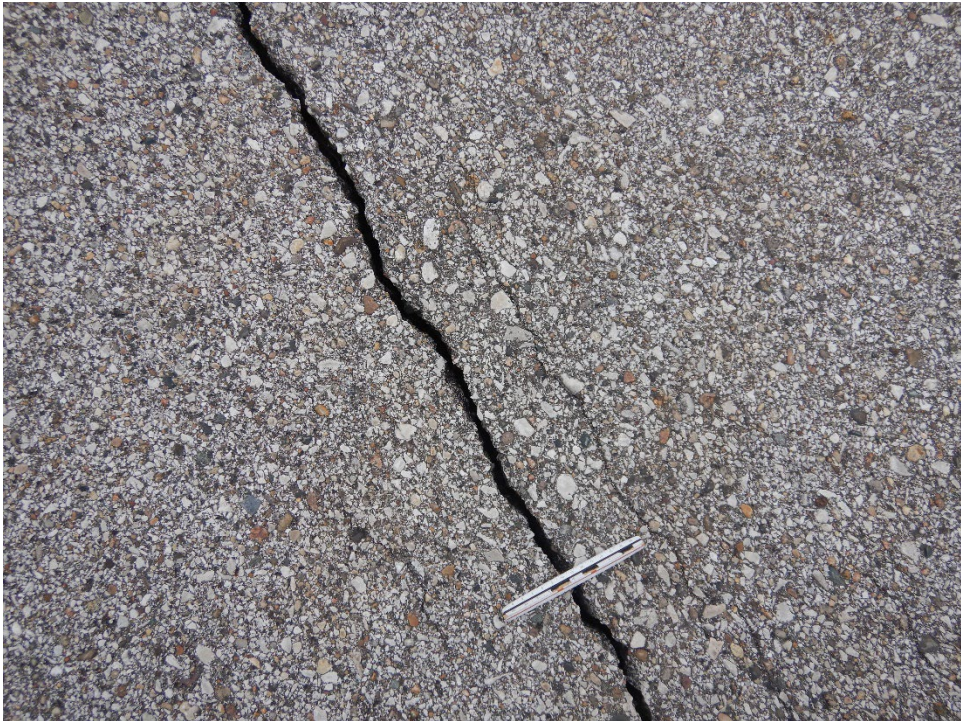
Taxiway 01 consisted of one section. Section 01 contained all severities of L&T cracking, low-severity raveling, and low- and medium-severity weathering. The low-severity cracking was unsealed, and the medium-severity cracking was due to either the development of secondary cracking or unsealed crack widths greater than $\frac{1}{4}$ in.

T01HU-01. L&T Cracking (Sample Unit No. 01).

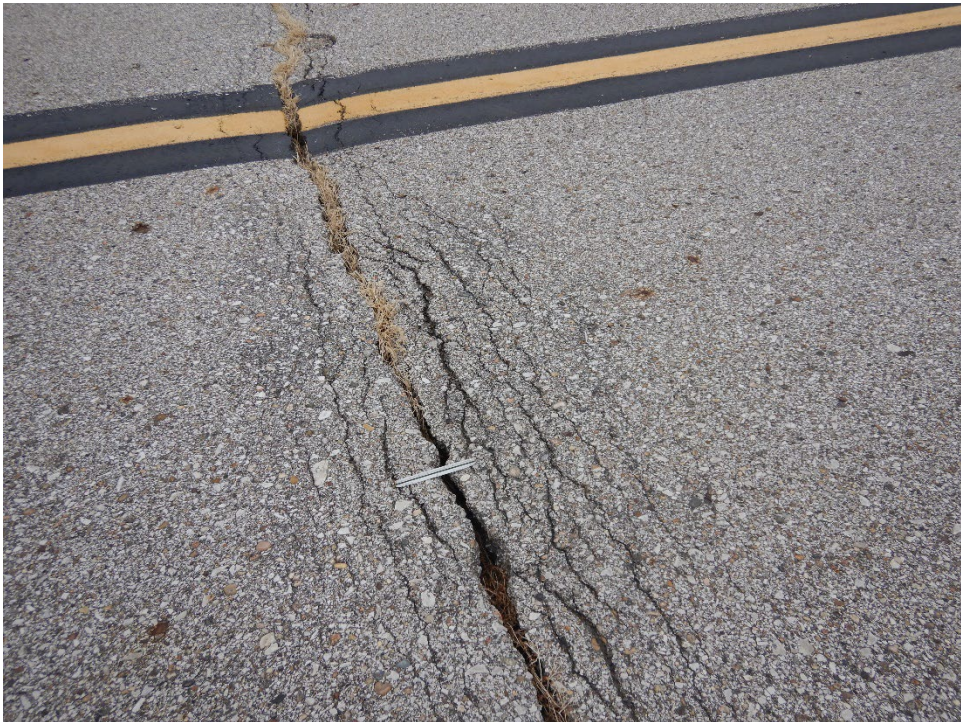
T01HU-01. L&T Cracking (Sample Unit No. 02).

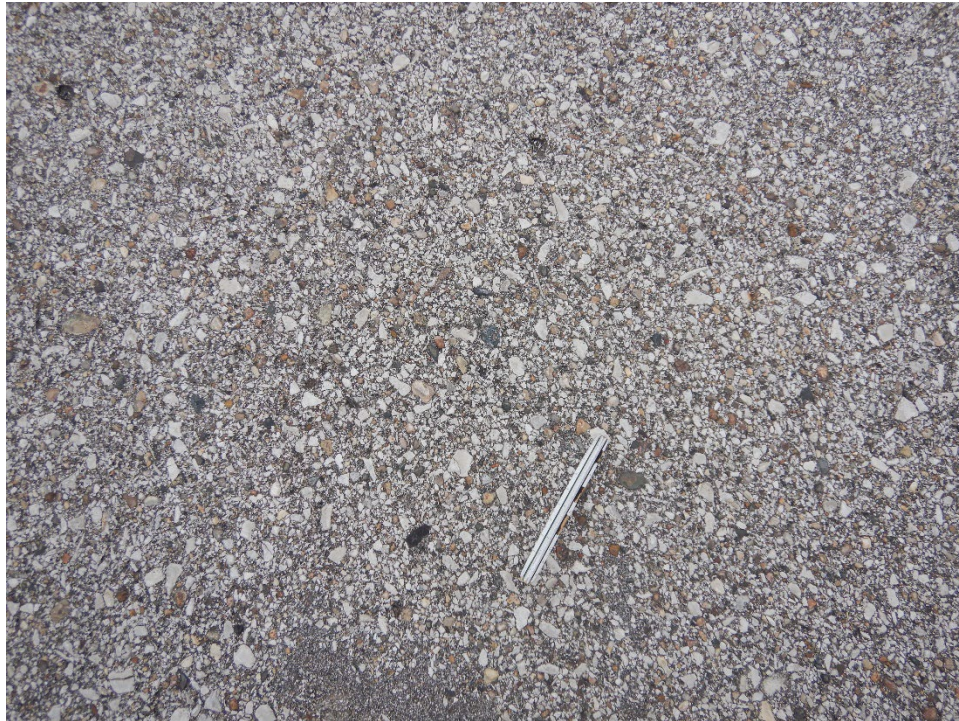
T01HU-01. Weathering (Sample Unit No. 01).

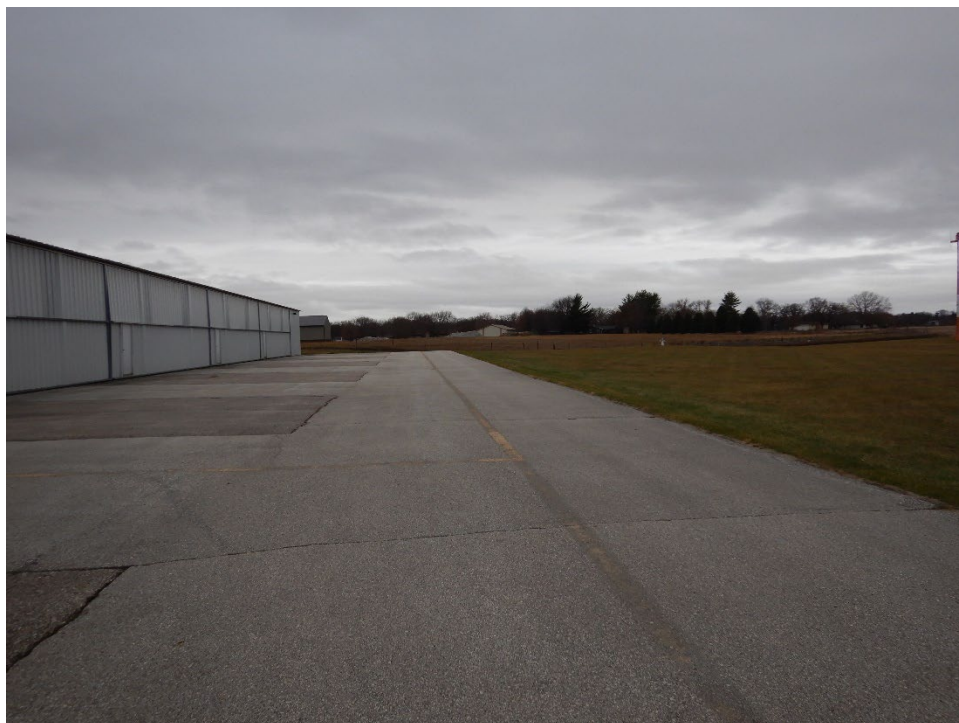
TH01HU-01. Overview.

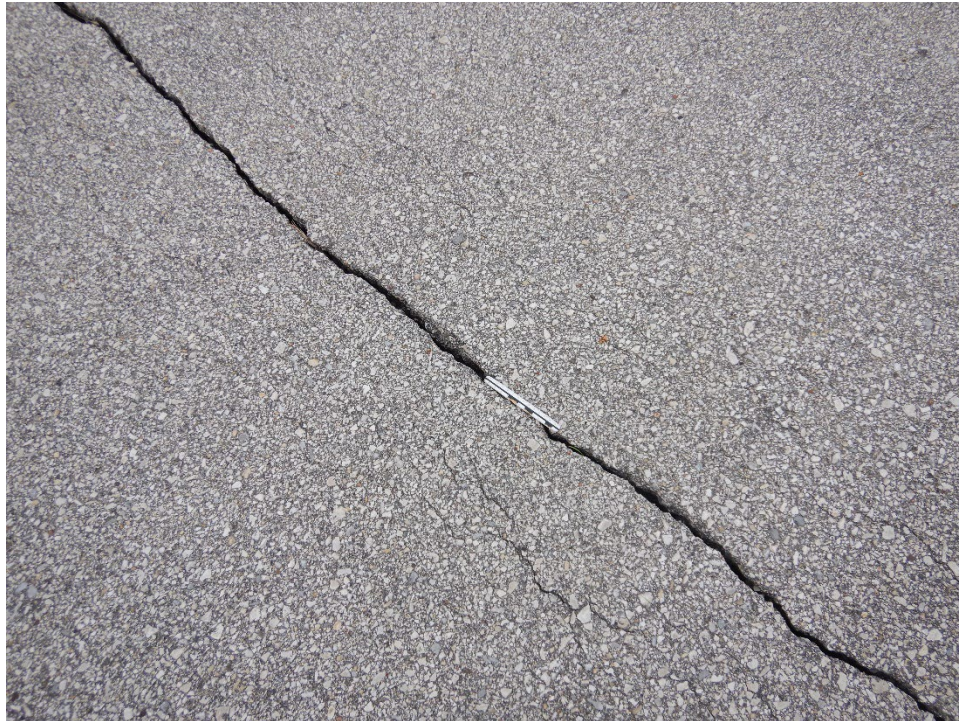
The T-hangar area contained one section. Low- and medium-severity L&T cracking and weathering and low-severity raveling were recorded in Section 01 during the inspection. The low-severity cracking was unsealed, and the medium-severity cracking was due to either the development of secondary cracking or unsealed crack widths that exceeded $\frac{1}{4}$ in.

TH01HU-01. L&T Cracking (Sample Unit No. 01).

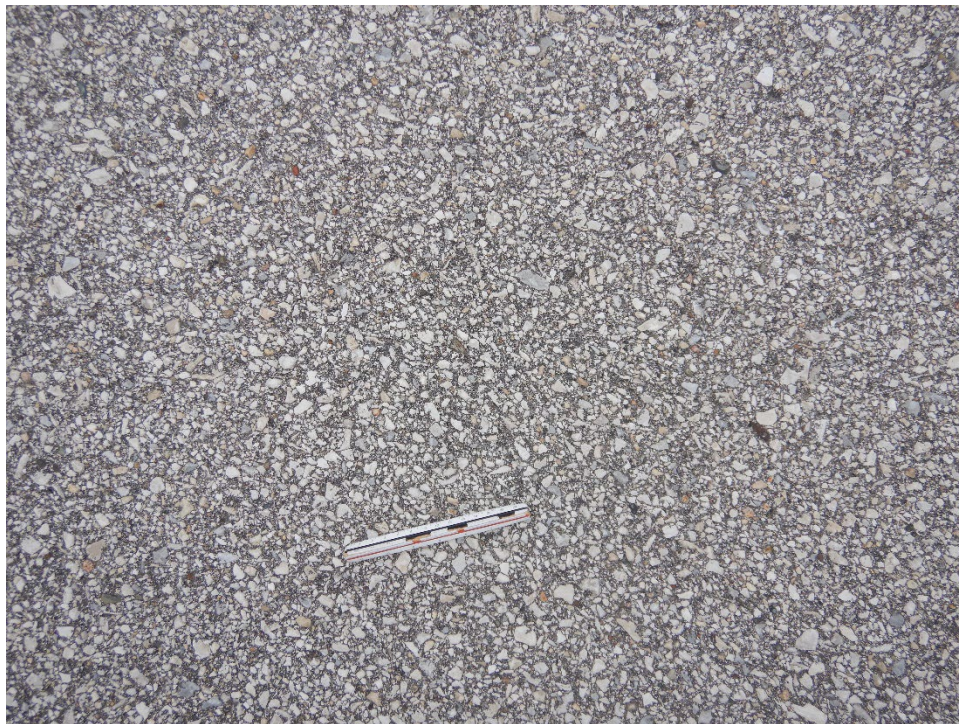
TH01HU-01. Weathering (Sample Unit No. 01).
