Iowa Falls Municipal Airport

Pavement Management Report

JULY 2024

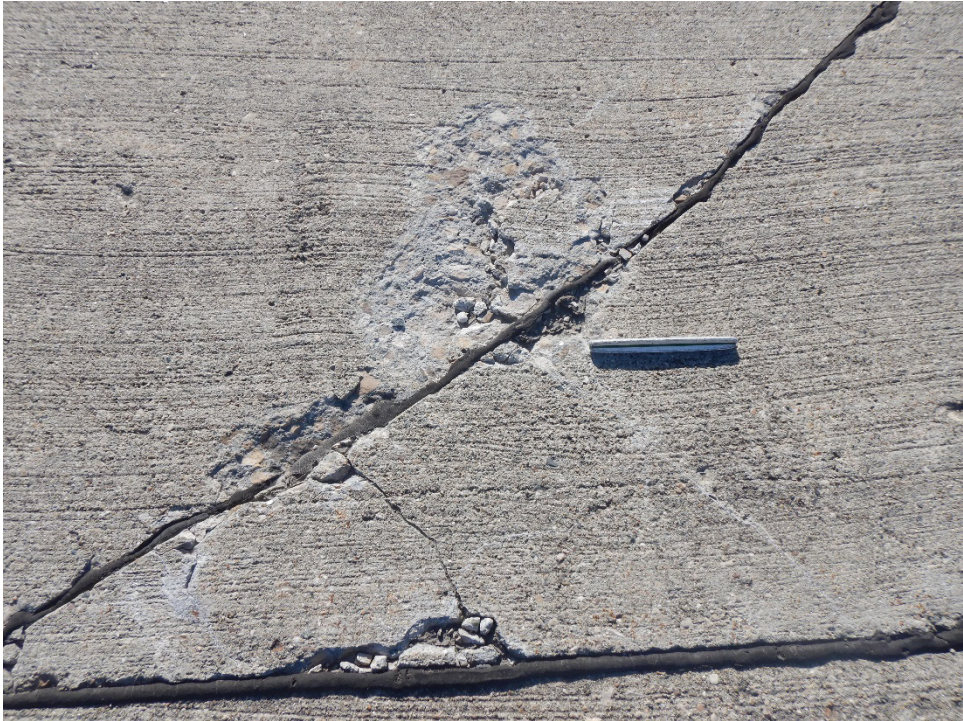
A011F-01. ASR (Sample Unit No. 04).

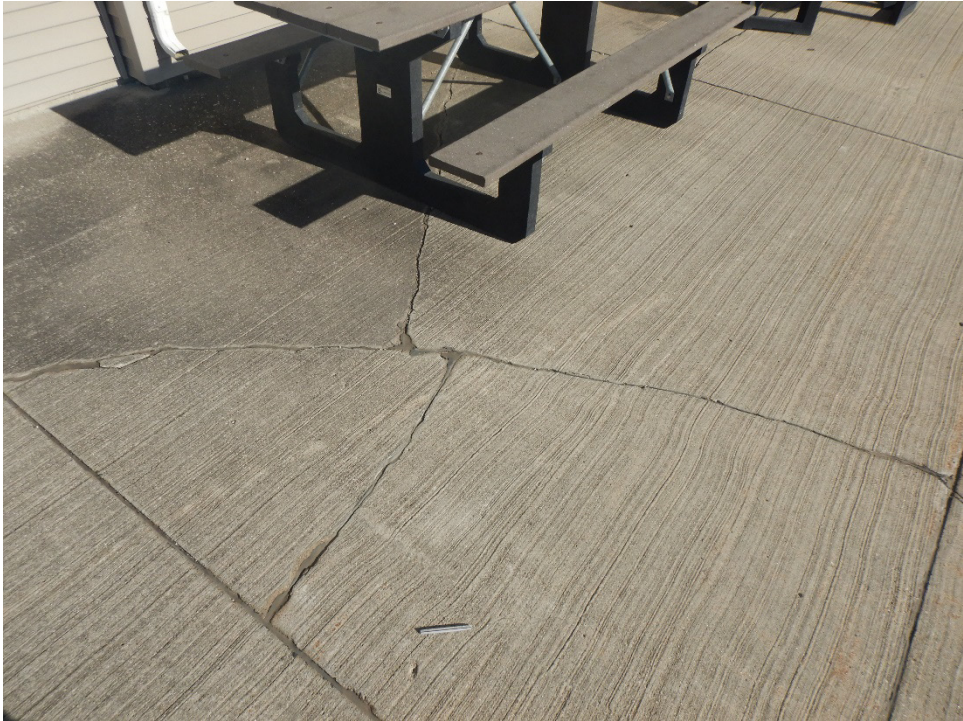
A01IF-01. Shattered Slab (Sample Unit No. 15).

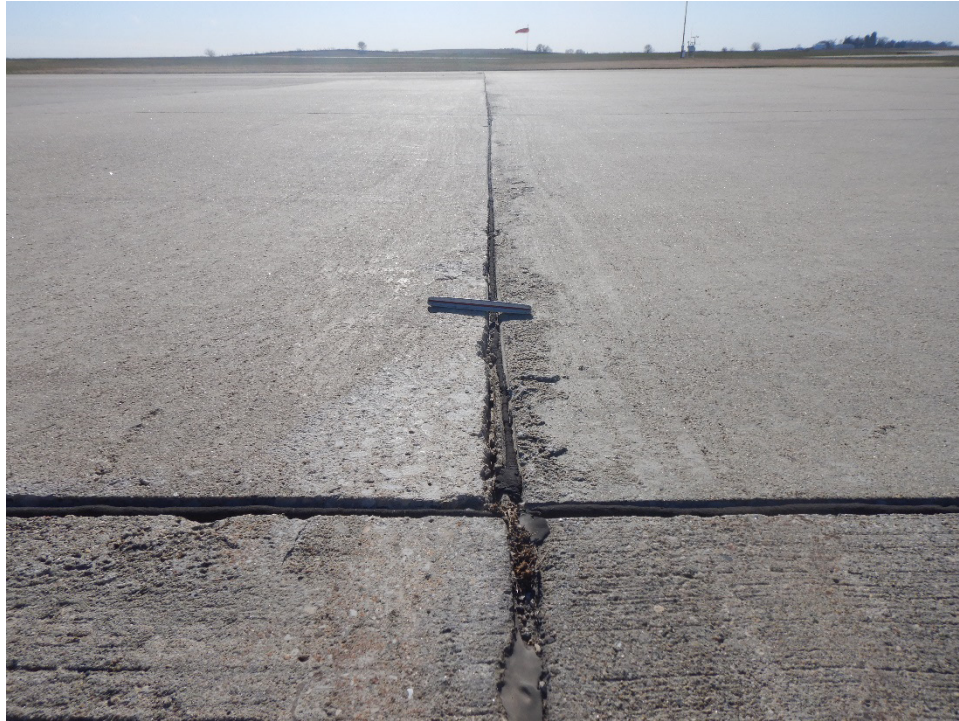
A01IF-02. Faulting (Sample Unit No. 08).

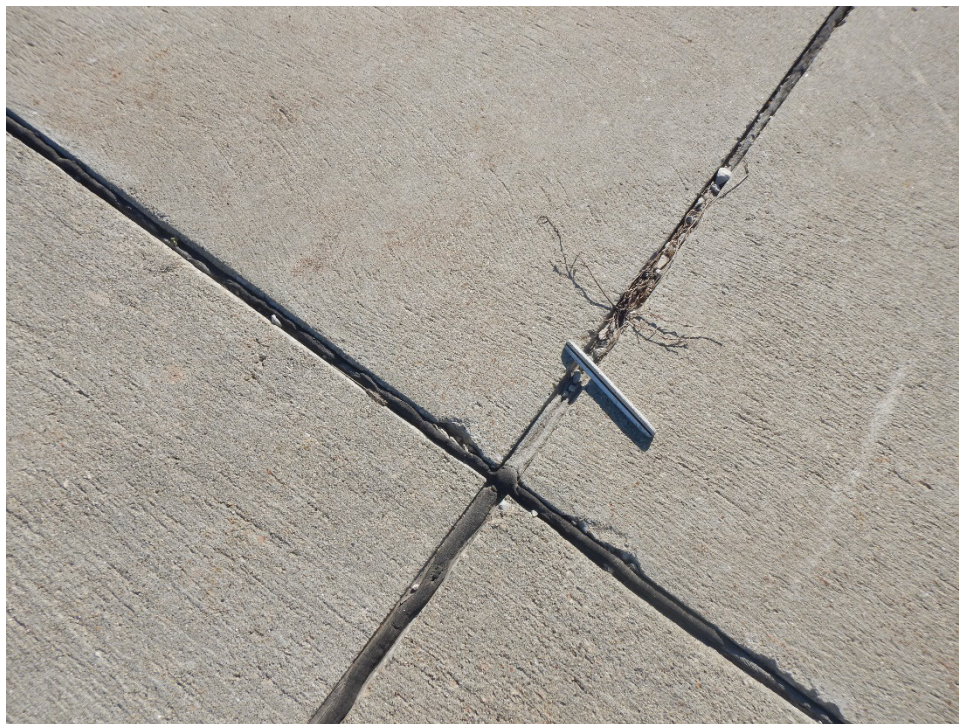
A01IF-02. Joint Seal Damage (Sample Unit No. 05).

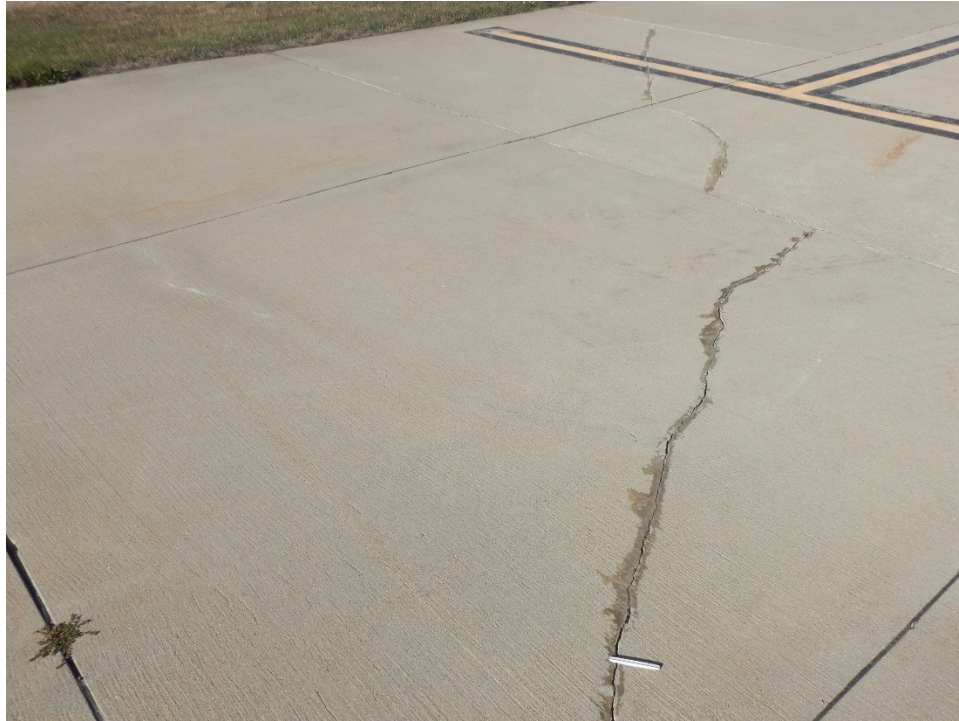
A01IF-02. LTD Cracking (Additional Sample Unit No. 06).

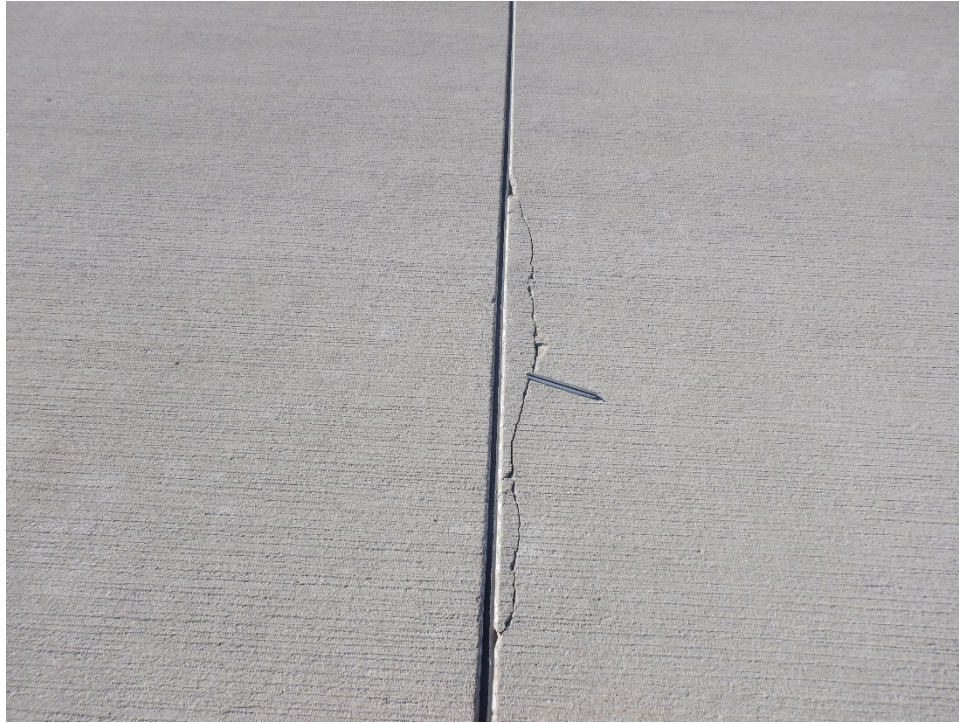
R13IF-01. Joint Spalling (Sample Unit No. 56).

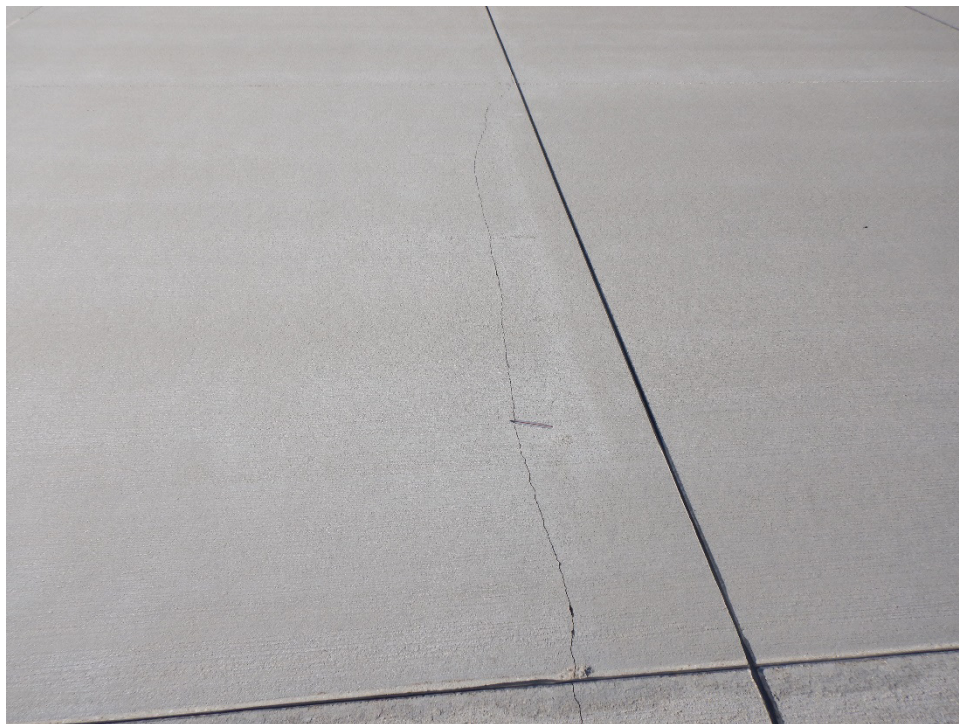
R13IF-01. LTD Cracking (Sample Unit No. 65).

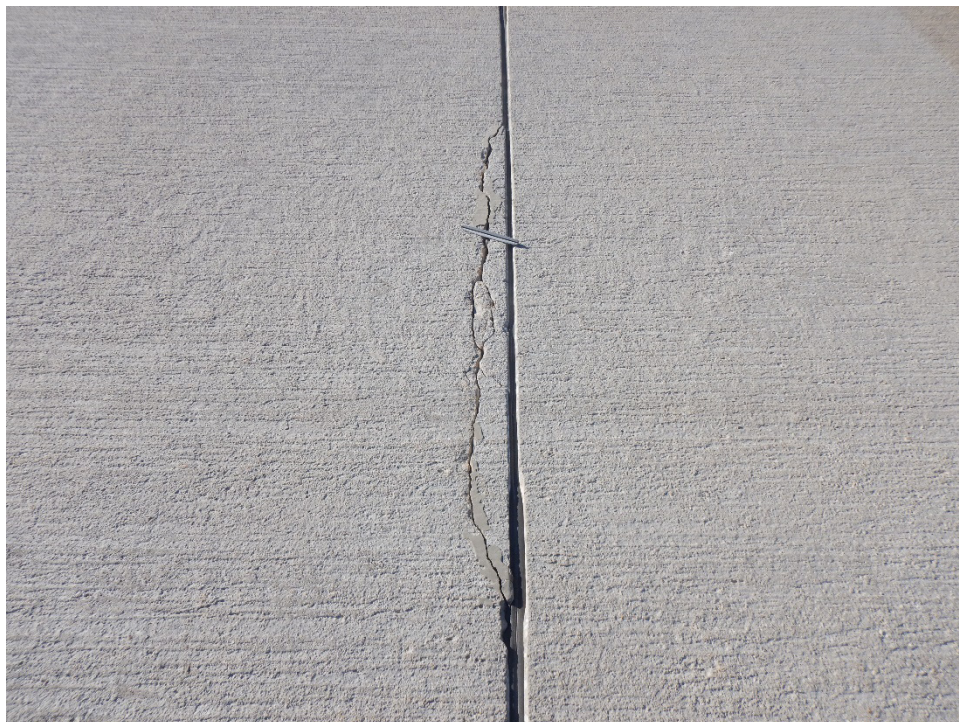
R13IF-02. Joint Spalling (Sample Unit No. 04).

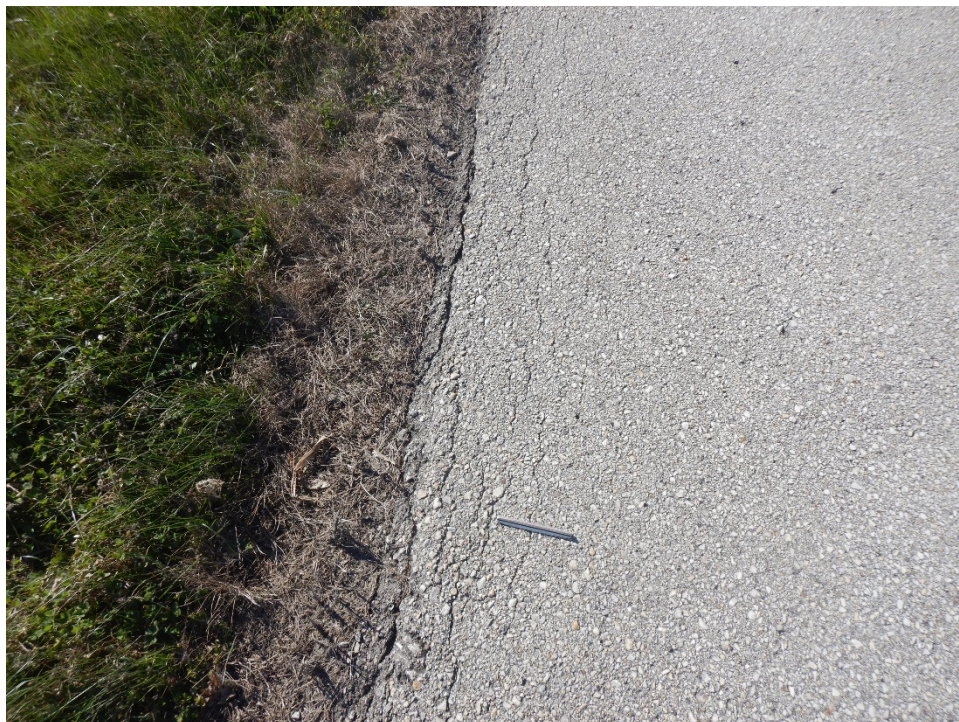
TAIF-01. Alligator Cracking (Sample Unit No. 03).

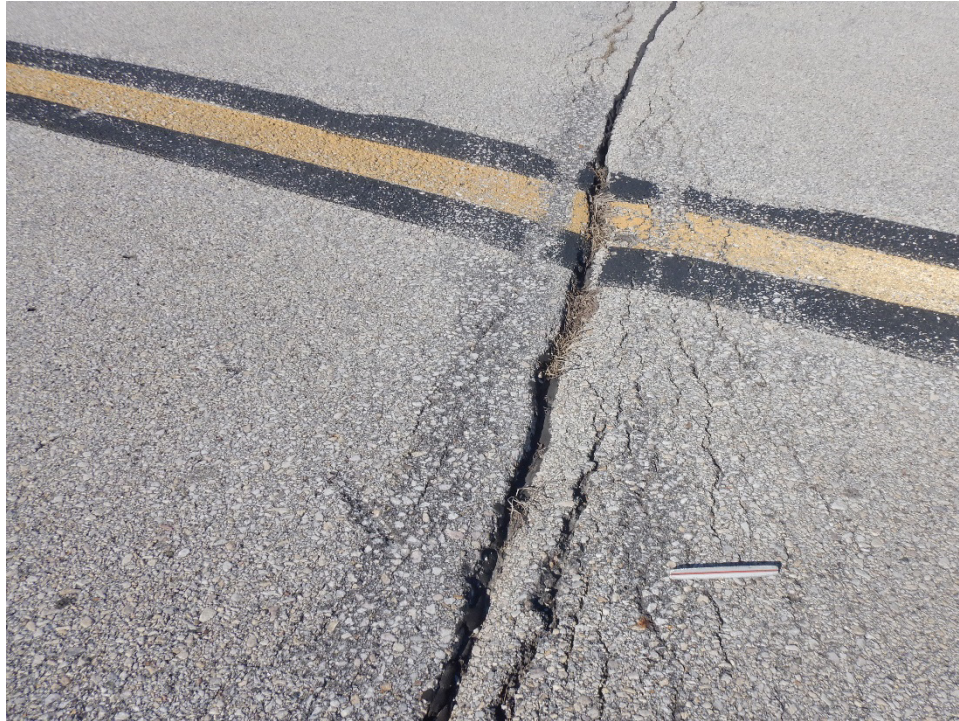
TAIF-01. L&T Cracking (Sample Unit No. 01).

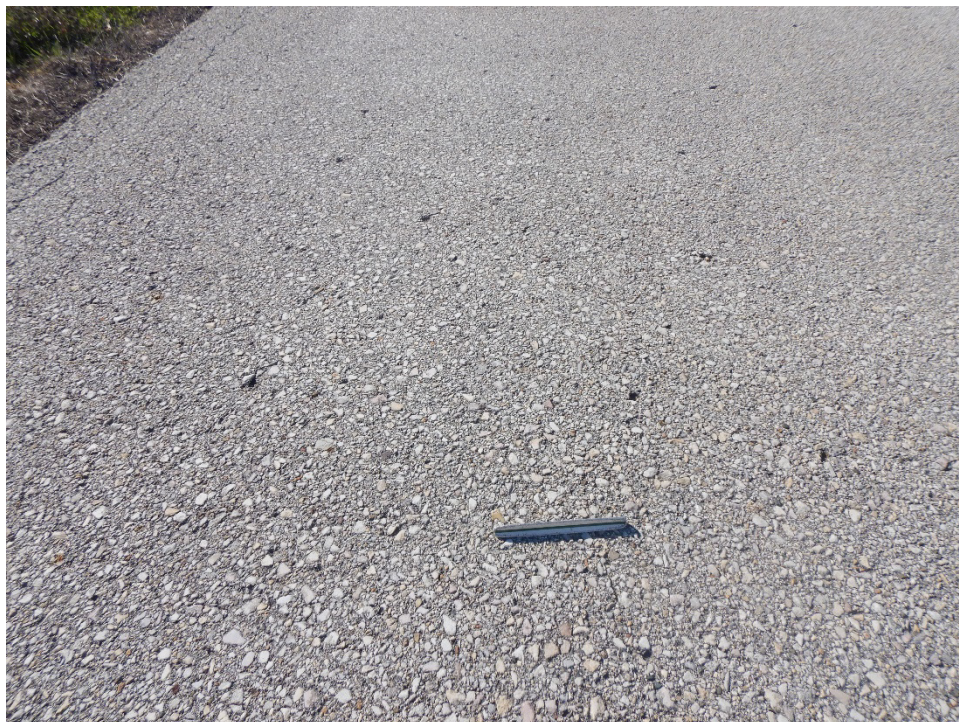
TAIF-01. Raveling (Sample Unit No. 02).

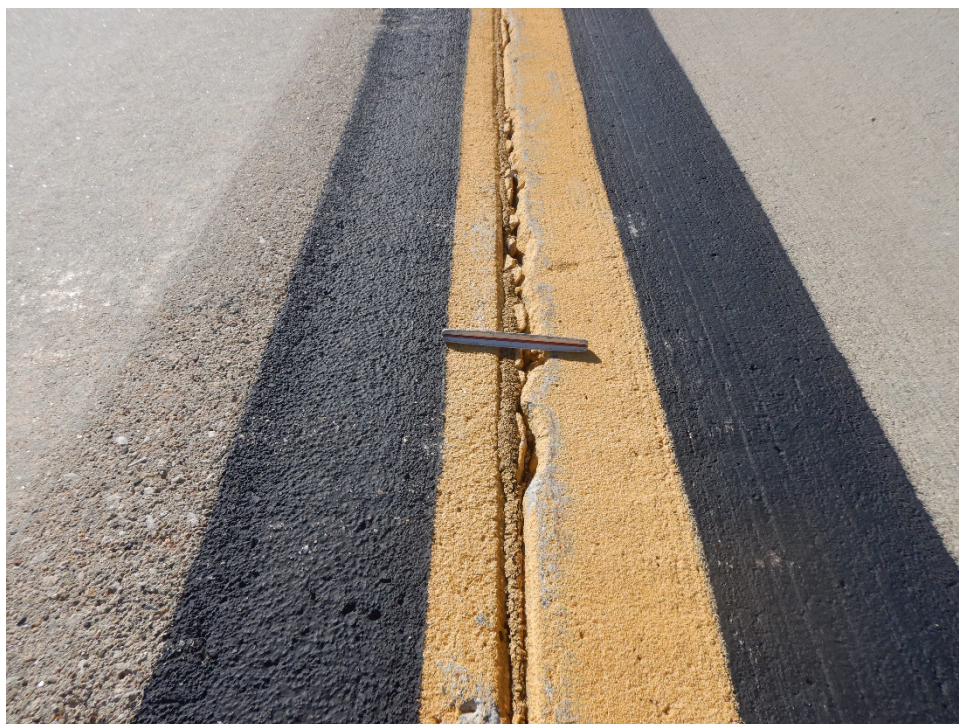
TAIF-03. Joint Seal Damage (Sample Unit No. 04).

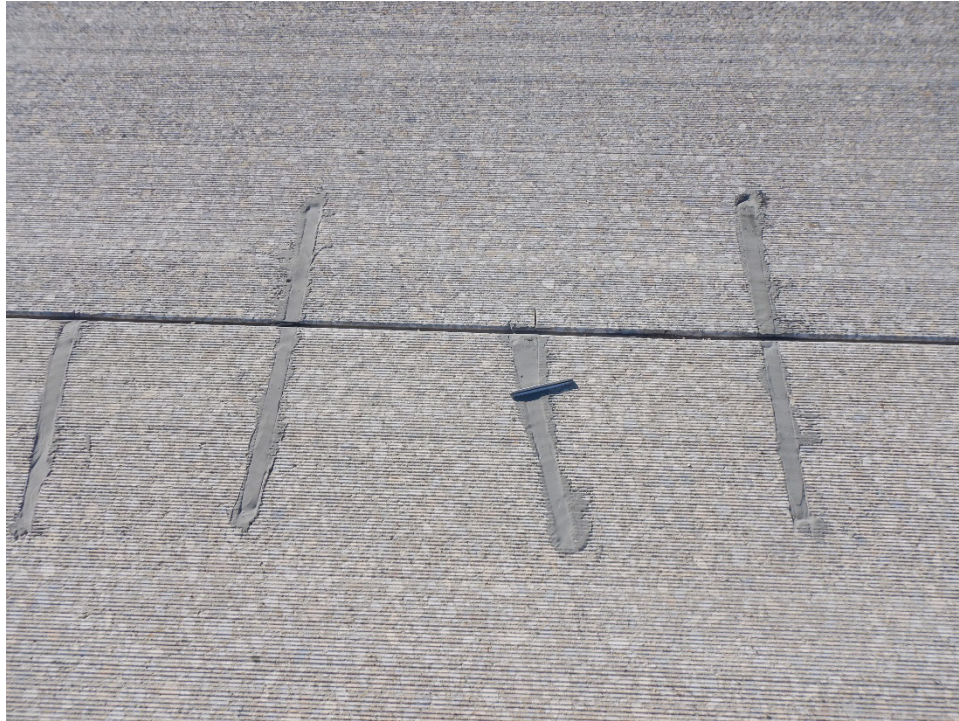
TBIF-01. Shrinkage Cracking (Sample Unit No. 70).

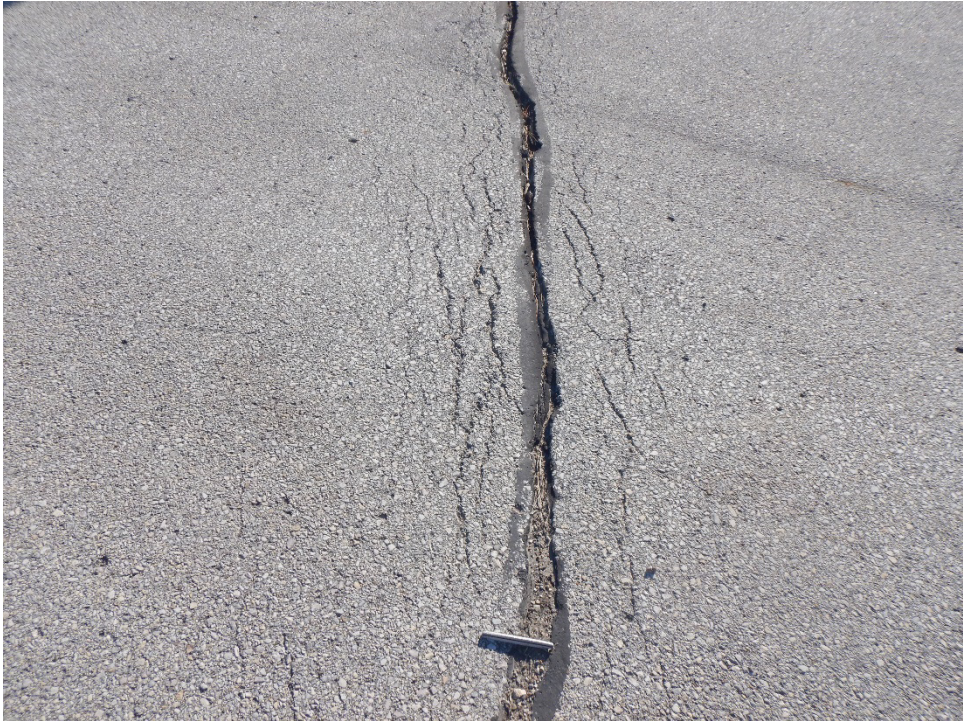
The T-hangar area was defined by two sections. Section 01 contained areas of low-severity rutting; low- and medium-severity swelling; low- and high-severity raveling; medium-severity alligator cracking, depression, and weathering; and all severities of L&T cracking. The low-severity L&T cracking was unsealed, while the medium-severity L&T cracking was due to either the unsealed crack widths that exceeded 1/4 inch or the development of secondary cracking. The high-severity L&T cracking was observed where areas of parallel secondary cracking wider

than 1 ft had developed. The high-severity raveling was due to mechanical damage. Low-severity weathering and low- and medium-severity L&T cracking were recorded in Section 02. The low-severity L&T cracking was unsealed, while the medium-severity L&T cracking was identified where the unsealed crack widths were greater than 1/4 inch.

TH01IF-01. L&T Cracking (Sample Unit No. 01).

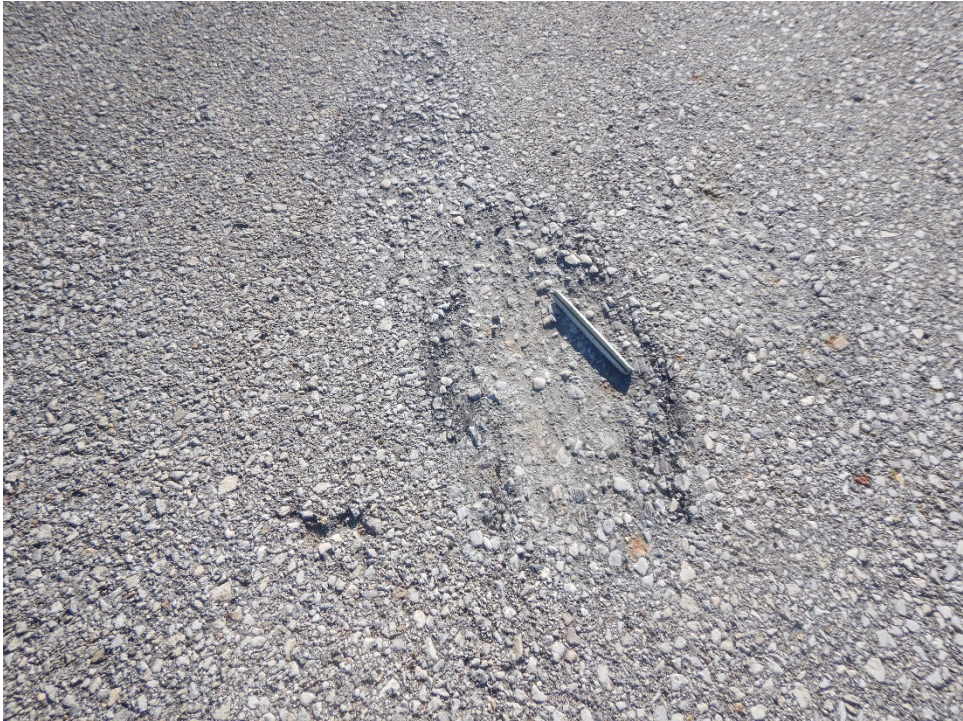
TH01IF-01. Raveling (Sample Unit No. 04).

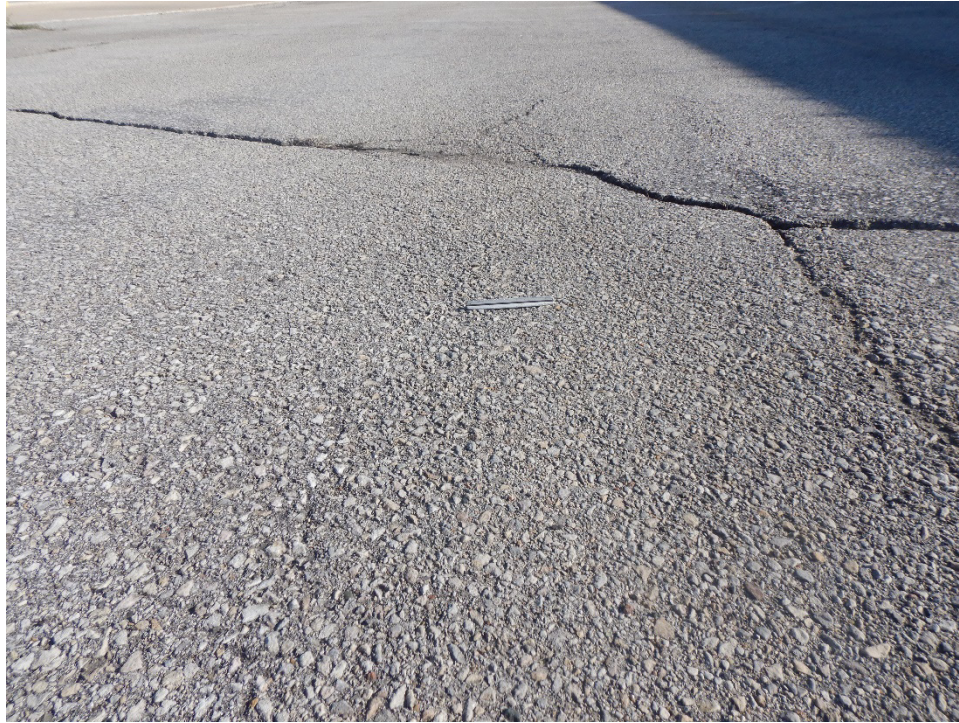
TH01IF-01. Rutting (Sample Unit No. 01).

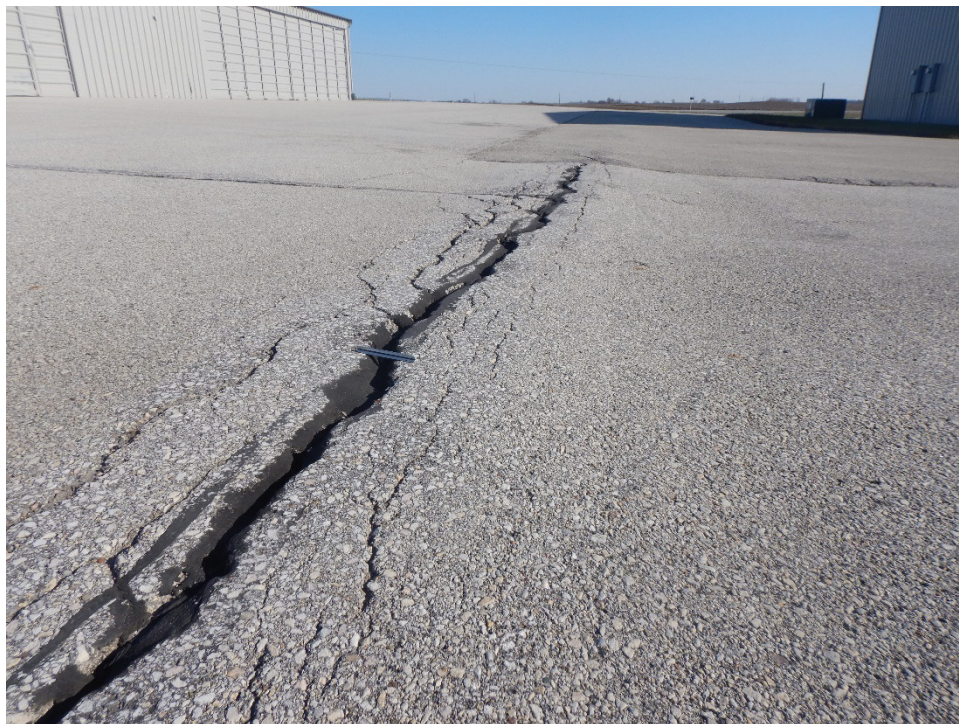
TH01IF-01. Swelling (Sample Unit No. 05).

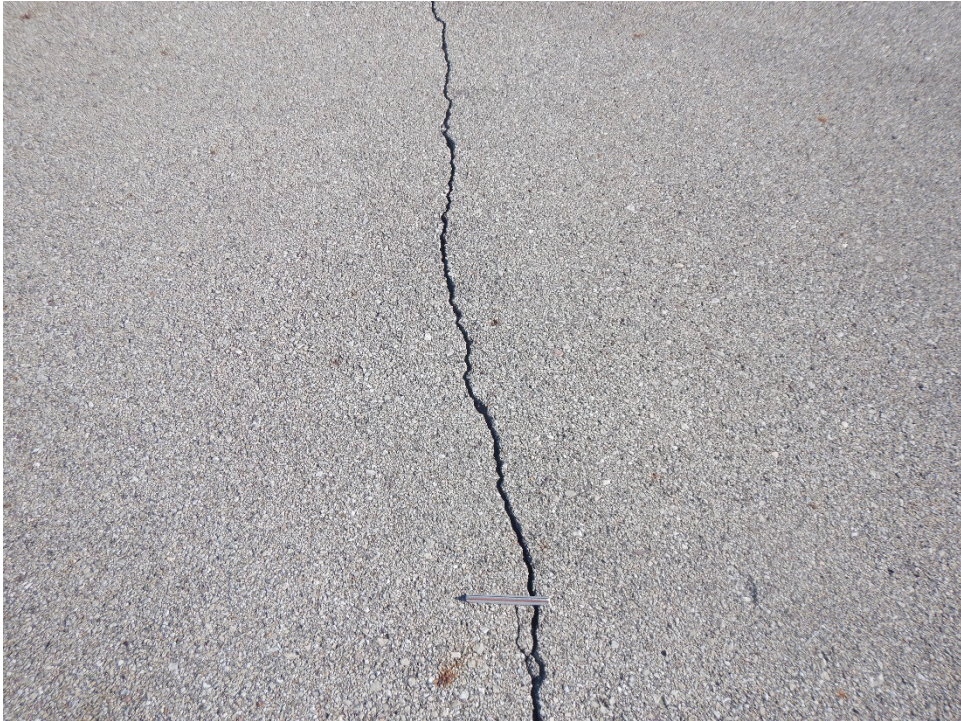
TH01IF-02. L&T Cracking (Sample Unit No. 01).

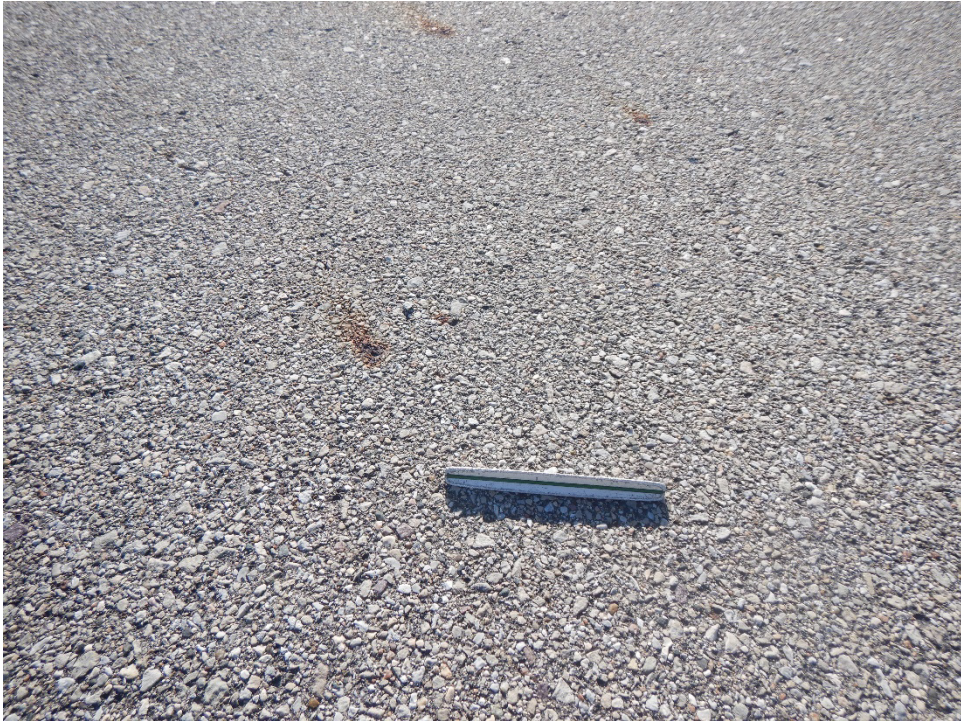
TH01IF-02. Weathering (Sample Unit No. 01).
