Keokuk Municipal Airport

Pavement Management Report

JULY 2024

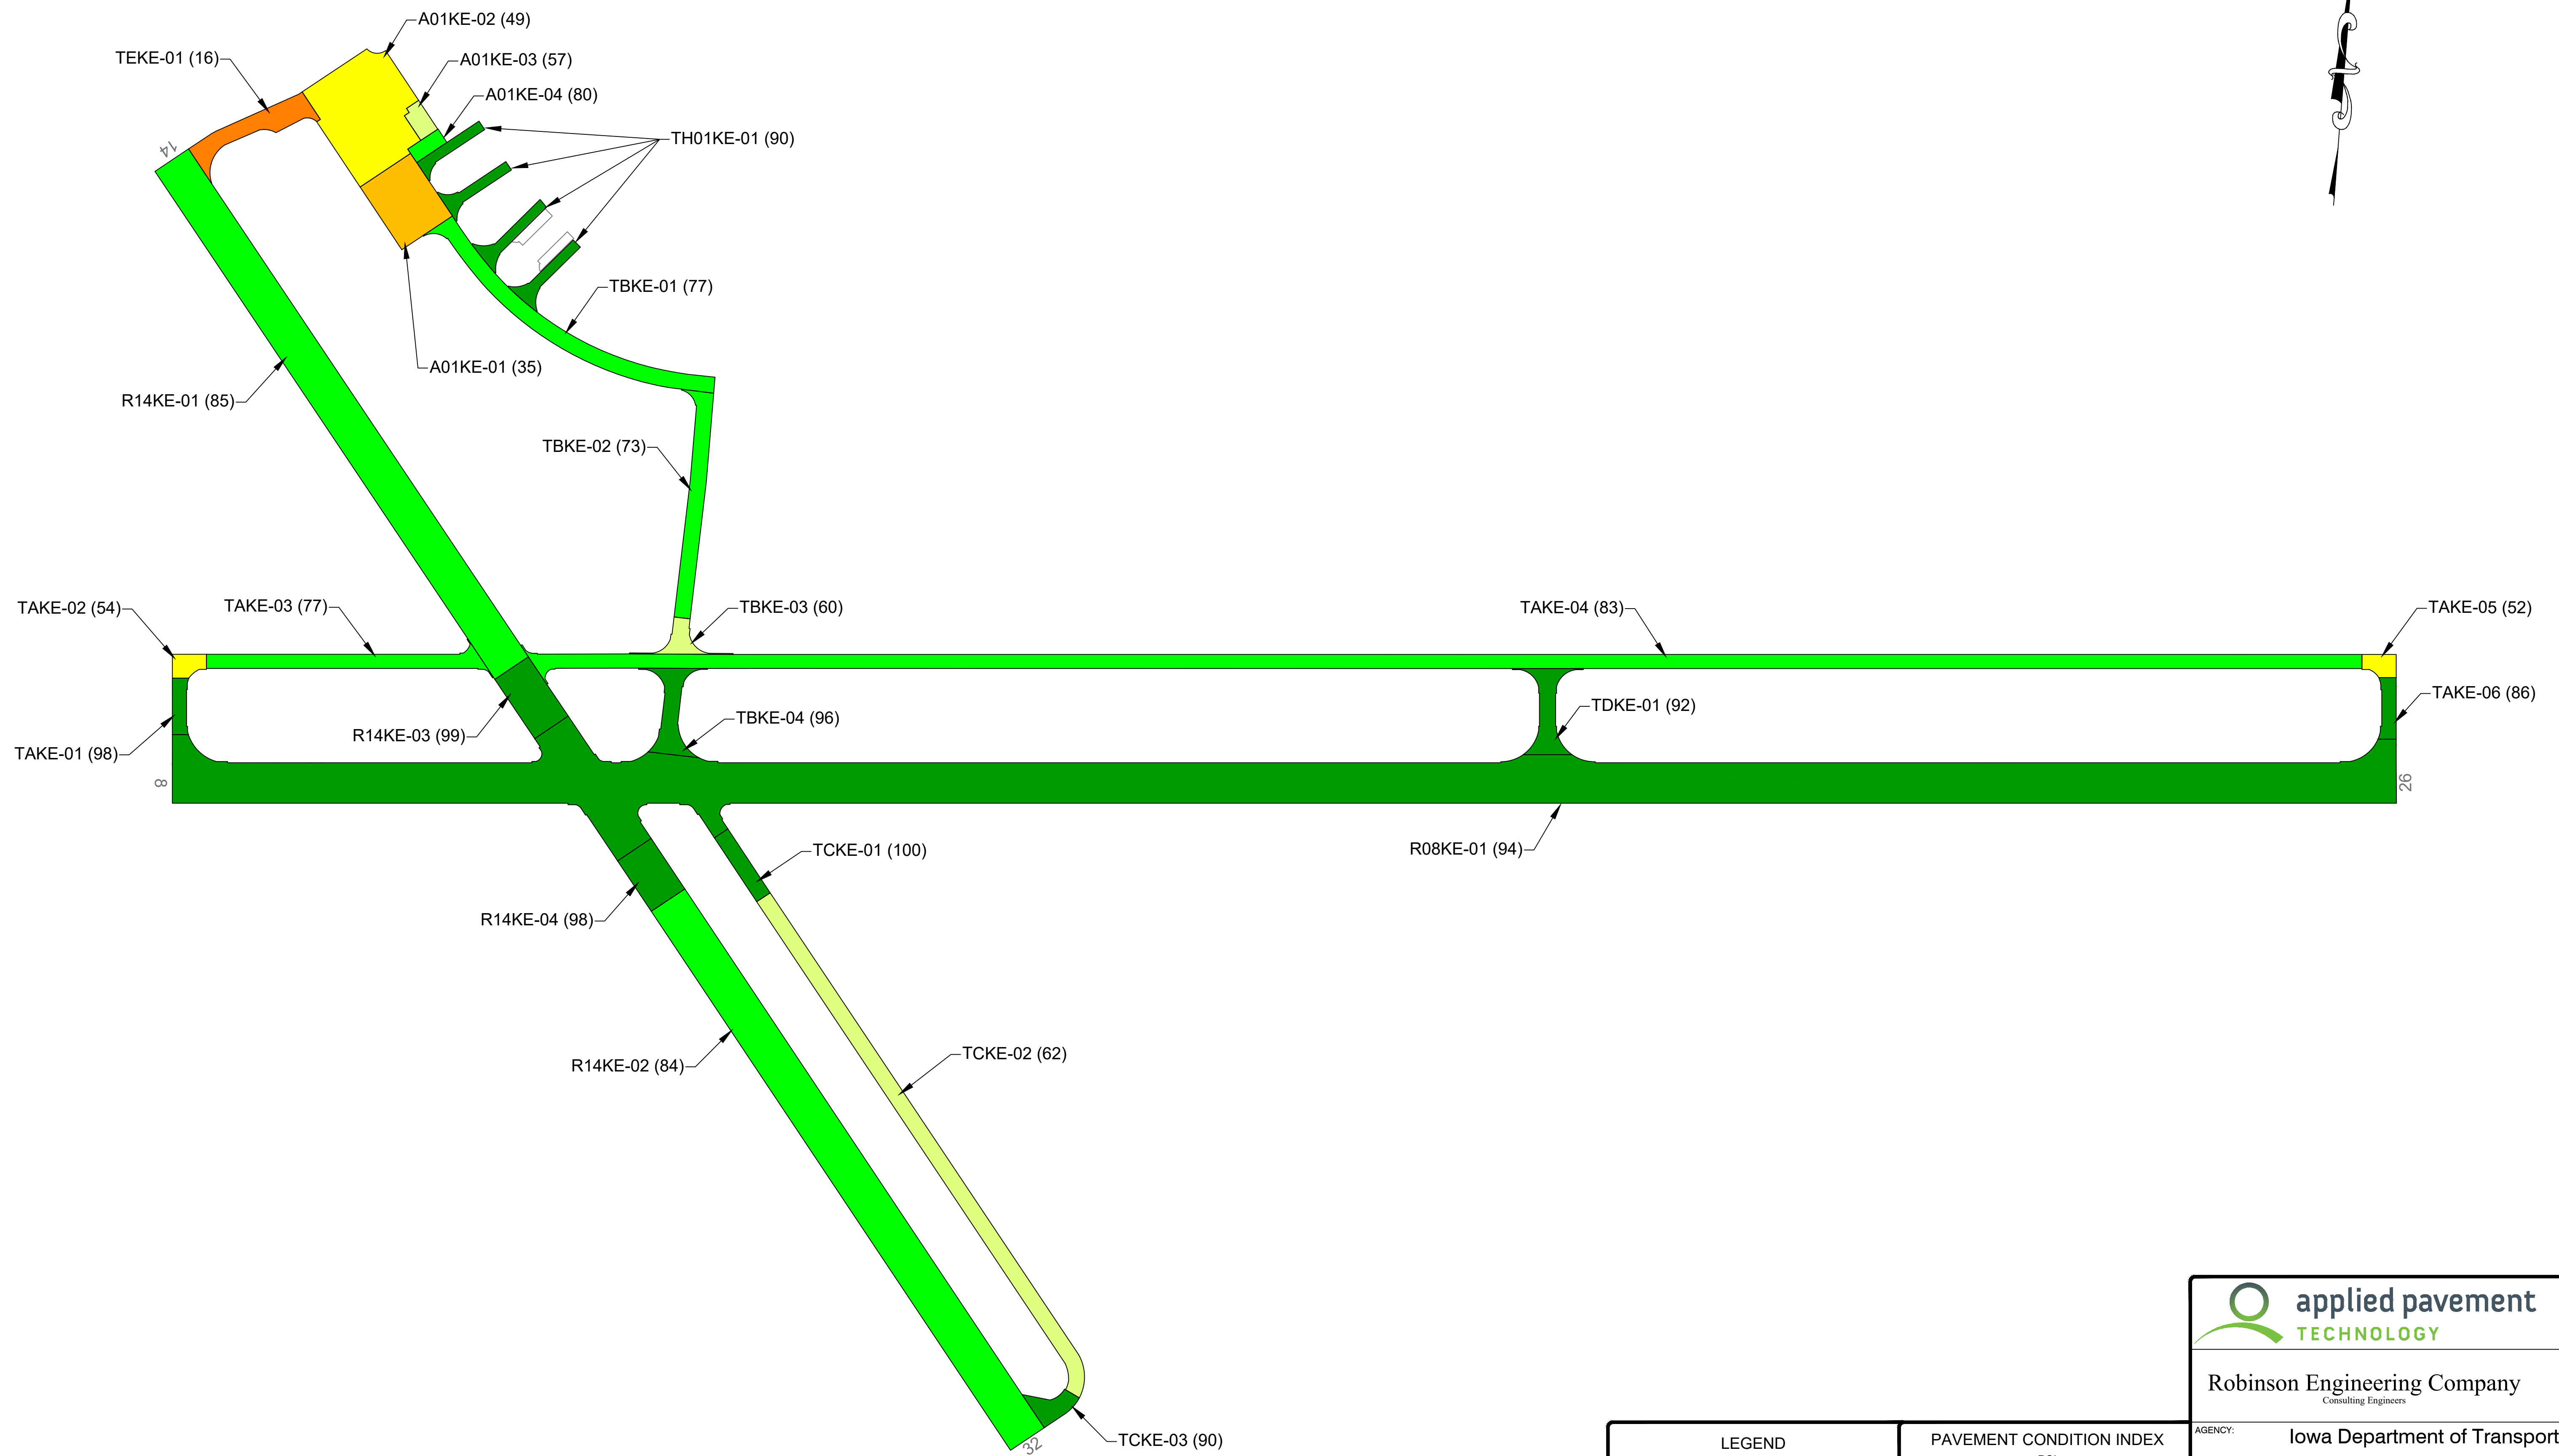
FIGURE 8. PCI MAP.

The pavements at Keokuk Municipal Airport were inspected in November 2023. The 2023 area-weighted condition of Keokuk Municipal Airport is 84, with conditions ranging from 16 to 100 (on a scale of 0 [failed] to 100 [excellent]). During the previous pavement inspection in 2020, the area-weighted PCI of the airport was 86.

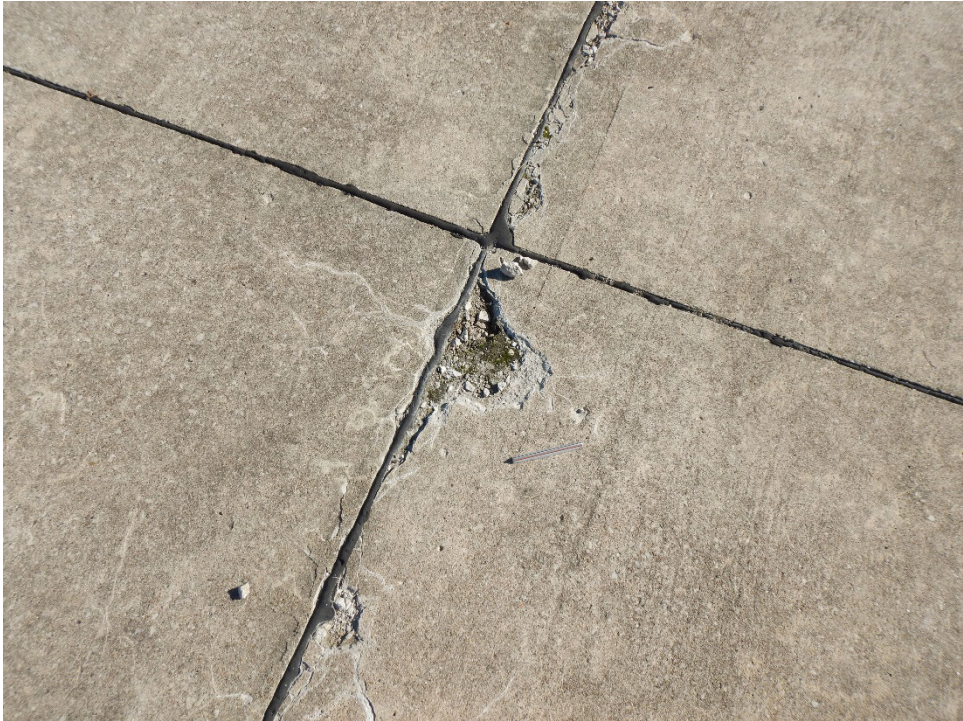
A01KE-01. ASR (Sample Unit No. 06).

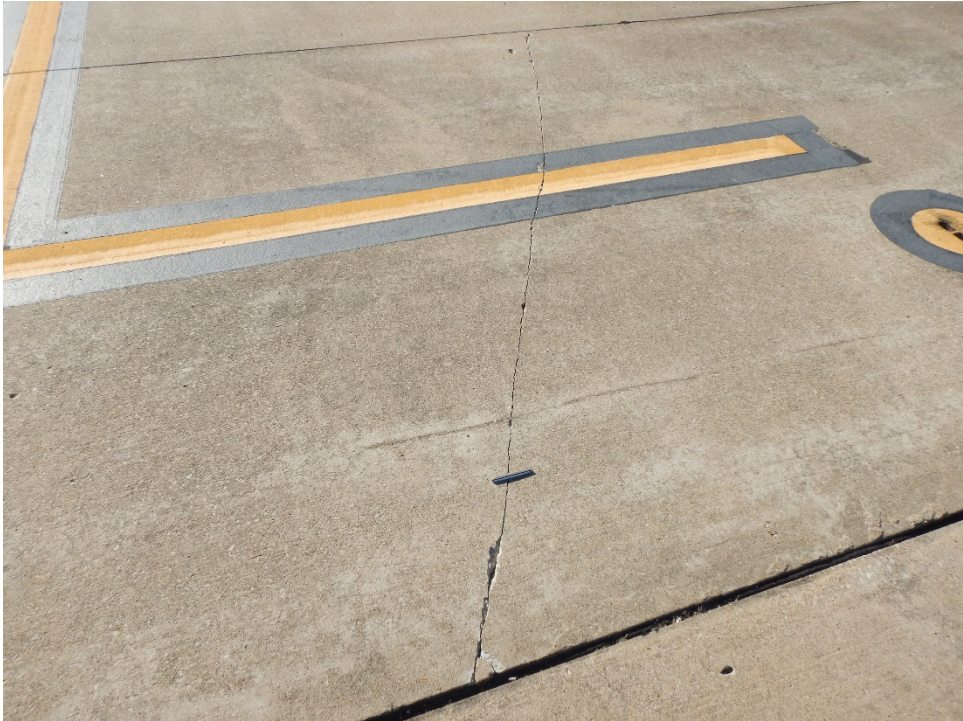
A01KE-01. LTD Cracking (Sample Unit No. 02).

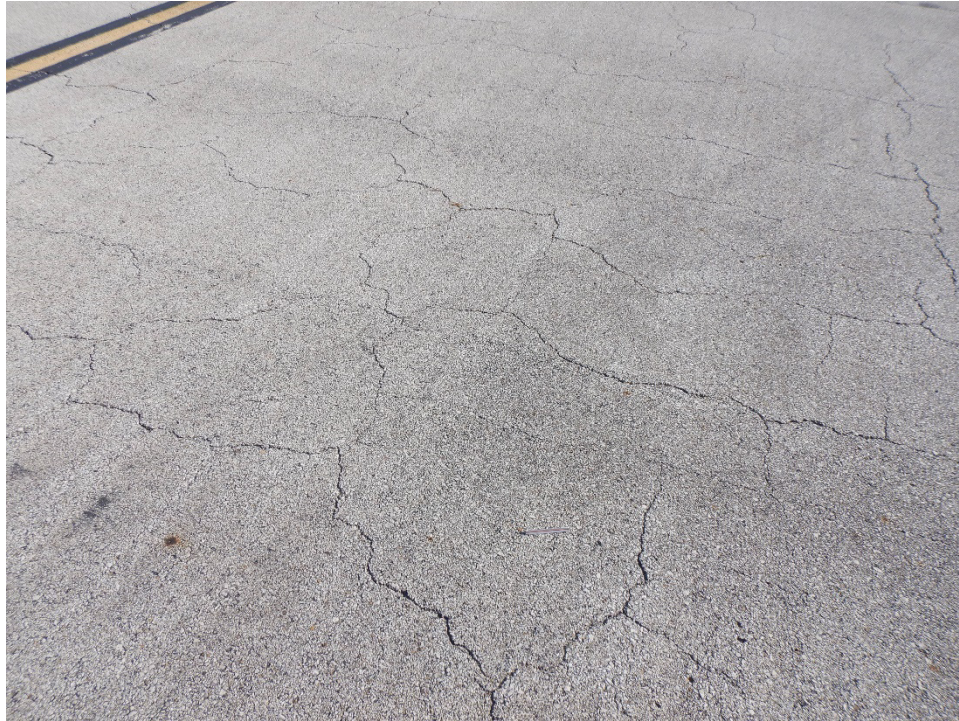
A01KE-02. Block Cracking (Sample Unit No. 02).

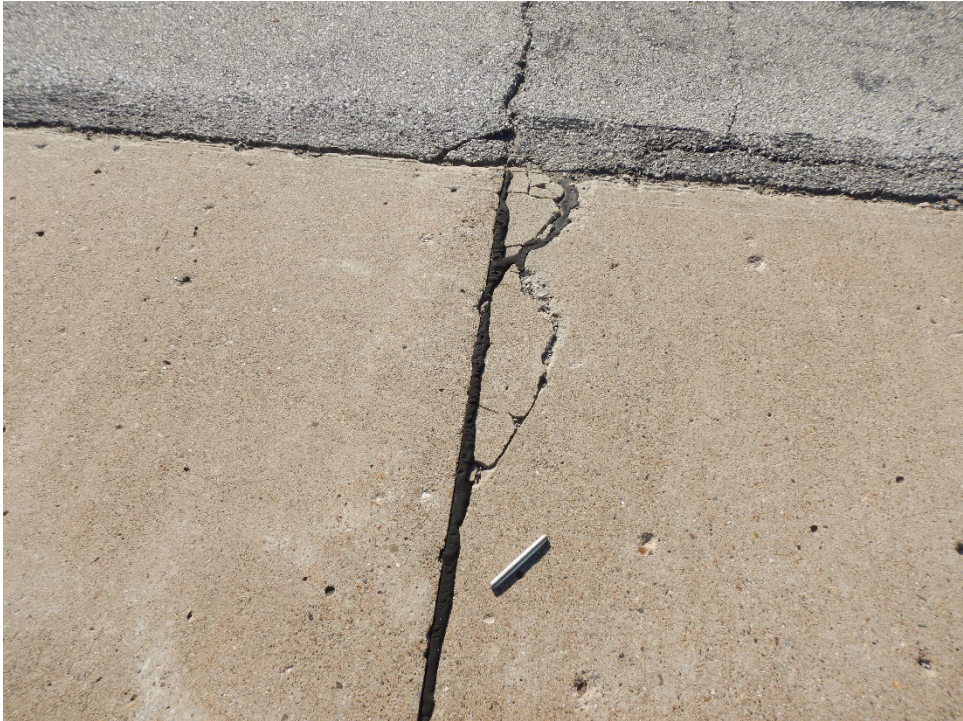
A01KE-03. Joint Spalling (Sample Unit No. 01).

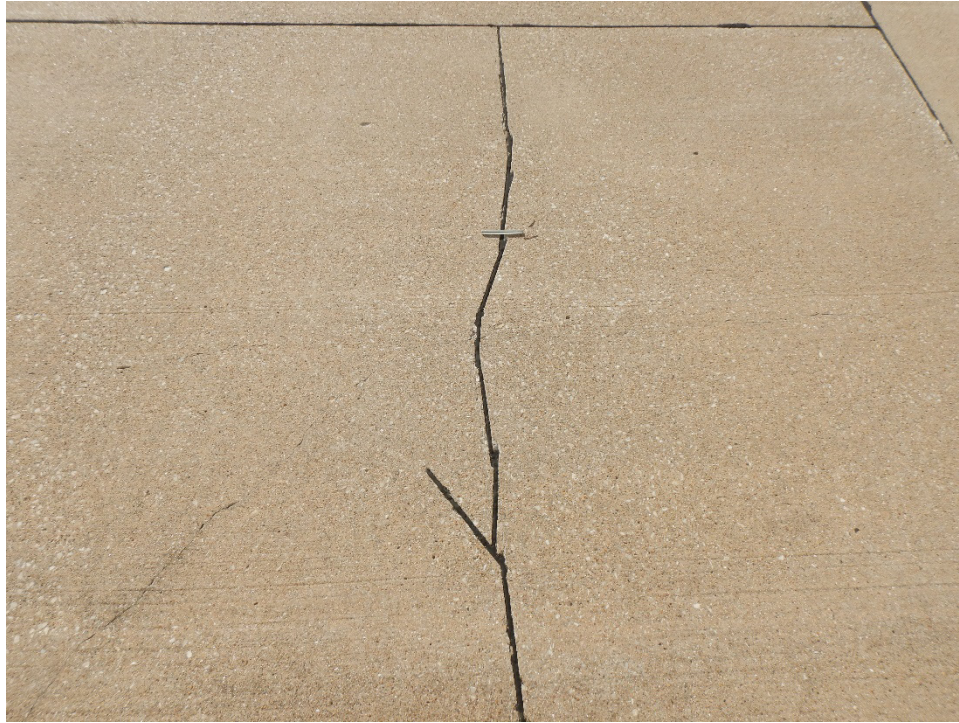
A01KE-03. LTD Cracking (Sample Unit No. 01).

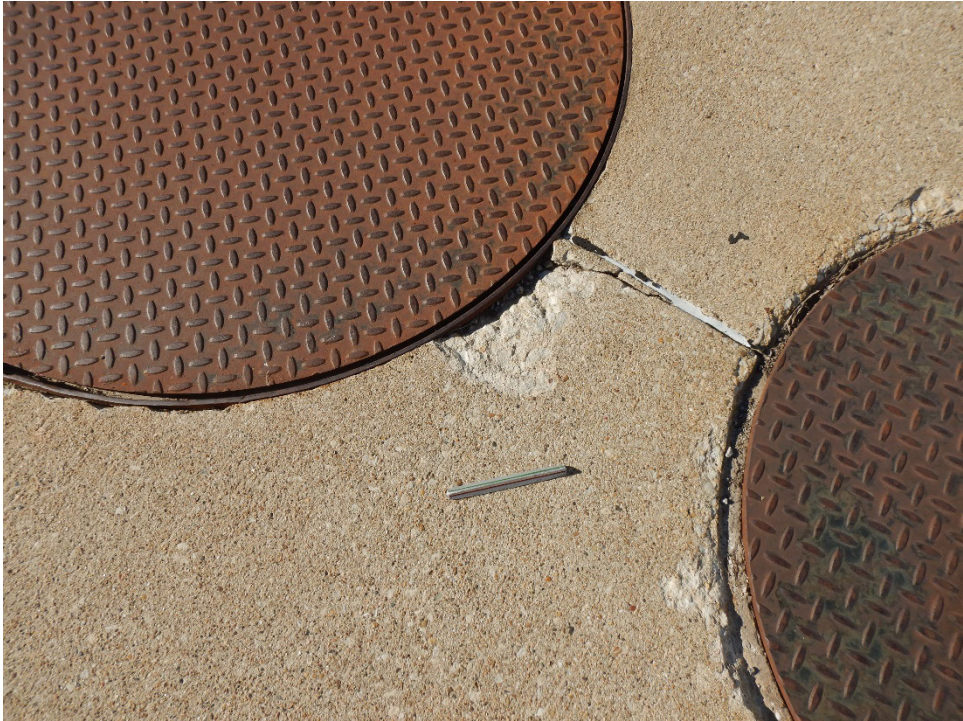
A01KE-04. Joint Spalling (Sample Unit No. 01).

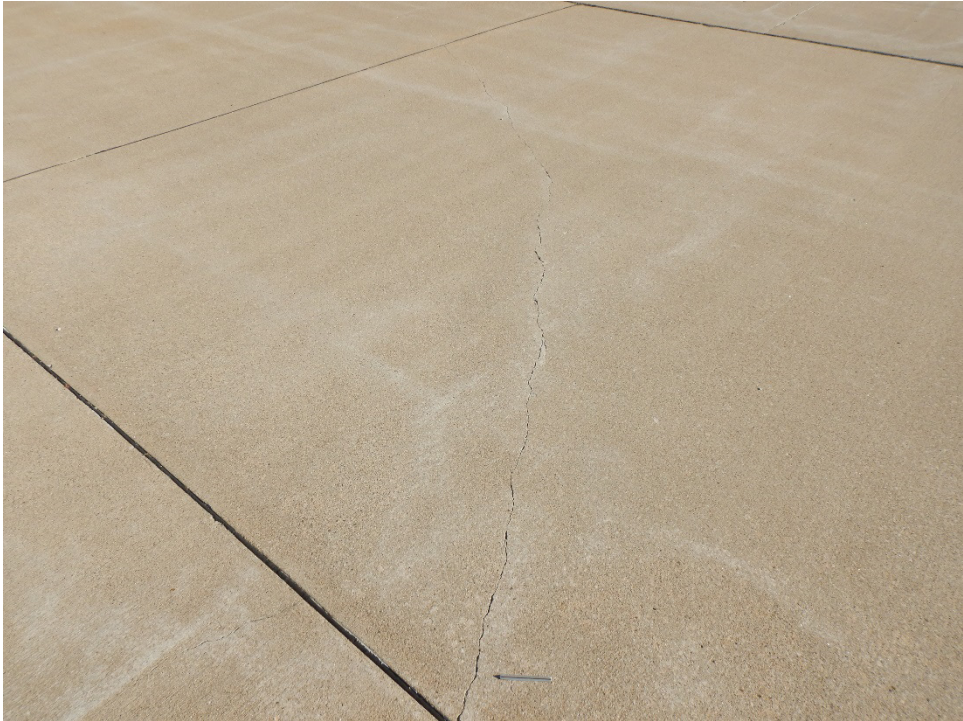
A01KE-04. LTD Cracking (Sample Unit No. 01).

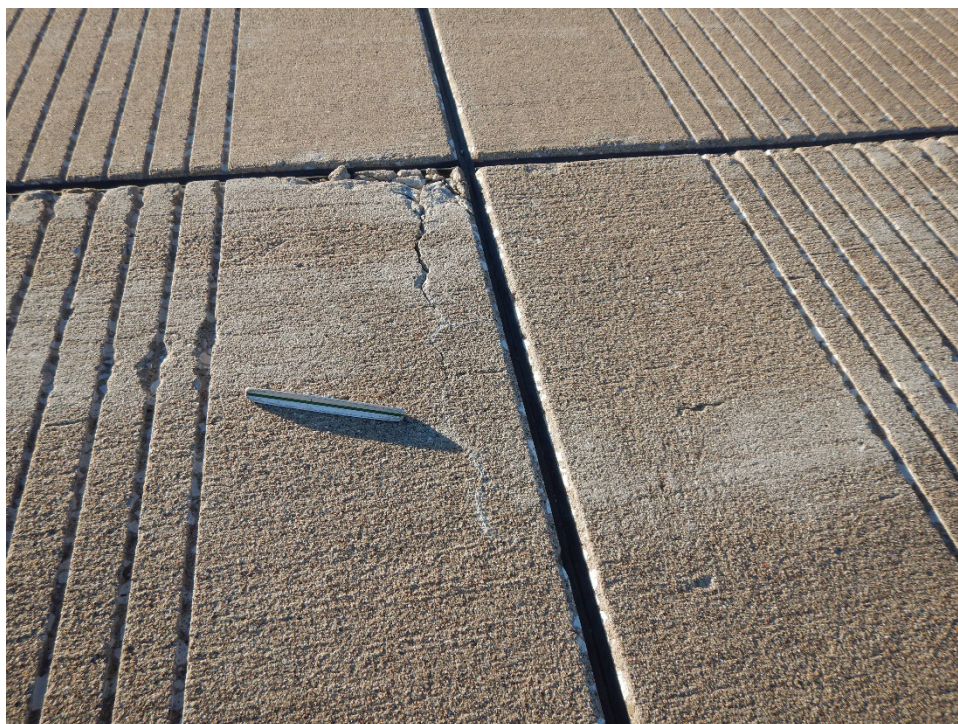
R08KE-01. ASR (Sample Unit No. 063).

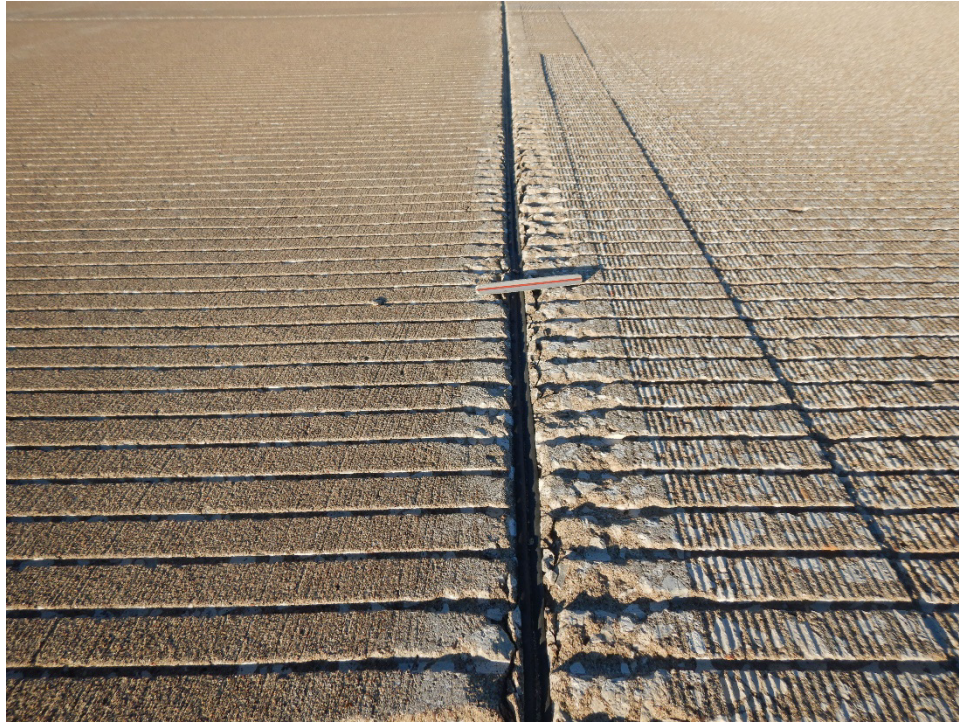
R08KE-01. Joint Seal Damage (Sample Unit No. 036).

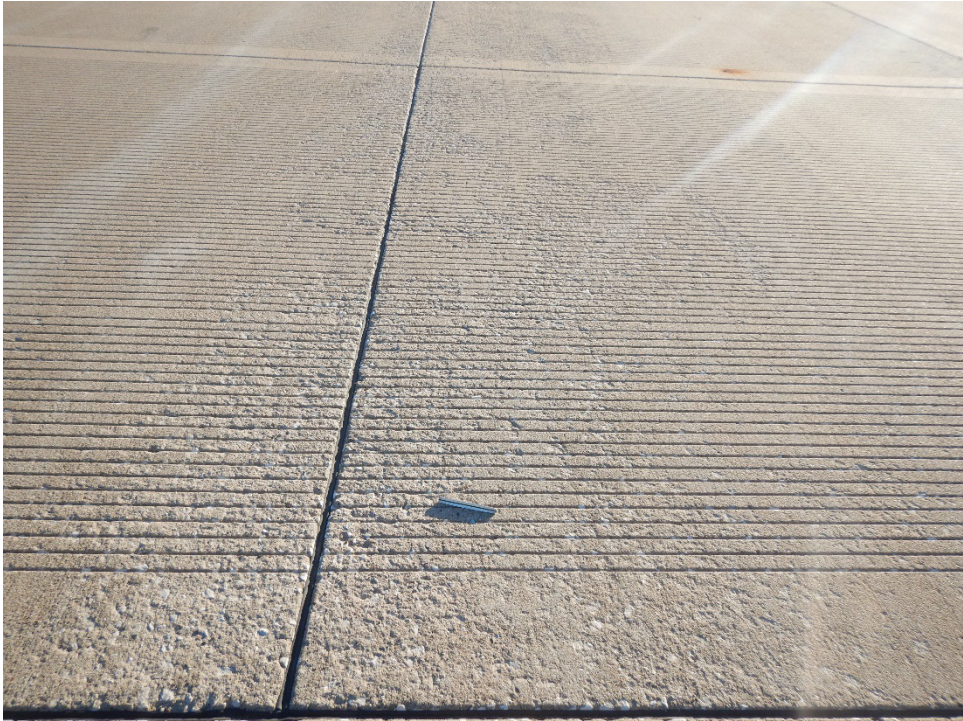
R08KE-01. Scaling (Sample Unit No. 126).

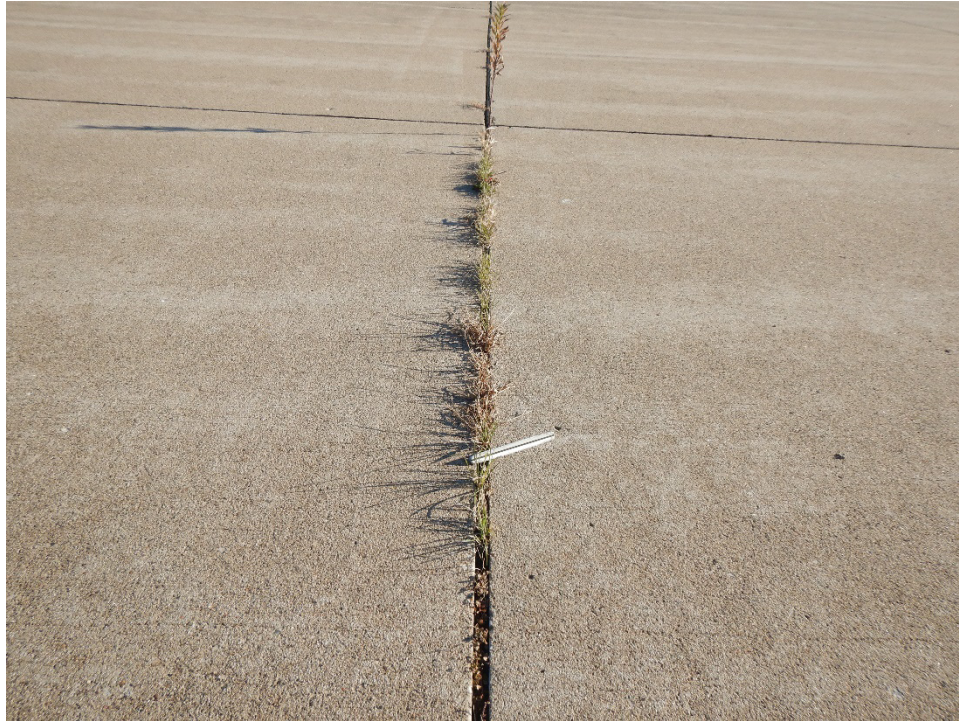
R14KE-01. Joint Seal Damage (Sample Unit No. 18).

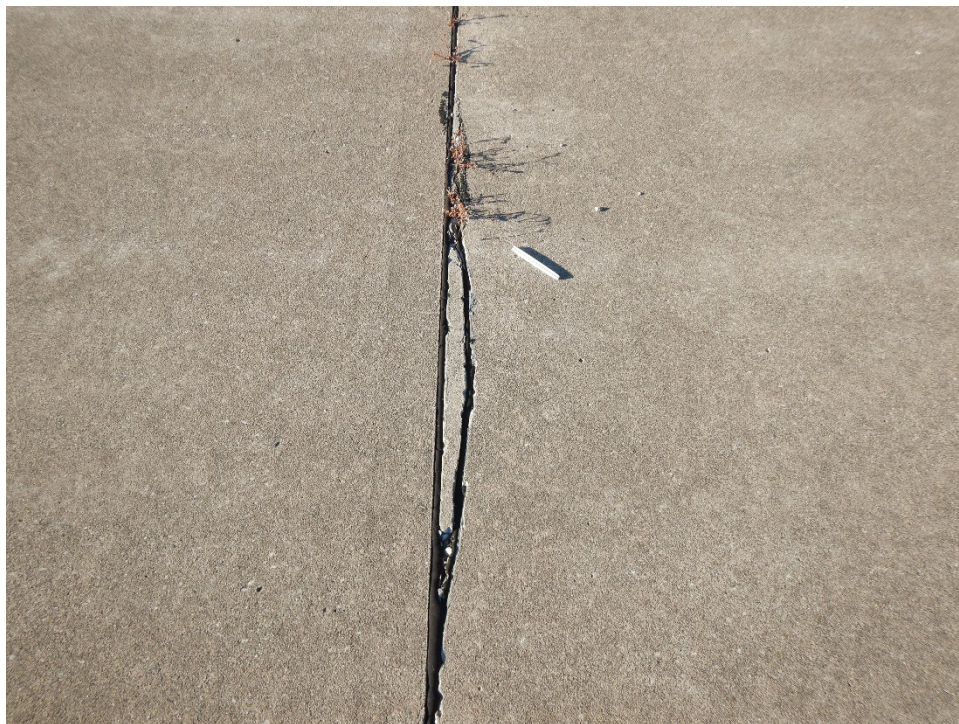
R14KE-01. Joint Spalling (Sample Unit No. 25).

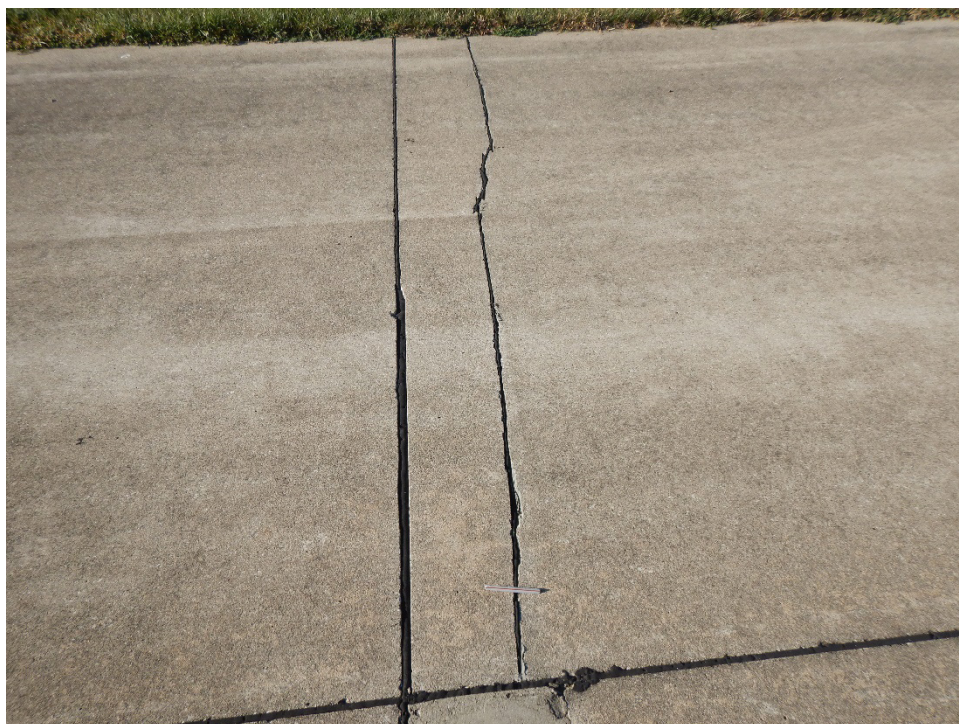
R14KE-02. LTD Cracking (Sample Unit No. 05).

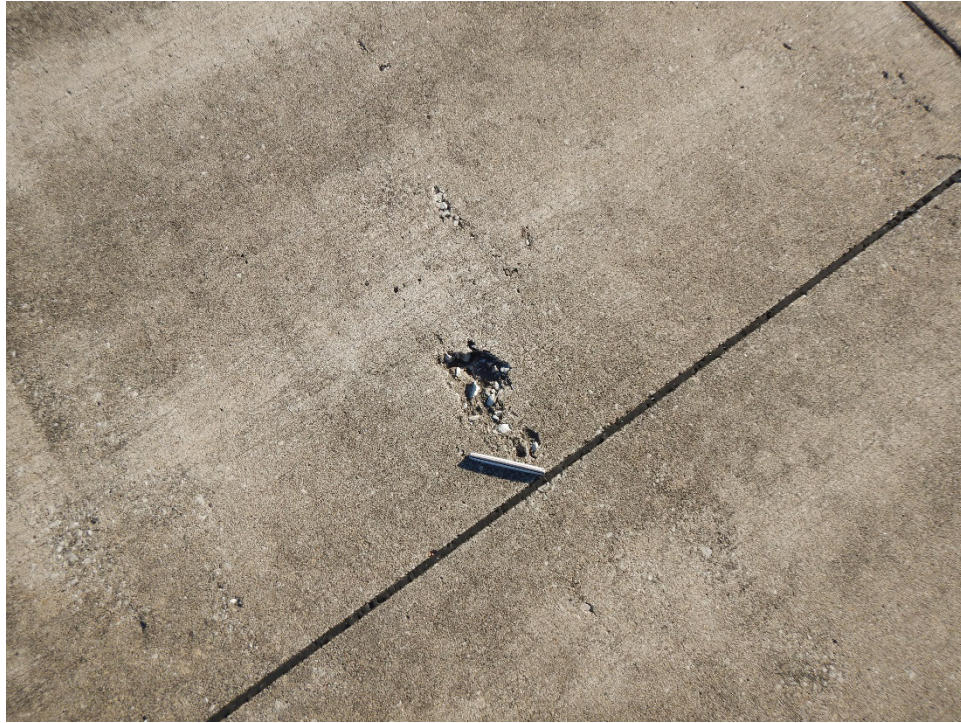
R14KE-02. Scaling (Sample Unit No. 12).

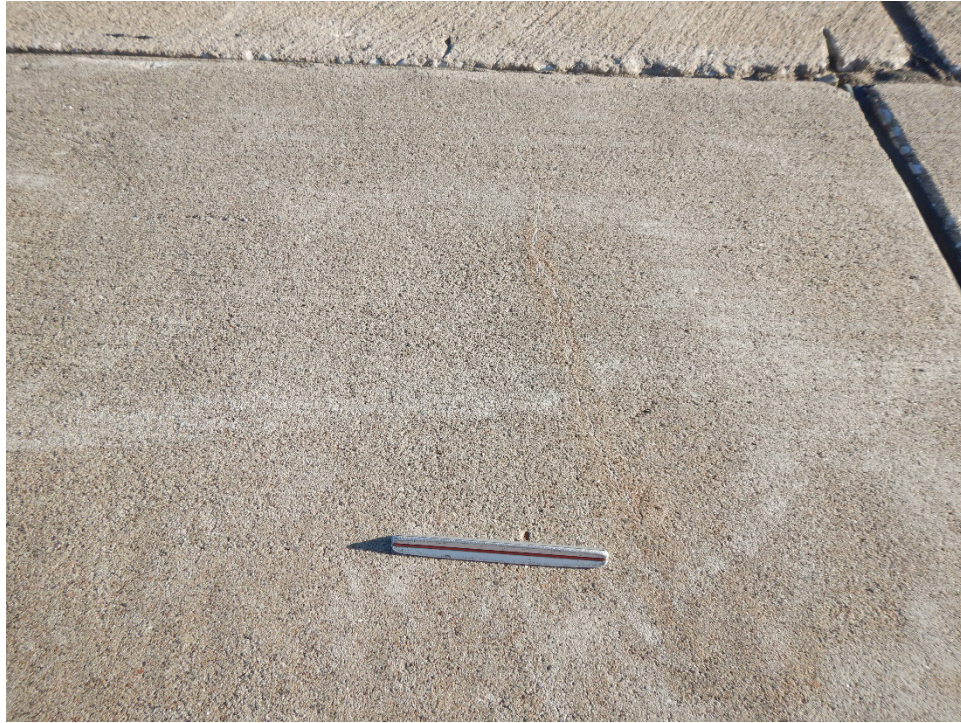
R14KE-03. ASR (Sample Unit No. 02).

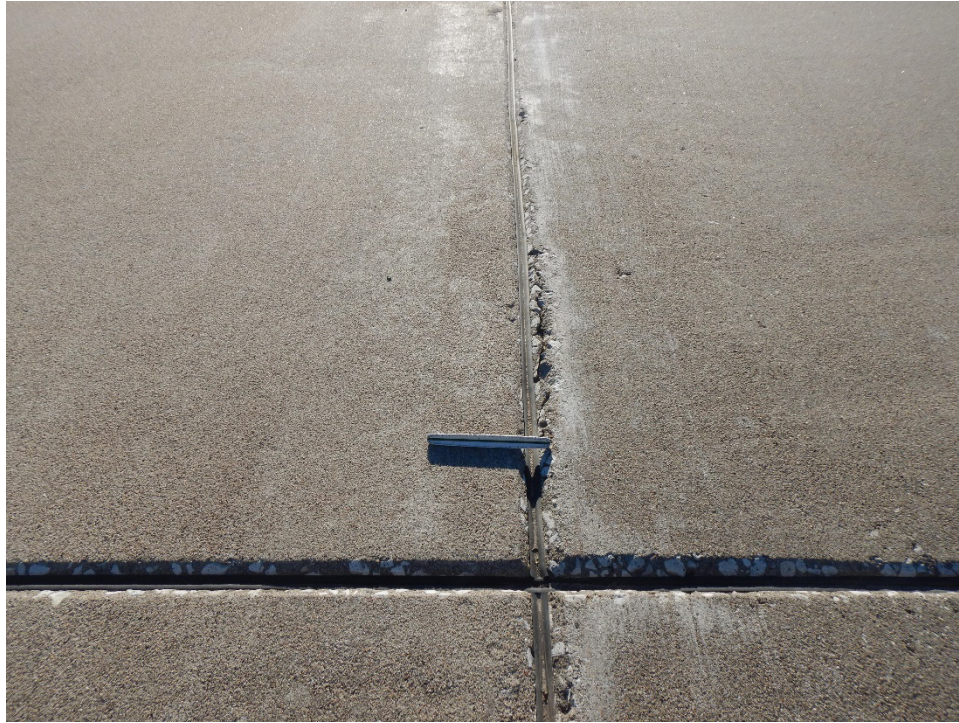
R14KE-04. Joint Seal Damage (Sample Unit No. 04).

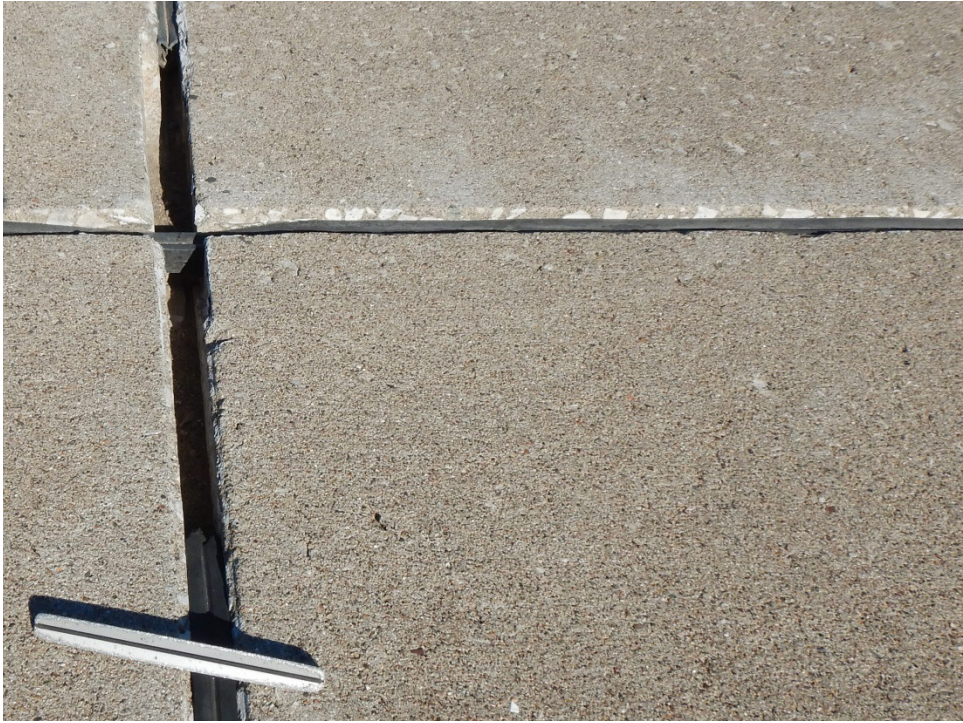
TAKE-01. Joint Seal Damage (Sample Unit No. 03).

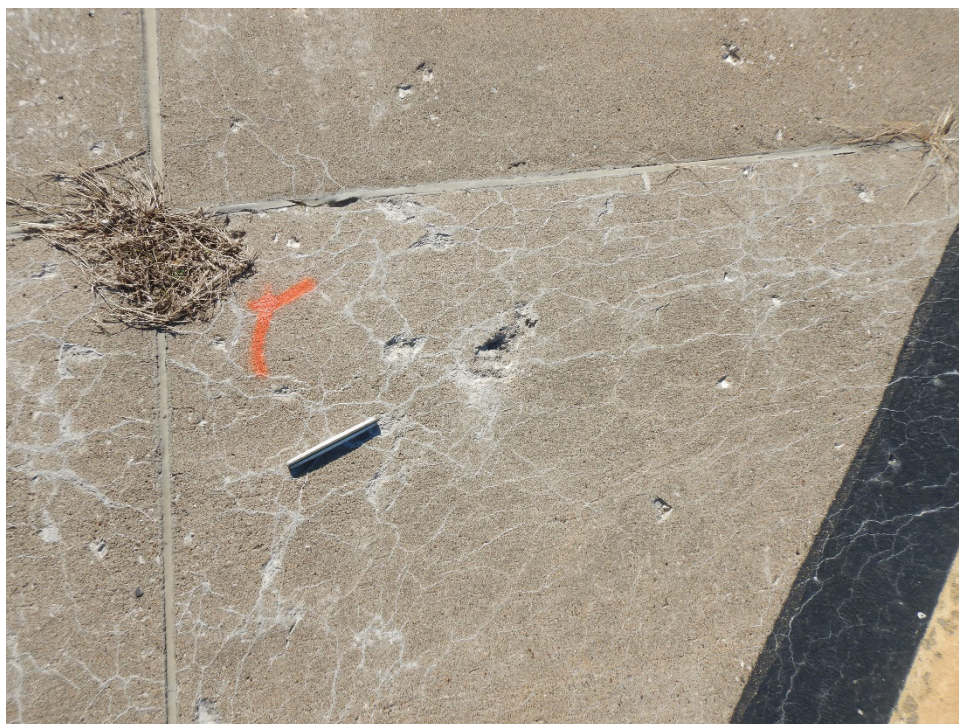
TAKE-02. ASR (Sample Unit No. 02).

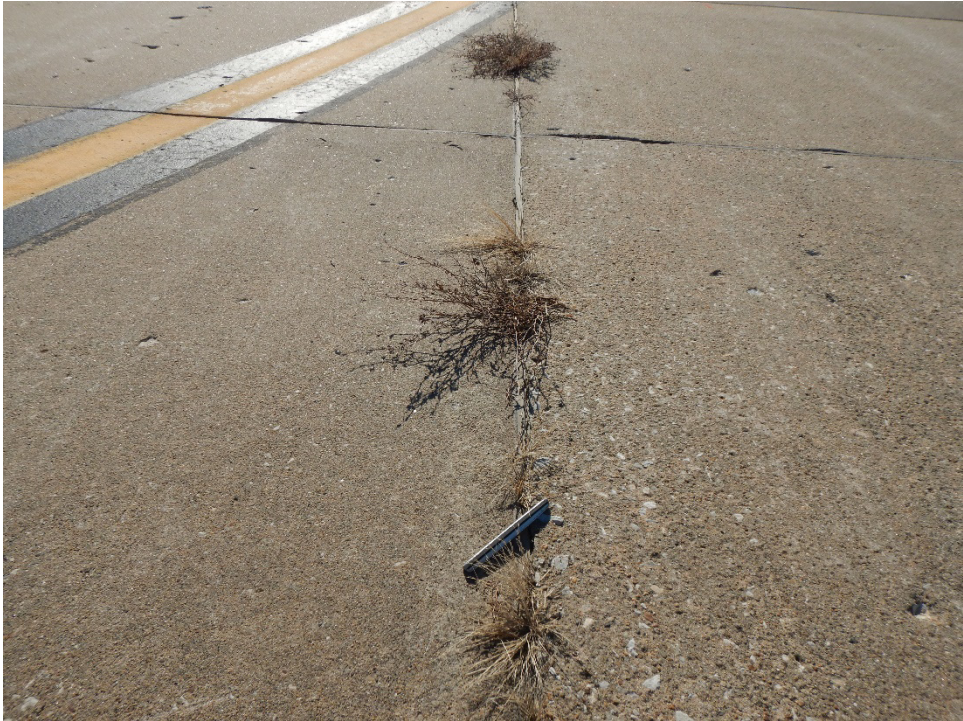
TAKE-02. Joint Seal Damage (Sample Unit No. 01).

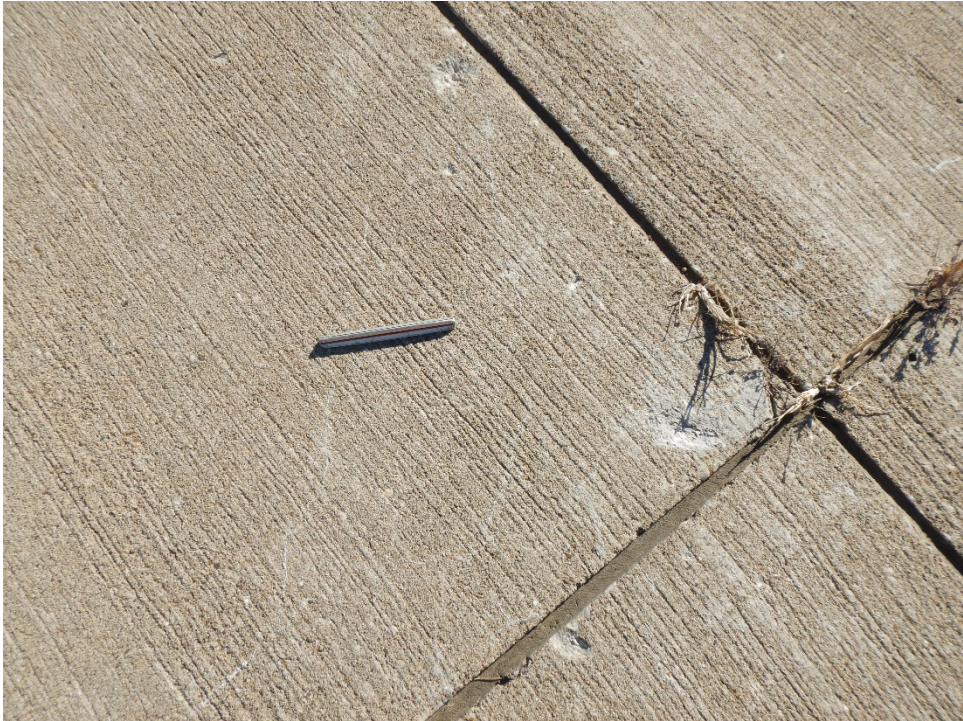
TAKE-03. ASR (Sample Unit No. 04).

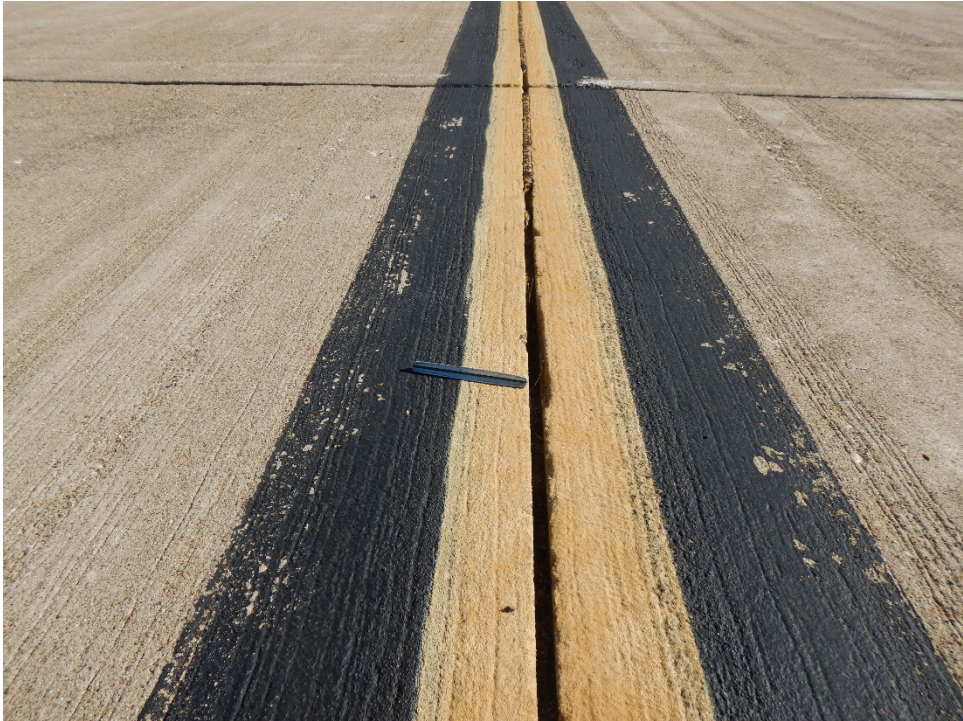
TAKE-03. Joint Seal Damage (Sample Unit No. 07).

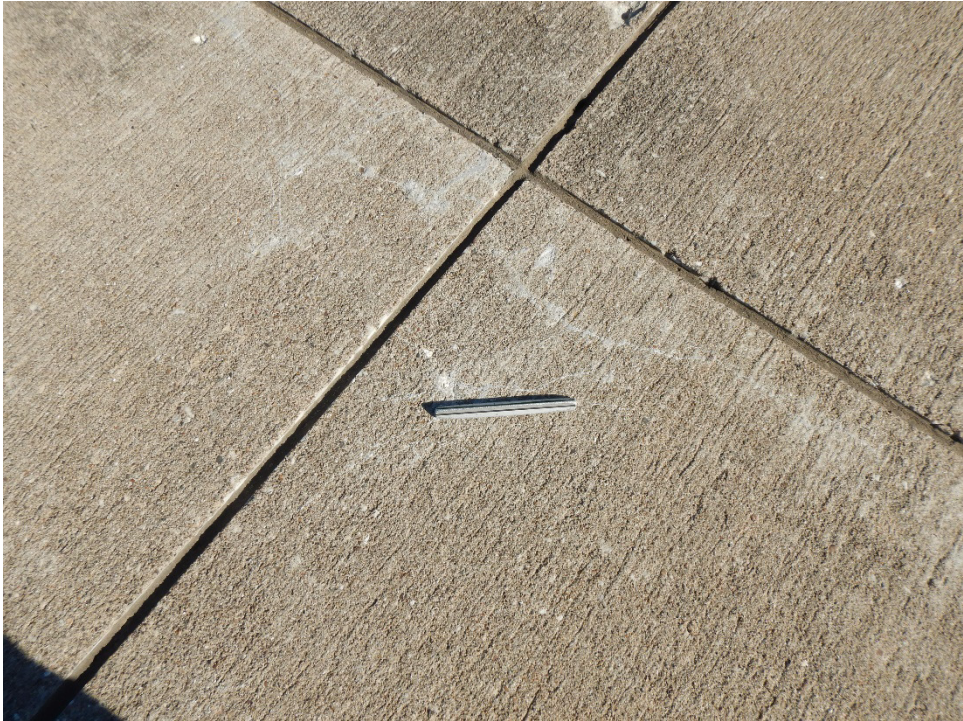
TAKE-04. ASR (Sample Unit No. 19).

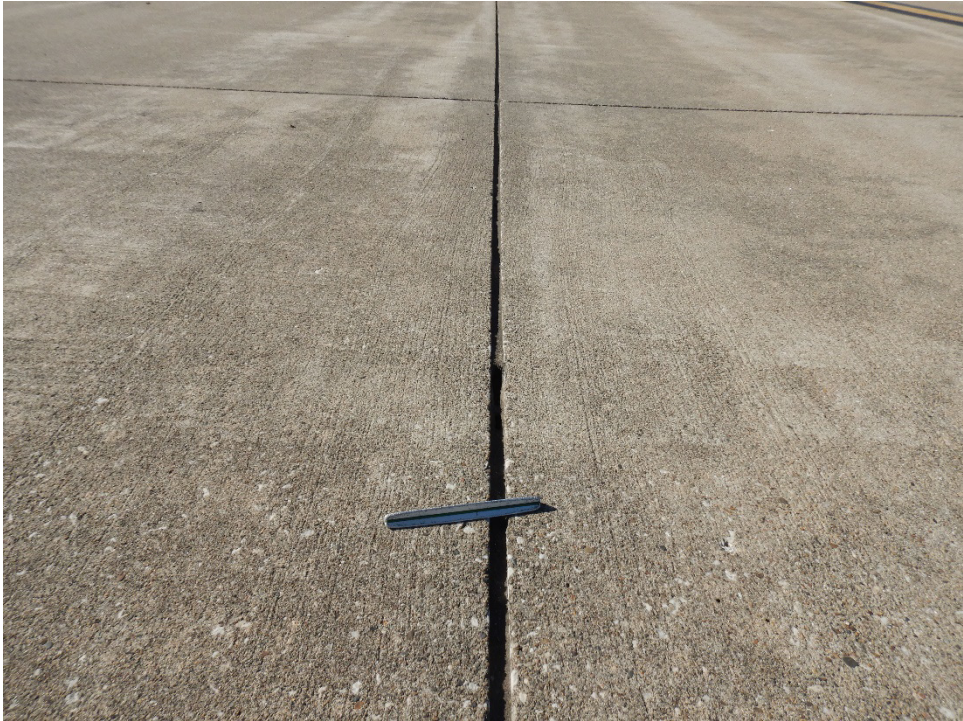
TAKE-04. Joint Seal Damage (Sample Unit No. 82).

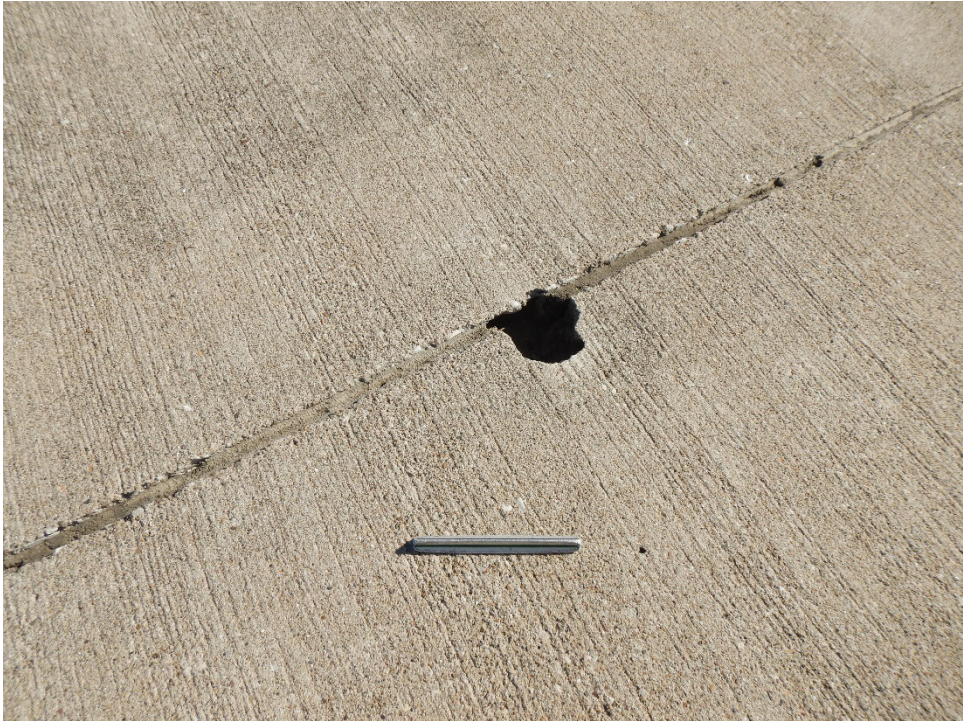
TAKE-04. Small Patching (Sample Unit No. 73).

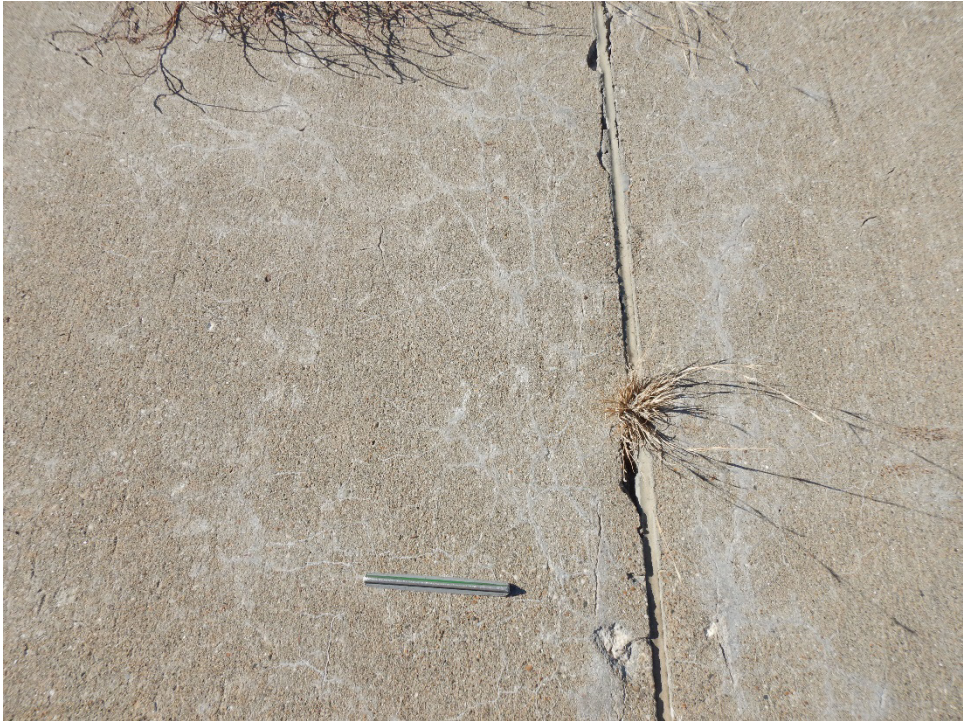
TAKE-05. ASR (Sample Unit No. 02).

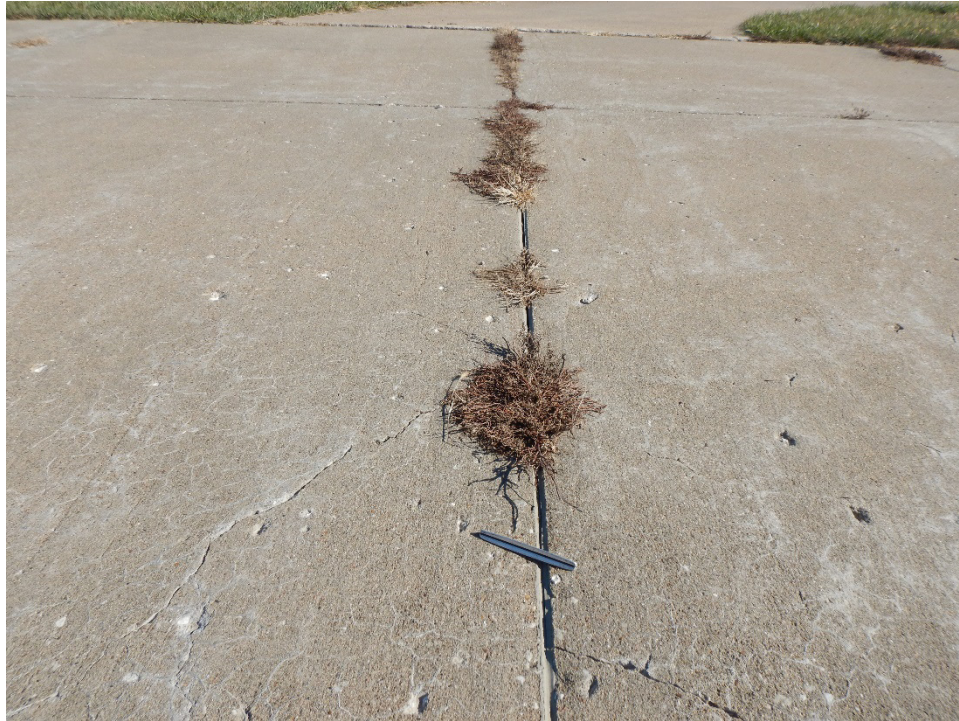
TAKE-05. Joint Seal Damage (Sample Unit No. 02).

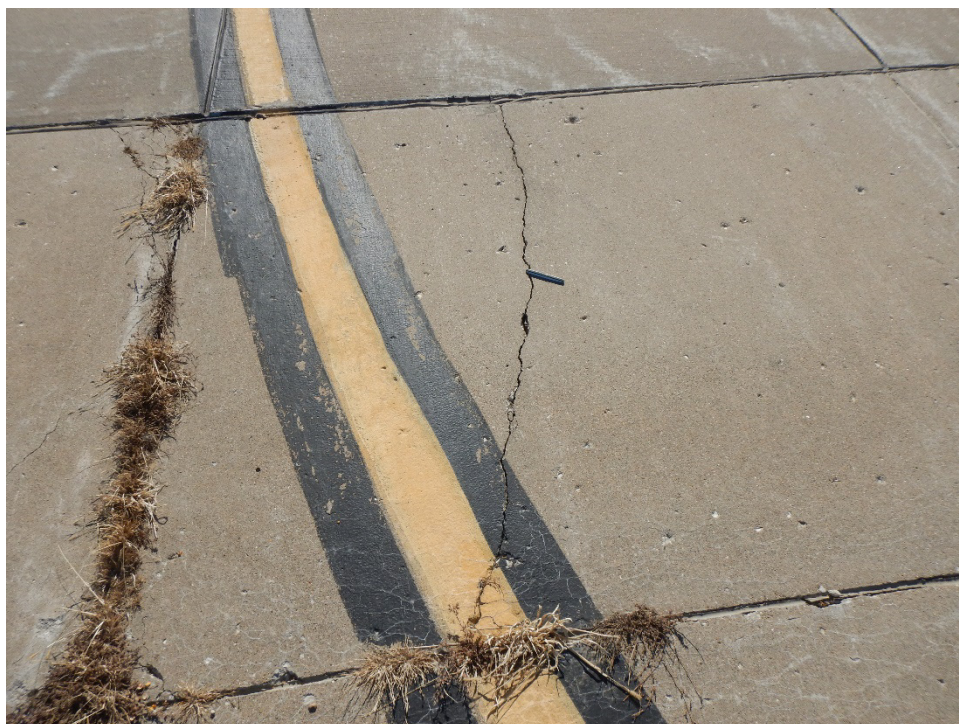
TAKE-05. LTD Cracking (Sample Unit No. 03).
