Keokuk Municipal Airport

Pavement Management Report

JULY 2024

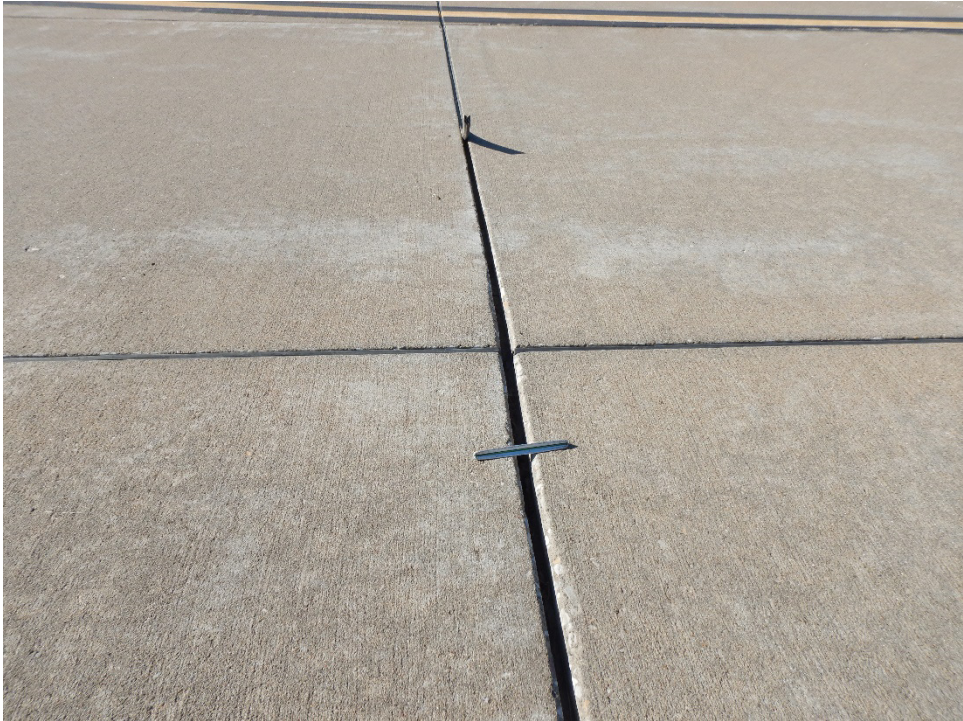
TAKE-06. Joint Seal Damage (Sample Unit No. 03).

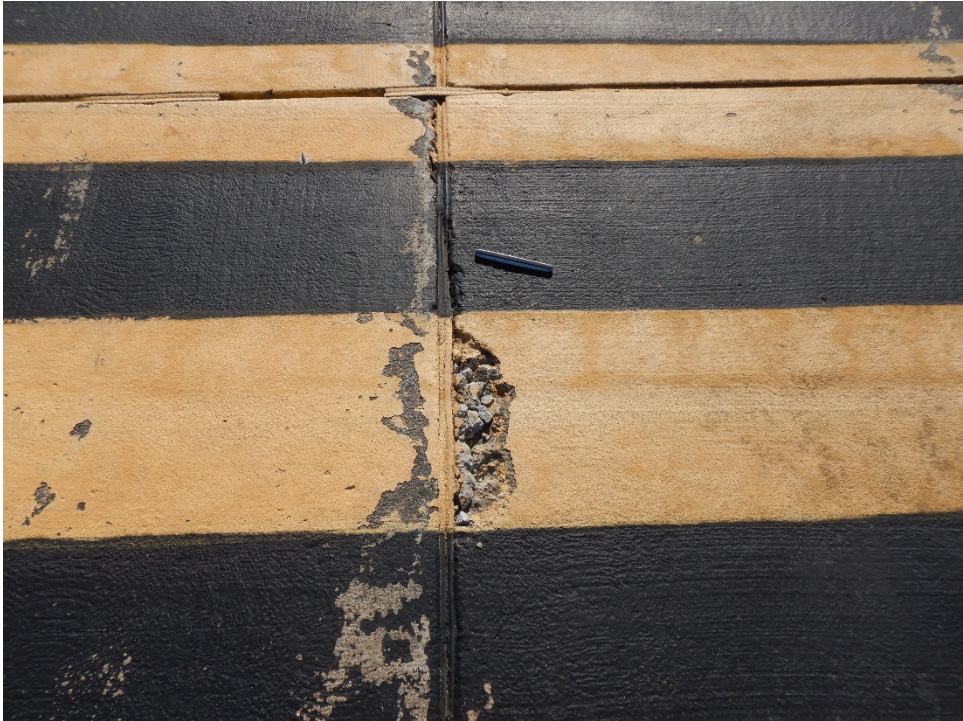
TAKE-06. Joint Spalling (Sample Unit No. 01).

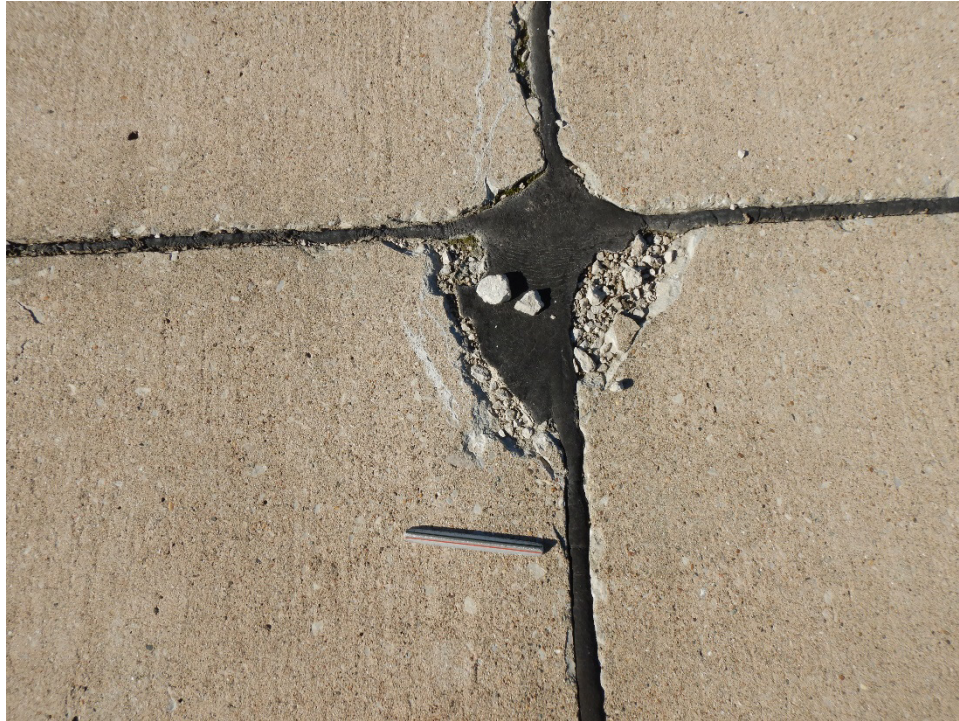
TBKE-01. ASR (Sample Unit No. 03).

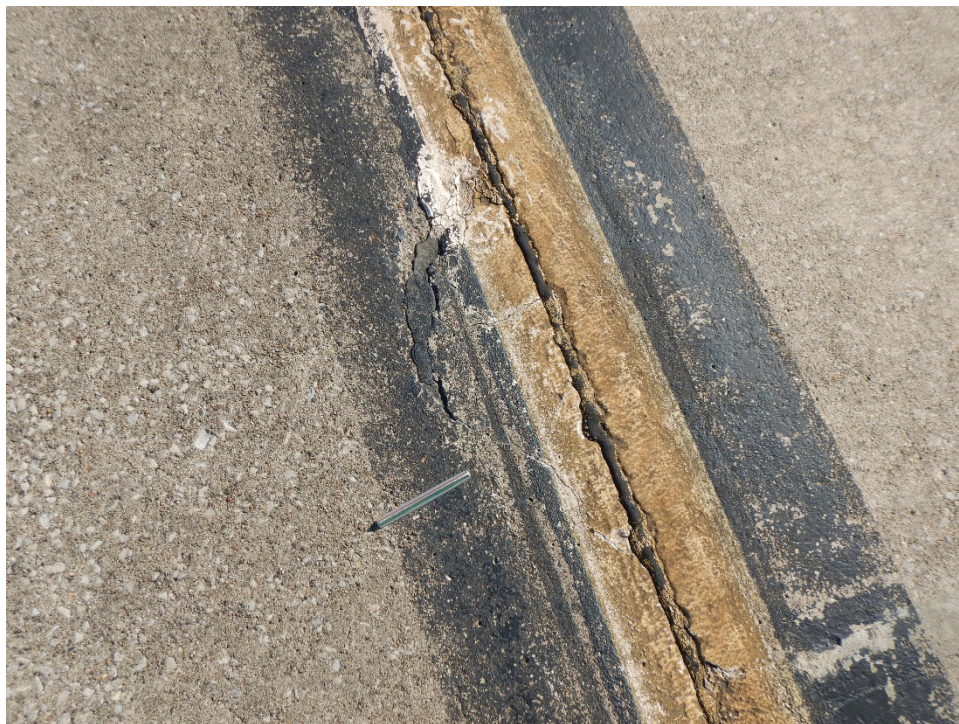
TBKE-01. Joint Spalling (Sample Unit No. 05).

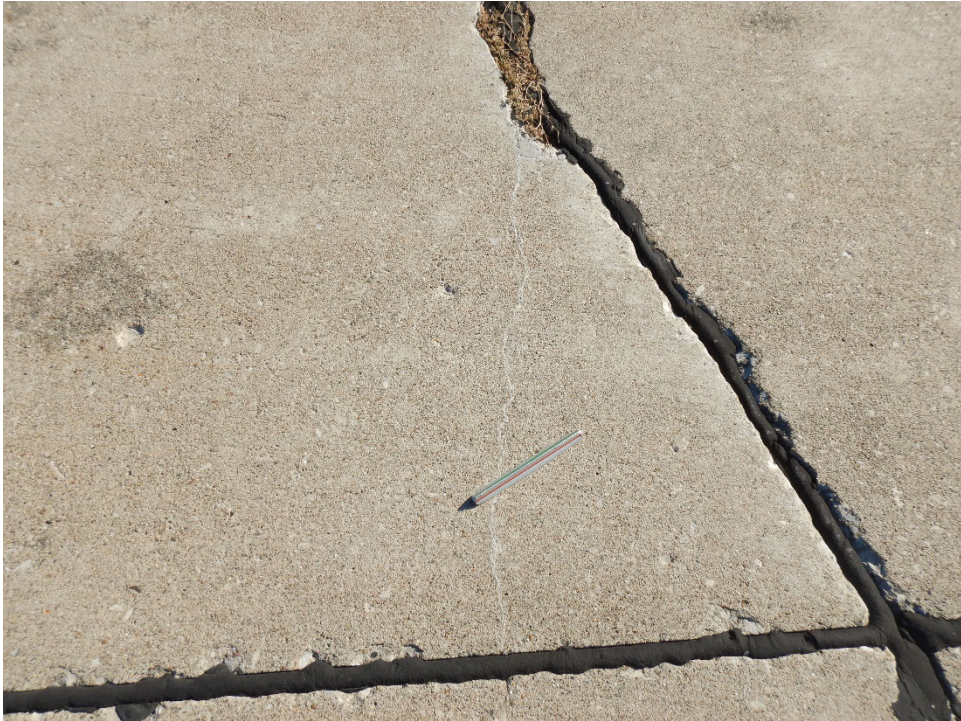
TBKE-02. ASR (Sample Unit No. 02).

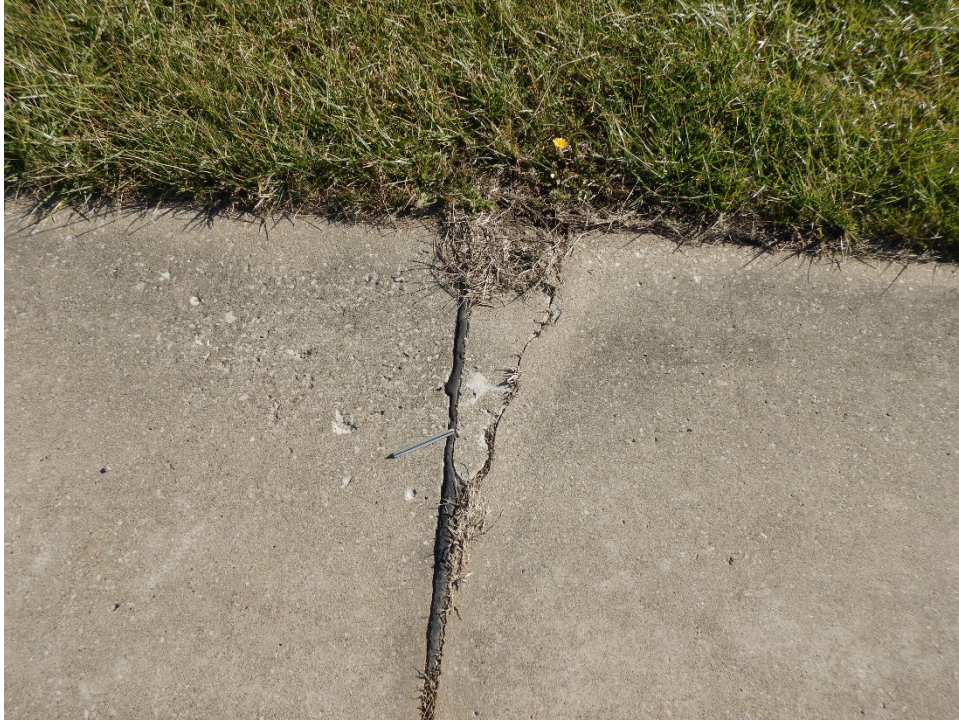
TBKE-02. Joint Spalling (Sample Unit No. 04).

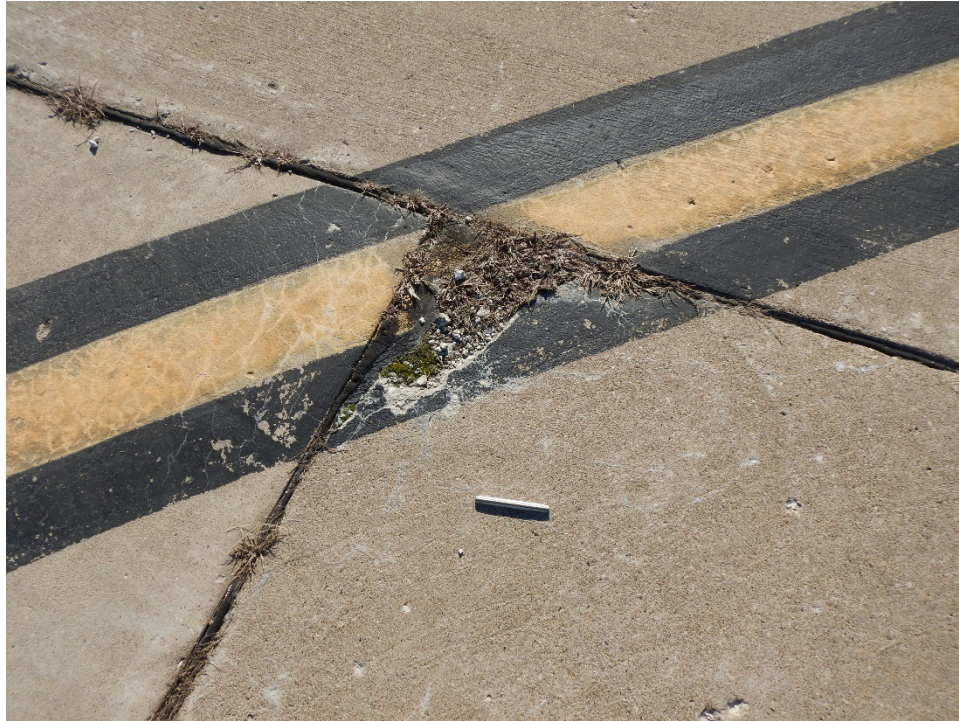
TBKE-03. ASR (Sample Unit No. 03).

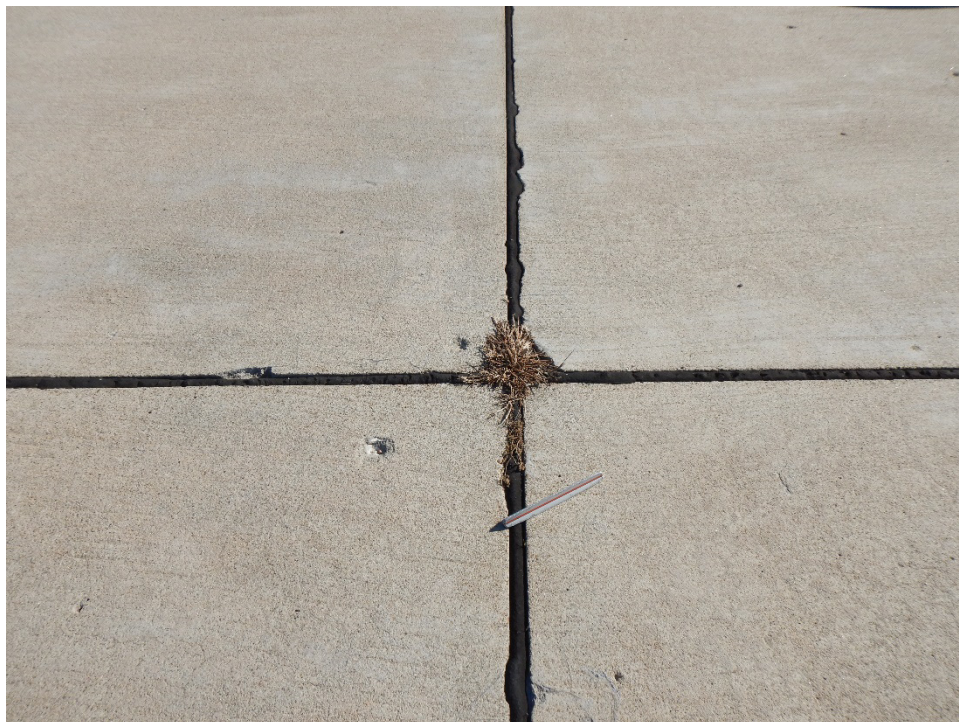
TBKE-03. Joint Seal Damage (Sample Unit No. 01).

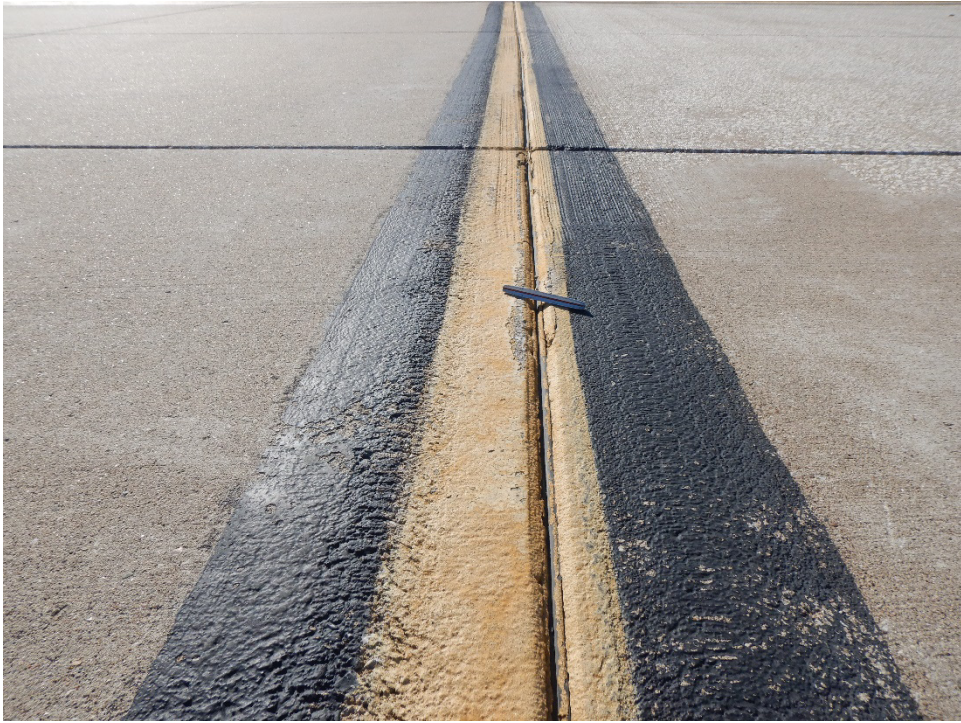
TBKE-04. Joint Seal Damage (Sample Unit No. 01).

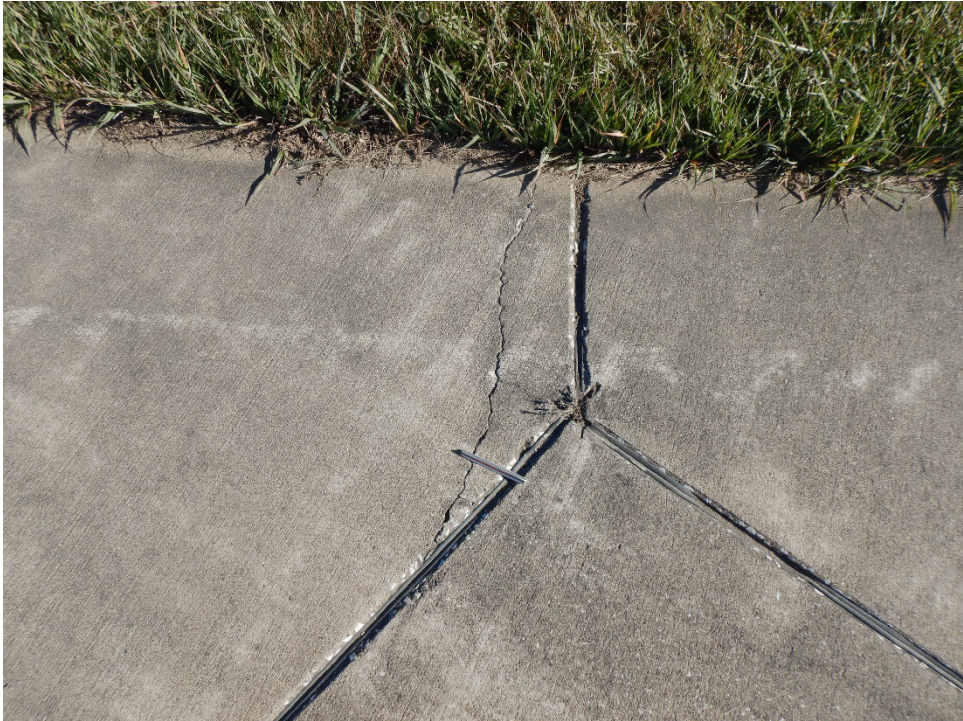
TBKE-04. Joint Spalling (Sample Unit No. 08).

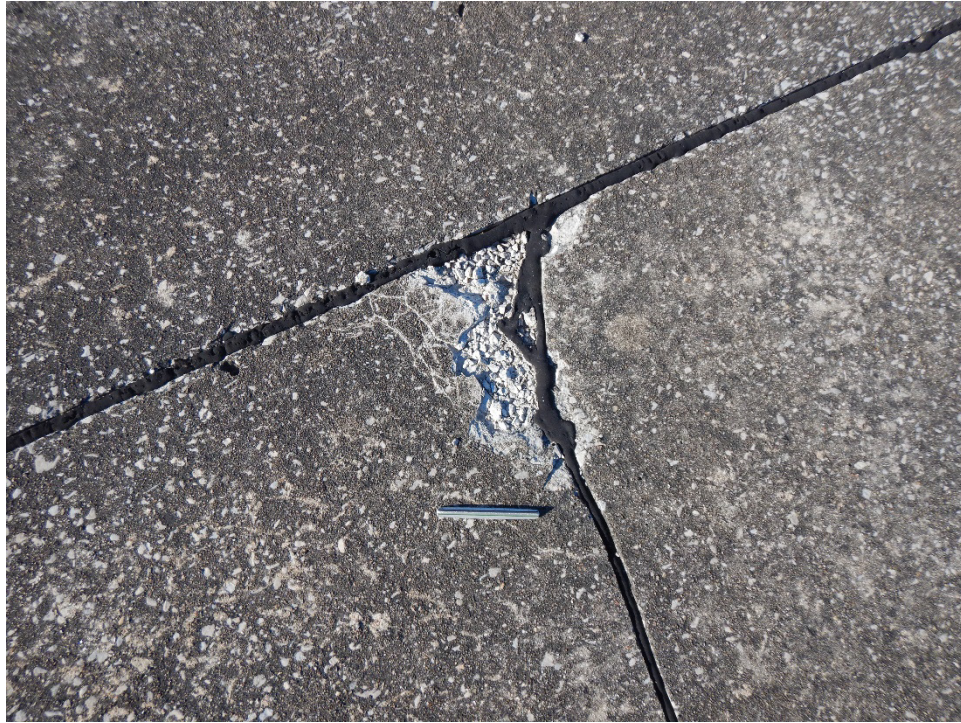
TCKE-02. ASR (Sample Unit No. 09).

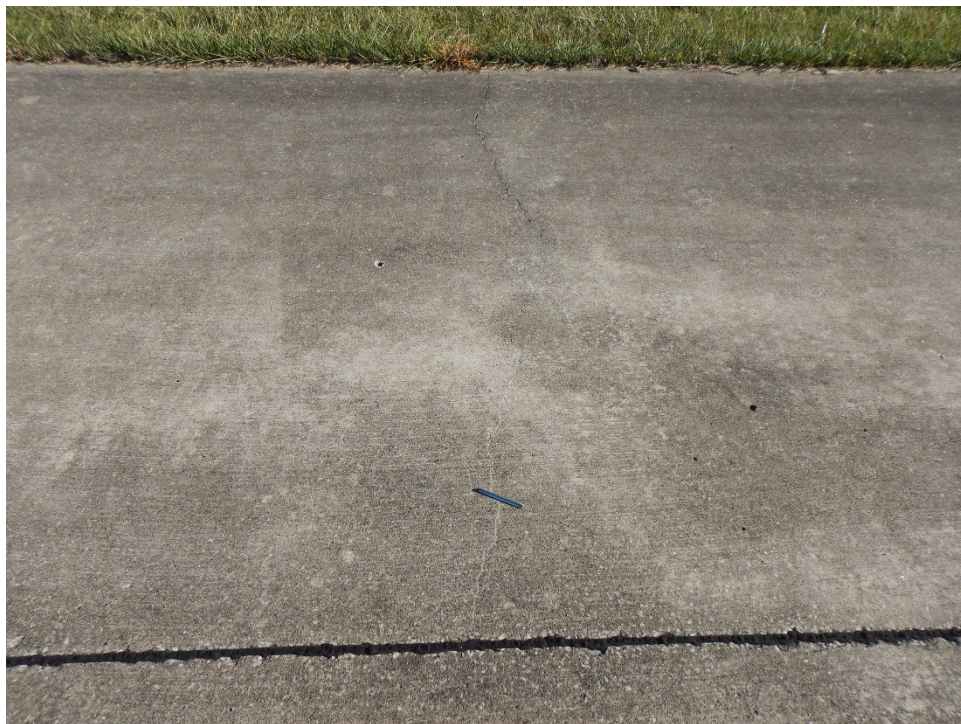
TCKE-02. LTD Cracking (Sample Unit No. 06).

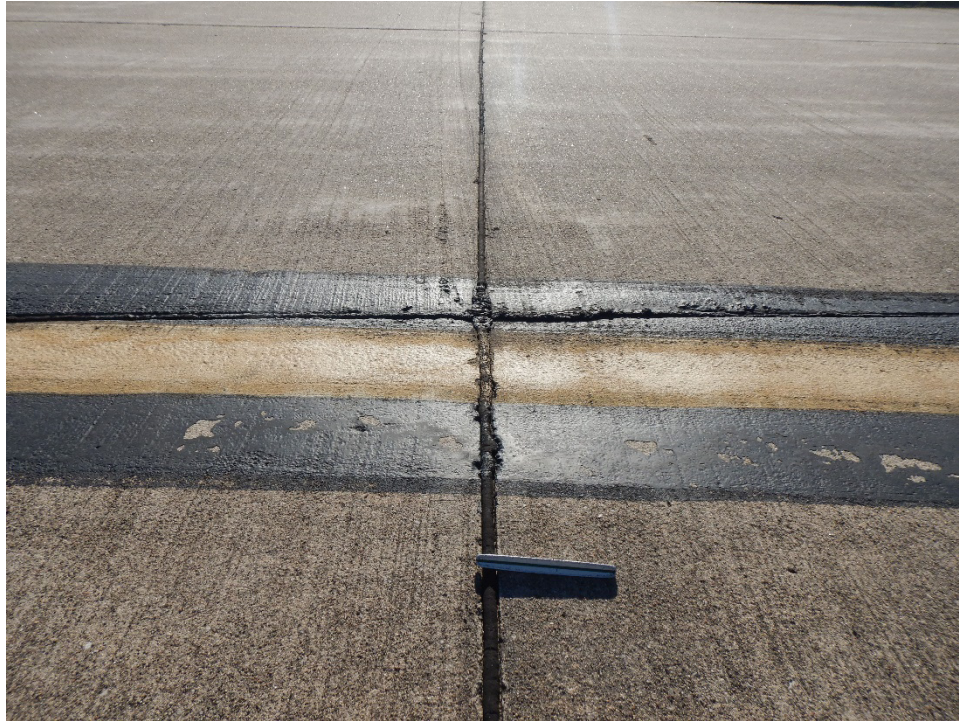
TCKE-03. Joint Seal Damage (Sample Unit No. 03).

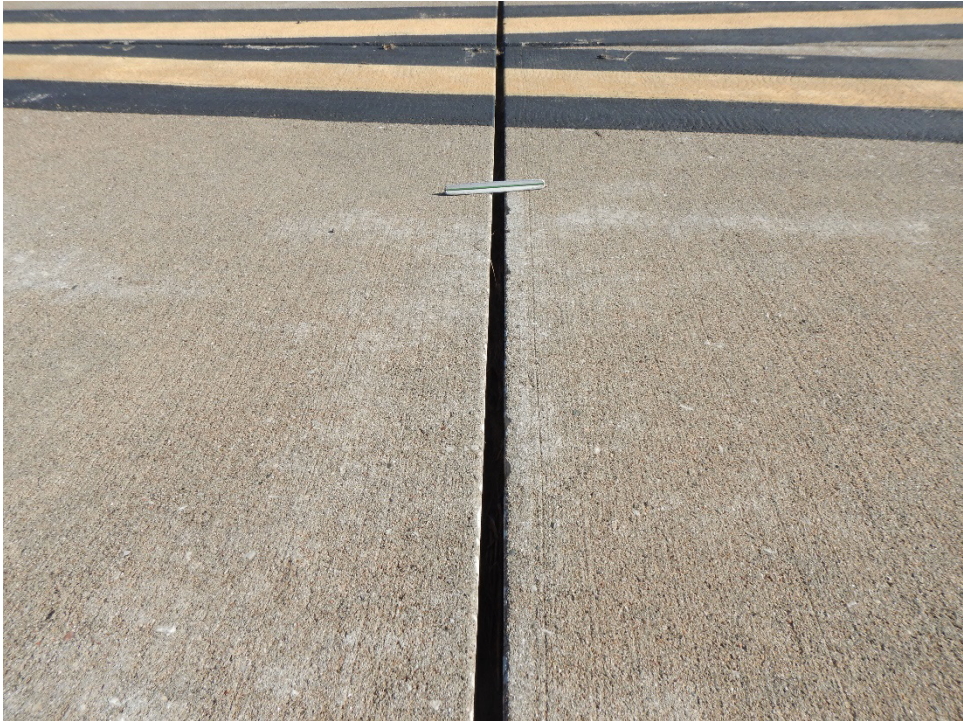
TDKE-01. Joint Seal Damage (Sample Unit No. 05).

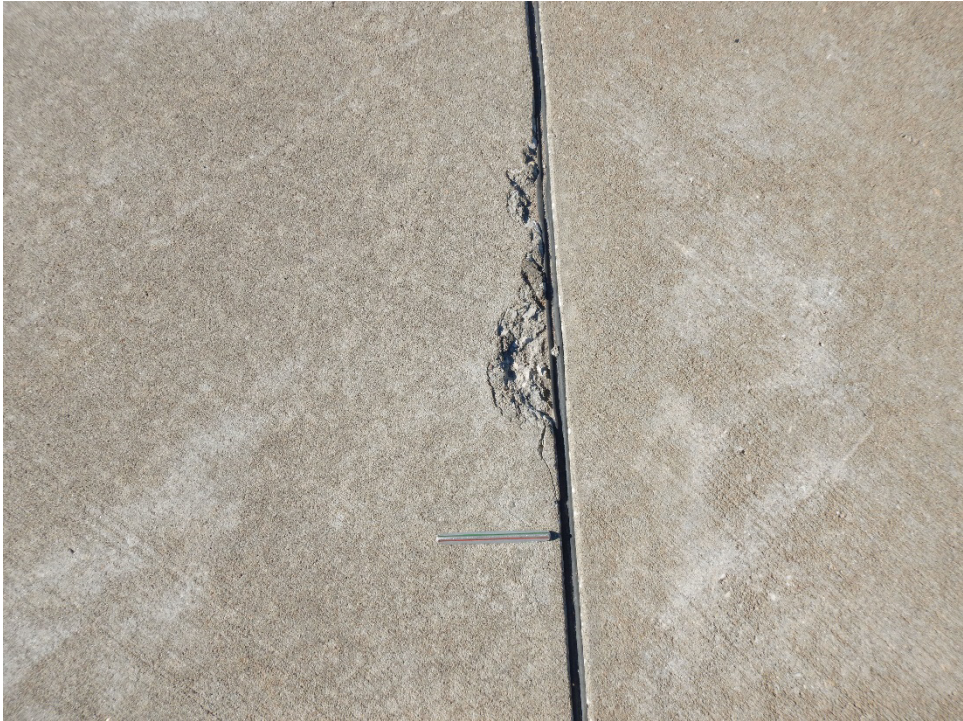
TDKE-01. Joint Spalling (Sample Unit No. 08).

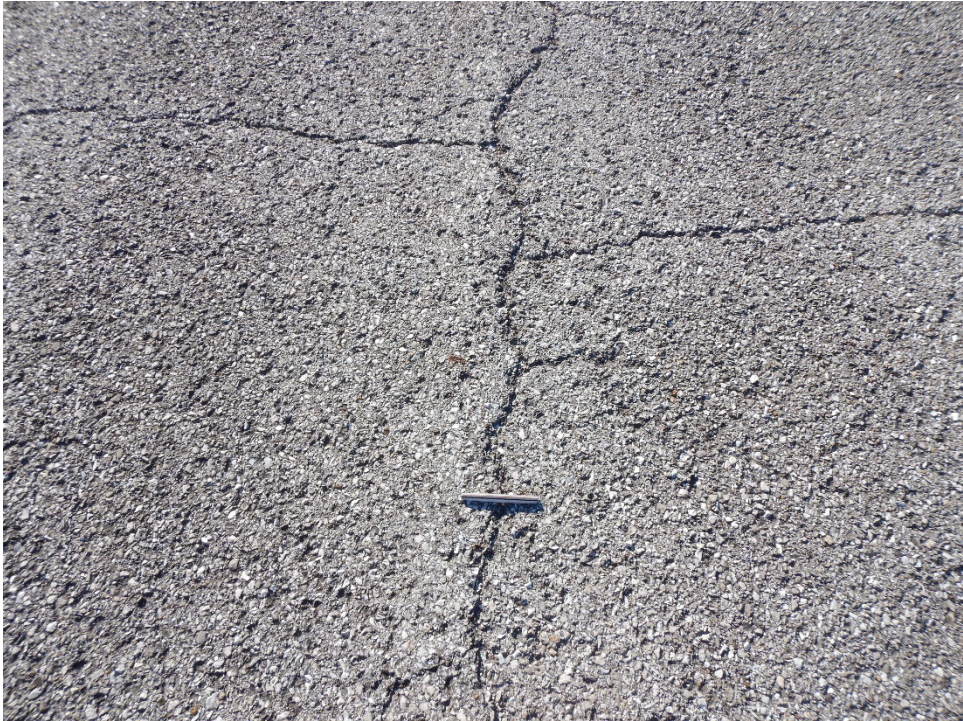
TEKE-01. L&T Cracking (Sample Unit No. 03).

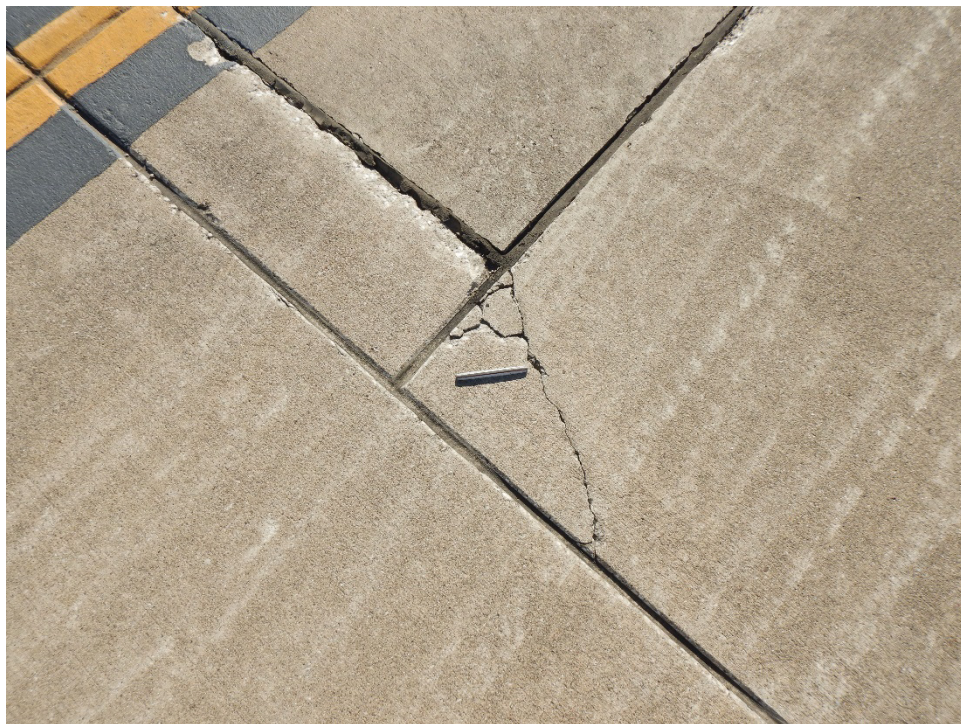
TH01KE-01. Corner Break (Sample Unit No. 24).

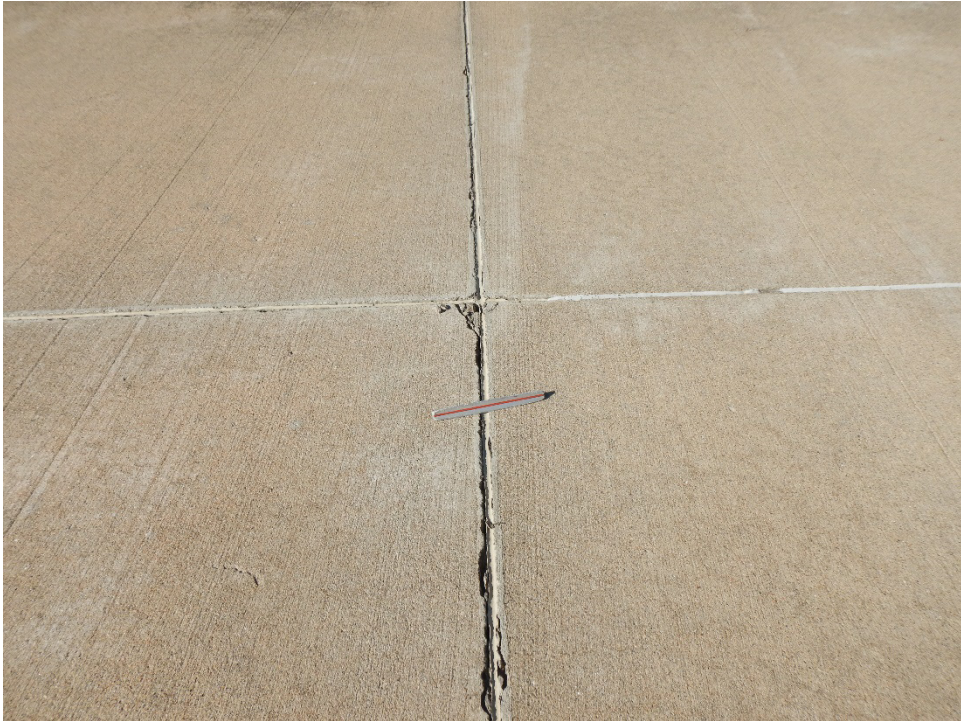
TH01KE-01. Joint Seal Damage (Sample Unit No. 18).
