# Knoxville Municipal Airport

**PAVEMENT MANAGEMENT REPORT**

**AUGUST 2019**

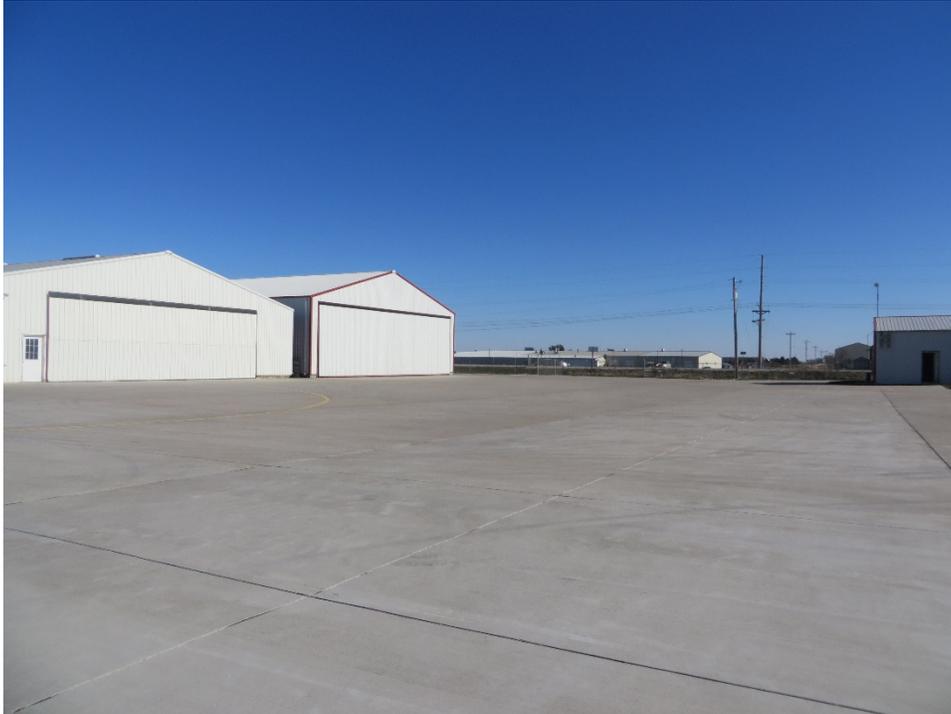
Apron 01 contained one recently rehabilitated section. Section 01 was in excellent condition with isolated amounts of low-severity LTD cracking and shrinkage cracking that were recorded as an additional sample unit according to ASTM D5340-12.

A01KN-01. Overview.

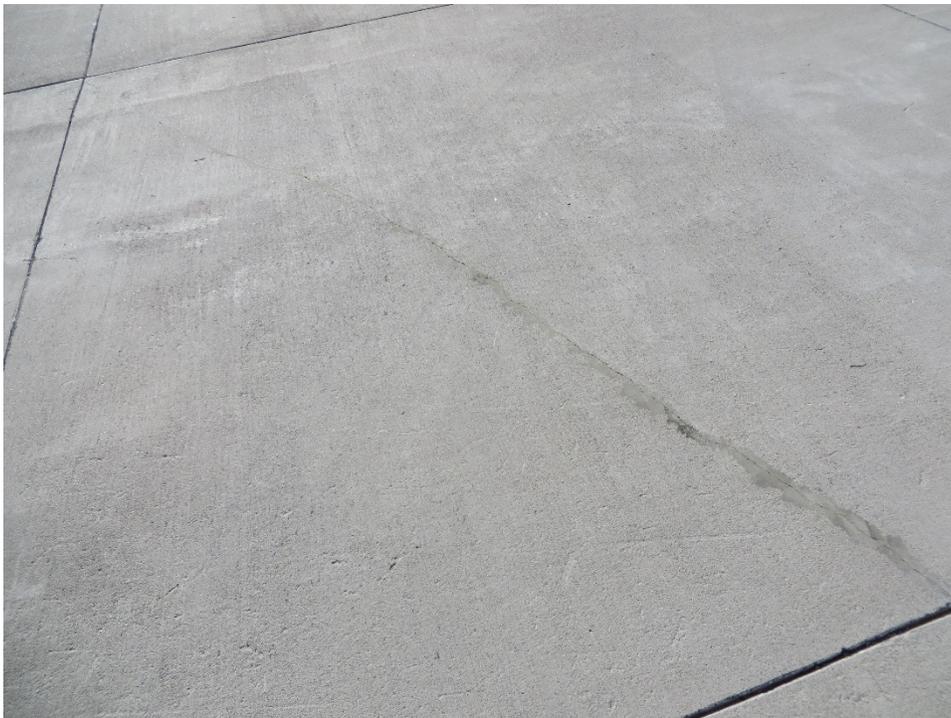
A01KN-01. LTD Cracking (Additional Sample Unit No. 12).

Sample Number: 12 Type: A Area: 20.00Slabs PCI = 94  
Sample Comments:  
63 LINEAR CRACKING L 1.00 Slabs Comments:  
73 SHRINKAGE CRACKING N 1.00 Slabs Comments:

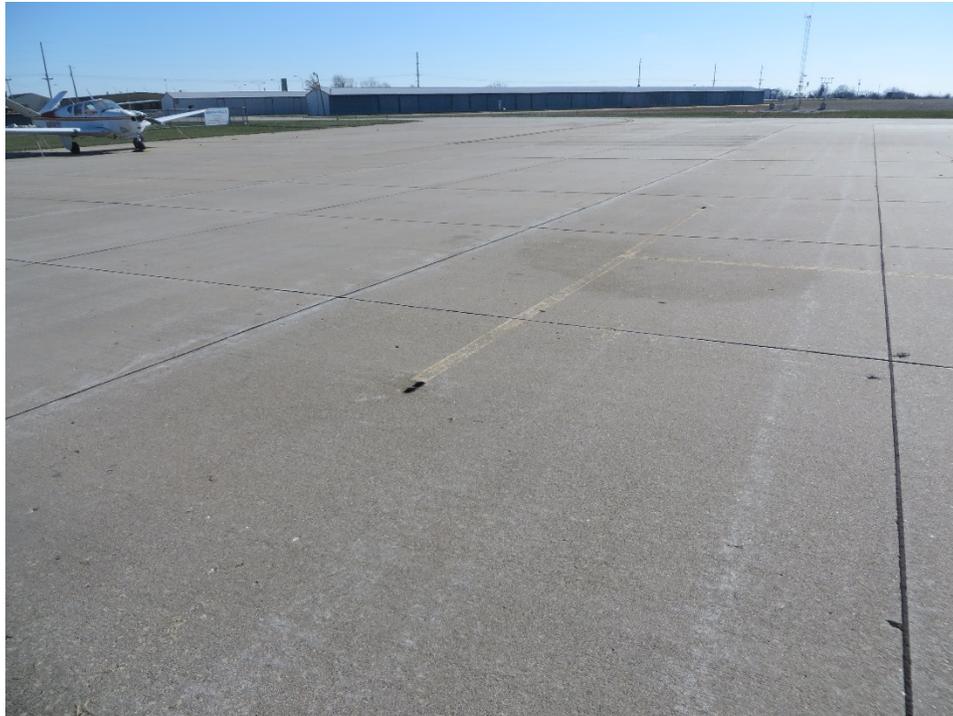
Apron 02 was defined by two sections. Low-severity corner spalling, faulting, joint seal damage, joint spalling, and LTD cracking were identified in Section 01. Section 02 was in excellent condition with low-severity joint seal damage recorded throughout along with areas of low-severity LTD cracking.

A02KN-01. Overview.

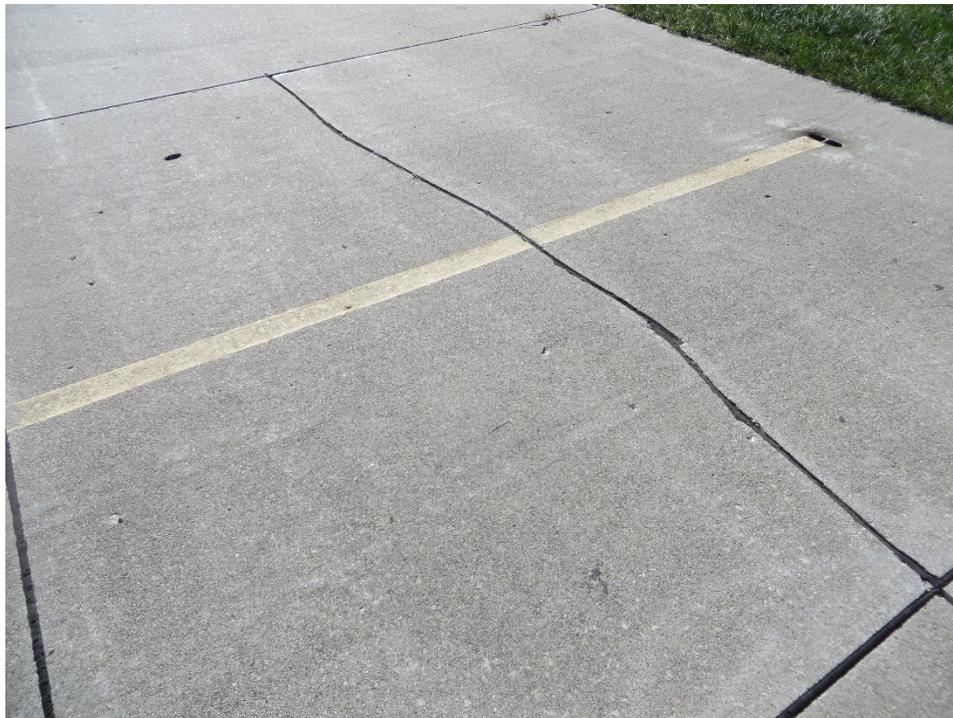
A02KN-01. LTD Cracking (Sample Unit No. 08).

Sample Number: 08 Type: R Area: 25.00Slabs PCI = 83  
Sample Comments:  
65 JOINT SEAL DAMAGE L 25.00 Slabs Comments:  
71 FAULTING L 3.00 Slabs Comments:  
74 JOINT SPALLING L 1.00 Slabs Comments:  
63 LINEAR CRACKING L 1.00 Slabs Comments:

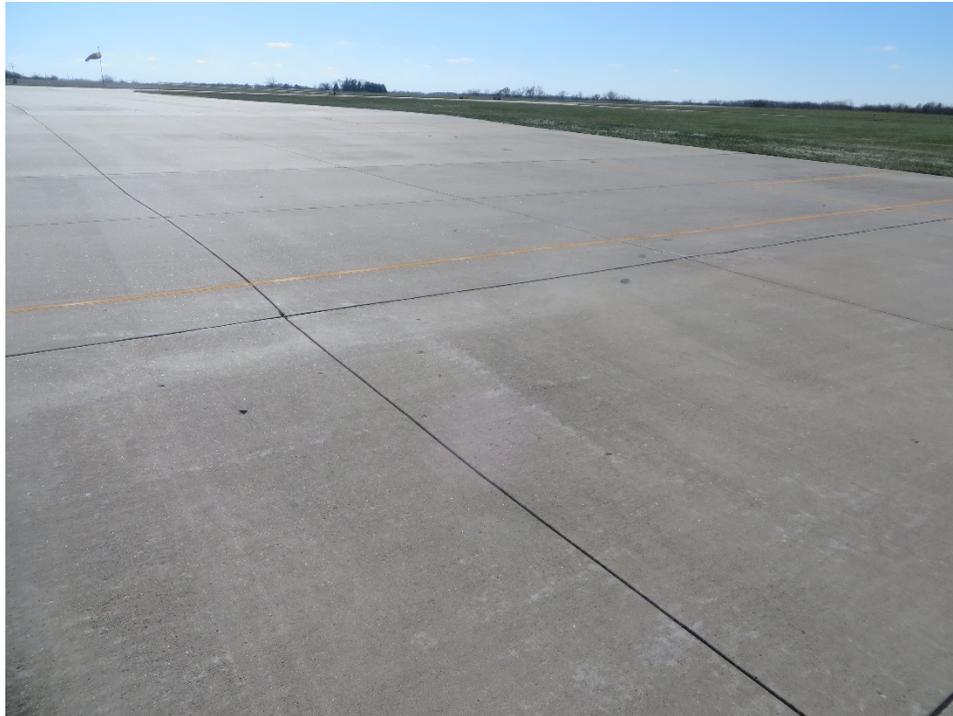
A02KN-02. Overview.

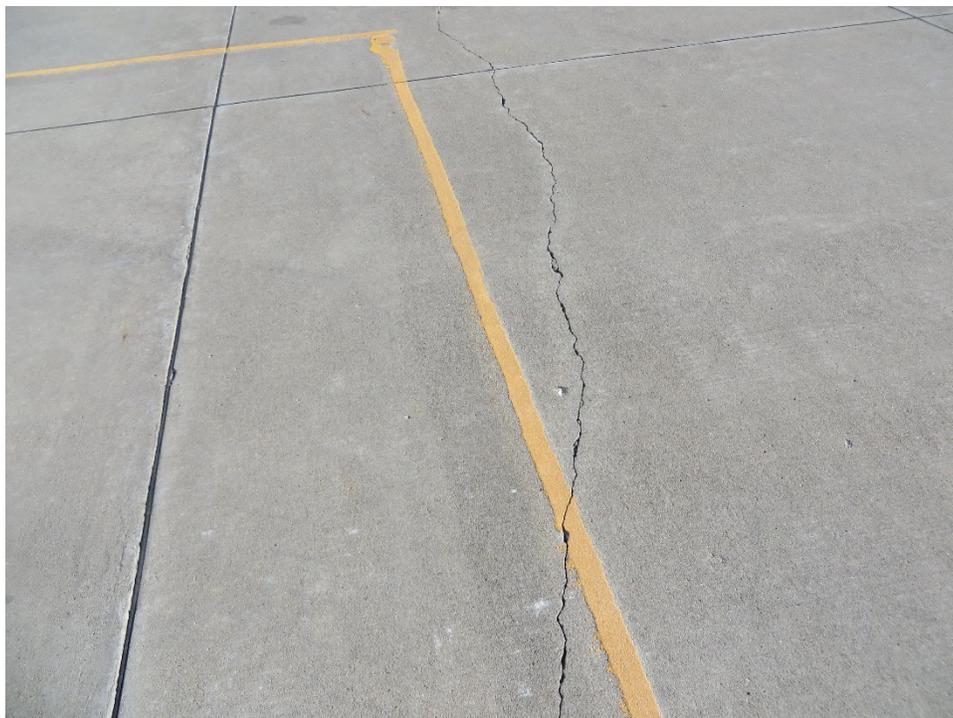
A02KN-02. LTD Cracking (Sample Unit No. 04).

Sample Number: 04 Type: R Area: 25.00Slabs PCI = 88  
Sample Comments:  
65 JOINT SEAL DAMAGE L 25.00 Slabs Comments:  
63 LINEAR CRACKING L 3.00 Slabs Comments:

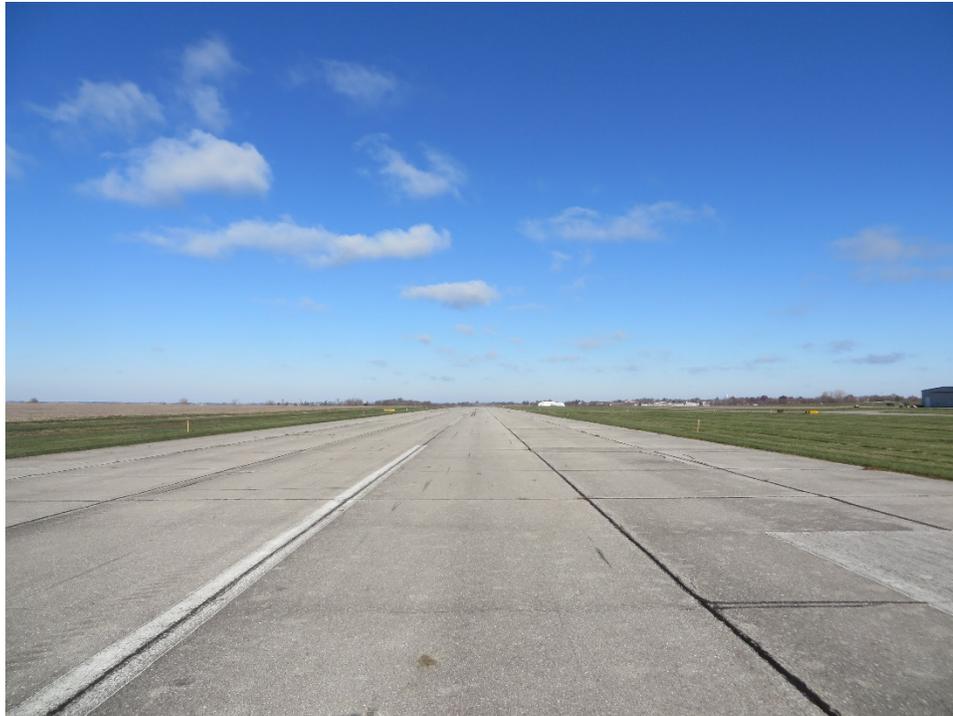
Runway 15/33 consisted of two sections. Section 01, which comprised the majority of the runway, was in poor condition with low- and medium-severity joint reflection cracking, longitudinal and transverse (L&T) cracking, swelling, and weathering; low-severity patching; and all severities of raveling recorded. The low-severity cracking was in either the sealed and unsealed condition, while the medium-severity cracking was due to either unsatisfactory crack sealant or unsealed crack widths greater than 1/4 in. Section 02, the extension located at the Runway 33 approach, had low- and medium-severity joint seal damage observed throughout along with smaller amounts of low-severity corner spalling and faulting and low- and medium-severity joint spalling.

R15KN-01. Overview.

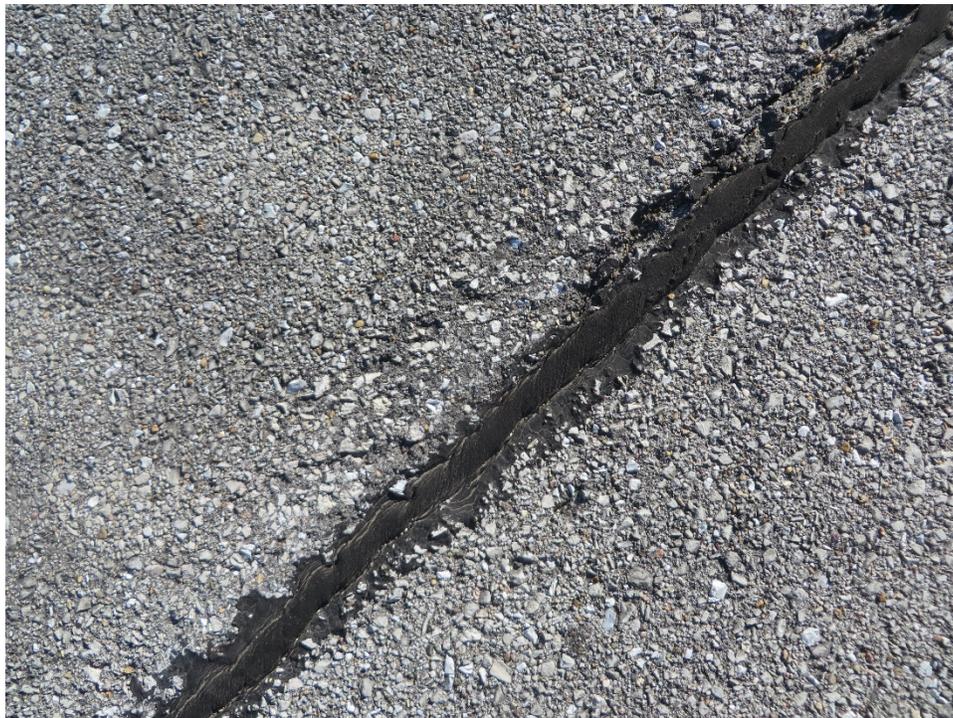
R15KN-01. L&T Cracking (Sample Unit No. 02).

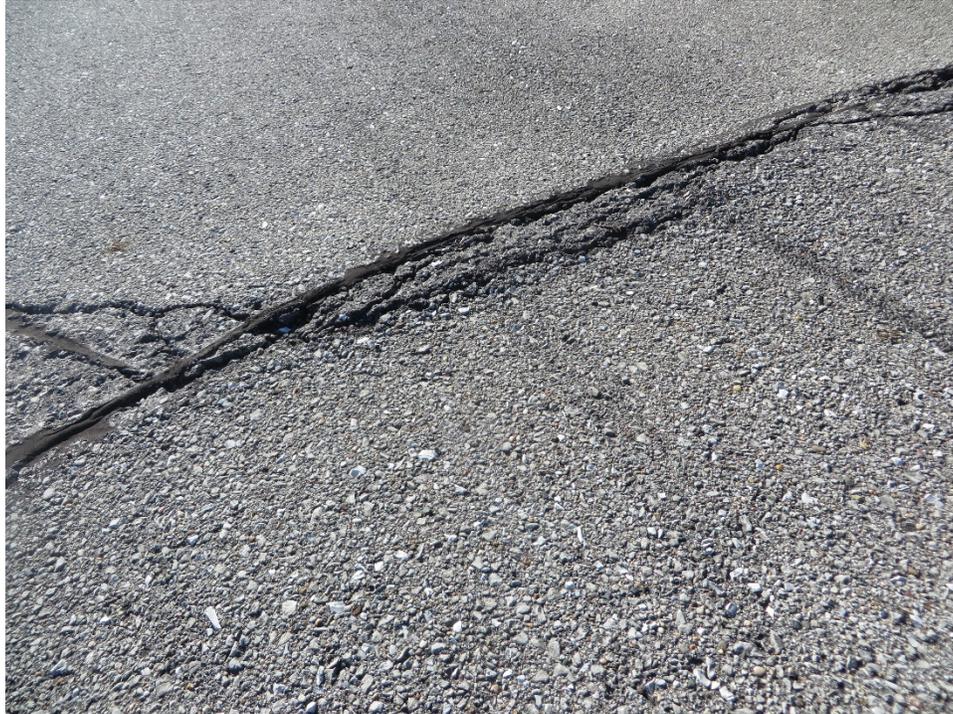
R15KN-01. Swelling (Sample Unit No. 29).

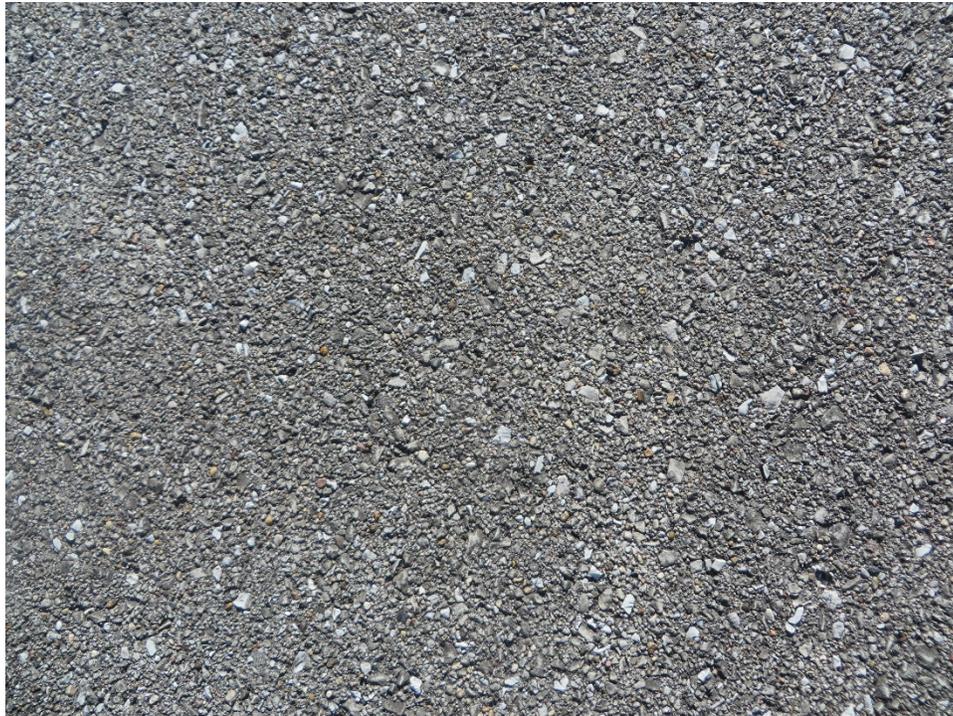
R15KN-01. Weathering (Sample Unit No. 02).

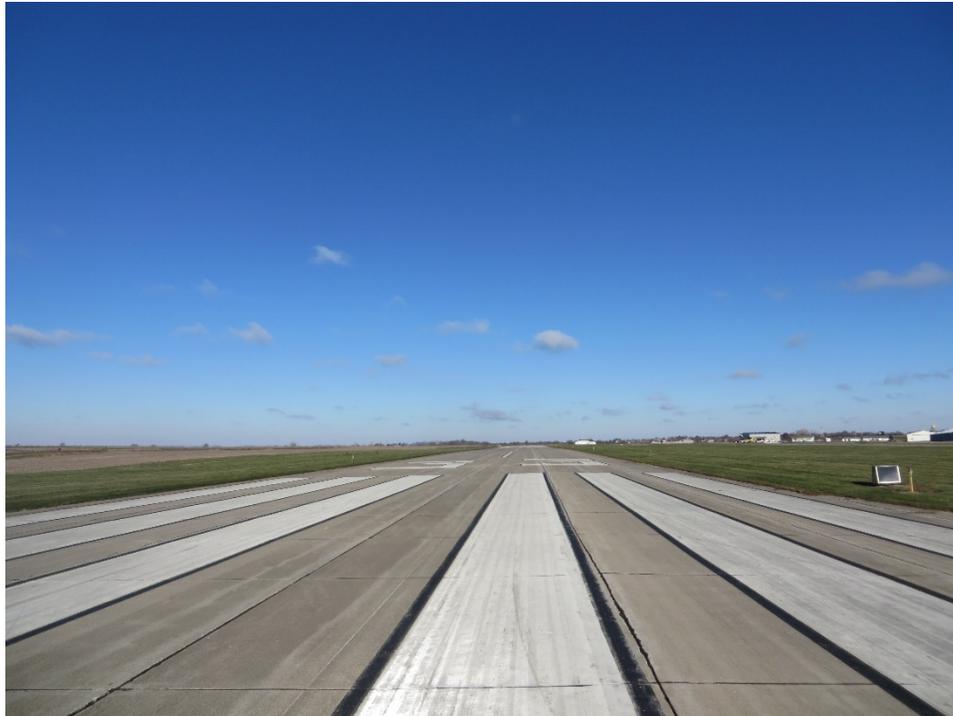
R15KN-02. Overview.

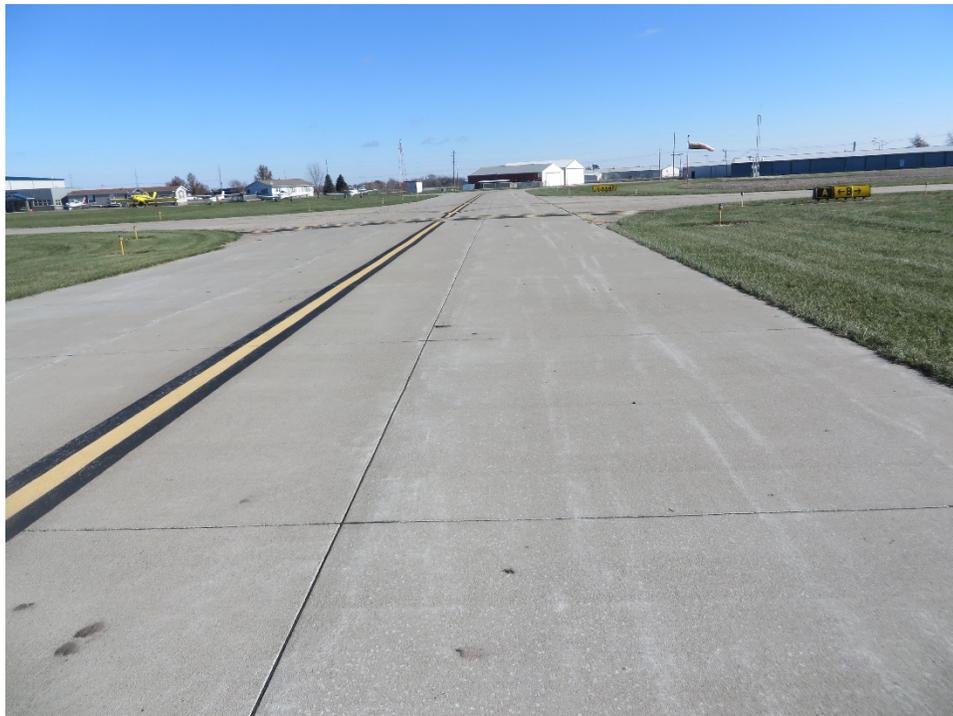
Taxiway 01 was defined by one section that was recently rehabilitated. Section 01 connected the apron areas to Runway 15/33 and was in excellent condition with only small amounts of shrinkage cracking and low-severity small patching identified.

T01KN-01. Overview.

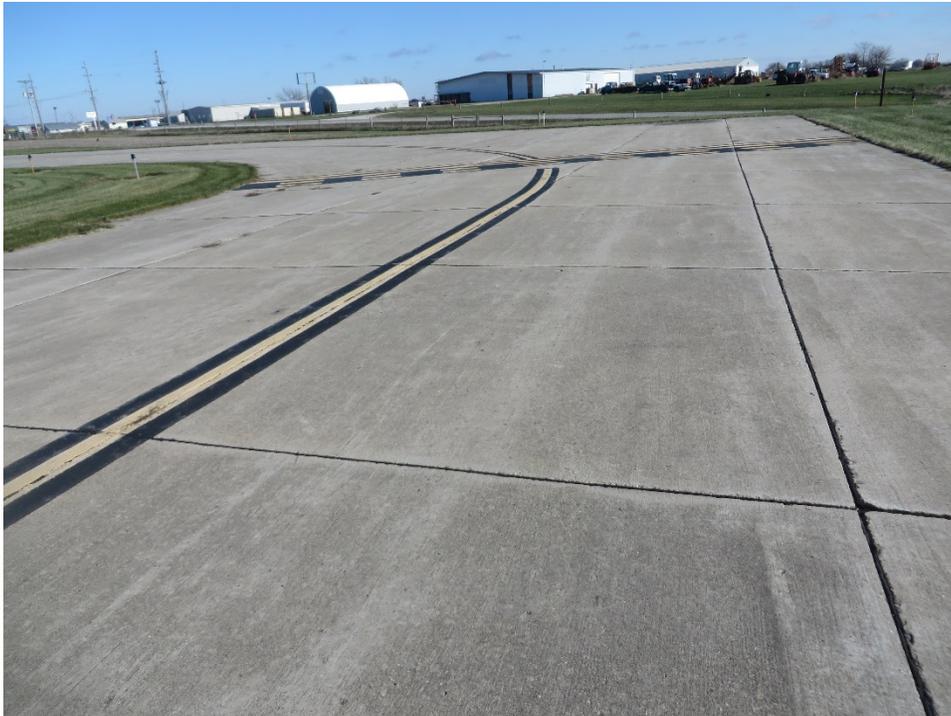
Taxiway 02 contained one section and was located at the Runway 33 approach. Section 01 was in excellent condition with medium-severity corner spalling and joint spalling and low-severity joint seal damage recorded.

T02KN-01. Overview.

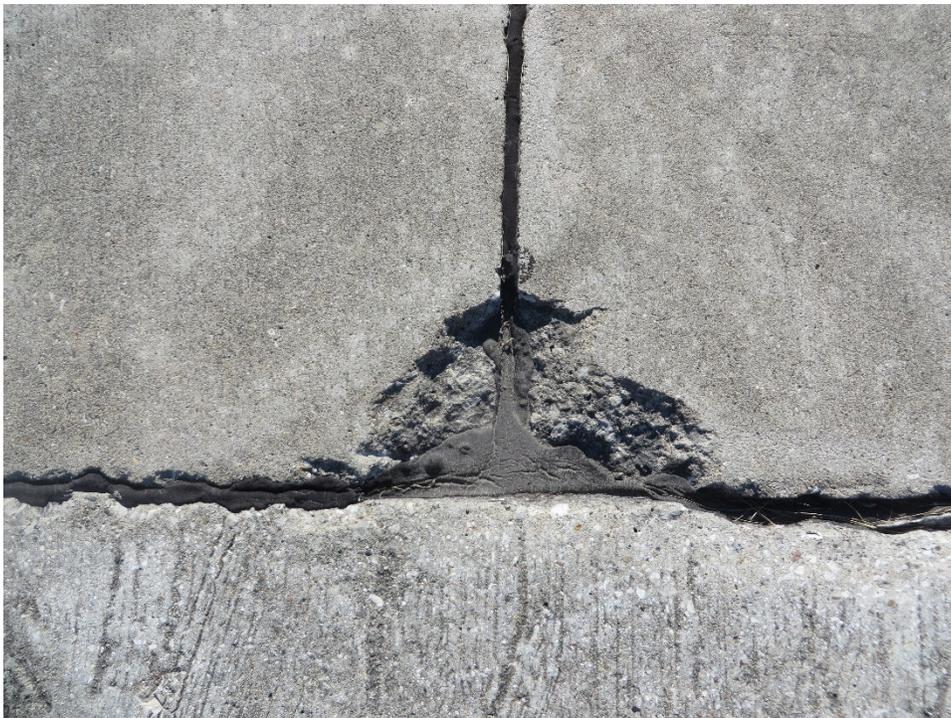
T02KN-01. Corner Spalling (Sample Unit No. 06).

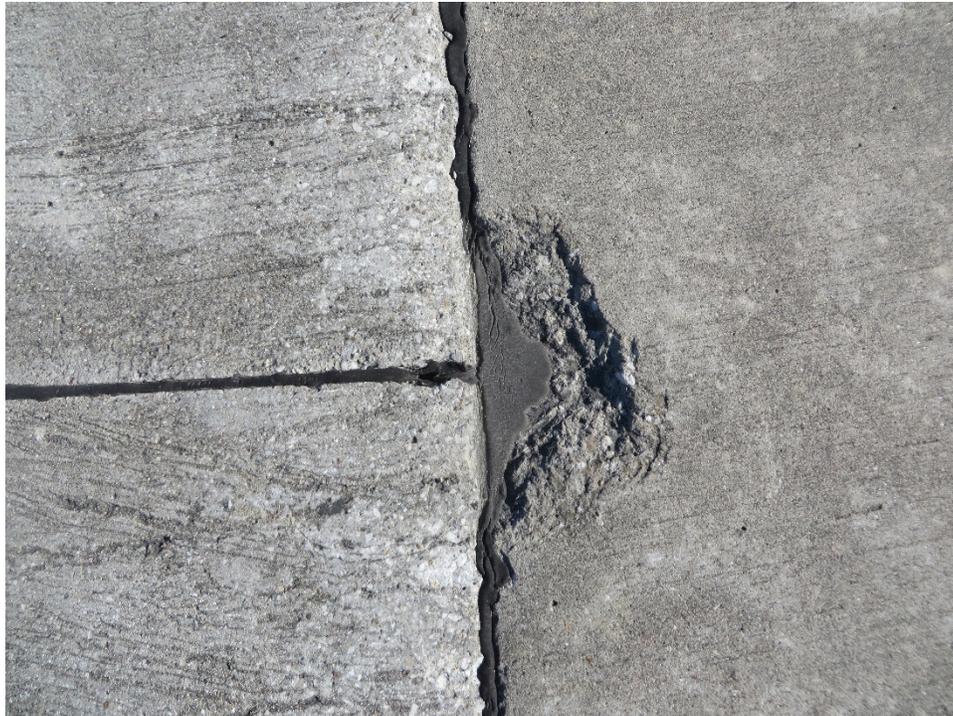
T02KN-01. Joint Spalling (Sample Unit No. 06).

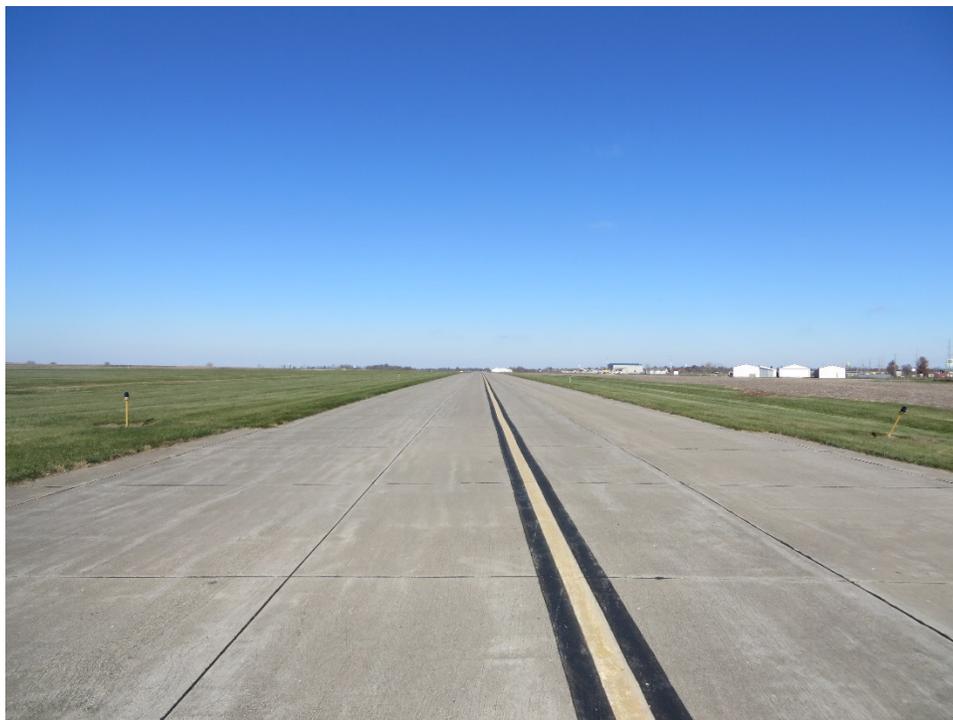
T03KN-01. Overview.

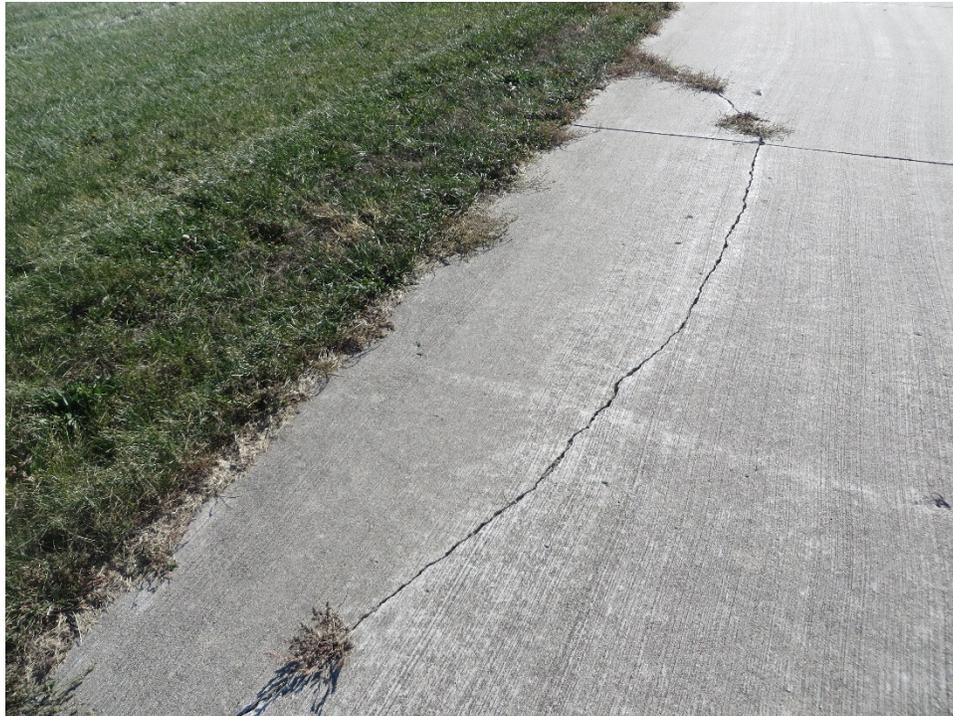
T03KN-01. LTD Cracking (Sample Unit No. 08).

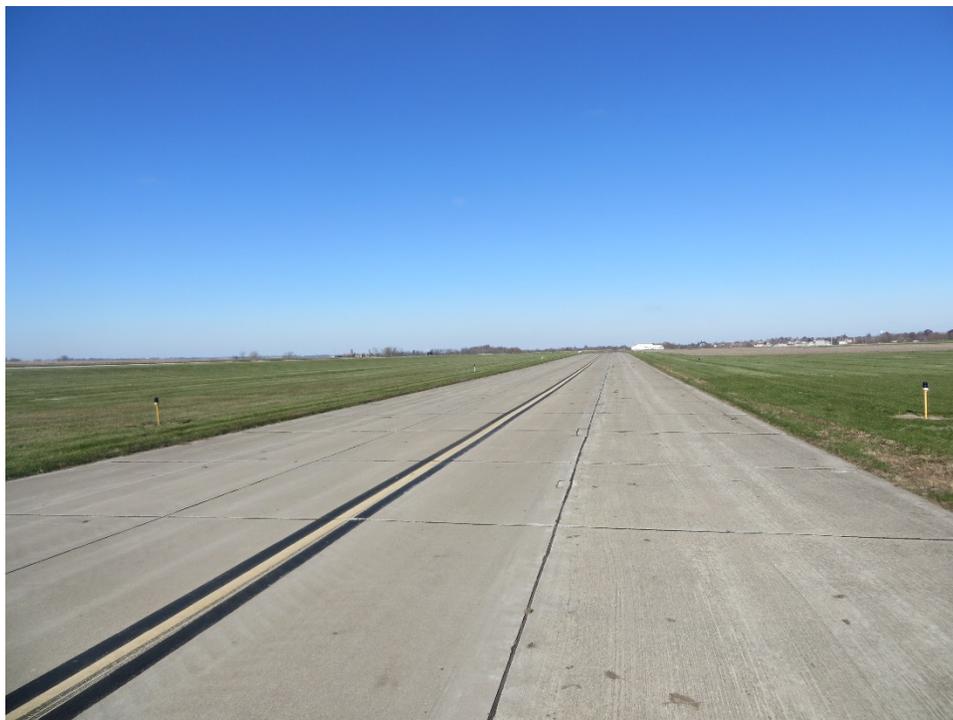
T03KN-02. Overview.

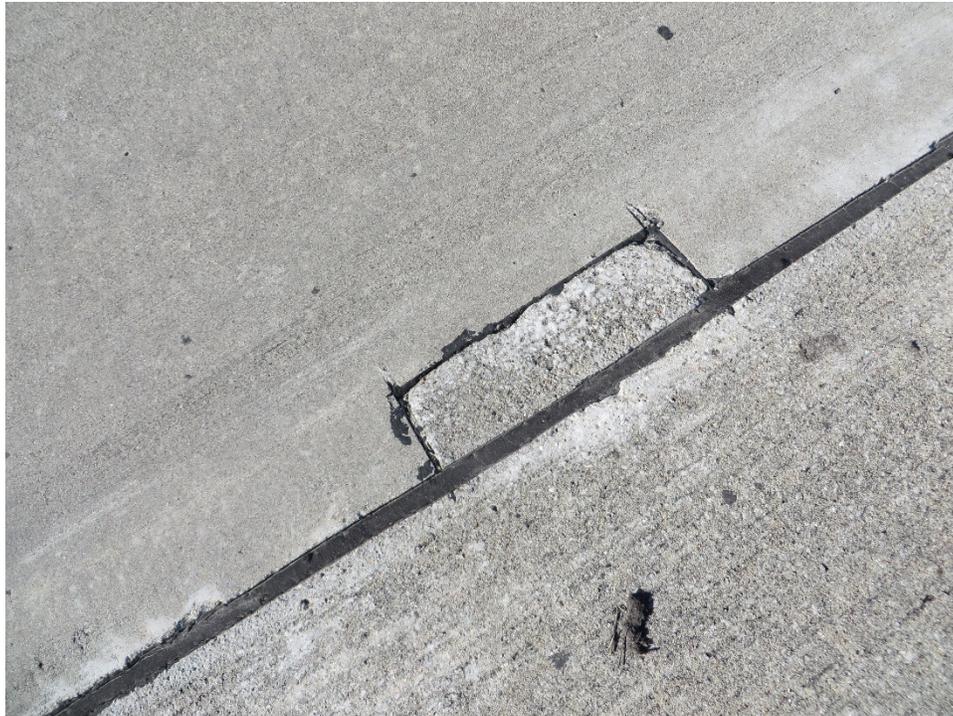
T03KN-02. Small Patching (Sample Unit No. 02).

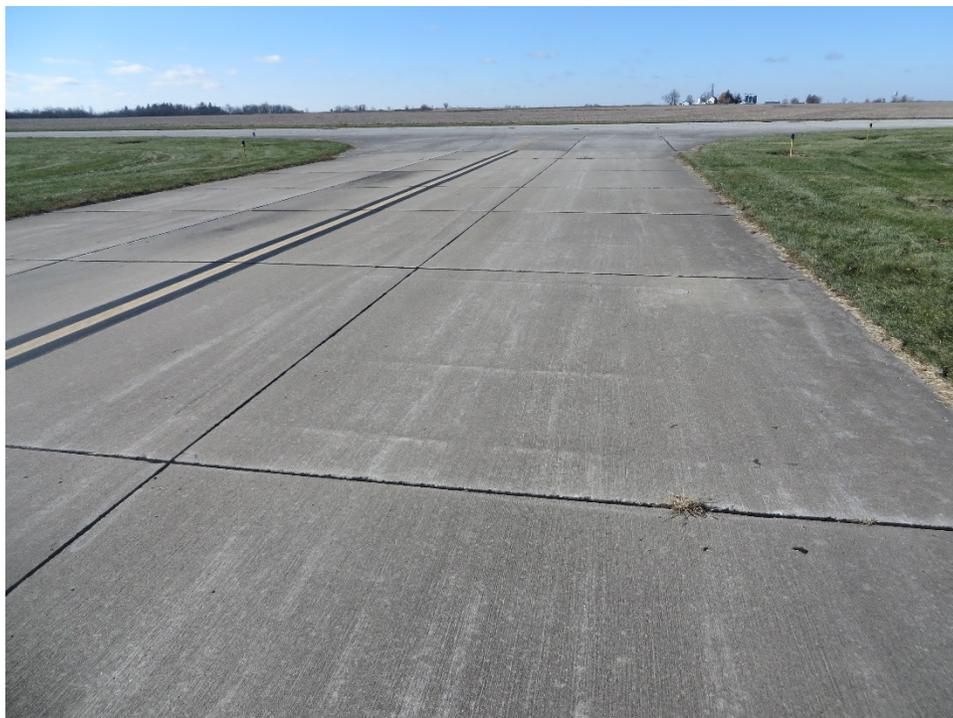
T03KN-03. Overview.

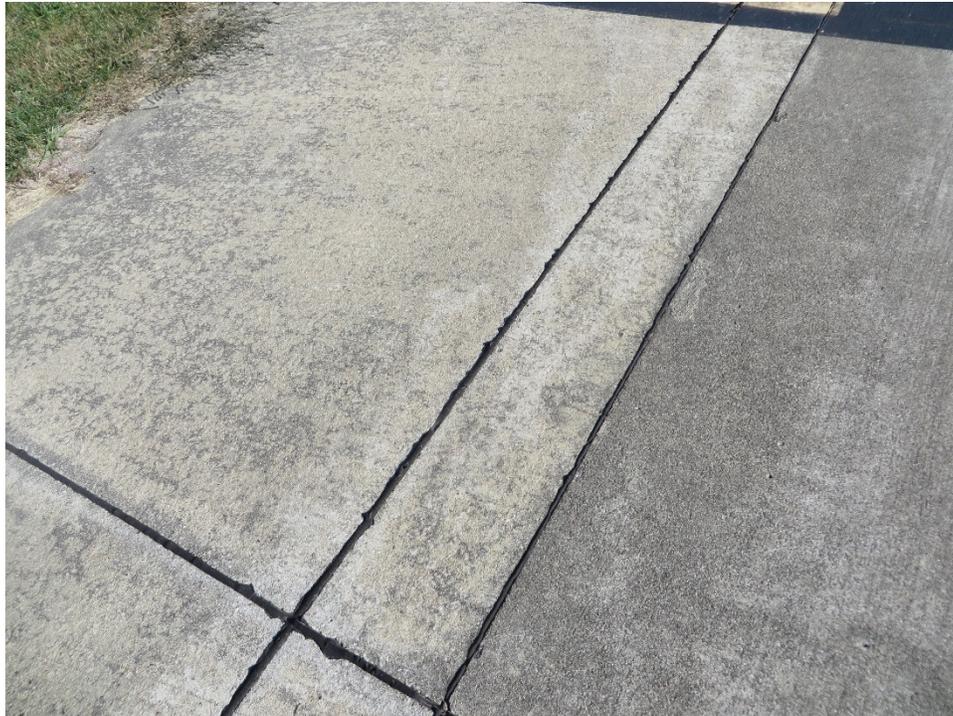
T03KN-03. Large Patching (Sample Unit No. 02).

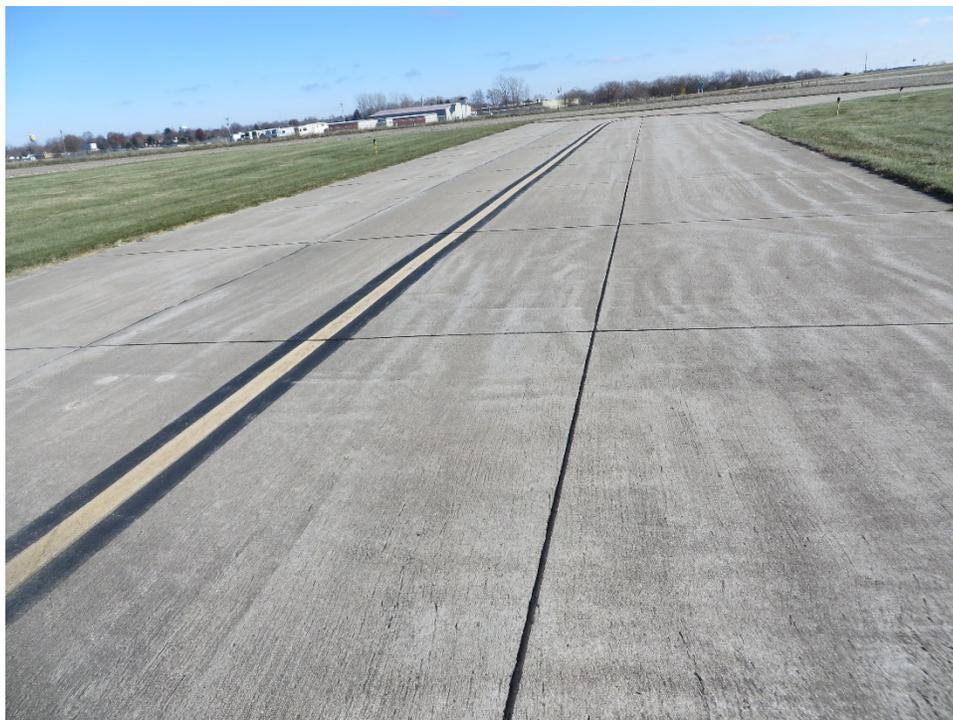
T03KN-04. Overview.

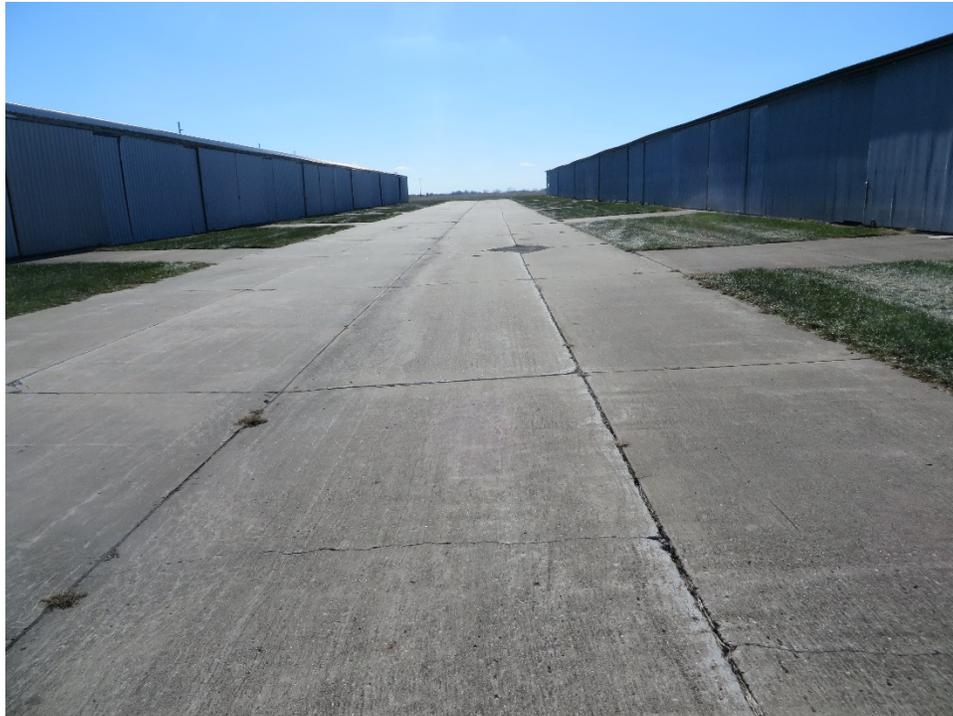
T-hangar 01 consisted of two sections located adjacent to Apron 01. Section 01 was in poor condition with all severities of alkali-silica reaction (ASR) and corner break, medium- and high-severity joint seal damage, medium-severity joint spalling, low-severity large patching, and low- and medium-severity LTD cracking and shattered slab observed. The suspected ASR was

recorded in accordance with ASTM D5340-12. Laboratory testing and analysis is the only definitive way to validate the presence of ASR. Section 02 was recently rehabilitated and was in excellent condition. Low-severity LTD cracking was identified during the inspection.

TH01KN-01. Overview.

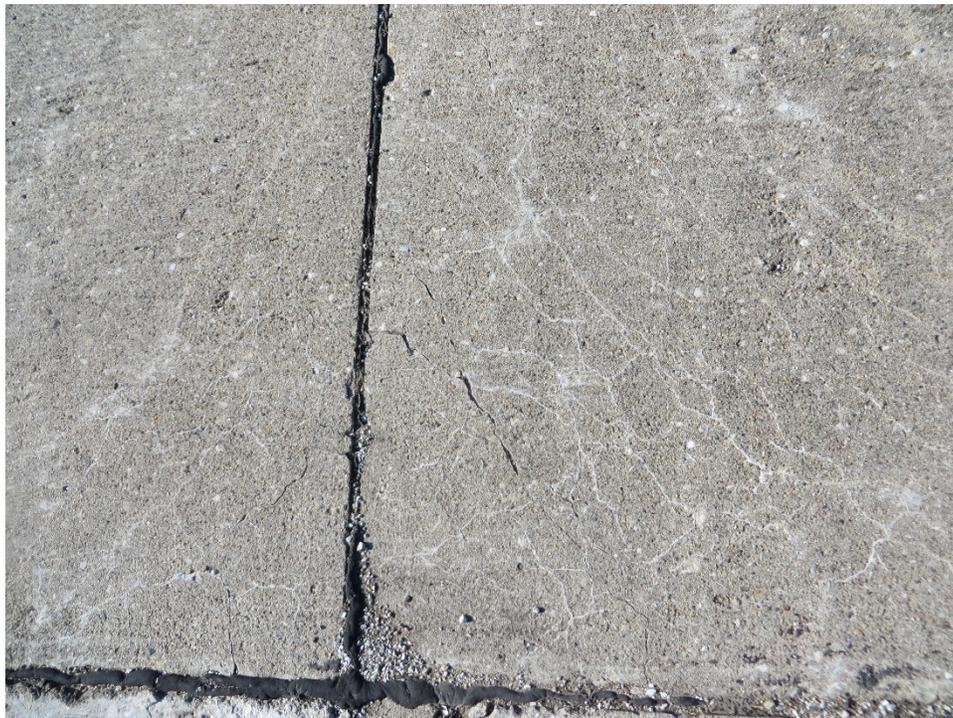
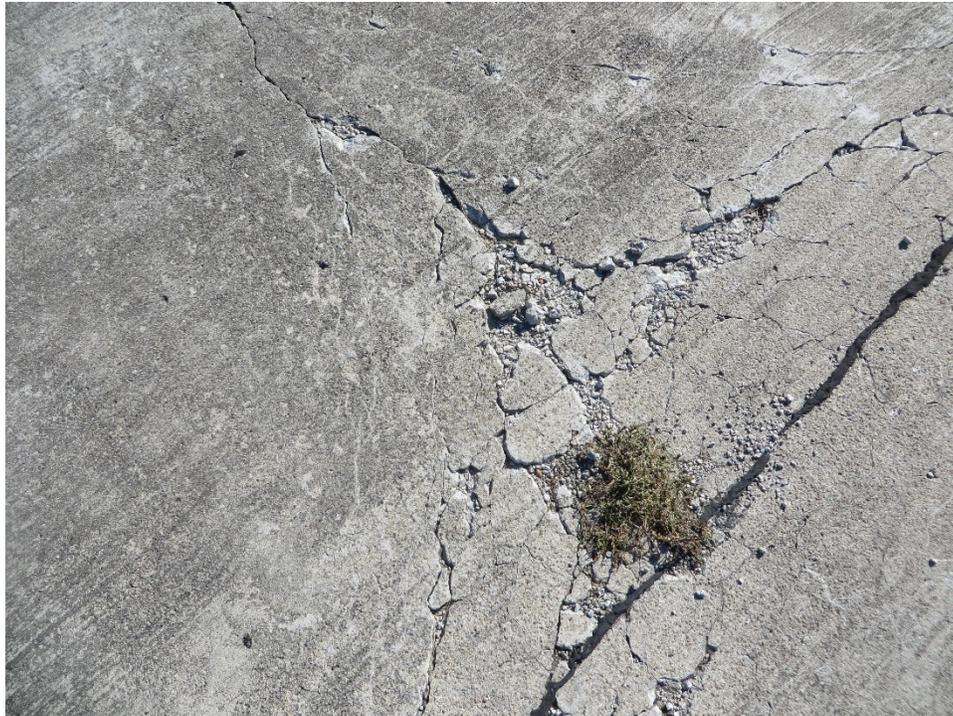
<b>Distress Type</b>	<b>Probable Cause of Distress</b>
ASR	Chemical reaction of alkalis in the portland cement with certain reactive silica minerals. ASR may be accelerated by the use of chemical pavement deicers.
Blowup	Incompressible materials in the joints.
Corner Break	Load repetition combined with loss of support and curling stresses.
Durability Cracking	Concrete's inability to withstand environmental factors such as freeze-thaw cycles.
Joint Seal Damage	Stripping of joint sealant, extrusion of joint sealant, weed growth, hardening of the filler (oxidation), loss of bond to the slab edges, or absence of sealant in the joint.
LTD Cracking	Combination of load repetition, curling stresses, and shrinkage stresses.
Patching (Small and Large)	N/A
Popouts	Freeze-thaw action in combination with expansive aggregates.
Pumping	Poor drainage, poor joint sealant.
Scaling	Over finishing of concrete, deicing salts, improper construction, freeze-thaw cycles, and poor aggregate.

TH01KN-01. ASR (Sample Unit No. 03) (1).

TH01KN-01. ASR (Sample Unit No. 03) (2).

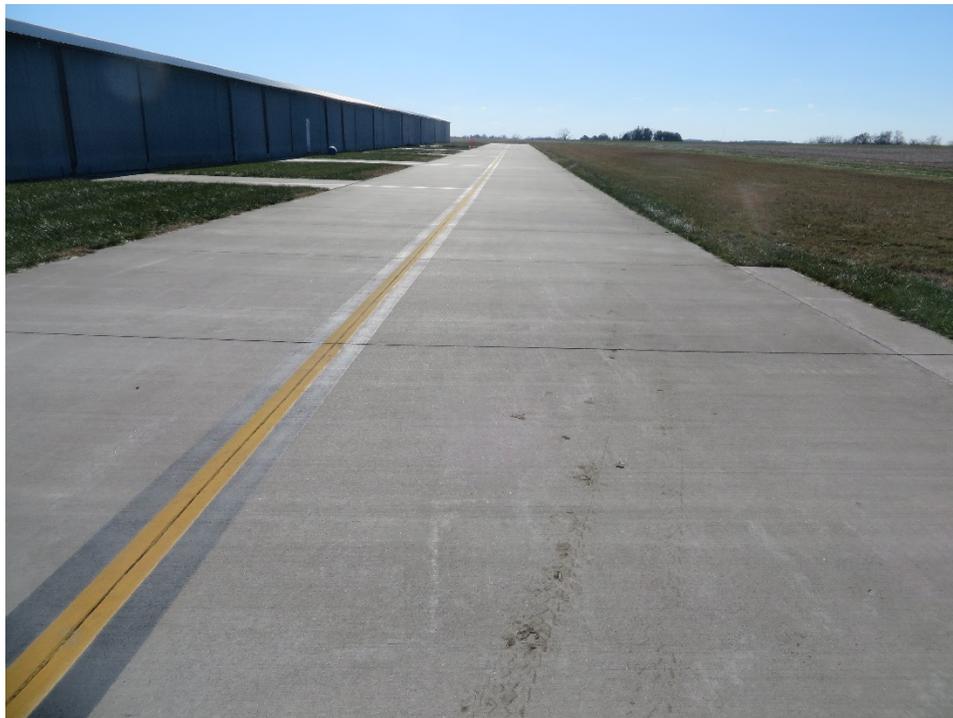
TH01KN-02. Overview.

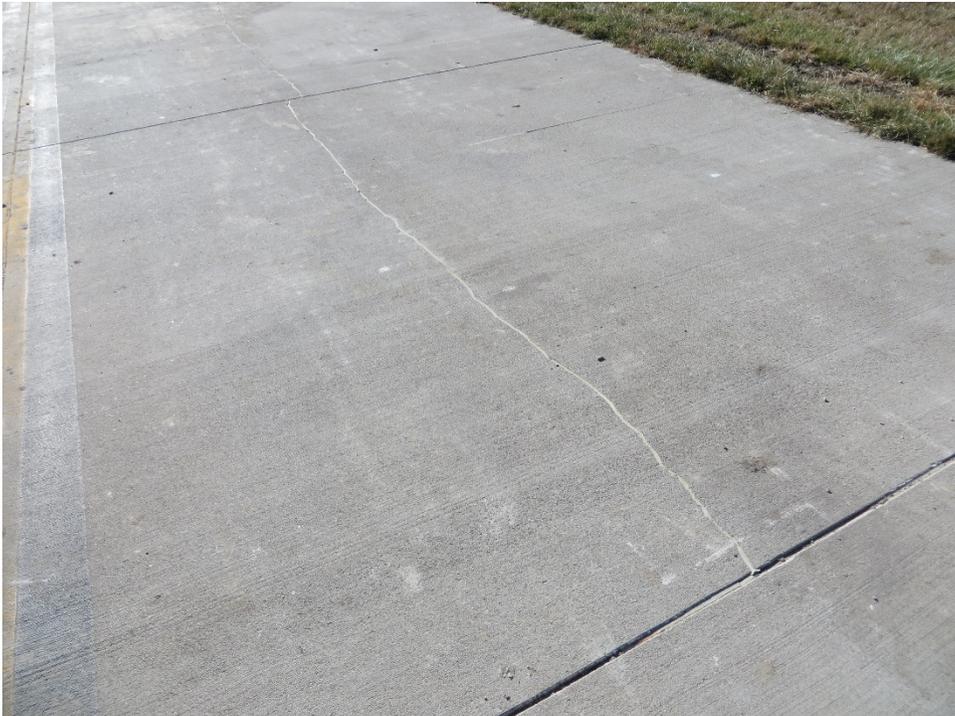
TH01KN-02. LTD Cracking (Sample Unit No. 02).
