# Knoxville Municipal Airport

## PAVEMENT MANAGEMENT REPORT

**JULY 2022**

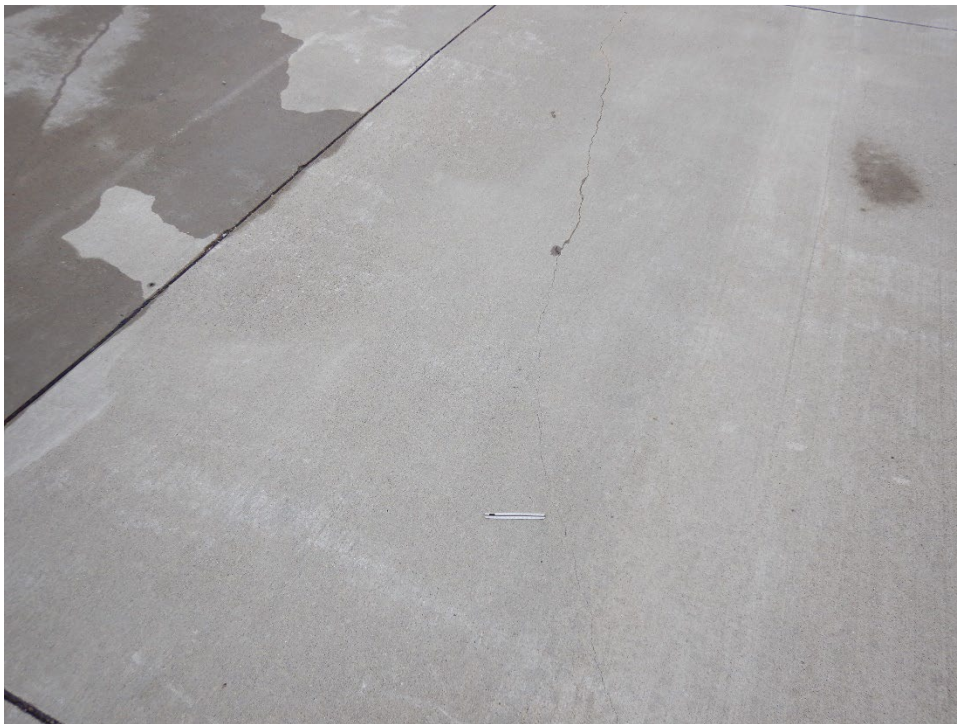
A01KN-01. LTD Cracking (Sample Unit No. 13).

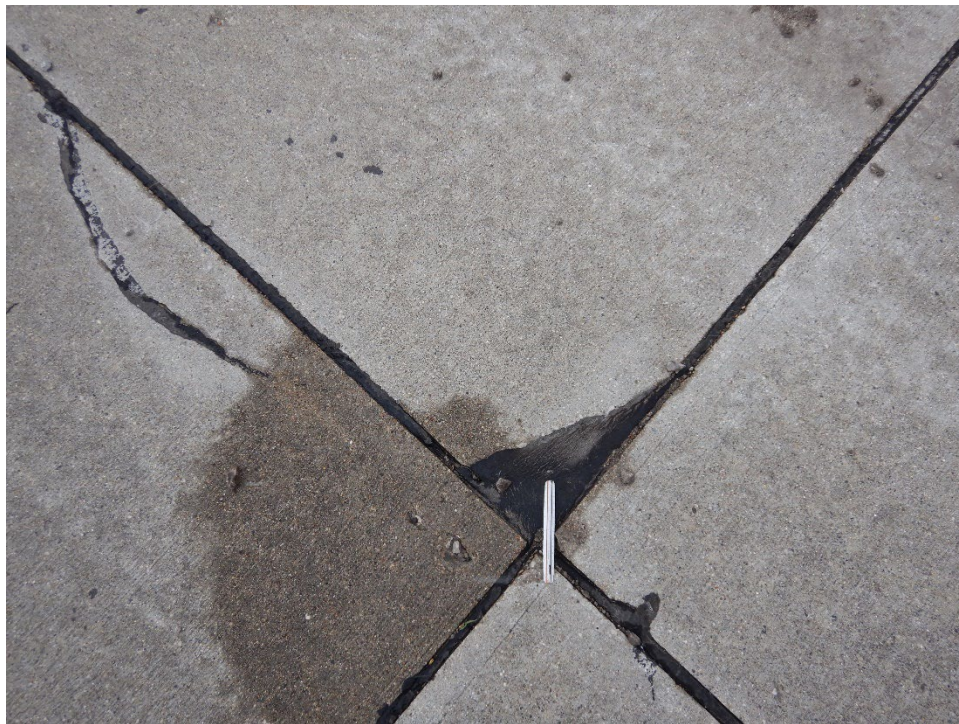
A02KN-01. Corner Spalling (Sample Unit No. 10).

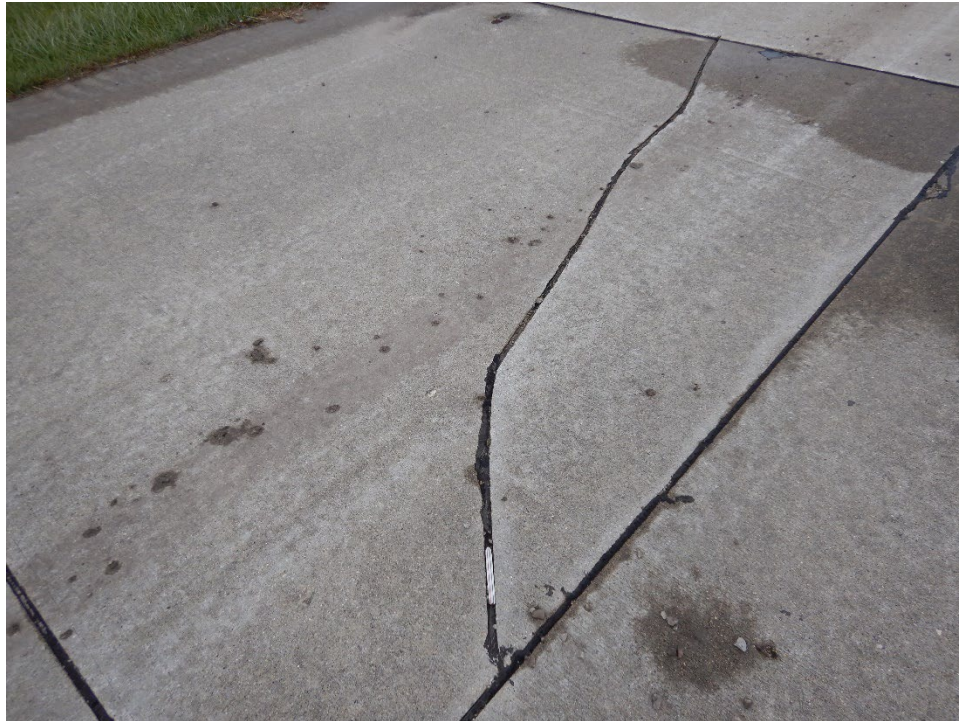
A02KN-01. LTD Cracking (Sample Unit No. 10).

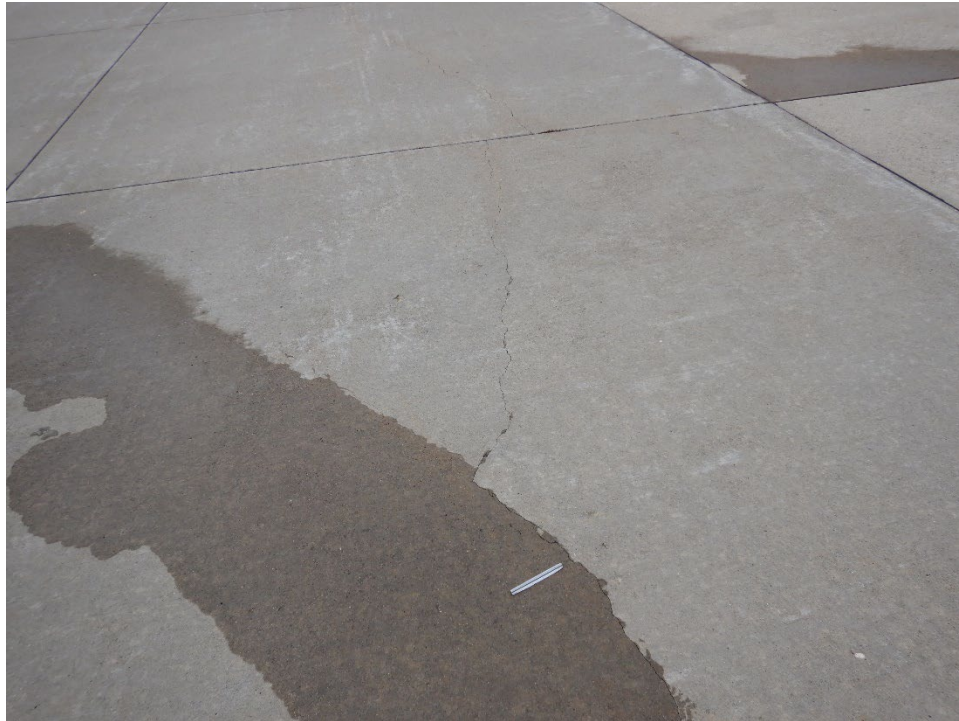
A02KN-02. LTD Cracking (Sample Unit No. 03).

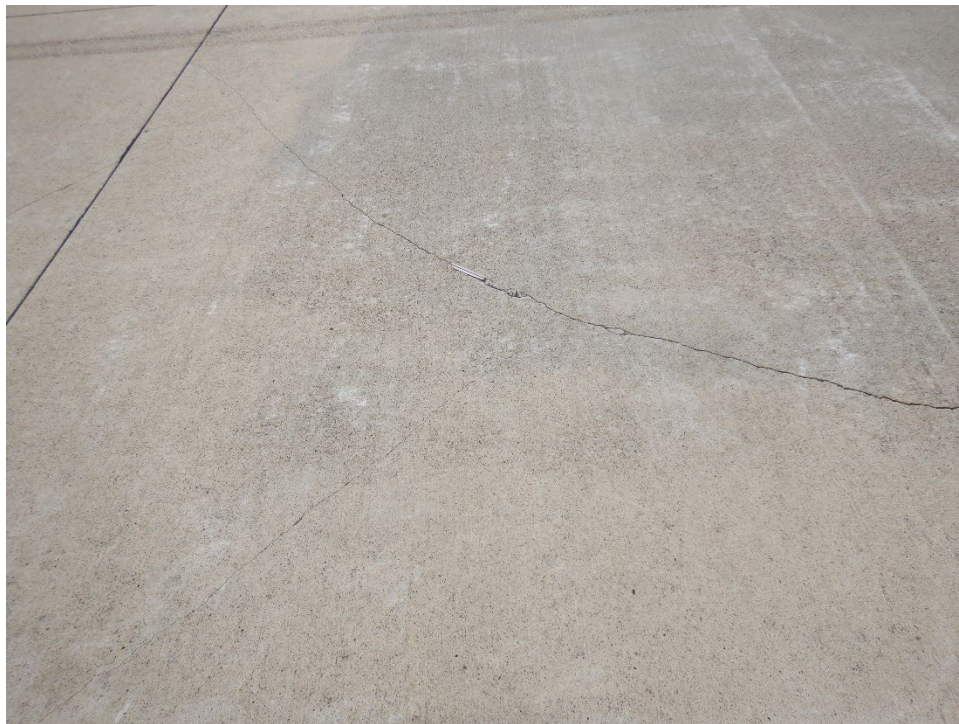
A02KN-02. Shattered Slab (Sample Unit No. 03).

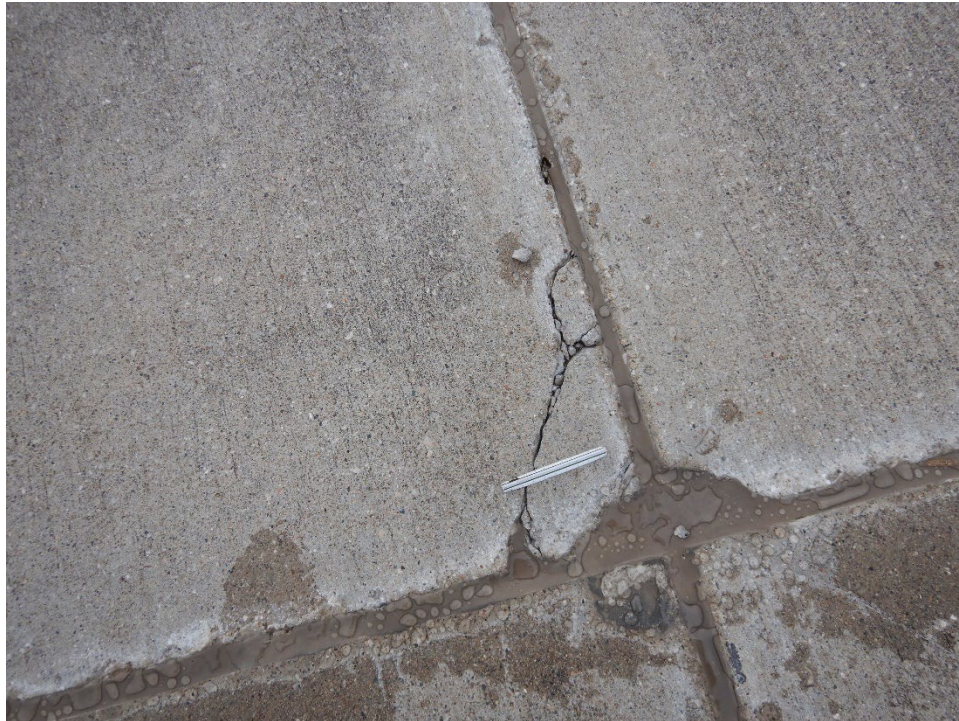
R15KN-02. Joint Spalling (Sample Unit No. 14).

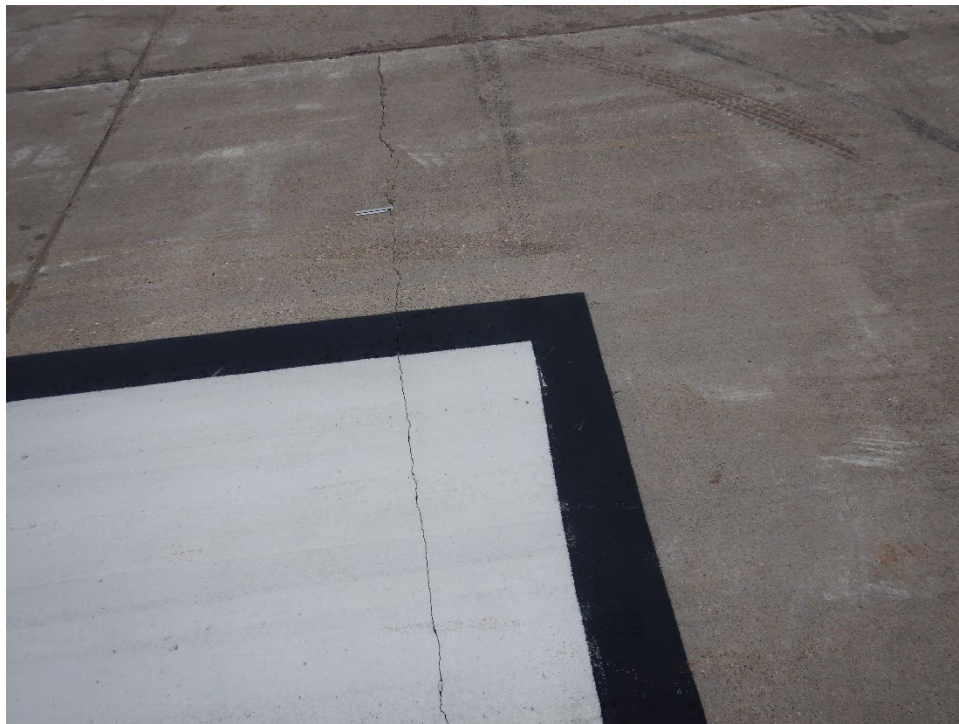
R15KN-02. LTD Cracking (Sample Unit No. 19).

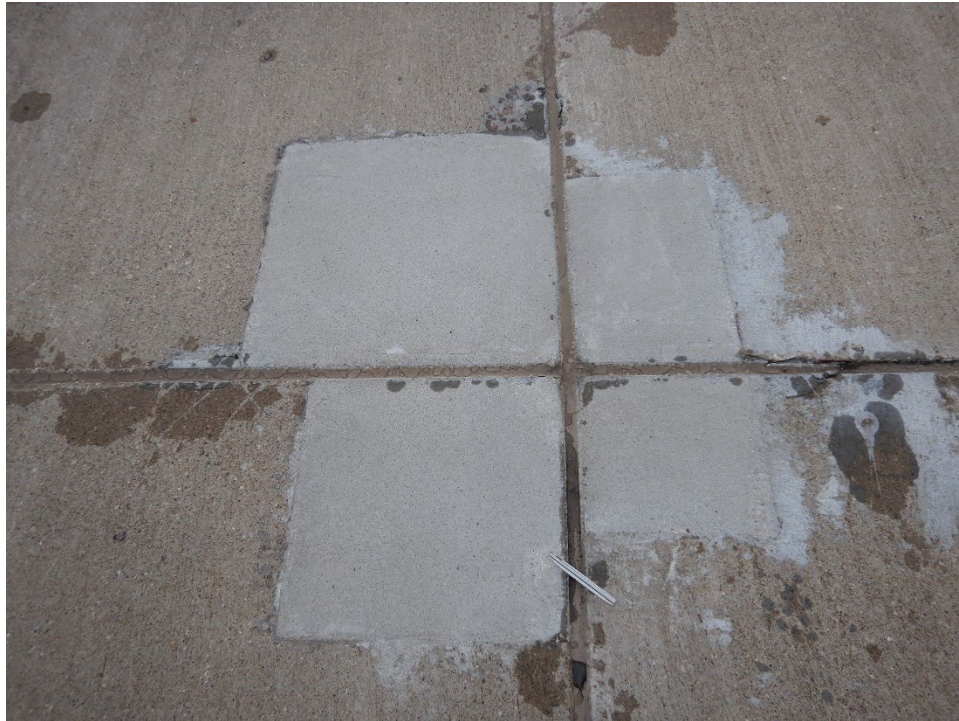
R15KN-02. Small Patching (Sample Unit No. 14).

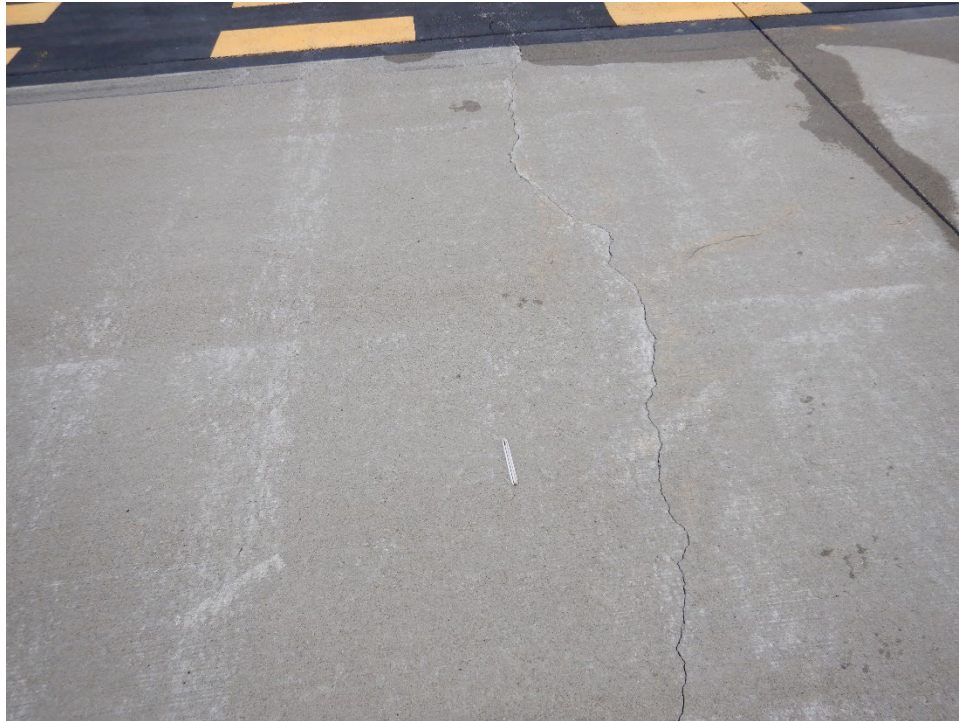
T01KN-01. LTD Cracking (Sample Unit No. 03).

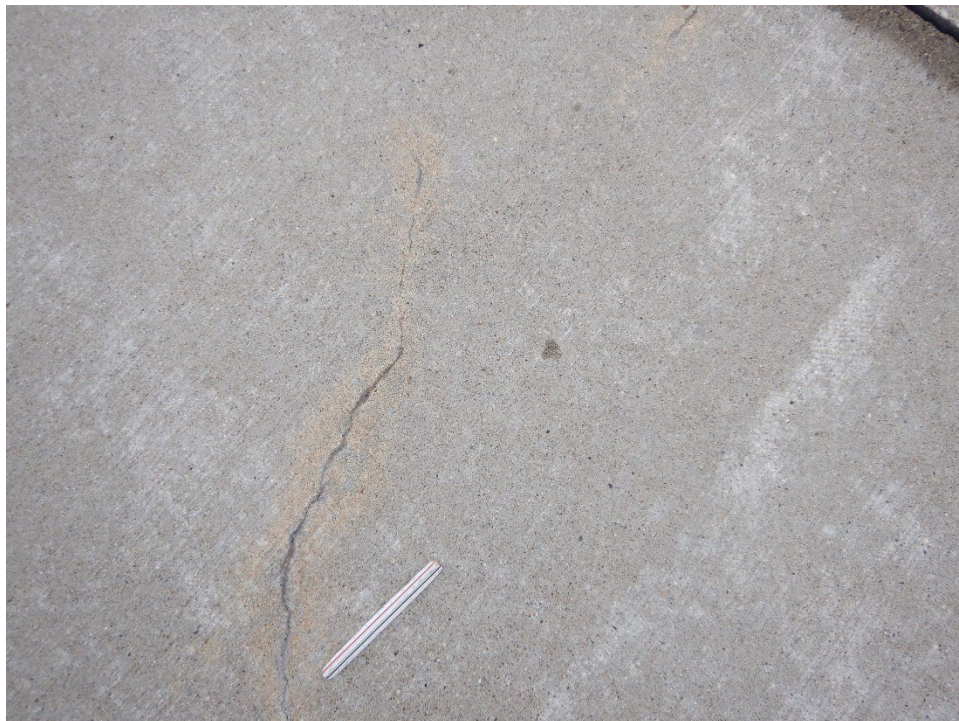
T01KN-01. Shrinkage Cracking (Sample Unit No. 03).

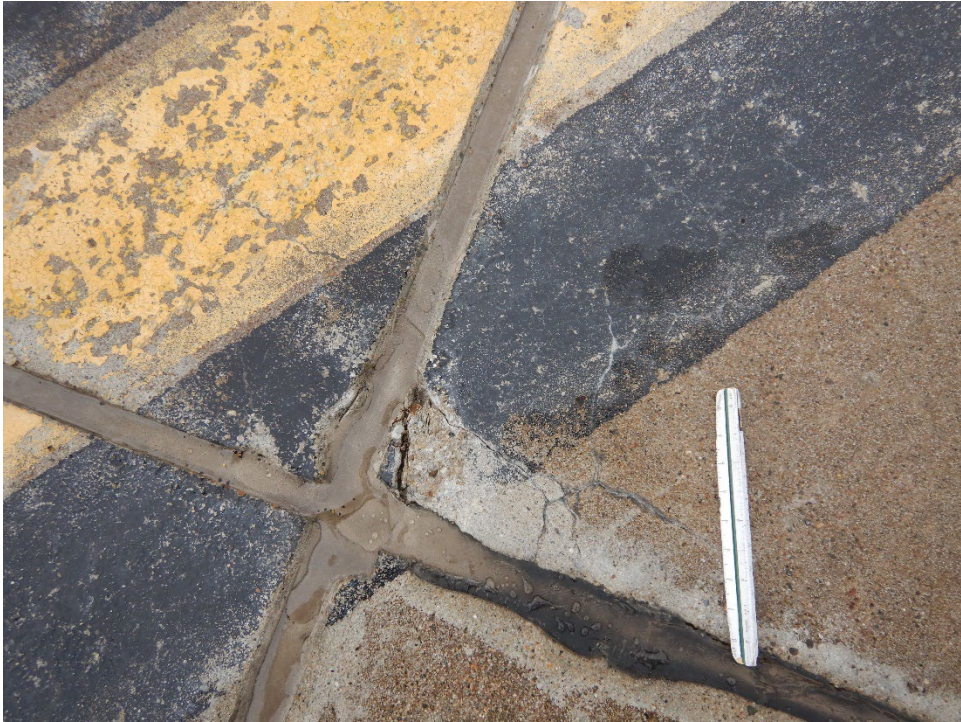
T02KN-01. ASR (Sample Unit No. 06).

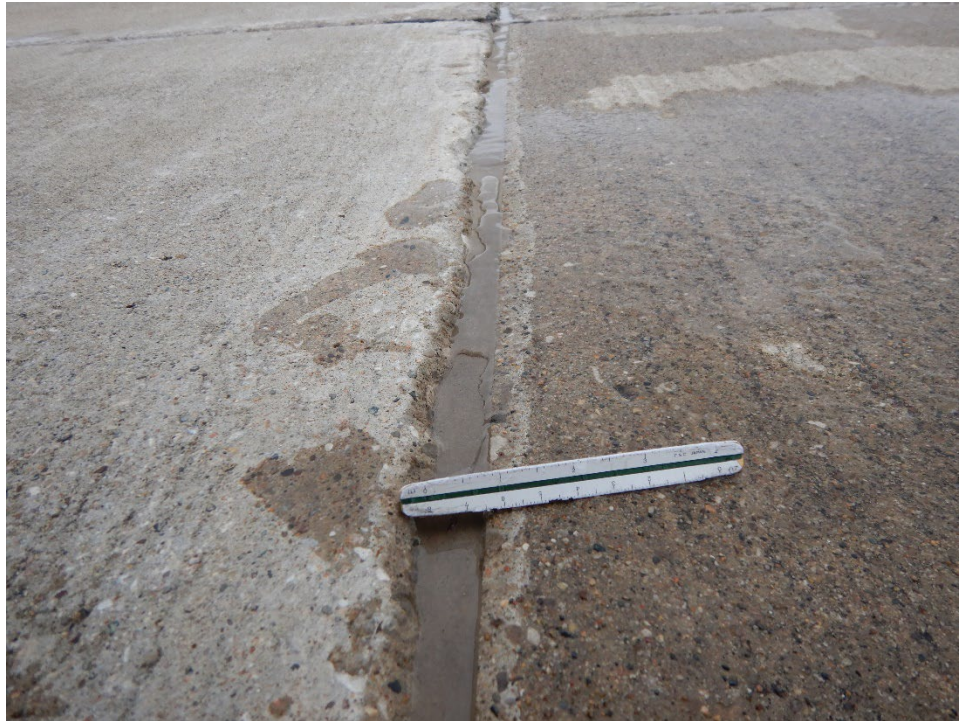
T02KN-01. Faulting (Sample Unit No. 02).

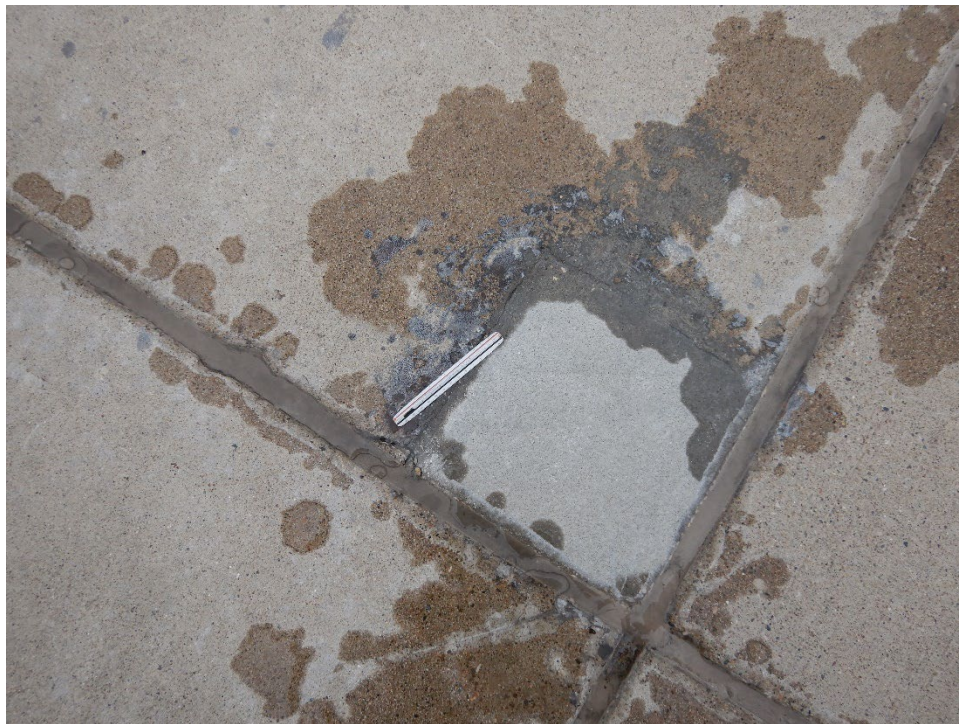
T02KN-01. Small Patching (Sample Unit No. 05).

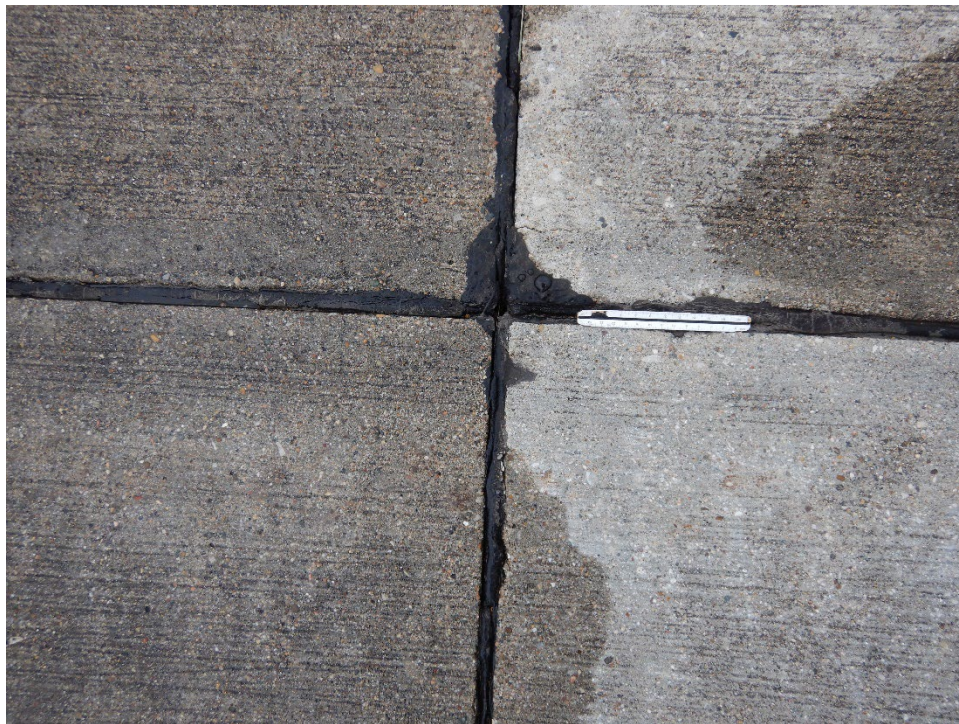
T03KN-01. Joint Seal Damage (Sample Unit No. 02).

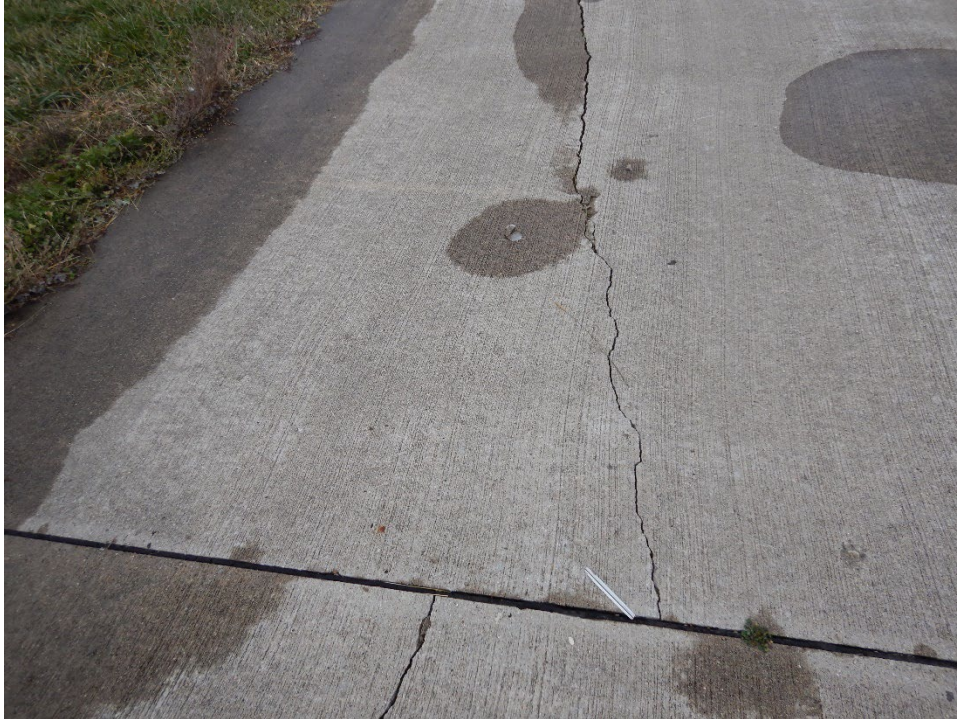
T03KN-01. LTD Cracking (Sample Unit No. 08).

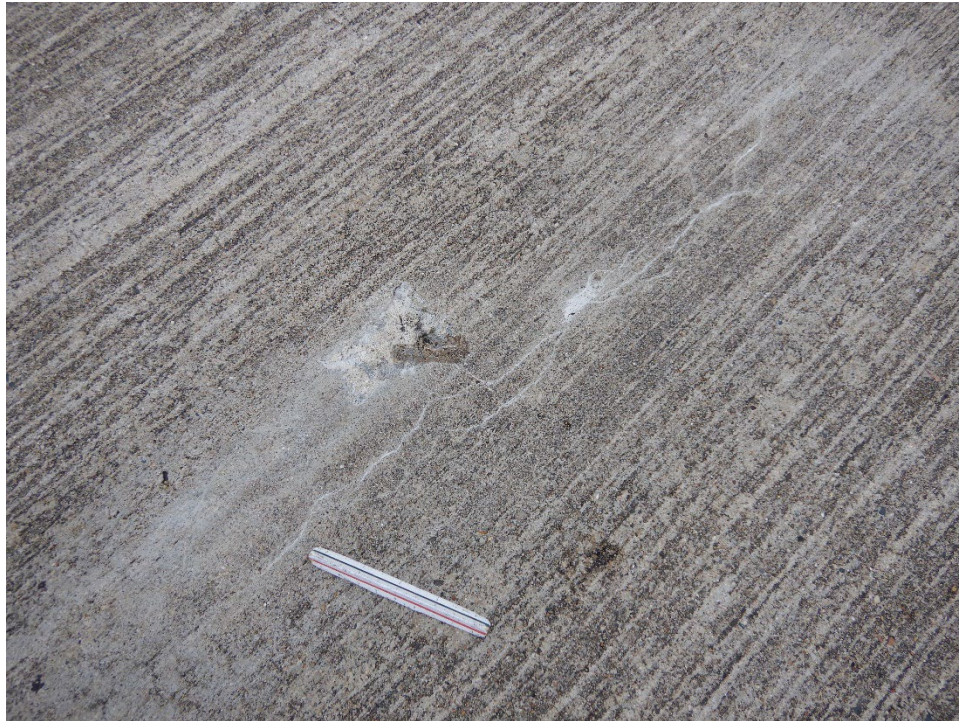
T03KN-02. ASR (Sample Unit No. 05).

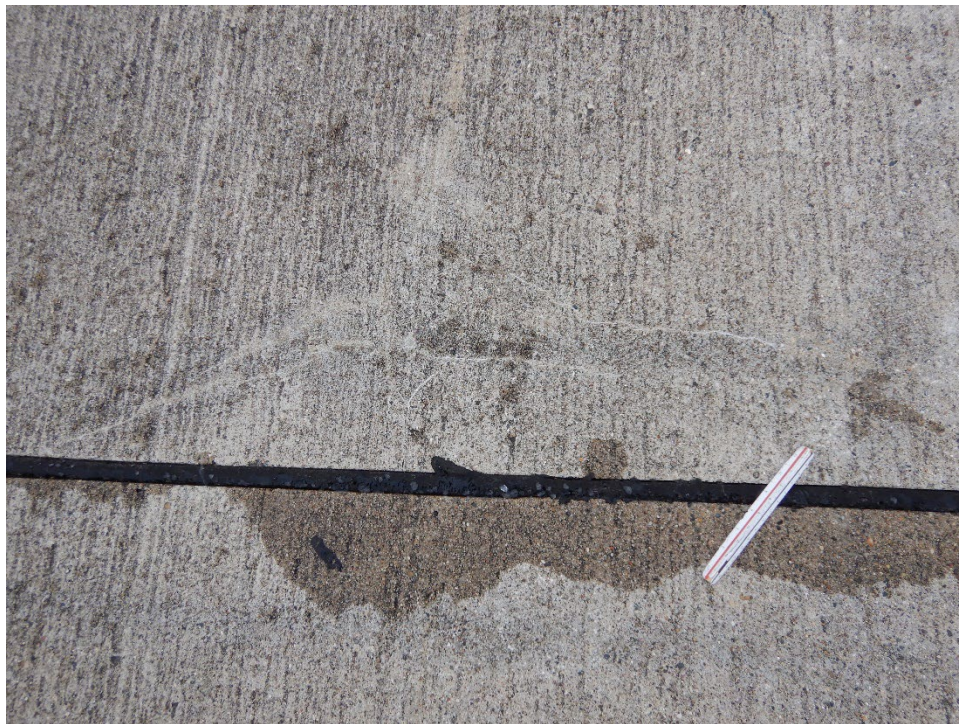
T03KN-02. ASR (Sample Unit No. 15).

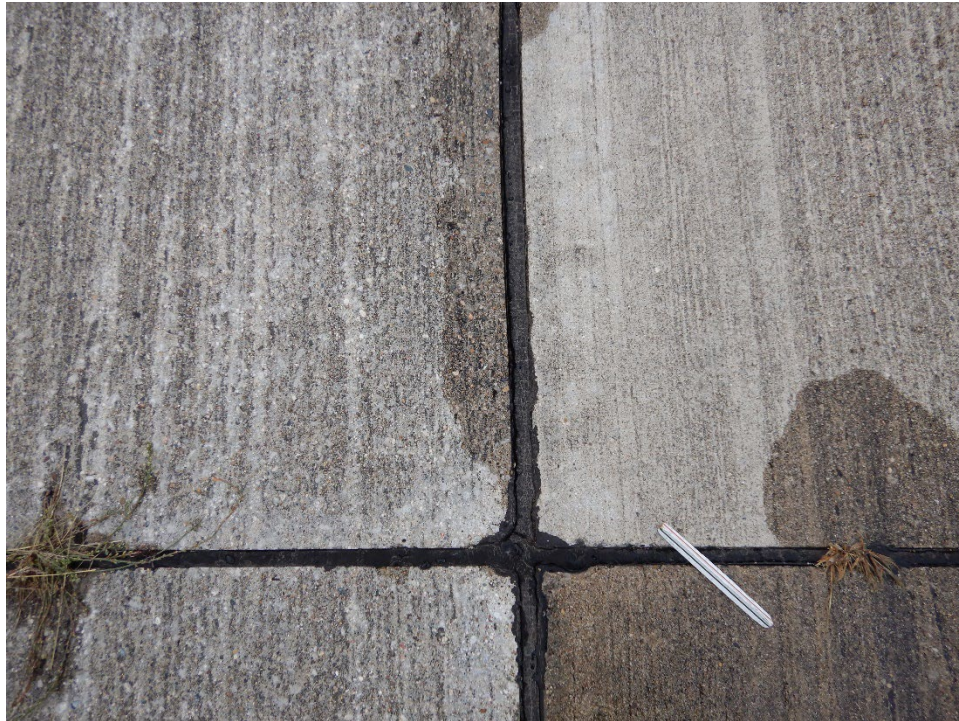
T03KN-02. Joint Seal Damage (Sample Unit No. 20).

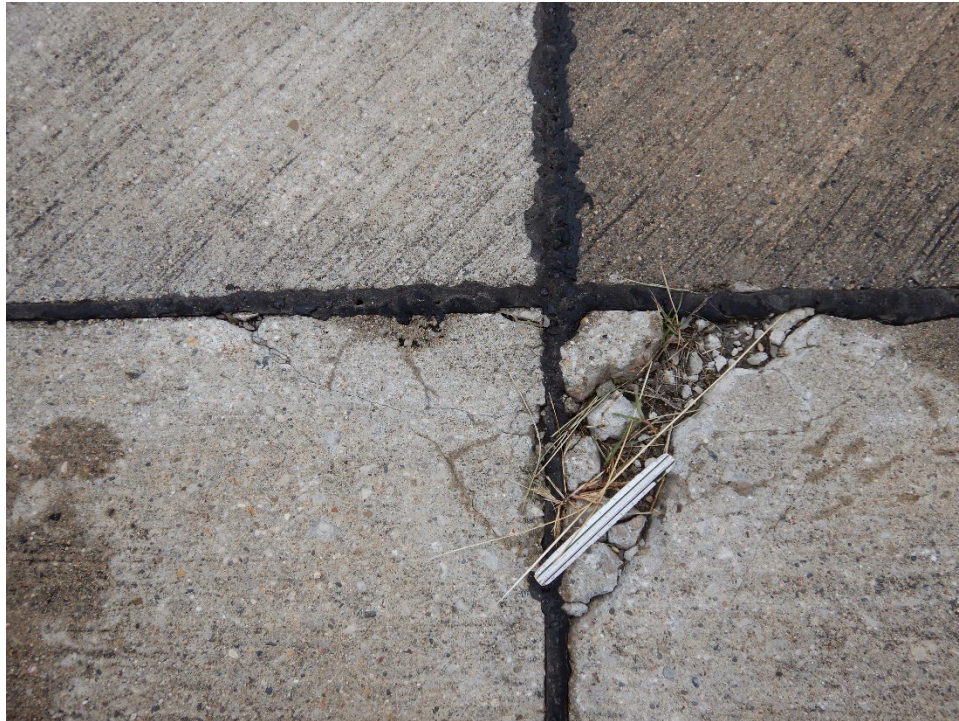
T03KN-03. Durability Cracking (Sample Unit No. 02).

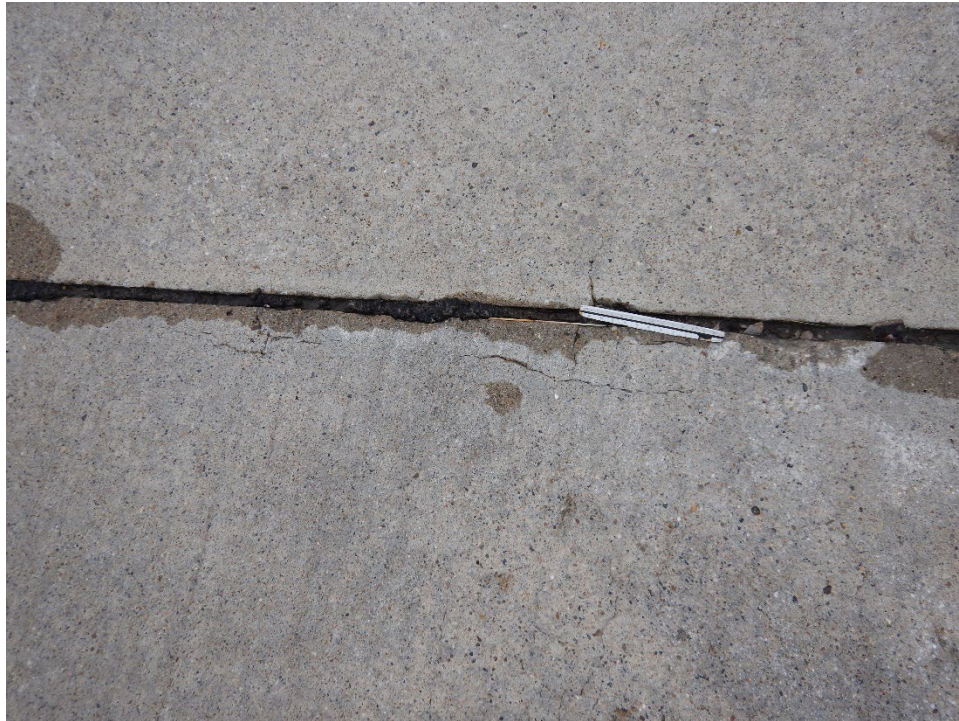
T03KN-04. Durability Cracking (Sample Unit No. 01).

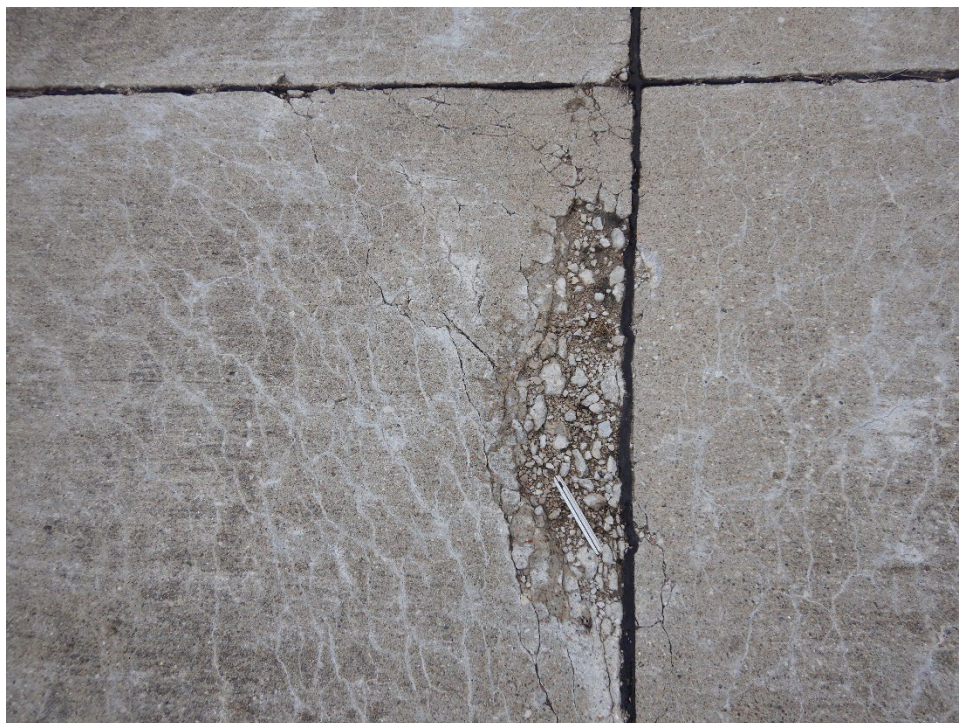
TH01KN-01. ASR (Sample Unit No. 04) (1).

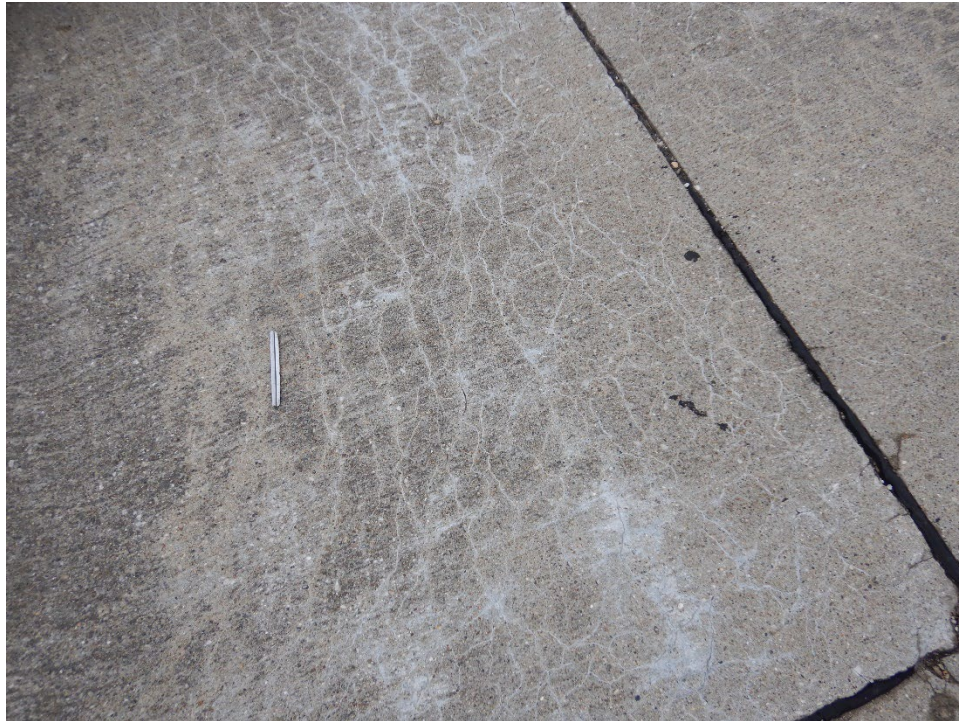
TH01KN-01. ASR (Sample Unit No. 04) (2).

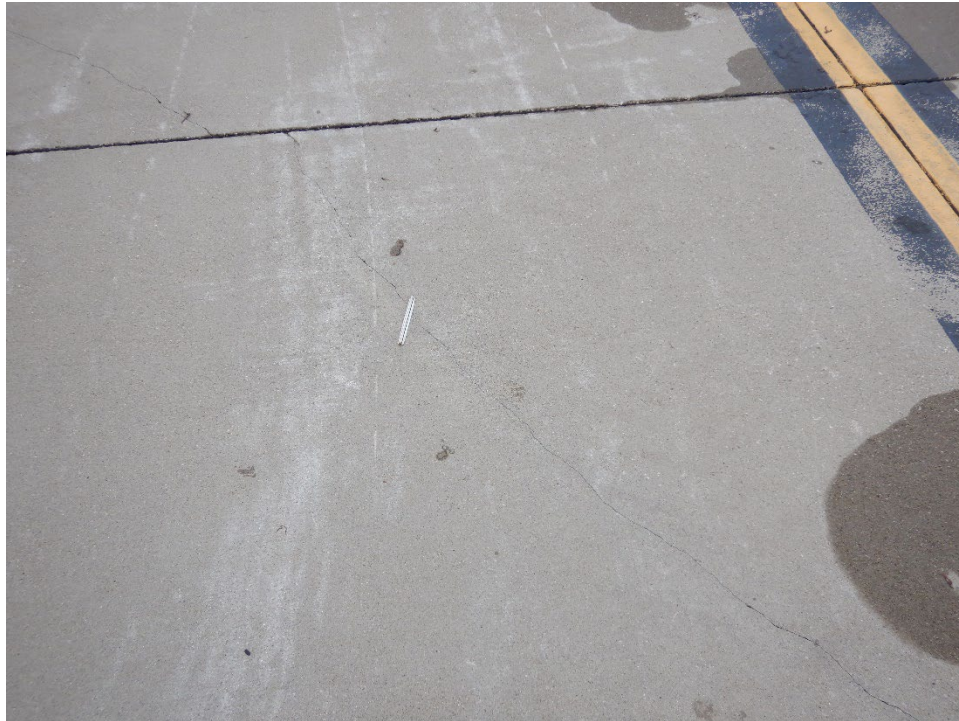
TH01KN-02. Corner Break (Sample Unit No. 01).
