# Lamoni Municipal Airport

**PAVEMENT MANAGEMENT REPORT**

**AUGUST 2019**

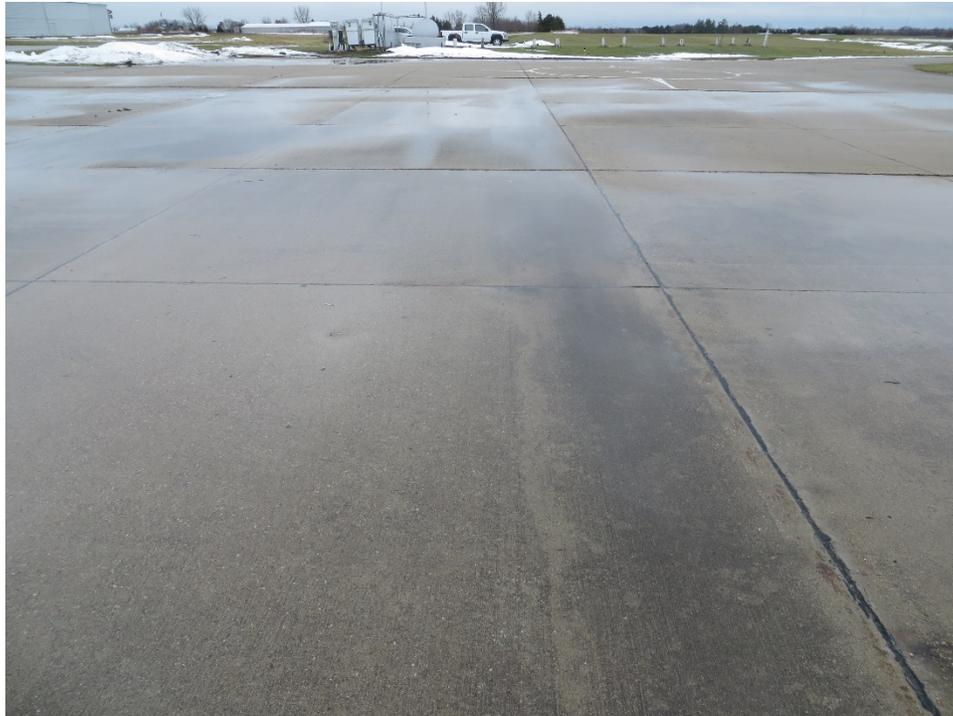
A01LA-01. Overview.

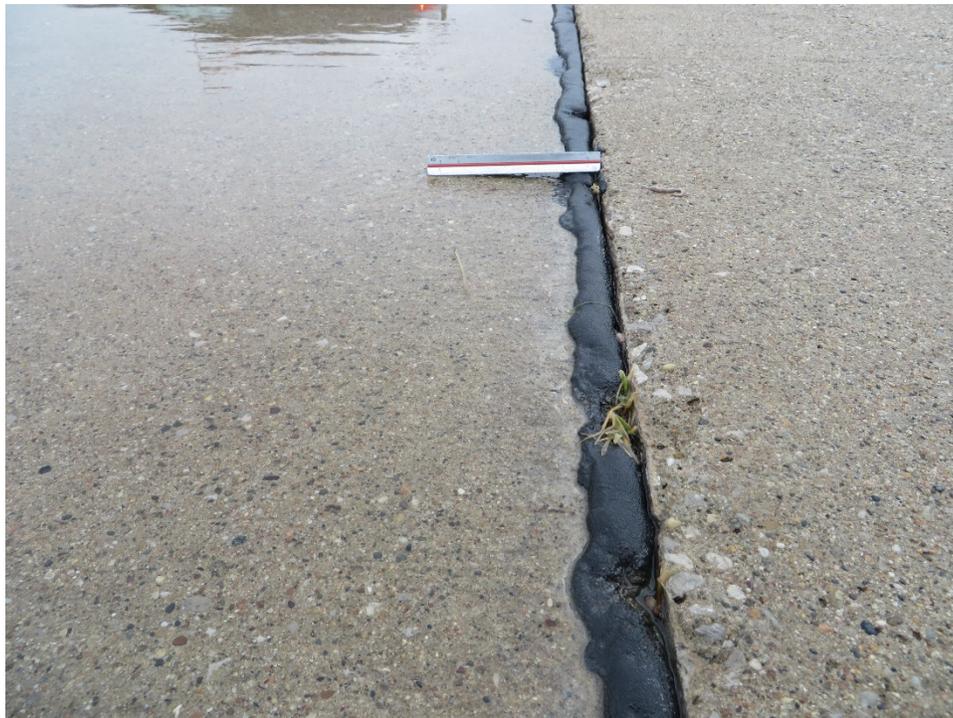
The apron area was defined by one section. High-severity joint seal damage, pumping, and low- and medium-severity joint spalling, faulting, and LTD cracking were identified in Section 01.

A01LA-01. Faulting (Sample Unit No. 04).

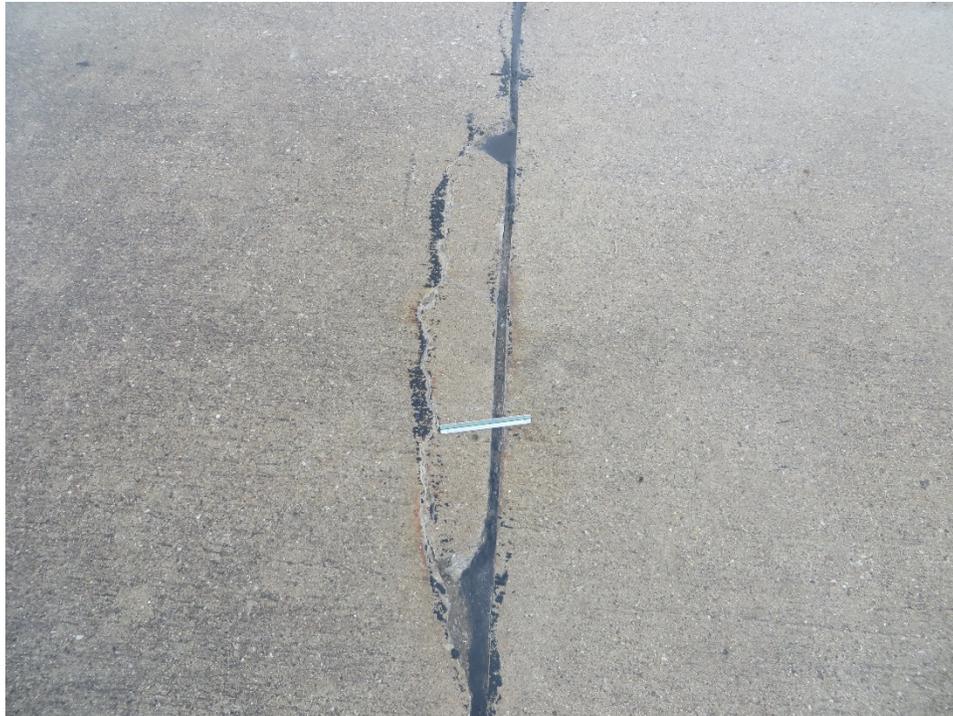
A01LA-01. Joint Spalling (Sample Unit No. 05).

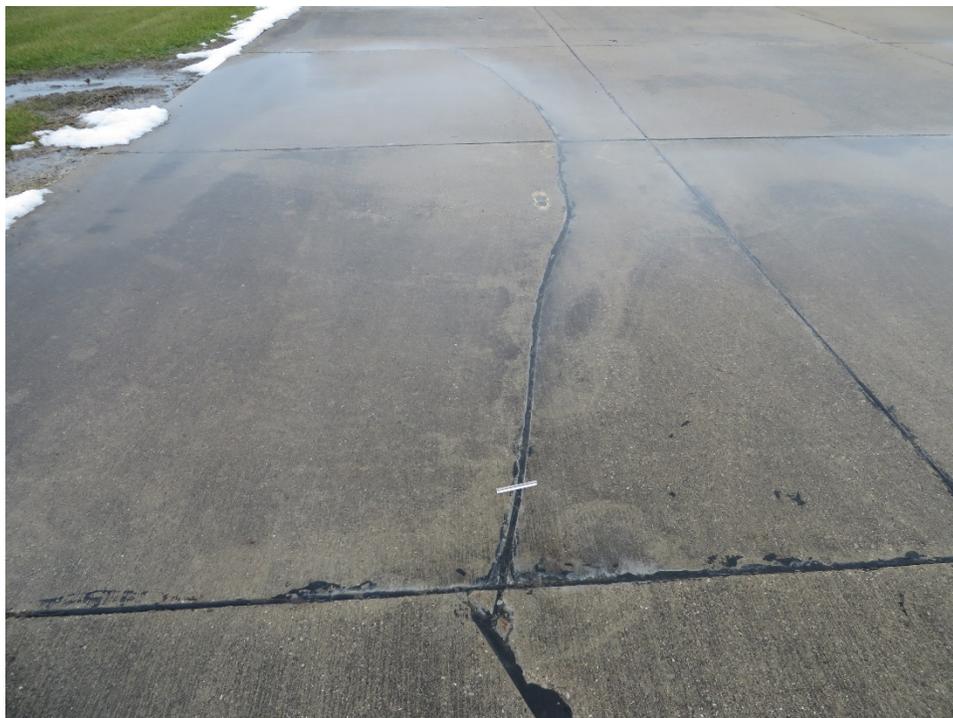
A01LA-01. LTD Cracking (Sample Unit No. 04).

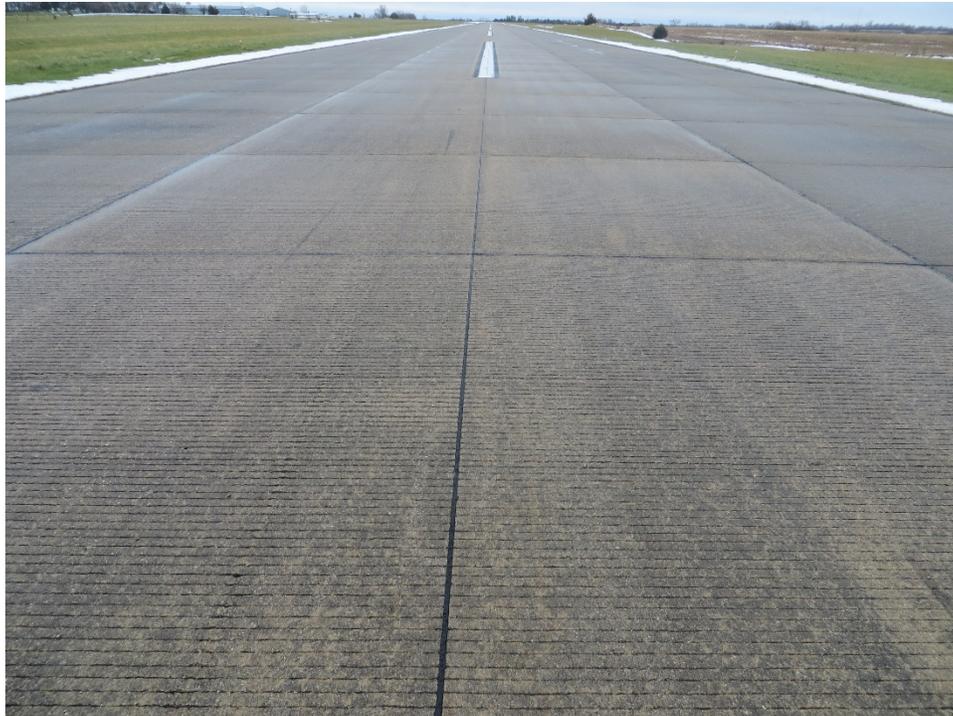
Runway 18/36 consisted of two sections. Section 01, which defined the majority of the runway pavement, had low-severity corner spalling and joint spalling, high-severity joint seal damage, and low- and medium-severity faulting and longitudinal, transverse, and diagonal (LTD) cracking recorded. Section 02 was defined by the recently constructed runway extension located at the Runway 36 approach. This section was in excellent condition with no distresses observed at the time of inspection.

R18LA-01. Overview.

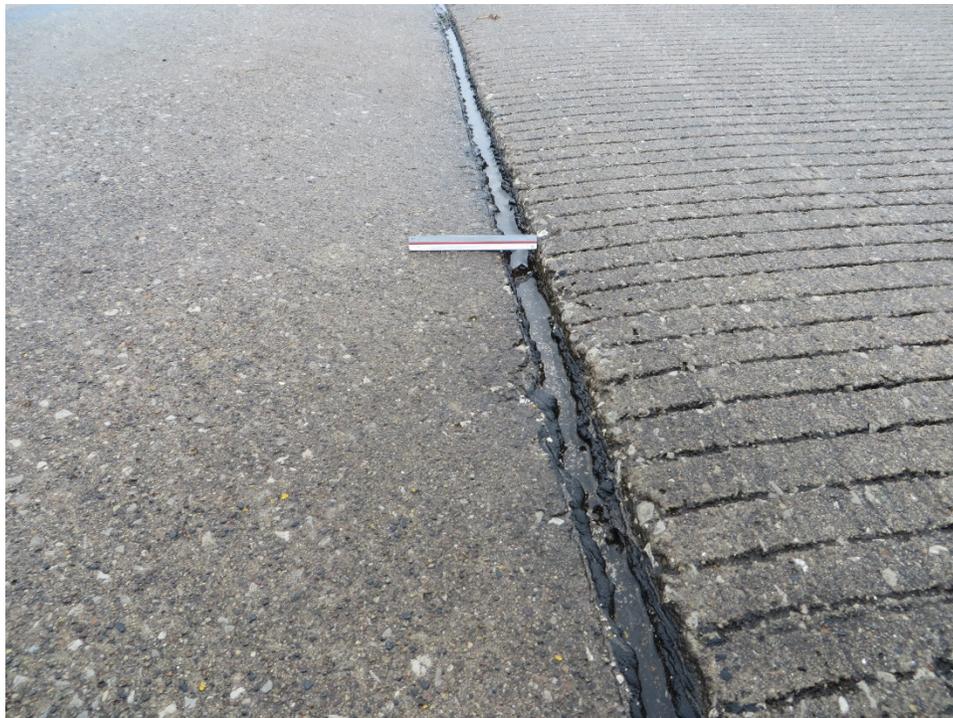
R18LA-01. Faulting (Sample Unit No. 01).

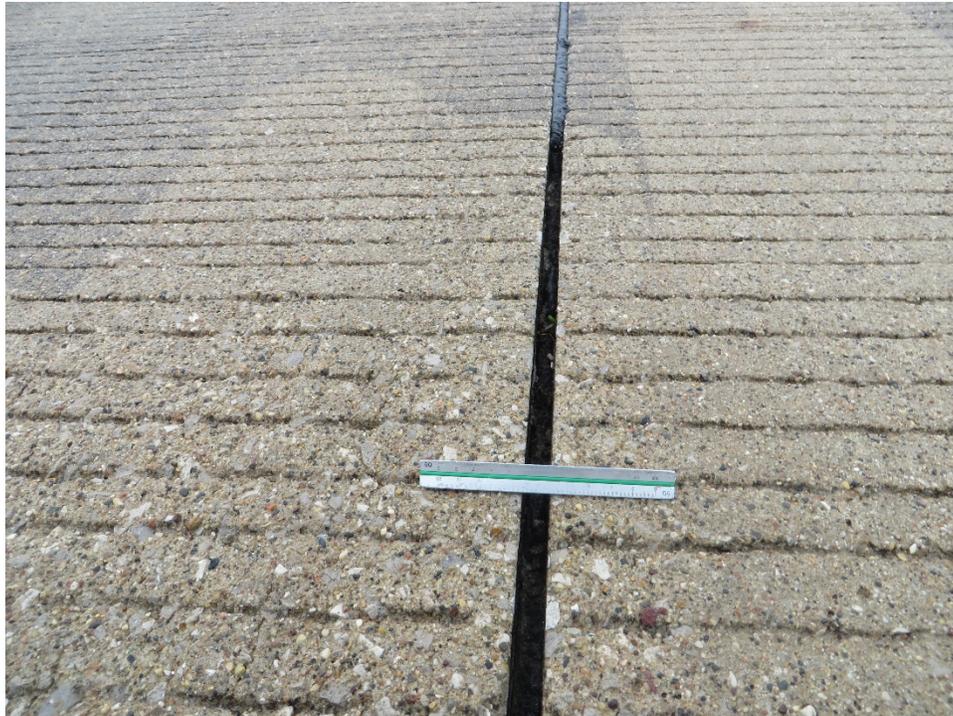
R18LA-01. Joint Seal Damage (Sample Unit No. 14).

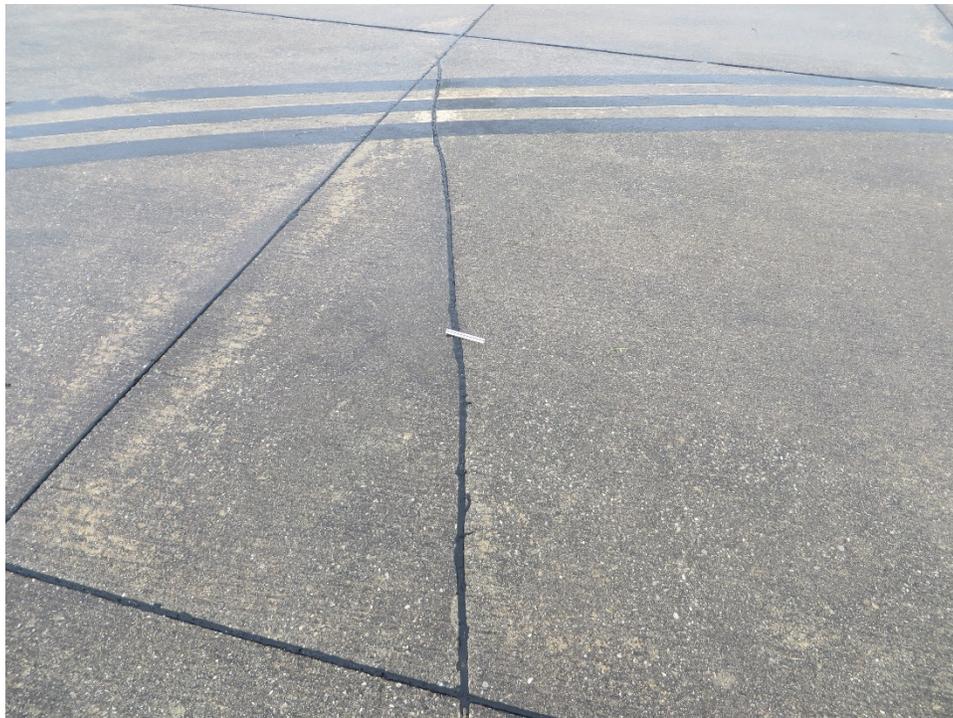
R18LA-01. LTD Cracking (Sample Unit No. 01).

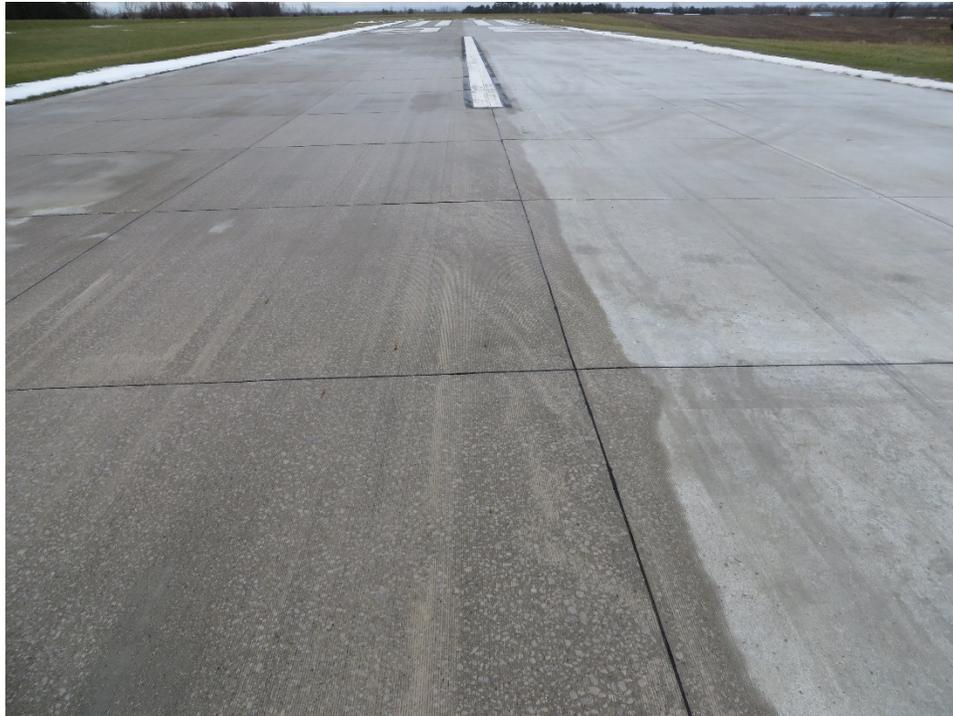
R18LA-02. Overview.

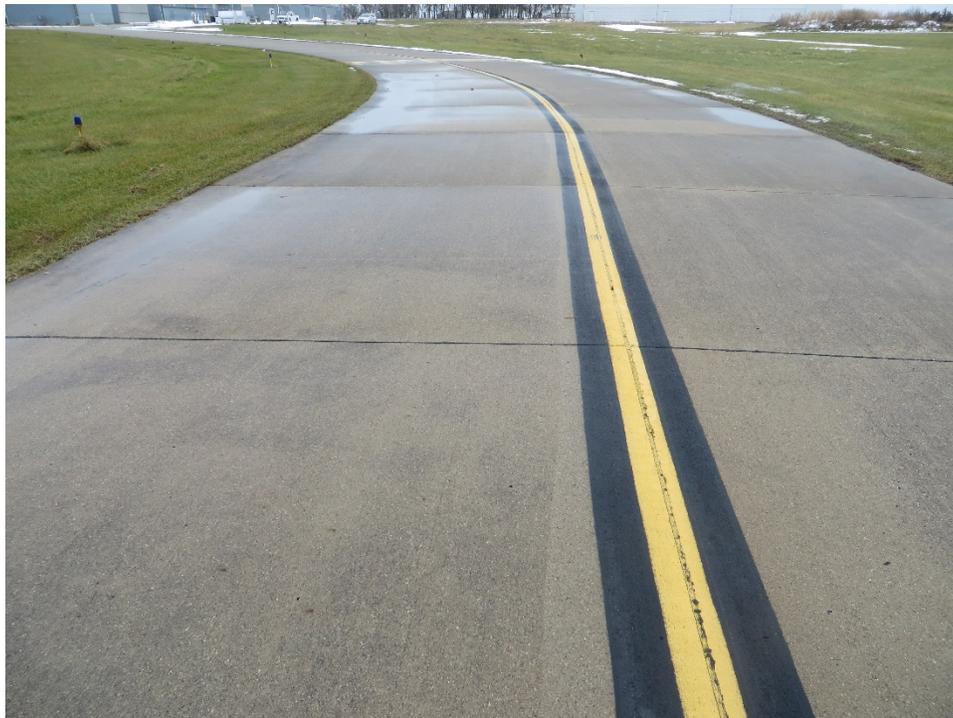
Taxiway 01 contained one section and connected the apron area with Runway 18/36. Low-severity joint seal damage was observed throughout Section 01 along with small amounts of low-severity ASR.

T01LA-01. Overview.

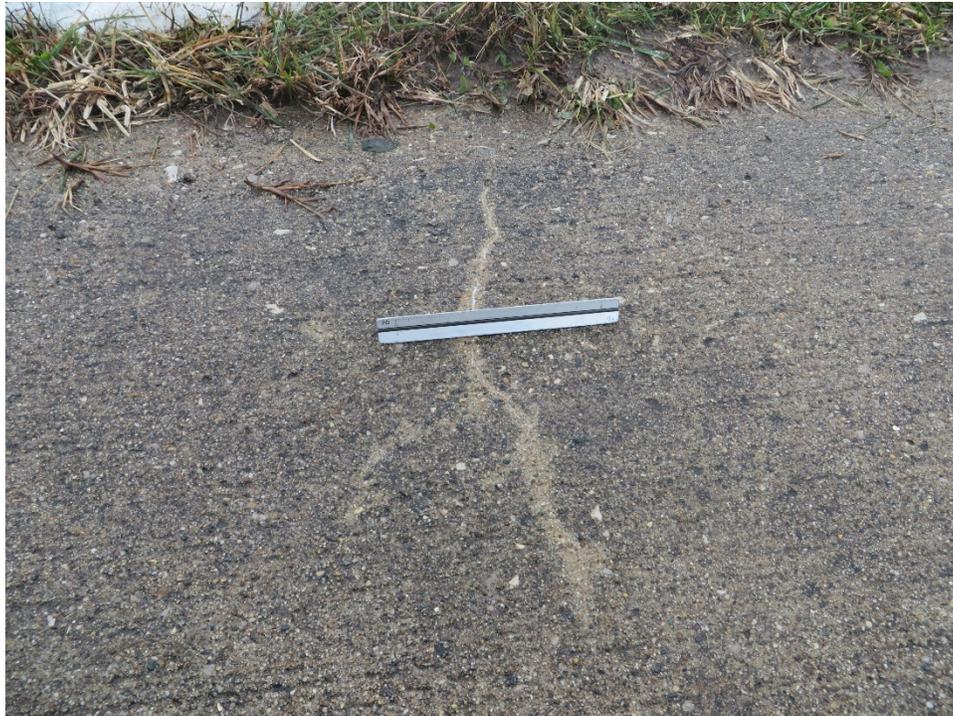
T01LA-01. ASR (Sample Unit No. 02).

Sample Number: 002 Type: R Area: 20.00Slabs PCI = 88  
Sample Comments:  
76 ASR L 3.00 Slabs Comments:  
65 JOINT SEAL DAMAGE L 20.00 Slabs Comments:

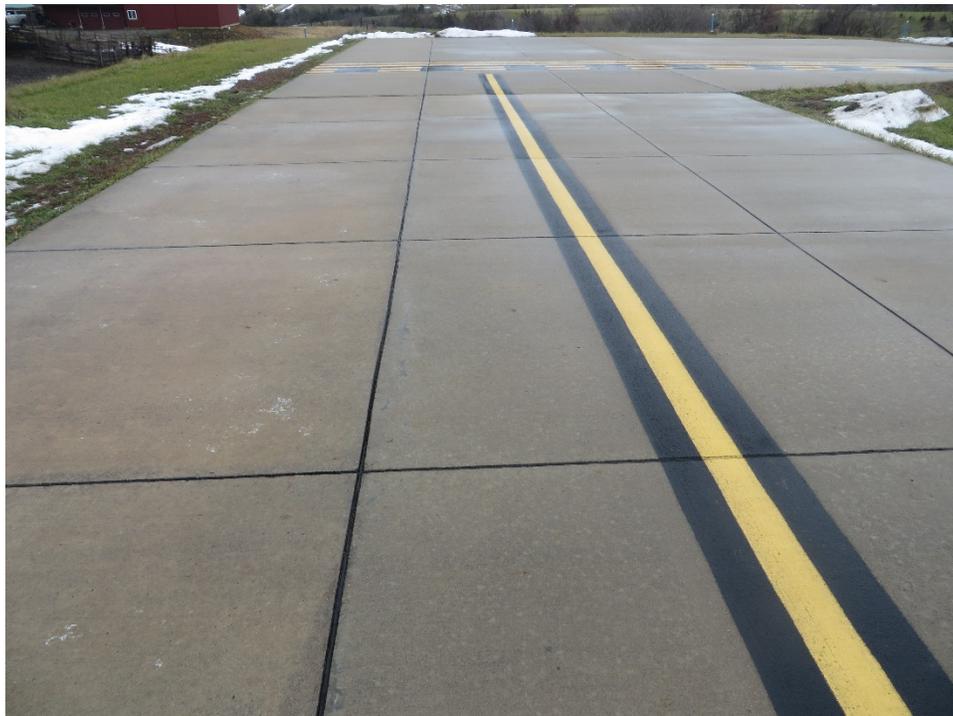
T02LA-01. Overview.

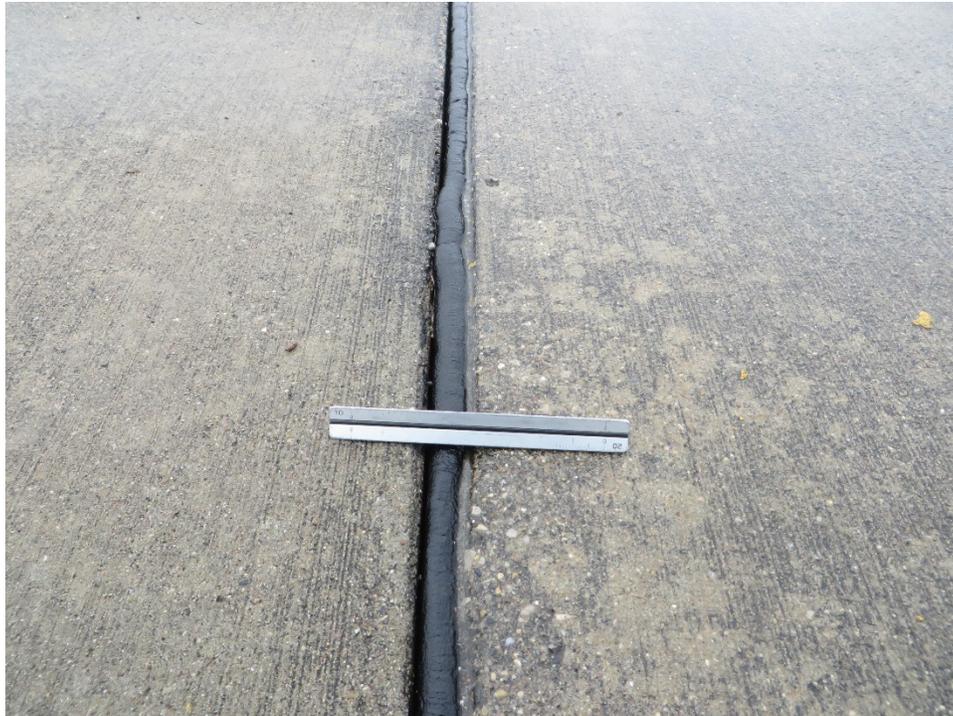
Taxiway 02, the turnaround located at the Runway 18 approach, consisted of one section. High-severity joint seal damage was recorded where joint sealant had deteriorated or visible gaps between the sealant and slab edge were observed.

T02LA-01. Joint Seal Damage (Sample Unit No. 01).

Sample Number: 01 Type: R Area: 20.00Slabs PCI = 88  
Sample Comments:  
65 JOINT SEAL DAMAGE H 20.00 Slabs Comments:

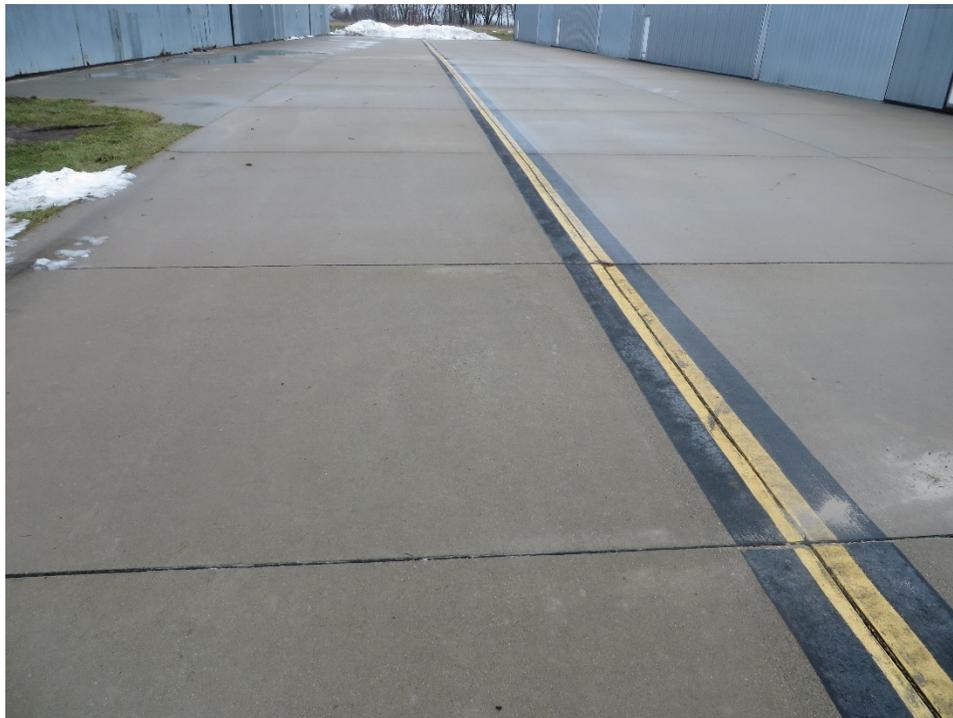
The T-hangar area consisted of two sections. Low- and medium-severity corner spalling and joint spalling and low-severity joint seal damage were observed in Section 01. An atypical area of low-severity ASR and LTD cracking was identified and recorded as an additional sample unit according to ASTM D5340-12. Section 02 was recently constructed and in excellent condition. No distresses were recorded during the inspection.

TH01LA-01. Overview.

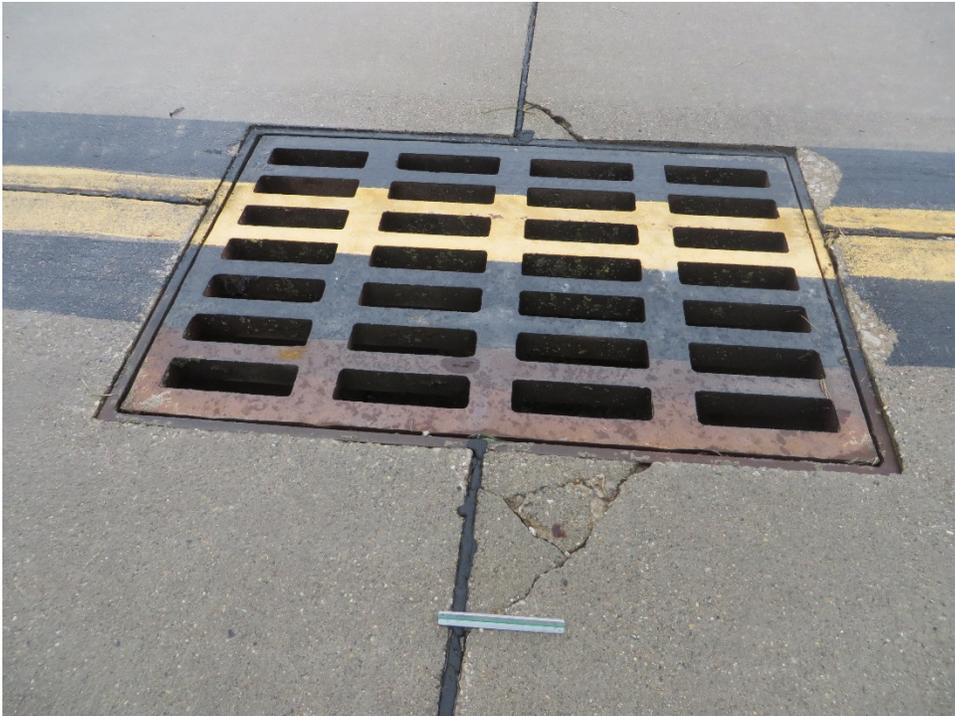
TH01LA-01. Corner Spalling (Sample Unit No. 01).

Sample Number: 01 Type: R Area: 20.00Slabs PCI = 87  
Sample Comments:  
75 CORNER SPALLING L 4.00 Slabs Comments:@DRAINAGE  
75 CORNER SPALLING M 1.00 Slabs Comments:@DRAINAGE  
65 JOINT SEAL DAMAGE L 20.00 Slabs Comments:

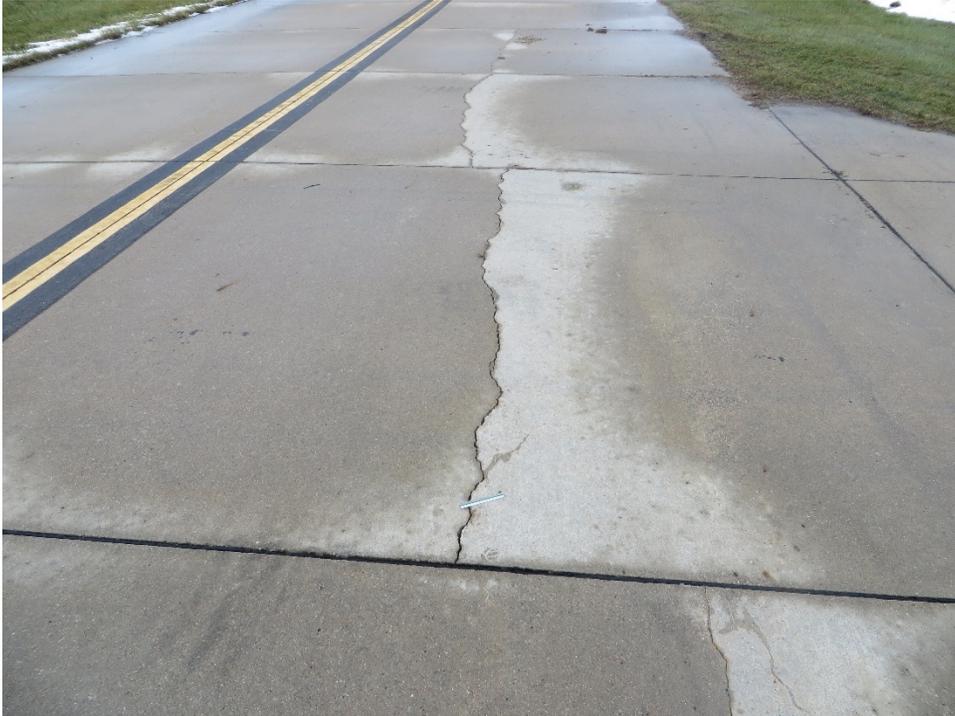
TH01LA-01. LTD Cracking (Additional Sample Unit No. 07).

Sample Number: 07 Type: A Area: 16.00Slabs PCI = 74  
Sample Comments:  
65 JOINT SEAL DAMAGE L 16.00 Slabs Comments:  
63 LINEAR CRACKING L 4.00 Slabs Comments:  
75 CORNER SPALLING L 1.00 Slabs Comments:  
76 ASR L 3.00 Slabs Comments:

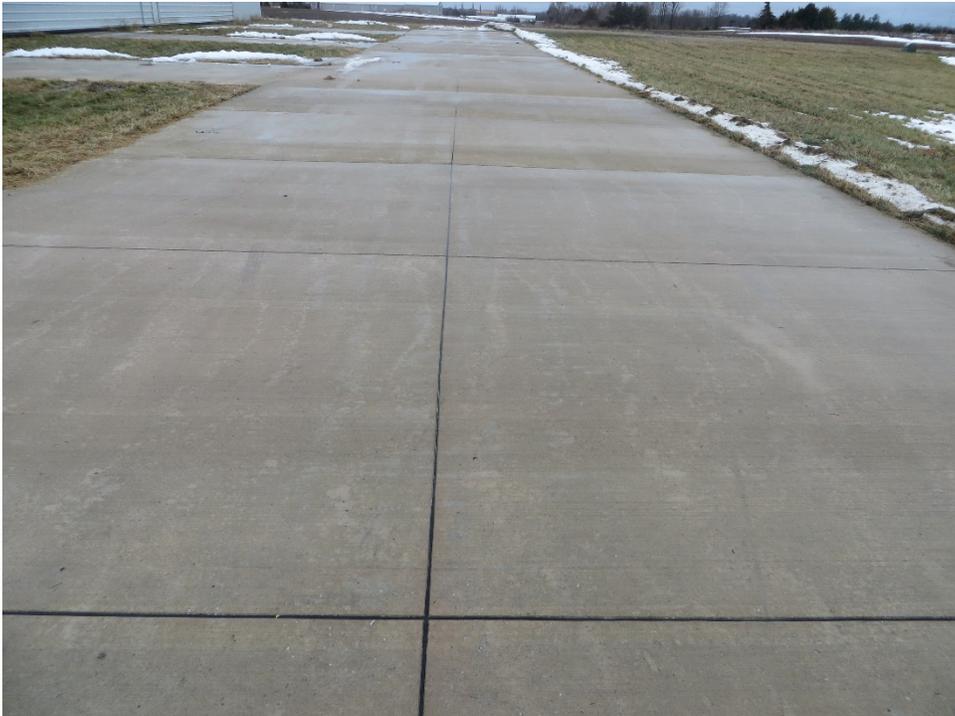
TH01LA-02. Overview.
