LE MARS MUNICIPAL AIRPORT PAVEMENT MANAGEMENT REPORT

Prepared For:
Iowa Department of Transportation
Office of Aviation

Prepared By:
Applied Pavement Technology, Inc.

April 2016

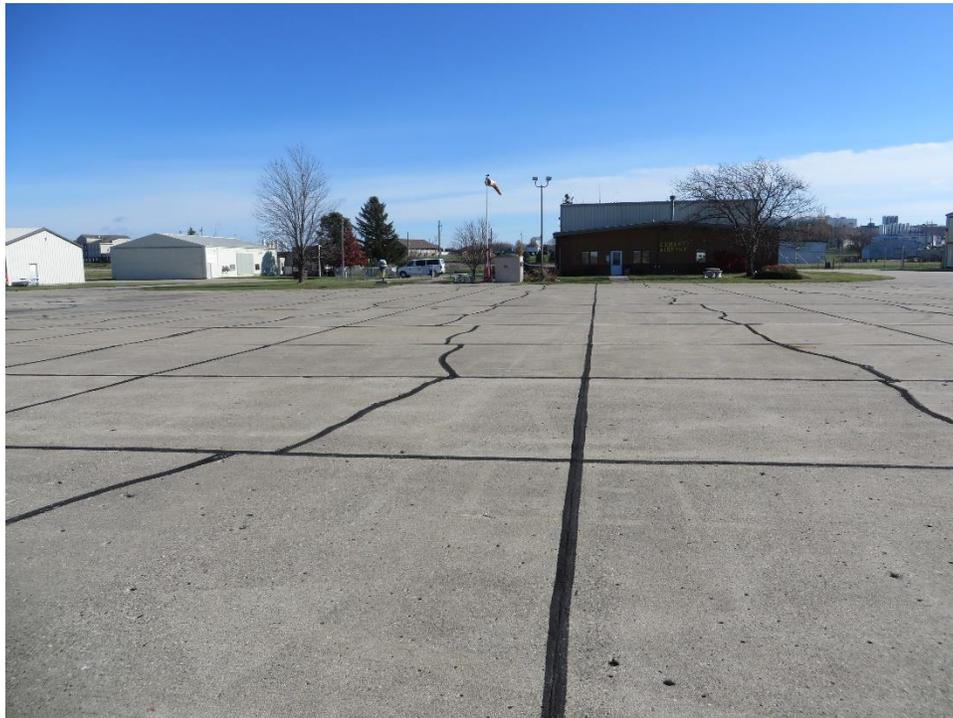
A01LE-01. Overview.

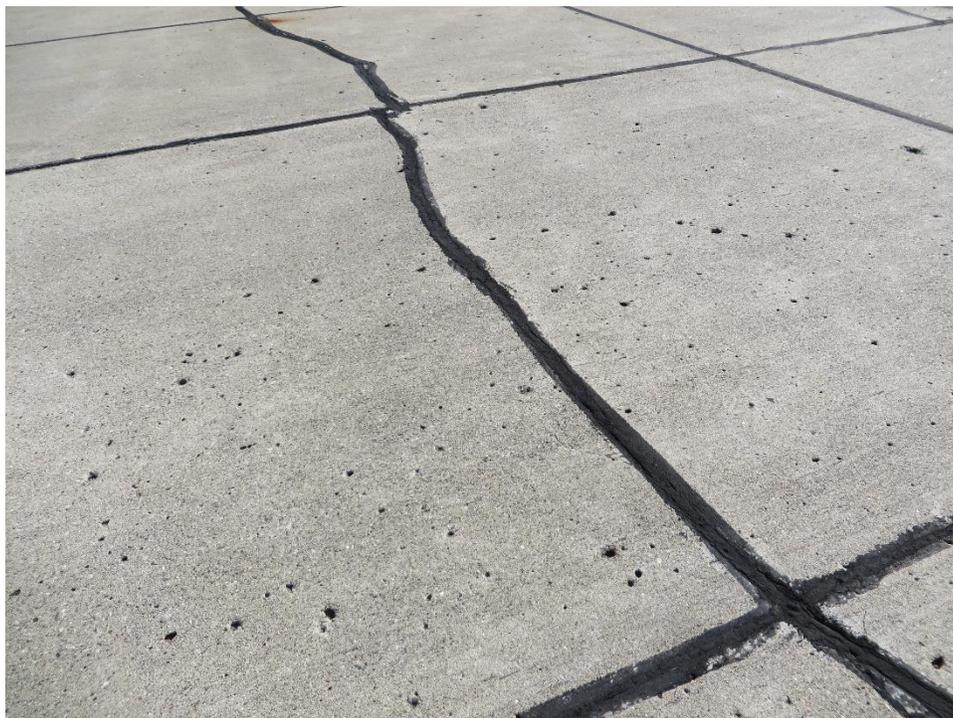
A01LE-01. LTD Cracking (Sample Unit No. 03).

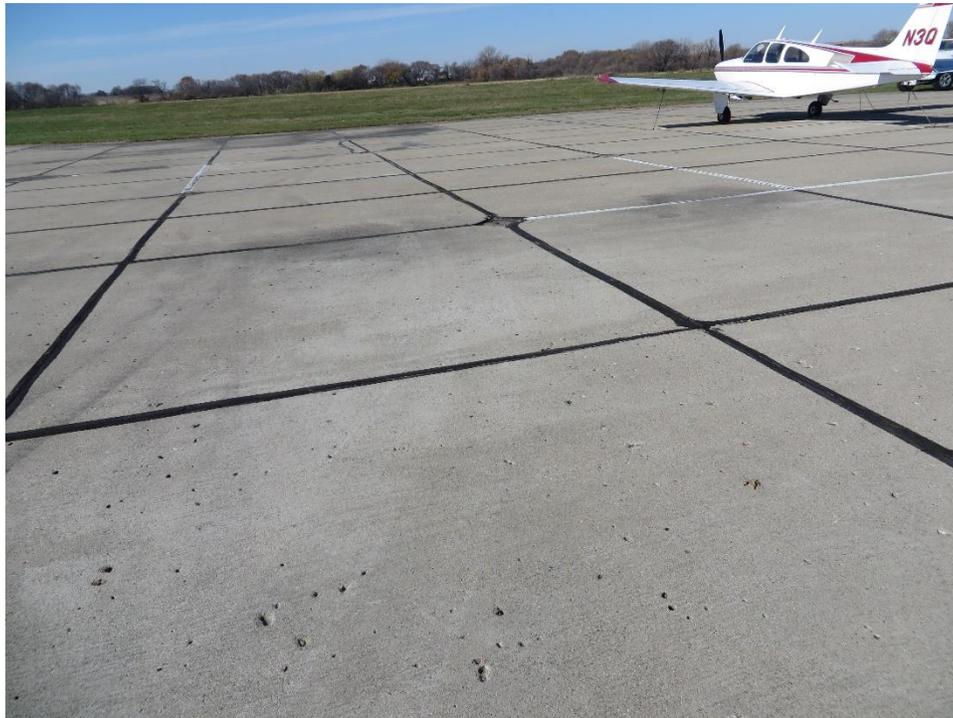
A01LE-02. Overview.

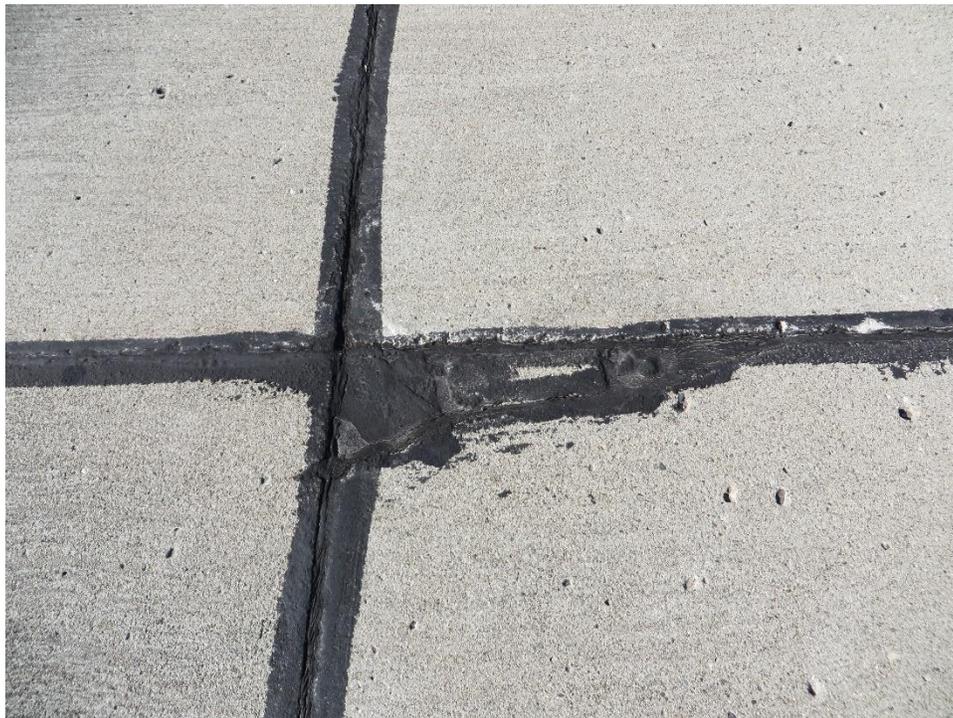
A01LE-02. Corner Spalling (Sample Unit No. 05).

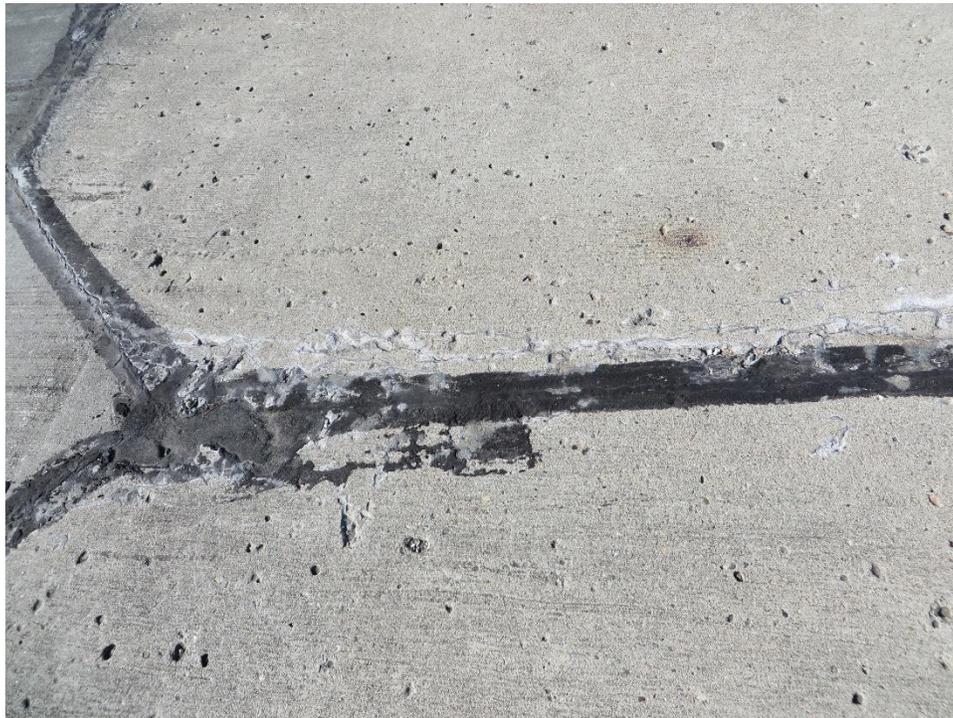
A01LE-02. Durability Cracking (Sample Unit No. 05).

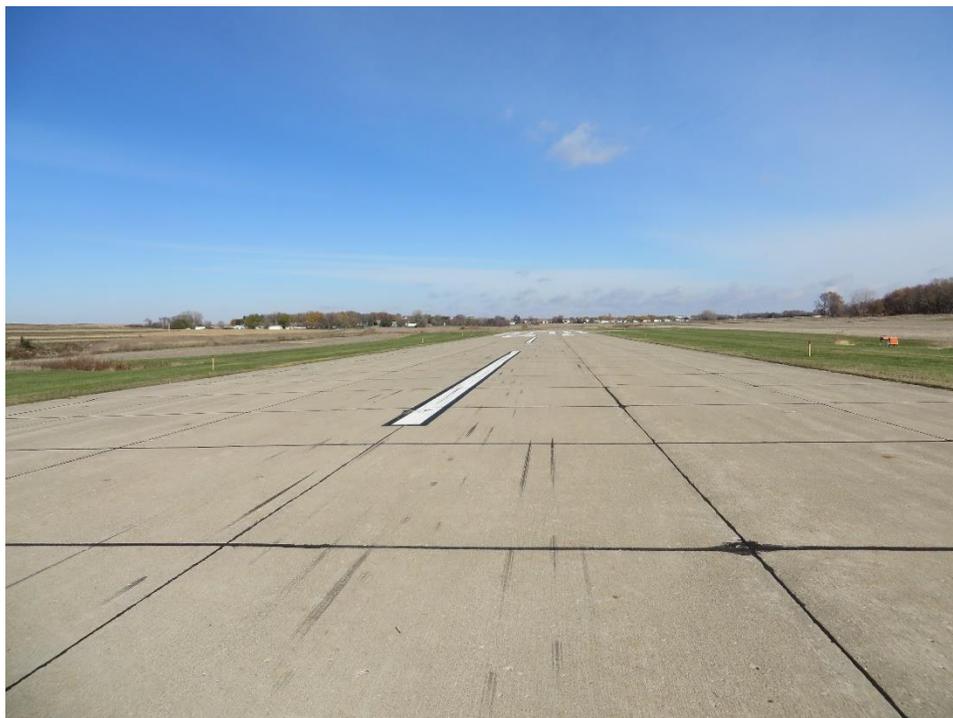
R18LE-01. Overview.

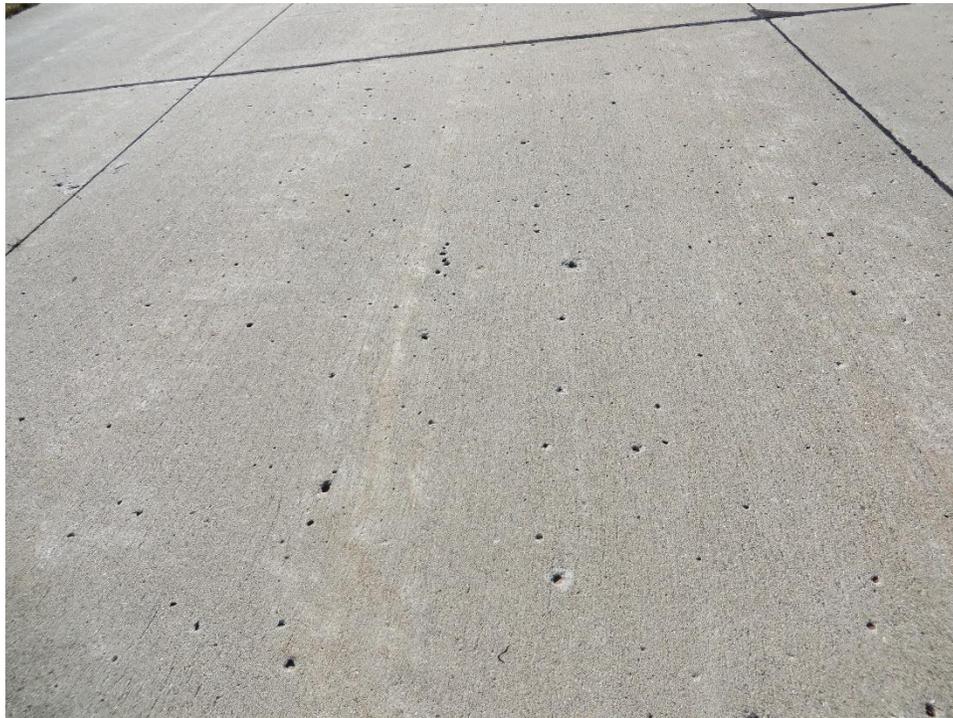
R18LE-01. Popouts (Sample Unit No. 11).

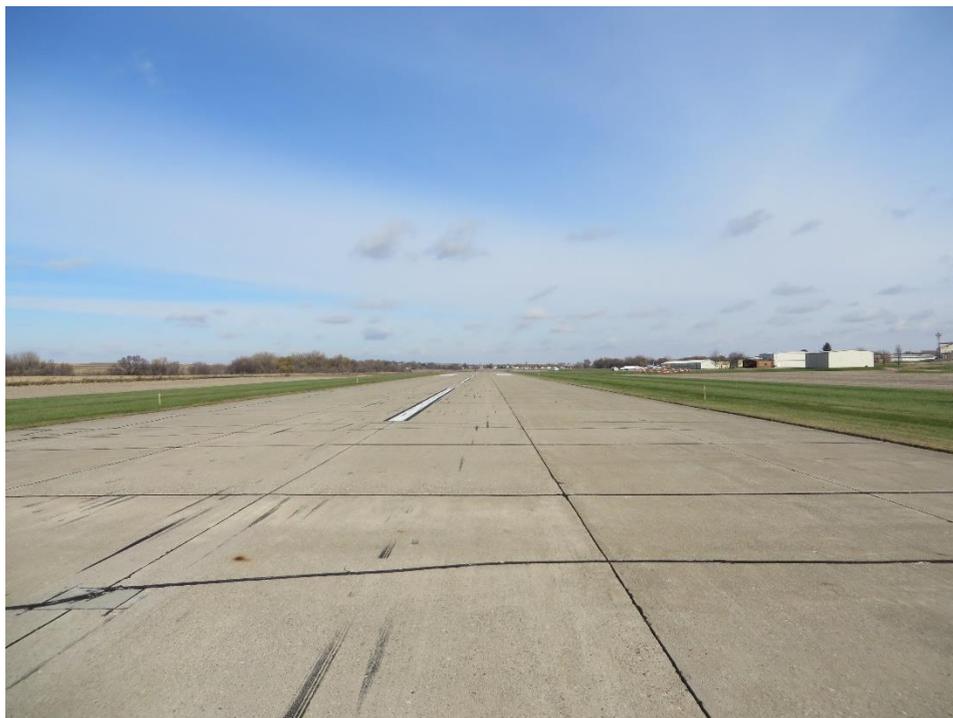
R18LE-02. Overview.

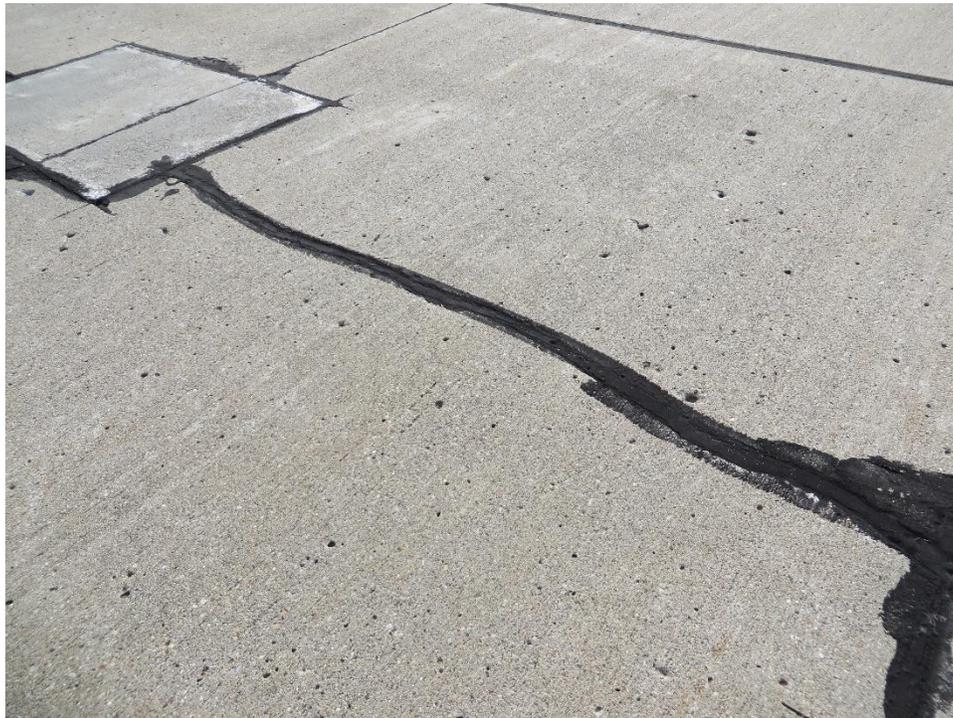
R18LE-02. LTD Cracking (Sample Unit No. 35).

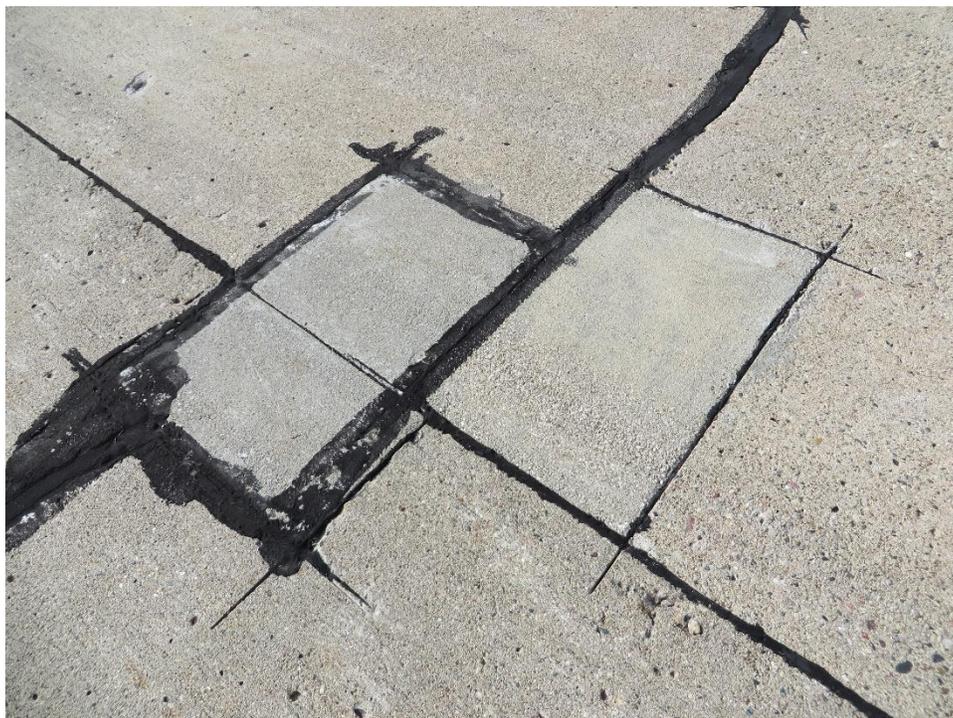
R18LE-02. Small Patching (Sample Unit No. 35).

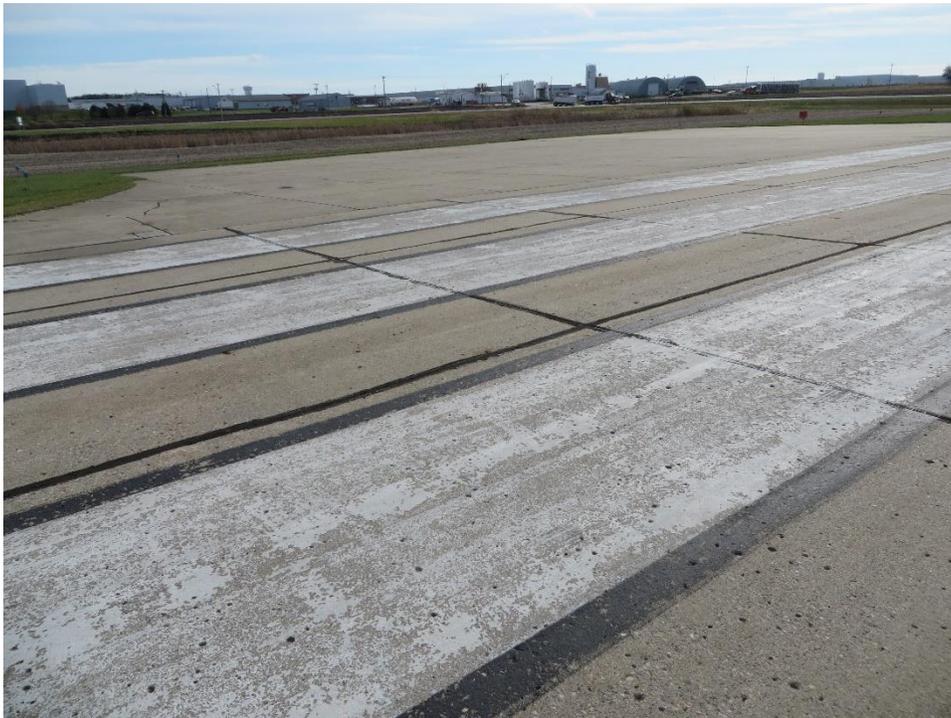
R18LE-03. Overview.

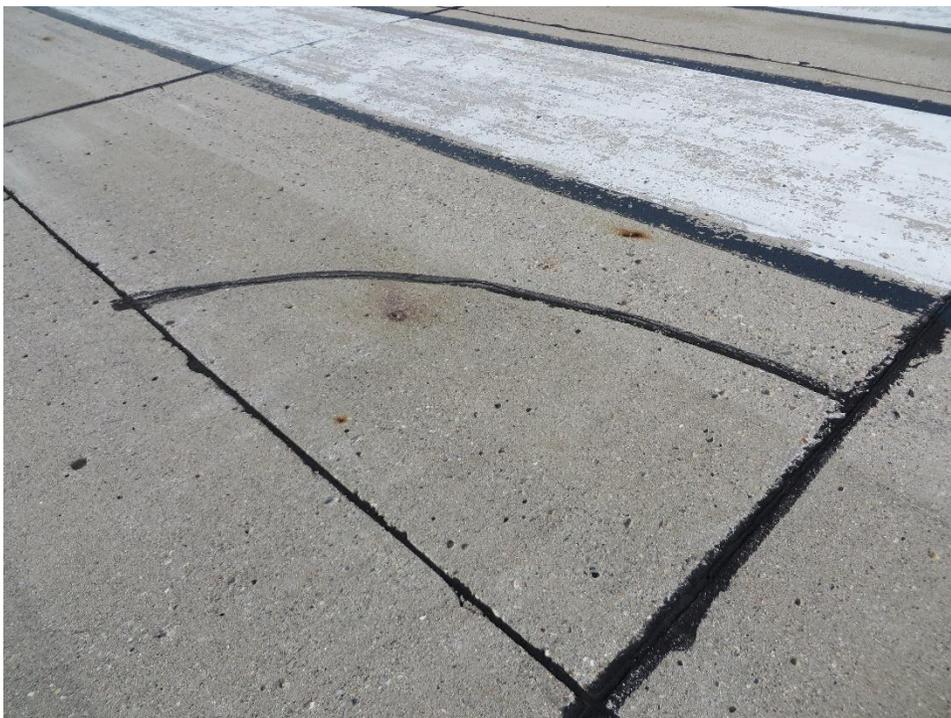
R18LE-03. Corner Break (Sample Unit No. 01).

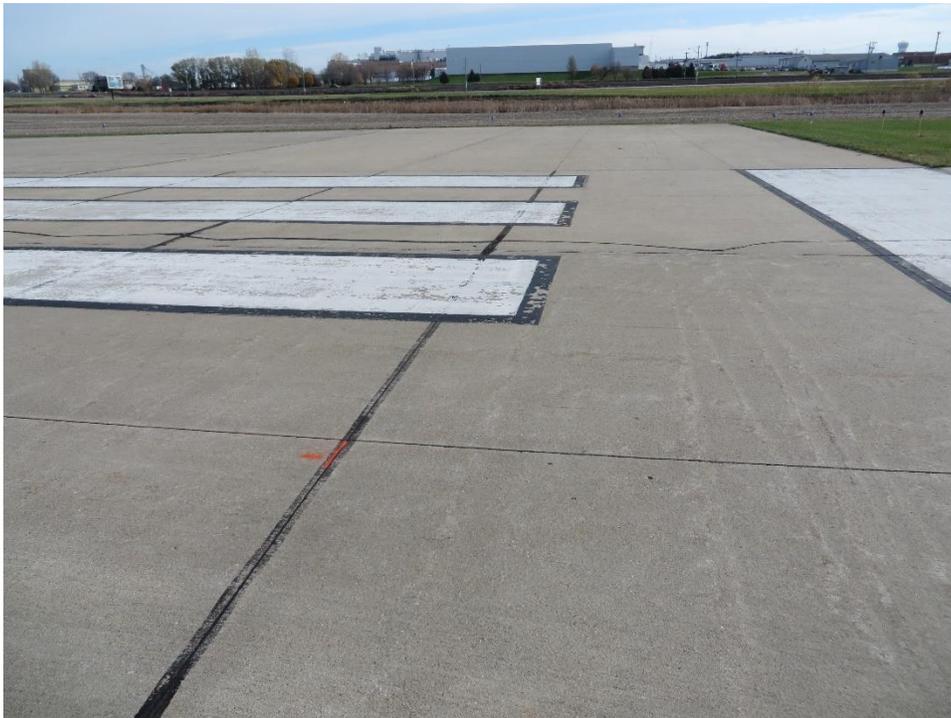
R18LE-04. Overview.

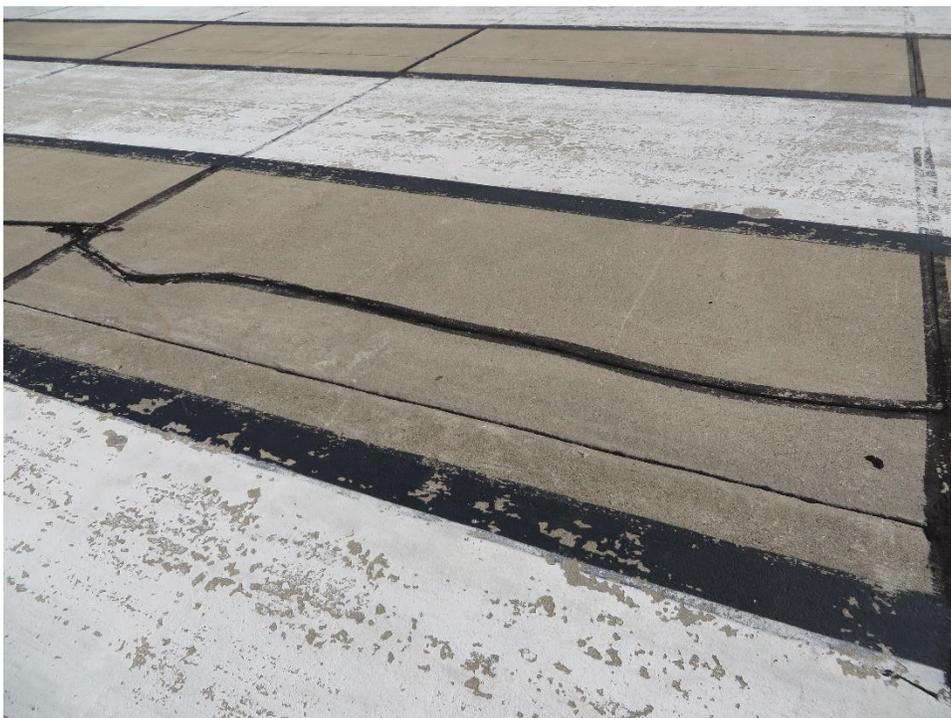
R18LE-04. LTD Cracking (Sample Unit No. 01).

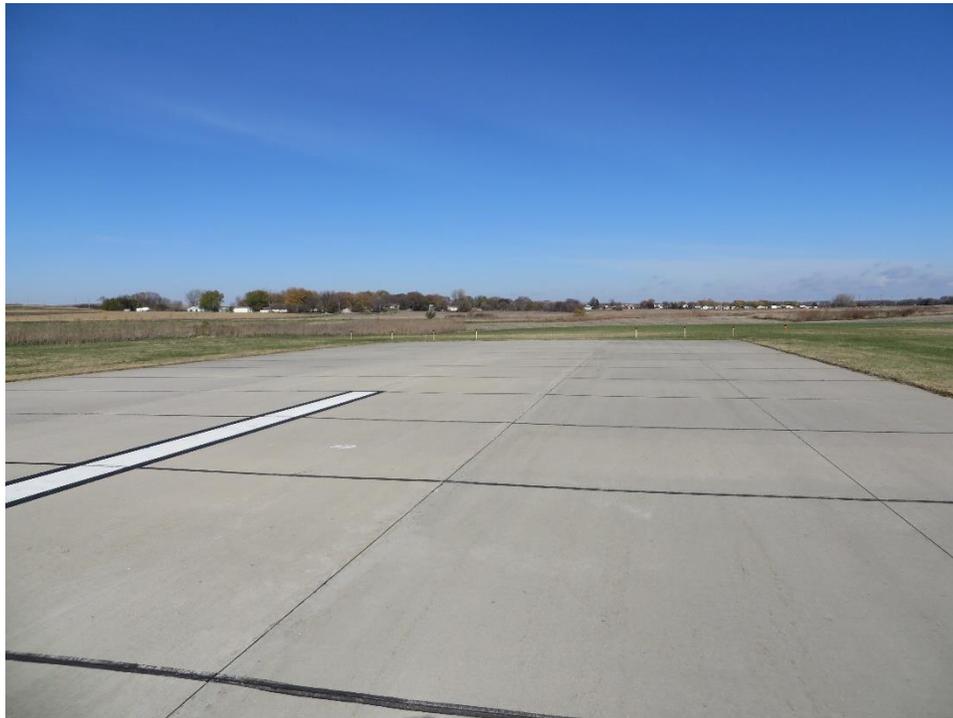
R18LE-05. Overview.

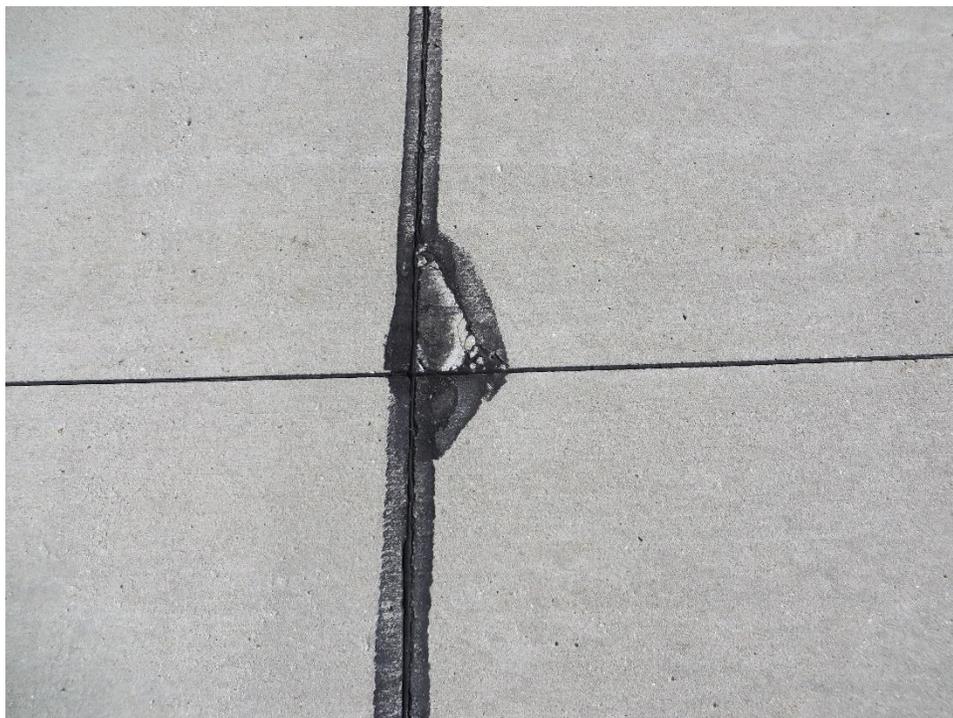
R18LE-05. Corner Spalling (Sample Unit No. 03).

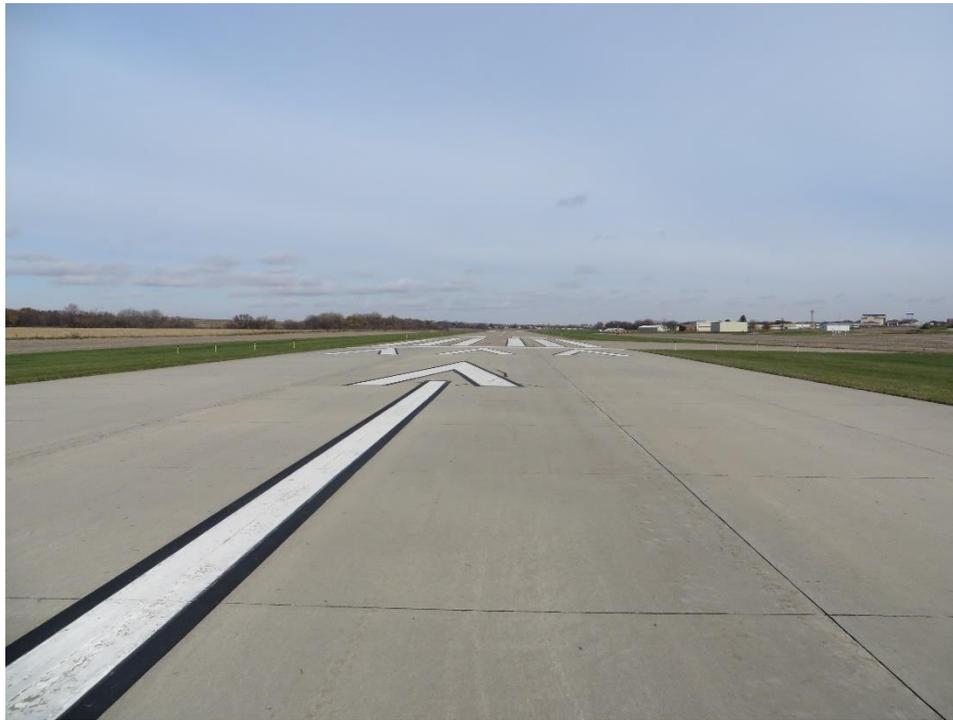
R18LE-06. Overview.

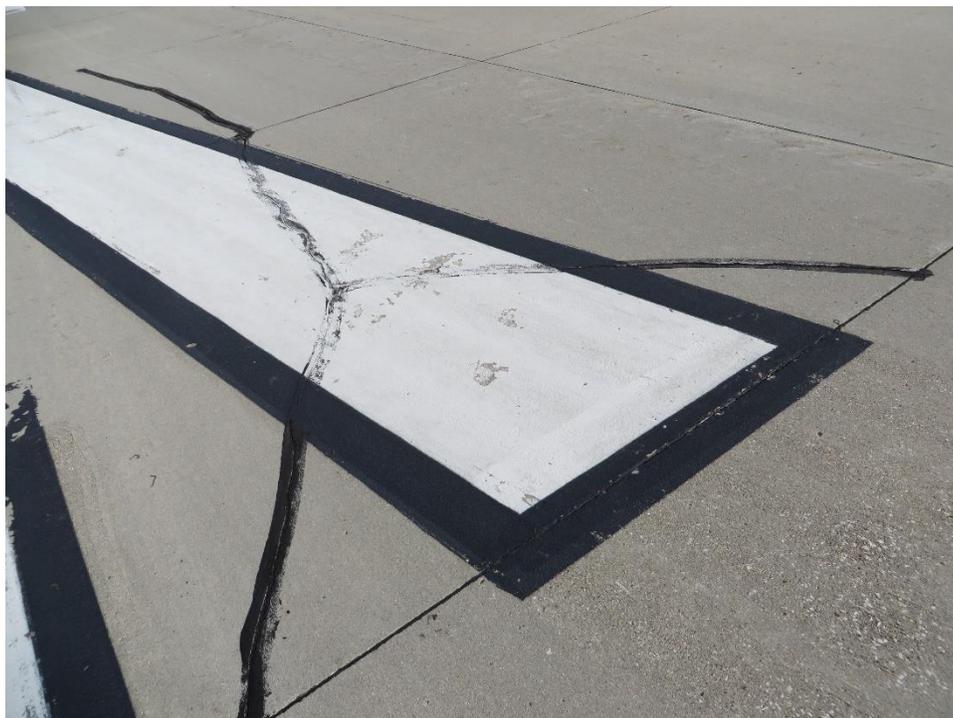
R18LE-06. LTD Cracking (Sample Unit No. 04).

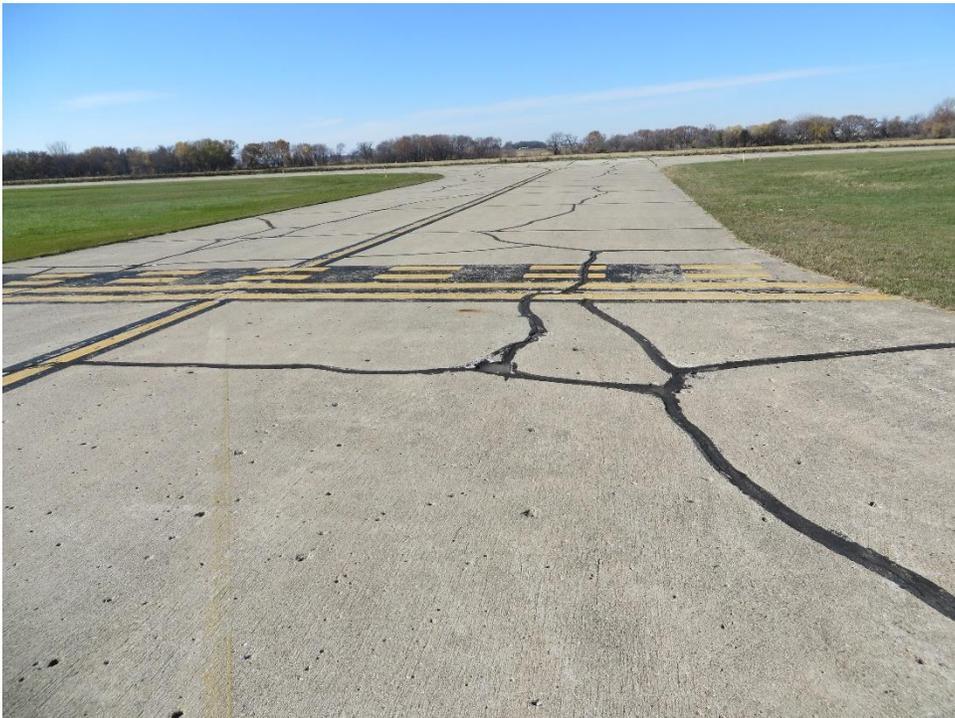
T01LE-01. Overview.

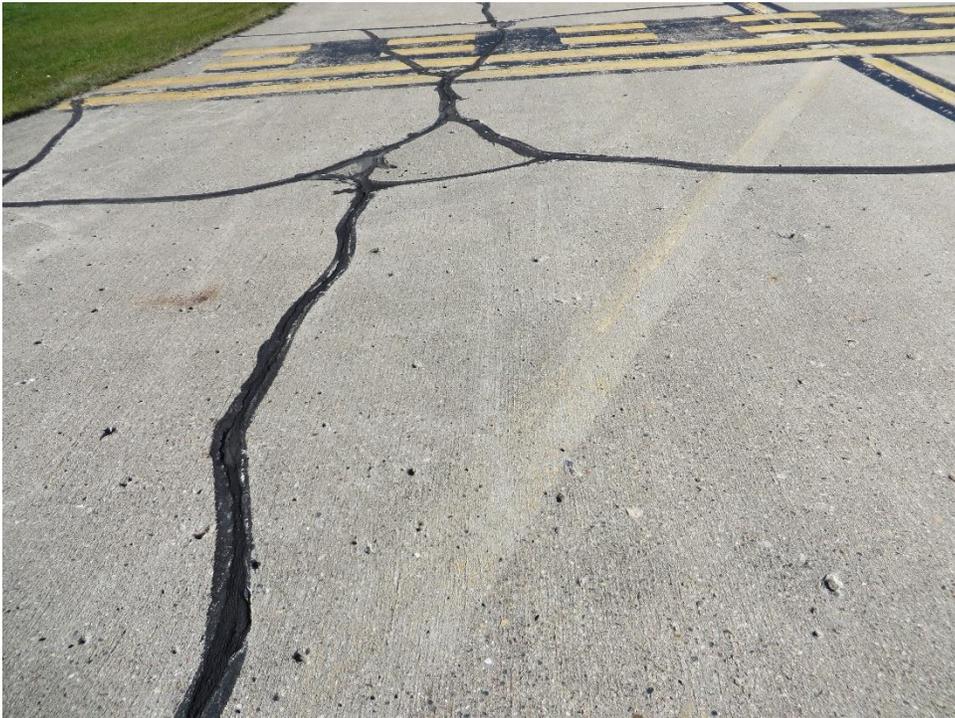
Taxiway 01 connected the apron area with Runway 18-36 and contained one section in poor condition. Section 01 had low-severity joint seal damage observed throughout along with areas of low- and medium-severity shattered slabs, LTD cracking, and joint spalling; low-severity corner breaks and corner spalling; and popouts.

T01LE-01. Shattered Slab (Sample Unit No. 01).
