Le Mars Municipal Airport

Pavement Management Report

JULY 2023

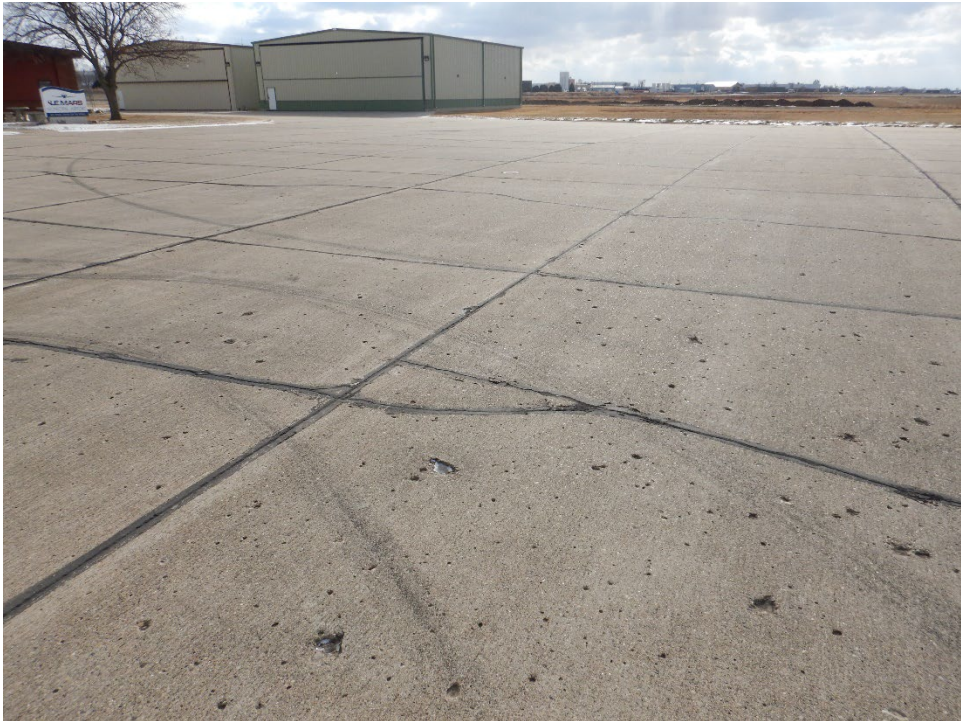
The apron area consisted of two sections. Section 01 was in poor condition with medium-severity shattered slab and corner break, low-severity joint seal damage and large patching, low- and medium-severity joint spalling and LTD cracking, and popouts. Section 02 contained areas of medium-severity ASR, corner break, shattered slab, LTD cracking and corner spalling; low-severity small patching; high-severity joint seal damage; low- and high-severity large patching; popouts; and shrinkage cracking.

A01LE-01. Overview.

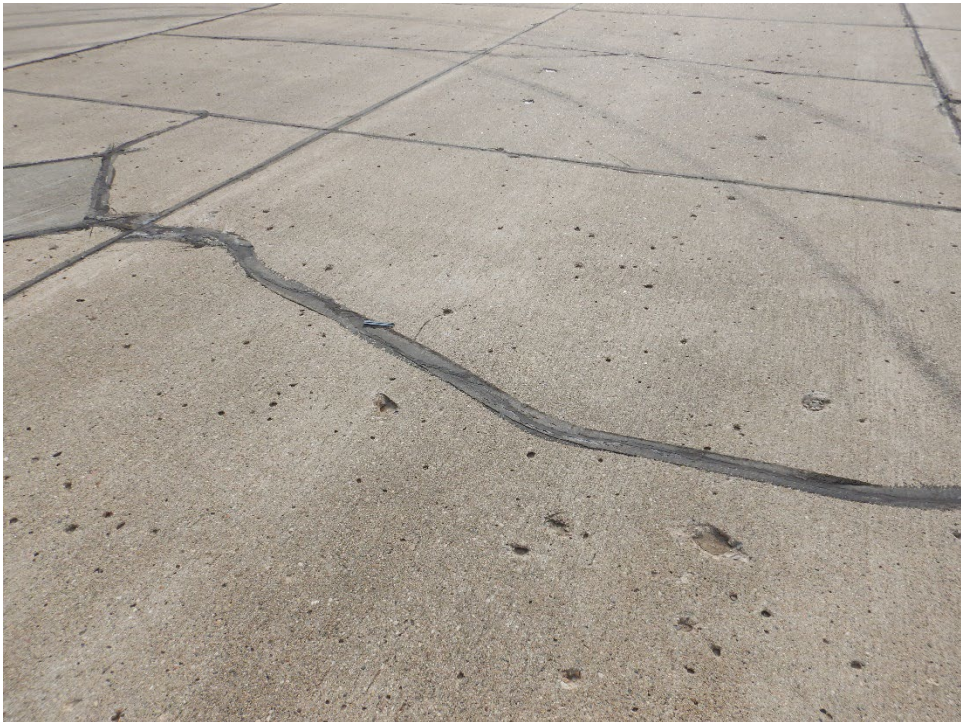
A01LE-01. LTD Cracking (Sample Unit No. 02).

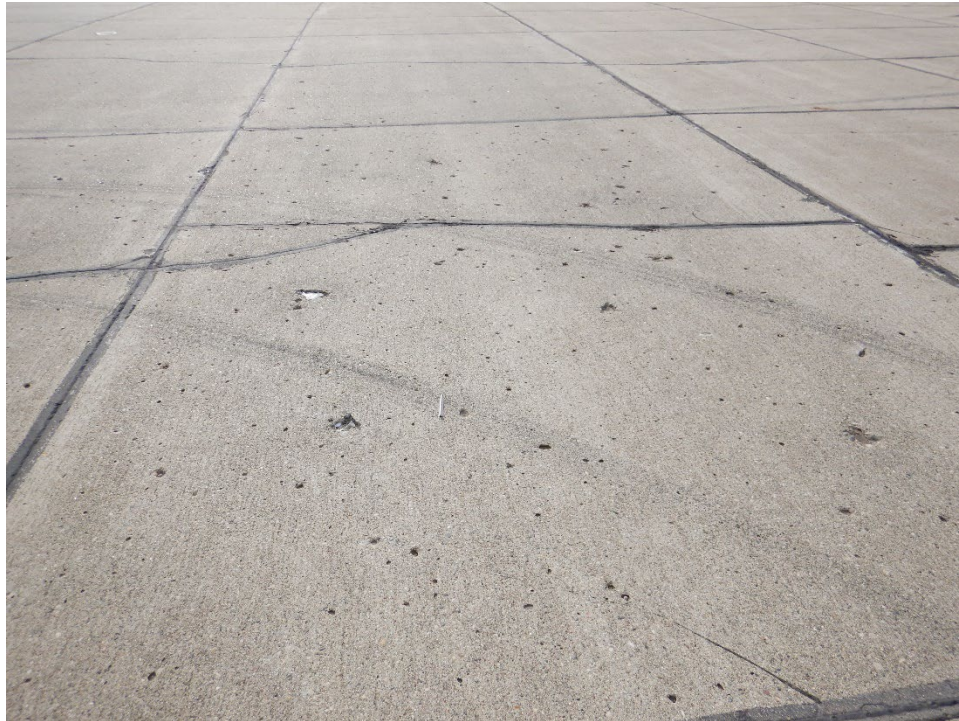
A01LE-01. Popouts (Sample Unit No. 02).

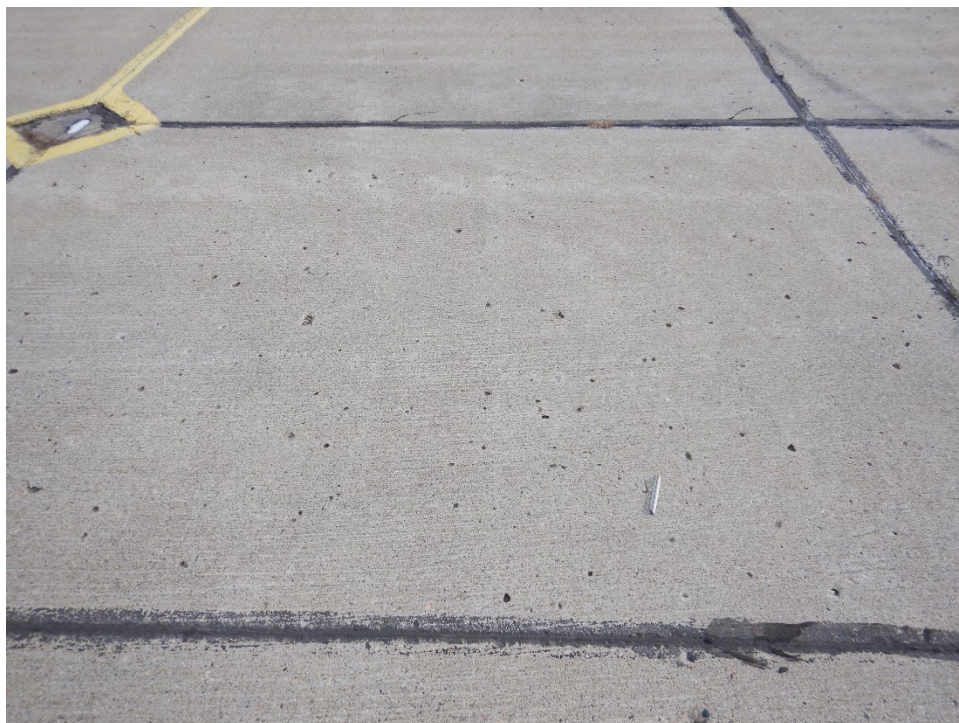
A01LE-02. Popouts (Sample Unit No. 06).

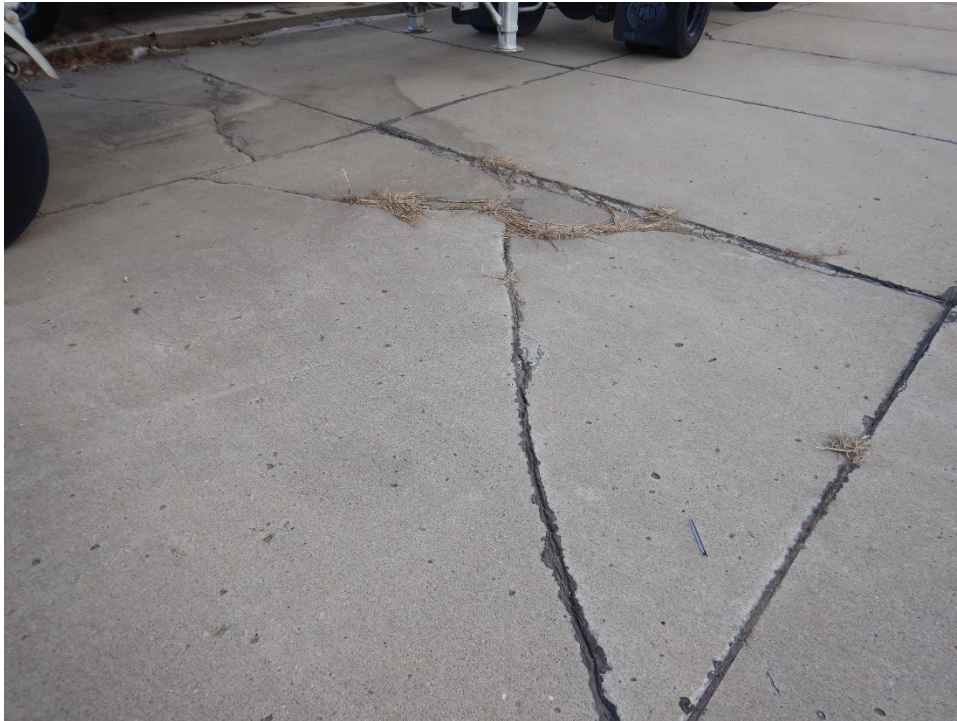
A01LE-02. Shattered Slab (Sample Unit No. 03).

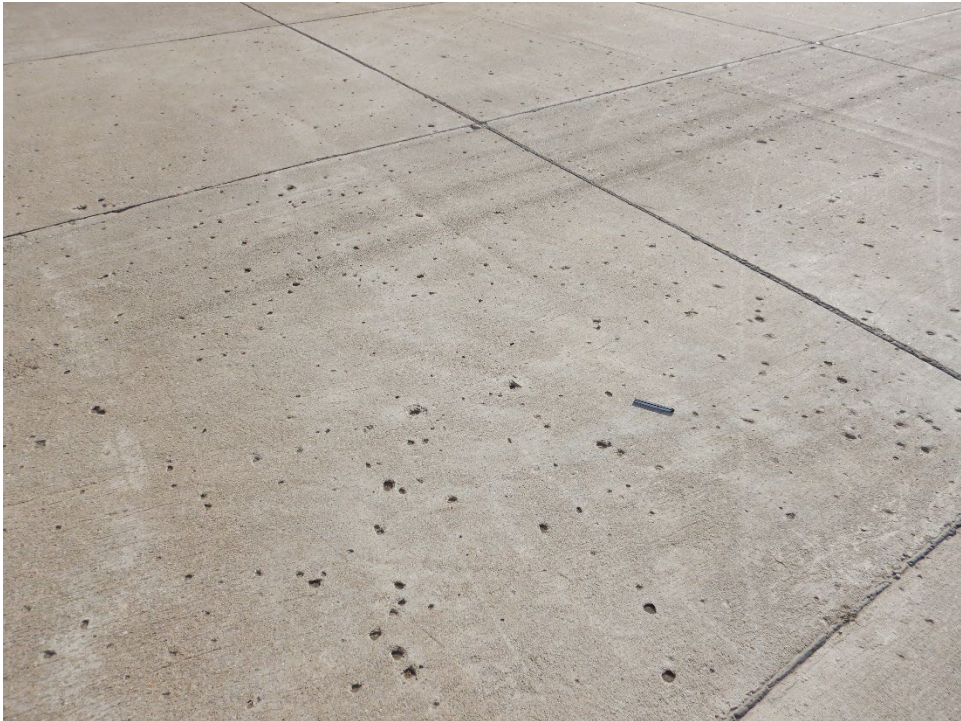
R18LE-01. Popouts (Sample Unit No. 01).

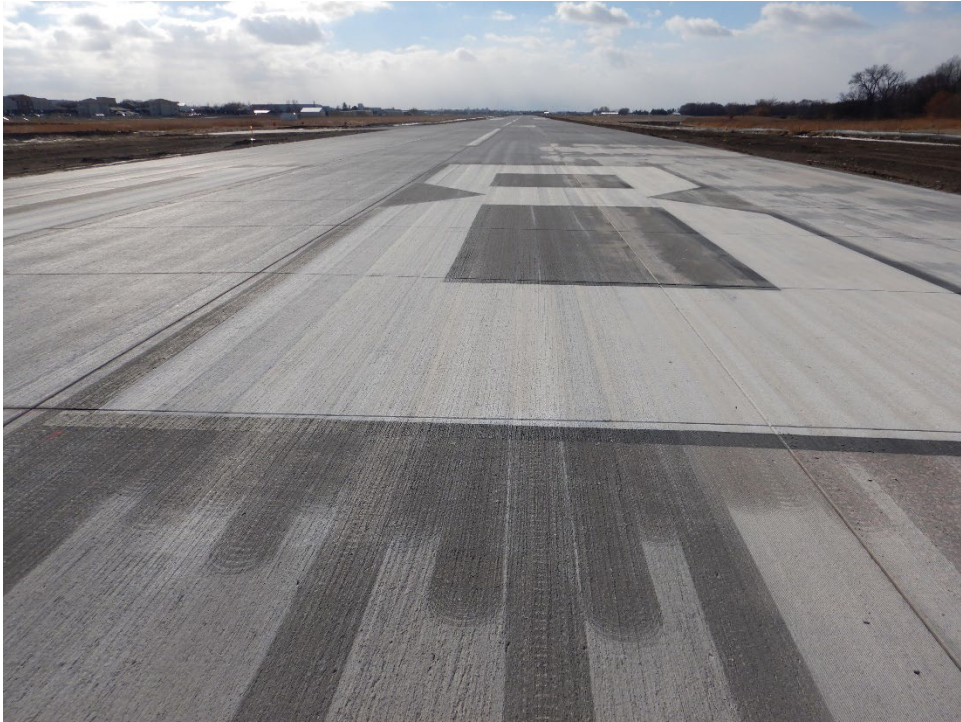
R18LE-02. Overview.

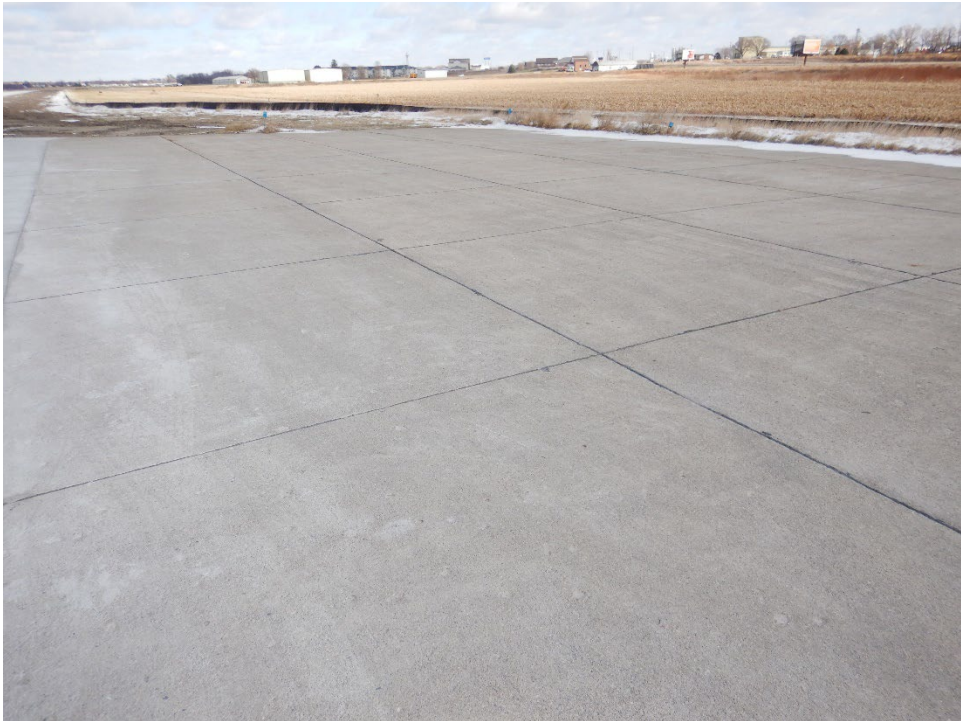
R18LE-03. Overview.

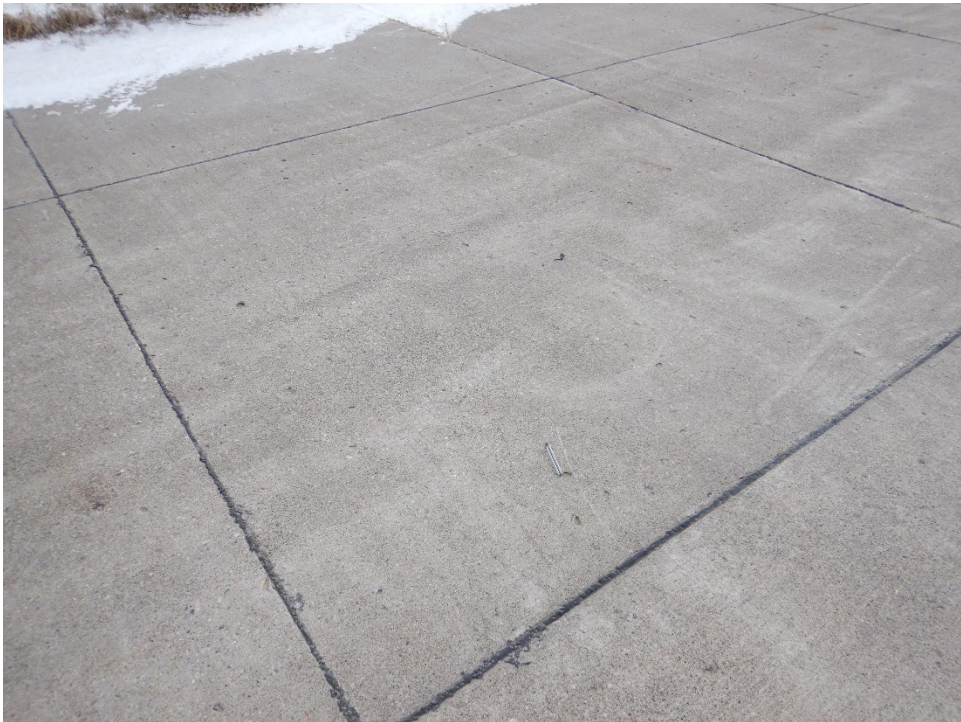
R18LE-03. Popouts (Sample Unit No. 01).

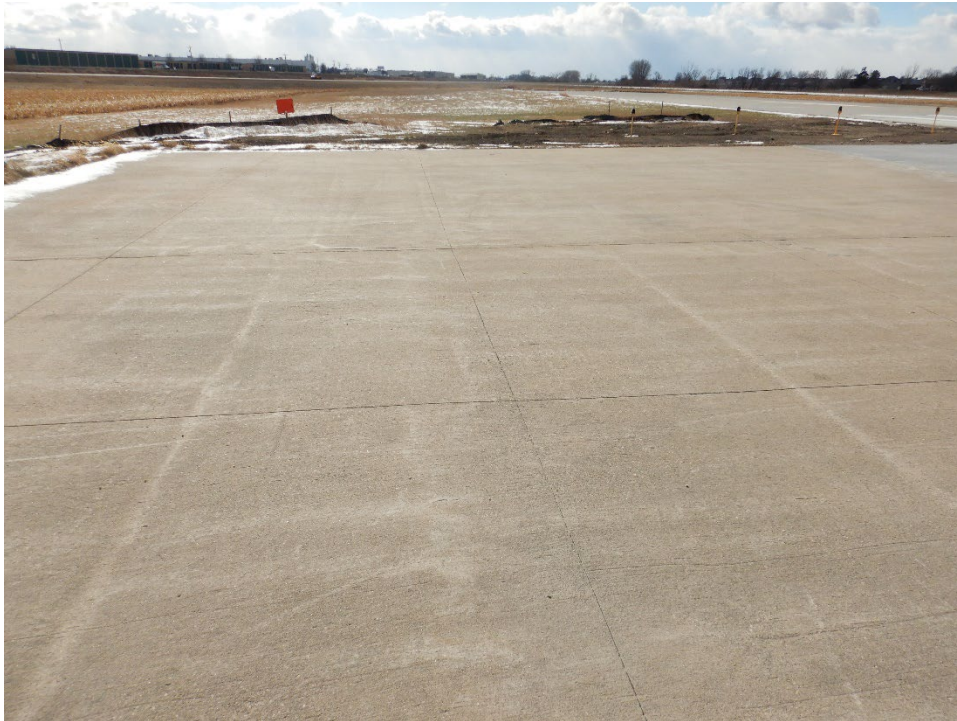
R18LE-04. Overview.

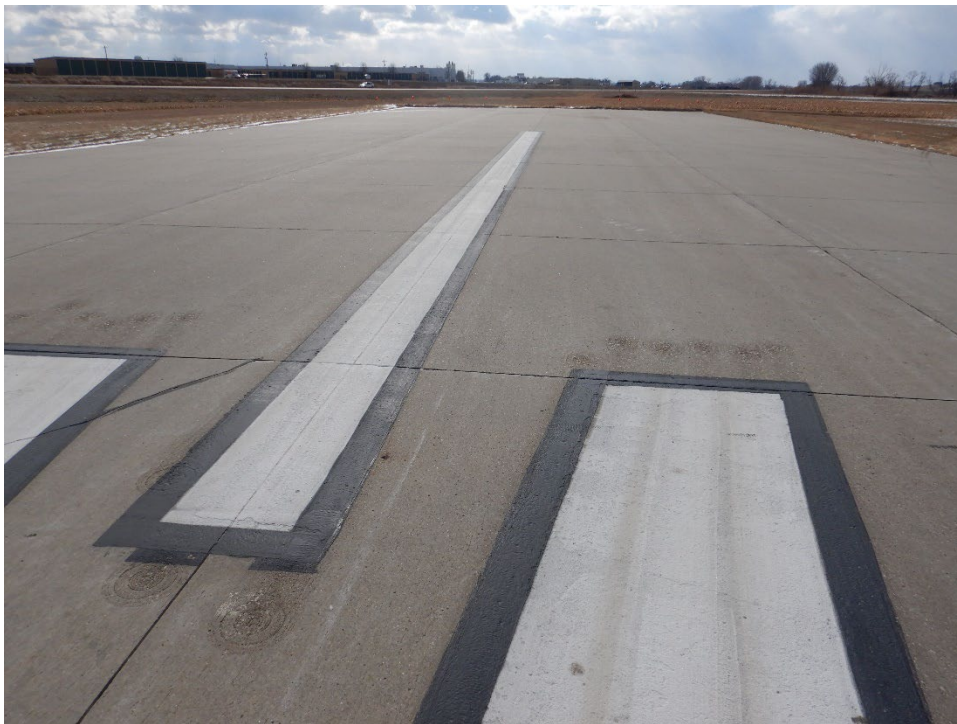
R18LE-05. Overview.

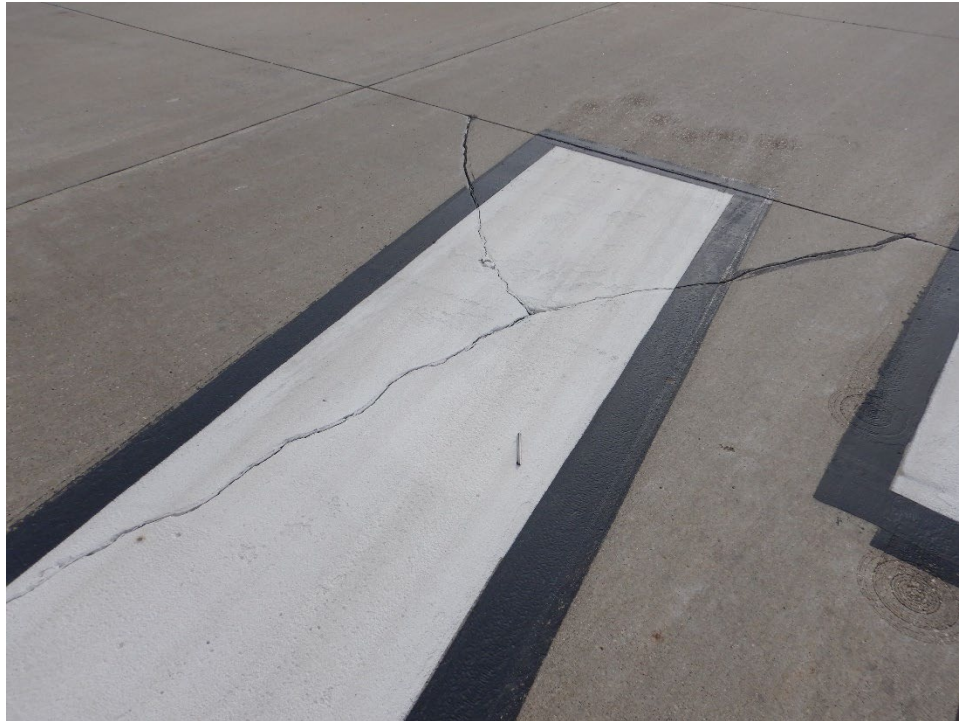
R18LE-05. LTD Cracking (Sample Unit No. 04).

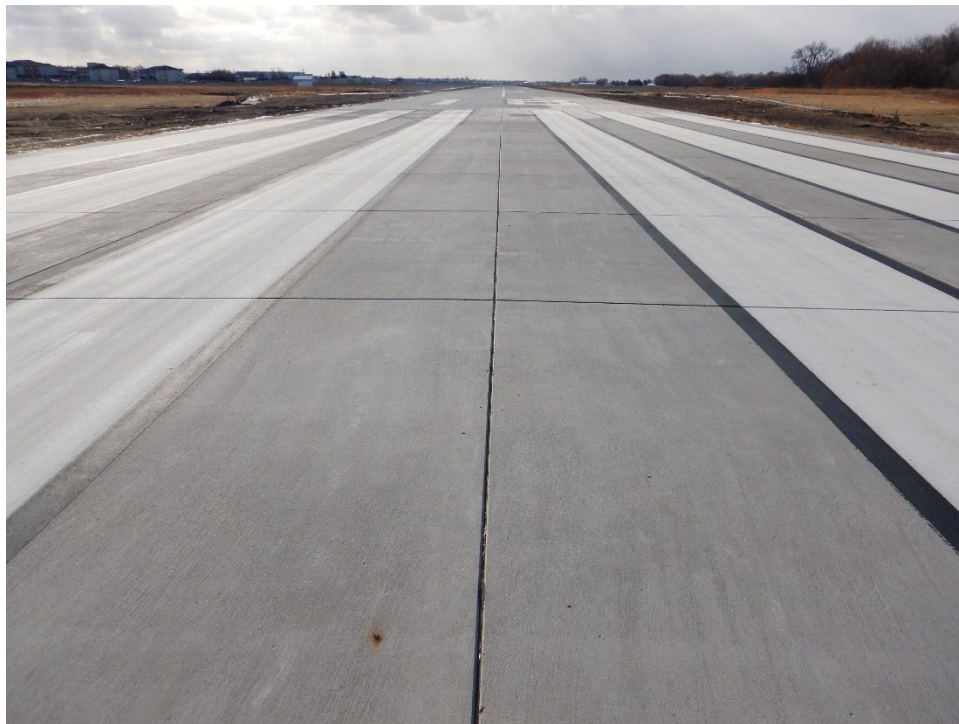
R18LE-06. Overview.

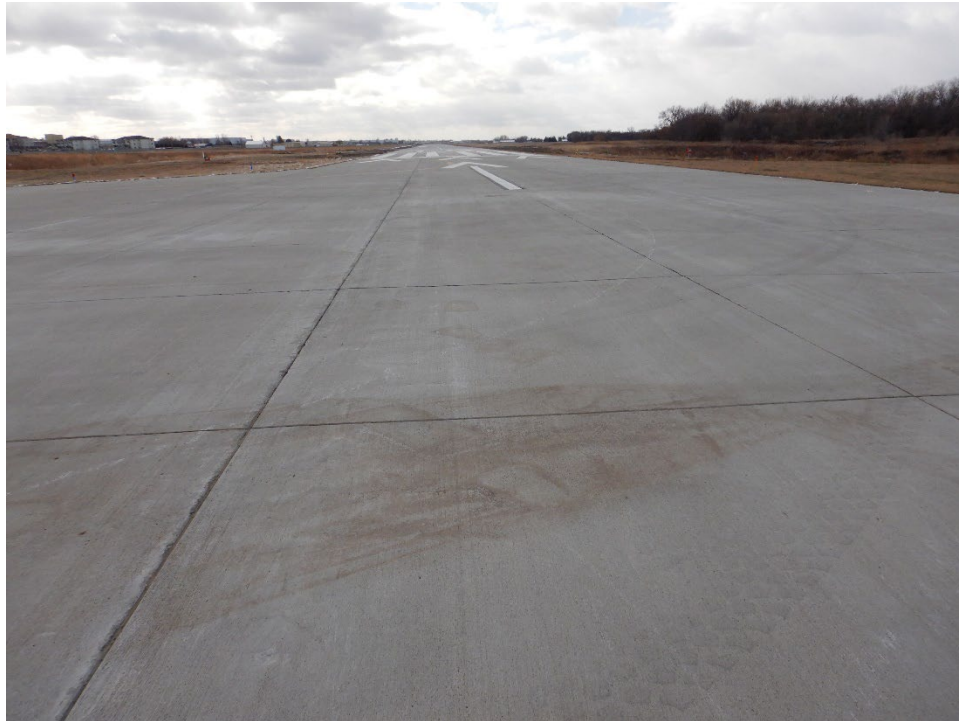
R18LE-07. Overview.

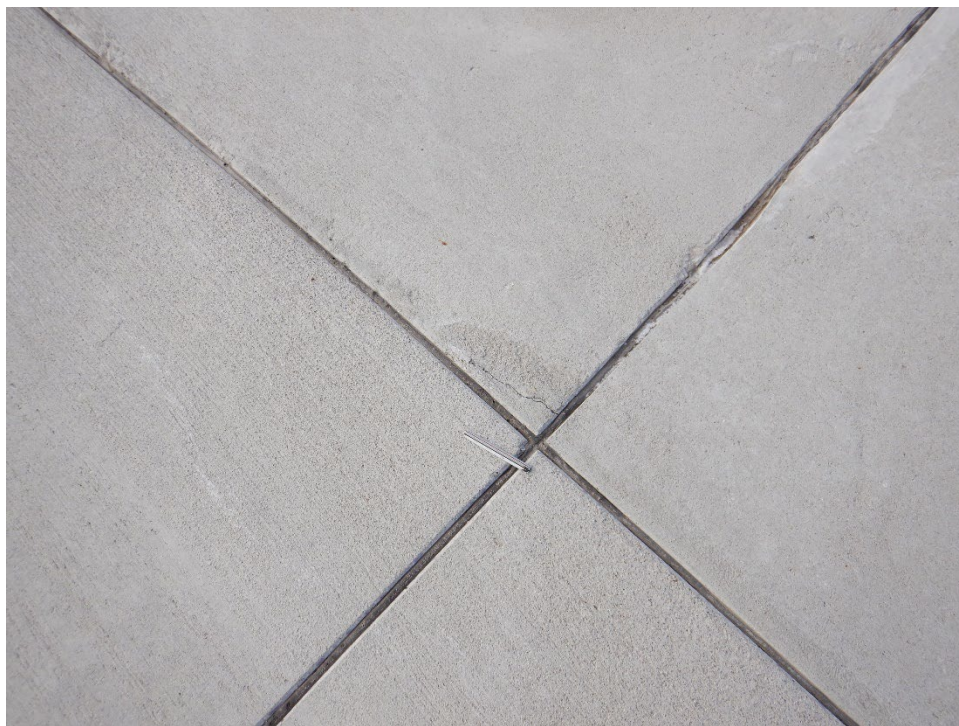
R18LE-07. Joint Spalling (Sample Unit No. 06).

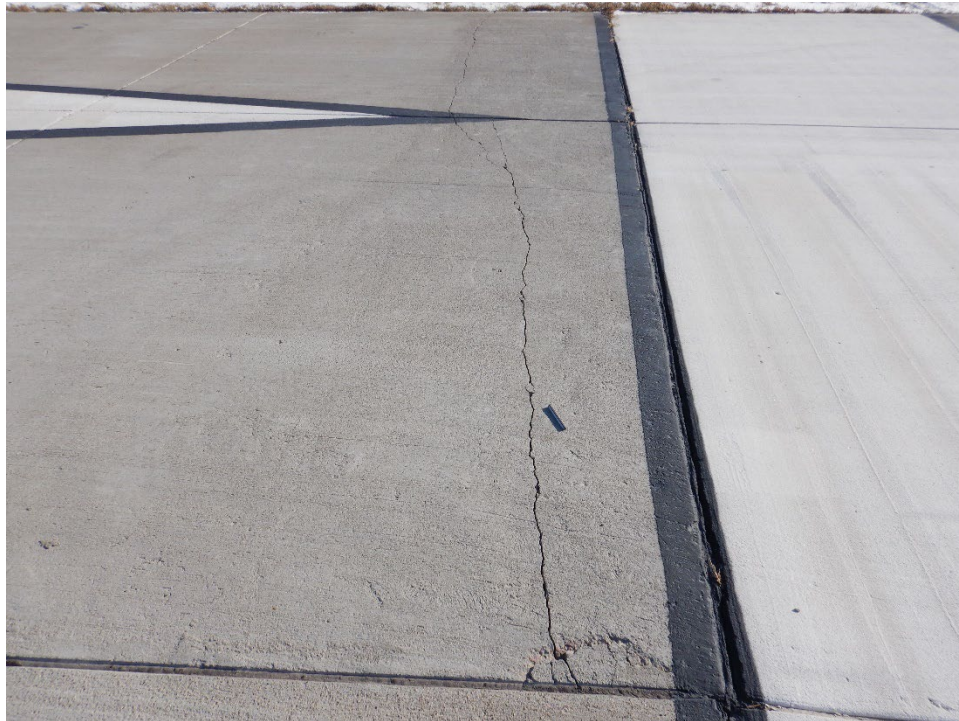
R18LE-07. LTD Cracking (Sample Unit No. 01).

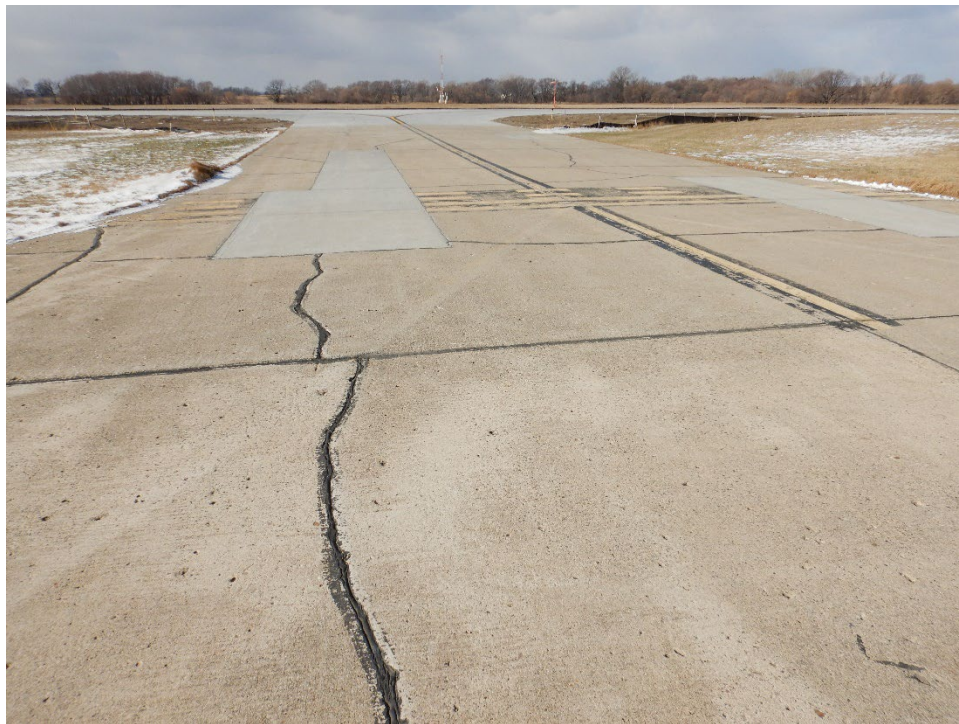
The taxiway pavement contained one section. Section 01 was in poor condition with low-severity small patching, joint spalling, and large patching; medium-severity shattered slab; high-severity joint seal damage; low- and medium-severity LTD cracking; popouts; and shrinkage cracking observed at the time of inspection.

T01LE-01. Overview.

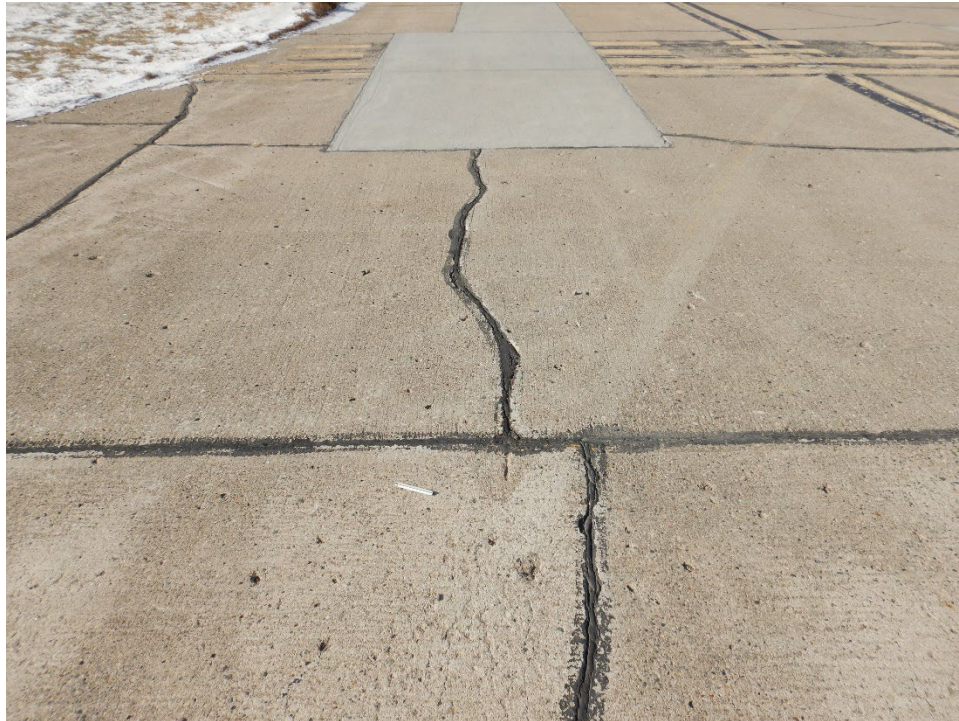
T01LE-01. LTD Cracking (Sample Unit No. 01).

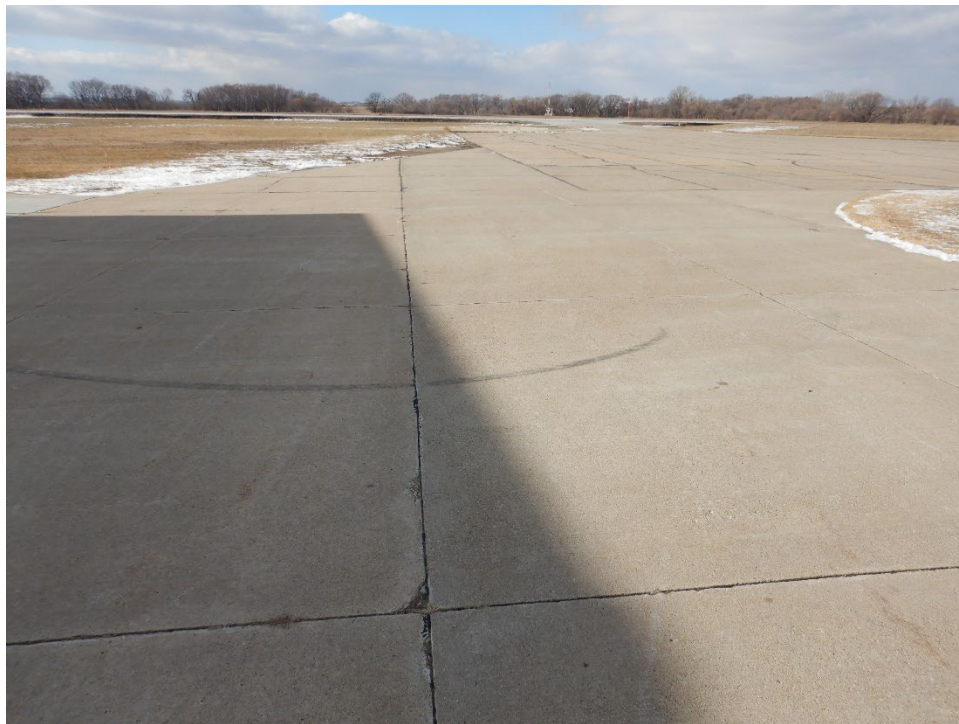
The T-hangar area was defined by two sections. Medium- and high-severity corner spalling, medium-severity joint spalling, low-severity faulting, and high-severity joint seal damage were recorded in Section 01. Section 02 contained areas of low- and medium-severity corner break, joint spalling, large patching, and shattered slab; all severities of corner spalling and small patching; medium- and high-severity joint seal damage; medium-severity LTD cracking; popouts; and shrinkage cracking.

TH01LE-01. Overview.

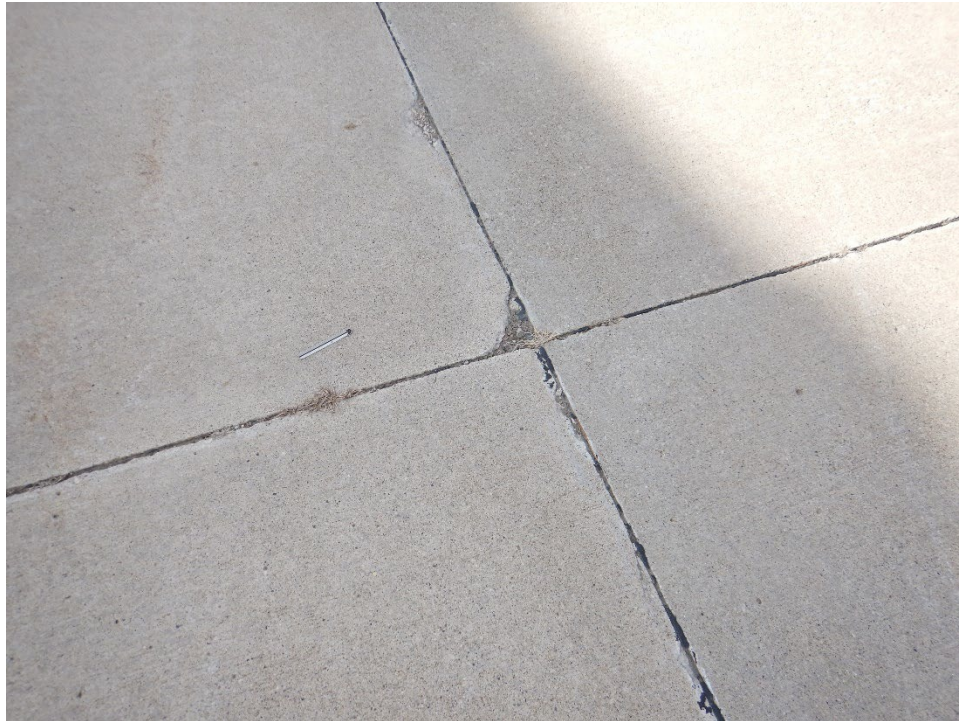
TH01LE-01. Corner Spalling (Sample Unit No. 01).

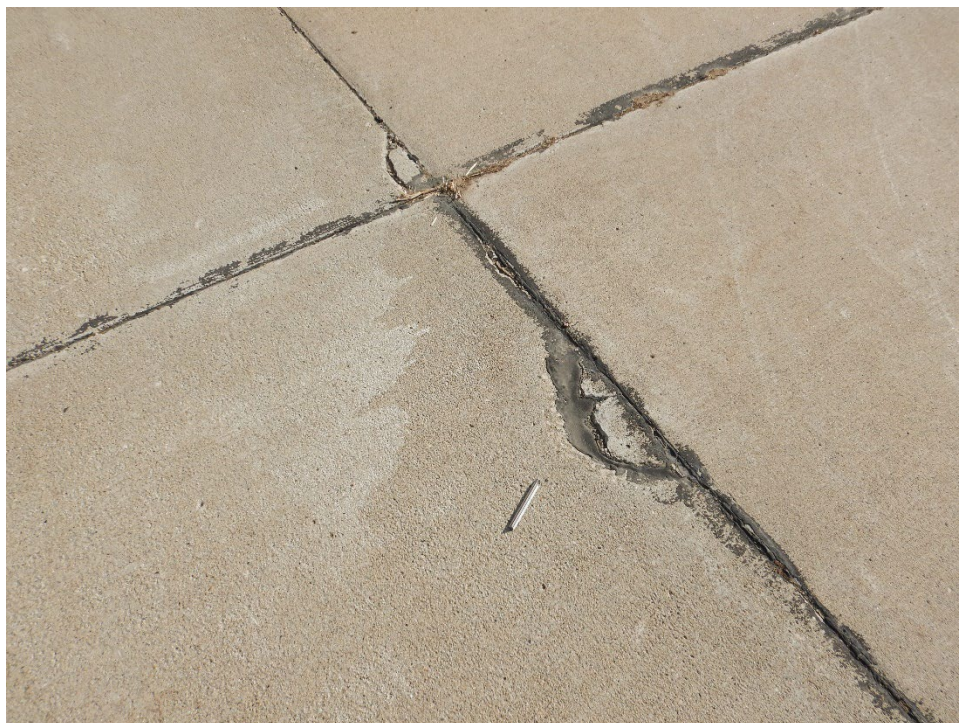
TH01LE-01. Joint Spalling (Sample Unit No. 01).

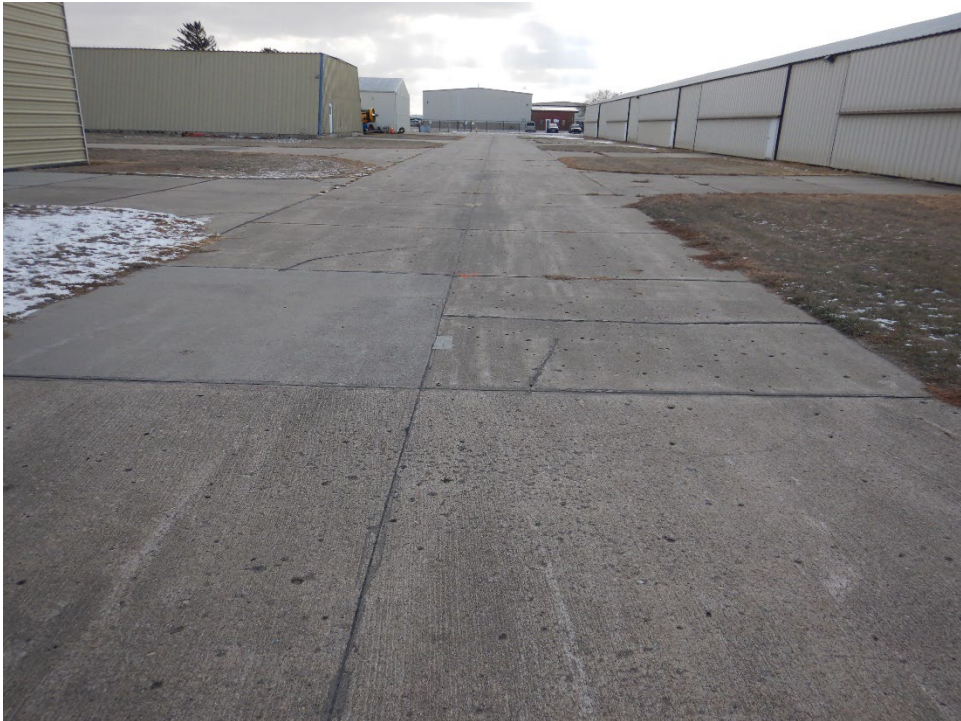
TH01LE-02. Overview.

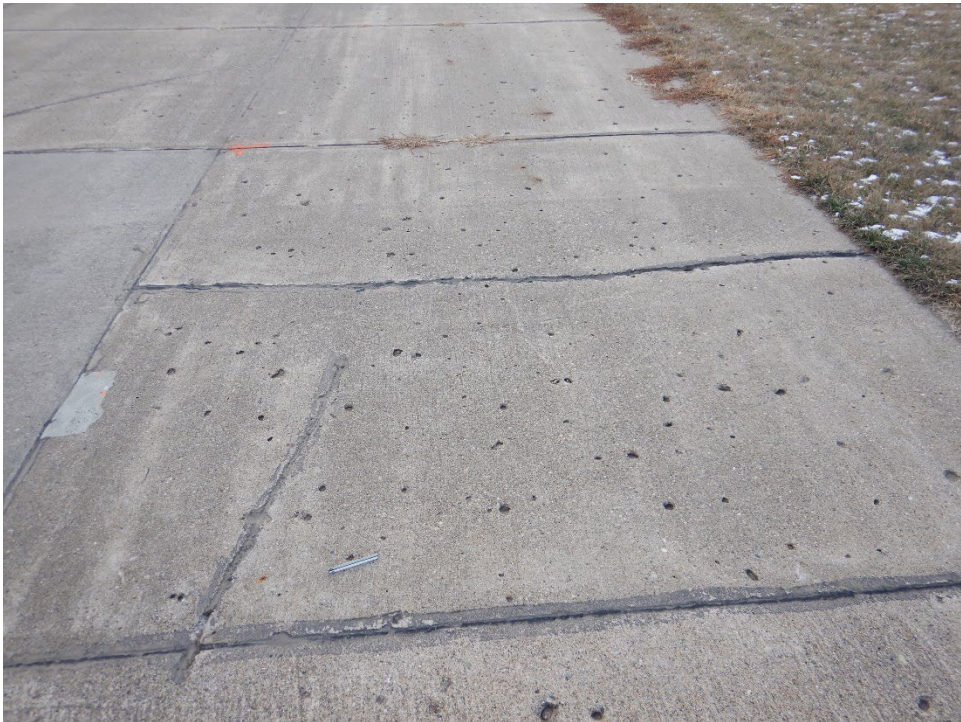
TH01LE-02. Popouts (Sample Unit No. 07).
