Manchester Municipal Airport

PAVEMENT MANAGEMENT REPORT

JULY 2022

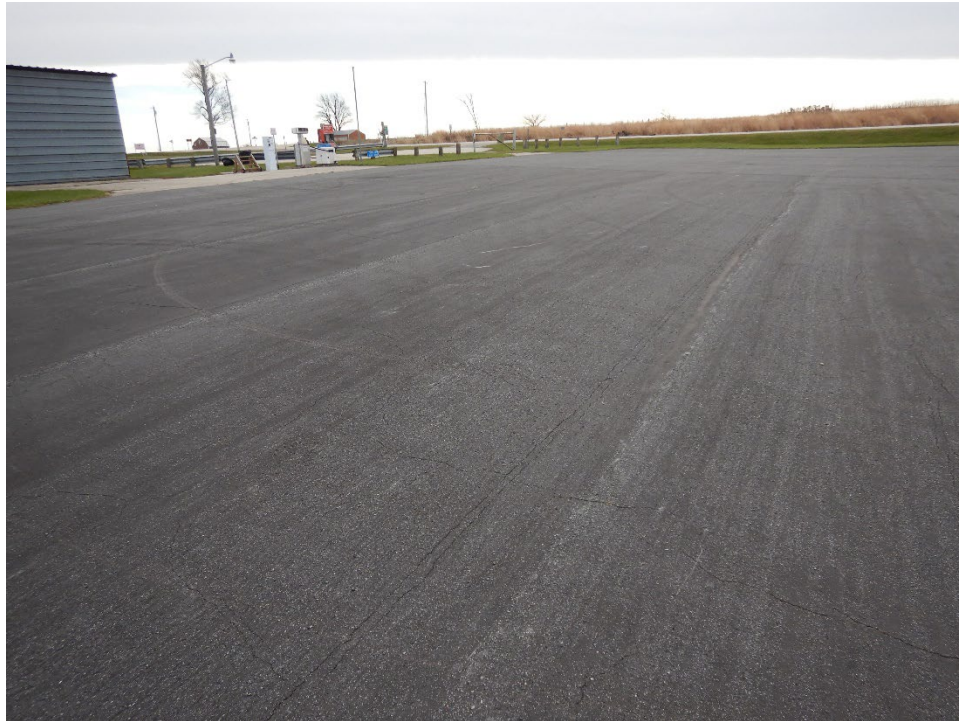
Apron 01 contained one section that had low-severity block cracking and L&T cracking observed throughout. The low-severity cracking was both sealed and unsealed.

A01C2-01. Overview.

Year	Branch	Section	Surface Type	Type of Repair	Estimated Cost
2022	R18C2	02	AAC	Preventive Maintenance	\$37
2022	T01C2	01	AAC	Major Rehabilitation	\$55,494
2023	TH01C2	01	AAC	Major Rehabilitation	\$8,286
2025	A01C2	01	AAC	Major Rehabilitation	\$132,419
2026	R18C2	02	AAC	Major Rehabilitation	\$174,570

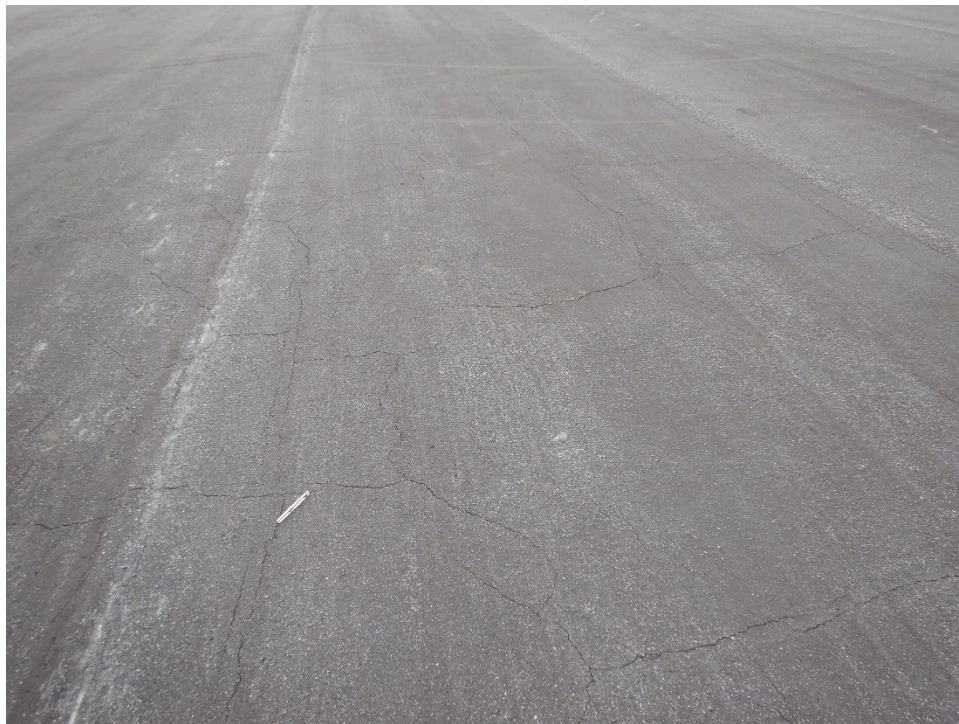
A01C2-01. Block Cracking (Sample Unit No. 02).

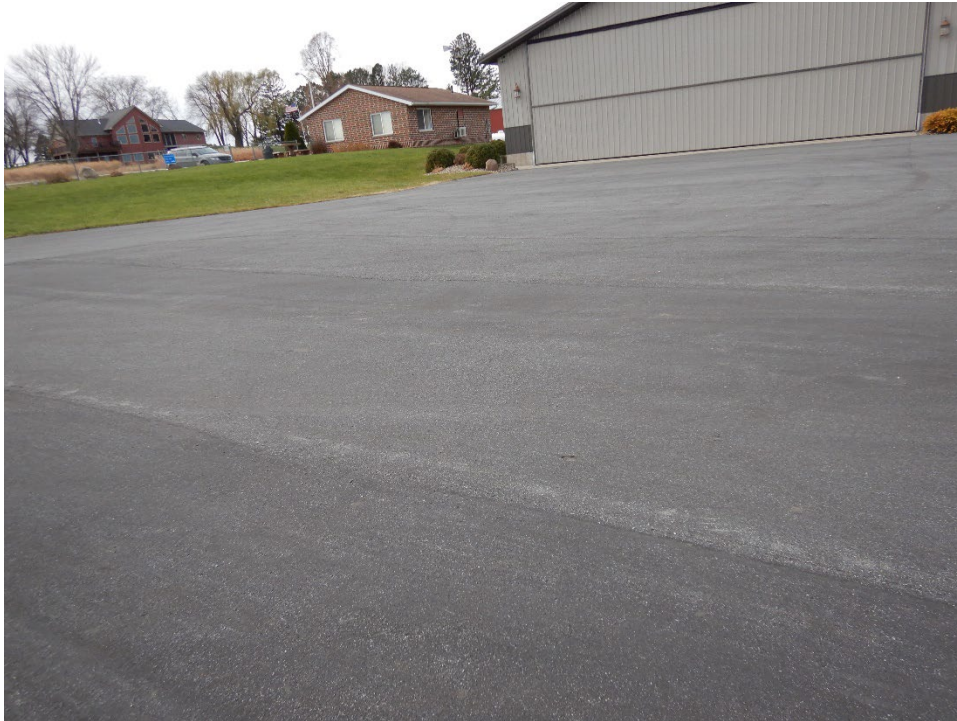
Apron 02 consisted of three sections. Sections 01 and 02 contained low-severity L&T cracking, both sealed and unsealed. Section 03 was in excellent condition with no distress identified at the time of the inspection.

A02C2-01. Overview.

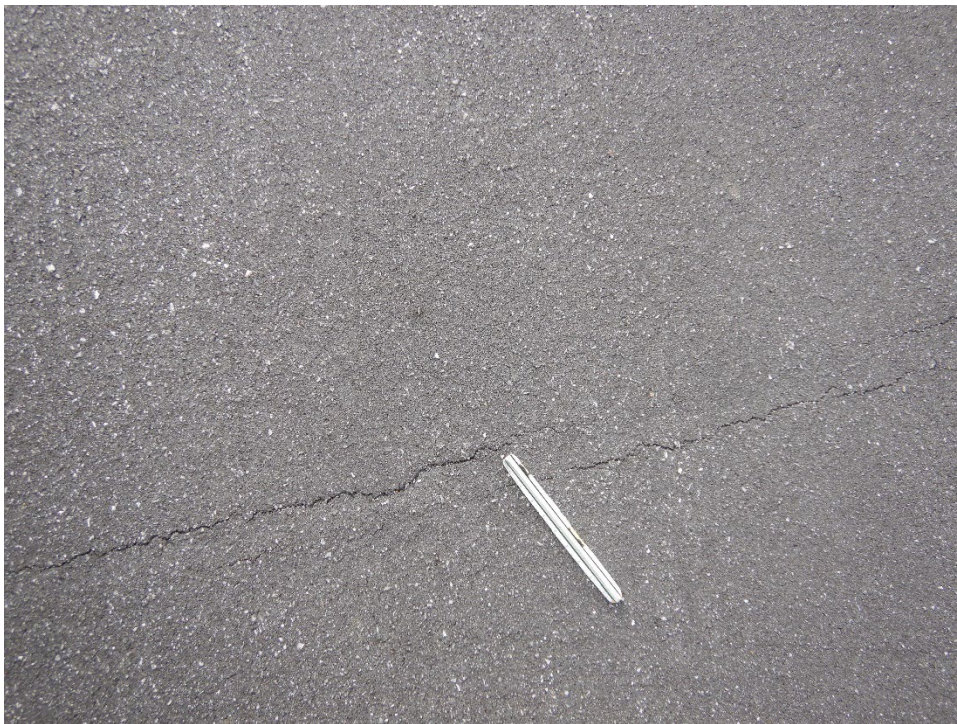
A02C2-01. L&T Cracking (Sample Unit No. 01).

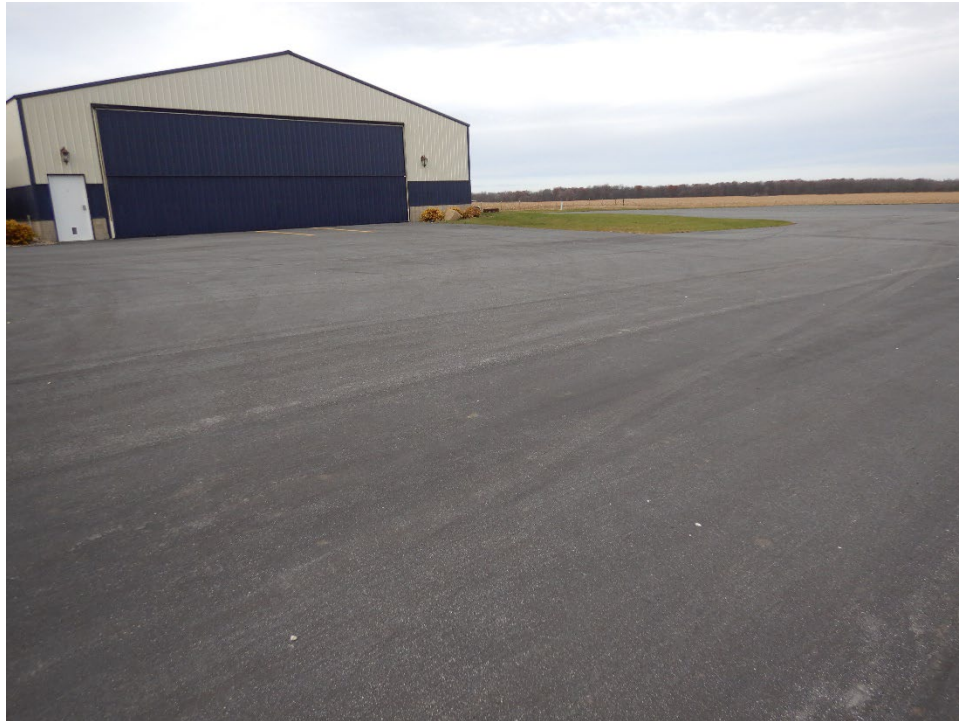
A02C2-02. Overview.

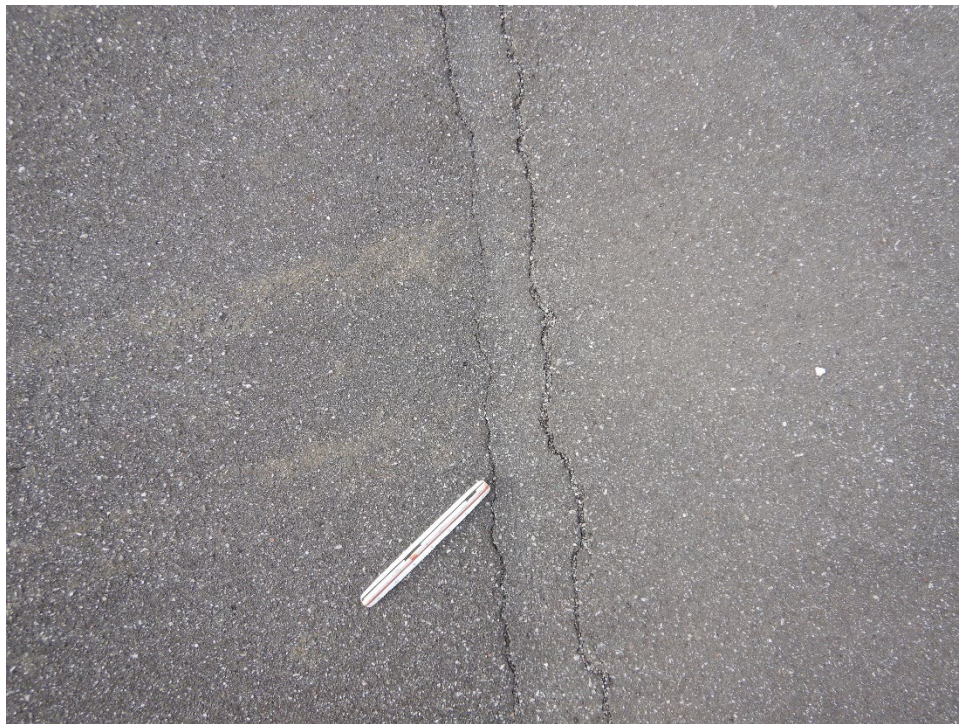
A02C2-02. L&T Cracking (Sample Unit No. 02).

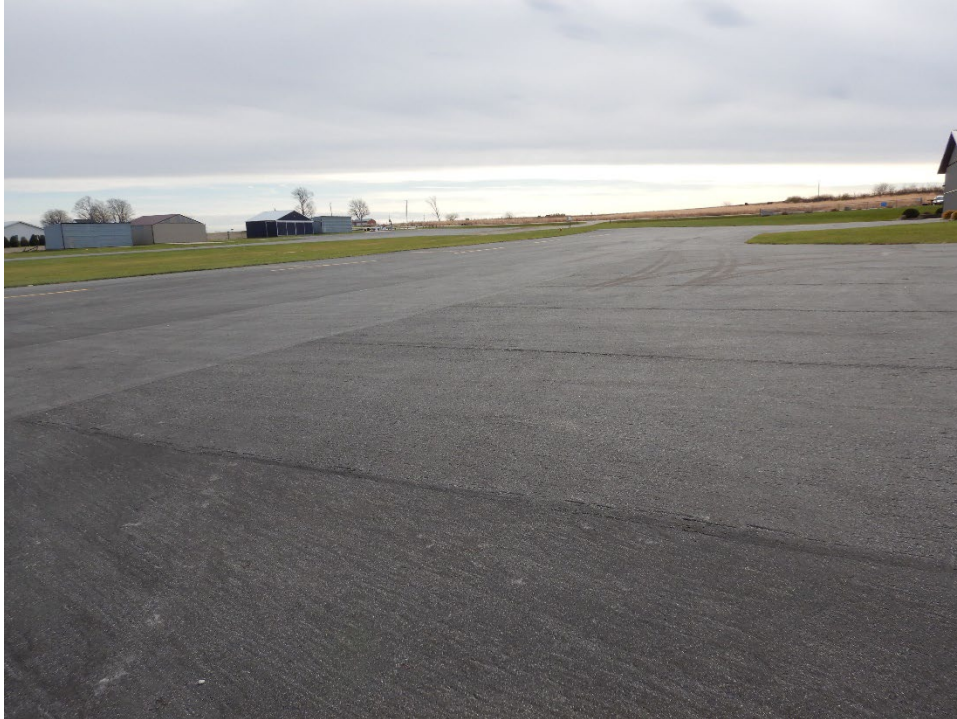
A02C2-03. Overview.

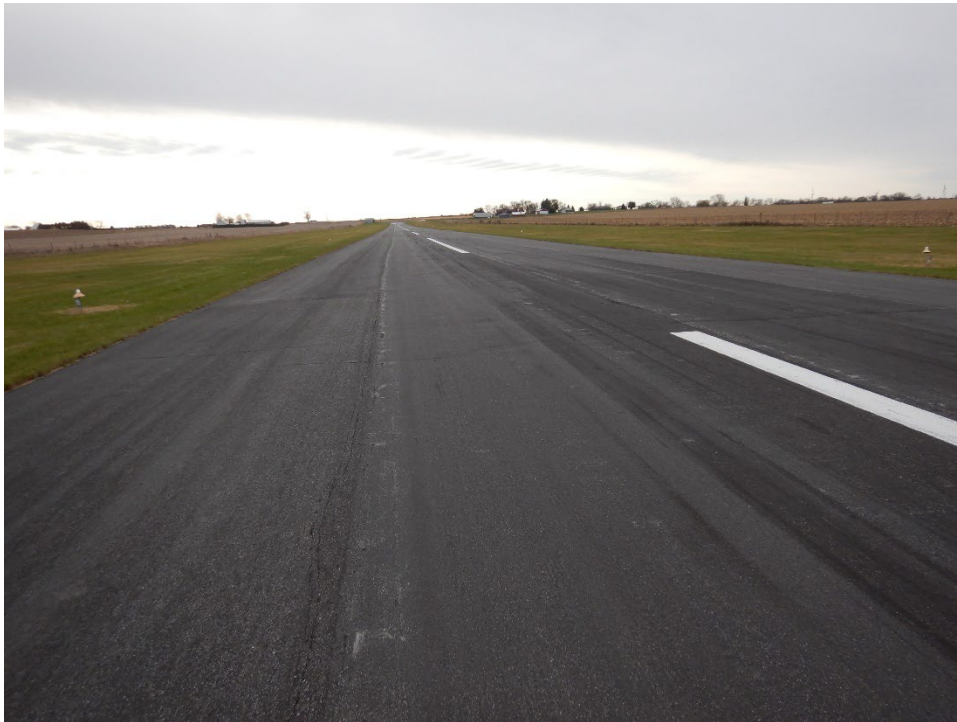
Runway 18/36 consisted of two sections. Section 01 had low-severity longitudinal and transverse (L&T) cracking, the majority of which was sealed, noted during the inspection. Section 02 contained areas of low- and medium-severity depression, low- and high-severity L&T cracking, and low-severity patching. The low-severity L&T cracking was both sealed and unsealed, while the high-severity L&T cracking was recorded where secondary cracking exceeded 1 ft in width.

R18C2-01. Overview.

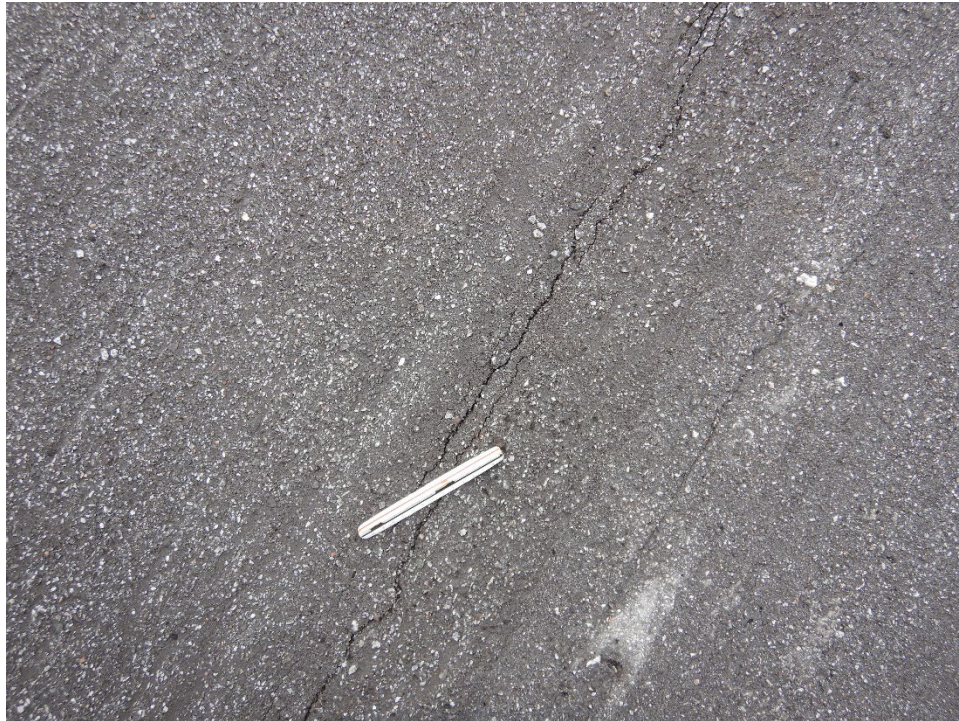
R18C2-01. L&T Cracking (Sample Unit No. 03).

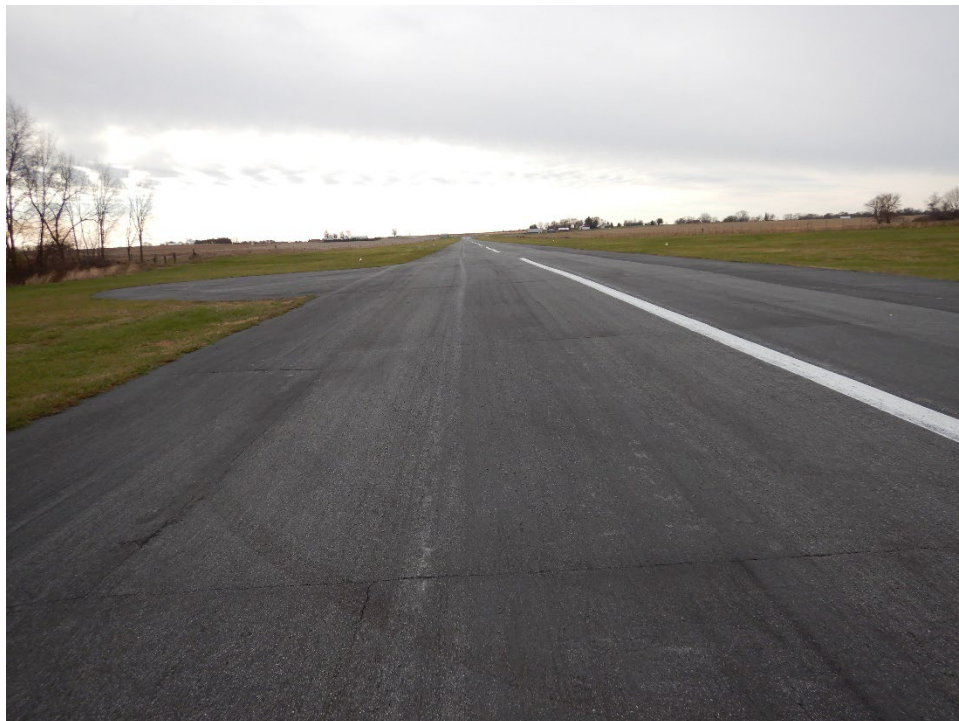
R18C2-02. Overview.

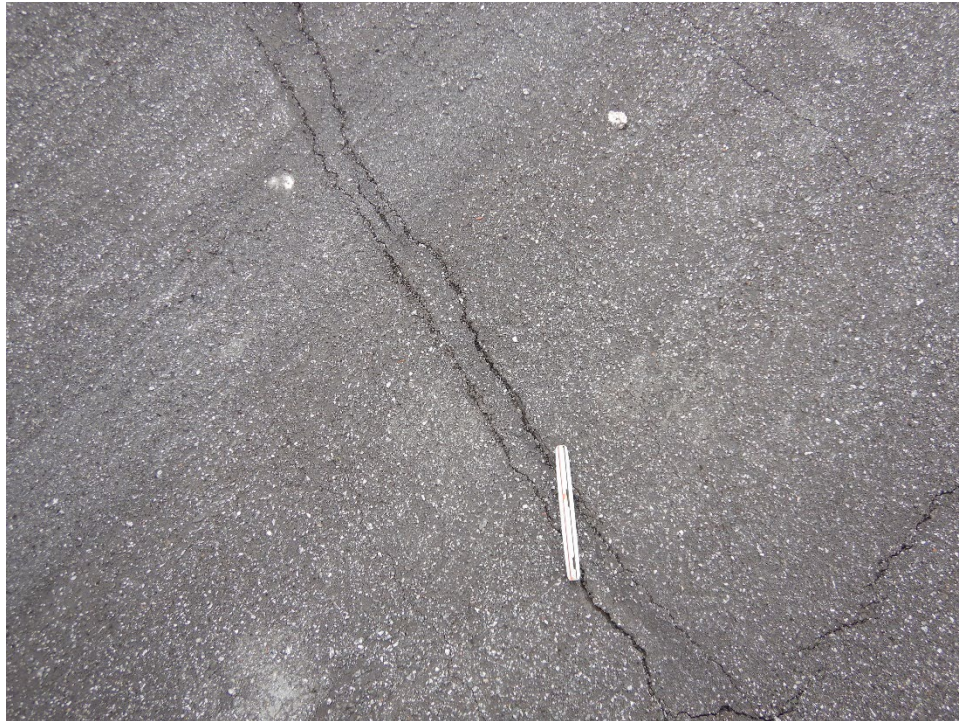
R18C2-02. L&T Cracking (Sample Unit No. 02).

Branch	Section	Distress Type	Severity	Distress Quantity	Distress Unit	Maintenance Action	Unit Cost	2022 Estimated Cost
R18C2	02	L&T Cracking	High	15	Ft	Crack Sealing - AC	\$2.51	\$37

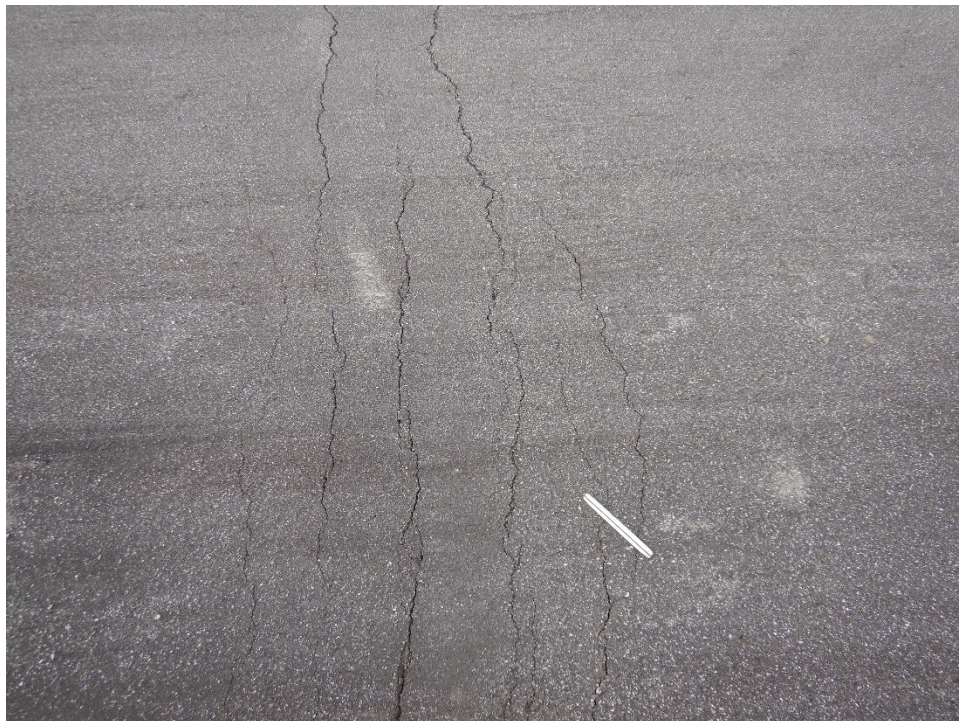
R18C2-02. L&T Cracking (Sample Unit No. 05).

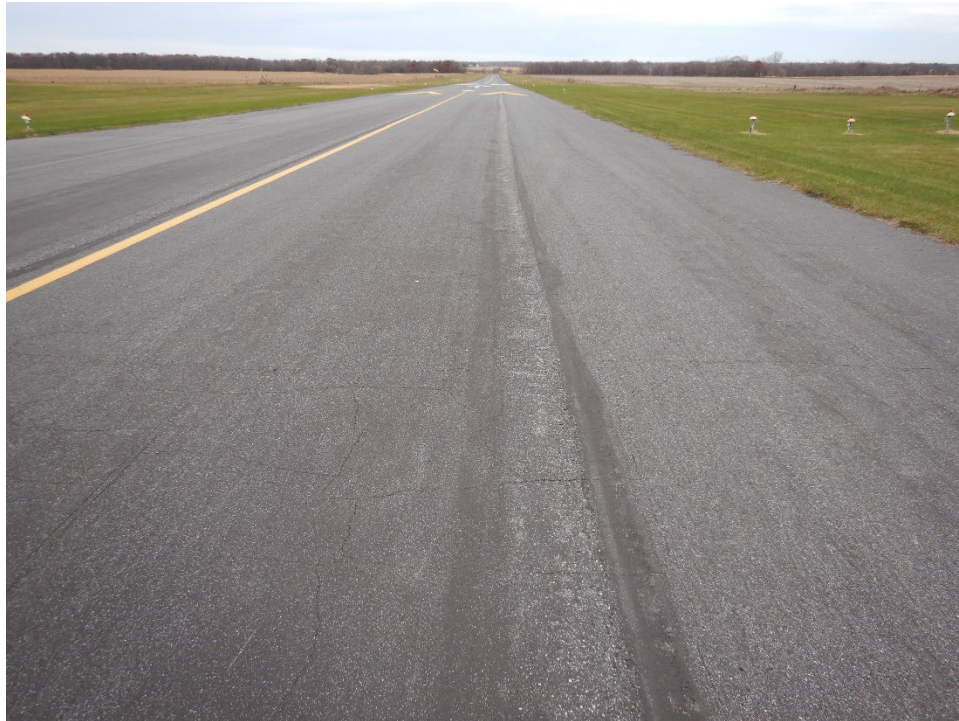
Taxiway 01 connected Runway 18/36 to the apron area and was defined by two sections. Medium-severity alligator cracking and low-severity block cracking and L&T cracking were recorded in Section 01. The low-severity cracking was both sealed and unsealed. Only low-severity, sealed L&T cracking was noted in Section 02.

T01C2-01. Overview.

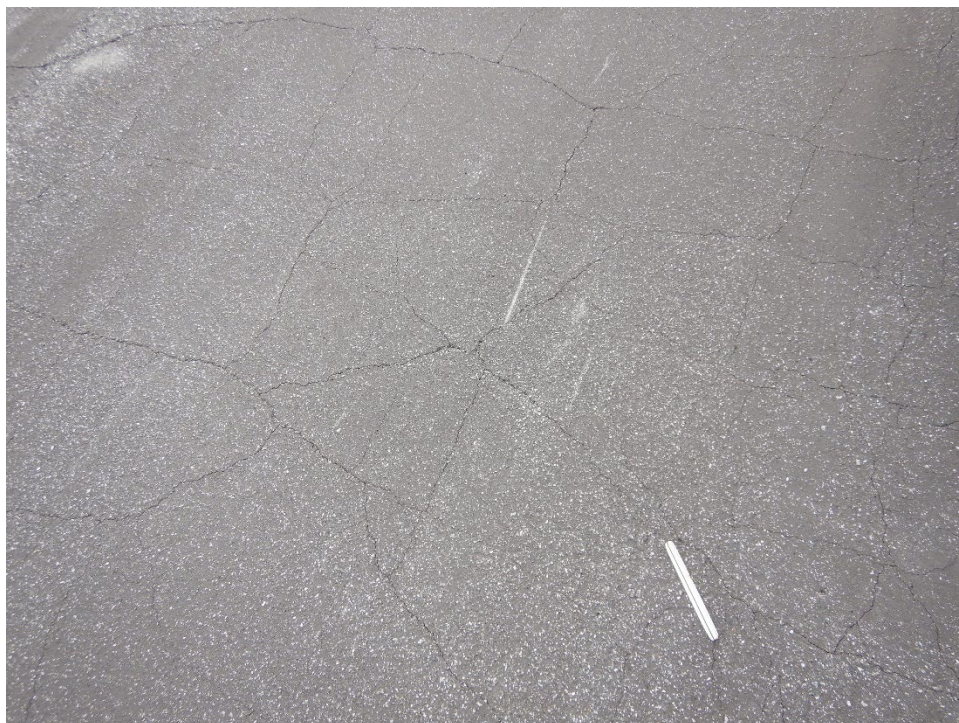
T01C2-01. Alligator Cracking (Sample Unit No. 01).

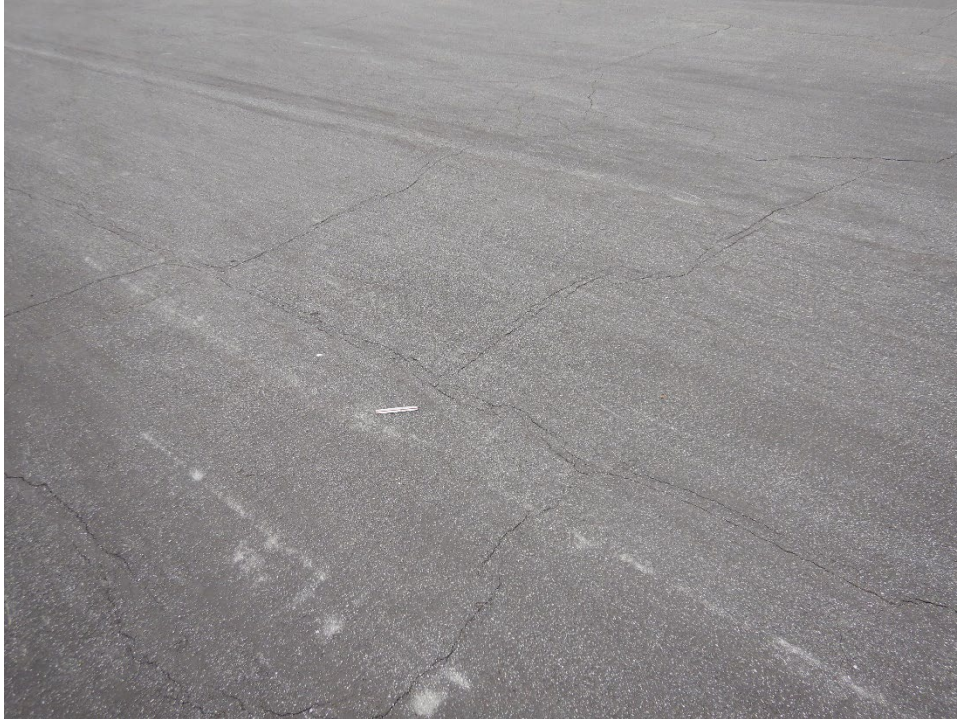
T01C2-01. Block Cracking (Sample Unit No. 02).

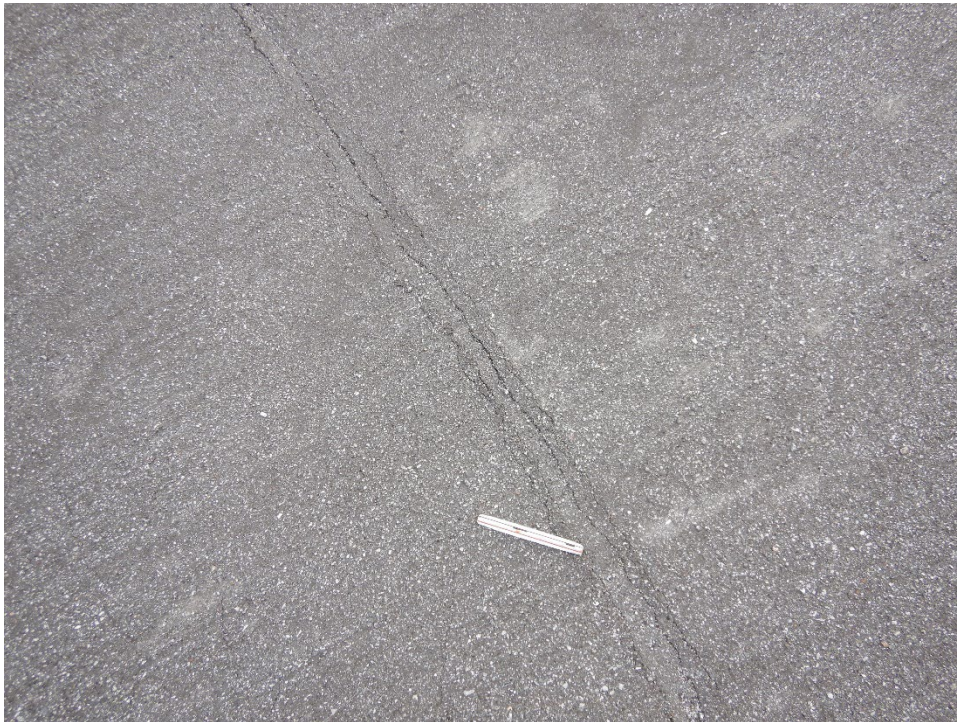
T01C2-01. L&T Cracking (Sample Unit No. 01).

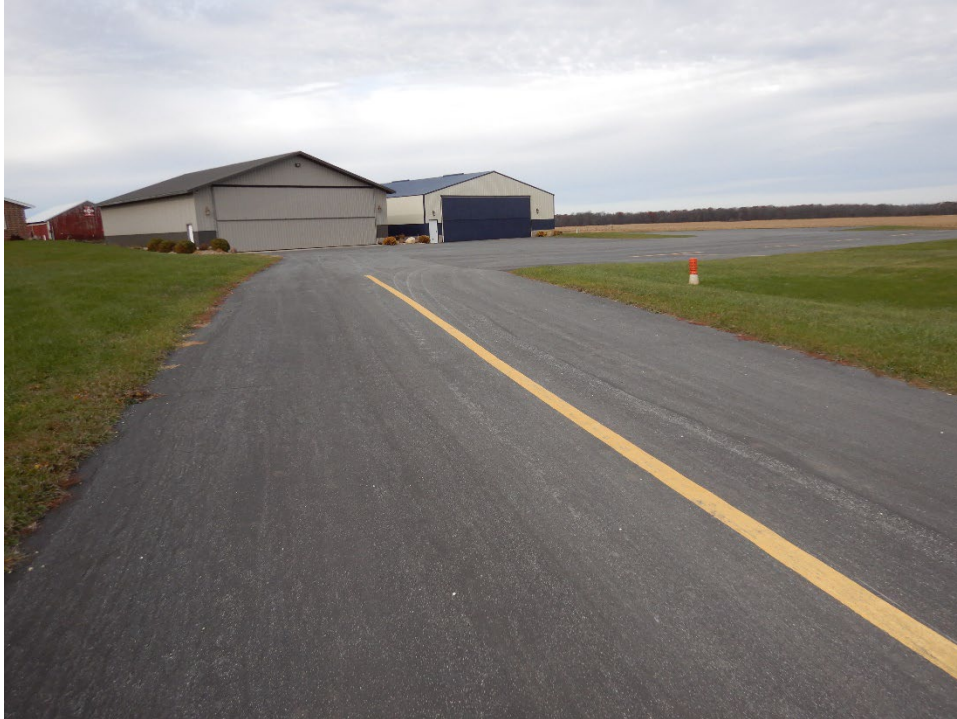
T01C2-02. Overview.

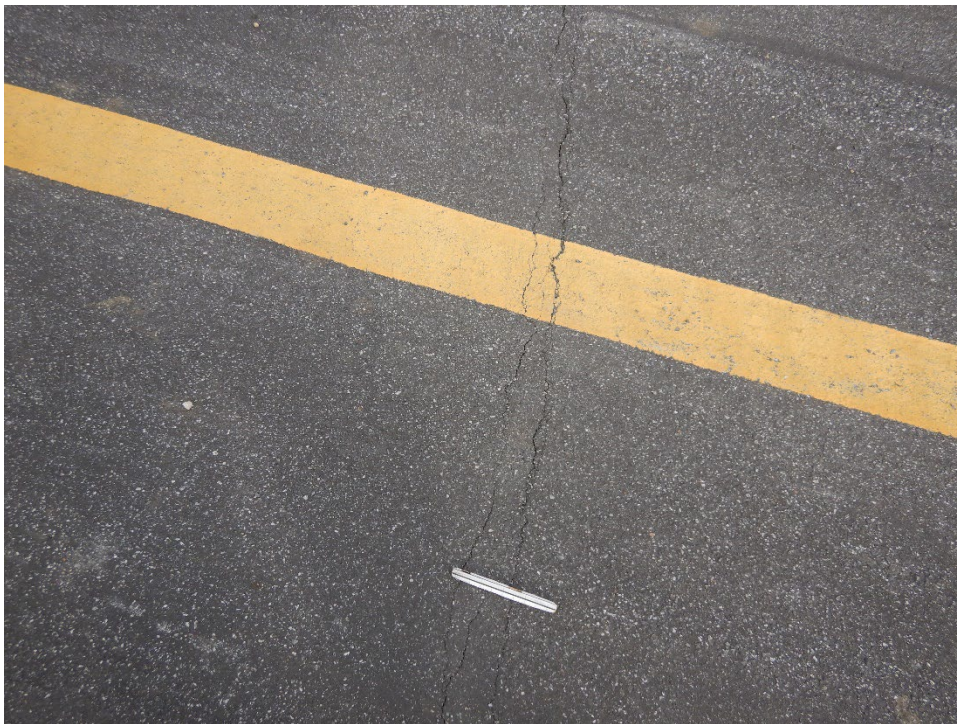
T01C2-02. L&T Cracking (Sample Unit No. 01).

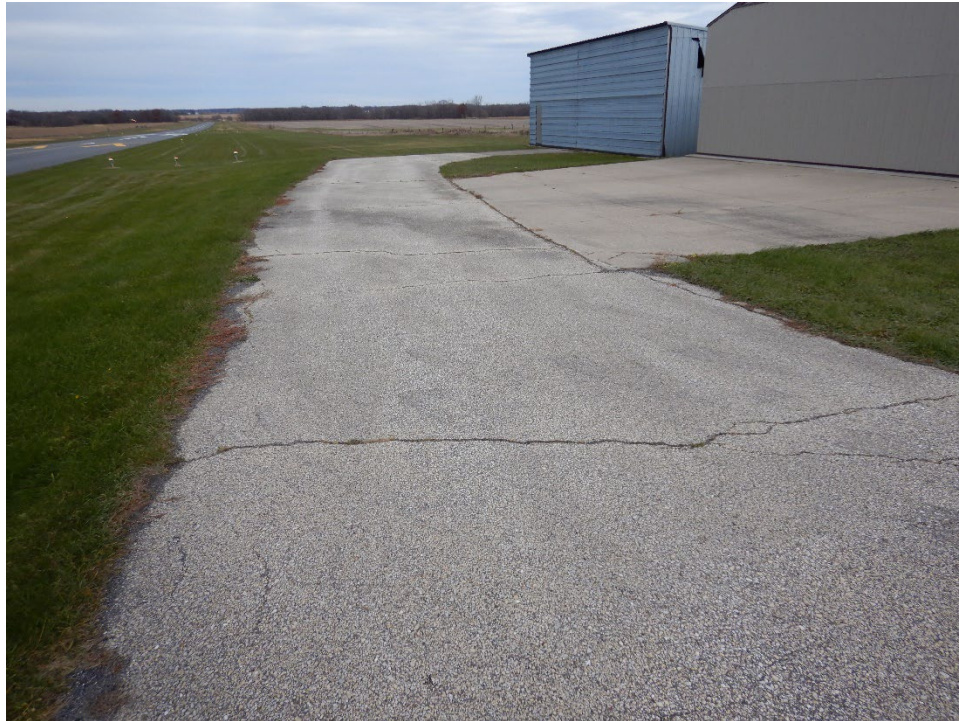
The T-hangar area was defined by one section. Low- and medium-severity L&T cracking and medium-severity weathering were recorded in Section 01. The L&T cracking was unsealed, with the medium-severity L&T cracking having crack widths that exceeded ¼ in.

TH01C2-01. Overview.

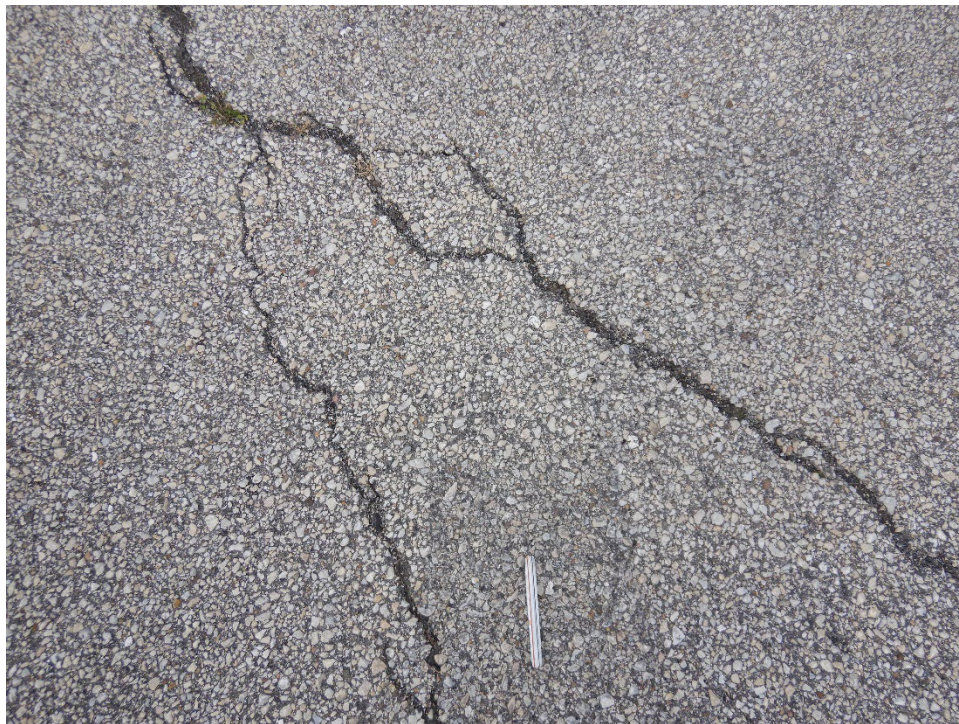
TH01C2-01. L&T Cracking (Sample Unit No. 01).

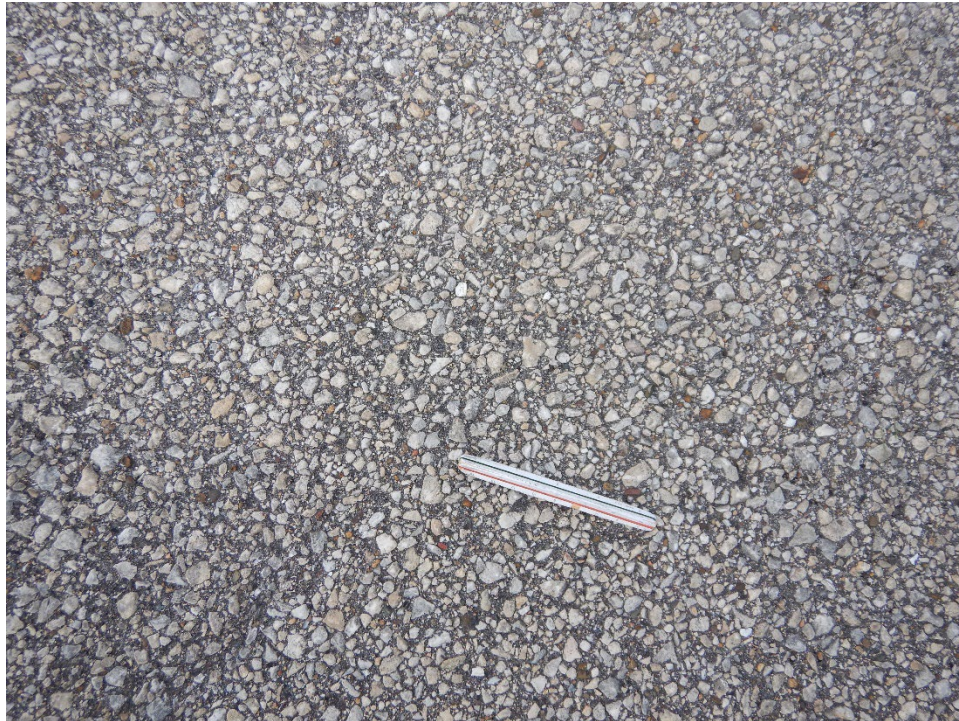
TH01C2-01. Weathering (Sample Unit No. 01).
