# Maquoketa Municipal Airport

PAVEMENT MANAGEMENT REPORT

**JUNE 2018**

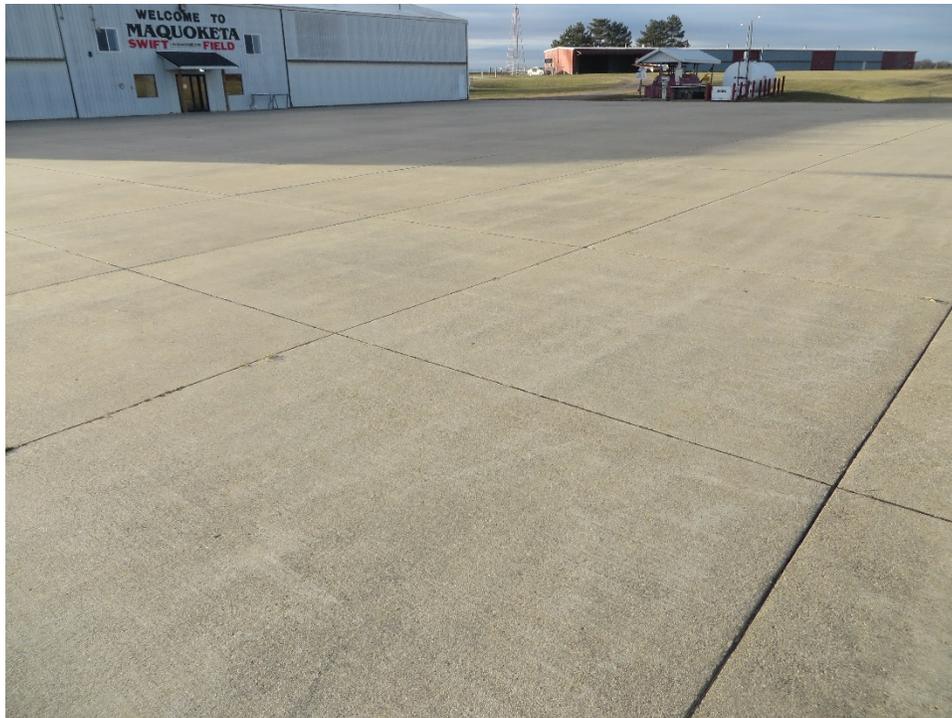
A01MQ-01. Overview.

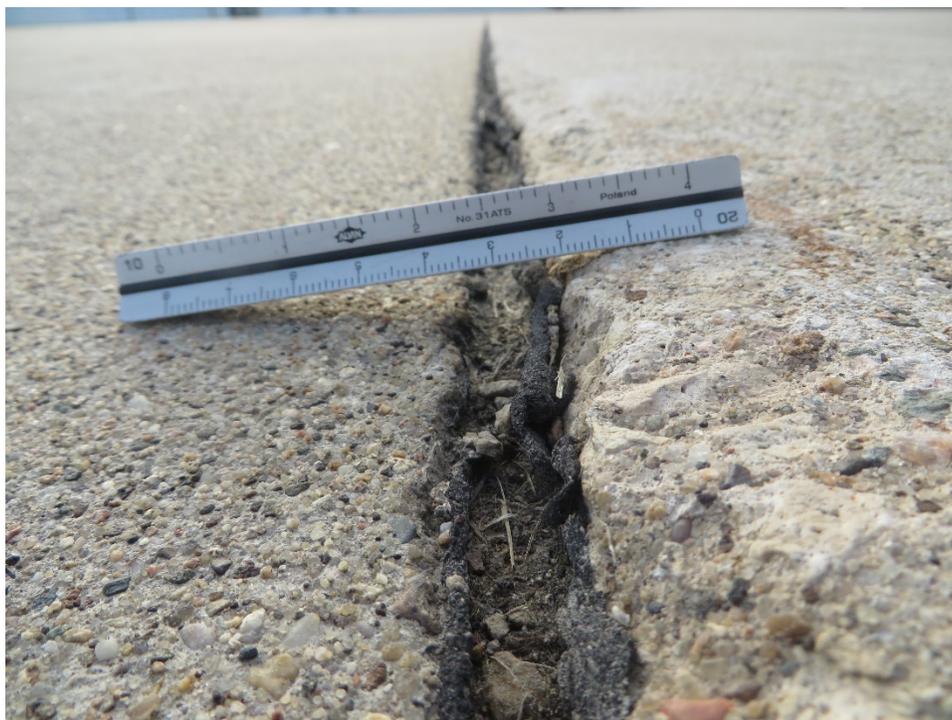
The apron area consisted of two sections. High-severity joint seal damage was recorded throughout Section 01 along with isolated amounts of low-severity corner breaking; low- and medium-severity faulting, LTD cracking, and joint spalling; and shrinkage cracking. Section 02 was observed with high-severity joint seal damage and low- and medium-severity joint spalling and corner spalling.

A01MQ-01. Faulting (Sample Unit No. 03).

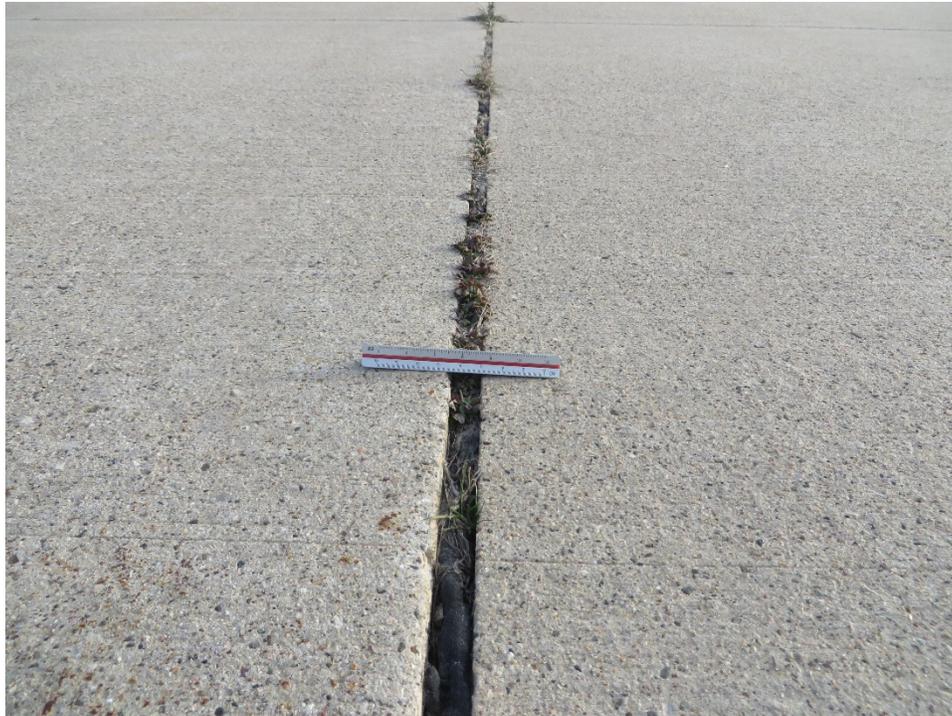
A01MQ-01. Joint Seal Damage (Sample Unit No. 01).

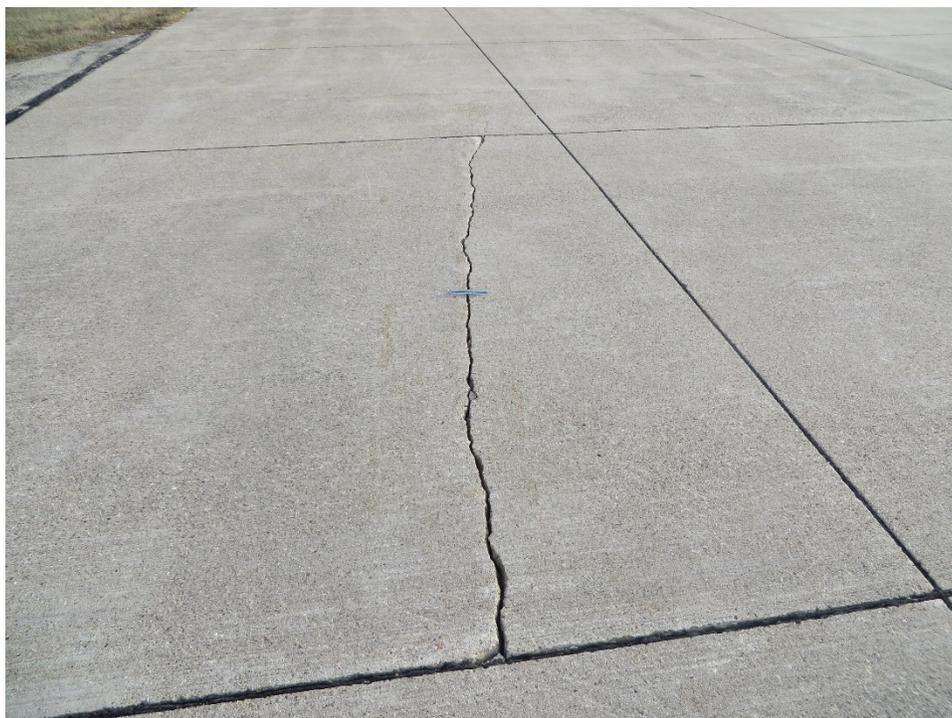
A01MQ-01. LTD Cracking (Sample Unit No. 01).

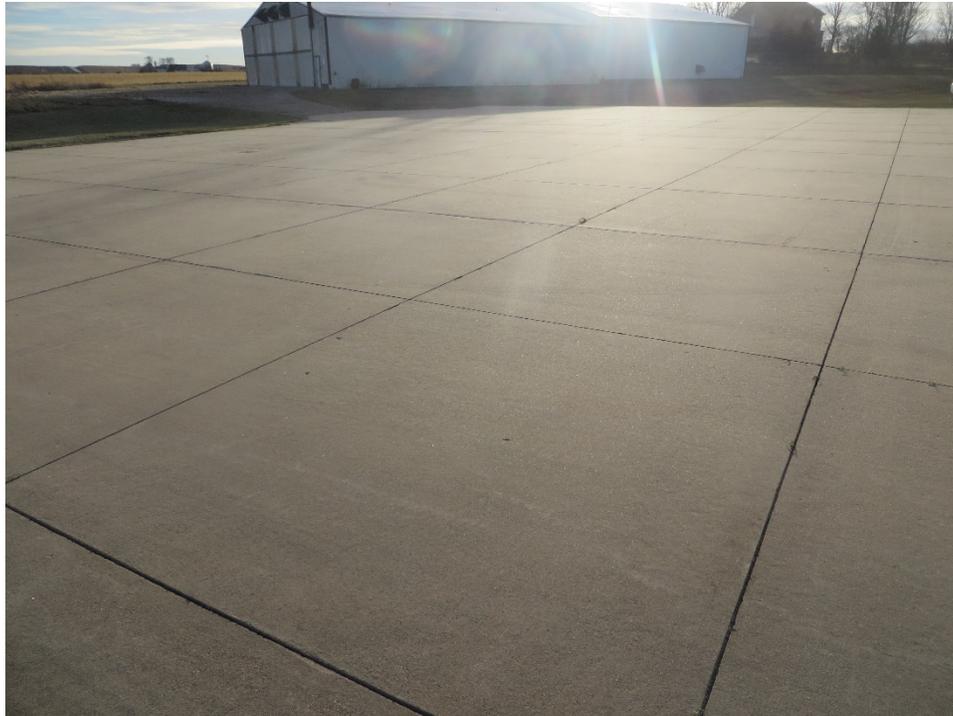
A01MQ-02. Overview.

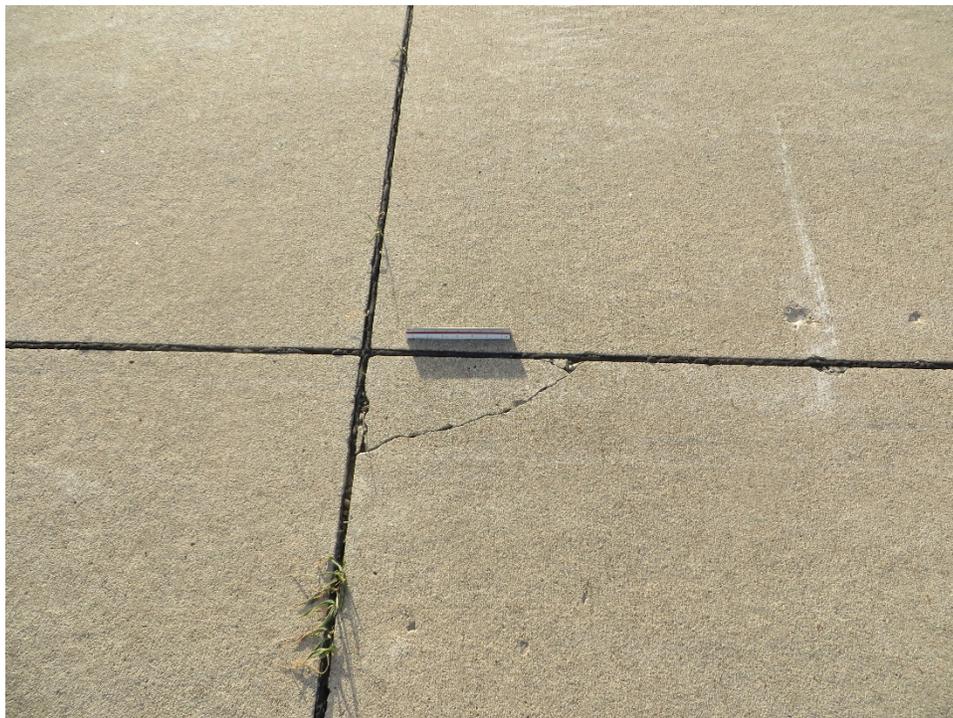
A01MQ-02. Corner Spalling (Sample Unit No. 02).

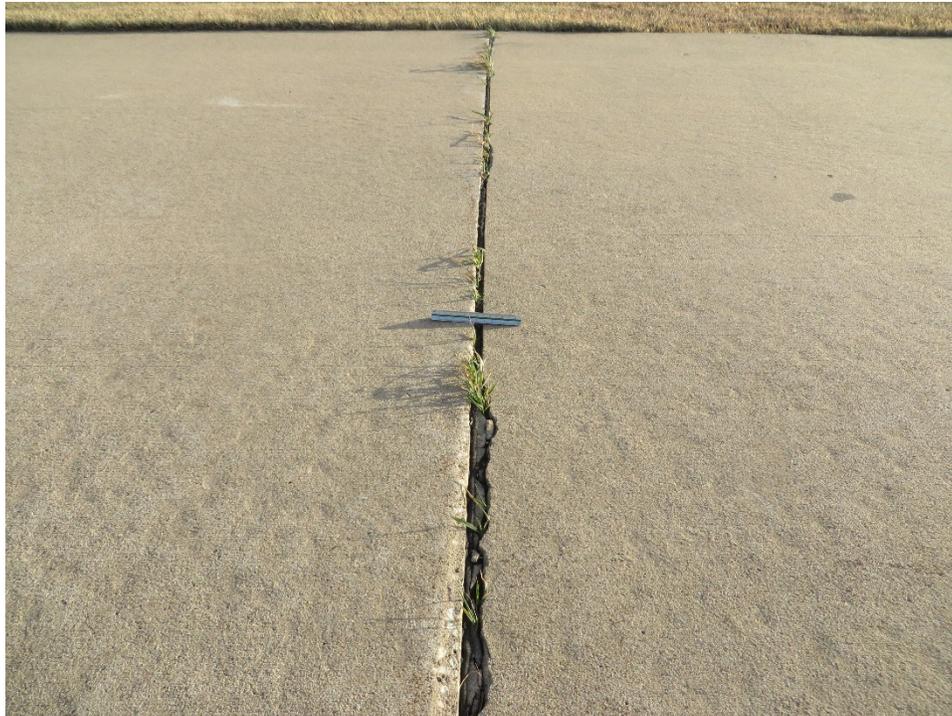
A01MQ-02. Joint Seal Damage (Sample Unit No. 02).

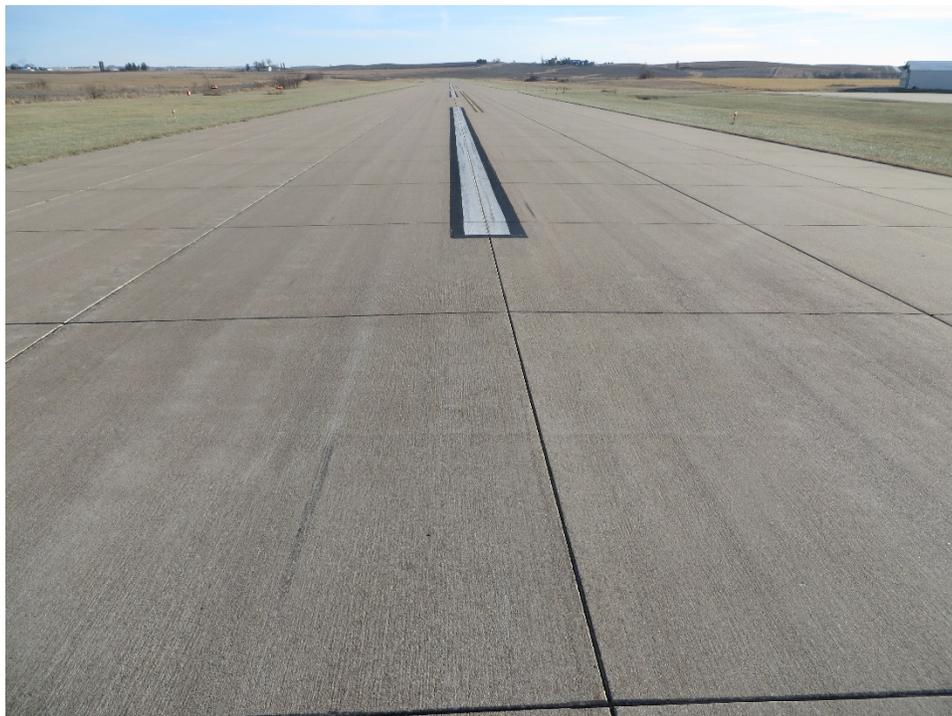
R15MQ-01. Overview.

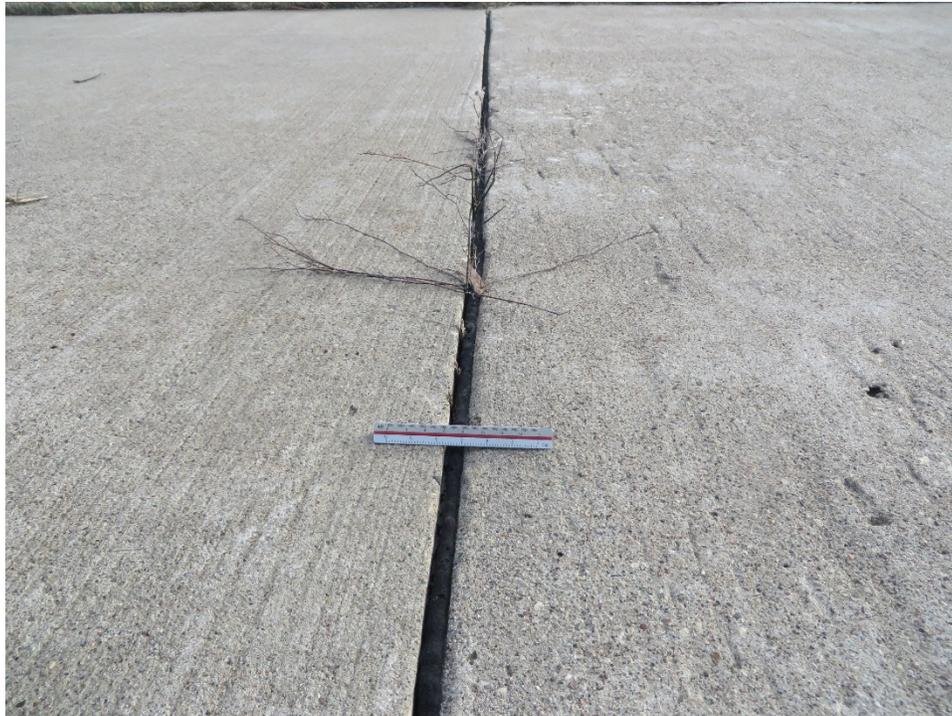
Runway 15-33 was defined by one section. Medium- and high-severity joint seal damage, low- and medium-severity joint spalling, and all severities of small patching were observed in Section 01.

R15MQ-01. Joint Seal Damage (Sample Unit No. 75).

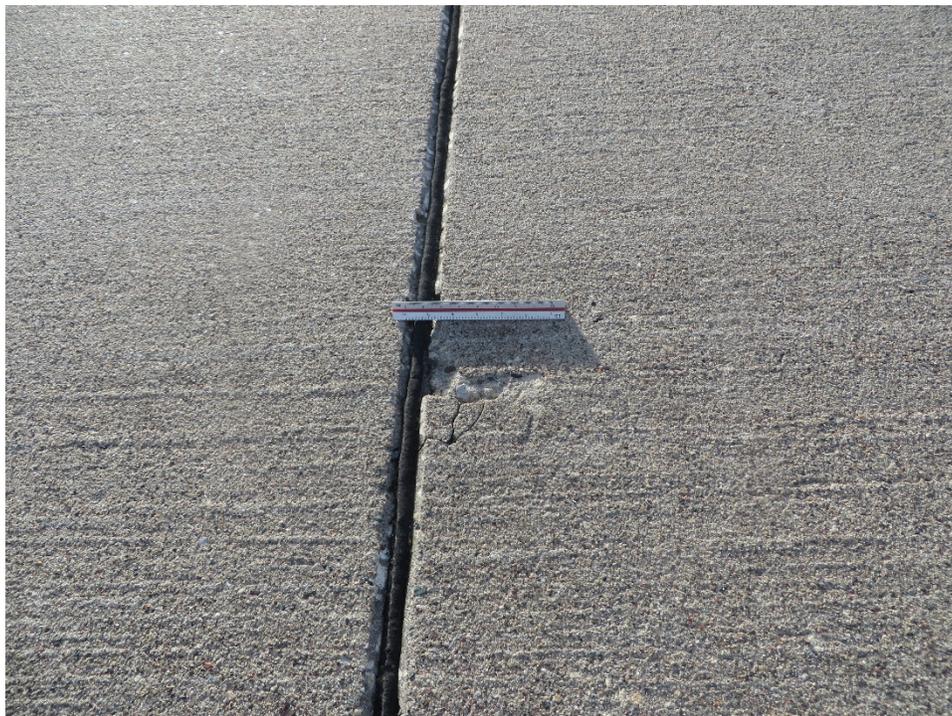
R15MQ-01. Joint Spalling (Sample Unit No. 24).

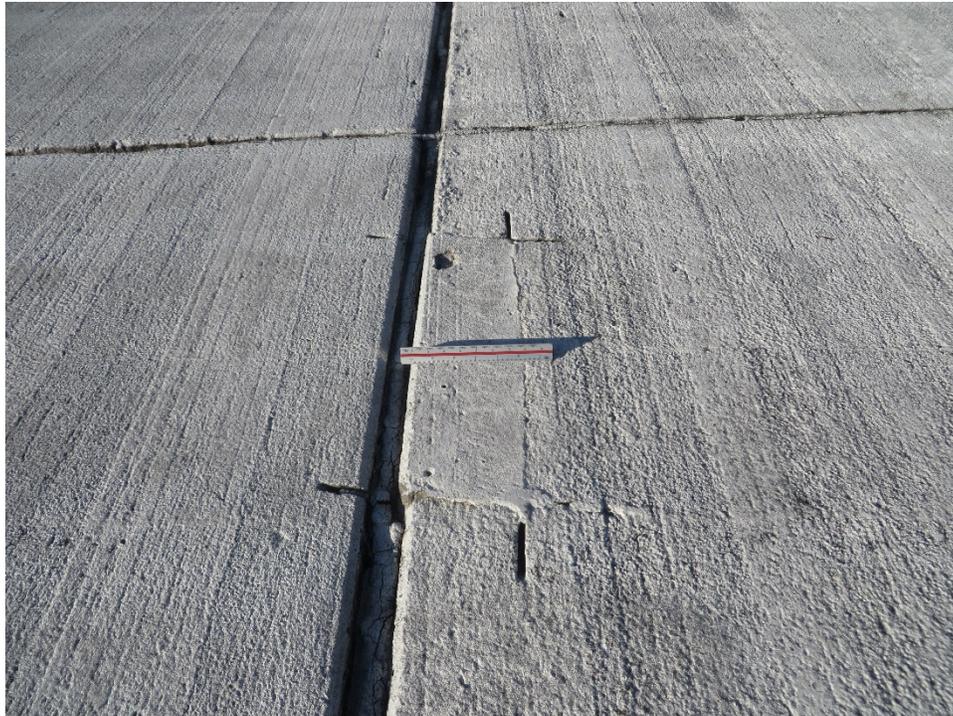
R15MQ-01. Small Patching (Sample Unit No. 06).

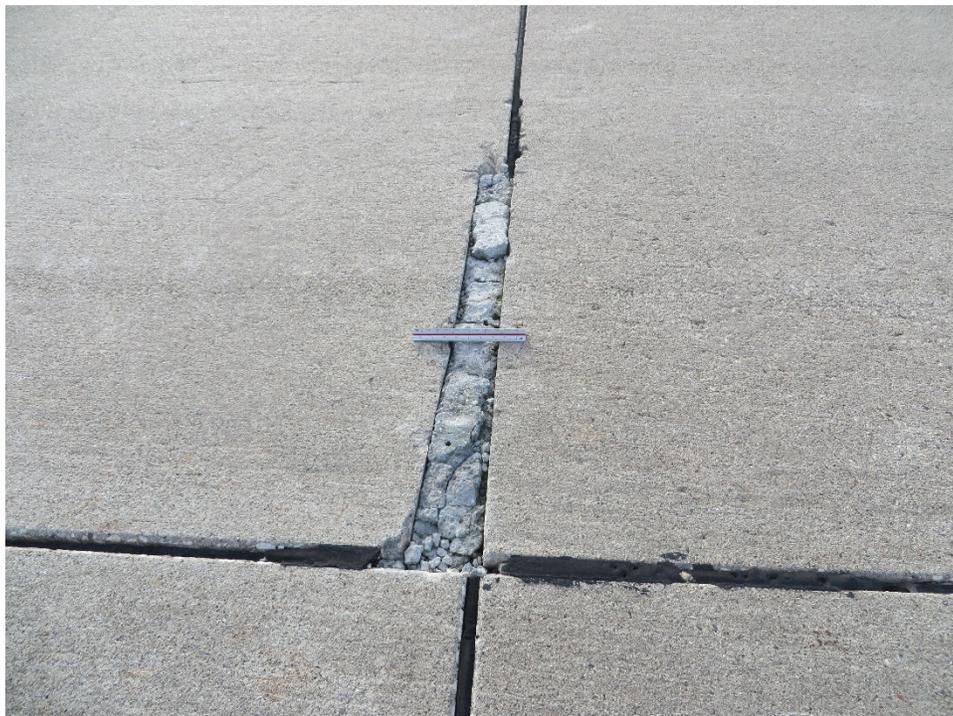
R15MQ-01. Small Patching (Sample Unit No. 60).

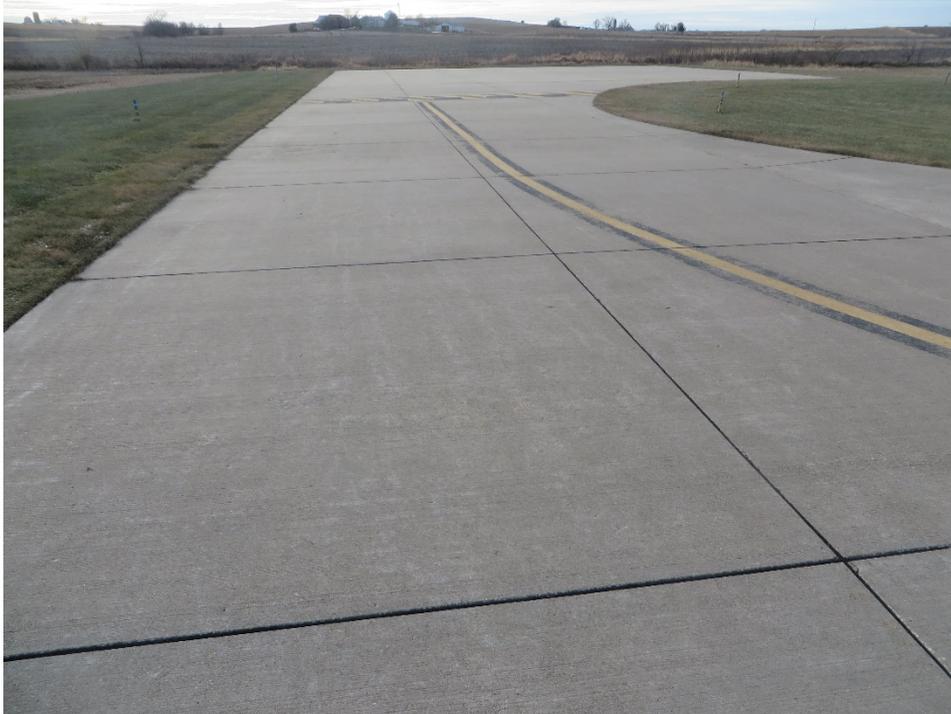
T01MQ-01. Overview.

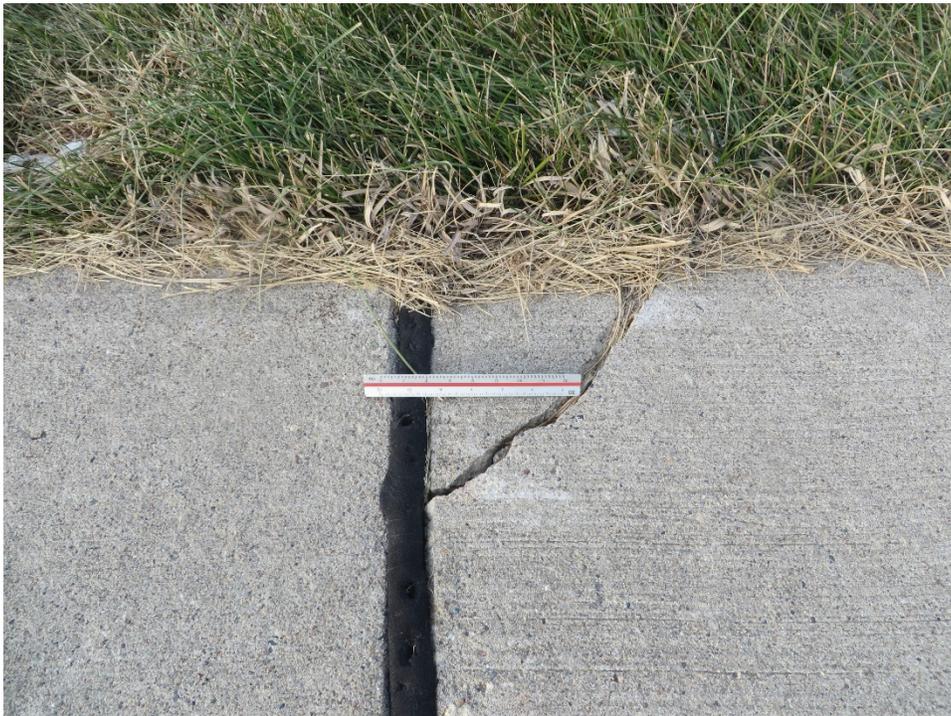
Taxiway 01 consisted of one section and was located at the Runway 33 approach. Medium- and high-severity joint seal damage were identified throughout Section 01 along with an isolated amount of low-severity corner spalling.

T01MQ-01. Corner Spalling (Sample Unit No. 05).

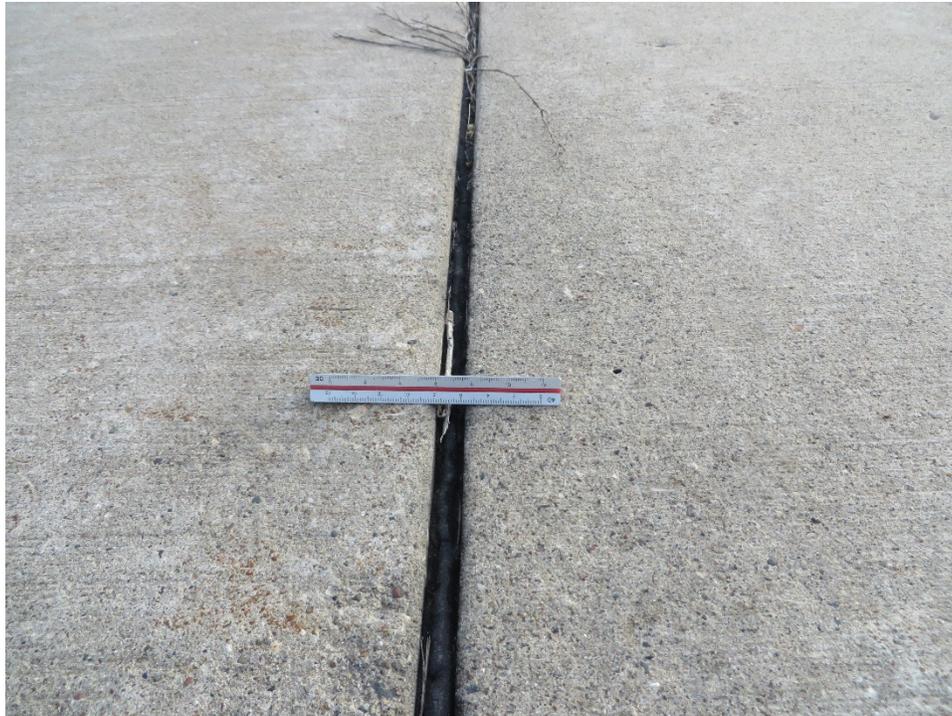
T01MQ-01. Joint Seal Damage (Sample Unit No. 05).

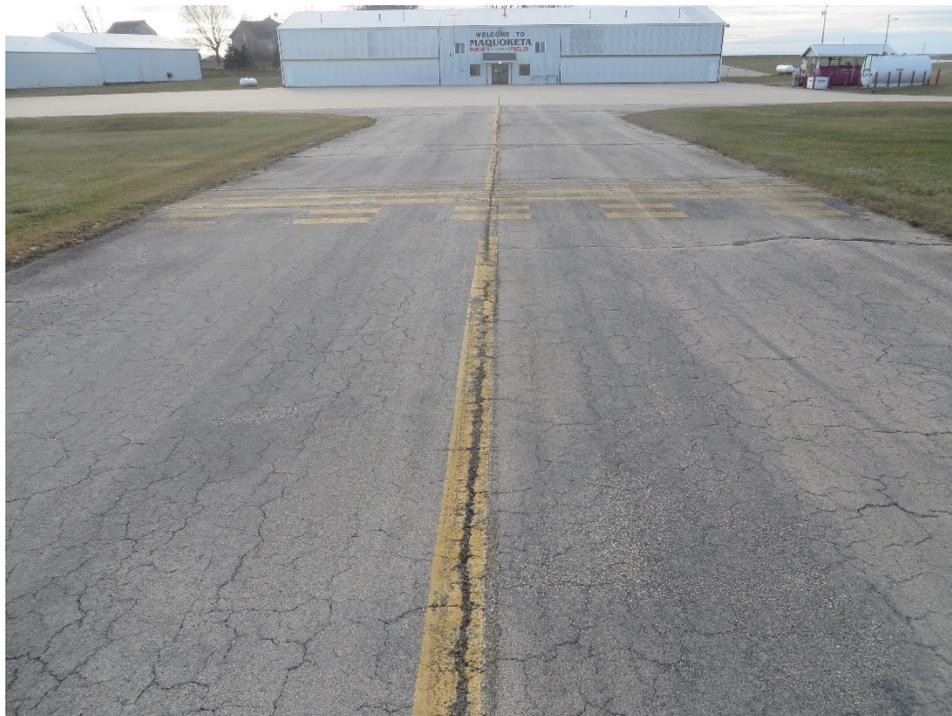
T02MQ-01. Overview.

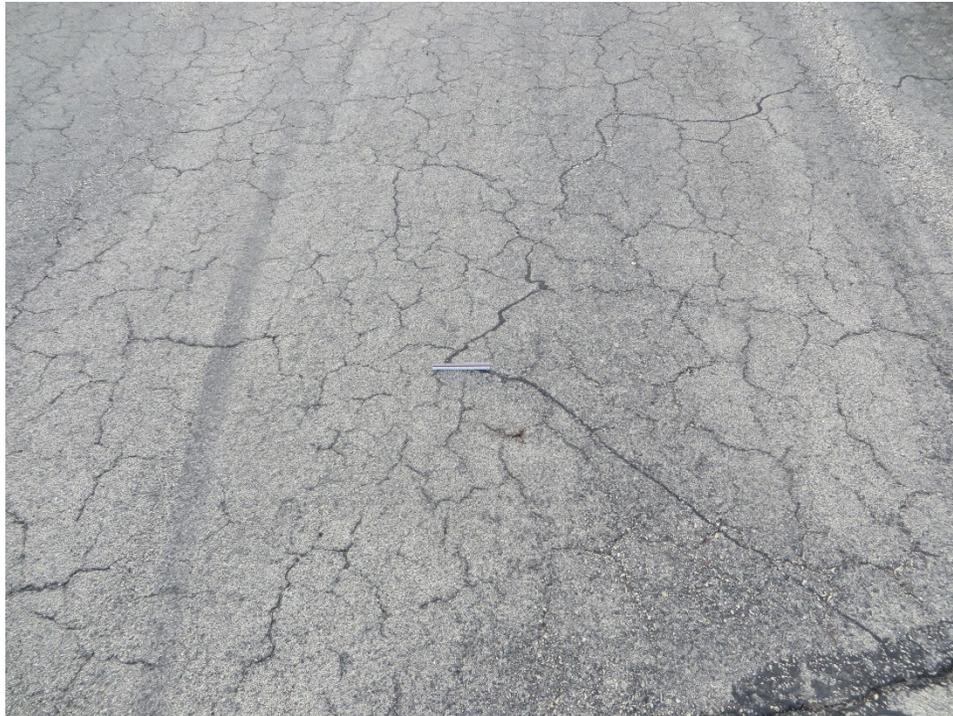
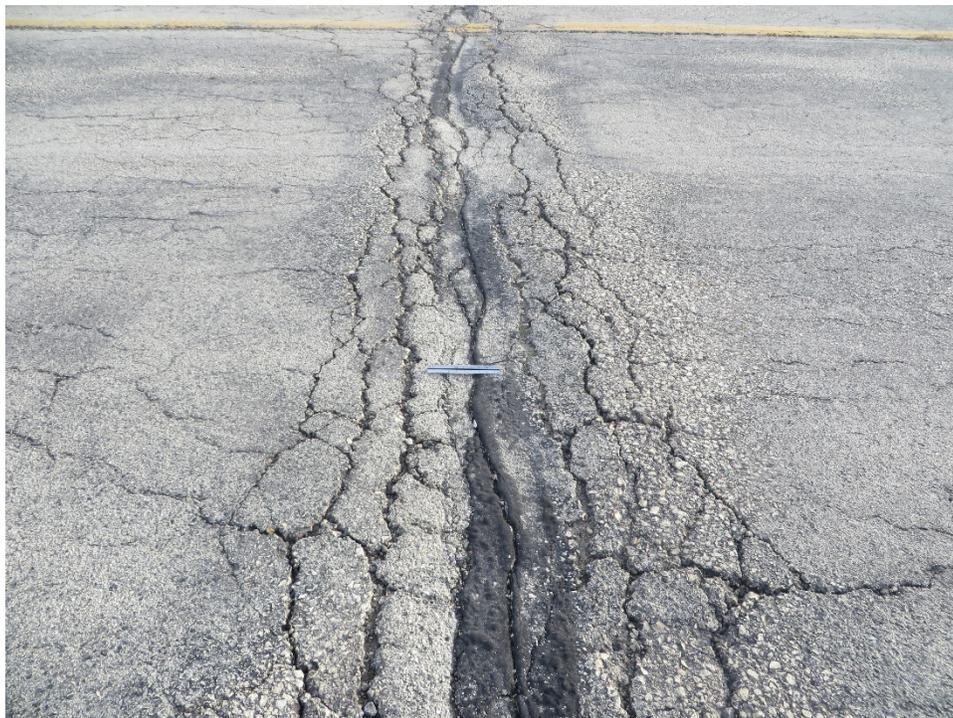
Taxiway 02 contained two sections. Section 01 was in poor condition with medium-severity alligator cracking and low-severity swelling. Additionally, high-severity raveling was observed in areas where the applied surface treatment has become dislodged. Unsealed, low-severity longitudinal and transverse (L&T) cracking was recorded in Section 02 along with medium-severity L&T cracking that was due to either unsealed crack widths greater than ¼ inch or the development of secondary cracking. Medium-severity weathering was also identified throughout the majority of the section where an oxidized pavement surface and missing fine material were observed. A small amount of medium-severity alligator cracking was also noted.

T02MQ-01. Alligator Cracking (Sample Unit No. 01) (1).

T02MQ-01. Alligator Cracking (Sample Unit No. 01) (2).

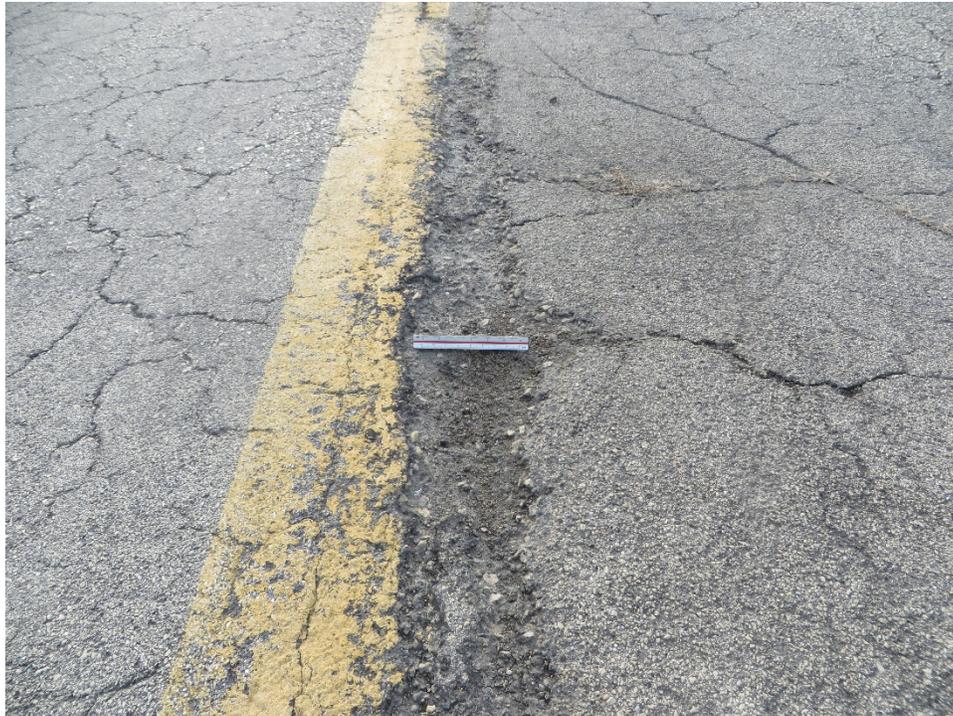
T02MQ-01. Raveling (Sample Unit No. 01).

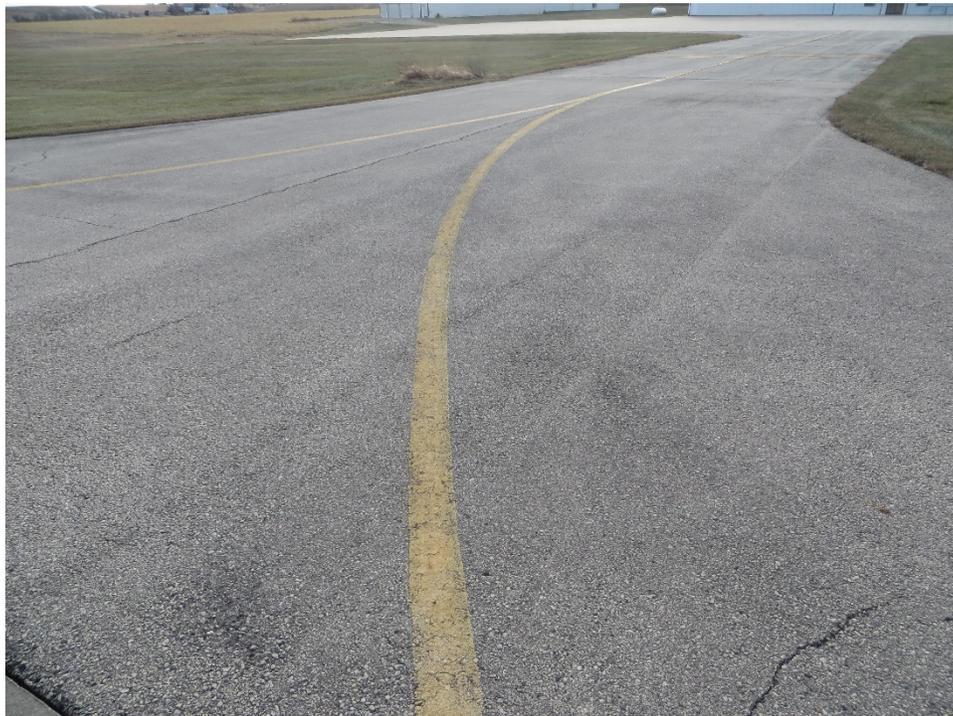
T02MQ-02. Overview.

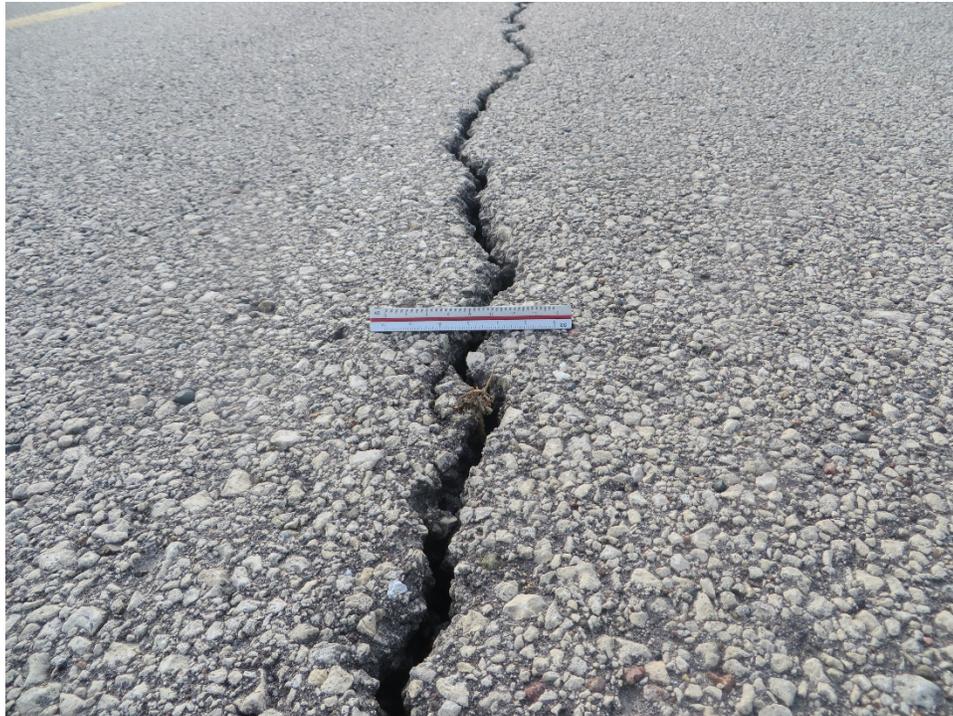
T02MQ-02. L&T Cracking (Sample Unit No. 01).

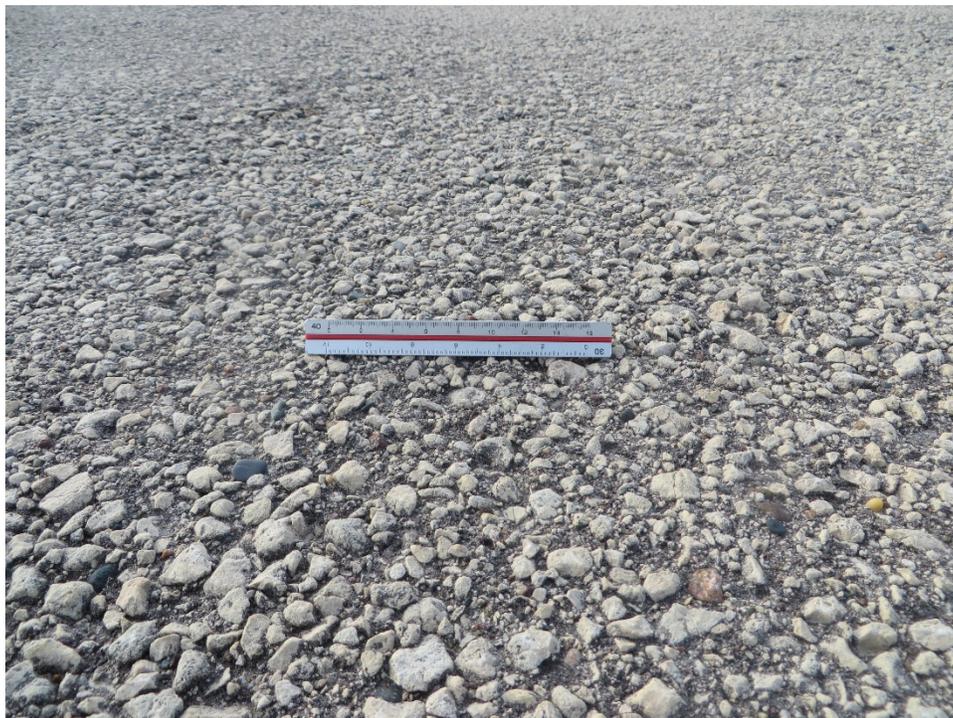
T02MQ-02. Weathering (Sample Unit No. 01).

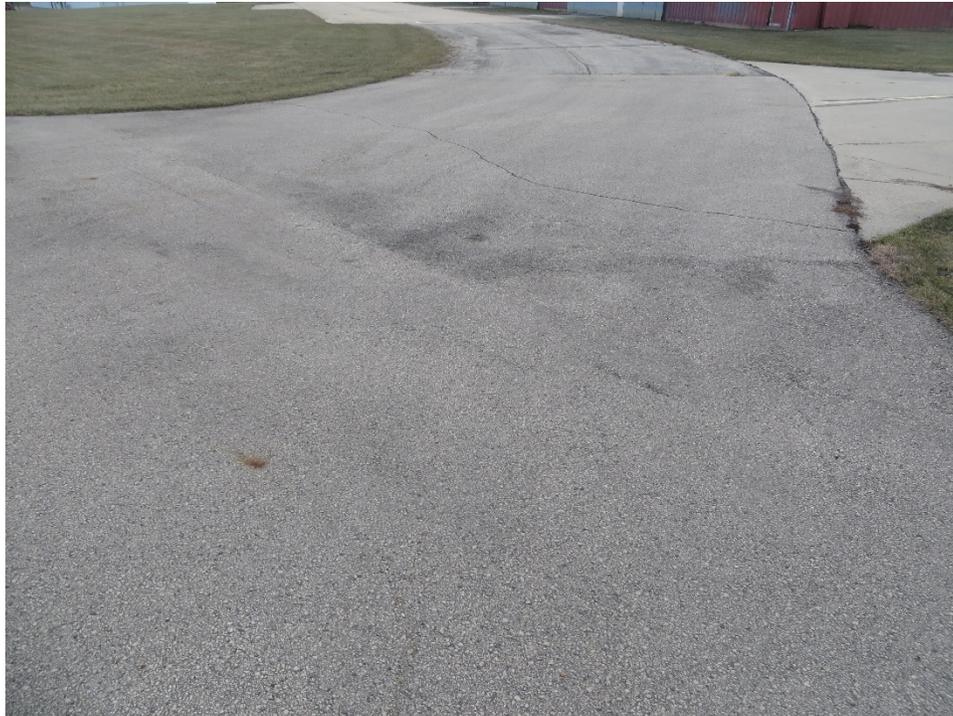
T03MQ-01. Overview.

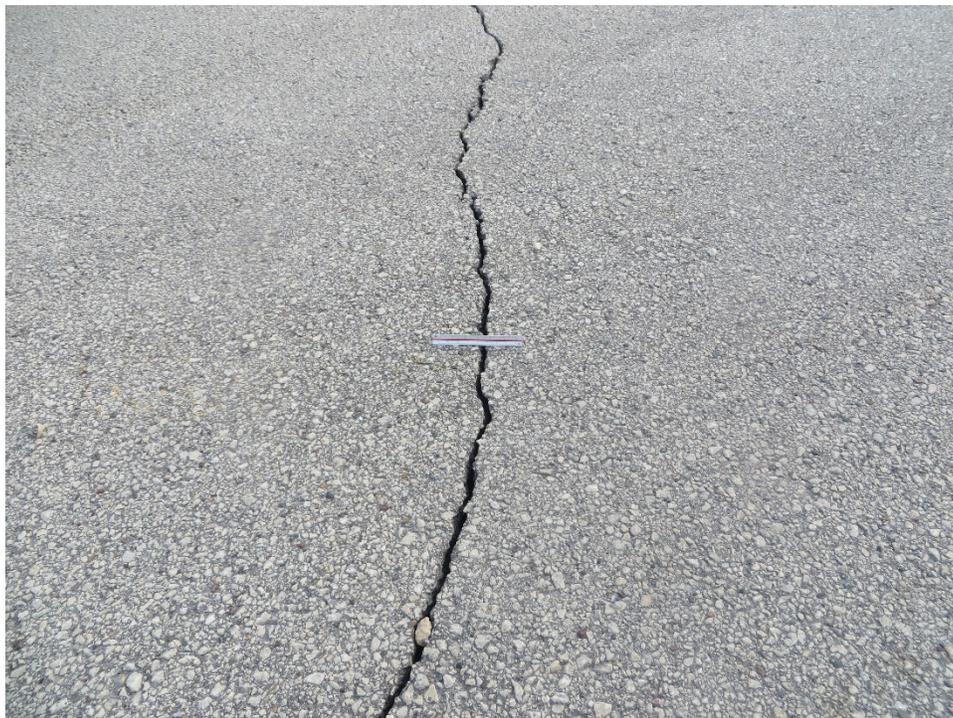
Taxiway 03 consisted of one section with medium-severity L&T cracking due to either the development of secondary cracking or unsealed crack widths greater than ¼ inch recorded. Medium-severity weathering was also observed.

T03MQ-01. L&T Cracking (Sample Unit No. 01).

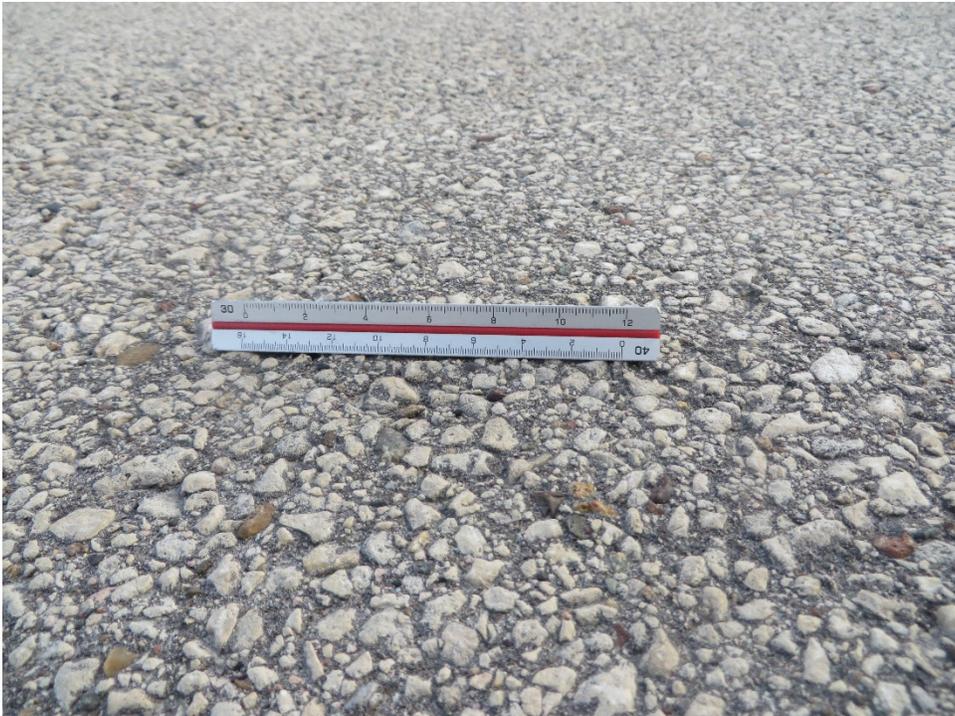
T03MQ-01. Weathering (Sample Unit No. 01).

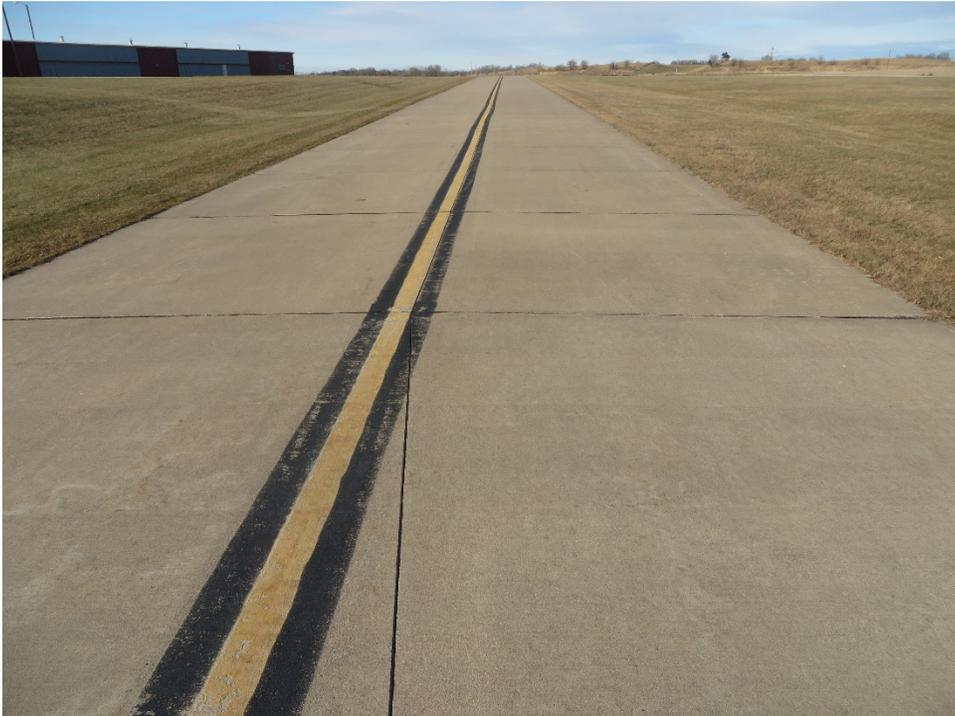
T04MQ-01. Overview.

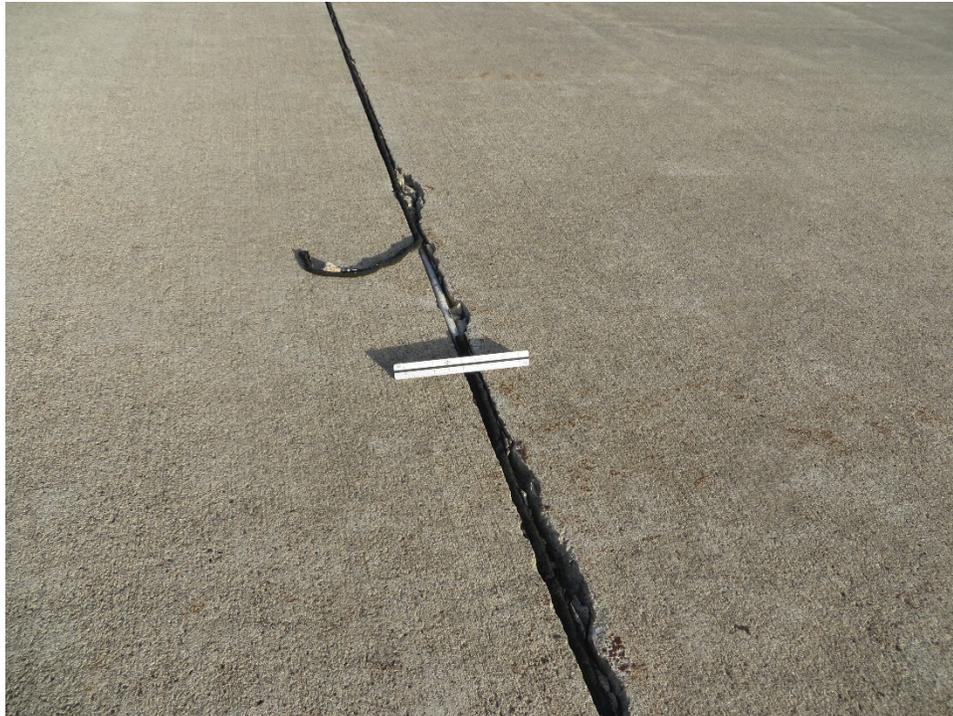
Taxiway 04 was defined by two sections. High-severity joint seal damage was recorded throughout Section 01. Isolated amounts of low-severity corner breaking; corner spalling; joint spalling; shattered slab; and longitudinal, transverse, and diagonal (LTD) cracking were also identified. Section 02, located adjacent to the Runway 15 approach, was observed with high-severity joint seal damage and low-, medium-, and high-severity joint spalling.

T04MQ-01. Joint Seal Damage (Sample Unit No. 01).

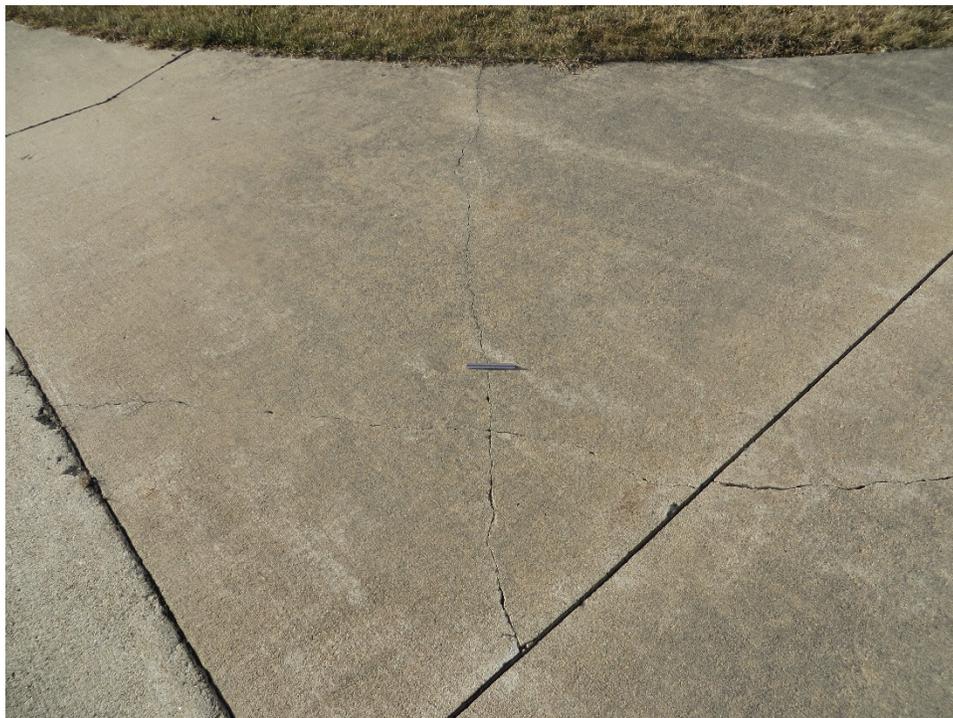
T04MQ-01. Shattered Slab (Sample Unit No. 01).

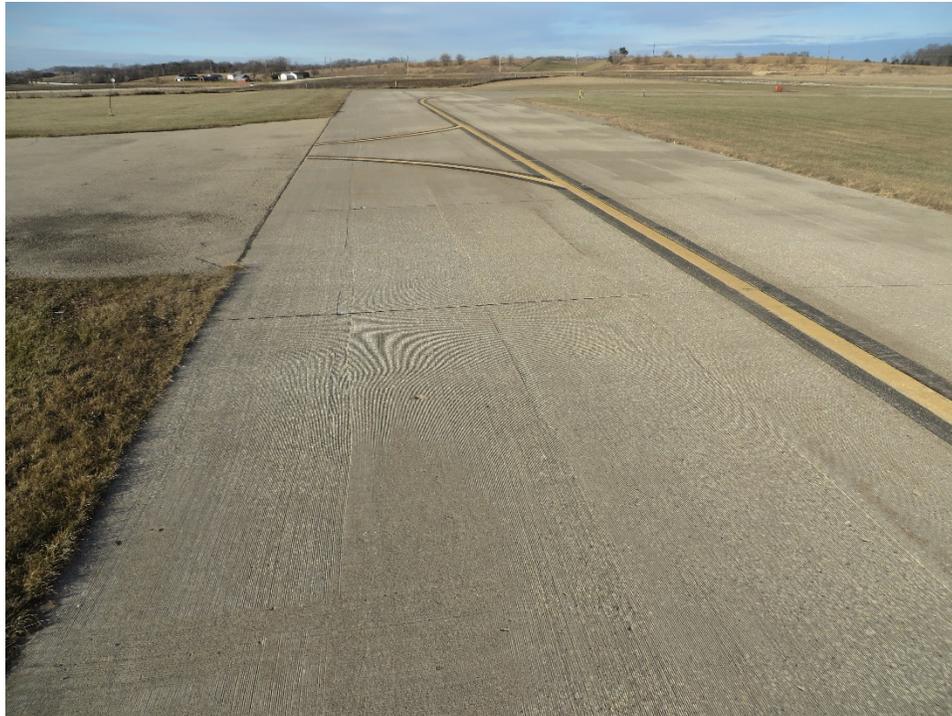
T04MQ-02. Overview.

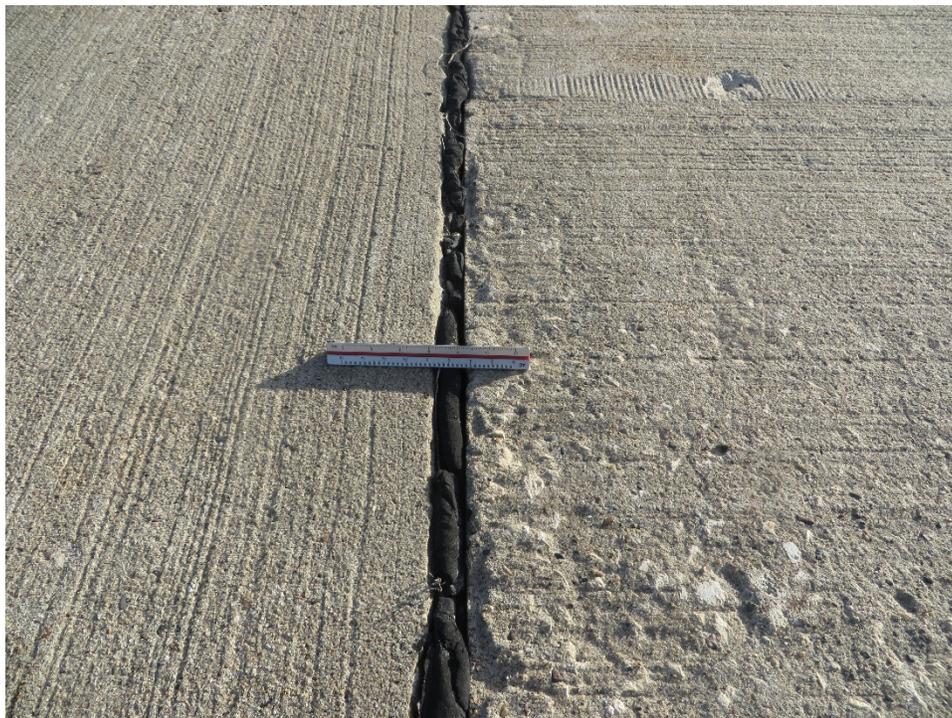
T04MQ-02. Joint Seal Damage (Sample Unit No. 03).

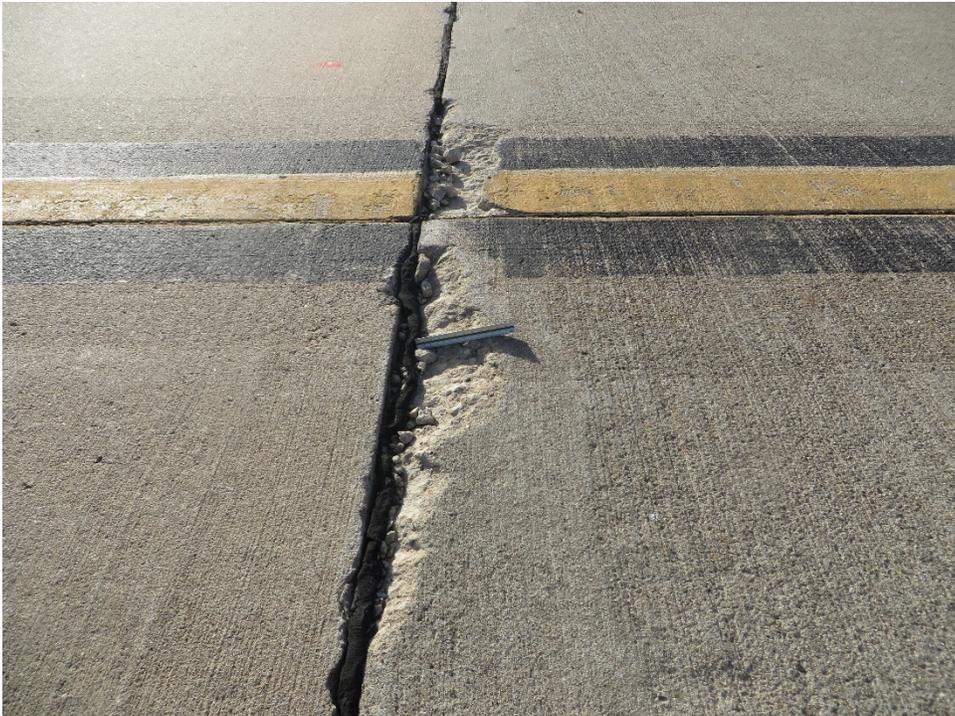
T04MQ-02. Joint Spalling (Sample Unit No. 05).

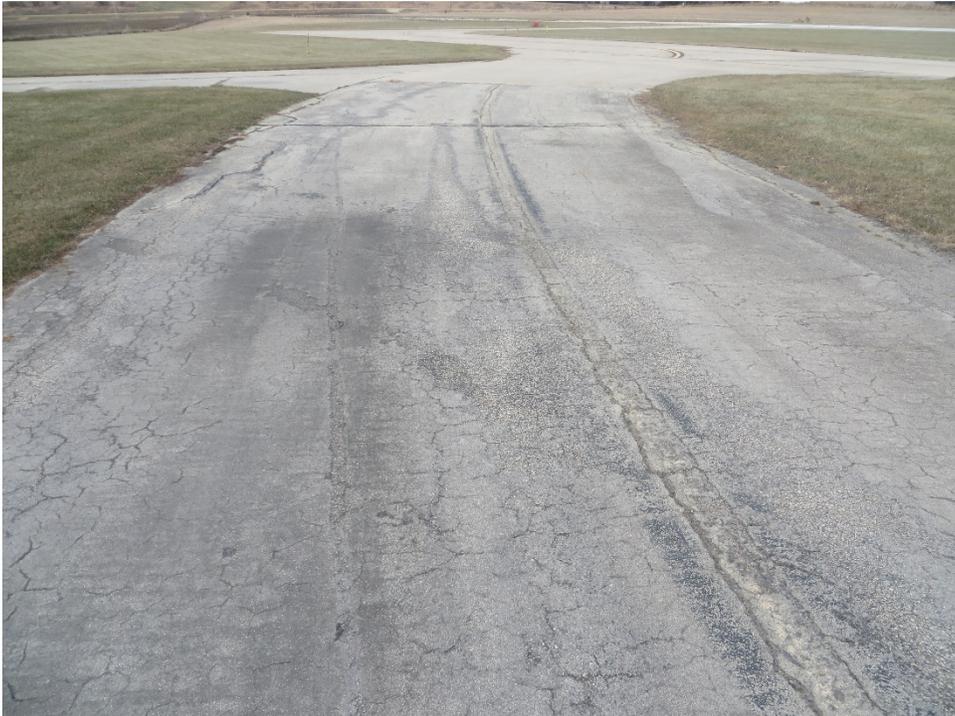
TH01MQ-01. Overview.
