# Maquoketa Municipal Airport

PAVEMENT MANAGEMENT REPORT

**JUNE 2018**

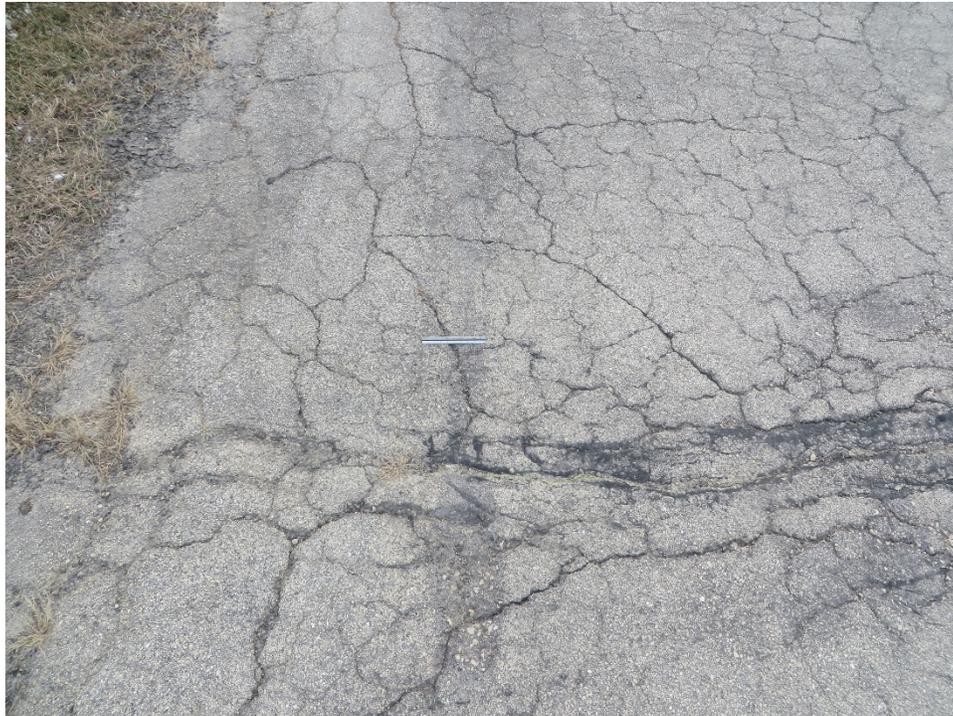
The T-Hangar area was defined by three sections. Section 01 was in poor condition with medium-severity alligator cracking identified throughout. High-severity raveling was recorded in areas where the applied surface treatment has become dislodged, producing foreign object debris (FOD) potential. High-severity weathering was observed where the applied surface treatment had worn away. Section 02 was identified with low-severity corner breaking and shattered slab, high-severity joint seal damage, low- and medium-severity joint spalling and LTD

TH01MQ-01. Alligator Cracking (Sample Unit No. 01).

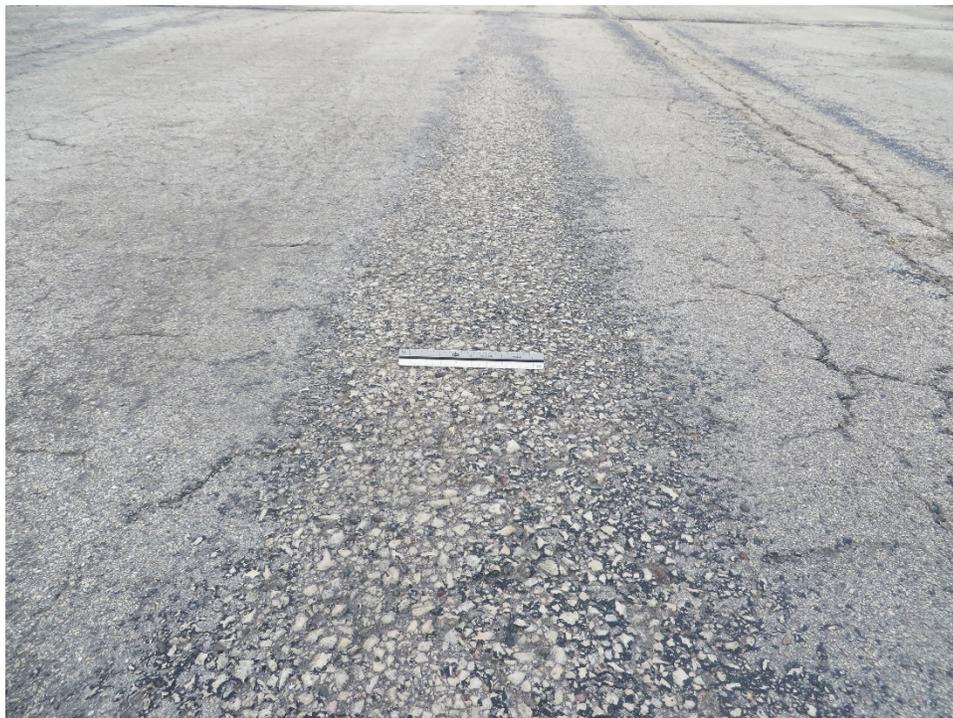
TH01MQ-01. Weathering (Sample Unit No. 01).

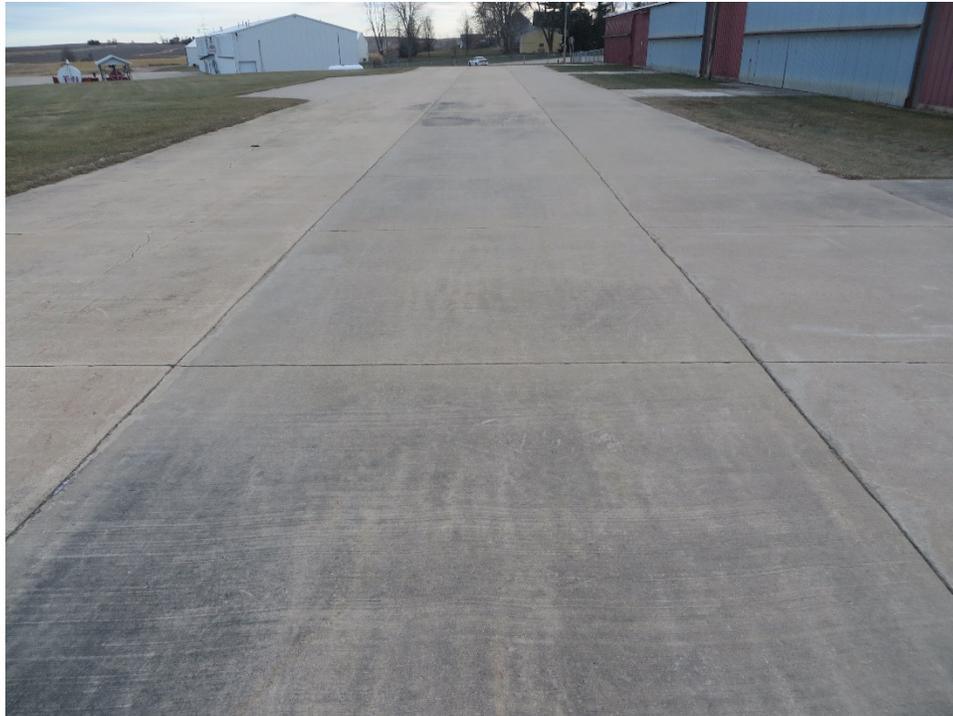
TH01MQ-02. Overview.

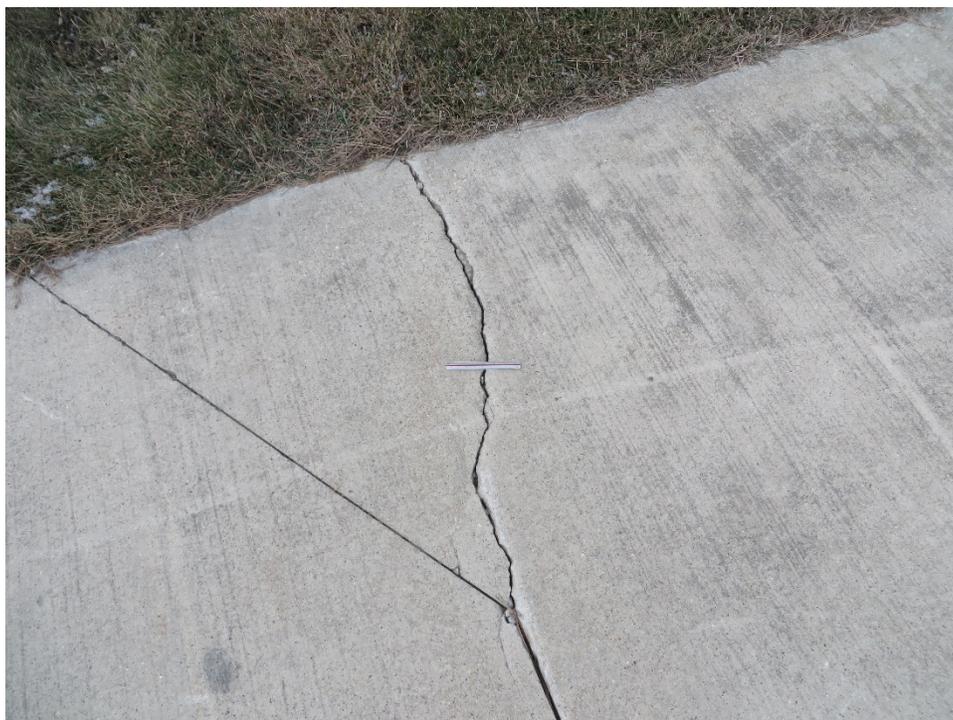
TH01MQ-02. Corner Break (Sample Unit No. 03).

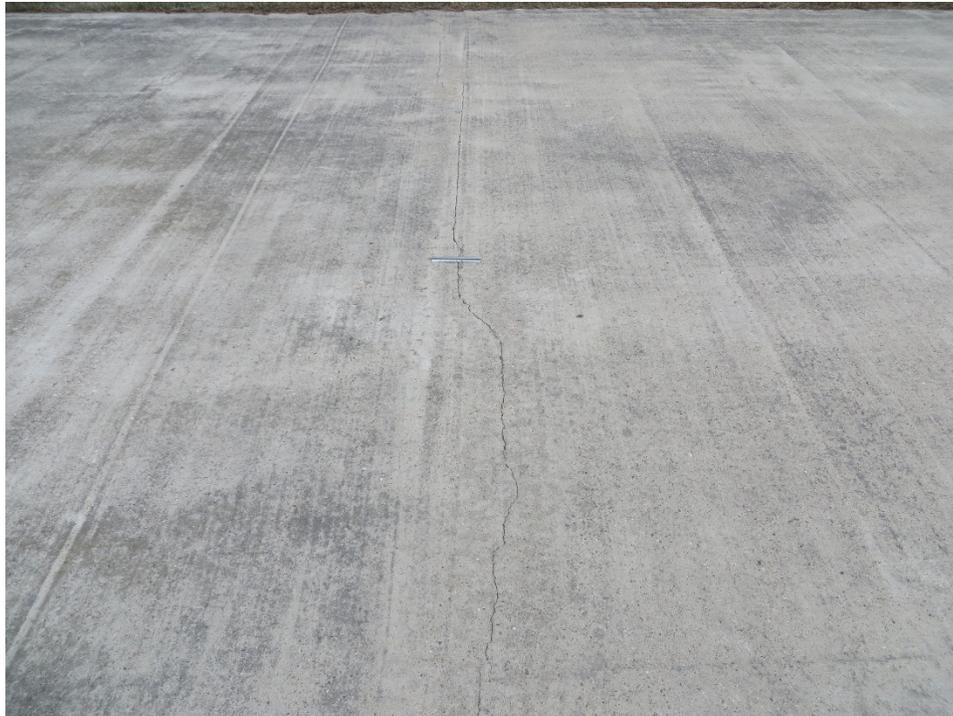
TH01MQ-02. LTD Cracking (Sample Unit No. 03).

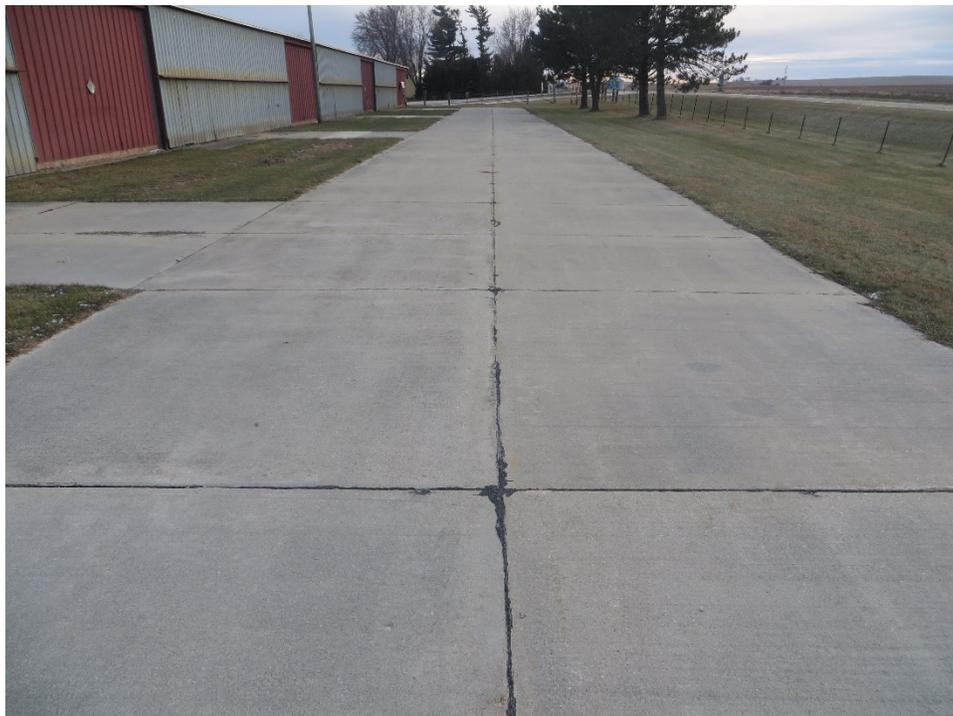
TH01MQ-03. Overview.

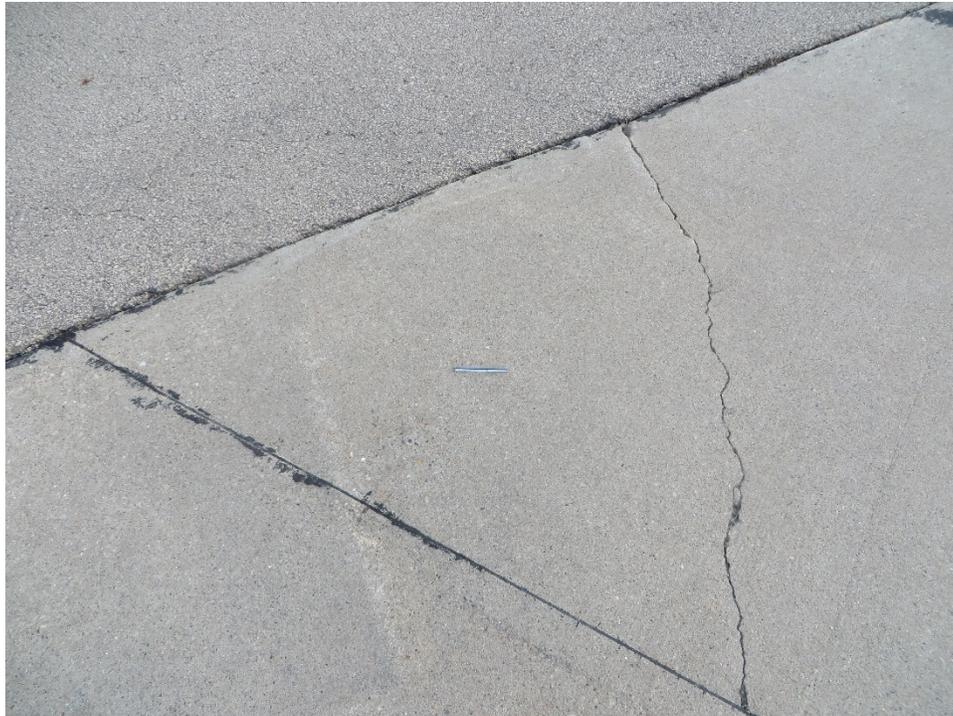
cracking, and shrinkage cracking. Section 03 was recorded with low-severity corner breaking, low- and medium-severity joint spalling and LTD cracking, and low-severity shattered slab. High-severity joint seal damage was also observed throughout the entire section.

TH01MQ-03. Corner Break (Sample Unit No. 01).

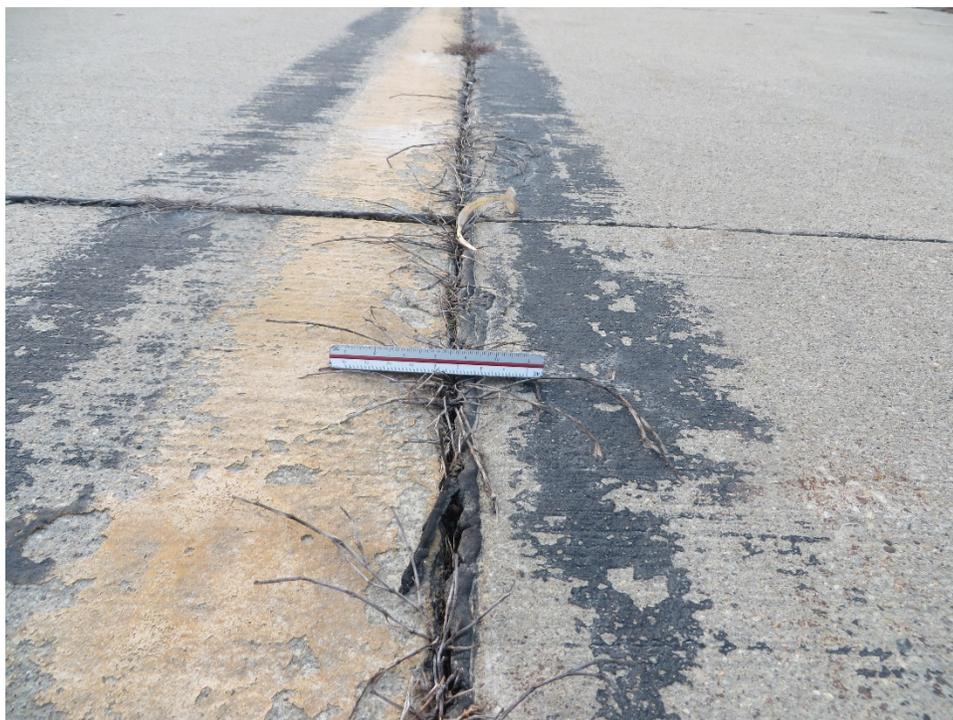
TH01MQ-03. Joint Seal Damage (Sample Unit No. 01).

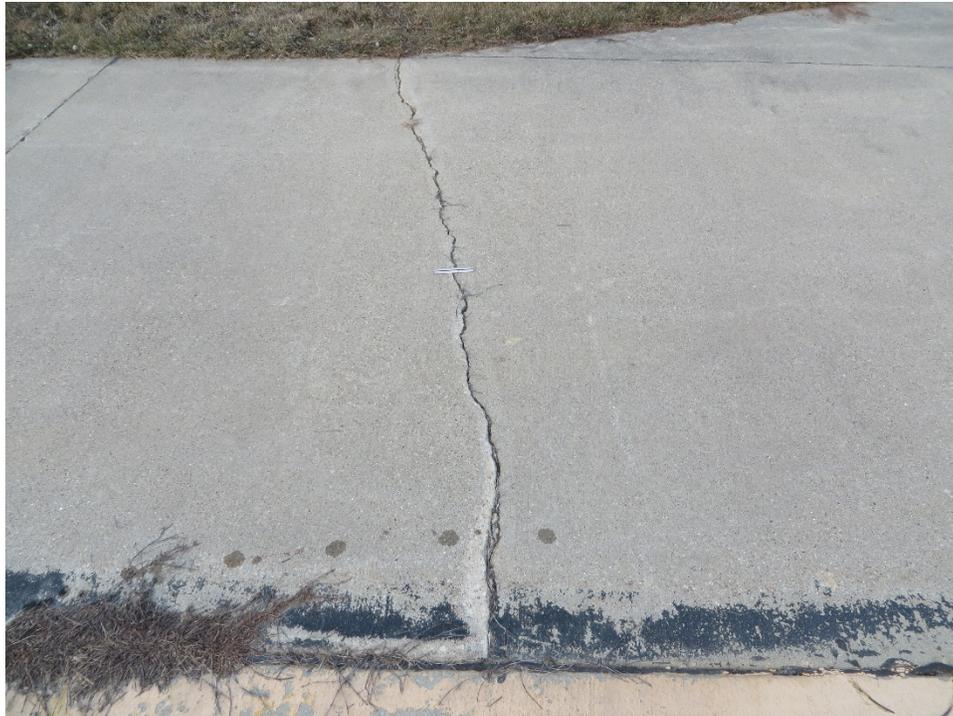
TH01MQ-03. LTD Cracking (Sample Unit No. 01).

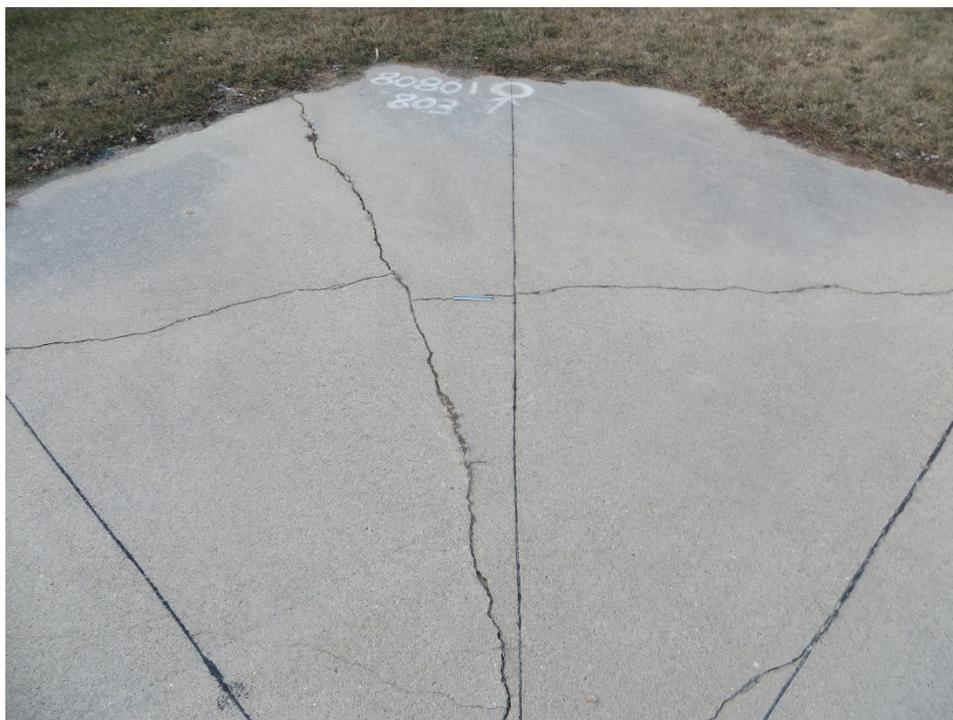
TH01MQ-03. Shattered Slab (Sample Unit No. 01).
