Maquoketa Municipal Airport

PAVEMENT MANAGEMENT REPORT

JULY 2021

Applied Pavement Technology, Inc.
115 West Main Street, Suite 400
Urbana, Illinois 61801
217-398-3977

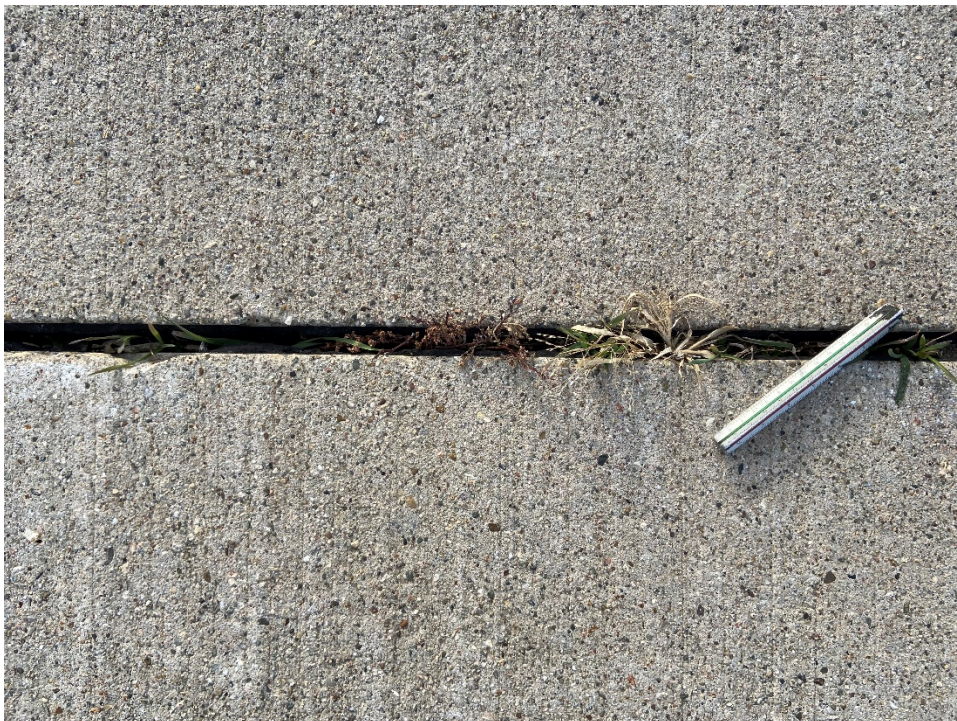
A01MQ-01. Joint Seal Damage (Sample Unit No. 01).

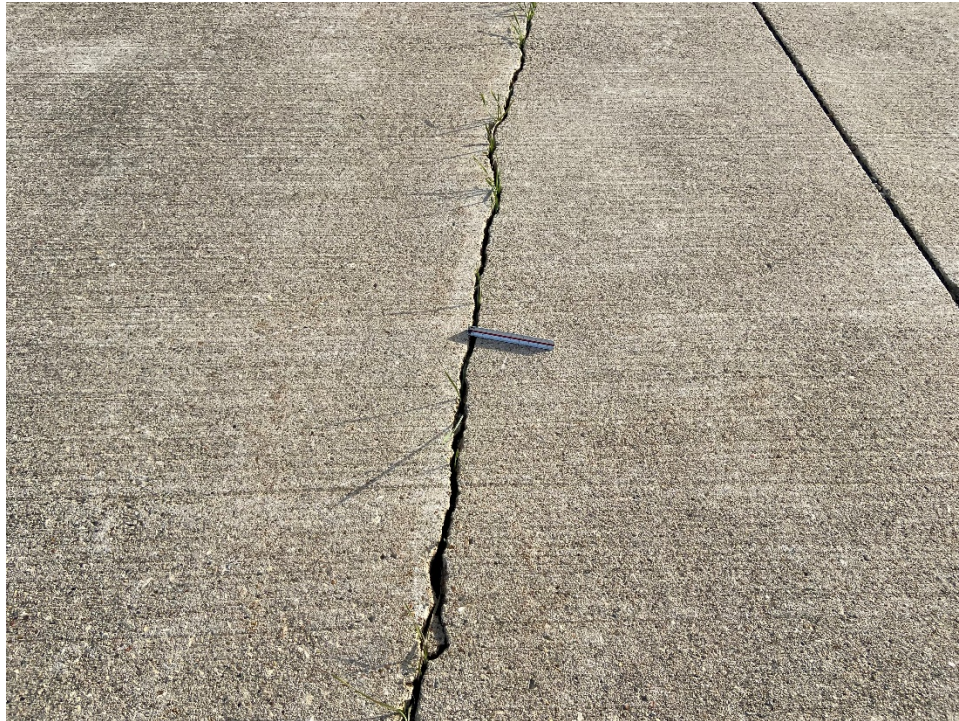
A01MQ-01. LTD Cracking (Sample Unit No. 01).

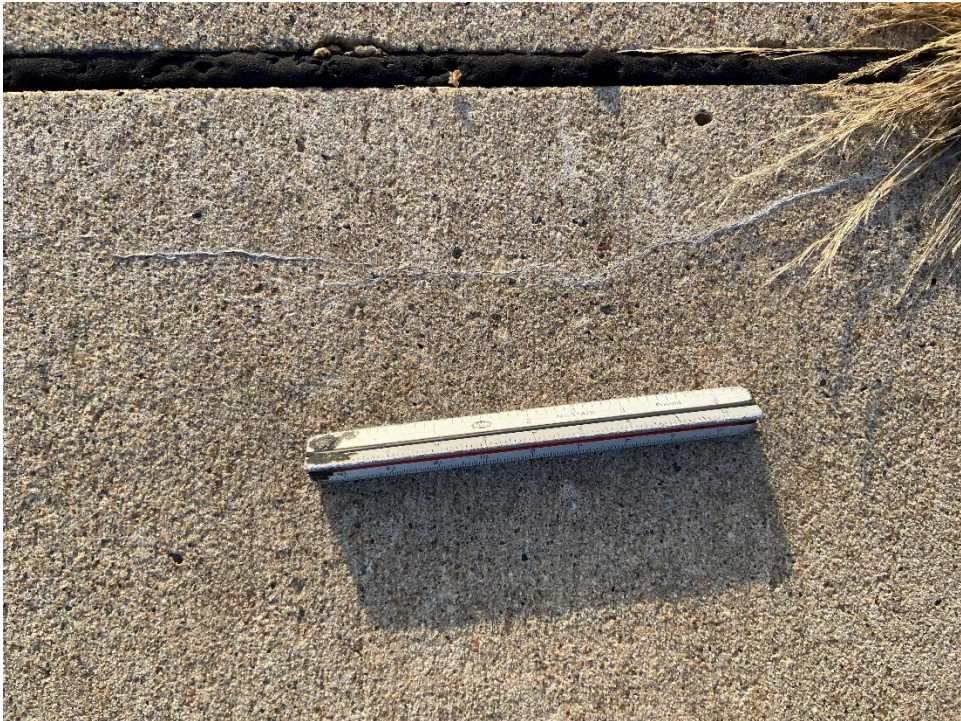
A01MQ-02. ASR (Sample Unit No. 02).

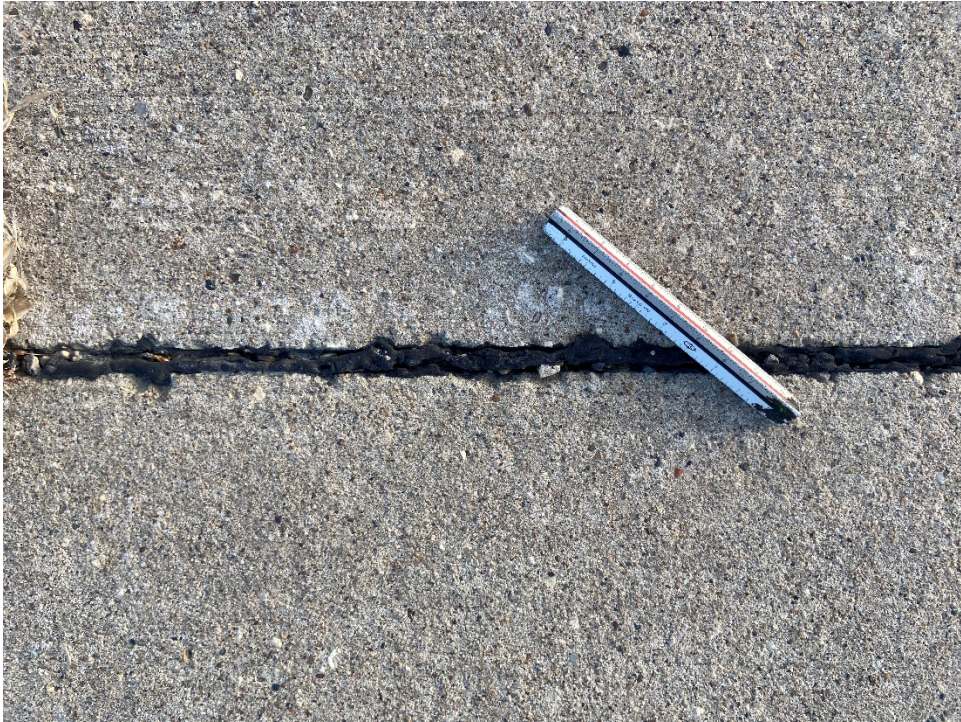
A01MQ-02. Joint Seal Damage (Sample Unit No. 02).

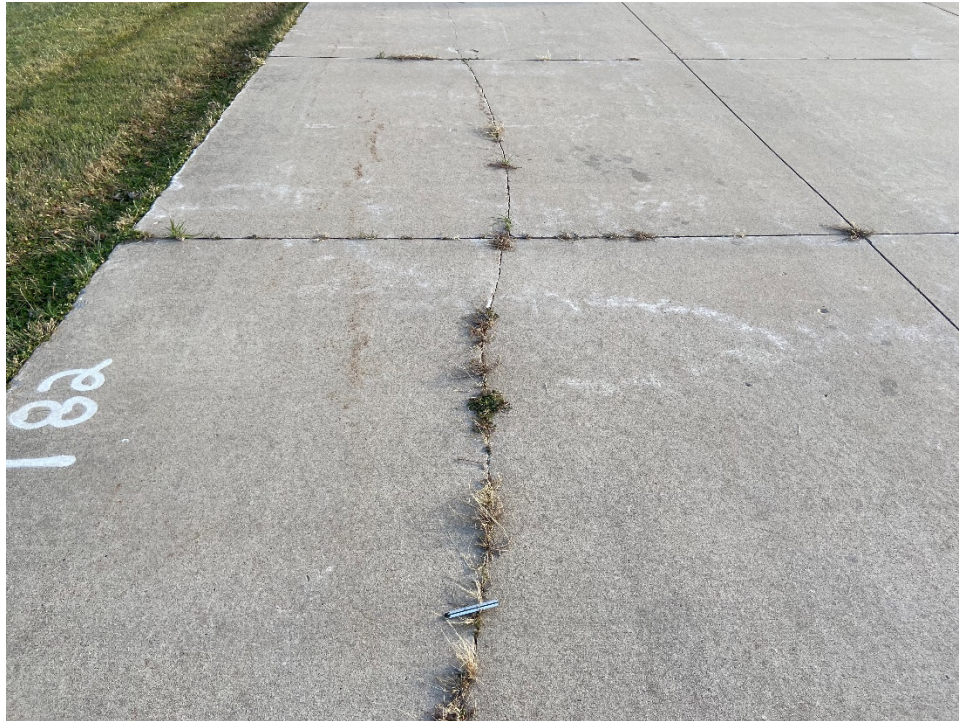
A01MQ-02. LTD Cracking (Additional Sample Unit No. 01).

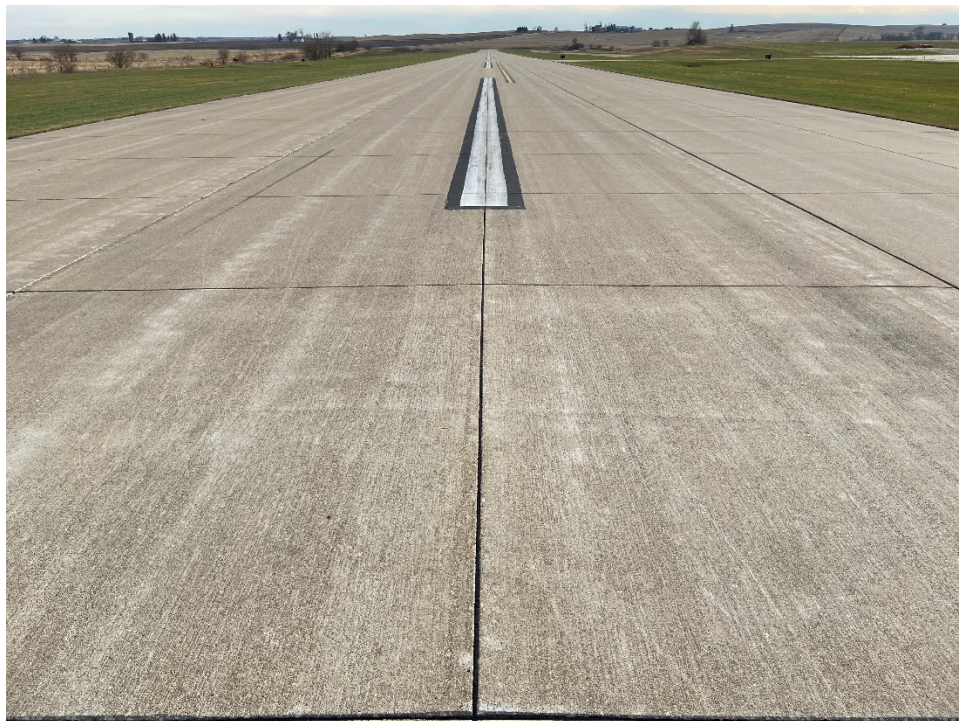
R15MQ-01. Overview.

Runway 15/33 was defined by one section. Low-severity faulting; medium-severity joint spalling; medium- and high-severity joint seal damage; all severities of small patching; and shrinkage cracking were identified in Section 01.

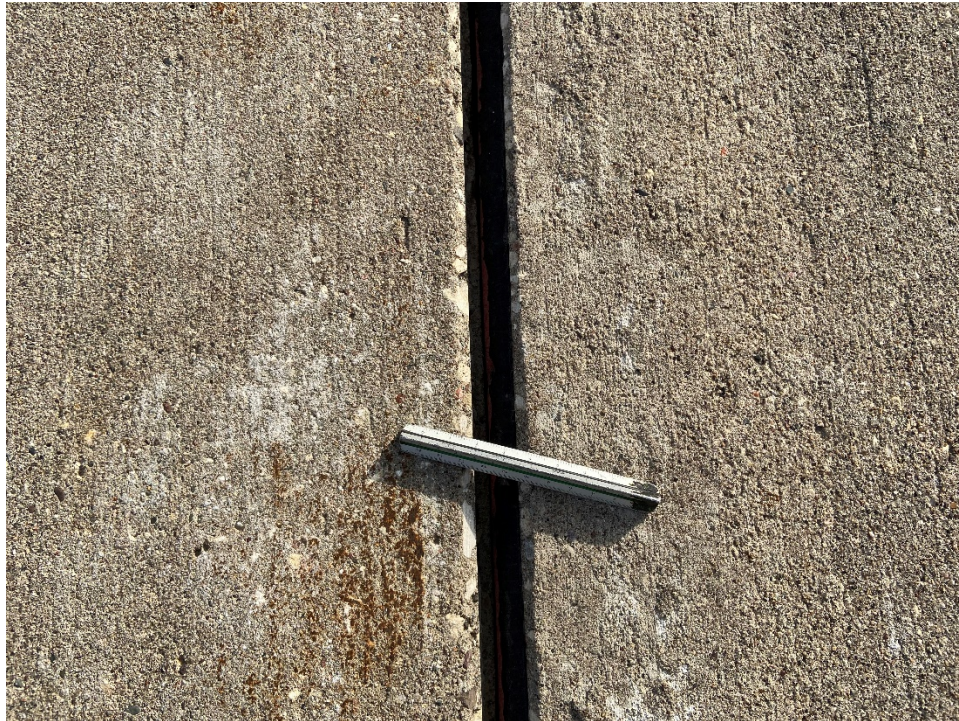
R15MQ-01. Joint Seal Damage (Sample Unit No. 06).

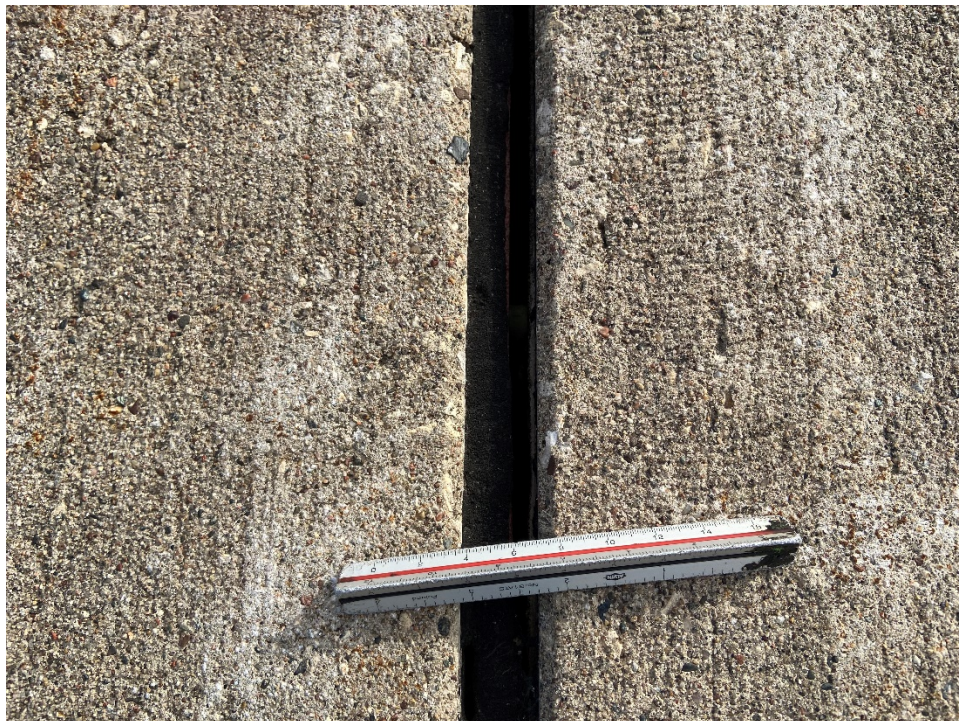
R15MQ-01. Joint Seal Damage (Sample Unit No. 69).

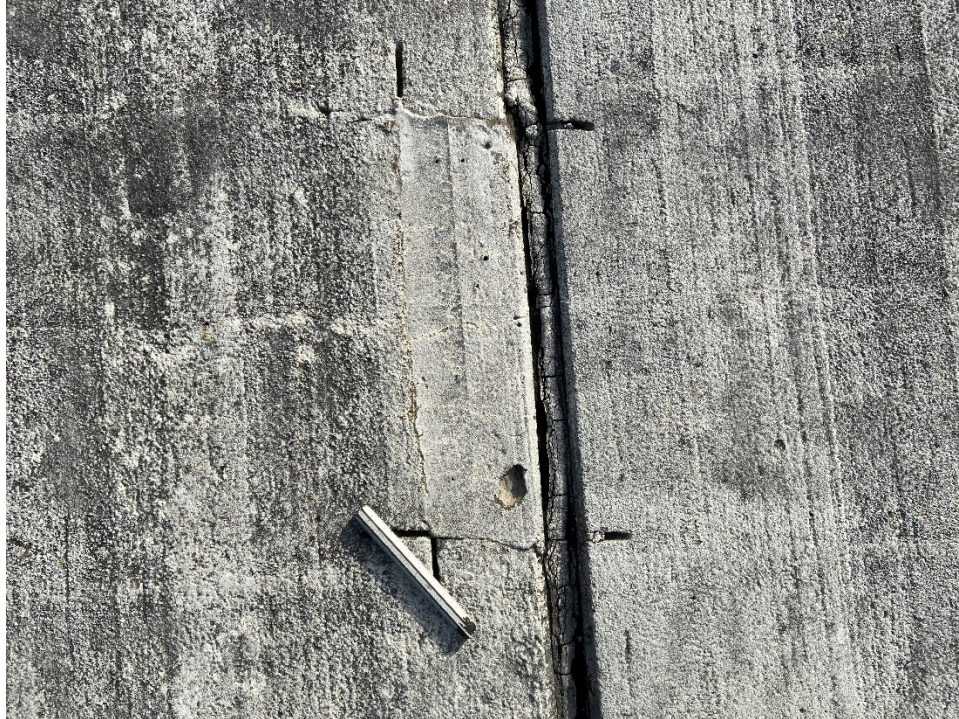
R15MQ-01. Small Patching (Sample Unit No. 06).

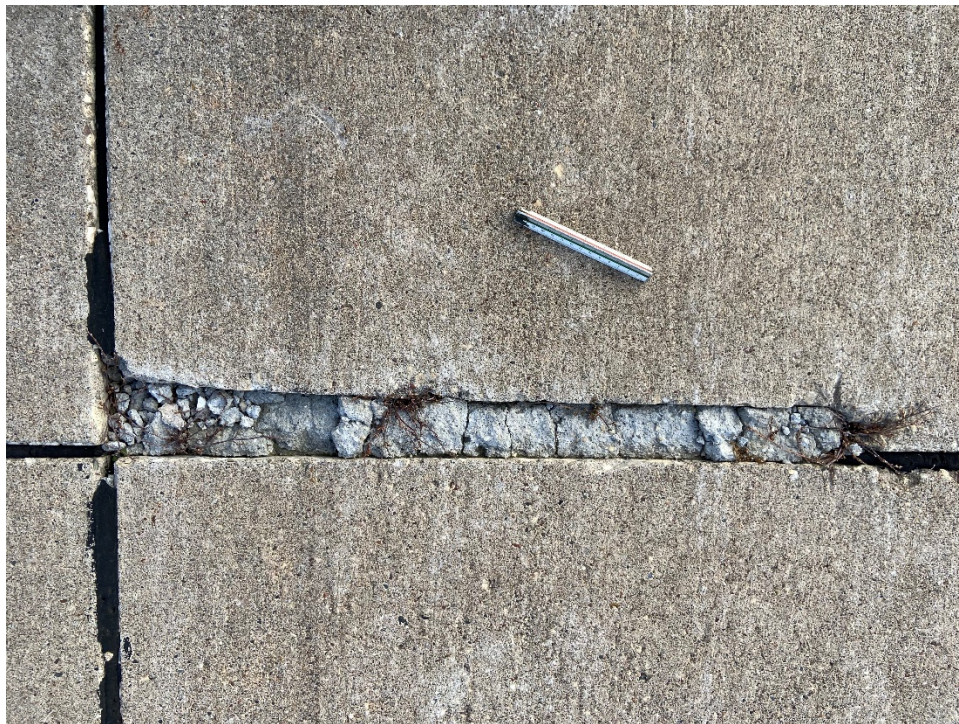
R15MQ-01. Small Patching (Sample Unit No. 60).

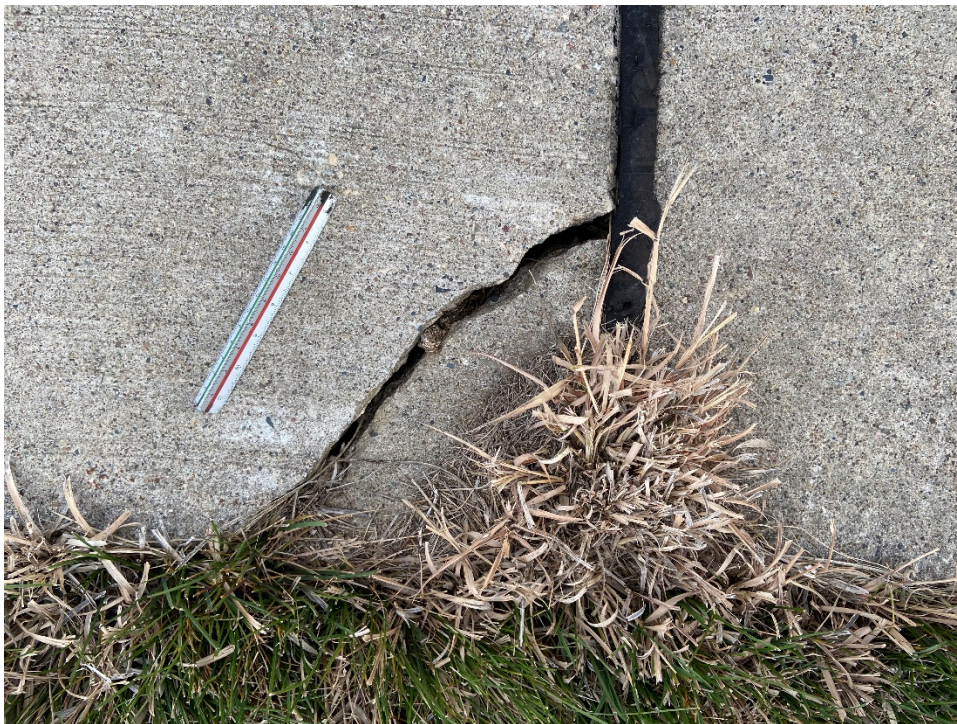
T01MQ-01. Corner Spalling (Sample Unit No. 05).

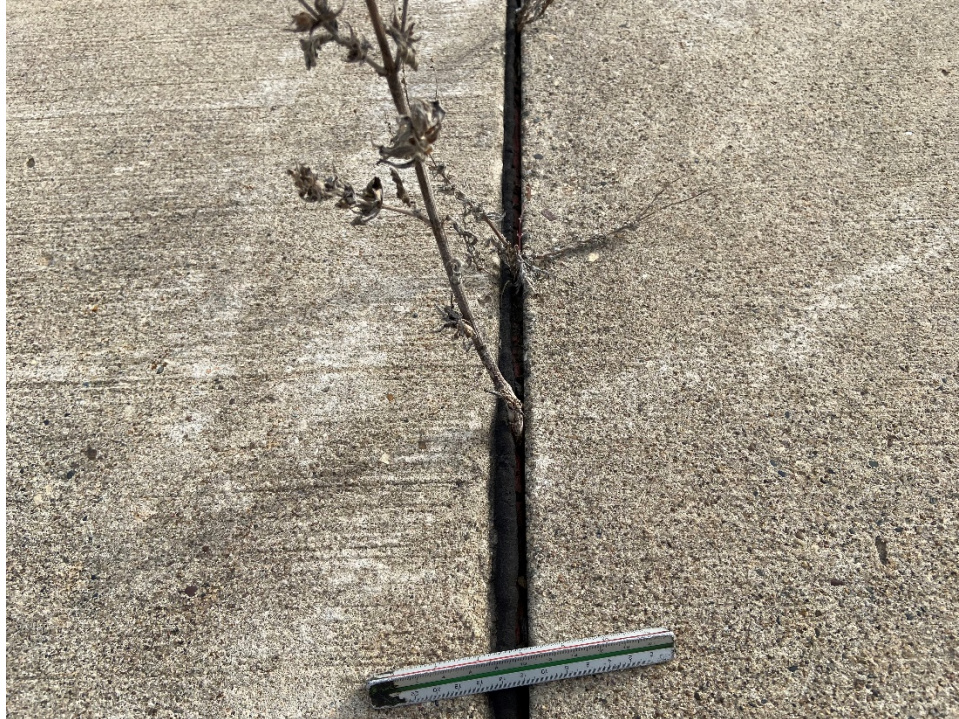
T01MQ-01. Joint Seal Damage (Sample Unit No. 05) (1).

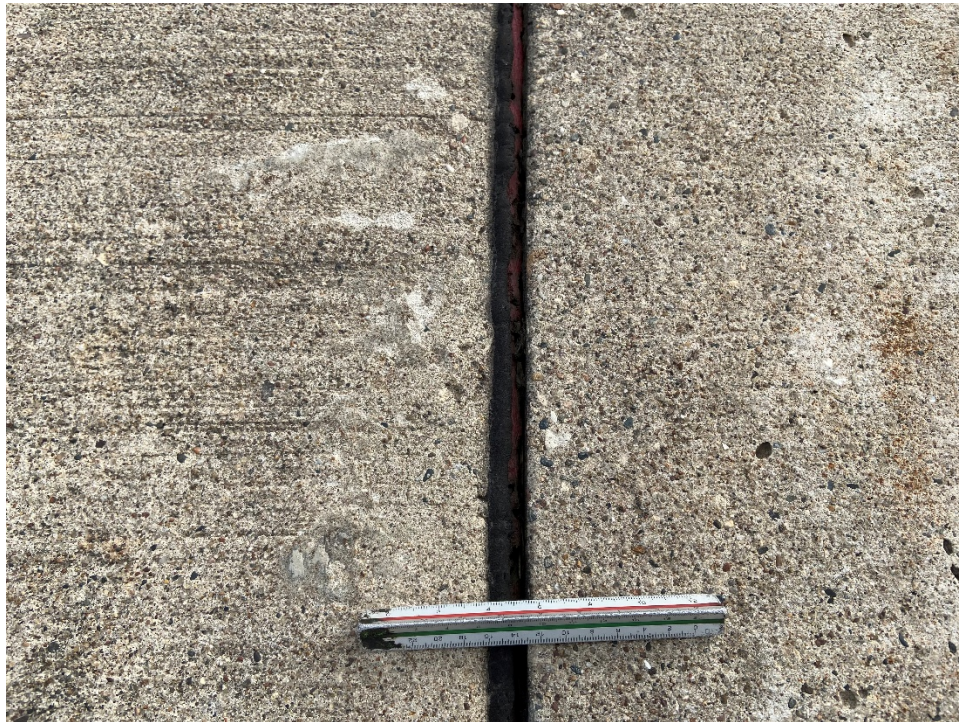
T01MQ-01. Joint Seal Damage (Sample Unit No. 05) (2).

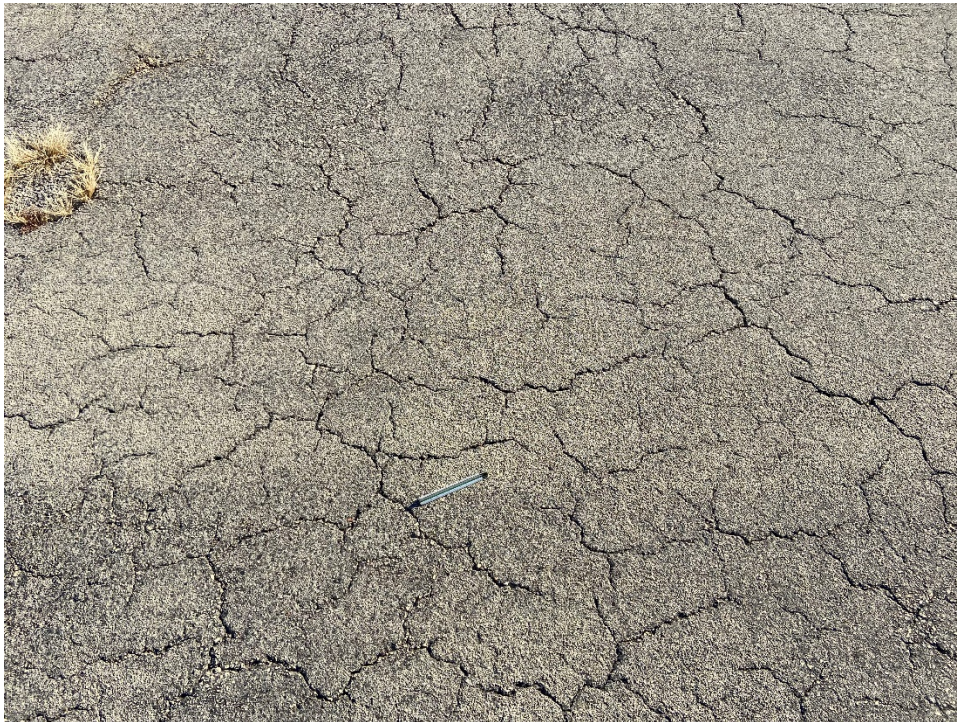
T02MQ-01. Alligator Cracking (Sample Unit No. 01).

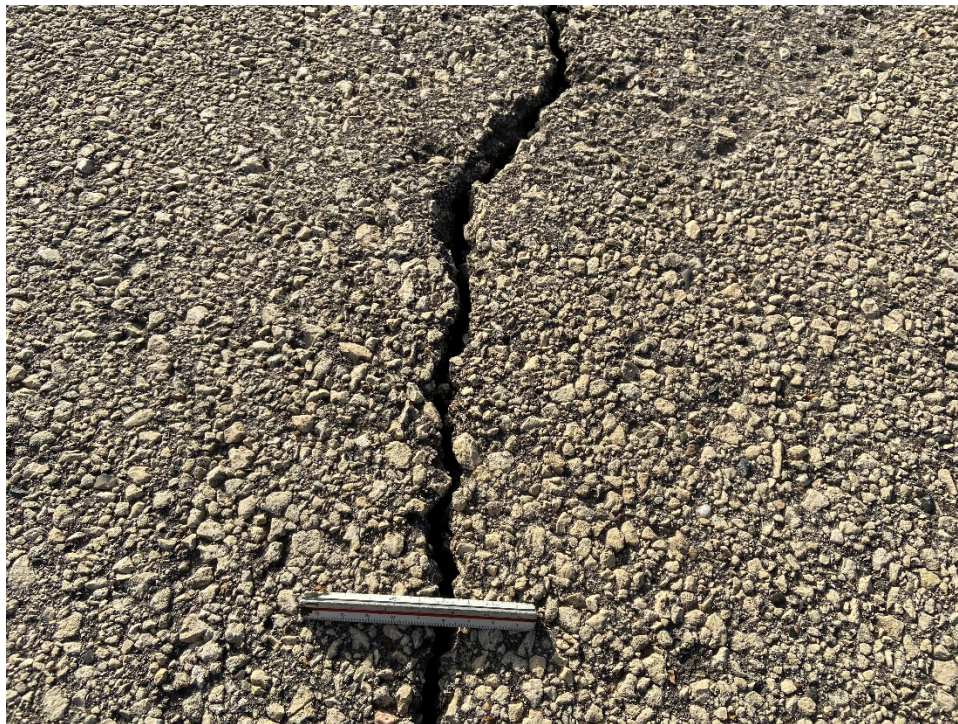
T02MQ-02. L&T Cracking (Sample Unit No. 01) (1).

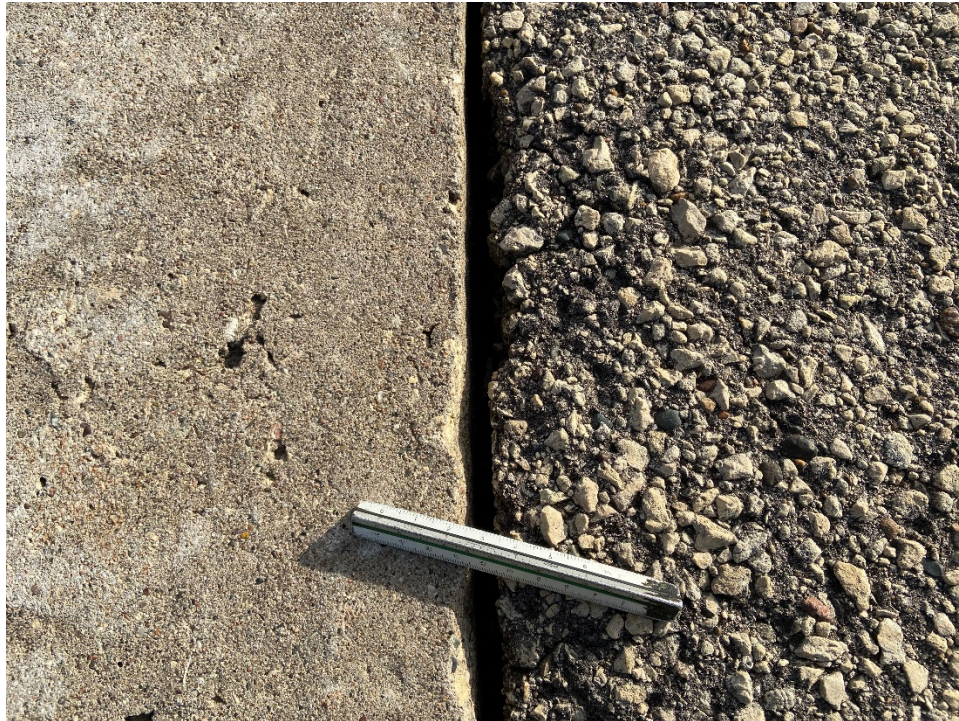
T02MQ-02. L&T Cracking (Sample Unit No. 01) (2).

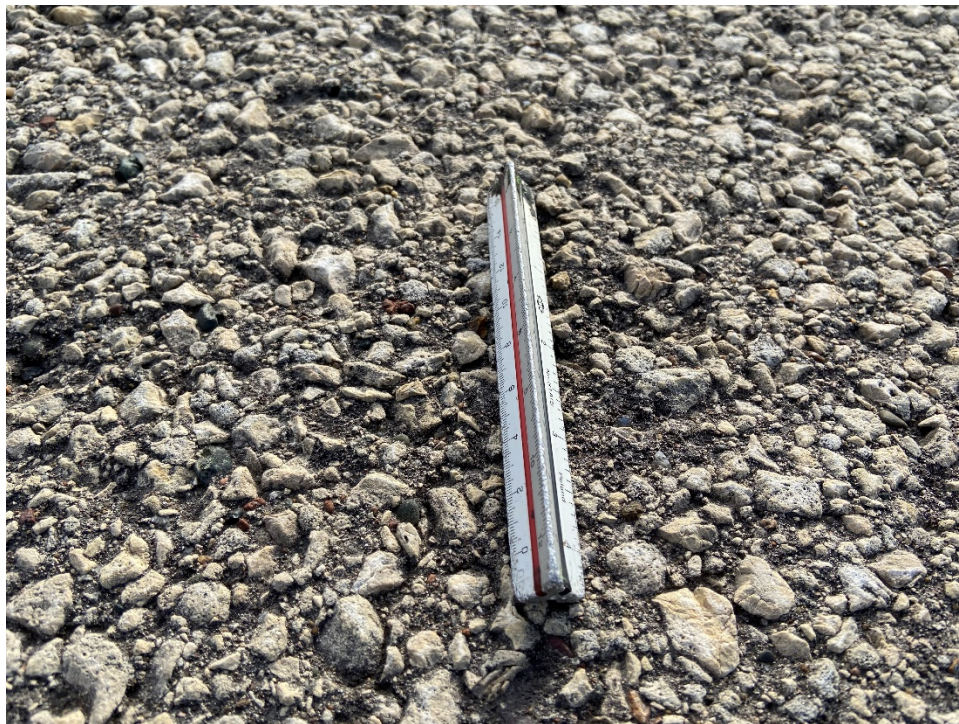
T02MQ-02. Weathering (Sample Unit No. 01) (1).

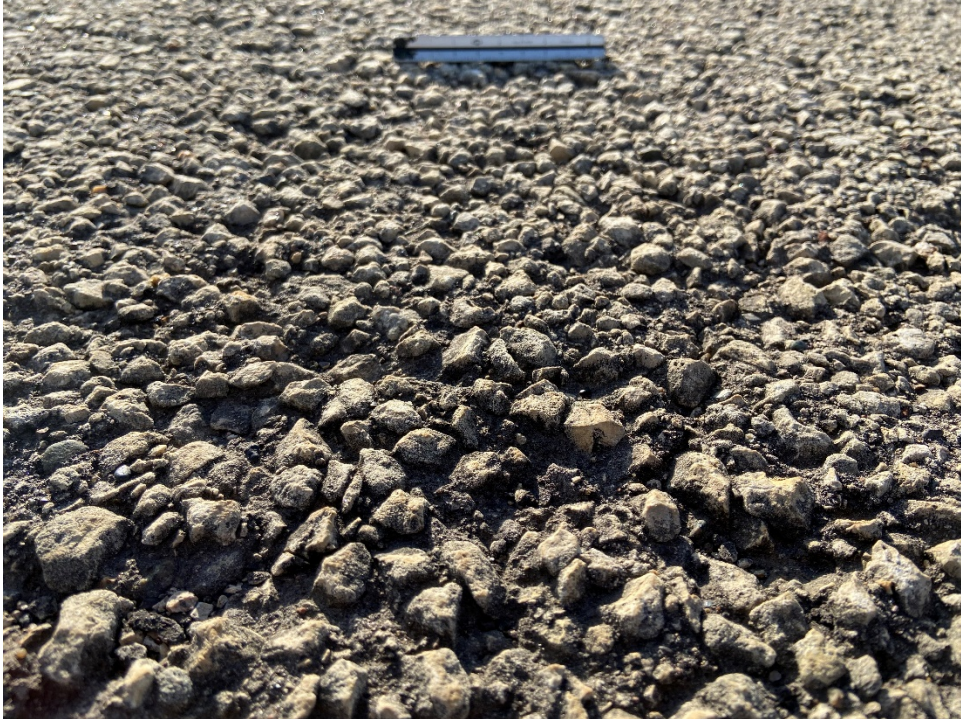
T02MQ-02. Weathering (Sample Unit No. 01) (2).

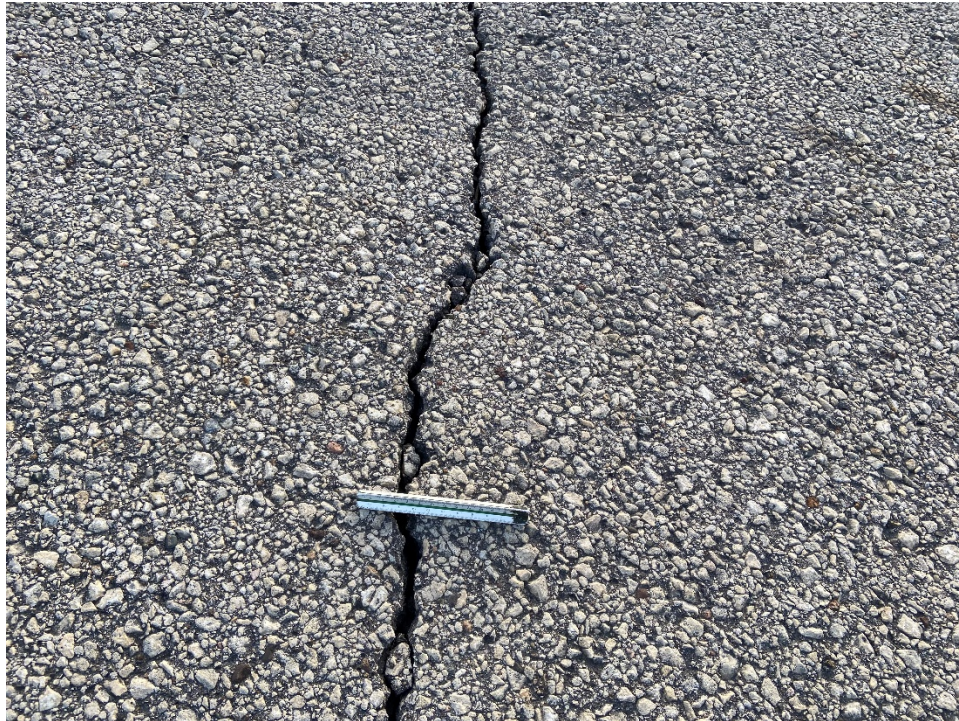
Taxiway 03 was defined by one section. Medium-severity L&T cracking was identified where either unsealed crack widths were greater than $\frac{1}{4}$ in or the crack sealant was no longer satisfactorily, preventing water from penetrating the pavement surface. In addition, medium- and high-severity weathering were recorded during the inspection.

T03MQ-01. L&T Cracking (Sample Unit No. 01).

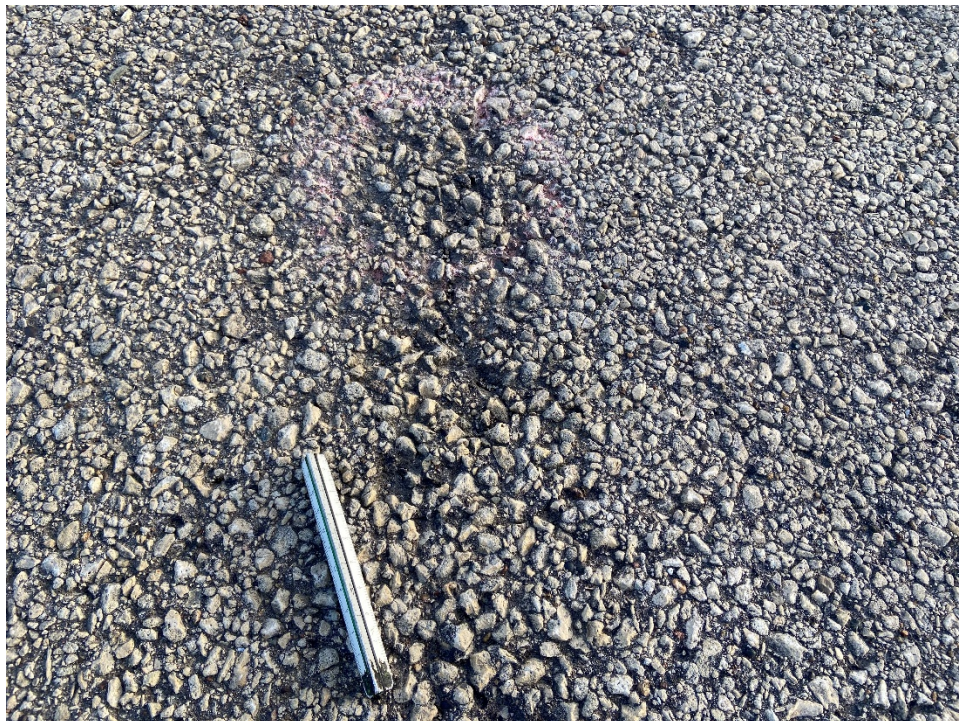
T03MQ-01. Weathering (Sample Unit No. 01).

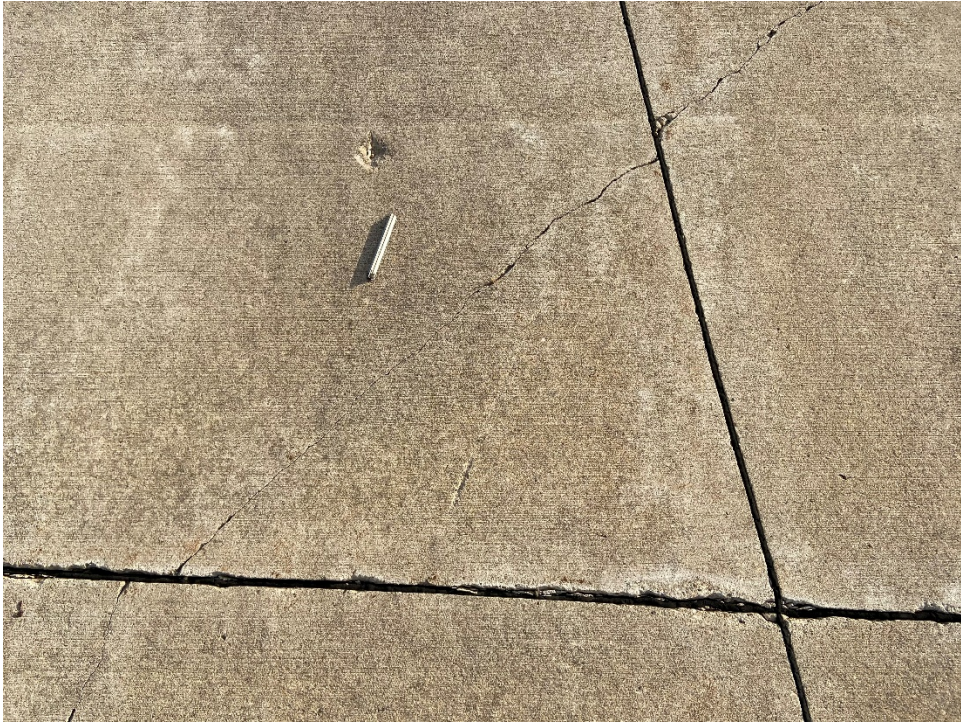
T04MQ-01. Corner Break (Sample Unit No. 01).

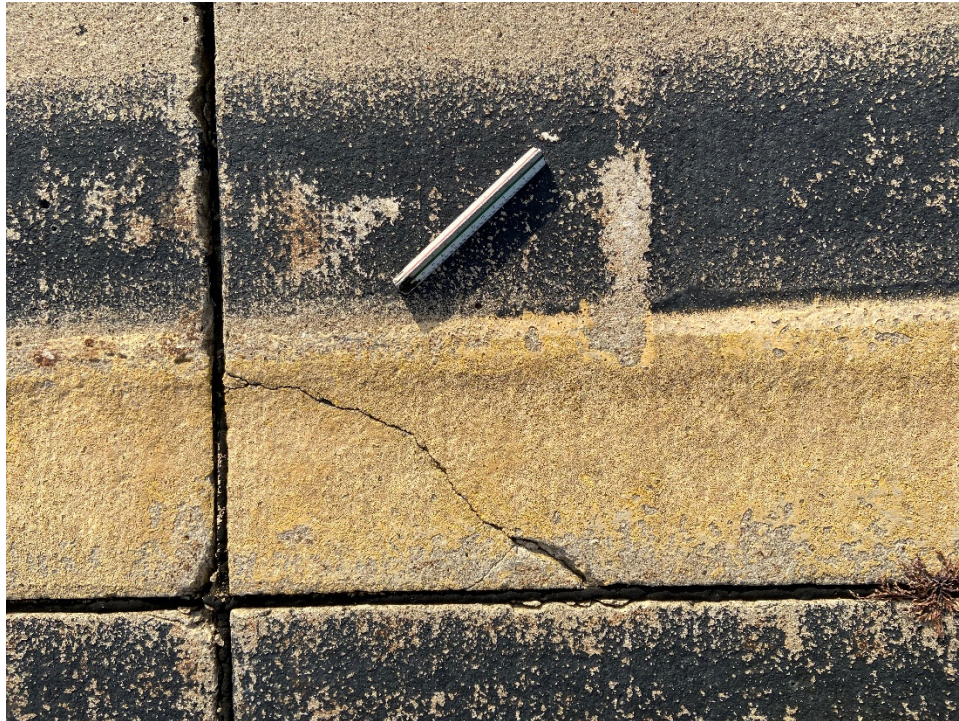
T04MQ-01. Corner Spalling (Sample Unit No. 01).

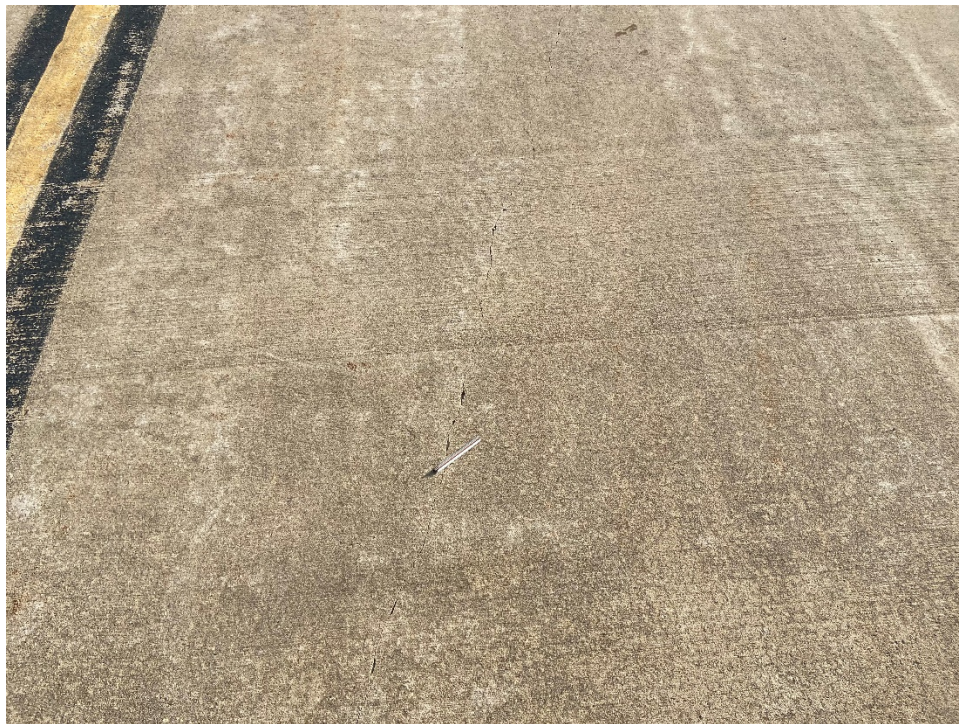
T04MQ-01. LTD Cracking (Sample Unit No. 01).

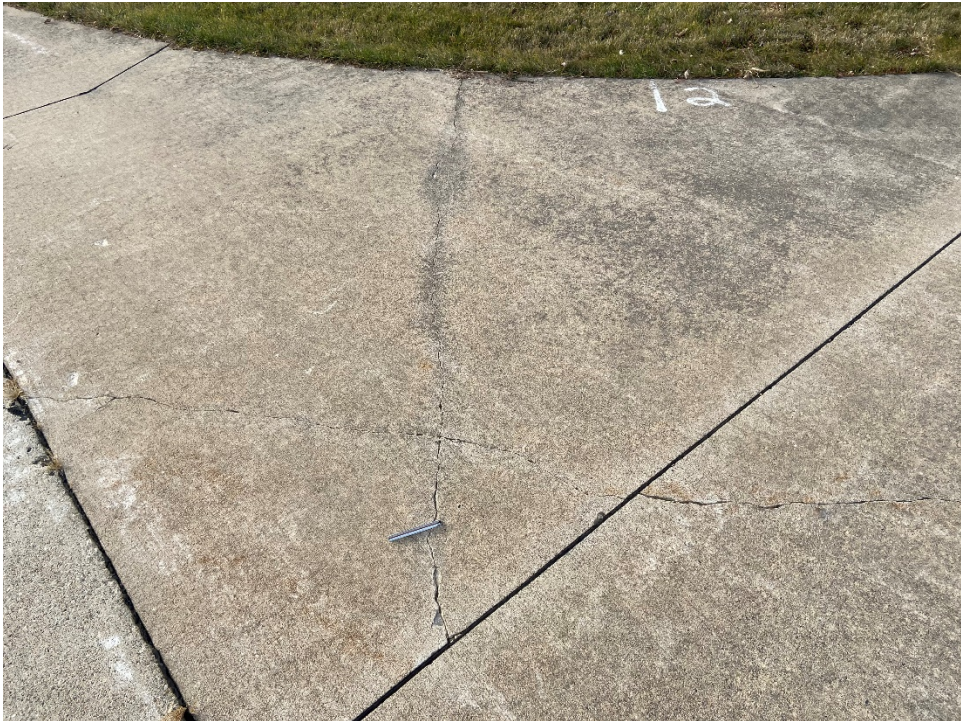
T04MQ-01. Shattered Slab (Sample Unit No. 01).

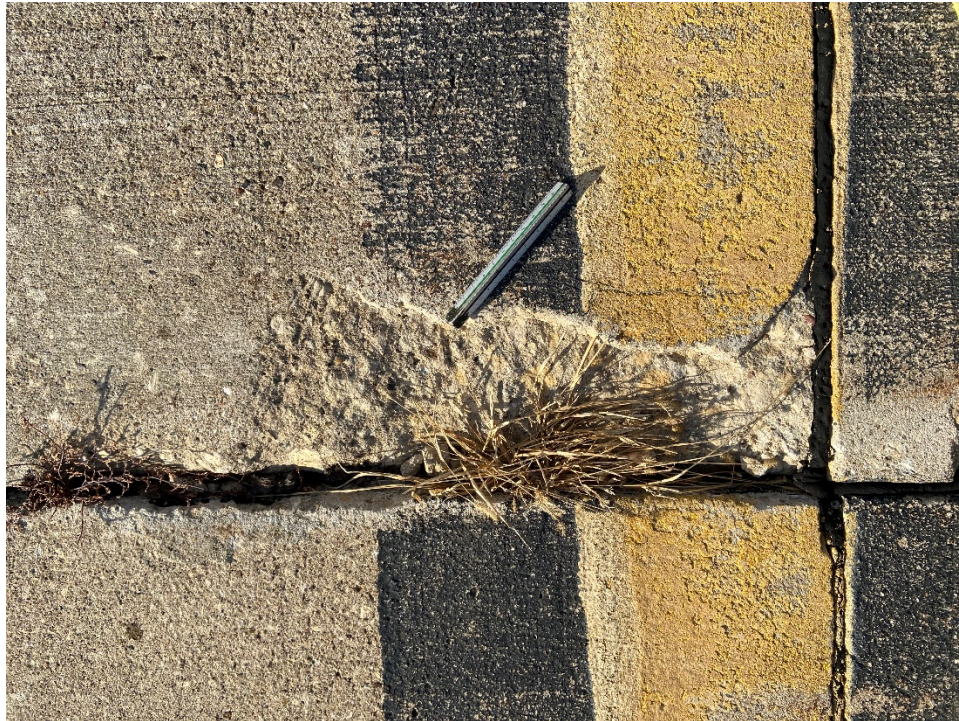
T04MQ-02. Joint Spalling (Sample Unit No. 05) (1).

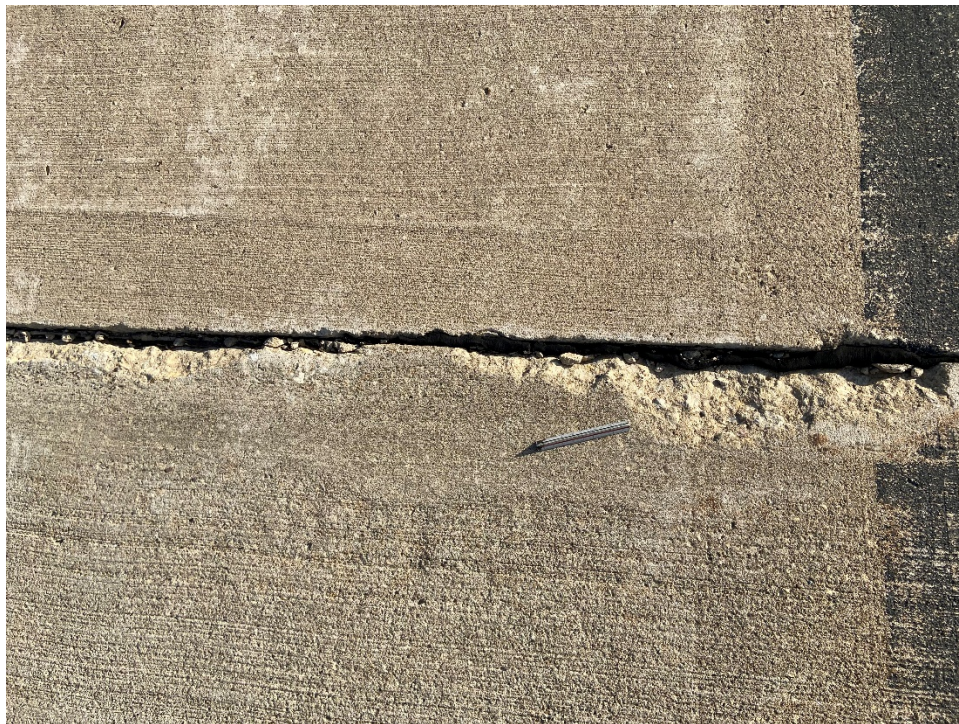
T04MQ-02. Joint Spalling (Sample Unit No. 05) (2).

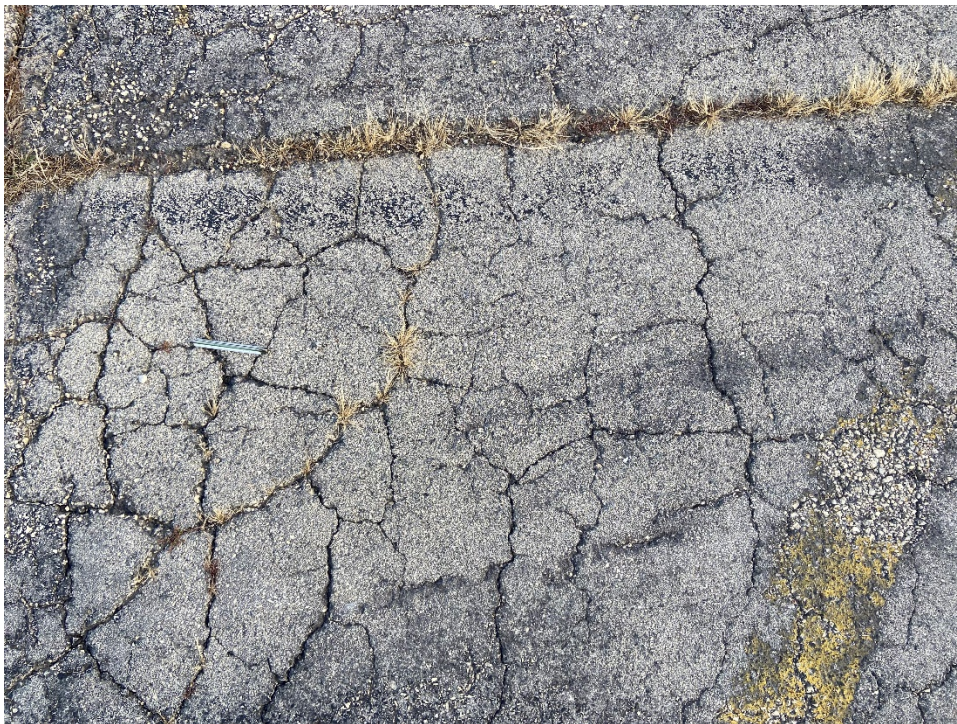
The T-Hangar area contained three sections. Section 01 was in poor condition with medium-severity alligator cracking and high-severity raveling and weathering identified during the inspection. Low-severity ASR and joint spalling; low- and medium-severity corner break and

TH01MQ-01. Alligator Cracking (Sample Unit No. 01).

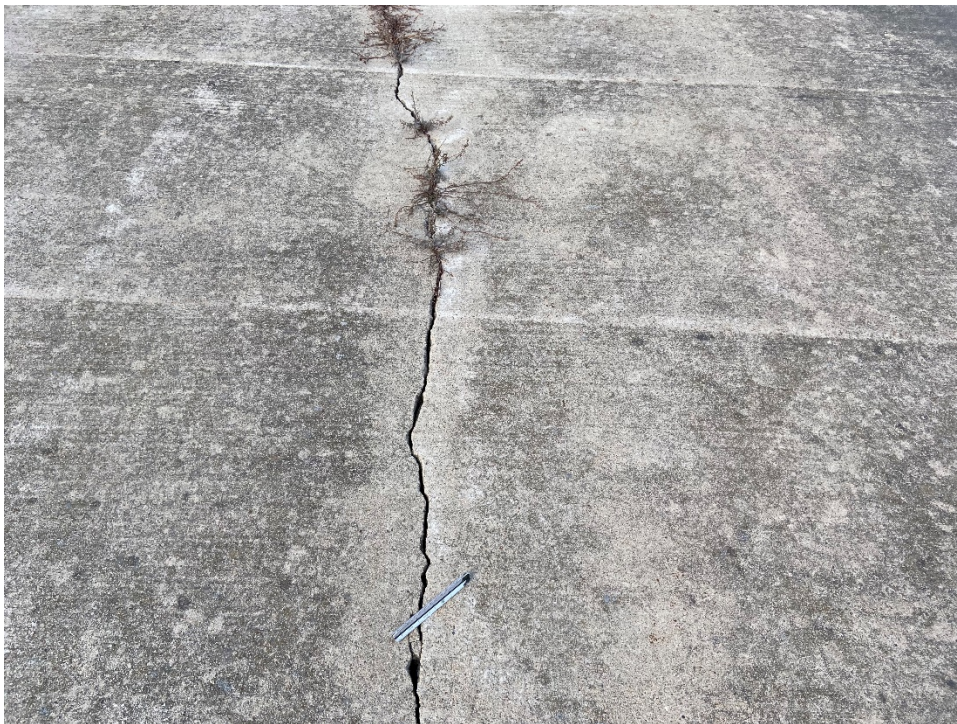
TH01MQ-02. LTD Cracking (Sample Unit No. 01).

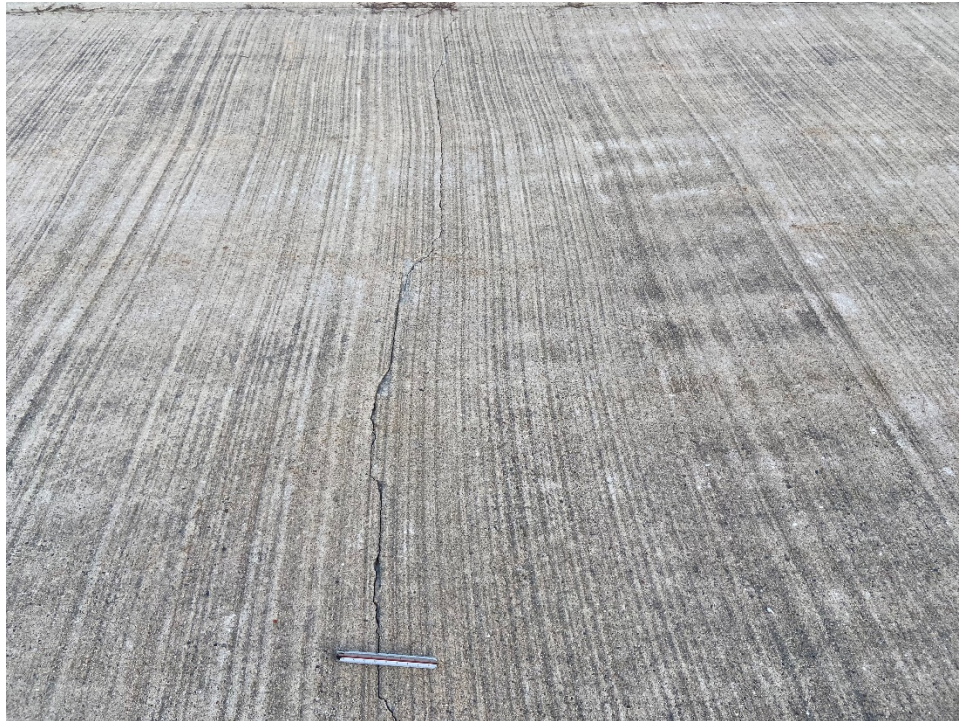
TH01MQ-02. LTD Cracking (Sample Unit No. 03).

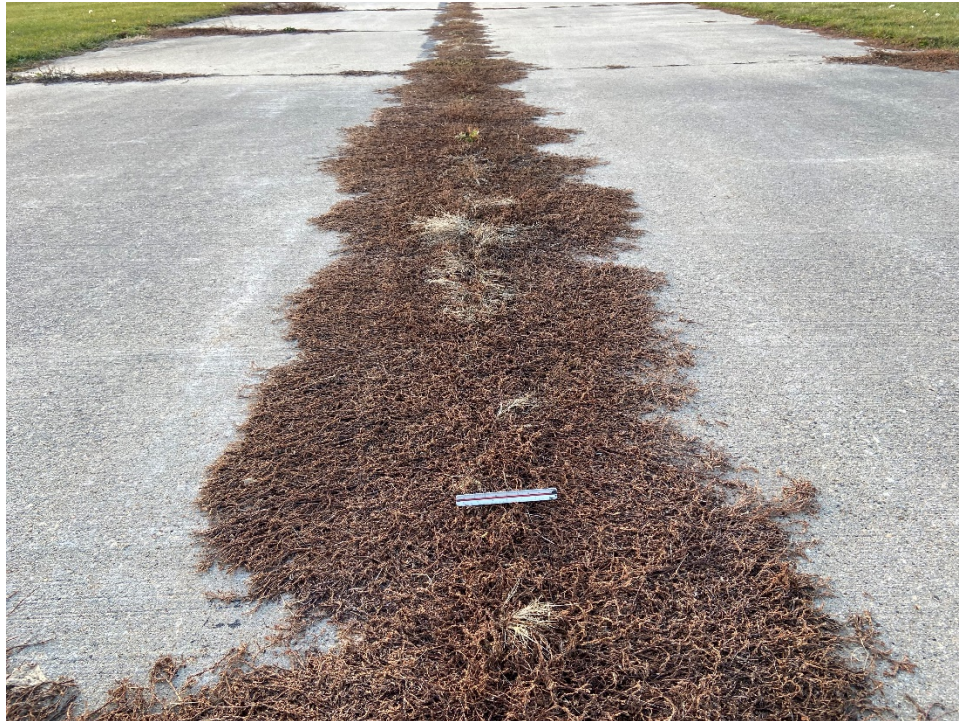
TH01MQ-03. Joint Seal Damage (Sample Unit No. 01).

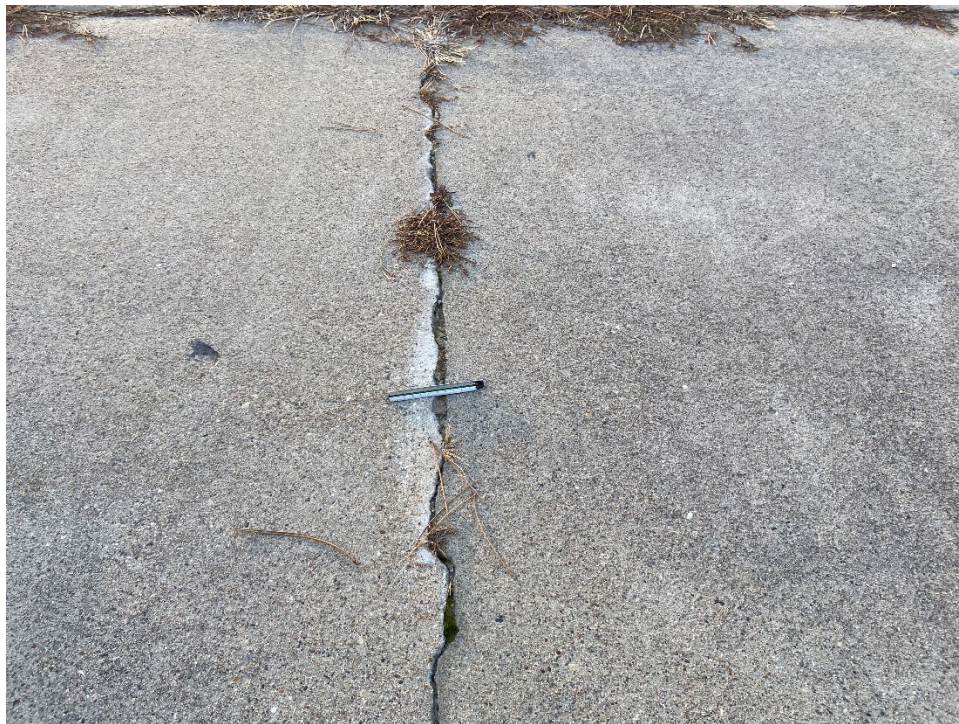
TH01MQ-03. LTD Cracking (Sample Unit No. 03).

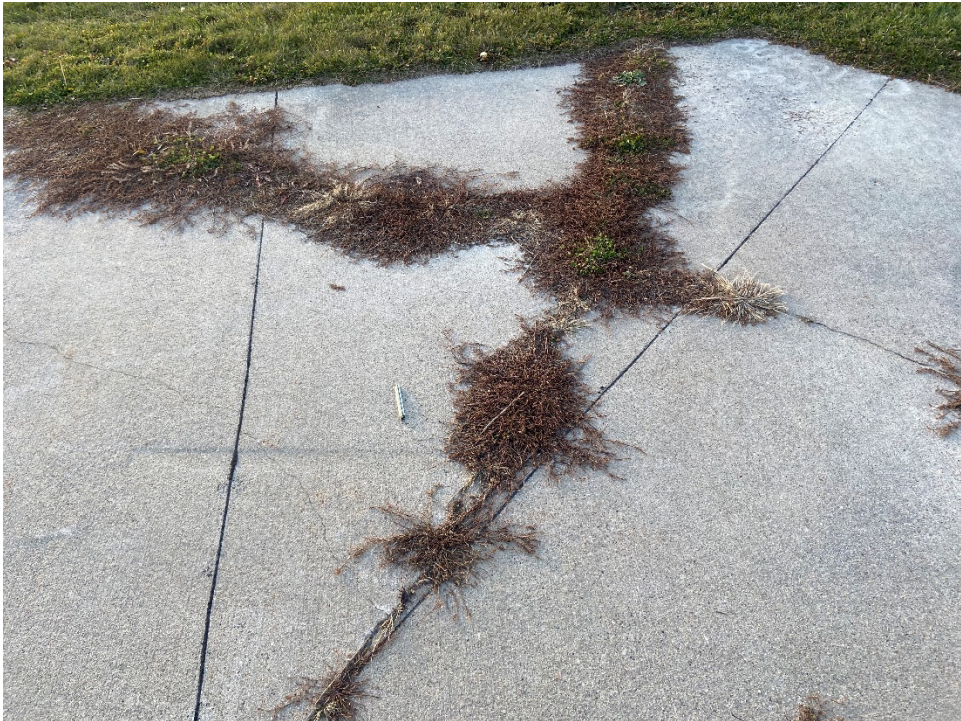
TH01MQ-03. Shattered Slab (Sample Unit No. 01).
