Maquoketa Municipal Airport

Pavement Management Report

JULY 2024

MAQUOKETA MUNICIPAL AIRPORT PAVEMENT MANAGEMENT REPORT

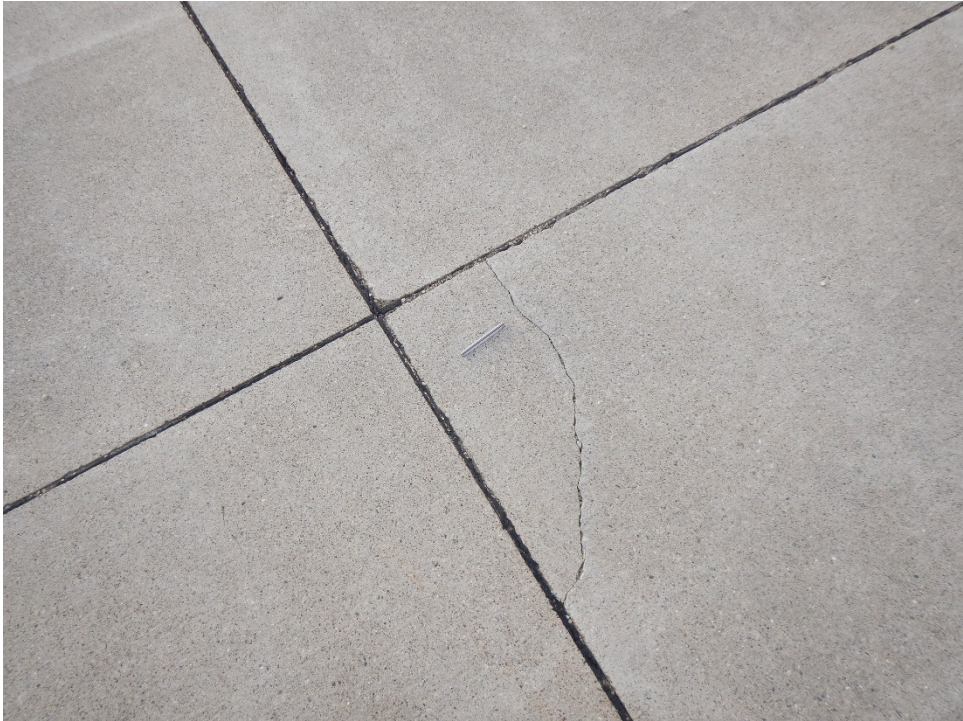
A01MQ-01. Corner Break (Sample Unit No. 09).

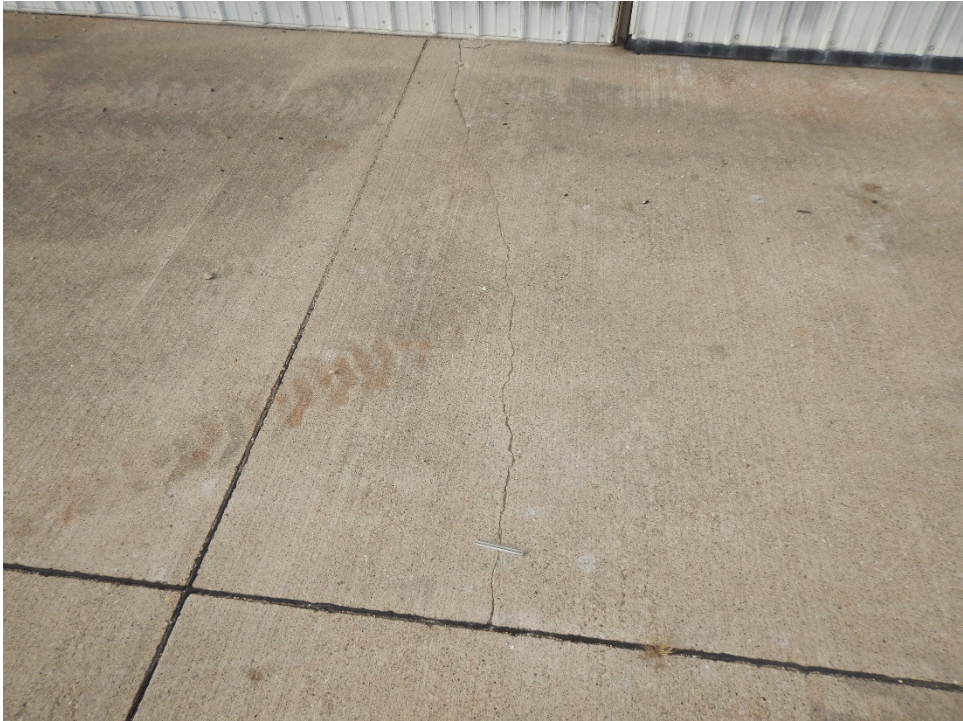
A01MQ-01. LTD Cracking (Sample Unit No. 11).

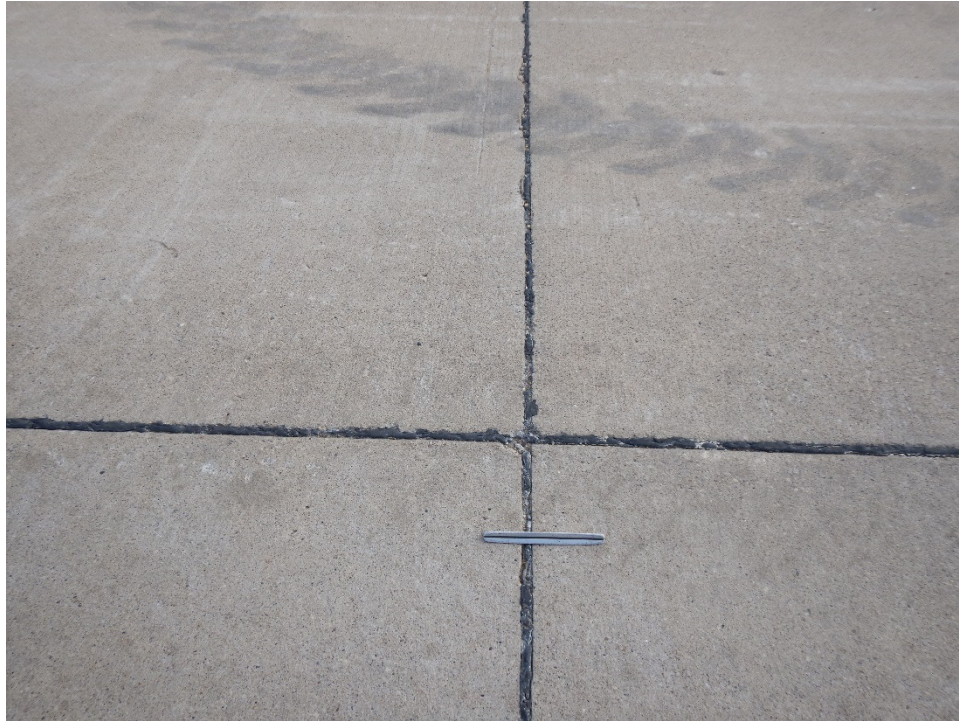
A01MQ-02. Joint Seal Damage (Sample Unit No. 07).

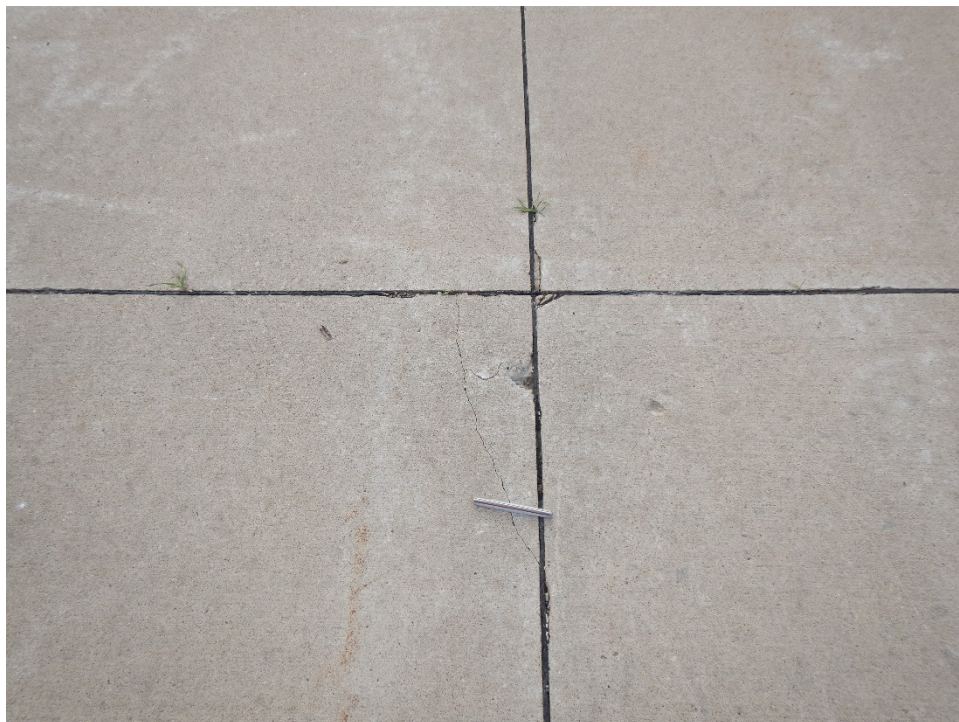
A01MQ-02. Joint Spalling (Sample Unit No. 02).

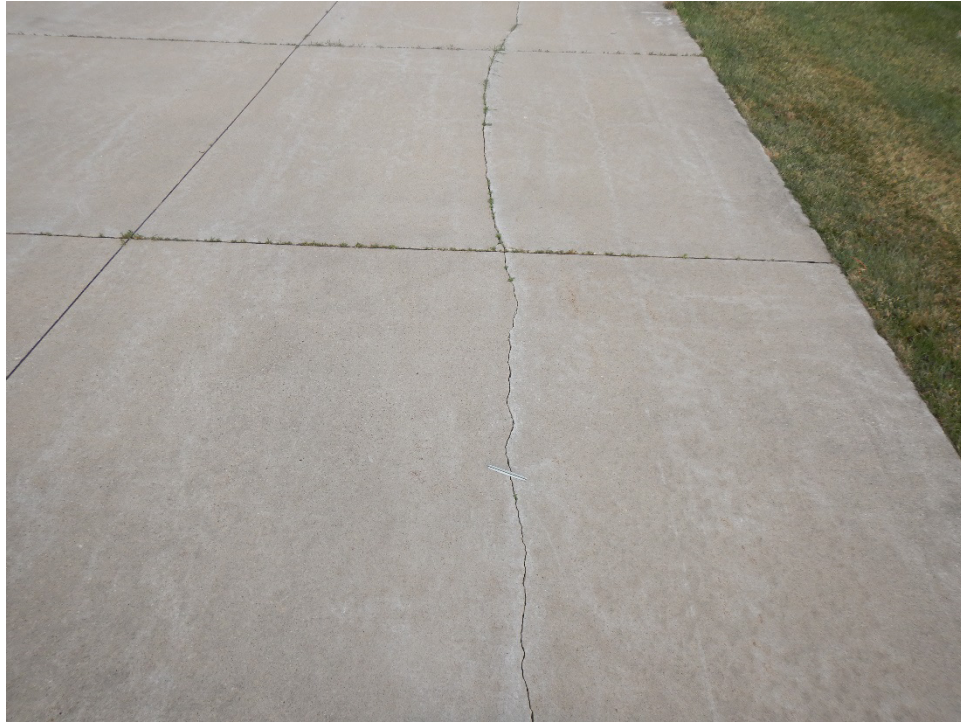
A01MQ-02. LTD Cracking (Additional Sample Unit No. 01).

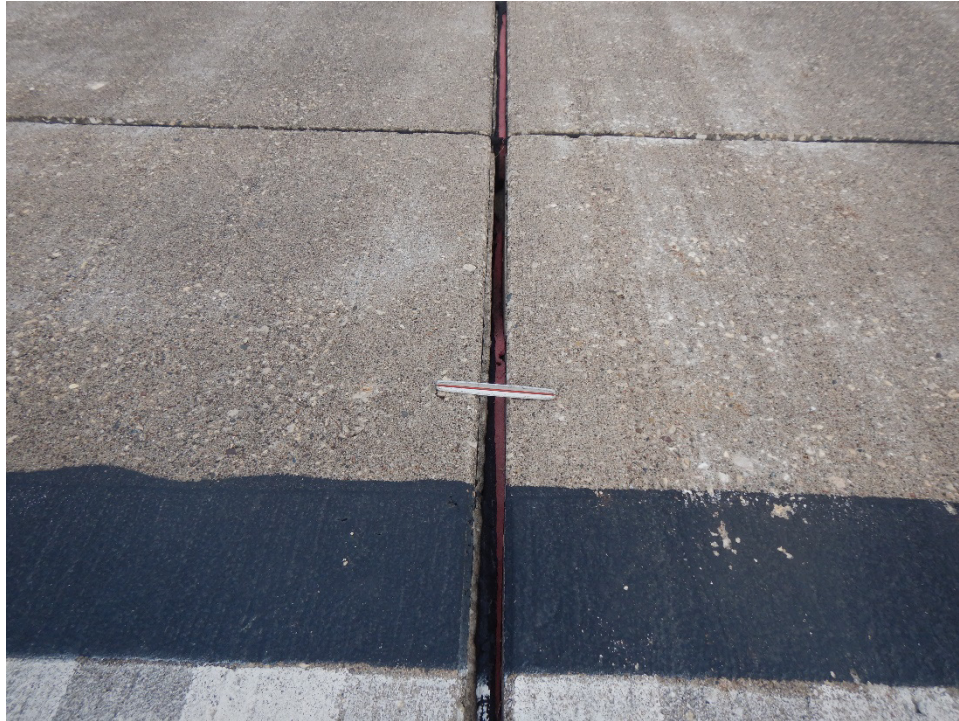
Runway 15/33 consisted of one section. Low-severity faulting, low- and medium-severity joint spalling, high-severity joint seal damage, all severities of small patching, and shrinkage cracking were recorded in Section 01.

R15MQ-01. Joint Seal Damage (Sample Unit No. 06).

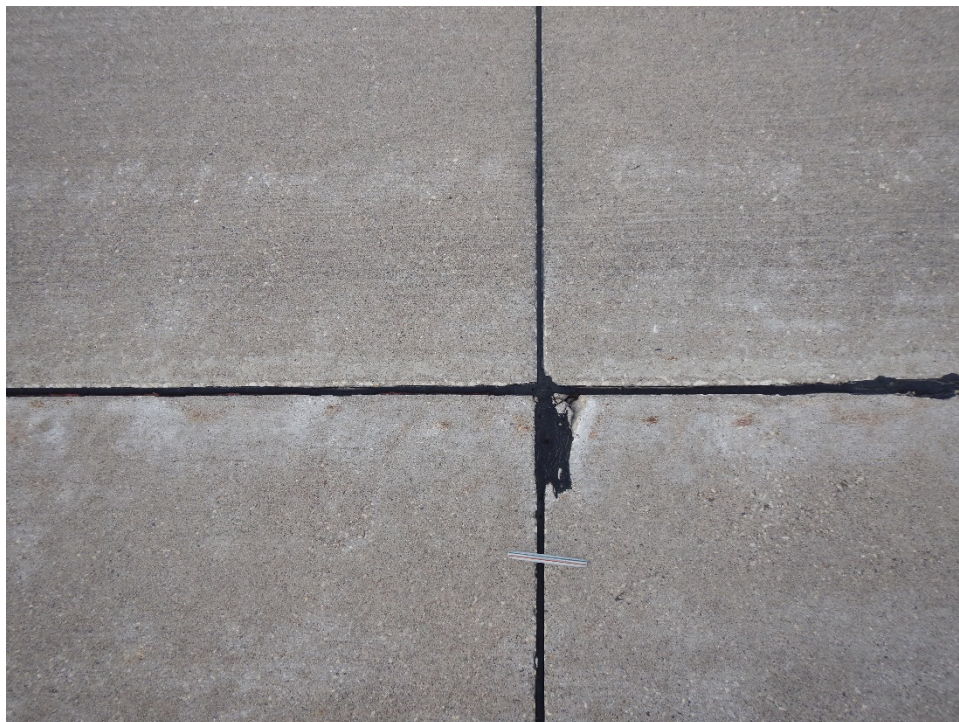
R15MQ-01. Joint Spalling (Sample Unit No. 33).

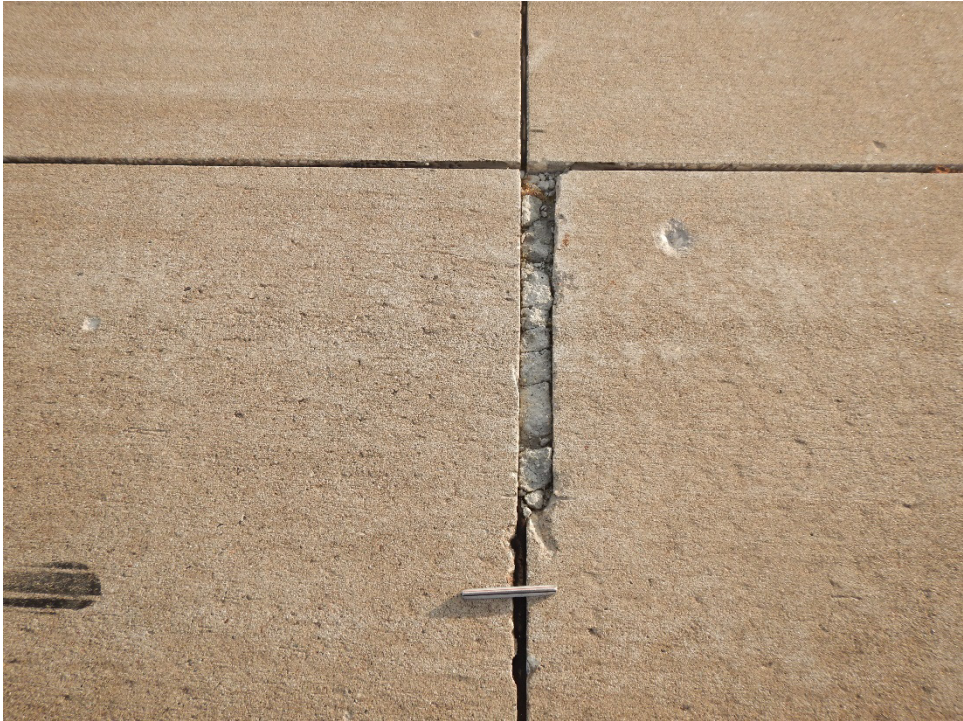
R15MQ-01. Small Patching (Sample Unit No. 60).

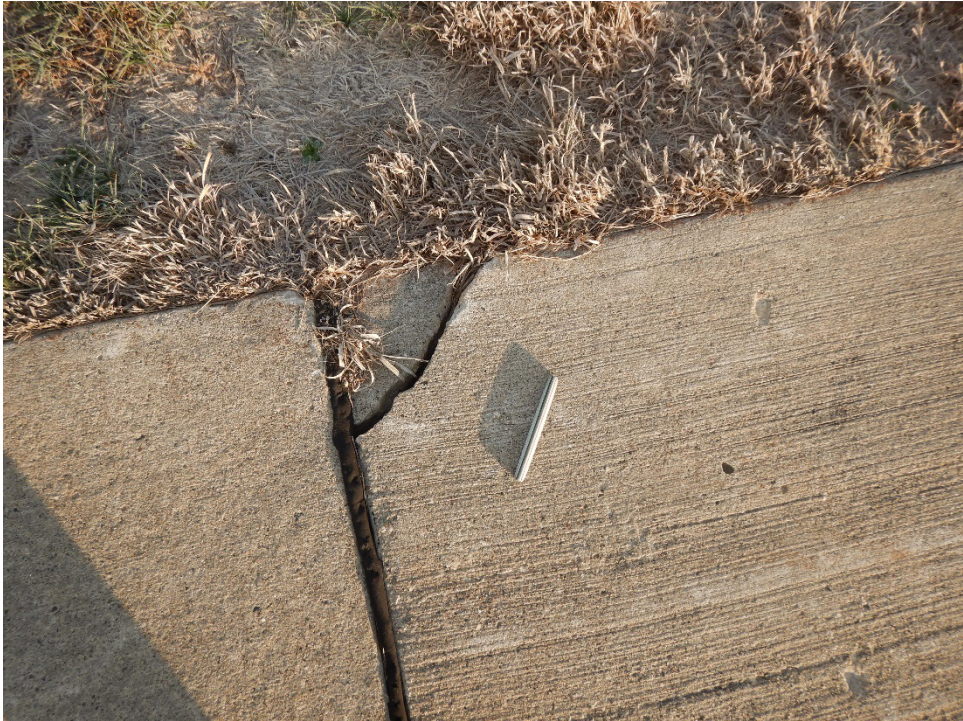
Taxiway 01 consisted of one section, located at the Runway 15 approach. Areas of low-severity LTD cracking, medium-severity corner spalling, and high-severity joint seal damage were identified in Section 01.

T01MQ-01. Corner Spalling (Sample Unit No. 05).

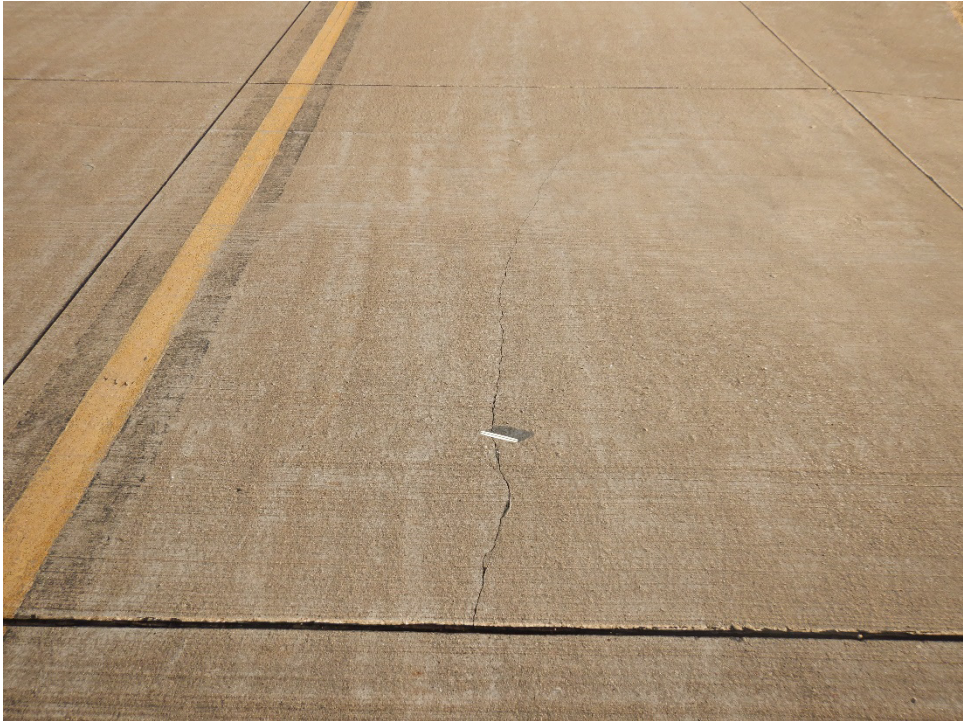
T01MQ-01. LTD Cracking (Sample Unit No. 02).

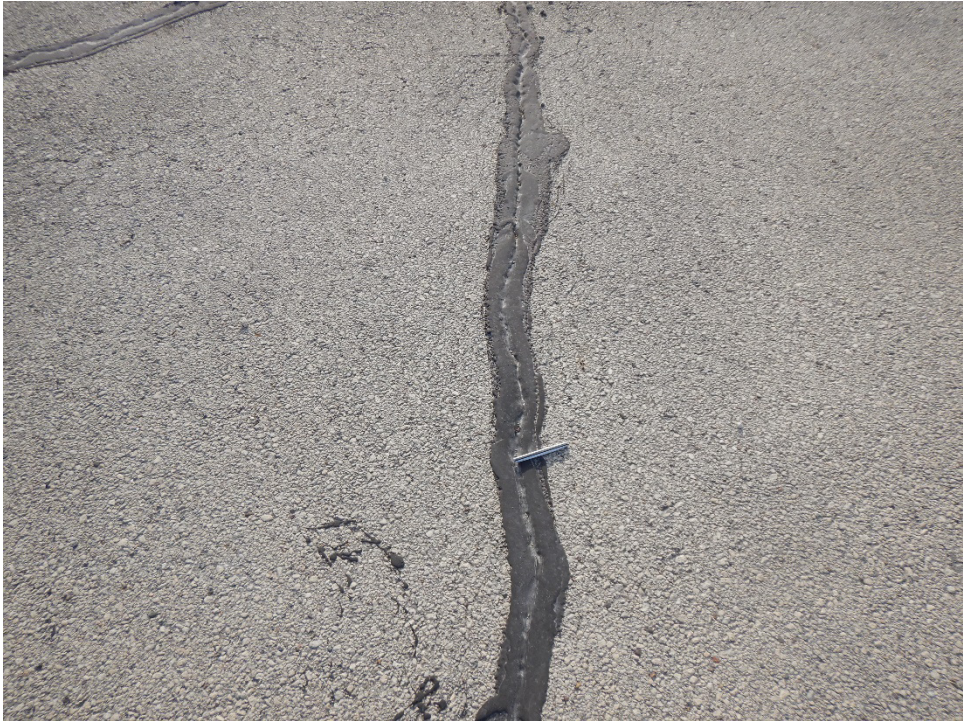
Taxiway 03 contained one section and connected Taxiway B to the T-hangar area. Low-severity L&T cracking and medium- and high-severity weathering were observed in Section 01. The low-severity L&T cracking was sealed.

T03MQ-01. L&T Cracking (Sample Unit No. 01).

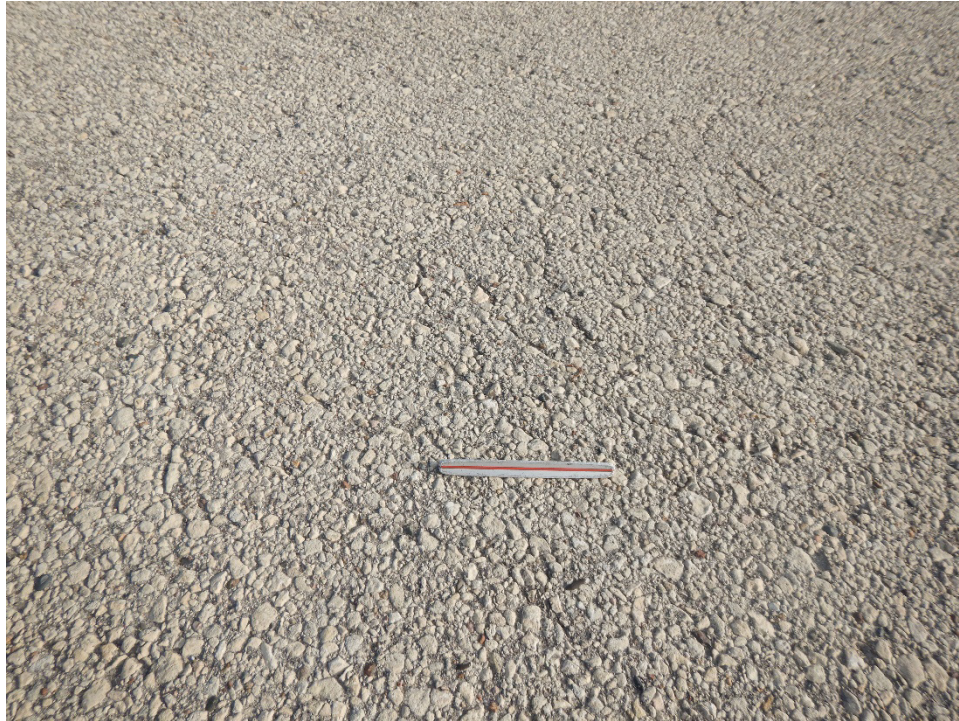
T03MQ-01. Weathering (Sample Unit No. 01).

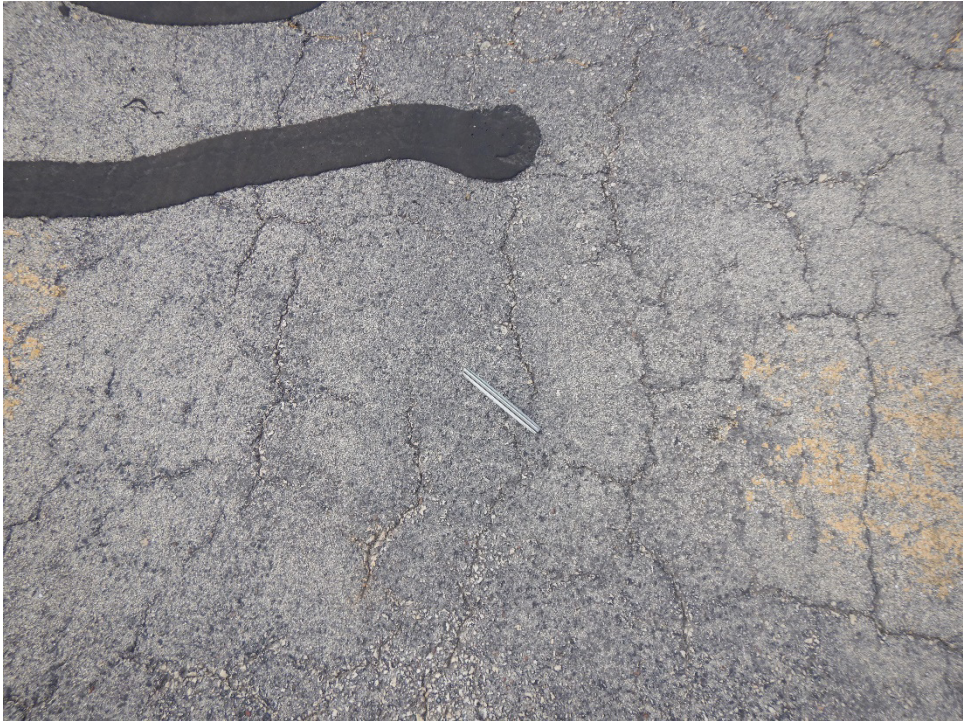
Taxiway A was defined by two sections that connected the apron area to Runway 15/33. Section 01 was in poor condition with low-severity swelling, medium-severity alligator cracking, and high-severity raveling observed. The high-severity raveling was recorded where the surface treatment had raveled away. Section 02 contained areas of low-severity longitudinal and transverse (L&T) cracking and swelling, medium-severity alligator cracking, and medium- and high-severity weathering. The low-severity L&T cracking was sealed.

TAMQ-01. Alligator Cracking (Sample Unit No. 01).

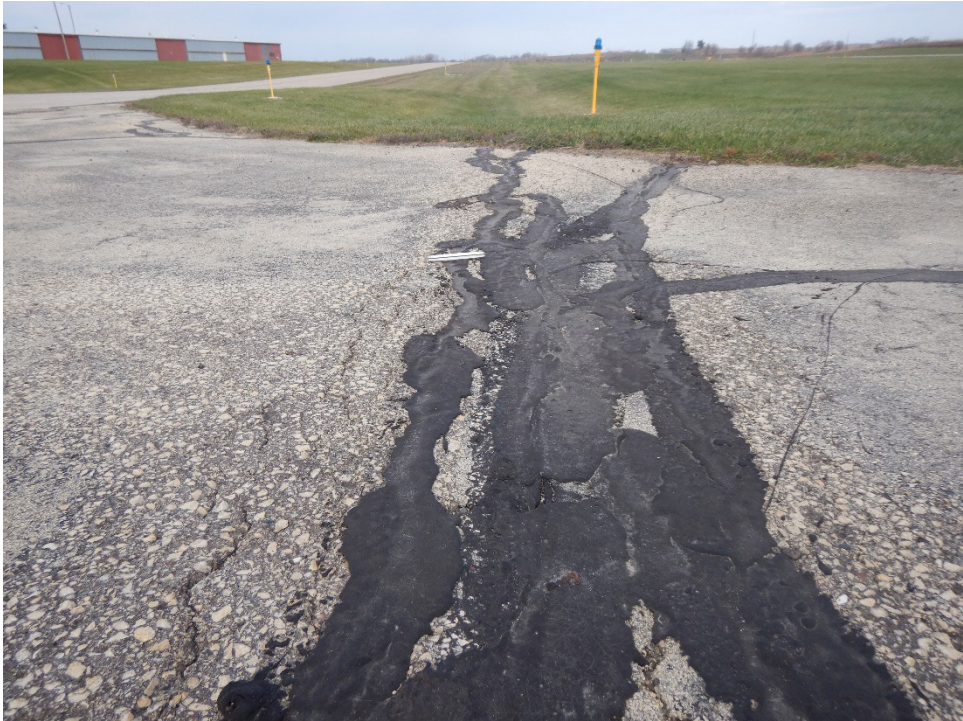
TAMQ-01. Swelling (Sample Unit No. 01).

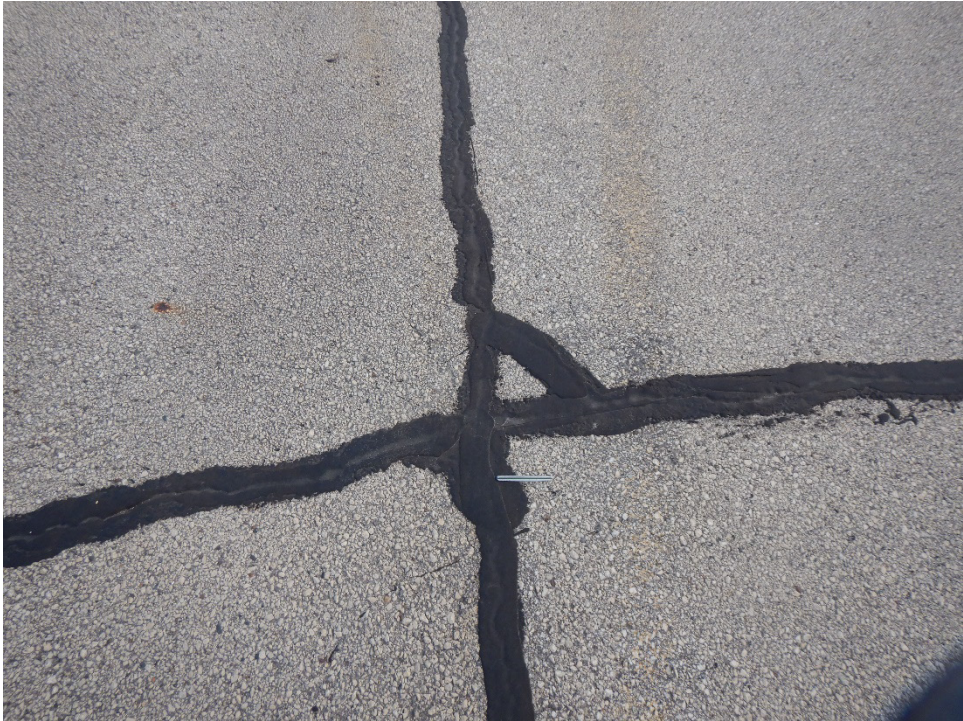
TAMQ-02. L&T Cracking (Sample Unit No. 01).

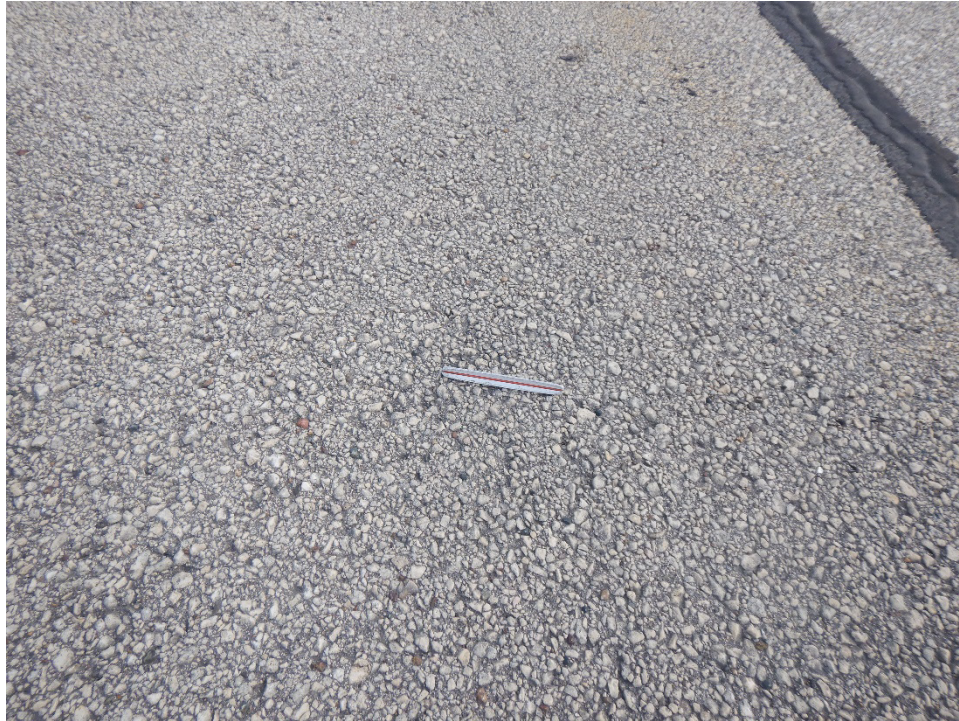
TAMQ-02. Weathering (Sample Unit No. 01).

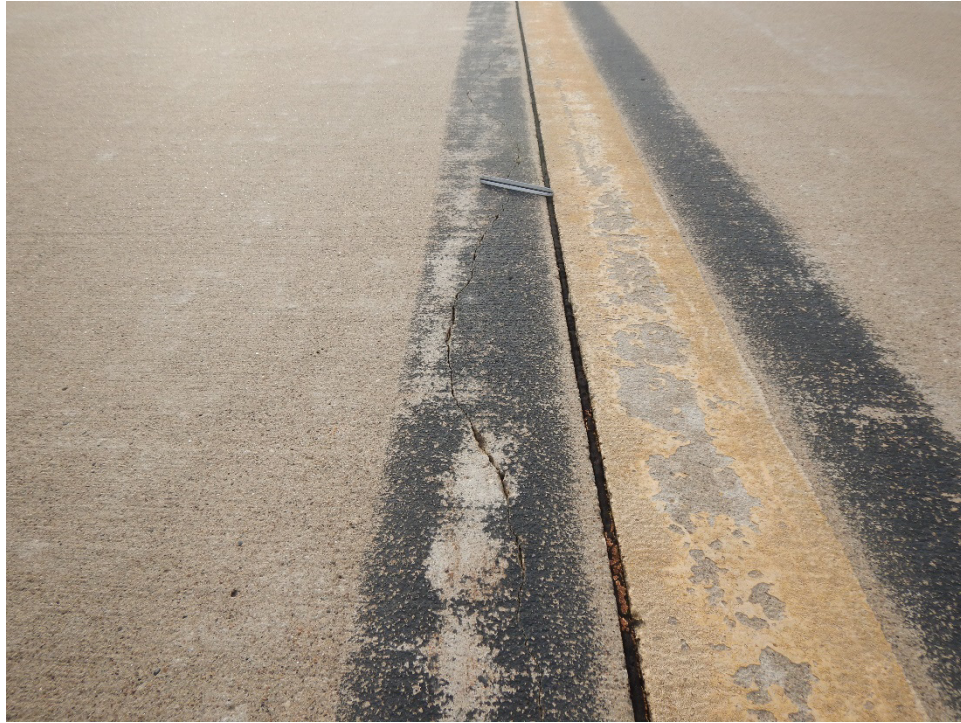
Taxiway B contained two sections that connected the apron area to the Runway 33 approach. Low-severity corner break, corner spalling, faulting, and shattered slab; low- and medium-severity joint spalling and longitudinal, transverse, and diagonal (LTD) cracking; and high-severity joint seal damage were observed in Section 01. Areas of medium-severity corner spalling and joint spalling, high-severity joint seal damage, and shrinkage cracking were recorded in Section 02.

TBMQ-01. Joint Spalling (Sample Unit No. 01).

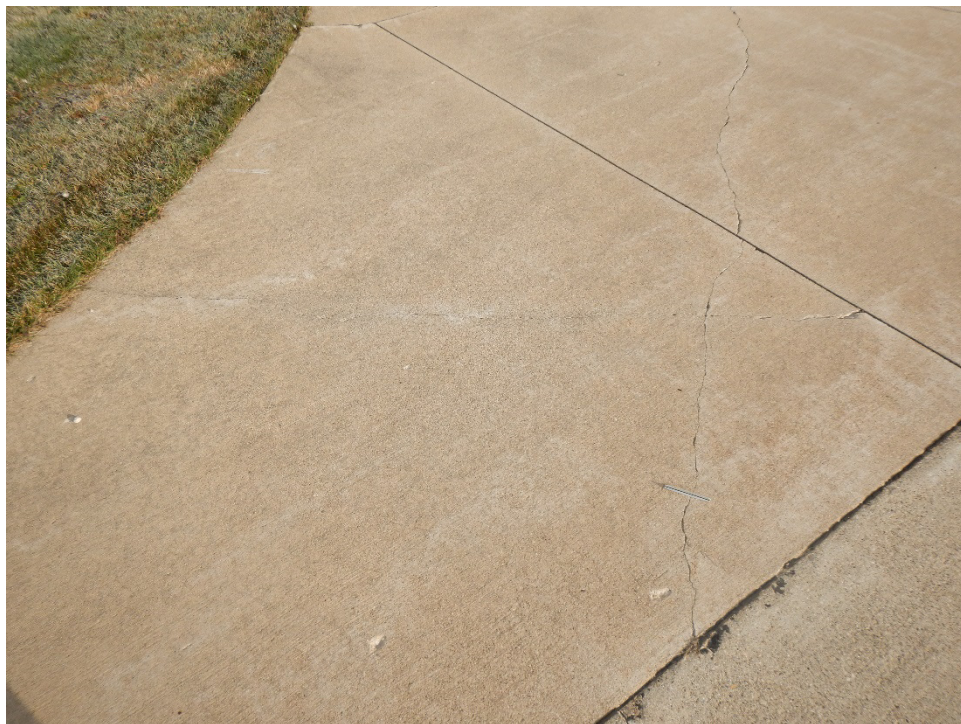
TBMQ-01. Shattered Slab (Sample Unit No. 01).

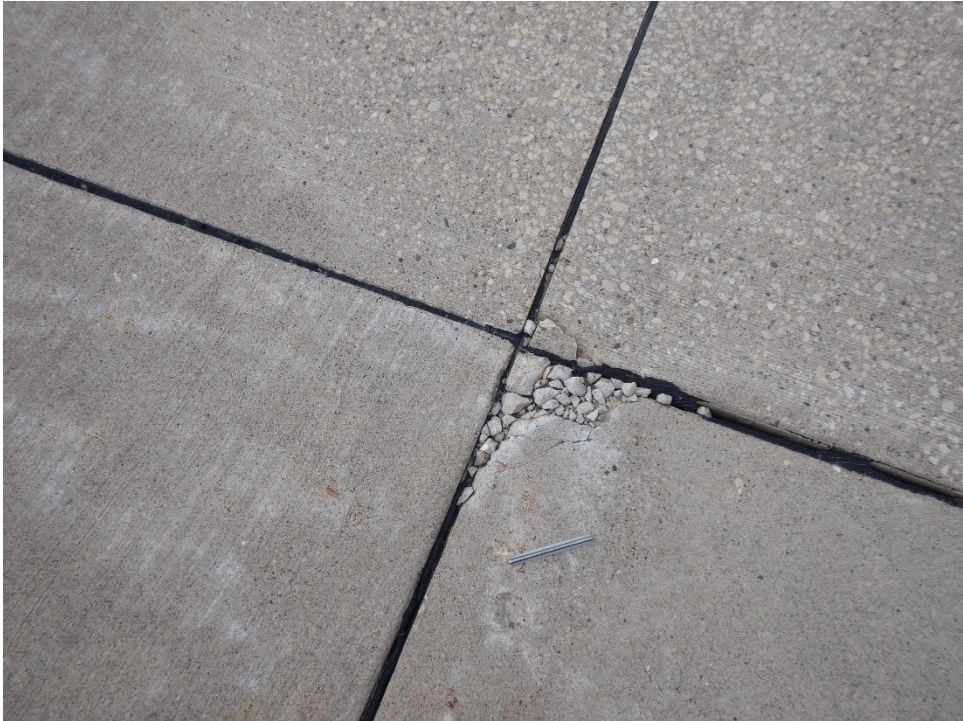
TBMQ-02. Corner Spalling (Sample Unit No. 03).

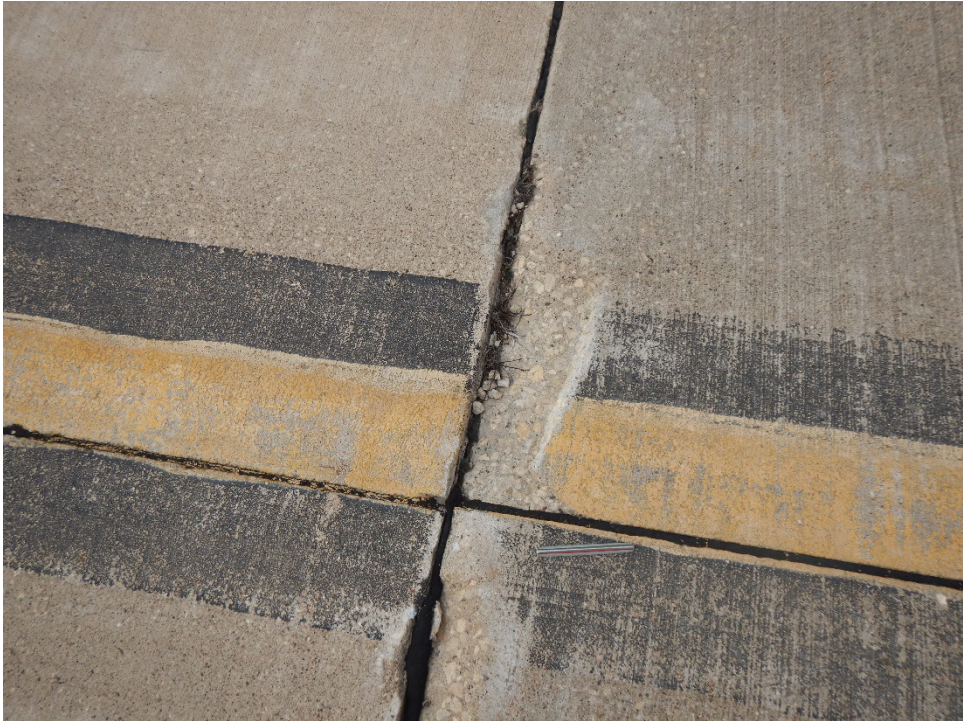
TBMQ-02. Joint Spalling (Sample Unit No. 05).

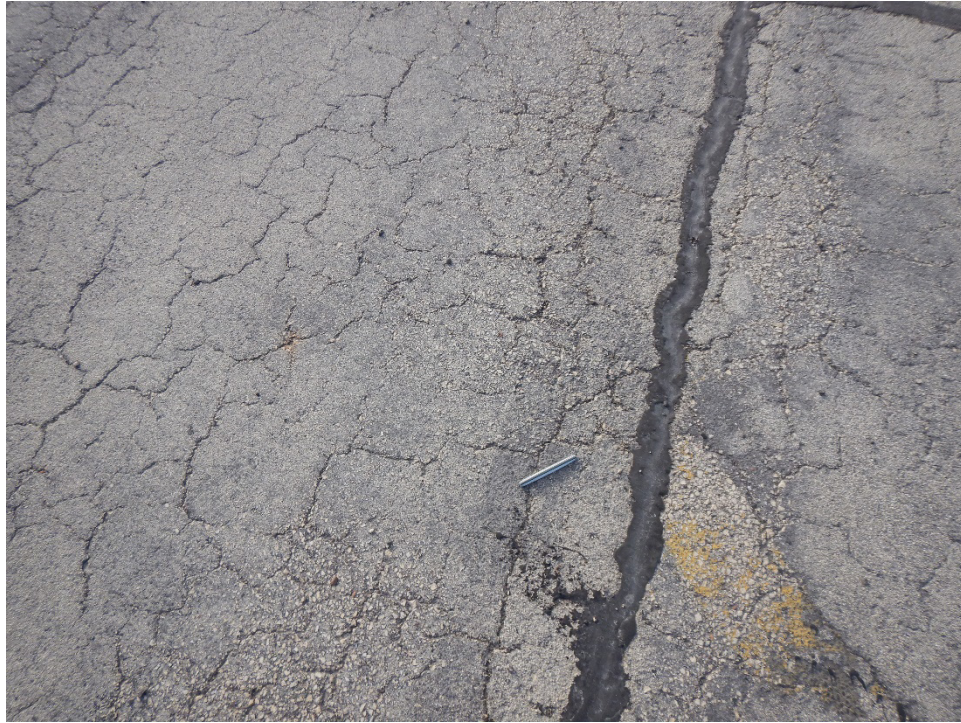
The T-hangar area contained three sections. Section 01 was in poor condition with medium-severity alligator cracking and high-severity raveling and weathering. The high-severity raveling and weathering were due to the loss of the surface treatment. Section 02 was also in poor condition with areas of low-severity shattered slab; low- and medium-severity corner break, joint spalling, and LTD cracking; and high-severity joint seal damage. Section 03 contained areas of low-severity corner spalling; low- and medium-severity corner break, joint spalling, LTD cracking, and shattered slab; medium-severity faulting; and high-severity joint seal damage.

TH01MQ-01. Alligator Cracking (Sample Unit No. 01).

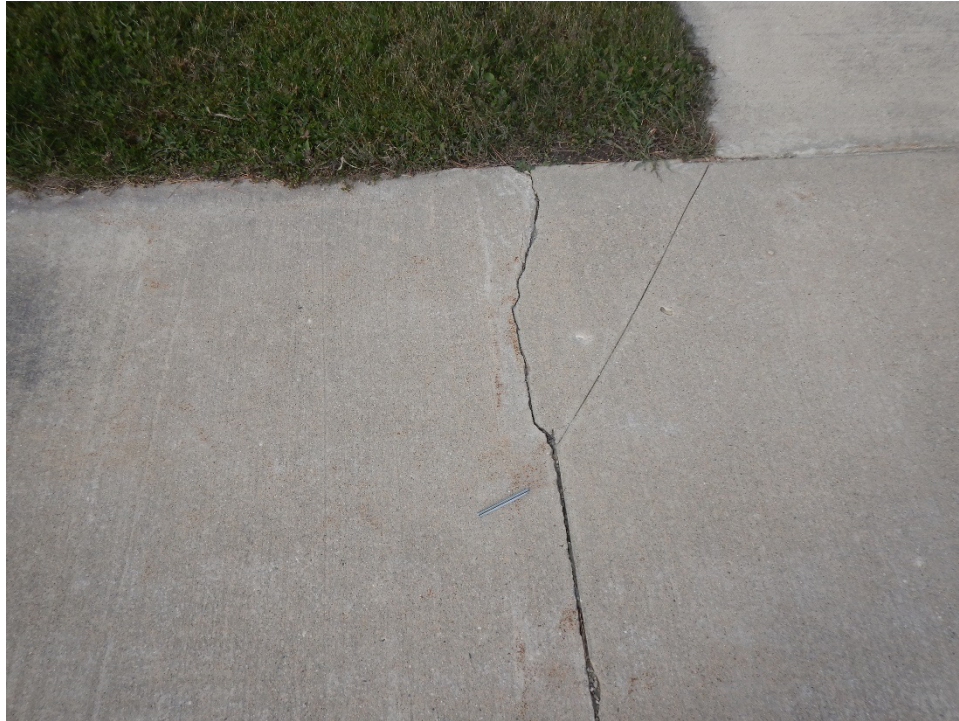
TH01MQ-02. Corner Break (Sample Unit No. 01).

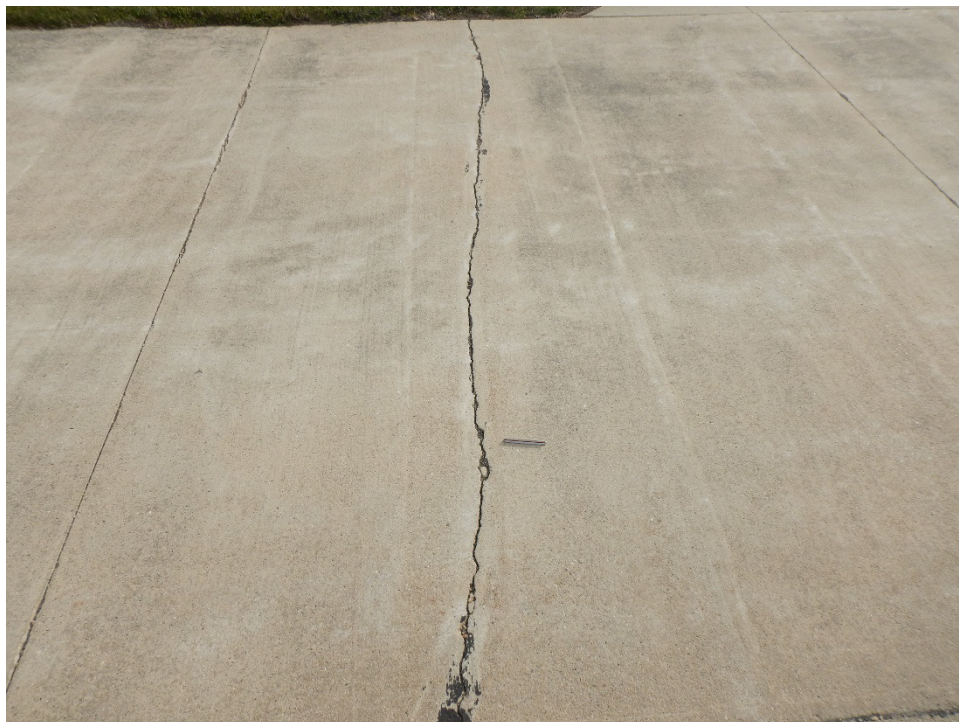
TH01MQ-02. LTD Cracking (Sample Unit No. 02).

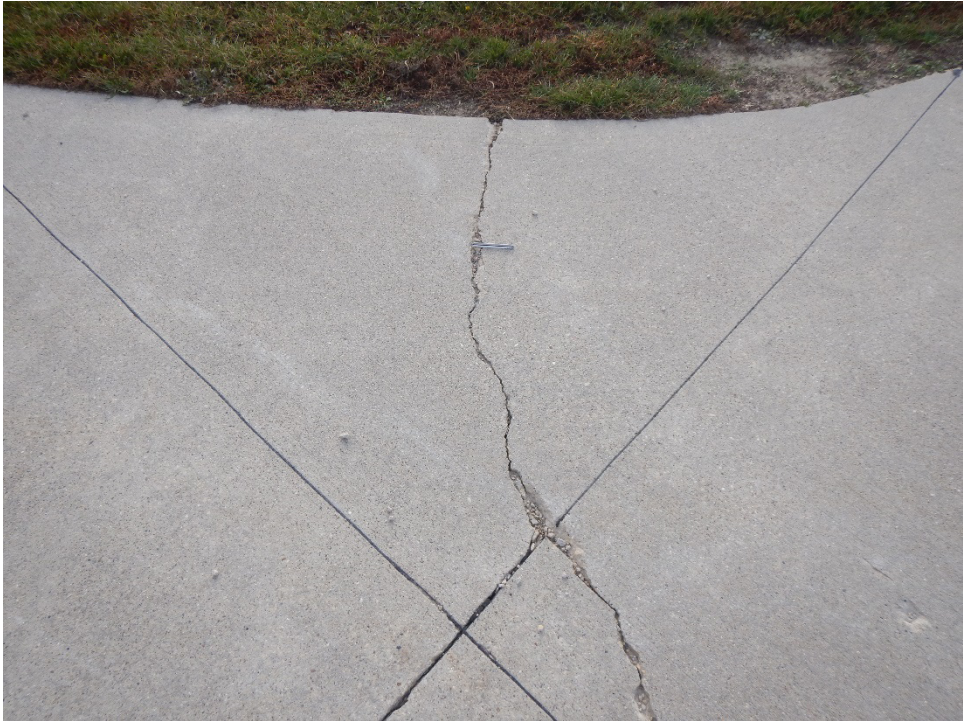
TH01MQ-03. LTD Cracking (Sample Unit No. 02).

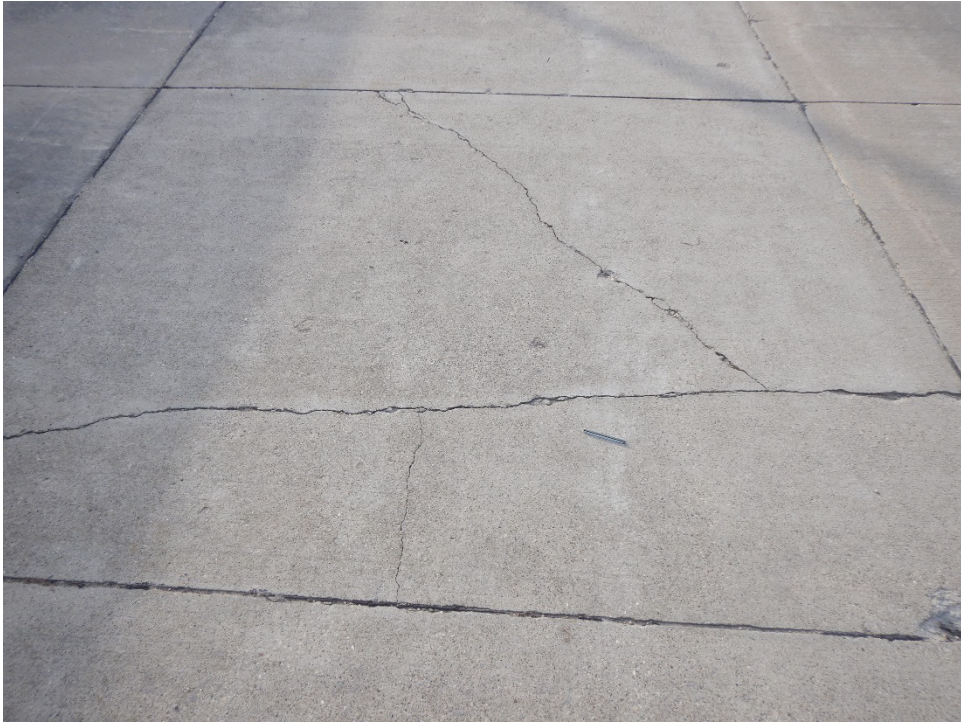
TH01MQ-03. Shattered Slab (Sample Unit No. 03).
