Monticello Regional Airport

PAVEMENT MANAGEMENT REPORT

JULY 2021

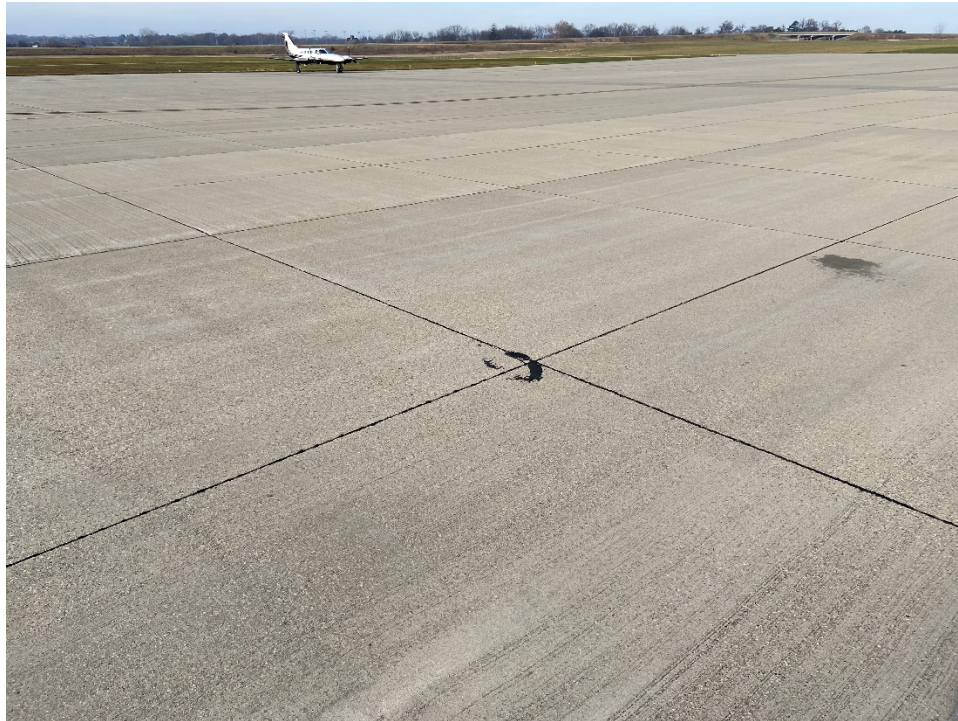
The apron area contained one section. Low-severity large patching; low- and medium-severity corner spalling, faulting, joint spalling, and LTD cracking; medium-severity corner break; high-severity joint seal damage; and shrinkage cracking were observed in Section 01.

A01MO-01. Overview.

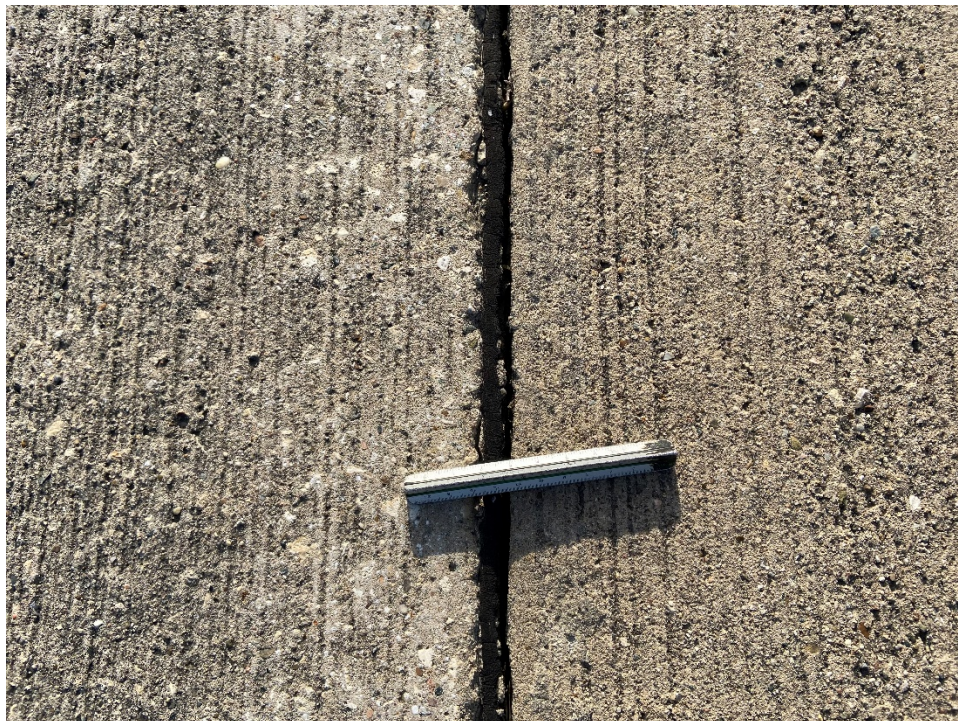
A01MO-01. Joint Seal Damage (Sample Unit No. 36).

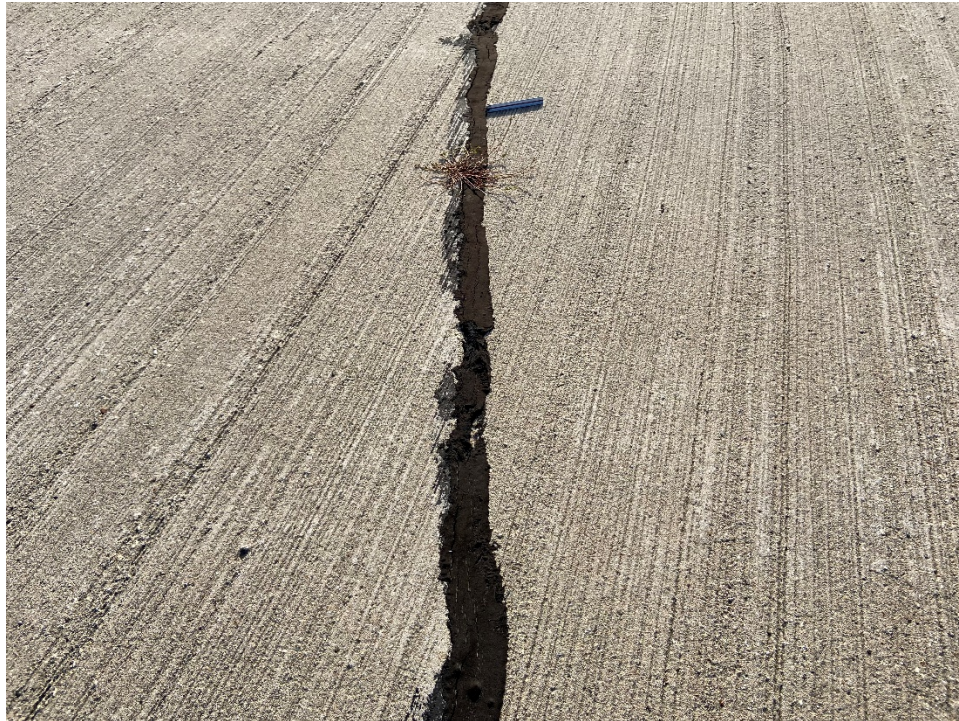
A01MO-01. LTD Cracking (Sample Unit No. 44).

Sample Number:	44	Type:	R	Area:	20.00Slabs	PCI =	65
Sample Comments:							
65	JOINT SEAL DAMAGE			H	20.00 Slabs	Comments:	
63	LINEAR CRACKING			L	3.00 Slabs	Comments:	
67	LARGE PATCH/UTILITY			L	1.00 Slabs	Comments:	
63	LINEAR CRACKING			M	1.00 Slabs	Comments:	
71	FAULTING			L	3.00 Slabs	Comments:

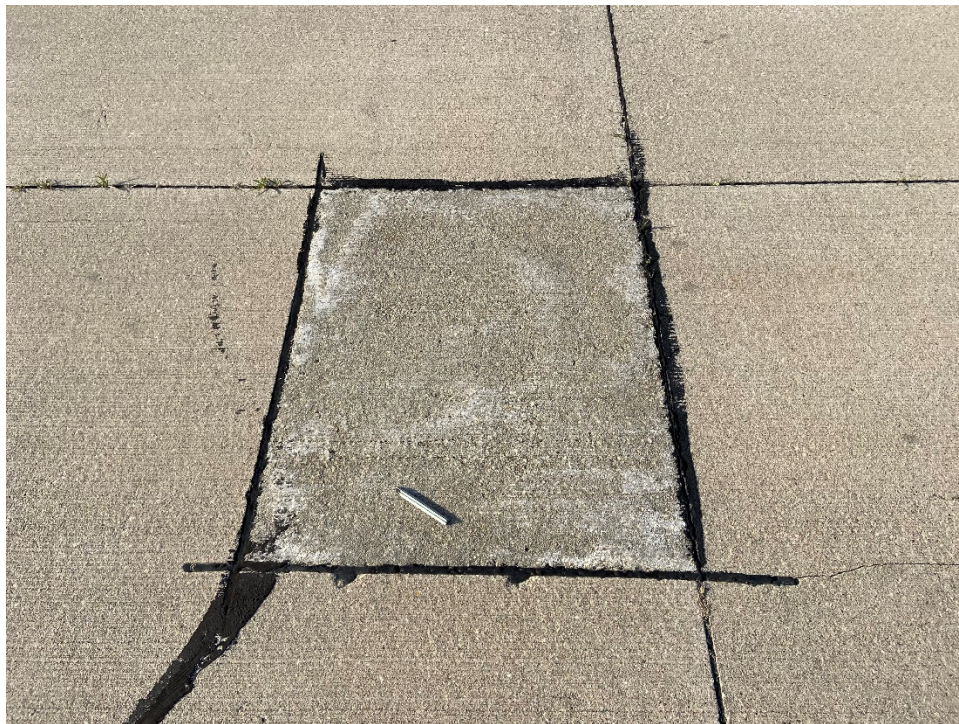
A01MO-01. Large Patching (Sample Unit No. 44).

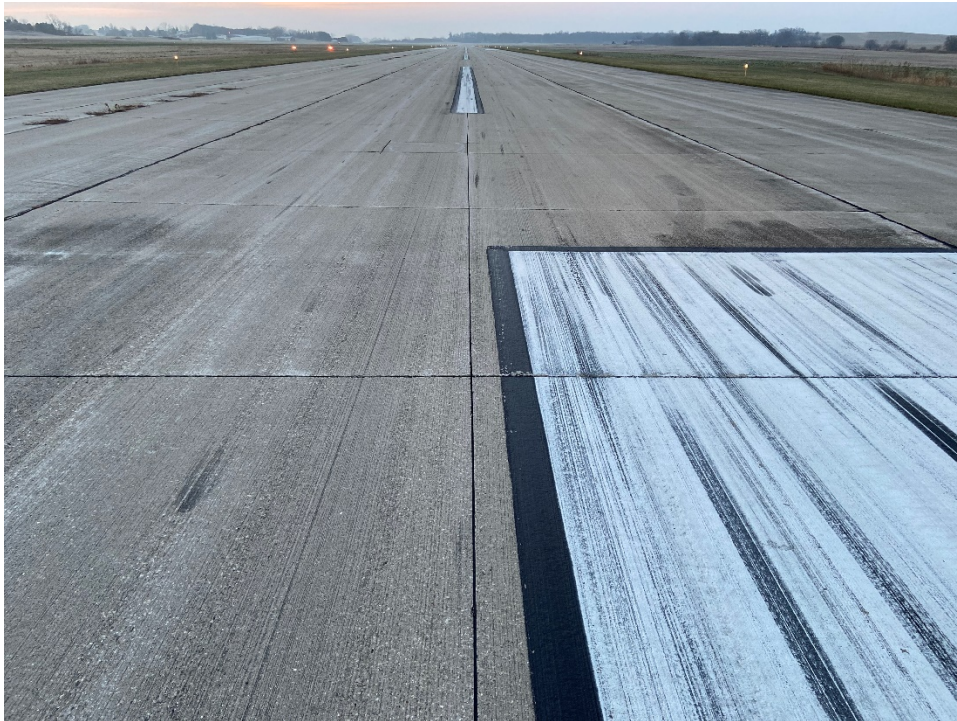
Runway 15/33 was defined by one section. Section 01 had low-severity large patching; low- and medium-severity corner spalling and joint spalling; high-severity joint seal damage; and medium-severity longitudinal, transverse, and diagonal (LTD) cracking recorded throughout.

R15MO-01. Overview.

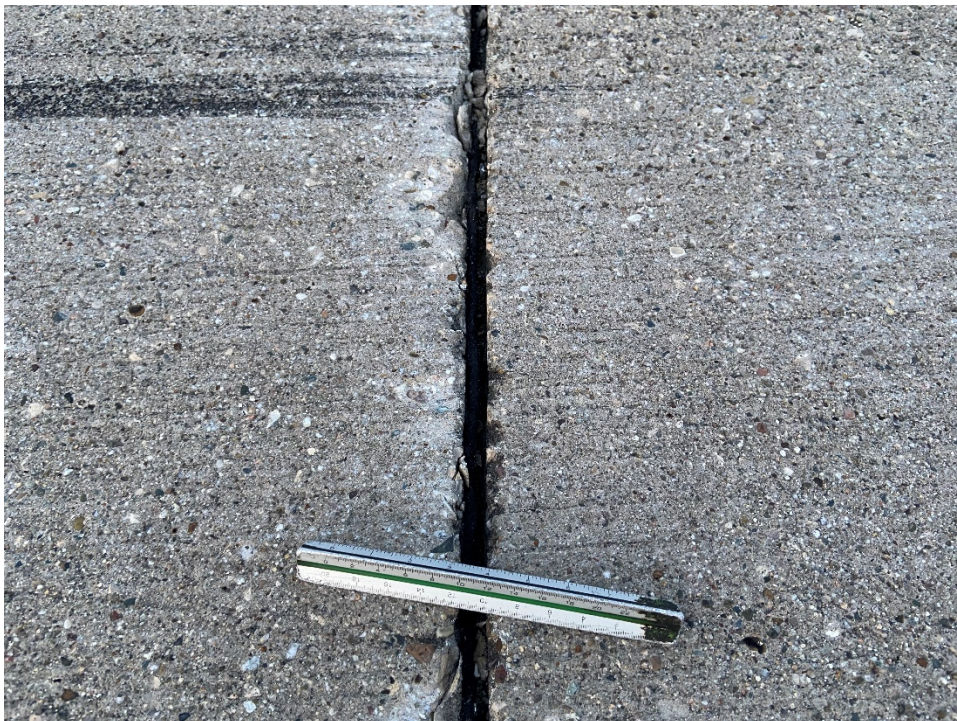
R15MO-01. Joint Seal Damage (Sample Unit No. 05).

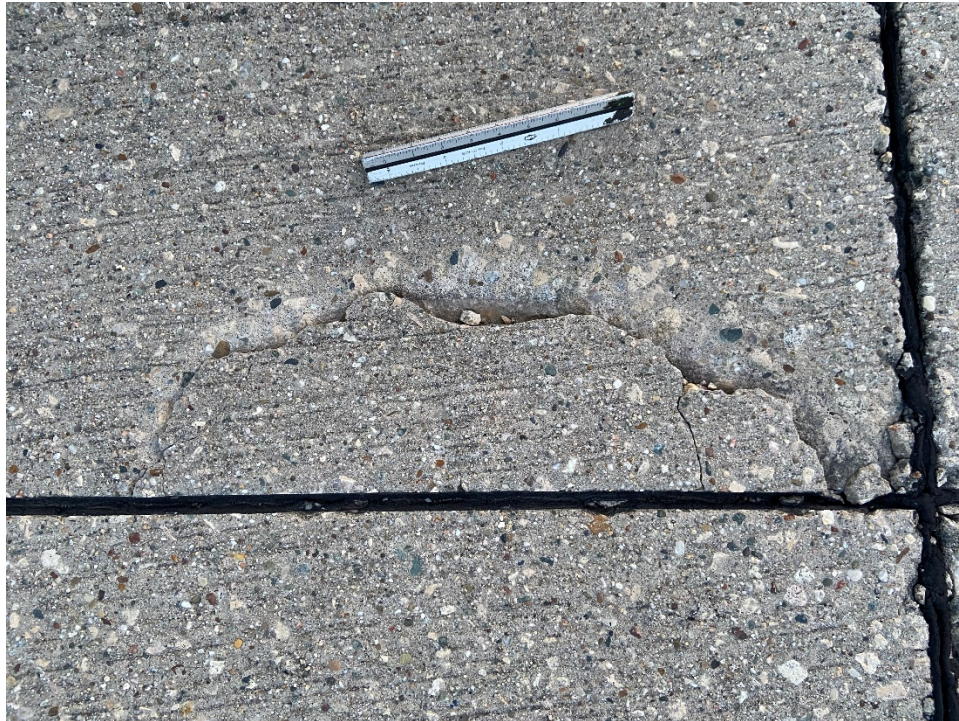
R15MO-01. Joint Spalling (Sample Unit No. 05).

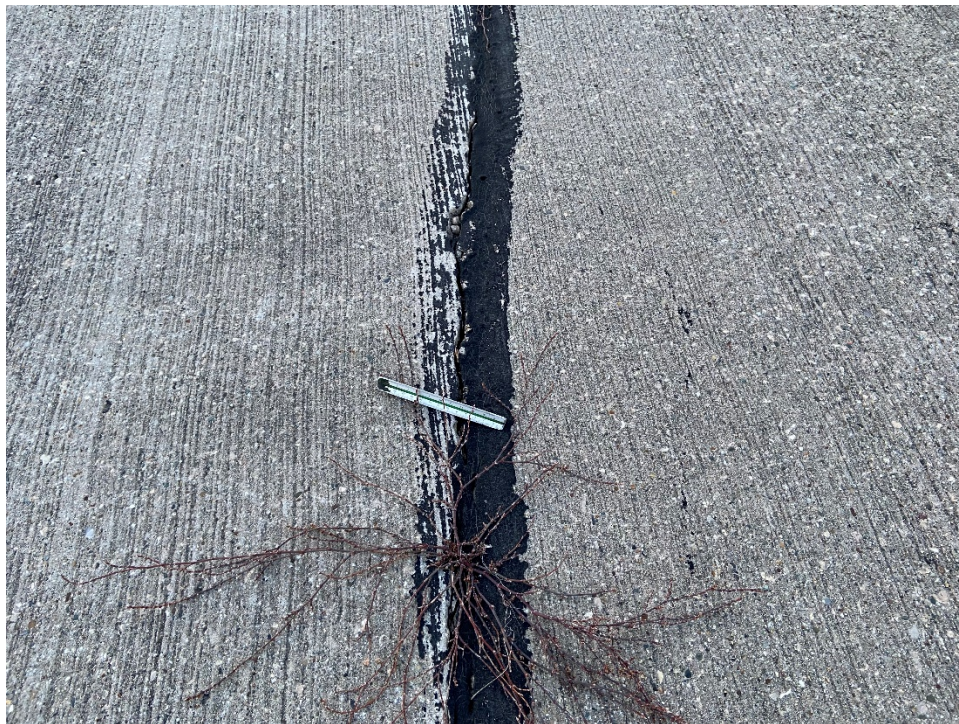
R15MO-01. LTD Cracking (Sample Unit No. 05).

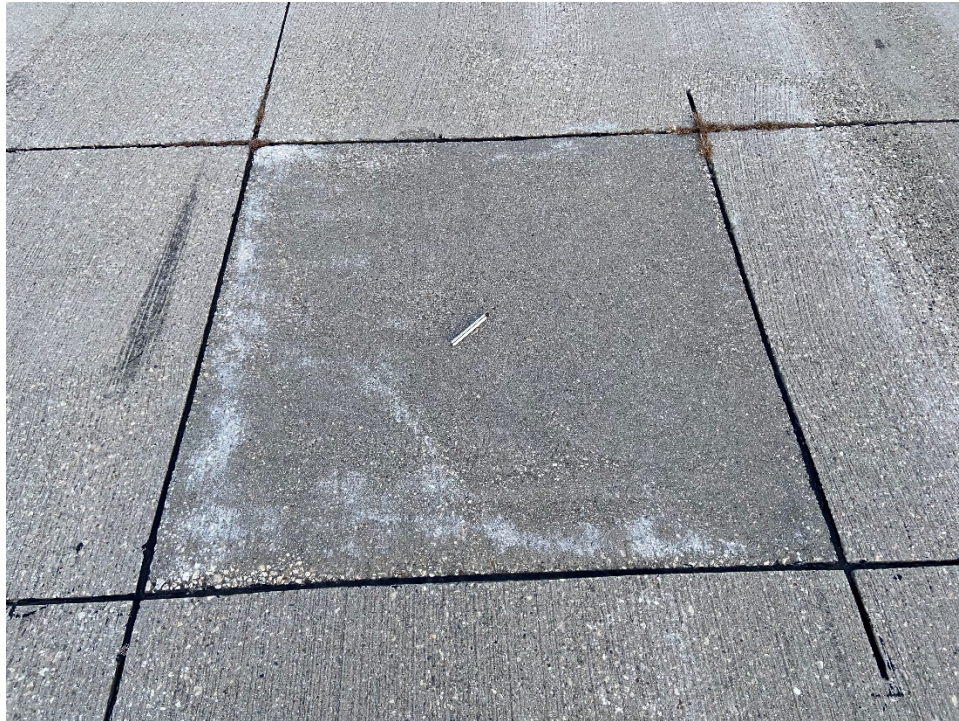
R15MO-01. Large Patching (Sample Unit No. 05).

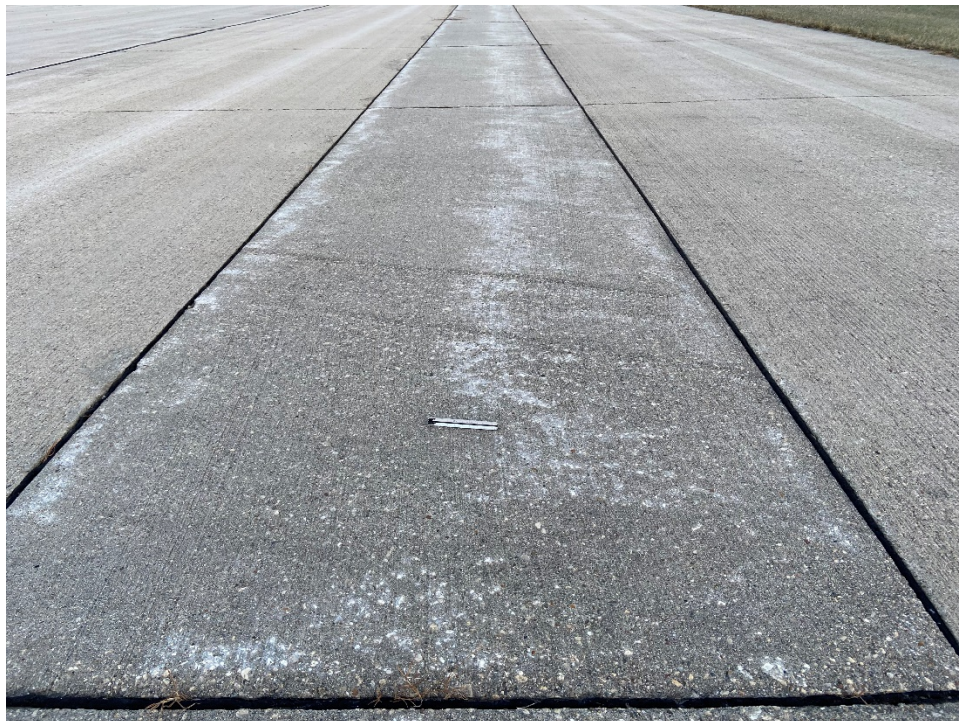
R15MO-01. Large Patching (Sample Unit No. 35).

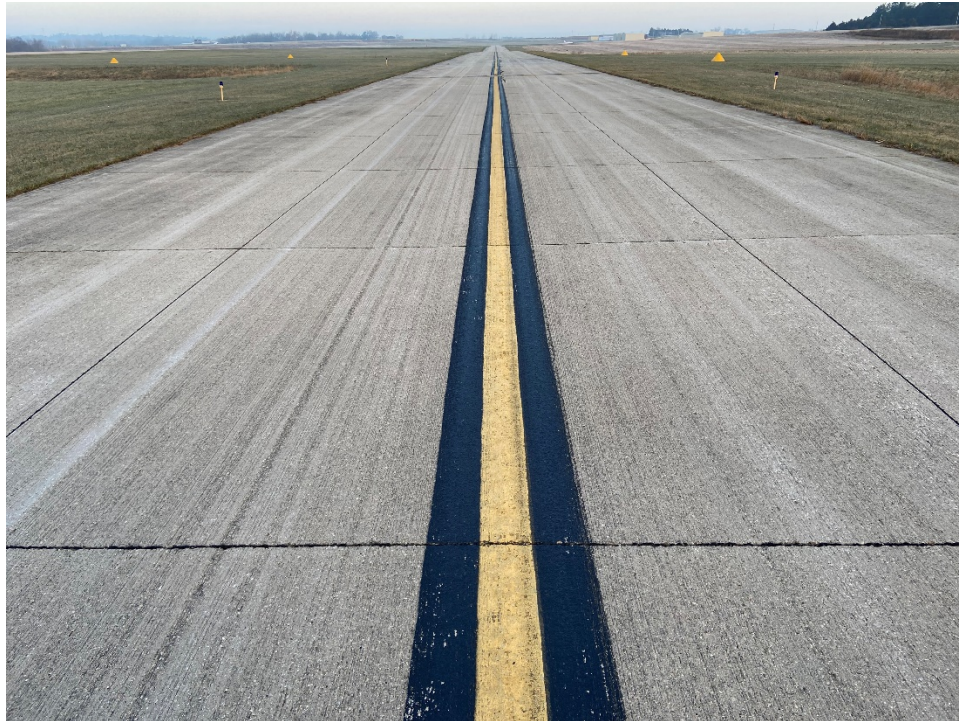
Taxiway 01 consisted of one section with low-severity small patching and large patching; low- and medium-severity LTD cracking; high-severity joint seal damage; and shrinkage cracking identified at the time of inspection.

T01MO-01. Overview.

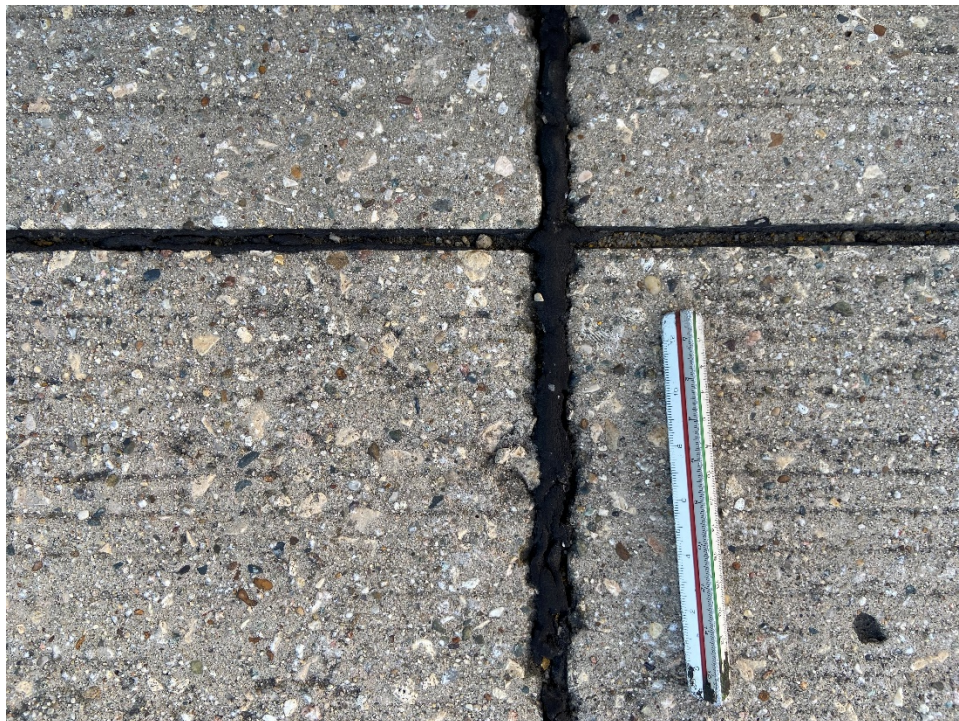
T01MO-01. Joint Seal Damage (Sample Unit No. 48).

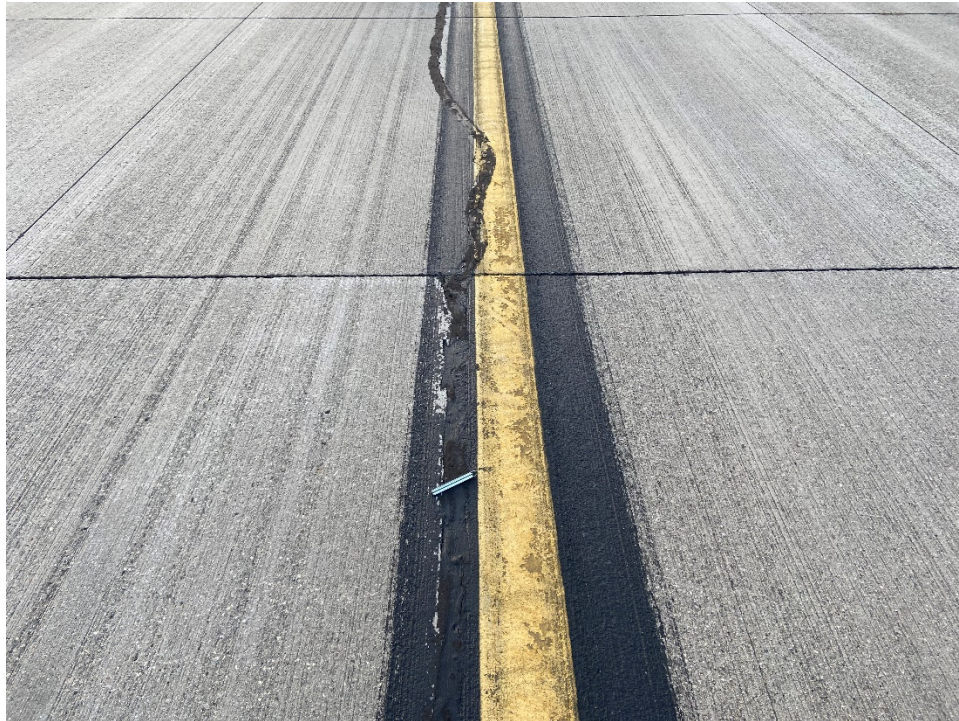
T01MO-01. LTD Cracking (Sample Unit No. 48).

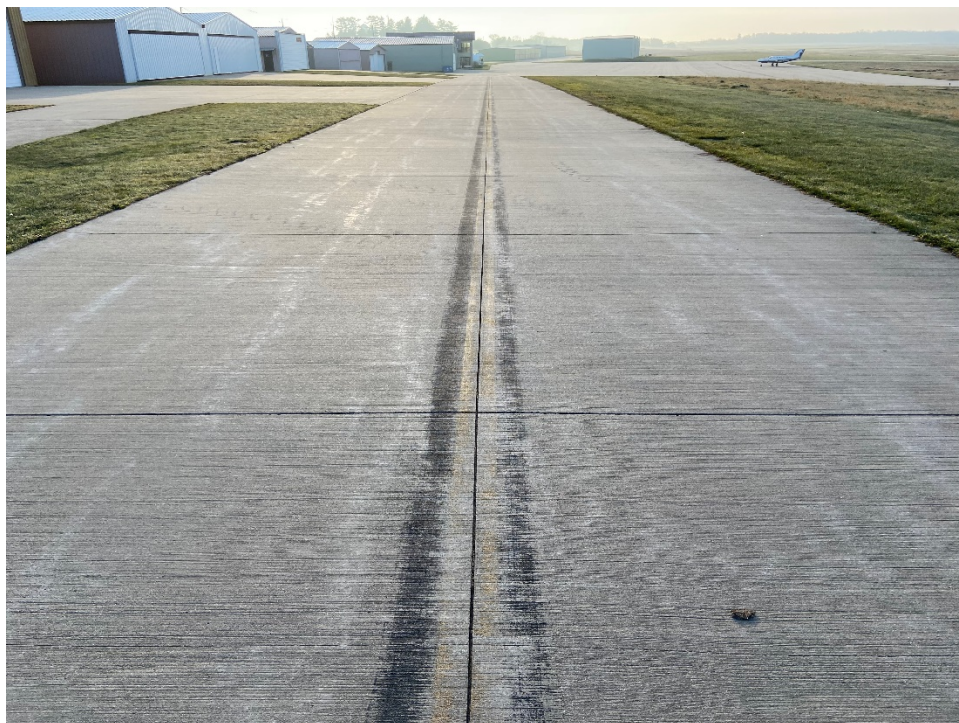
TH01MO-01. Overview.

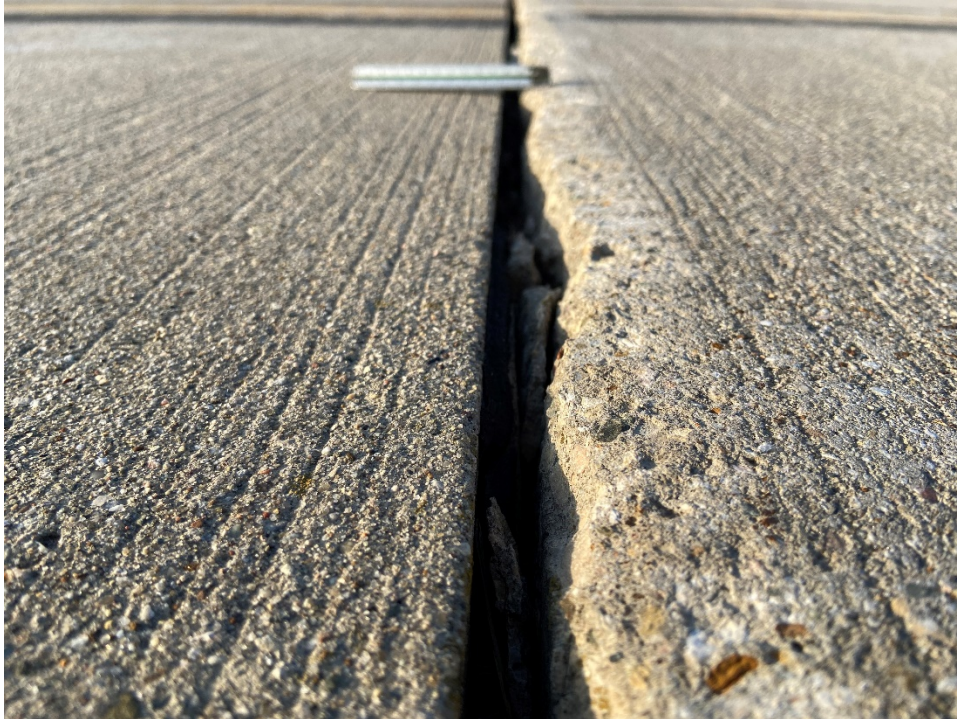
TH01MO-01. Faulting (Sample Unit No. 01).

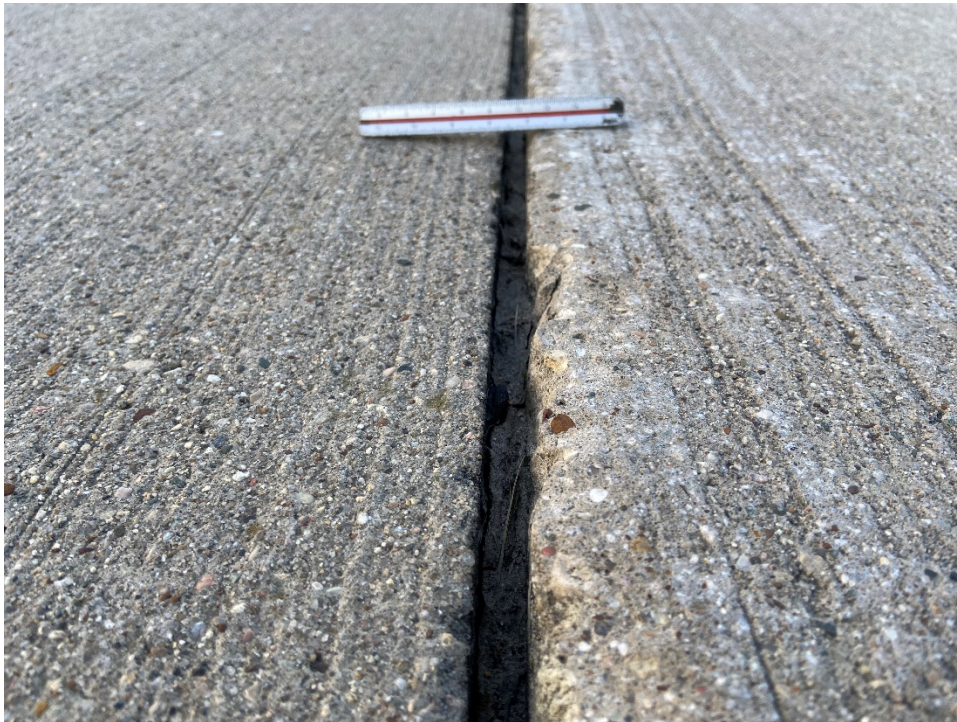
TH01MO-01. Faulting (Sample Unit No. 02).

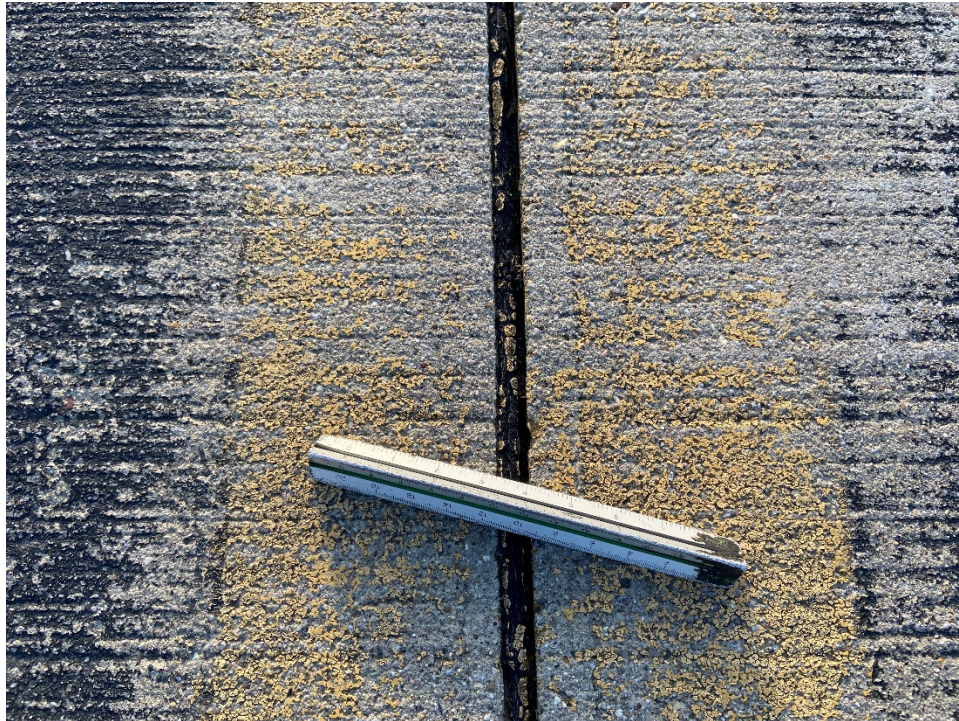
TH01MO-01. Joint Seal Damage (Sample Unit No. 01) (1).

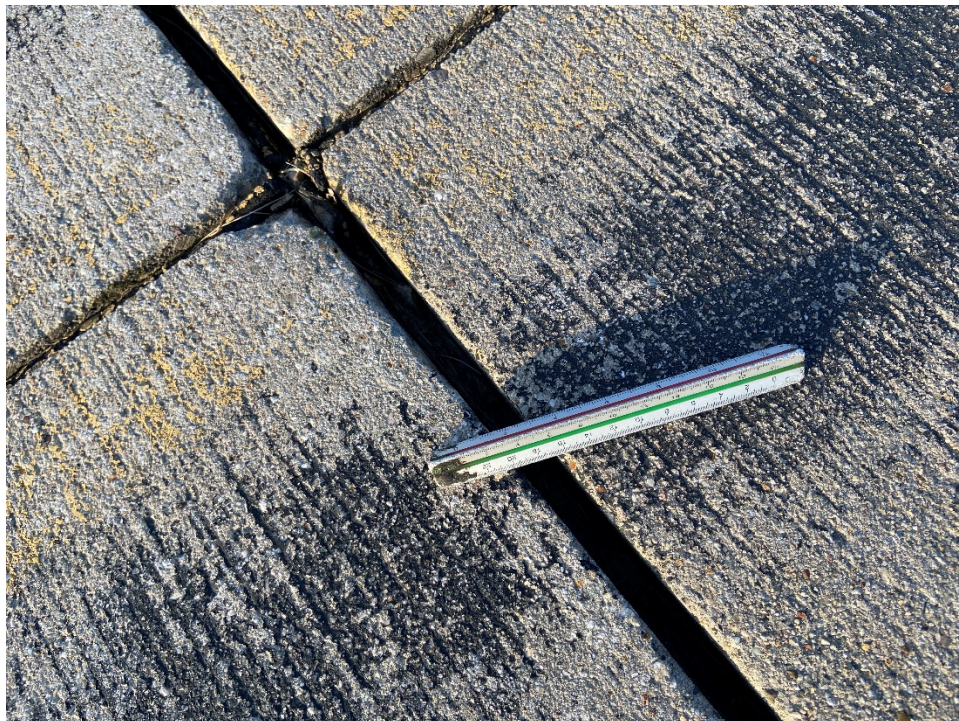
TH01MO-01. Joint Seal Damage (Sample Unit No. 01) (2).

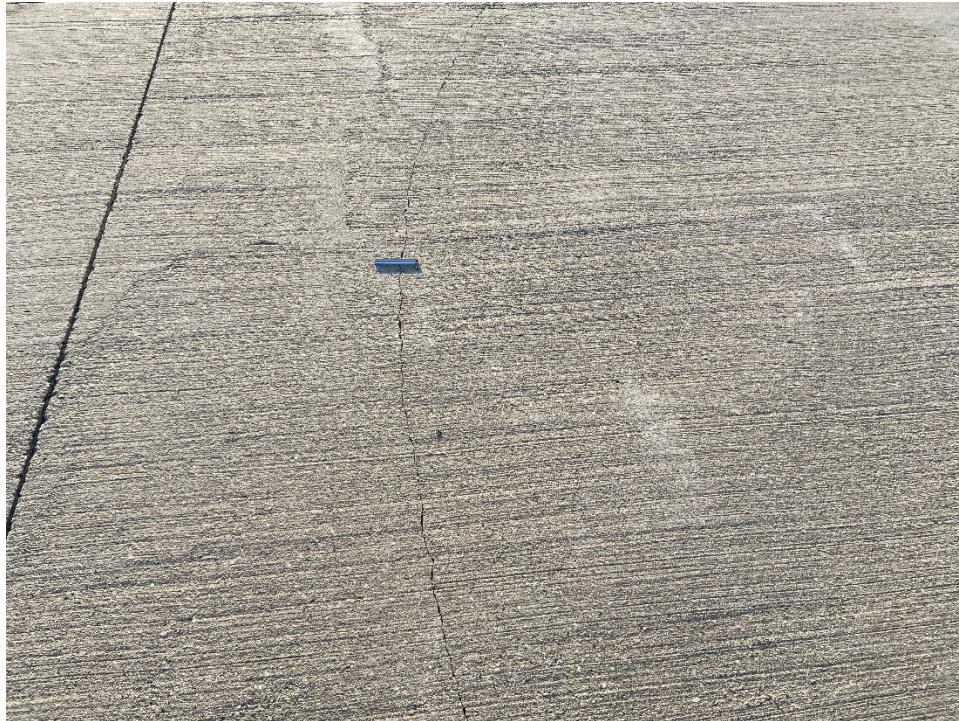
TH01MO-01. LTD Cracking (Sample Unit No. 03).

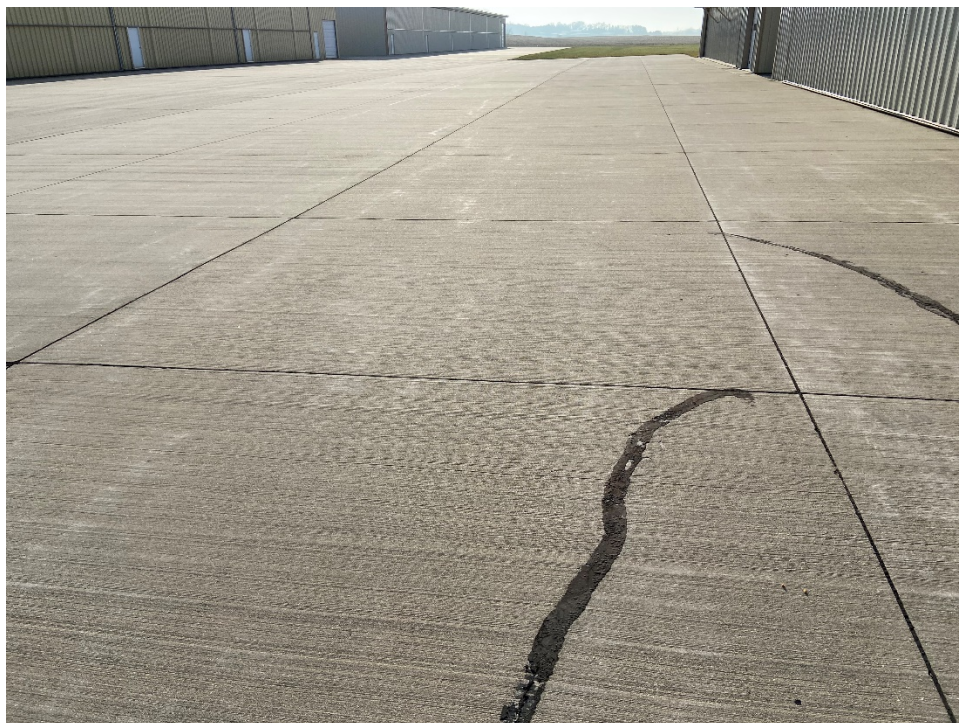
TH01MO-02. Overview.

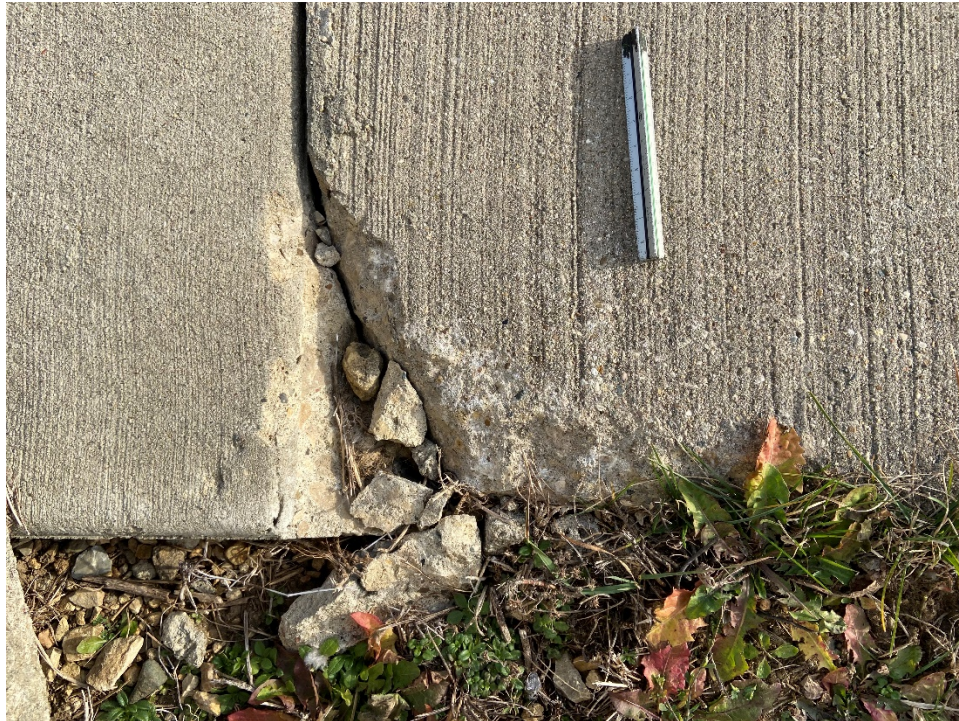
TH01MO-02. Corner Spalling (Sample Unit No. 04).

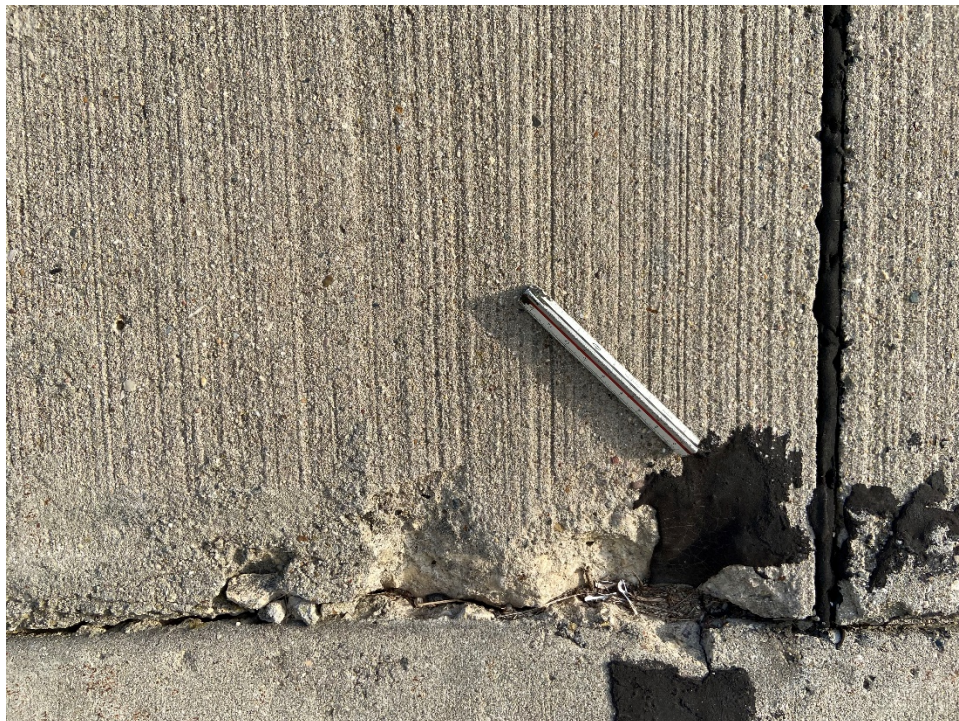
TH01MO-02. Joint Spalling (Sample Unit No. 03).

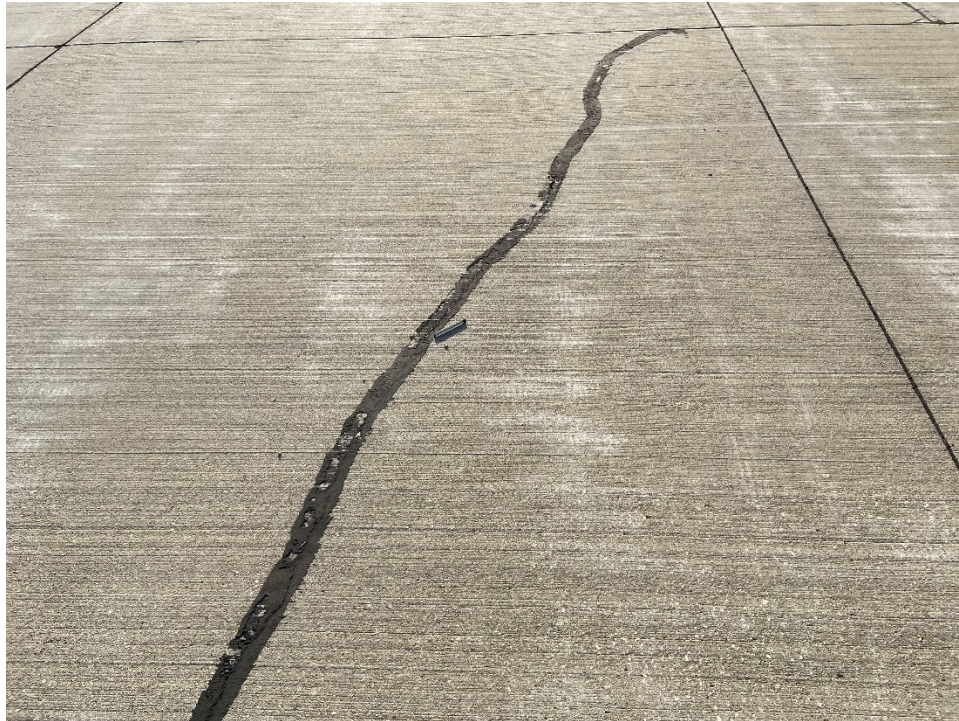
TH01MO-02. LTD Cracking (Sample Unit No. 01).

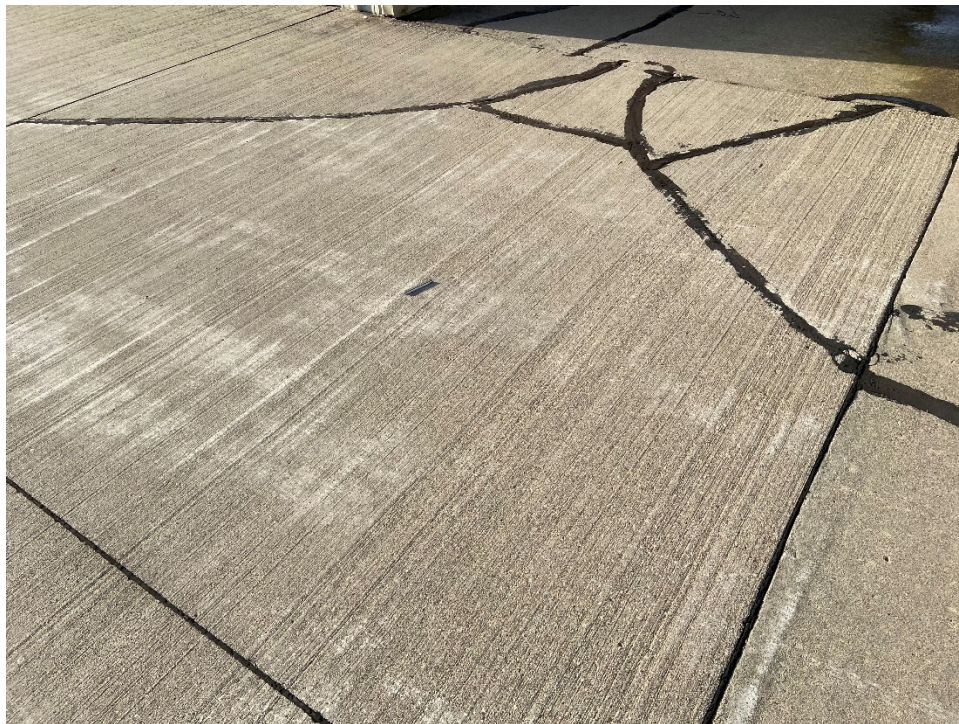
TH01MO-02. Shattered Slab (Sample Unit No. 01).

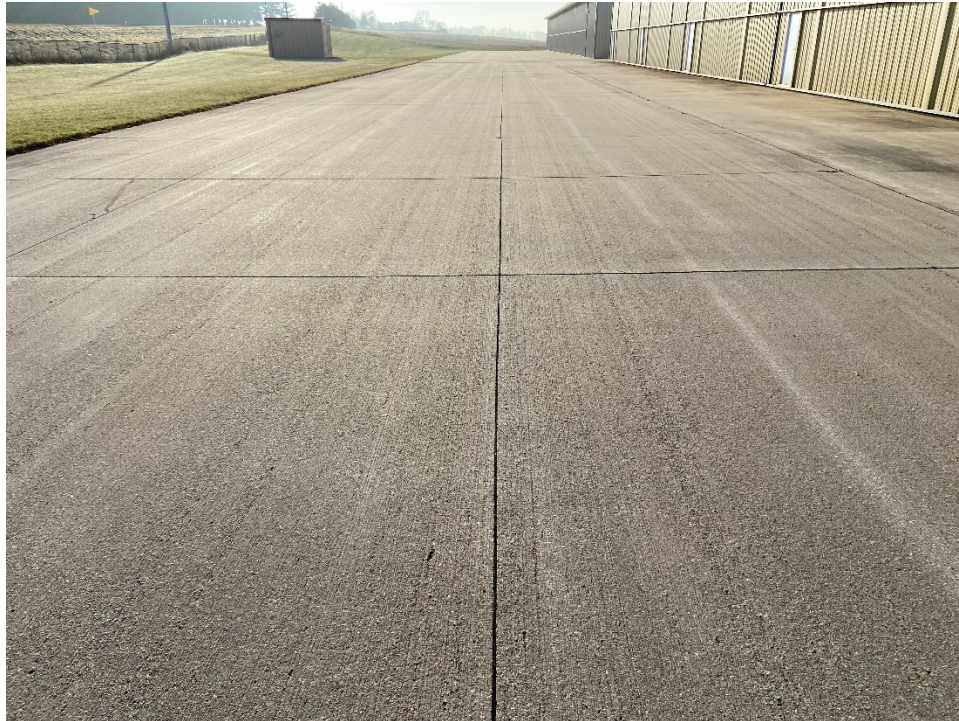
TH01MO-03. Overview.

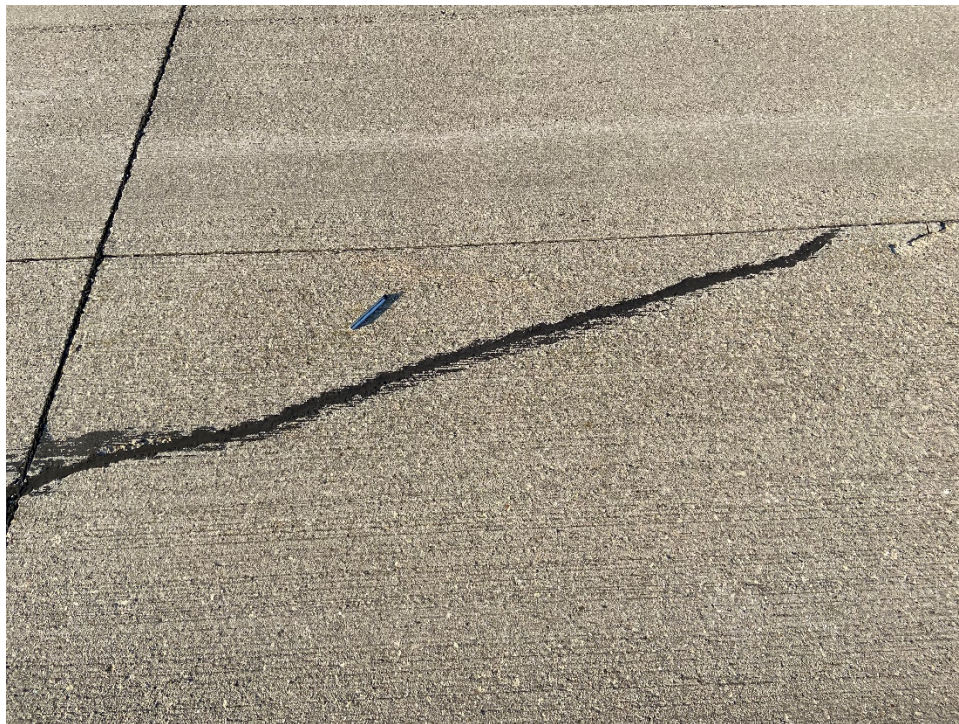
TH01MO-03. Corner Break (Sample Unit No. 04).

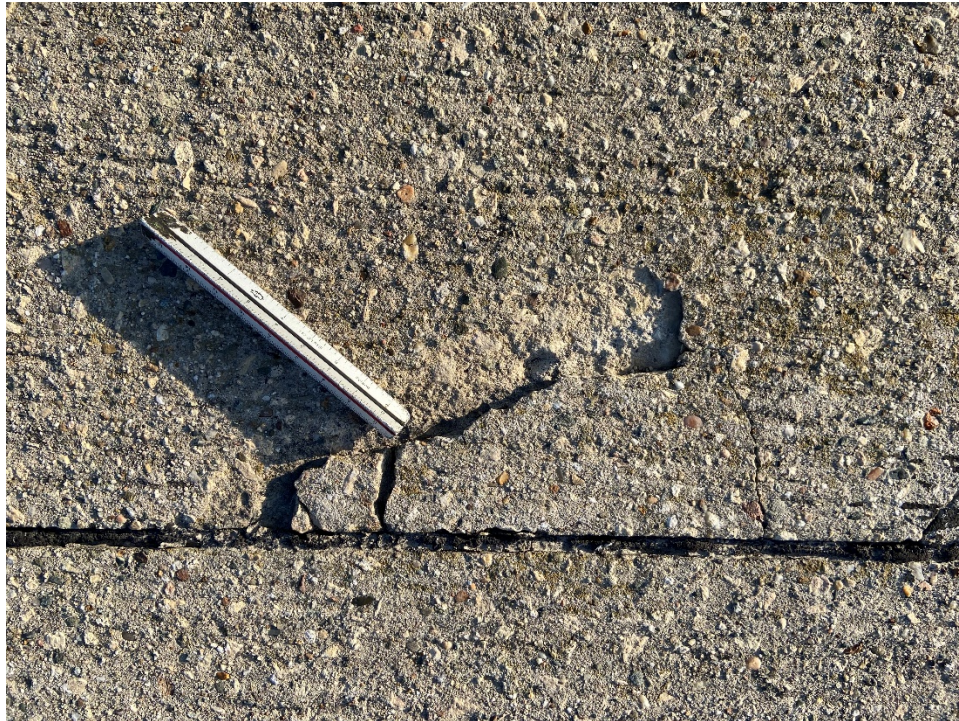
TH01MO-03. Joint Spalling (Sample Unit No. 04).

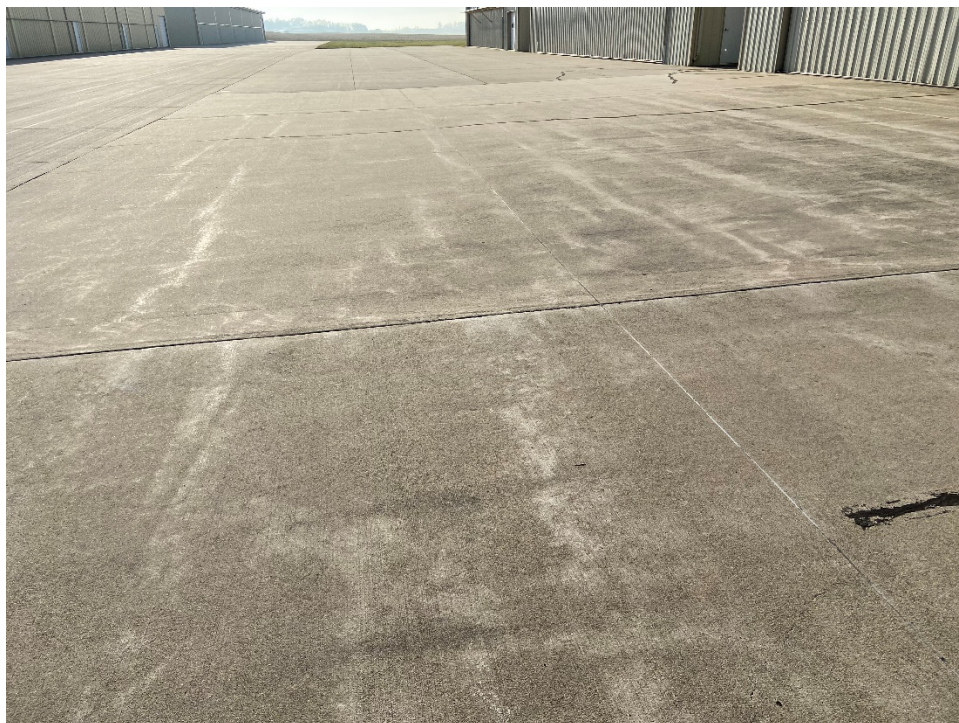
TH01MO	04	PCC	3,974	8/1/2003	51	82	18	0	Corner Break, Joint Seal Damage, LTD Cracking, Shattered Slab
TH01MO	05	PCC	22,633	6/3/2016	98	0	100	0	Joint Seal Damage

TH01MO-04. Overview.

Year	Branch	Section	Surface Type	Type of Repair	Estimated Cost
2021	A01MO	01	PCC	Localized Maintenance	\$67,124
2021	R15MO	01	PCC	Localized Maintenance	\$150,539
2021	T01MO	01	PCC	Localized Maintenance	\$78,675
2021	TH01MO	01	PCC	Localized Maintenance	\$3,572
2021	TH01MO	02	PCC	Localized Maintenance	\$5,393
2021	TH01MO	03	PCC	Localized Maintenance	\$13,533
2021	TH01MO	04	PCC	Major Rehabilitation	\$31,395

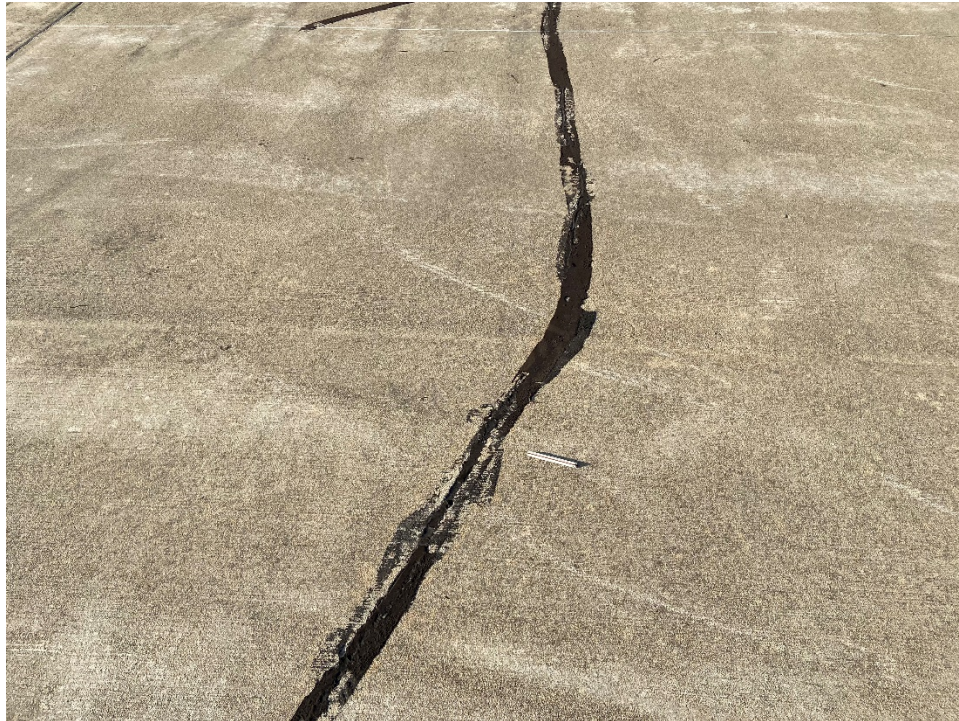
TH01MO-04. LTD Cracking (Sample Unit No. 01).

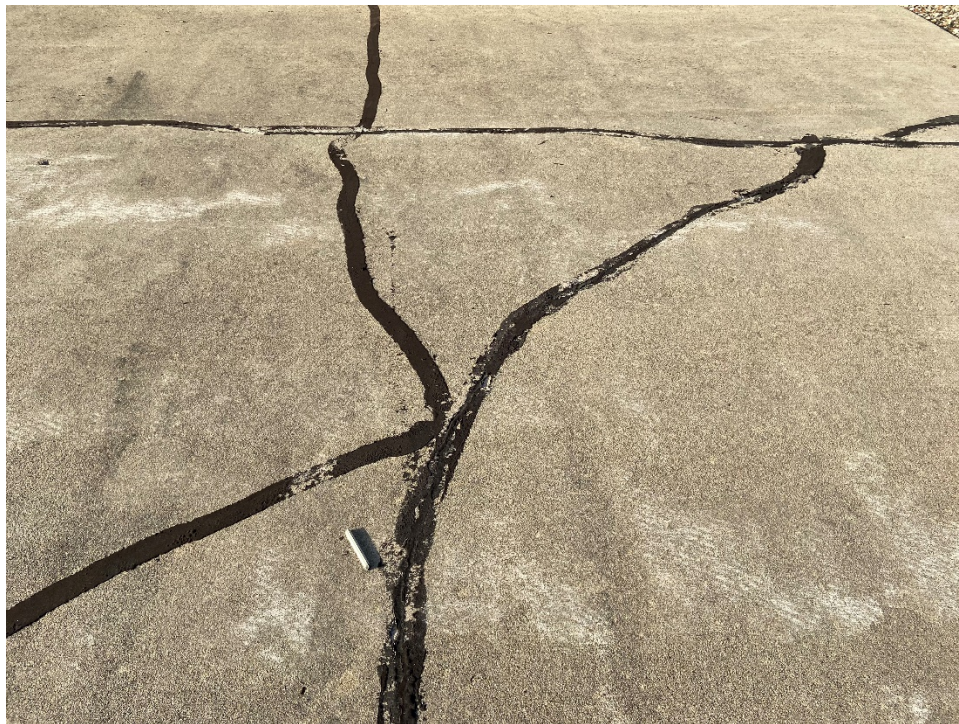
TH01MO-04. Shattered Slab (Sample Unit No. 01).

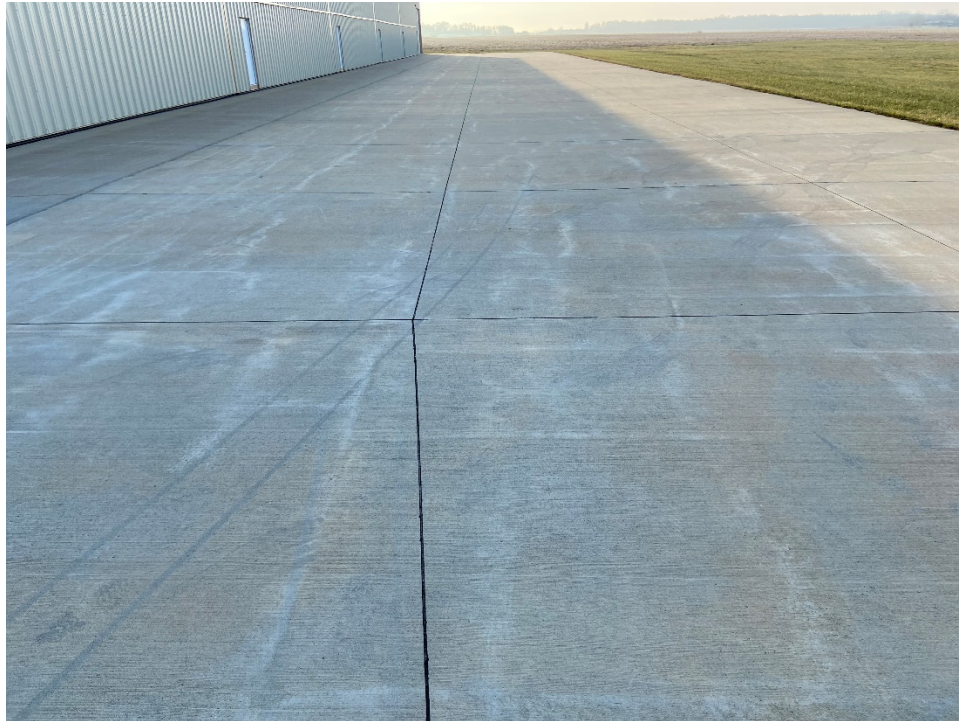
TH01MO-05. Overview.

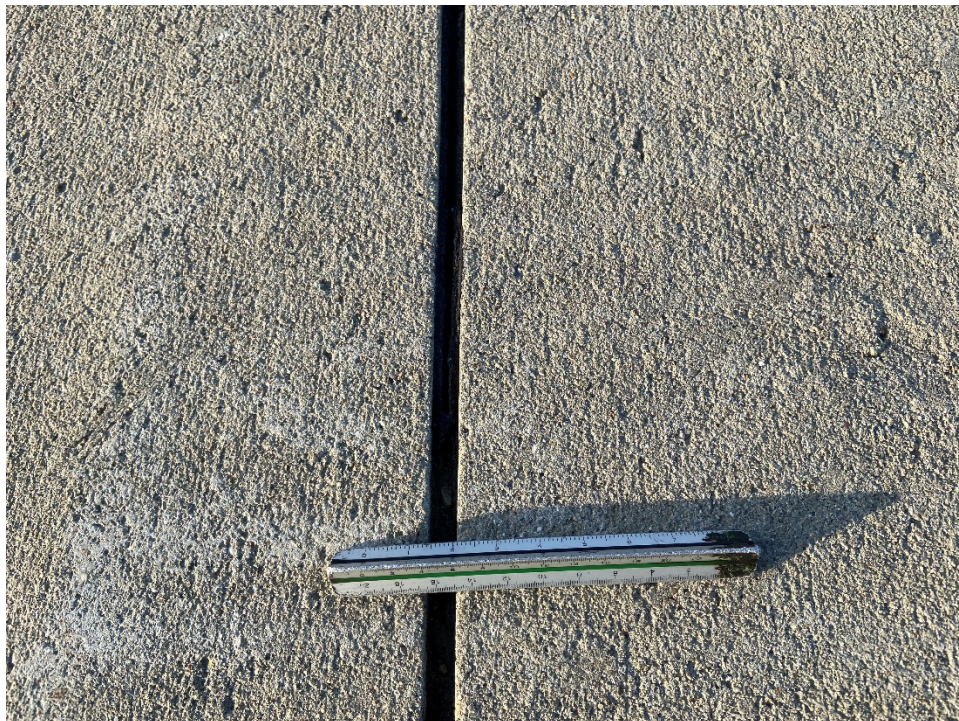
TH01MO-05. Joint Seal Damage (Sample Unit No. 06).
