Monticello Regional Airport

Pavement Management Report

JULY 2024

MONTICELLO REGIONAL AIRPORT PAVEMENT MANAGEMENT REPORT

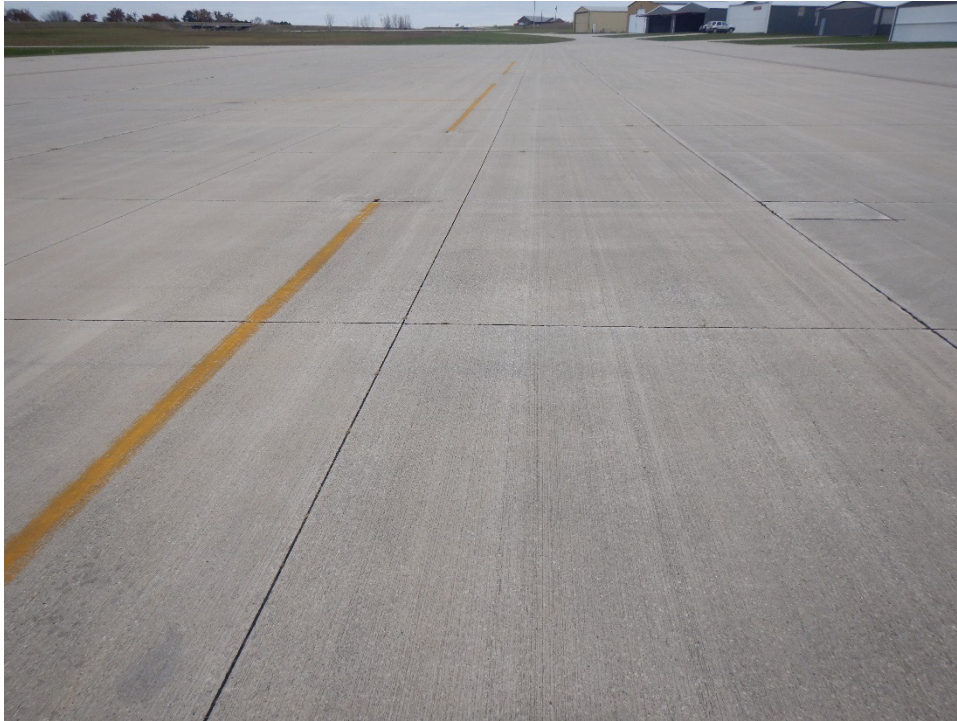
A01MO-01. Overview.

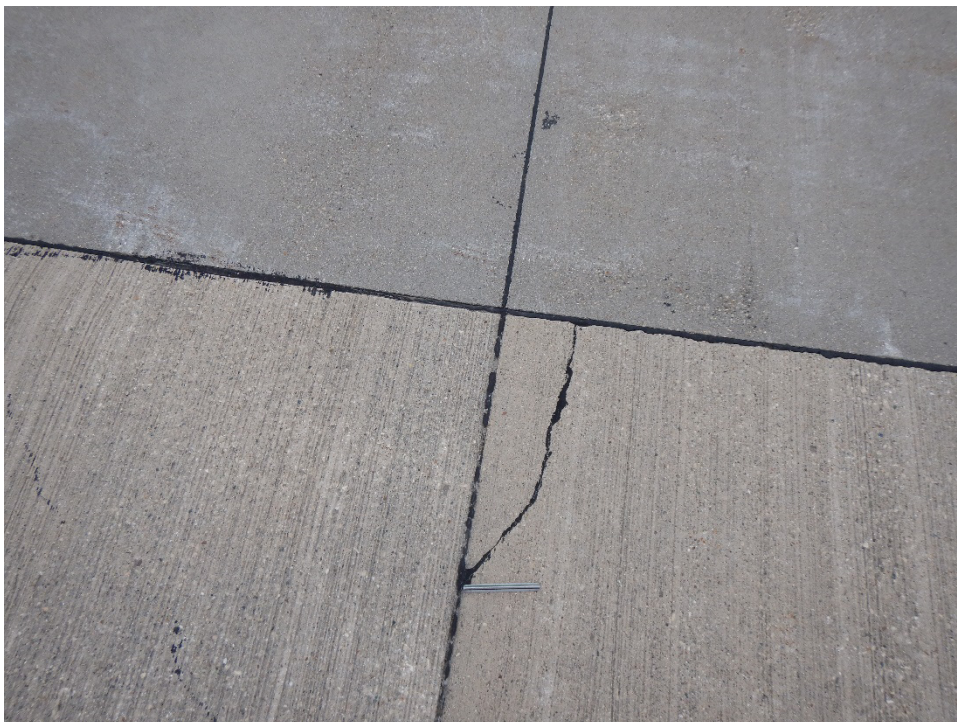
A01MO-01. Joint Spalling (Sample Unit No. 32).

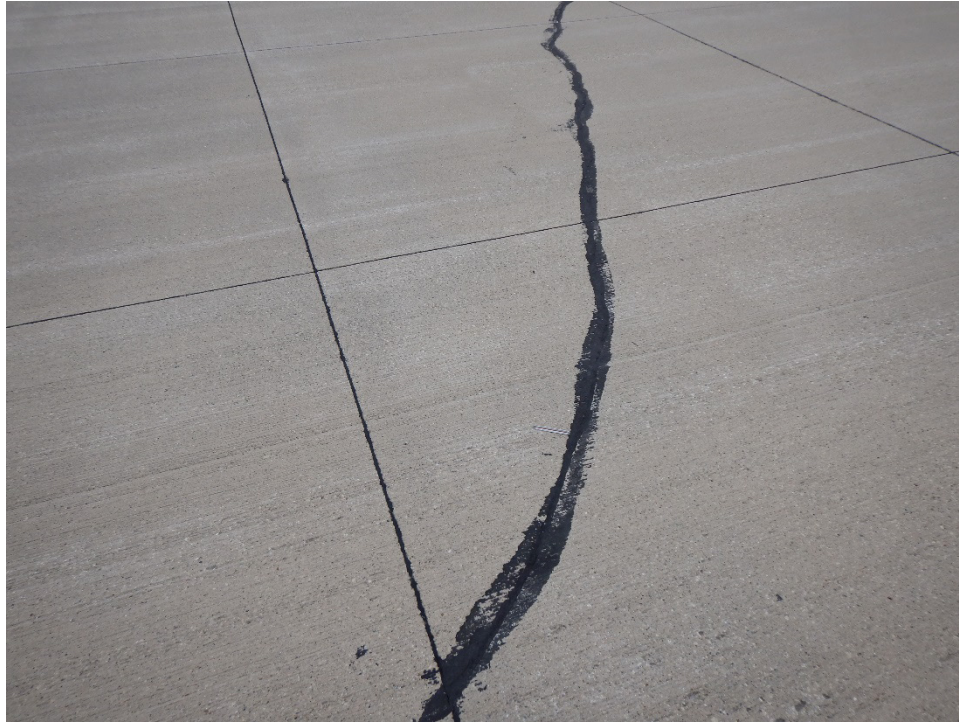
A01MO-01. LTD Cracking (Sample Unit No. 16).

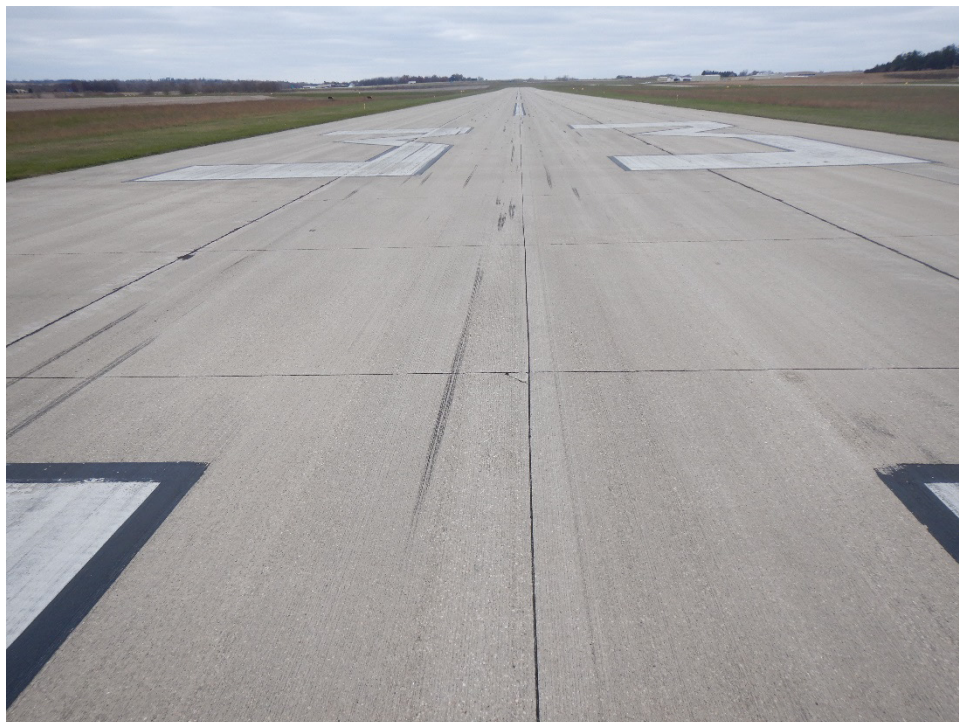
R15MO-01. Overview (1).

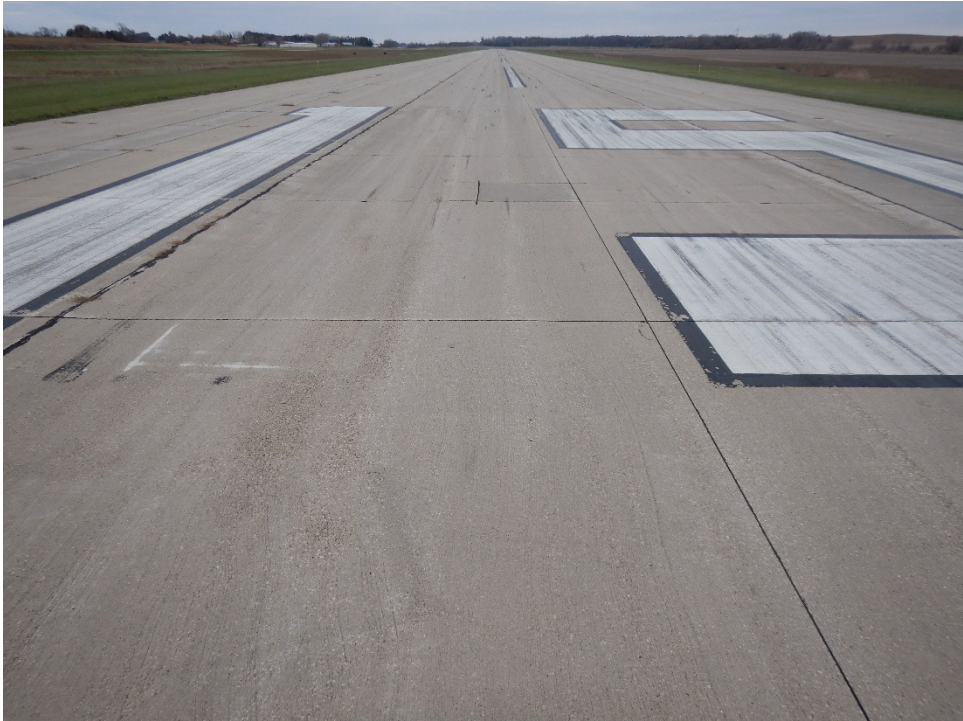
R15MO-01. Overview (2).

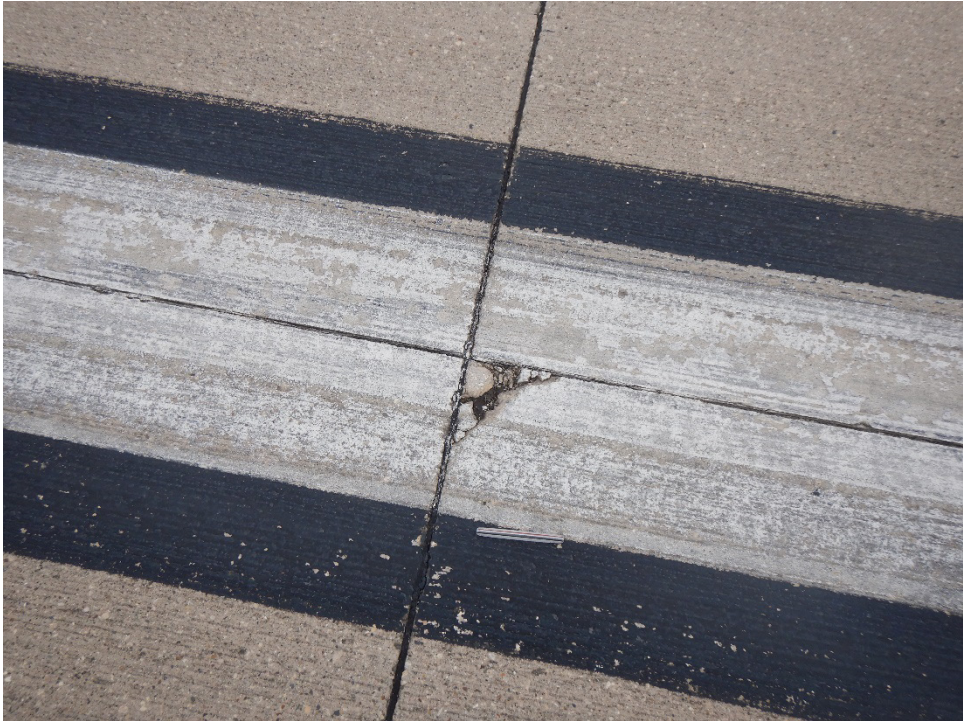
R15MO-01. Corner Spalling (Sample Unit No. 25).

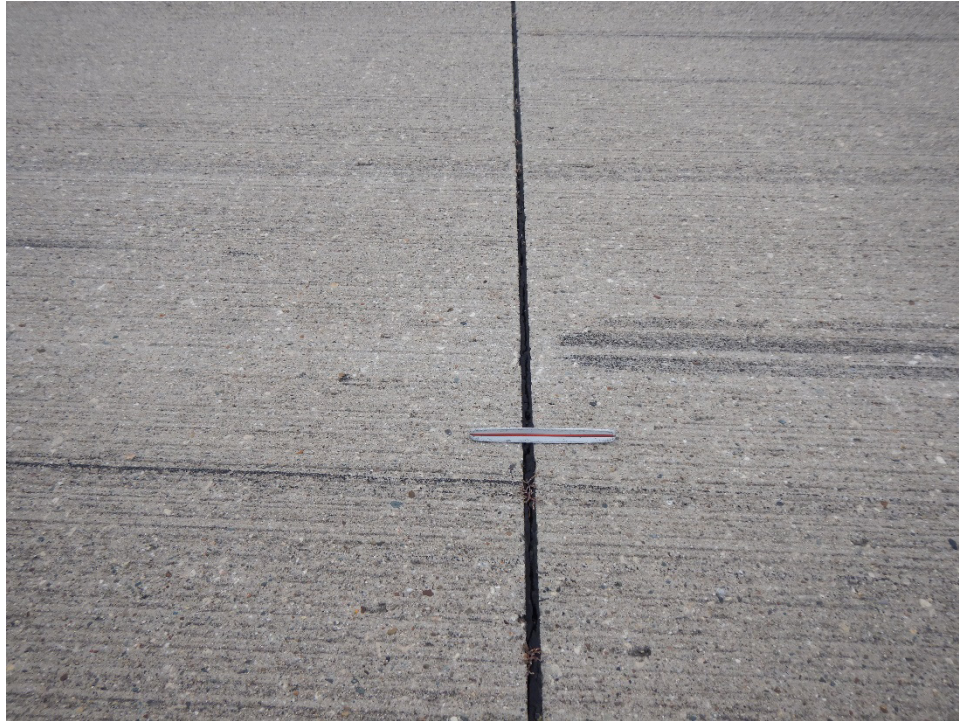
R15MO-01. Joint Seal Damage (Sample Unit No. 75).

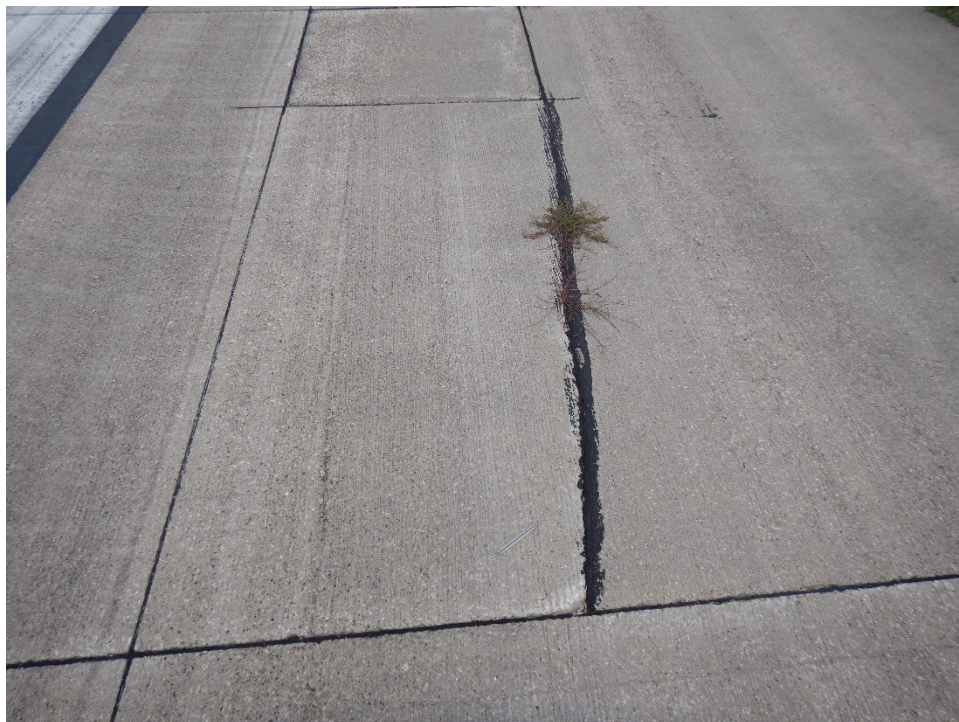
R15MO-01. LTD Cracking (Sample Unit No. 05).

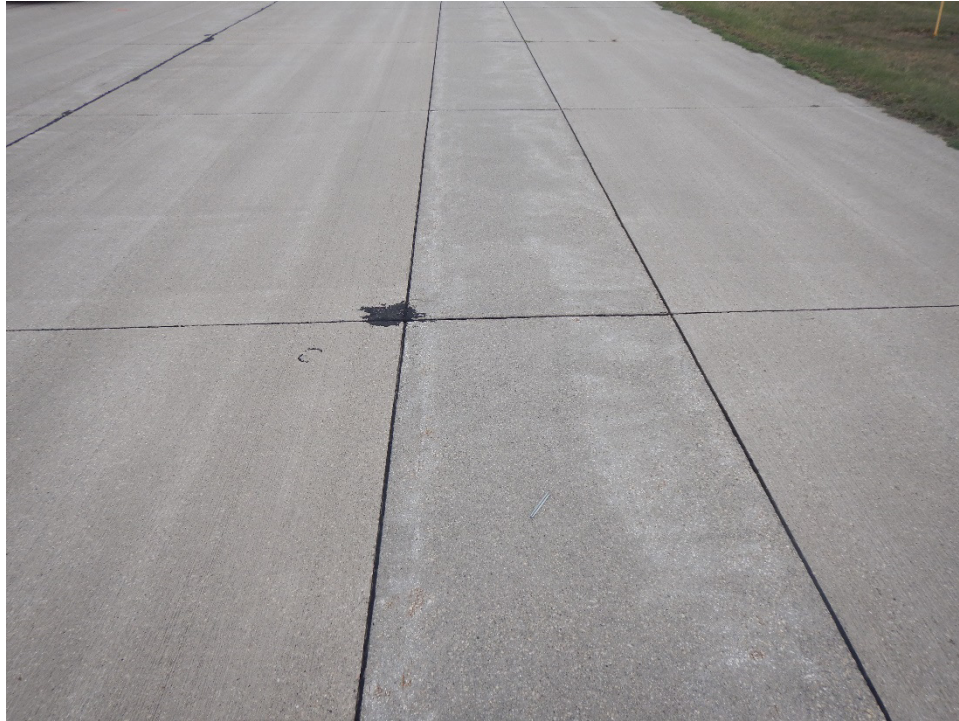
R15MO-01. Large Patching (Sample Unit No. 55).

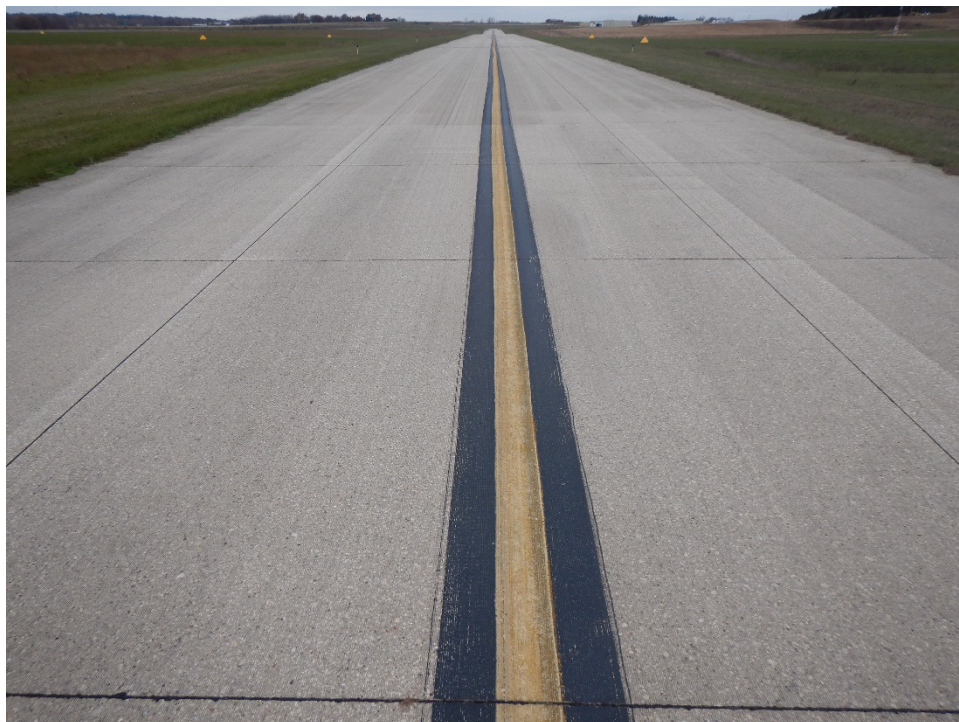
T01MO-01. Overview.

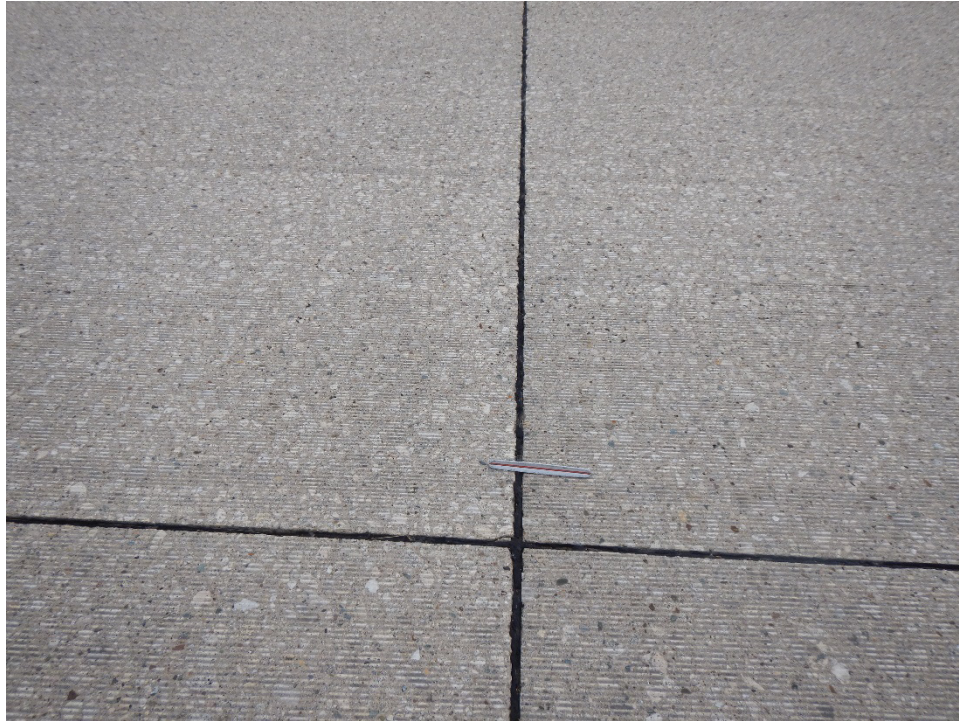
T01MO-01. Joint Seal Damage (Sample Unit No. 13).

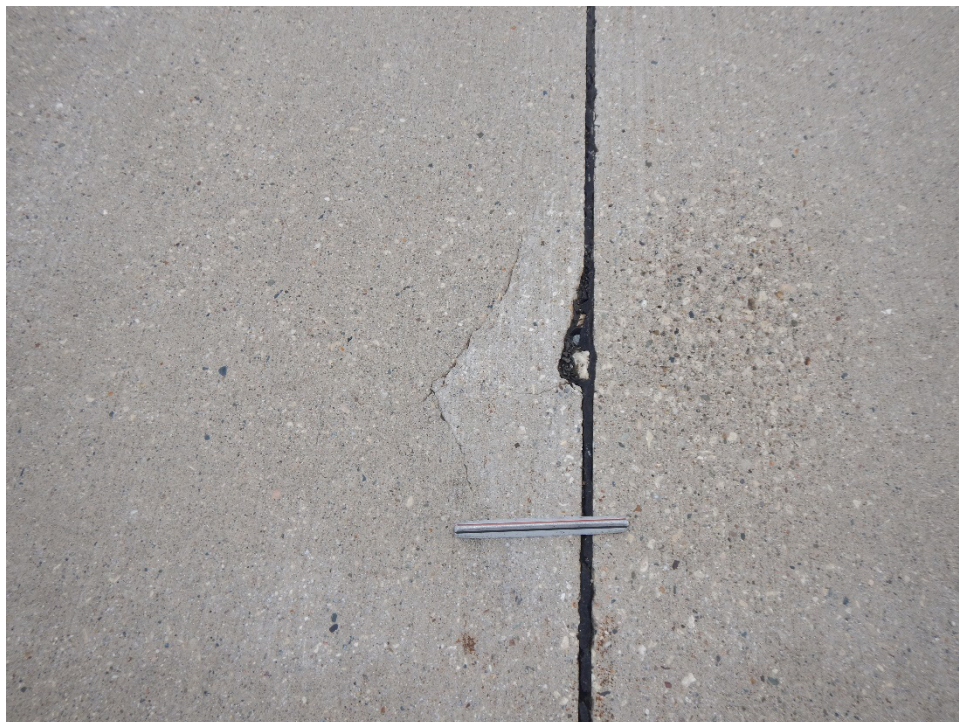
T01MO-01. Joint Spalling (Sample Unit No. 33).

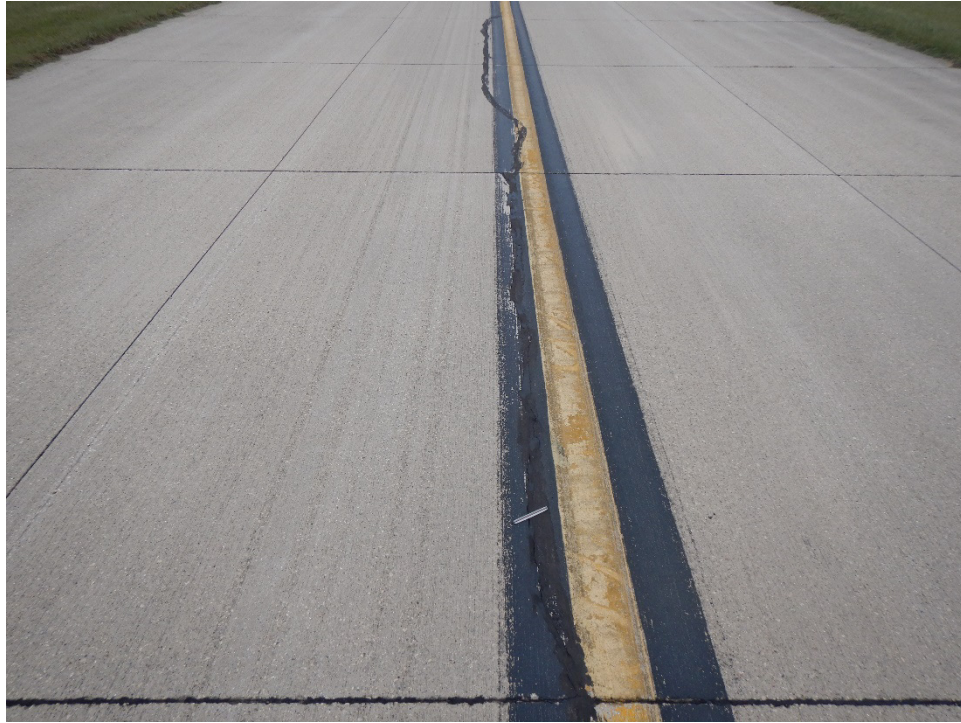
T01MO-01. LTD Cracking (Sample Unit No. 48).

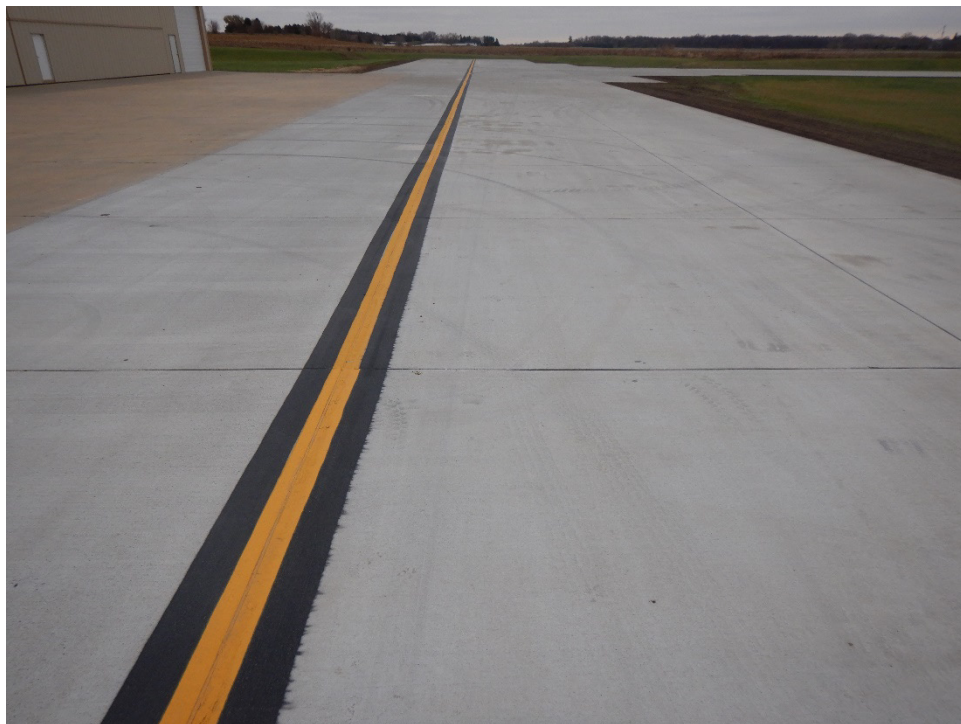
T01MO-02. Overview (1).

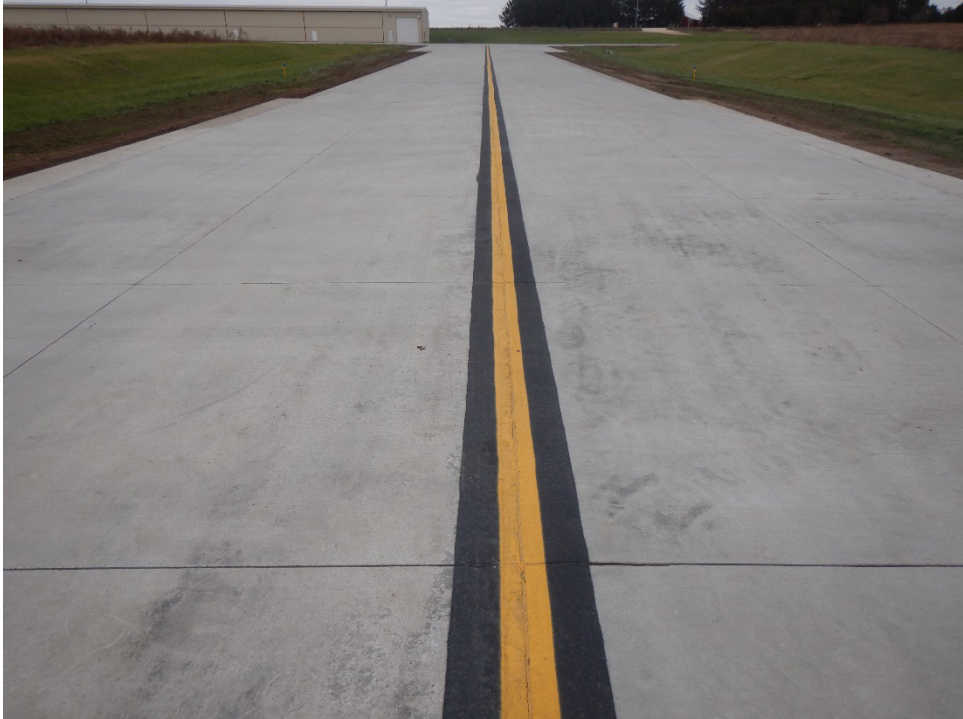
T01MO-02. Overview (2).

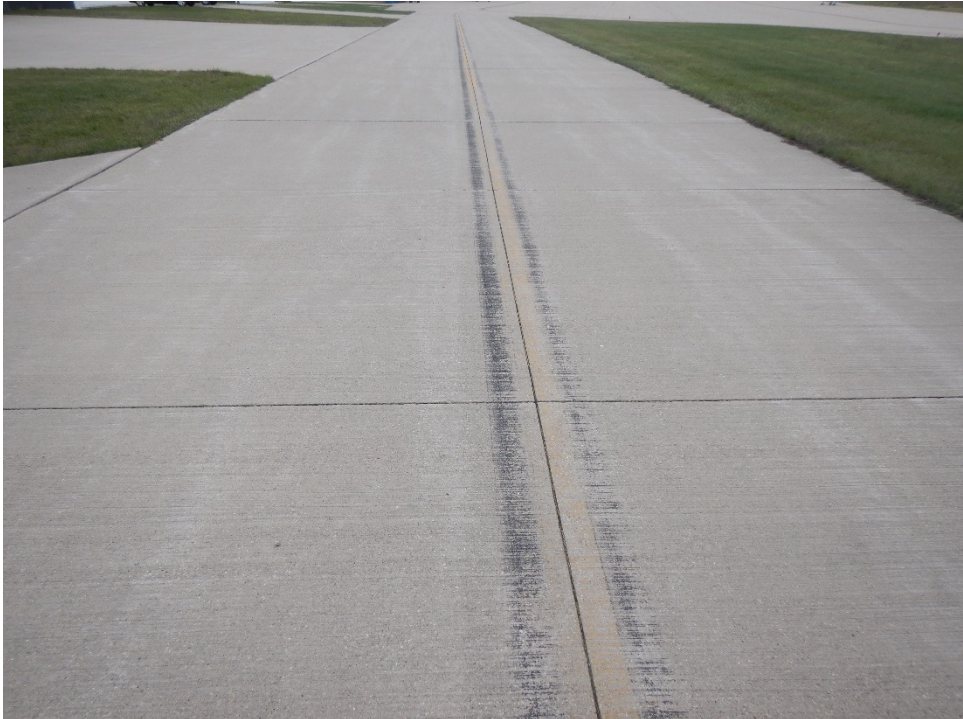
TH01MO-01. Overview.

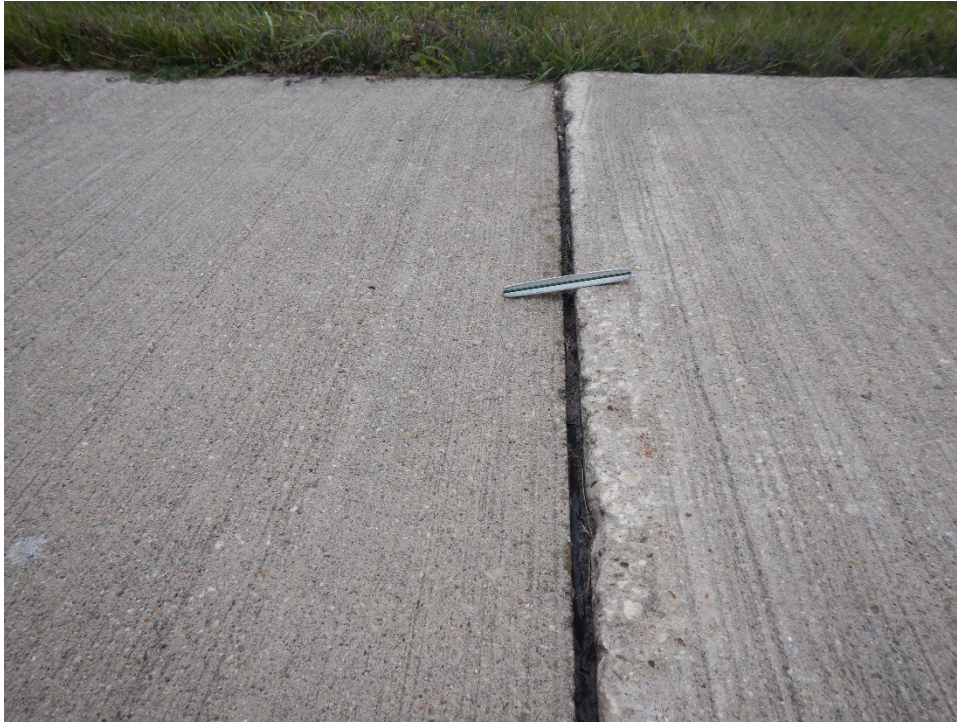
TH01MO-01. Faulting (Sample Unit No. 02).

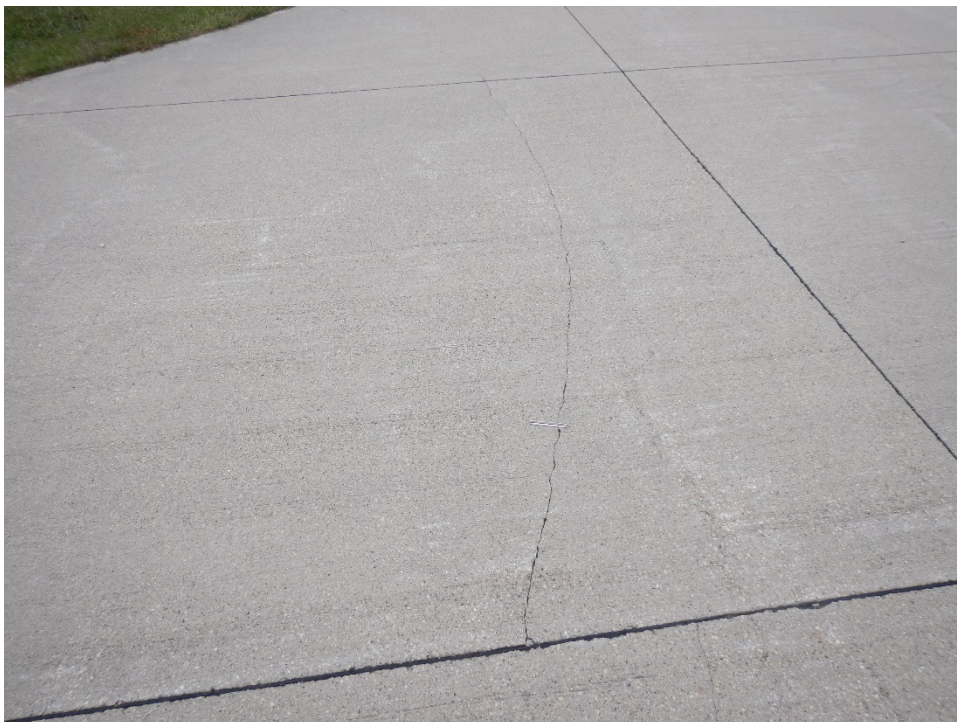
TH01MO-01. LTD Cracking (Sample Unit No. 03).

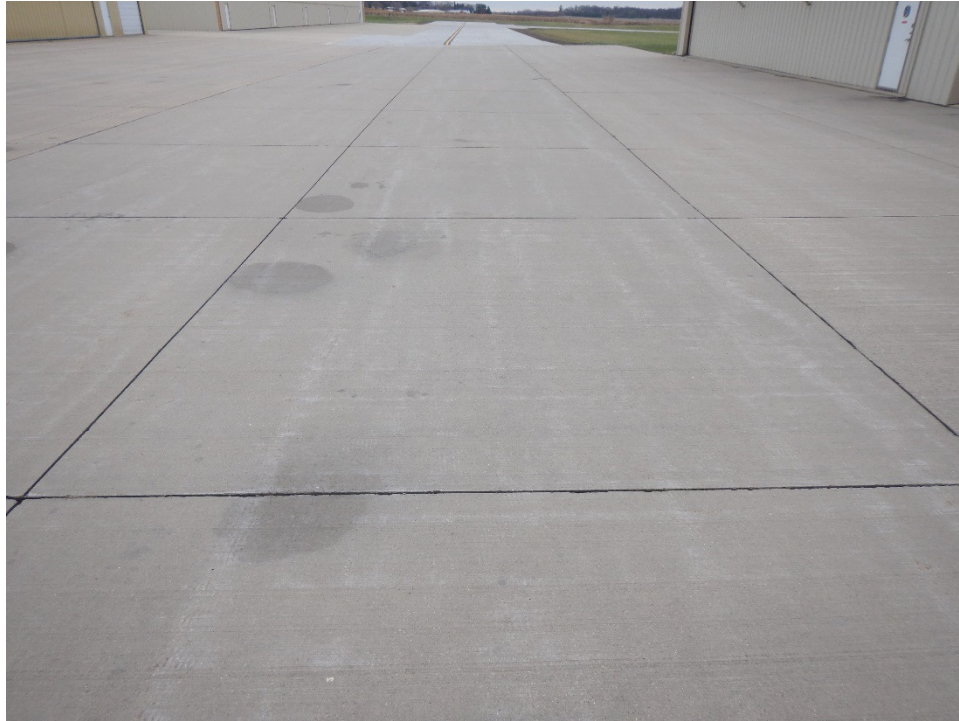
TH01MO-02. Overview.

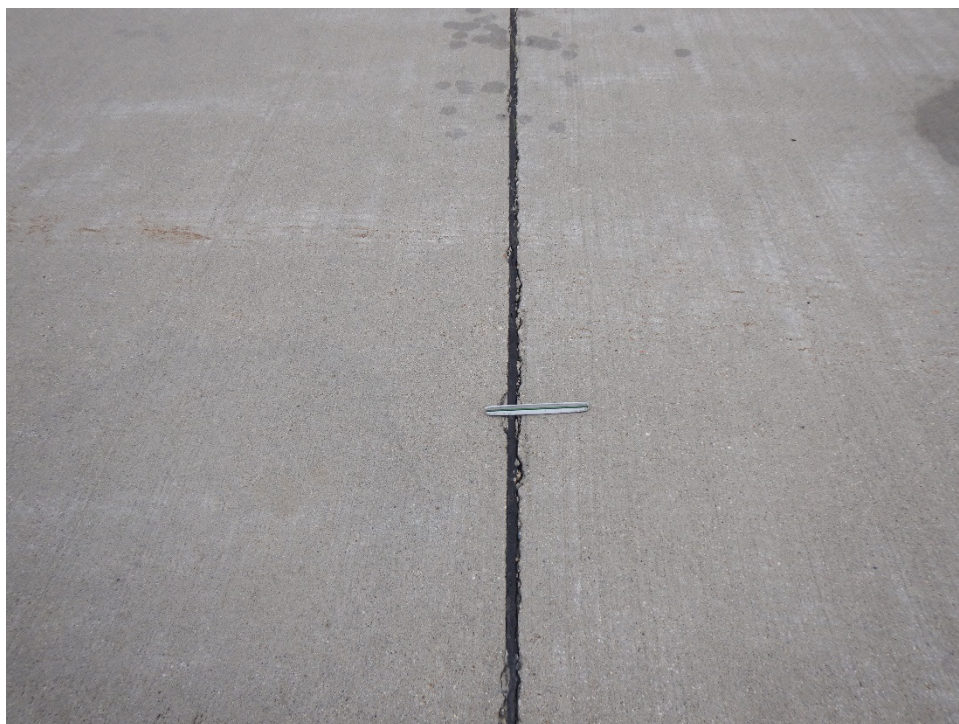
TH01MO-02. Joint Seal Damage (Sample Unit No. 02).

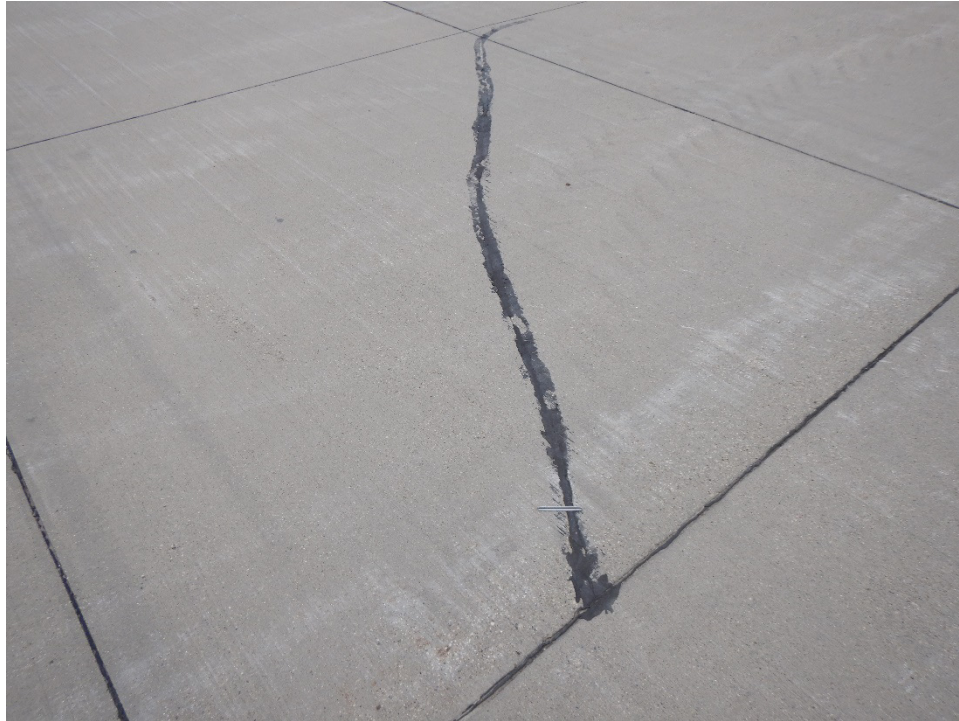
TH01MO-02. LTD Cracking (Sample Unit No. 04).

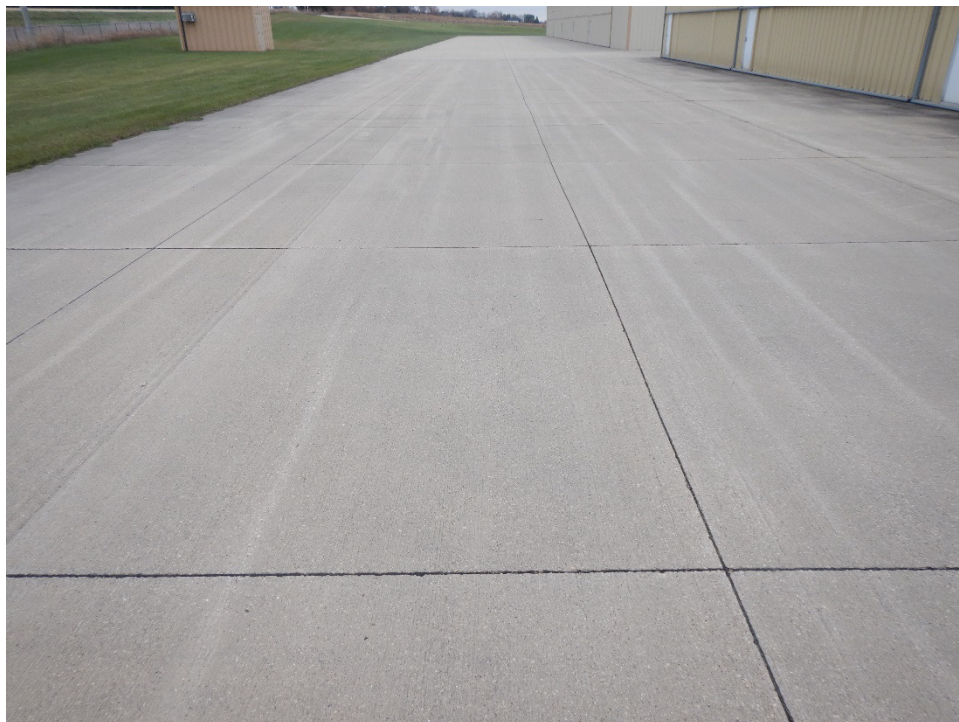
TH01MO-03. Overview.

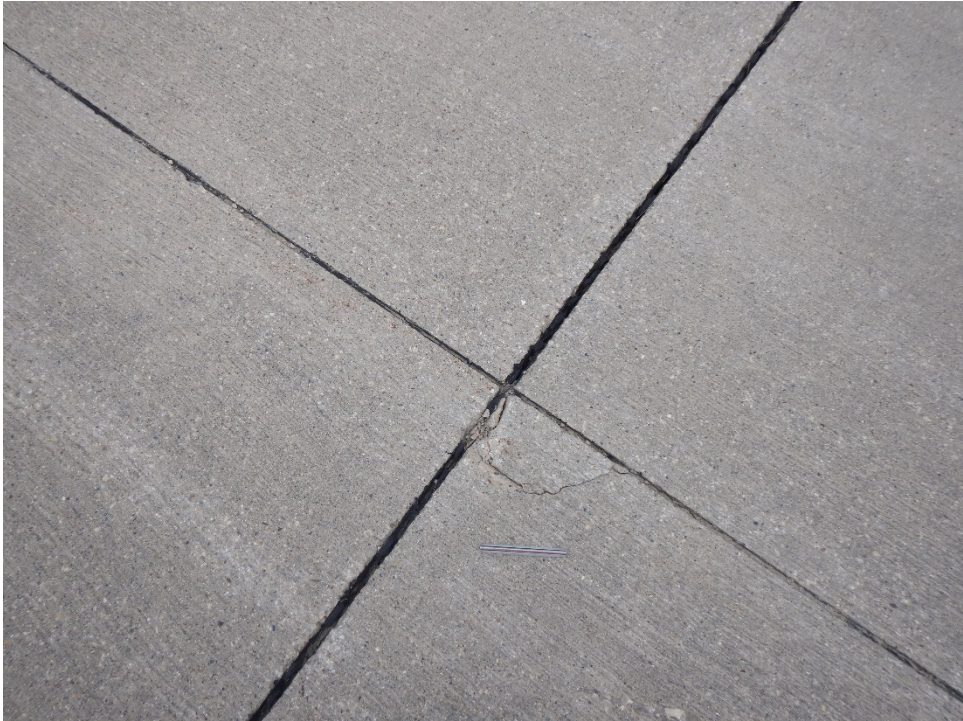
TH01MO-03. Corner Spalling (Sample Unit No. 08).

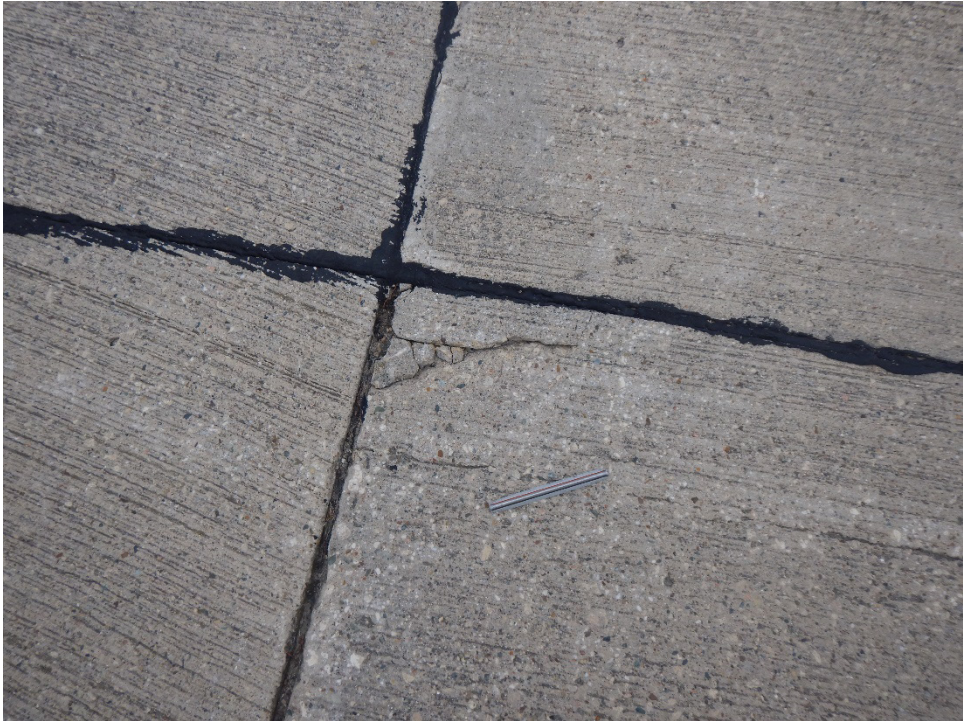
TH01MO-03. Joint Spalling (Sample Unit No. 02).

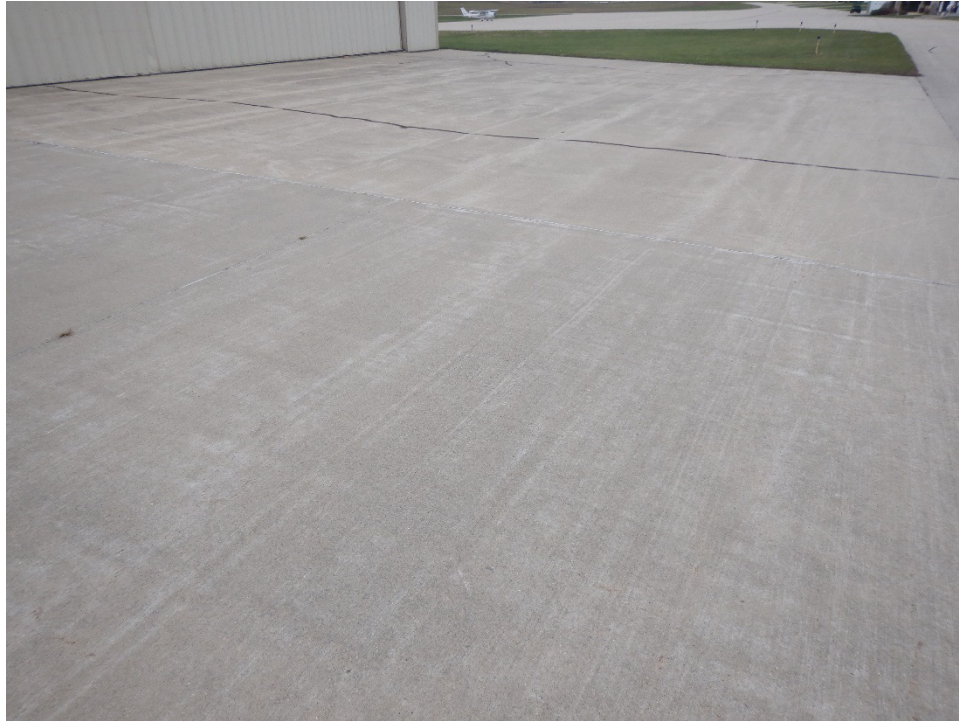
TH01MO-04. Overview.

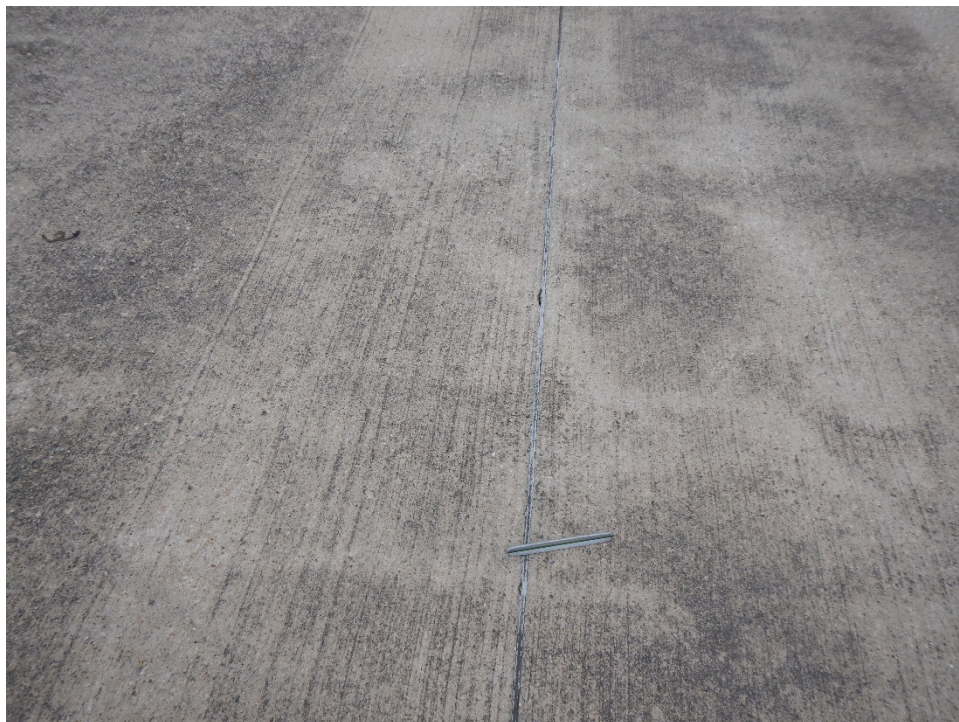
TH01MO-04. Joint Seal Damage (Sample Unit No. 01).

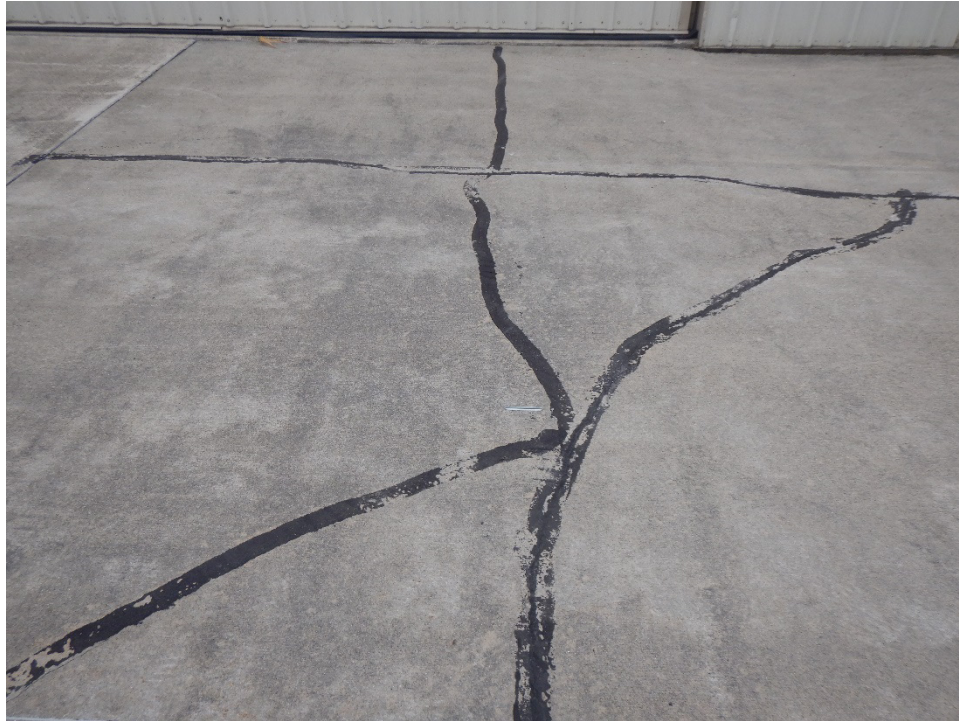
TH01MO-04. Shattered Slab (Sample Unit No. 01).

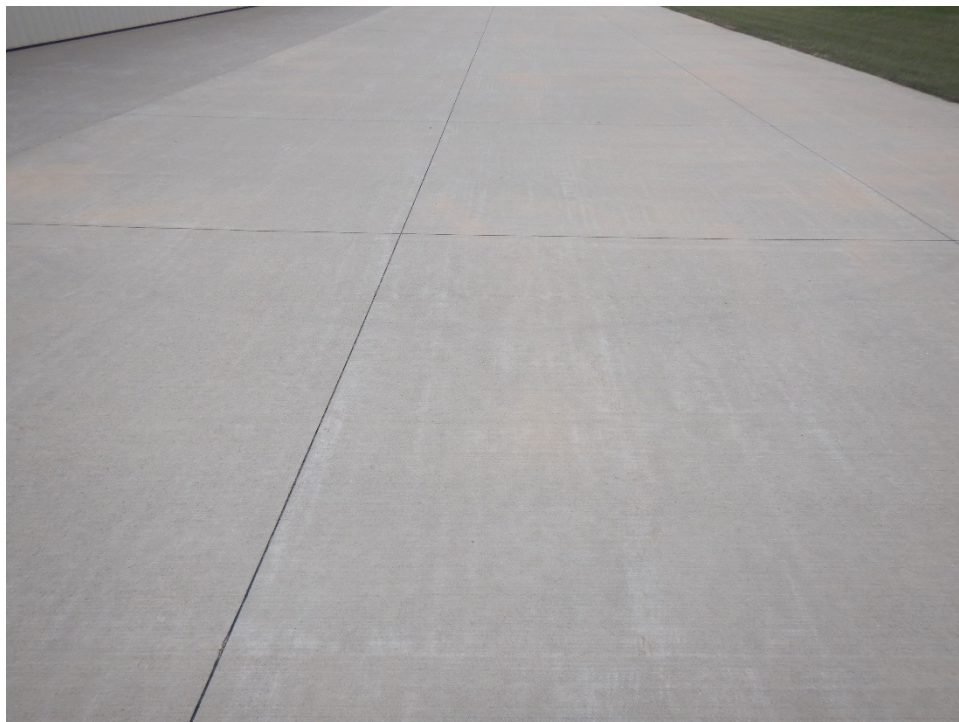
TH01MO-05. Overview.

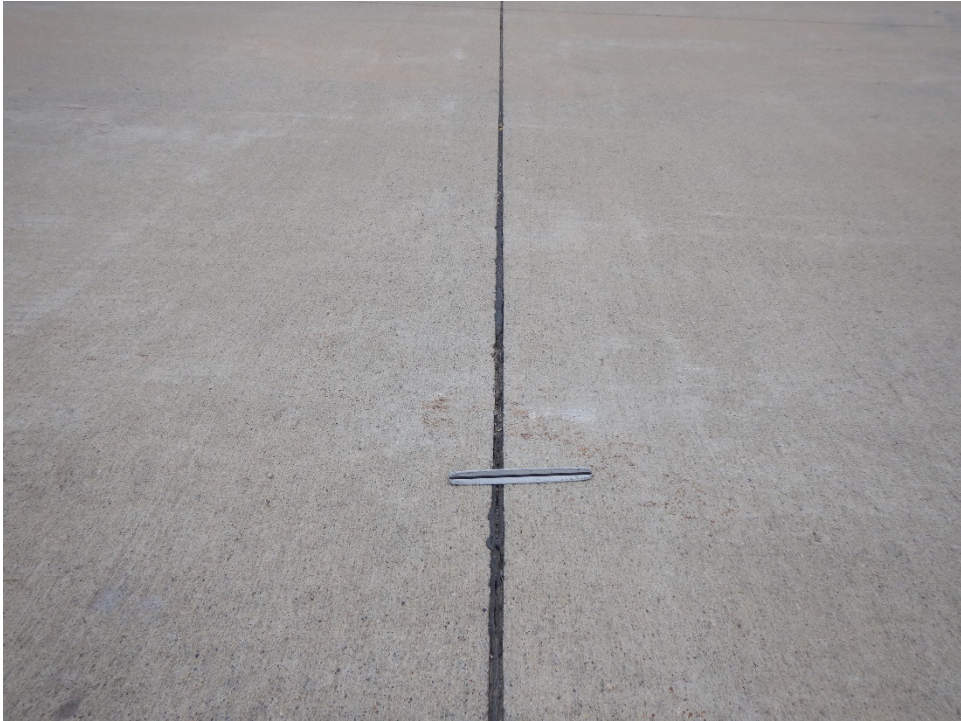
TH01MO-05. Joint Seal Damage (Sample Unit No. 06).
